**FAILURE OF THICK, LOW DENSITY AIR PLASMA SPRAYED THERMAL  
BARRIER COATINGS**

**Michael Aaron Helminiak**

Submitted to the Graduate Faculty of  
Swanson School of Engineering in partial fulfillment  
of the requirements for the degree of  
Doctorate of Philosophy

University of Pittsburgh

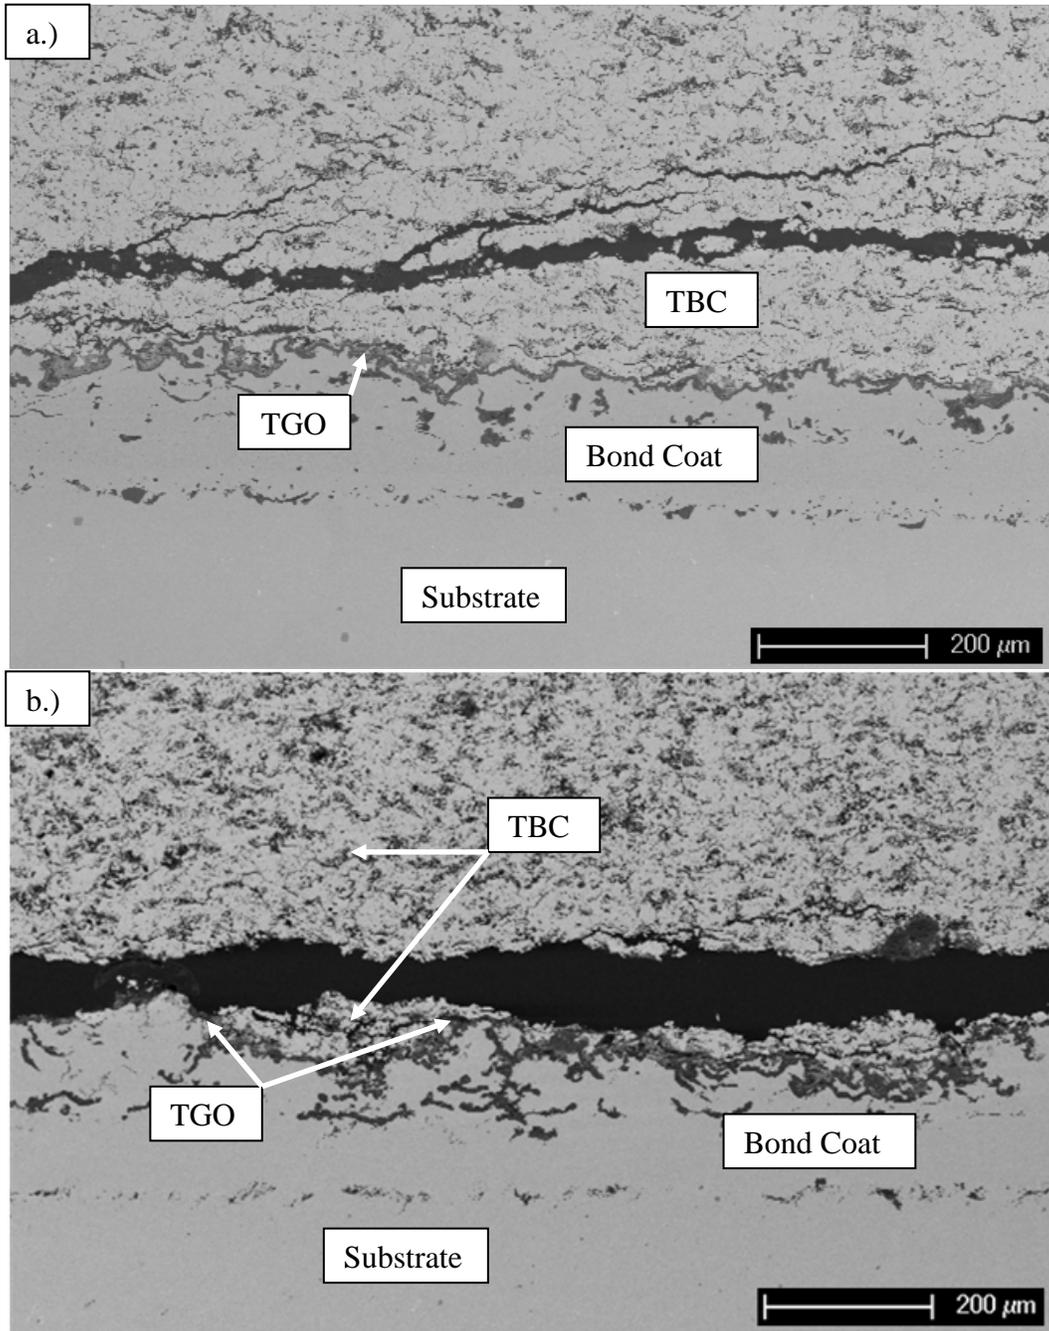
**Figure 13 - Cross-sectional micrographs of failures of a) 1.1mm and b) 0.75mm TBC failures. The TBC in a) failed after 20 thermal cycles and b) failed after 140 thermal cycles in a bottom-loading furnace. Note the location of the failure in both micrographs: a) failure occurs within the TBC and b) at the TBC/TGO interface.**

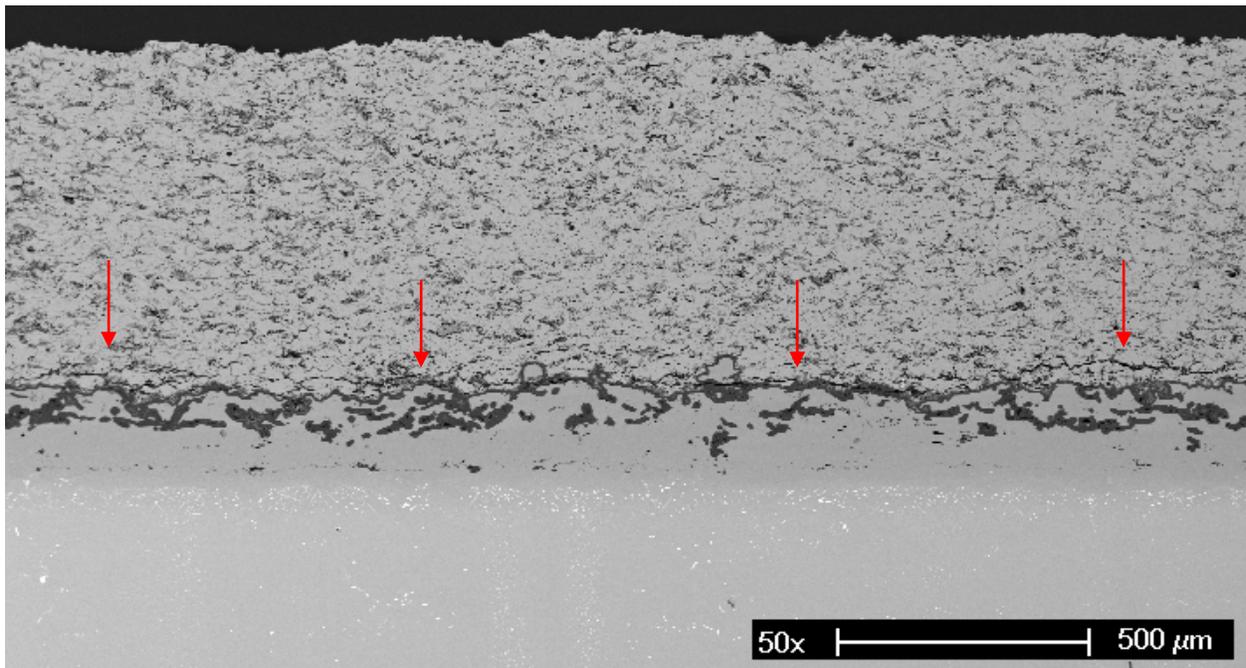
**Figure 71 – 750  $\mu\text{m}$  coating with 440 cycles until a technical failure occurred. This micrograph was taken in the interior of the specimen as indicated by the black box in Figure 65.**

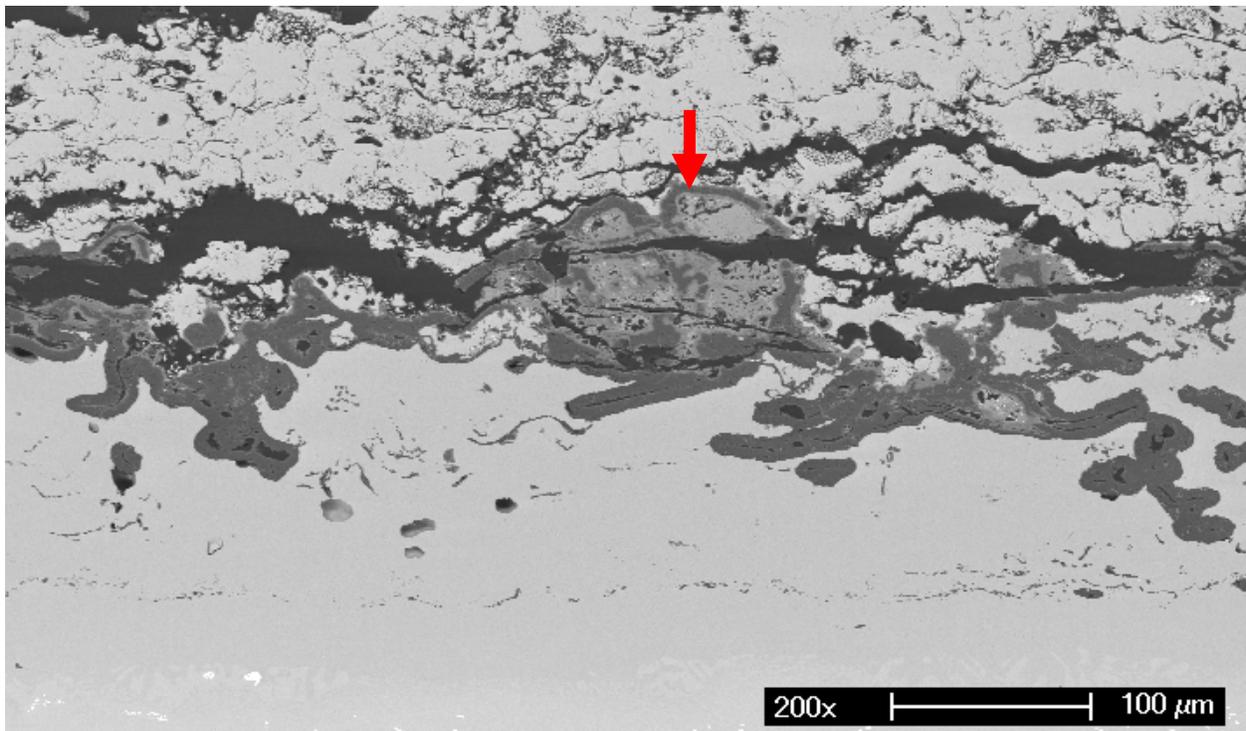
**Figure 73 - 100  $\mu\text{m}$  topcoat after 830 cycles at 1100°C. The white arrow points out areas in the outer portion of the dual layer bond coat that experienced chemical failure.**

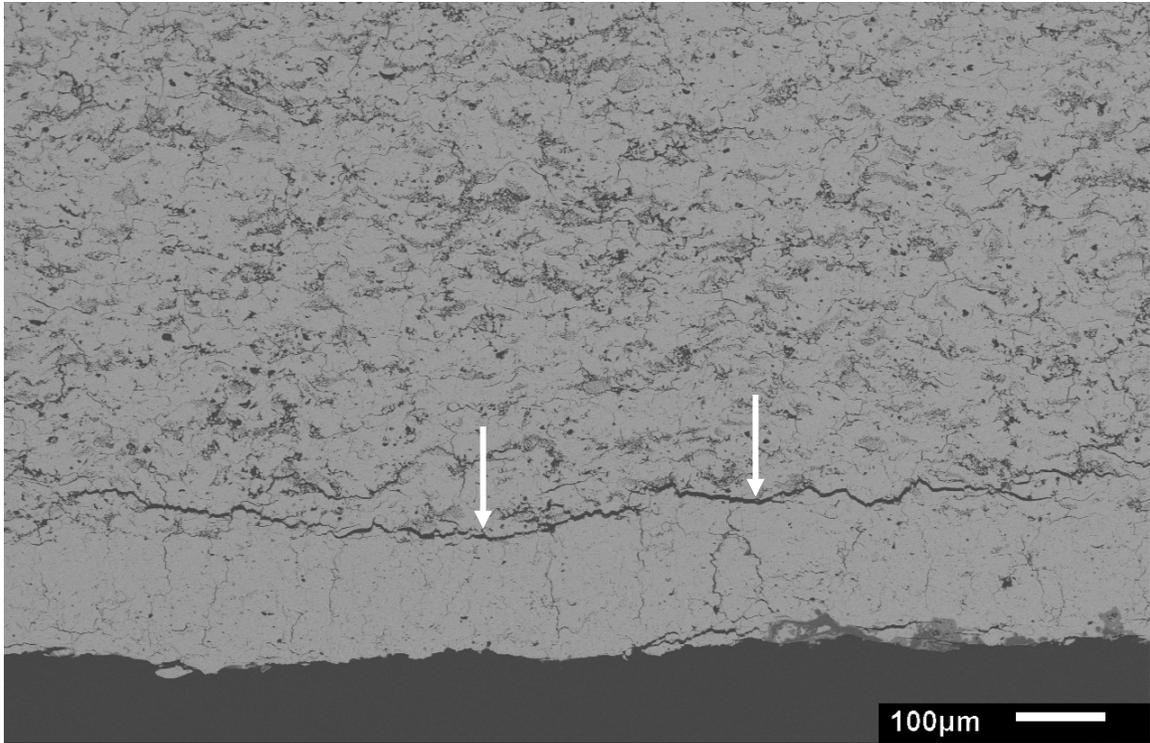
**Figure 89 - Failed dual TBC specimen after 860 cycles. This is only a micrograph of the spalled topcoat.**

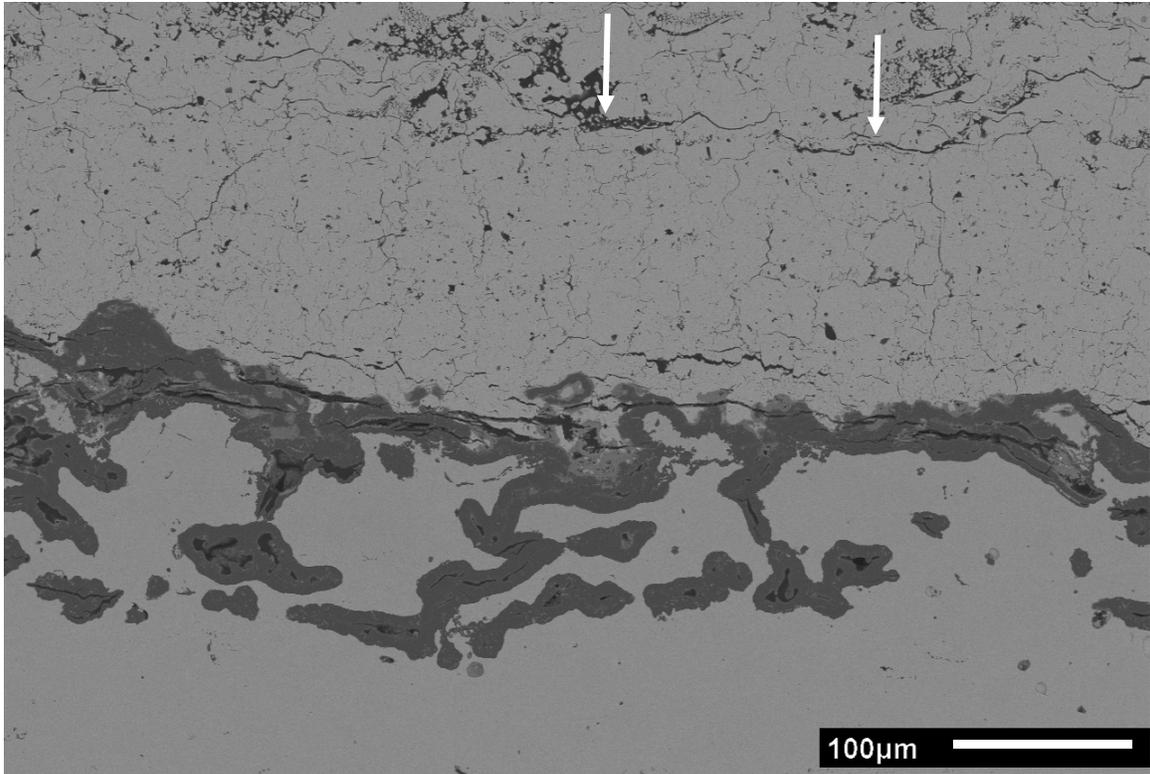
**Figure 90 – Dual TBC specimen which experienced a technical failure after 1020 cycles. Arrows indicate horizontal micro-cracks at the interface between the LD and DVF layers.**

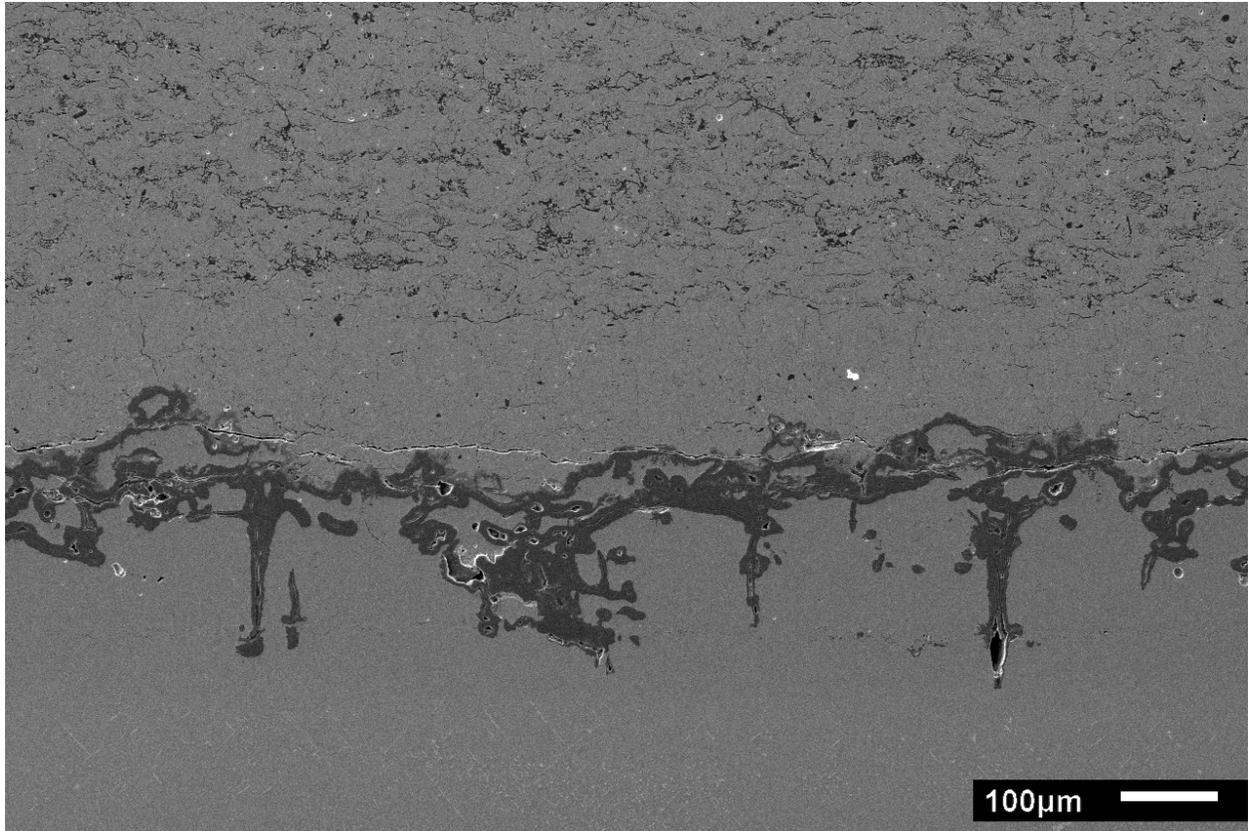
**Figure 91 - Failed dual TBC with 1020 cycles at failure.**

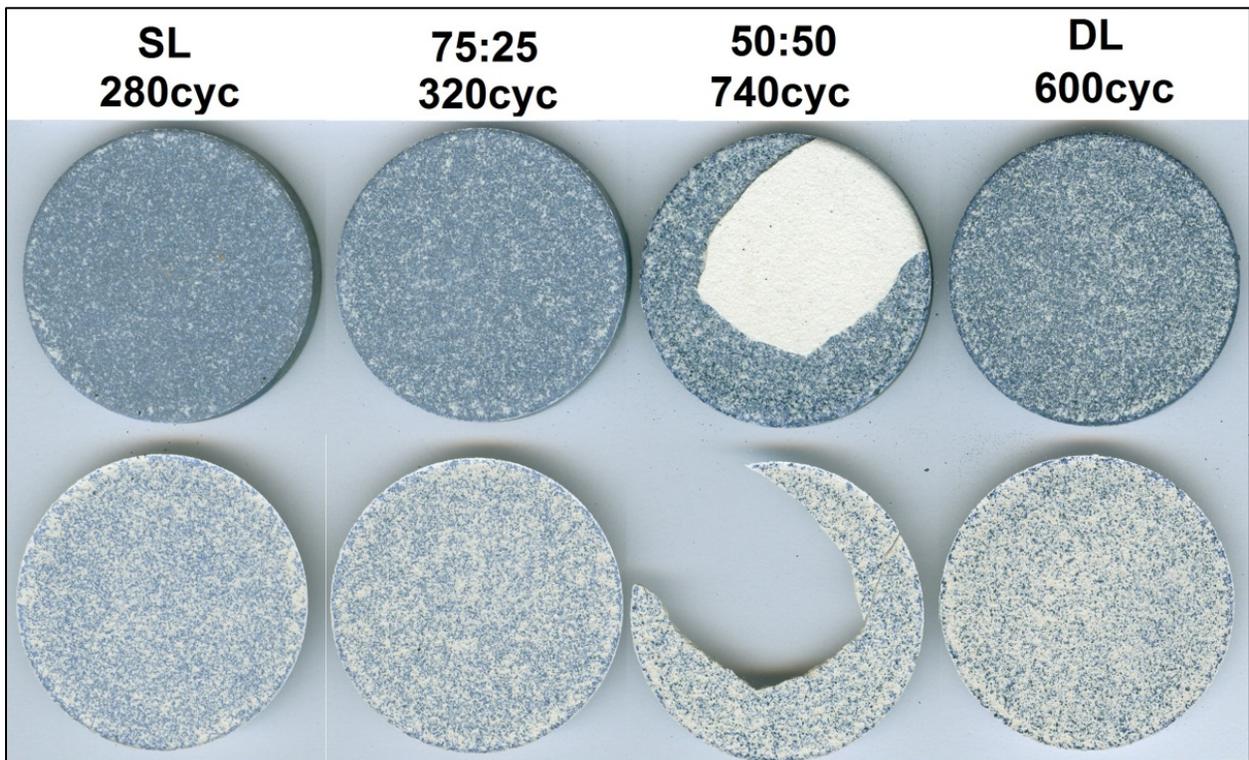
**Figure 117 - High resolution images of fracture surfaces. Top specimen is the bond coat surface and the bottom specimen is the spalled topcoat surface. The white material is YSZ and the blue is the TGO.**

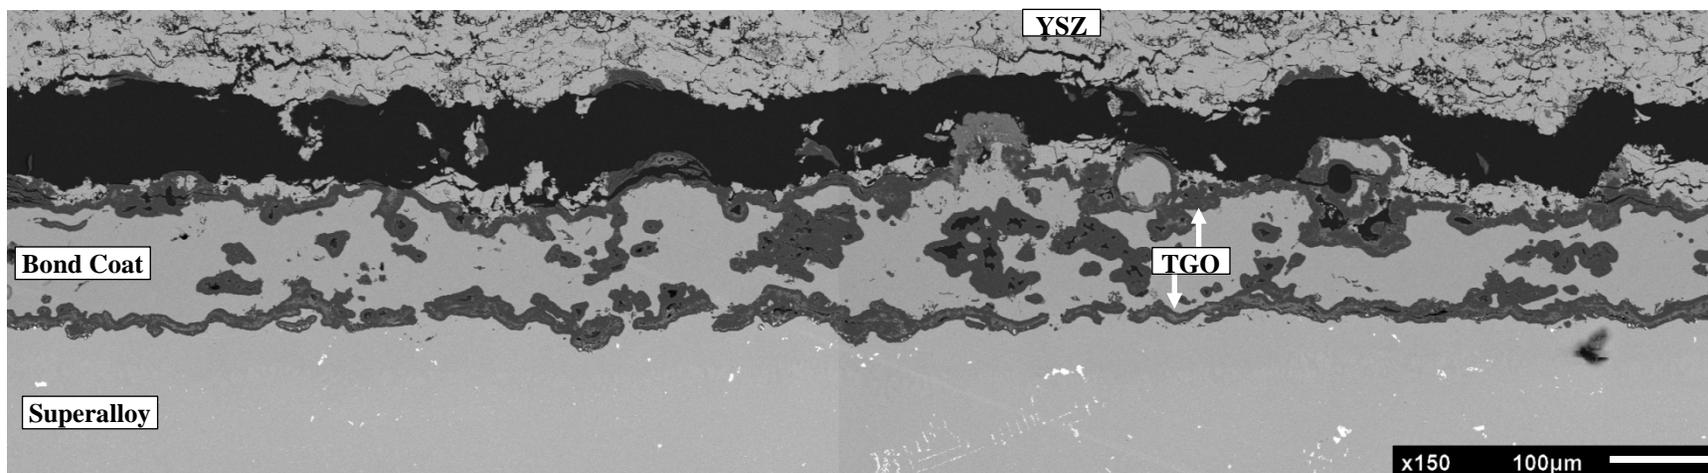
Figure 120 – Failed 50:50 bond coat TBC on N5 after 720 cycles.

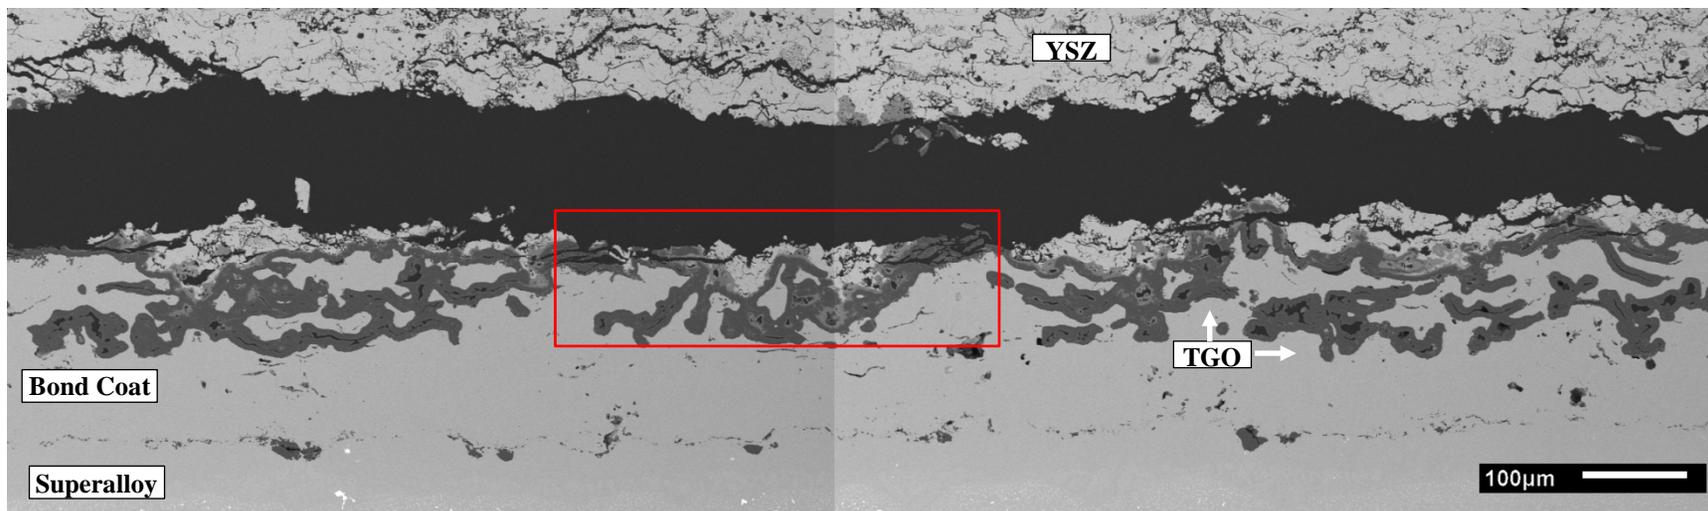
Figure 121 – Failed DL bond coat TBC on N5 after 600 cycles.

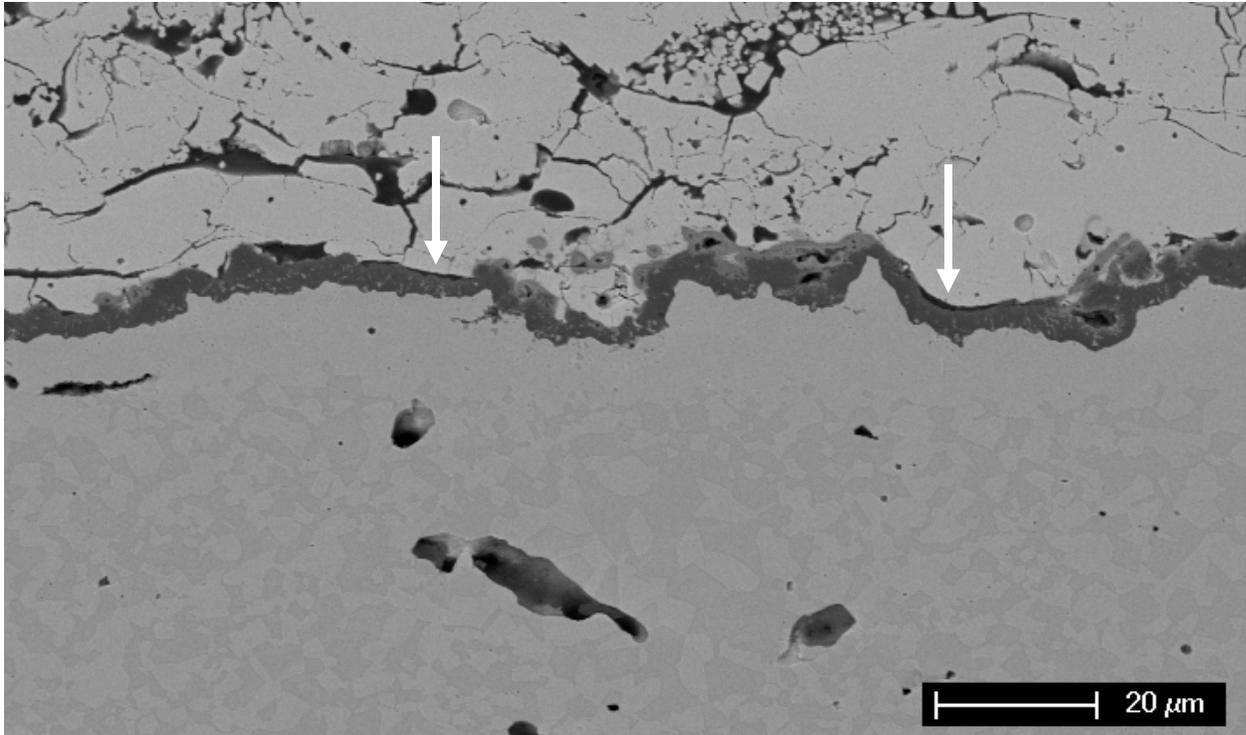
**Figure 129 - SL bond coat on PWA 1484 with 140 cycles. White arrows point out cracks at interface between TGO and YSZ.**
