IDENTIFICATION OF FACTORS CONTROLLING THE DEVELOPMENT OF SUBSIDENCE IMPACTS FORECASTING METHODOLOGY TO THE I-70 ALIGNMENT OVER LONGWALL MINING OF THE TUNNEL RIDGE MINE, WASHINGTON COUNTY, PA

Task 2: Undermining Activities Report
Submitted 3 February 2020; Finalized on 4 January 2021

The University of Pittsburgh Master Agreement
Contract No. 4400018535

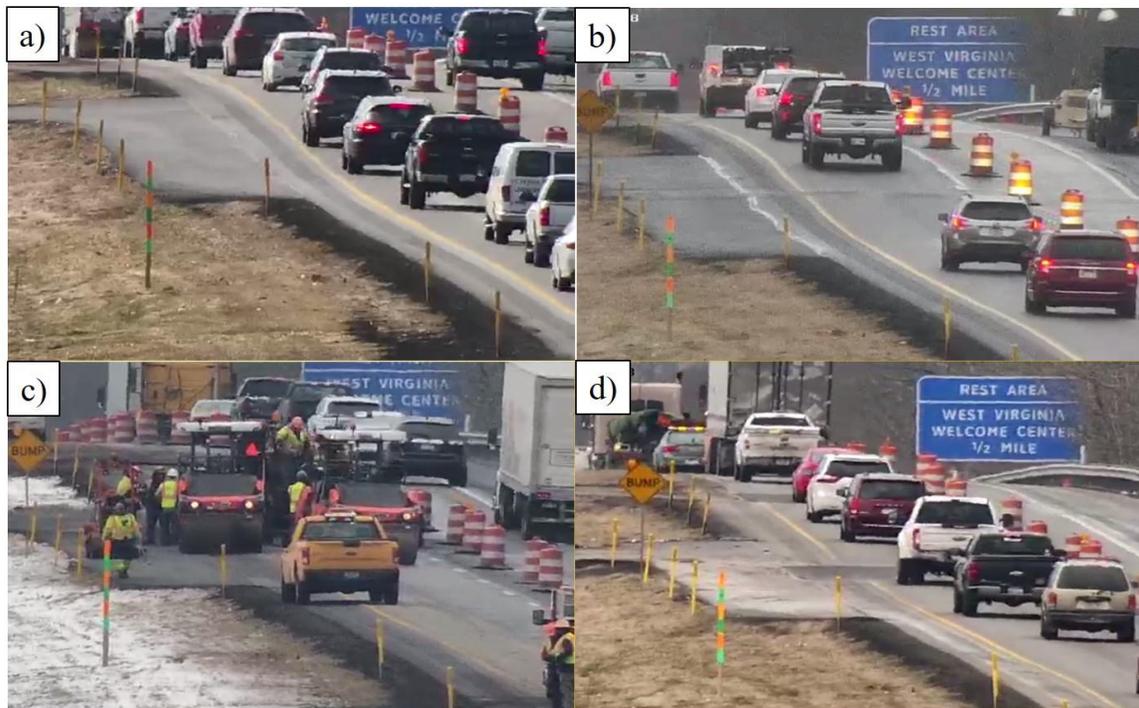
Another example is shown in Figure IIc.4 where a compression bump formed in the westbound lanes and an effective recovery measure was successfully implemented with minimal traffic interruptions. Subsidence impacts of this scale were continuously monitored by PennDOT and its contractors. During University visits to the study area, subsidence impacts (both large and small) were observed, measured, photographed, and located using highway alignment survey markings. The results of activities helped to build a rich inventory of information which is chronicled throughout this report.

Figure IIc.4 – a) 15 February 2019 at 14:23 the longwall face is under this section of highway, b) 17 February at 15:49 compression bump begins to form, c) 1 March at 13:16 the asphalt patch applied to a previously milled surface, and d) 2 March at 10:50 repair work completed.

- 1) monitored conditions,
- 2) alerted vehicles to slow-down with flagging, signs, and flares,
- 3) mobilized surface grinders, often stored close-by, and
- 4) applied asphalt patches.

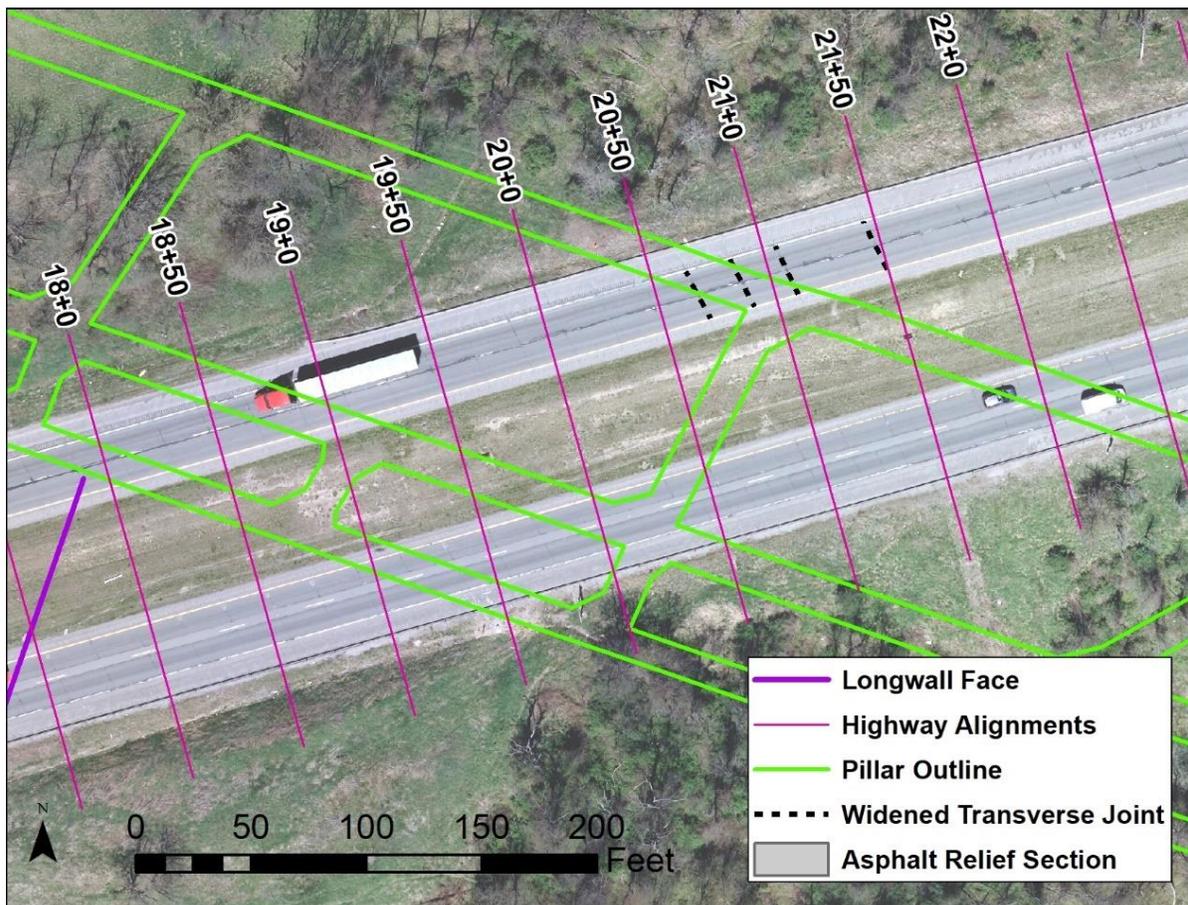
The observed damage highway surface was seen on 29 January 2019 when the panel first crossed beneath the highway. During this visit, four expansion joints at the edge of the study area began to open from the subsidence forces. These expansion joints were located over the edge of the gate roads approximately 250-ft behind the longwall face. The location of the observed features can be seen in Figure IIIc.1.

Figure IIIc.1 – Pavement features observed on 29 January

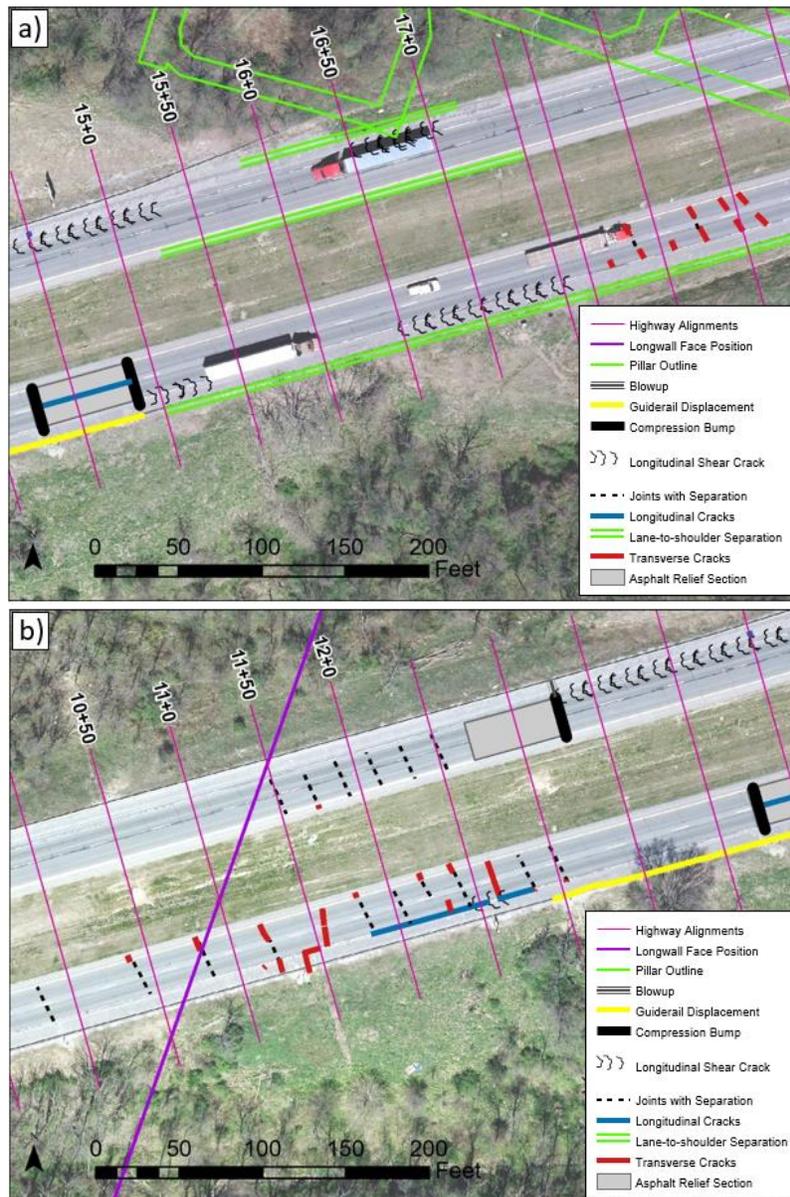
Figure IIIc.2 – Pavement features observed on 5 February

Some of the most notable features observed during this site visit were the three compression bumps and a large transverse crack. The compression bump and adjacent blowup on the westbound lane formed on 5 February, approximately 150-ft behind the longwall face. The two compression bumps on the eastbound lane formed on 4 February, between 175-ft and 225-ft behind the longwall face. Two of the three compression bumps formed in the asphalt relief sections. The large transverse crack formed about 60-ft behind the longwall face and opened to a width of more than 2.5-in wide. Images of these failures can be seen in Figure IIIc.3 below.

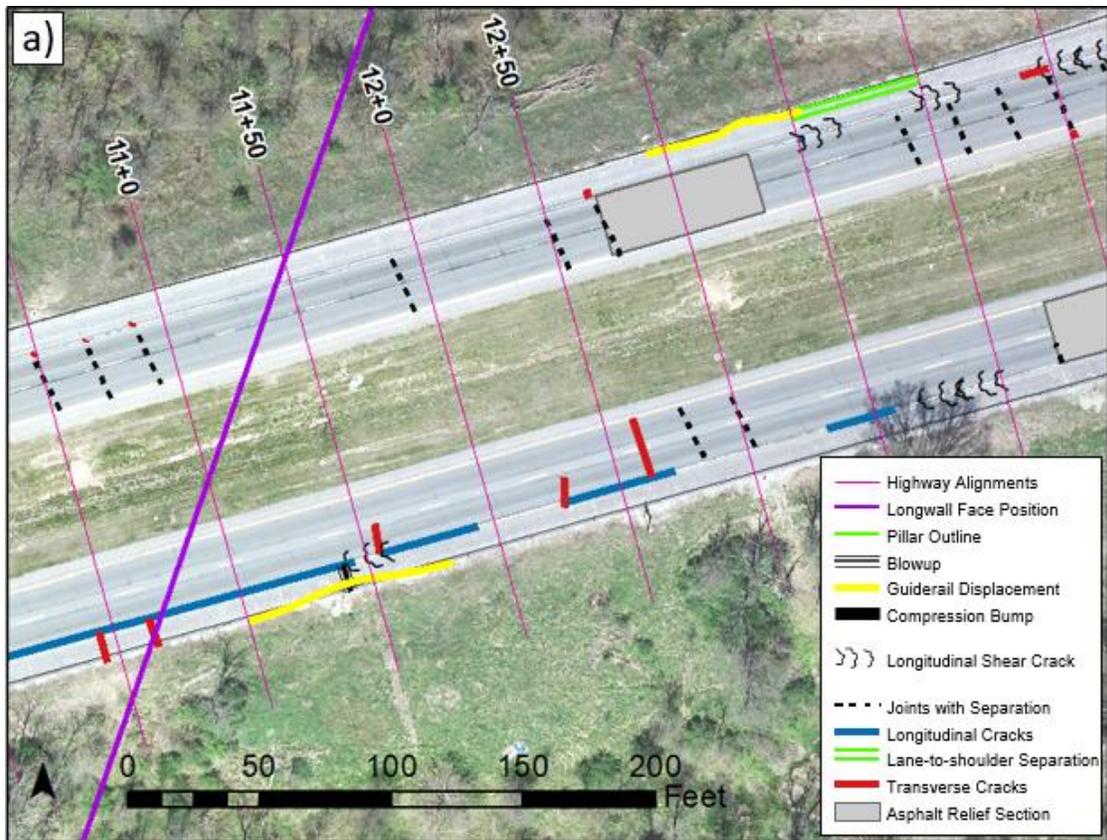
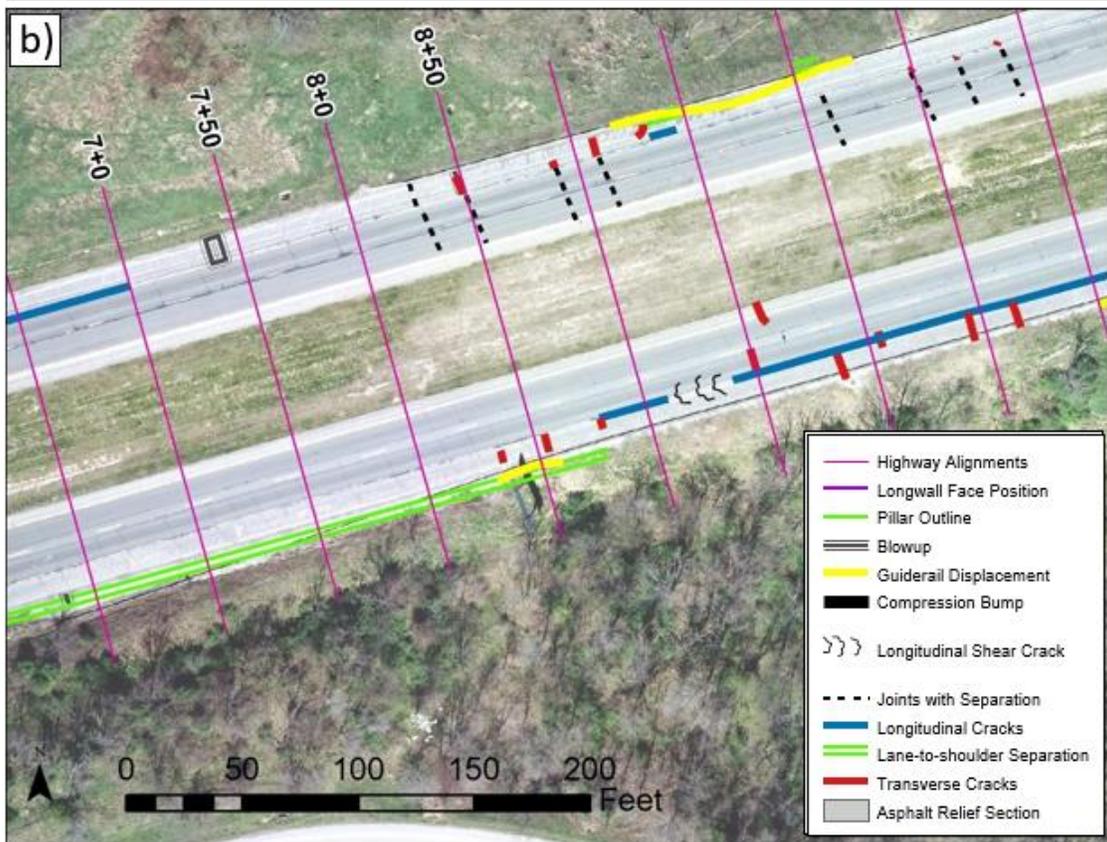
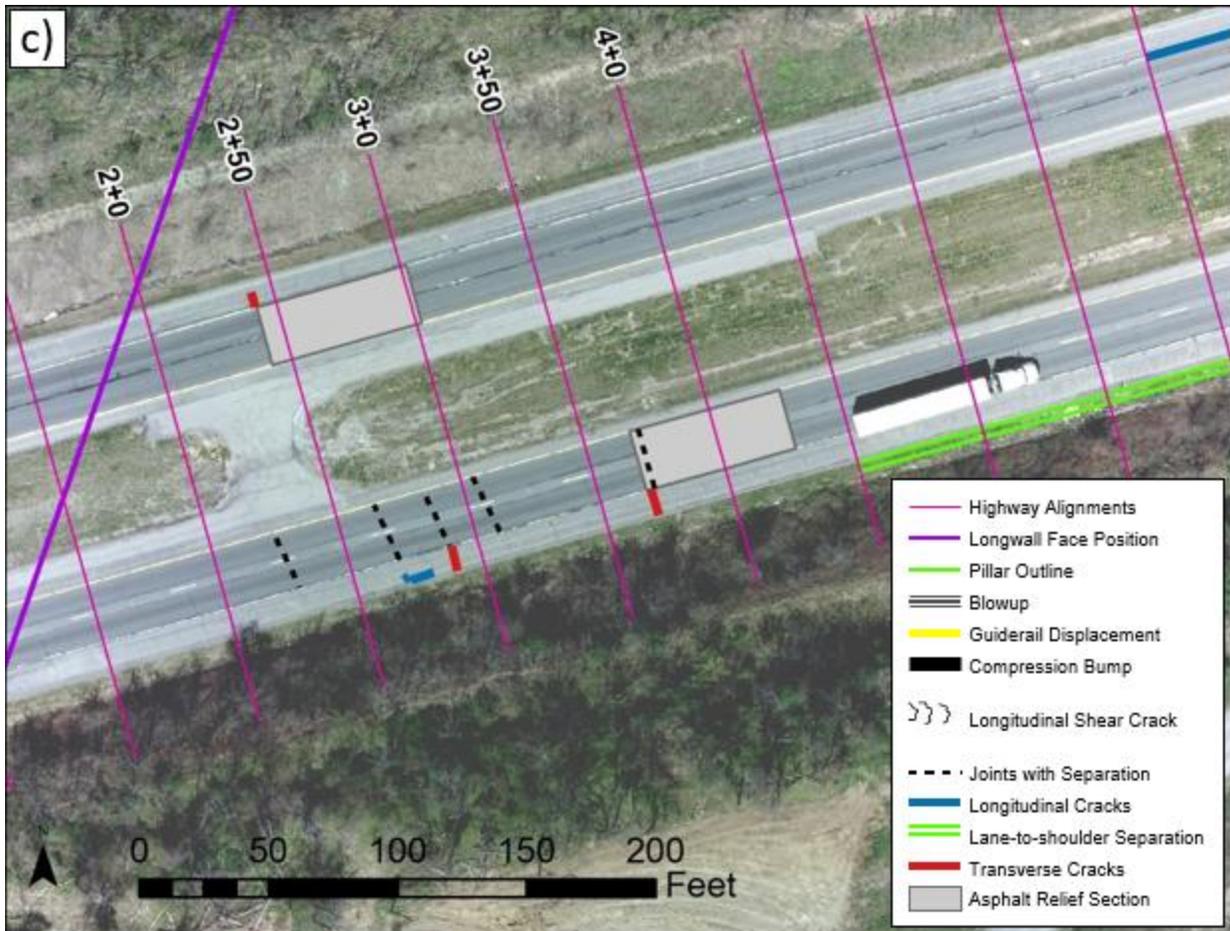
Figure IIIc.4 – Pavement features observed on 14 February

Two new compression bumps formed between the University’s observations on 5 February and 14 February. On the eastbound side of the road, a new blowup ~7-in tall formed on top of the existing transverse crack. This blowup occurred on 6 February when the longwall face was about 200-ft passed the location of the original crack. On the other side of the road, a compression bump formed on 14 February approximately 450-ft behind the longwall face. Images of these compression features were taken by the University and can be seen in Figure IIIc.5.

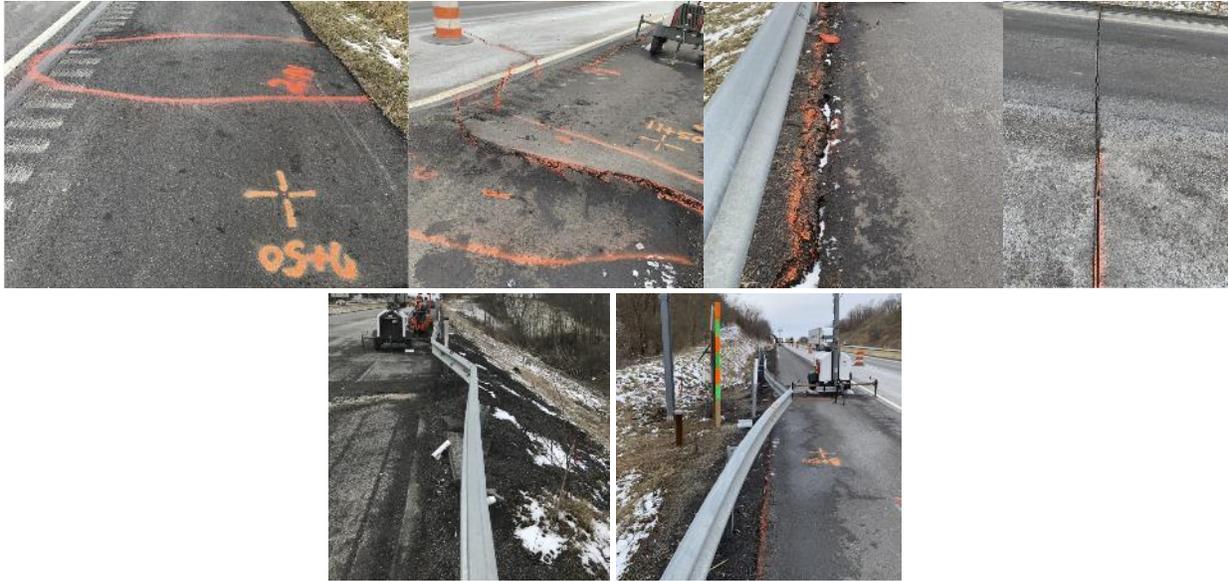
In addition to these two new compression features, significant separations between the edge of the pavement and the adjacent soil on both sides of the road, guiderrail displacements, and open expansion cracks were observed. On the eastbound side of the road, separations as much as 6-in wide were observed. Expansion joints as much as 0.75-in wide were observed on both sides of the road. These features were also photographed by the University and can be seen in Figure IIIc.5.

Figure IIIc.5 – Field images of observed features from left to right; westbound blowup, eastbound blowup 7-in tall, eastbound separation of pavement from soil, open expansion joint 0.75-in wide, sheared guiderail on westbound highway, sheared guiderail on eastbound highway

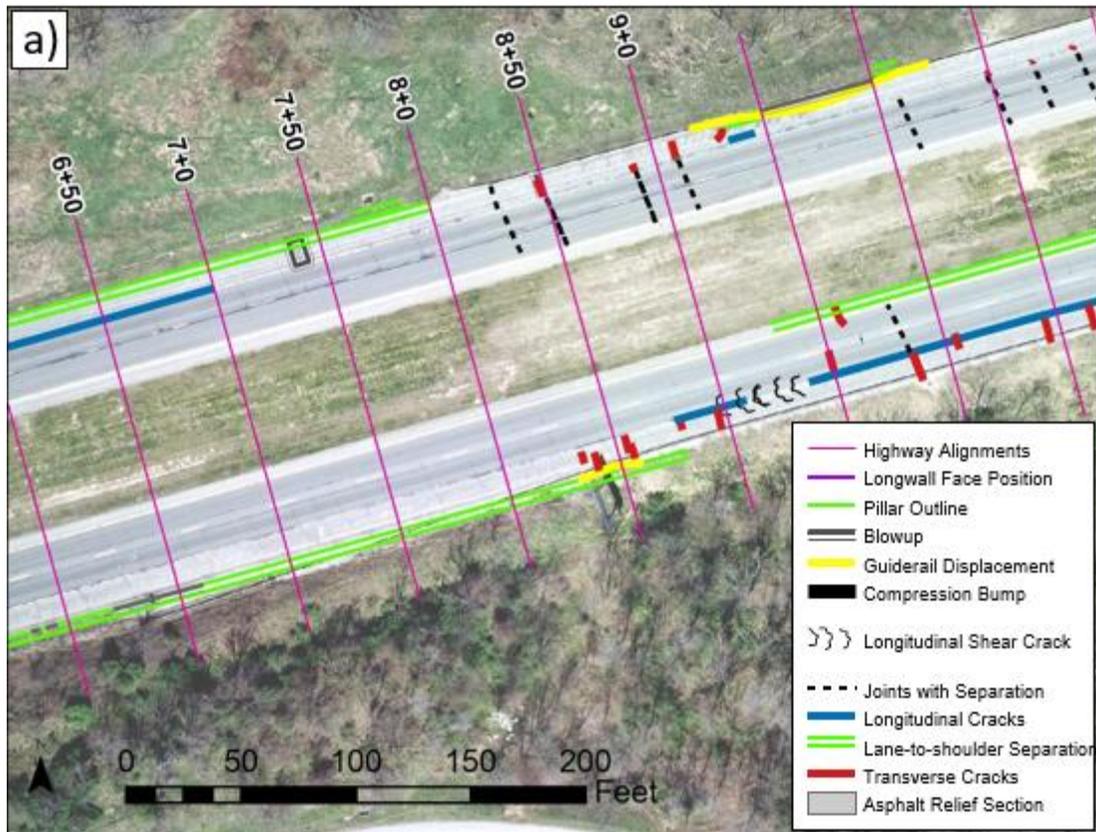
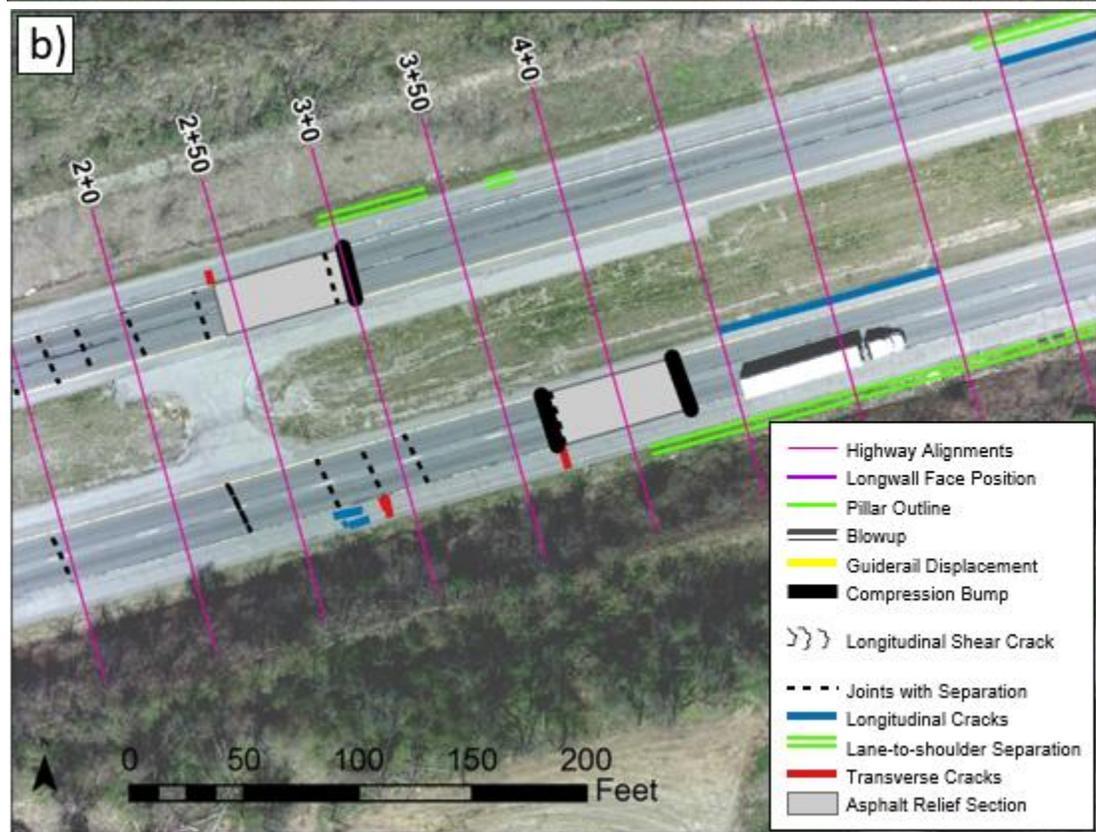
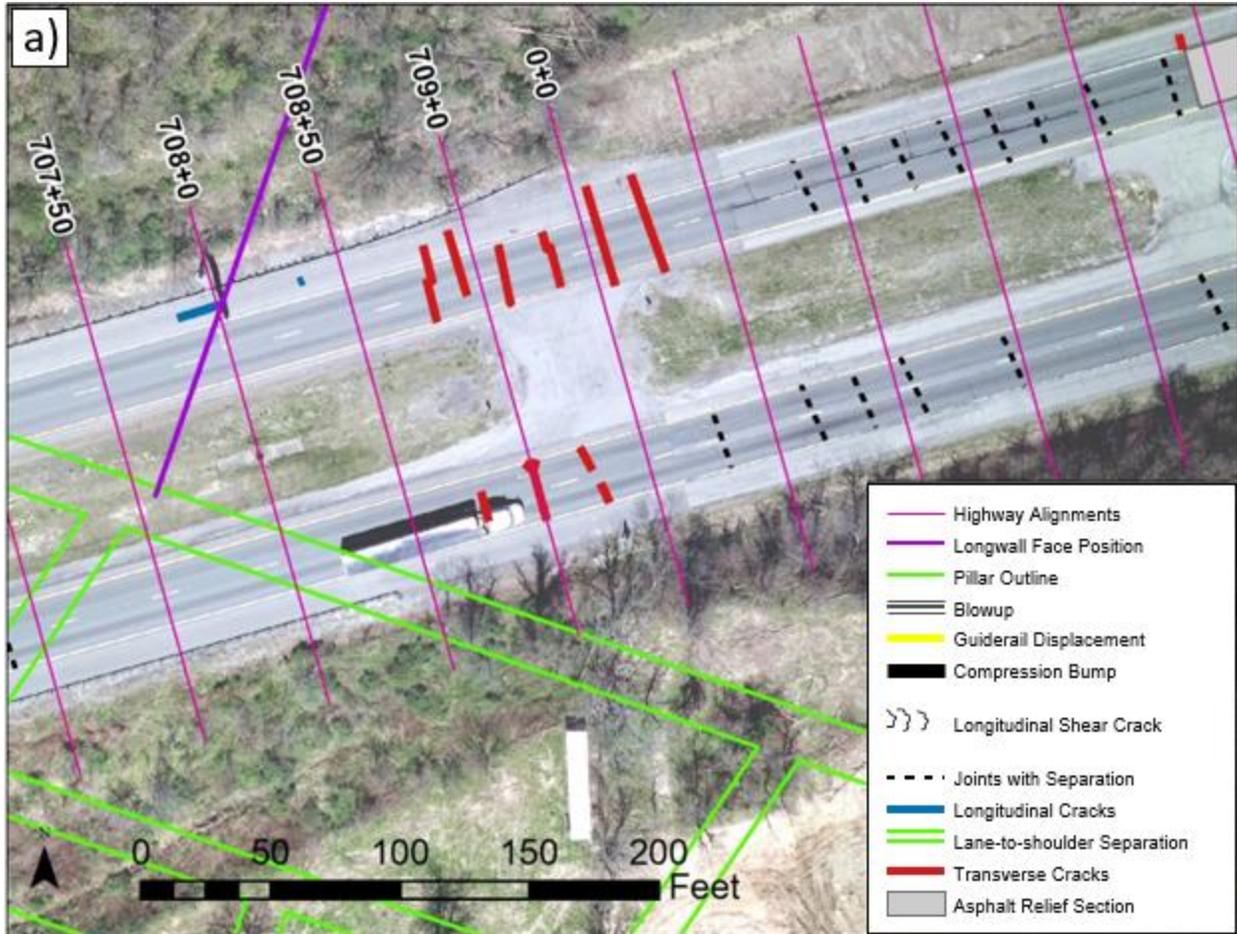
Figure IIIc.6 – Pavement features observed on 19 February

Very few new features were observed during the University’s site visit on 19 February. Some new expansion joints opened, and transverse cracks formed as much as 300-ft behind the longwall face. Additionally, new longitudinal crack opened just beyond the longwall face. The new damage observed on this site visit was not as significant as the damage observed in similar features near the center of the panel. Slight separations also occurred on the inside of the eastbound lanes between the pavement and the adjacent soil.

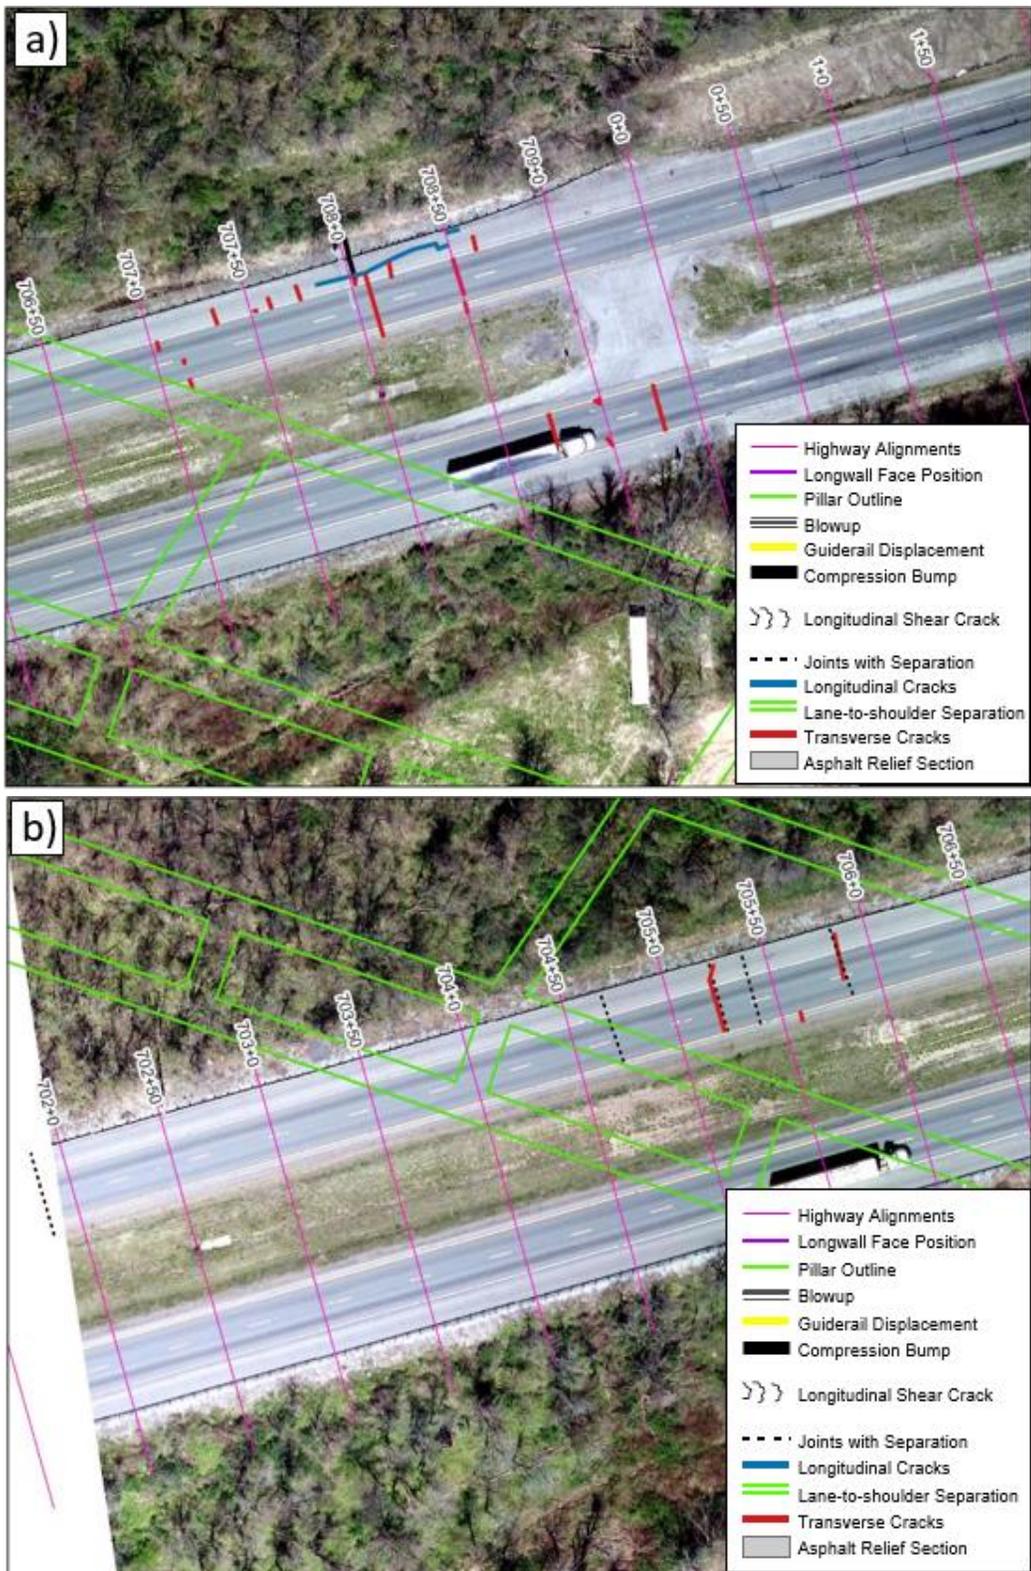
The University returned to the site on 26 February 2019 to observe the condition of the pavement. By this date, the longwall face was approximately 465-ft beyond the extent of I-70. Various extents of damage were present throughout the entire 2,400-ft section of interstate influenced by the subsidence basin. The location of damage observed near the western edge of the panel during this site visit can be seen in Figure IIIc.7 and the remainder of the observed damage can be seen in Appendix II.

Figure IIIc.7 – Pavement features observed on 19 February

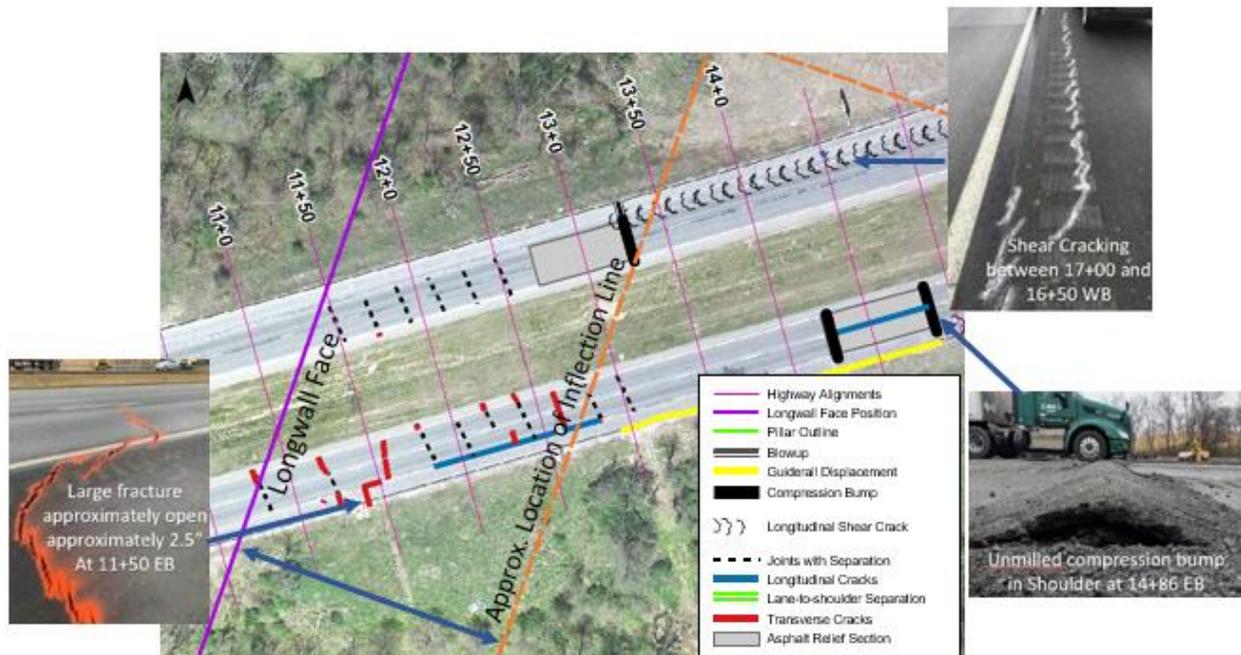
Reviewing the observations made during the undermining process has allowed the University to reach some preliminary inferences about the behavior of the pavement surface when subjected to longwall subsidence. As can be seen in Figure IIIc.8, the trends in the observed features show that the tensile features, such as separations and open expansion joints, tended to occur within 300-ft beyond the longwall face and 150-ft behind the longwall face. Once the longwall face was approximately 150-ft passed a point, the surface forces switched from tension to compression, causing the formation of compression features, such as blowups. These compression features tended to concentrate in the asphalt relief sections.

Figure IIIc.8 – Failures of the highway surface as the subsidence basin formed, demonstrating areas of tension, compression, and differential movement.

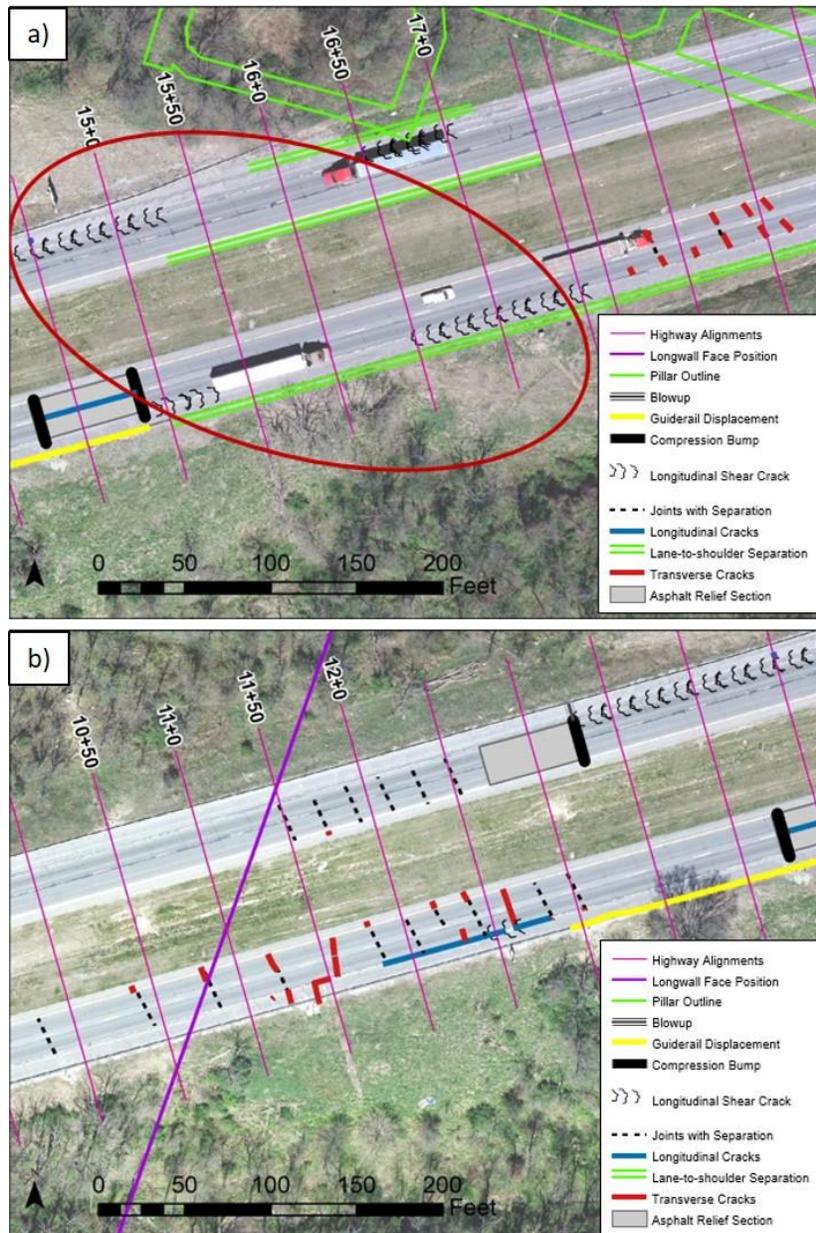
Figure IVa.12 – Highway observations in areas of large horizontal movements on 5 February 2019: a) 14+50 to 19+00; and b) 10+00 to 14+50

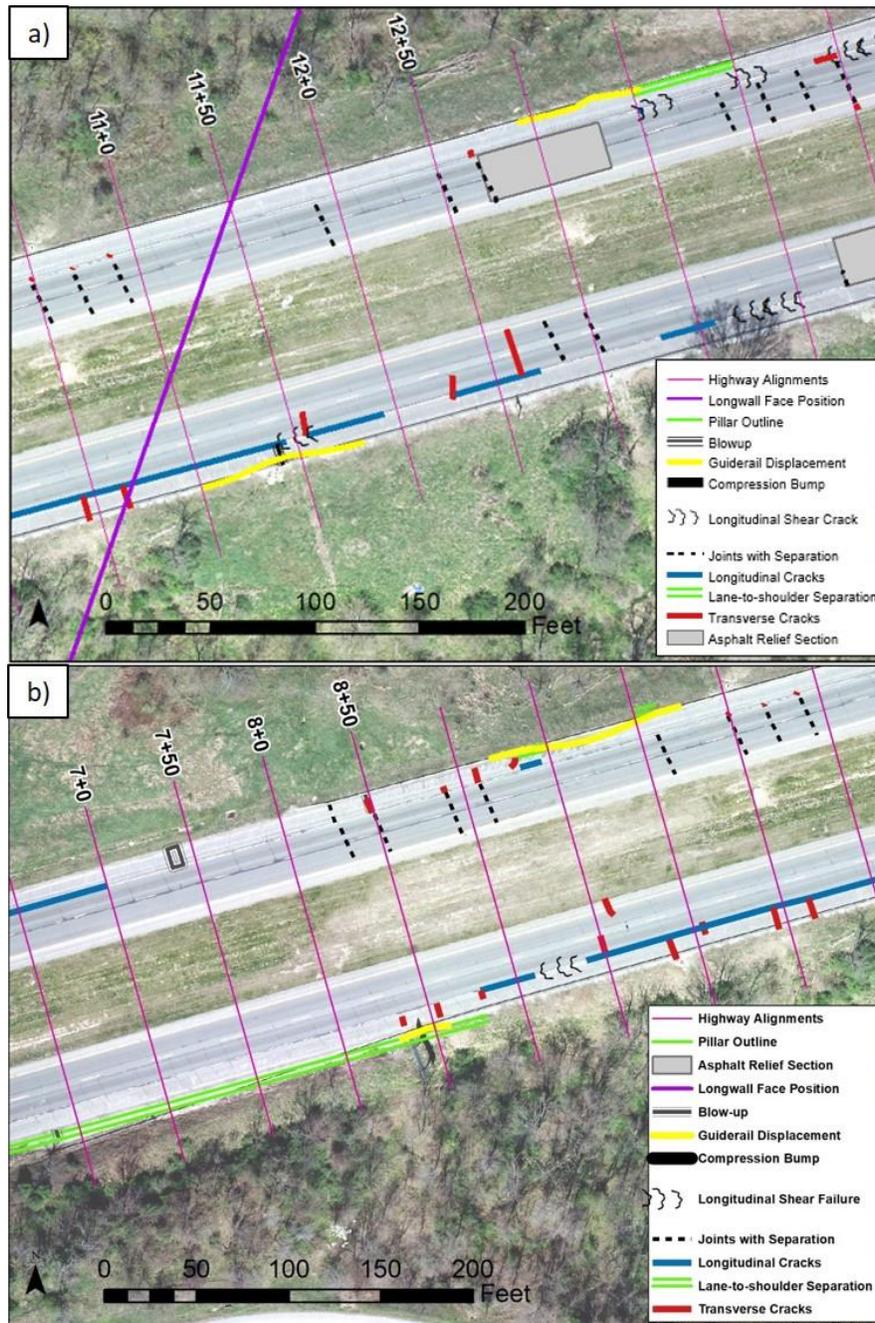
Figure IVa.13 – Highway observations in areas of large horizontal movements on 14 February 2019: a) 10+50 to 14+50; and b) 6+50 to 10+50

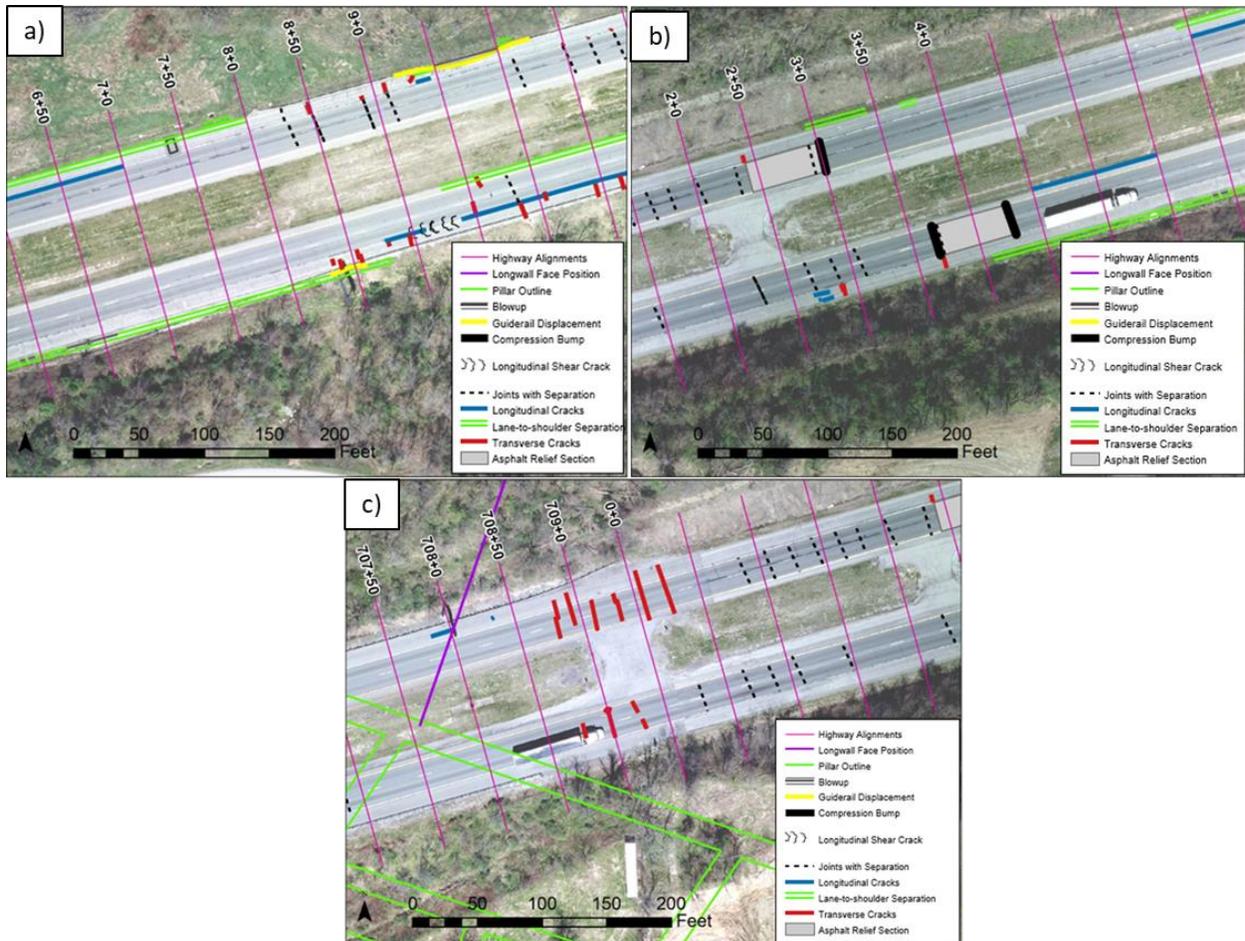
Figure IVa.14 – Highway observations in areas of large horizontal movements on 19 February 2019: a) 6+00 to 10+50; b) 1+50 to 6+00; and c) 707+00 to 2+50

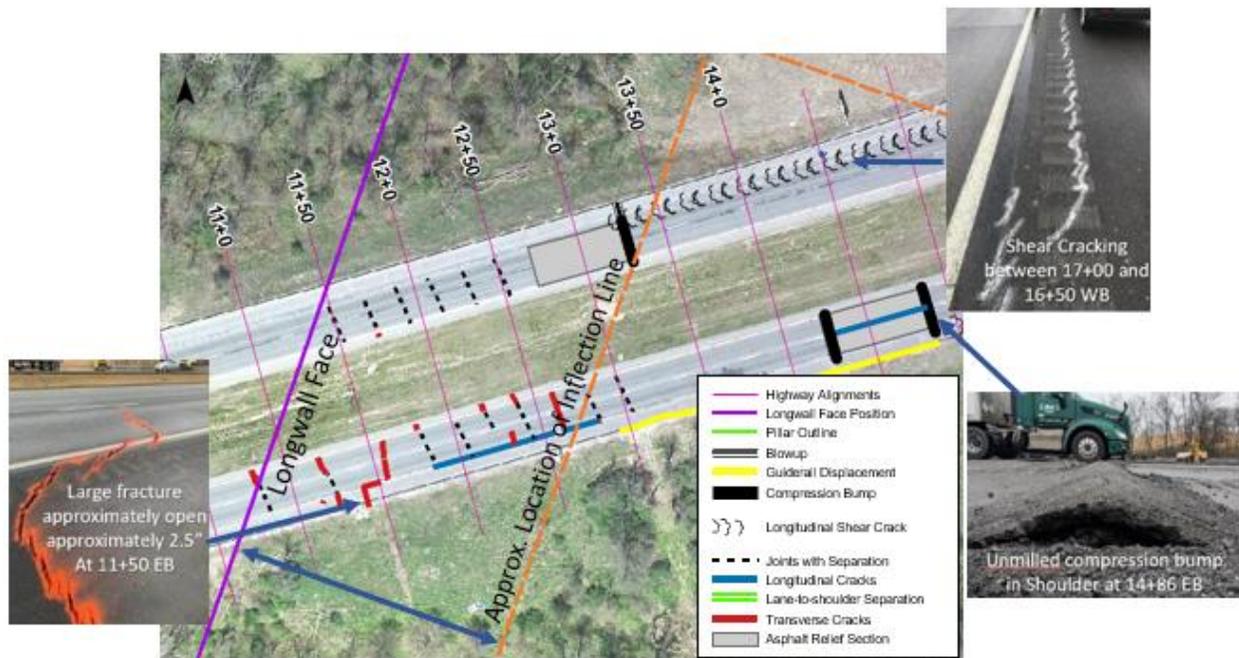
Figure IVc.4 – Failures of the highway surface as the subsidence basin formed on 5 February 2019, demonstrating areas of tension and compression

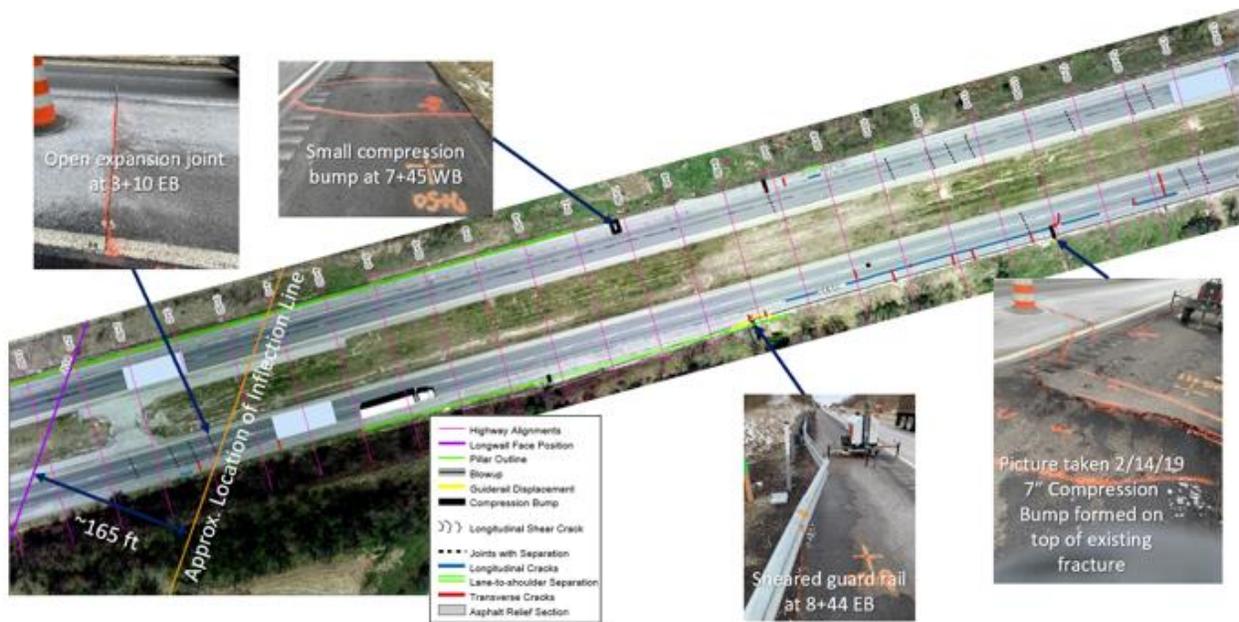
Figure IVc.5 – Failures of the highway surface as the subsidence basin formed on February 14th, demonstrating areas of tension and compression

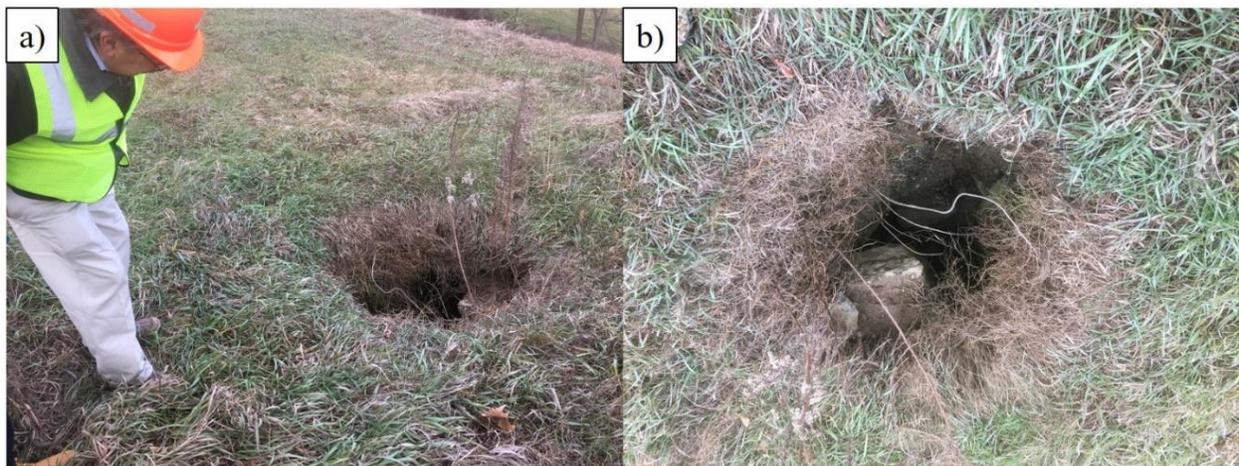
Figure Vb.4 - a) One of two sinkholes found along the north side of the west bound lanes adjacent to Embankment #1

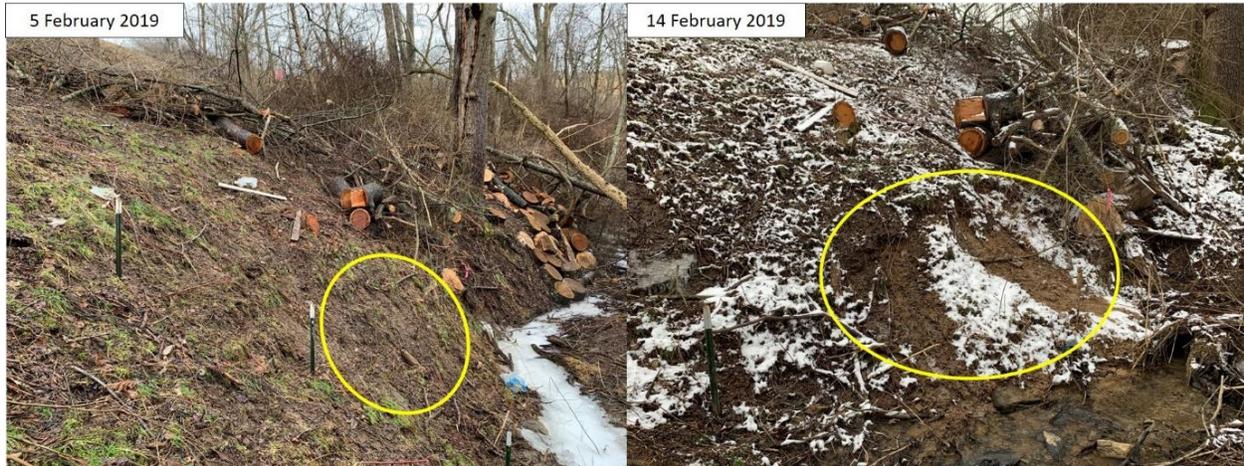
Figure Vb.14 – Two photographs of the slope directly to the west of the culvert on the north side of Embankment #1. Some minor mass wasting appears in the 14 February 2019 picture. The Vertical subsidence of survey stakes near this slope on 7 February show ~1-ft of movement. On 14 February the longwall face was more than 400-ft from this area and the vertical subsidence is ~4-ft.

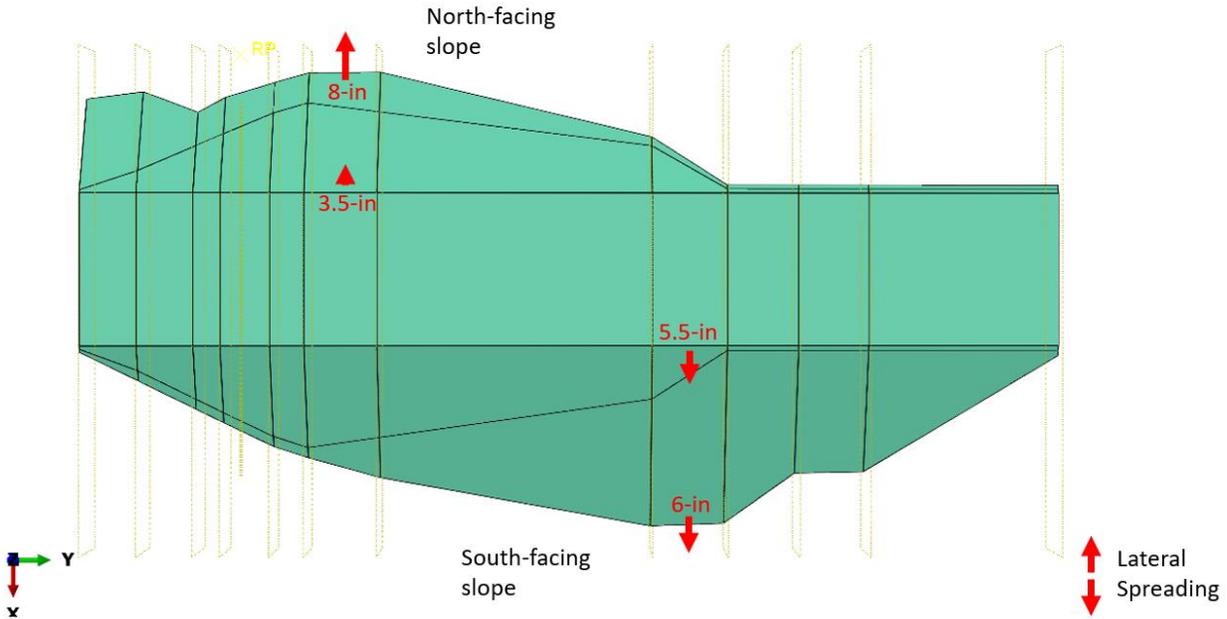
Figure Vc.1 – Lateral spreading on Embankment #1 after subsidence
