**SECTION IV: A Summary of the PA DEP
Observations on the Effects of Undermining
Interstate 79 during the 3rd Assessment
Period**

The Effects of Subsidence Resulting from Underground Bituminous Coal Mining on Surface Structures and Features and on Water Resources, 2003 to 2008 – University of Pittsburgh

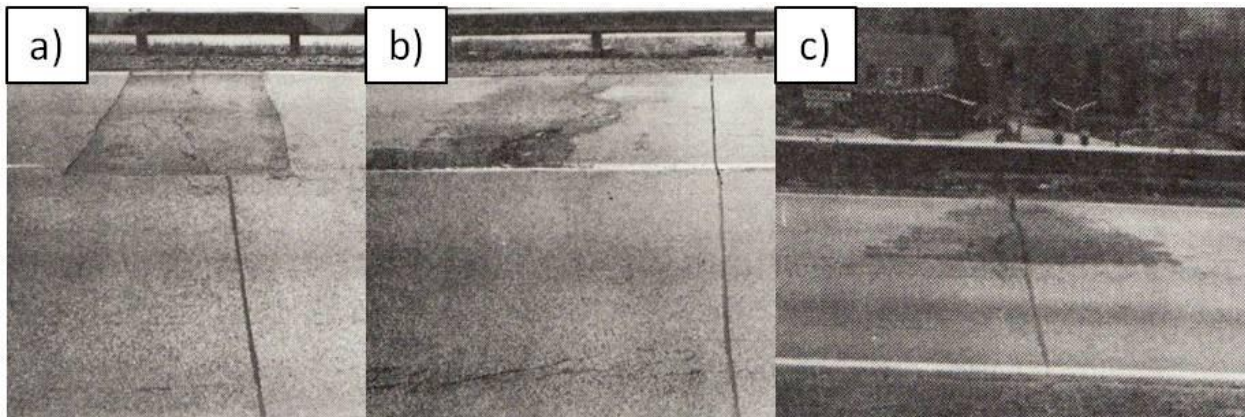
Yancich (1986) reported that only minor damage occurred to the northbound lanes of I79 that were undermined by longwall mining. Figure IV-5 shows repaired damage to I79 at: a) 900-ft along the survey profile, between the centerline and southern edge of the 0-Butt panel; b) 1,800-ft along the survey profile, near the southern edge of 1-Butt panel; and c) 3,300-ft along the survey profile, near the northern edge of 2-Butt panel. The Yancich study described a subset of impacts, making it difficult to determine the overall magnitude of damage and repairs associated with the development of multiple Gateway Mine subsidence basins under I79.

Figure IV-5 - Photographs of impacts to the northbound lanes of I79 over the 0-Butt (a), 1-Butt (b), and 2-Butt (c) panels of the Gateway Mine (Photographs from Yancich, 1986).

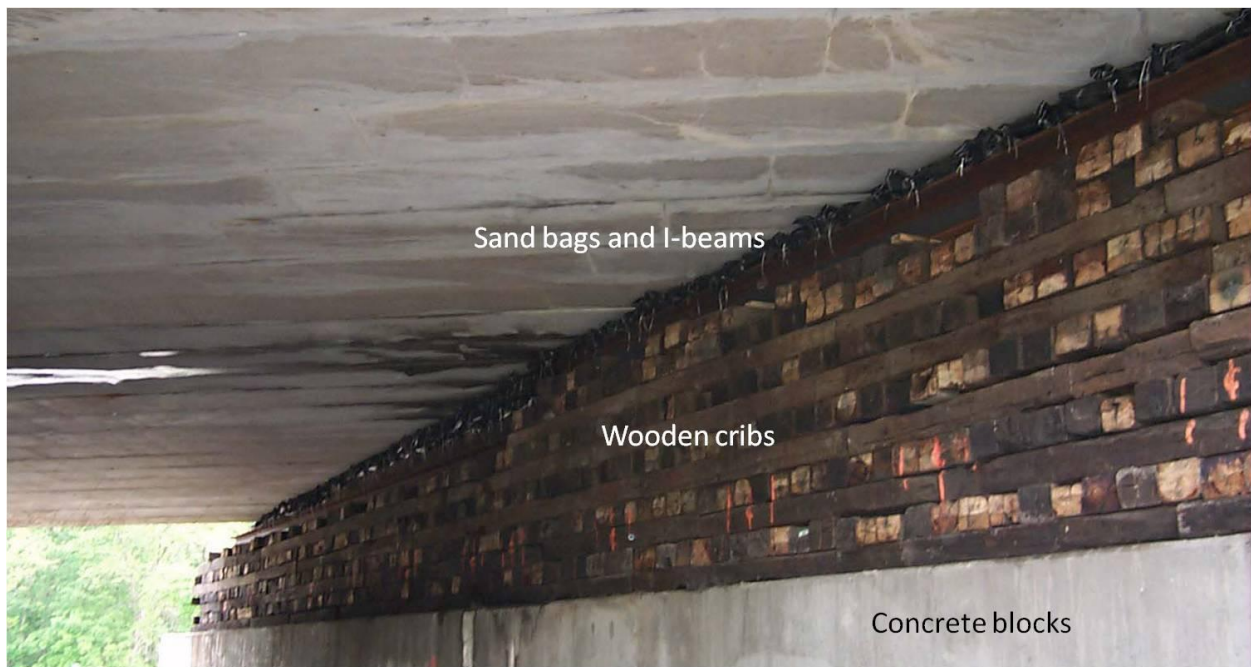
Information on the undermining of this section of I70 was reported by O'Connor in 2001. An array of tiltmeters was installed adjacent to the highway to detect hazardous deformations to the highway during undermining. The 32 tiltmeters were outfitted with real-time data acquisition systems, capable of sounding an alarm if levels of tilt exceeded 0.002-ft/ft. During undermining PennDOT implemented a plan that: 1) temporarily supported the Zediker Station Road overpass (Figure IV-7), 2) dismantled some of some overhead signs, 3) imposed a speed-limit of 40-mph, 4) provided for lane closures and detours, and 5) visually monitored highway conditions (O'Connor, 2001). As a result, there were no accidents attributed to undermining this section of I70.

Figure IV-7 – Mitigation techniques used at the Zediker Station Road Overpass (Photograph from PA DEP files).

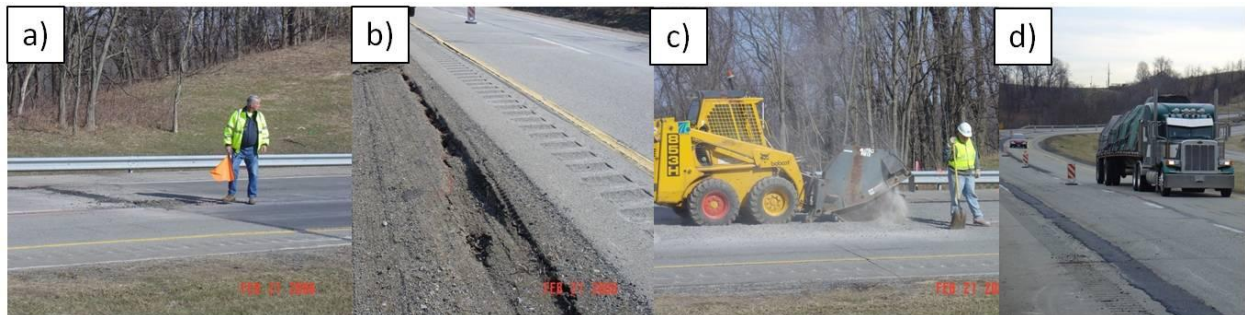
Cracks along the I79 were first observed on February 14, 2006, in the northbound lanes. One section of pavement contained longitudinal cracking (No. 3, Table IV-5) with a separation of about 1-in. Other longitudinal cracking was observed closer to the edges of the road with

On February 21, 2006, the southbound lanes were still relatively free of impacts. A small transverse compression heave or blowup (No. 11, Table IV-5 developed in the northbound passing lane (Figure IV-13a) and required milling and patching (Figure IV-13c). In addition, a large lane-to-shoulder separation (No. 14, Table IV-5) formed along the boundary between the pavement and the shoulder (Figure IV-13b). Between February 22, 2006 and March 8, 2006, PennDOT restricted traffic to one-lane and did extensive patching to the shoulders of both the north and southbound sides (Figure IV-13d). While this area had not required extensive milling, some heaving was noted near the end of the panel. The surface curvature produced at this time would have exerted a dominant compressive force on the highway foundation. The lane-to-shoulder separation might have been caused by the heaving of large concrete slabs in response to this compressive loading.

Figure IV-13 – Panel B3 photographs showing (a) a transverse compression heave, (b) lane-to-shoulder separation, (c) blowup compression bump being milled, (d) single lane restrictions with longitudinal patching, February 21, 2006 (Photographs from PA DEP files).

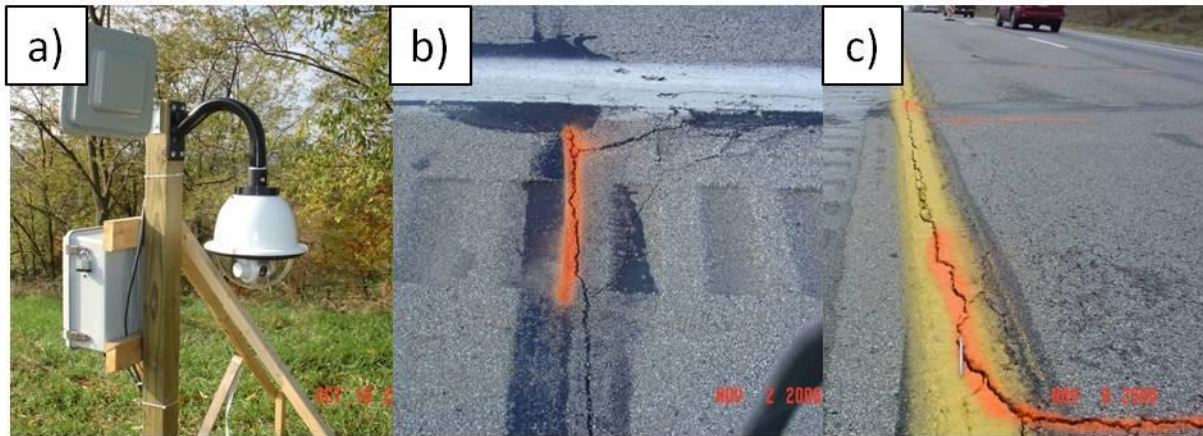
PennDOT personnel installed cameras to take photos of the roadway every 5-min. (Figure IV-14a). Some minor longitudinal and transverse cracking (No. 3 & 4, Table IV-5) were observed (Figure IV-14b and c). Many of these cracks existed prior to undermining and were observed to extend and widen during the observation period.

Figure IV-14 – Panel B4 Photograph showing (a) remote camera system, (b) transverse crack, and (c) longitudinal crack (Photographs from PA DEP files).

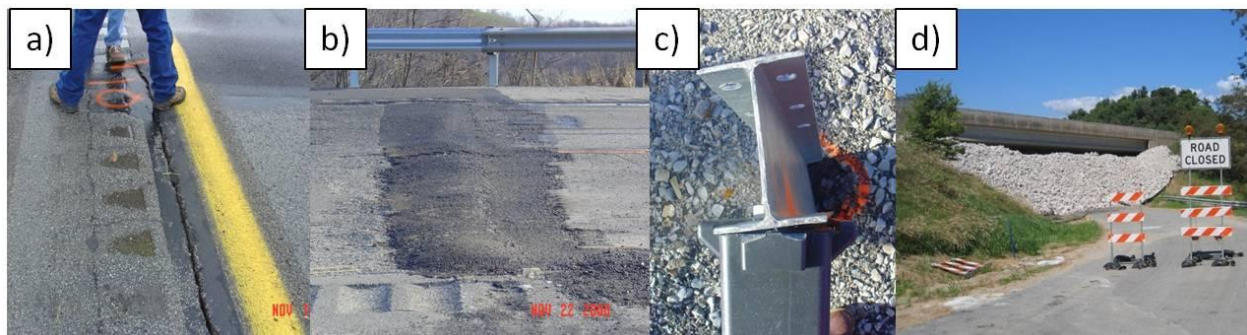
On November 6, 2006, some hairline cracks were visible in the northbound lanes. Minor lane-to-shoulder separations (No. 14, Table IV-5) occurred in both northbound and southbound lanes by November 16, 2006 (Figure IV-15a). These separations were typically 1/8 to 3/4-in wide. Some minor lane-to-shoulder drop-off (No. 13, Table IV-5) was also observed in these same areas. On November 22, 2006, a large blowup (No. 11 Table IV-5 and Figure IV-15b) and deformed guard rails were observed (Figure IV-15c).

Figure IV-15 - Panel B4 photograph showing (a) lane-to-shoulder separation, (b) blowup, (c) distressed guard rails, and (d) mitigation method to protect I79 Bridge at Moony Road (Photographs from PA DEP files).

Moony Road (also known as Tower Road) crosses under I79 in this area (Figure IV-12). PennDOT placed aggregate underneath both the north- and southbound overpass structures as well as in the median area (Figure 15d). Once the aggregate was at sub-grade, a temporary section of road was built in the median area. The southbound traffic was relocated to the median area and the southbound structure (bridge deck, beams, and parapets) were then removed. The structure was replaced with a two lane asphalt roadway. When the work was completed on the southbound side, the same measures were completed on the northbound overpass structures.

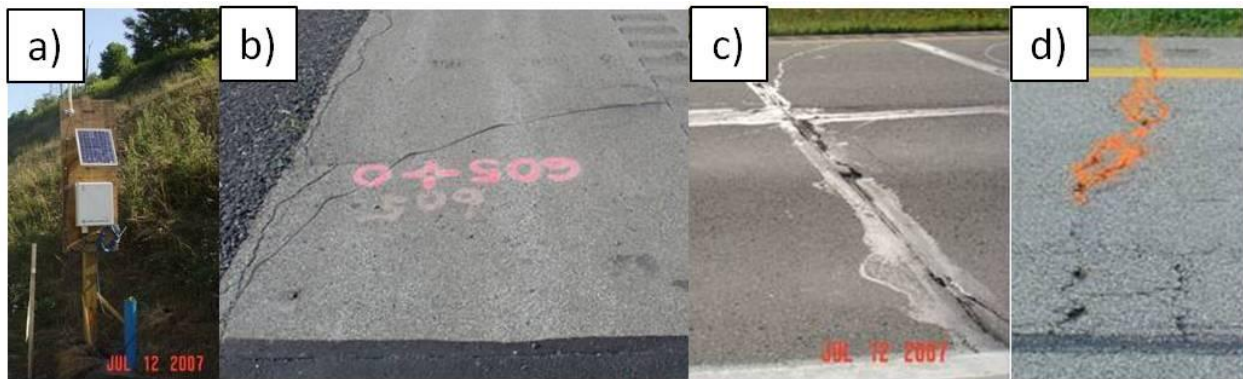
PennDOT utilized remote data acquisition systems and transferred information collected while I79 was undermined to their offices for review and analysis (Figure IV-16a). Monitoring occurred 24-hours a day and traffic was limited to one lane in each direction at a rate of 45-mph. Tensile forces caused the first recognized impacts. For example, on June 21, 2007, a corner break (No. 1, Table IV-5) was observed (Figure IV-16b). Later, in late July and early August (Figure IV-16c and d) spalling of transverse joints (No. 6, Table IV-5) and transverse cracking (No. 4, Table IV-5) occurred. Many of the joints and cracks ranged in size between 1/8 and 2-in.

Figure IV-16 – Panel B5 photographs showing (a) data acquisition equipment, (b) corner breaks, (c) transverse joints, and (d) transverse cracks (Photographs from PA DEP files).

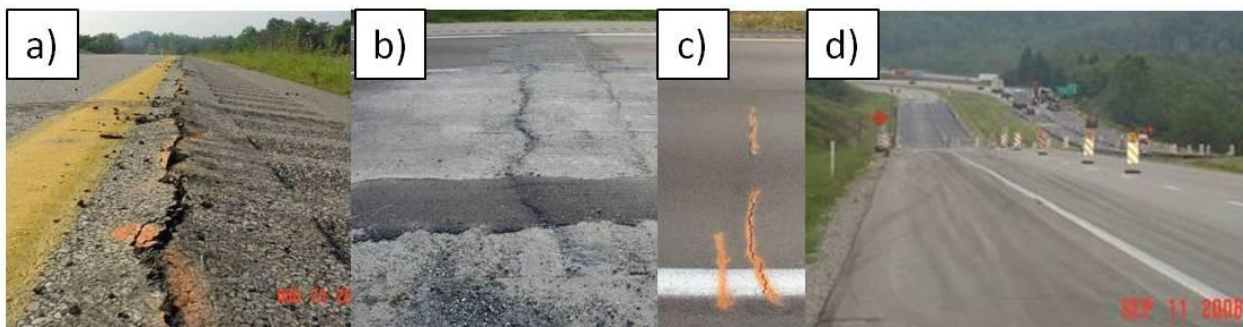
In August, the compressive failures became more dominant. Lane-to-shoulder dropoff (No. 13, Table IV-5) and separation (No. 14, Table IV-5 and Figure IV-17a) and blowup (No. 11, Table IV-5 and Figure IV-17b) were observed. In addition, transverse cracks (No. 4, Table IV-5) continued to occur (Figure IV-17c). Open joints were either filled or patched. The blowups were repaired by milling and patching. Figure IV-17d provides a view of the subsidence basin as of September 11, 2007.

Figure IV-17 – Panel B5 photographs showing (a) lane-to-shoulder separation, (b) blowups, (c) transverse cracks, and (d) view of the final subsidence basin (Photograph from PA DEP files).

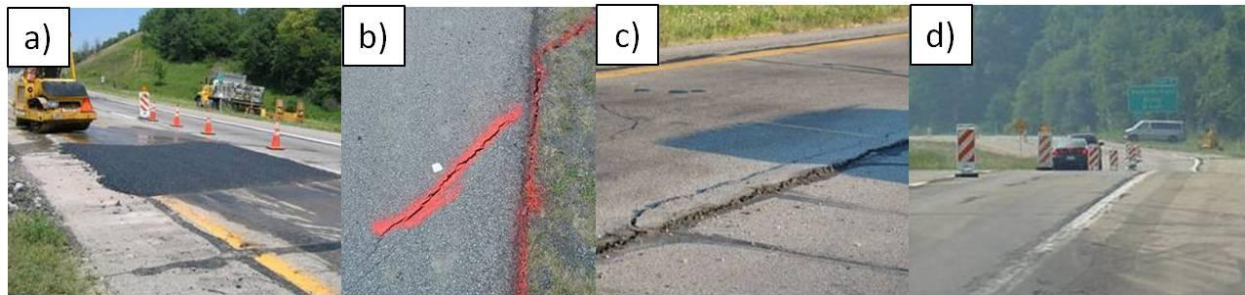
By August 3, 2005 the longwall panel had mined past I79 and PennDOT began patching damaged sections (Figure IV-19a). On that same day, a corner break (No. 1, Table IV-5) was observed (Figure IV-19b). Two days later, faulting occurred along a joint (No. 12, Figure IV-19c). Figure IV-19d shows the subsidence basin on August 11, 2005.

Figure IV-19 - Panel LW-50 photographs showing (a) patching activity, (b) a corner break, (c) faulting of joints, and (d) subsidence basin (Photographs from PA DEP files).

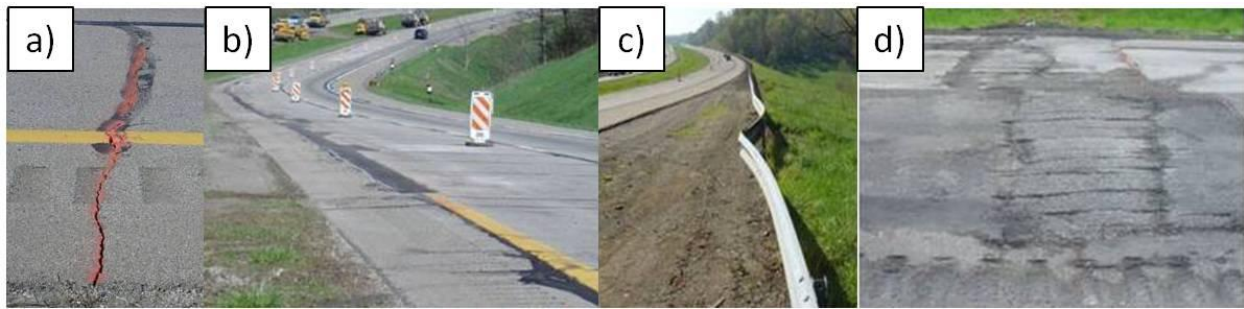
Transverse joint spalling (No. 7, Table IV-5) was observed on April 21st (Figure IV-20a). On April 27, 2005 PennDOT patched separations (No. 14, Table IV-5) along the lane-to-shoulder area (Figure IV-20b). Figure IV-20c shows compression along highway guard rail and a photograph on May 11, 2005 (Figure IV-20d) shows a recently repaired blowup (No. 11, Table IV-5).

Figure IV-20 – Panel LW-51 photographs showing (a) spalling of transverse joint, (b) lane-to-shoulder separation, (c) compression of guard rail, and (d) blowup (Photographs from PA DEP files).

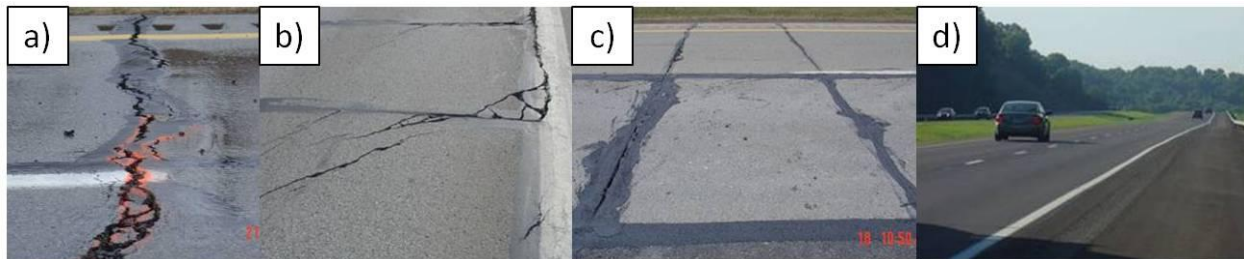
On December 21, 2006 the longwall panel began to advance underneath I79 at a 30-deg angle, and a large transverse crack (No. 7, Table IV-5) was observed (Figure IV-21a). Corner breaks (No. 1, Table IV-5) were observed on January 4, 2007 as the longwall face advanced to half the transversal distance (Figure IV-21b). PennDOT used saw cuts to de-stress the highway on January 11, 2007 (Figure IV-21c). Figure IV-21d shows the resurfaced highway on July 12, 2007 approximately 6-months after longwall mining.

Figure IV-21 – Panel LW-52 photographs showing (a) transverse cracking, (b) corner breaks, (c) highway deformation between saw cuts in the slabs, and (d) rehabilitated highway surface (Photographs from PA DEP files).

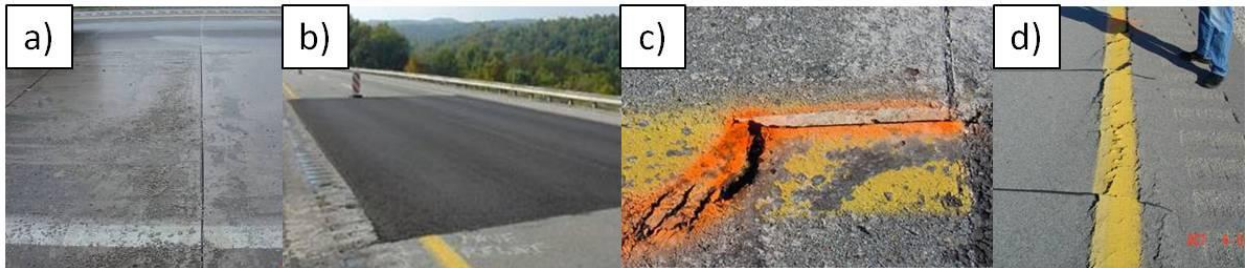
Several months prior to the undermining of I79, PennDOT used saw cuts on sections of highway slabs to help mitigate future deformations (June 26, 2007, Figure IV-22a). Temporary patching occurred during various stages of I79 undermining (Sept. 27, 2007, Figure IV-22b). On Oct. 4, 2007, I79 was directly over the center portion of the advancing longwall face. Faulting of

transverse joints (No. 12, Table IV-5) and lane-to-shoulder drop-off (No. 13, Table IV-5) were observed by PA DEP personnel.

Figure IV-22 – Panel LW-53 photographs showing (a) pre-mining saw cuts, (b) temporary patching, (c) faulting of transverse joints, and (d) lane-to-shoulder drop-off (Photographs from PA DEP files).

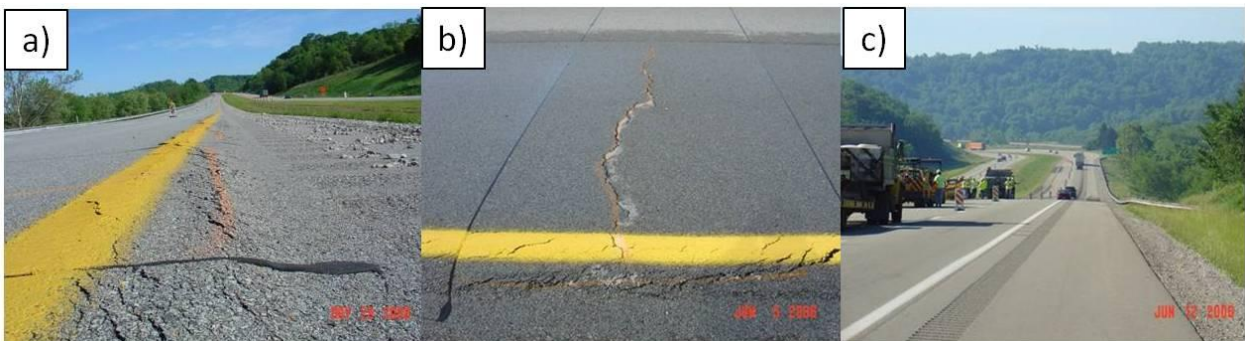
During the mining of Panel LW-54, lane-to-shoulder drop-off (No. 13, Table IV-5) and transverse (No. 4, Table IV-5) and longitudinal cracking (No. 3, Table IV-5) occurred (Figures IV-23a and b). Figure IV-23c shows the final subsidence basin as of June 12, 2008.

Figure IV-23 – Panel LW-54 photographs showing (a) lane-to-shoulder drop-off, (b) transverse and longitudinal cracking between saw cuts, and (c) final subsidence basin (Photographs from PA DEP files).
