## **SECTION VII: Effects of Mining on Land**

## **VII.A - Overview**

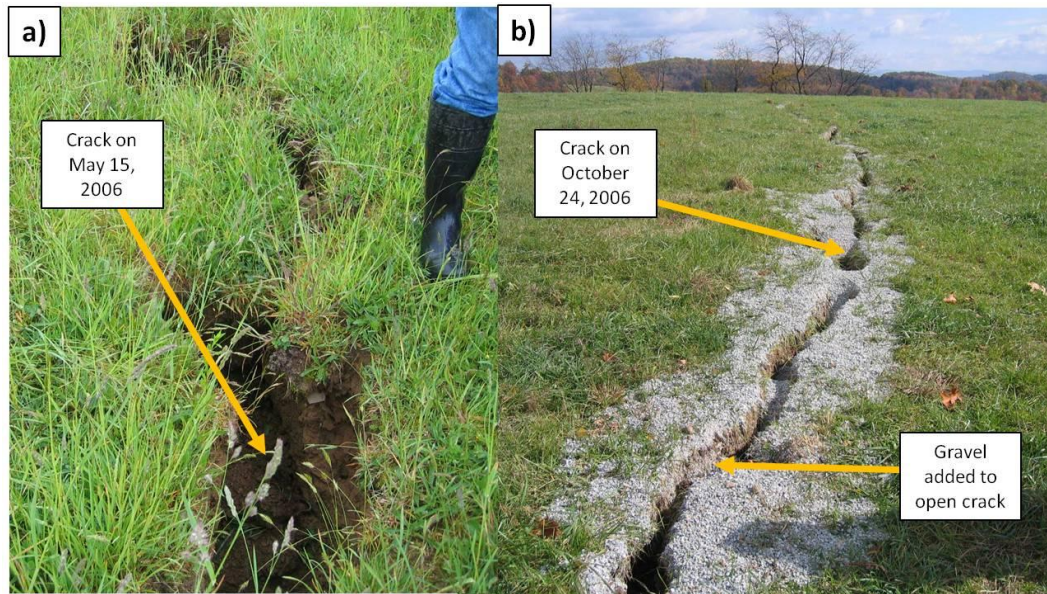
Tension cracks were a dominate cause of land reported effects. There were 37 claims with tension cracks identified as the primary cause (Table VII-6). These features were associated with the formation of the subsidence basin (Section IV, V, and VI). Typically, the largest tension cracks were curvilinear and extended for hundreds of feet along the surface with an open fracture several feet in depth (Figure VII-2). In one case, the property owner reported hearing a loud boom and, upon inspection the next day, found a large crack in their front yard. When the tension cracks were smaller in scale, i.e. tens of feet, they might be associated with other causes such as mass wasting or settlement.

Figure VIII-2 – Photograph of large tension crack a) open shortly after the underlying longwall panel was mined, and b) partially repaired by filling with gravel and other aggregate products until the ground surface becomes level (Photographs from PA DEP files).

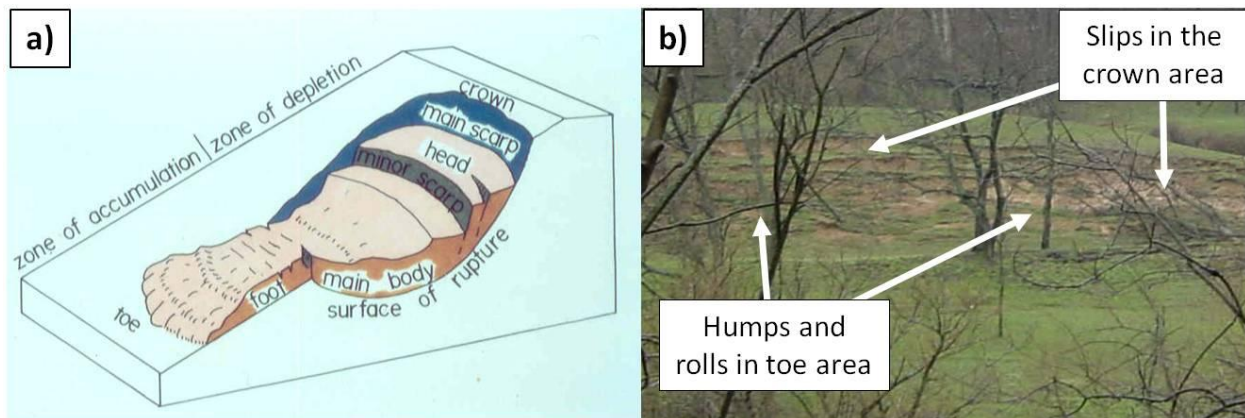
Figure VII-3 – a) General characteristics of mass wasting episodes taken from Varnes (1978) and b) large mass wasting event in Greene Co., PA (photograph from PA DEP files).

Western Pennsylvania is known to have significant problems with mass wasting (Davies, et al. 1978; and Hackman, et al, 1978). These problems are particularly acute in Greene and Washington Counties where steep slopes contain thick masses of slumped hummocky soil and

rock from ancient remnants of mass wasting events. When a subsidence basin is formed above a longwall panel, these thick colluvial slopes can become unstable. Iannacchione and Ackman (1984) mapped several such features similar to the one shown in Figure VII-3b over the Gateway Mine. In that study, the two largest reactivated landslides occurred above a thin sandstone strata with several associated springs, and ranged from 100 to 300-ft in length and from 100 to 200-ft in width. The maximum scarp-slope displacements were approximately 7-ft. The University found a few examples of similar large mass wasting cases in the PA DEP files. The sizes of these mass wasting events could only be estimated from photographs.

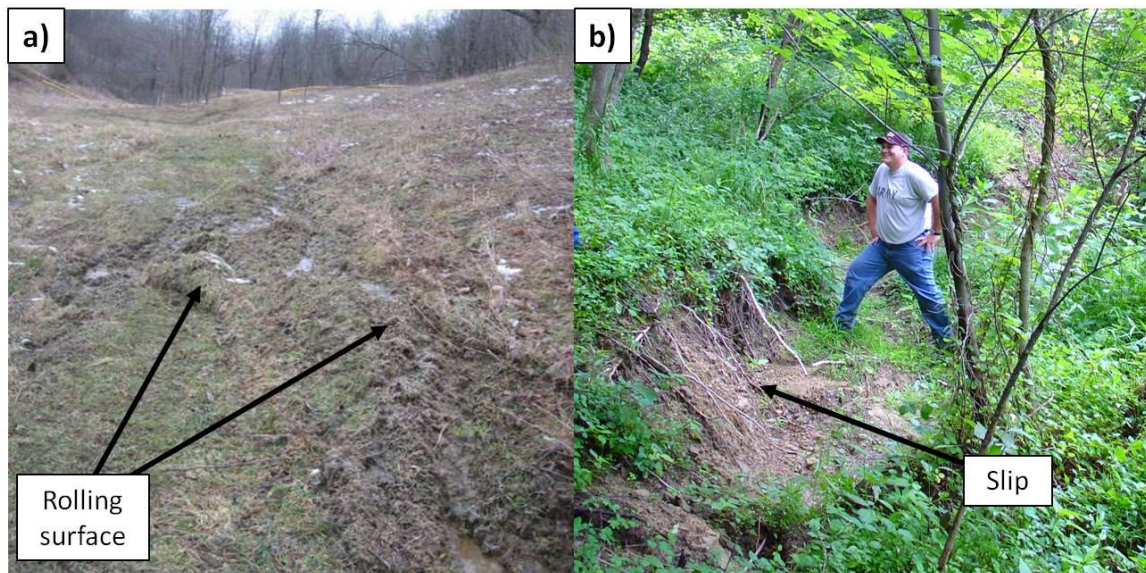
Less dramatic mass wasting occurs when the colluvial soil layer is thinner. This type of mass wasting is associated with creep or flowing colluviums that produce rolling features with occasional slip surfaces (Figure VII-4). The Agent Observations found within BUMIS of mass wasting were mainly of this nature.

Figure VII-4 - Photographs of a) rolling surface and b) slip (Photographs from PA DEP files).

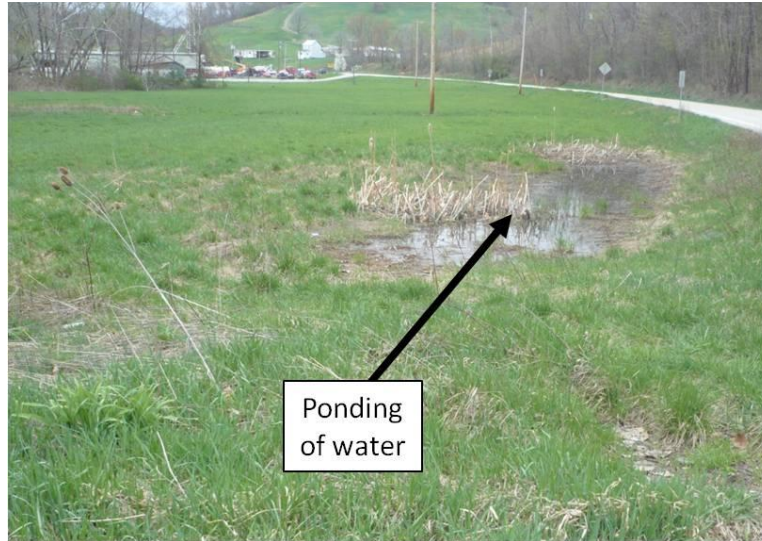
Twelve cases were classified as caused by settlement. When a subsidence basin is formed in relatively flat topography, settlement of the ground produced depressions that impact the normal use of the land. The maximum vertical subsidence over a Pittsburgh Coalbed longwall panel reached over 4-ft (see Section IV). This amount of surface elevation change can disrupt drainage patterns which can in-turn allow water to pond (Figure VII-5). Ponding of water in fields, pastures, and residential lawns impacts the intended use of this land.

*Figure VII-5 - Ground settlement over a longwall panel allowed water to pond in depression (Photograph courtesy of N. Iannacchione).*

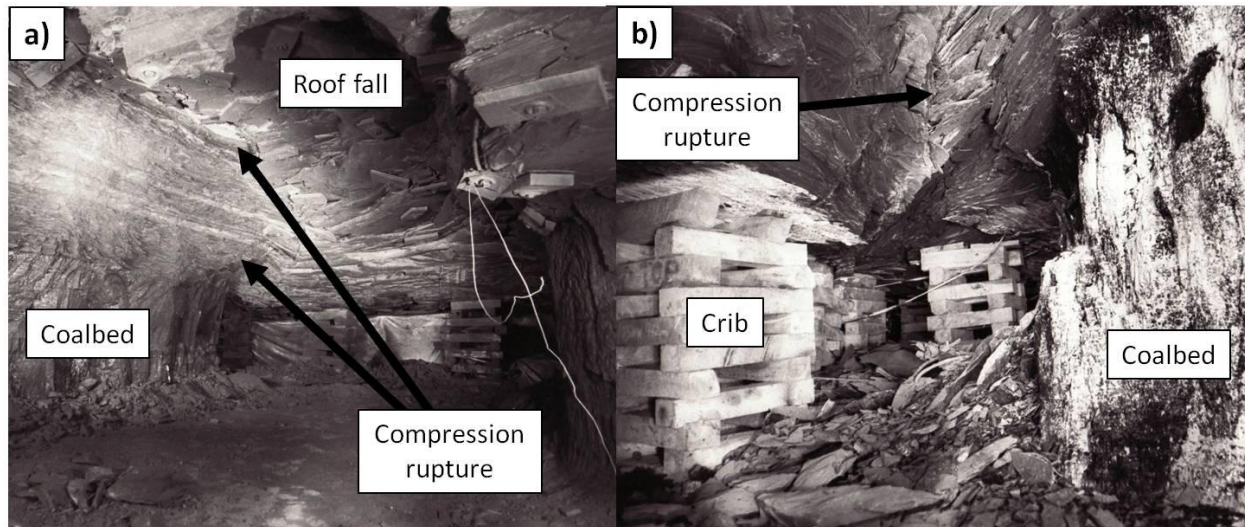
Molinda, et al. (1992) reported a close relationship between the valley bottom and unstable roof conditions at Mine 60. This mine is located adjacent to Mine Eighty-Four. The unstable conditions are often associated to compression ruptures occurring in the mine's roof rock. Mining professionals refer to this condition as cutter-roof failures (Figure VII-6). These compression ruptures buckle the strata, producing a very distinctive inverted “tee pee” shaped structure. Local mine operators reported that the most severe roof rock conditions occurred in north-south oriented entries (Molinda, et al., 1992), especially at low overburden (< 300-ft). Numerical modeling exercises indicated that steep-walled valleys concentrate more horizontal stress than broad-bottom valleys (Molinda, et al., 1992).

Figure VIII-6 - Photographs of compression ruptures a) along the side of a roof fall and b) close up within the roof-rib intersection area, Kitt Mine, northern West Virginia (photograph courtesy of A. Iannacchione).

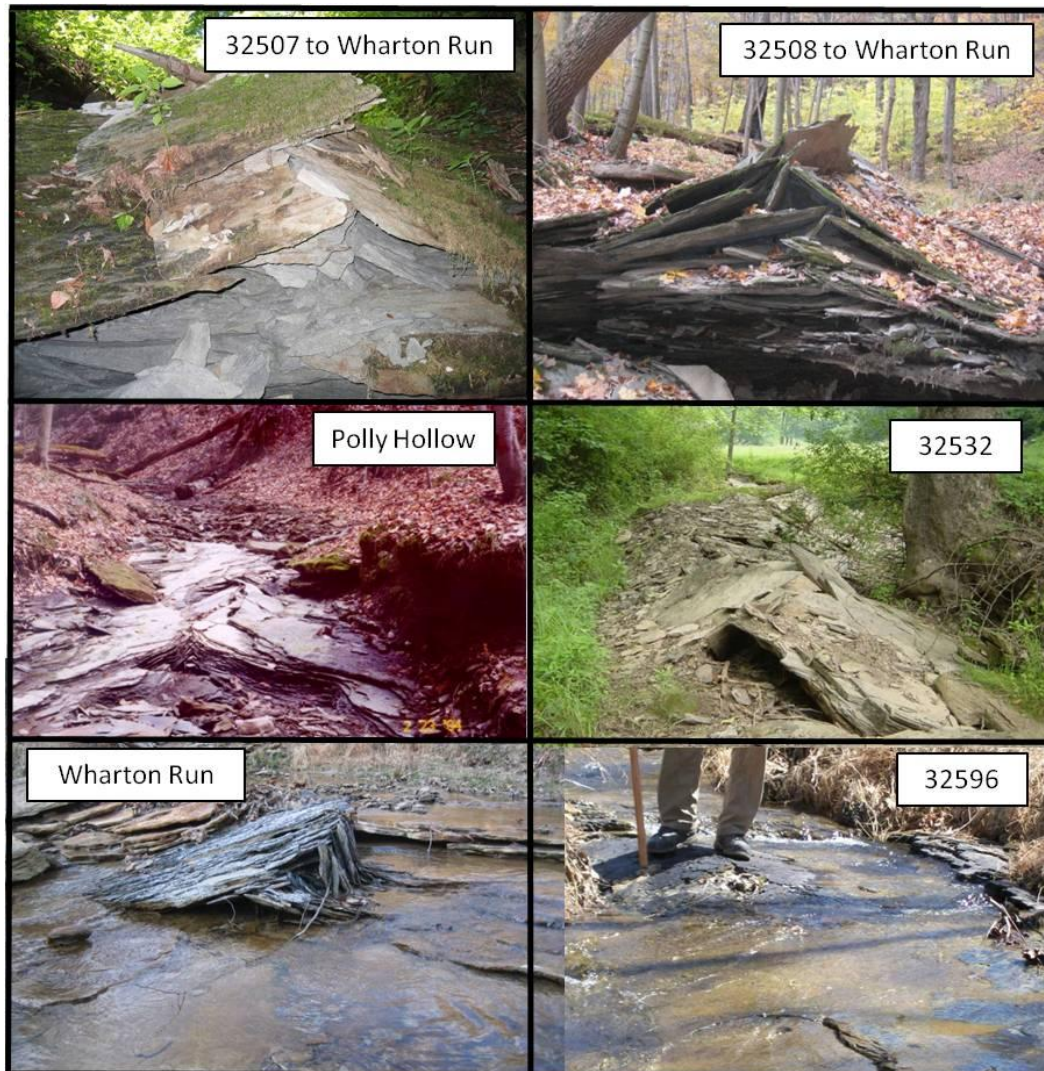
Compression ruptures, similar to those found in unstable roof rock conditions below north-south trending steep-sided stream valleys, can be found in several stream beds undermined by longwall mining. These compression ruptures buckle the strata, producing a distinctive “tee pee” shaped structure (Figure VII-7). These features are immediately subjected to the pull of gravity and to weathering, making them somewhat short-lived. When observed in the field, it is a relatively recent occurrence. Also, when stiff rocks like sandstone and siltstones rupture in response to compressive forces, the rupture surface propagates rapidly. Some residences have reported loud rumblings during the times when compression ruptures presumably occurred.

*Figure VII-7 –Photographs of compression ruptures found in stream beds over the Bailey Mine (Photographs from PA DEP files).*

When a compression rupture occurs, the stream flow can be diverted beneath the surface. For this to occur, the rupture must extend many feet into the stream bed and propagate the entire length of dry sections. The force needed to generate ruptures of the magnitude shown in Figure

VII-7 must be large. The University observed grout pumped into the rupture along stream No. 32596 (Figure VII-7). This grouting effectively filled the voids associated with the rupture surface and kept the water flowing across the top of the stream bed.

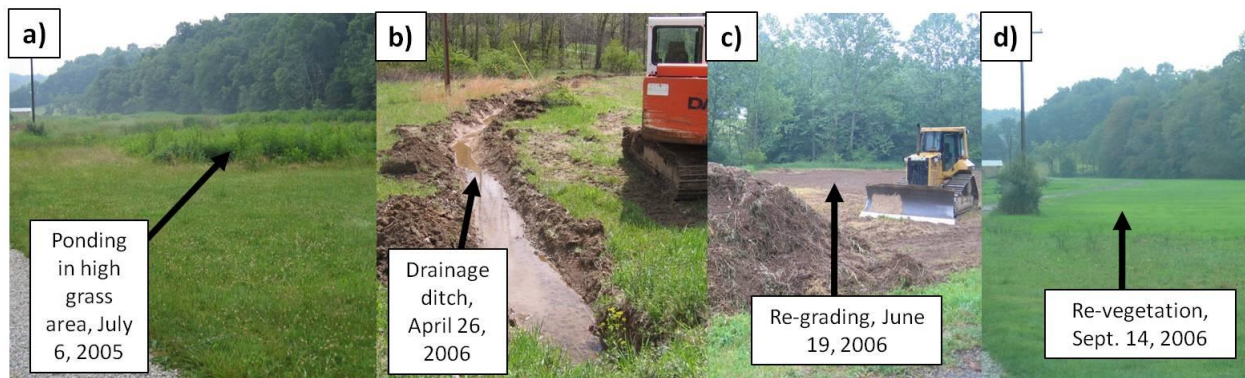
Figure VII-11 – Photographs of a commonly used method to repair settlement impacts after ponding resulted within a field or pasture (Photographs from PA DEP files).

- The extent of abnormal standing water was established (Figure VII-11a),
- A ditch was established to improve drainage (Figure VII-11b),
- The settled area was re-graded (Figure VII-11c), and
- The site was re-vegetated (Figure VII-11d).

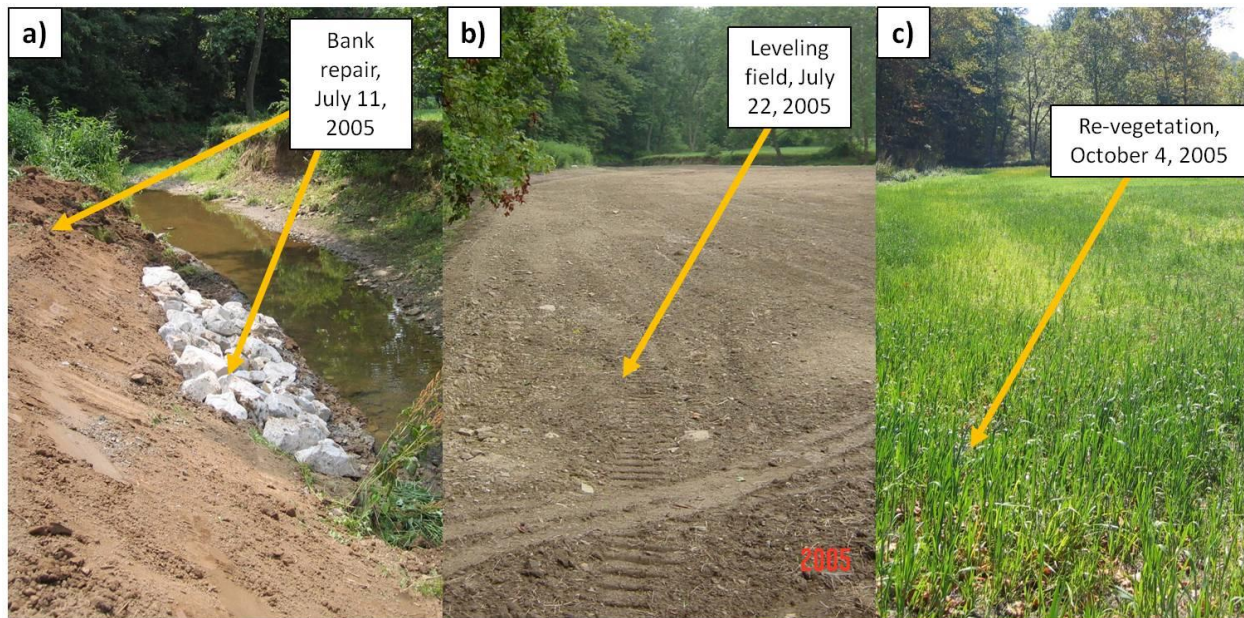
*Figure VII-12 – Photographs of a common repair technique for settlement impacts adjacent to streams that caused ponding within a field or pasture (Photographs from PA DEP files).*

- The extent of abnormal standing water was established,
- The bank of stream was built-up to prevent the stream from flooding the adjacent field or pasture (Figure VII-12a),
- The settled area was re-graded (Figure VII-12b), and
- The site was re-vegetated (Figure VII-12c).

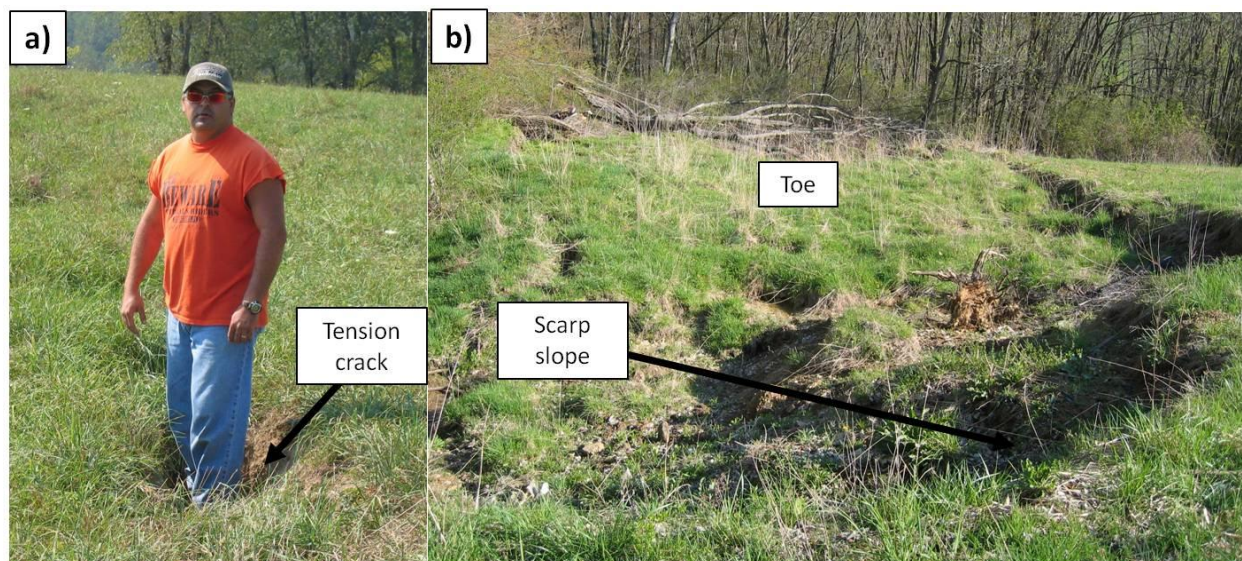
Examples of a tension crack and a mass wasting impacts are shown in Figure VII-14. Tension cracks like the one shown in Figure VII-14a can present a hazard for people and animals traveling over them. Determining the cause of mass wasting impacts requires professional judgment. Figure VII-14b shows a mass wasting impact over the Cumberland Mine that was not classified as a reported effect.

Figure VII-14 - Photographs of a) tension crack and b) mass wasting impacts to the surface. The first is a reported effect and the second is not (Photograph from PA DEP files).

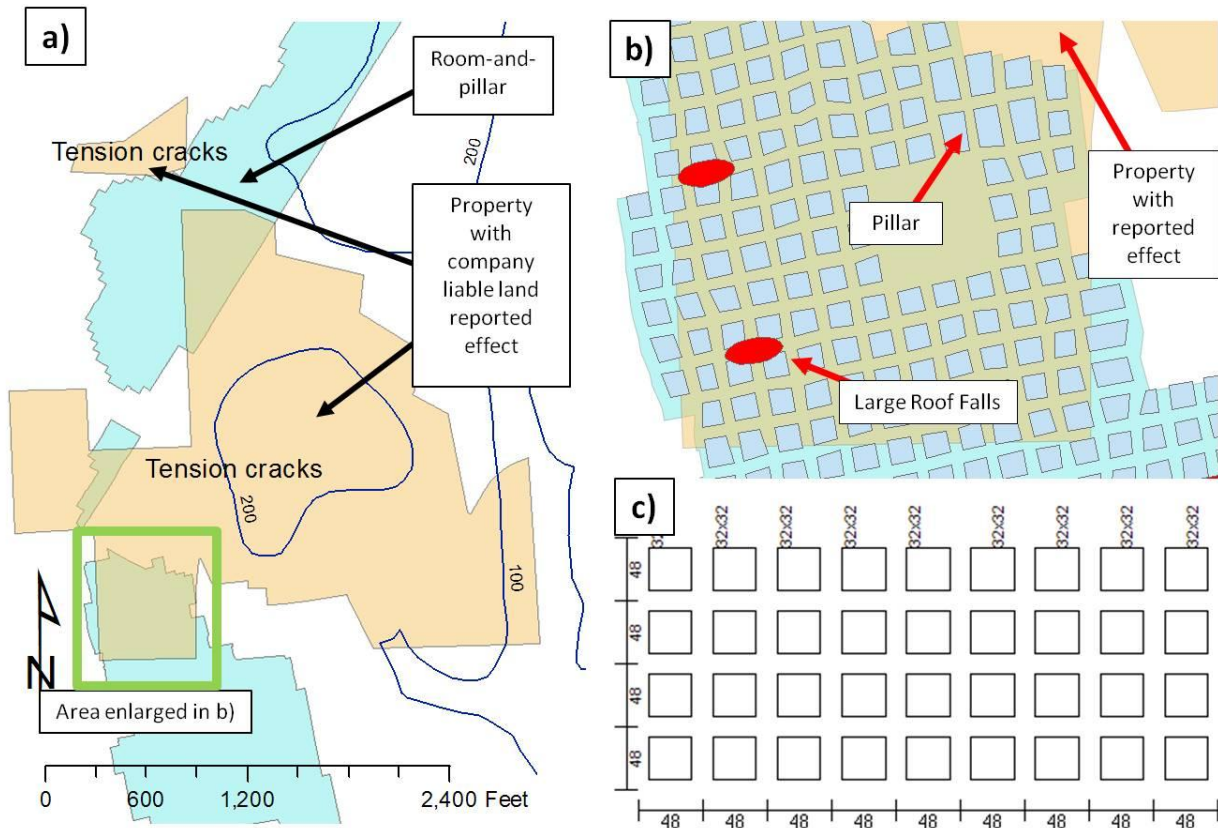
The Ridge Mine had two land reported effects and both were Company Liable (Figure VII-19a). Both property descriptions involved cracks in the ground surface. BUMIS listed pillar failure as the source of the impact, but the pillar layout does not change over the mine (Figure VII-19b) and the overburden above the room-and-pillar areas of the two properties was shallow (< 185-ft, Table II-16). The ARMPS program was used to examine the stability factor for this design. Using the 6-ft extraction height that is common for the Pittsburgh coalbed, 32 by 32-ft pillars, 16-ft entry widths, and an overburden of 150-ft, a stability factor of approximately six was calculated (Figure VII-19c). With a stability factor this large, it is highly unlikely that pillar failure was the cause of these reported effects. An alternative cause might be associated with roof falls that occurred in different parts of the mine where the overburden ranges from 100 to 200-ft. These roof falls were found on 6-month mining maps. It is possible that the surface could develop tension cracks above large roof fall areas underground, when overburden is low.

Figure VII-19 - Location of a) properties with land reported effects where the Ridge Mine is liable, b) pillar layout beneath the property where tension cracks were observed and roof falls noted on the 6-month mining maps, and c) ARMPS pillar layout characteristics.

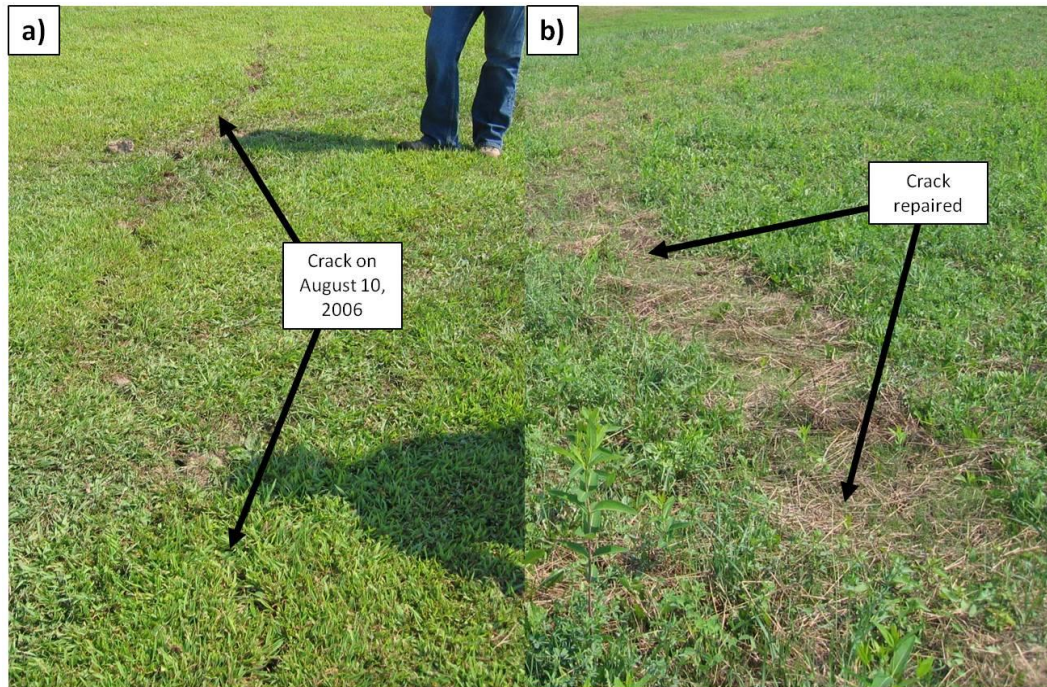
The tension cracks associated with these land reported effects were smaller in length and narrower in width than some of the tension cracks discussed for longwall mines (Figure VII-20a). For both reported effects, the tension cracks were filled to produce a level surface (Figure VII-20b).

Figure VII-20 - Photographs of a) crack on August 10, 2006 and b) repair of a previous crack at the Ridge Mine (Photographs from PA DEP files).
