THE FAILURE OF THERMAL BARRIER COATINGS AT ELEVATED TEMPERATURES

Submitted to the Graduate Faculty of
the School of Engineering in partial fulfillment
of the requirements for the degree of
Doctor of Philosophy

University of Pittsburgh

2004

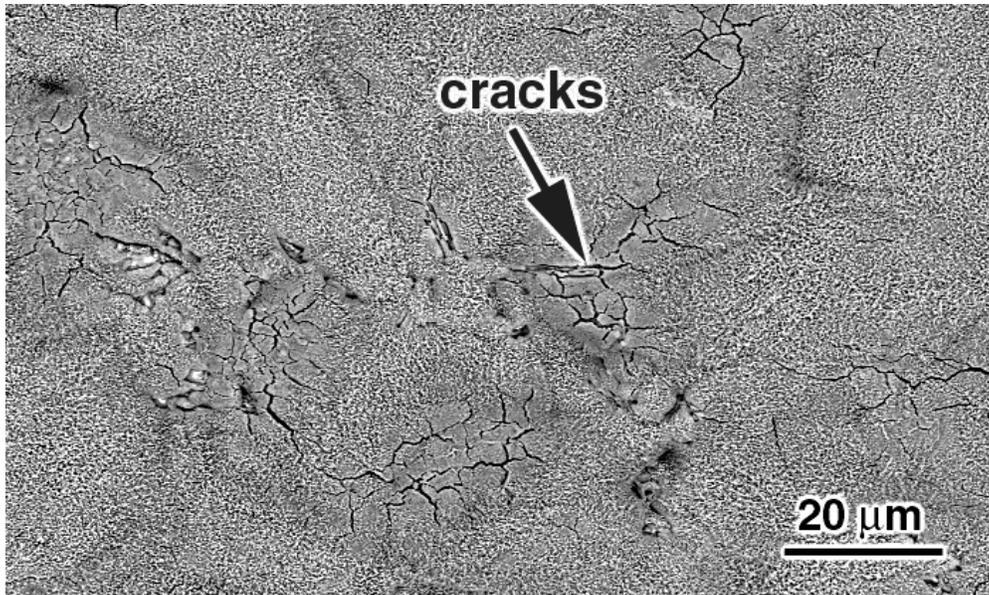
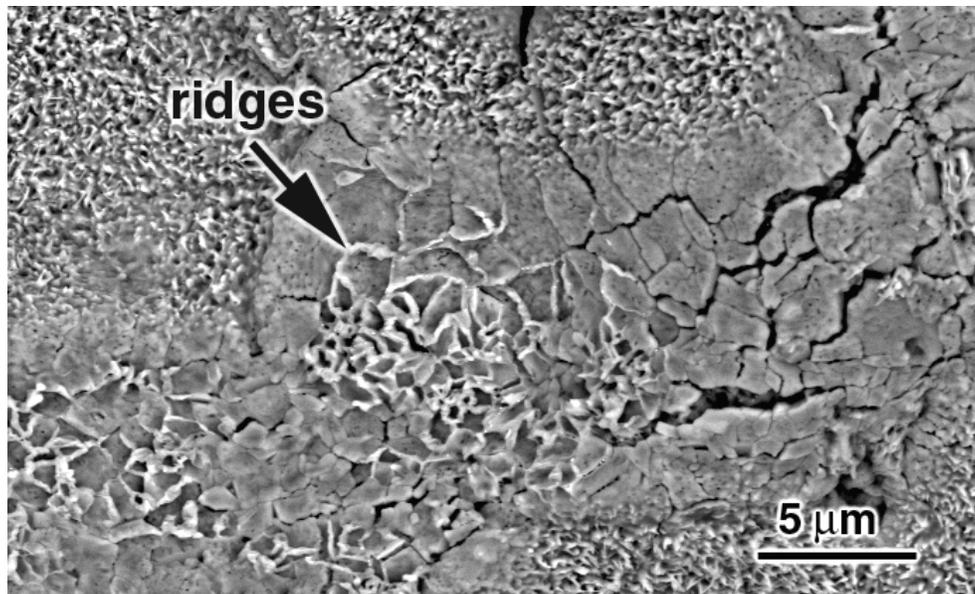
Figure 19 Scanning electron micrographs from the surface of the Pt aluminide bond coat, which was exposed at 1200°C for 15 hours, showing the cracks that developed due to volume reduction following the phase transformation from metastable to stable alumina, (a), and the oxide ridges developing at these cracks, (b).

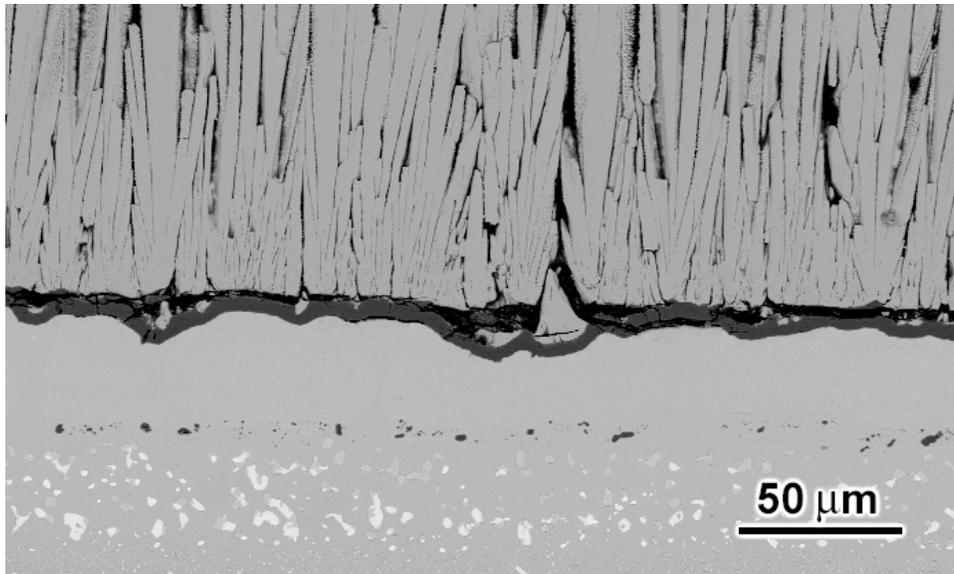
Figure 60 Scanning electron micrographs from the fracture surface of a state of the art TBC system with Pt Aluminide bond coat at (a) low and (b) high magnifications. A significant amount of failure was above the TGO/BC interface.

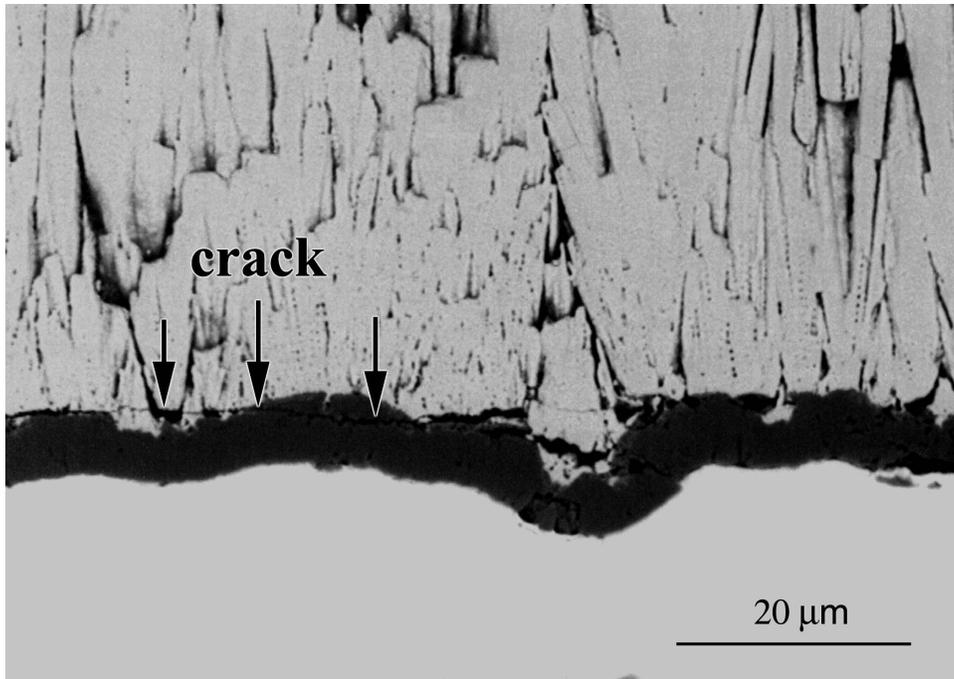
(c)

Figure 61 Scanning electron micrographs of TBC systems with state of the art Pt aluminide bond coats before (a), and after failure (b), both of which give examples to deformation of the bond coat with thermal exposure. Cracks initiate in the vicinity of the deformed areas (c).

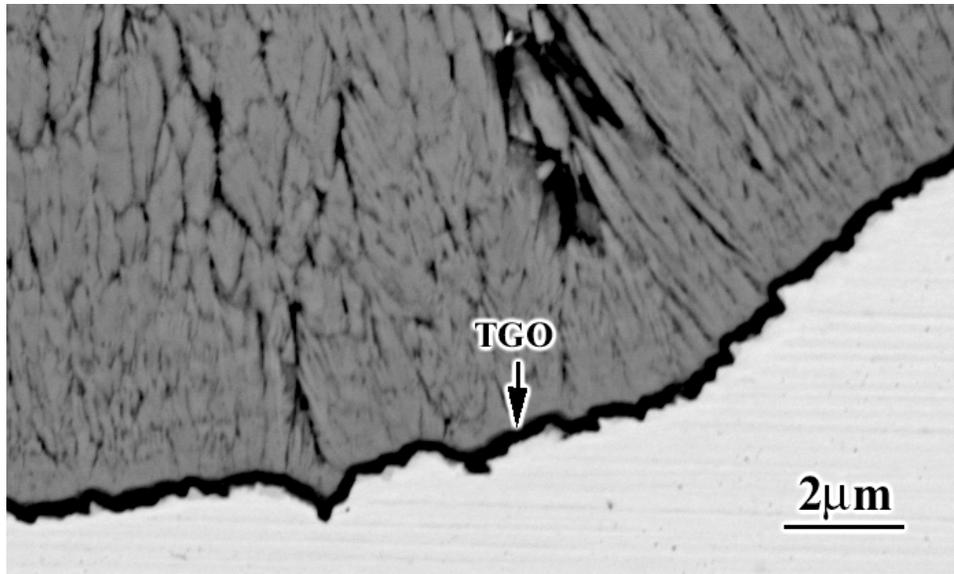
Figure 67 Scanning electron micrographs of a TBC system with a Pt overlayer on NiCoCrAlY bond coat in the as processed condition showing (a) highly irregular interface with associated TBC defects, (b) defective areas in the vicinity of large embedded grit blast particles, (c) very uniform and continuous TGO.

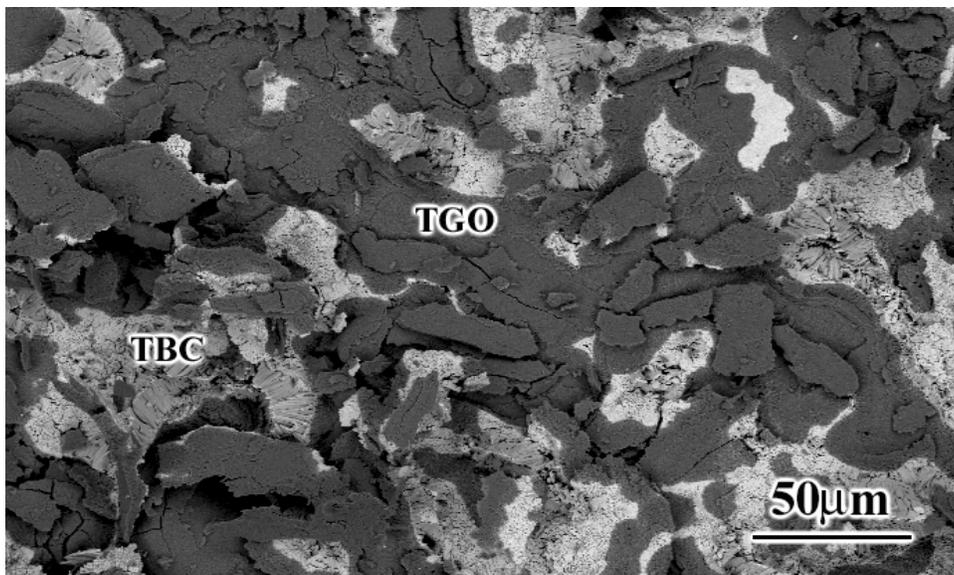
(b)

Figure 69 Fracture surface of the TBC system with Pt overlayer on the NiCoCrAlY bond coat showing that the failure was mainly along the TGO/TBC interface, as well as in the TBC and in the TGO (a). A higher magnification micrograph from the fracture surface is presented in (b).

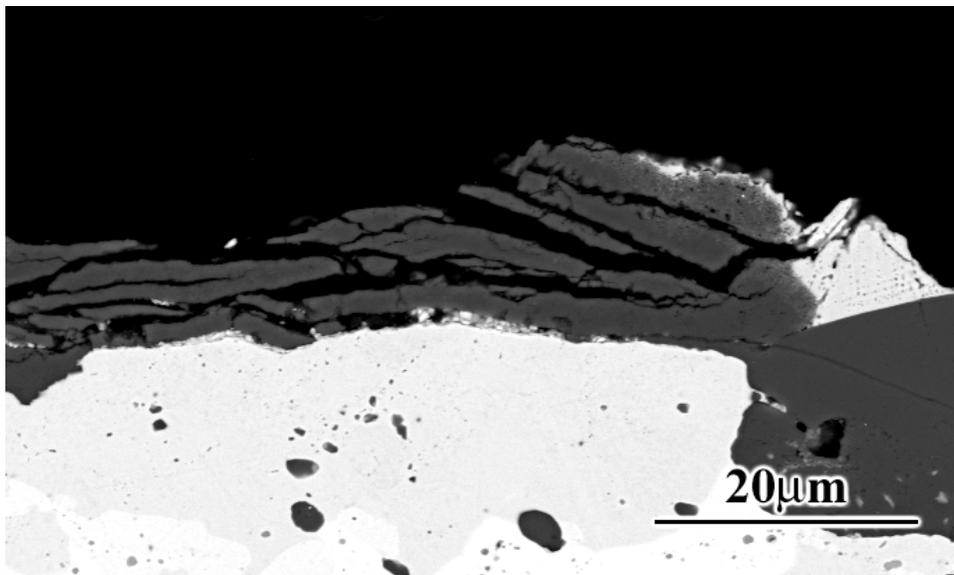
(d)

Figure 71 Scanning electron micrograph of the TBC system with Pt overlayer on the NiCoCrAlY bond coat after it failed, showing the extensive amount of oxidation along the initial bond coat/ Pt overlayer interface

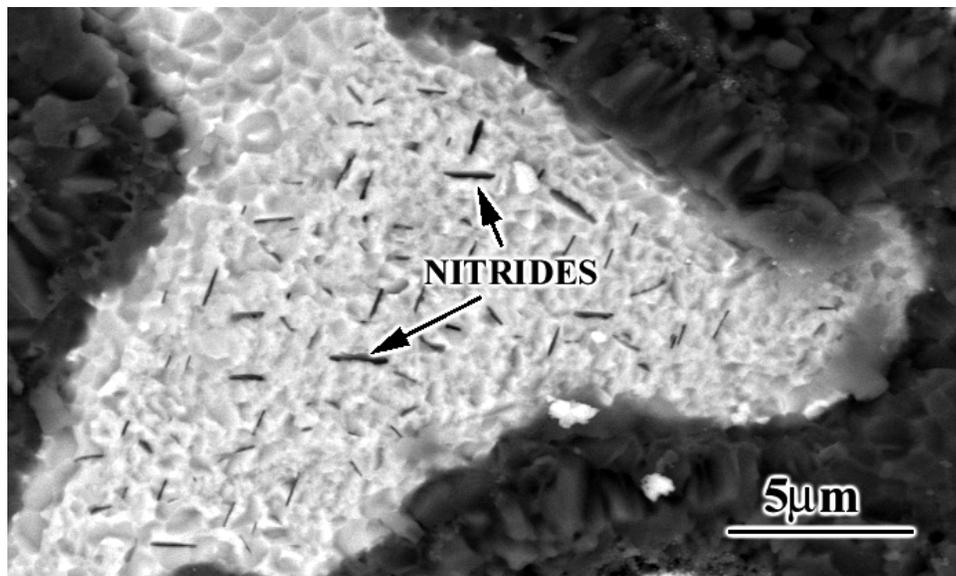
Figure 79 Scanning electron micrographs of TBC systems with aluminized NiCoCrAlY bond coats after failure. (a) The interface became more irregular with time, (b) Significant amount of failure was along or close to TGO/TBC interface, (c) There were indications of separation and reformation of the alumina prior to failure, (d) Al rich nitrides were observed at these sites where separation occurred prior to failure

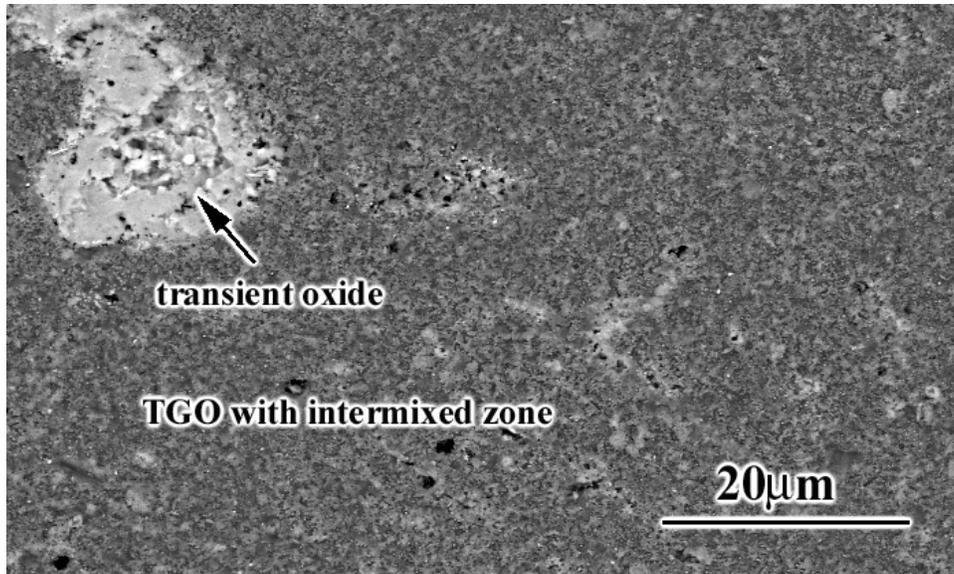
(e)

Figure 84 Scanning electron micrographs of a TBC system on hand polished NiCoCrAlY bond coat which failed after 220 cycles of exposure at 1100°C. Significant amount of failure was along the TGO/intermixed zone interface as can be seen at (a) low and (b) high magnification micrographs from the fracture surface, as well as cross sectional micrographs, (c) and (d). Transient oxides were also present embedded in the intermixed zone, (e).

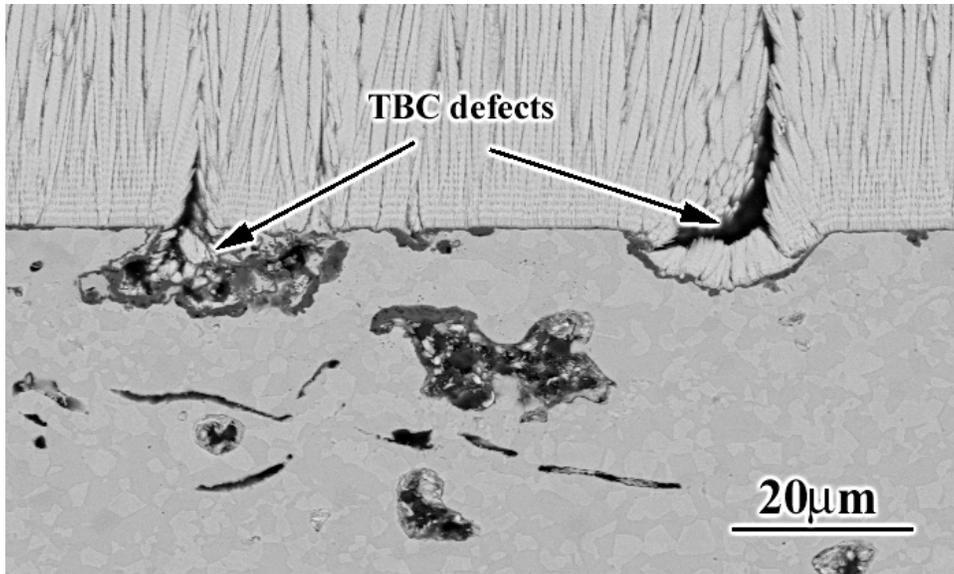
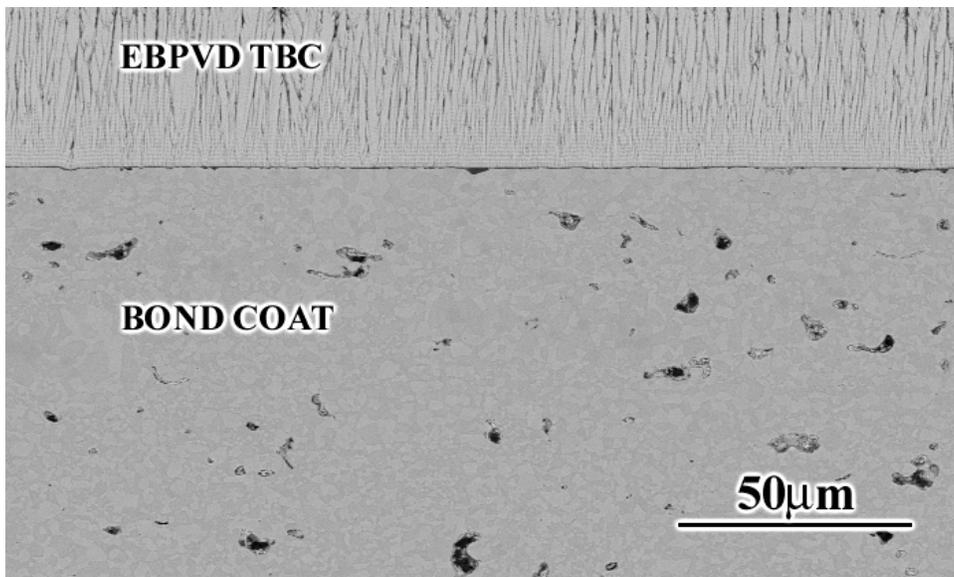
Figure 85 Scanning electron micrographs of a TBC system with vibro finished NiCoCrAlY bond coat in the as processed condition showing large TBC defects, (a). There were also smooth areas along the interface, (b).

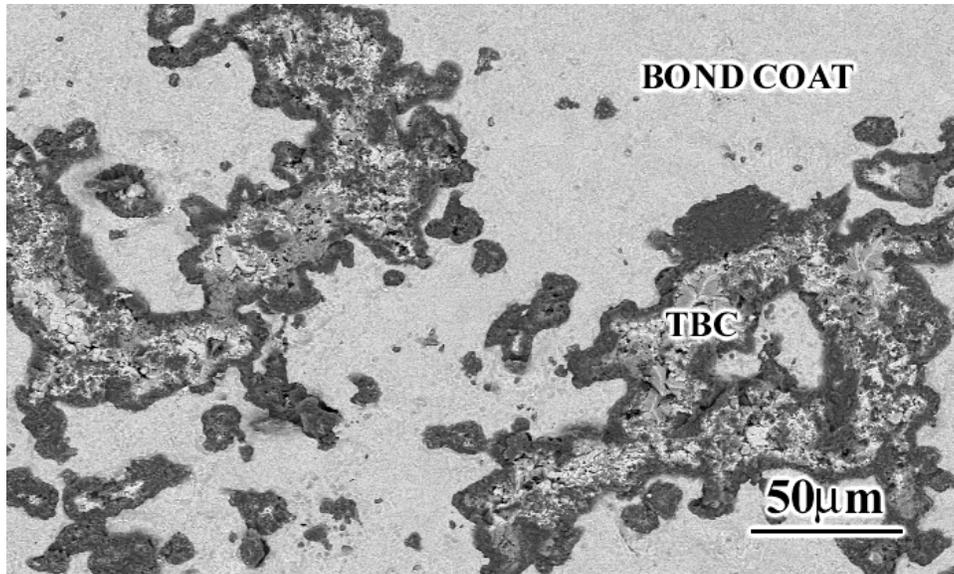
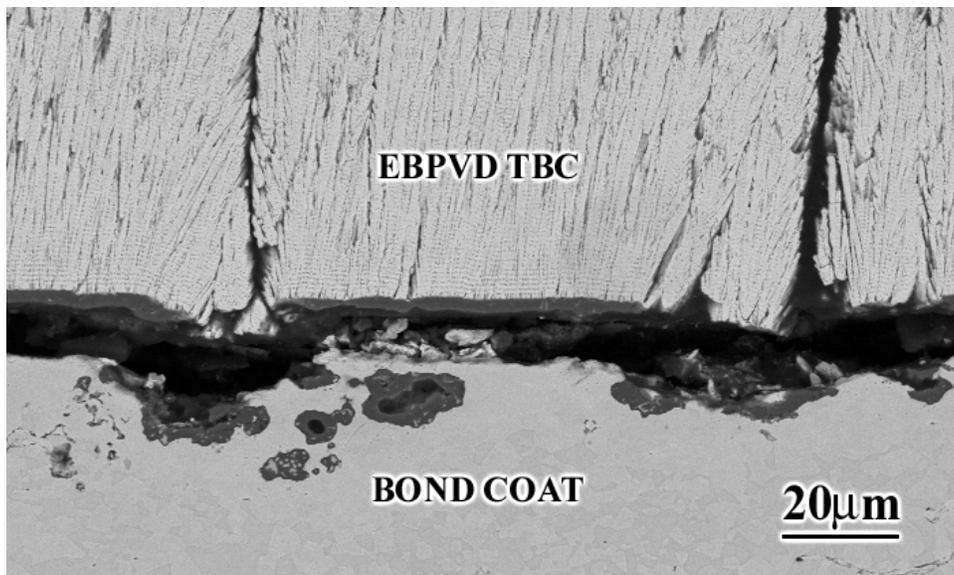
Figure 86 Scanning electron micrographs of a TBC system with vibro finished NiCoCrAlY bond coat from the fracture surface, (a), and cross section, (b), showing failure in the vicinity of pronounced TBC defects.

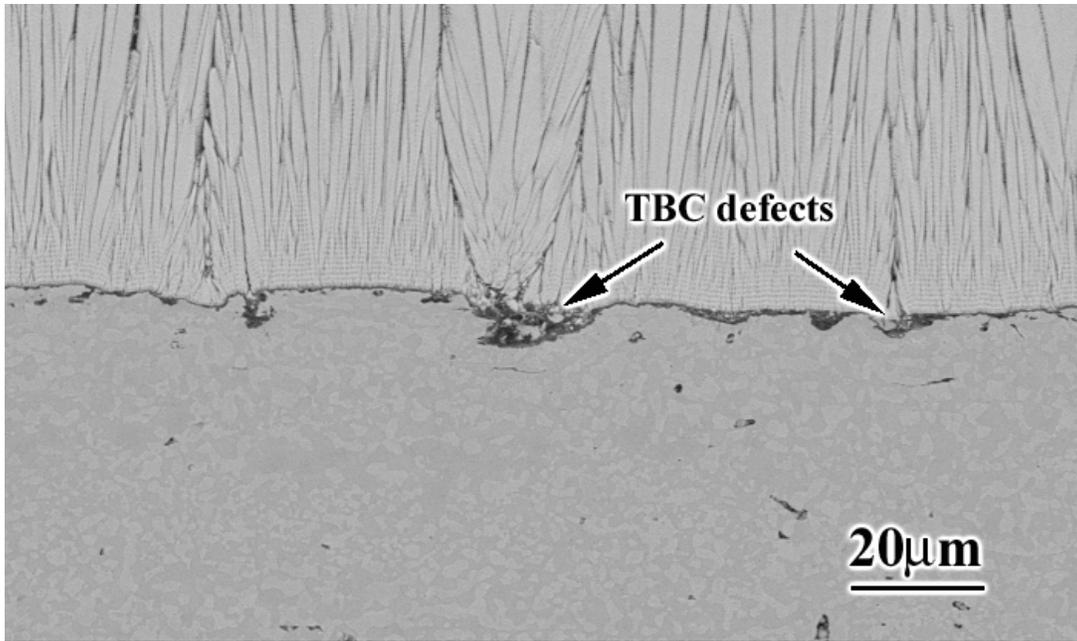
Figure 87 Scanning electron micrograph from a TBC systems with media finished NiCoCrAlY bond coat in the as processed condition showing the presence of TBC defects.

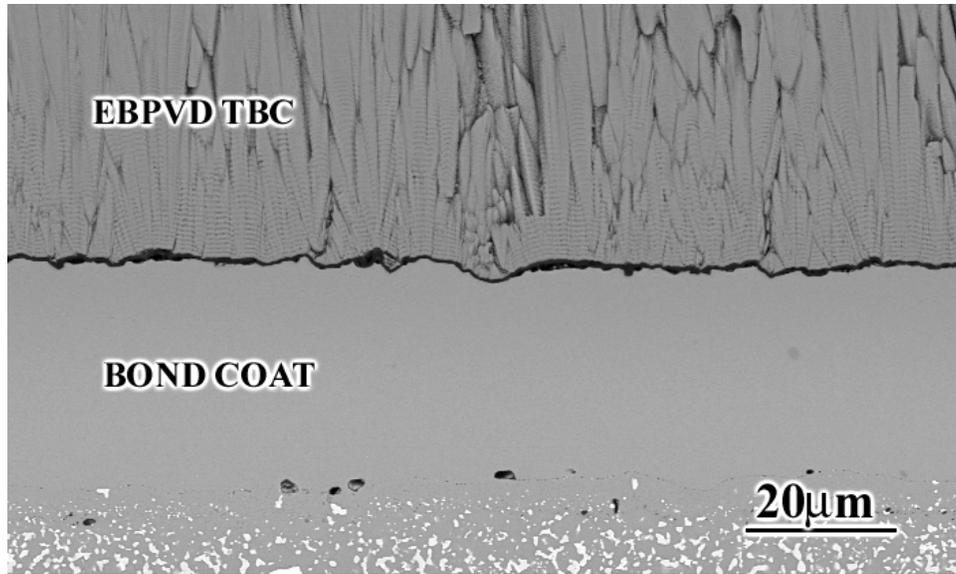
Figure 96 Scanning electron micrograph of a TBC system with light grit blasted Pt aluminide bond coat in the as processed condition showing a relatively smooth interface compared to the interfaces of heavy grit blasted Pt aluminides.
