AN EVALUATION OF THE SUBSTRATE EFFECT ON THE PERFORMANCE OF
YSZ EB-PVD THERMAL BARRIER COATINGS

Igor Steven Garcia

Submitted to the Graduate Faculty of
School of Engineering in partial fulfillment
of the requirements for the degree of
Master of Science

University of Pittsburgh

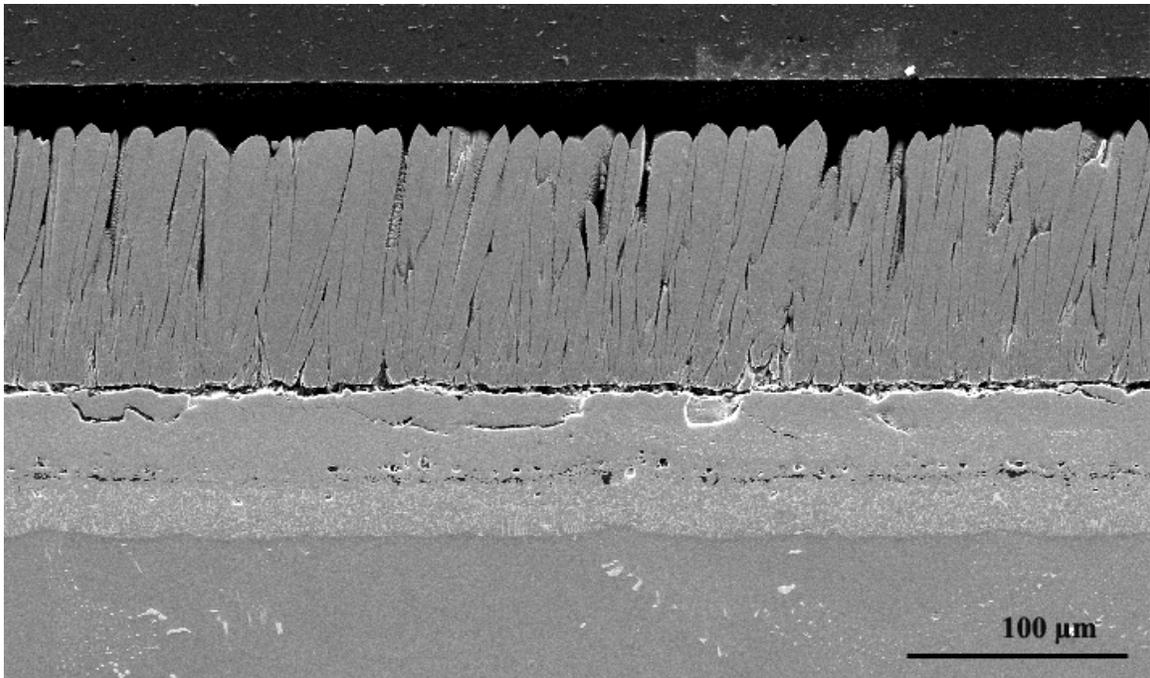
Figure 7.3 As processed thermal barrier coating system with cracks present inside the bond coat and along the YSZ and bond coat interface.

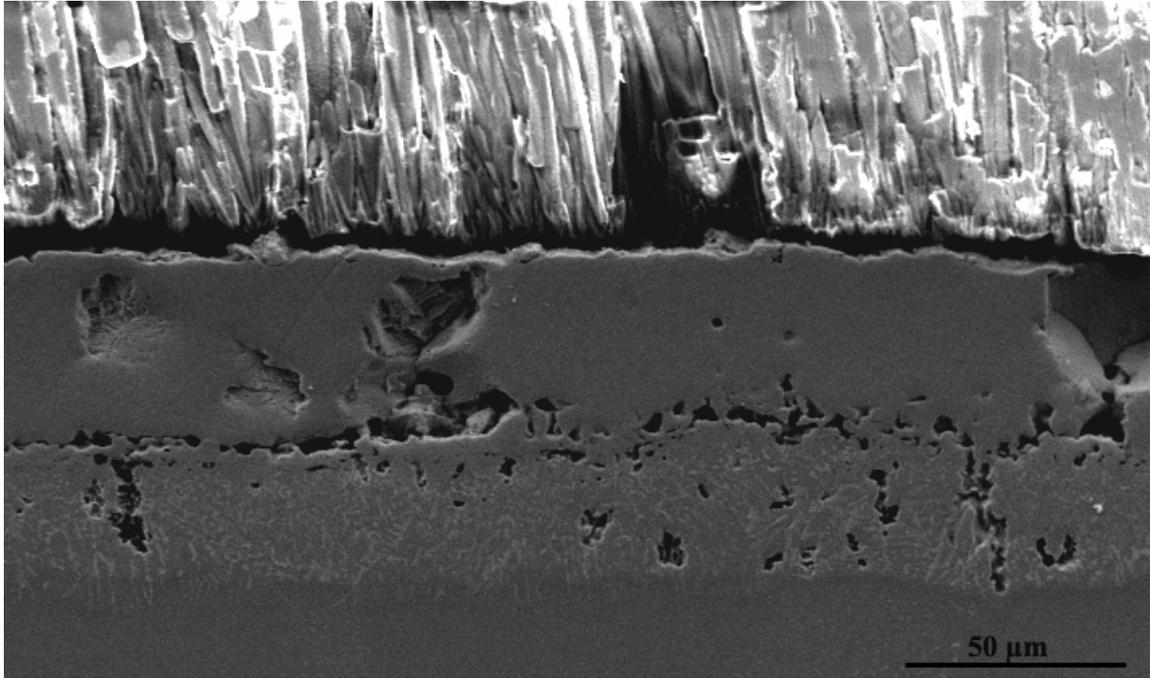
Figure 7.4 As processed bond coat with numerous holes along the bond coat /ceramic overlayer interface. Holes run into the interdiffusion area.

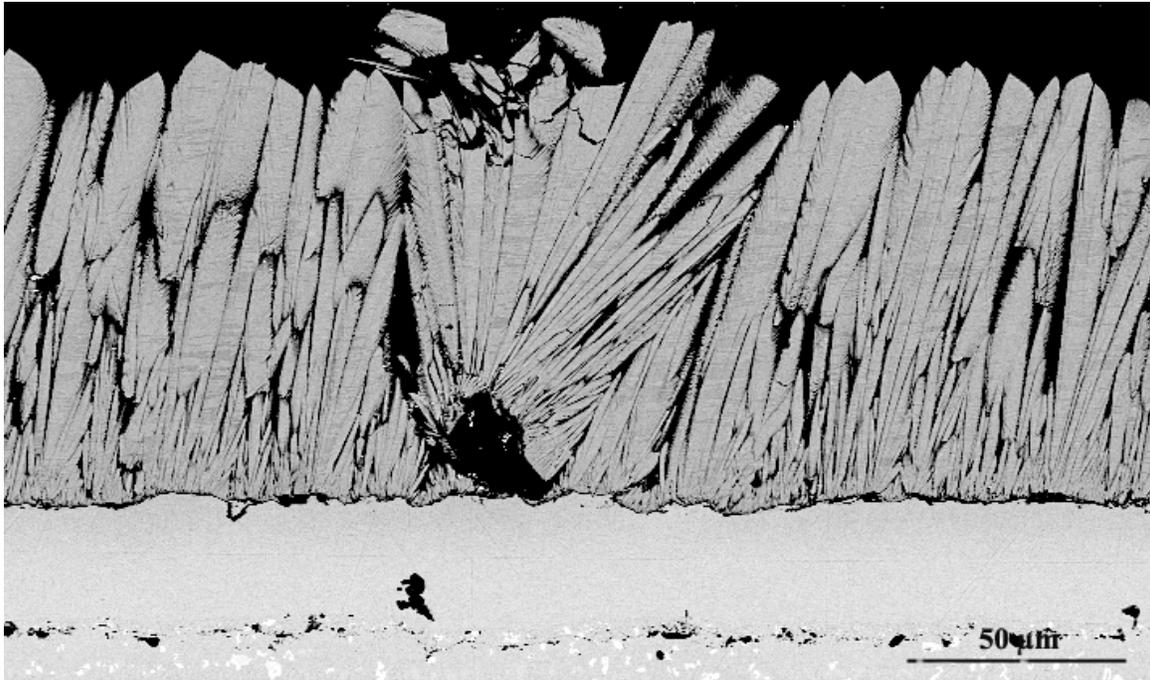
Figure 7.6 Conical defect created by the rough surface does not have a contact point with the bond coat.

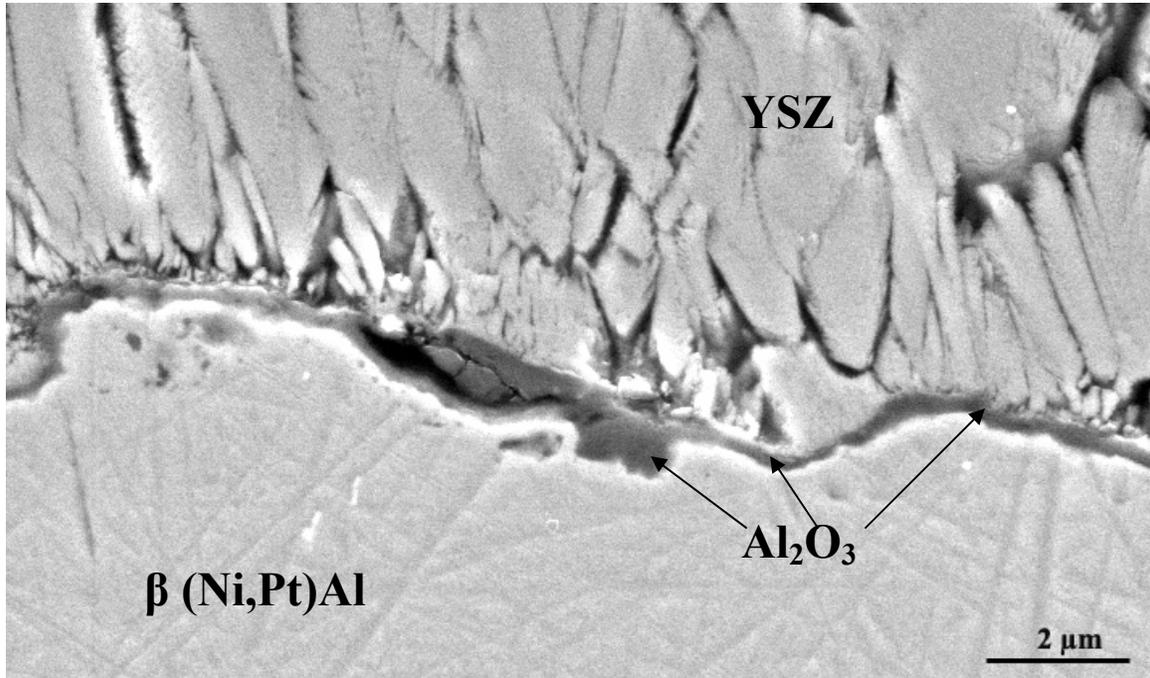
Figure 7.9 A porous YSZ/TBC interface with various discontinuities, also a thin Al₂O₃ layer close to 200 nm.

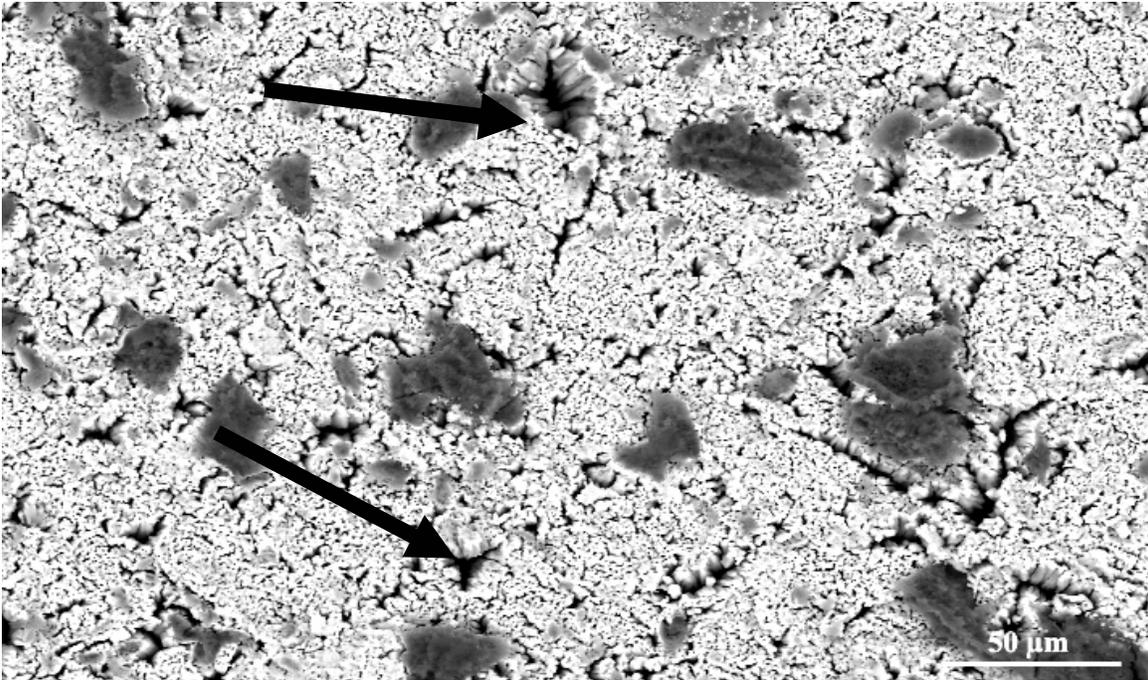
Figure 7.14 Closer look at the YSZ/TGO failure surface shows the loss of YSZ noted by black arrows, and the alumina adhered to the surface.

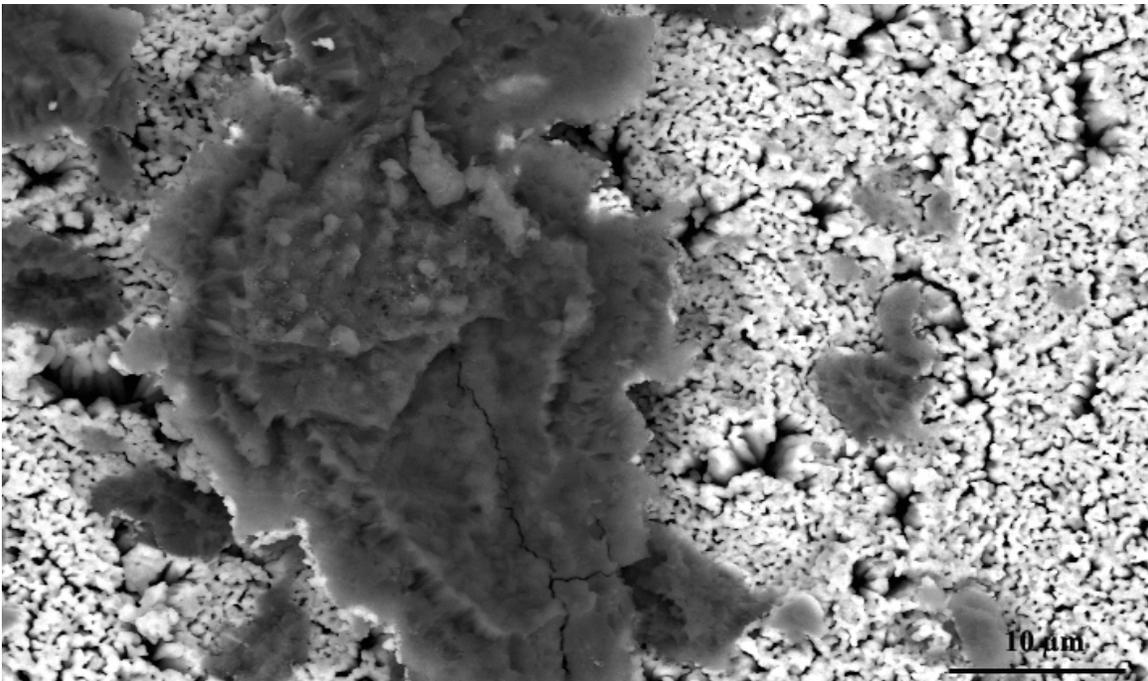
Figure 7.15 Thermally grown oxide adhered to the YSZ after failure of the TBC system on a N5 specimen.

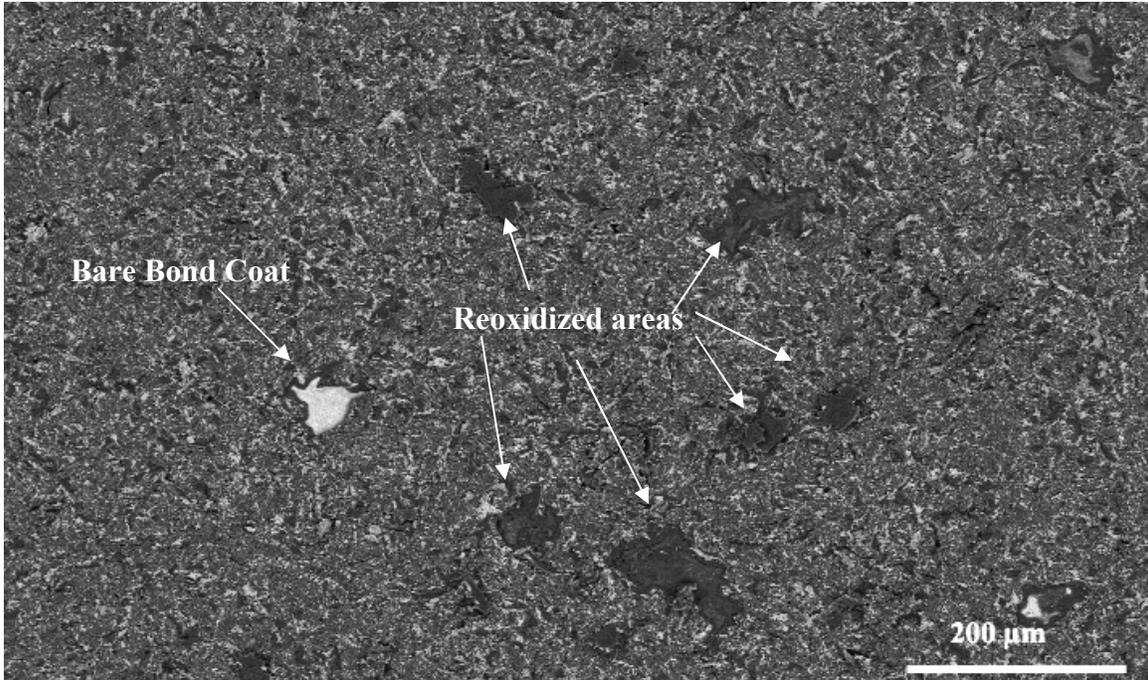
Figure 7.16 Surface area of the substrate after failure shows a large amount of alumina and various bond coat reoxidized sites.

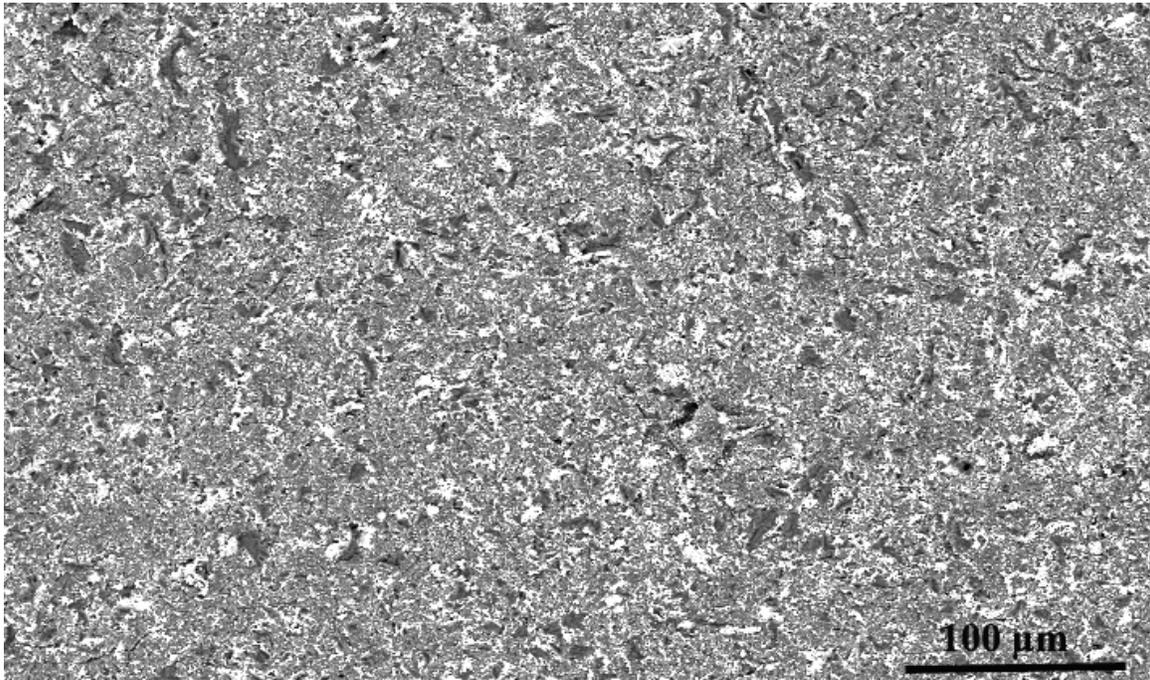
Surface holes were also present at the substrate surface failure as seen in Figure 7.17. A magnification of these holes on Figure 7.18 yielded high traces of Ni, Al, and O. Figures 6.19-6.21 show an area of the bare bond coat, which shows very different features. Figure 7.19 shows a micrograph of a reoxidized area, with large traces of Ni, and some traces of Cr. The following figure exposed surface, shows the formation of alumina on a Ni rich surface, Figure 7.20. Finally, Figure 7.21 shows the initial stage of a bare bond coat prior to reoxidation. In this figure, different shades on the substrate are seen, which are featured holes along which grain boundaries are noted.

Figure 7.17 Substrate failure surface shows some YSZ adhered and underneath the thermally grown oxide.

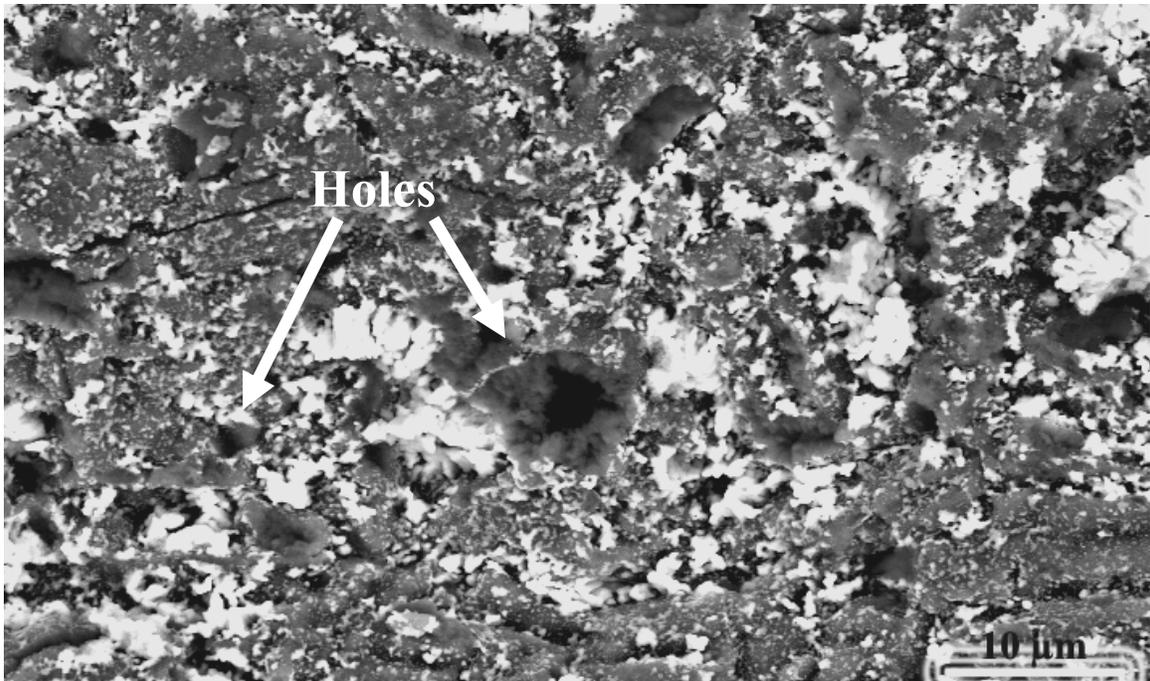
Figure 7.18 Numerous holes on the substrate surface after failure, also seen is the detached YSZ adhered to the TGO.

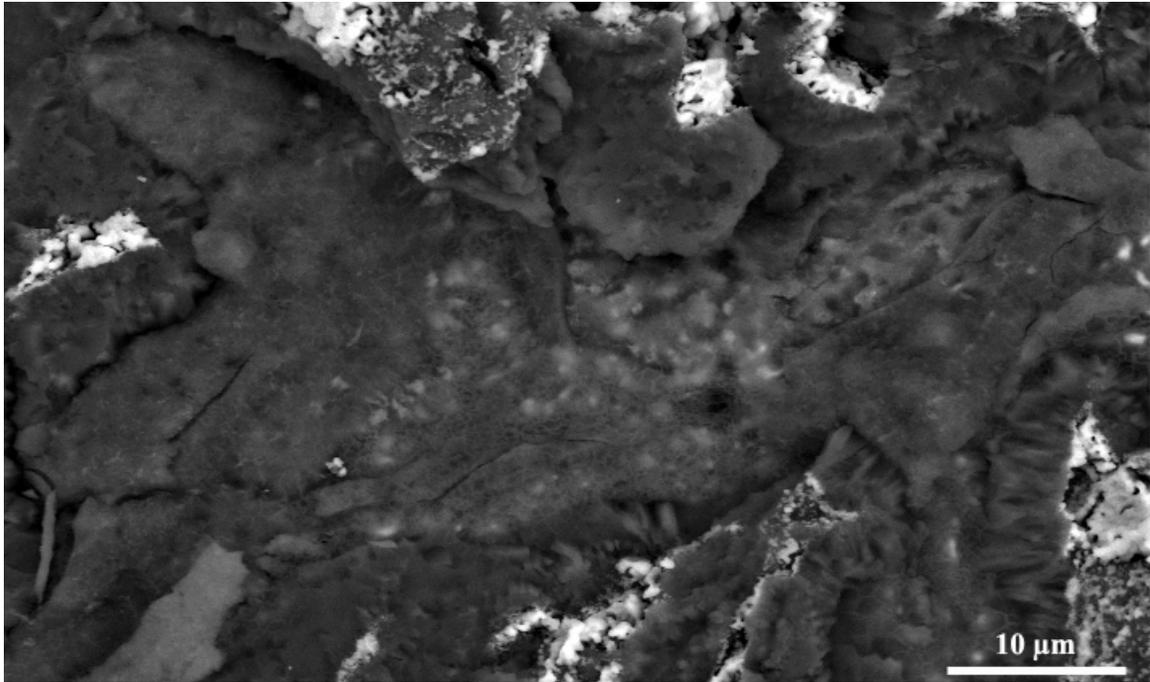
Figure 7.19 Reoxidized bond coat surface.

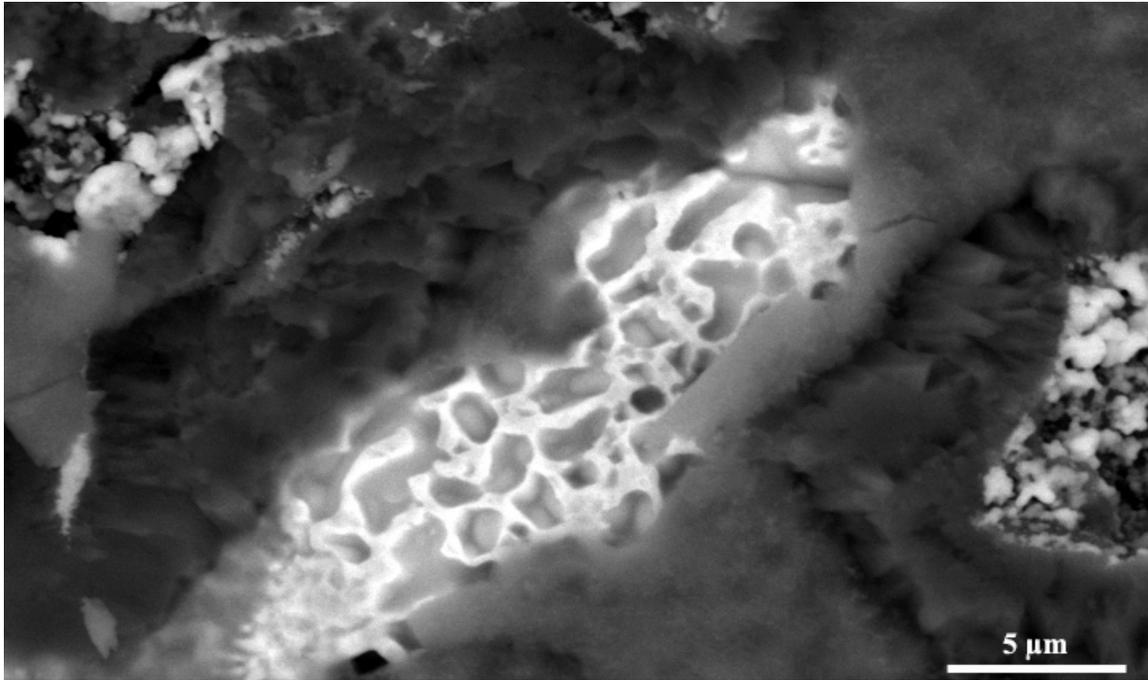
Figure 7.21 Nickel rich bare bond coat shows holes and grain boundaries on the bond coat.

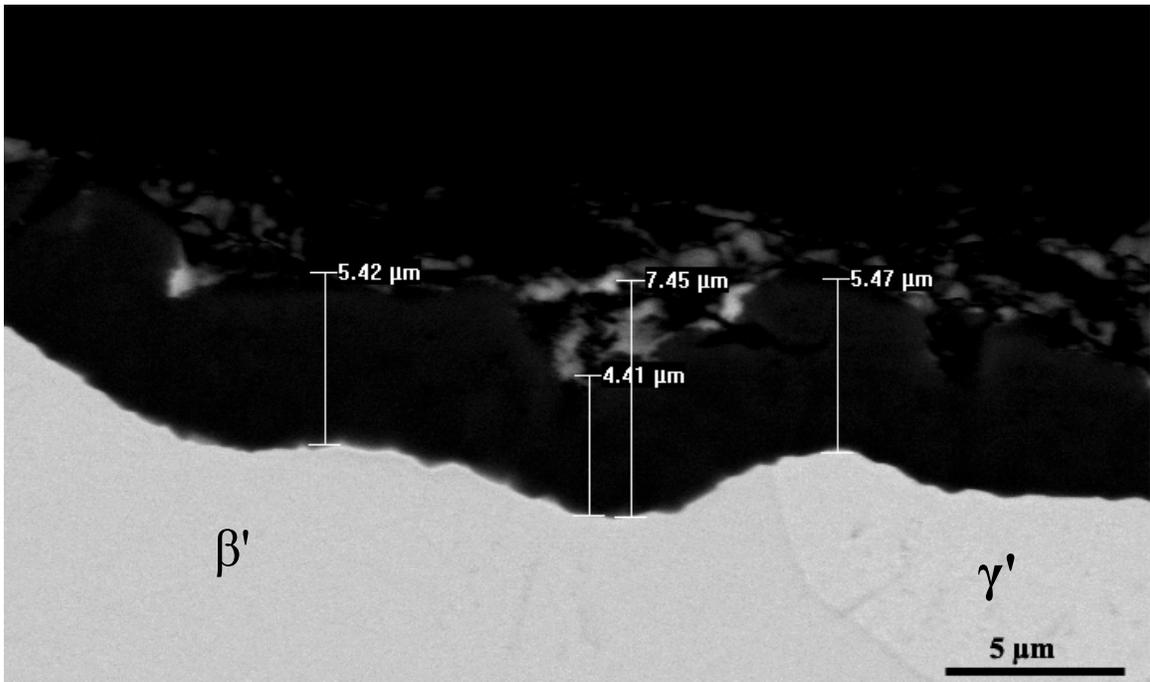
Figure 7.23 Ratcheting effect increases undulations while simultaneously accumulating oxide. Both β' and γ' populate the bond coat region.

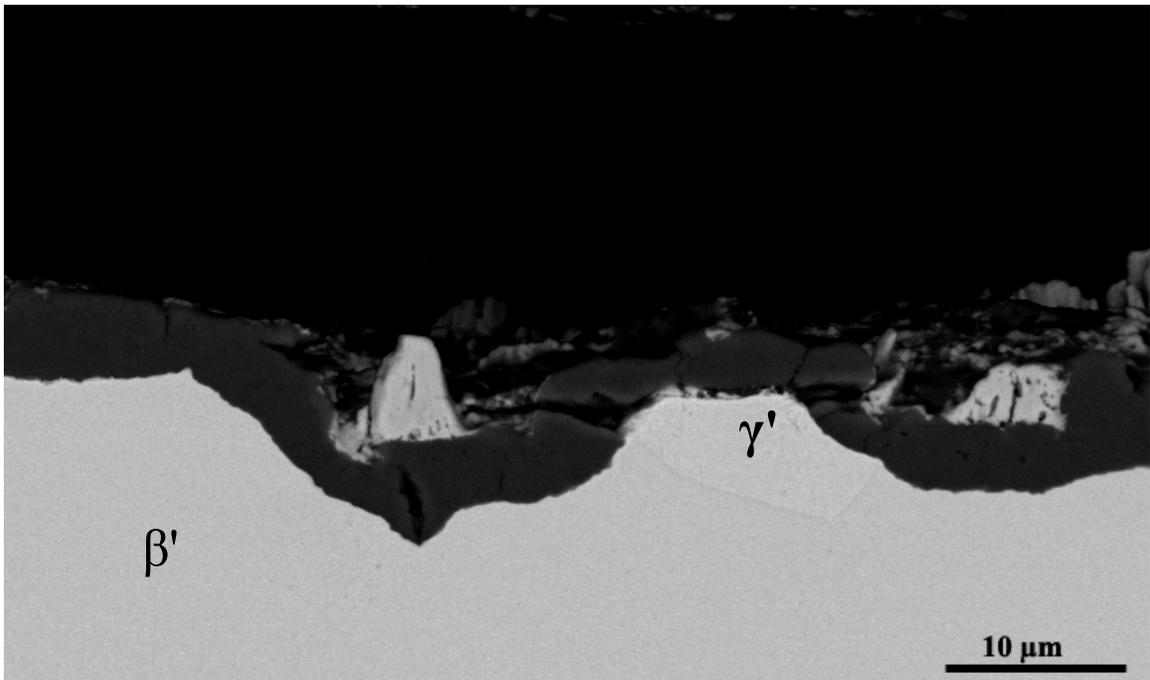
Figure 7.24 TGO thickness at failure for N5. TGO appeared to deform at martensitic regions and not FCC.

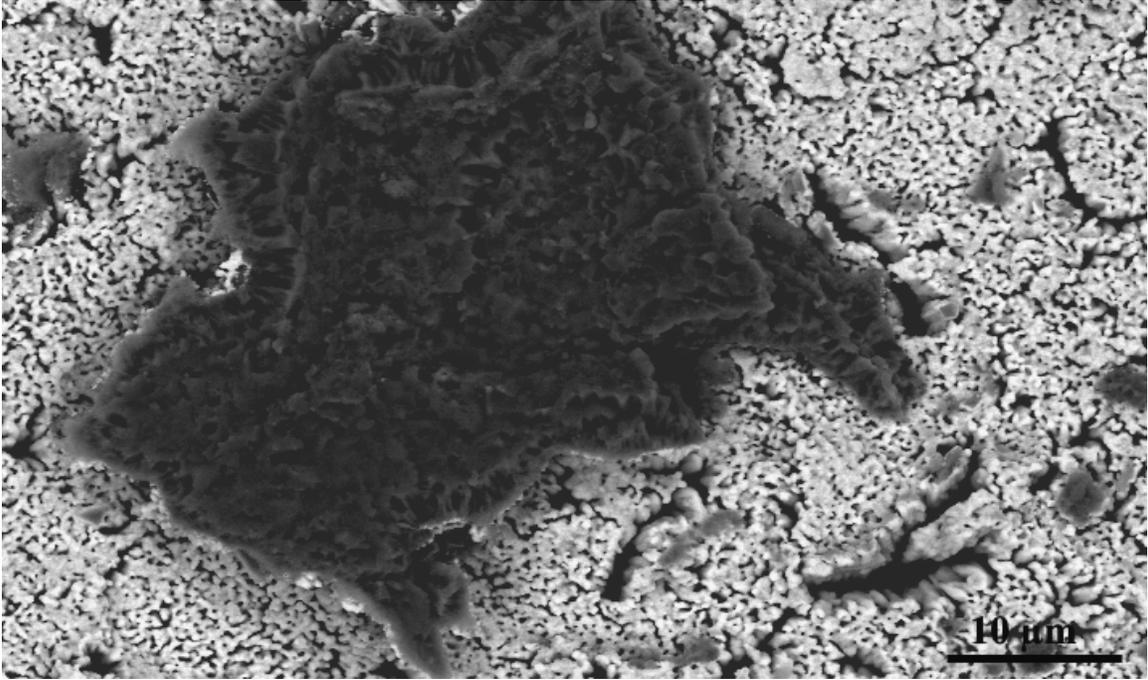
Figure 7.27 Alumina bit adhered to the YSZ scale after failure. YSZ holes also are present on this surface, indicative of YSZ loss during cyclic heat treatment.

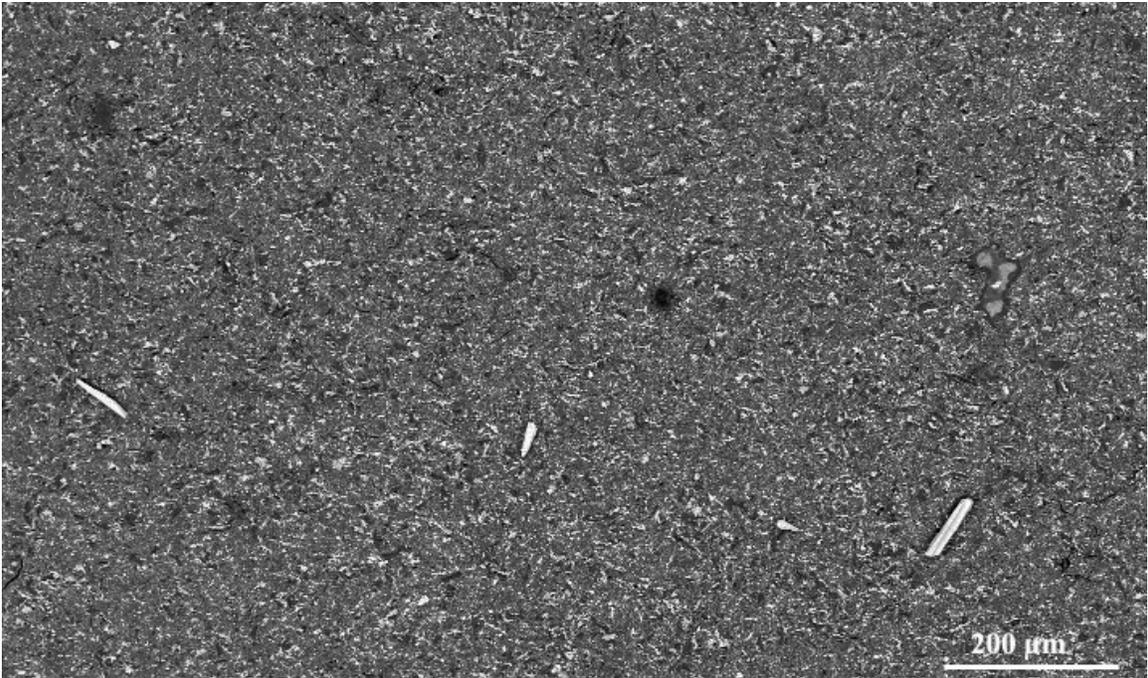
Figure 7.28 Substrate failure surface after 740 cycles, with spalled/reoxidized area at the mid right area and numerous holes.

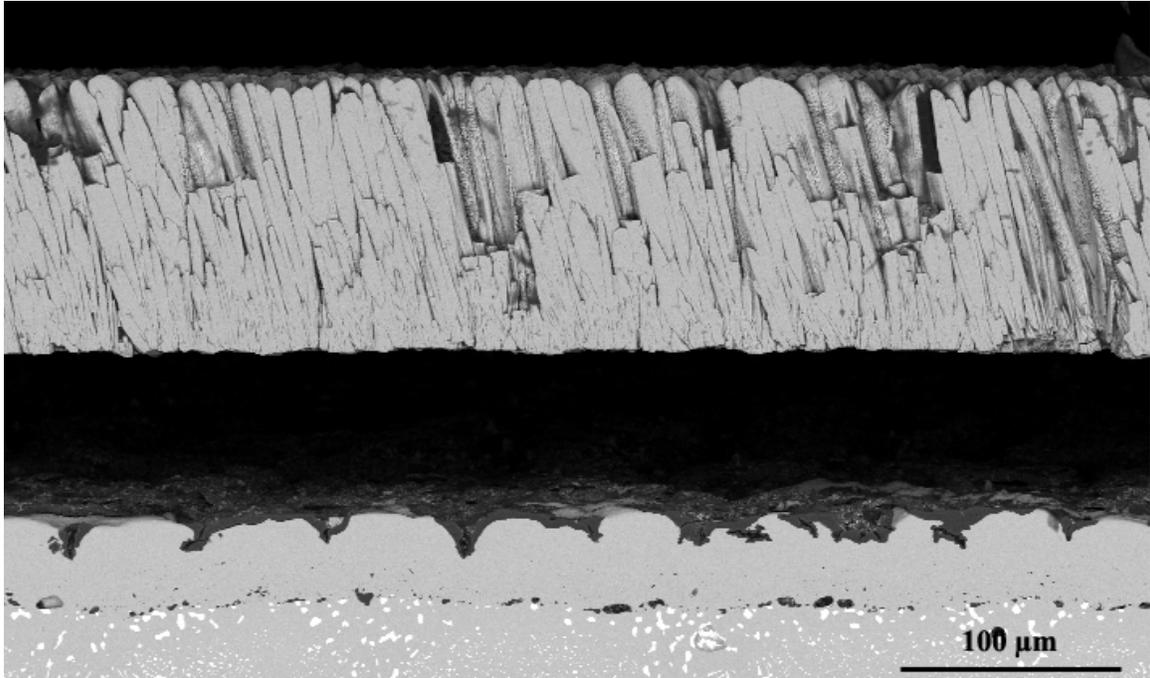
Figure 7.32 Cross sectional micrograph of ME2 points to a weak YSZ/TGO interface as well as to failure by a ratcheting mode.

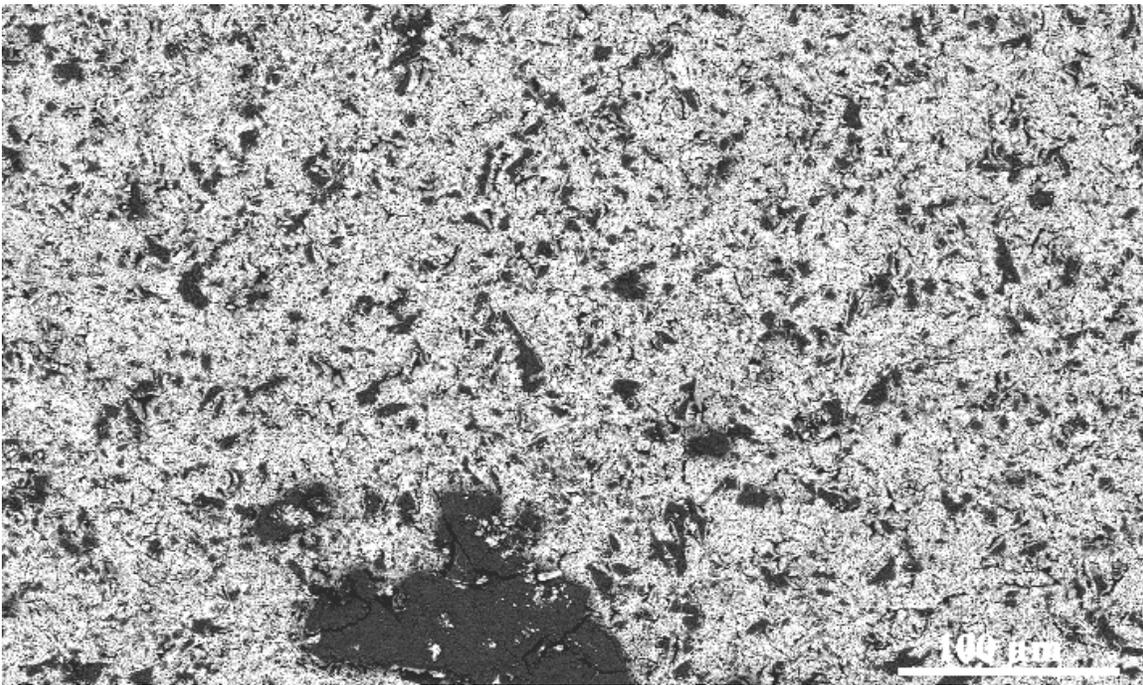
Figure 7.35 Inconel 738 YSZ failure surface displays a large amount of TGO bits as well as large portions of TGO.

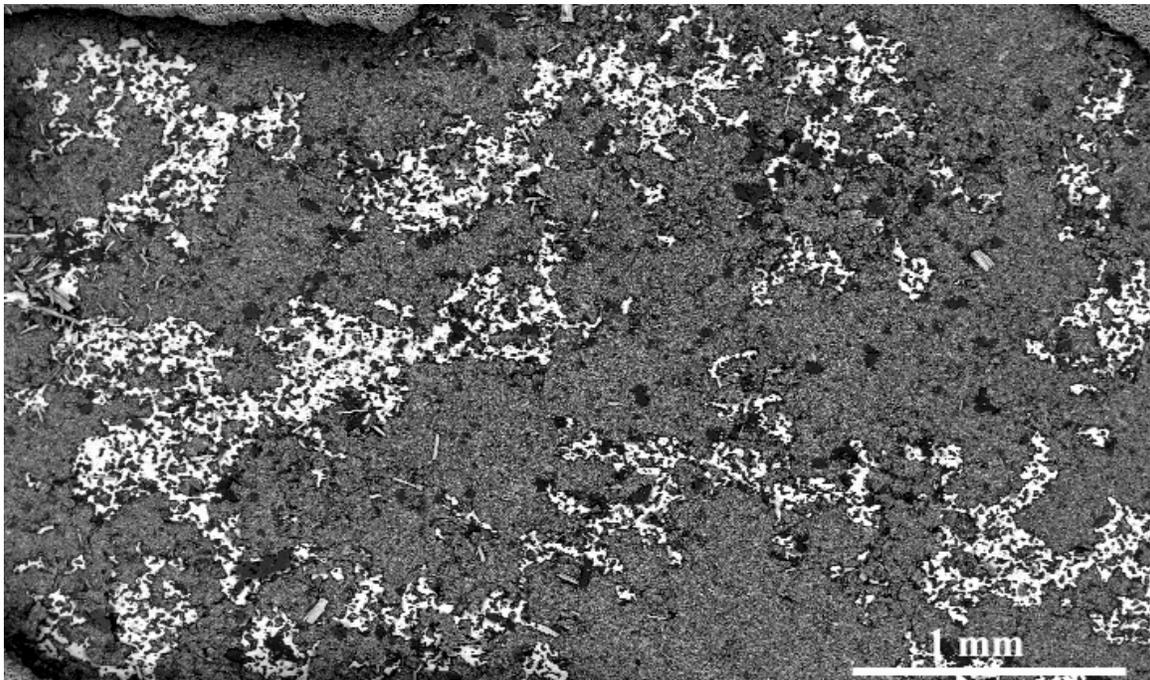
Figure 7.37 Substrate surface after failure of the TBC system displays large amounts of spalled areas, showing the bare bond coat.

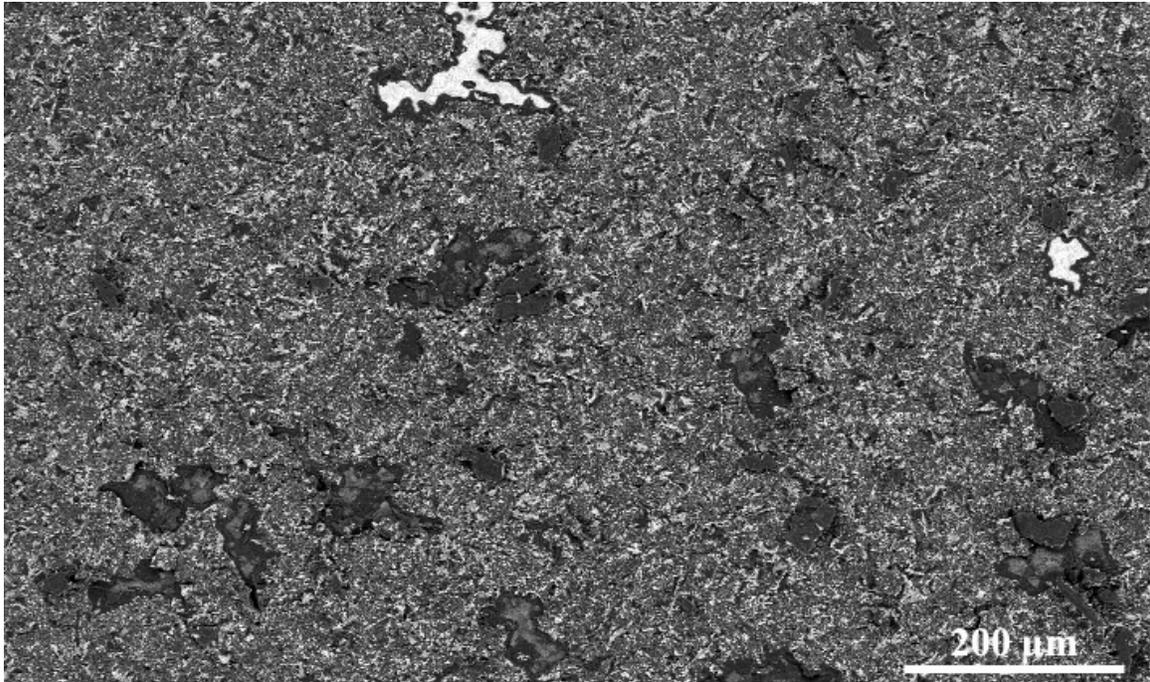
Figure 7.38 Substrate surface of Inconel 738 displays reoxidized surfaces, pointed by arrows.

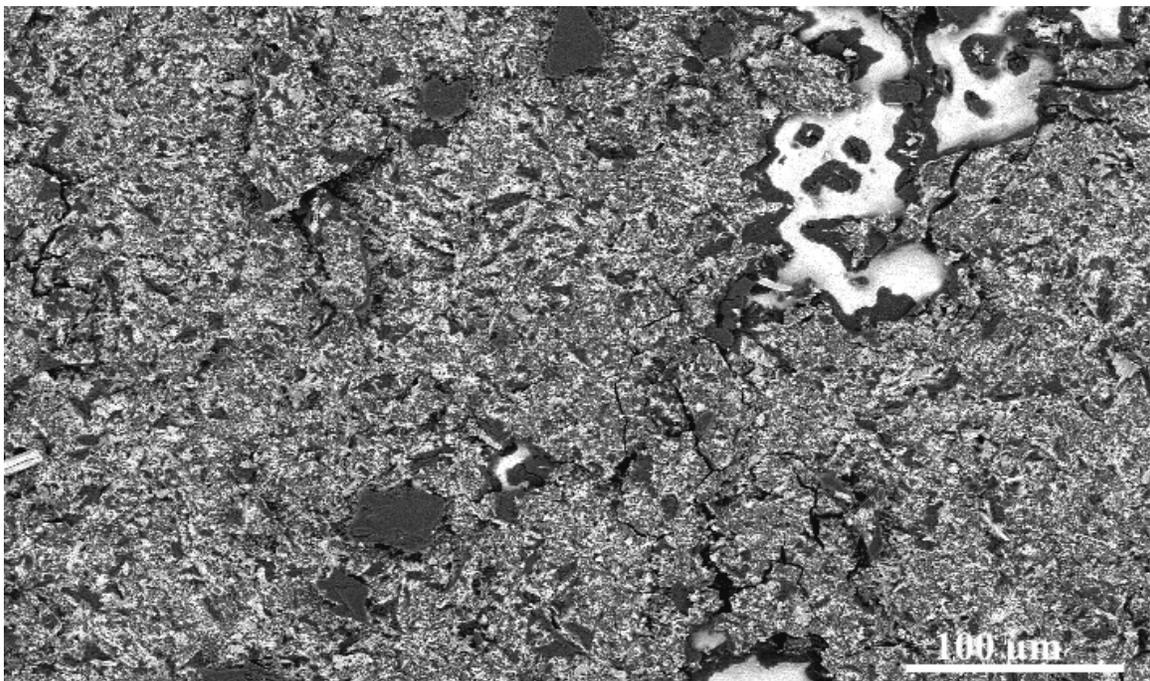
Figure 7.39 IN738 substrate surface contains cracks, spalled bare bond coat surfaces and holes.

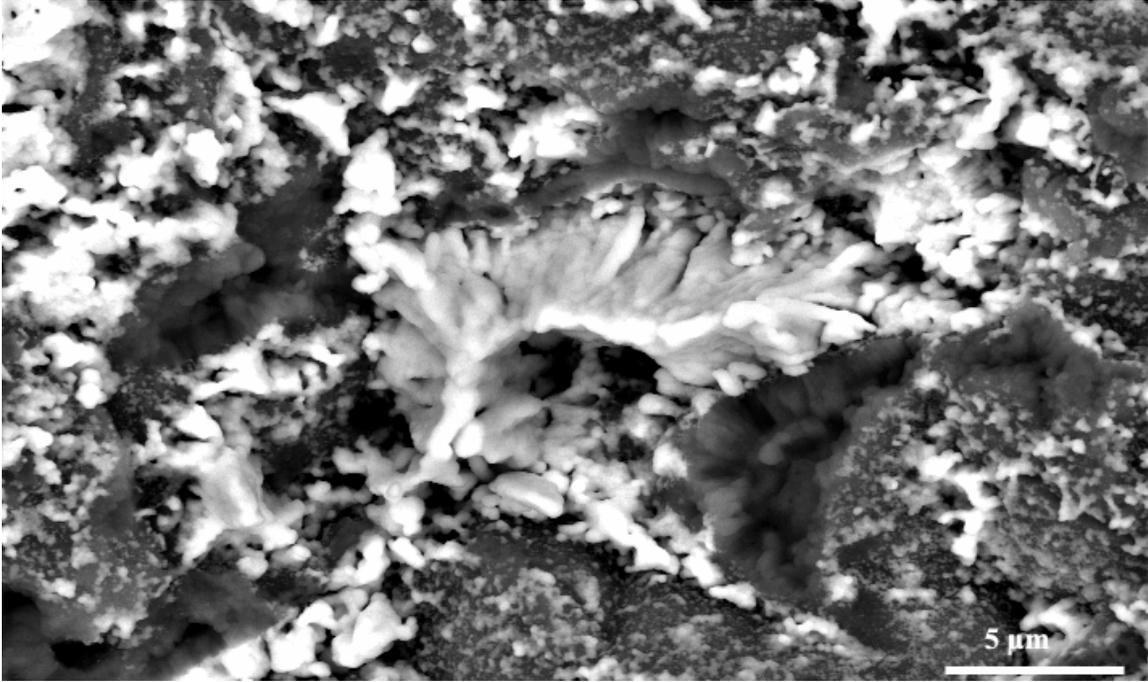
Figure 7.40 Holes on the surface of IN738, surrounded by YSZ grains.

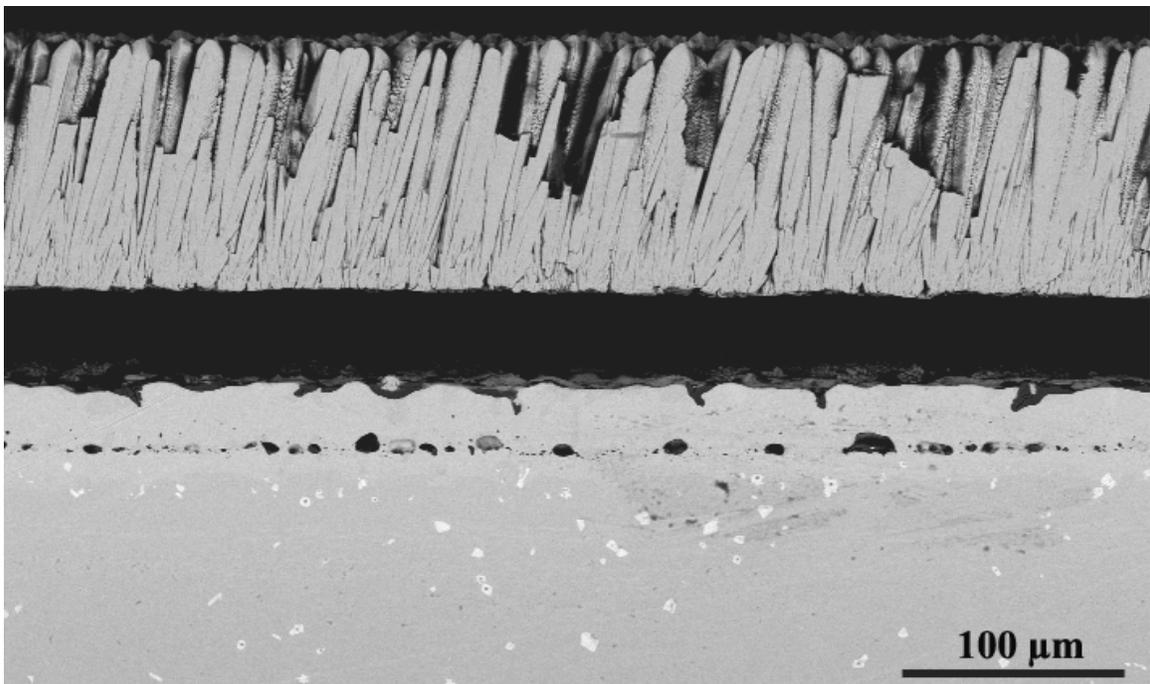
Figure 7.41 Cross sectional view of IN738 displays, YSZ/TGO weak interface, ratcheting mechanism, holes in the bond coat, and the interdiffusion area.

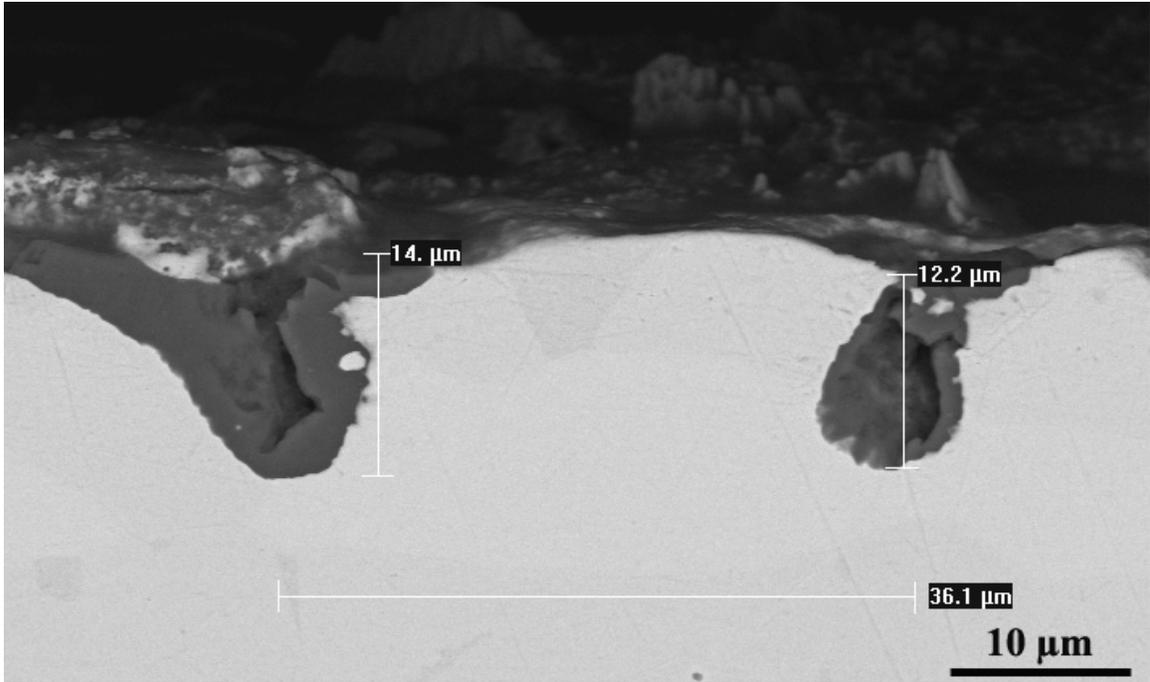
Figure 7.42 Bond coat of IN738 displays displays the failure mode of ratcheting.

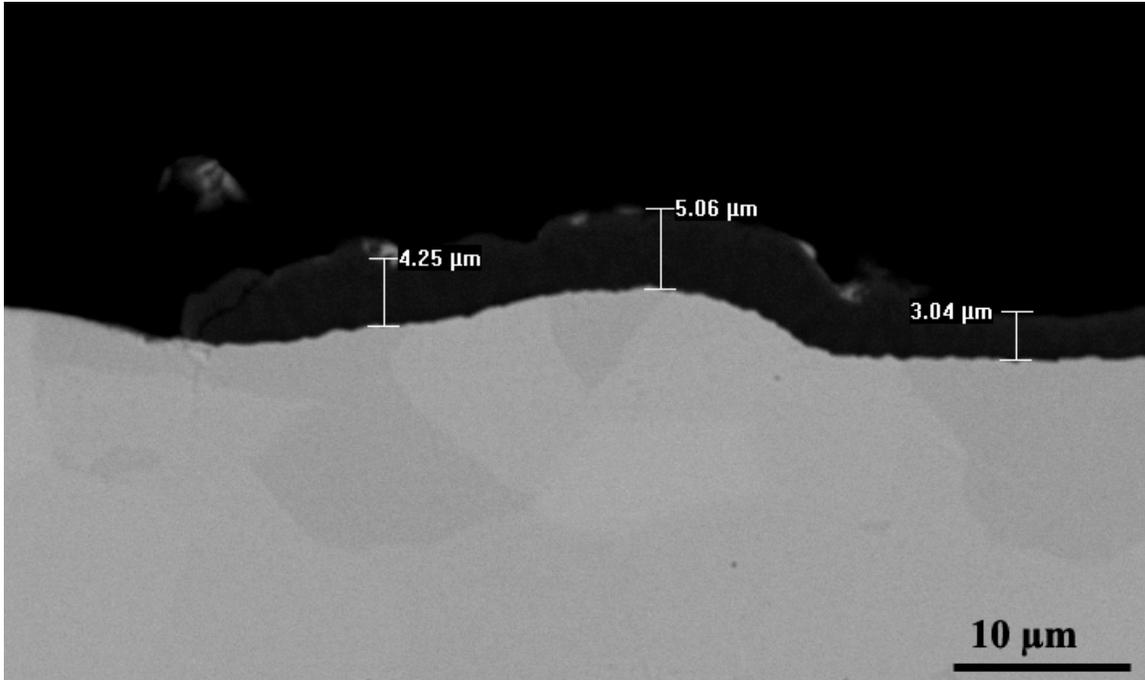
Figure 7.44 TGO thickness average on IN738 similar to N5; in addition, some bare areas also show on the cross section.

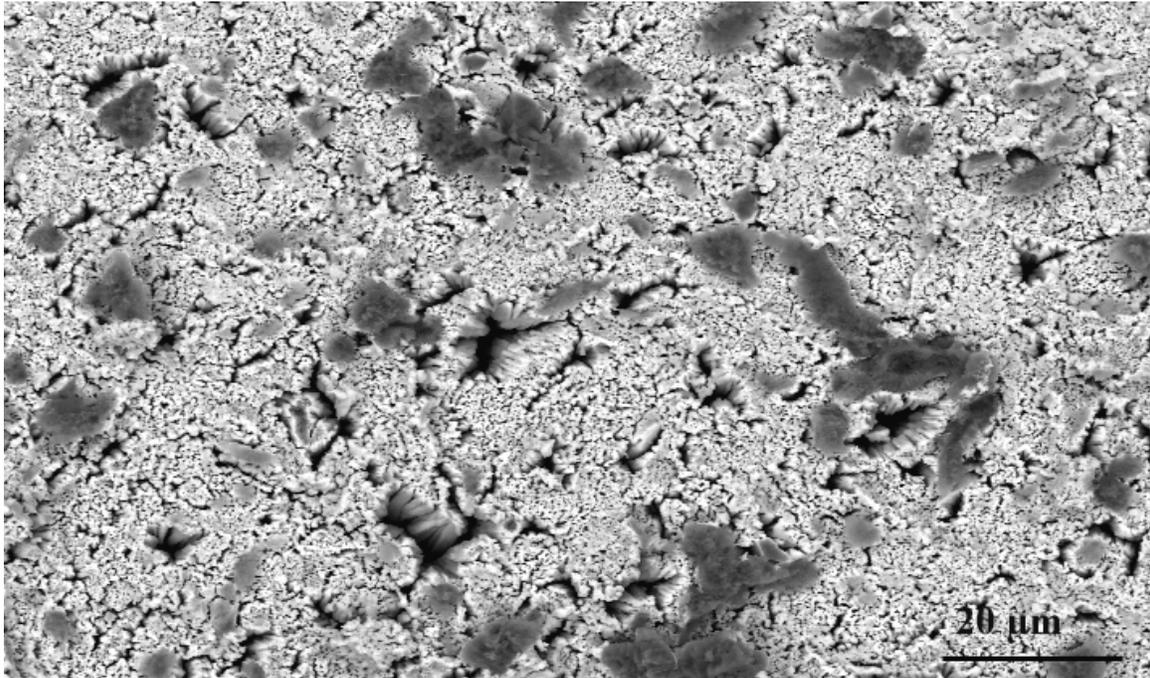
Figure 7.45 YSZ scale from CE1 displays bits of alumina, and missing YSZ.

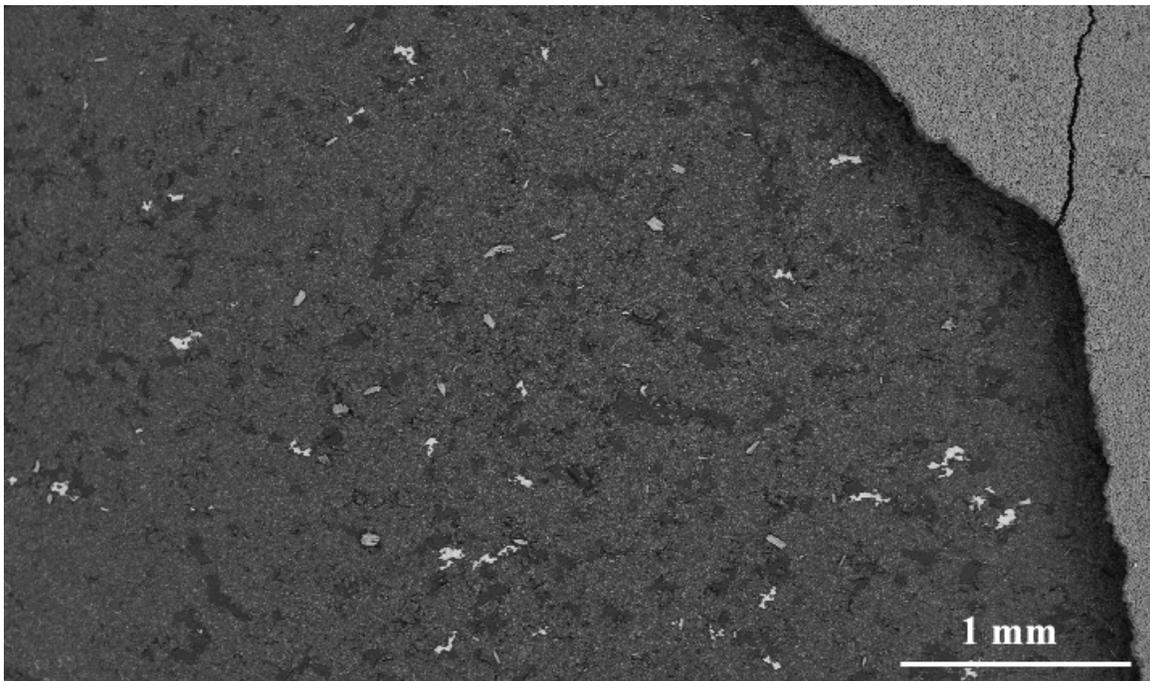
Figure 7.47 CE1 substrate surface displays areas from where the TGO has spalled as well as reoxidized spots.

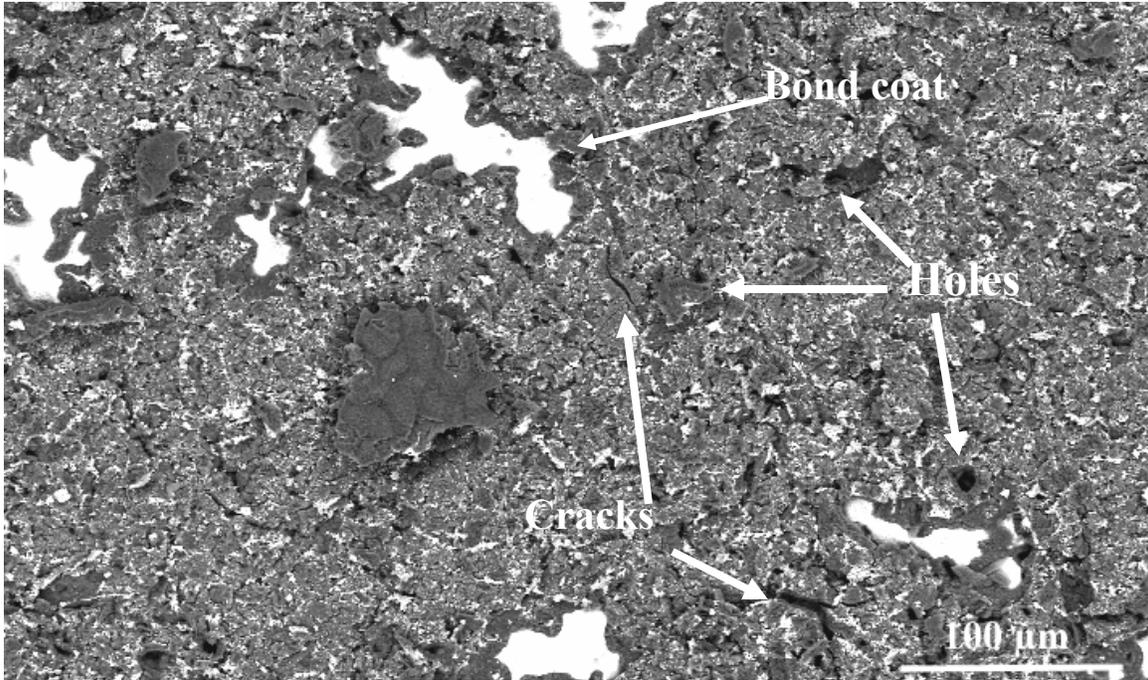
Figure 7.48 Magnification of CE1 failure surface shows TGO spalled areas, cracks, holes, and reoxidized areas.

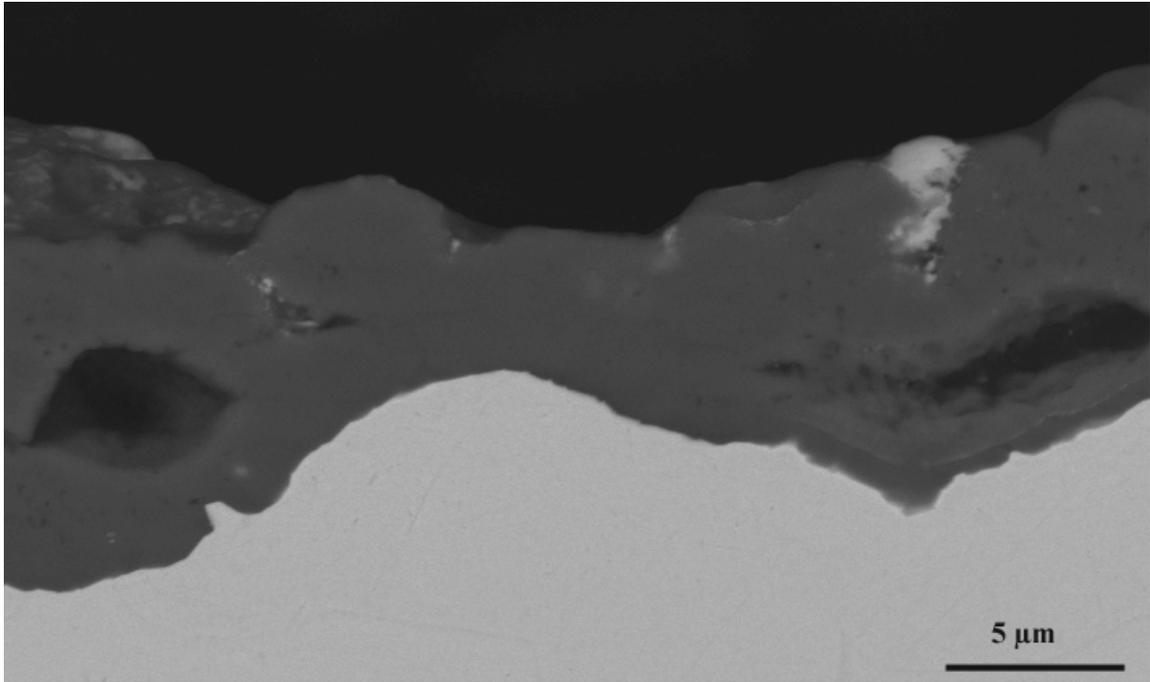
Figure 7.50 TGO thickness on CE1 substrate surface displays heterogeneous growth. Unlike previous deformations, TGO cracks propagate parallel and not normal to the YSZ/TGO interface.
