AN EVALUATION OF THE SUBSTRATE EFFECT ON THE PERFORMANCE OF
YSZ EB-PVD THERMAL BARRIER COATINGS

Igor Steven Garcia

Submitted to the Graduate Faculty of
School of Engineering in partial fulfillment
of the requirements for the degree of
Master of Science

University of Pittsburgh

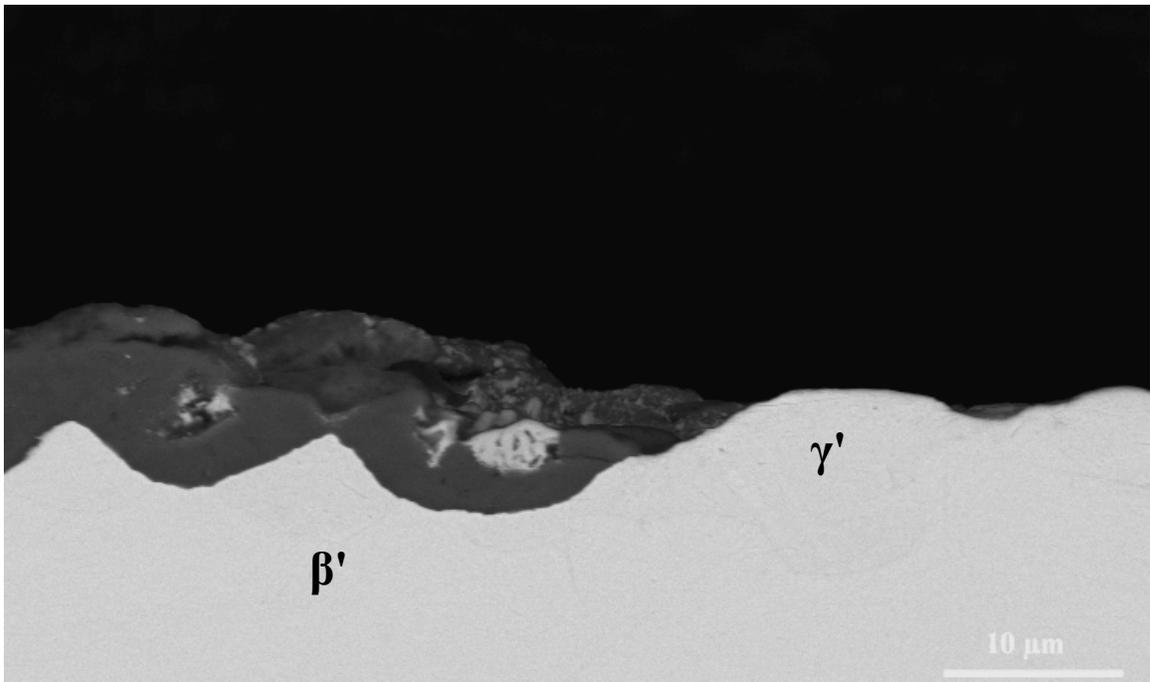
Figure 7.51 Bond coat remains unprotected after loss of TGO, while other areas are still protected.

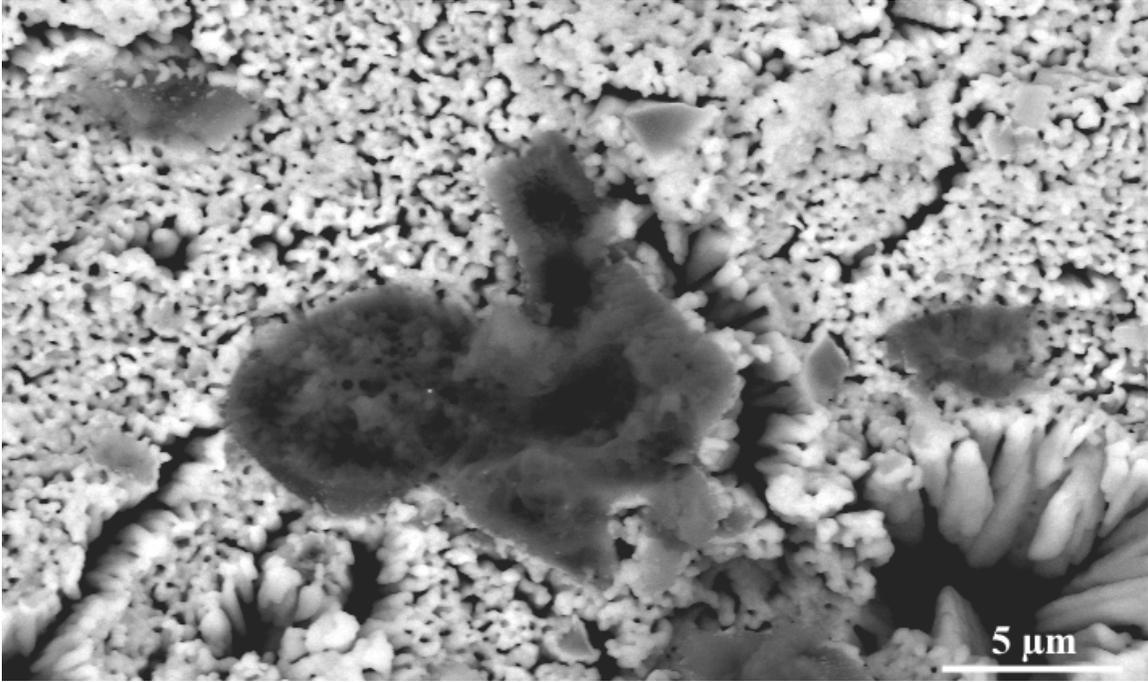
Figure 7.54 TGO bits on the YSZ failure surface accompanied by holes and cracks on the surface.

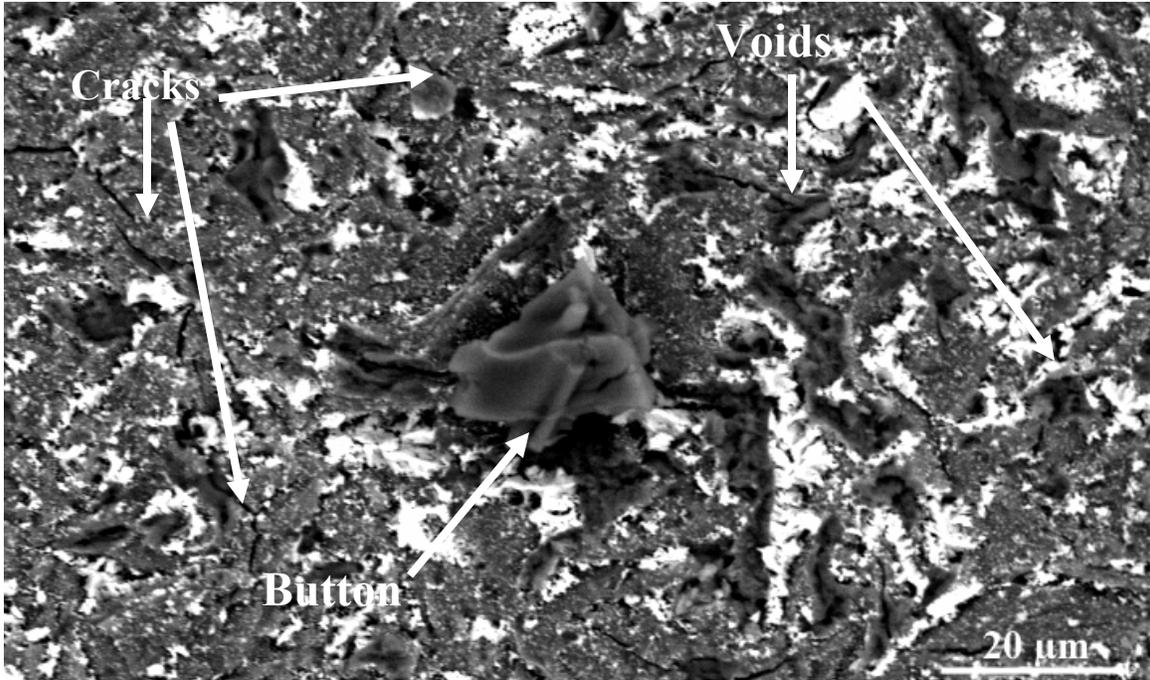
Figure 7.56 Substrate failure surface of CE3 displays cracks, YSZ and perforations, as well as oxidized buttons.

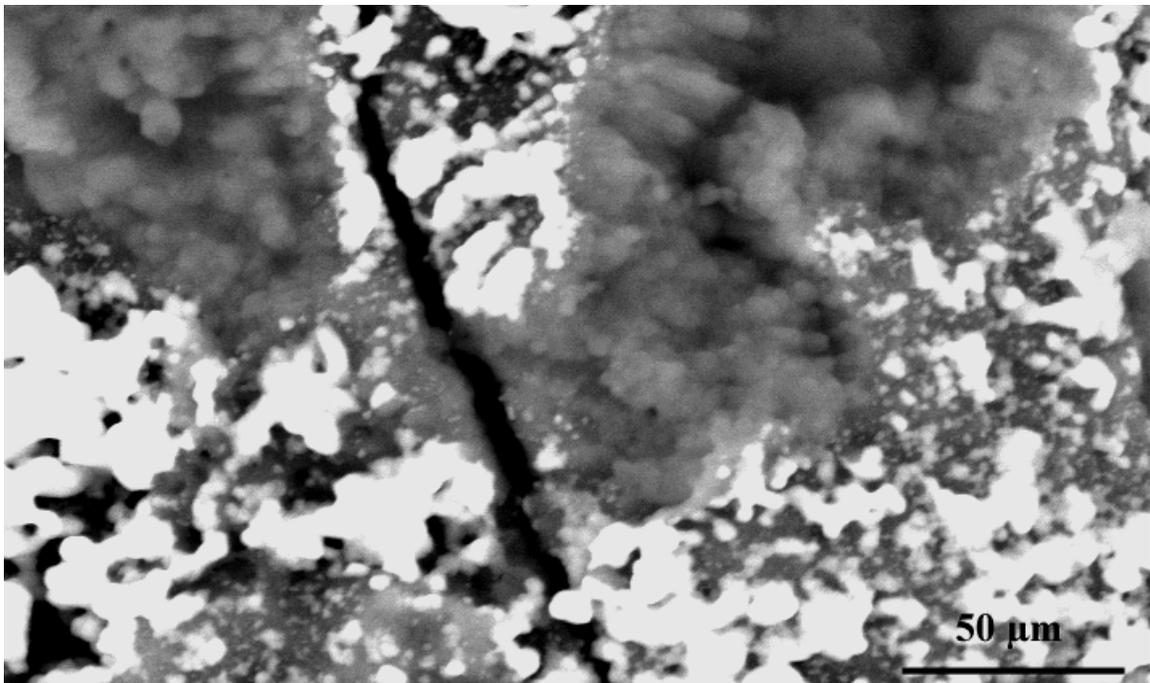
Figure 7.57 Crack propagation on the surface of CE3 at failure expands for over 50 μm .

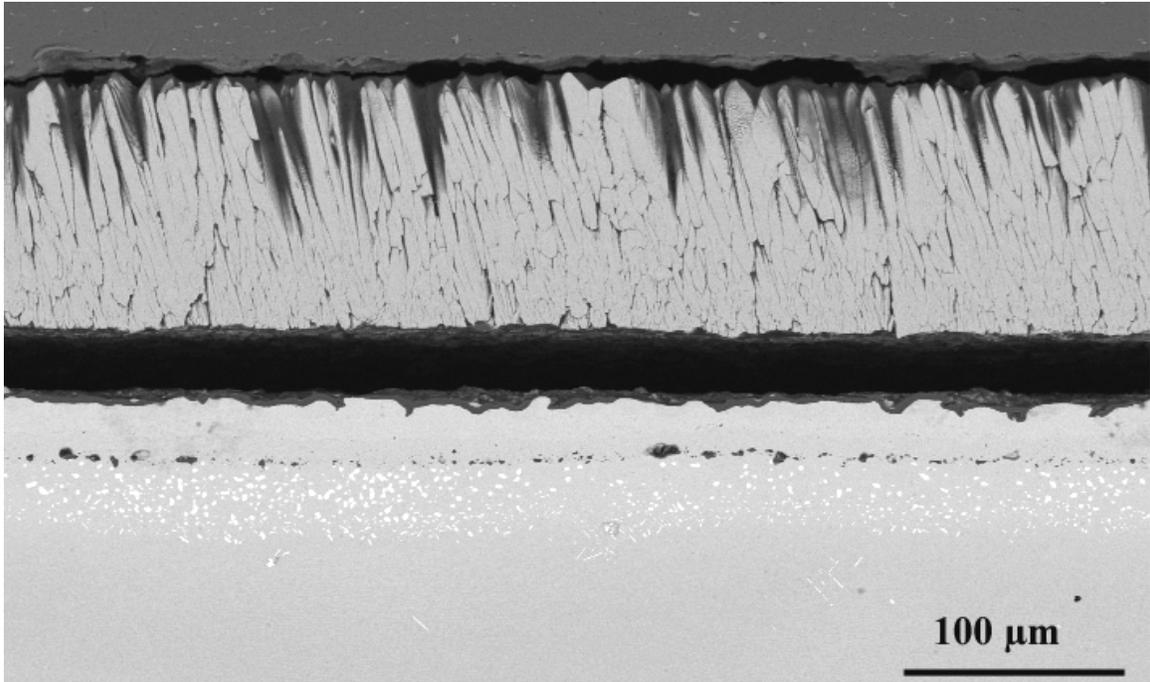
Figure 7.59 Cross section CE3 shows the interdiffusion area, ratcheting effect, and alumina particles in the bond coat.

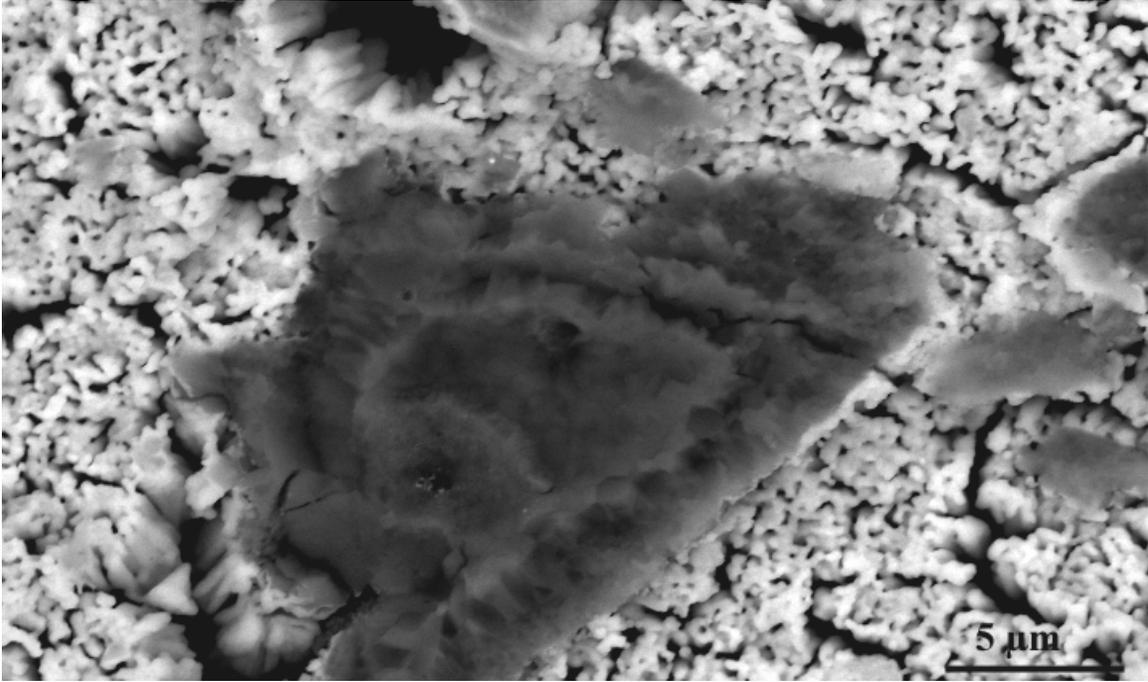
Figure 7.62 Thermally grown oxide, holes, and cracks on the YSZ failure surface of a CE8 specimen.

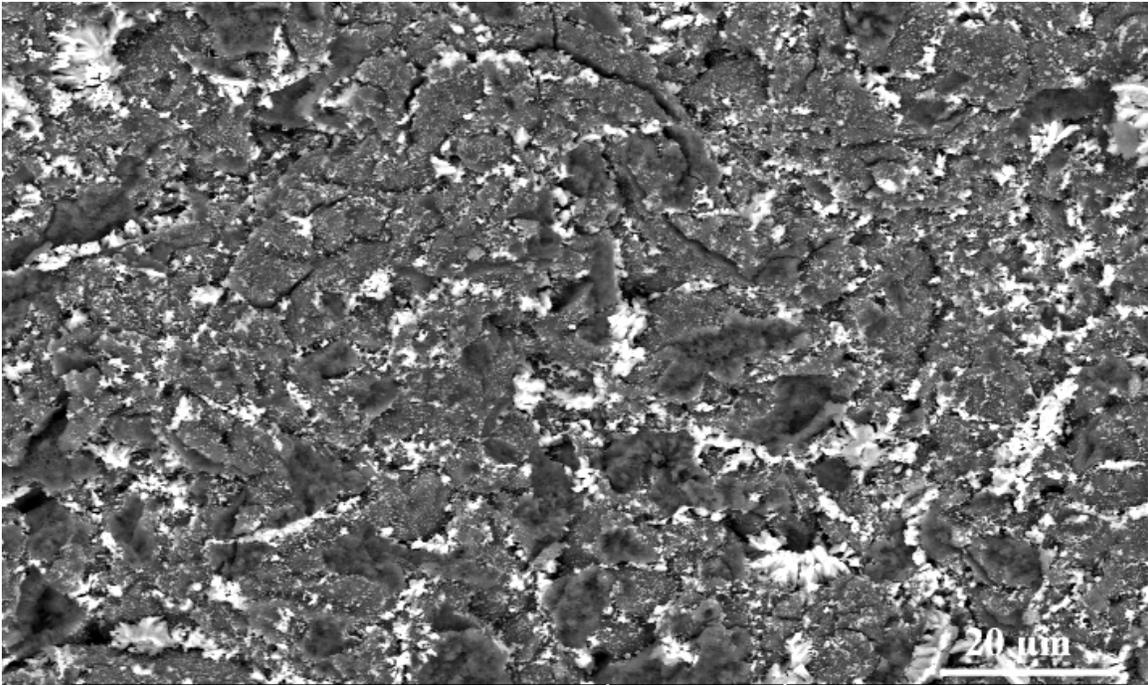
Figure 7.63 TGO failure surface from a CE8 specimen, showing holes, cracks and YSZ remains.

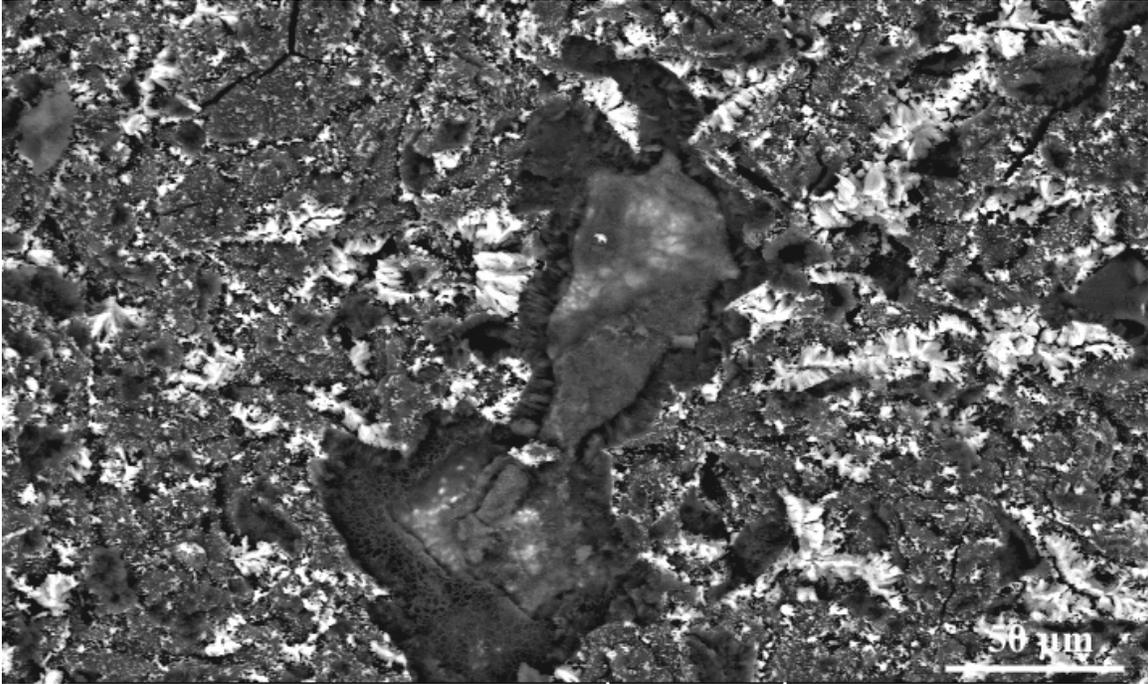
Figure 7.64 Reoxidized area seen only once on a CE8 specimen, other specimens did not show a bare or reoxidized area at all.

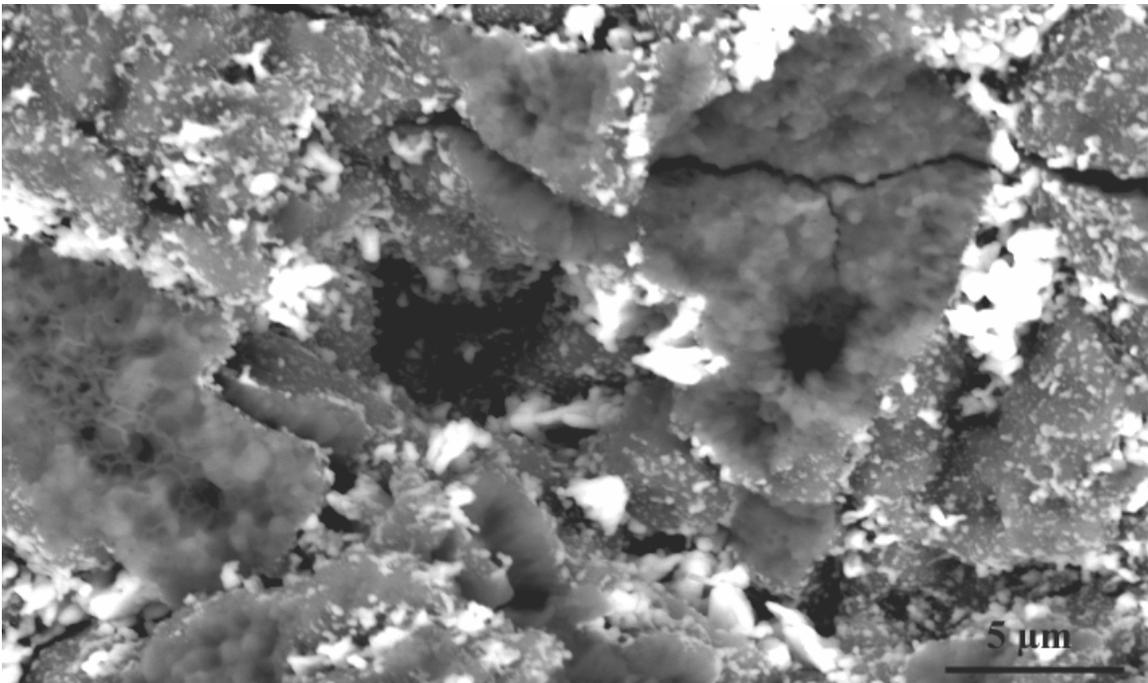
Figure 7.65 A closer look at the cracks and holes populating the TGO failure surface from a CE8 specimen.

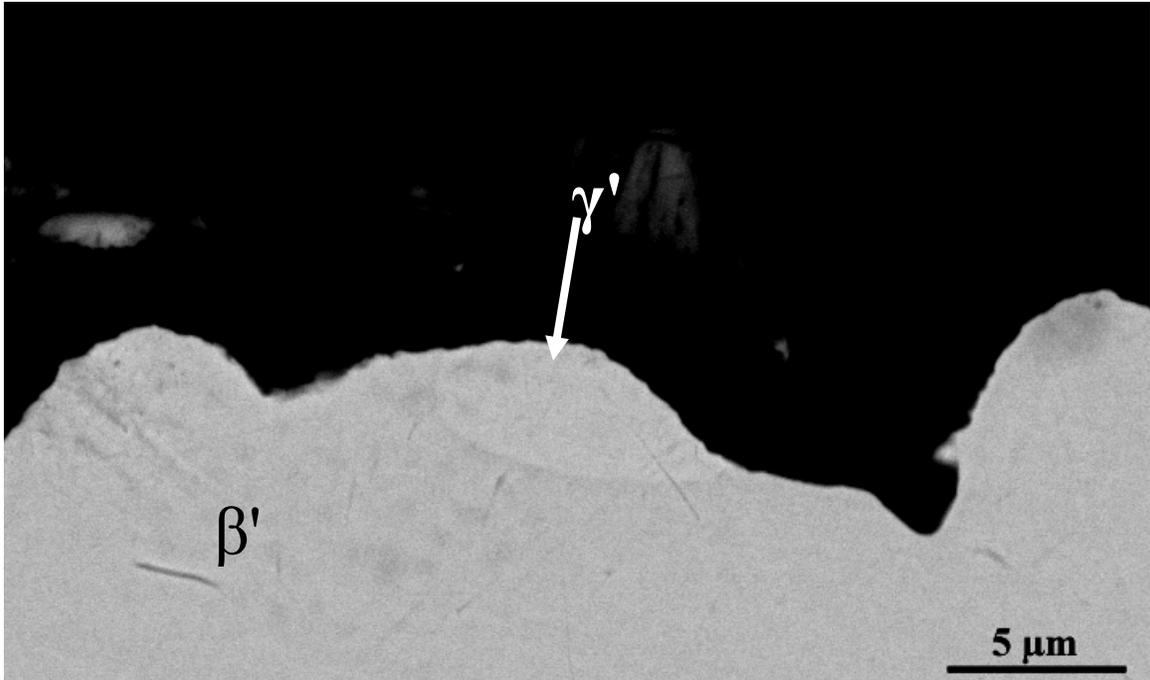
Figure 7.67 Ratcheting mechanism present in failure of CE8 specimens; noted in the back grains of the YSZ top coat. Martensite and gamma prime also present.

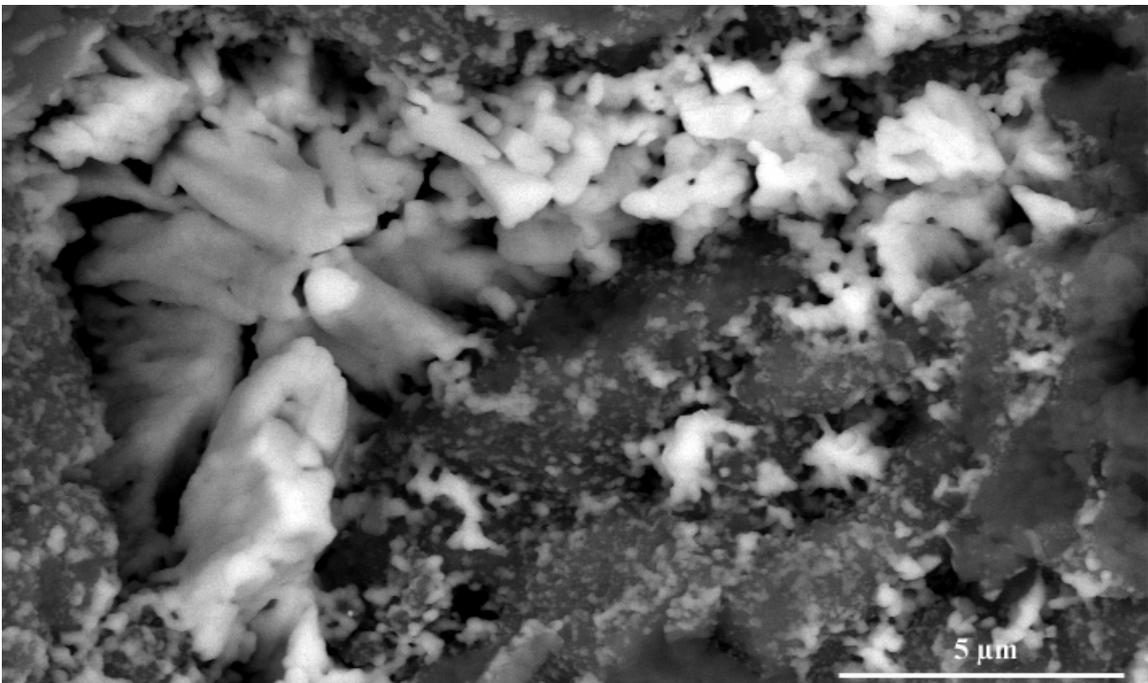
Figure 7.72 YSZ grains are swallowed by the TGO during deformation.

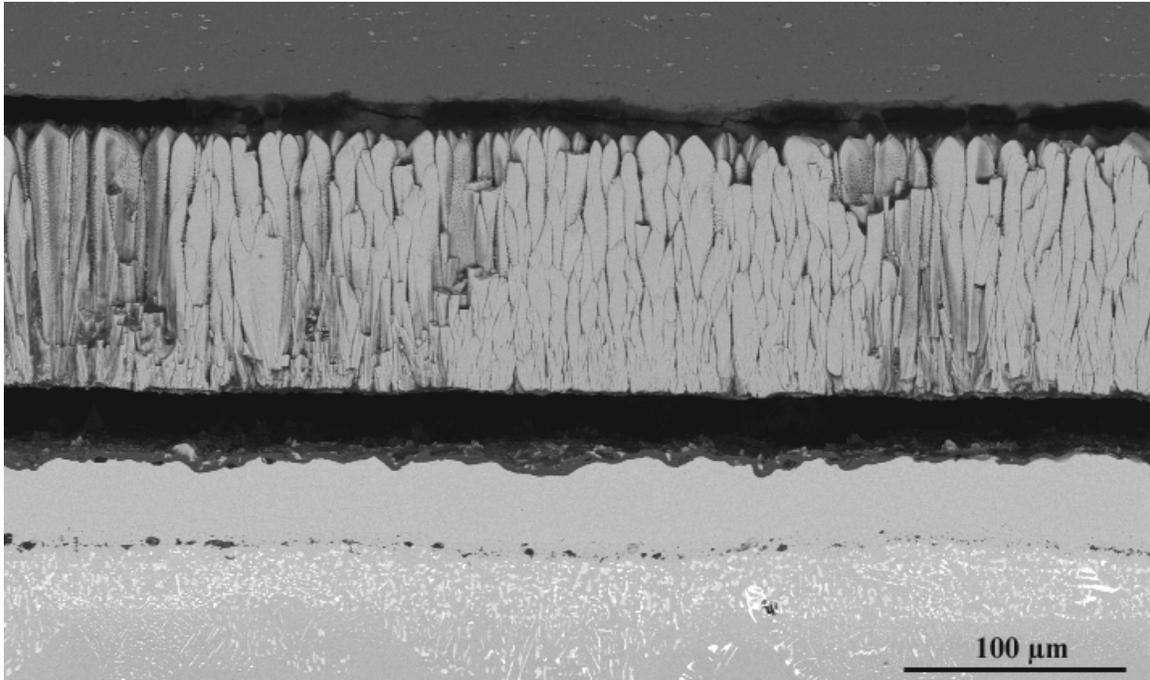
Figure 7.73 Cross sectional micrograph of ME13 shows ratcheting effect, bond coat, interdiffusion area and alumina particles in the bond coat.

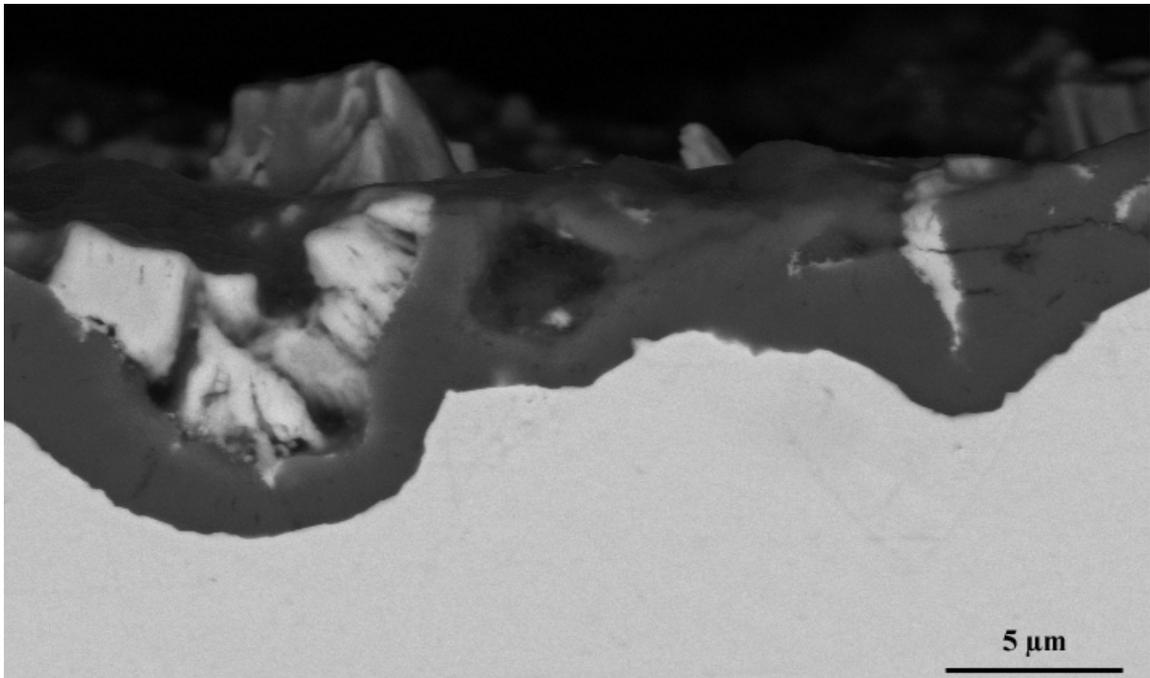
Figure 7.74 ME13 cross section shows YSZ debris remains attached to the TGO after failure. Note appearance of the TGO which is cracked laterally with heterogeneous thickness.

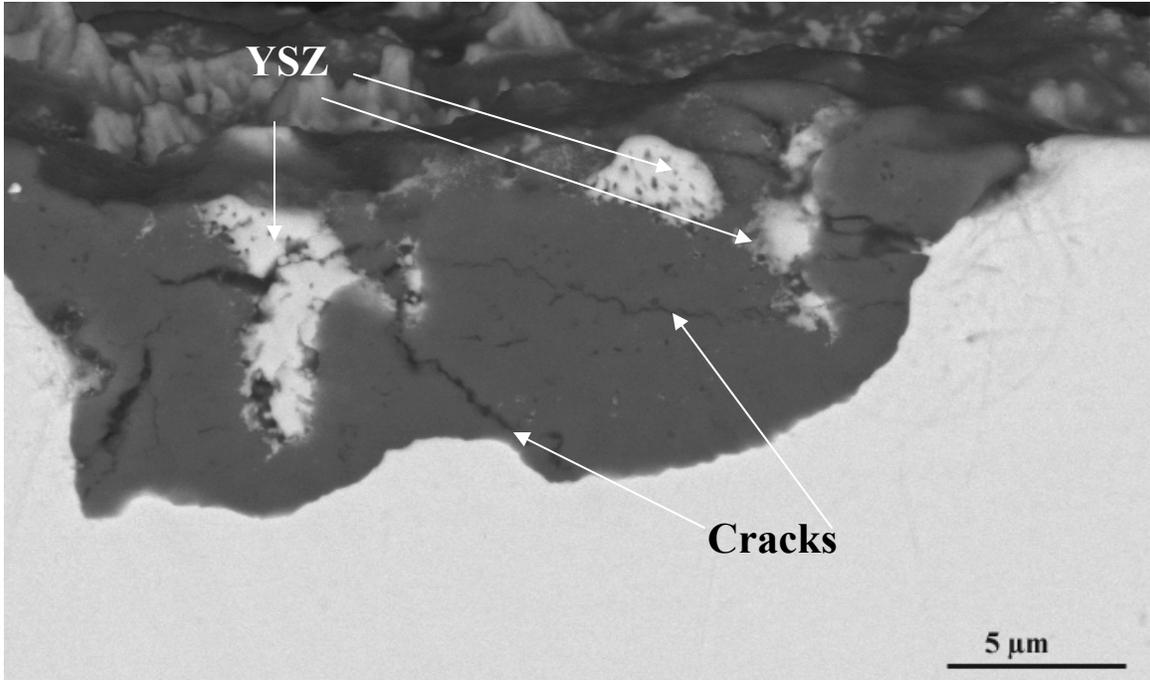
Figure 7.75 TGO on the ME13 shows cracks which appear to originate from the YSZ/TGO interface propagate.

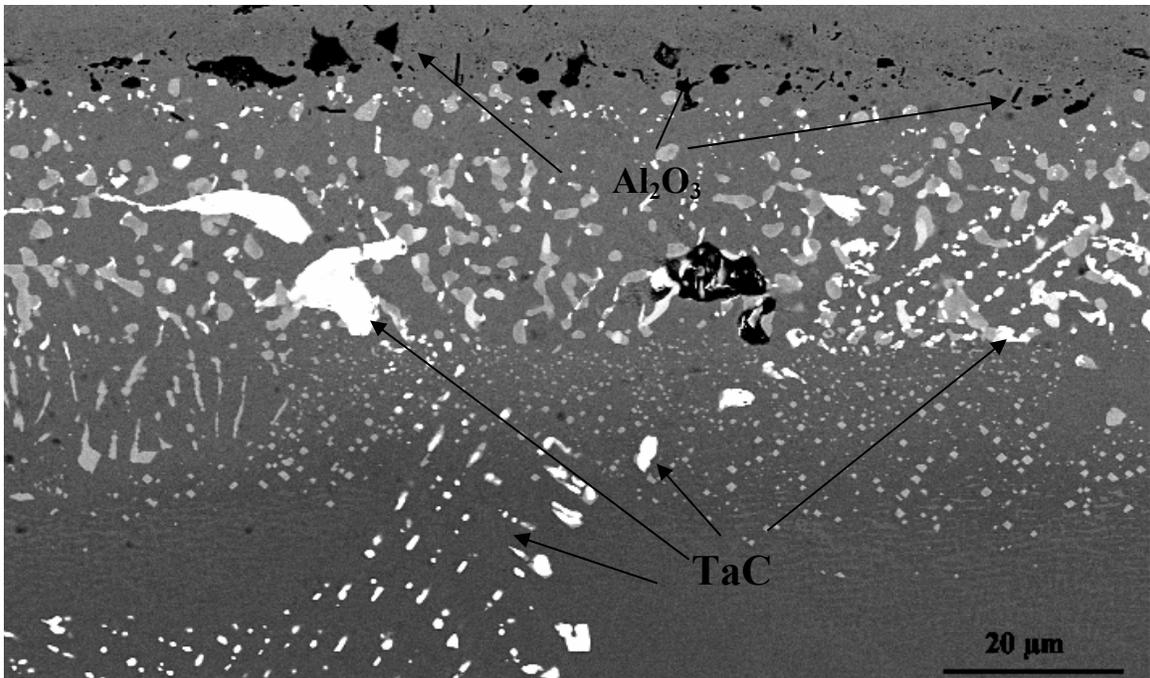
Figure 7.76 Interdiffusion area of a ME13 specimen after failure shows carbides and precipitates rich in Re, W, Cr, Co, and Ni.

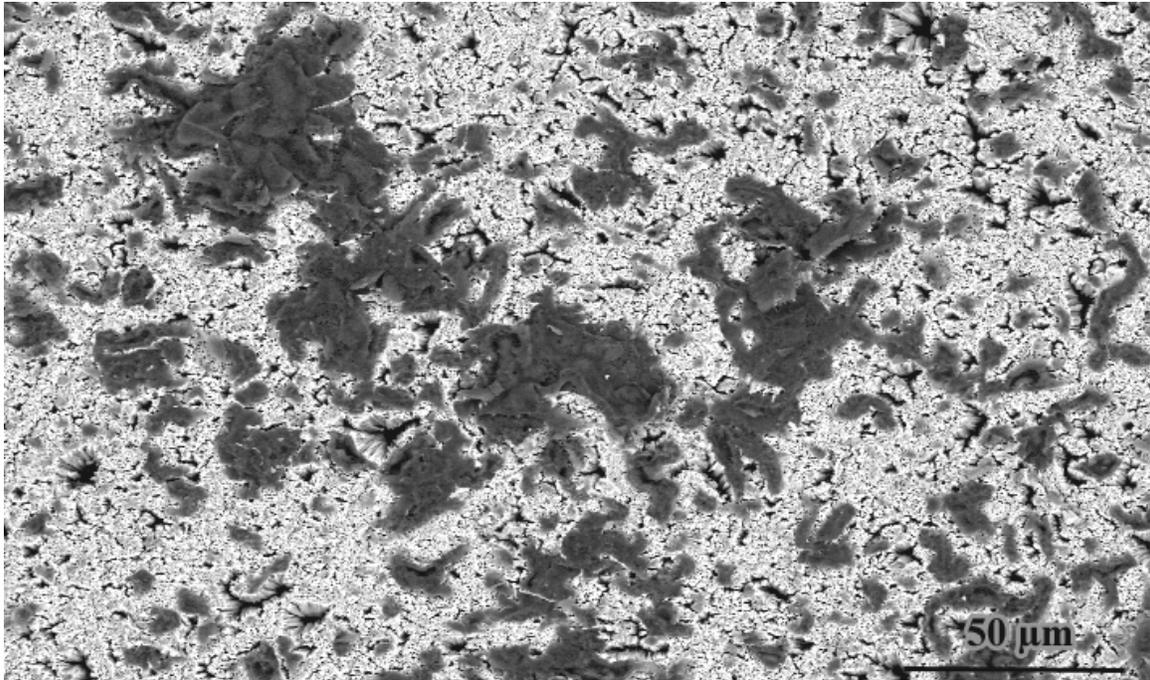
Figure 7.78 High magnification of the YSZ failure surface on a CE6 specimen shows holes on the YSZ and large scale TGO.

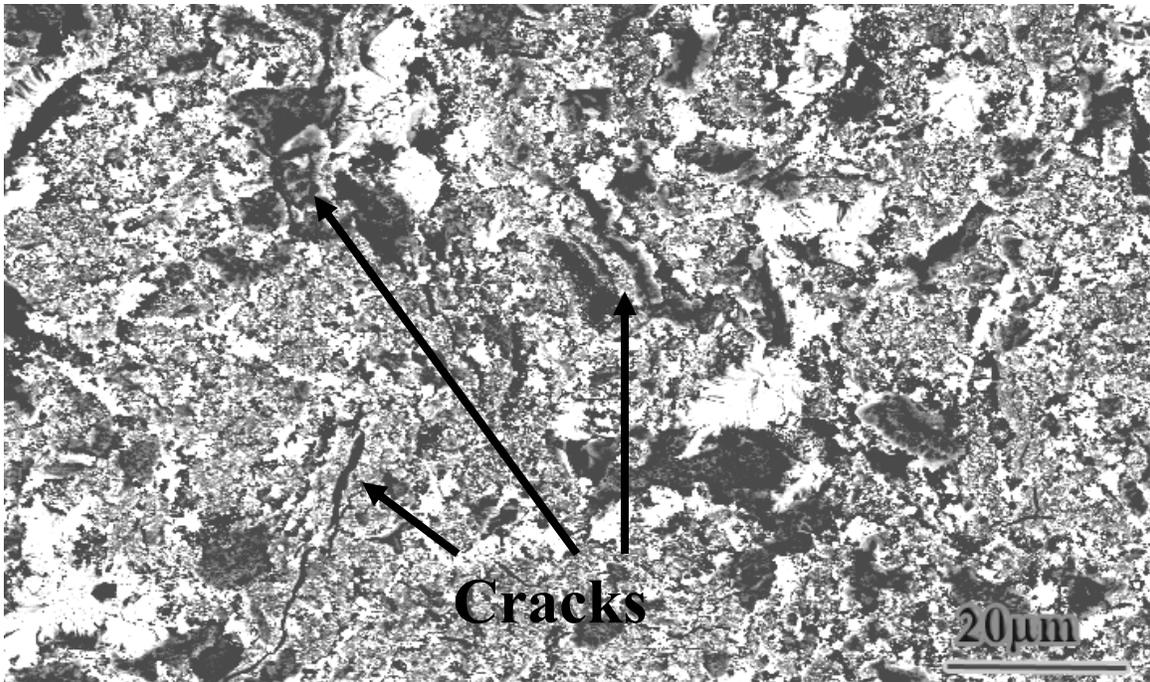
Figure 7.79 Substrate surface shows large amounts of YSZ on the TGO surface, also seen are numerous cracks.

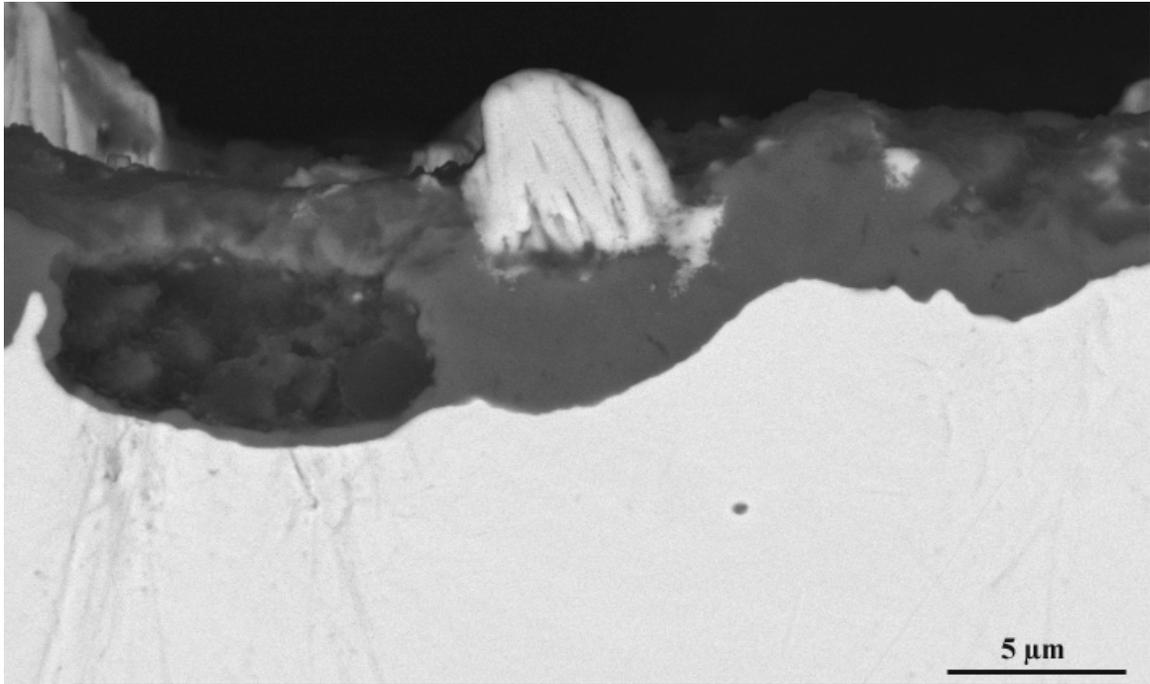
Figure 7.83 Bond coat on CE6 is homogeneous, while TGO shows expanded lateral cracks.

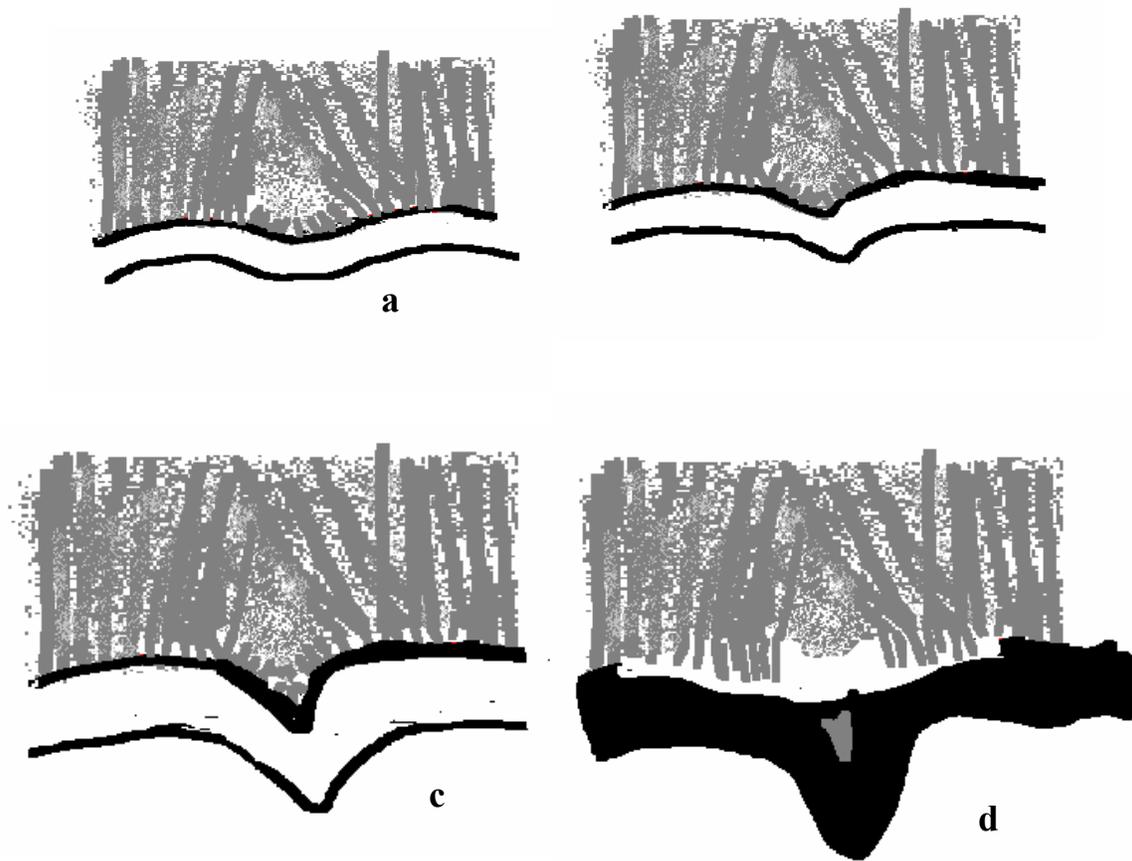
Figure 8.1 Evolution of the ratcheting effect: (a) Displays early deformation of the bond coat which deprives the YSZ grains from growing. (b) Deformation of the bond coat grows as the residual stresses appear compress the TGO. (c) Oxide scale deforms the bond coat and shapes undulation into a cone as the residual stresses continue to compress the TGO scale. (d) Thermally grown oxide detaches itself from the YSZ/TGO interface and a crack appears.
