#### IDENTIFICATION OF FACTORS CONTROLLING THE DEVELOPMENT OF SUBSIDENCE IMPACTS FORECASTING METHODOLOGY TO THE I-70 ALIGNMENT OVER LONGWALL MINING OF THE TUNNEL RIDGE MINE, WASHINGTON COUNTY, PA

Task 1: Pre-Undermining Activities Report Submitted 2 July 2019; Finalized 19 January 2020

#### The University of Pittsburgh Master Agreement Contract No. 4400018535

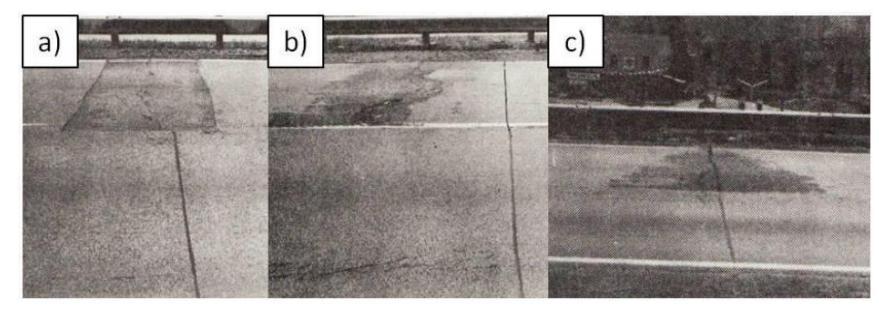
Despite these higher slopes and curvatures, only minor damage was reported on the northbound lanes of I-79 as a result of undermining. Figure IIa.5 depicts repaired damage to I-79 a) between the centerline and southern edge of panel 0-Butt, b) near the southern edge of panel 1-Butt, and c) near the northern edge of panel 2-Butt. However, the Yancich study only described a subset of the impacts, making it difficult to determine the overall magnitude of damage and repairs associated with this undermining event.

Figure IIa.5 – Photographs of impacts to northbound lanes of I-79 over a) 0-Butt, b) 1-Butt, and c) 2-Butt panels of the Gateway Mine (Yancich, 1986)

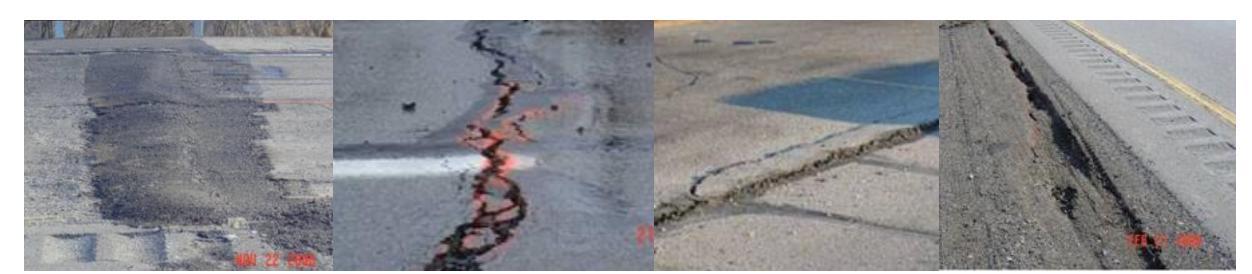
Throughout the undermining process of these panels for both the Cumberland and Emerald mines, the Pennsylvania Department of Environmental Protection (PADEP) and PennDOT staff routinely visited I-79. During these visits, they observed a variety of types of damage on the highway surface during the undermining process including compression bumps, transverse cracking, longitudinal cracking, joint faulting, and lane-to-shoulder separations. Some examples of these failures can be seen in below in Figure IIa.10. Most of the damage was considered to be localized and was repaired during or following the undermining period.

Figure IIa.10 – Examples of surface damage on I-79 caused by Emerald and Cumberland undermining a) compression bump, b) transverse crack, c) joint faulting, and d) lane-to-shoulder separation (Iannacchione, et al., 2011)

Prior to undermining, the Pennsylvania Department of Transportation (PennDOT) implemented several mitigation techniques to lessen the impact of subsidence on drivers. Sections of concrete were removed from beneath the asphalt pavement in areas of predicted high stresses and strains to provide the road with additional flexibility to adapt to the subsidence event. During active mining and repair periods, speed-limits were reduced to 45-mph and lanes were reduced from two to one in both directions. In addition, the interstates were under constant observation and monitoring to ensure that damage was fixed before it could cause accidents or injury.

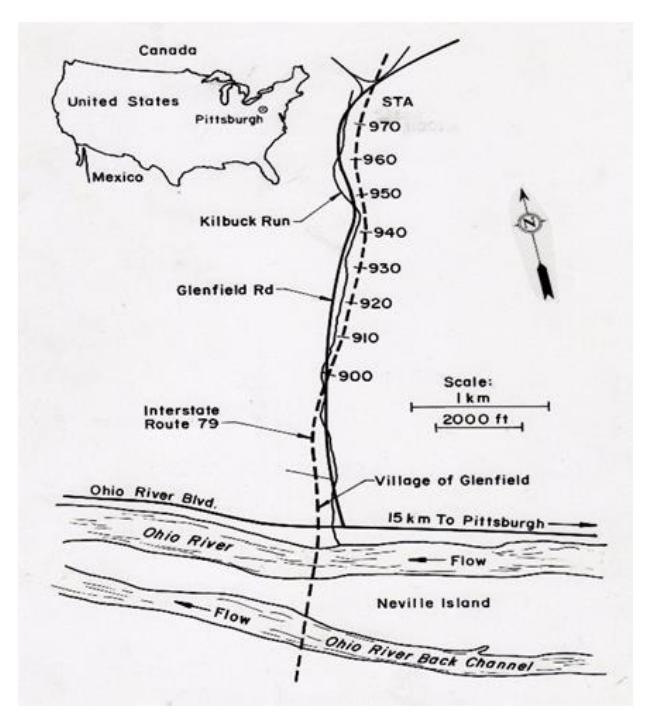
Arguably the largest and most prominent slope failure to impact interstate alignments in southwestern Pennsylvania occurred along I-79 just north of where it crosses the Ohio River, nine miles northwest of Pittsburgh (Figure IIb.4). Construction on this section of I-79 began in the autumn of 1968. Massive slope instabilities began to occur soon after construction began and continued into 1969. Hamel and Flint (1972) and Hamel and Adams (1981) published reports that detailed the local soil and rock conditions.

*Figure IIb.4 – Location of multiple slope instabilities along I-79 in 1968 and 1969 (the exact station values were not provided)*

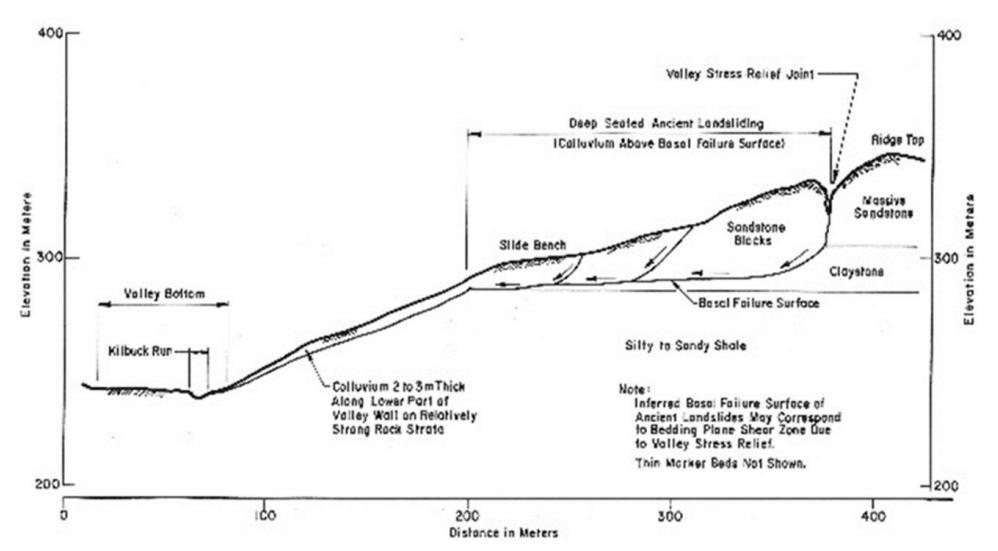
The Hamel reports indicated that slope instabilities were observed at multiple locations along the highway alignment: 899 to 904, 916, 920 to 922, 926 o 932 and 950 to 955 (Figure IIb.4). A cross-section of one of these slides in shown in Figure IIb.5. Here the bottom-most failure surface was located at the base of a weak rock unit. The colluvium and strata above these planes of weakness moved away from the hillside and into the valley at varying rates. These slope failures added significant cost to the project and delayed the opening of this section of I-79.

Figure IIb.5 – Slope cross-section Sta 908 (Hamel and Adams, 1981)
