**DEVELOPMENT AND VALIDATION OF A WHEELCHAIR CASTER TESTING
PROTOCOL**

Submitted to the Graduate Faculty of
School of Health and Rehabilitation Sciences in partial fulfillment
of the requirements for the degree of
Doctor of Philosophy

University of Pittsburgh

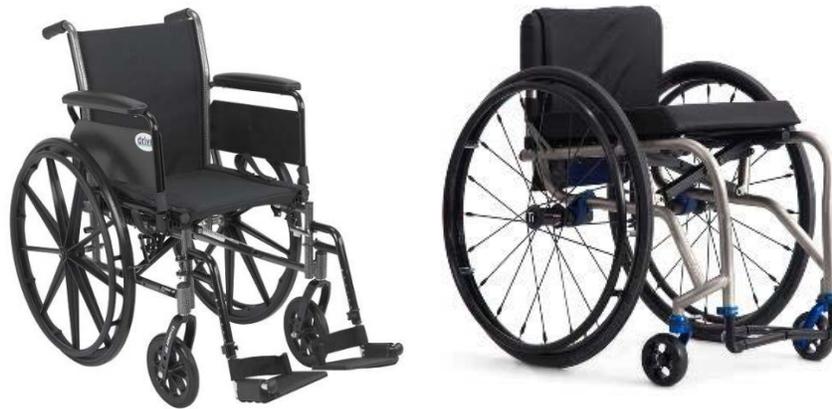
Figure 3. Lightweight wheelchair (left) and Ultra-lightweight wheelchair (right)[81]

lightweight wheelchairs (LWC) and ultra-lightweight wheelchairs (UWC) (see Figure 4). Wheelchair models were in new condition and were already available on the market. Information regarding their prior ISO testing was not available. Some testing studies referred to ANSI/RESNA standards. Table 1 presents study results from ISO section 8 fatigue tests and lists the observed failures.

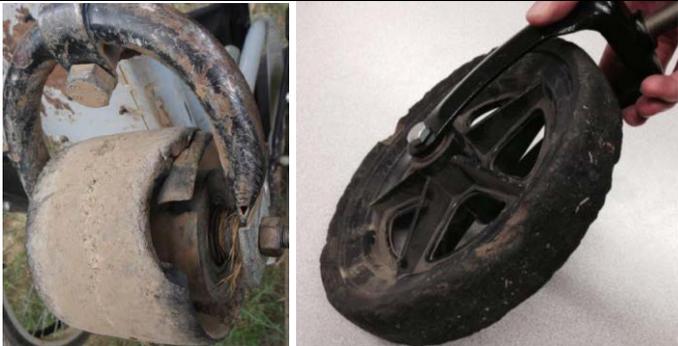
Field failures	Failure photographs
<p>Casters: Casters are damaged because of abrasion of tires and wide-ranging loads on rough and unpaved terrains, accelerated ageing of material and corrosion. Other issues are caster instability because of flutter and caster floatation (performance after penetration in soft ground).</p>

<p>Casters after 15 months of ISO-tested wheelchairs</p>
<p>Rear wheels and tires: Tire type can have a big impact on rollability. Spokes break, tires puncture and poor air retention are evident on rocky unpaved terrain. Wheels lose shape as they deform and wear too quickly.</p>

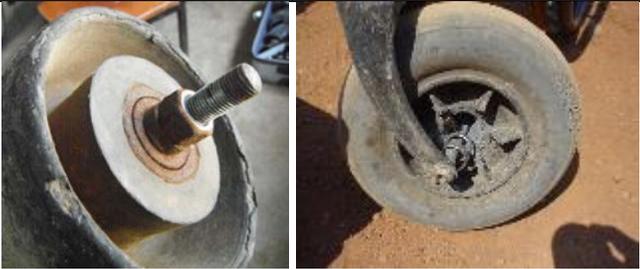
<p>Bearings: Quality of bearings (seal, lubrication, the ability of a type of bearing to tolerate contamination and loss of lubrication) can have a huge impact on rollability. Bearings rust easily because of contamination – debris causes resistance in propulsion. Larger turning force required on casters.</p>

<p>Corroded caster bearing from an ISO tested wheelchair after 15 months of use (left) and fractured bearing (right)</p>
<p>Back and seat upholstery: Sling designs may make the rider sit in a poor-seated position increasing risk of pressure sores. Upholstery is observed to sometimes tear or loose easily or hold moisture. Covers are not waterproof and chemical-resistant. Failure often occurs at mounting points.</p>

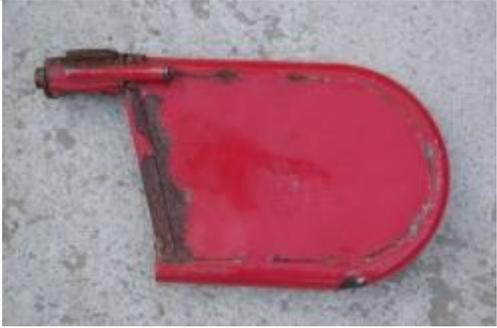
<p>Footrests: Footrests have poor strength; they often break because of contact with the ground when descending curbs or surface depressions.</p>

<p style="text-align: center;">Broken footrest</p>
<p>Frame and cross braces: Rust because of corrosion often caused by paint chipping, poor paint application or pooling of water inside tubes. Poor strength of frame causes backrest failure, wheel misalignment, failure with push handles or canes. Bent frames are typical. Rust degrades folding mechanism.</p>

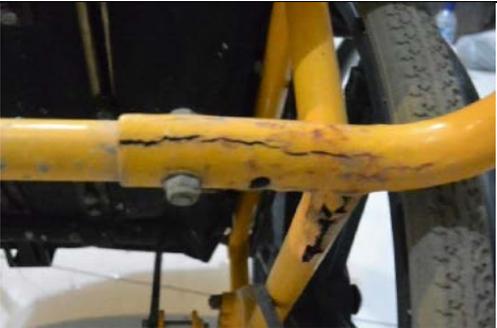
<p style="text-align: center;">Frame failure on an end-of-life wheelchair</p>
<p>Arm pads: Worn-out arms pads are frequent.</p>

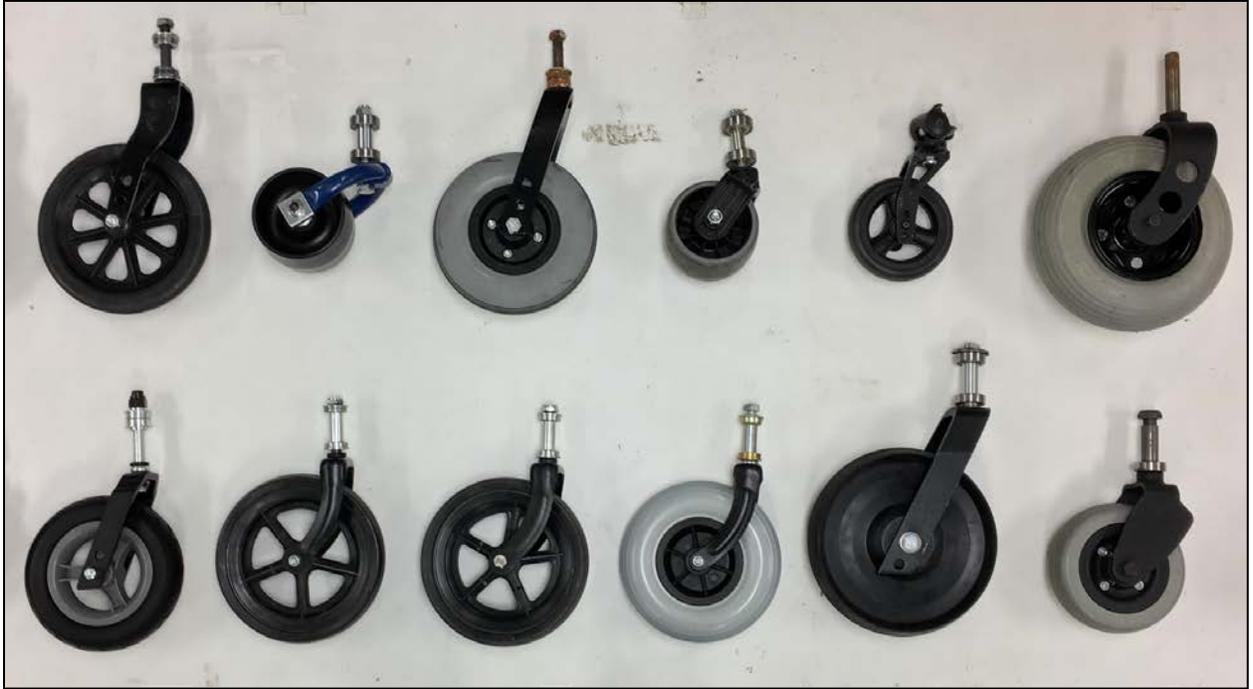
Figure 5. Caster designs used on wheelchairs

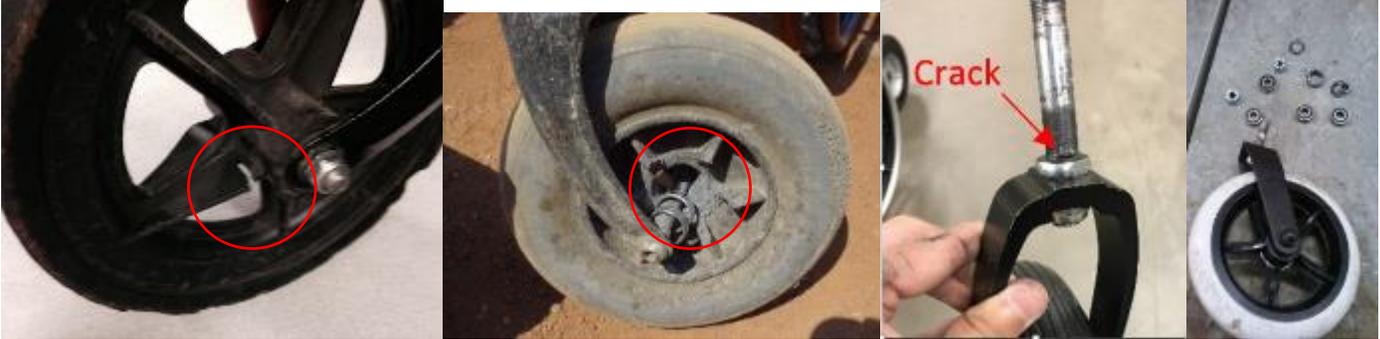
<p data-bbox="495 673 1875 743">Failures: Fracture in caster wheel spoke (left), axle bearing fracture (center-left), stem bolt fracture (center-right) and stem bearing fracture (right)</p>
2. Corrosion failure

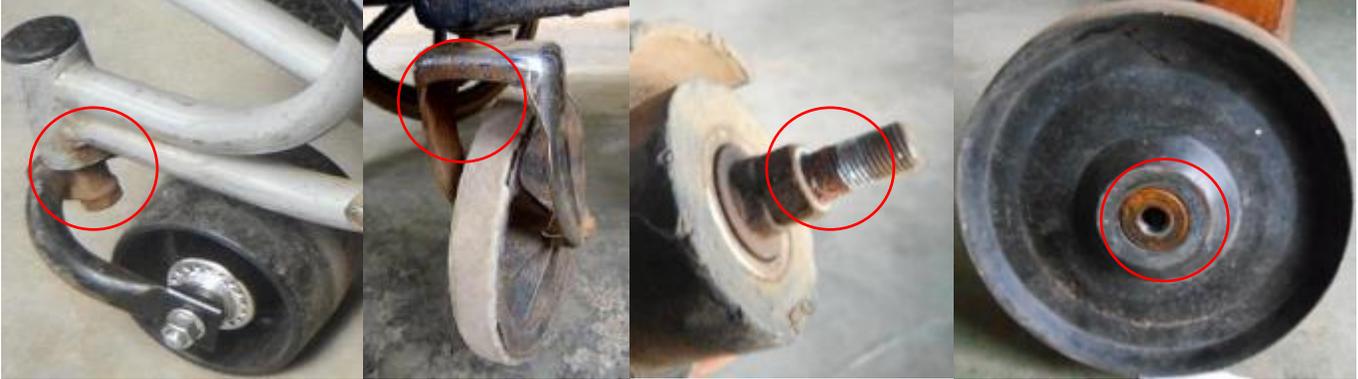
<p data-bbox="485 1130 1885 1162">Failures: Corrosion of stem assembly (left), fork (center-left), axle bolt (center-right) and axle bearing (right)</p>

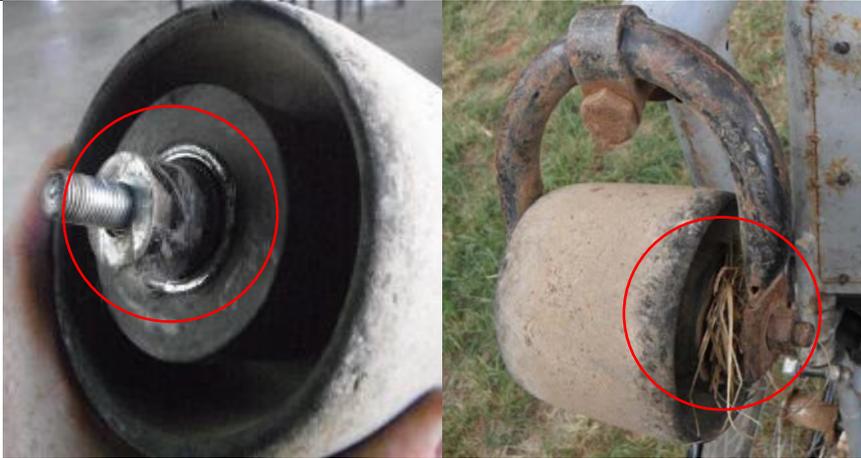
<p>Failures: Resistance to rolling caused due to strings (left) and debris (right) caught in caster axles</p>
<p>4. Tire Failures</p>

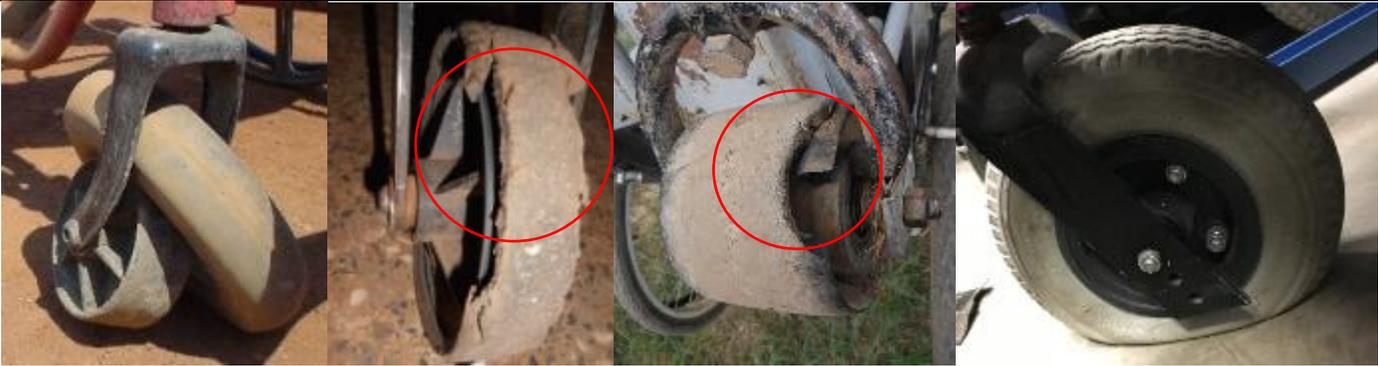
<p>Failures: Tire-roll off (left), tire etching (center-left and center-right) and tire deflation (right)</p>

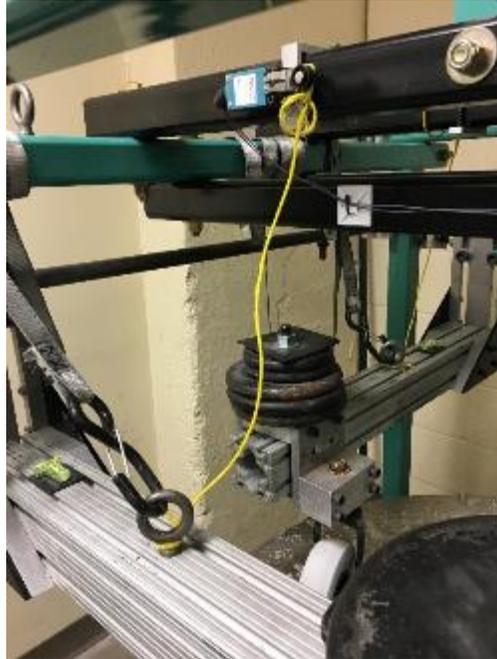
Figure 8. Limit switch for detecting caster arm fall.

Fracture failure of casters during testing could result in the caster arm to falling on the turntable crushing the caster or damaging the turntable. To immediately detect the fall, a limit switch with rotating lever is mounted above of each the caster arms and strings are used to connect the lever from the limit switch to an eyebolt on the arm (see Figure 8 below). For appropriate detection of failure and avoiding any damages, a safety strap is used to prevent a vertical drop of the arm after a failure and hold the arm while the limit switch is triggered. Figure 9 shows the new caster testing equipment that was fabricated and assembled. The parts were powder-coated green and black for aesthetic appeal and to reduce the risk for corrosion.

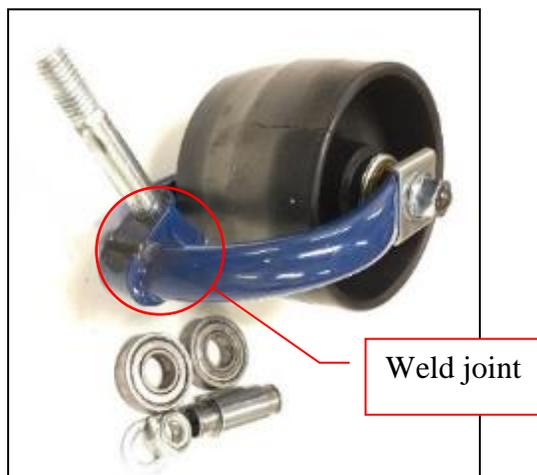
Figure 13. Fork weld joint on model C

The strength of caster models was affected by design factors such as tire thickness and hardness as well. While model A tires are pliable, the casters suffered greatly from slat impacts because the sidewall tires are not as thick. All large-size casters had significantly greater sidewall thickness, and among them model B was found to be more durable because the tires were able to absorb impacts. Tire hardness for caster B and F is 70A while other models have a hardness ranging from 78 to 90A. Hard tires were found to transmit the moment-forces from impacts directly to the stem bolt and fork connection, which causes bolts to shear. Model B caster parts (especially tire and fork) were reportedly expensive and high-quality, and hence, the casters endured the slat impacts without significant failures. However, this model did experience tire cracking failure after 500,000 testing cycles because of excessive heating of rubber. Tire failures such as cracking and wearing are common in the field with Model C casters as per the manufacturer. The caster test was able to simulate this failure for Model C in the laboratory; however, it should be noted that there are several other outdoor conditions apart from mechanical stress and heat that cause this type of failure.

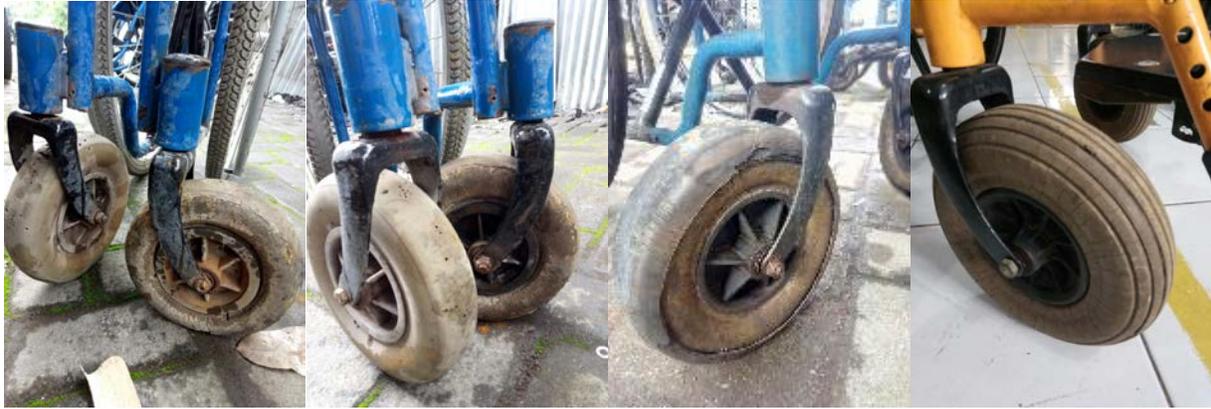
Figure 15. Caster failures with Harmony wheelchairs.

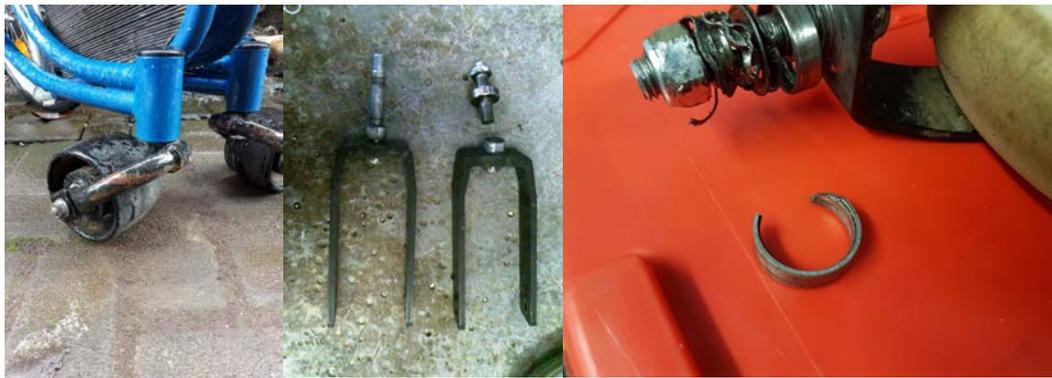
Figure 16. Caster failures with Whirlwind Roughrider (left), Sunrise Quickie Rumba (center) and Invacare Mirage (right)

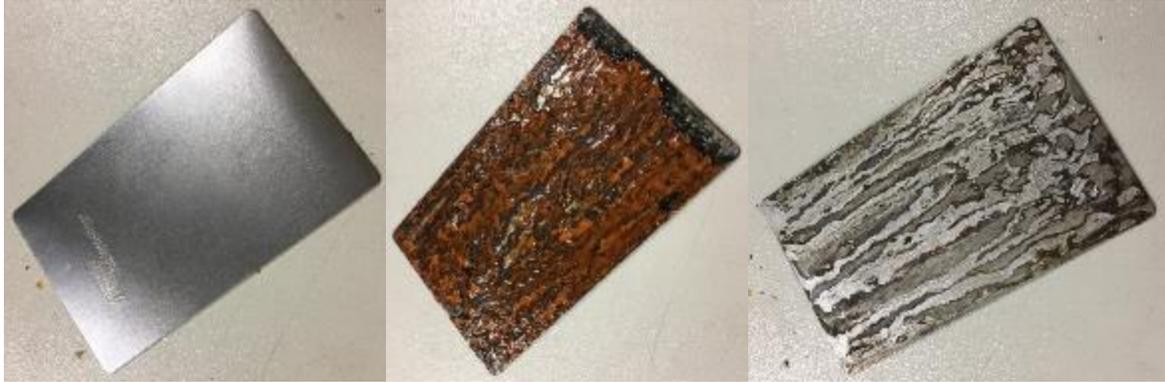
Figure 26. Mass loss test panel before corrosion (left), corroded panel after 100hrs of salt fog exposure (center) and cleaned panel before weighing (right)

SAE 1008 steel panels were used for corrosion in the salt fog chamber. Three panels were cleaned and placed in the salt fog chamber for constant fog exposure at 48°C with high relative humidity (about 97%). Weight loss on test panels was evaluated every 100 hours till 300 hours on a weight scale. Prior to weighing, panels were cleaned, and all rust was scraped from the panels (see Figure 26) surface using a scrubber as specified in ASTM G1 and ASTM B117. Chemical cleaning was not conducted as prescribed in these standards.

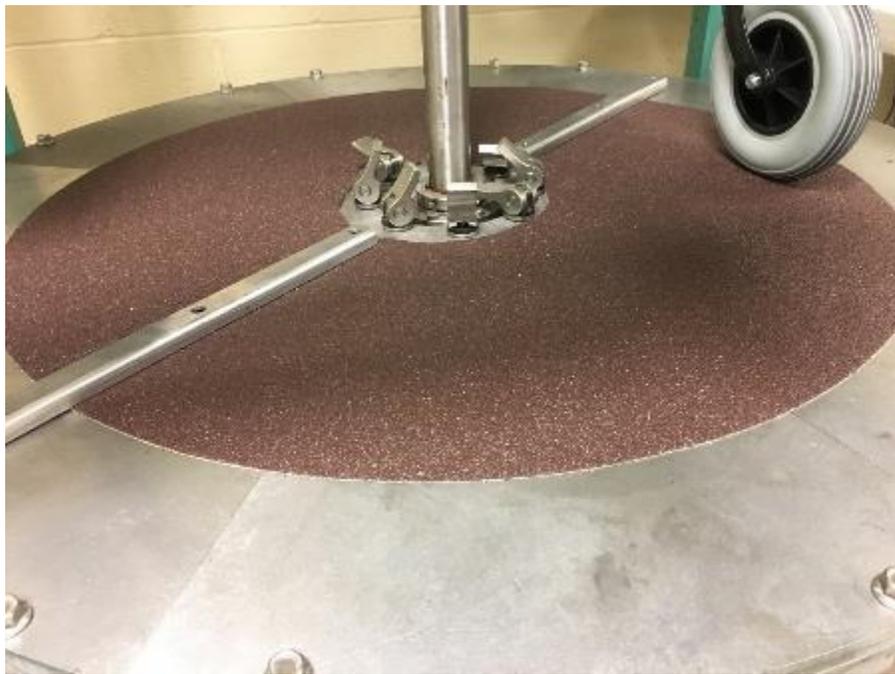
Figure 27. Sanding disc attached to the turntable to simulate abrasion

Sandpaper of 20 and 36 grit sizes was attached to the turntable to simulate rough surface. To evaluate the rate of tire wear, two new HKC samples were tested. Slats were bolted through the sandpaper and the pattern was based on validated shock testing. Reduction in tire thickness was calculated following shock exposure corresponding to one year of outdoor exposure. Figure 27 shows the setup for abrasion validation experiment with the 36-grit, 30 inches wide sanding disc. The tested models experienced wear of 0.0725 ± 0.0275 in with 36-grit sand paper⁷ compared to 0.02 ± 0.01 in with the 20-grit sand paper⁸. Comparing the abrasion rate with that experienced in the field (Table 22), the 36-grit sand paper was chosen for abrasion testing.

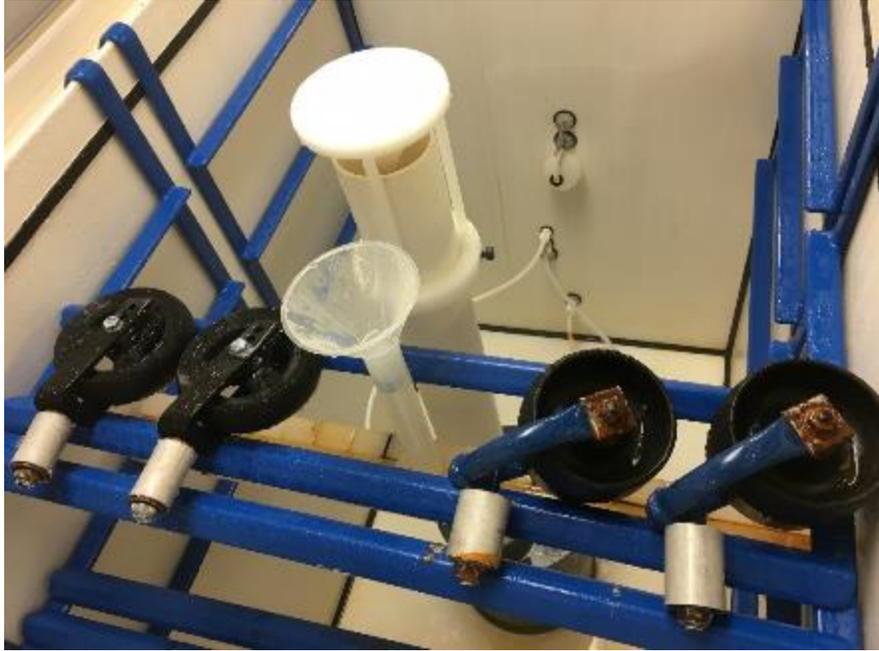
Figure 29. Casters exposed to corrosion in the salt fog chamber

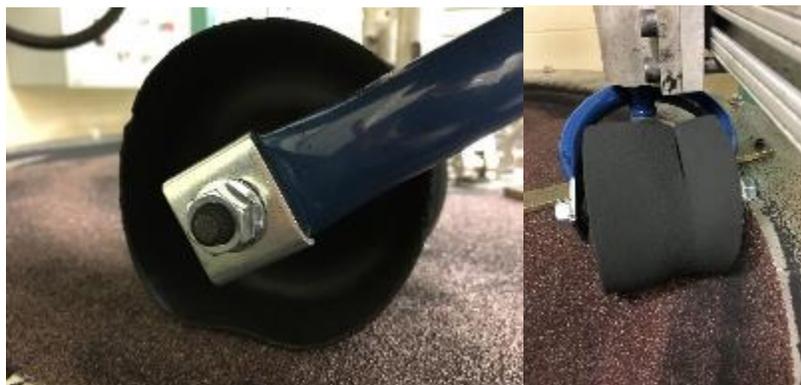
Figure 33. Worn out tires of abraded model B samples. Tire cracking failure (right).

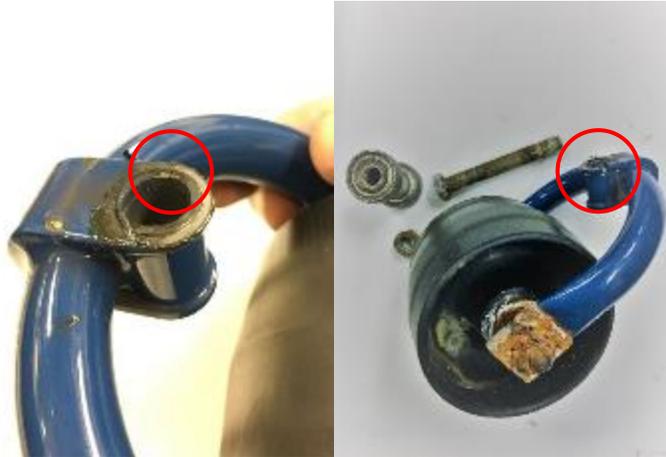
Figure 34. Fork cracks in model B samples.

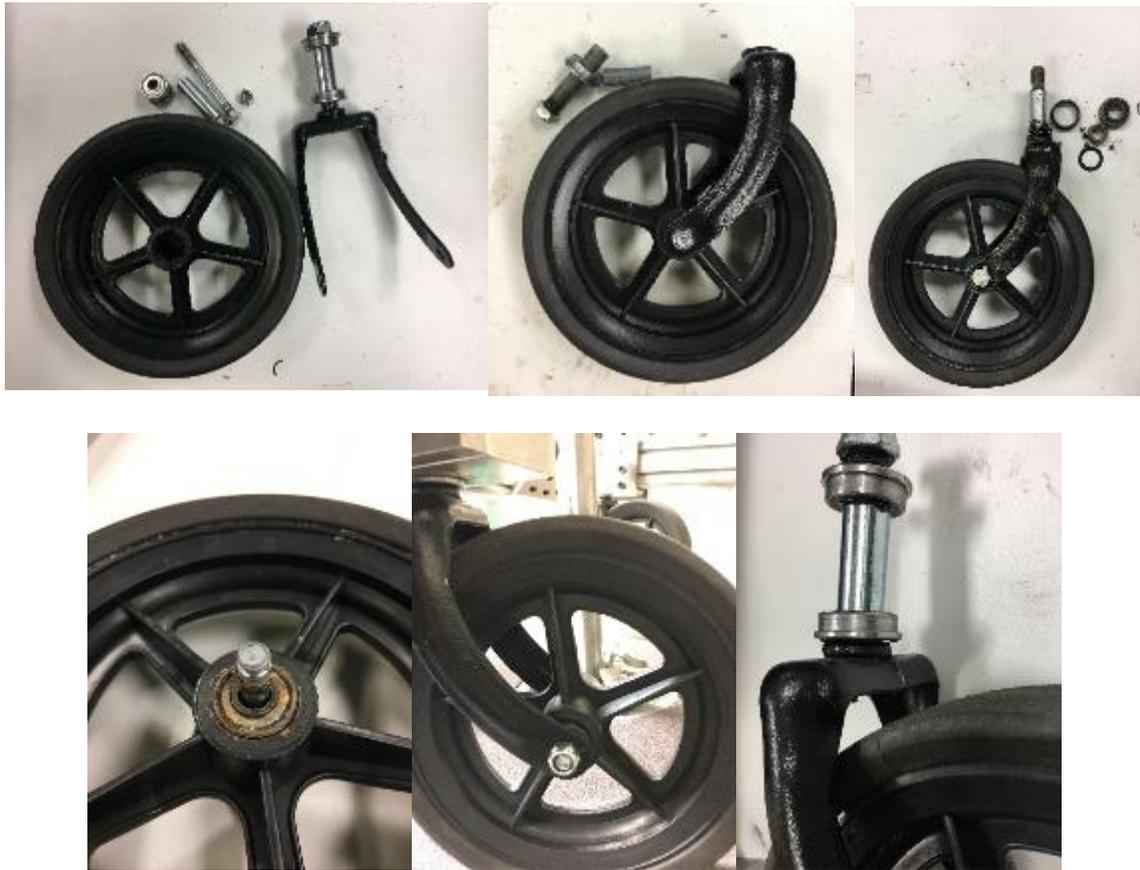
Figure 35. Failures with model C

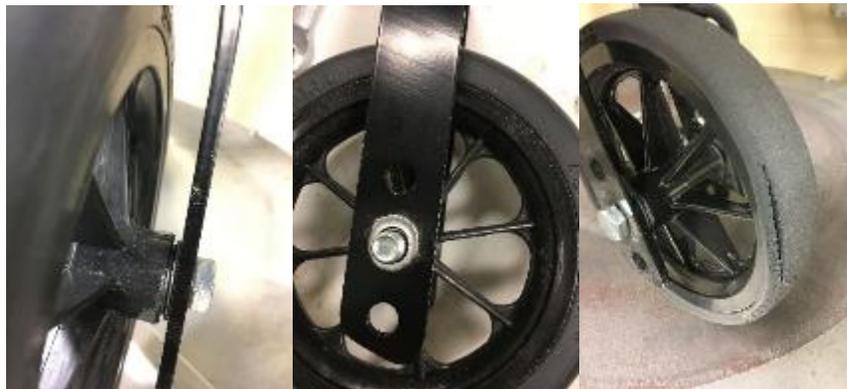
Figure 36. Model D failures. Shock tested samples (left and center) and abrasion + shock tested sample (right)

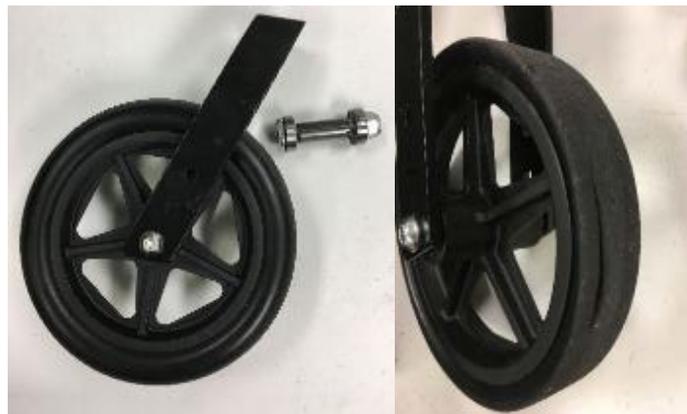
Figure 37. Model E failures. Shock tested sample (left) and abrasion + shock tested sample (right)

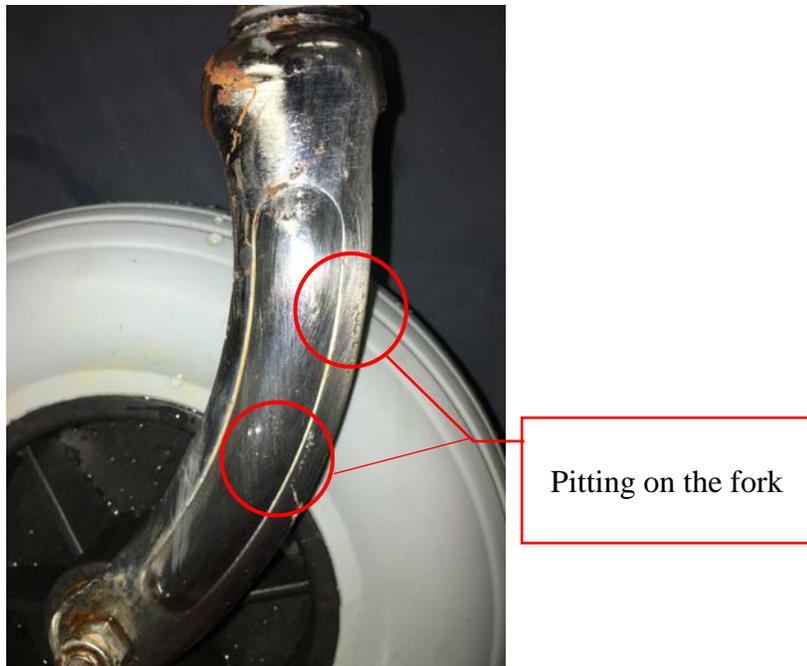
Figure 38. Corrosion effects on a chrome plated castor fork

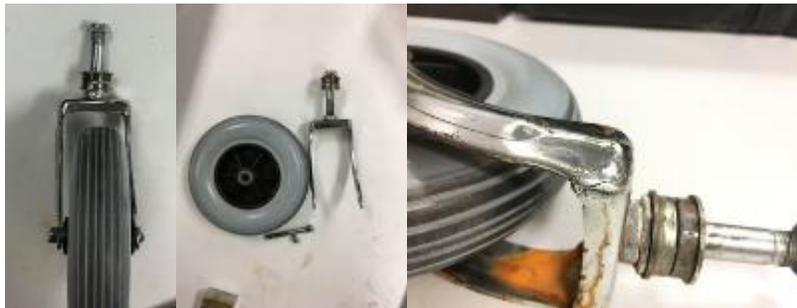
Figure 39. Model F failures. Shock tested sample (left and center) and corrosion + shock tested sample (right)

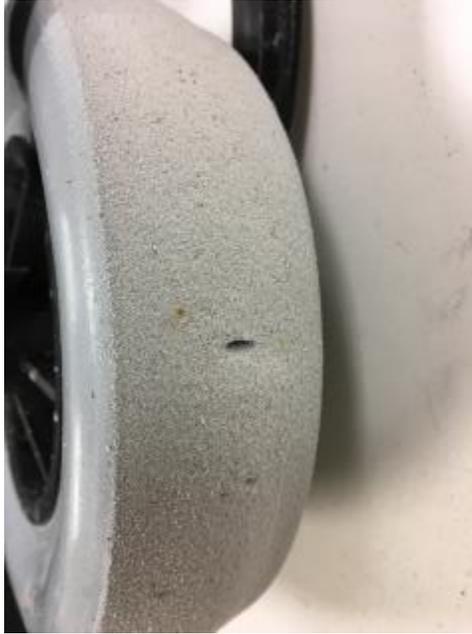
Figure 40. Irregularities found in the tire once the tire dressing comes off.

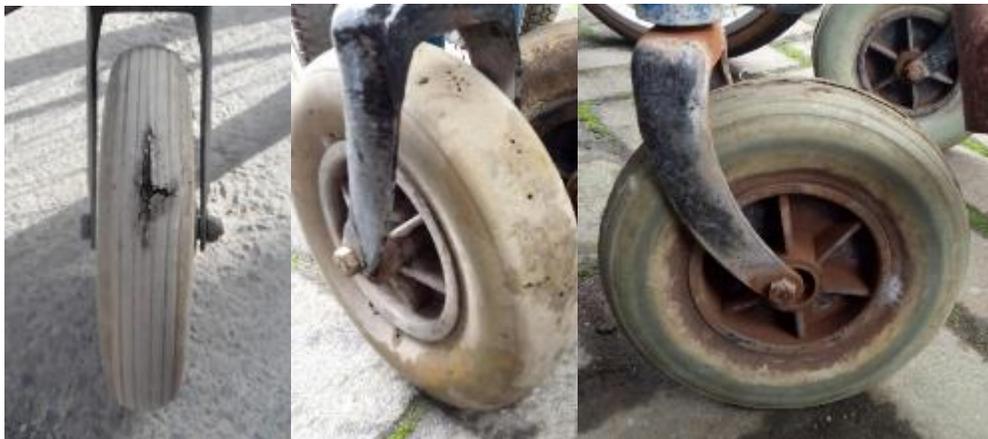
Figure 41. Wear issues reported with tires of models F and G in the field

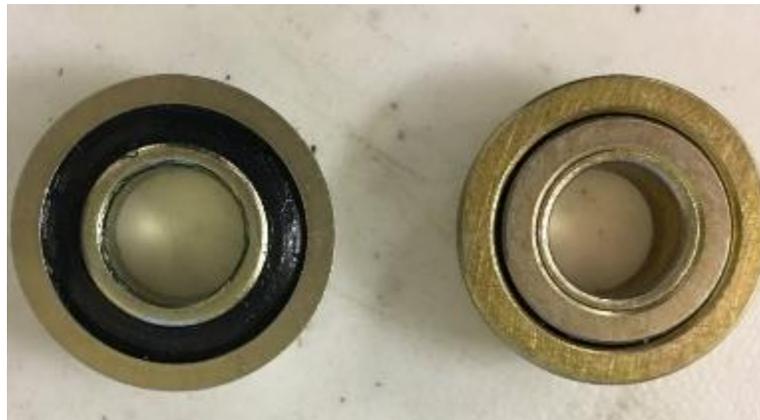
Figure 42. Bearings used with model F (left and right) and model G (right) casters

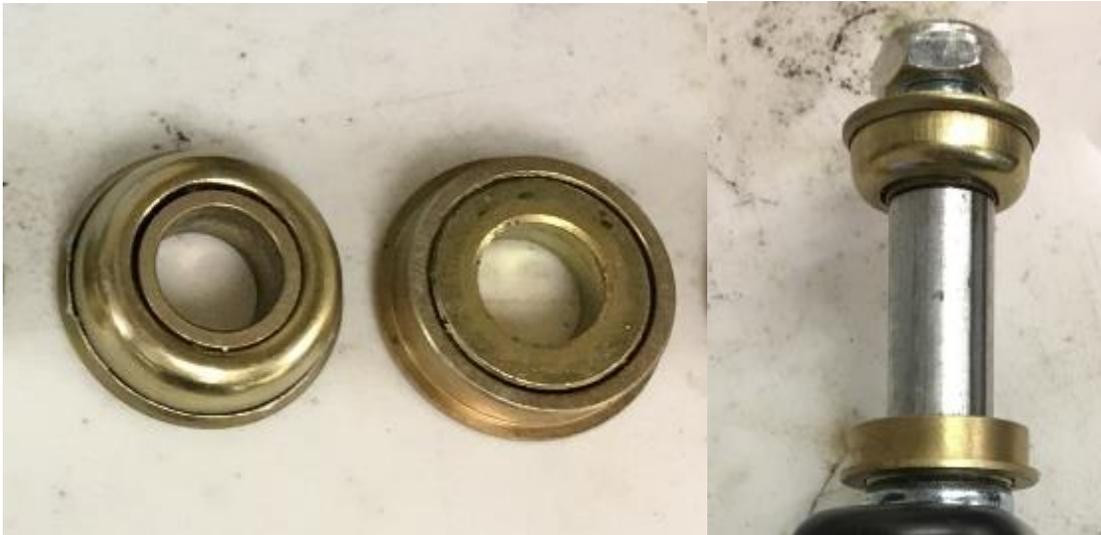
Figure 43. Stem bearings supplied with model G for testing

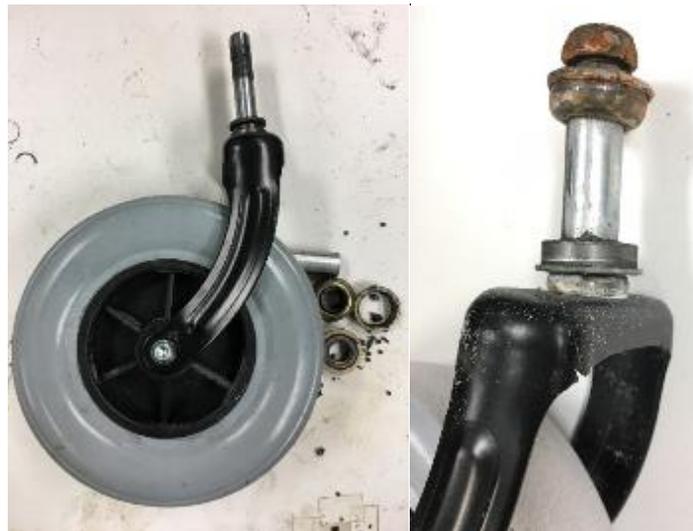
Figure 44. Failure mode seen with model G, bearing fractures (left) and fork crack (right)

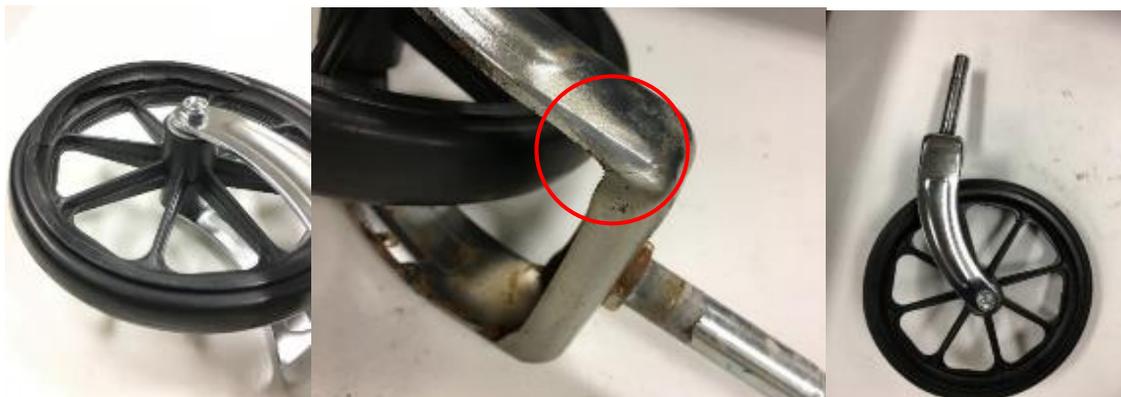
Figure 45. Model H testing failures. Wheel fracture (left), fork crack (center) and bent stem bolt (right)

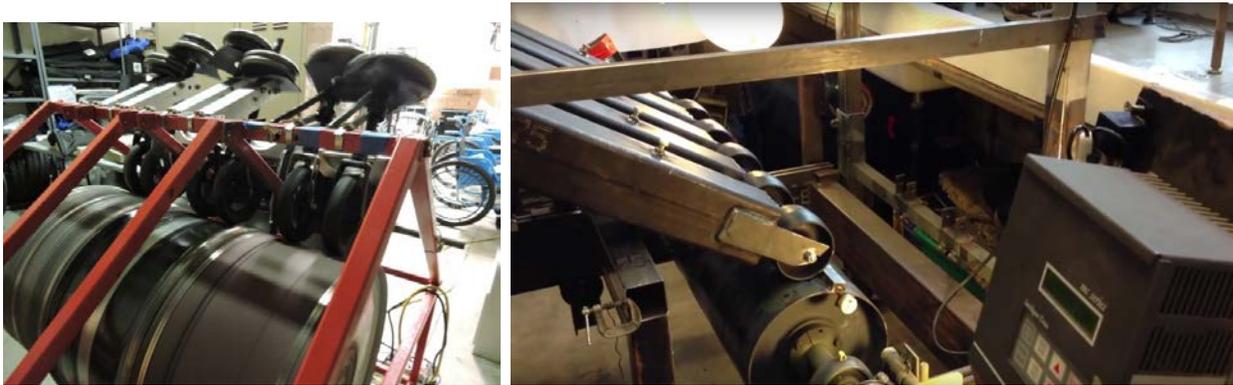
Figure B 1. Caster testing drum equipment with wheelchair manufacturers
