**The Influence of Subsidence Laws and Regulations on the Underground Bituminous Coal Industry in the Commonwealth of Pennsylvania over the Last 25 Years**

Submitted to the Graduate Faculty of  
Swanson School of Engineering in partial fulfillment  
of the requirements for the degree of  
Master of Science

University of Pittsburgh

2019

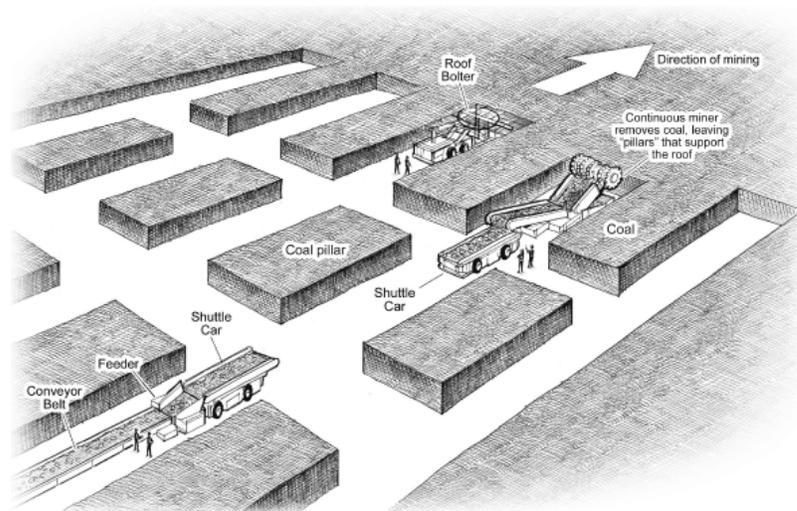
**Figure 1. Classic room-and-pillar mining method (Lehmann et al., 2015)**

The classic room-and-pillar mining method is done in moderate to thick, and flat to moderately inclined coal beds. The coal is mined in horizontal strips starting at the top of the coal seam and benching down towards the mine floor (Hustrulid et al., 2001).

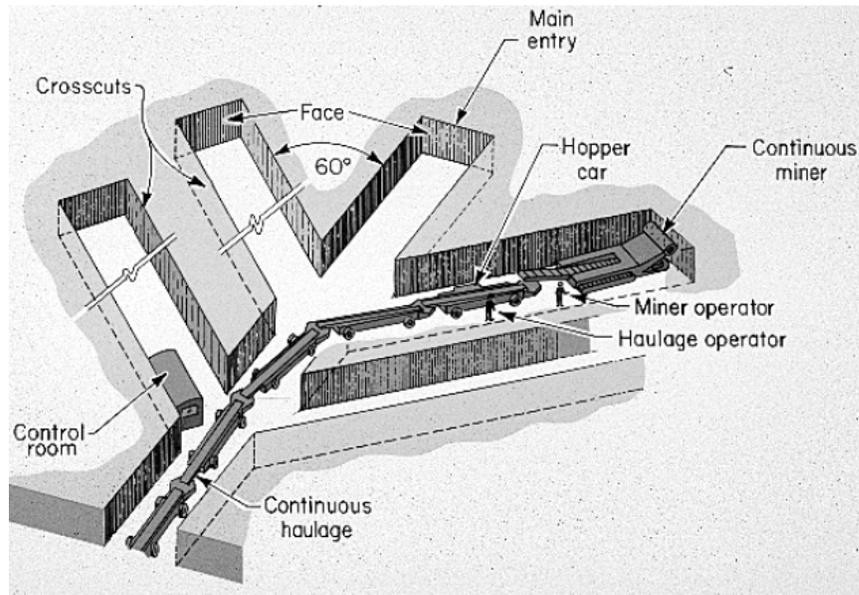
**Figure 2. Place change room-and-pillar mining operation with a continuous haulage machine  
(Sammarco, 1996)**

In the most recent years, some Pennsylvania room-and-pillar operations have implemented continuous haulage room-and-pillar mining. The same method of place changing is used with the continuous miner and the roof bolter, but the coal from the continues miner is loaded directly onto a haulage system behind the continuous miner. The continuous haulage system transports the coal to the fixed conveyer belt (Sammarco,1996). The continuous haulage system eliminated the need for loading shuttle cars to transport the coal from the room-and-pillar face. From August 21, 2013 to August 20, 2018 at least 66% of Pennsylvania room-and-pillar mines used the continuous haulage method. Figure 2 shows an example of a continuous haulage in a room-and-pillar mine.

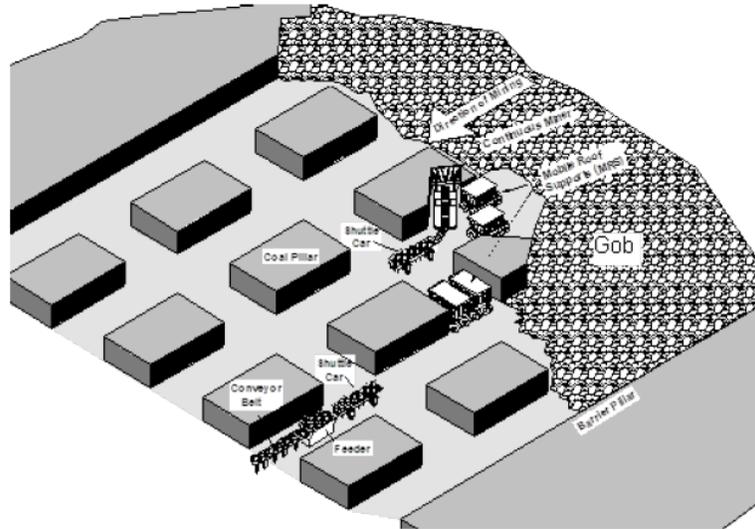
**Figure 3. Pillar recovery of a room-and-pillar mine, the gob area represents the area where the pillars have already been extracted (Mark et al., 2016).**

In a limited number of room-and-pillar mines, pillar recovery is implemented. Pillar recovery is the extraction of a coal pillar after the initial room-and-pillar mining has taken place. The extraction of the pillars retrieves additional coal; however, the removal of the pillars decreases the roof support and can cause subsidence to form at the surface (Mark et al., 2016). In Pennsylvania from August 21, 2013 to August 20, 2018 only 11% of room-and-pillar mines used pillar recovery. Figure 3 shows an example of the gob that is formed from the extraction of the supporting pillars.

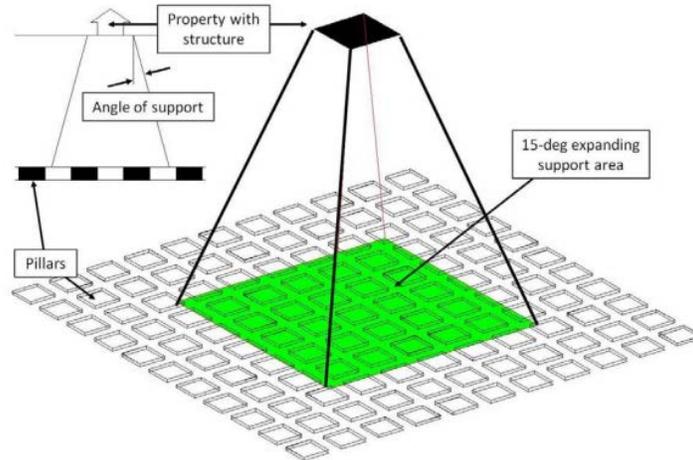
**Figure 5. Example of the angle of support required by BMSLCA (1996) (Iannacchione et al., 2011)**

In 1970, Gray and Meyer developed an angle of support that could be used as a guide to determine a stable area over a mine and reduce subsidence damage. The angle varied from 15 to 25 degrees from the vertical (Figure 5) and relied heavily on the geology of the area. The angle of support was an important contribution to subsidence protection because it showed that even if a structure is directly over solid coal there can still be subsidence effects (Keener, 2014).

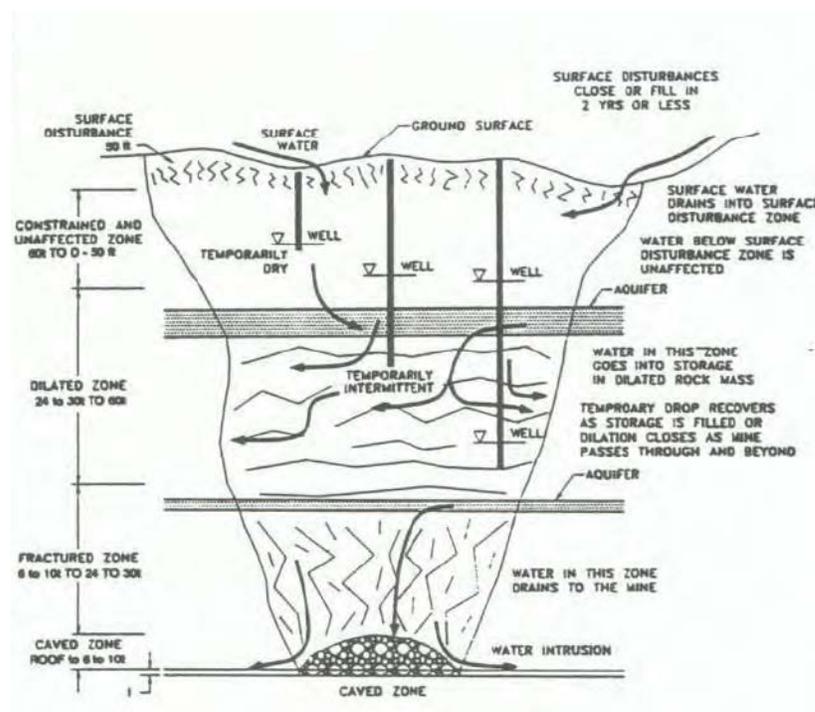
**Figure 6. Kendorski's diagram of the zones above a subsided mine (Kendorski, 1993)**

Kendorksi played a pivotal role in the initial understands of groundwater movement above a mine. In 1979, he developed a subsidence model that depicted different zones above mined panel. The most important zone dealing with groundwater was the aquatic zone that was located below the zone of increased permeability at the surface. The aquatic zone is an area of low permeability that prevents or limits that shallow groundwater and surface water from entering the mine. In 1993, Kendorksi refined his 1979 model further to include the dilatated zone (Figure 6). The surface and ground waters that drain into this zone can be recovered as the subsidence progresses away from the area by the closing of dilations and or the filling of void space. The bending of the strata increases permeability and storability in the rocks of the dilated zone allowing the water to say in the dilated zone. The zone below it however is fractured and water in that zone will be able to drain to the mine. It was estimated that it could take up to two years for ground water condition to return to a pre-mining state. This zone was extremely important for wells located in it because there was potential for the wells that went dry during mining to recover after mining.

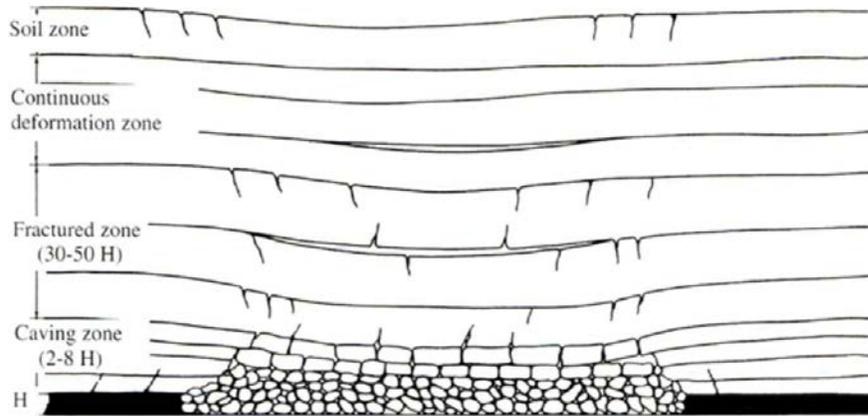
**Figure 7. Four zones of strata movement above a longwall panel (Peng, 1992)**

Since the above factors influencing subsidence are specific to the region that the mine is in, the subsidence theory reviewed here focuses on the Northern Appalachian region. The damaged overburden in this region can be divided into four zones: caved zone, fractured zone, continuous bedding (deformation) zone, and soil zone (Figure 7, reproduced from Peng, 1992).

Dependent on overburden thickness surface structures, ponds, and some wells are in the soil zone, while deep wells and aquifers can extend to the continuous deformation zone. The soil zone has the least dramatic movement of all the zones but structures and wells in this zone can still be affected by subsidence. The deep wells and aquifer located below the soil zone in the continuous deformation zone are even more likely to be damaged (Keener, 2014).

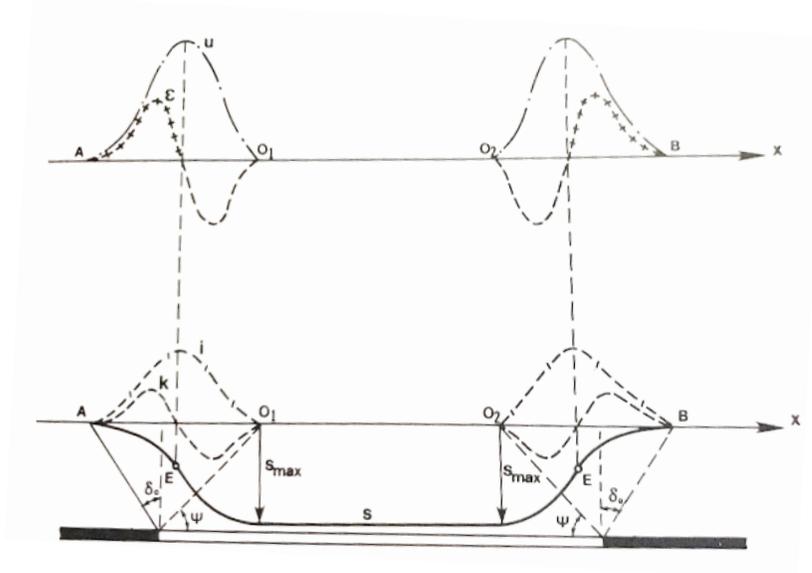
Figure 8. Surface deformation distribution on a major cross section (Peng and Chiang, 1984)

Figure 8 shows horizontal strain occurring over a supercritical subsidence basin. The highest tensile strain occurs over the gate roads of the panels and the compressional strain occurs a quarter of the length into the panel. The point of zero strain occurs at the inflection point, this is the point in which the curve changes from concave up to concave down, of the subsidence basin.

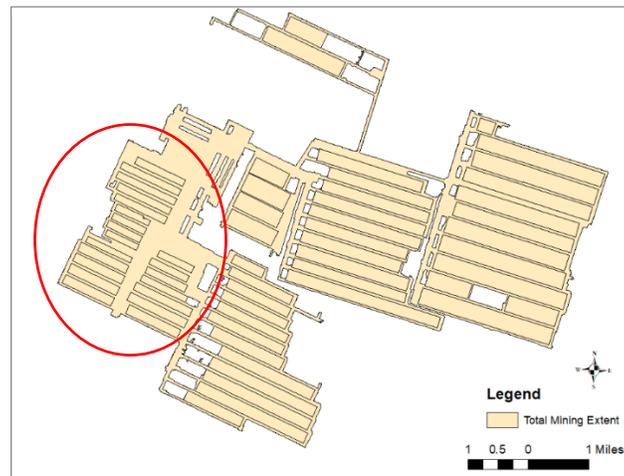
**Figure 14. Total Extent of Emerald mine, the area circled in red shows examples of older mining**

more uniform longwall panel size, while the older mining is characterized by smaller panels with erratic size and orientation. The area circled in red indicates area mined prior to the 1994 Act 54.

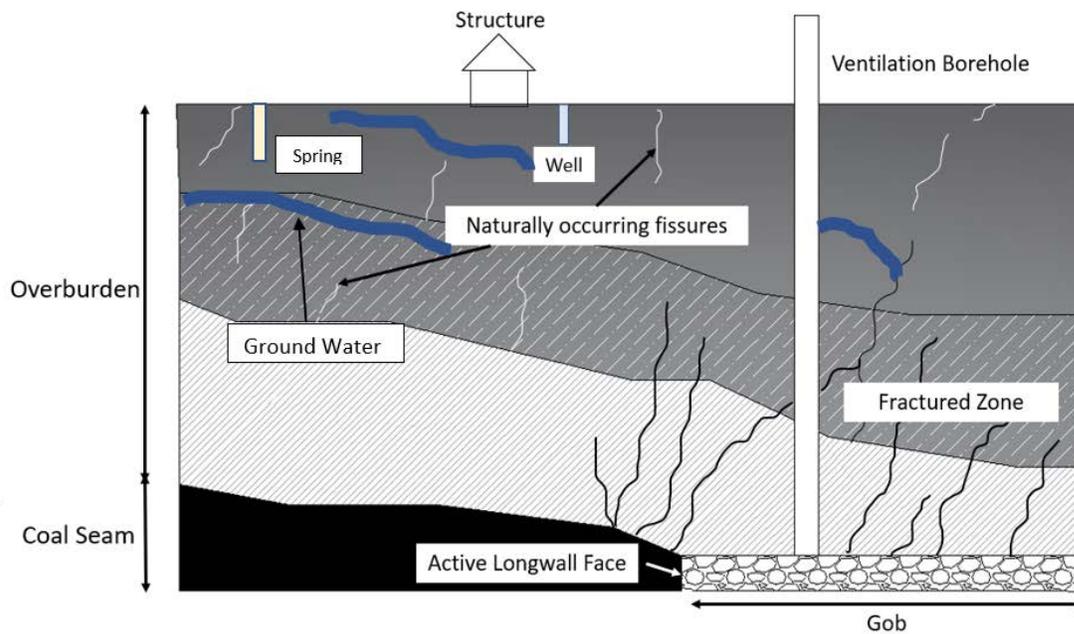
**Figure 22. Diagram of the cracks and fissures formed during mining and the disruption of ground water**

Watersources have the most overall impacts as well as the most company liable impacts (Tables 13 and 14). A watsource is listed as a spring, well, or pond. Watersources do not necessarily need the formation of a subsidence basin to be damaged. Watsource can lose water through small cracks and fissures can occur from small movement in the overburden (Figure 22).

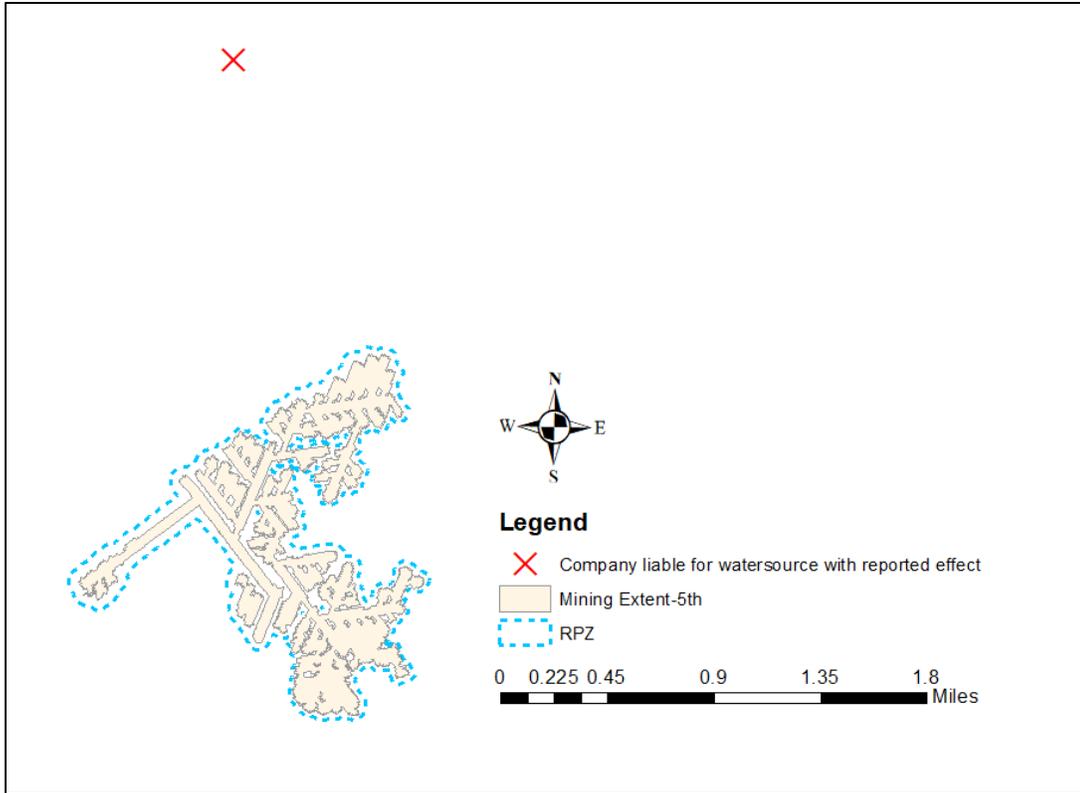
**Figure 23. Knob Creek mining extent from the 5<sup>th</sup> assessment period and the impacted watersource located 7,000-ft from mining**

The remaining six company liable that were outside of the RPZ during the 5<sup>th</sup> assessment did not occur over mining that had occurred in the last 25-years. These six reported effects generally occurred within hundreds of feet of active mining and may be due to mining as the angle that Carver and Rauch studied in 1994 for affected watersources in West Virginia was not exactly 35-degrees, rather it ranged between 27-38-degrees. There is one company liable impact that occurred in Knob Creek that cannot be reasonably explained with current known mechanics. The impact is located over 7,000 feet from active mining of the 5<sup>th</sup> assessment period, and the mining located directly below it occurred in the 1930's. Figure 23 depicts a map of Knob Creek 5<sup>th</sup> assessment mining and the RPZ and the distance to the company liable impact.

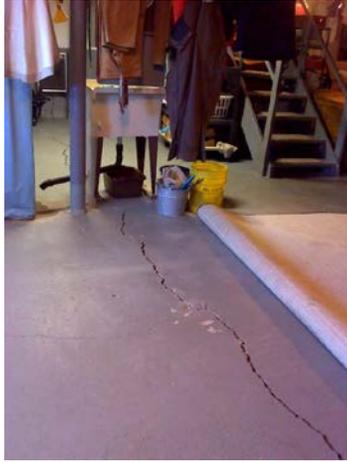
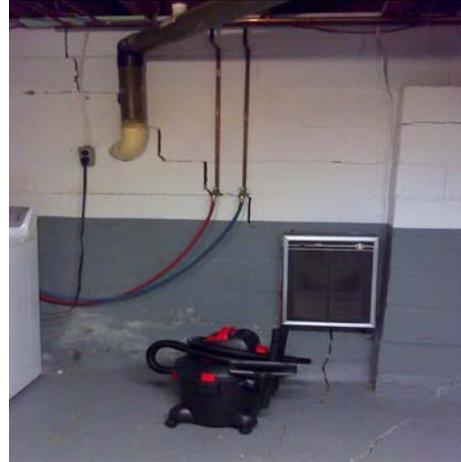
**Figure 25. Damage to a dwelling located over an Enlow Fork panel (photographs courtesy of the PA DEP)**

An example of structure damage that occurred over the Enlow Fork mine is shown in Figure 25. A crack developed along the basement floor of the dwelling and into the brick walls. This structure was located above a panel, slightly off center of the panel, so the damage was undisputedly due to underground mining. The landowner and the mining company entered into an unspecified agreement six months after the damage occurred

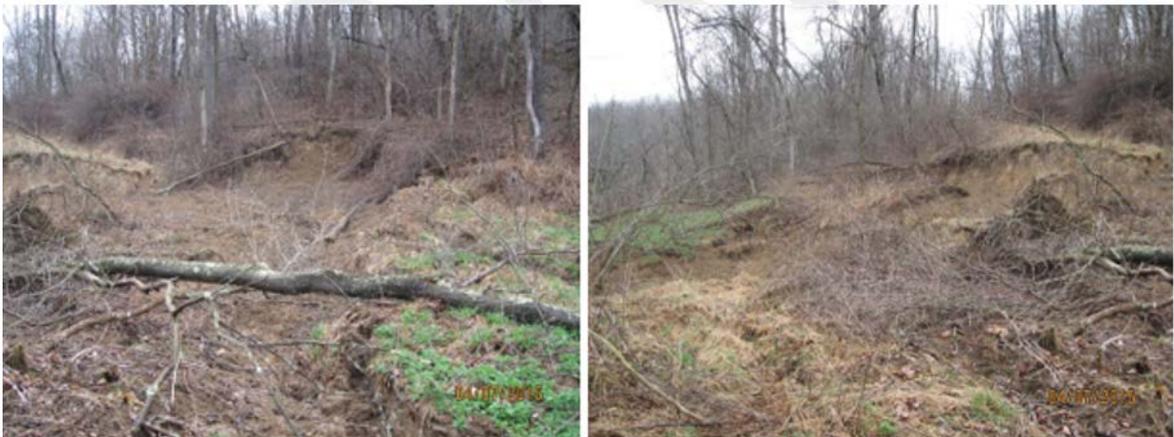
**Figure 27. Mass wasting occurring over the Harvey mine during the 5th assessment (Photographs from the PADEP files)**

In the 5<sup>th</sup> assessment there were 46 instances of landslides or mass wasting, it was the most common land impact in the assessment period. Figure 27 is an example of mass wasting occurring over the Harvey mine. This was a company liable impact that occurred over the corner of a panel and was repaired.

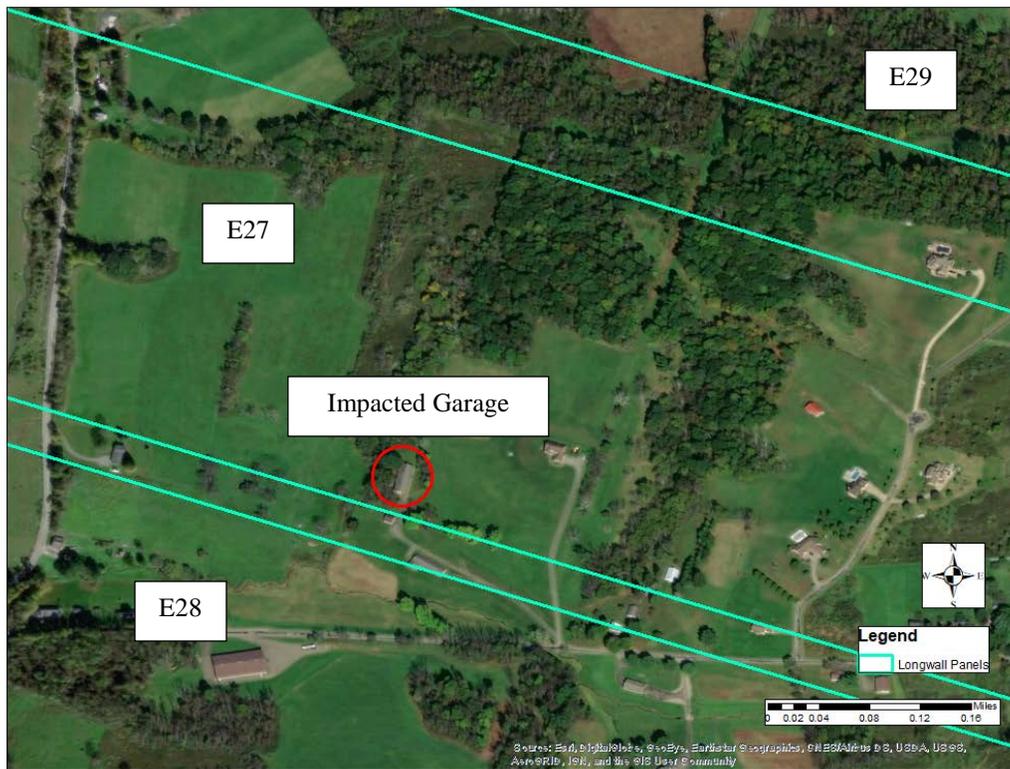
**Figure 28. Impacted garage that was surveyed to compare the deformation of the garage with the predicted subsidence basin**

In the 5<sup>th</sup> assessment period there was an impacted garage located at the edge of a panel of the Enlow Fork mine. The damage of the impacted garage included the uneven settlement of the concrete garage floor. The University was able to survey the damages to the garage floor to obtain the total vertical drop across the garage. Because of the location of the garage, shown in Figure 28, the profile of the sloping garage floor was able to be compared to the predicted subsidence profile developed by empirical methods.

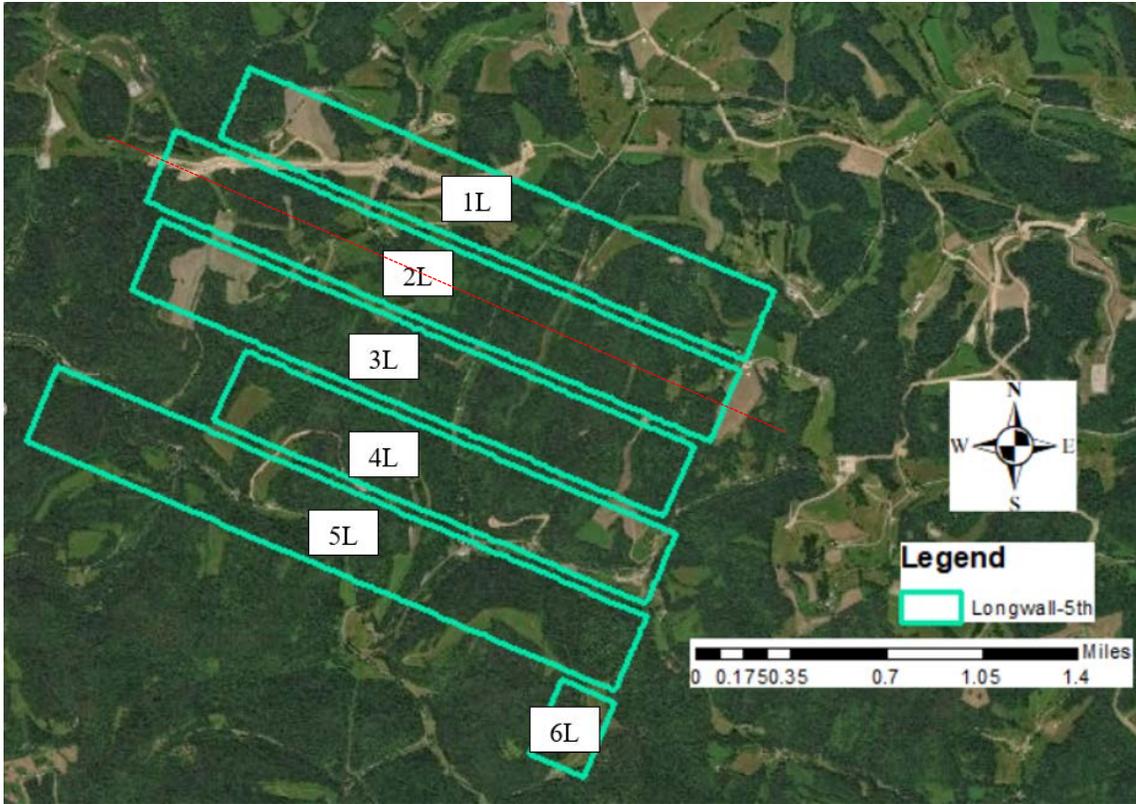
**Figure 30. Map of Bailey 2L panel**

The Bailey mine is in the Pittsburgh coalbed in Greene County and is operated by CONSOL Energy. Between August 21, 2013 and August 20, 2018 Baily mined seven total panels completely, and one panel was being actively mined at the conclusion of this assessment period. The 2L panel is located between the 1L and 3L panels and was completed in 2016. Figure 30 shows the location of the 2L panel. It can be noted that the panel does not undermined a heavily populated as per Figure 24, which is an important factor when estimating structure and watersource impacts due to undermining.

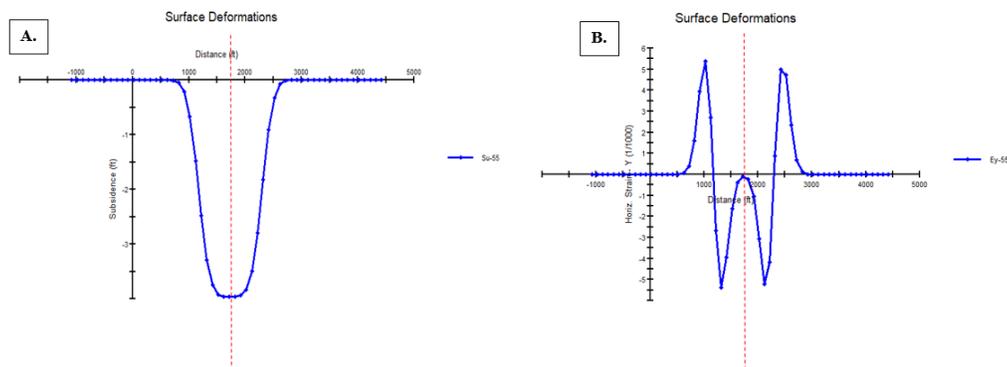
**Figure 31. A. Vertical Subsidence of the 2L panel B. Ground Strain of the 2L panel.**

The areas of positive tension are zones of the ground that are being pulled into the subsidence basin. The areas of highest strains are often the best indicator for predicting subsidence damage (Karmis et al., 2008). So, if 2L was a single panel the damage from the subsidence would be predicted to be the most substantial around the edge of the panel, not directly in the middle of the panel.

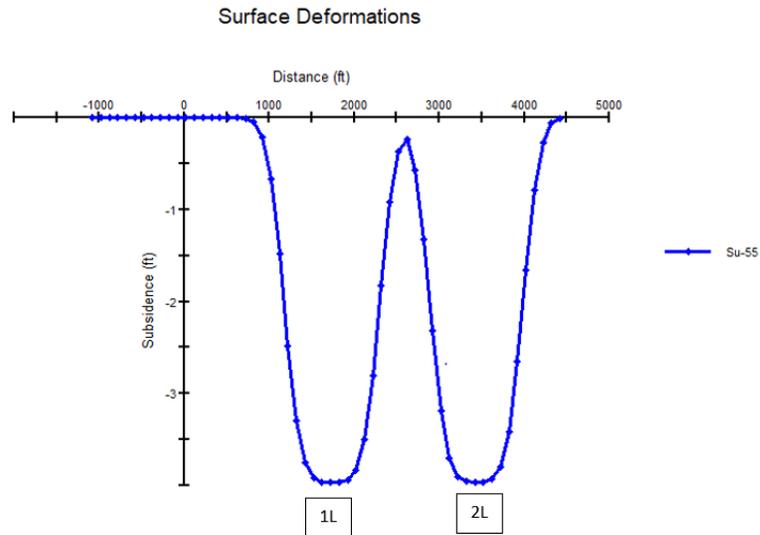
**Figure 32. SPDS vertical subsidence prediction for the 1L and 2L panels**

The next SDPS model was run with the influence of the mined 1L panel on the 2L panel. A previously mined panel can have influence on the subsidence basin of the panel adjacent to it. Figure 32 shows the vertical subsidence of the 1L and 2L panels. The overall vertical subsidence is not noticeably different. However, there is a slight subsidence over the gate road between the two panels. Both panels have reached their maximum predicted subsidence.

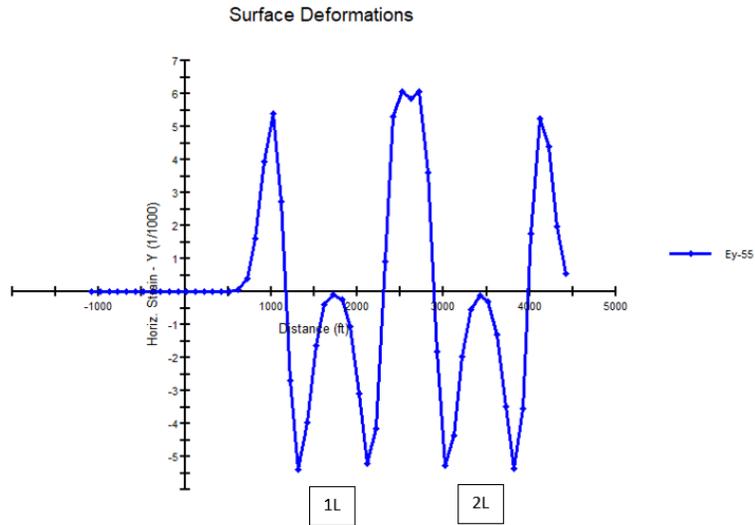
**Figure 33. Strain predictions for the 1L and 2L panels**

The strain induced from the mining of the two panels is shown in Figure 33. As with the modeling of a single panel the strain is highest over the gate roads and approaching zero at the middle of the panels. The maximum strain occurs along edge of the gateroad located between the 1L and 2L panels. This strain value is larger than the maximum over the single panel. This indicates that operators must be more aware when they are mining consecutive panels because the forces are predicted to be larger and therefore have the potential to cause more damage.

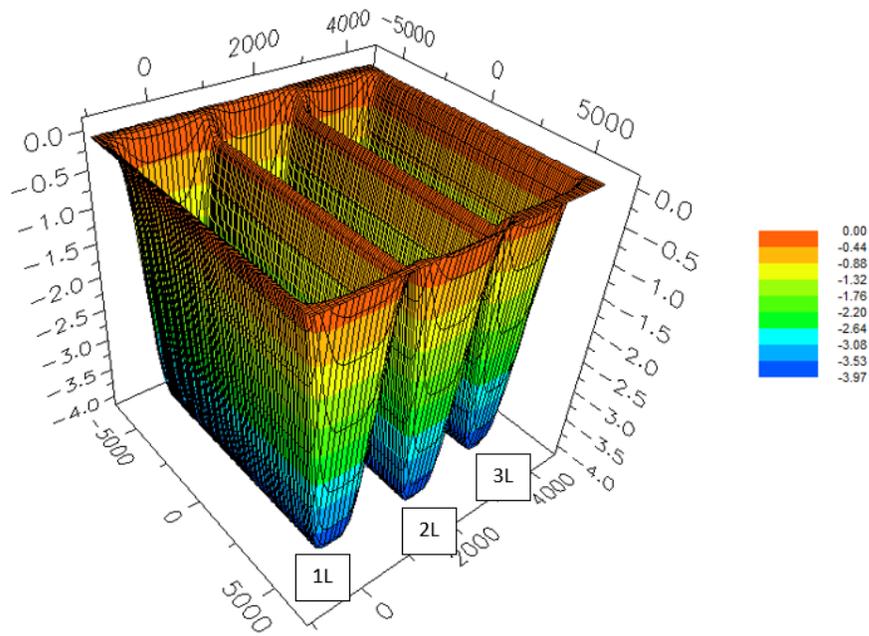
**Figure 34. 3D vertical subsidence prediction model for the 1L, 2L, and 3L panels**

The final SDPS model run was after the 1L, 2L, and 3L panels were mined. This is the most realistic prediction of the final subsidence basin and horizontal strain of the 2L panel because the mining on each side of the panel has been completed. Figure 34 is a 3-D model of the final predicted subsidence basin. Once again, the maximum vertical subsidence at the middle of each of the panels does not vary drastically, and the maximum of each panel is the same. There is very minimal subsidence over gateroads between the 1L and 2L panels as well as the 2L and 3L panels.

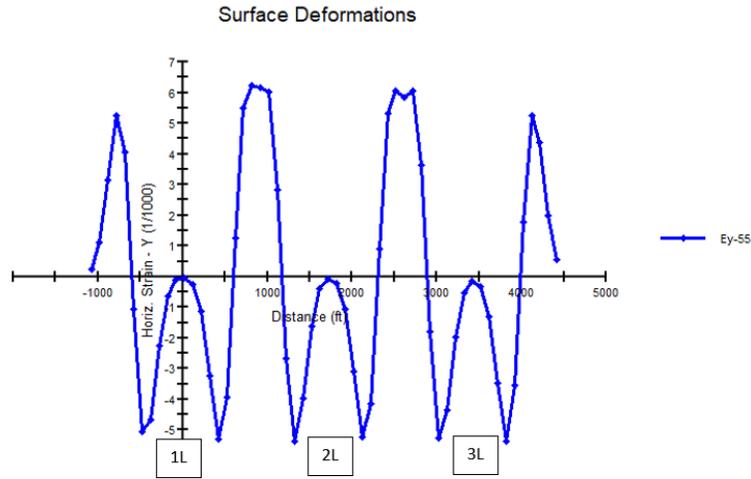
**Figure 35. Strain prediction for the 1L, 2L, and 3L panels**

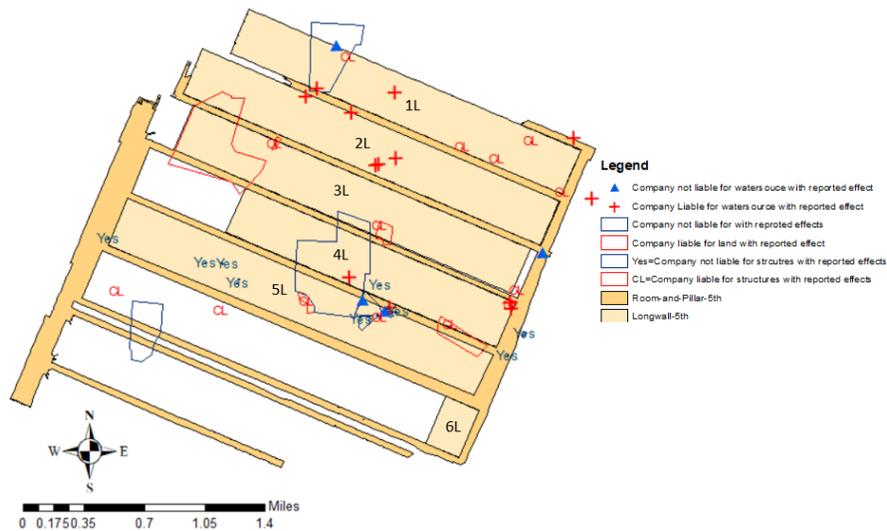
**Figure 36. Location of all reported effects over the Bailey 1L, 2L, and 3L panels**

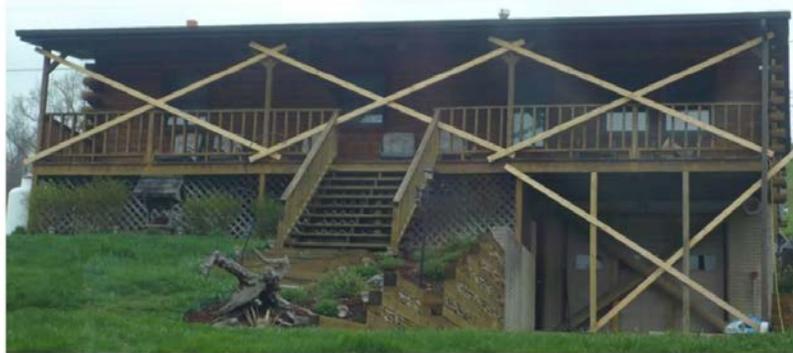
**Figure 37. Bracing of an undermined structure in the 3rd Act 54 assessment (Photograph courtesy of N. Evanek)**

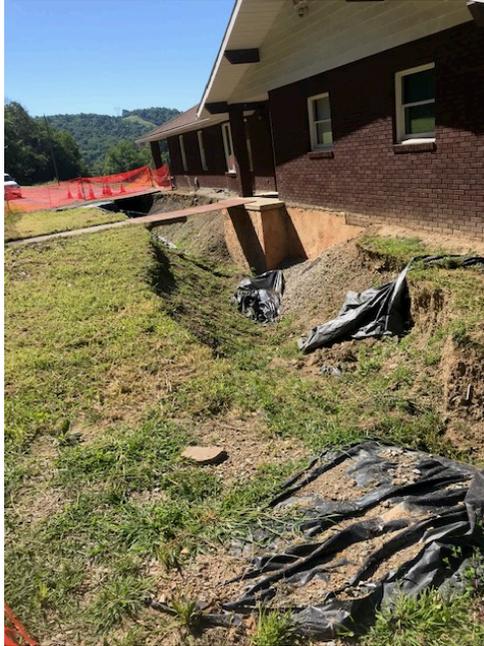
**Figure 38. Trenching of an undermined structure in the 5th Act 54 assessment**

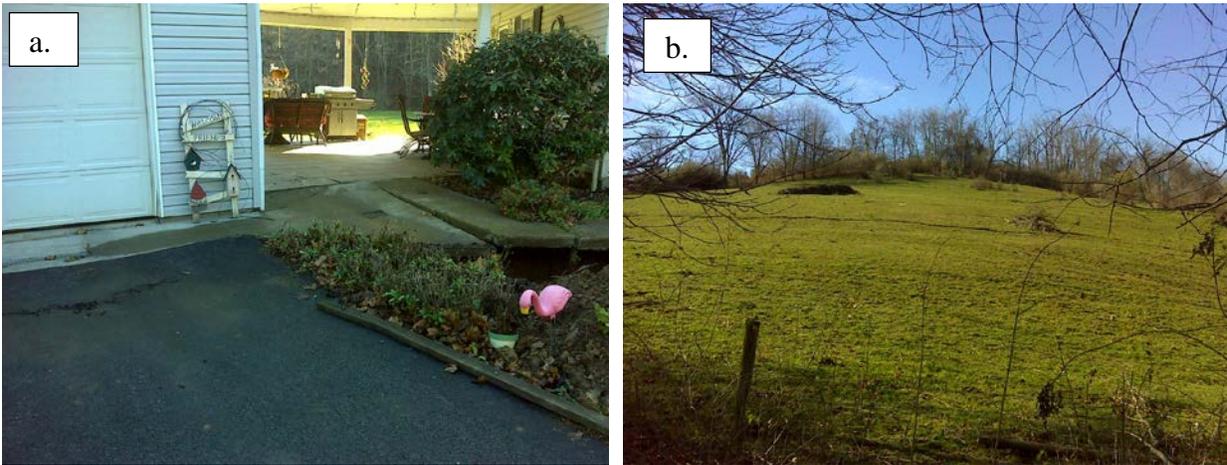
**Figure 40. a.) Damage to the driveway b.) roll forming in the hillside across from the property**

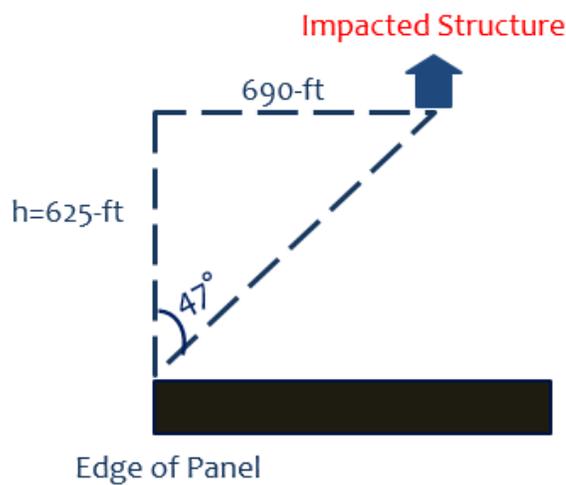
**Figure 43. Angle of deformation of far feild effect\***

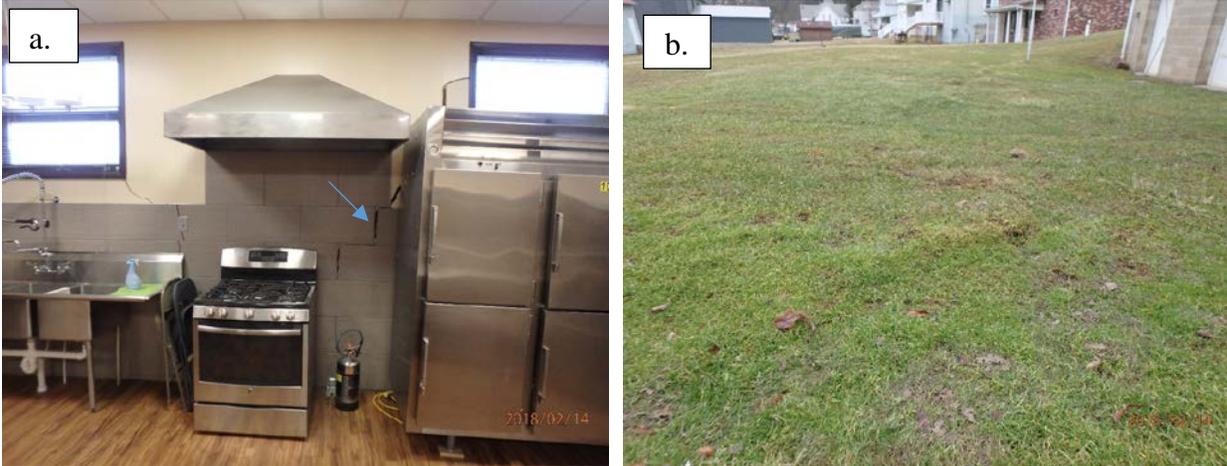
**Figure 49. a.)Crack in the wall of the community center b.) Compression hump in the yard  
(Photographs courtesey of the PA DEP files )**

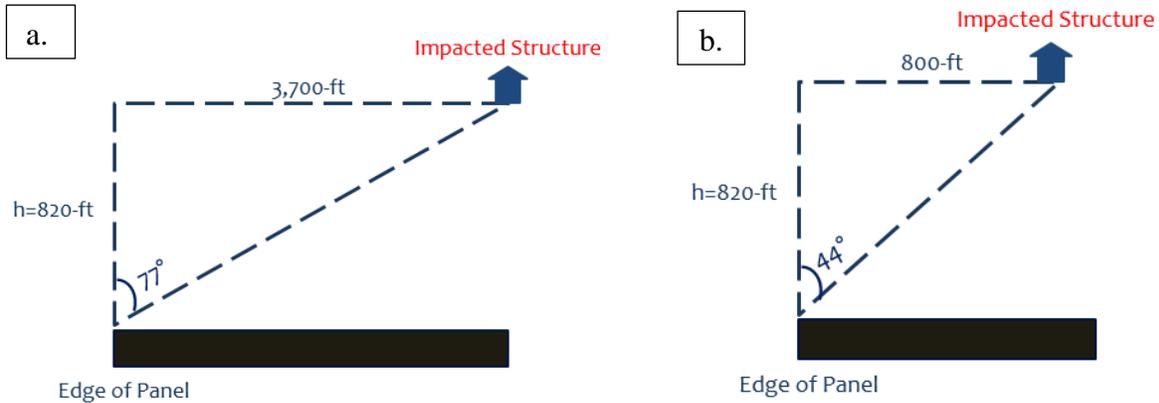
**Figure 50. a.) Angle of deformation of the first far field effect\* b.) Angle of deformation of refollowing far feild impacts\***

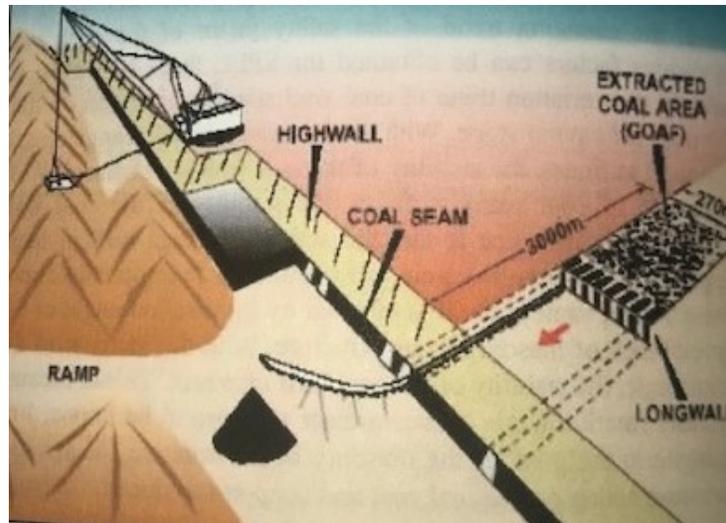
**Figure 58. Punch longwall layout (Martin et.al, 2018)**

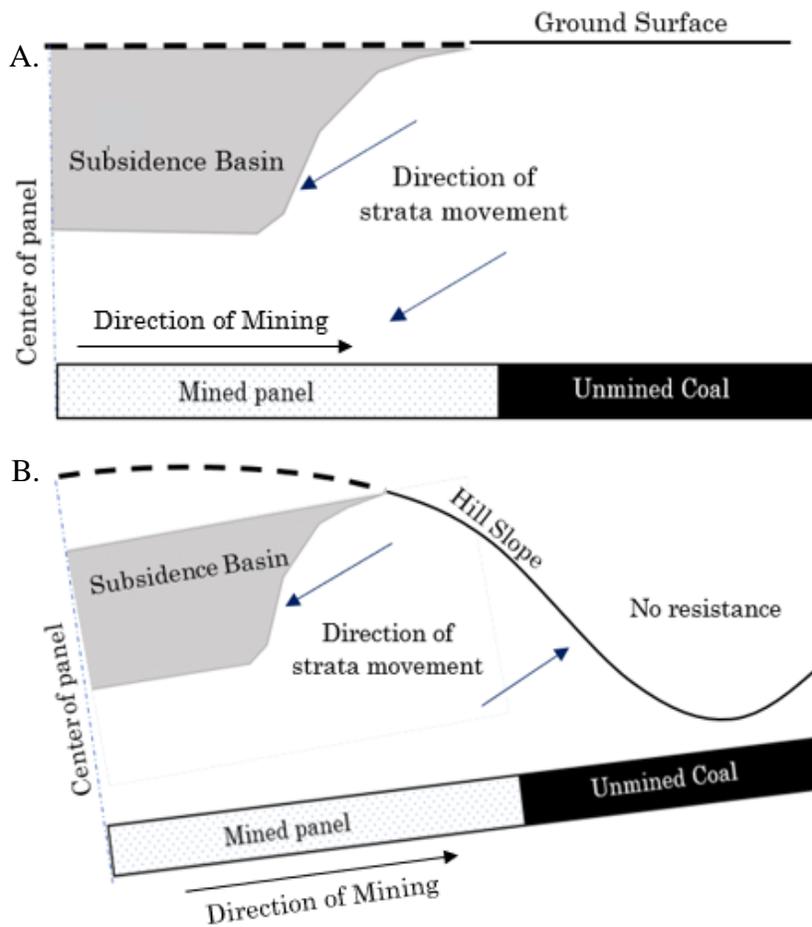
**Figure 59. A.) Longwall panel mining the same elevation in flat terrain B.) Longwall panel increasing in elevation mining in a area of hills and vallyes**
