**An Investigation of the Longwall Mining Subsidence Impacts on Pennsylvania
Highway I-70: A Case Study**

Submitted to the Graduate Faculty of the
Swanson School of Engineering in partial fulfillment
of the requirements for the degree of
Master of Science in Civil Engineering

University of Pittsburgh

2020

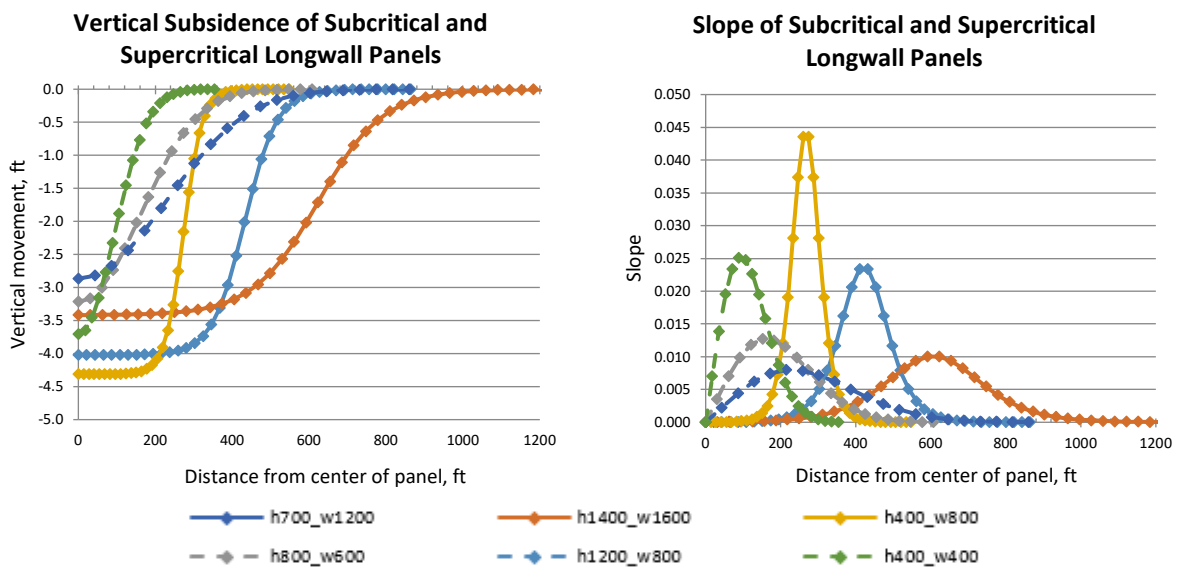
Figure 8 Profile function models of longwall panels vertical subsidence (left) and slope (right) for supercritical (solid lines) and subcritical (dashed lines) panels

seen in this figure, overburden and panel width impact the amount of vertical subsidence, the width of the subsidence basin, and the slope of the basin sides. Typically, shallower panels produce more vertical subsidence, while deeper panels cause less vertical subsidence. The width of the panel is directly proportional to the width of the final subsidence basin and the radius of influence, r . The figure also shows that shallow panels tend to produce larger slopes than deep panels and supercritical panels tend to cause larger slopes than their subcritical equivalents. The slope parameter is important, as it, along with strain, can be used as a surrogate to horizontal deformation.

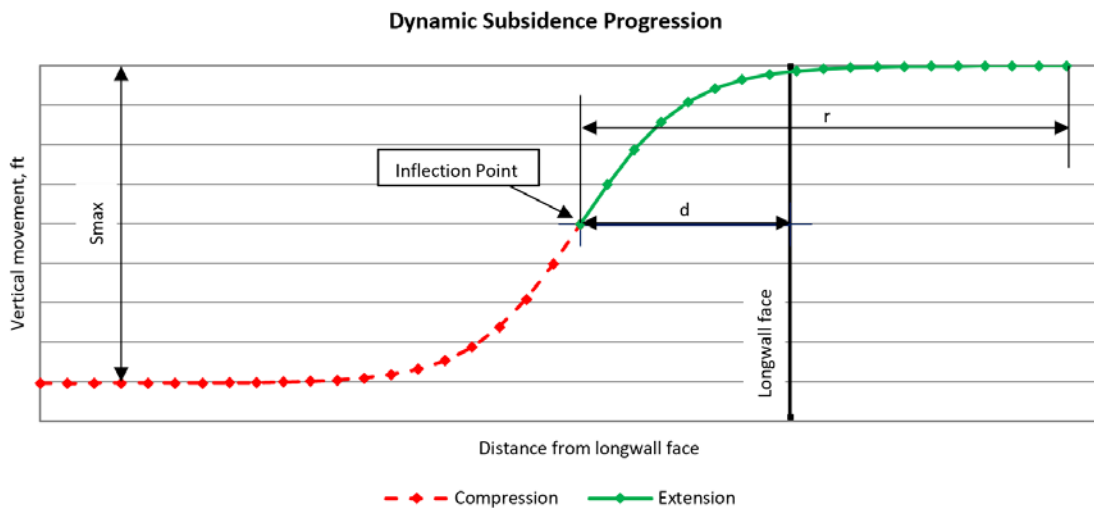
Figure 9 Relationship between vertical subsidence and tension/compression deformations caused by a dynamic subsidence wave

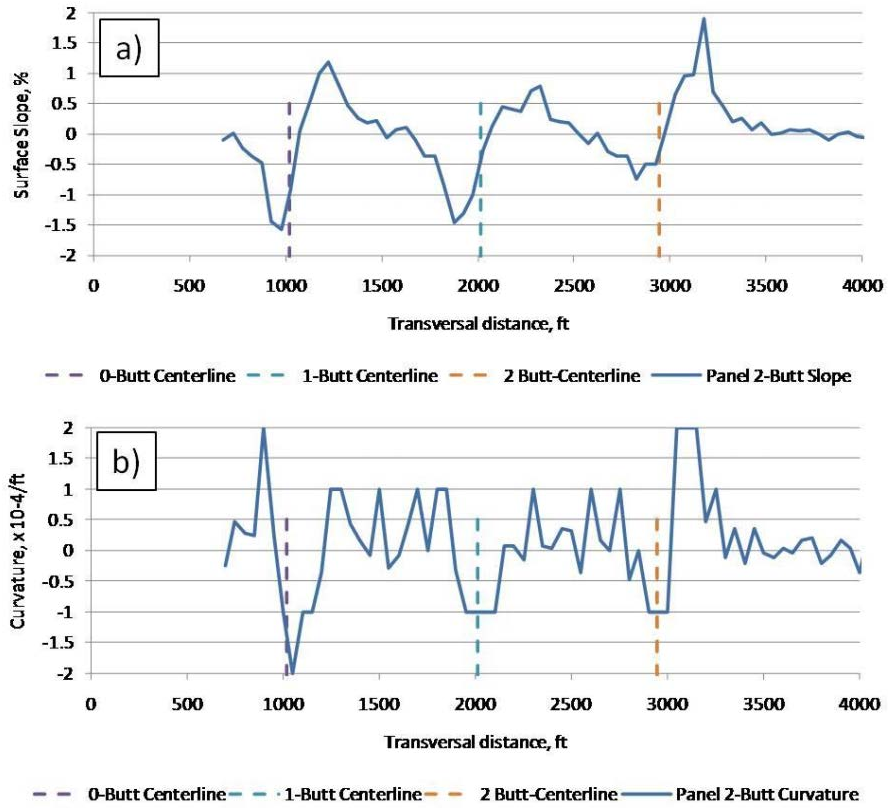
Figure 16 Profiles of a) surface slope and b) curvature from three Gateway panels undermining I-79 northbound (Yancich, 1986)

The study went on to examine the slope and curvature of these panels derived from the final subsidence basins (Figure 16). The maximum slope ranged from +1.9% to -1.56% and the points of zero slopes were located at the approximate location of the center of the panels and the gateroad entries. The maximum curvature ranged between $+2 \times 10^{-4}/\text{ft}$ and $-2 \times 10^{-4}/\text{ft}$, with the areas of highest curvature between the edges and centers of the panels (Yancich, 1986). Most impacts on I-79 were expected to occur in these areas of highest slope and curvature.

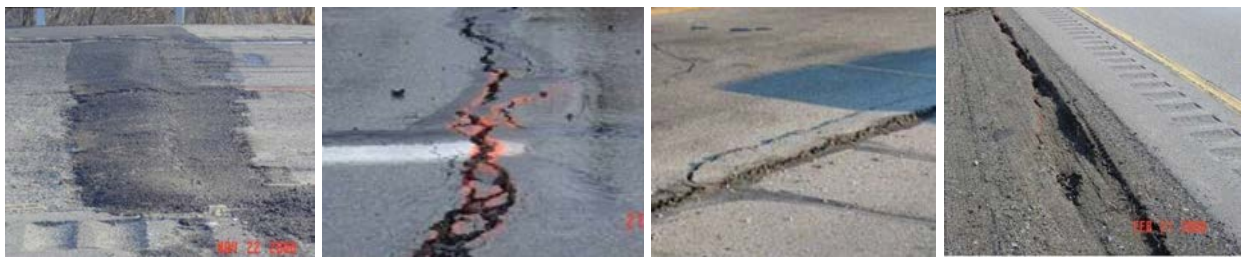
Figure 22 Examples of surface damage on I-79 caused by Emerald and Cumberland undermining showing a) compression bump, b) transverse crack, c) joint faulting, and d) lane-to-shoulder separation (Iannacchione et al., 2008)

Throughout the undermining of these panels for both the Cumberland and Emerald mines, PA DEP and PennDOT staff routinely visited I-79. During these visits, they observed a variety of types of damage on the highway surface including compression bumps, transverse cracking, longitudinal cracking, joint faulting, and lane-to-shoulder separations. Some examples of these failures can be seen in Figure 22. Most of the damage was localized and was repaired during or following the undermining process.

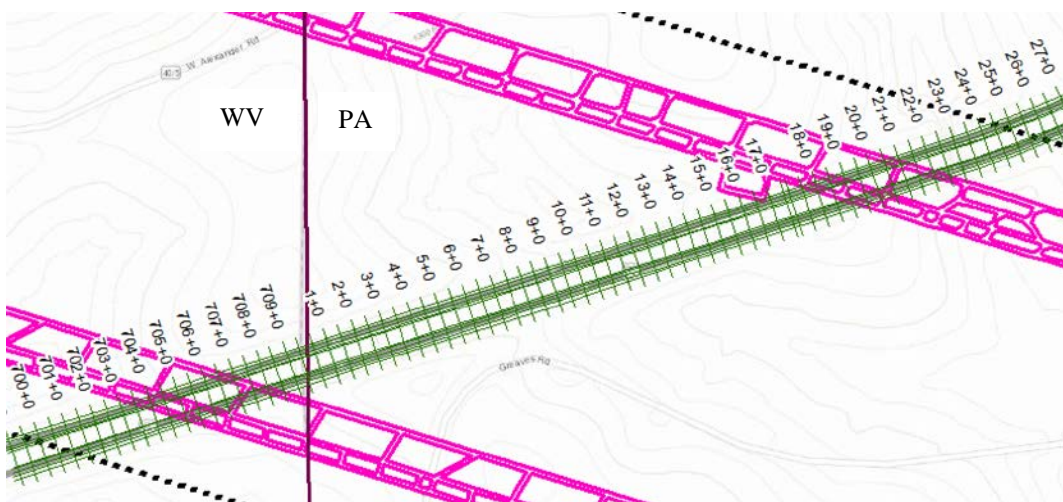
Figure 27 Gridwork on I-70 in study area

To ease in locating any signs of failure that may occur on the highway surface, the University of Pittsburgh staff utilized a grid system marked on the roadway. A simplified layout for the gridwork can be seen in Figure 27 below. The full layout shows that in each direction the road was separated into four categories: the inside shoulder, passing lane, travel lane, and outside shoulder. The layout also has cross gridlines that match the PennDOT stations of the baseline median alignment that were marked on the pavement. This allowed the inspectors to identify each feature and the location in which it occurred.

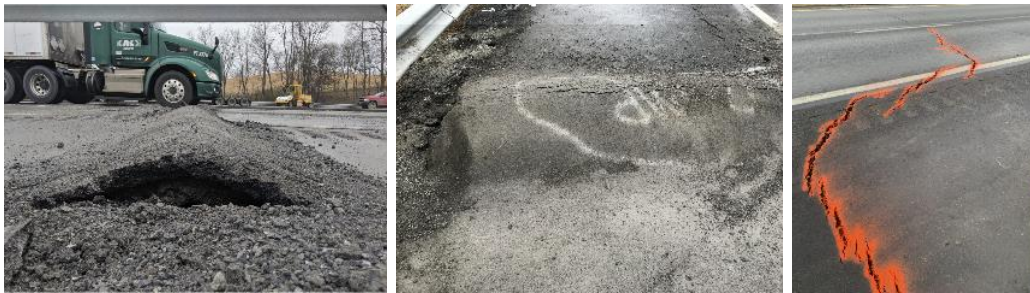
Figure 49 Field images of observed features on February 5th from left to right; eastbound compression bump/blow-up 1-foot tall, westbound blow-up, and eastbound transverse crack 2.5-inches wide

Some of the most notable distresses observed during this site visit were the three compression bumps and a large transverse crack. The compression bump on the westbound lane formed on February 5th, approximately 150-feet behind the longwall face. The two compression bumps on the eastbound lane formed on February 4th, between 175-feet and 225-feet behind the longwall face. All three of these compression bumps formed in the asphalt relief sections. The large transverse crack formed about 60-feet behind the longwall face and opened to a width of more than 2.5-inches wide. Images of these distresses can be seen in Figure 49 below.

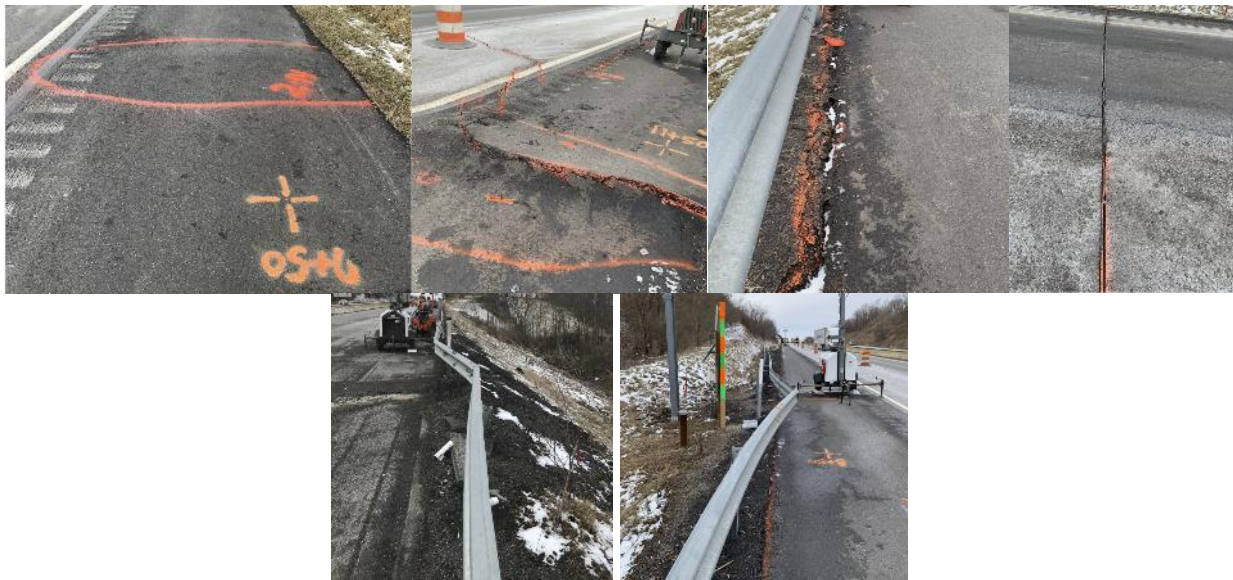
Figure 51 Field images of observed features on February 14th from left to right; westbound blow-up, eastbound blow-up 7-inches tall, eastbound separation of pavement from soil, joint width of 0.75-inches, sheared guiderail in westbound lanes, sheared guiderail in eastbound lanes

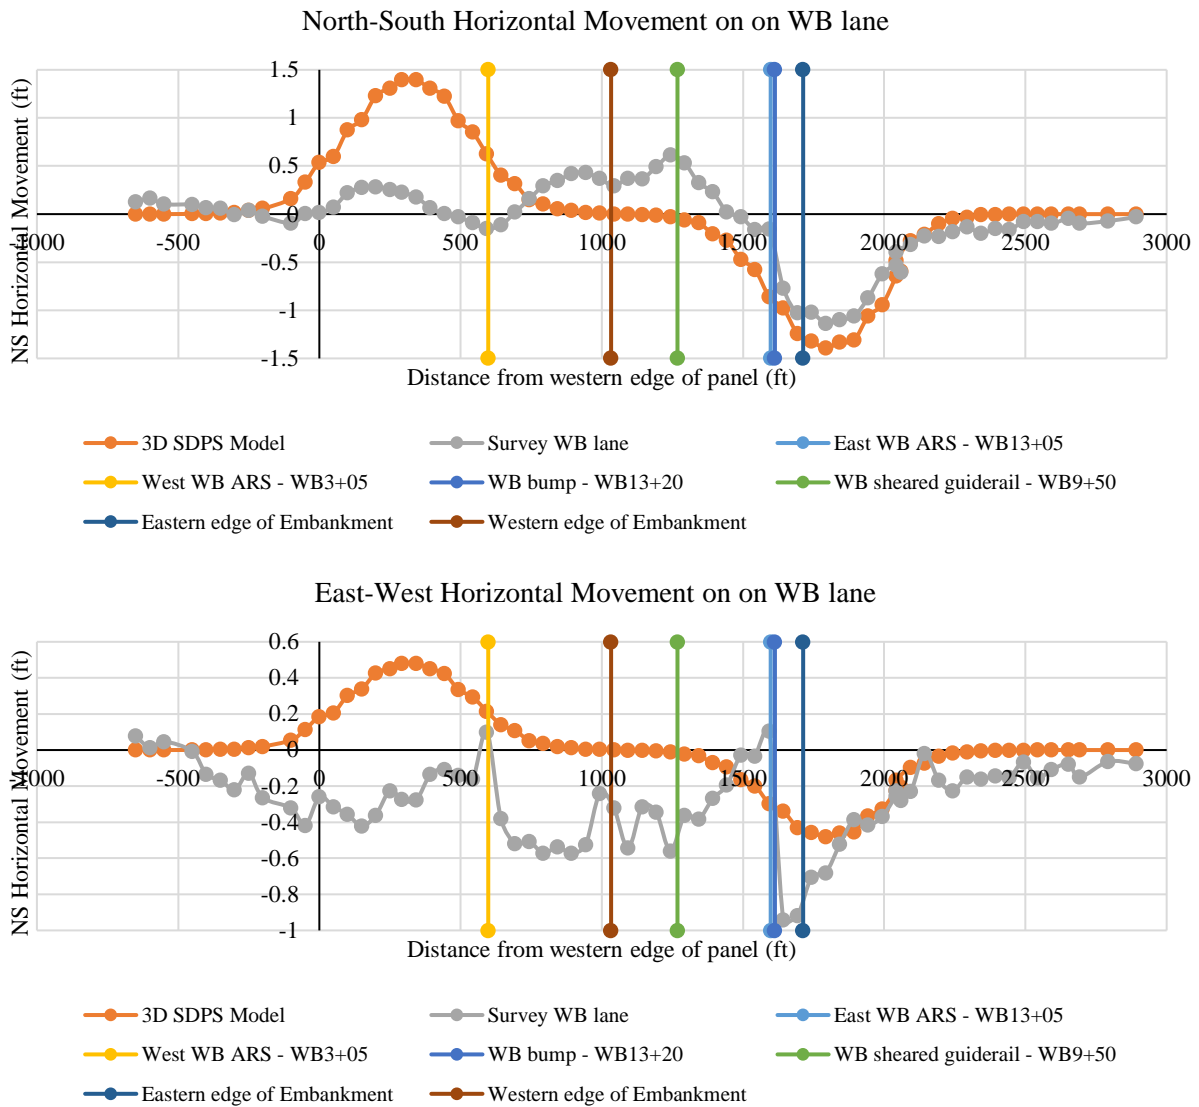
Figure 76 Horizontal on Westbound lane of I-70 compared with location of surface features

movement, with more significant deviation caused by the western asphalt relief section. Based on this data, both the sheared guiderail and the western edge of the embankment correspond with small deviations in the horizontal movement on the westbound lane.

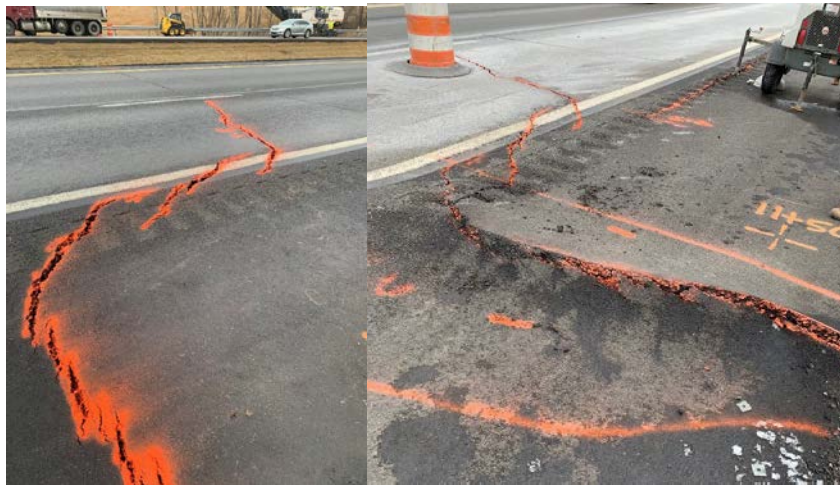
Figure 77 Image of tensile crack that formed at EB 11+05 on February 5 (left) and compression bump that formed in shoulder at EB 11+05 on February 6 (right)

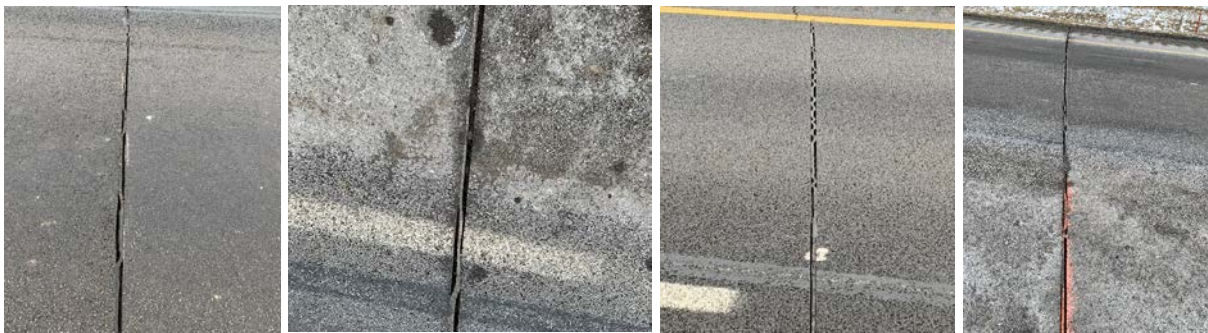
Figure 81 Field images of open pavement joints during undermining

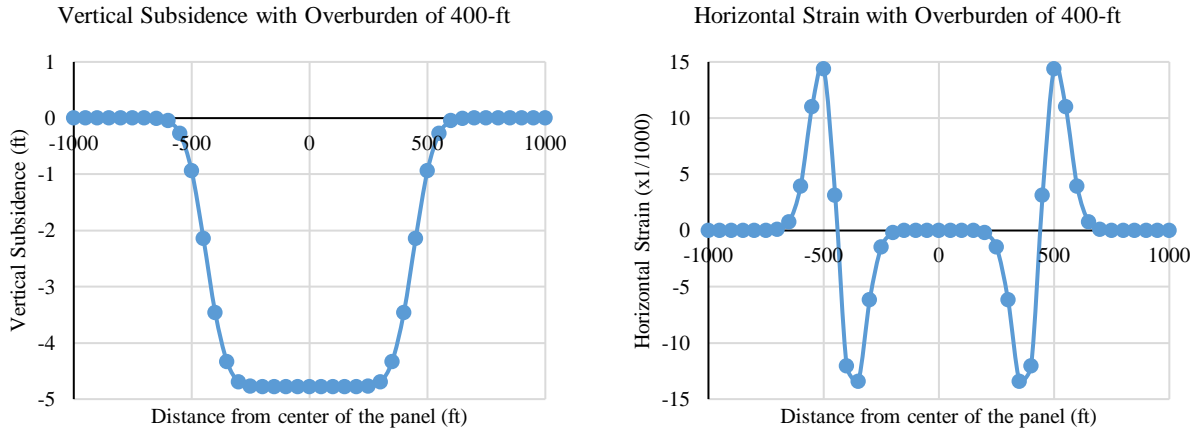
Figure 83 Vertical subsidence (left) and horizontal strain (right) predicted by SDPS for a panel with an overburden of 400-feet

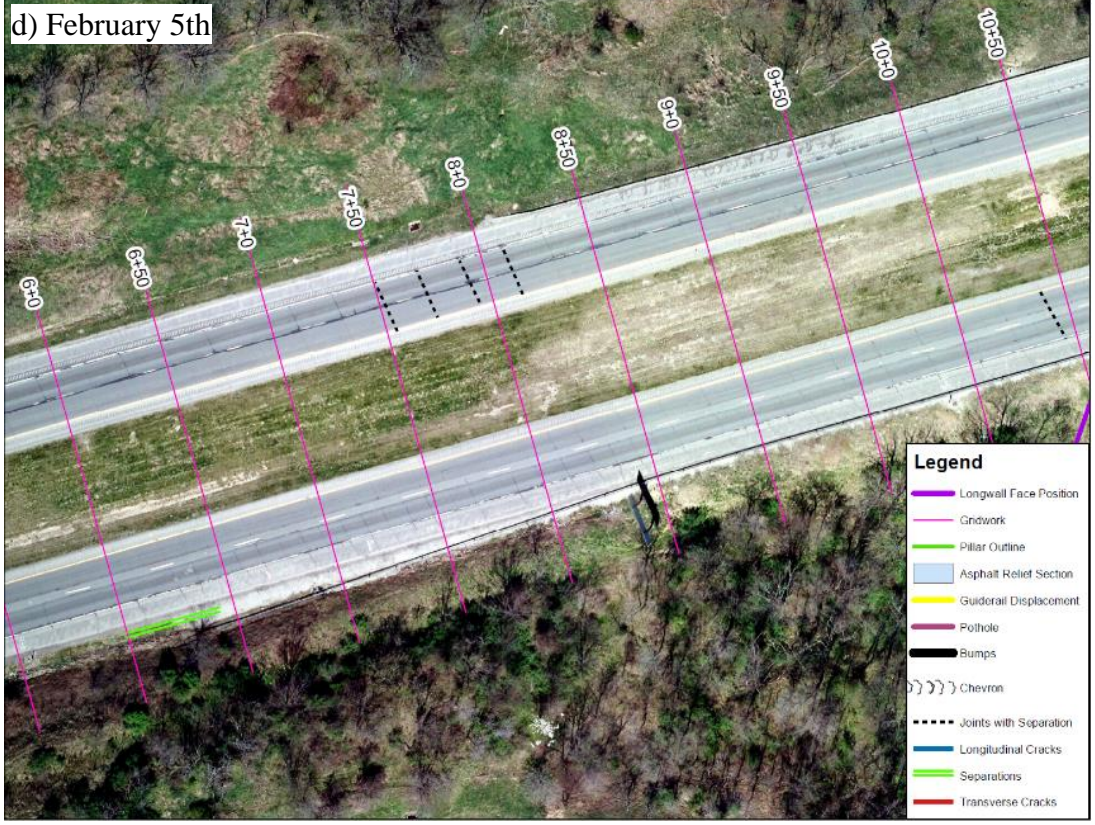
Appendix Figure 2 Damage observed on highway on February 5th

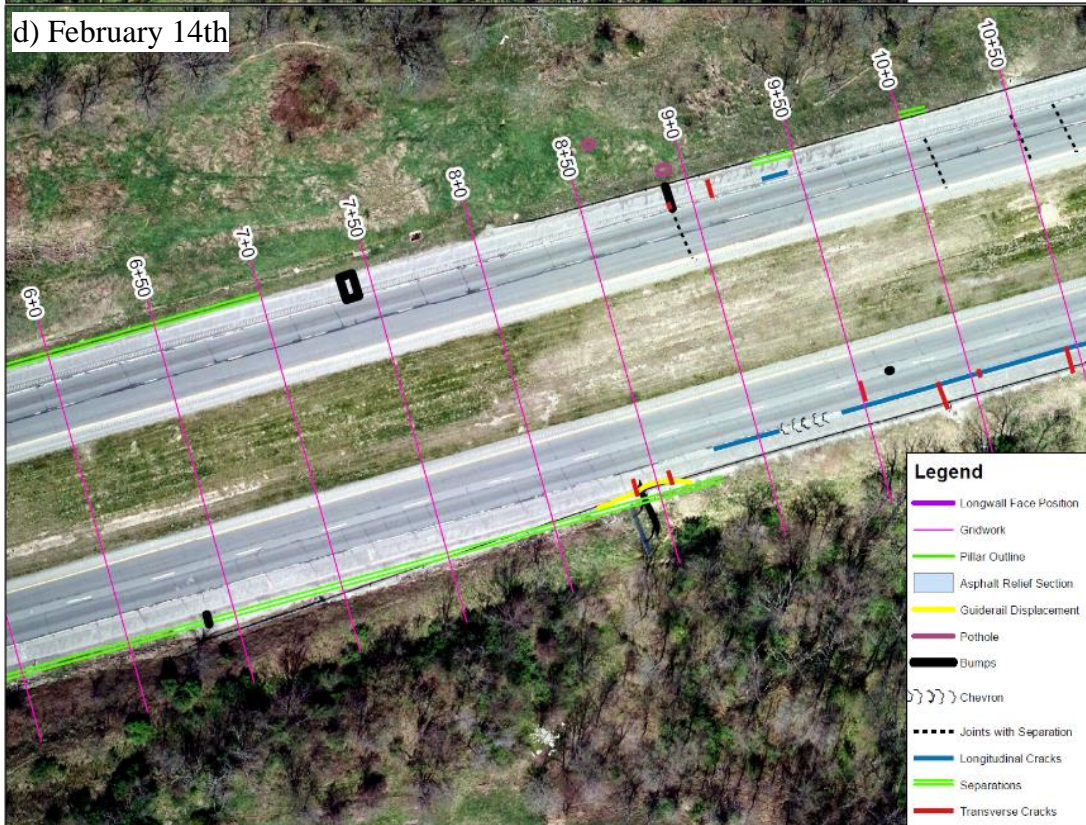
Appendix Figure 3 Damage observed on highway on February 14th

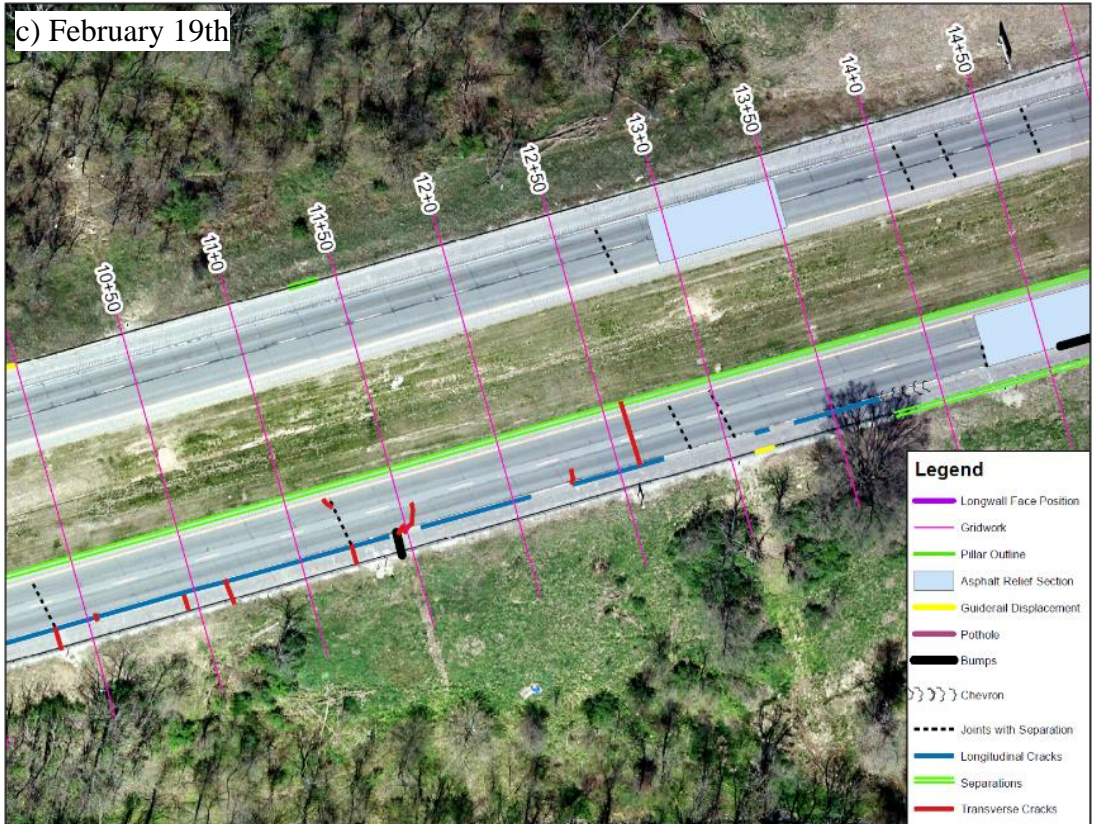
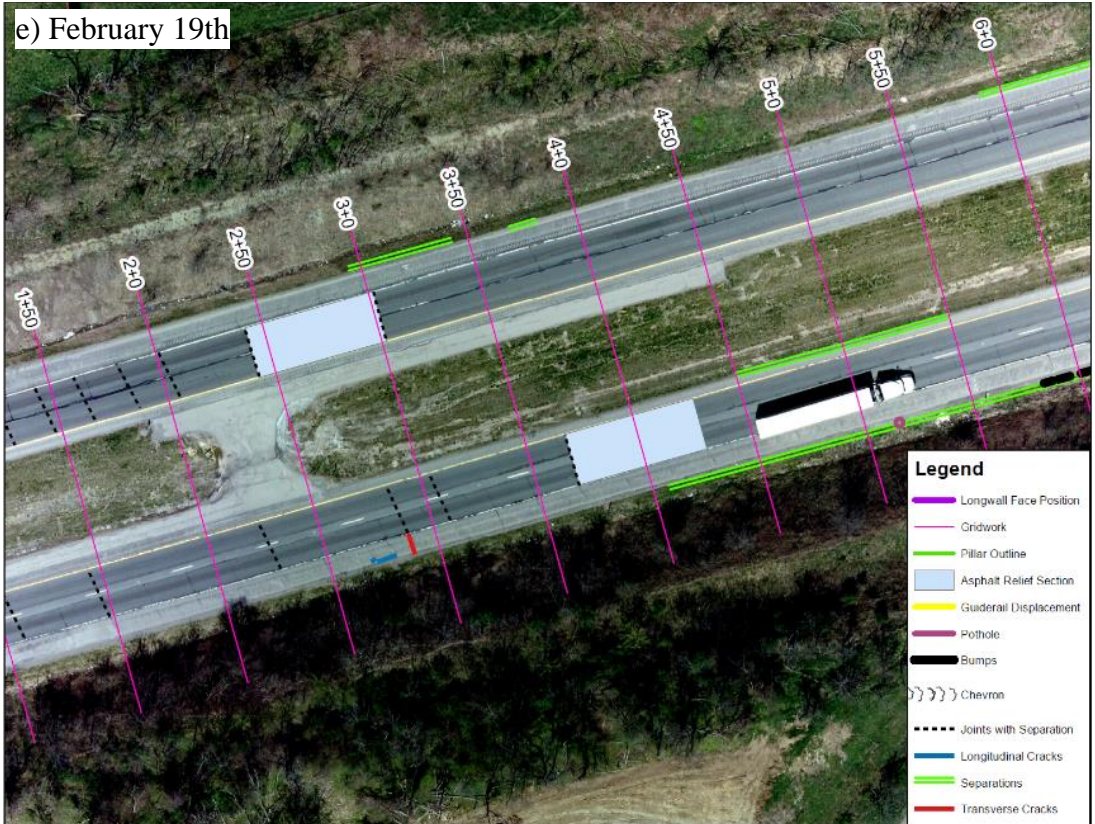
Appendix Figure 4 Damage observed on highway on February 19th

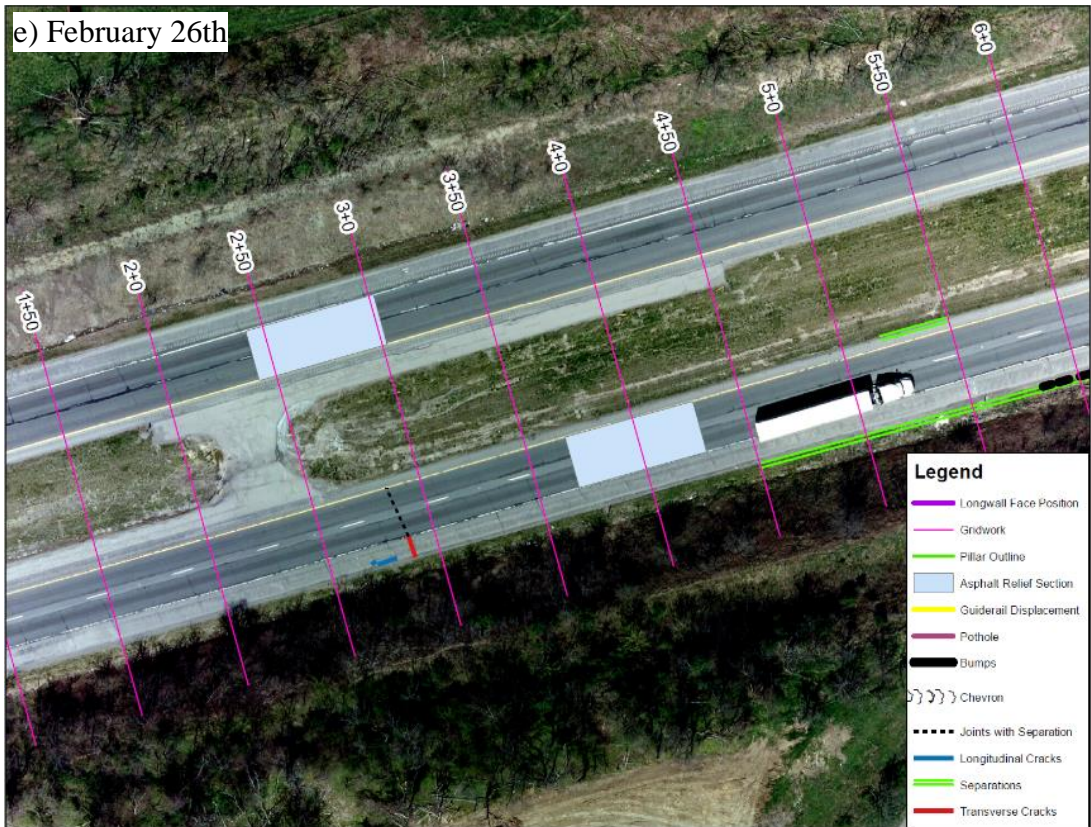
Appendix Figure 5 Damages observed on highway on February 26th
