**Interactions between Stress, Environment, and Microstructure causing Irradiation-assisted
Stress Corrosion Cracking in Austenitic Stainless Steels**

Submitted to the Graduate Faculty of
The Swanson School of Engineering in partial fulfillment
of the requirements for the degree of
Doctor of Philosophy

University of Pittsburgh

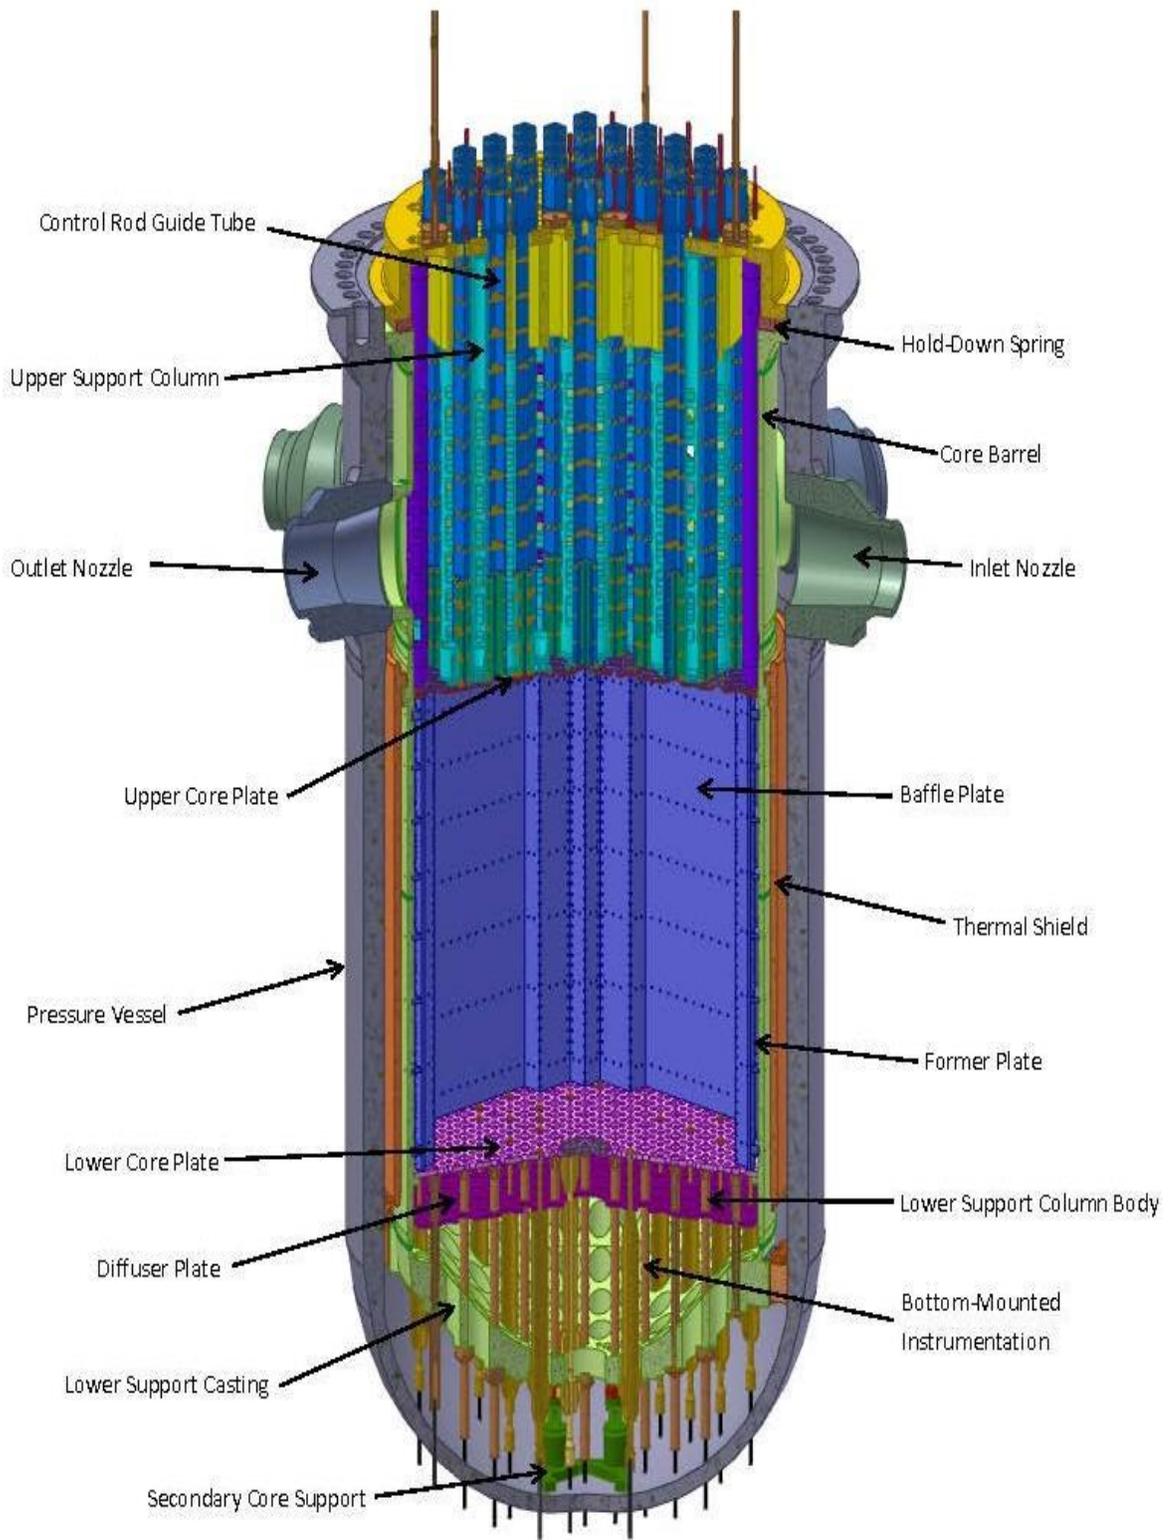
Figure 5. Westinghouse 4-loop downflow reactor internals assembly

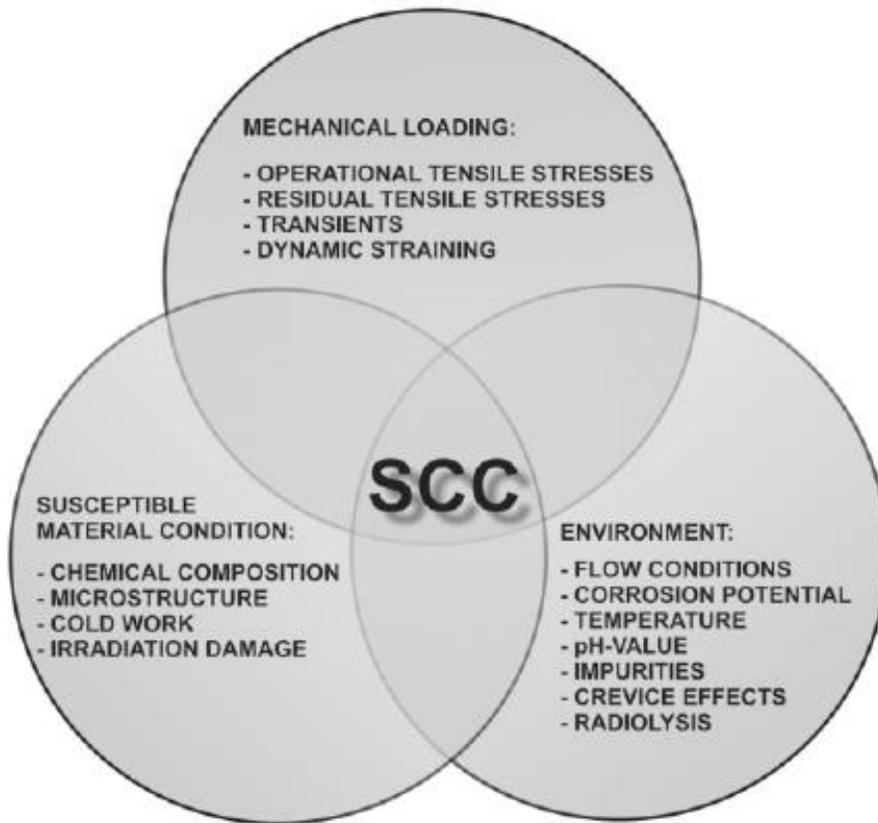
Figure 8. Elements of Stress Corrosion Cracking - Adapted from Reference 8

factors present (stress, susceptible material, aggressive environment), a stress corrosion crack will not form. This is shown schematically in Figure 8.

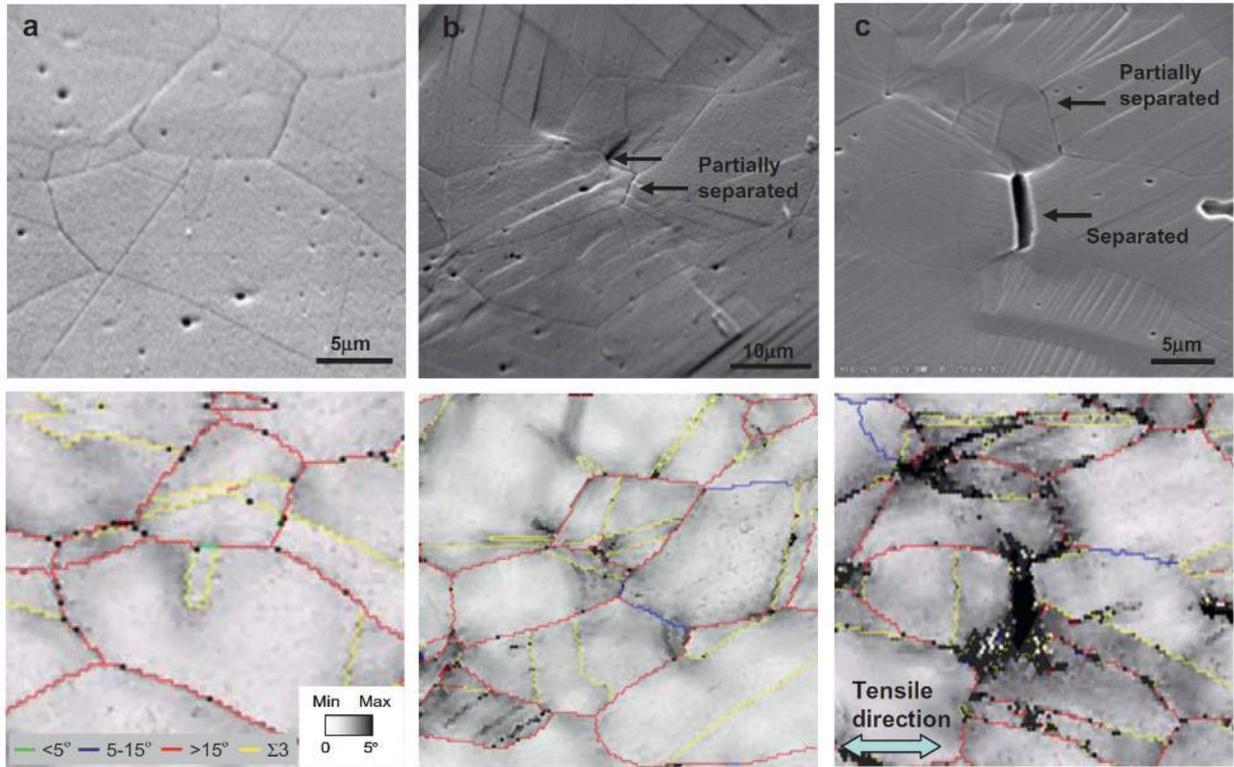
Figure 10. Grain Boundary Separation in Irradiated Material under Strain – Adapted from Reference 17

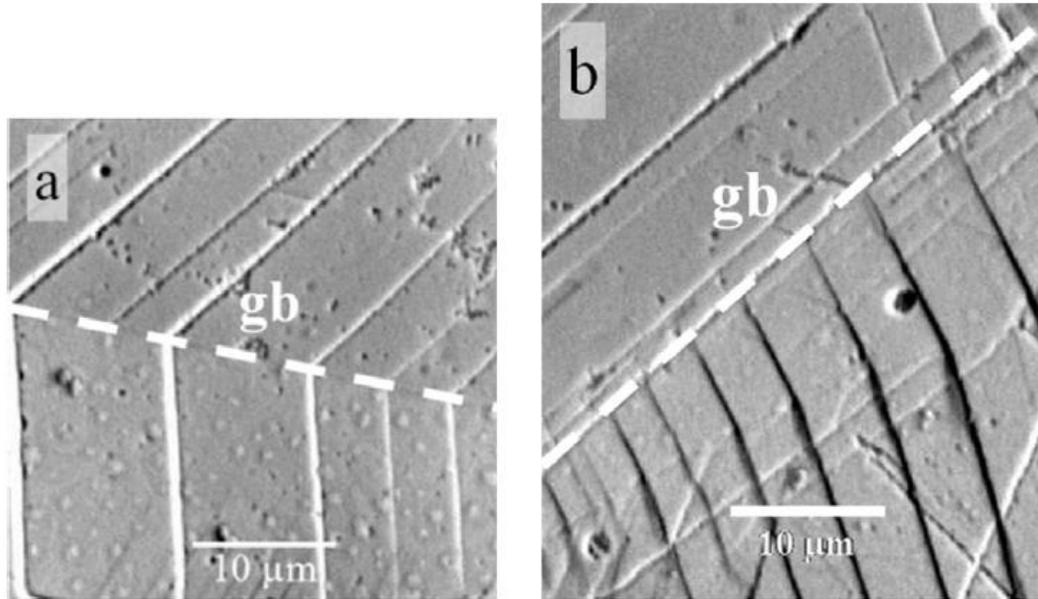
Figure 11. Slip at Grain Boundaries. (a) is an Example of Continuous Slip, and (b) is an Example of Discontinuous Slip. Adapted from Reference 16

boundary (Reference 16). An example of continuous versus discontinuous slip is shown in Figure 11.

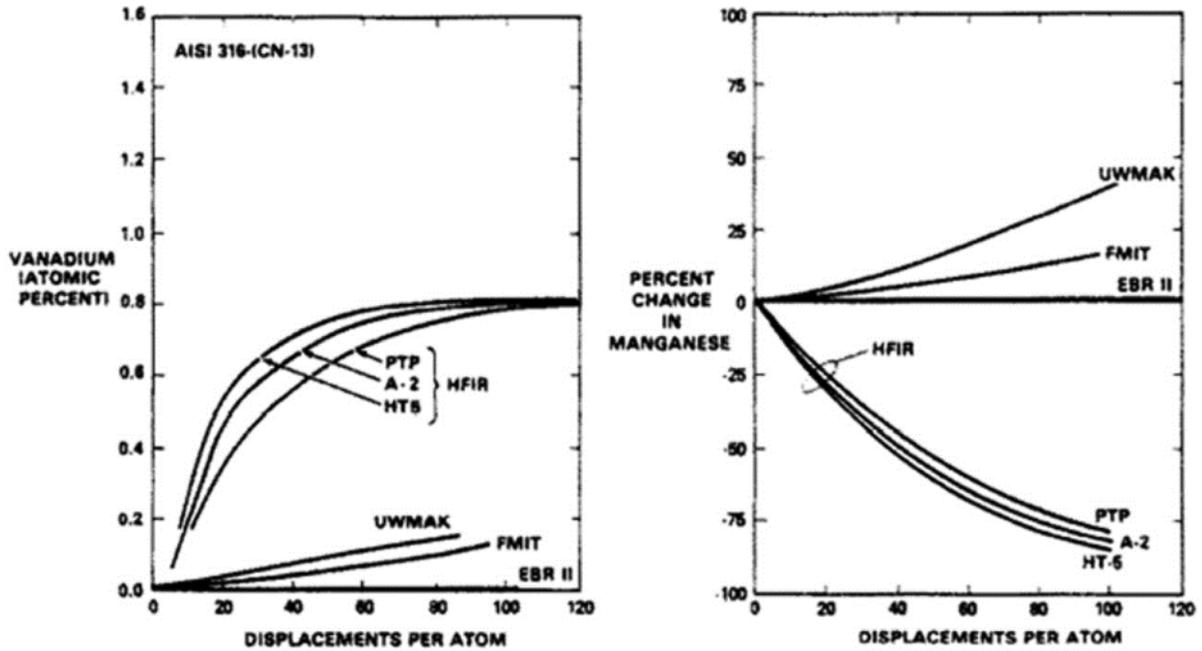
Figure 13. Elements transmuting with the potential for phase stability issues in stainless steel (Reference 28)

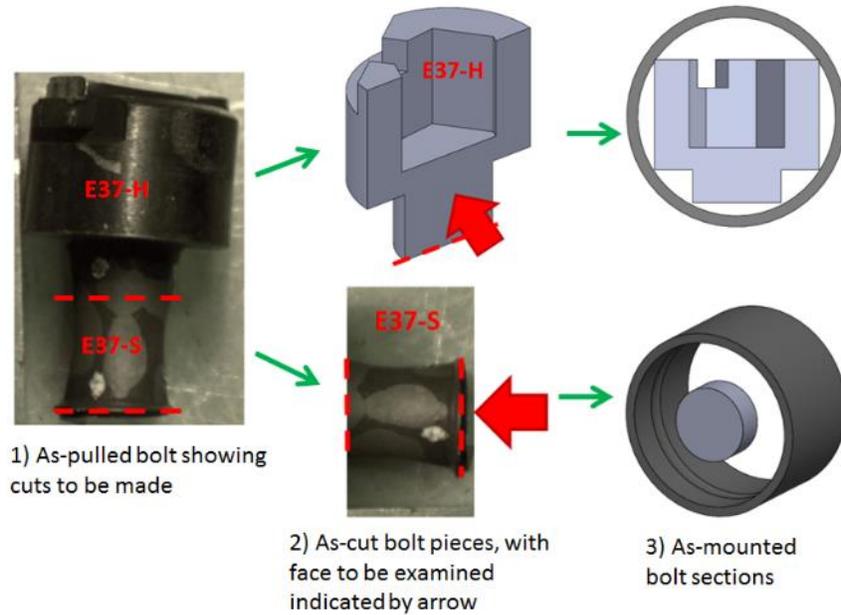
Figure 18. Example sectioning diagram for baffle bolt metallography

The bolts were sectioned as desired (example sectioning diagram shown in Figure 18), mounted in epoxy, ground flat and polished to a mirror finish using OP-S silica slurry, and characterized using the Keyence VHX5000 digital optical microscope. After examination in the as-polished condition, the mounts were electro-polished in a 10% oxalic acid solution for 1-3 minutes at 3-6 volts and examined again.

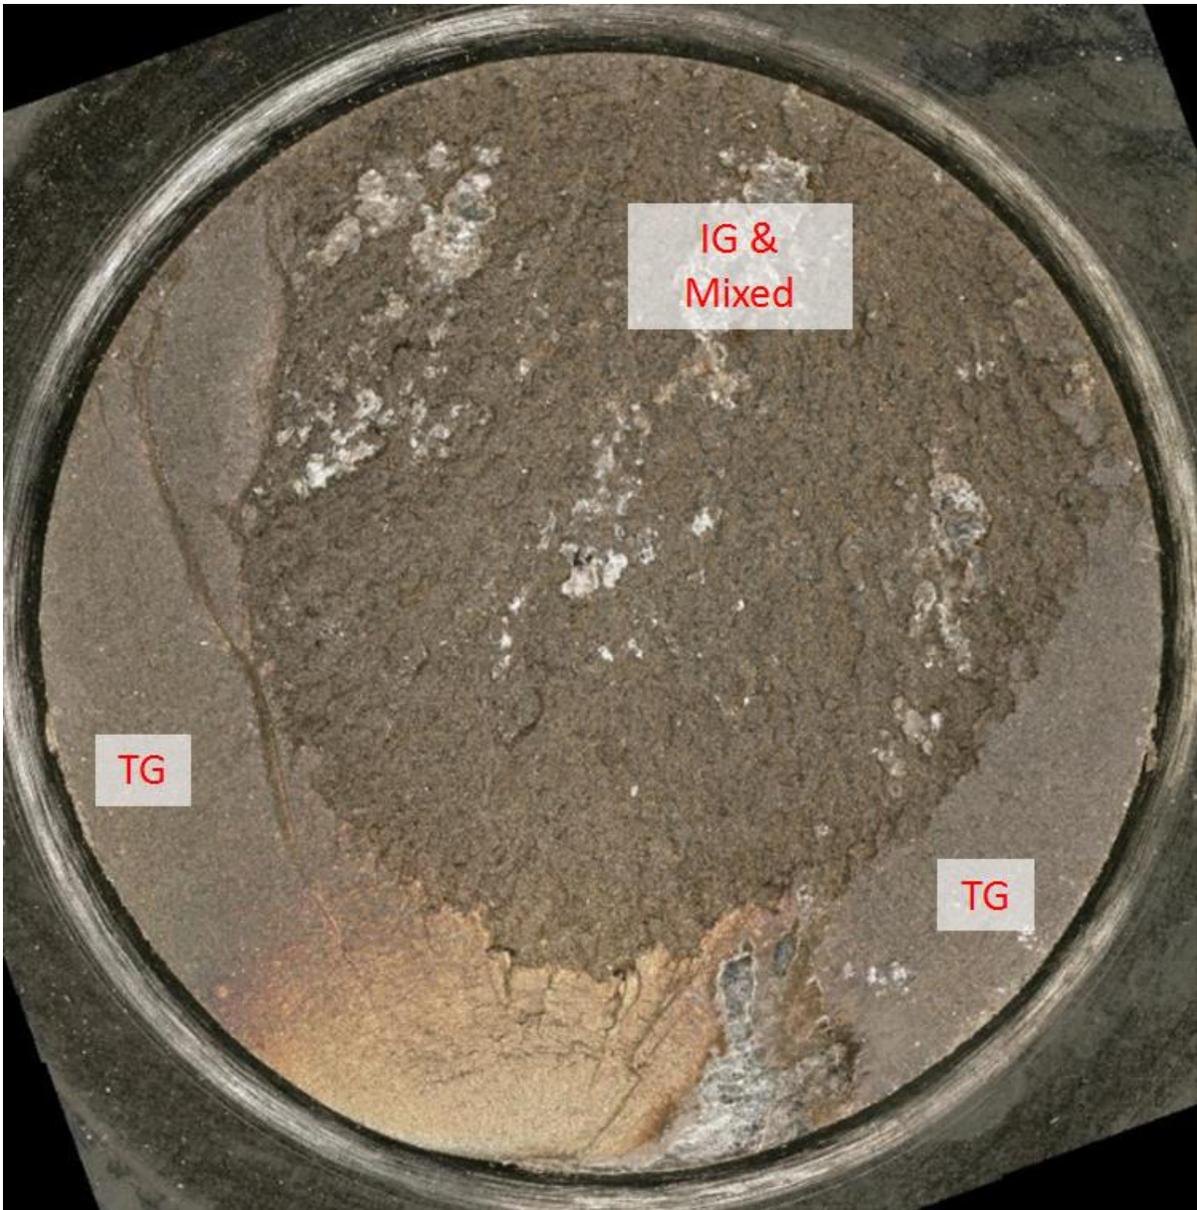
Figure 21. S1 Bolt B77 Light Optical Microscope View of Fracture Surface

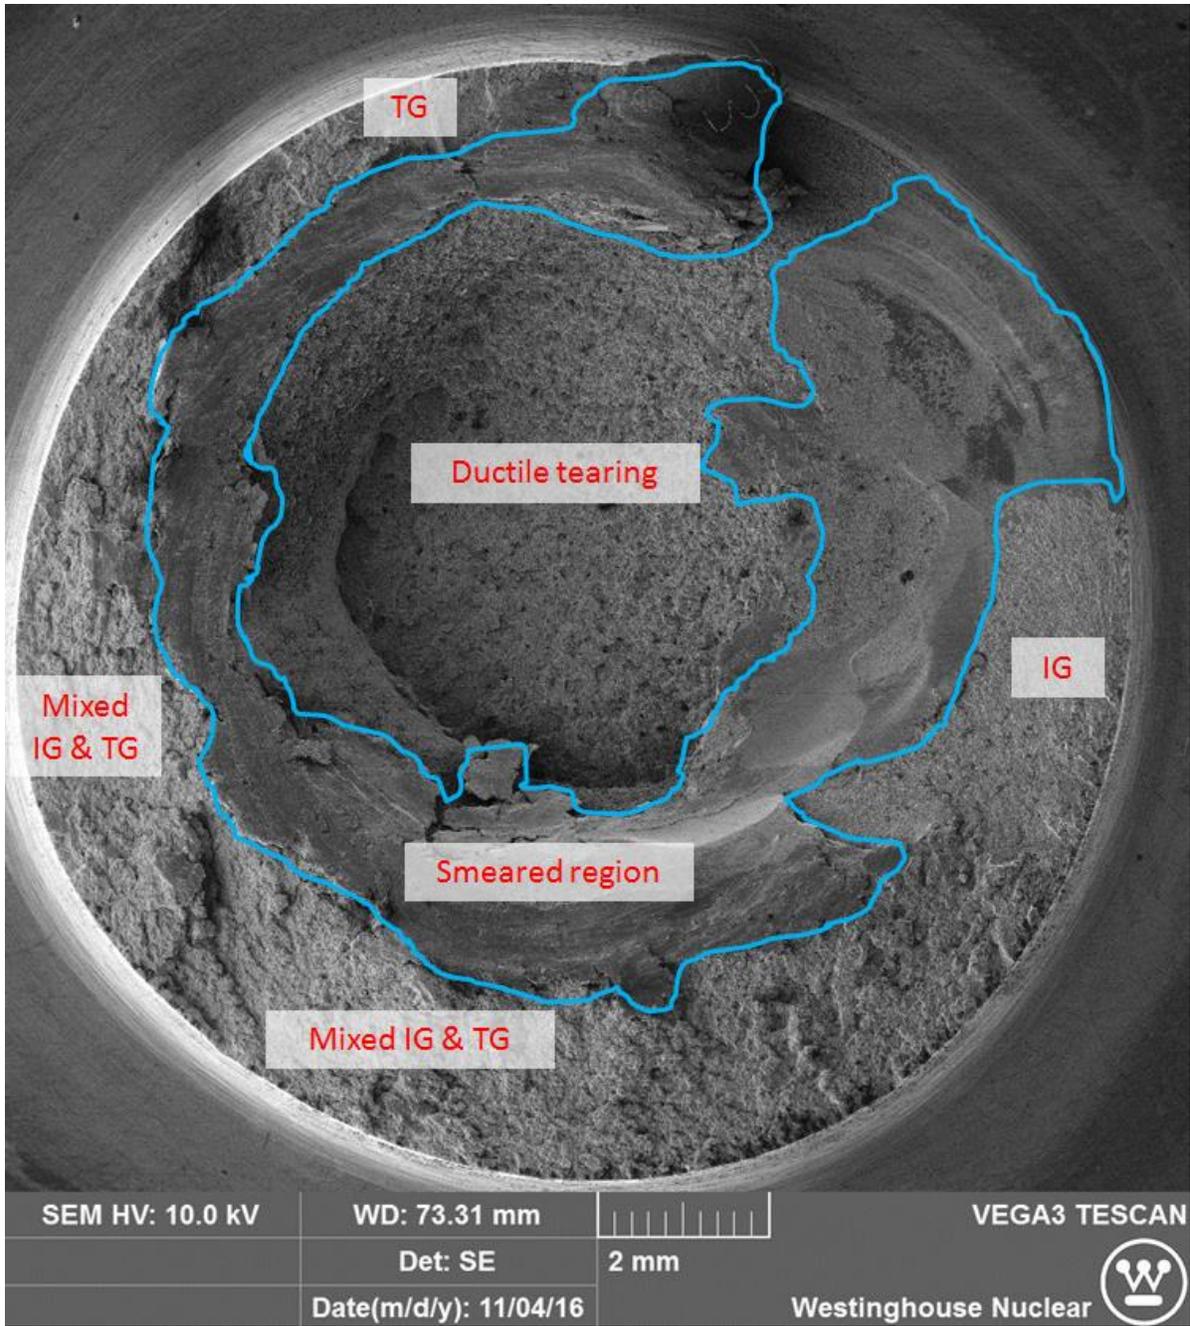
Figure 22. S1 Bolt G77 SEM Overall View of Fracture Surface

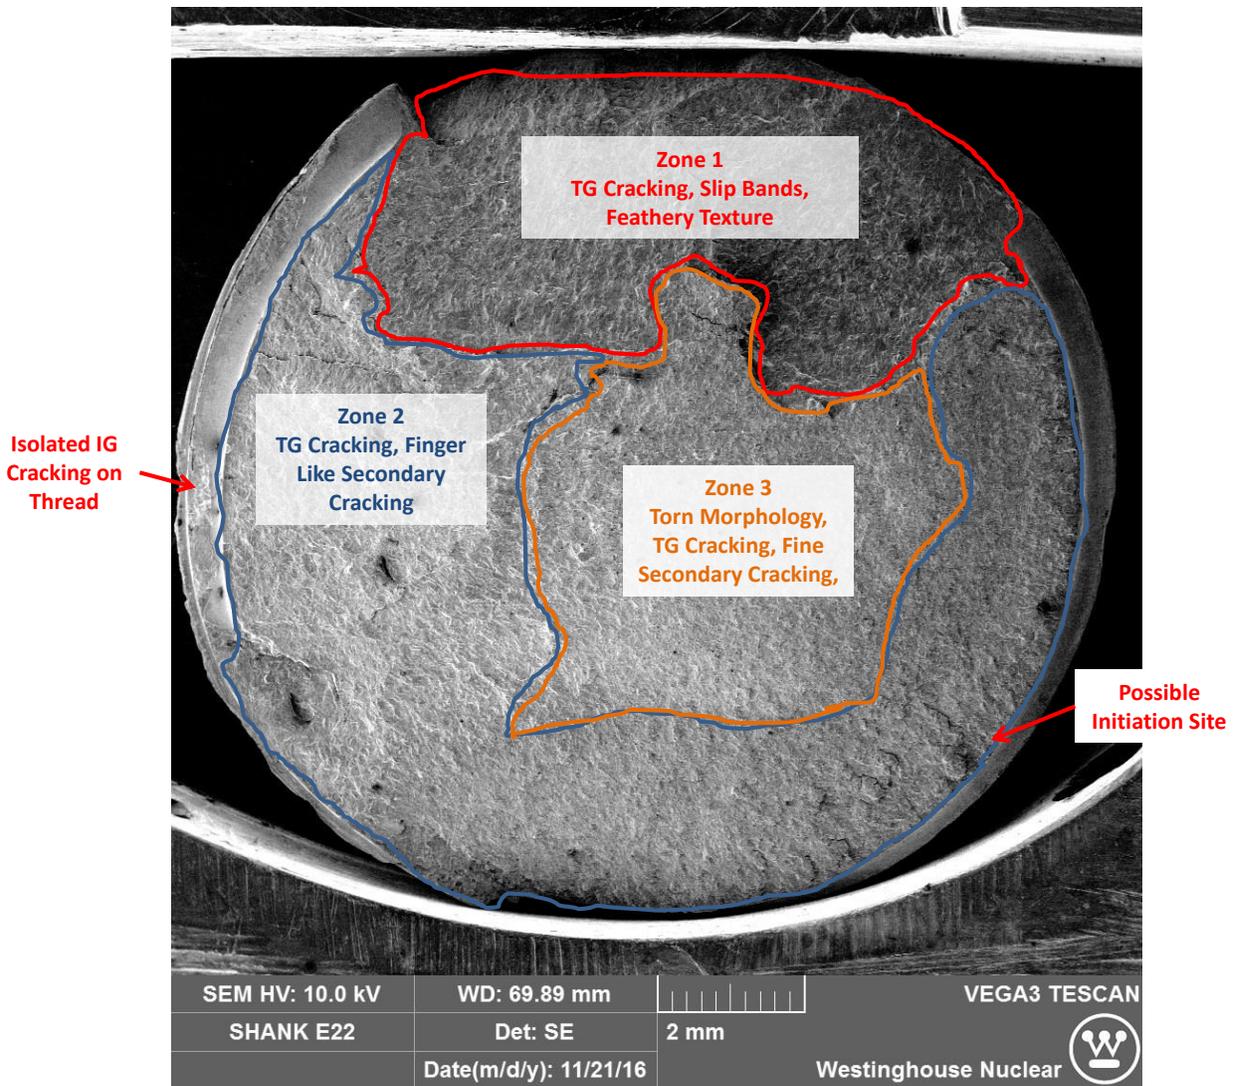
Figure 23. Overall Image of E22 Fracture at Head-to-shank Region

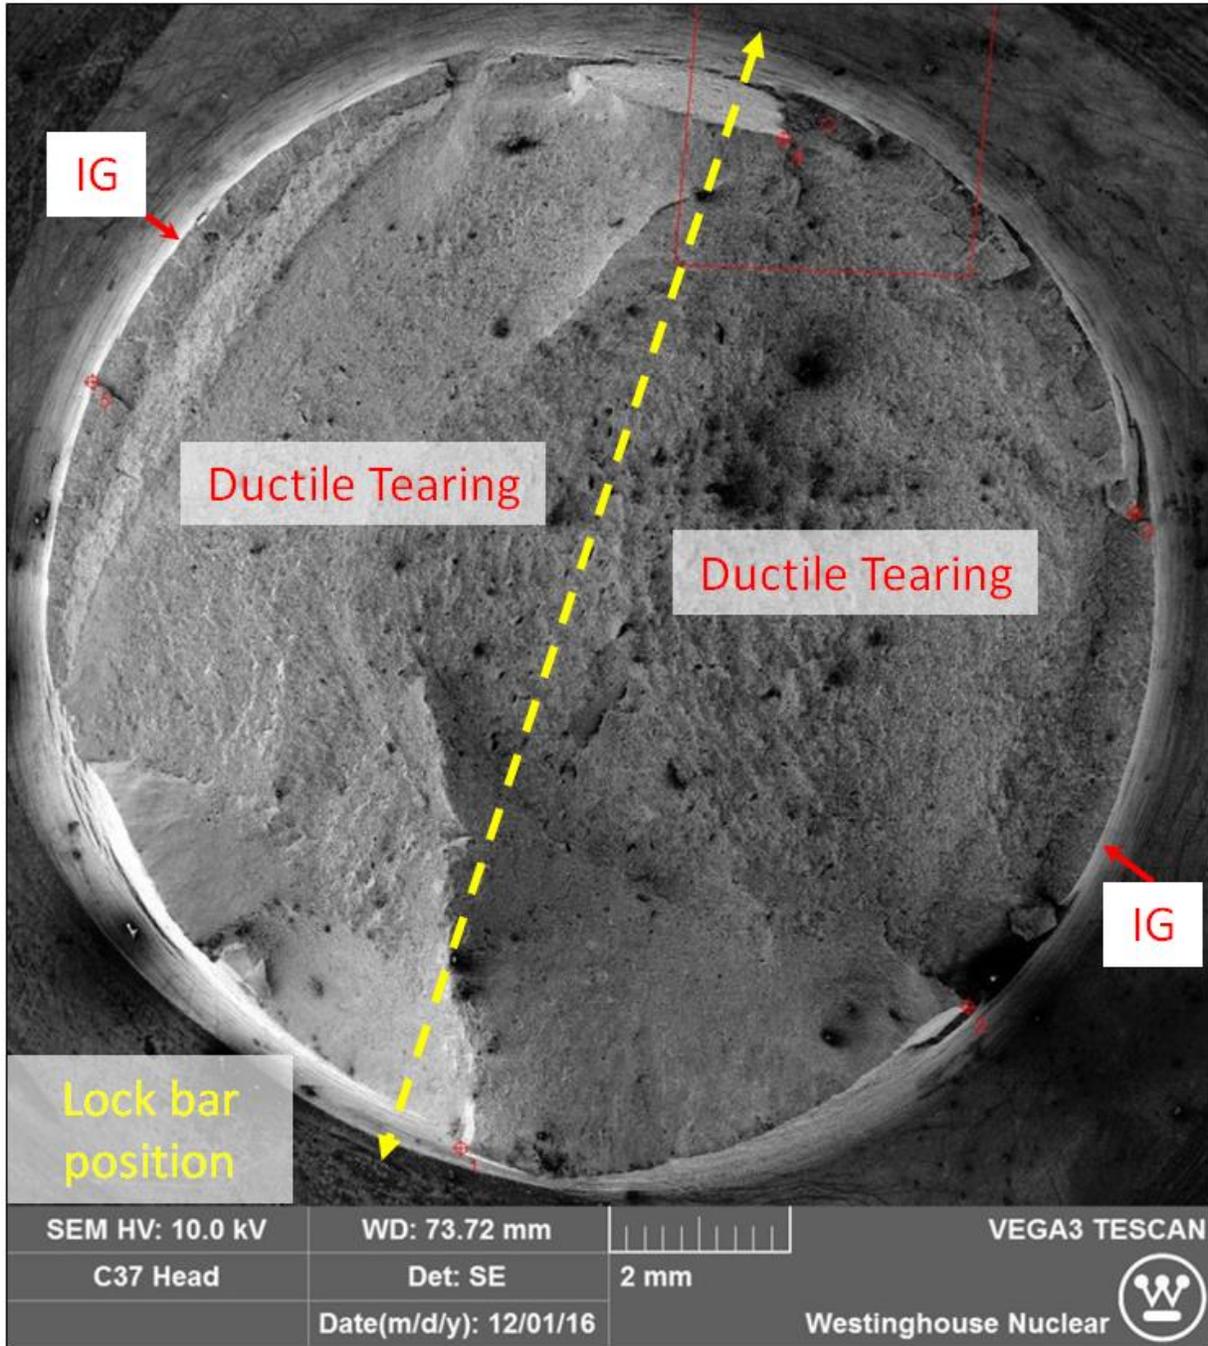
Figure 24. IP2 bolt C37 – Overall fracture surface (head side). IG crack regions are service-induced cracking, while ductile tearing resulted from laboratory tensile testing.

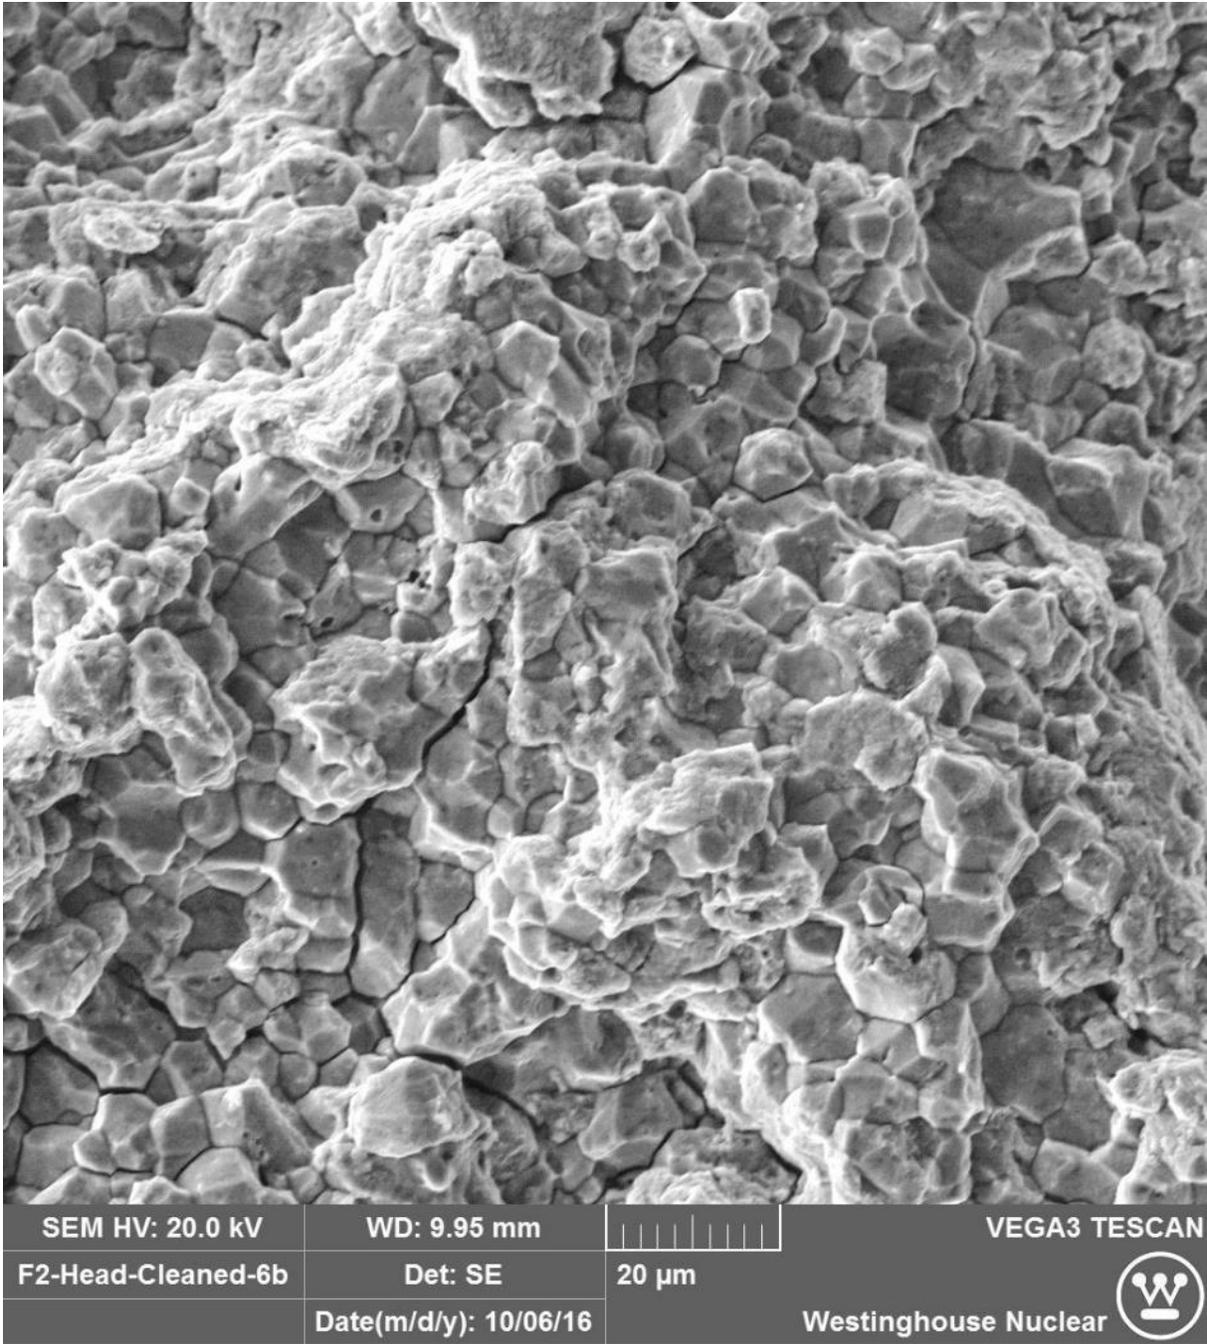
Figure 25. IP2 bolt F2, IG cracking and secondary cracking

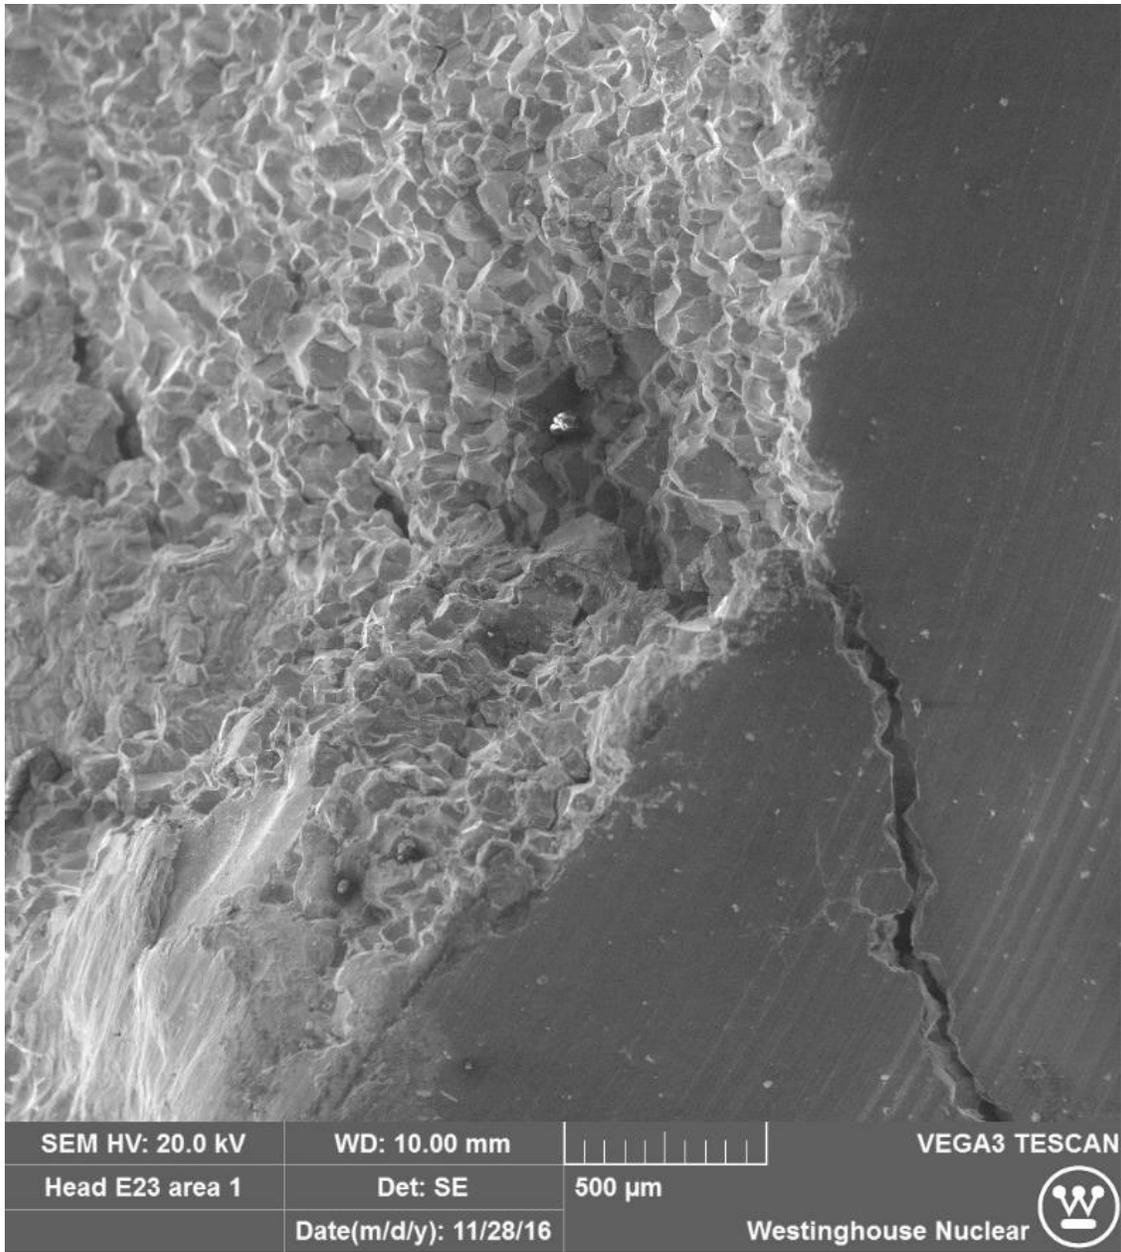
Figure 26. SEM Micrograph of E23 Head Fracture – Area 1, IG Cracking Extending into the Head

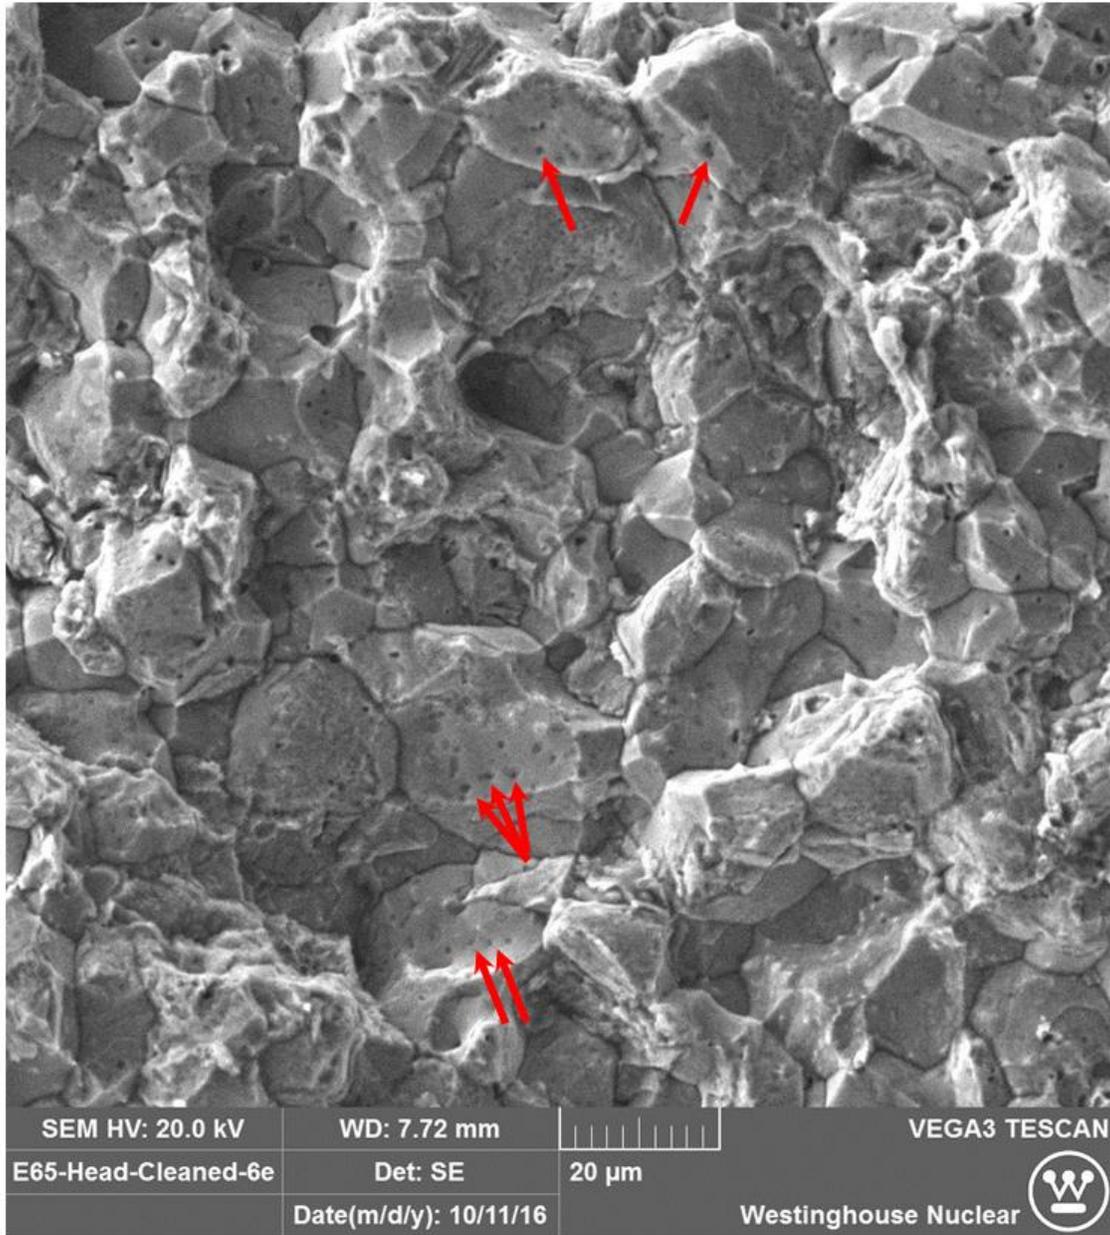
Figure 27. IP2 bolt E65, IG cracking and fine particles on grain boundaries. Red arrows indicate unknown surface spots

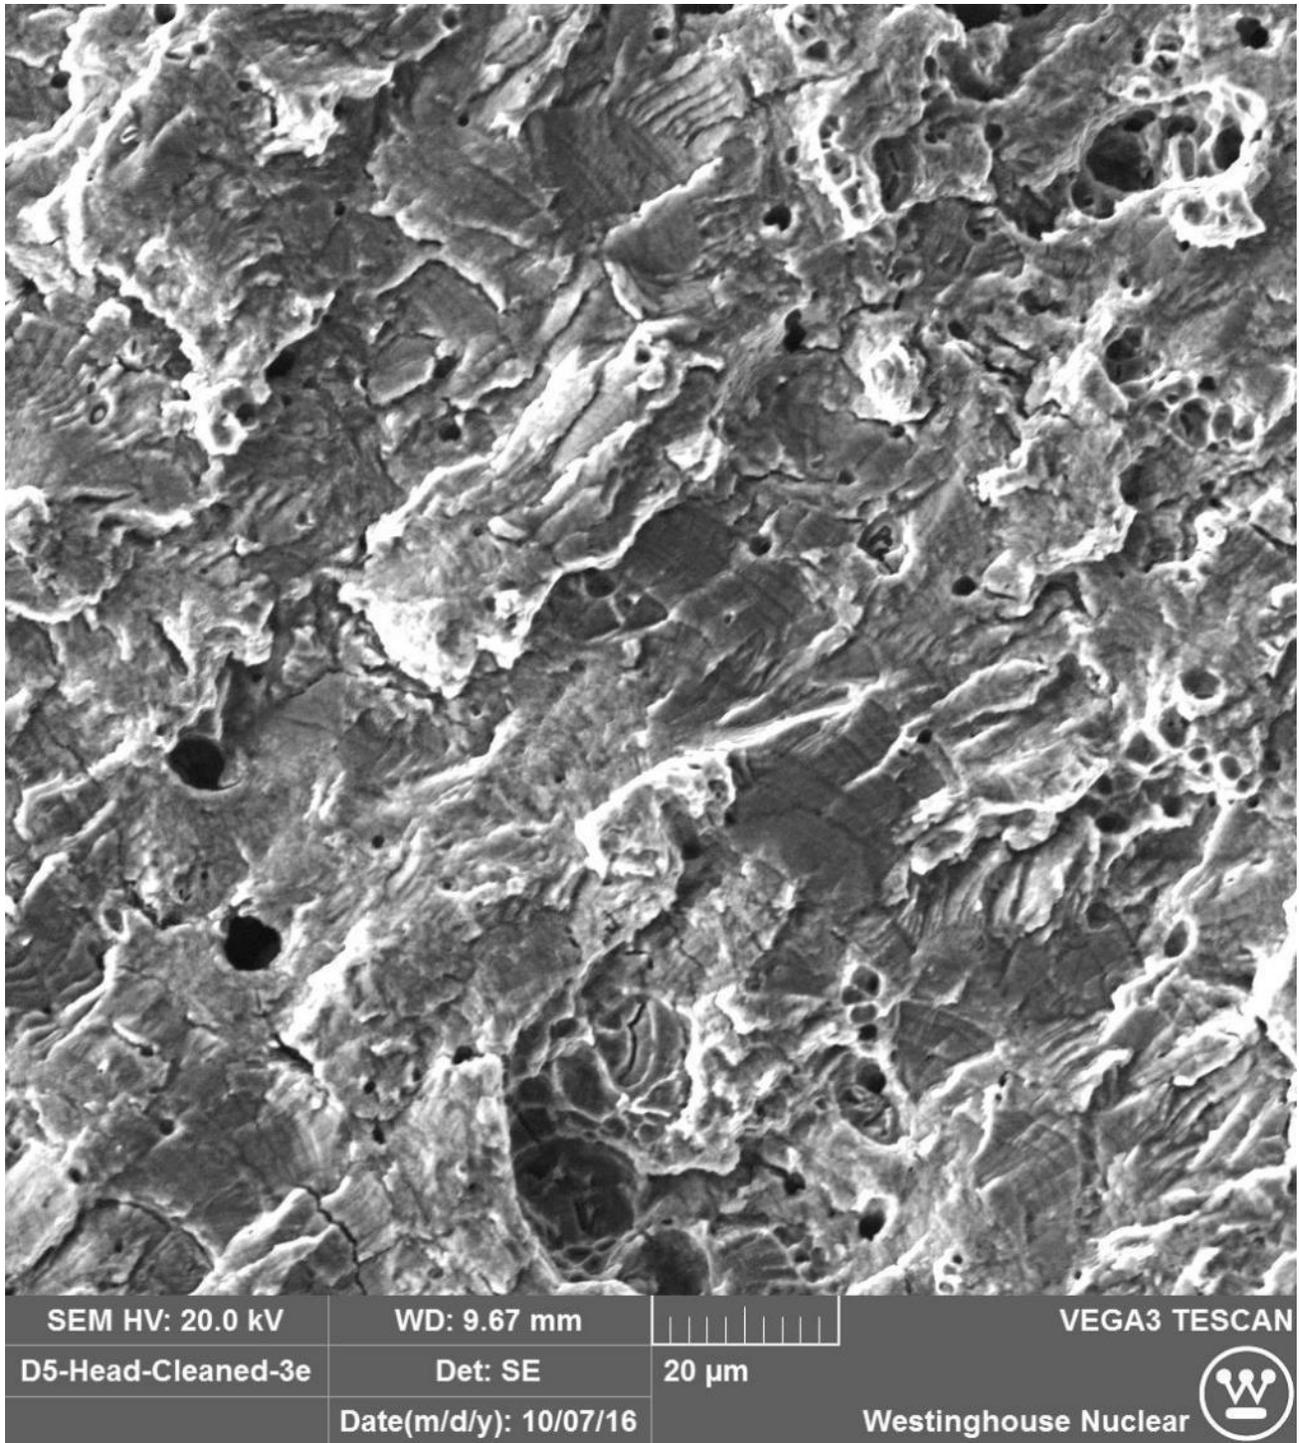
Figure 28. IP2 bolt D5, TG cracking with striations and holes

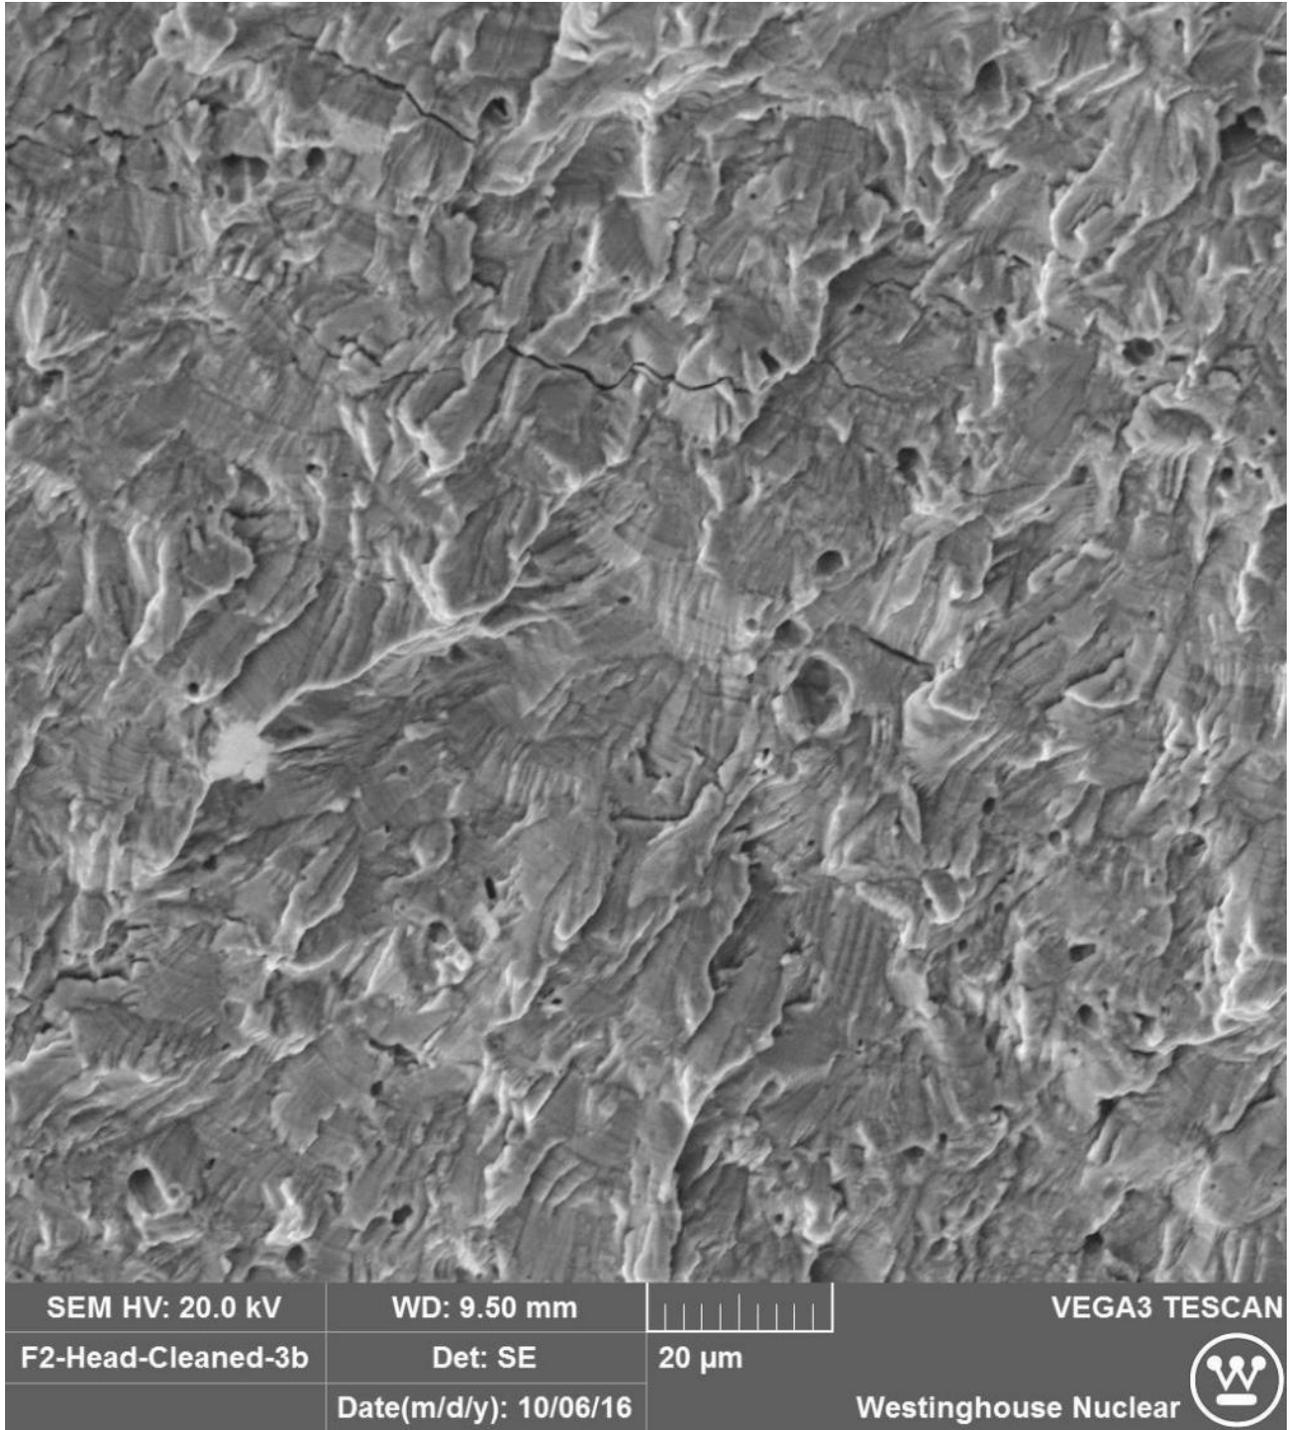
Figure 29. IP2 bolt F2, TG cracking showing striations and secondary cracking

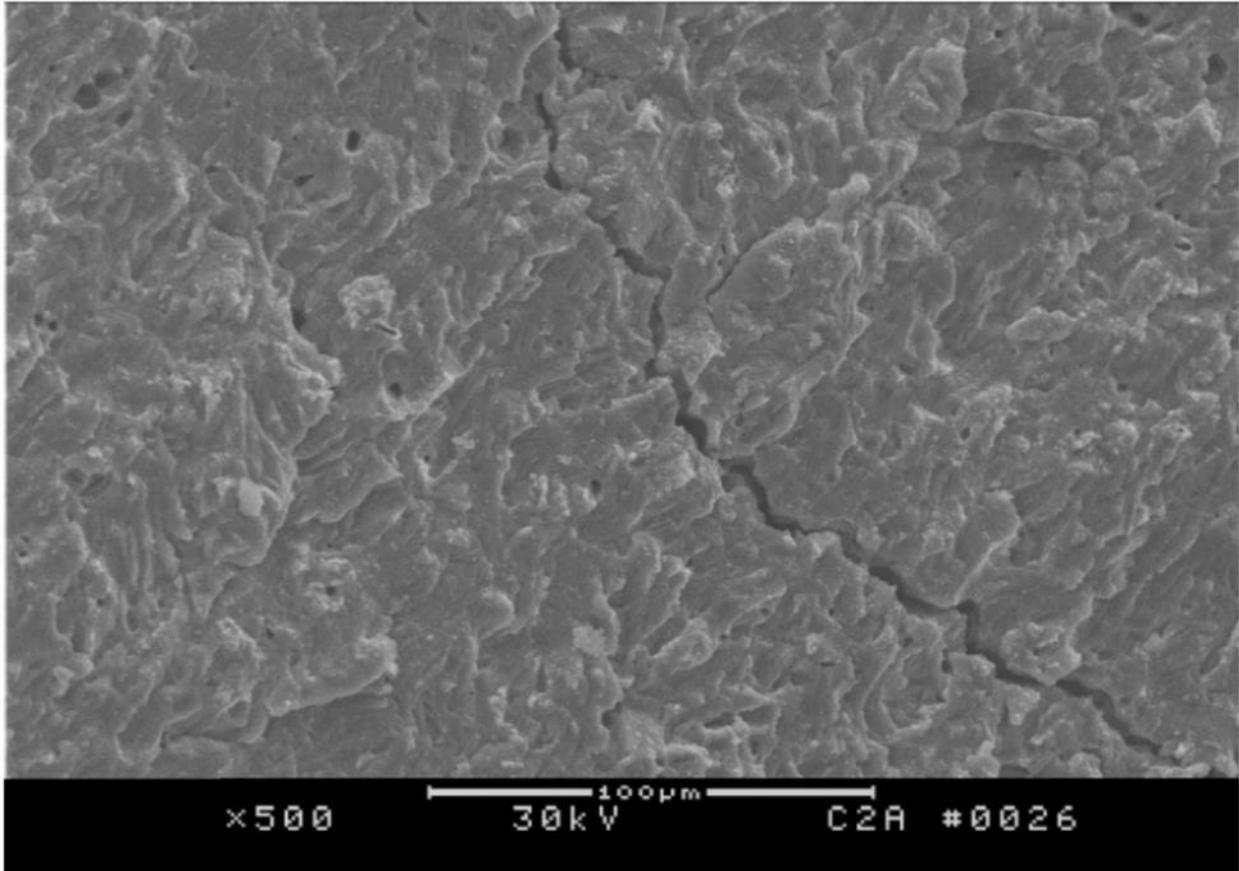
Figure 30. Secondary crack branching on the TG portion of the bolt S-R2C6 fracture surface

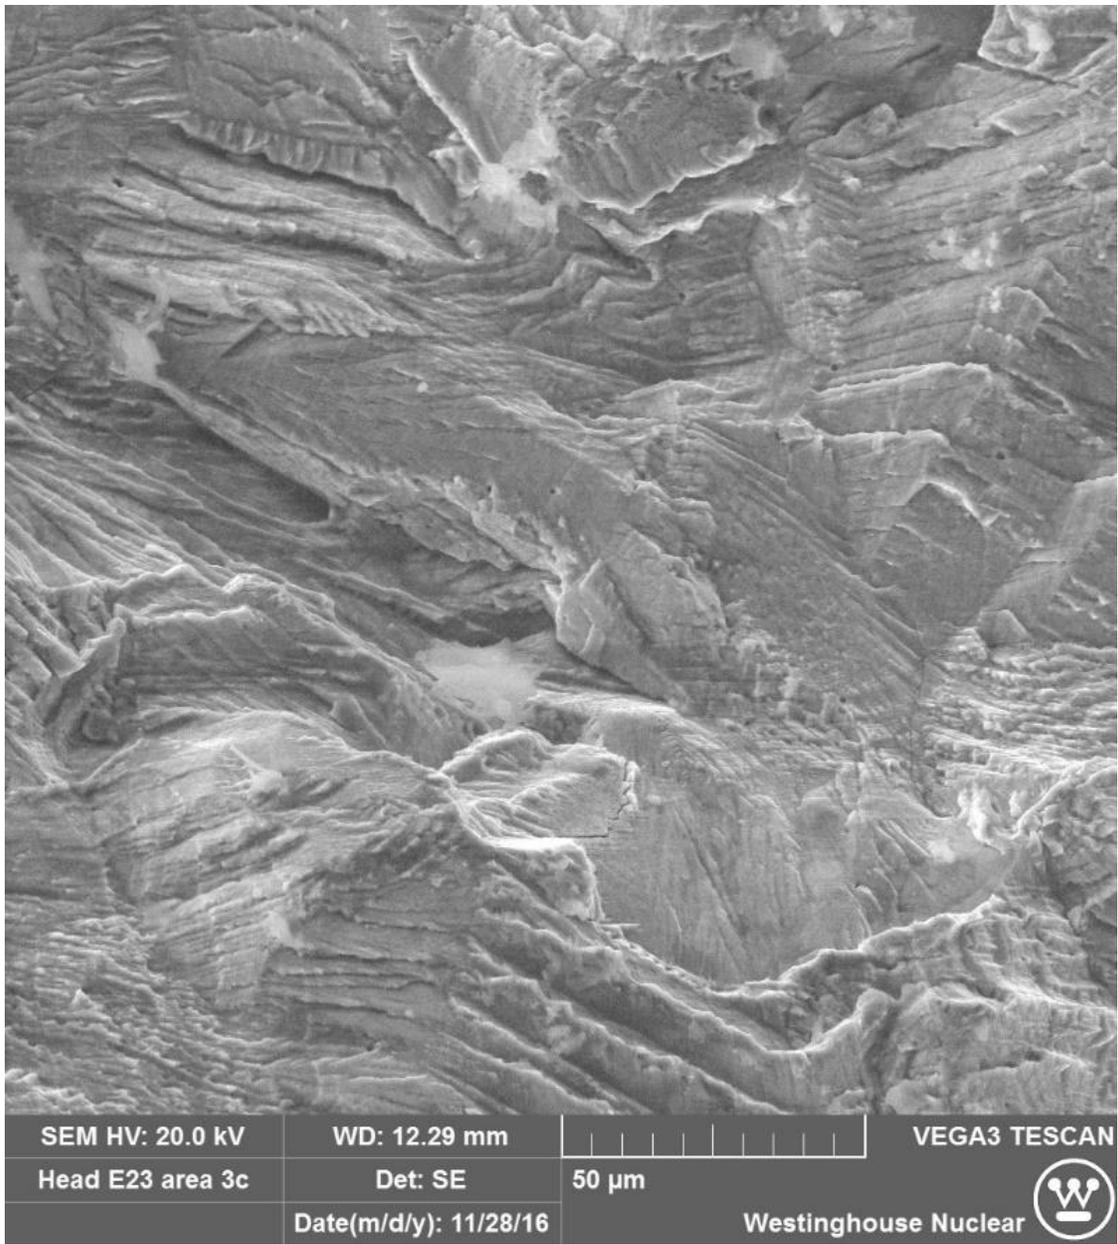
Figure 31. SEM Micrograph of E23 Head Fracture – Area 3, TG Cracking with Slip Bands
