**Interactions between Stress, Environment, and Microstructure causing Irradiation-assisted
Stress Corrosion Cracking in Austenitic Stainless Steels**

Submitted to the Graduate Faculty of
The Swanson School of Engineering in partial fulfillment
of the requirements for the degree of
Doctor of Philosophy

University of Pittsburgh

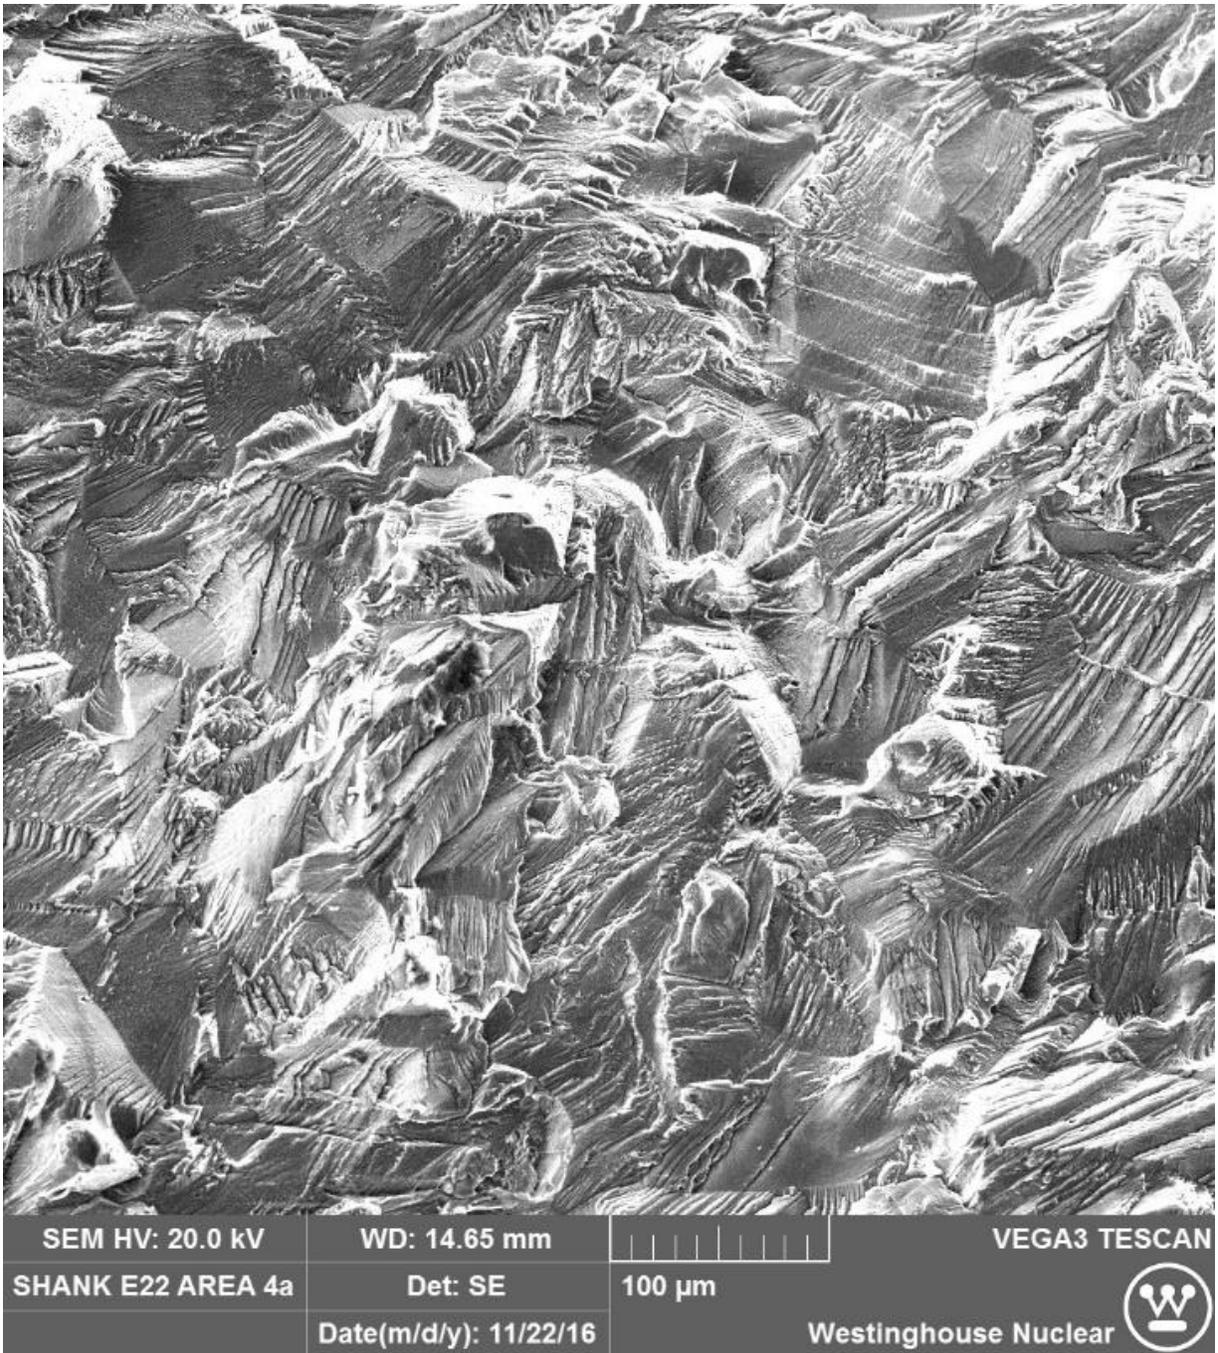
Figure 32. TG Cracking in Bolt E22 Feathery cracking with slip bands, limited secondary cracking, no striations

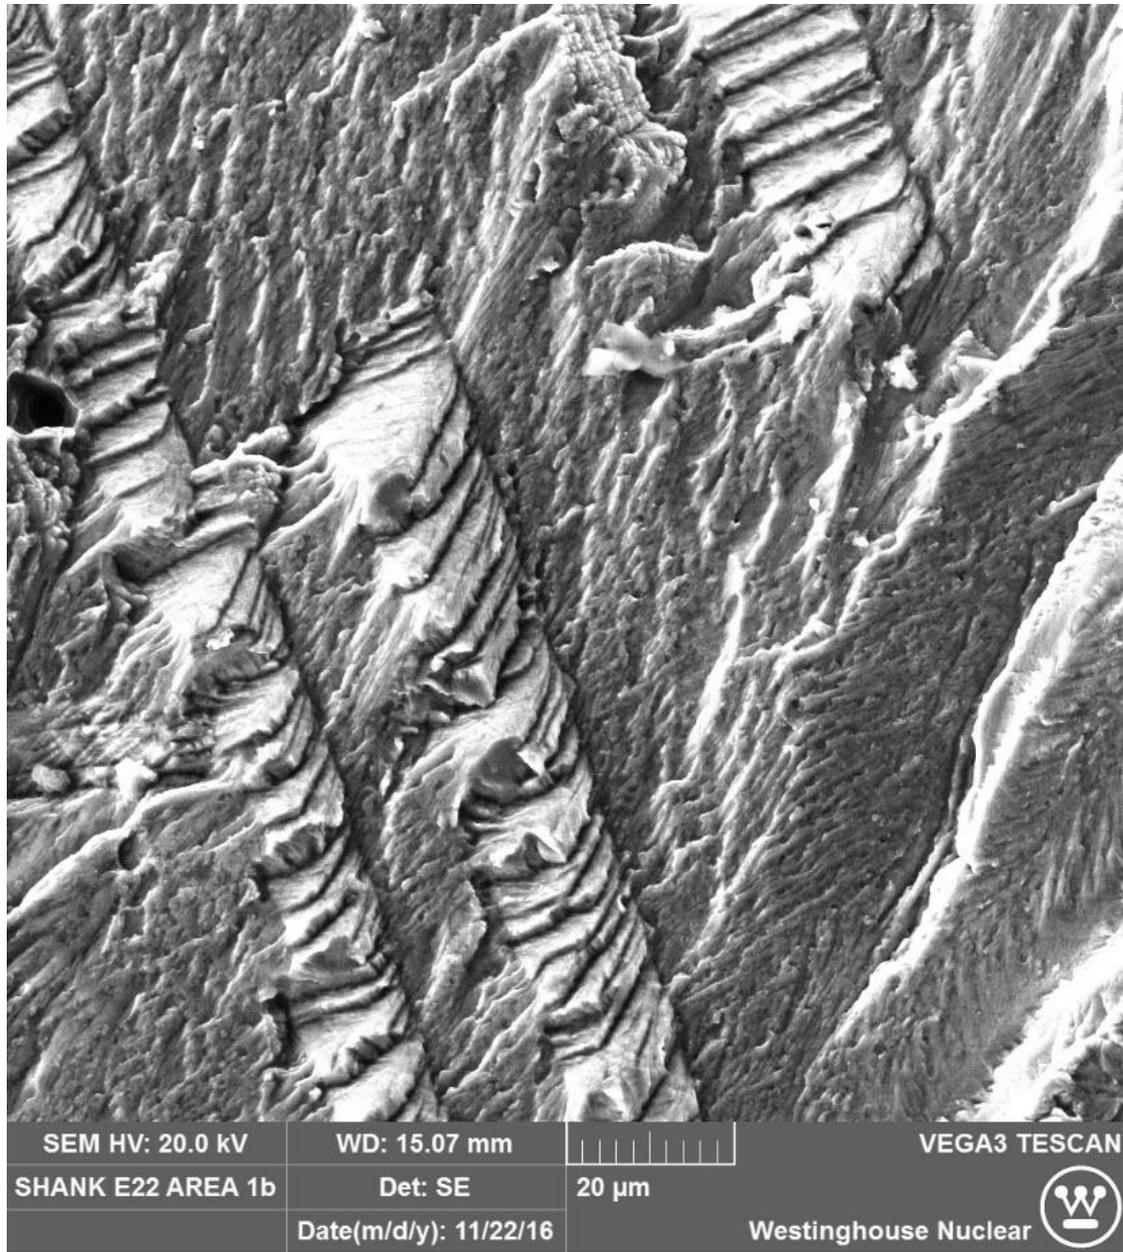
Figure 33. TG Cracking with Slip Bands in Bolt E22

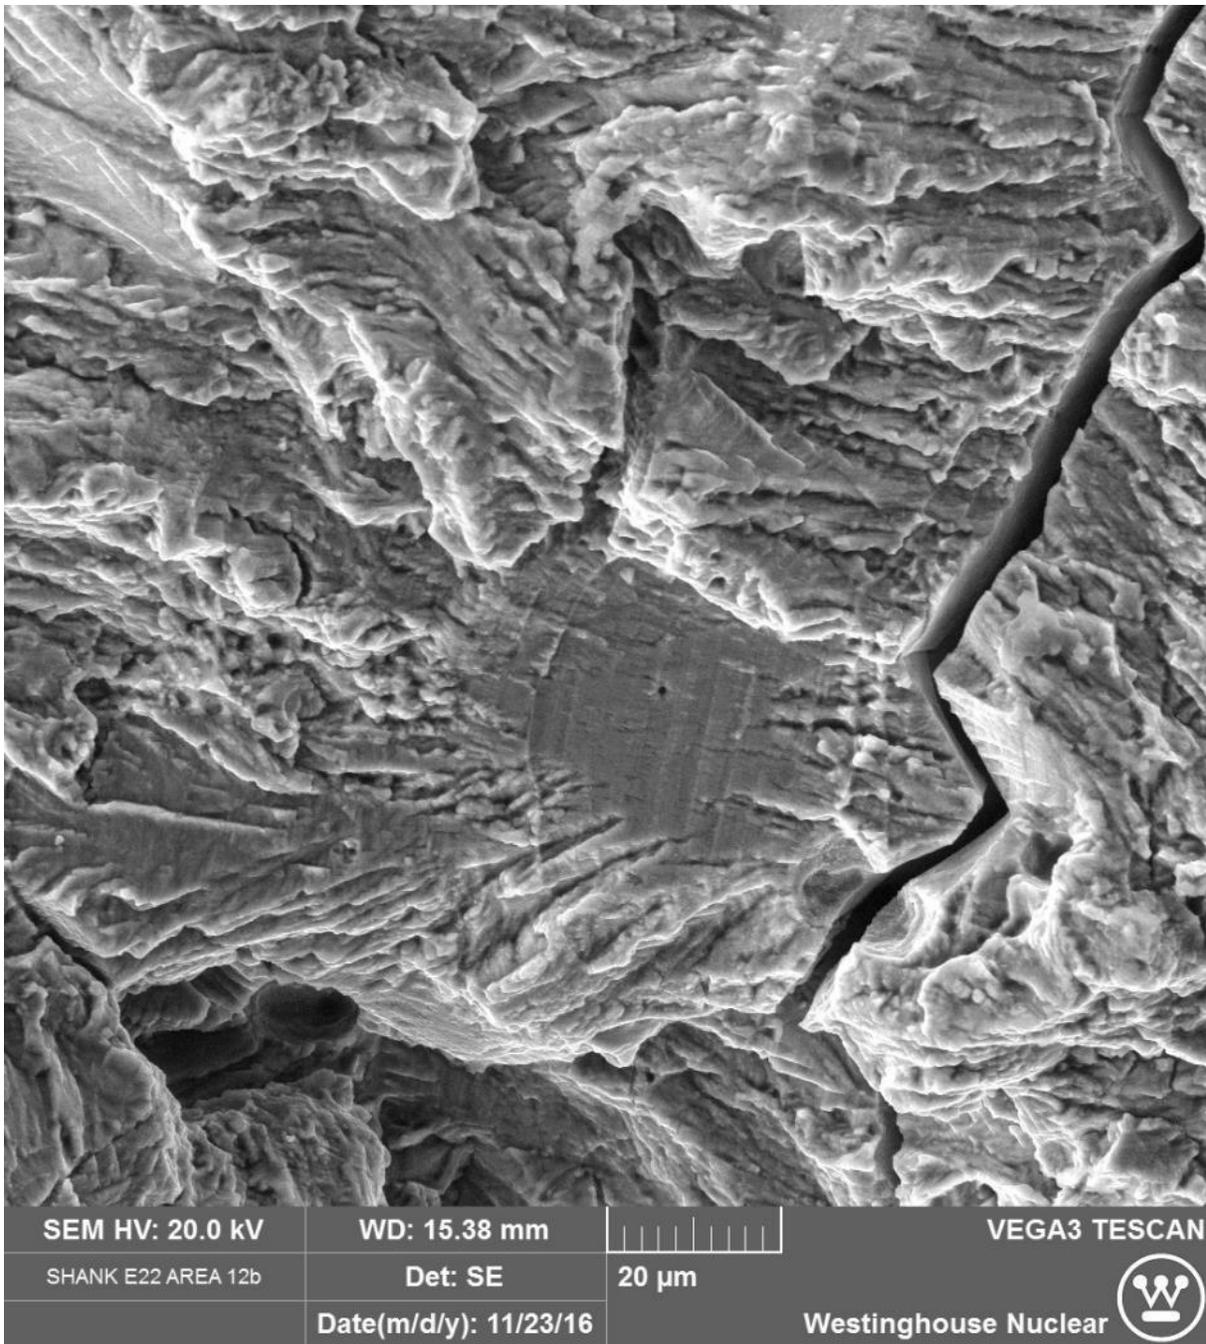
Figure 34. SEM Micrograph of E22 Shank Fracture, Striations and Secondary Cracking in Area of TG Fracture

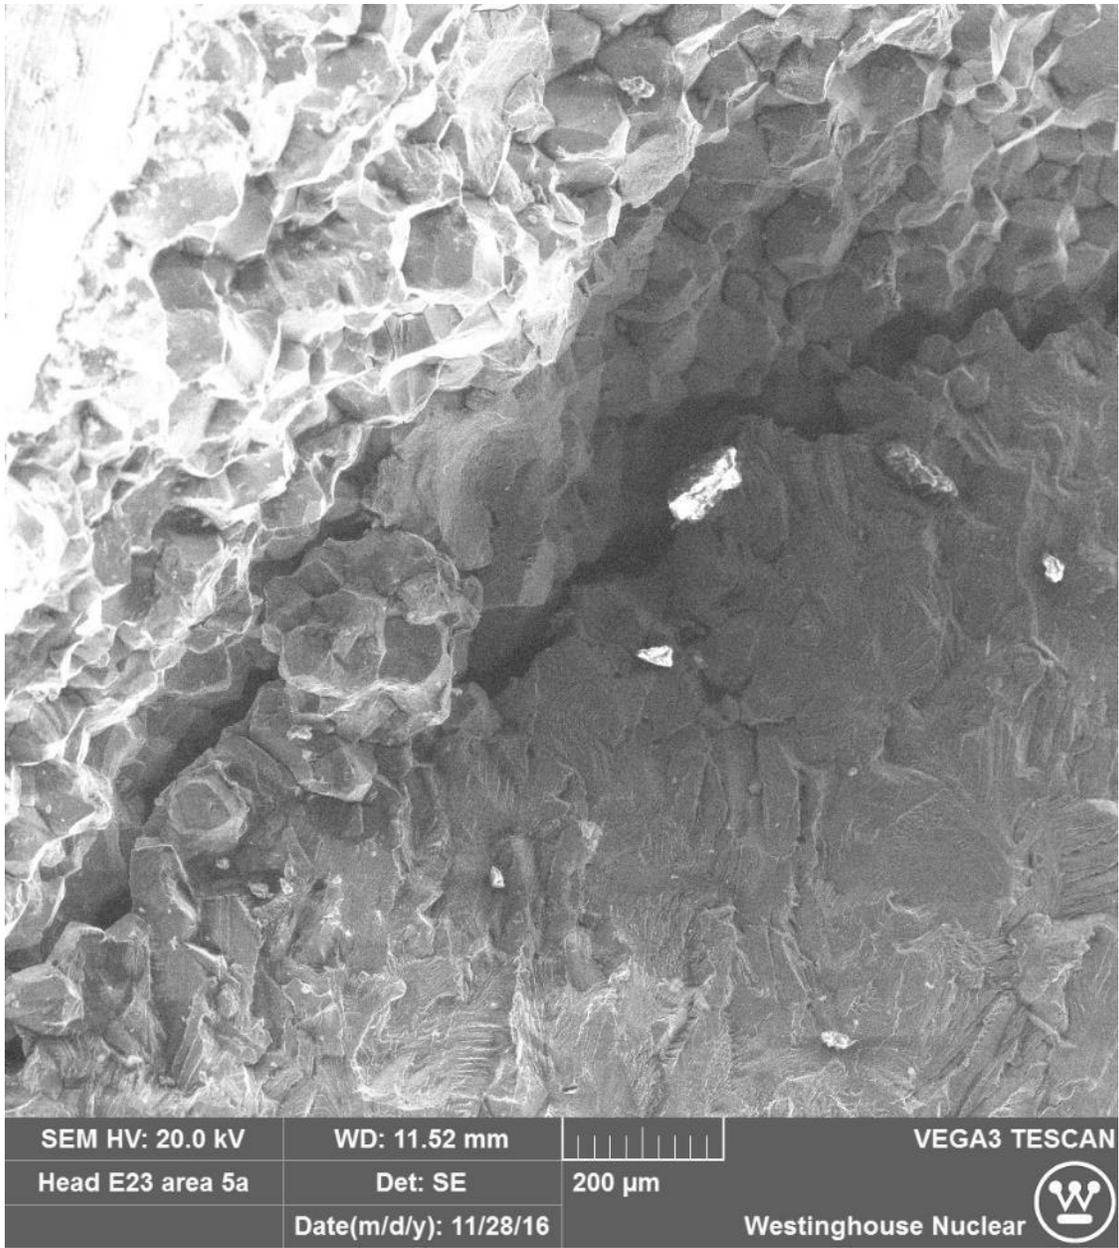
Figure 35. SEM Micrograph of E23 Head Fracture – Area 5, Transition between TG and IG Cracking

The transitions between IG and TG cracking were at times abrupt and associated with secondary cracks (such as in Figure 35) or took place over regions of mixed TG and IG cracking. Also identified on several fracture surfaces of IP2 bolts was microvoid coalescence (Figure 36) with a flatter morphology consistent with ductile tearing. This morphology appeared in between regions of TG cracking as shown in the previous figures and the final ductile fracture of the remaining bolt cross section (which appeared as typical microvoid coalescence).

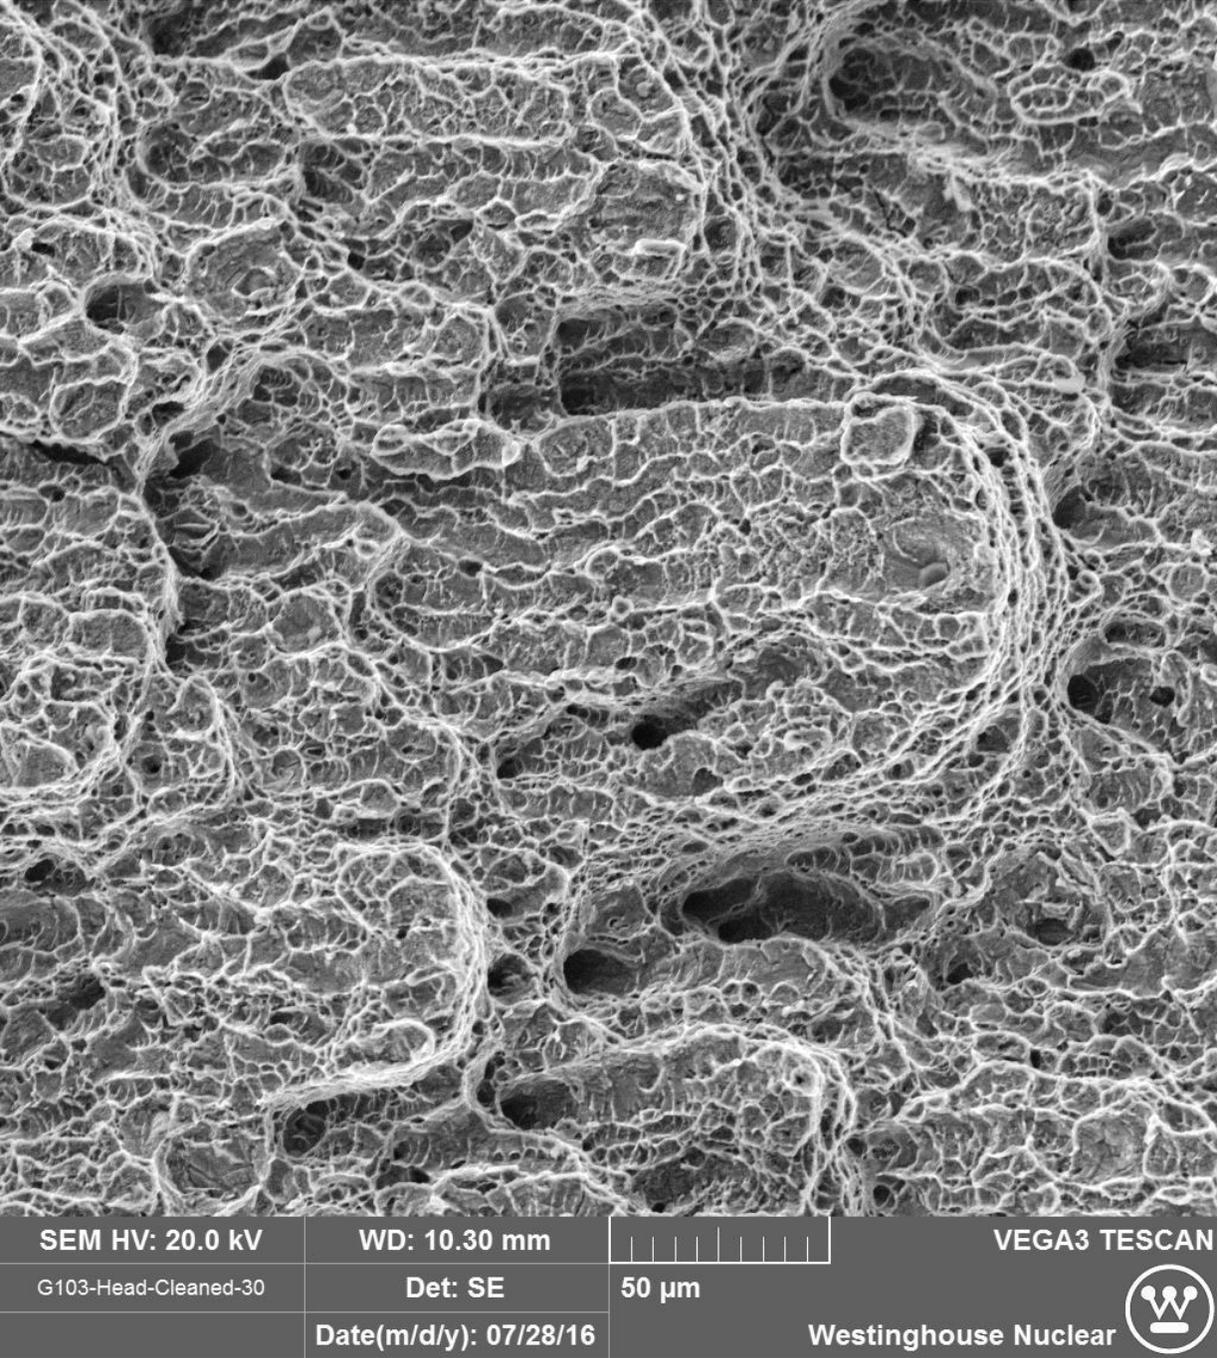
Figure 36. IP2 bolt G103, Blocky microvoid coalescence, showing numerous holes into the fracture surface.

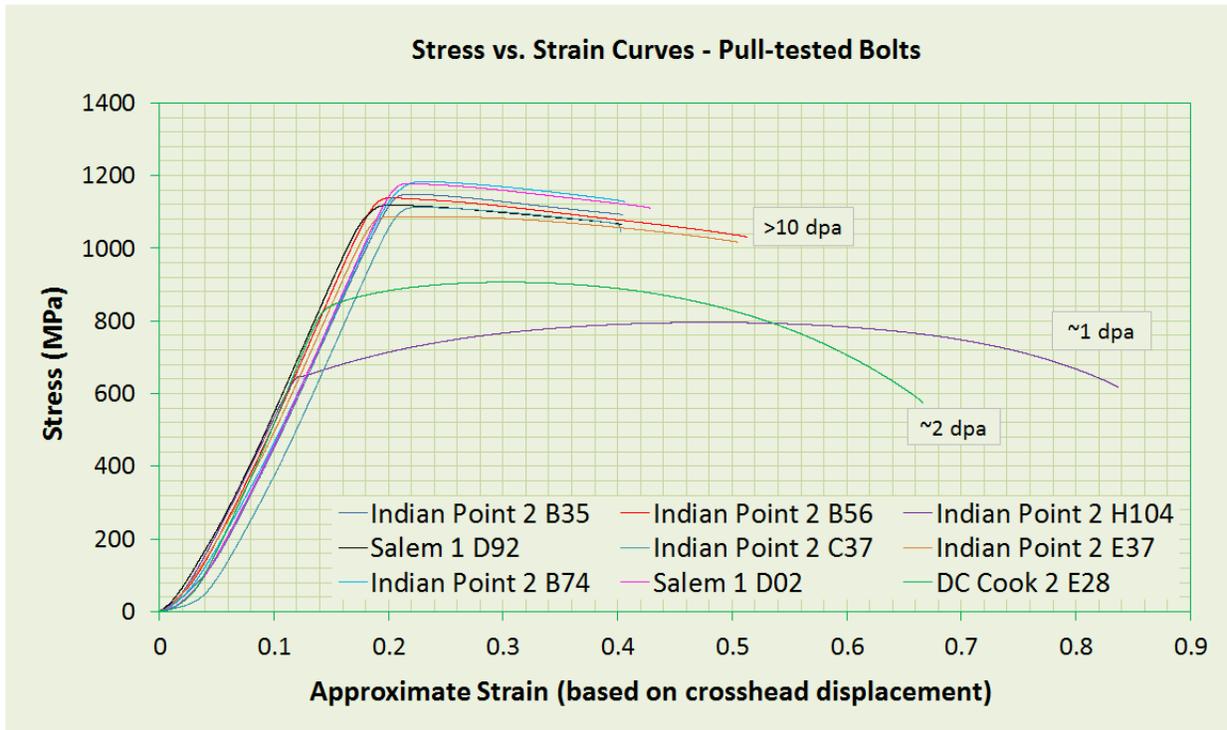
Figure 37. Stress-strain curves for bolt pull tests

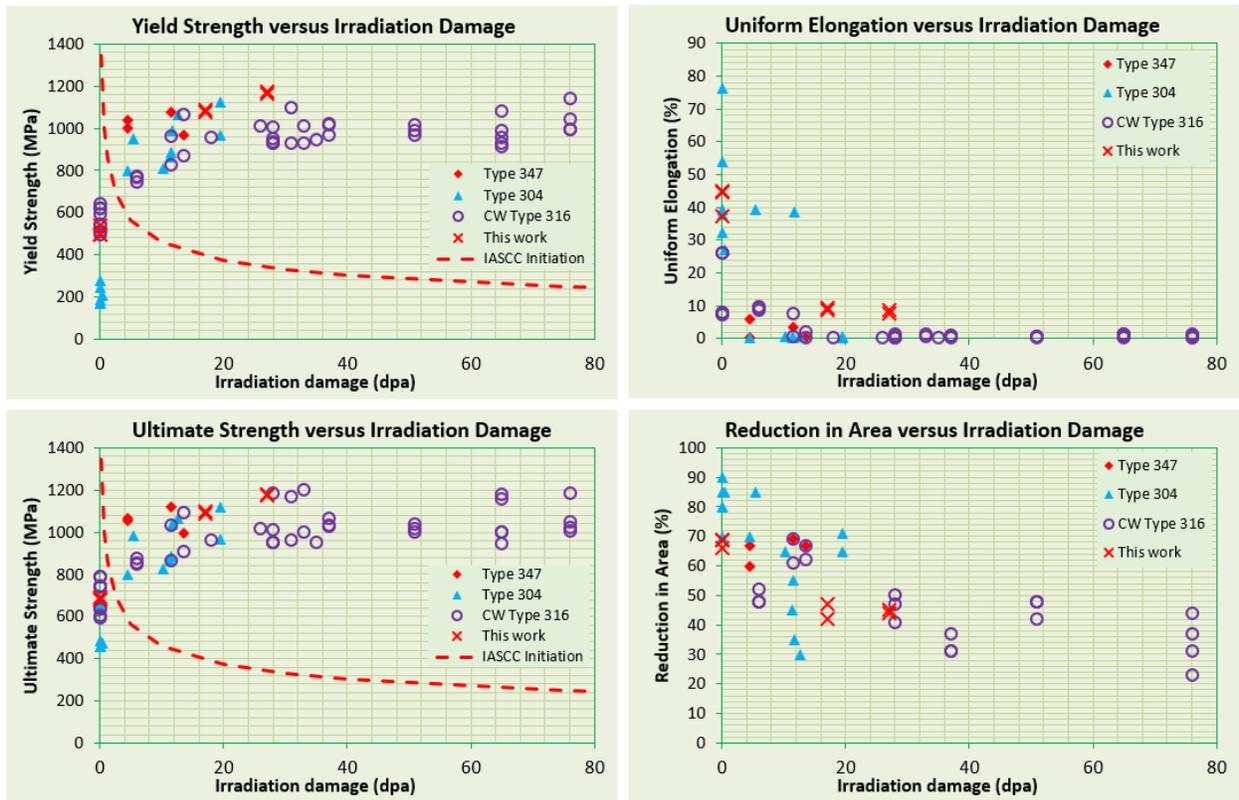
Figure 39. Tensile properties of PWR-irradiated austenitic stainless steels versus irradiation damage

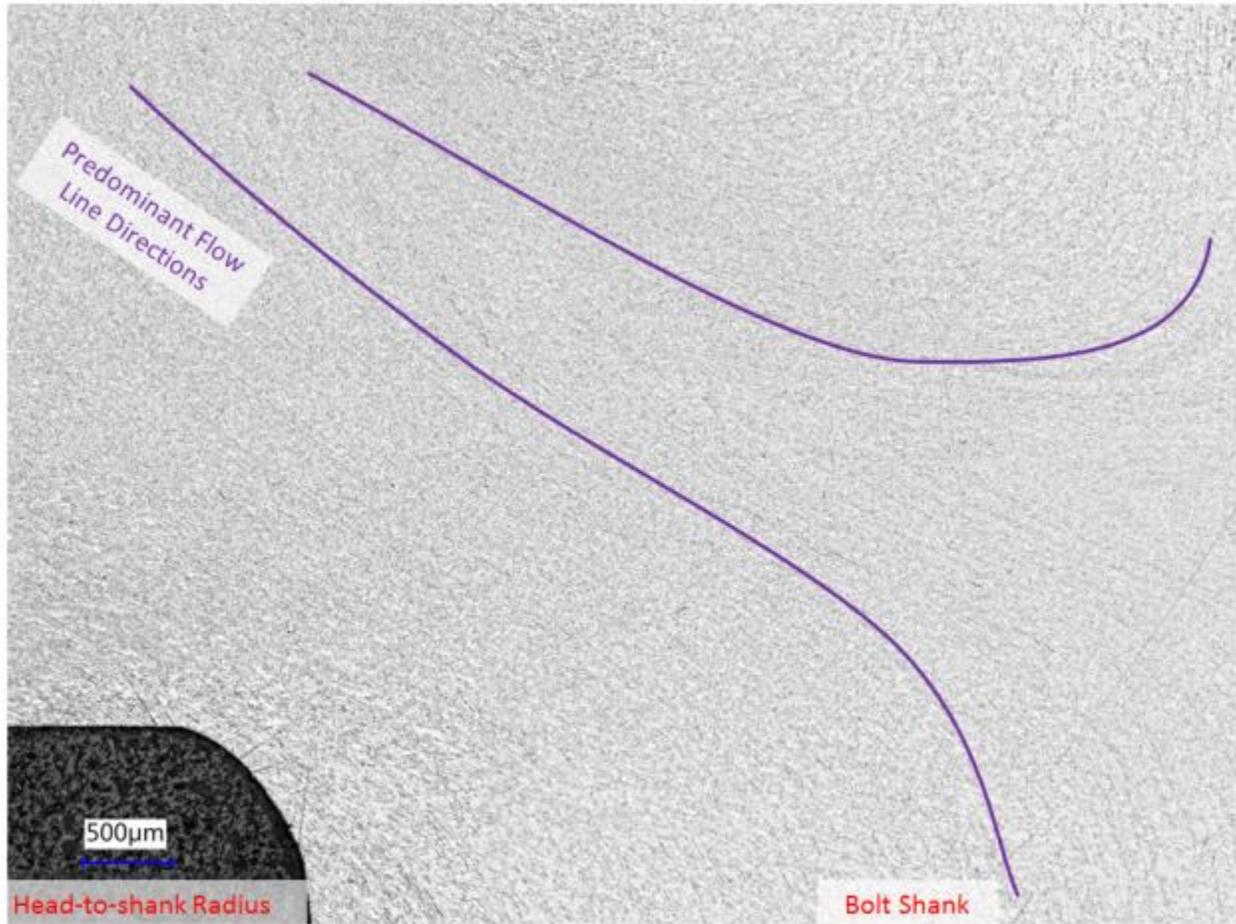
Figure 40. IP2 E37-H flow lines near head-to-shank transition (etched)

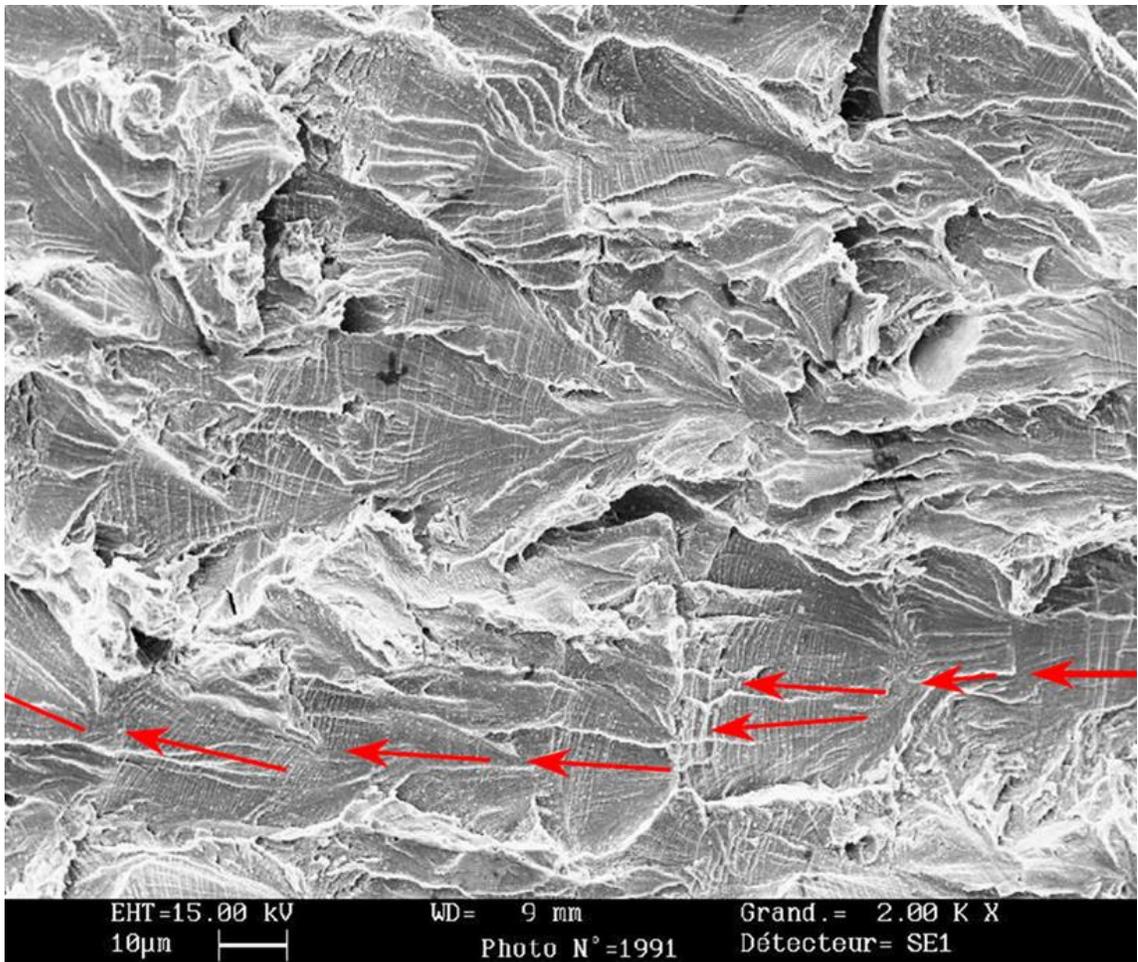
Figure 43. TGSCC at a constant strain rate of $4.7E-8:s$ in PWR water from Reference 41

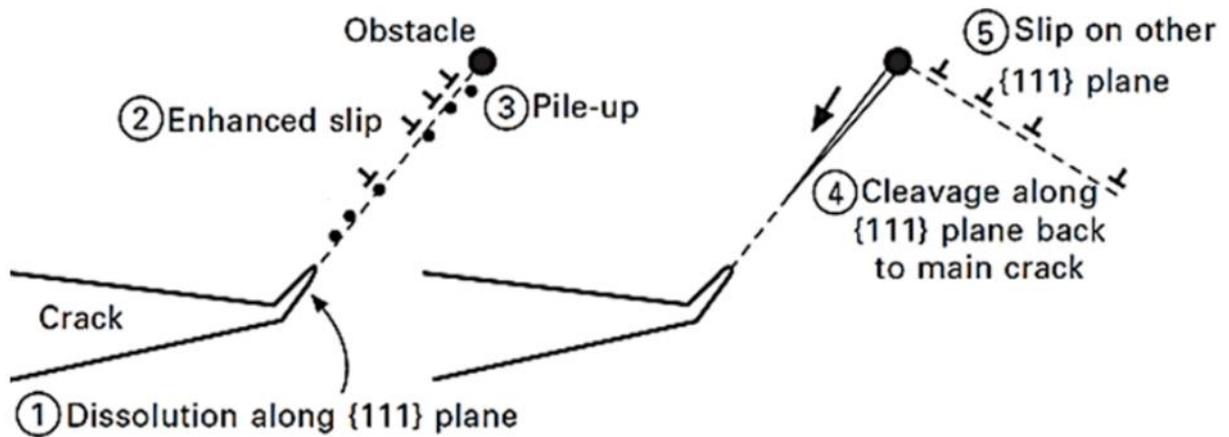
Figure 46. Mechanism of TG IASCC, with locally enhanced slip provided by dislocation channeling - Figure adapted from Reference 51

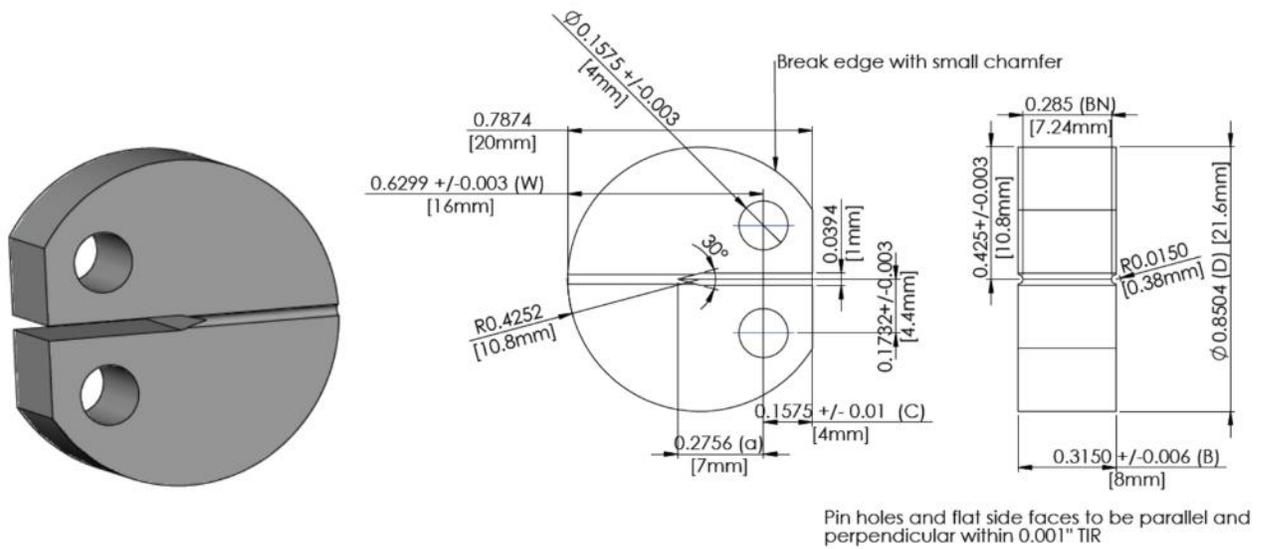
Figure 48. Dimensions of RCT specimens to be used in this project. Dimensions in inches unless otherwise noted.

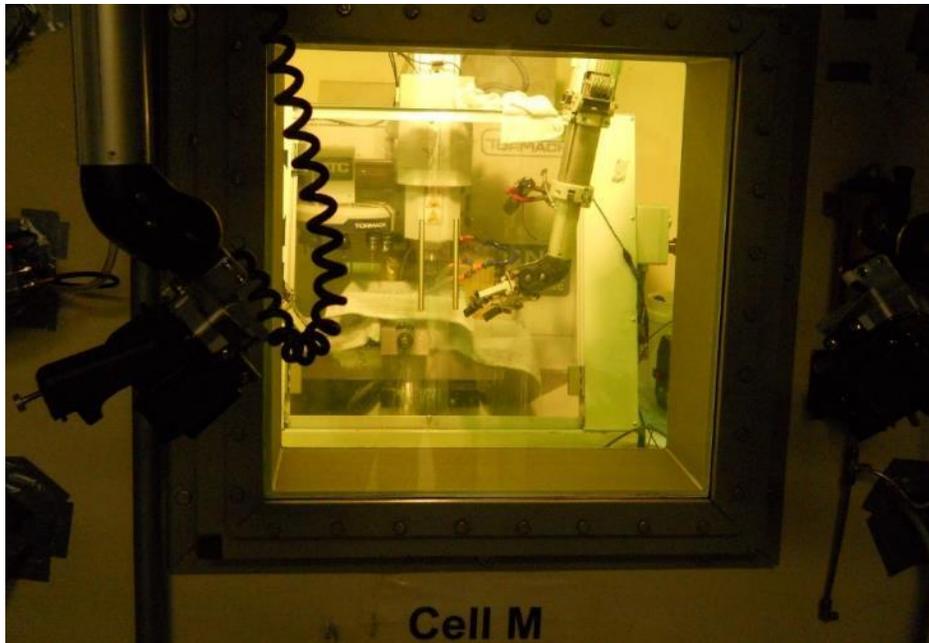
Figure 49. View of CNC Machine through Shielded Hot Cell Window.

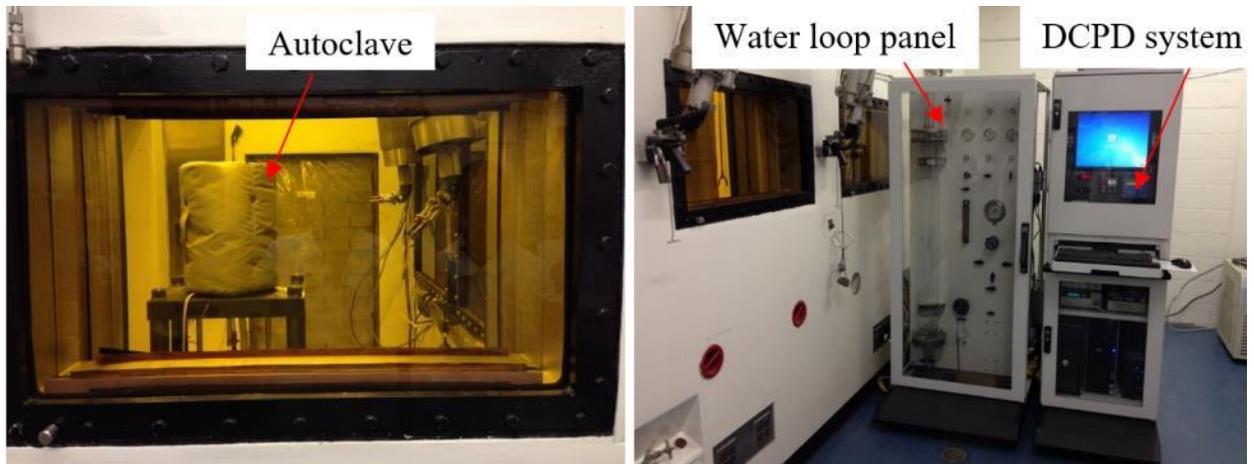
Figure 50. Autoclave control station at the University of Michigan IMTL

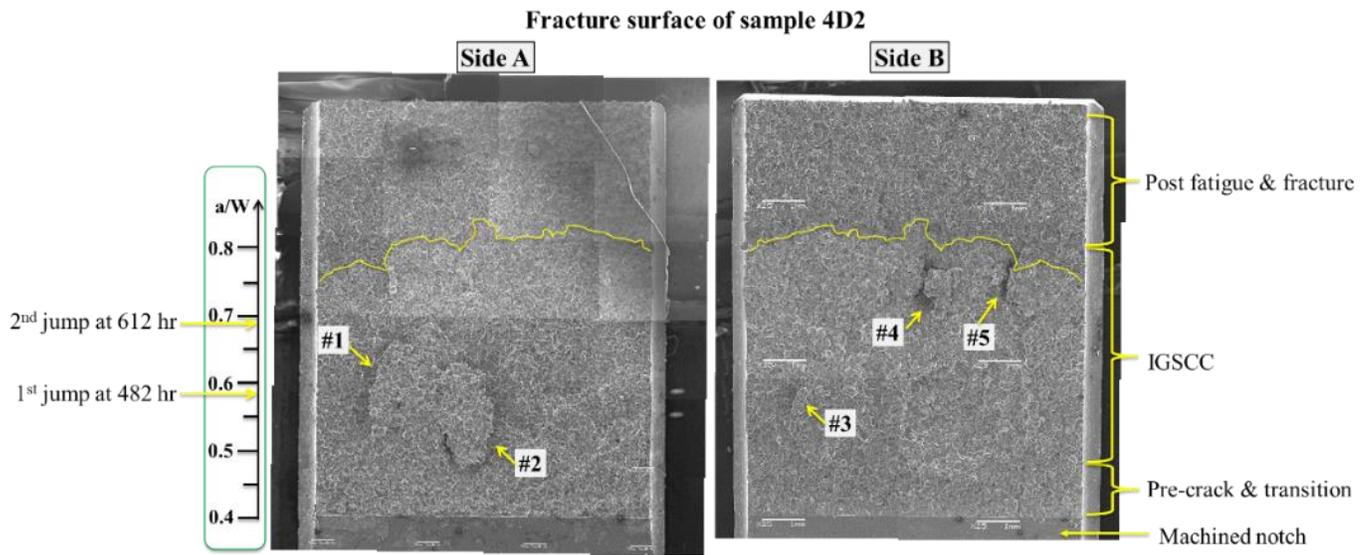
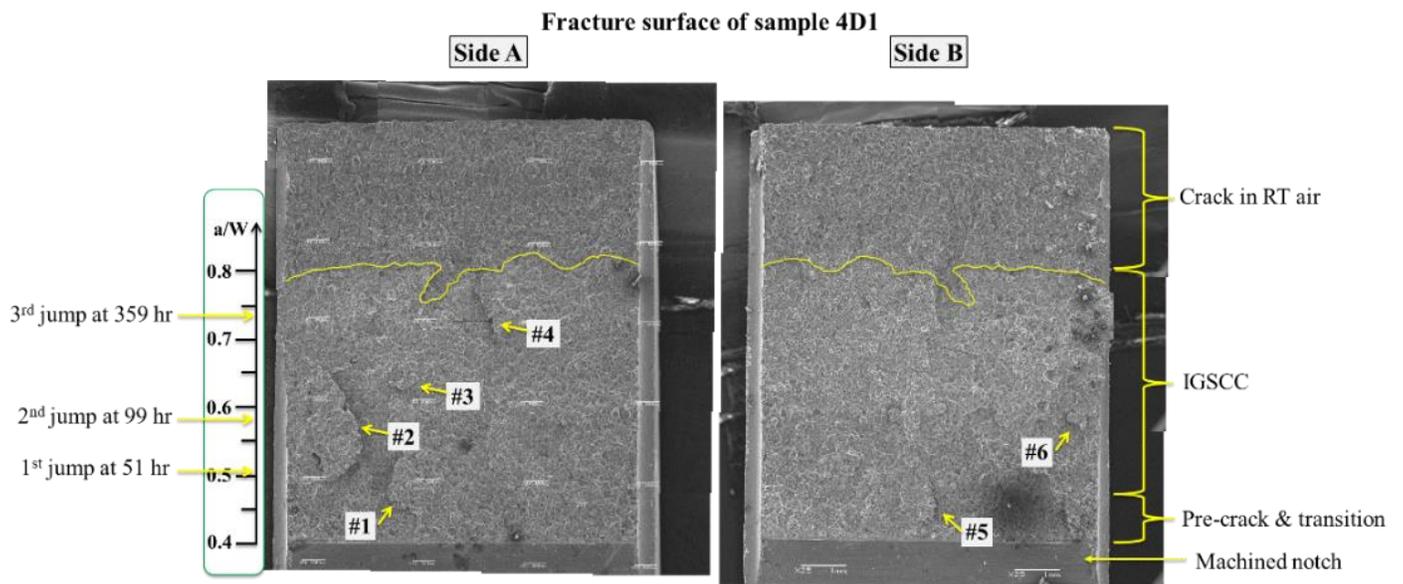
Figure 55. Fracture surface with marked ligaments on both sides of (a) specimen 4D2, (b) specimen 4D1.

The fractographs for specimen 4D2 are given in (Figure 55). A notable feature of the fracture surface was the appearance of lifted-up areas of the crack surface. On the surface of some of these lifted up areas are regions without any apparent oxide deposits on the surface (Figure 56). This would suggest that this region is a ligament which was initially bypassed by the primary fracture and remained intact until a later portion of the test or even until the final fracture of the specimen in room temperature air. Generally similar features were observed in specimen 4D1. The overall features of the two specimens are summarized in Figure 57.

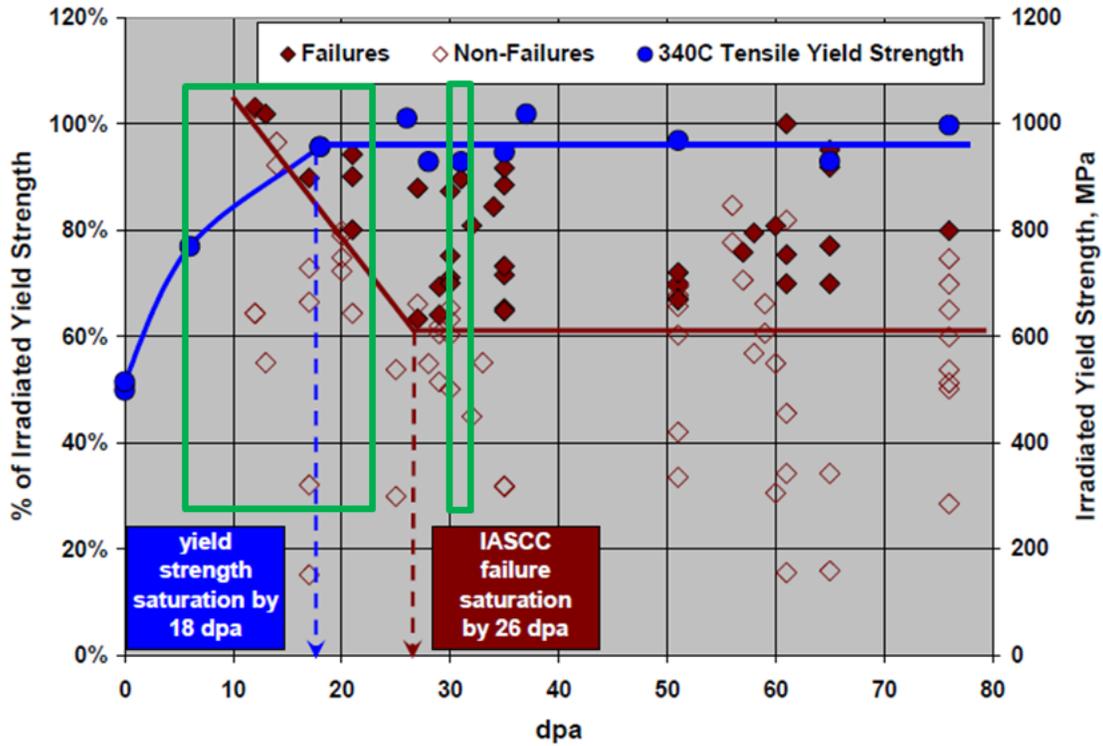
Figure 61. Areas to be investigated by this experiment shown in green boxes, relative to data generated by testing Type 316 O-rings irradiated in PWRs (Figure adapted from Reference 60)

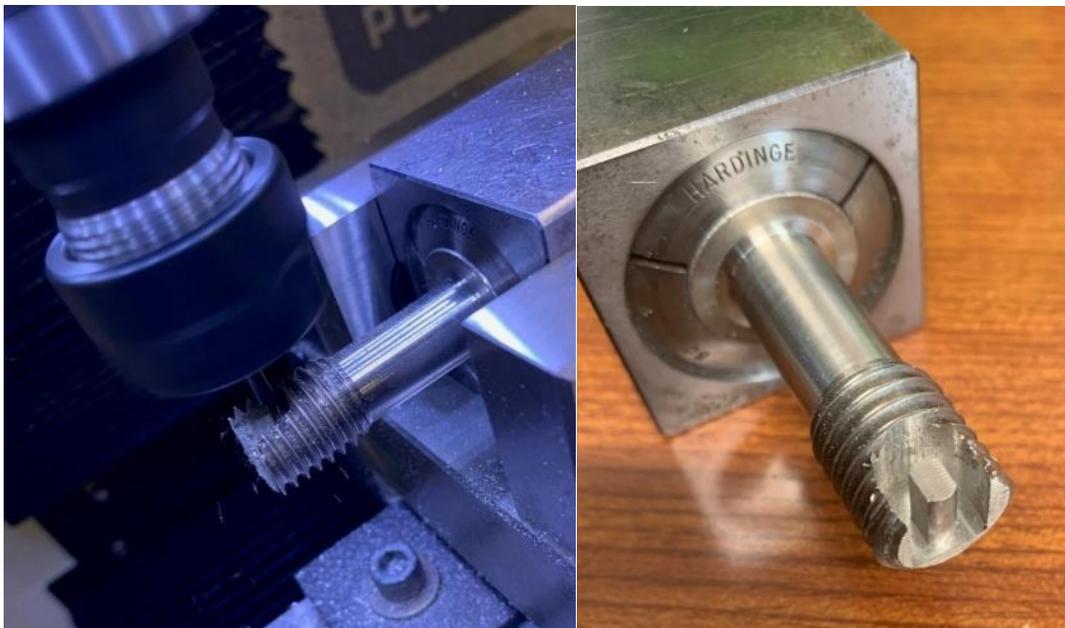
Figure 63. Machining of 4-point bend samples from unirradiated practice bolt

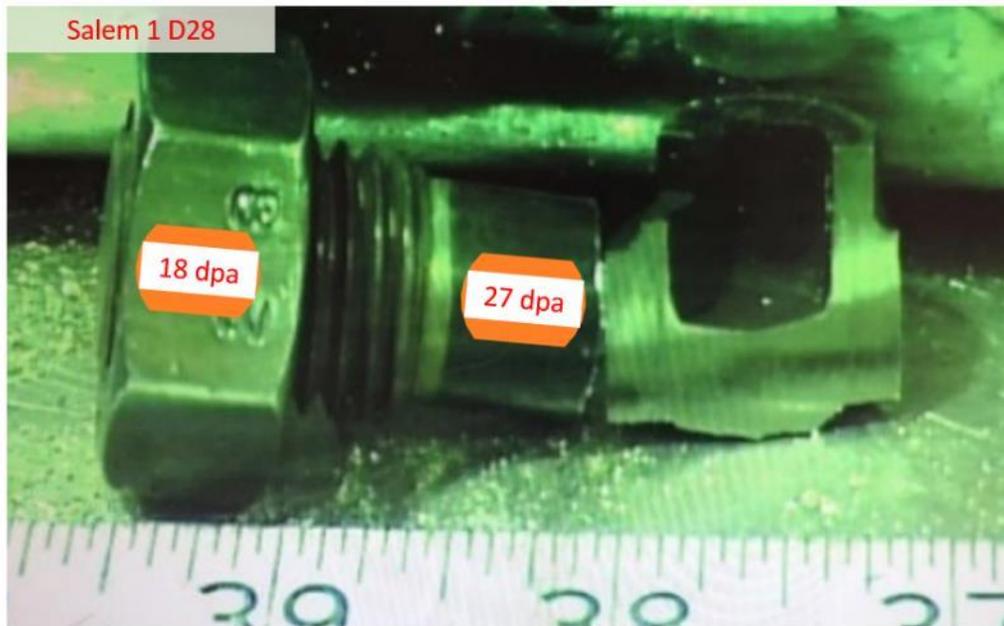
Figure 64. Approximate locations for specimen machining for Salem 1 bolt D28. The 18 dpa sampling location is at the end of the threaded portion of the bolt, obscured by the nut used for ID purposes.

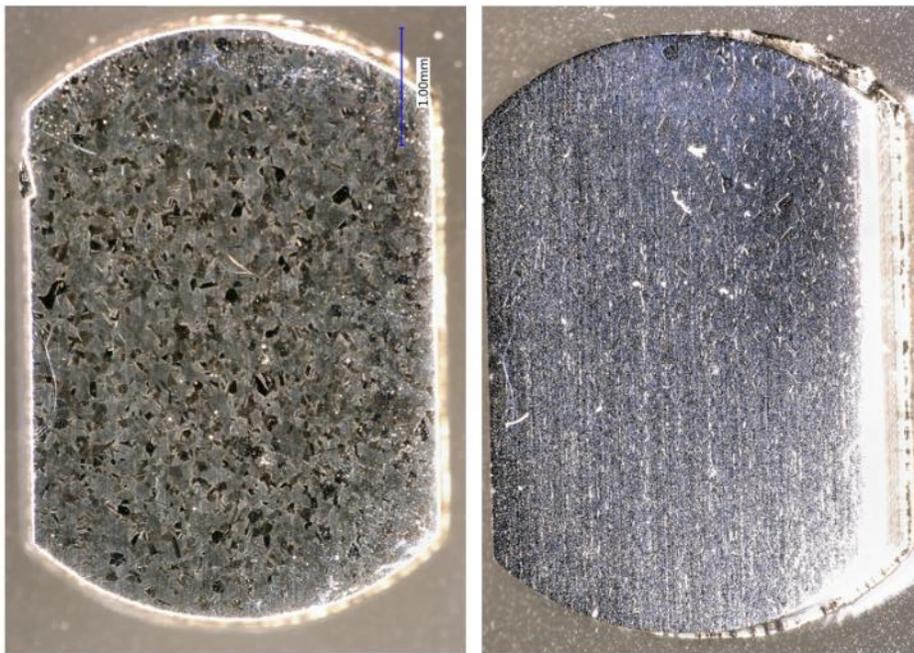
Figure 70. Effect of electropolishing showing difference between (left) as polished specimen and (right) specimen after 15 seconds of electropolishing

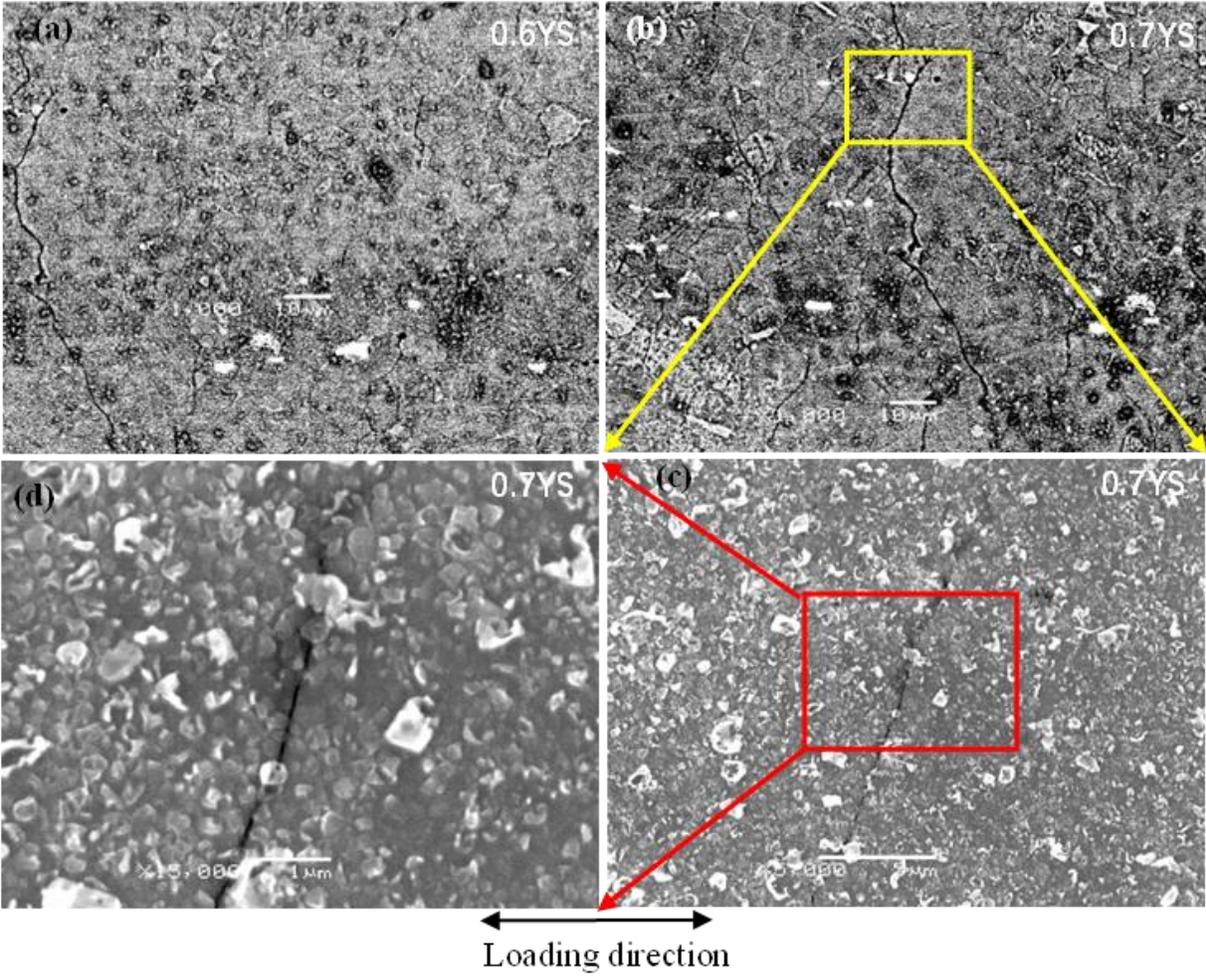
Figure 83. An example crack from specimen D28-H-3 at 26.4 dpa, viewed in back scatter mode after testing at 60% and 70% of the irradiated yield stress in KOH water chemistry

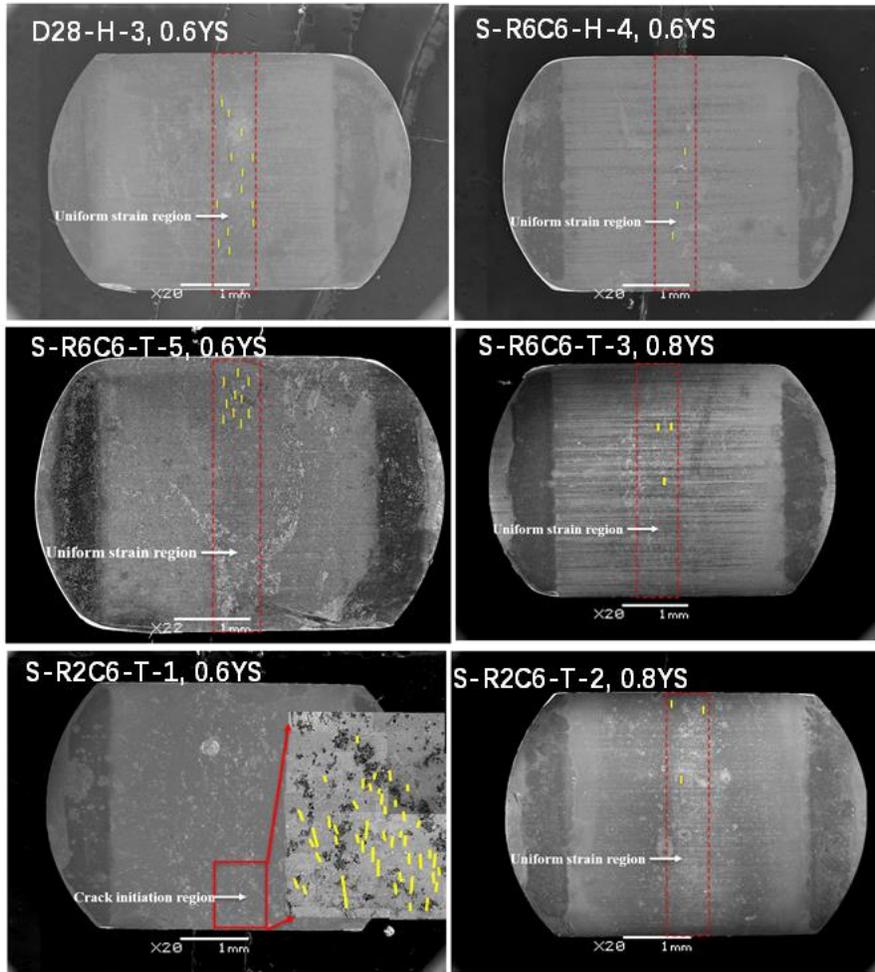
Figure 84. Images of 4-point bend specimens after testing in KOH water chemistry. The dashed red boxes indicate regions of uniform surface stress.

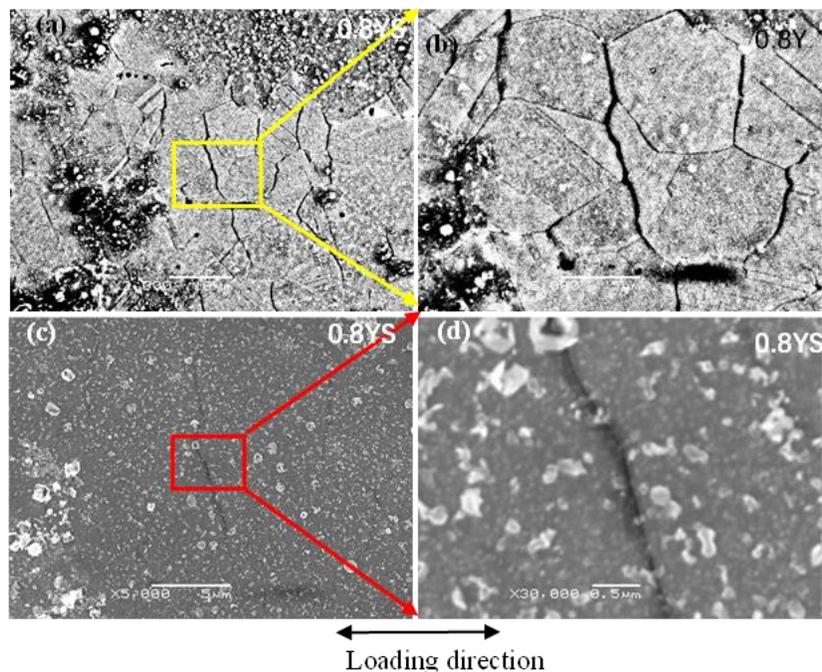
Figure 85. An example crack from specimen D28-H-1 at 26.4 dpa, viewed in back scatter mode (top) and secondary electron mode (bottom) after testing at 80% of the irradiated yield stress in LiOH water chemistry

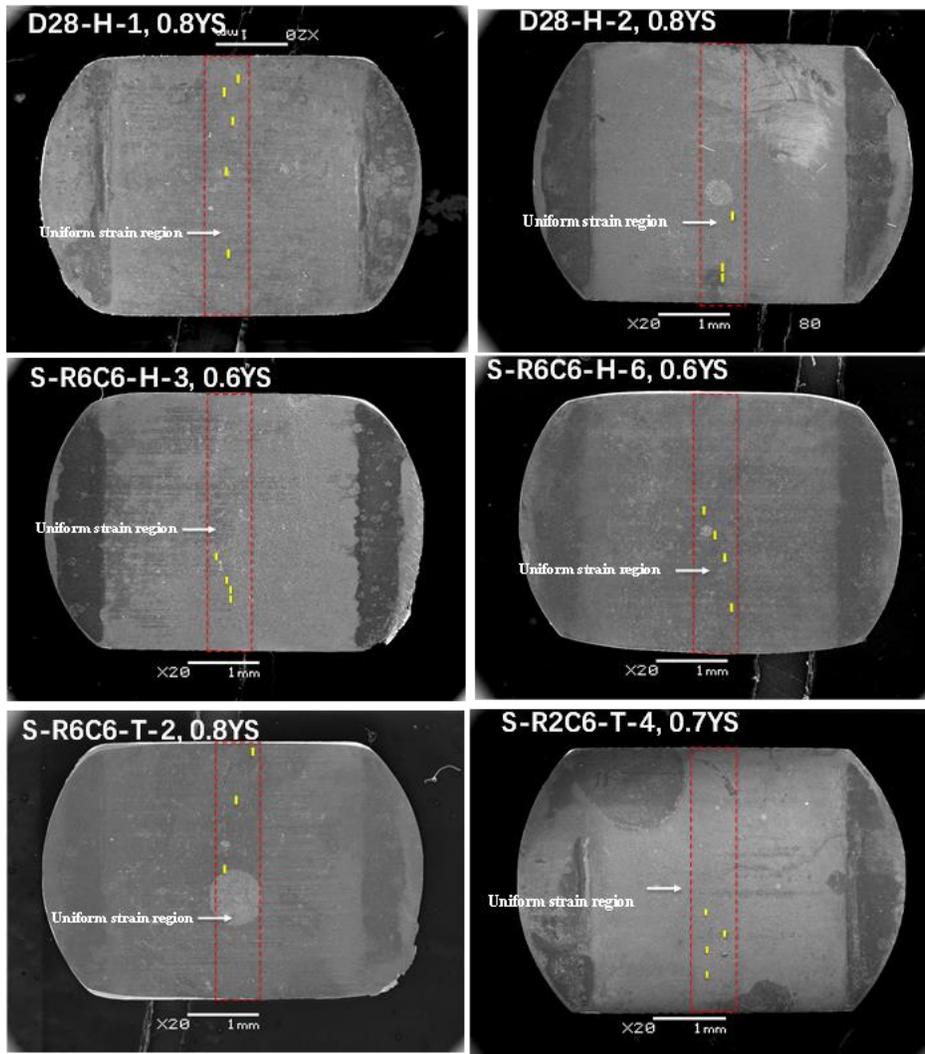
Figure 86. Images of 4-point bend specimens after testing in LiOH water chemistry. The dashed red boxes indicate regions of uniform surface stress.
