**Interactions between Stress, Environment, and Microstructure causing Irradiation-assisted
Stress Corrosion Cracking in Austenitic Stainless Steels**

Submitted to the Graduate Faculty of
The Swanson School of Engineering in partial fulfillment
of the requirements for the degree of
Doctor of Philosophy

University of Pittsburgh

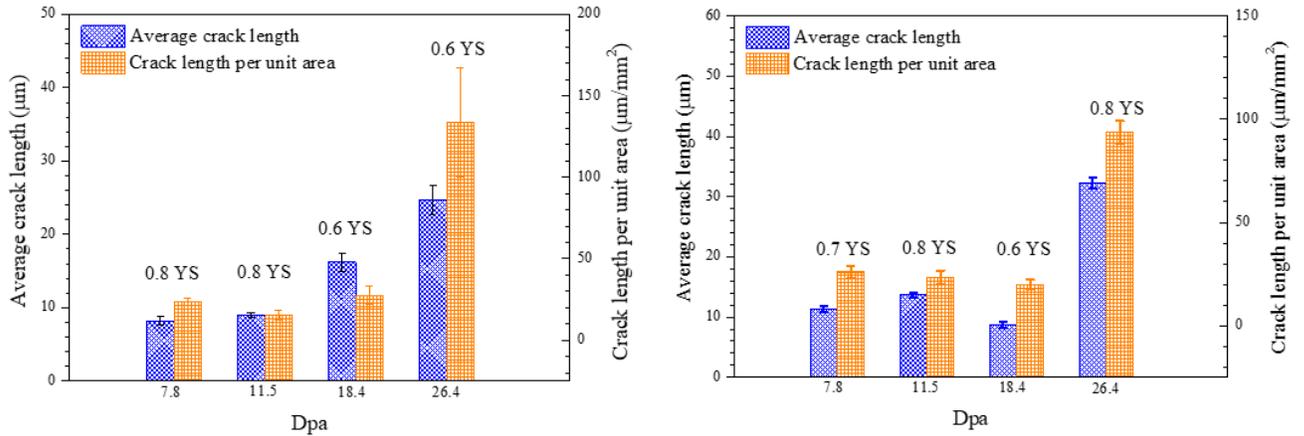
Figure 87. Average crack length (μm) and crack length per unit area ($\mu\text{m}/\text{mm}^2$) for samples tested in KOH water chemistry (left) and LiOH water chemistry (right)

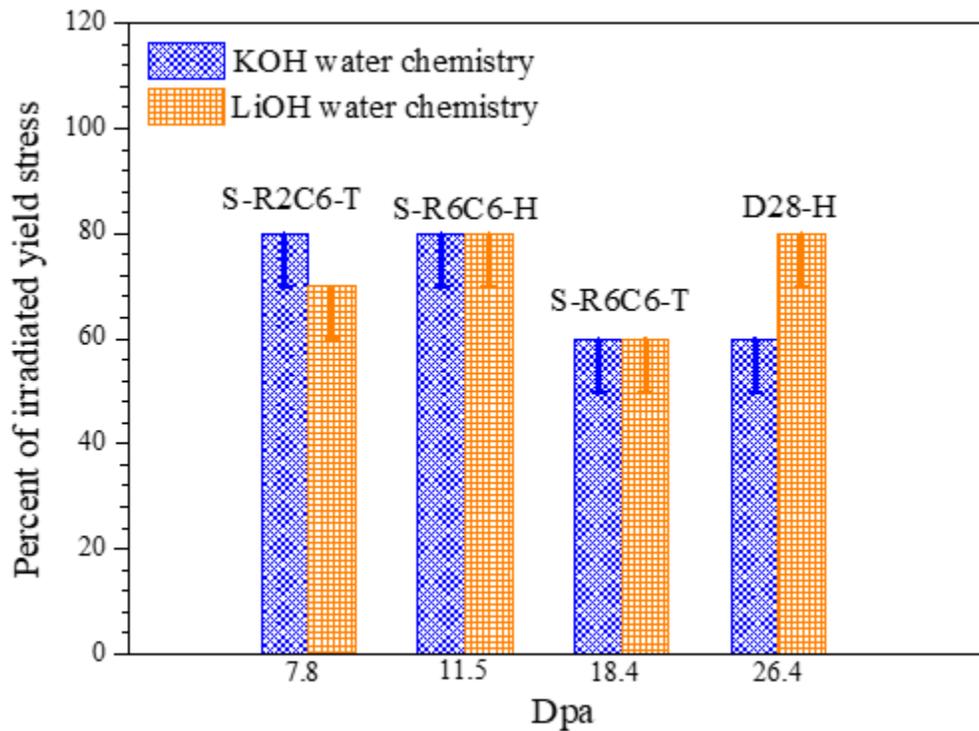
Figure 88. Comparison of crack initiation stress at the investigated dose rates for KOH and LiOH water chemistries

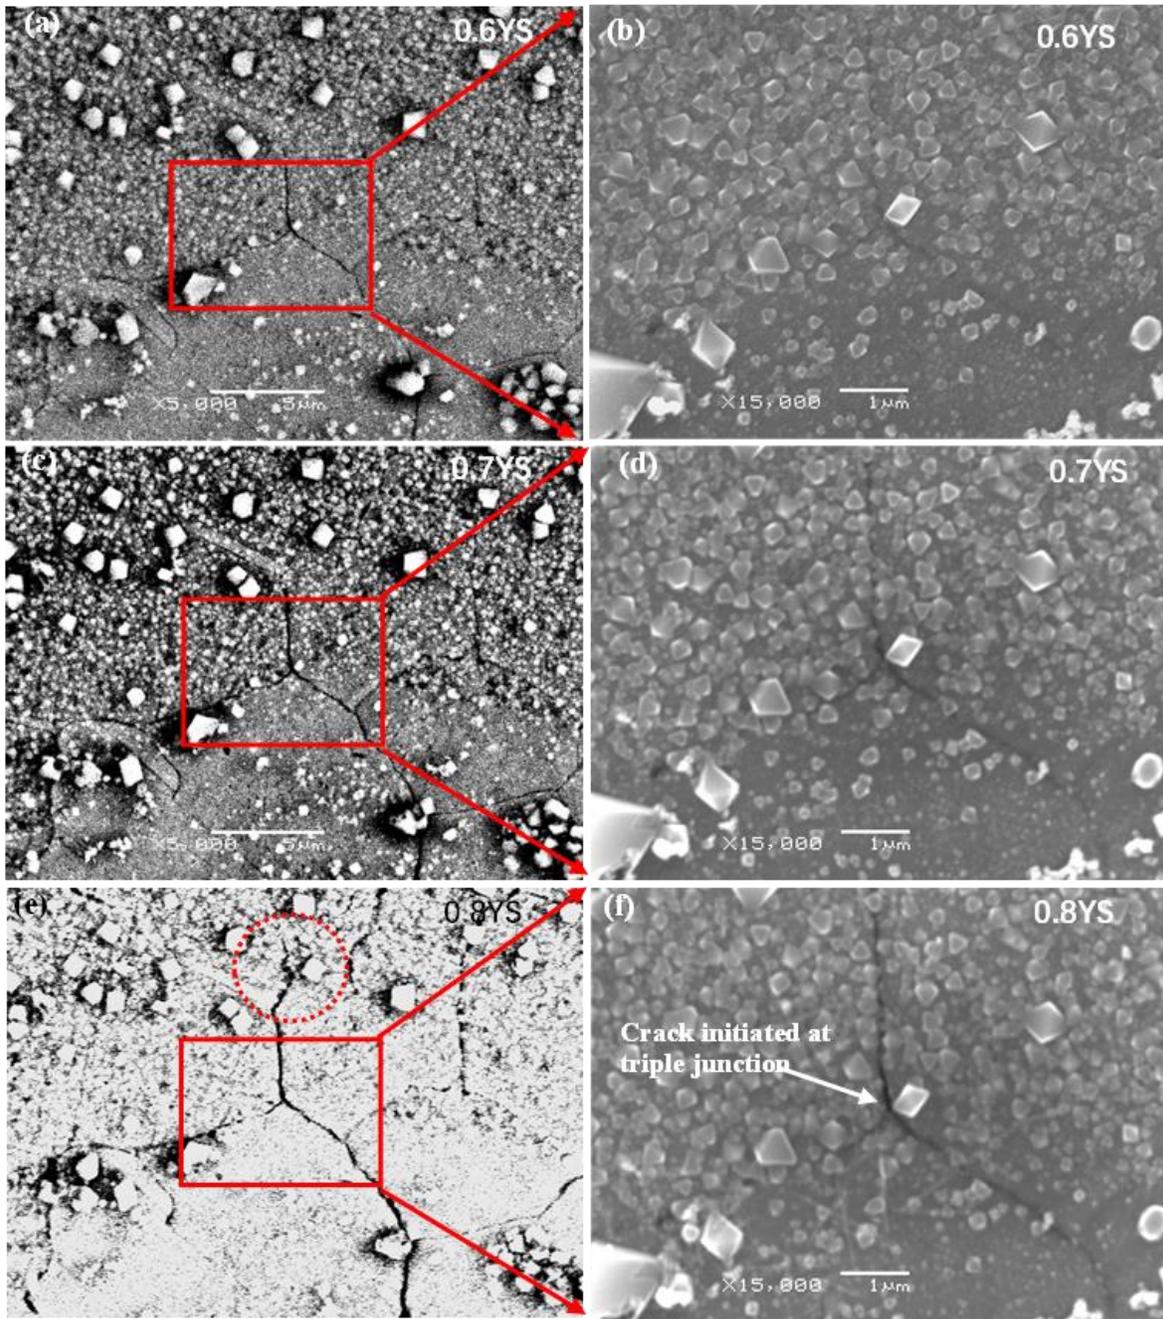
Figure 89. Images in (left) backscatter mode and (right) secondary electron mode of the progression of crack initiation at a location on sample D28-H-2

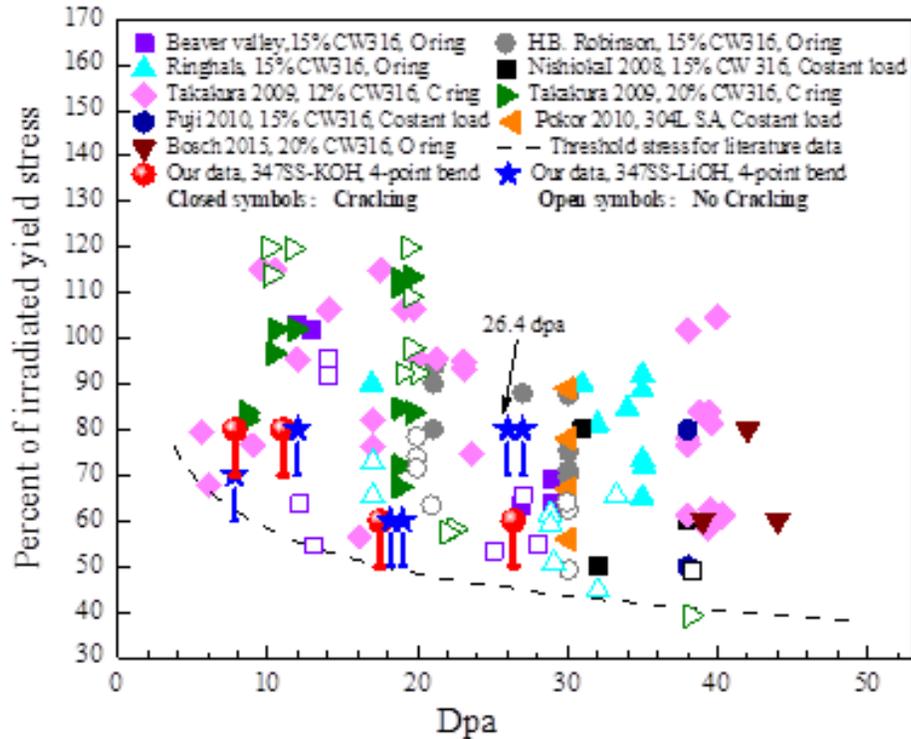
Figure 90. Comparison of data generated in this program to literature data

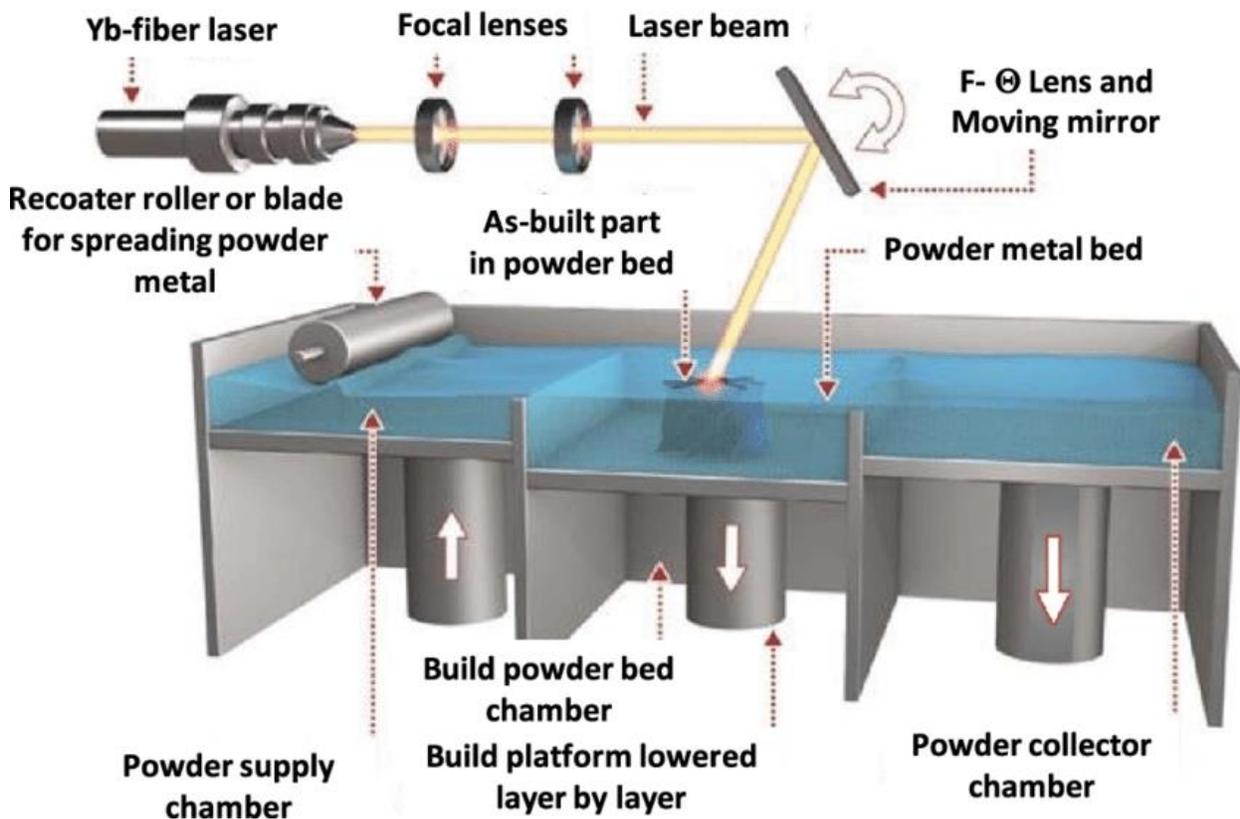
Figure 91. Illustration of the laser powder bed fusion (LPBF) process from Reference 63.

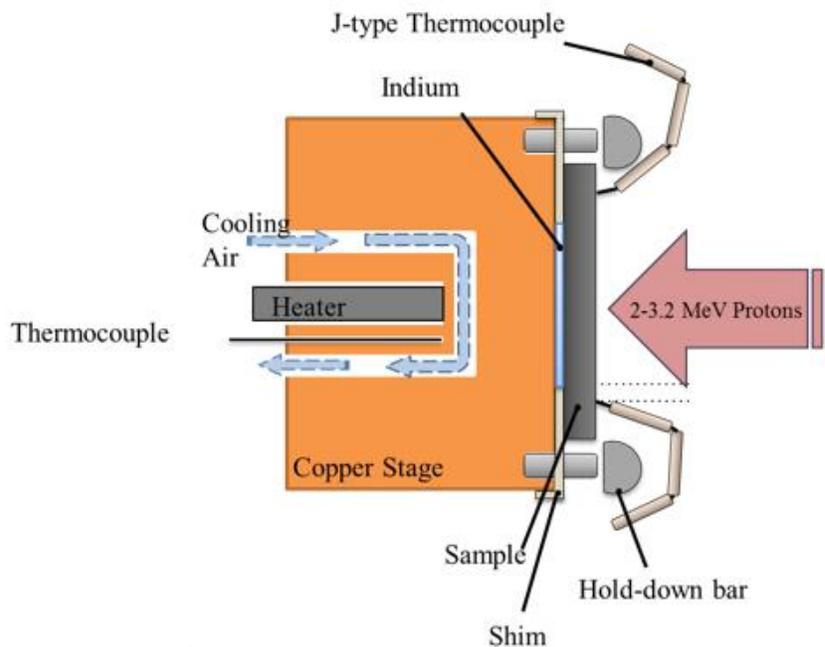
Figure 95. Stage Design

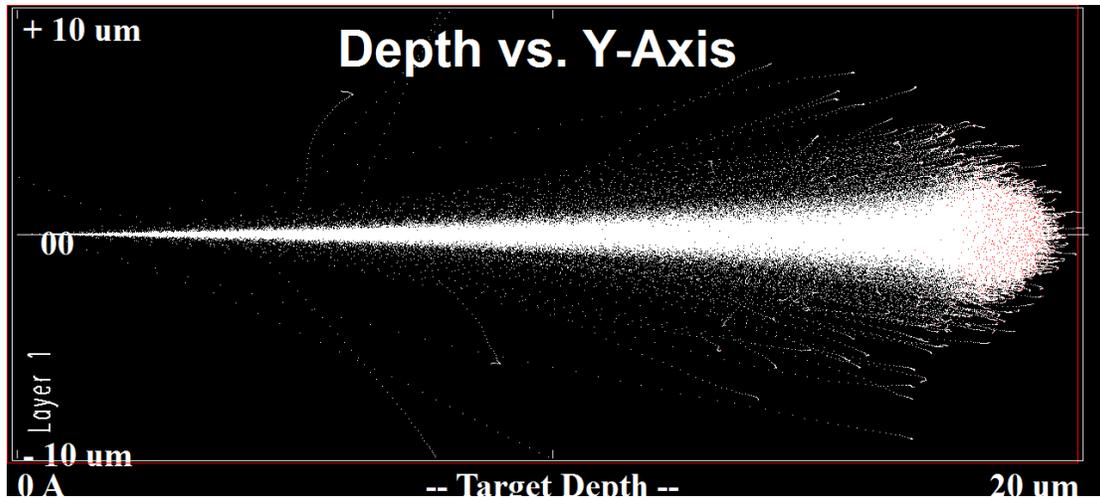
Figure 96. SRIM Results indicating depth of irradiation

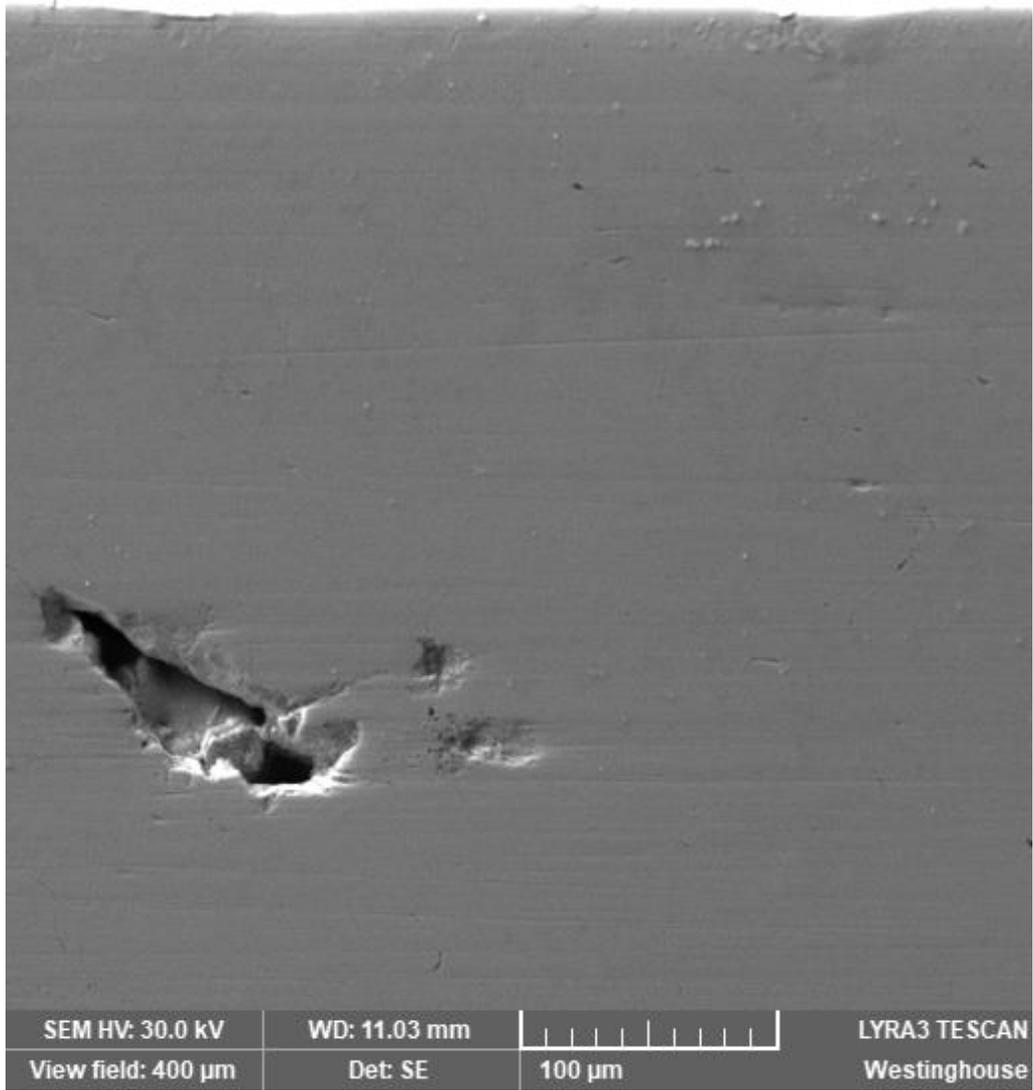
Figure 102. Example of image of surface of as-irradiated binder jet tensile sample

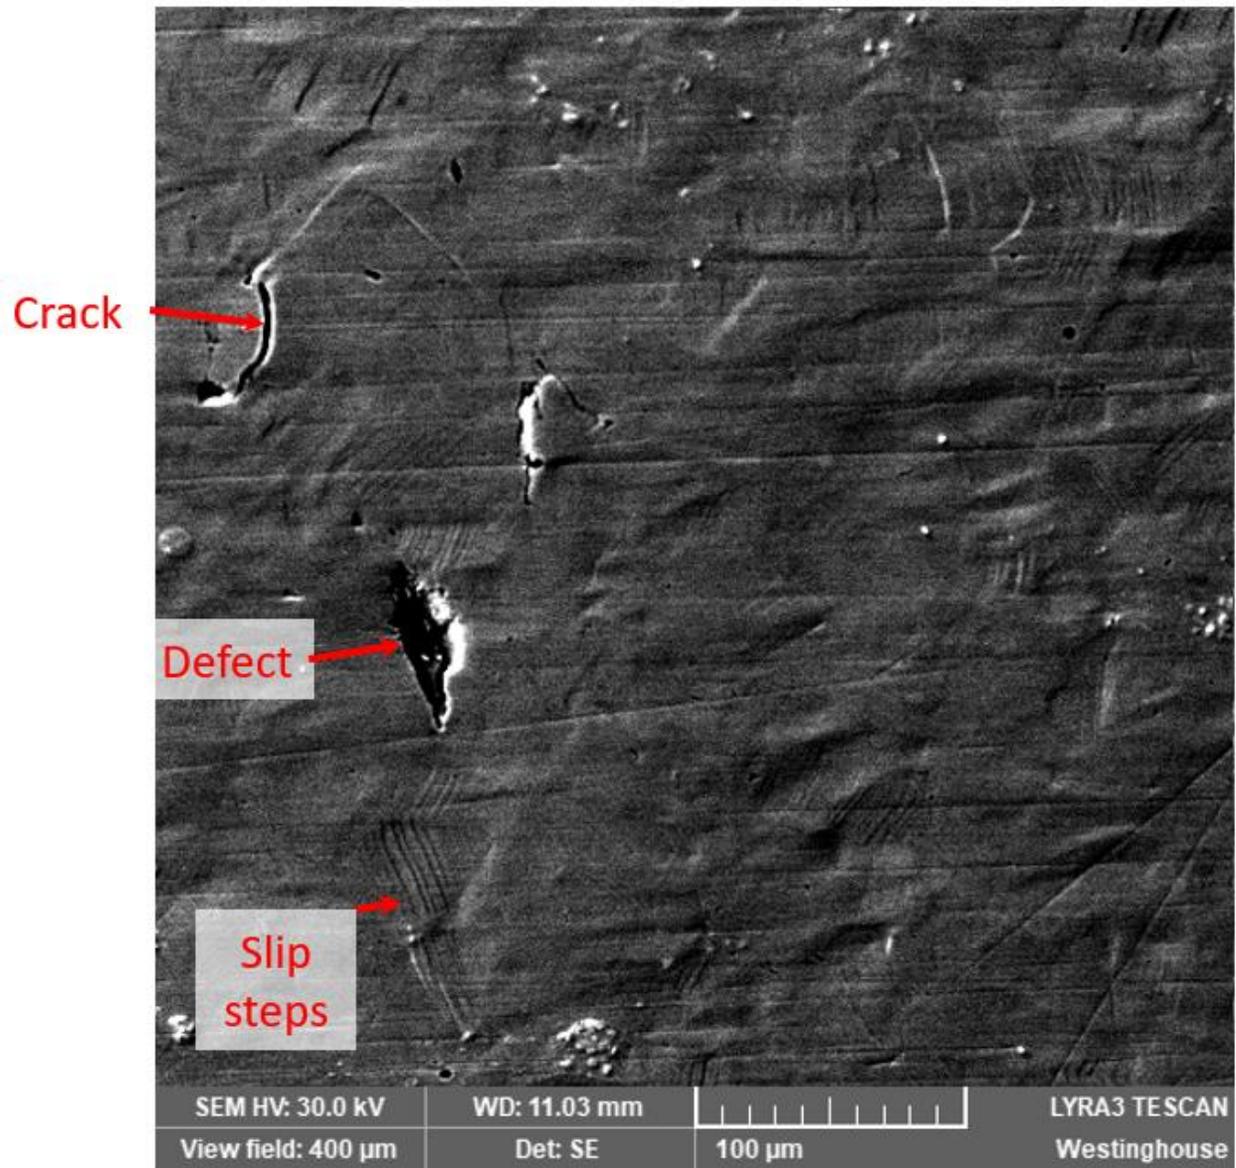
Figure 105. Example image of surface of LPBF sample strained to 4% in argon, with slip steps and cracks visible. The strain direction was horizontal in this image.

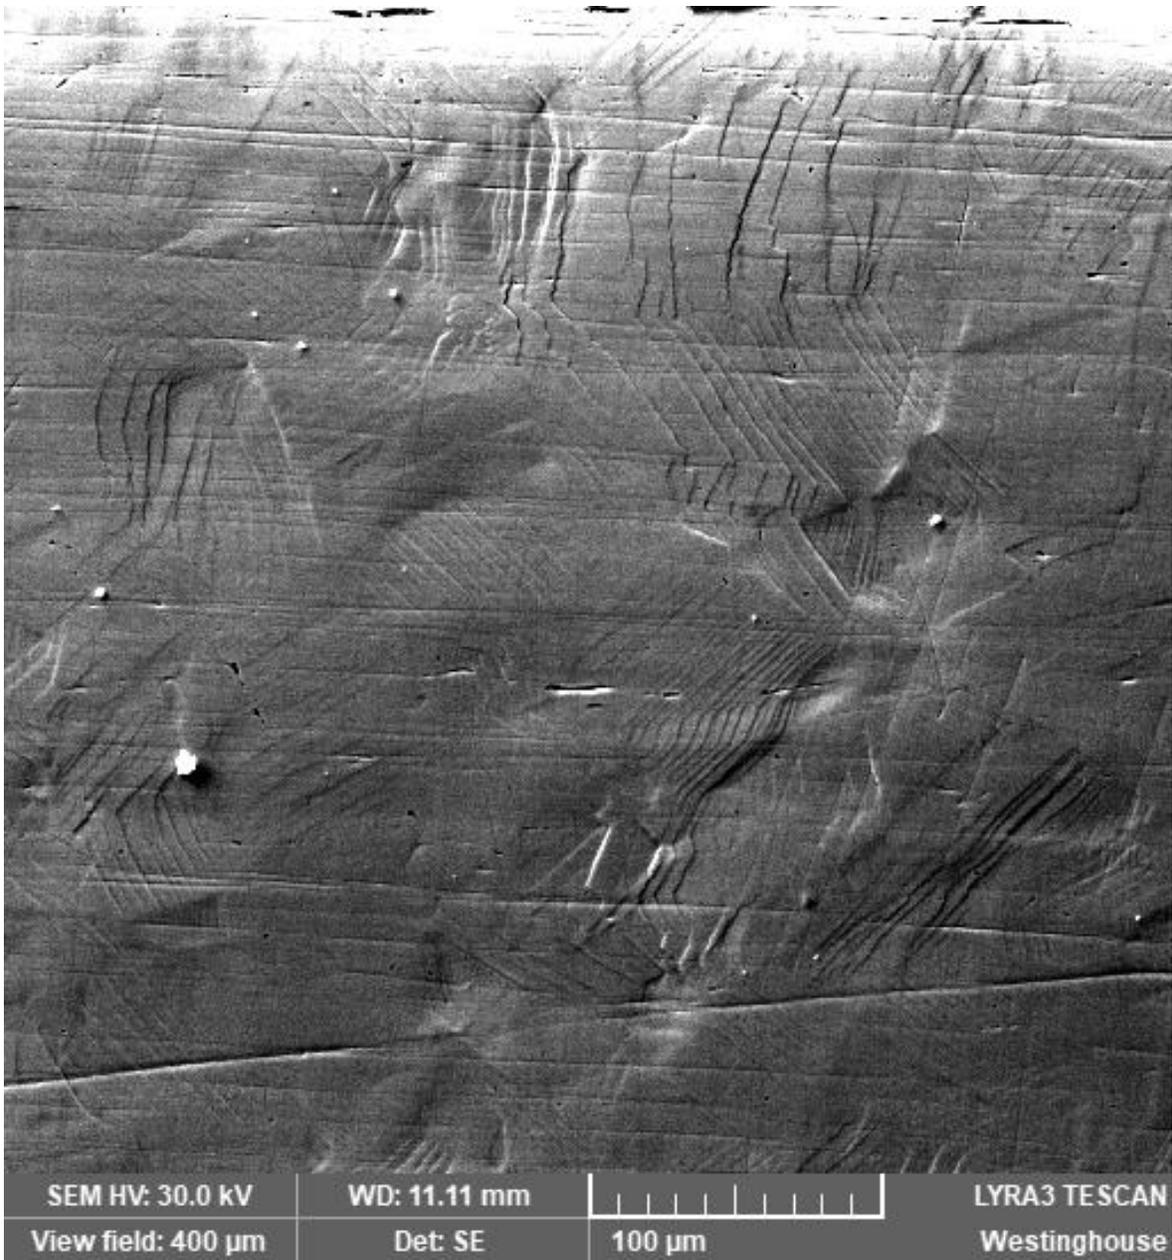
Figure 106. Example image of surface of wrought sample strained to 4% in argon, with slip steps visible. The strain direction was horizontal in this image.

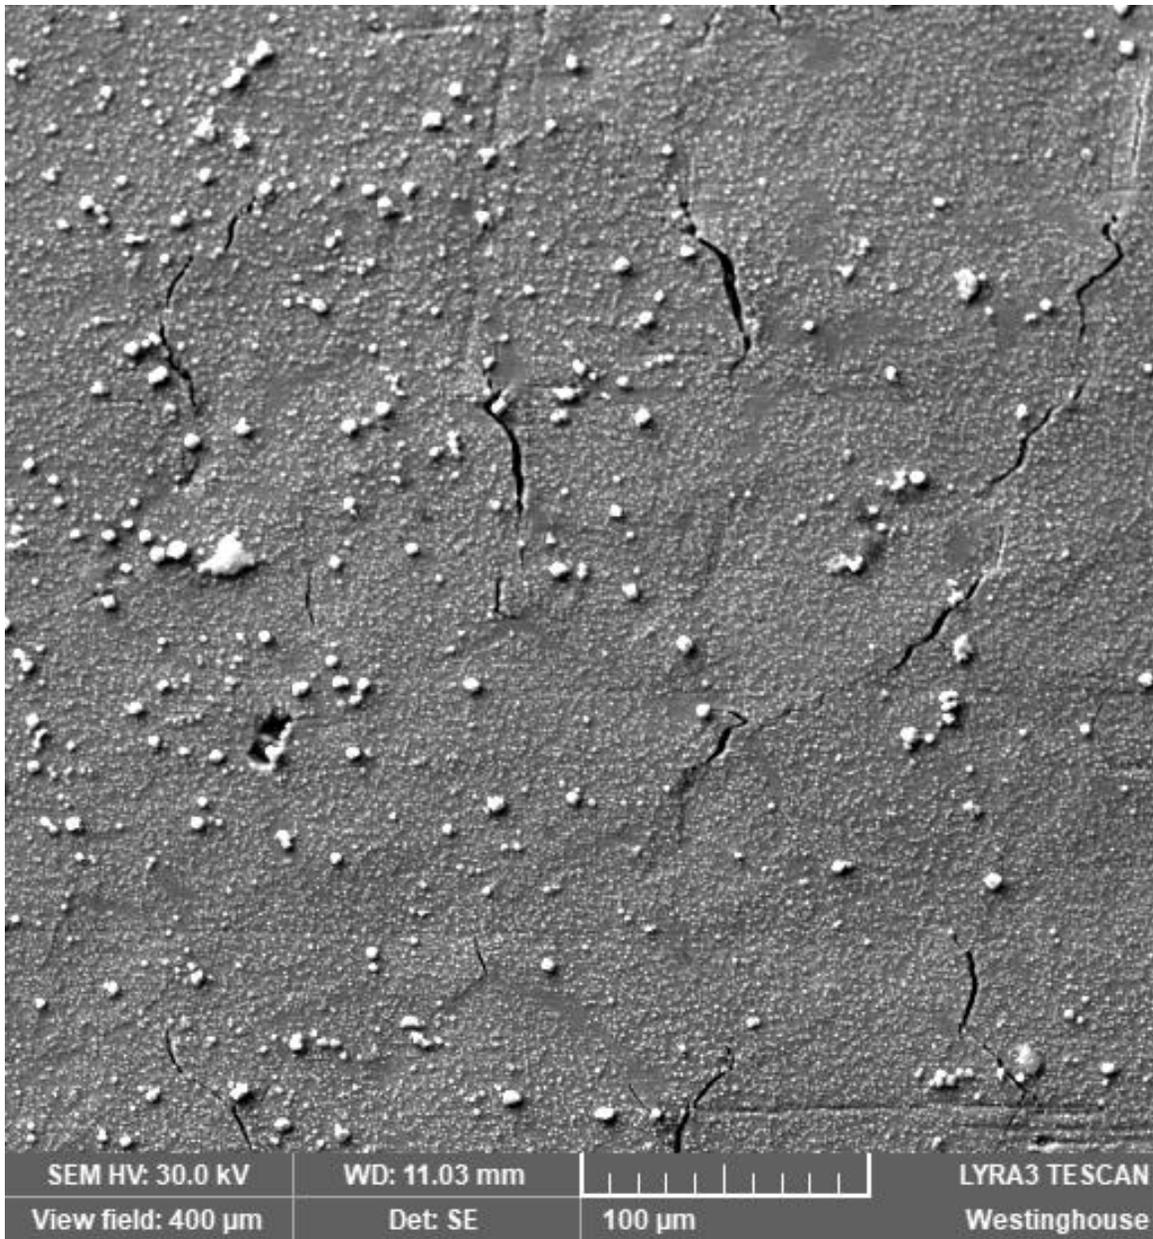
Figure 107. Example image of surface of binder jet sample strained to 4% in simulated PWR water, with hydrothermal oxide deposits decorating the surface and cracking observed. Strain direction was left to right in this image.

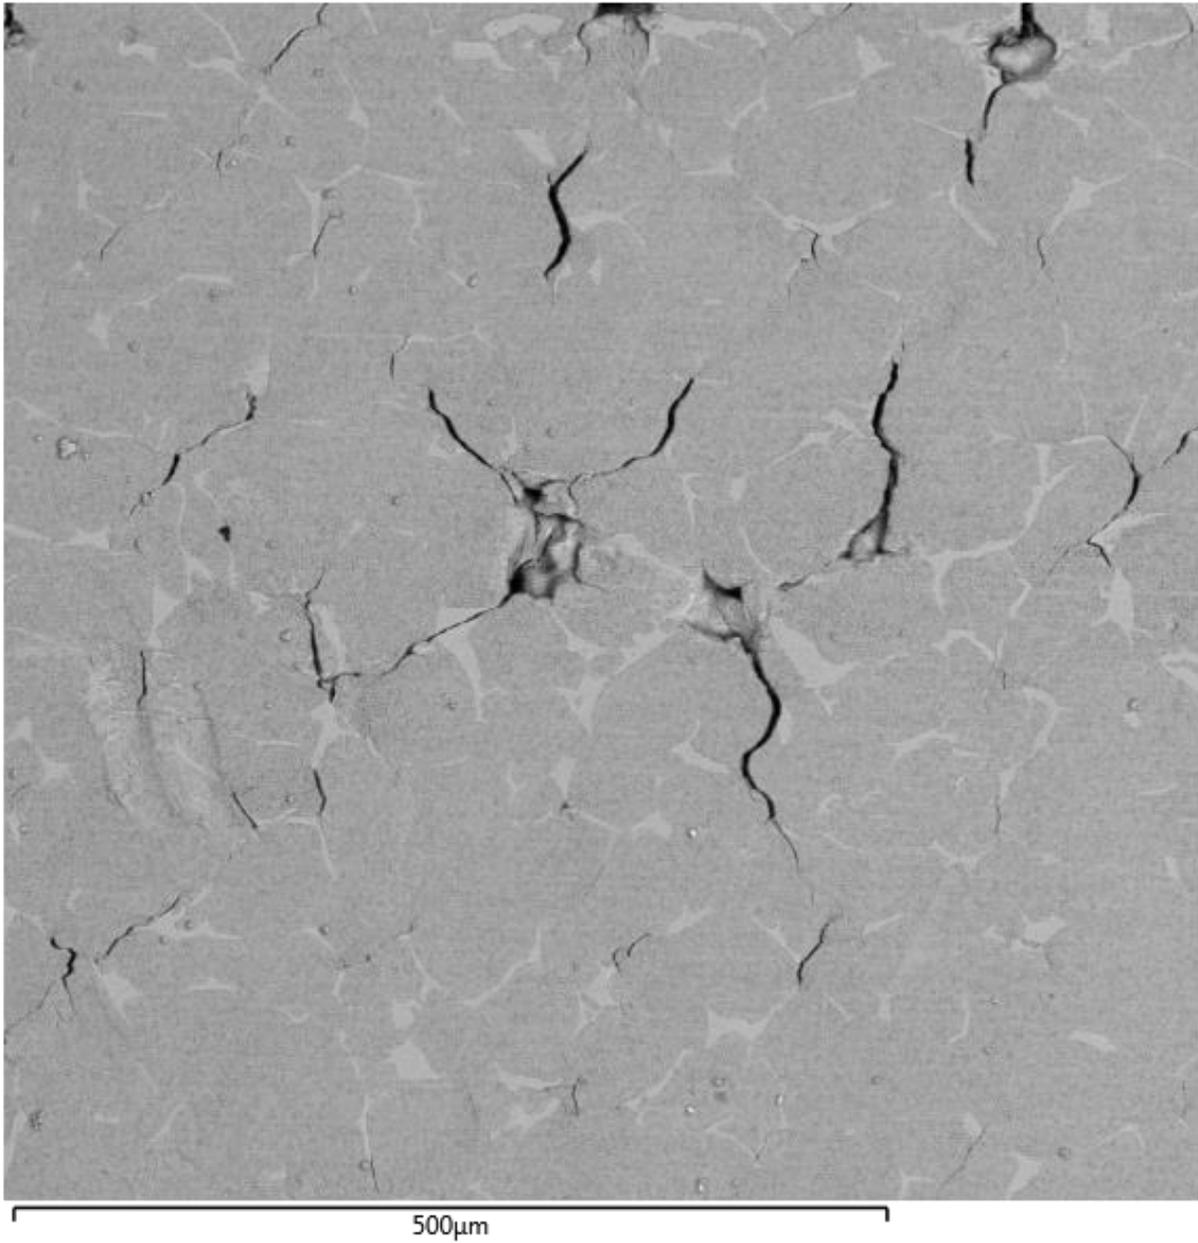
Electron Image 2

Figure 108. SEM image for EDS map of irradiated binder jet sample strained to 4% in simulated PWR water. This image was taken in backscatter mode.

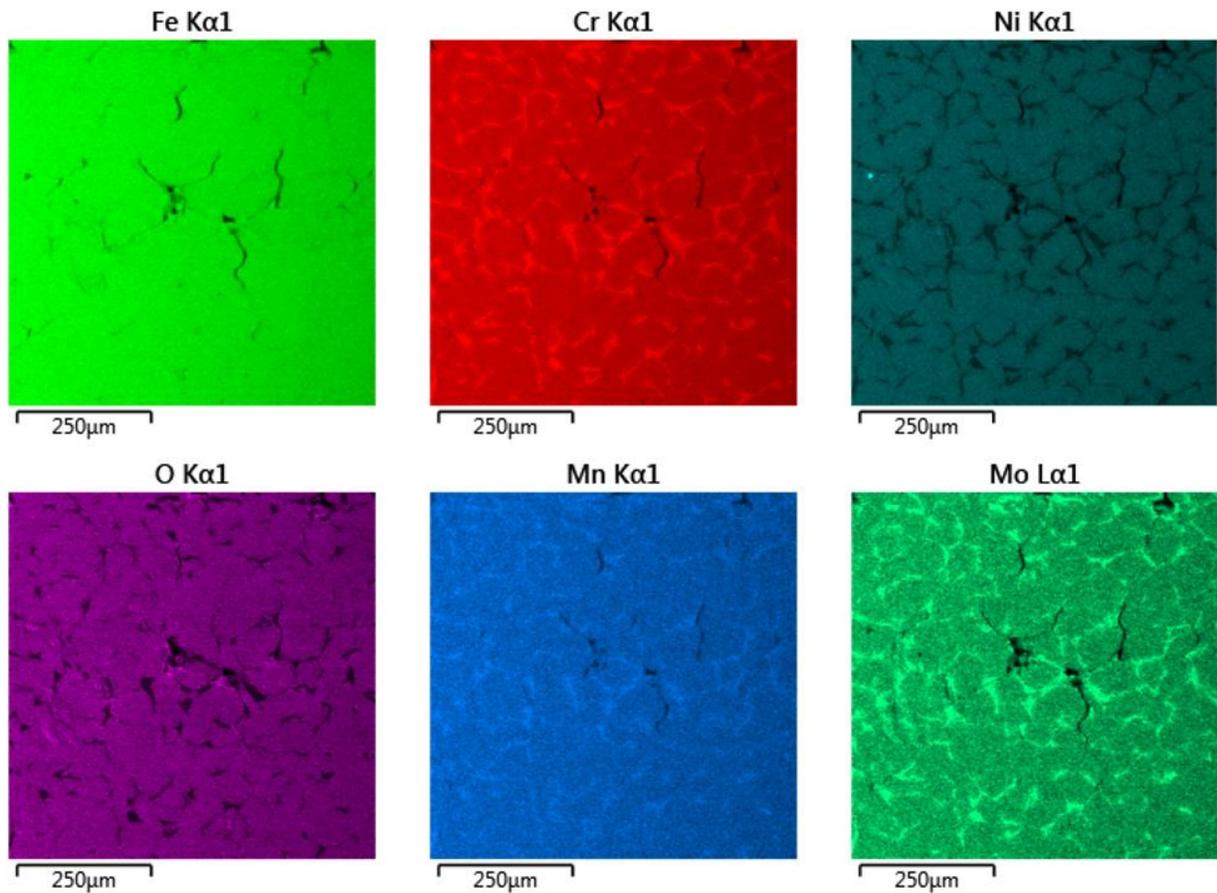
Figure 109. EDS maps of irradiated binder jet sample strained to 4% in simulated PWR water.

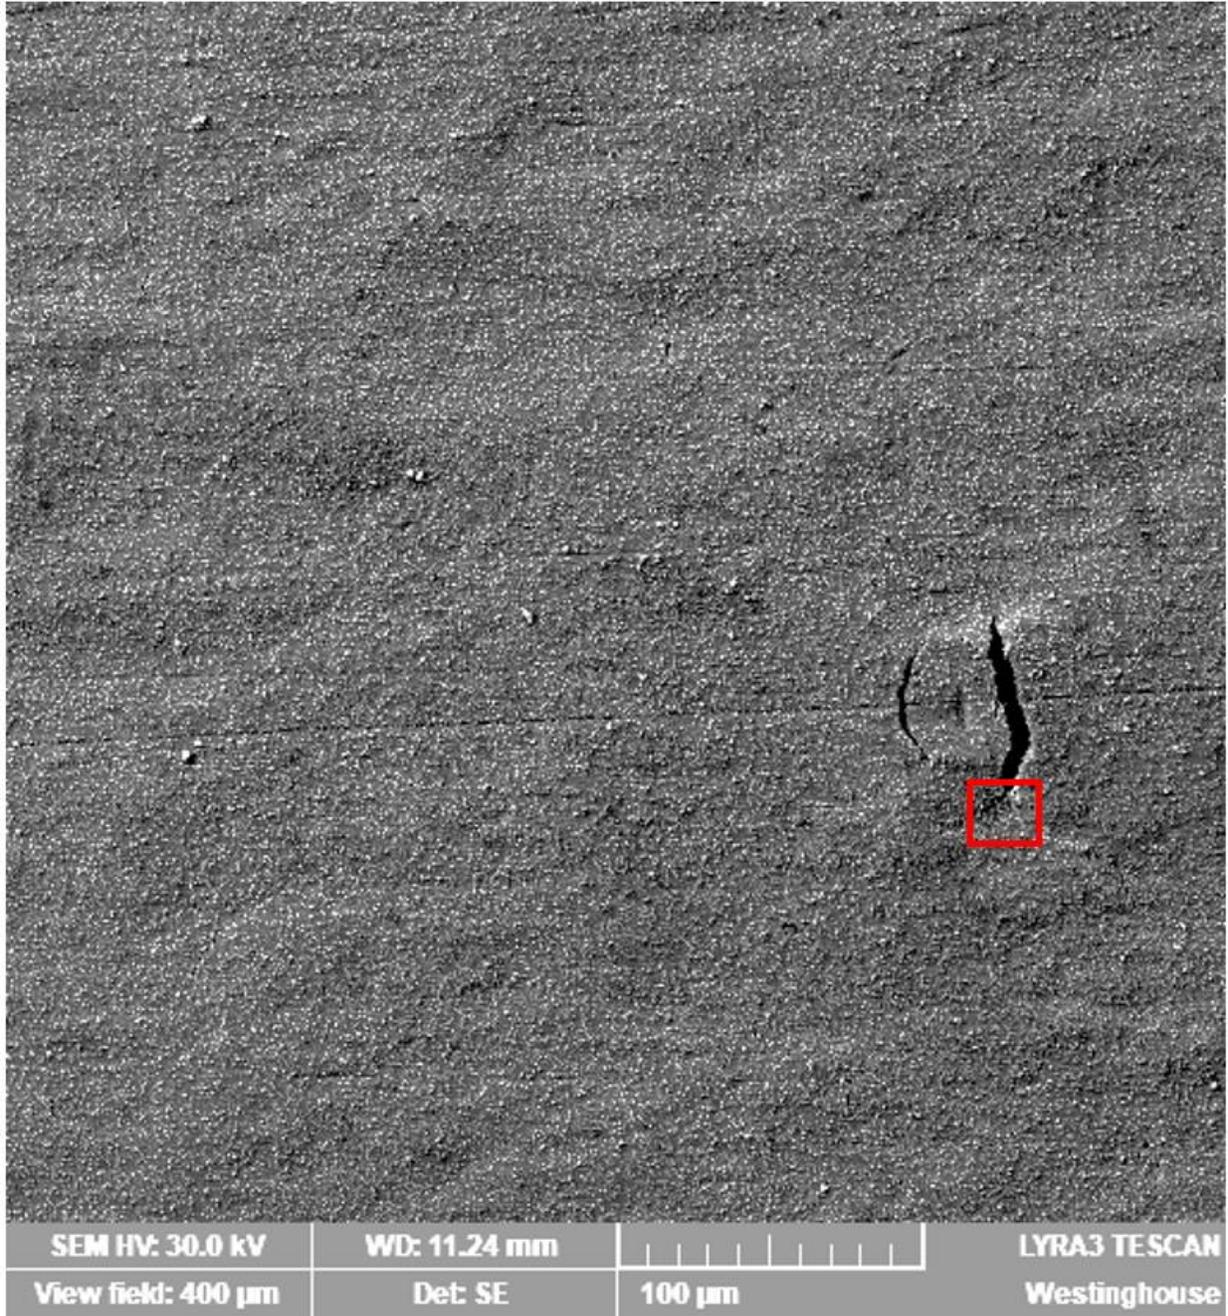
Figure 110. Example image of surface of LPBF sample strained to 4% in simulated PWR water. The red box indicates area of higher magnification shown in Figure 111. Strain direction was left to right in this image.

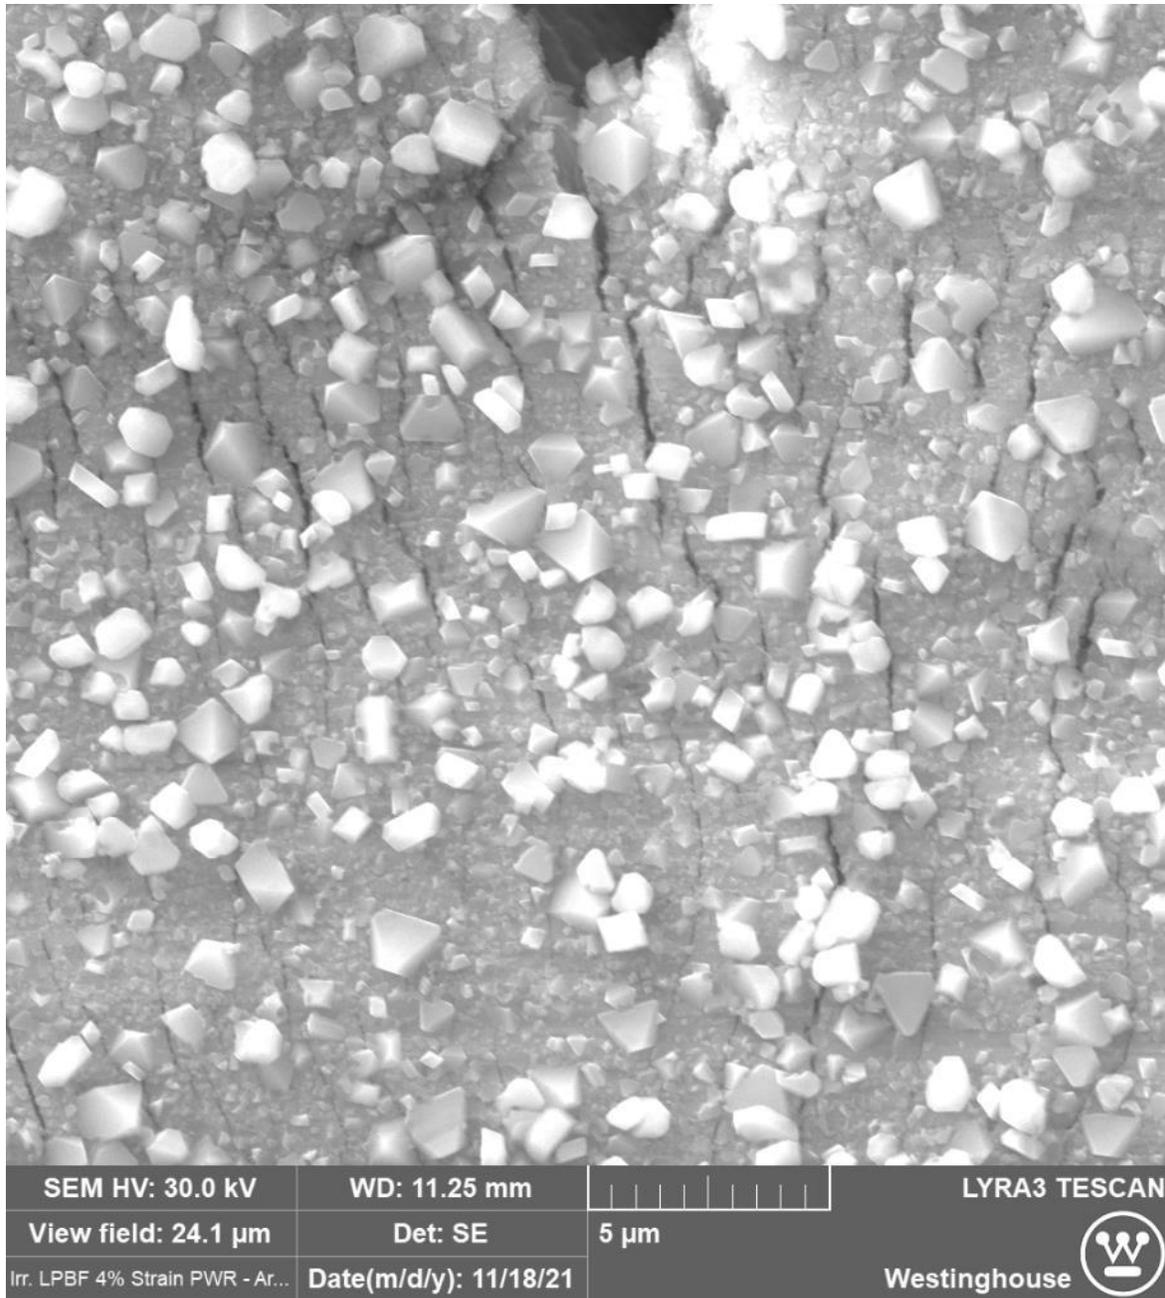
Figure 111. Enlarged image of region indicated in Figure 110 on the surface of LPBF sample strained to 4% in simulated PWR water, showing fine scale cracking emanating from crack tip of larger crack. Strain direction was left to right in this image.

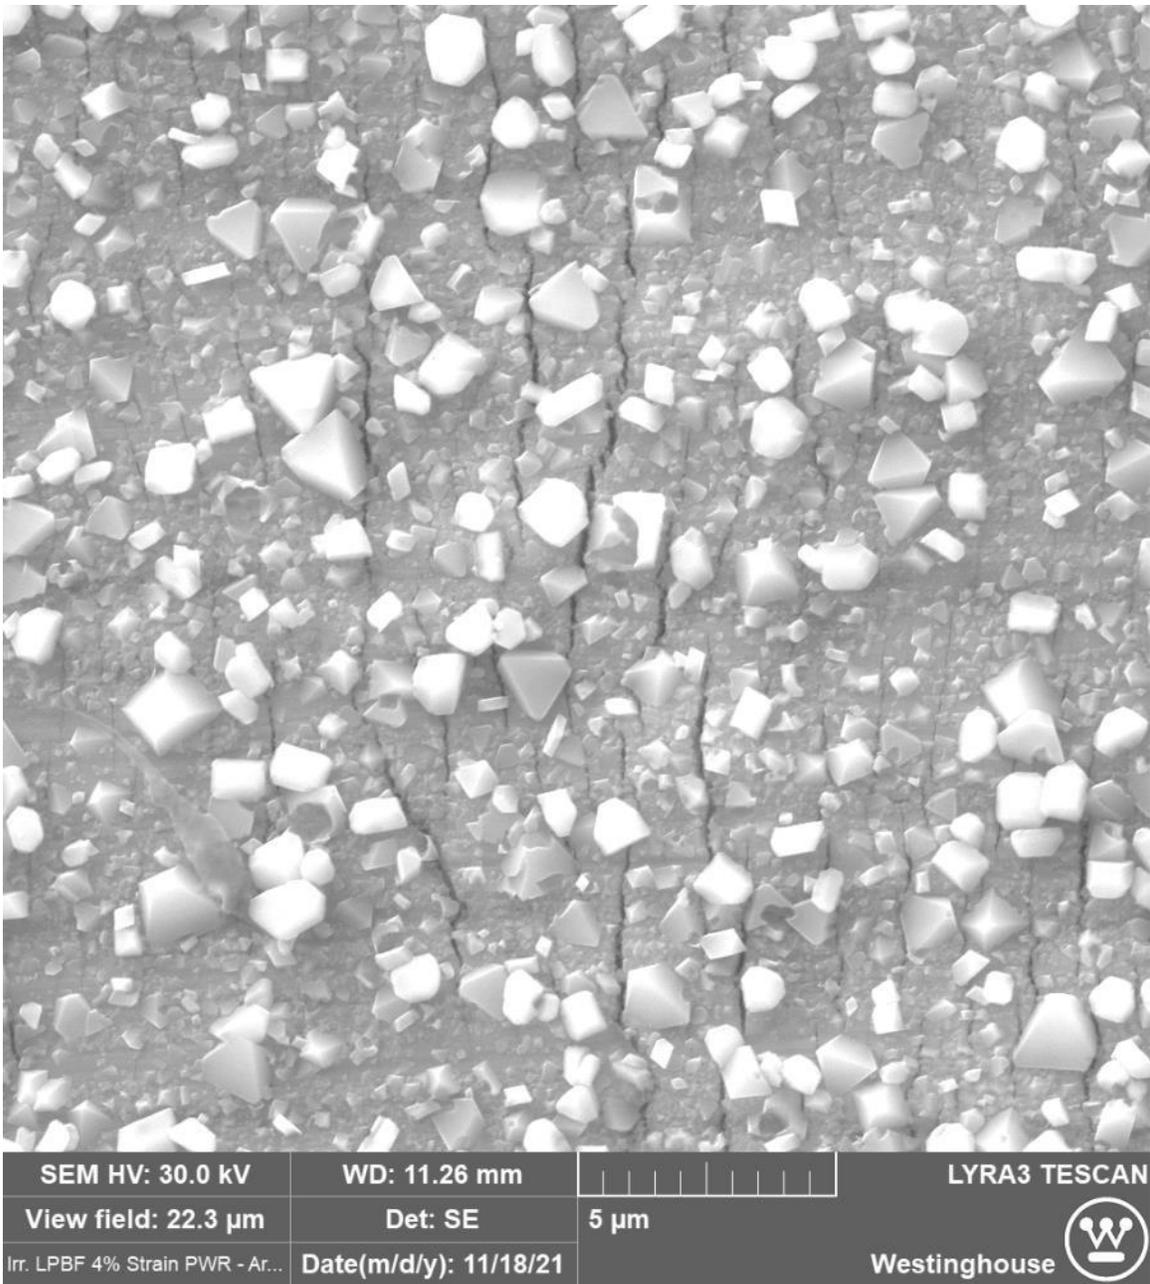
Figure 112. Example image of surface of LPBF sample strained to 4% in simulated PWR water showing isolated fine cracking. This region was far way from any larger cracks such as that visible in Figure 110. Strain direction was left to right in this image.

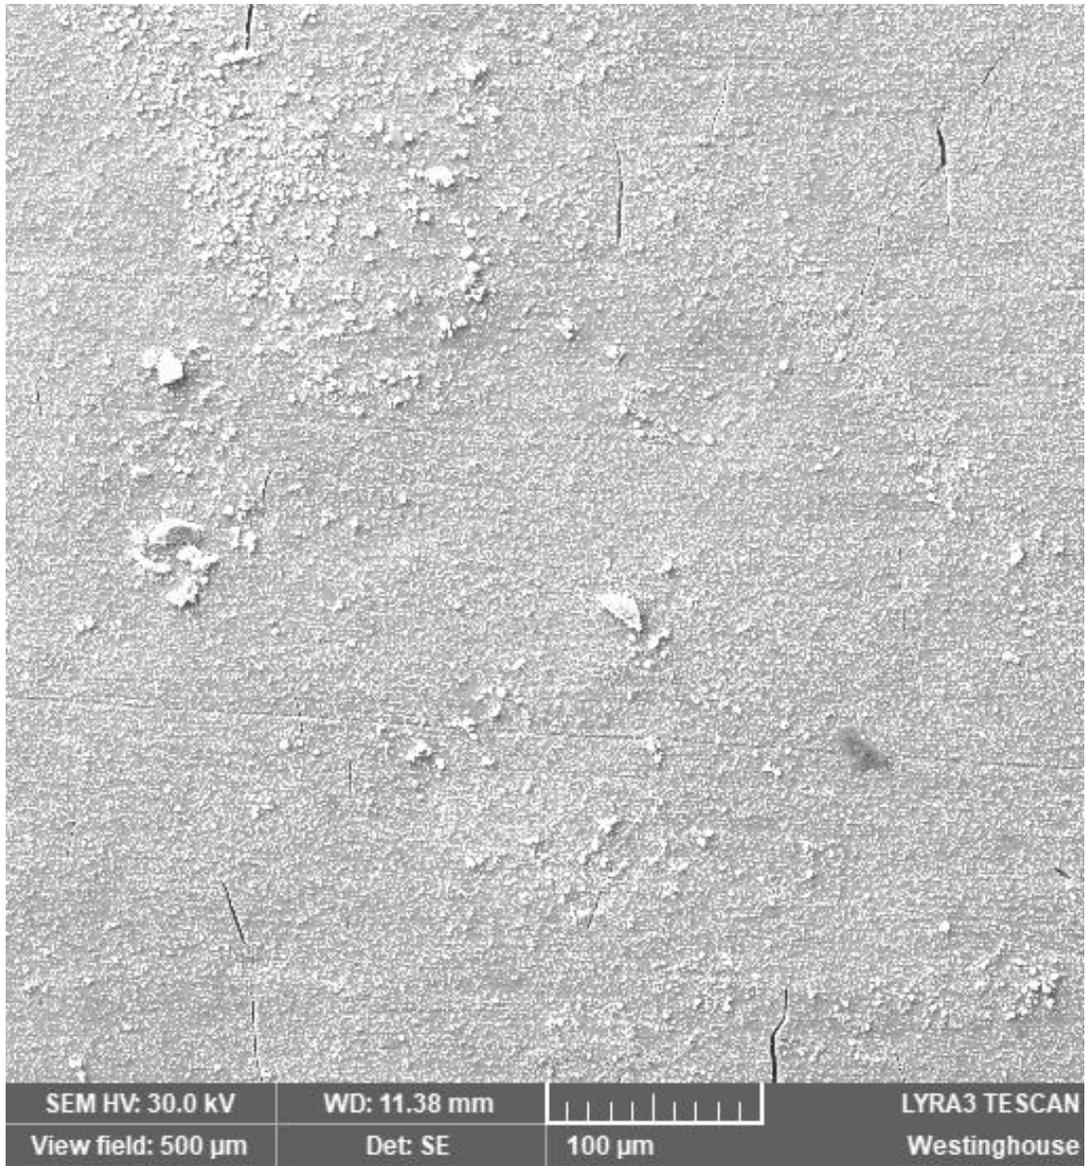
Figure 113. Example image of surface of wrought sample strained to 4% in simulated PWR water. Strain direction was left to right in this image.

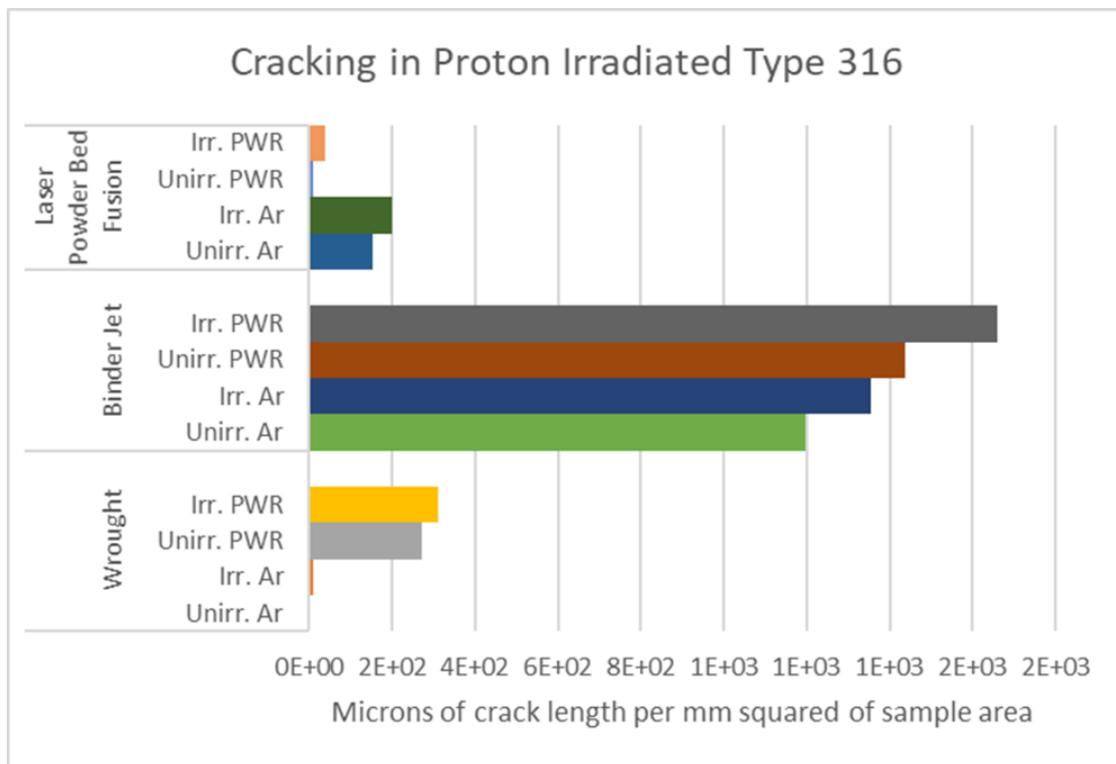
Figure 114. Results of quantitative sample cracking evaluation as a function of environment during straining and material type.

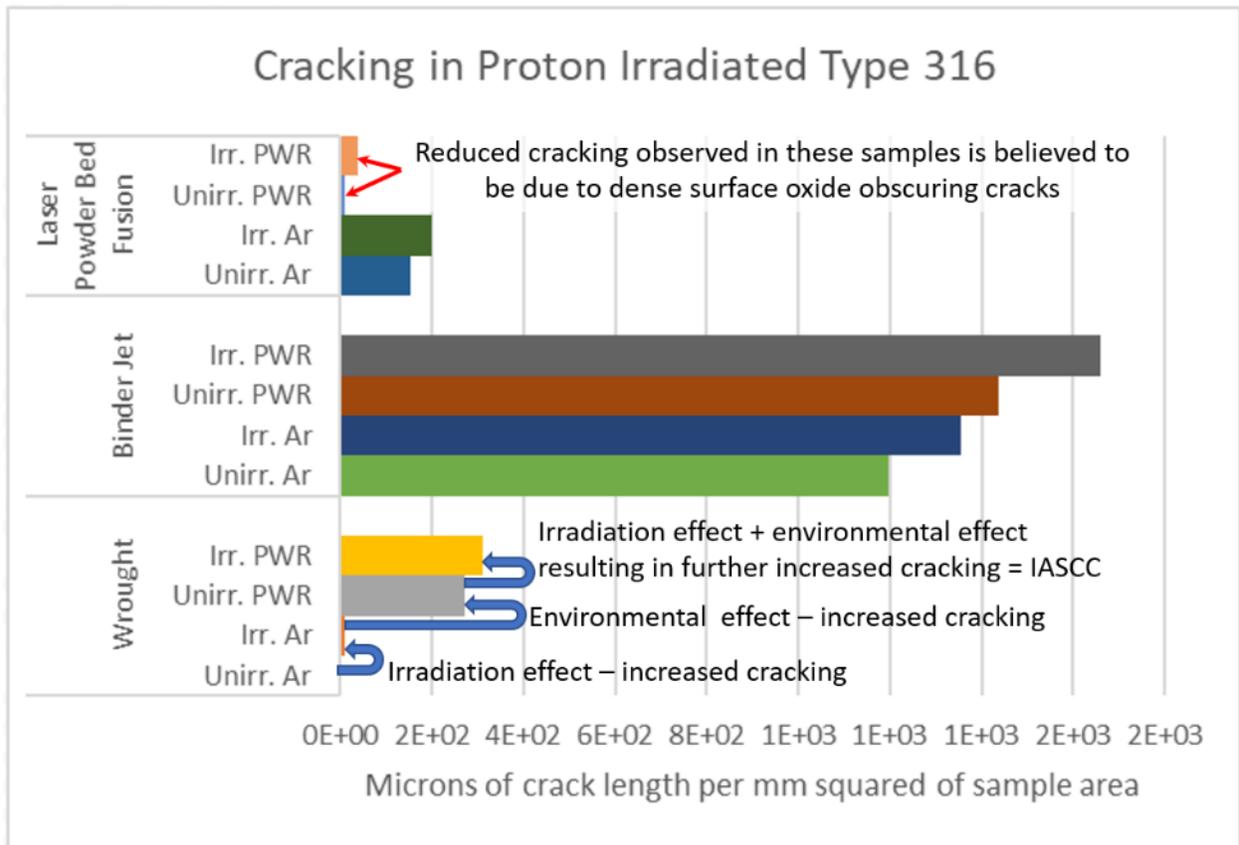
Figure 115. Trends in quantitative cracking evaluation results
