**Interactions between Stress, Environment, and Microstructure causing Irradiation-assisted
Stress Corrosion Cracking in Austenitic Stainless Steels**

Submitted to the Graduate Faculty of
The Swanson School of Engineering in partial fulfillment
of the requirements for the degree of
Doctor of Philosophy

University of Pittsburgh

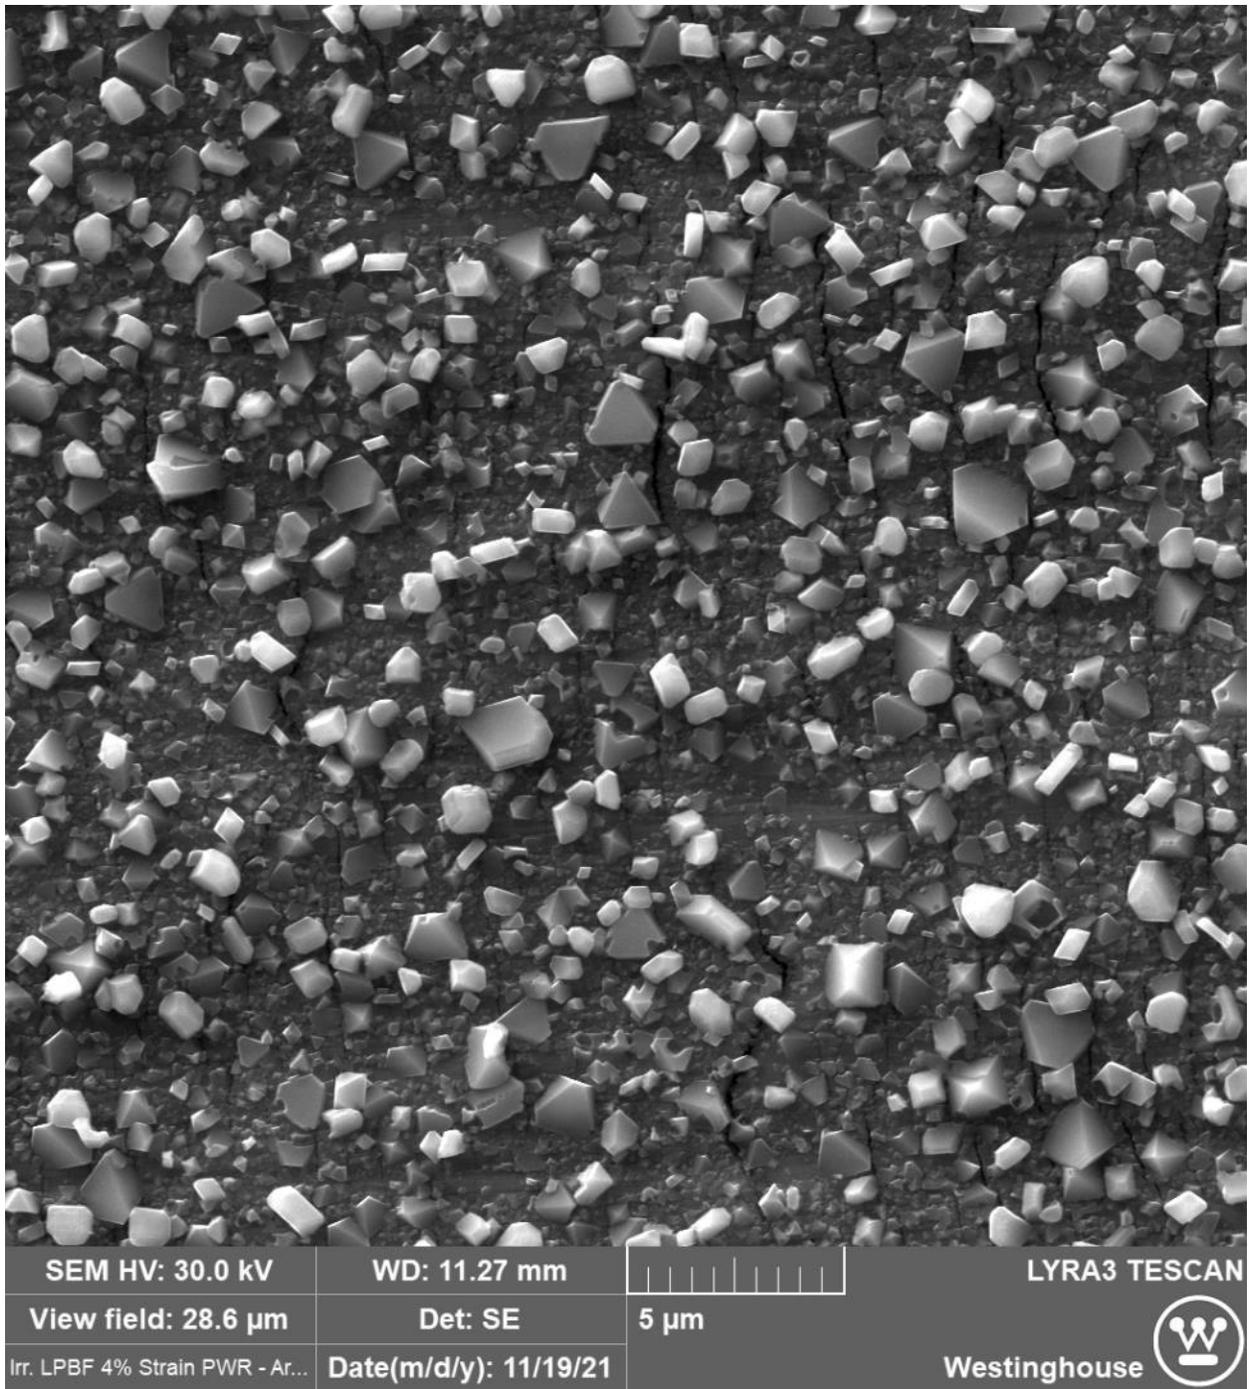
Figure 116. Oxide partially obscuring cracks on LPBF sample strained in PWR water
