Repair Strategies for Corroded Steel Bridge Girder End Regions

Submitted to the Graduate Faculty of the
Swanson School of Engineering in partial fulfillment
of the requirements for the degree of
Doctor of Philosophy

University of Pittsburgh

2022

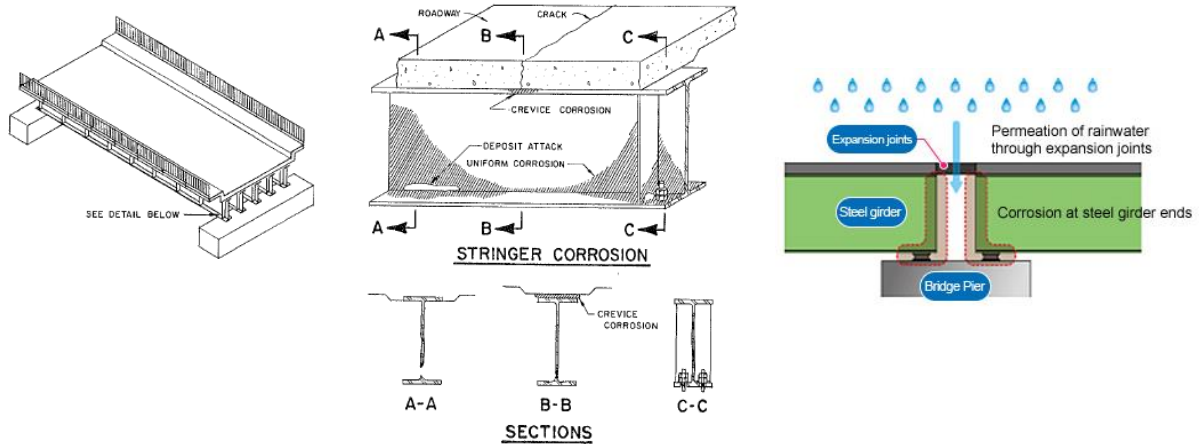
Figure 1 National and International Descriptions of Beam End Corrosion

- a) description of stringer corrosion in NCHRP Report 333 (1990)
- b) description of expansion joint leaking (Hanshin Expressway 2020)

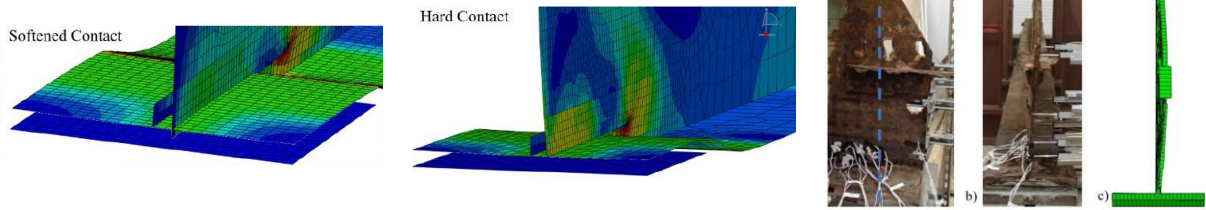
c) softened contact of flange to bearing (note resulting variation of flange stress)

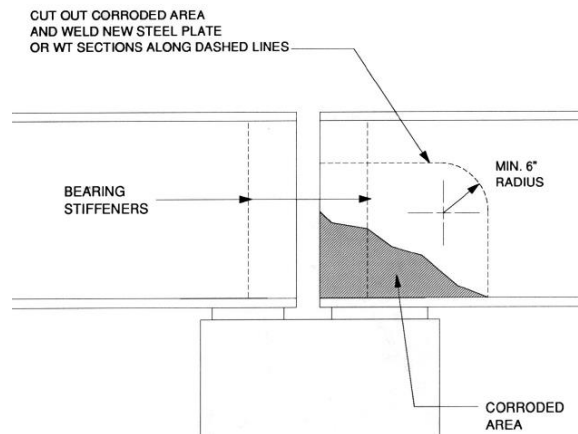
Figure 4 Steel Beam End Repair – Replacing Deteriorated Region

a) schematic representation (PennDOT 2010)

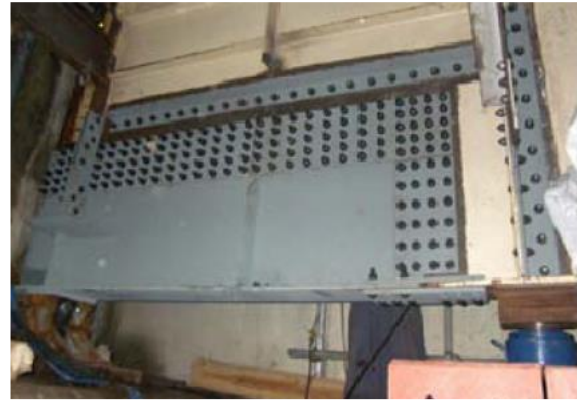
b) bolted beam end replacement
(Wakabayashi et al. 2013)

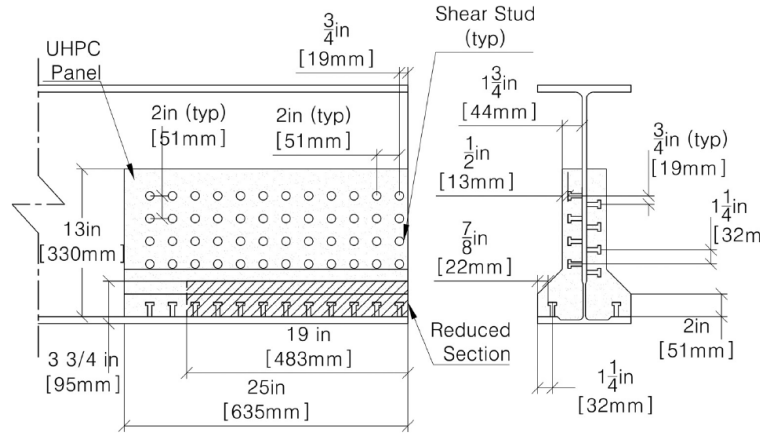
a) headed stud and UHPC layout

As reported in Table 7, The UHPC-repaired girder exhibited the first cracks in the UHPC at a bearing load of 35 kips. Shear cracks appeared at 69 kips and the girder exhibited evidence of web yielding (circled regions in Figures 7c and d) at an applied bearing load of 176 kips when the test was stopped. The observed cracking of the UHPC was relatively well distributed and minor (Figures 7c and d). The inclination of the cracks suggests a compressive strut developed in the UHPC resisting the bearing force. The UHPC prevented the web from buckling and/or crippling.

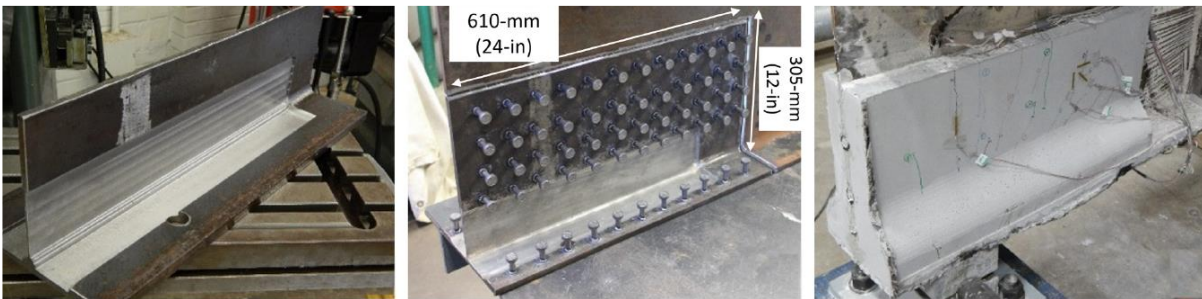
b) progression or repair (note that left image shows only damaged tee region prior to being rewelded into girder)

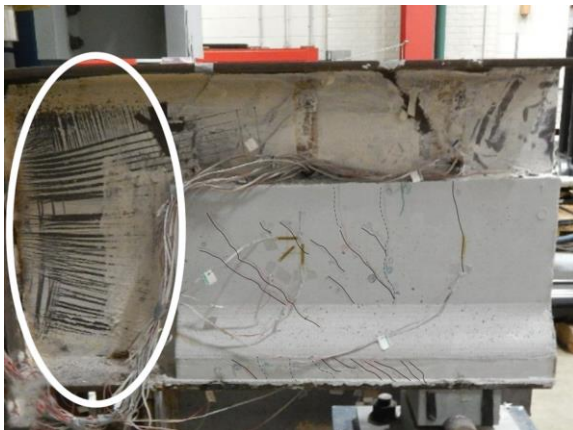
c) cracking of near side of UHPC panel
(end of girder at right)

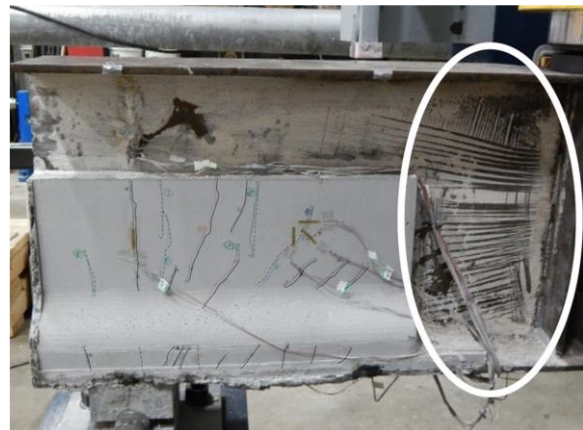
d) cracking of far side of UHPC panel
(end of girder at left)

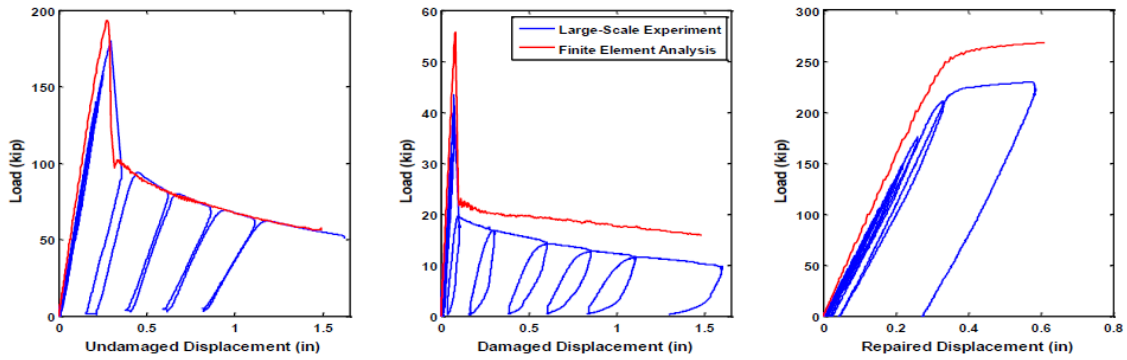
a) FE-predicted (red) and experimental (blue) bearing load versus displacement curves

girders, solid elements to model the UHPC and beam elements were used to model the studs. The models were validated using the experimental results (Figure 8) prior to being extended to investigate other girder repair geometries. Figure 8b shows the test girder models with a composite concrete deck added. The addition of the deck has little effect on girder predictions since behavior was driven by web crippling in each case.

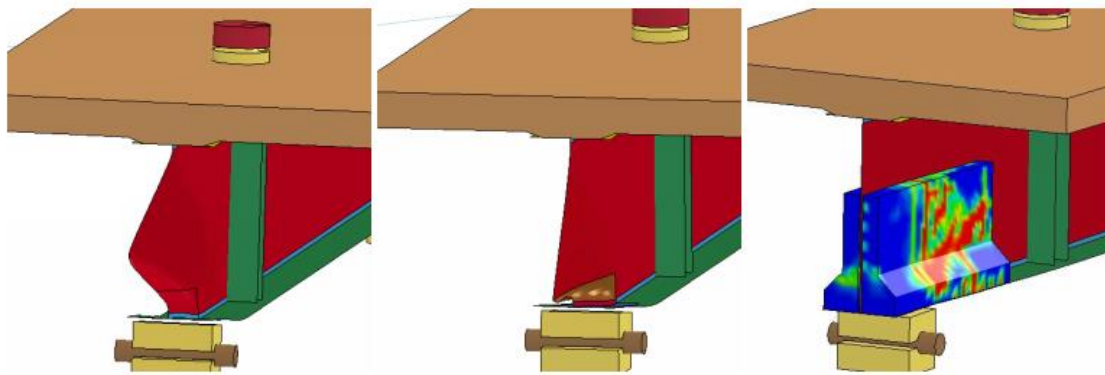
b) FE-predicted failure modes in presence of composite deck

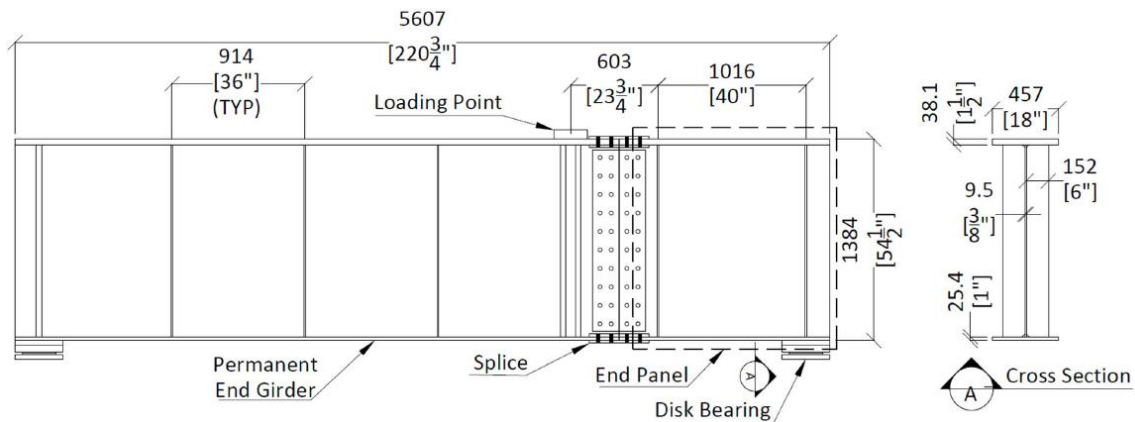
a) test arrangement showing test panel at right of slice and reused girder element to left

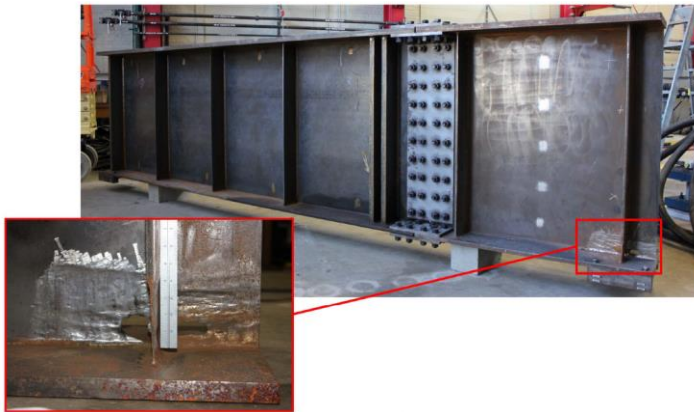
b) specimen with damaged end region

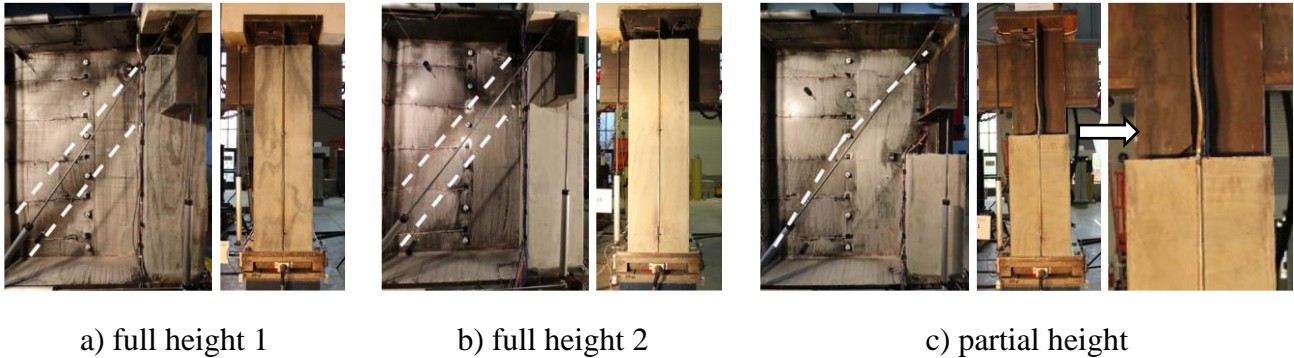
**Figure 11 Failure Modes of UHPC Encased Girders Reported by McMullen and Zaghi (2020)**

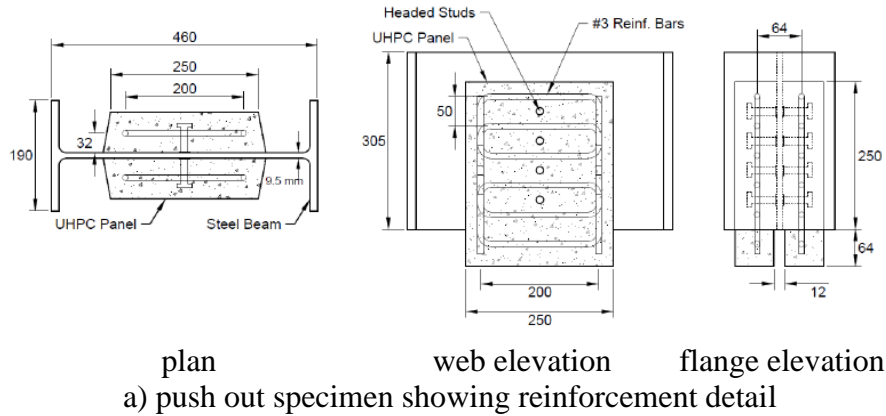
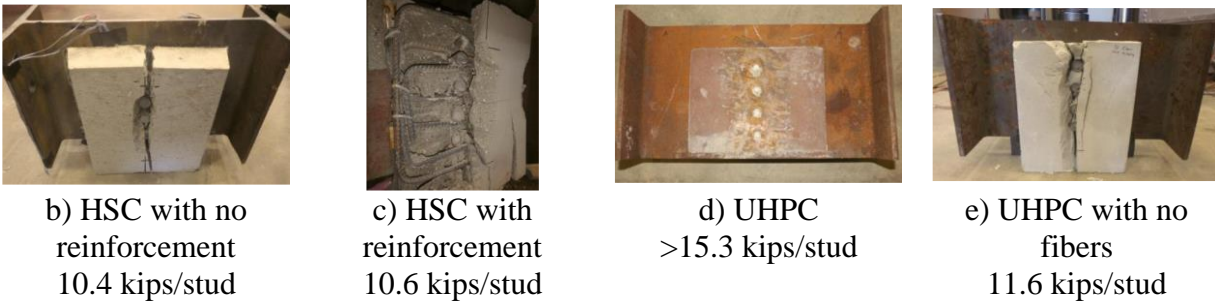
Figure 15 Push Out Tests of HSC and UHPC (Kruszewski 2018)

It is important to note that the test arrangement does not comply with AASHTO LRFD §6.10.10.1 requirements for stud pitch (greater than 6 stud diameters = 3 in.) or top cover (greater than 2 in.). Provines et al. propose that the minimum pitch can be safely reduced to 4 stud diameters. The 2 in. top cover requirement, on the other hand, is presumed to address durability (corrosion) rather than stud capacity. For interior exposure, ANSI/AISC 360-16 requires only 0.5 in. top cover. Nonetheless, reduced cover with no additional reinforcement may be expected to split, especially when a cluster of studs is called upon to transfer large loads in a small area.

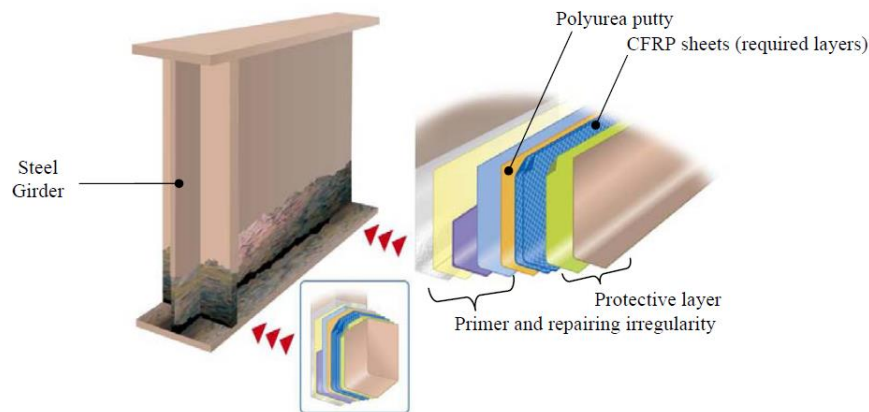
Figure 18 Schematic Representation of CFRP Repair of Corroded Beam End (Wakabayashi et al. 2013)

In the only known study of its kind, Wakabayashi et al. (2013) proposed and demonstrated a CFRP repair of corroded beam ends. The proposed system is shown schematically in Figure 18.

Two repair scenarios were demonstrated. The first, shown in Figure 18 involved restoring the bearing capacity of corroded bearing stiffeners. The design (uncorroded) capacity of the specimen was 431 kips. Artificially induced (machined) corrosion reduced this to 377 kips. The CFRP repair shown in Figure 19 restored the capacity to 448 kips.

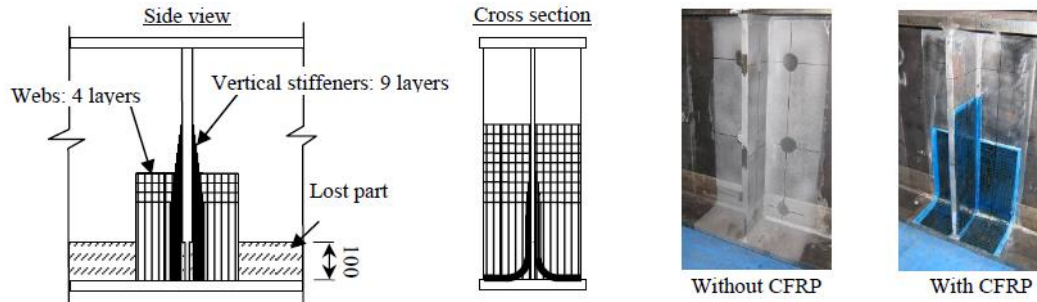
Figure 19 CFRP Repair of Corroded Bearing Stiffener (Wakabayashi et al. 2013)

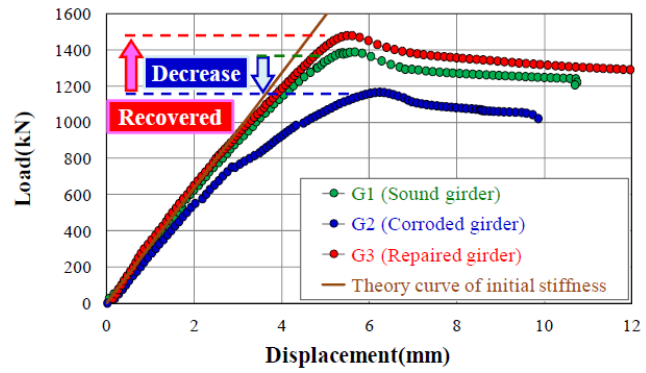
e) load displacement relationships

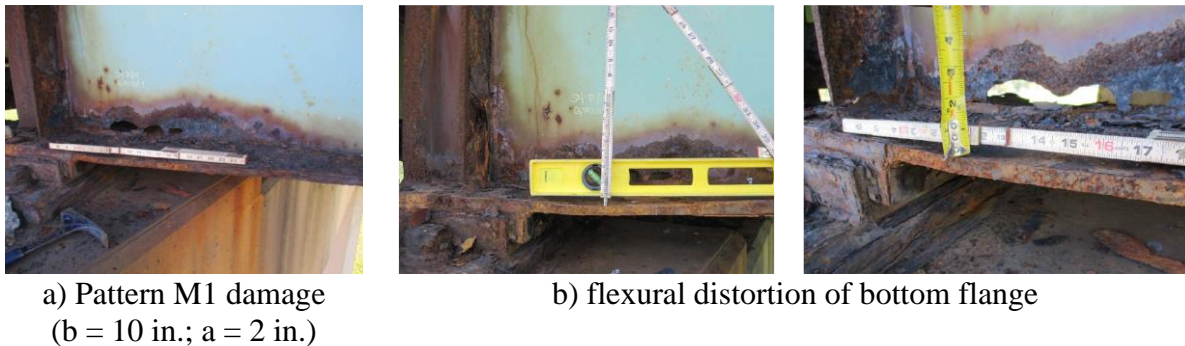
Figure 23 Flexural Distortion of Flange Accompanying Significant Pattern M1 Damage (Bridge J)

remains. Bridge J, shown in Figure 23, has bearing stiffeners. In this case, the loss of web section has resulted in an obvious flexural distortion of the flange.

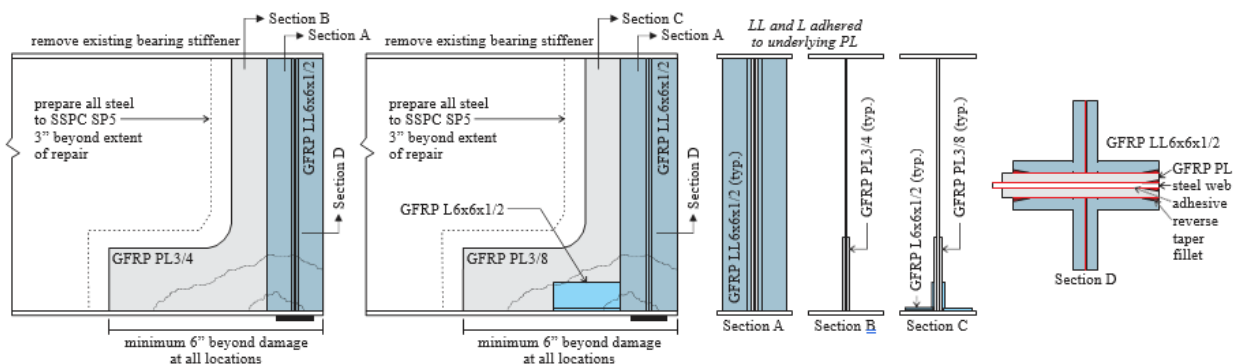
Figure 28 Adhesive Bonded FRP Repairs for Plate Girders

Refining this approach for the archetypal damage assumed in Case I could result in a thinner web plate being used over the damaged region having partial section loss. The region of total web loss would be reinforced with an additional angle as shown in Figure 28, resulting in more than the full $\frac{3}{4}$ - in. GFRP thickness at this location. The entire GFRP assembly would be fabricated in the shop and adhesive bonded only to the steel on site. Care needs to be taken with the fillet detail; a reverse taper fillet should be used at all joints if possible

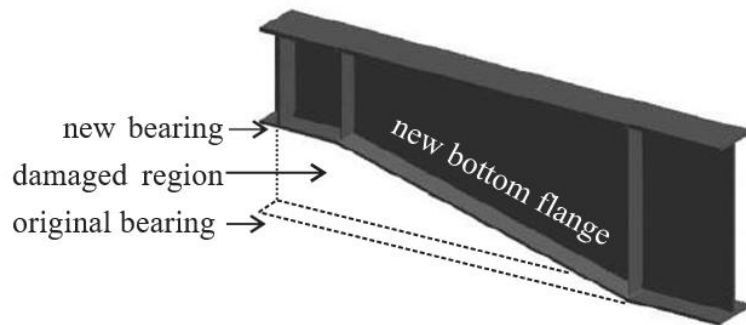
Figure 31 Dapped Plate Girders (based on Fry et al. 2005)

beam end replacement that might permit a simpler construction process is to provide a dapped girder in lieu of a full depth girder replacement. In some cases, such a repair might be feasibly made with the girder in place and only jacked and lifted to transfer load from the deteriorated bearing region to the newly built dapped end. Figure 31 shows a schematic representation of dapped steel girders. Dapped steel plate girders were studied by the Texas DOT (Fry et al. 2005). Due to their reduced depth, tension fields can be better developed, in many cases improving the shear capacity of the dapped end.

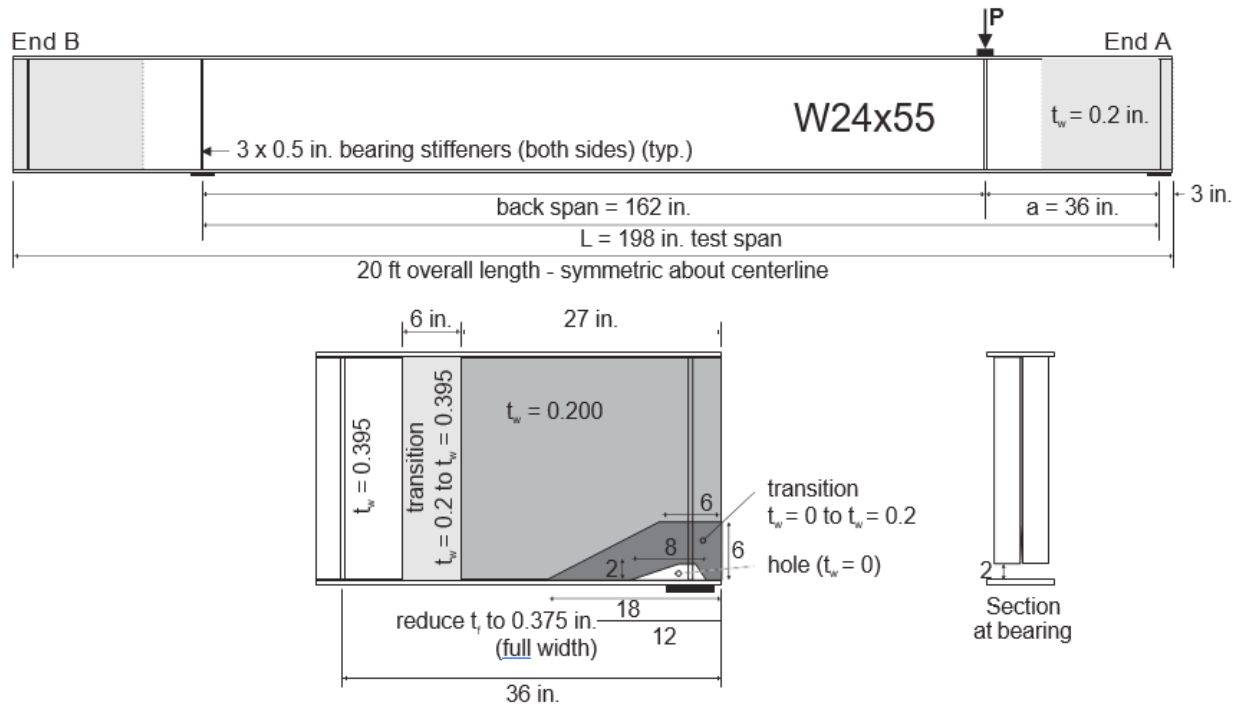
Figure 32 Proposed W24x55 Specimen

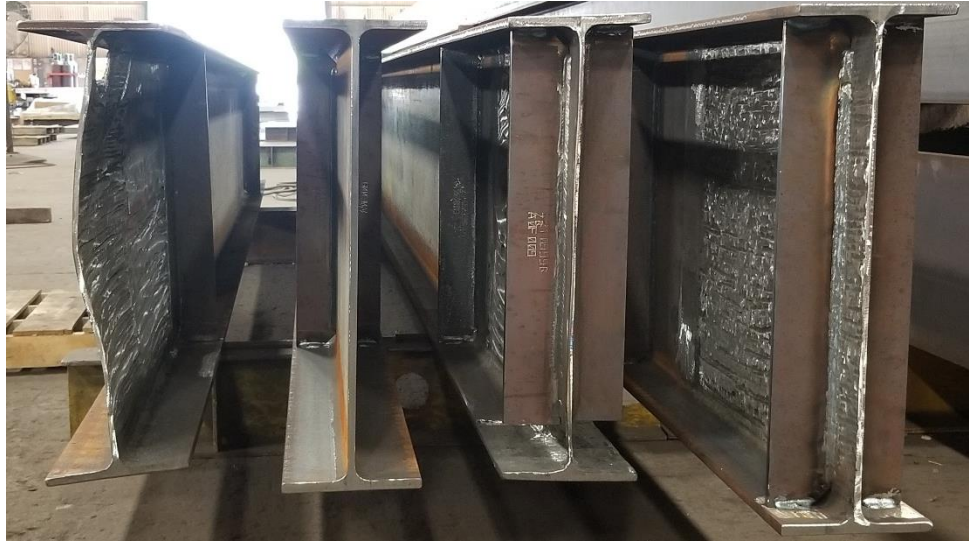
a) Girder 8; fabricated without a stiffener (not tested in this study) b) W24 x 55 prior to machining c) Girder 2 d) Girder 1

The web distortion was measured as the deviation of the web from straight at the mid-height of each girder end at the location of the bearing (i.e., 3 in. from the girder end). The values are reported as a_{max} in Table 14.

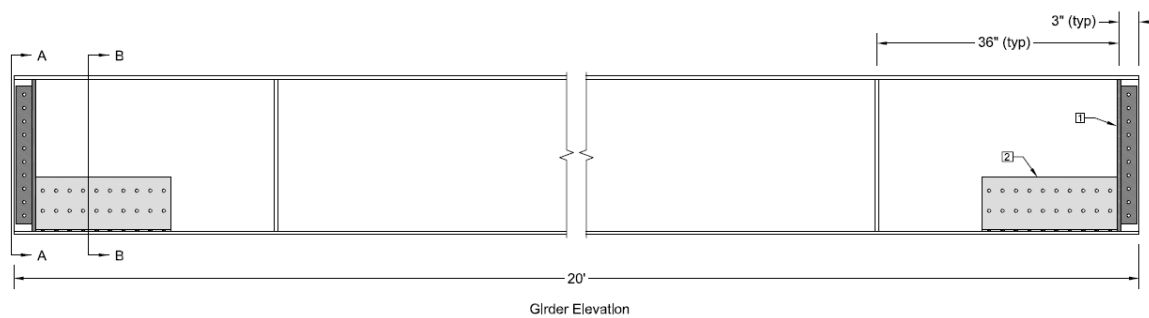
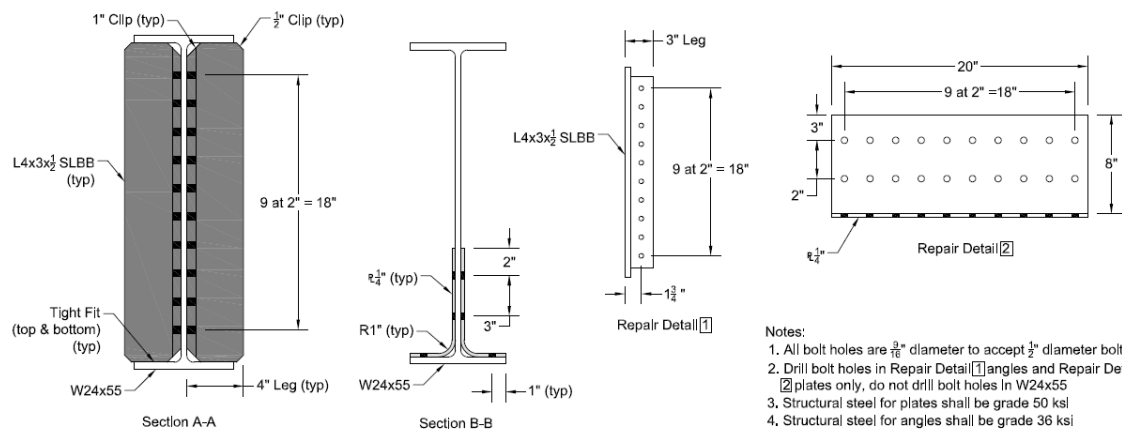
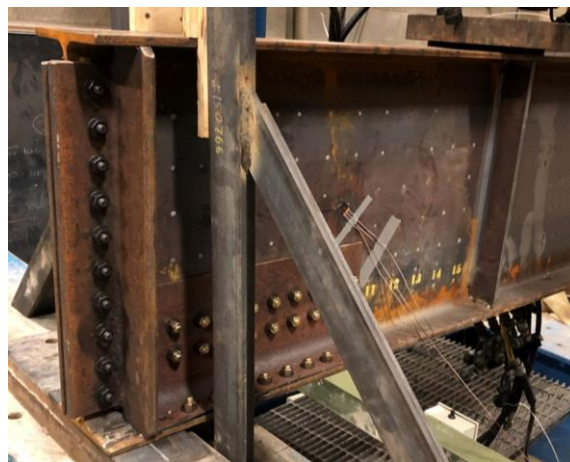
Figure 34 Bolted Steel Repair Detail for Girder 3

Girder 3 was a ‘control’ specimen. The bolted steel repair was intended to match as closely as possible to current practice. The bolted steel repair of Girder 3 (Figure 34) is essentially the same as that used to repair the archetypical damaged girder from Bridge D (see Section 2.3). The bolted steel repair design was based on industry standards for steel retrofits. The repair consists of replacing the damaged 3 x 0.5 in. bearing stiffeners with 3 x 3 x 1/2 SLBB angles. An additional bent 0.25 in. plate was used along both sides of the lower web-to-flange interface. 9/16 in. diameter holes were drilled into the web and flanges to accommodate the 0.5 in. diameter Grade 8 bolts that were used. All bolts were torqued to 110 ft-lbs which provides a pretension of 13.2 kips. The repair components were fabricated by the same fabricator who provided the beams. The material properties of the repair components was not determined.

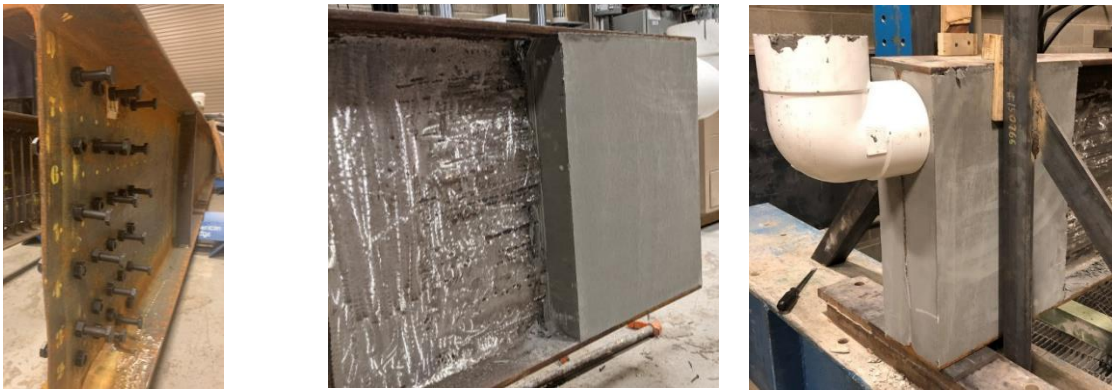
Figure 35 UHPC Repair Detail for Girder 4

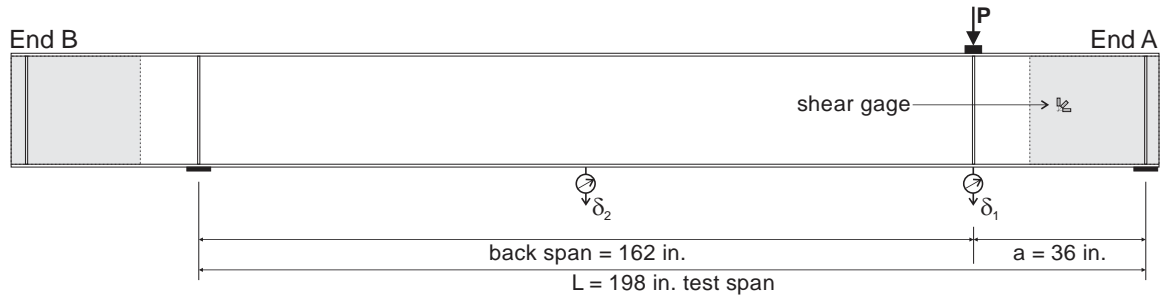
a) overall span instrumentation

A triaxial electrical resistance strain gage (i.e., shear gage) was installed in the middle of the 36 in. shear span at the girder mid-depth (neutral axis). Using a triaxial gage, the oriented shears, maximum shear strain and orientation of the maximum strain were obtained as shown in Figure 39c. All strains were recorded with a precision of 1 microstrain.

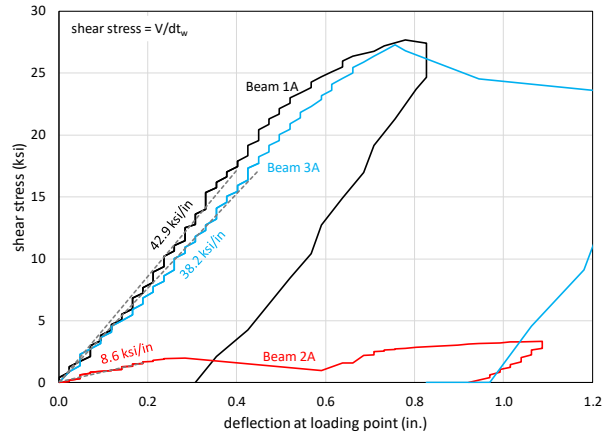
a) Girders 1A, 2A and 3A (bolted steel)

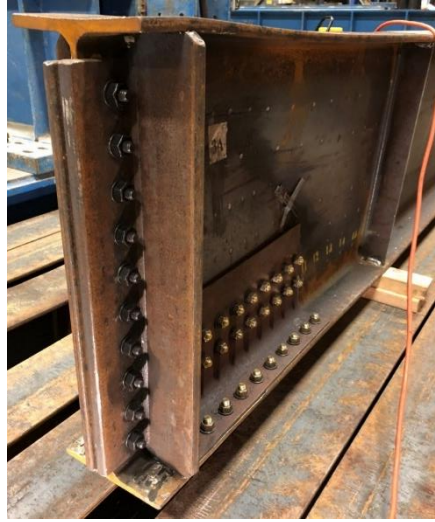
a) bearing region following testing

Girder 3A demonstrated a conventional bolted steel repair. The girder capacity was effectively restored to approximately that of 1A: $V = 197$ kips ($v = 27.3$ ksi). 3A exhibited very clear web buckling in the unstrengthened region of shear span as shown in Figure 44. Following testing, the bolted stiffeners were removed (Figure 44d); no web distortion or collapse was observed although a few of the bolt holes appear to show evidence of bolt-bearing distortion (“ploughing”).

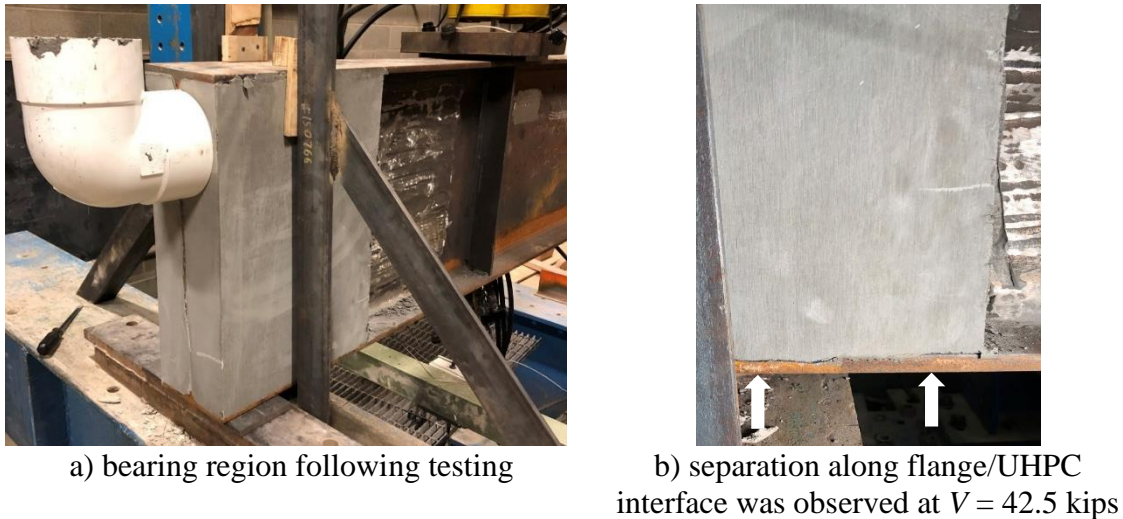
Figure 45 Girder 4A Following Testing

did not appear to vary through the remainder of the test. The presence of the crack at relatively low (service) load levels indicates the potential for crevice corrosion at these interfaces. The assumed strains at which this crack appeared suggests that it would not be mitigated by providing shear connectors along the flange.

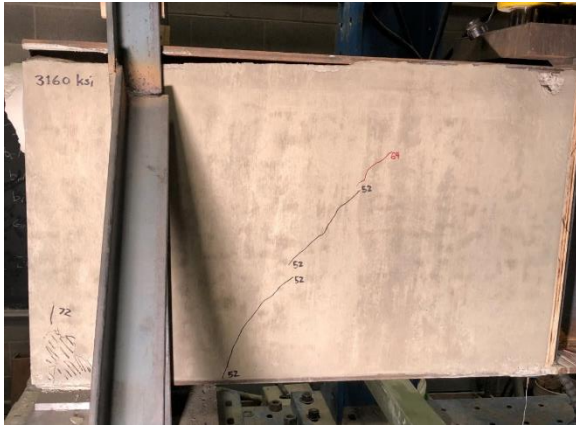
a) initial cracking at $V = 42.6$ kips;
crack angle $\approx 45^\circ$

Figure 46d shows the web distortion inside the concrete. This distortion is that around which the concrete was placed; the distortion was unaffected during testing. Thus, the confined concrete effectively restrained the damaged web. Shear strain data (Figure 41) indicates that this web did not resist as great a proportion of the load as in other specimens with load sharing between the concrete and steel web. This observation is supported by the nature of the concrete cracking and is discussed further in Section 5.5.

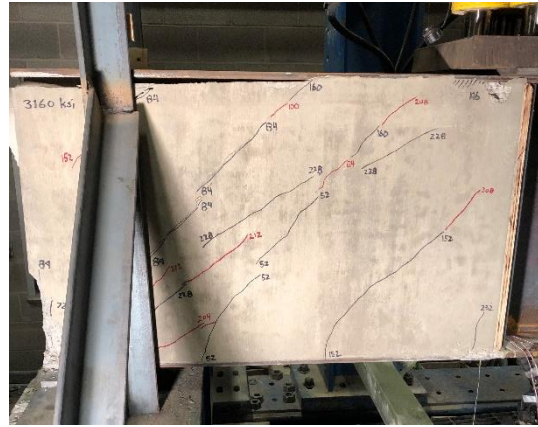
b) final crack pattern after completion of
tests; late-forming crack angle $\approx 30^\circ$

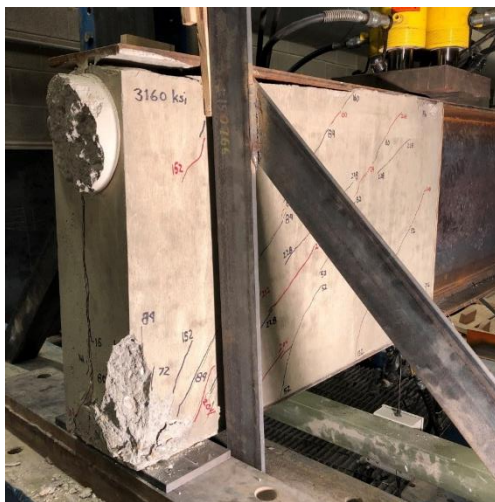
c) concrete bearing failure

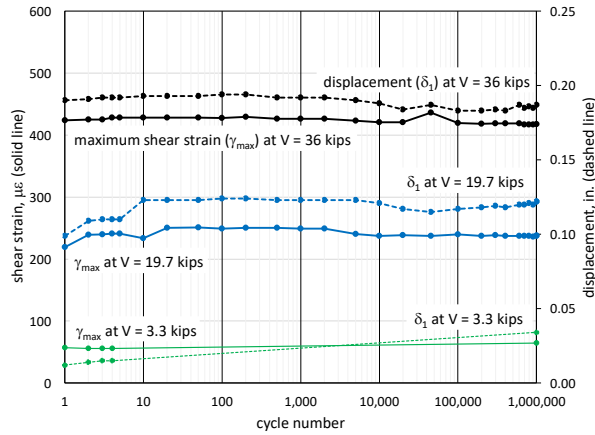
a) Girder 3B

In order to quantify deterioration, the history of the maximum shear strain, γ_{max} and displacement of the load point, δ_l with cycling for all specimens is reported in Figure 48. Data is reported at the peak shear force, $V = 36$ kips ($P = 44$ kips) and mean shear, $V = 19.7$ kips ($P = 24$ kips). Only initial and final cycle data is reported at the minimum shear, $V = 3.3$ kips ($P = 4$ kips). Any deterioration would result in an increase in these values as the apparent stiffness of the girder fell. Although displacement data is shown in Figure 48, this is not directly comparable with that reported in the monotonic tests. Displacement during fatigue conditioning is determined from the actuator LVDT and therefore includes compliance of the actuator and test frame.

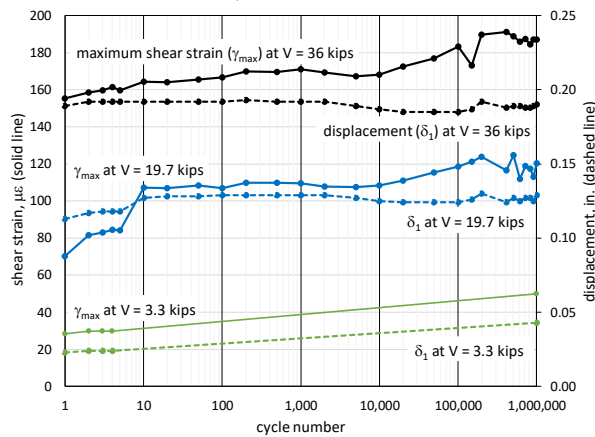
c) Girder 5B (note different scale for strain axis)

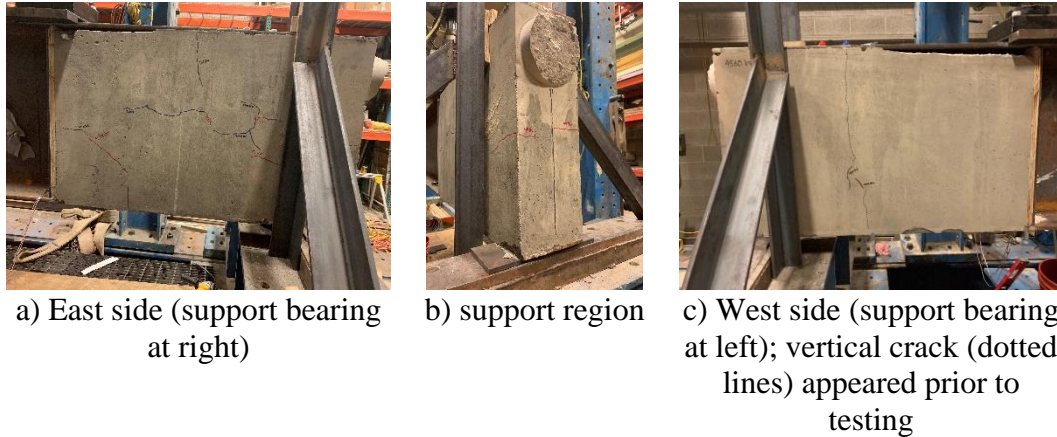
Figure 49 Cracking Observed during Fatigue Conditioning of Girder 5B

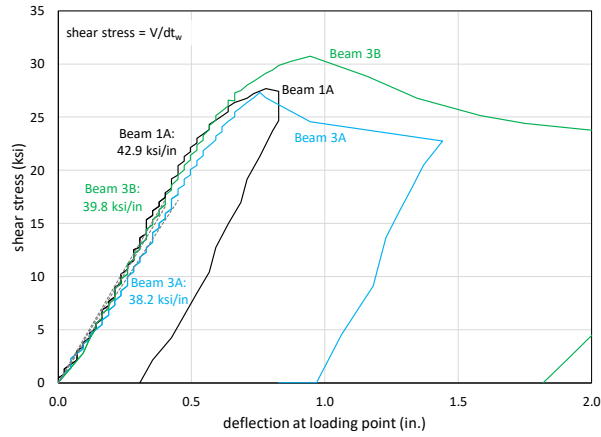
a) Girders 1A, 3A and 3B

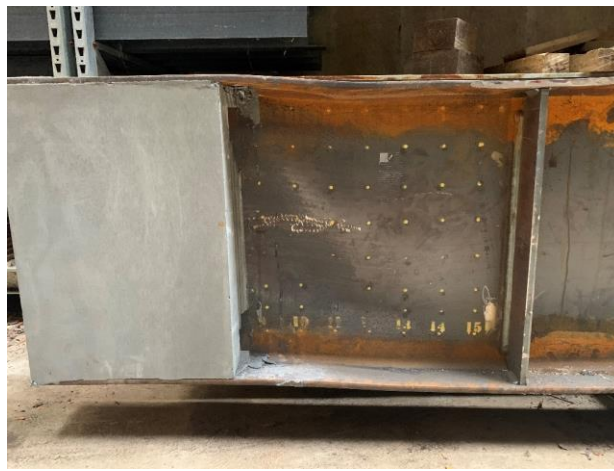
Figure 53 Girder 4B Following Testing Showing Well Controlled Panel Buckling

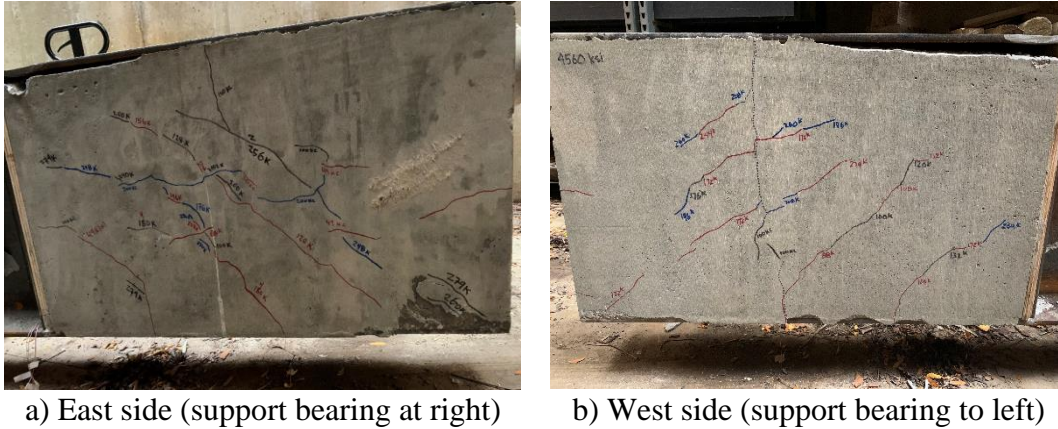
Figure 54 Girder 5B Following Testing

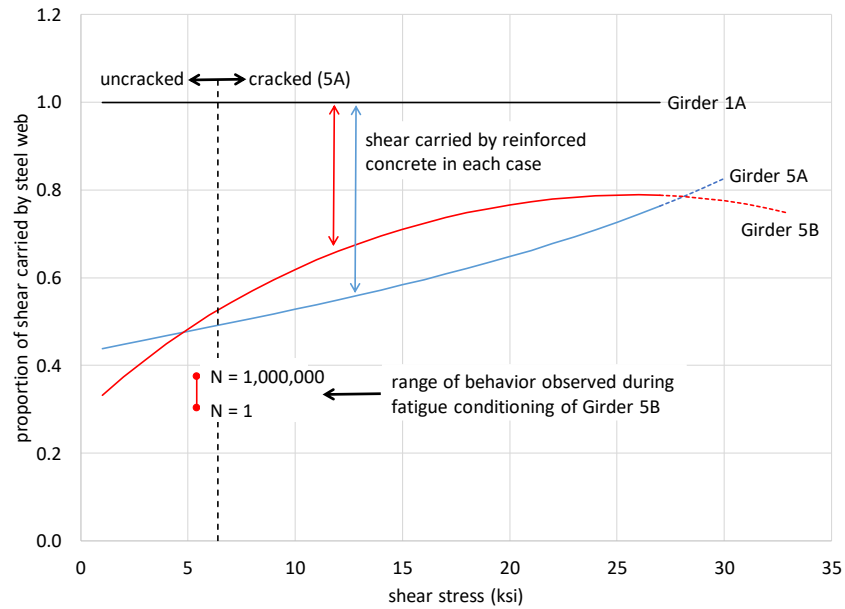
Figure 55 Proportion of Shear Resisted by Steel Web in Girder 5

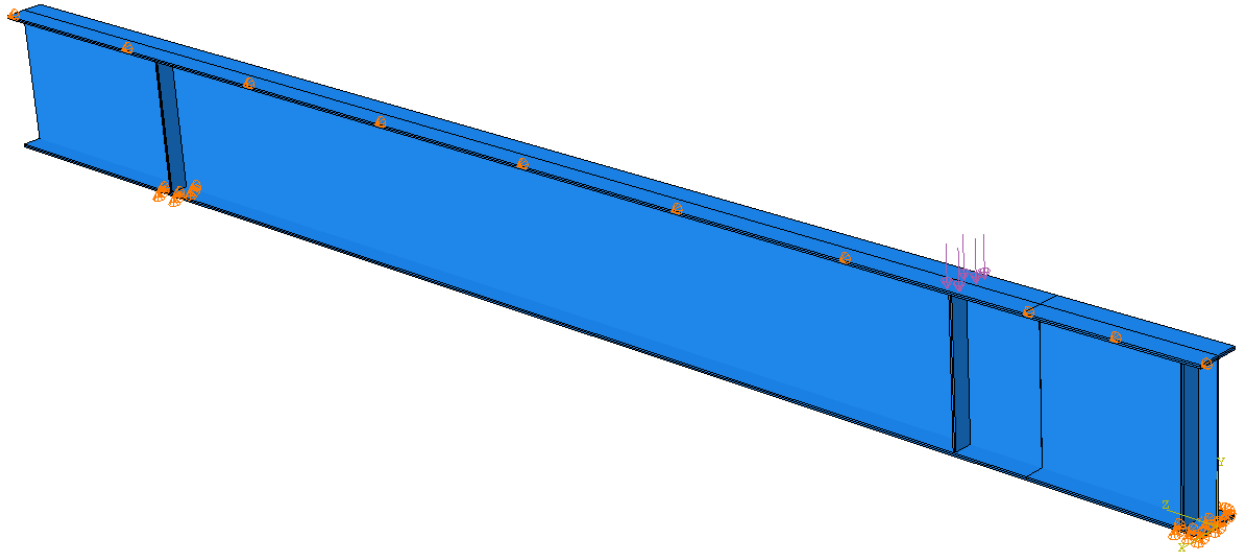
Figure 60 Numerical Model Boundary Conditions

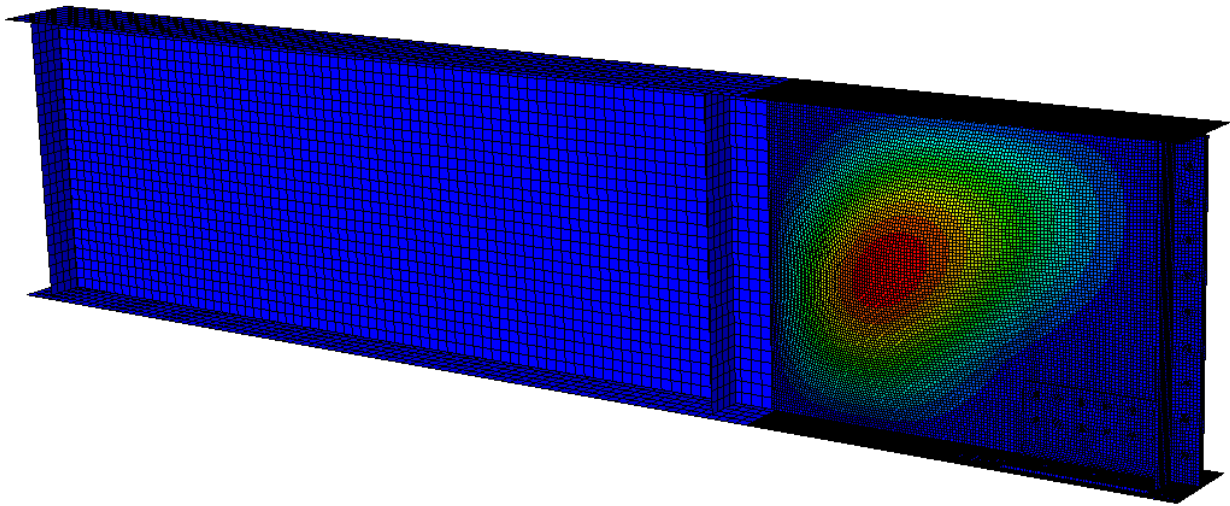
Figure 61 Girder Imperfections Based on Eigenvalue Buckling Analysis (deflection amplified)

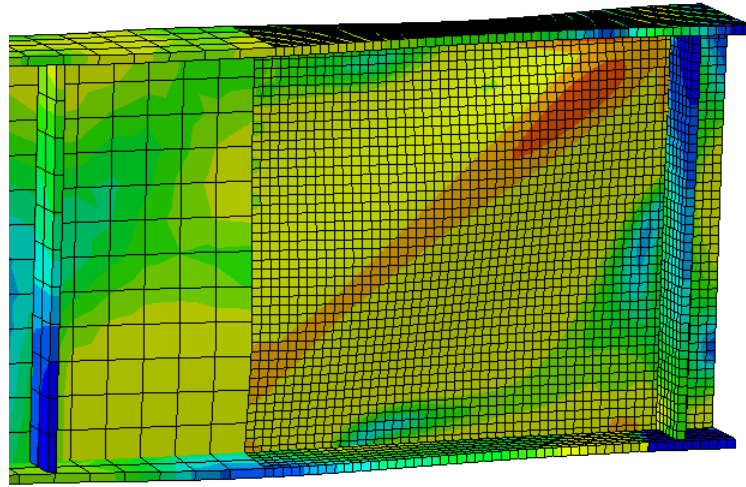
Figure 62 Girder 1A Loaded End Elevation with Maximum (von Mises) Stresses Plotted

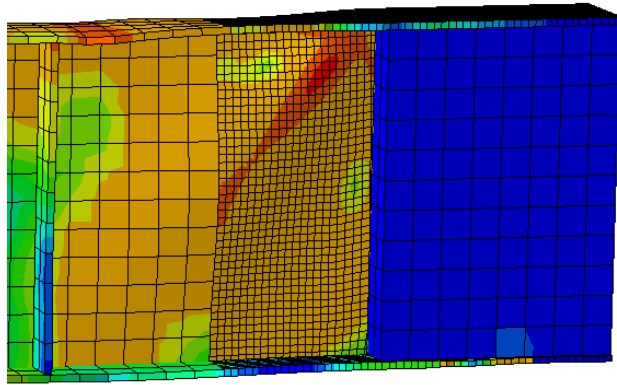
a) failure of UHPC encasement repair with tension field action evident

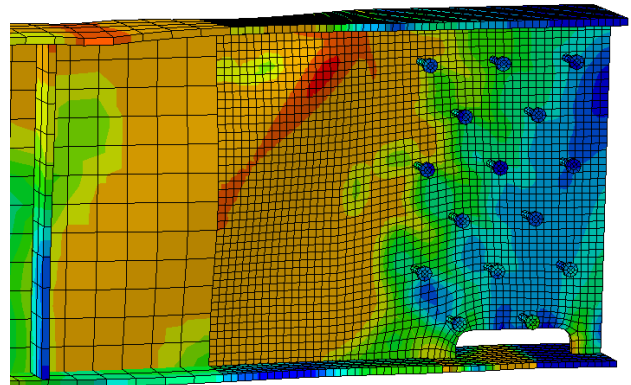
b) bolted shear studs (UHPC hidden)

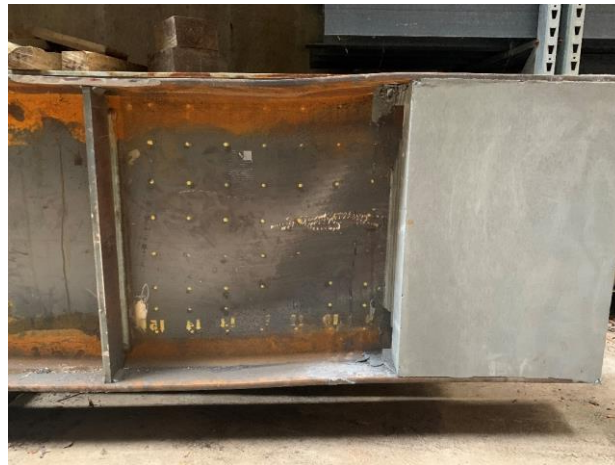
c) observed web buckling behaviour (image mirrored)

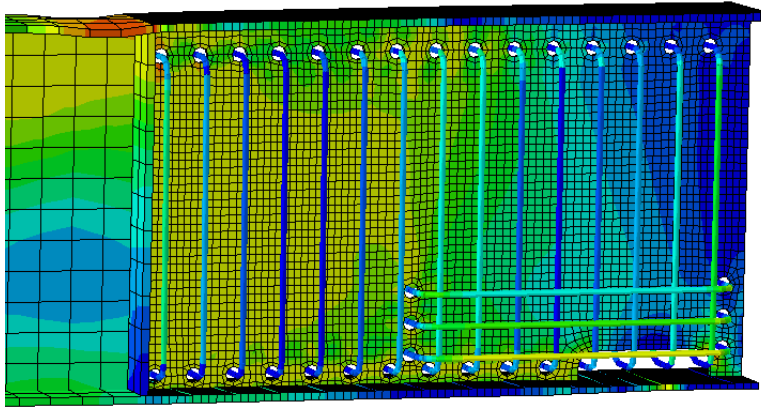
a) bearing region shown with concrete elements hidden

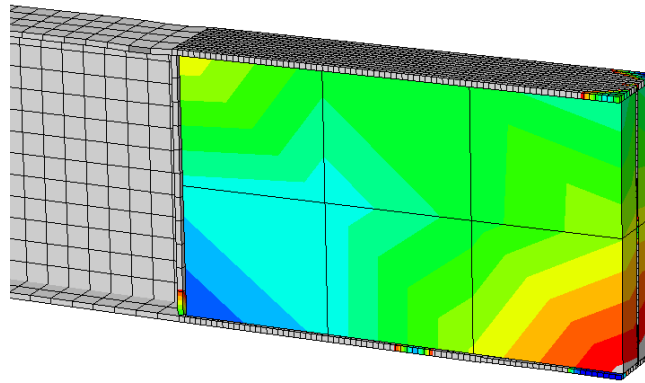
b) bearing region with maximum stress plot set to f'_c
note: concrete crushing and strut formation

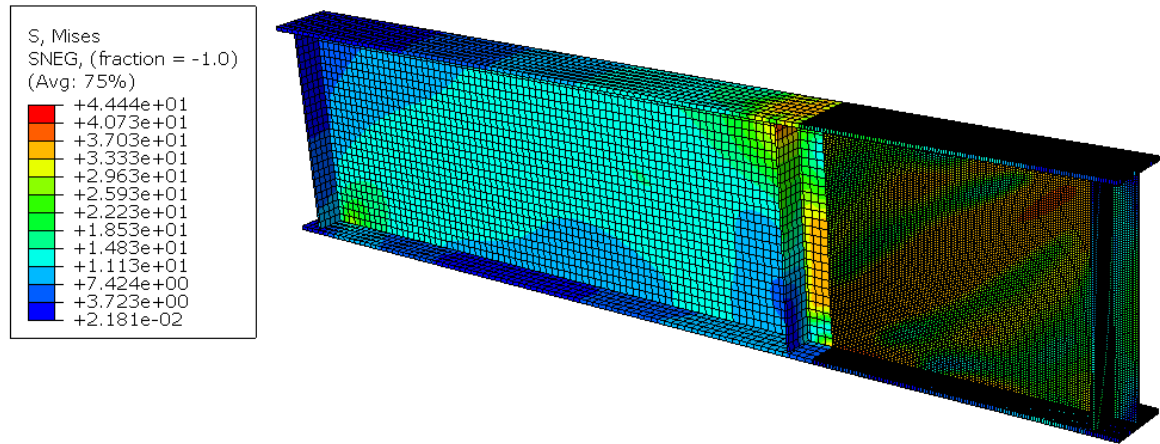
a) girder elevation with maximum (von Mises) stresses plotted

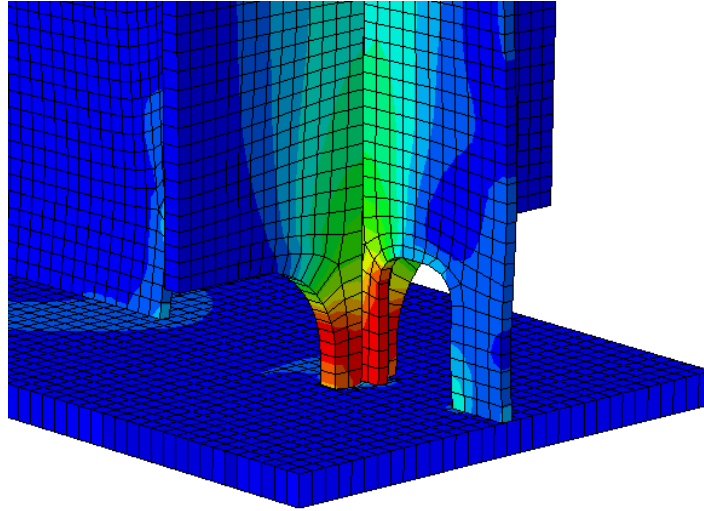
Figure 68 Bearing Region Failure of Case I Archetypical Damage (stress plot on deformed model)

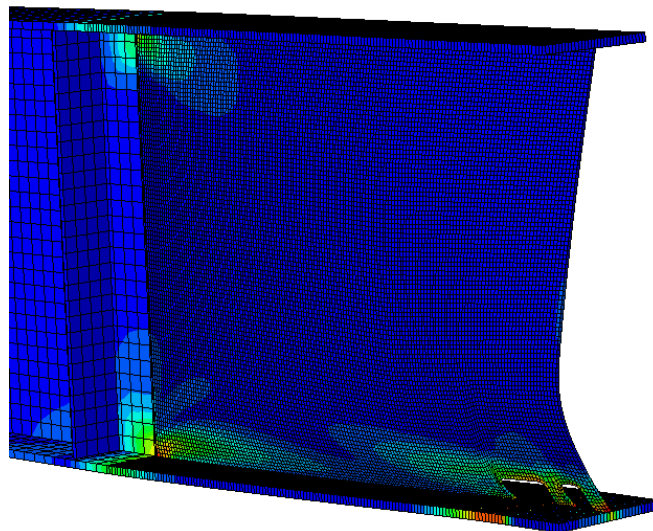
Figure 69 Failure of Case I Damaged Girder without Bearing Stiffener (stress plot on deformed model)

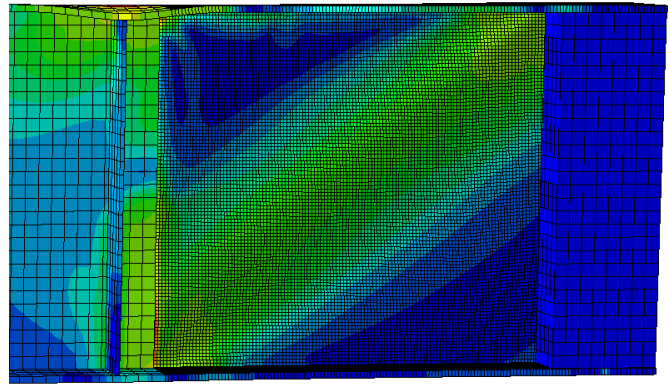
b) Failure of UHPC encasement repair (stress plot on deformed model)

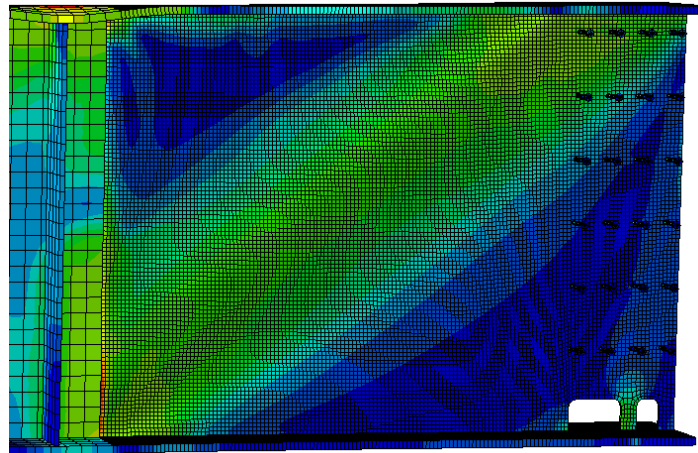
c) UHPC hidden
