Repair Strategies for Corroded Steel Bridge Girder End Regions

Submitted to the Graduate Faculty of the
Swanson School of Engineering in partial fulfillment
of the requirements for the degree of
Doctor of Philosophy

University of Pittsburgh

2022

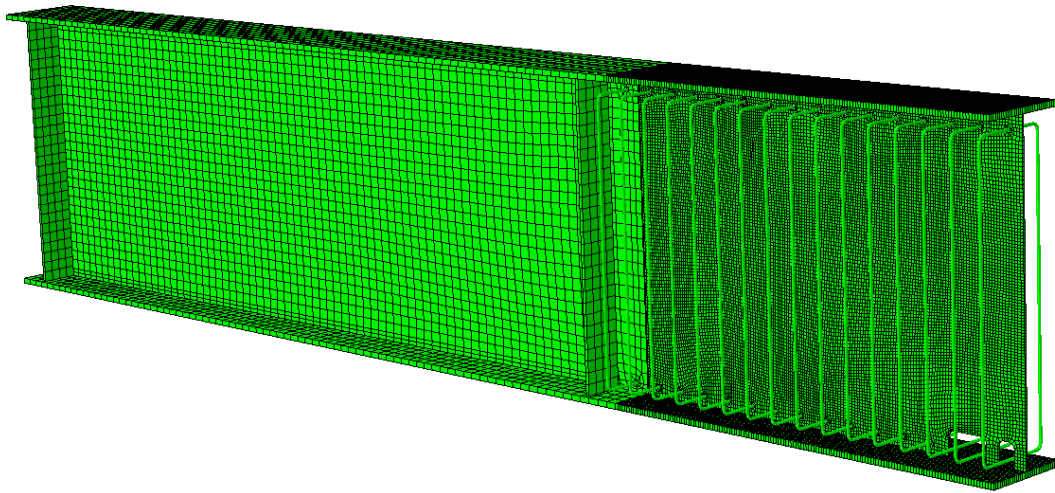
a) overall view of NSC encased model (concrete hidden)
