**STORMWATER RUNOFF MITIGATION AND WATER QUALITY IMPROVEMENTS
THROUGH THE USE OF A GREEN ROOF IN PITTSBURGH, PA**

Submitted to the Graduate Faculty of
the School of Engineering in partial fulfillment
of the requirements for the degree of
Master of Science

University of Pittsburgh

2007

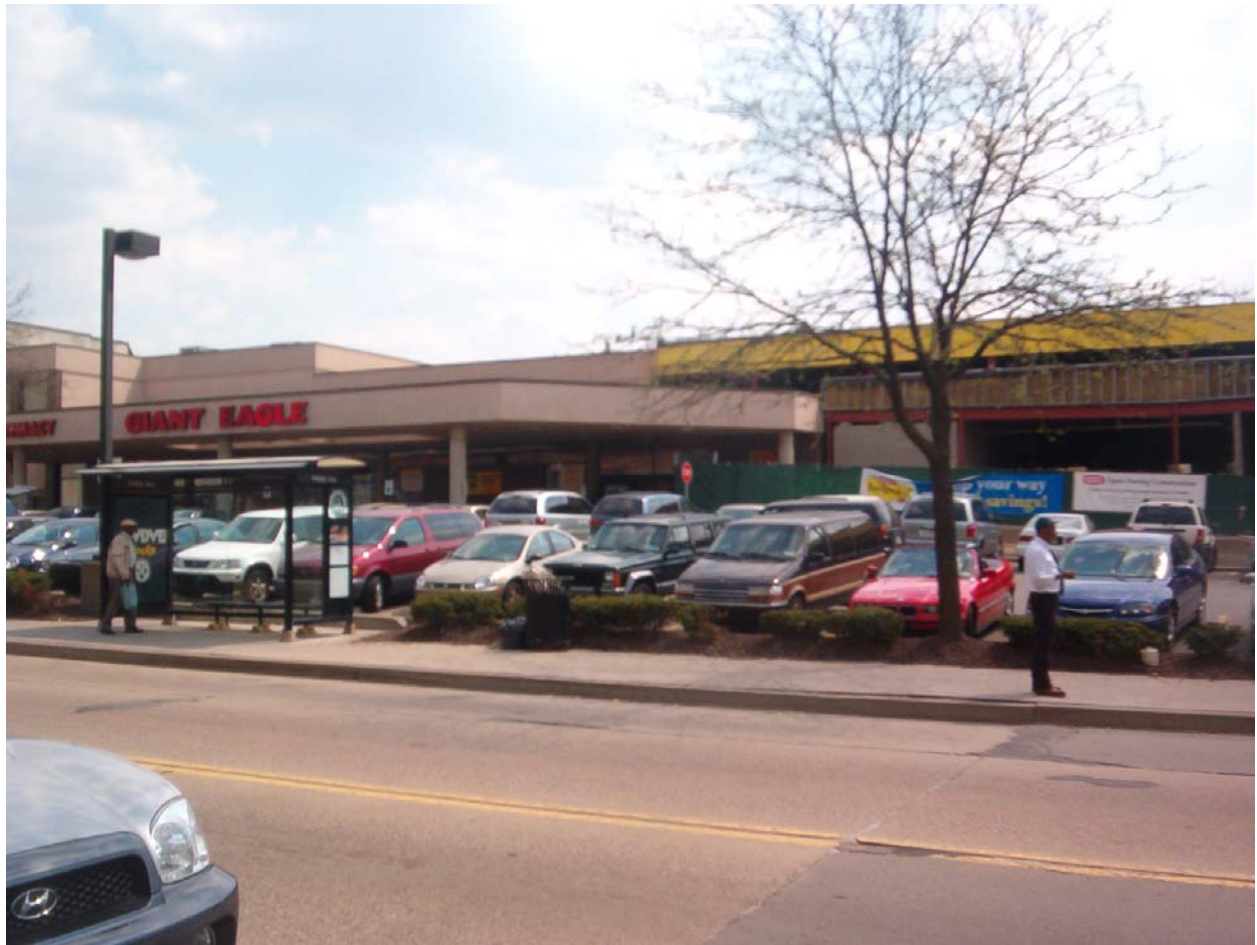
Figure 1 - Shadyside Giant Eagle – Existing Structure

The site originally contained the supermarket, several commercial buildings, a parking garage, several houses and an apartment building. The new site extensively renovated and expanded the Shadyside Giant Eagle and demolished the other structures. The store itself was more than doubled in size. In addition, a two-storey parking garage was built beneath the structure and seventy-eight condos occupy five-stories built above the rear of the supermarket. Figure 1 shows the original structure (on the left of the picture) and Figures 2 and 3 show the expanded portions of the store during construction.

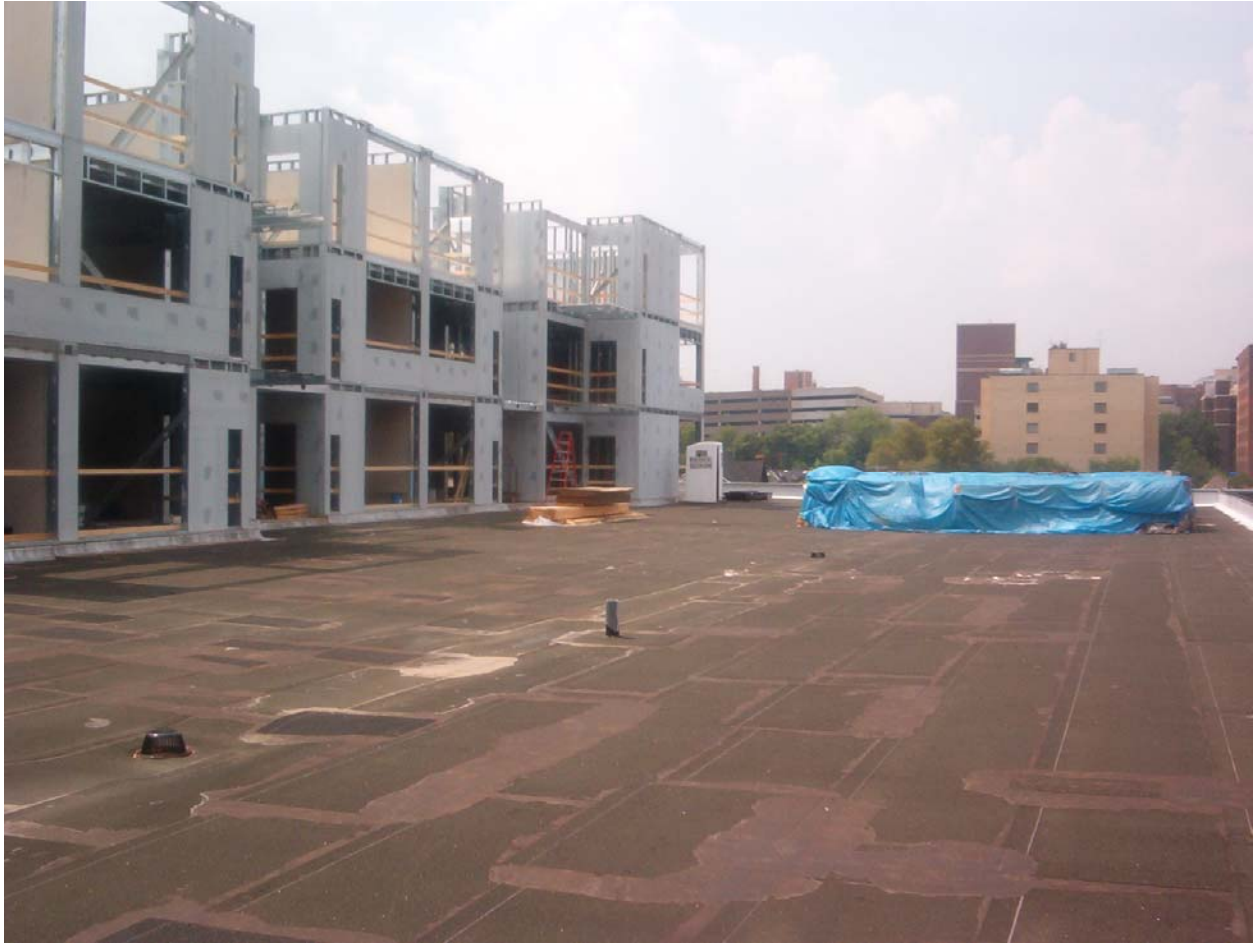
Figure 4 - Giant Eagle Green Roof - Early in the Construction Process

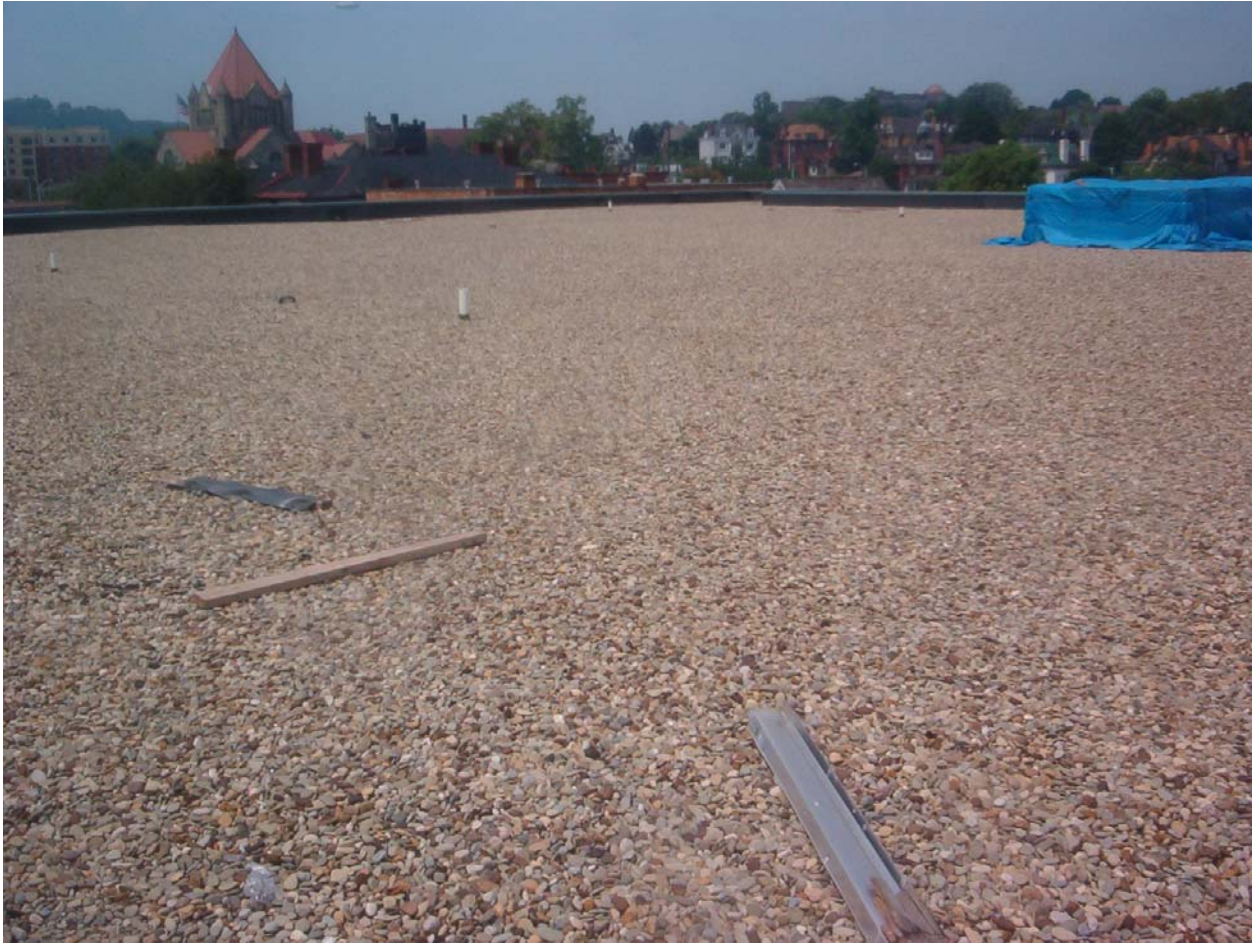
Figure 5 - Giant Eagle Control Roof - Early in the Construction Process

Figures 4 through 10 depict the green and control roofs at various stages of construction. Figure 4 shows the green roof area early in the construction process. The black surface visible in the photograph is the waterproofing layer. The control at the same point in time is shown in Figure 5. The root barrier and drainage and filter layer are shown in Figure 6, just after they were applied above the waterproofing layer. The substrate was then installed on top of these layers (Figure 7). The green roof is picture just after the installation of the plants in Figure 8. Figure 9 shows the control at this time. Prior to the completion of the green roof, several skylights were installed on both roofs. They are visible in the last few photographs. Finally, Figure 10 shows the green roof near the end of the first growing season.

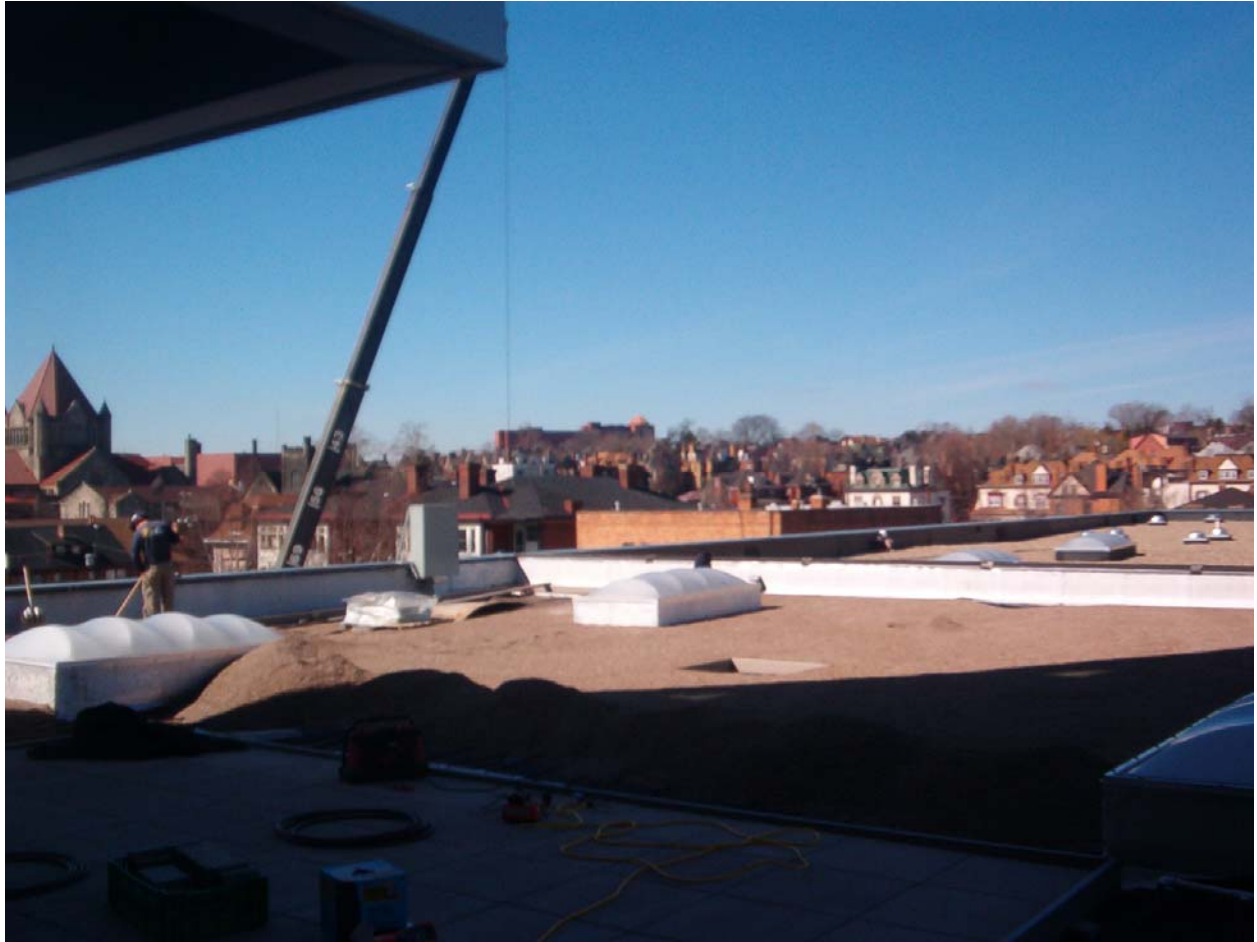
Figure 7 - Giant Eagle Green Roof as Soil is Installed

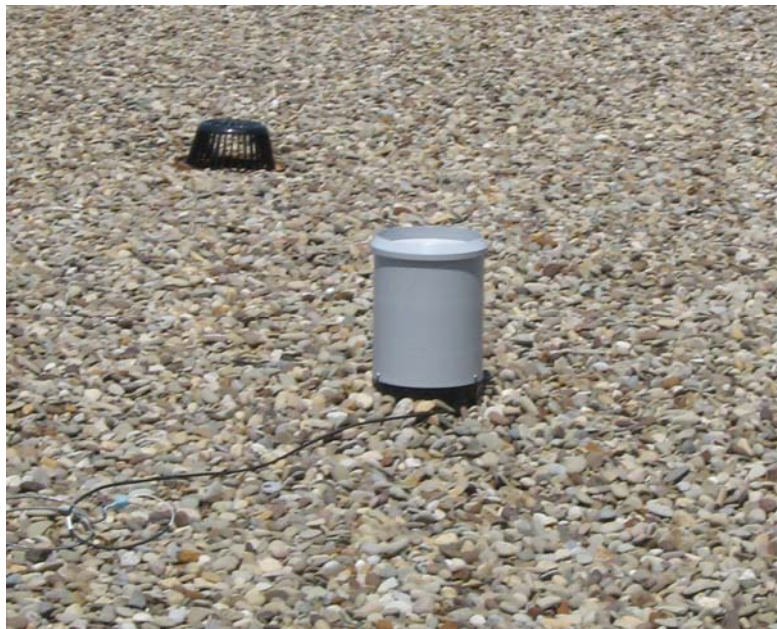
Figure 11 - Rain Gauge Installed on the Green Roof

The first step is to determine an accurate measure of the rainfall reaching the rooftop. To accomplish this, a Hydrologic Services RG703 8 inch Tipping Bucket Rain Gauge (Figure 11) was used. A siphon mechanism allows the gauge to measure all rainfall intensities. After each

one hundredth of an inch of rain falls, the bucket tips and sends a reading to the datalogging system, which will be discussed in detail later. The rain gauge not only takes a measurement on the rainfall volume that falls on the roof, but also rate of rainfall. The rainfall data was used to calculate both the total volume of water that reaches the roof and the rate. Along with runoff data, this will show the affect the green roof has on reducing runoff. Similarly, the rainfall rate will show the delay in runoff accumulation from each roof.

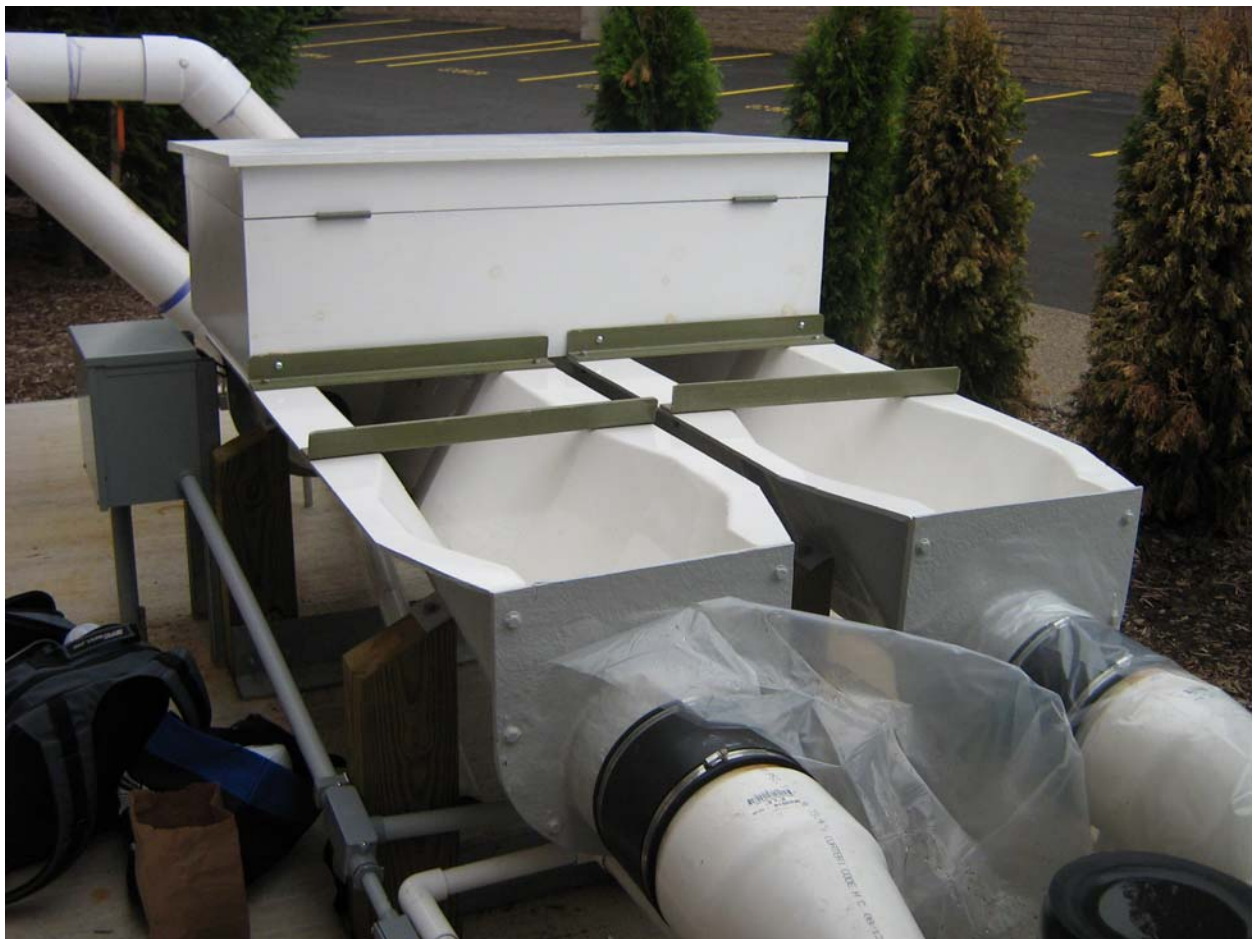
Figure 12 – Flumes

not feasible to measure all the runoff that is created by each roof. Therefore, one roof drain on each roof was chosen to measure. Each drain has approximately 3530 square feet of roof sloping towards the drain, allowing measurements to be equalized. The drain from each roof has a flume installed in line before the water is deposited into the sewer system. They are at ground level, near the back of the building. An ultrasonic sensor is suspended eight inches above the top of each flume, at the measurement point. These sensors send a sound wave into the flume, which then bounces back. The time that the wave takes to return allows the equipment to measure the depth of water in the flume at that point. From the depth of water, the flow rate and cumulative volume of runoff are calculated.

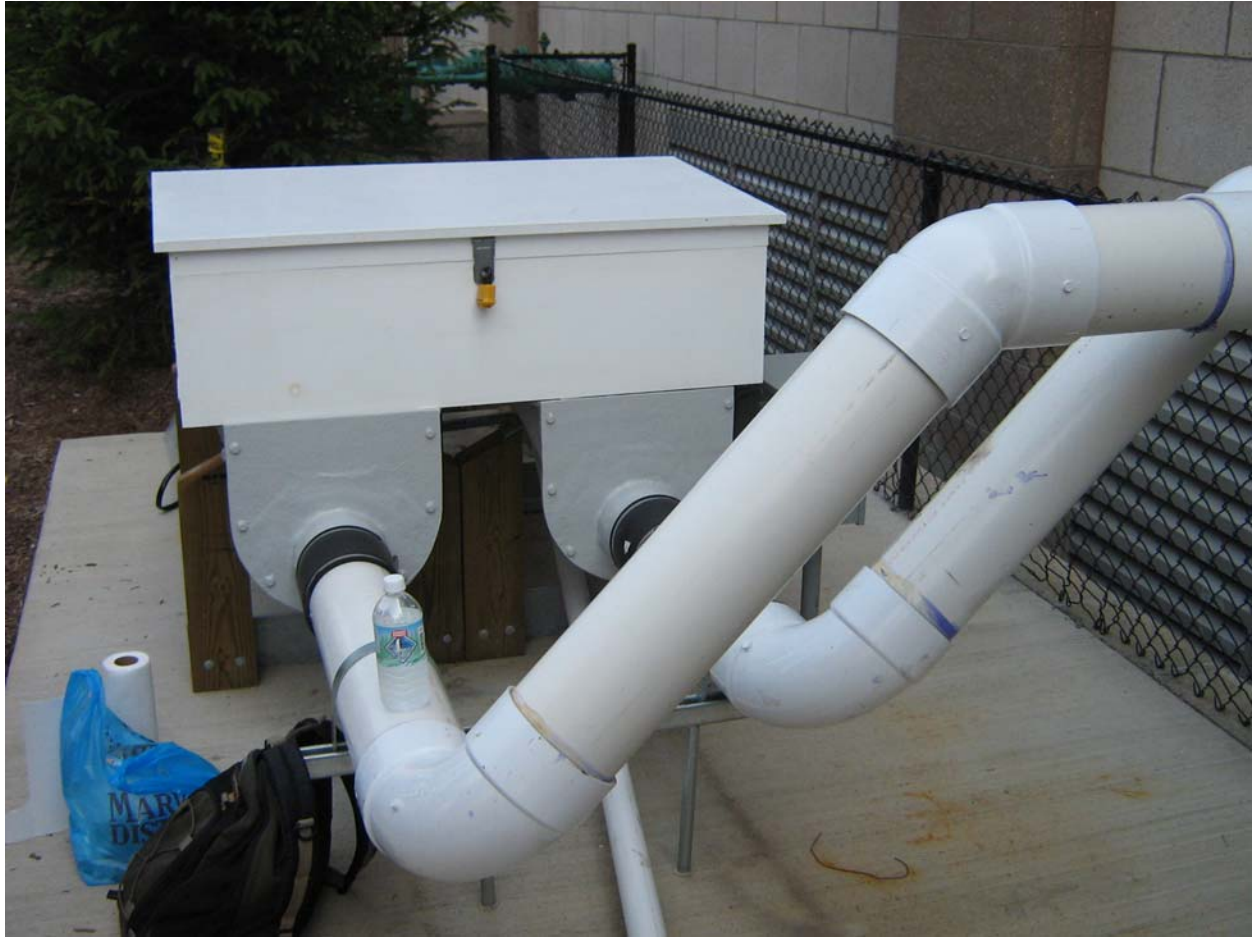
Figure 13 - Flumes (Opposite Angle)

To measure the runoff created by each roof, two important pieces of equipment are required: Tracom 60-degree Extra Large Trapezoidal Flumes (Figures 12 and 13) and Greyline Instruments LIT25 (Level Indicating Transmitter) Ultrasonic sensors (Figures 14 and 15). The flumes are essentially open pipes. There is a known shape, in this case a trapezoid, on the upstream side of the flume. If the depth of water is measured at this point, the volume of water in the flume at that instant can be calculated due to the known dimensions. Since the green roof and control roof have different surface areas (12,300 and 21,000 square feet, respectively), it was

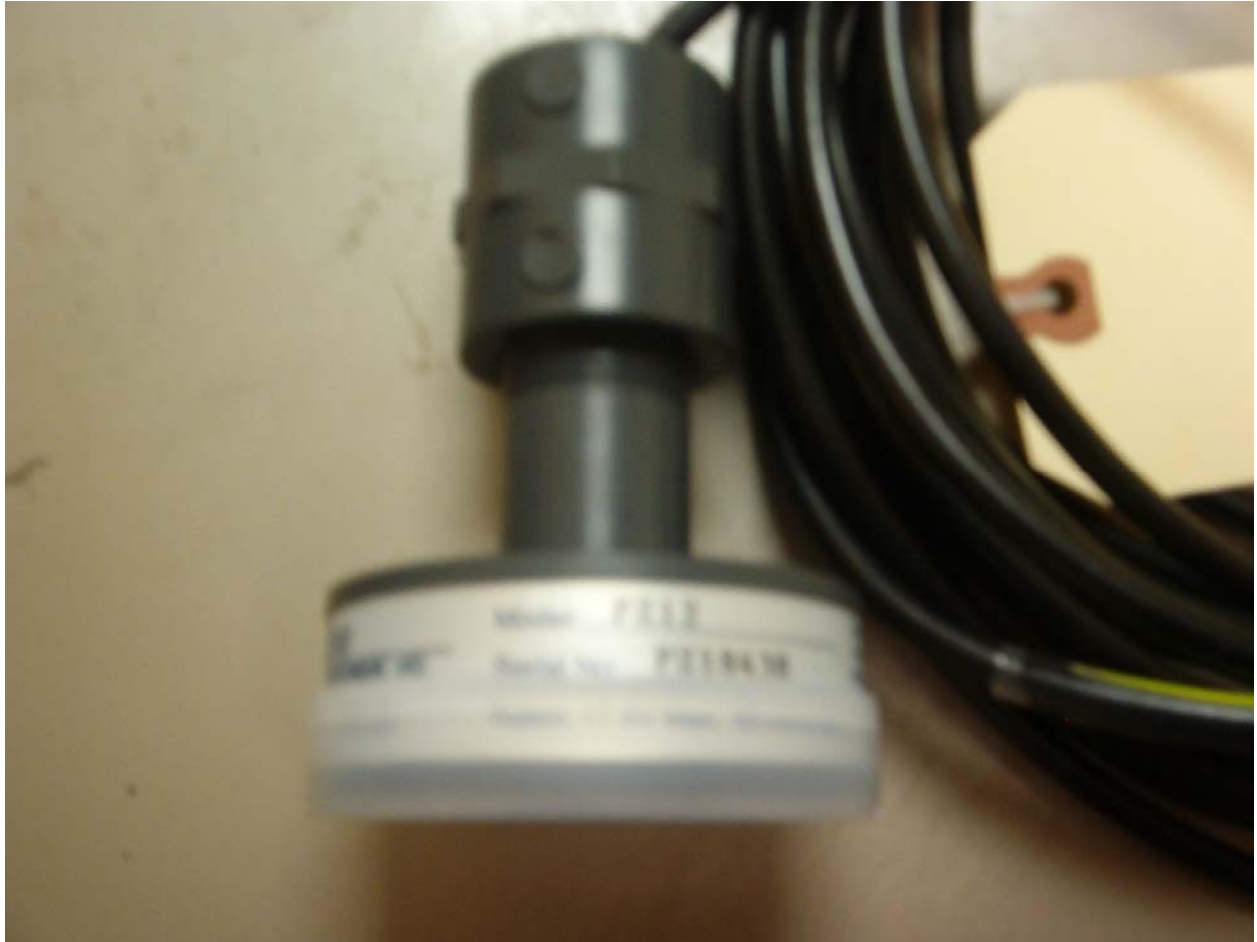
Figure 14 - Ultrasonic Sensor

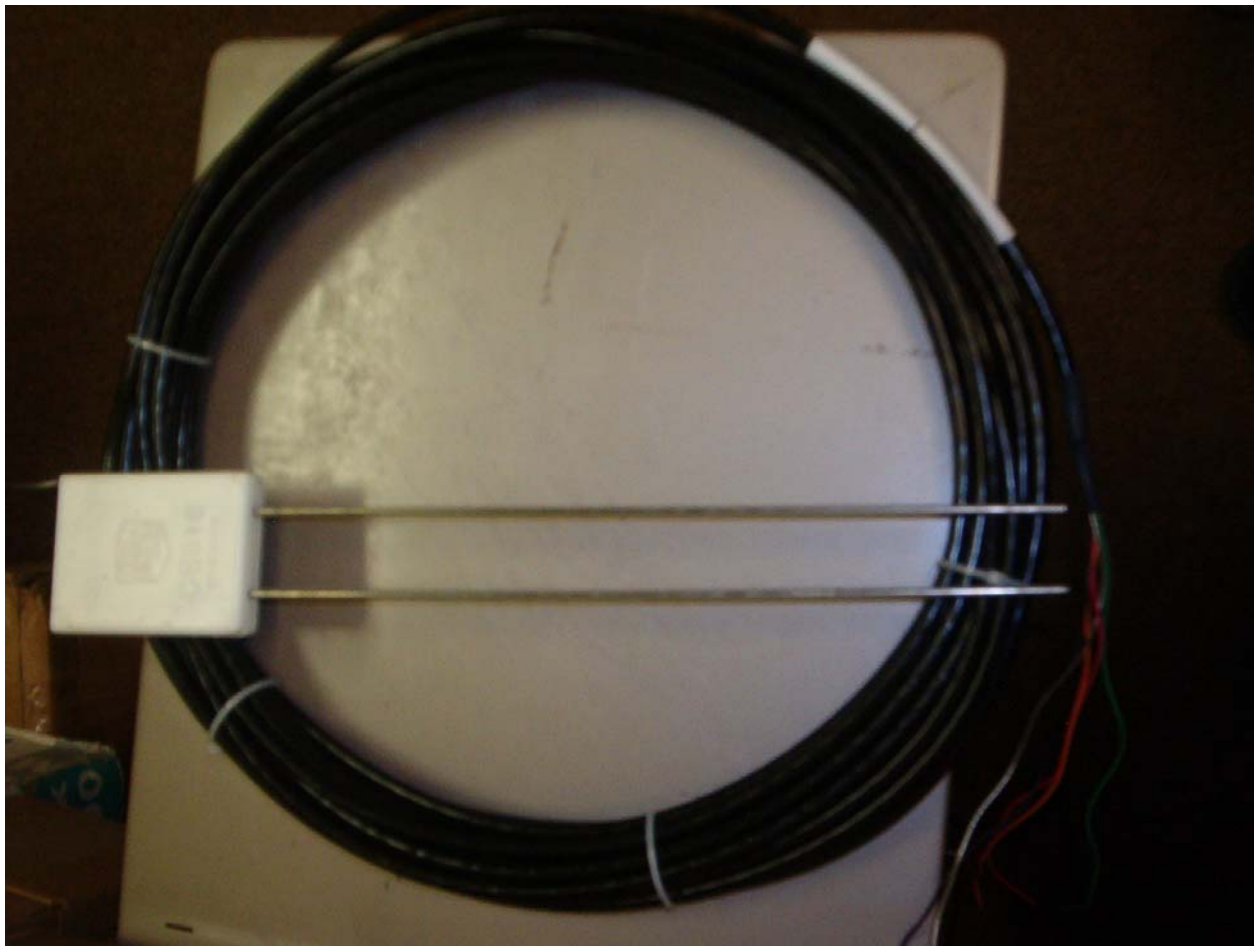
Figure 16 - Soil Moisture Sensor

Soil moisture is an important parameter that affects stormwater runoff. During a rainstorm, the pores of the soil absorb water. As the storm progresses, the soil becomes saturated and reaches its maximum storage point. After this time, the green roof will act similarly to a conventional roof in regards to runoff quantity, although there will still be a runoff delay as the water filters through the soil. Because of this process, it is important to monitor the moisture content of the soil both before and during a storm. The dryer the soil is when a storm begins, the greater the amount of runoff reduction. In order to monitor this process, two Campbell Scientific SM616 Soil Water Content Sensors (Figure 16) were installed on the green

roof. Electric pulses are sent out of the two metal probes that penetrate the soil. By measuring the dielectric permittivity of the soil, the sensors calculate the water content of the soil. Water has a high dielectric permittivity, while soil does not, so any changes in the quantity are a result of a change in water content. The volume of soil on the roof is known, so the amount of water within the soil at each point in time can be determined with simple multiplication. The rate of absorption can be calculated by dividing the volumetric water content by the time in between readings.

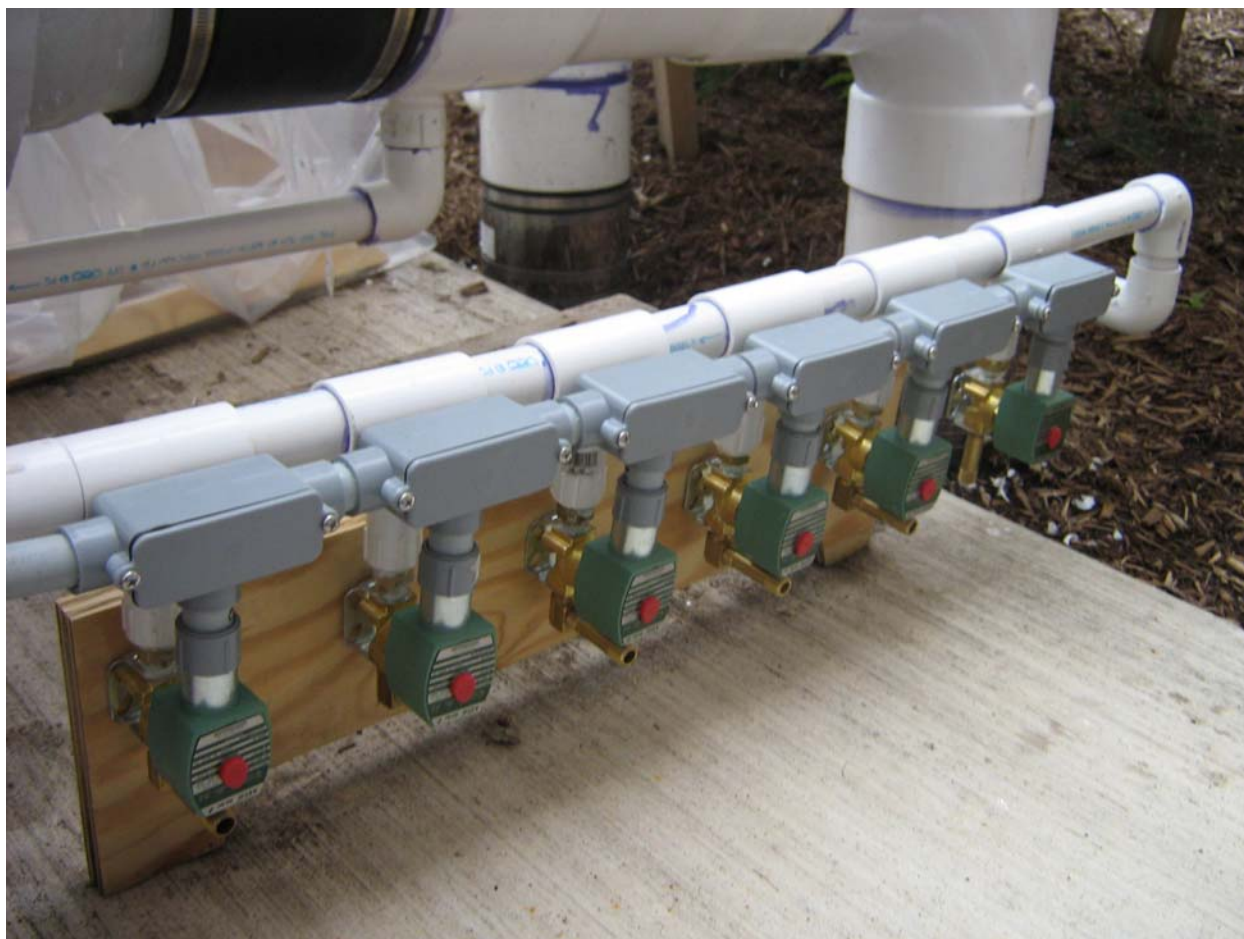
Figure 17 - Solenoid Valve Sampling Manifold

system connected to the green roof flume. These solenoid valves are normally closed and are opened when energized. Each of the valves is connected to a 500 mL low density polyethylene sample bottle (Figure 18). The valves are wired to the datalogger located on the roof, which controls when the valves are opened. Each of the six valves are programmed to open at a set value of cumulative runoff. Since runoff can start at different times and flow at different rates on the green and control roofs, this allows the samples to be matched from both roofs. Additionally, the series of valves allows for samples to be taken at six different points during a storm. With samples taken in this manner, the first flush effect can be studied. Less specifically, it lets the changes in water quality throughout the storm be measured. The 500 mL of sample provided enough water to complete the series of water quality tests in the protocol. The valves were programmed to stay open for as short a time as possible to allow the sample bottles to fill while minimizing overflows.

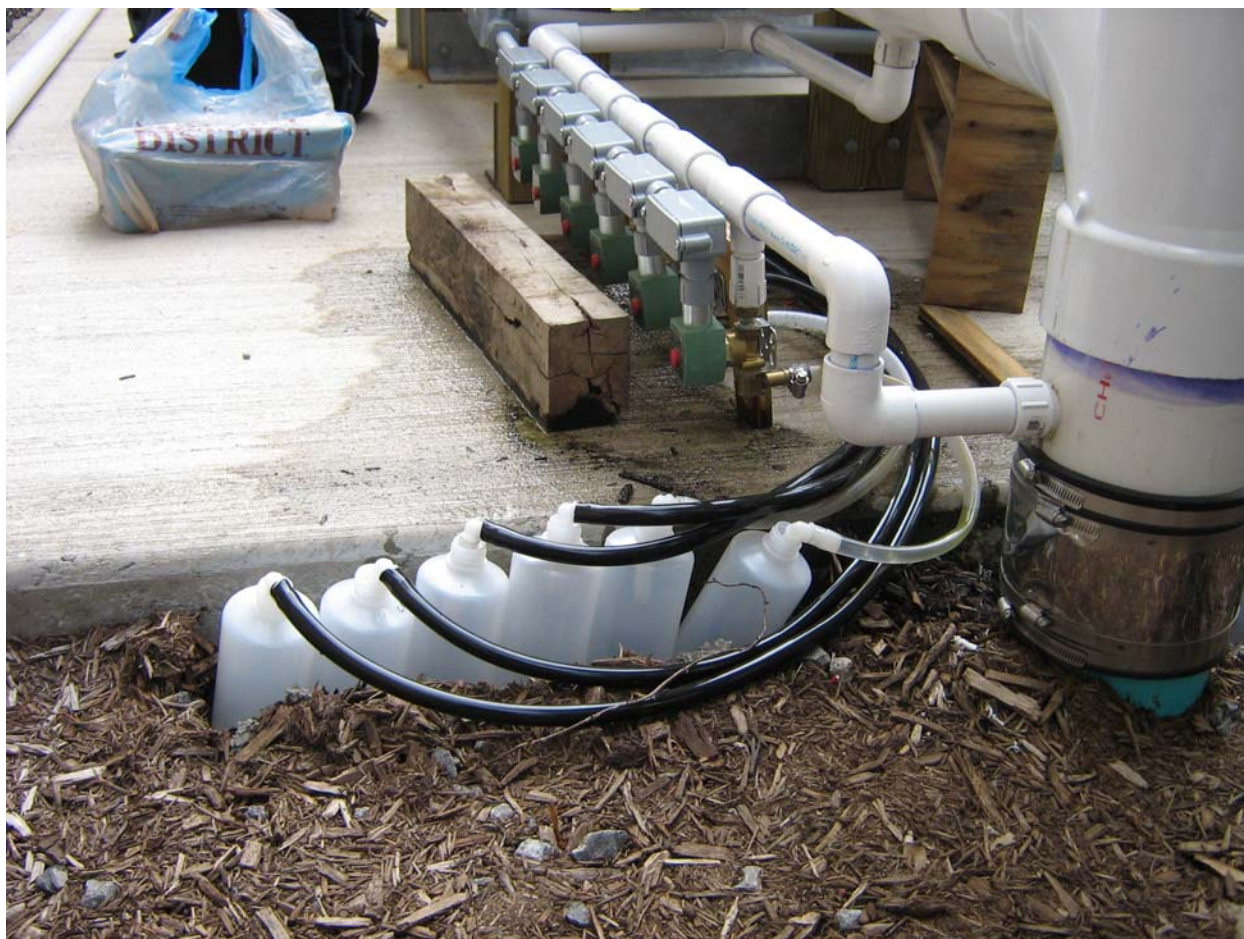
Figure 18 - Solenoid Valves and Sample Bottles

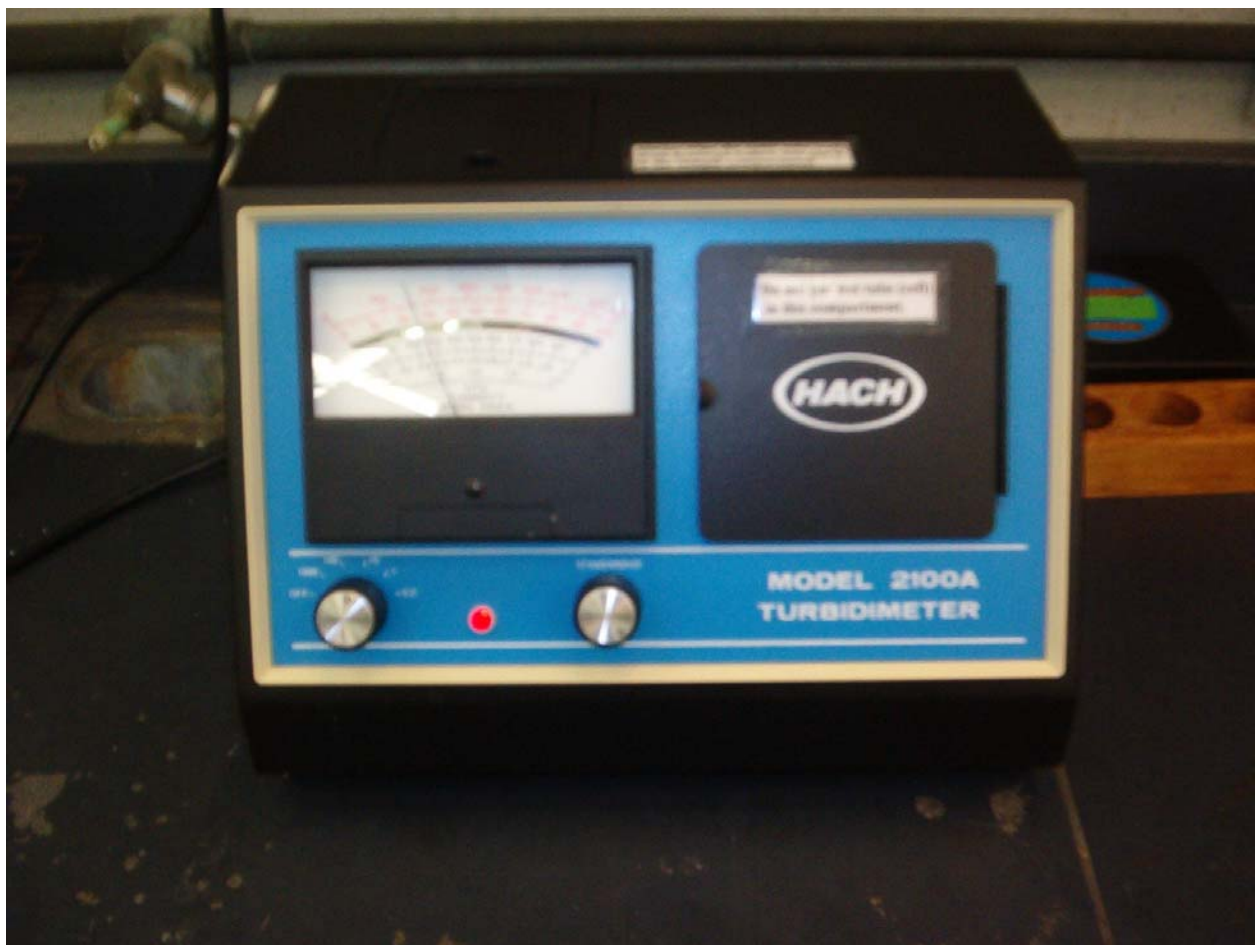
Figure 19 - Turbidimeter

To test for turbidity, the nephelometric method (2130 B) from *Standard Methods* (1992) was followed. A turbidimeter (or nephelometer) is used in testing. A HACH Model 2100A Turbidimeter (Figure 19) was used for this study. A water sample is placed in a chamber and light is shown through it. A photoelectric detector measures the intensity of light scattered at a 90 degree path to the incident light. As more particles are present in a sample, more light is scattered. This higher intensity of scattered light corresponds to a higher turbidity, measured in nephelometric turbidity units (NTU).

It is necessary to allow the turbidimeter to warm up for a few minutes before beginning testing. The turbidimeter used for this project (and most models) contain several ranges. For instance, 0 to 0.02 NTU, 0 to 10 NTU, 0 to 100 NTU and 0 to 1000 NTU. A standard is required for each range. As with all samples, it is necessary to clean the outside of the standard sample before placing it in the turbidimeter. Once it is in the chamber, an opaque cylinder is placed over the portion of the cell that protrudes from the chamber. The turbidimeter is then set to the turbidity of the standard and testing can begin. Each water sample to be tested must be shaken, poured into a clean and dry sample cell and have the outside of the cell whipped clean before it is placed in the cylinder for a reading. If a sample has a turbidity near the top or bottom of the range, a reading would also be taken for the next higher or lower range to ensure accuracy. The turbidimeter used on this project frequently falls out of calibration. Therefore, it is recalibrated after every other sample.

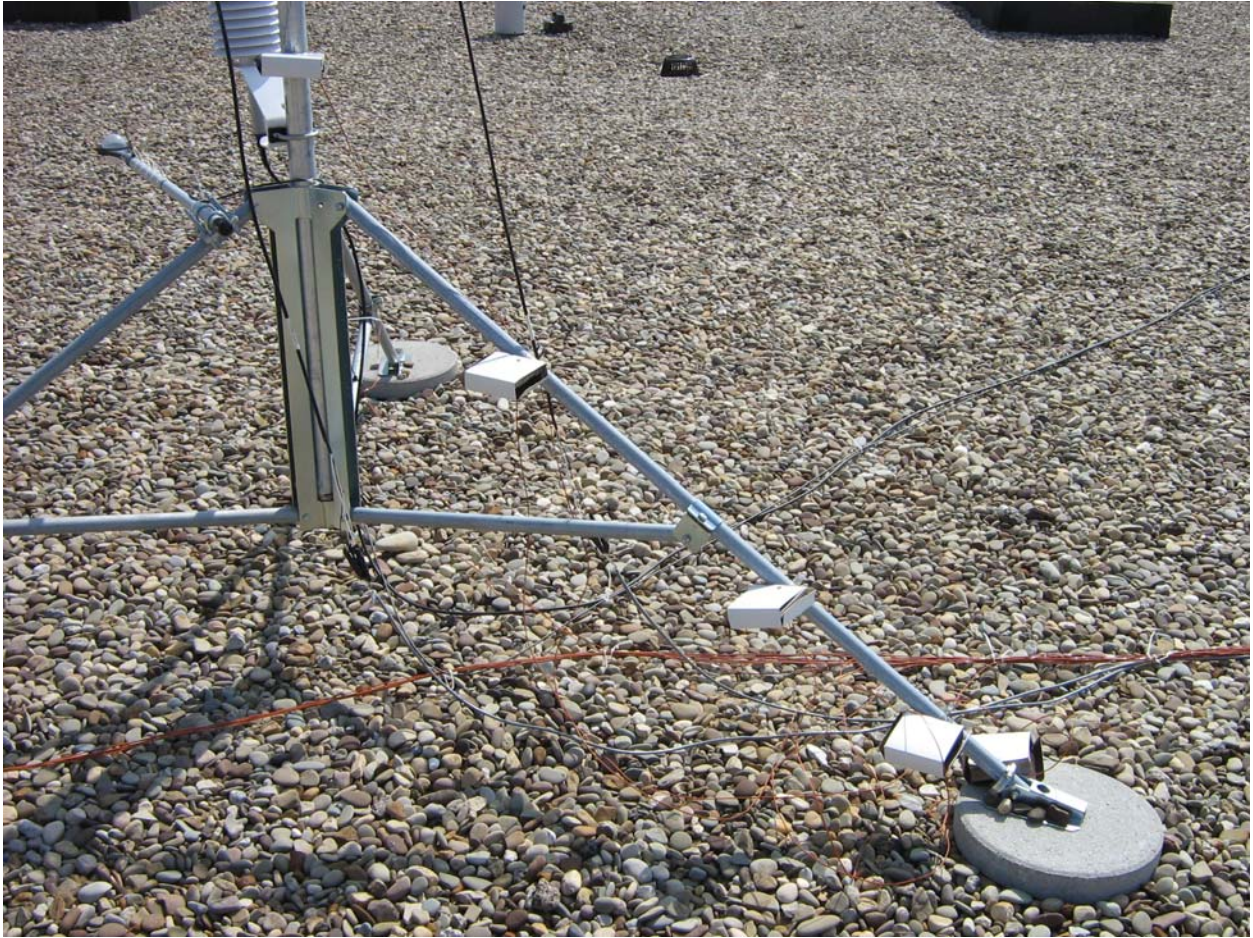
Figure 22 - Thermocouples Installed on a Control Roof Tripod

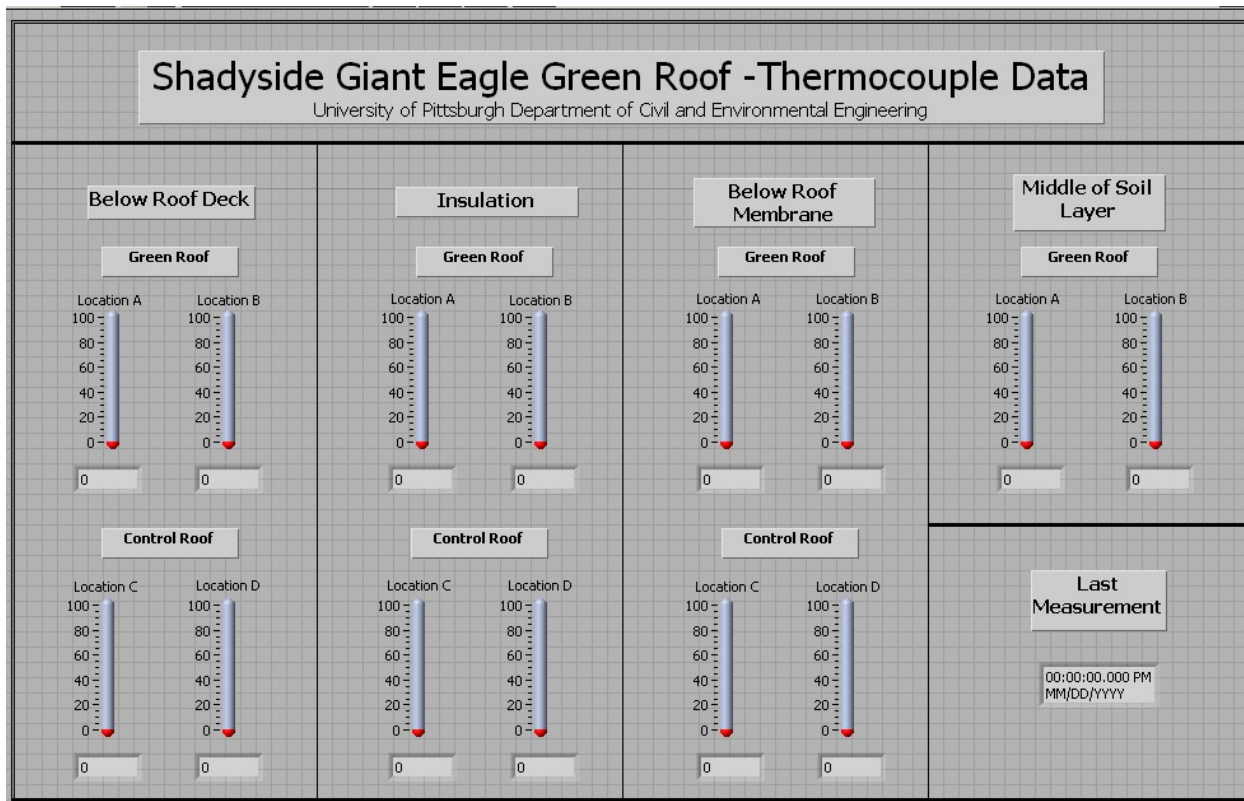
Figure 23 - Thermocouple LabVIEW Program Display - Top Half

The LabVIEW program displayed is shown in two figures. Figure 23 shows the top third of the display. The thermometers show the current temperature at all four measurement locations for selected vertical points. In Figure 24, several graphs display trend data for the previous 3 and a half days. An example LabVIEW code is depicted in Figure 25. The reading from a single thermocouple is read every five minutes, stored in a data file (the temperature reading itself plus its location is recorded) and displayed. This must be done for each thermocouple measurement point. This is also the basic procedure follow in all programs, but more complex programming is required for the other pieces of equipment.

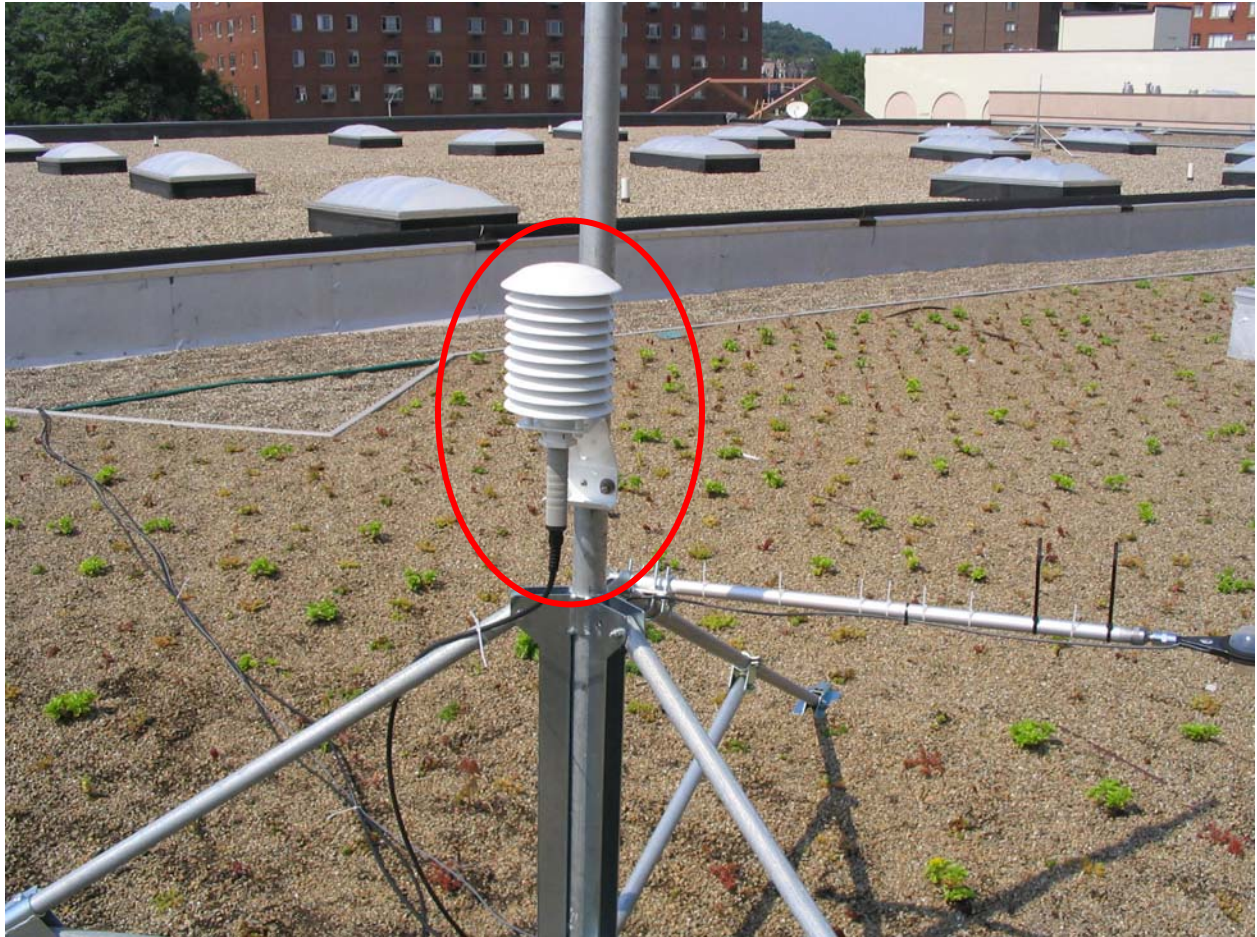
Figure 26 - Temperature/RH Sensor (Circled) Installed on a Green Roof Tripod

The program for the remaining thermal equipment is more complex. It also relies on a five minute sampling period. The temperature and relative humidity sensors (Figure 26) return readings in voltages, which are then converted in the program into degrees Fahrenheit and percent relative humidity, respectively. The temperature range of the sensor is -40 degrees to 60 degrees Celsius. The humidity range is 0 to 100 percent. In both cases, the output voltage ranges from 0 to 1 volt. A simple linear equation was derived for both measurements.

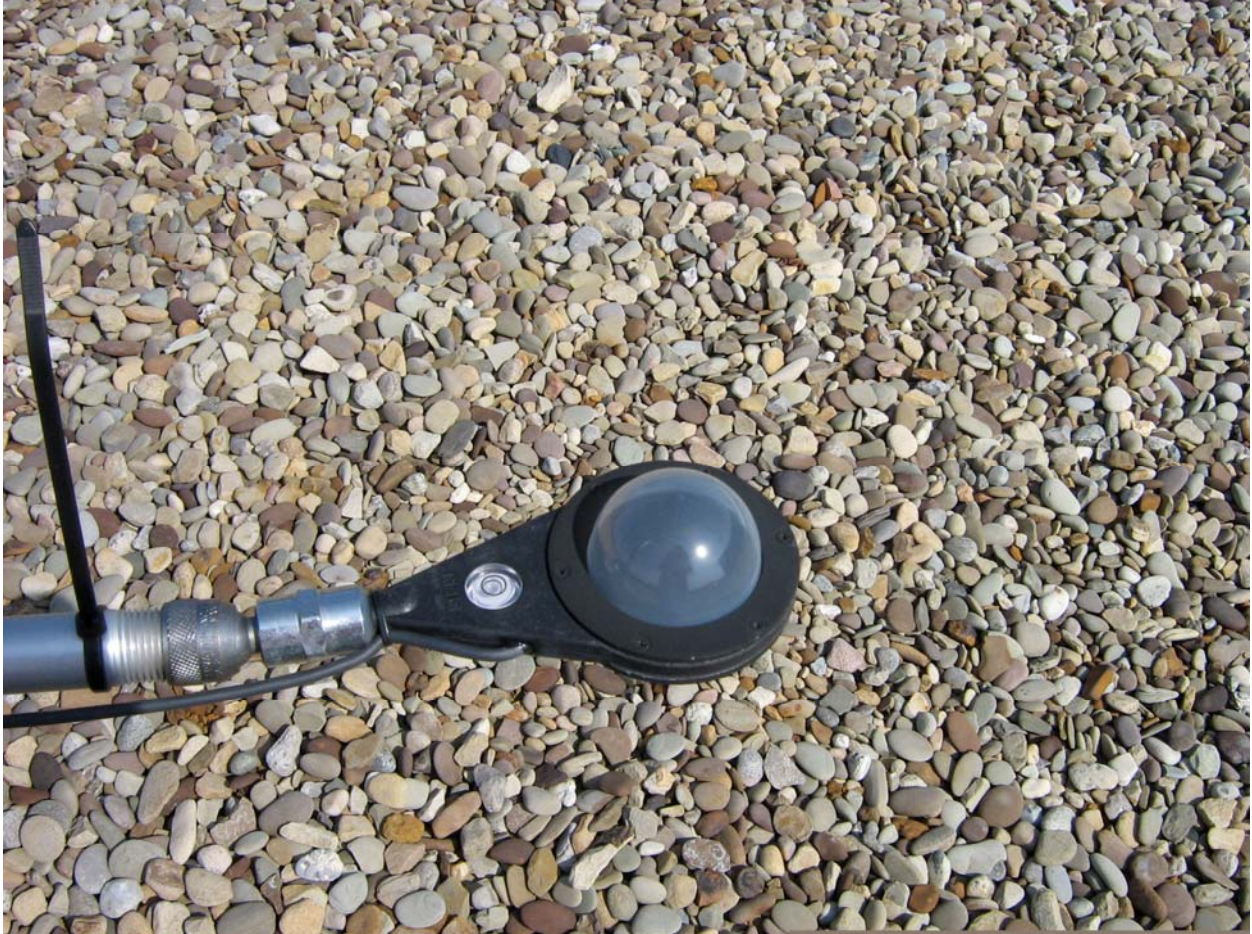
Figure 27 - Net Radiometer Installed on Green Roof Tripod

The net radiometers (Figure 27) follow the same process, but the results are converted to Watts per square meter. There is one equation for the conversion, but different factors are used for positive and negative readings. Each radiometer is factory calibrated and has slightly different factors.

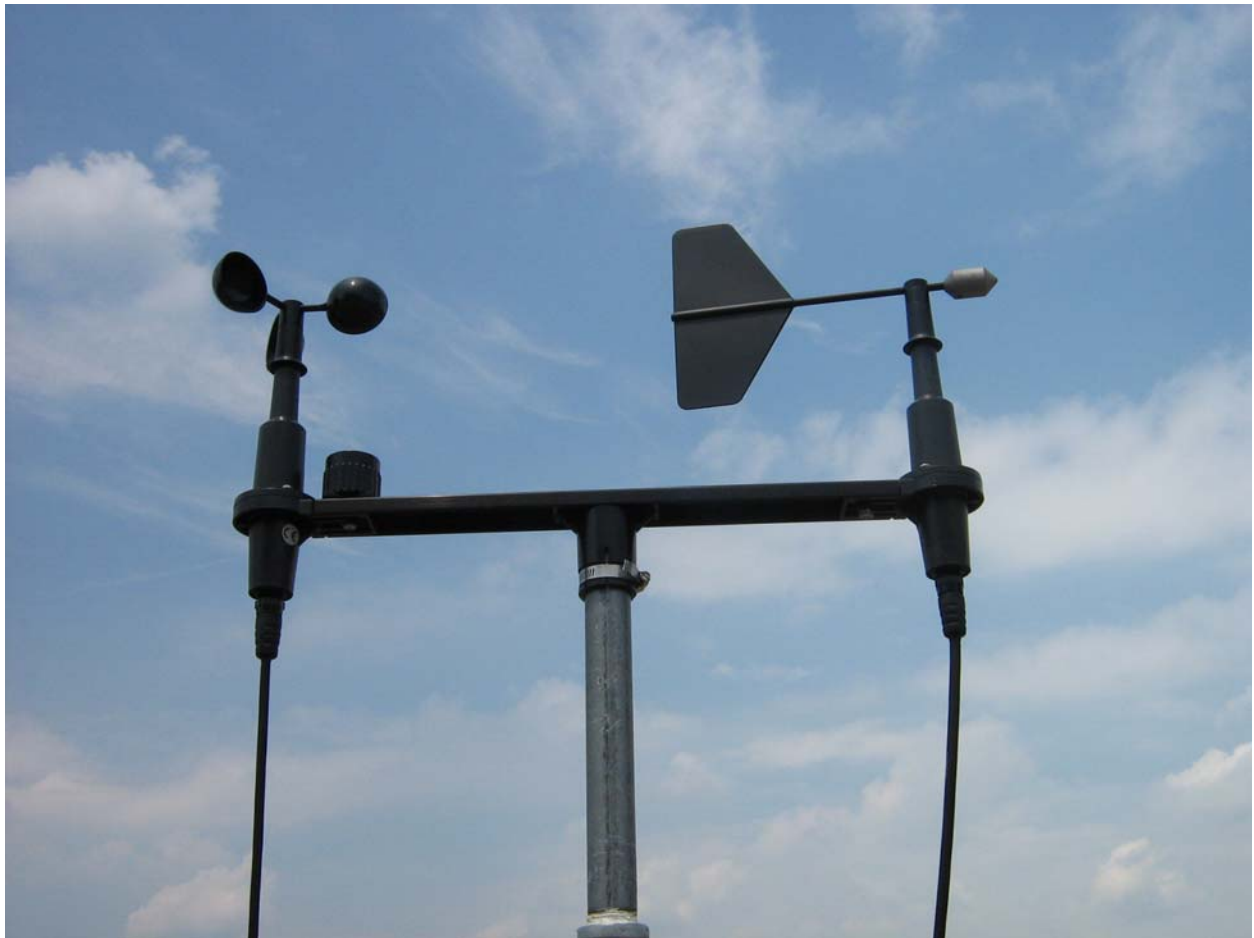
Figure 28 - The Wind Speed Anemometer (Left) and Wind Direction Vane (Right)

The wind speed anemometer (Figure 28) returns a sinusoidal wave of voltage readings. The program first calculates the number of peaks in the wave during a one second period. This value is then translated to a wind speed in miles per hour.
