**STORMWATER RUNOFF MITIGATION AND WATER QUALITY IMPROVEMENTS
THROUGH THE USE OF A GREEN ROOF IN PITTSBURGH, PA**

Submitted to the Graduate Faculty of
the School of Engineering in partial fulfillment
of the requirements for the degree of
Master of Science

University of Pittsburgh

2007

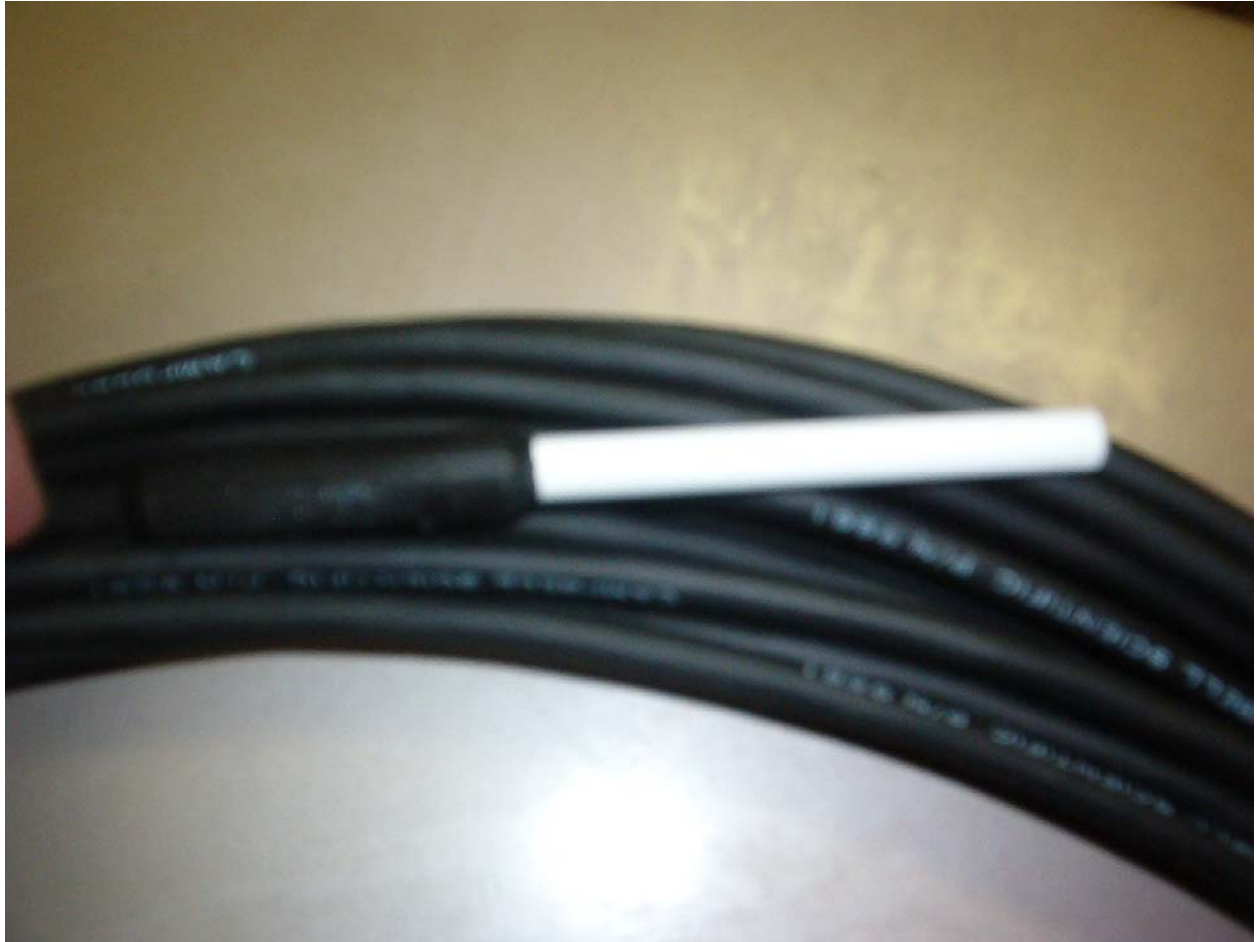
Figure 29 - 107-L Temperature Sensor

The 107-L temperature sensors (Figure 29) used on the soil surface follow the same procedure, but the voltage readings are converted to degrees Fahrenheit.

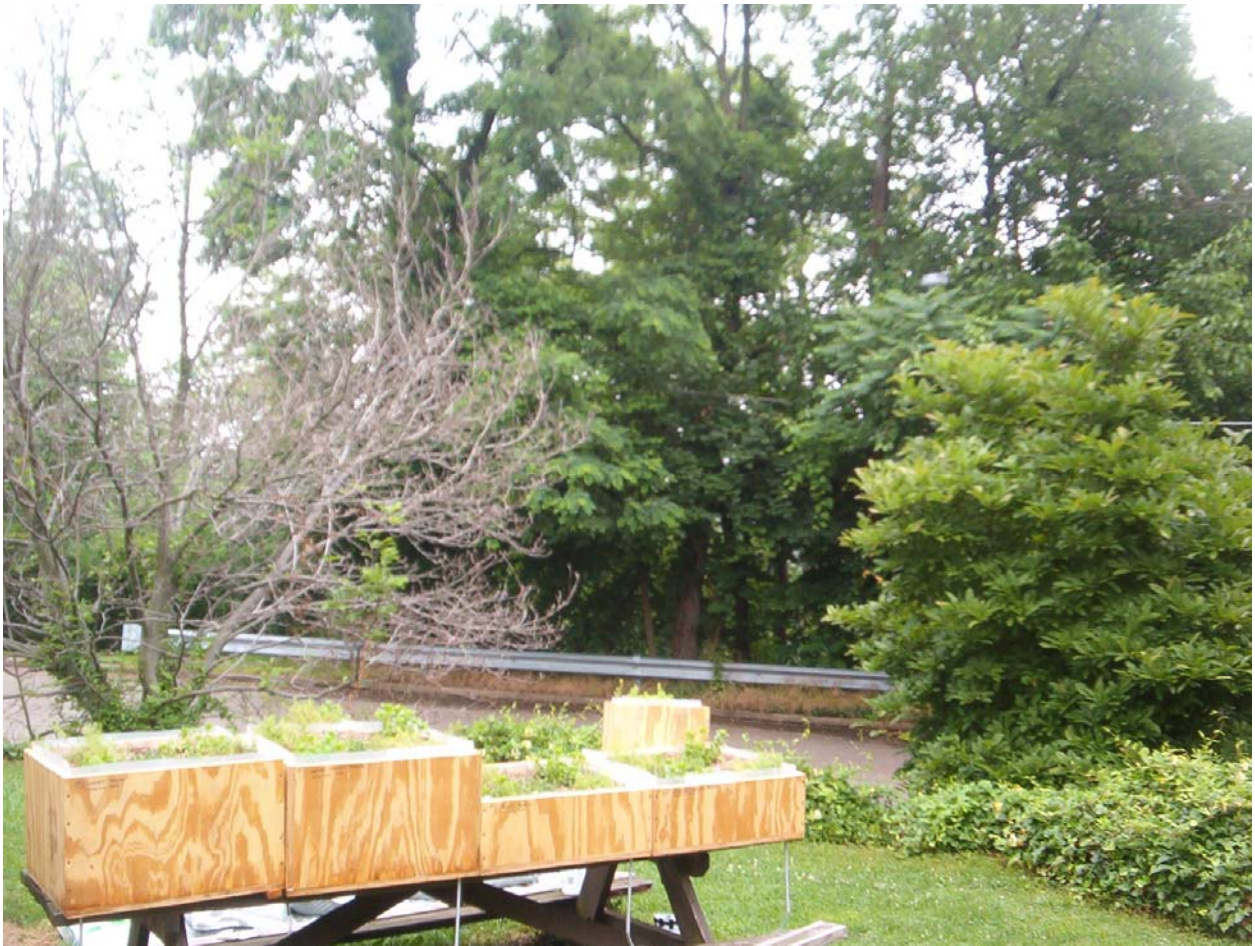
Figure 33 - Pilot Project Green Roof Test Plots

The pilot project consisted of six green roof test plots (Figure 33). Four of the plots were two-foot by two-foot in size, while the other two were one-foot square. Two of the two-foot square test plots were intensive green roofs with twelve inches of soils, as was both of the one-foot square test plots. The other two large test plots were extensive green roofs with a five and a half inch substrate (Figure 34).

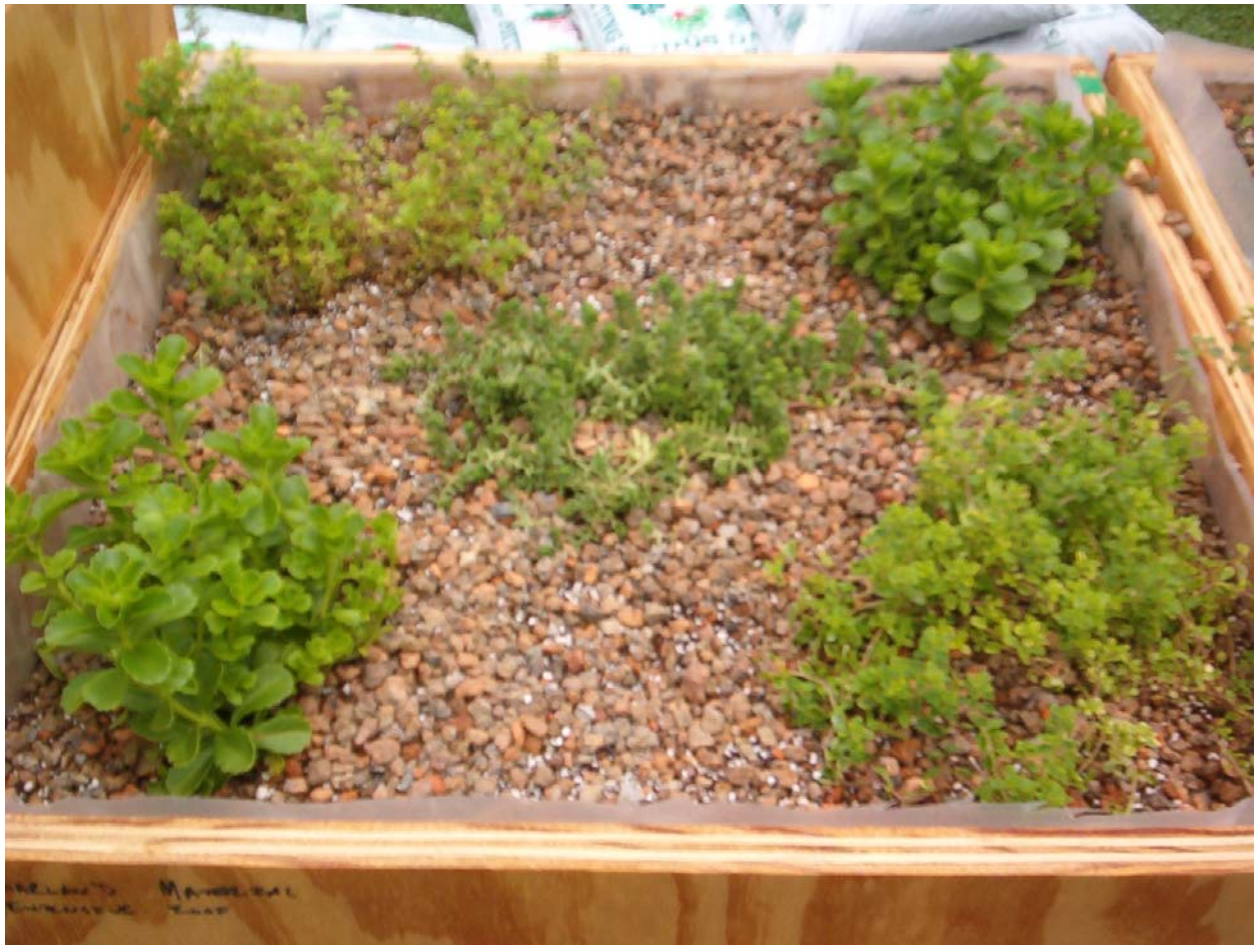
Figure 34 - Garland Extensive Green Roof Test Plot

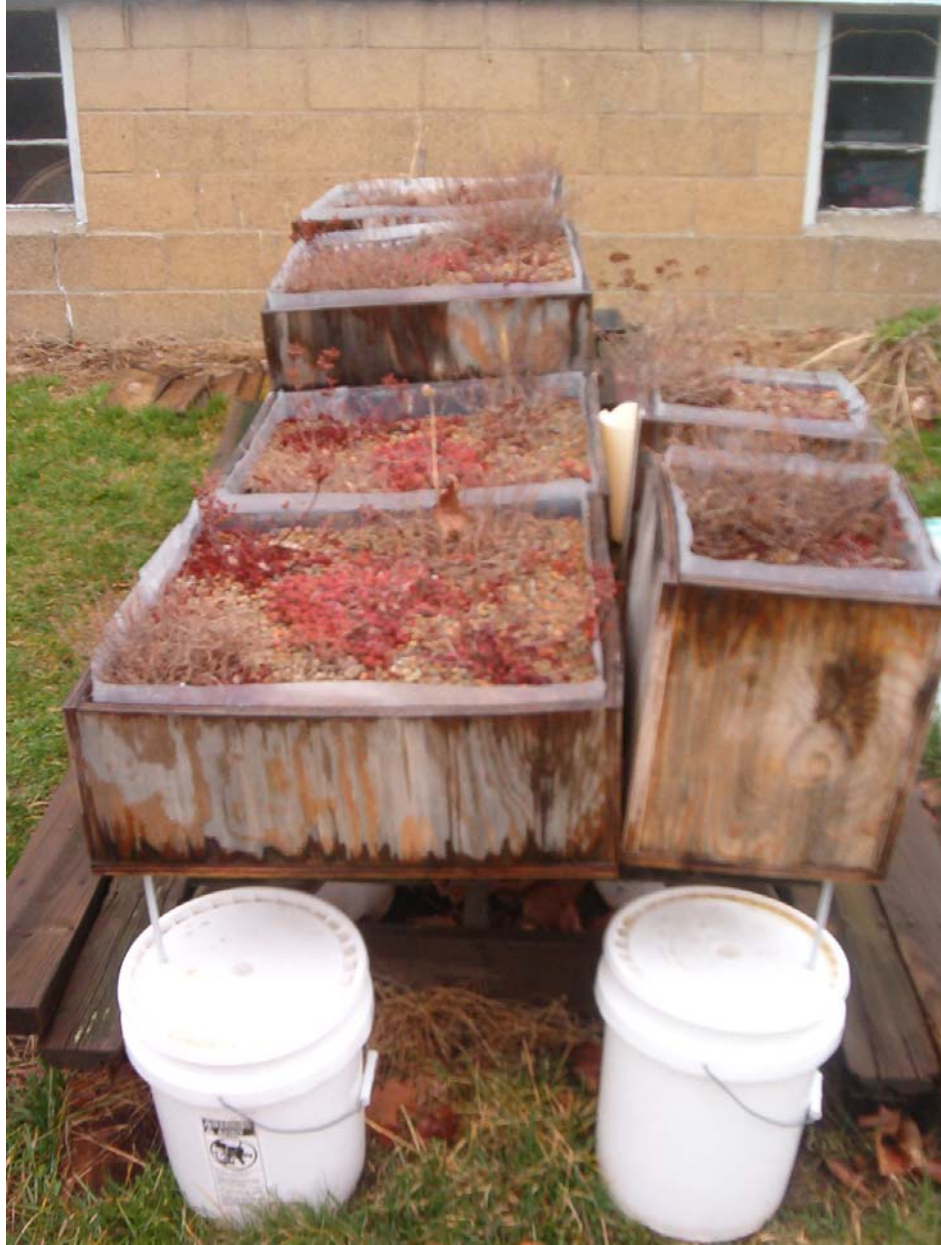
Figure 35 - Pilot Project Collection Buckets

To monitor the amount of runoff leaving each green roof test plot, a drain pipe was placed in a corner of the plots which was then connected to a bucket (Figure 35). Actual rainfall and runoff data was collected, along with several simulated storms. After each rain storm or test, the amount of water in each bucket was recorded, along with the amount of rainfall from a simple grain gauge positioned next to the plots.

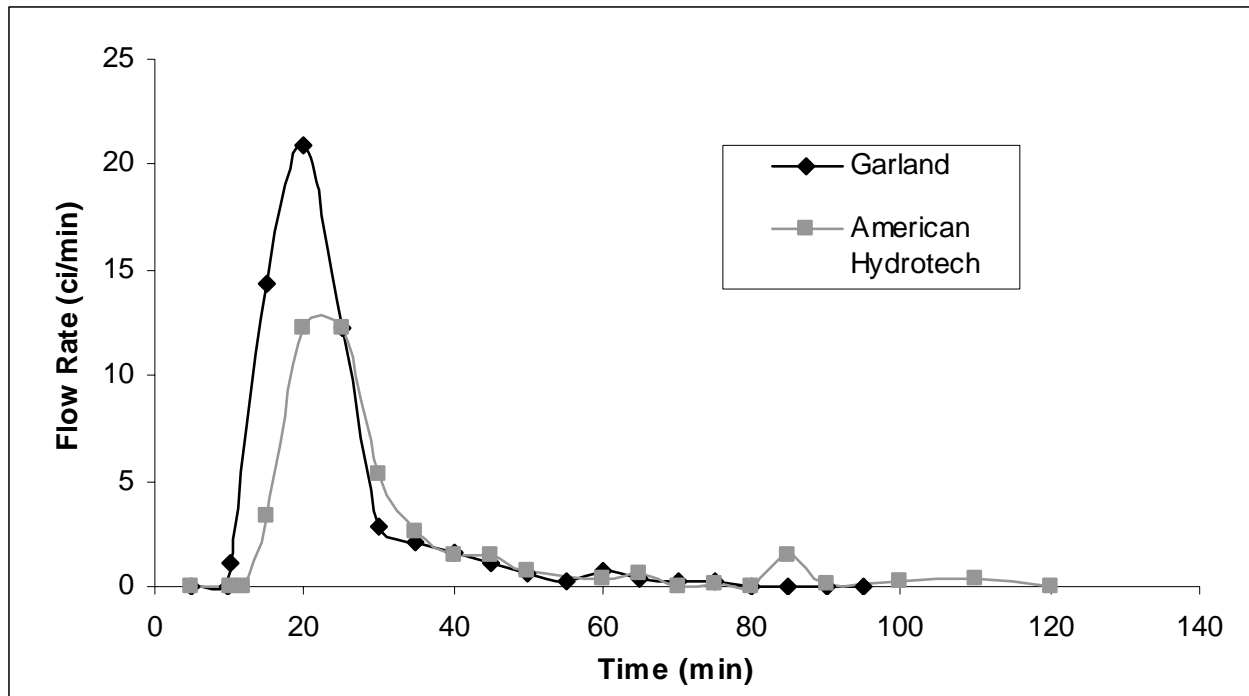
Figure 36 - Intensive Green Roof Flow Rates - Controlled Runoff Experiment 1

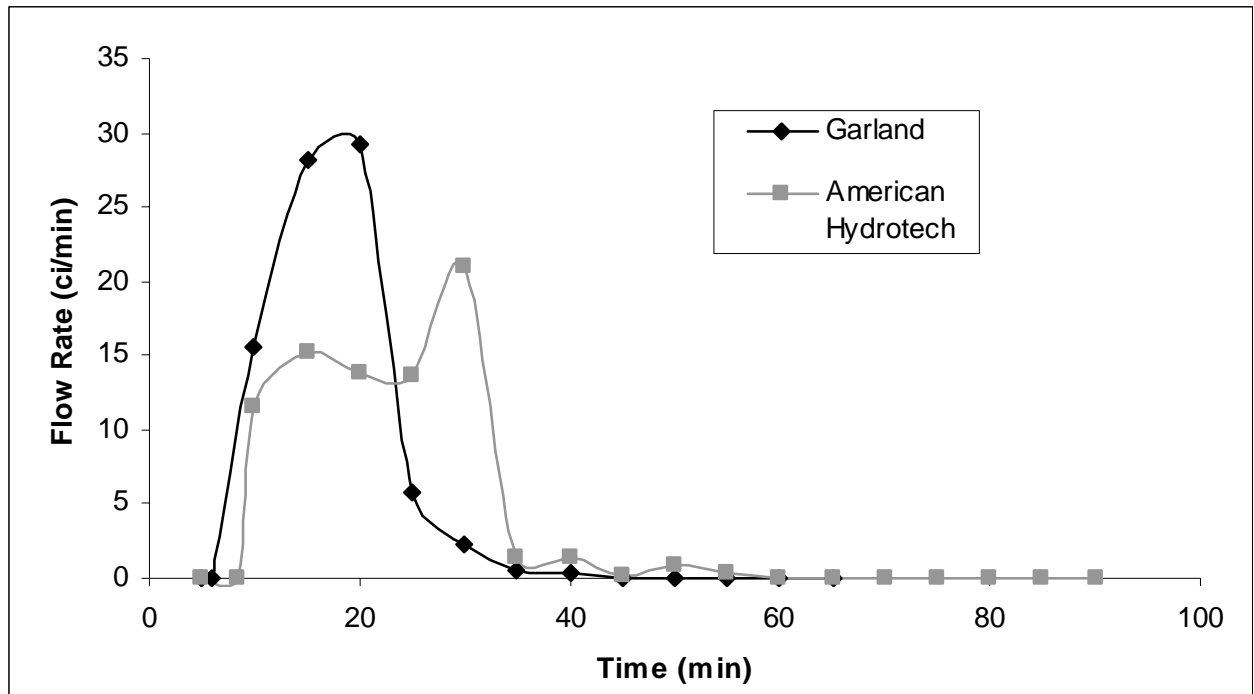
Figure 37 - Extensive Green Roof Flow Rates - Controlled Runoff Experiment 1

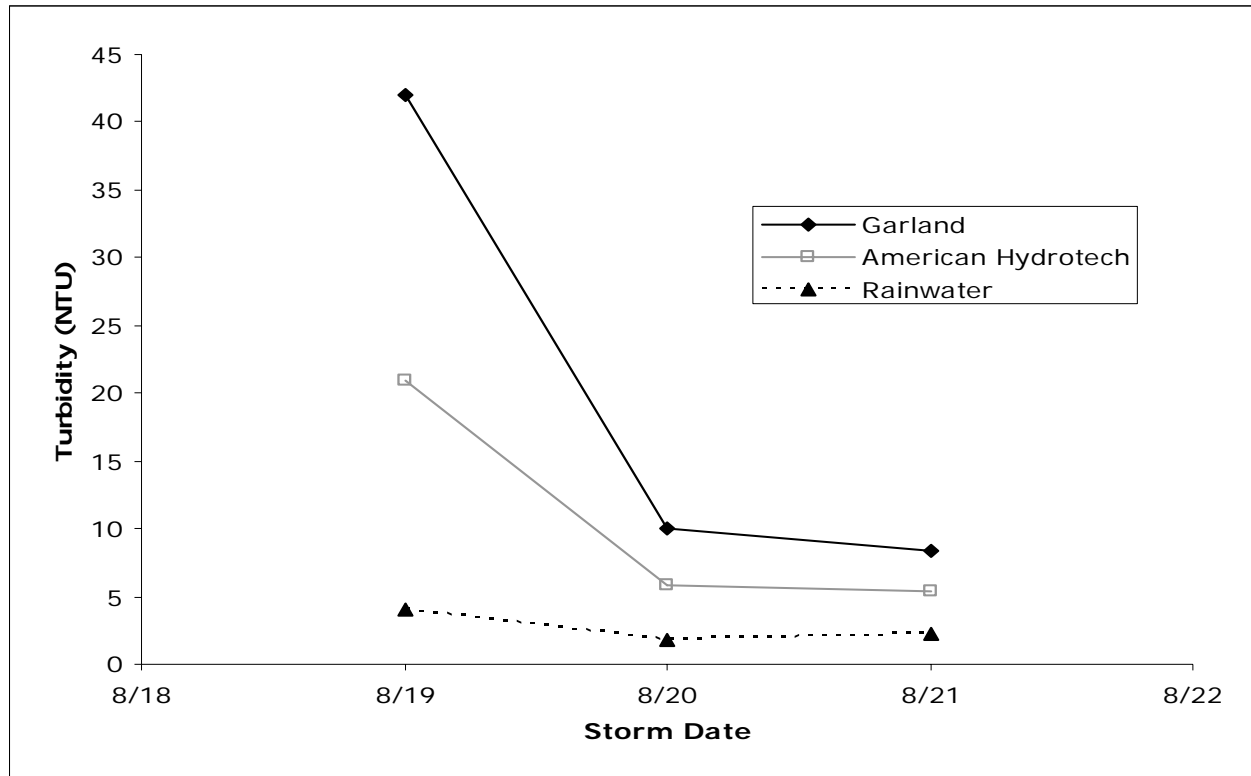
Figure 40 - Turbidity Results

After a three week break without runoff, the process was repeated again, as shown in Figure 40. Turbidities decreased from 42 to 8 NTU to 15 to 5.4 NTU in the course of two days.

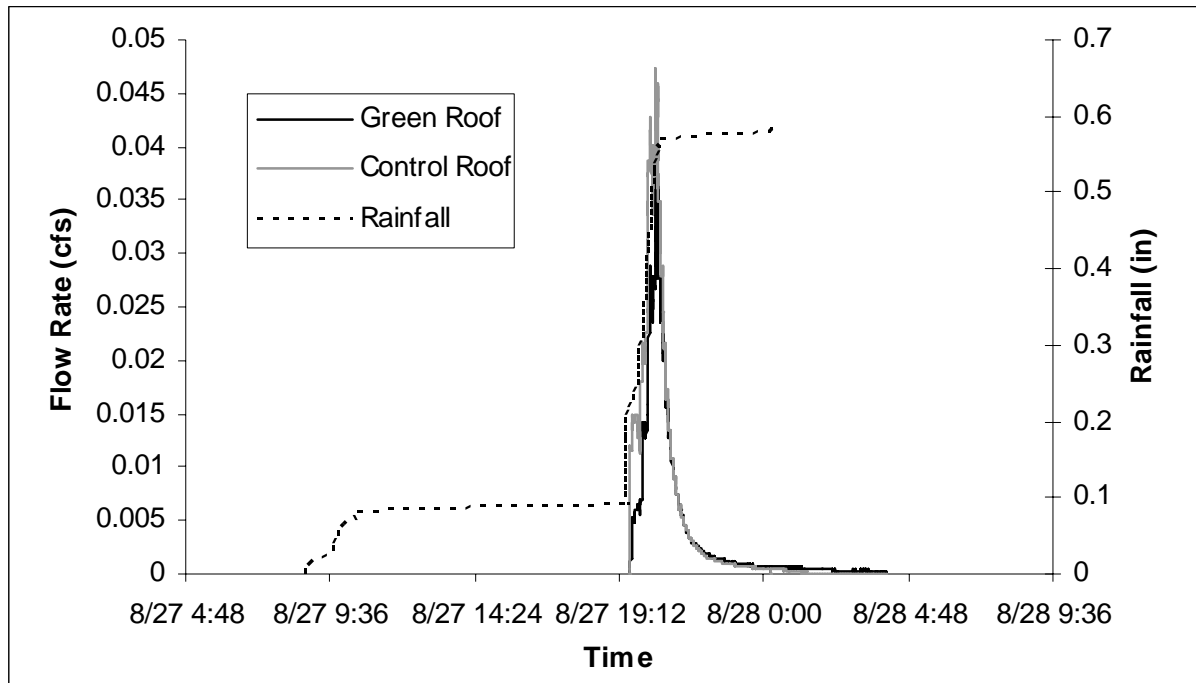
Figure 41 - Runoff Flow Rates - August 27, 2006 Storm
