**ACOUSTIC EMISSION MONITORING OF REINFORCED CONCRETE SYSTEMS
RETROFITTED WITH CFRP**

Submitted to the Graduate Faculty of
Swanson School of Engineering in partial fulfillment
of the requirements for the degree of
Master of Science

University of Pittsburgh

2008

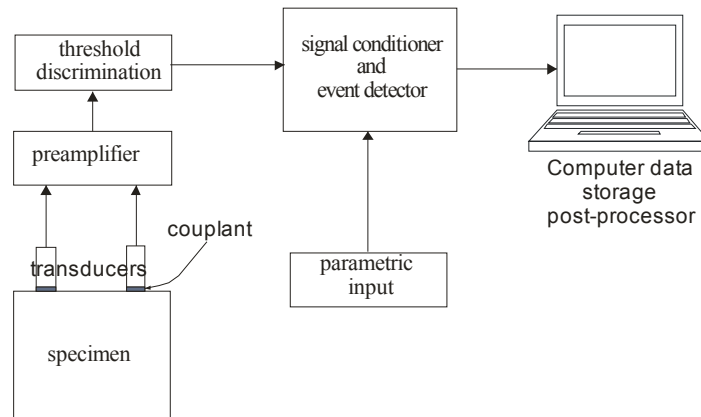
Figure 3-2 Elements of modern AE detection system.

The main elements of a modern AE instrumentation system are shown schematically in Figure 3-2 and they consist of:

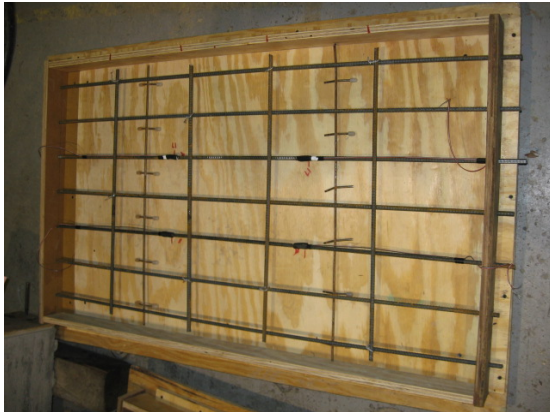
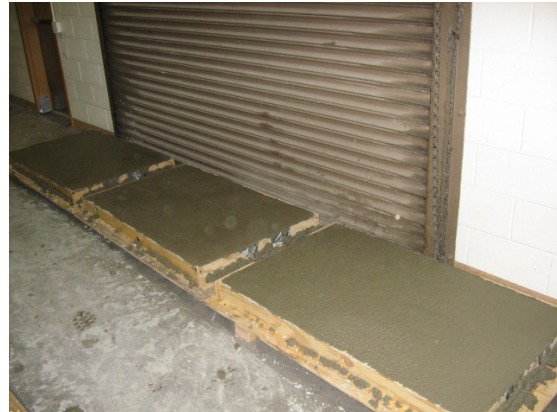
(a) typical formwork

(b) three slabs after casting

Figure 4-2 Typical Formwork and casting of slabs

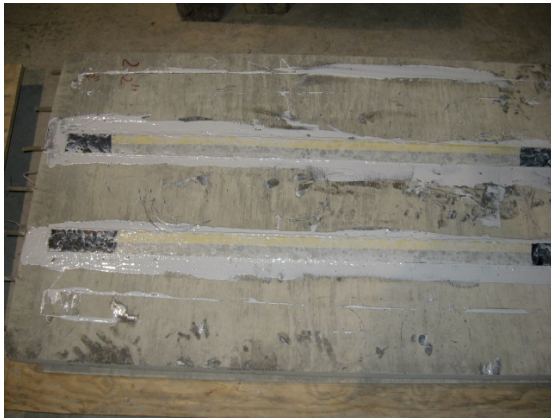
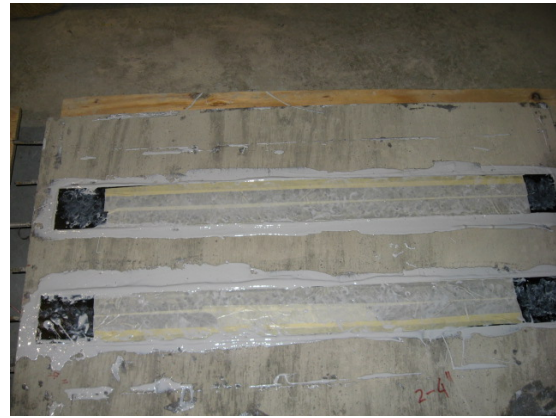
(a) Specimen 2x2

(b) Specimen 2x4

All nine slabs were tested in a monotonic load-to-failure protocol under displacement control and monitored using an AE instrumentation suite. Each slab possessed a different CFRP strip geometry described by the ratio of CFRP width-to-CFRP spacing (b_f/s). Typical retrofitted slab specimens are shown in Figure 4-3.

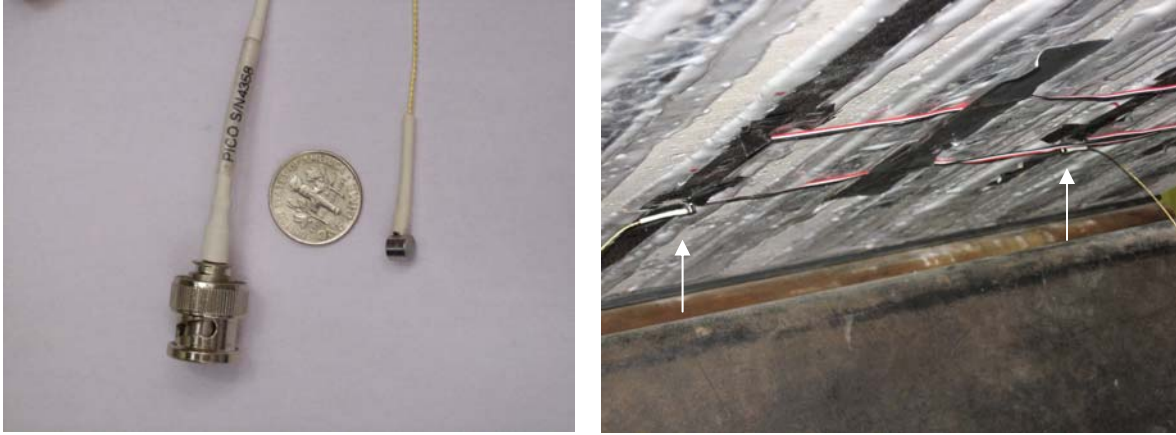
(a) Broad-band PICO sensor (AE)

Figure 4-6 Details of the AE workstation and sensor employed.

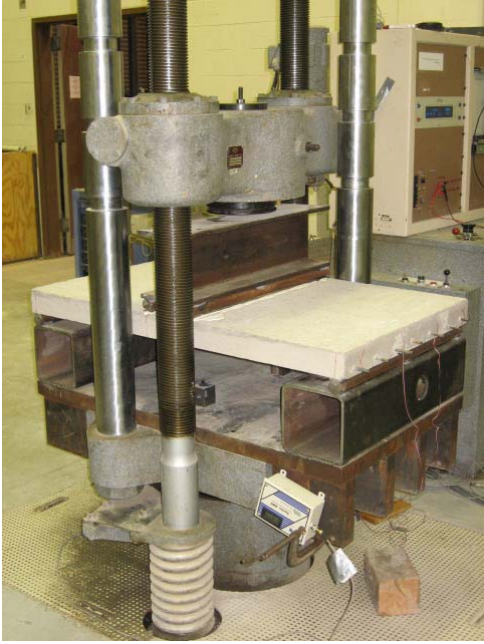
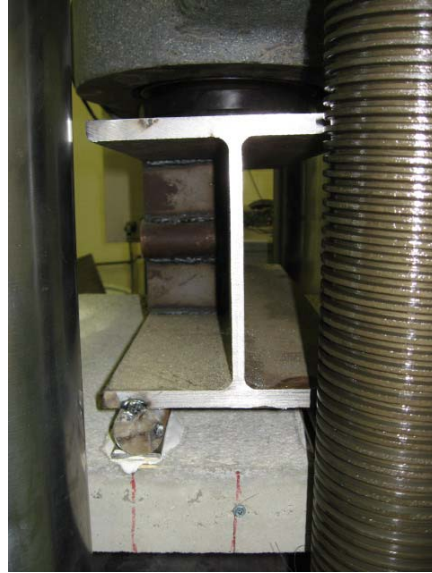
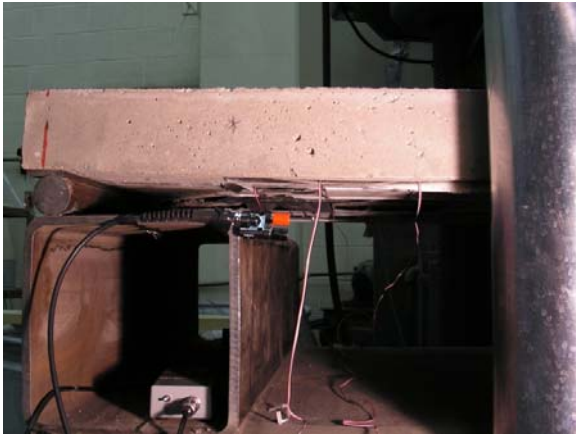
(a) Overall test set-up

(b) Details of the loading arrangement

(c) Details of the support

(d) Draw wire transducer details

All the slab specimens were tested in a monotonic load-to-failure protocol under a four point bending (flexural) load set-up. The test frame was mounted in a Baldwin universal testing machine (UTM) with a capacity of 200 kips (890 kN). Loading was applied at midspan using a system of two 1.5 in. (38 mm) diameter rollers spaced at 6 in. (152 mm) which loaded the slab uniformly across its entire width. The 30 in. (762 mm) wide by 50 in. (1270 mm) long one way slabs were simply supported over a clear span of 48 in. (1220 mm). Photographs of the test setup, support condition and instrumentation are shown in Figure 4-8.

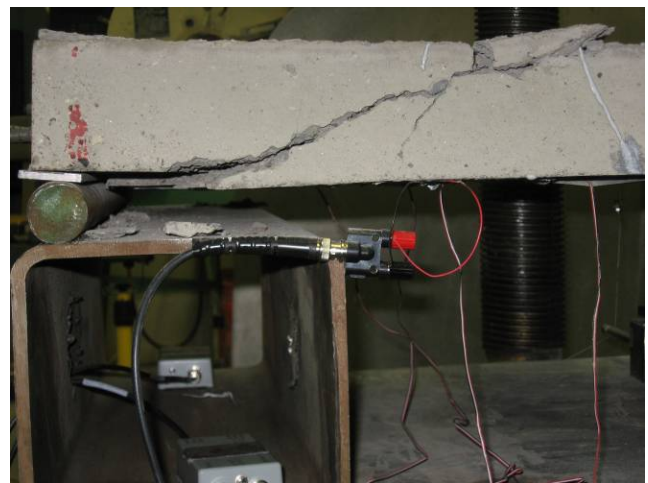
(a) debonding of CFRP (Specimen 1x4).

(b) shear failure of Specimen 4x2.

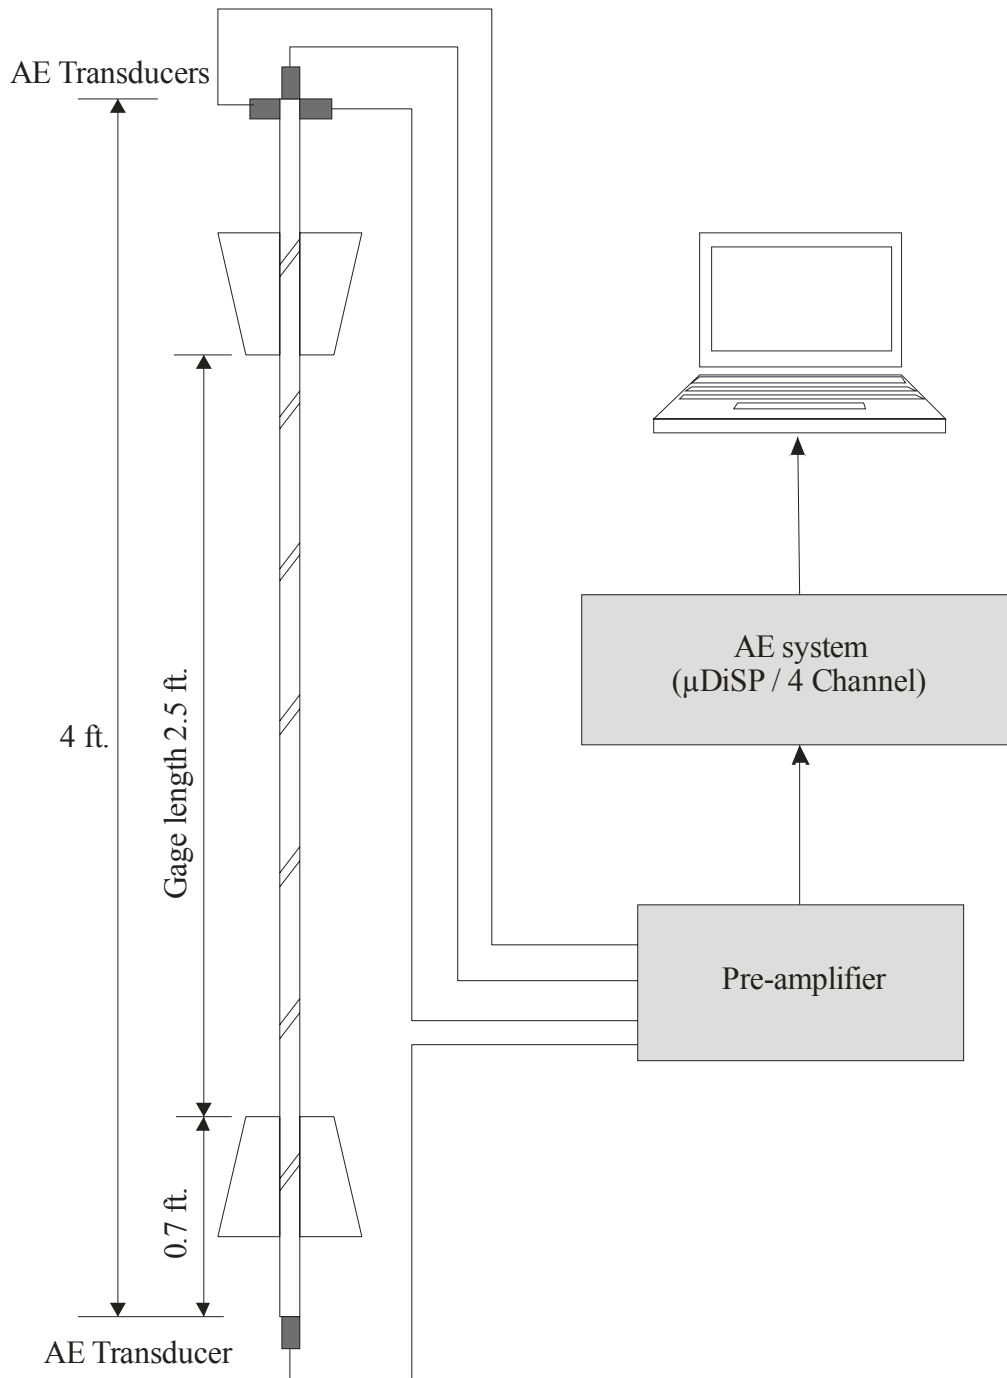
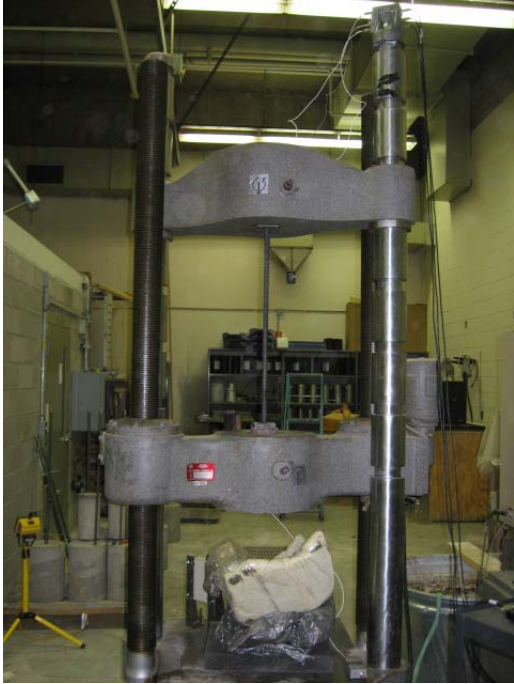
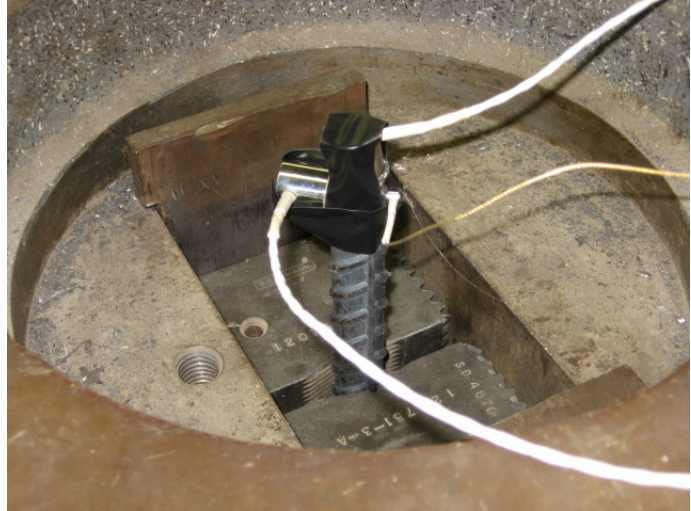
Figure 7-2 Details of the test setup

(a) Test setup

(b) AE sensor arrangement on top of rebar
