**INVESTIGATION OF TECHNIQUES AND PROCEDURES TO OBTAIN α -Al₂O₃
SCALES ON COATINGS WITH IMPROVED OXIDATION RESISTANCE**

Submitted to the Graduate Faculty of
The School of Engineering in partial fulfillment
of the requirements for the degree of
Master of Science

In this study, two types of coating systems were investigated for their ability to withstand cyclic oxidation conditions. NiCoCrAlY coatings with either 0.1 or 0.5 weight percent yttrium as well as platinum modified aluminide coatings were examined. All of the samples were exposed cyclically, in a bottom-loading furnace at 1100°C in laboratory air. Optical and scanning electron microscopy (SEM) were used to characterize the samples. Various surface treatments were performed on the coatings prior to their exposure. Samples were either exposed as-received, with no treatment, light grit blasted (LGB), light grit blasted and etched with NaOH, or fine polished.

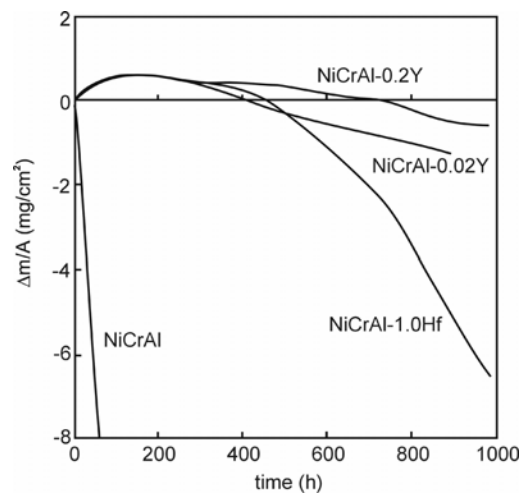
Figure 7. Cyclic oxidation kinetics for model Ni-Cr-Al alloys exposed at 1100°C [16].

As was mentioned previously, it has been found that the addition of small amounts of reactive elements, such as yttrium, can significantly enhance the oxidation resistance of high temperature alloys [13]. The reason for this is not completely understood. Both alumina and chromia-forming alloys can benefit from the addition of these elements, which also include cerium and hafnium. The main improvements in the oxidation behavior arise from increased adherence of the thermally-grown oxide and a decrease in the growth rate of the oxides [14]. Improving these characteristics leads to better thermal cycling resistance of the oxides. The effect is usually more pronounced in chromia forming alloys, where the oxide grain size is often decreased in addition to the improved adherence and a decrease in oxide growth rate is observed [15]. Figure 7 illustrates the reactive element effect for Ni-Cr-Al alloys under cyclic oxidation conditions. It can be seen that the lifetime of the alloys is greatly increased by the addition of Y and Hf.

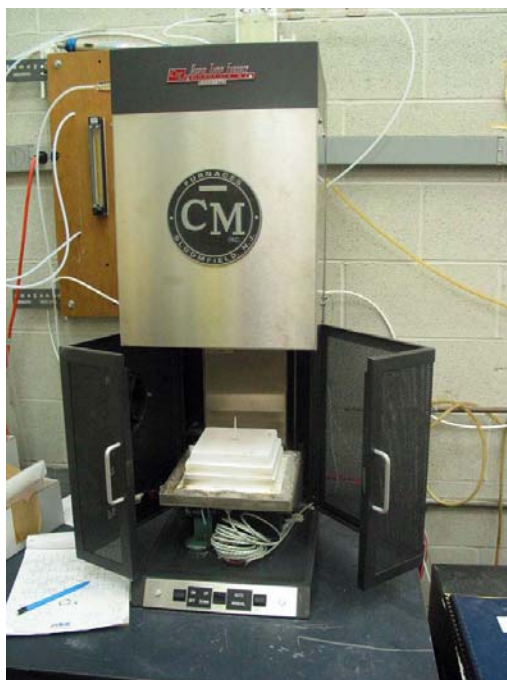
Figure 12. Bottom-Loading Furnace for Cyclic Oxidation Tests

Most of the samples were exposed to cyclic oxidation conditions in a CM bottom-loading furnace in laboratory air. All of the tests were performed at 1100°C. Each cycle consisted of a ten minute heat-up period to 1100°C, a 45 minute hold at temperature, followed by a ten minute cooling period to approximately 100°C with forced laboratory air blowing on the samples. This furnace set-up is shown in Figure 12.

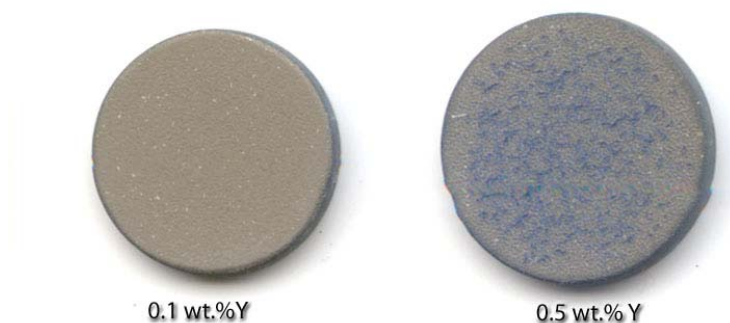
Samples removed after 3700 cycles at 1100°C continued to follow the trend of the previous coatings. Figure 25 shows surface scans of two as-received coatings with different yttrium contents. The blue oxide in Figure 25 has formed a continuous network over almost the entire coating surface of the 0.5 wt% sample. Cross sectional images of this sample are shown below.

Figure 25. Surface Images of Sample Surfaces after 3700 Cycles
