**GREEN ROOF STUDY: STORMWATER QUANTITY, QUALITY AND THERMAL
PERFORMANCE**

Submitted to the Graduate Faculty of
Swanson School of Engineering in partial fulfillment
of the requirements for the degree of
Master of Science

University of Pittsburgh

2009

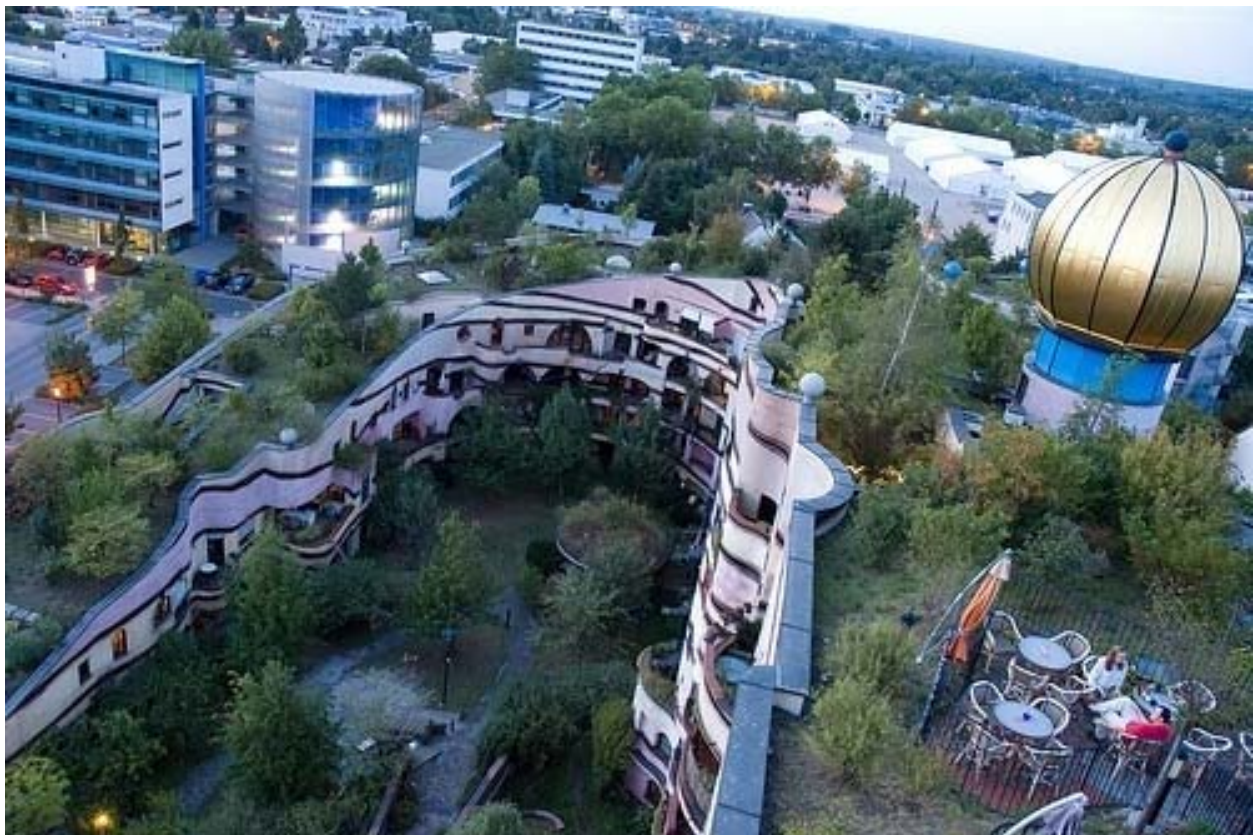
Figure 1. An intensive green roof on the top of Waldspirale, a residential building complex in Darmstadt, Germany

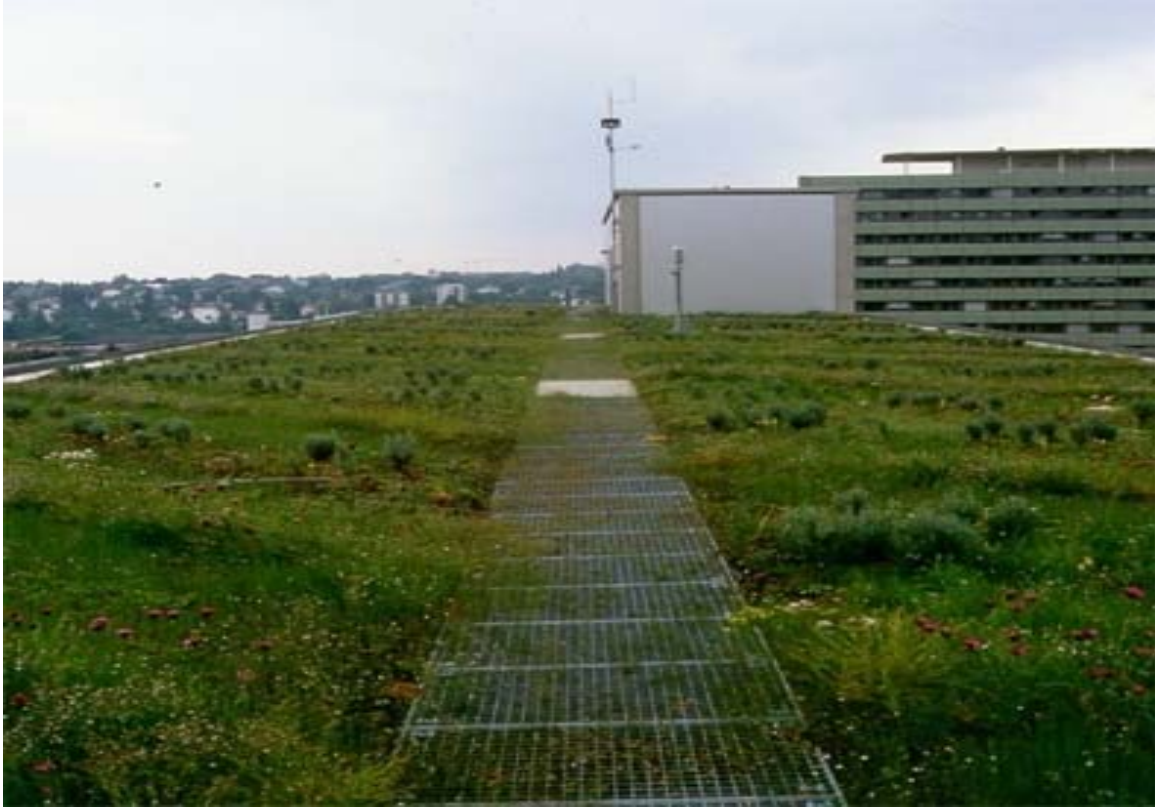
Figure 2. Typical extensive green roof (Soka-Bau green roof case study 2009)

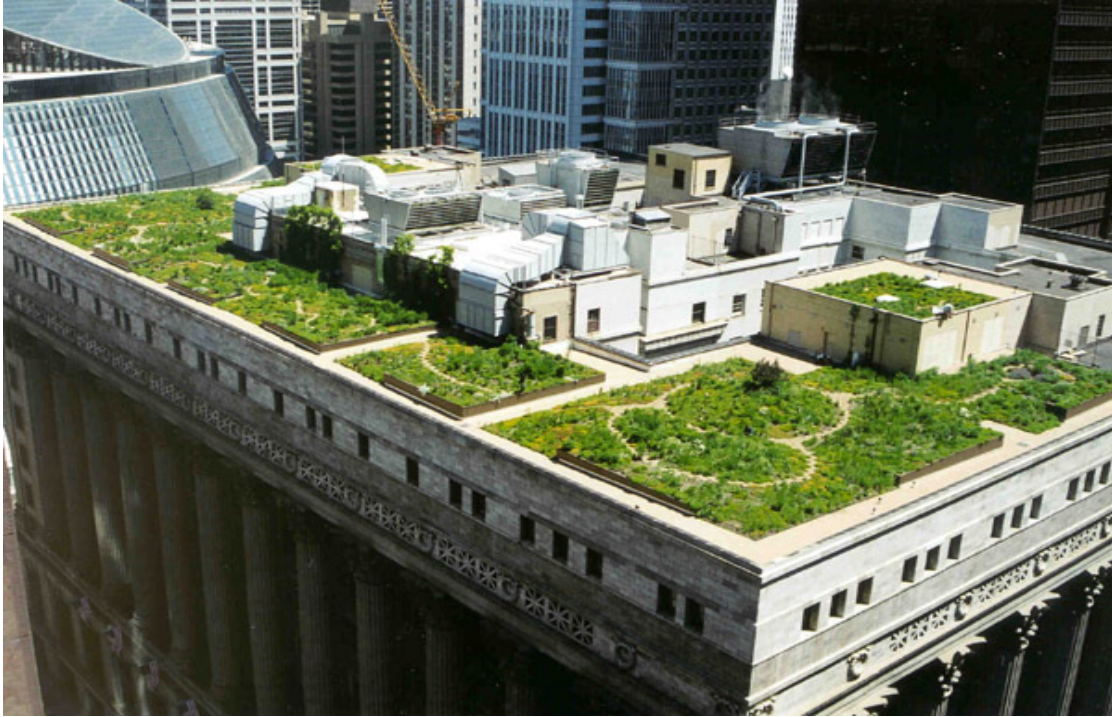
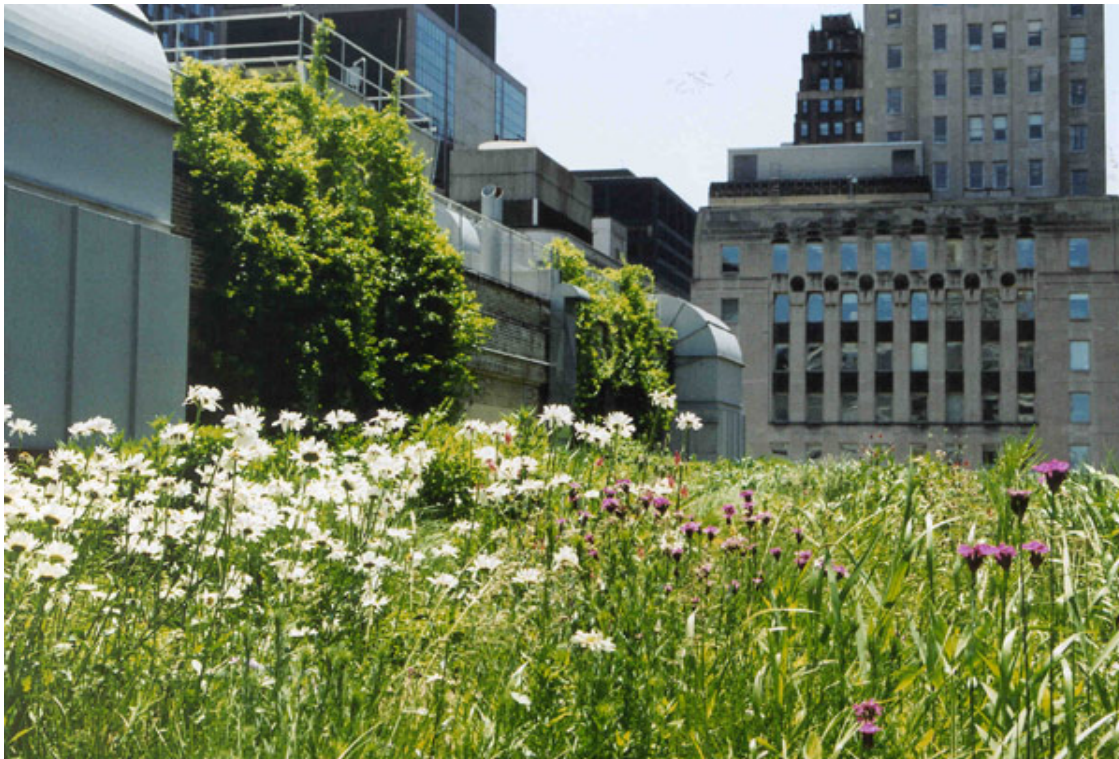
(a) An overview of the green roof on the Chicago City Hall

(b) Plants upon the Chicago City Hall's green roof

Figure 4. Pictures of the green roof on the Chicago City Hall (images by www.cityofchicago.org)

The city of Chicago is one five U.S. cities selected by the EPA to participate in the Urban Heat Island Pilot Project. The goal of the pilot study is to measure elevated ambient air temperatures in a metropolitan area and study the benefits of cooling urban heat islands to improve air quality. Figure 4 shows two pictures of the green roof on the top of the Chicago City Hall (FEMP 2006).

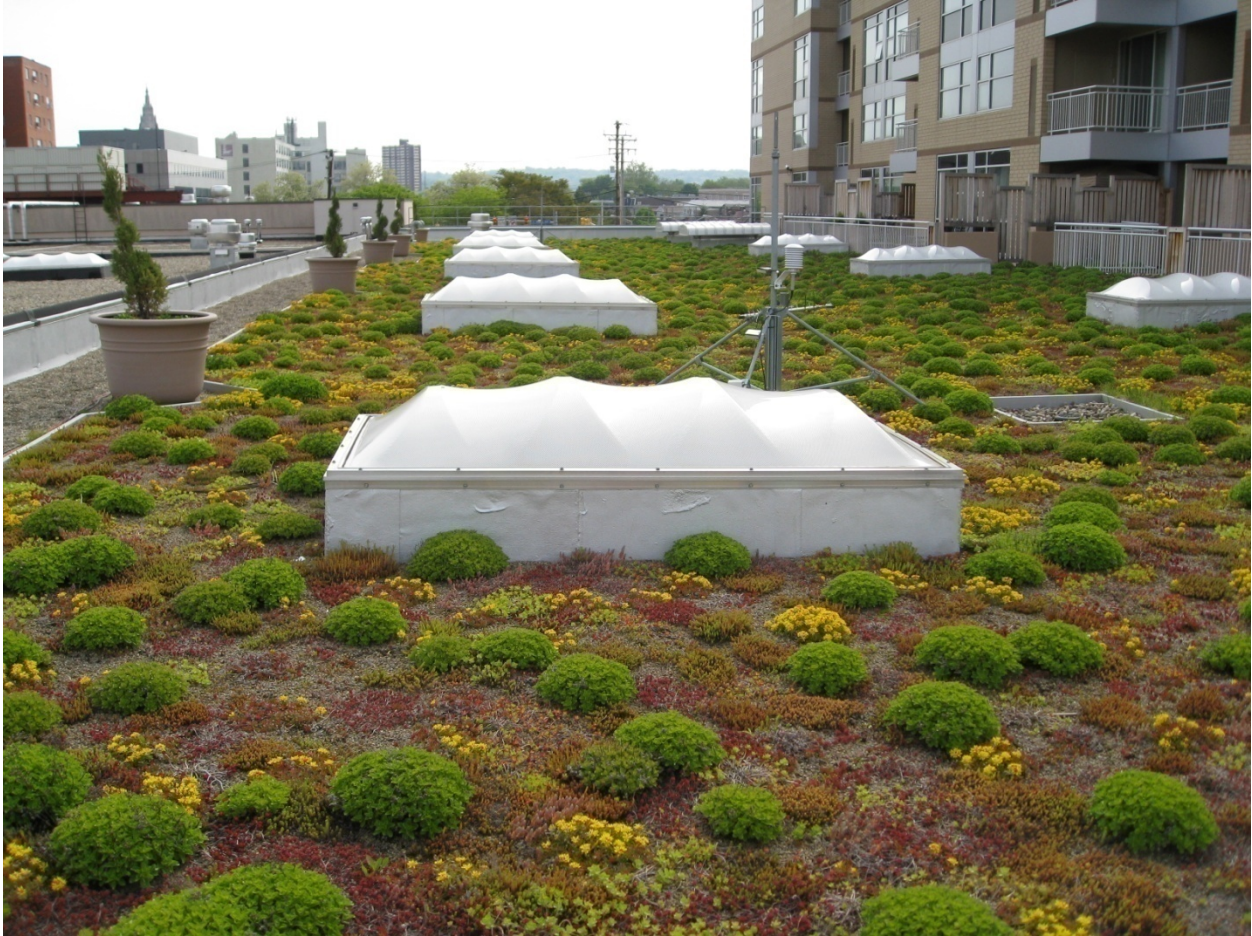
Figure 6. Green roof on the top of the Shadyside Giant Eagle supermarket

Figure 6 and Figure 7 are site overviews of the green and control roof, respectively. One of the tripods located at green roof is shown in Figure 8, and Figure 9 is one of the tripods located at control roof. In addition, two flumes (Figure 10) were disposed outside the building and used for runoff drainage from the green and control roof. Two separate rooftop drains drain similar 3,530 square foot drainage areas of the control roof and green roof, which are directly connected to the flumes.

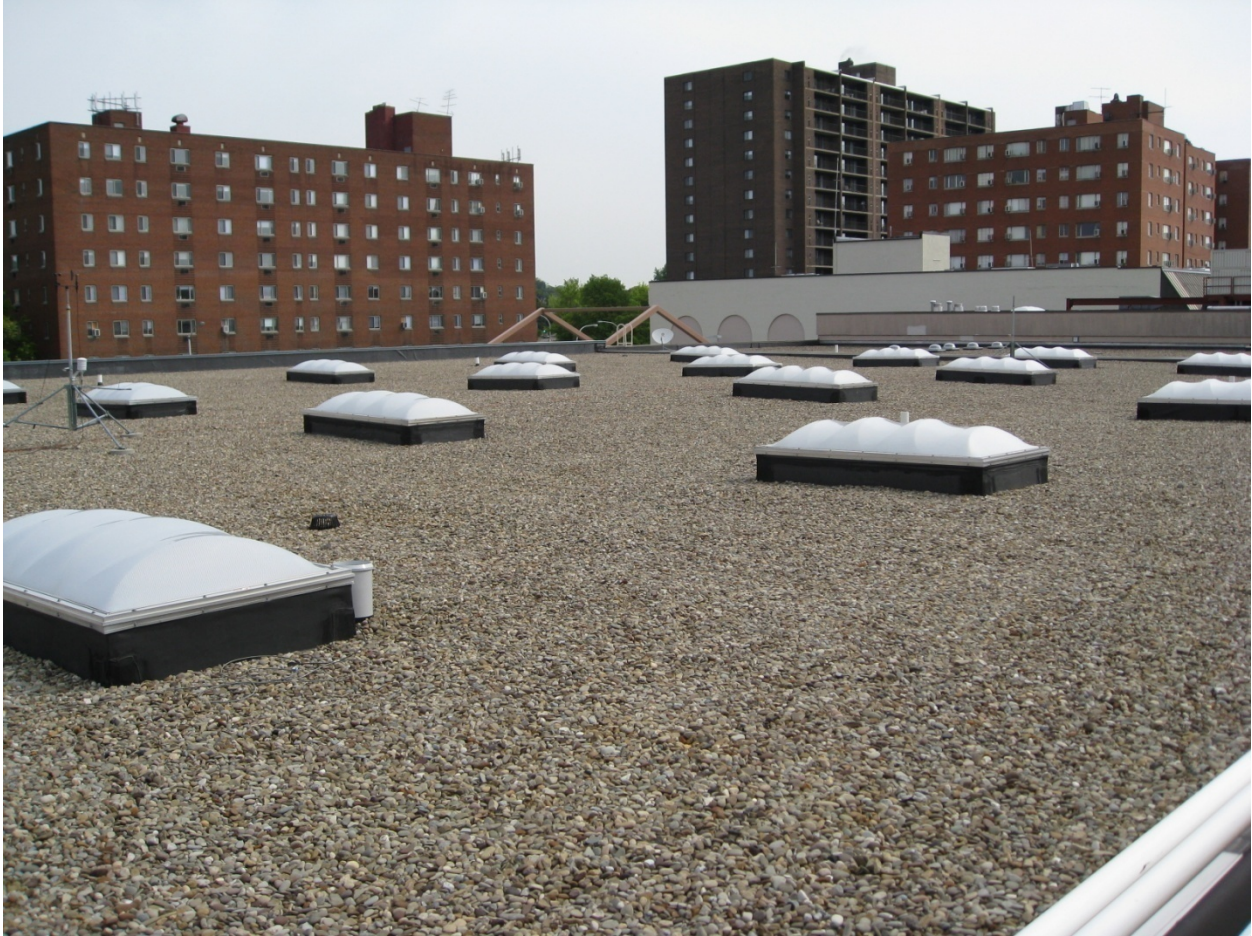
Figure 7. Control roof on the top of the Shadyside Giant Eagle supermarket

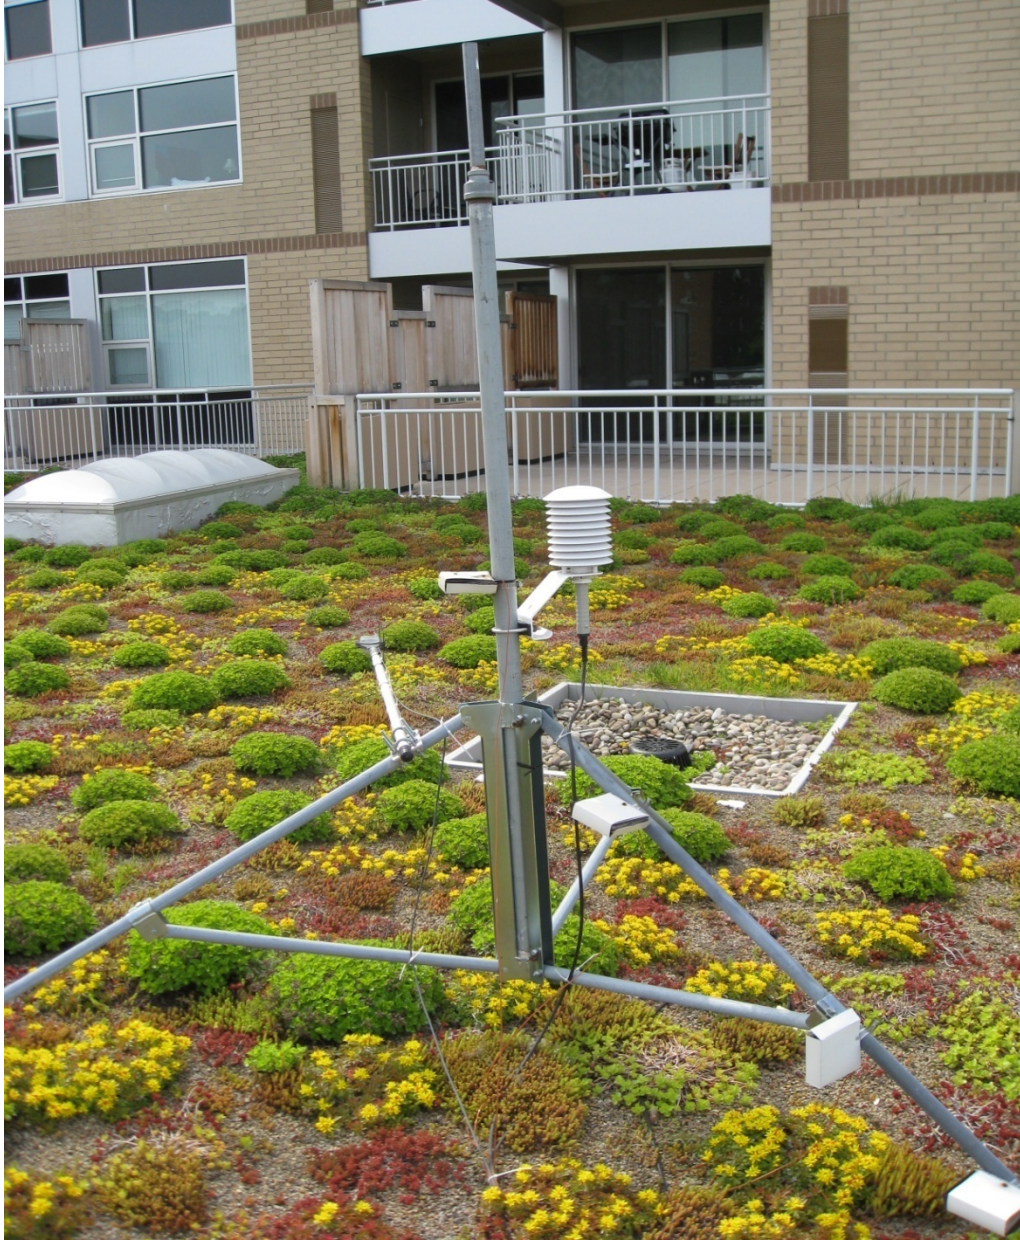
Figure 8. One of the Tripods for monitoring temperature at green roof side (Giant Eagle)

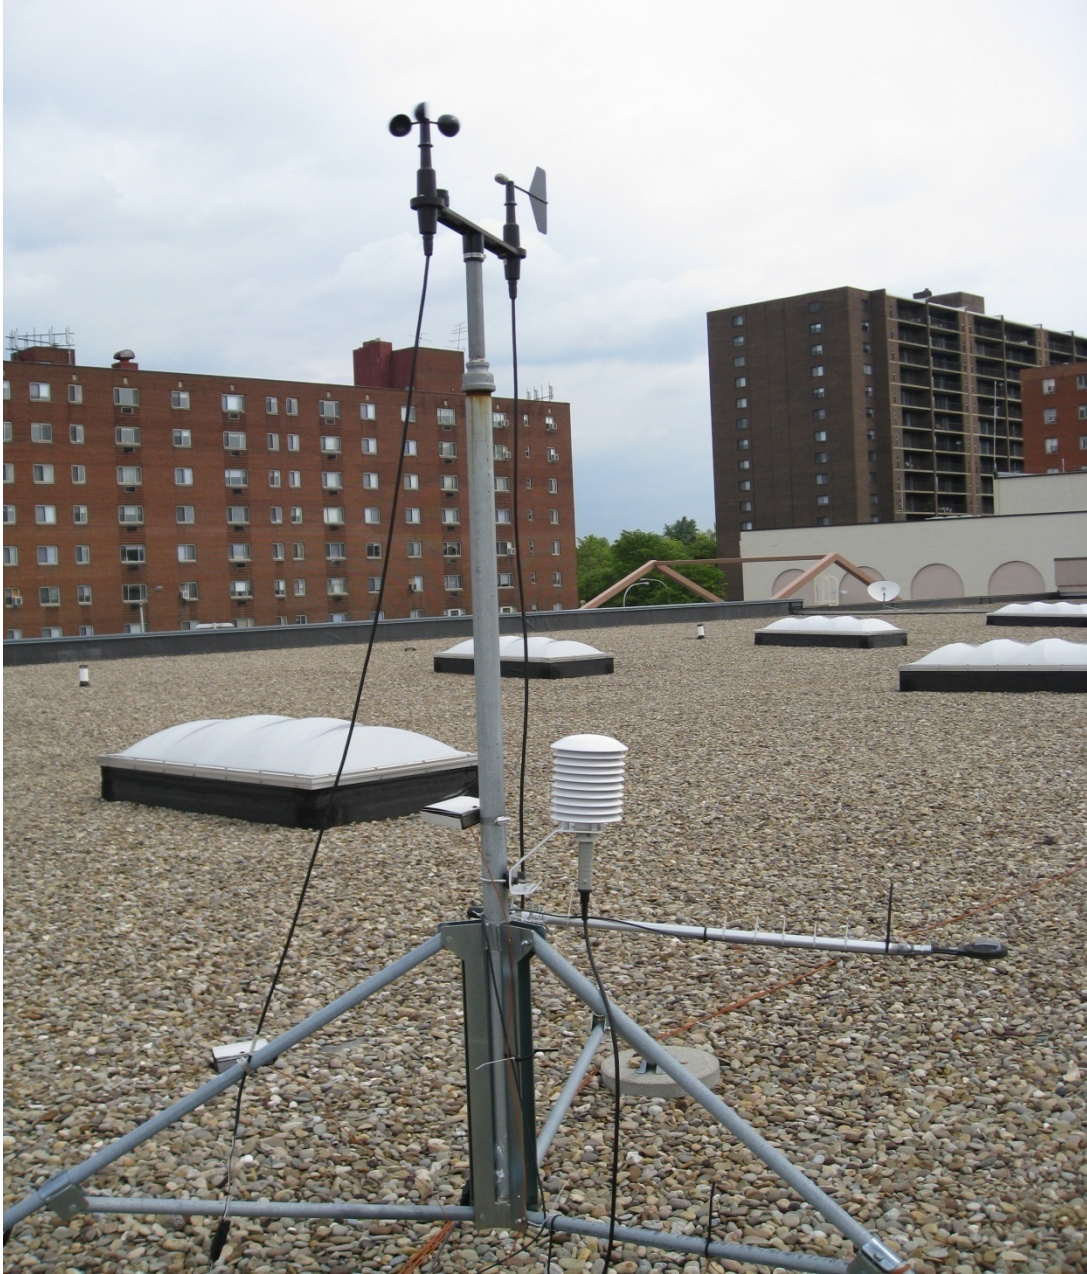
Figure 9. One of the Tripods for monitoring temperature at control roof side (Giant Eagle)

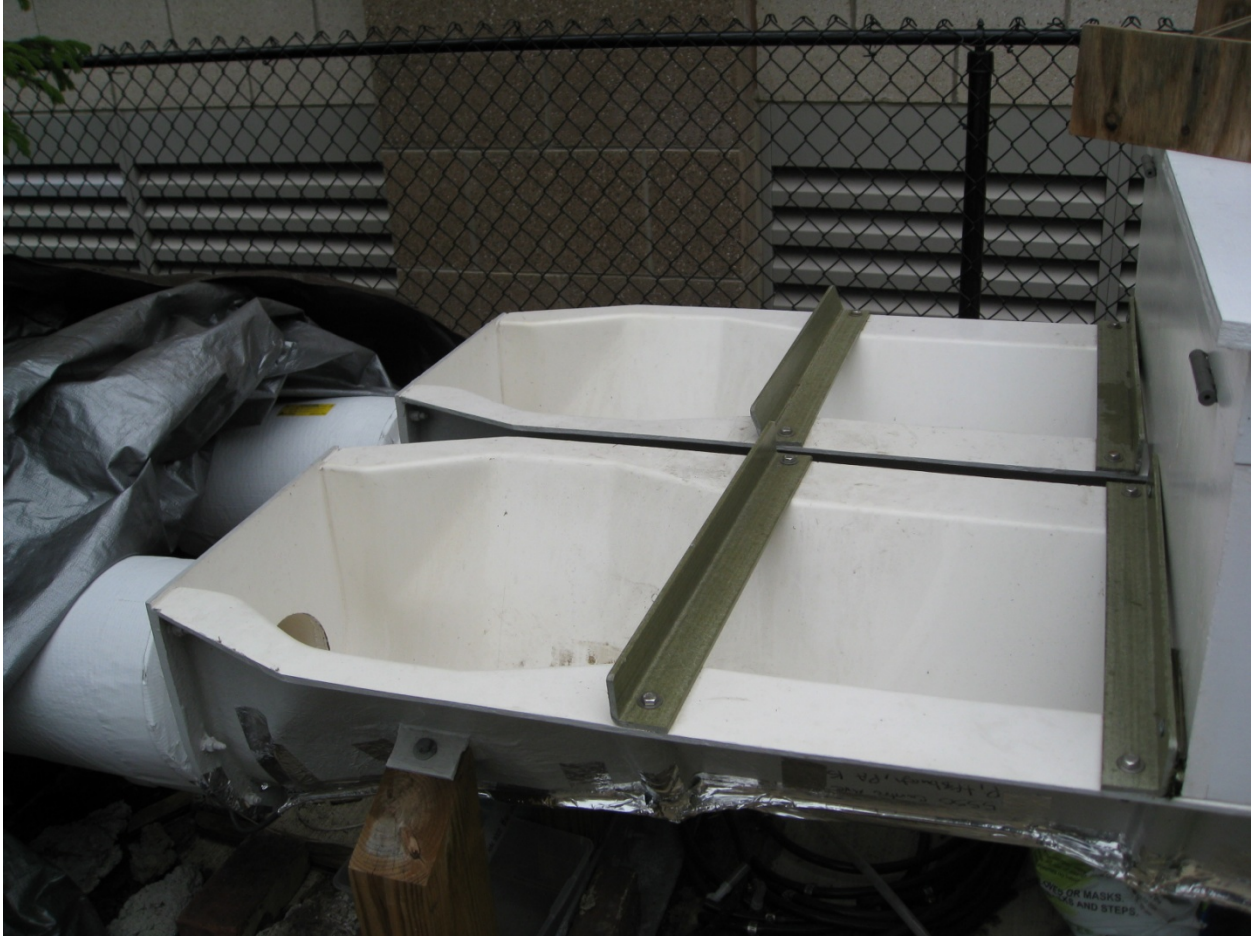
Figure 10. Flumes for runoff drainage at Giant Eagle site

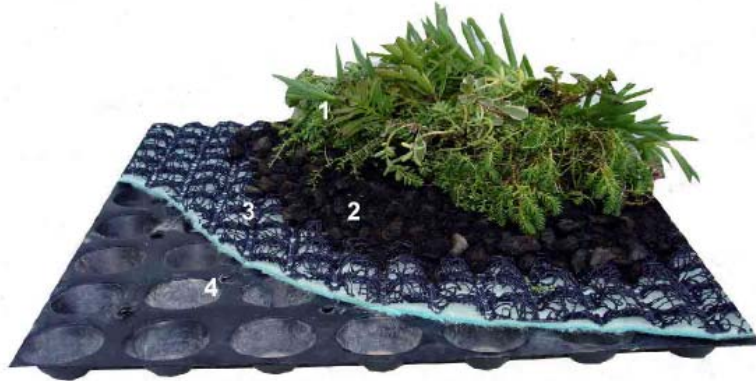
1. Vegetation
2. Engineered Lightweight Growing Media
3. Water Retention Mat and Root Stabilizer
4. Water Reservoir

Figure 12. Typical GLT Green Roof system Cross-Section (similar to Homestead)
(Source: Green Living Technologies, LLC <http://www.agreenroof.com/>)

There are a few key differences between the Shadyside and Homestead green roofs. The most important difference is in the structure of green roofs. The Shadyside green roof is composed of a five and a half inch thick growing (“soil”) media placed above the filter fabric and drainage layers. The cross section of the Giant Eagle green roof is similar to a typical green roof as shown in Figure 11. The Homestead green roof, on the other hand, has a one and a half inch thick growing media that covers a series of water reservoirs. All water reservoirs are interconnected with holes on its upper portion for drainage purposes. These water reservoirs are able to retain part of stormwater when rainfall comes and the water retained is stored for plant irrigation during dry periods. An illustration of the green roof system manufactured by Green Living Technologies, L.L.C. (GLT) that was installed at the Homestead site is shown in Figure 12.

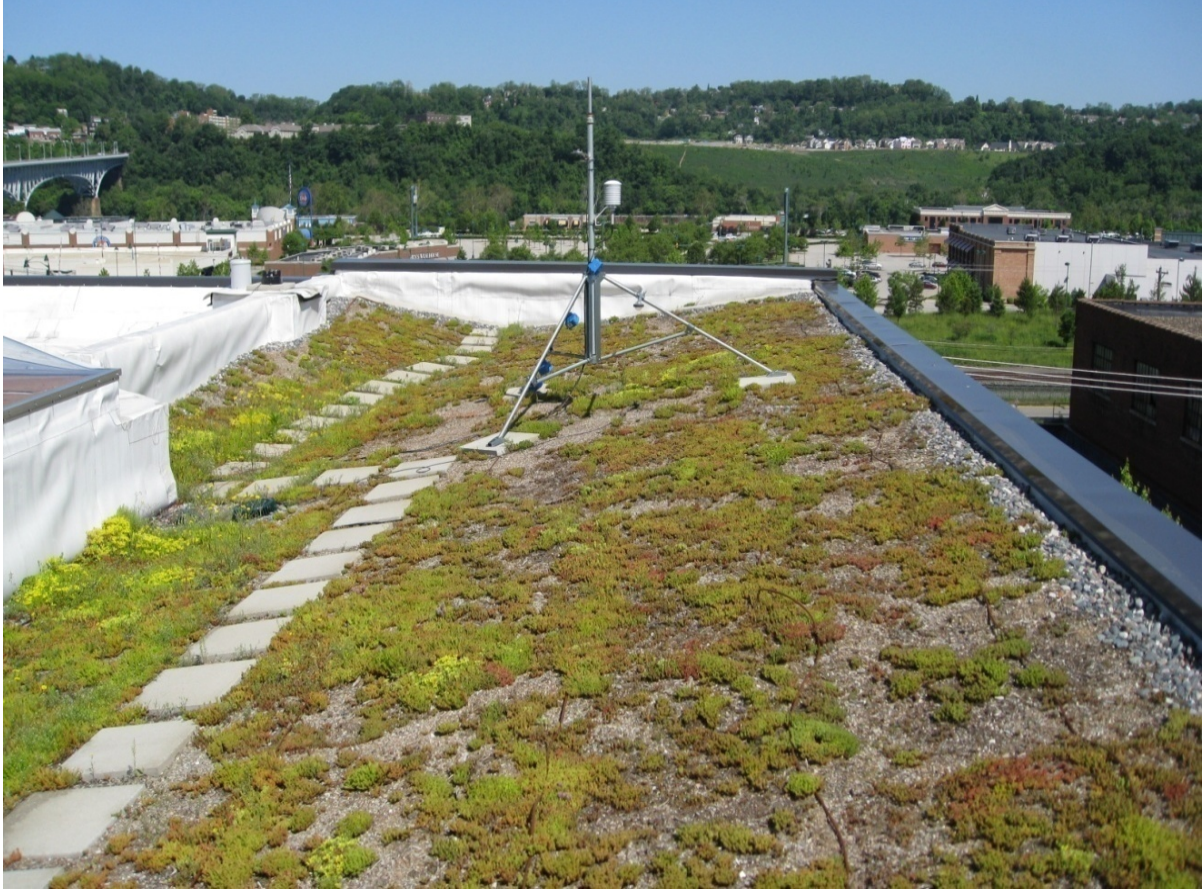
Figure 14. GLT Green roof at Homestead site

The rooftop layout at Homestead site is shown in Figure 13, including the position of monitoring locations. Photographs of green roof and control roof located at Homestead are

shown in Figure 14 and Figure 15 respectively. Each roof covers approximately 2000 square feet. A small paver-based sidewalk across the green roof gives people access to the roof. The control roof is covered with a waterproofing membrane and separated from the green roof by a parapet wall.

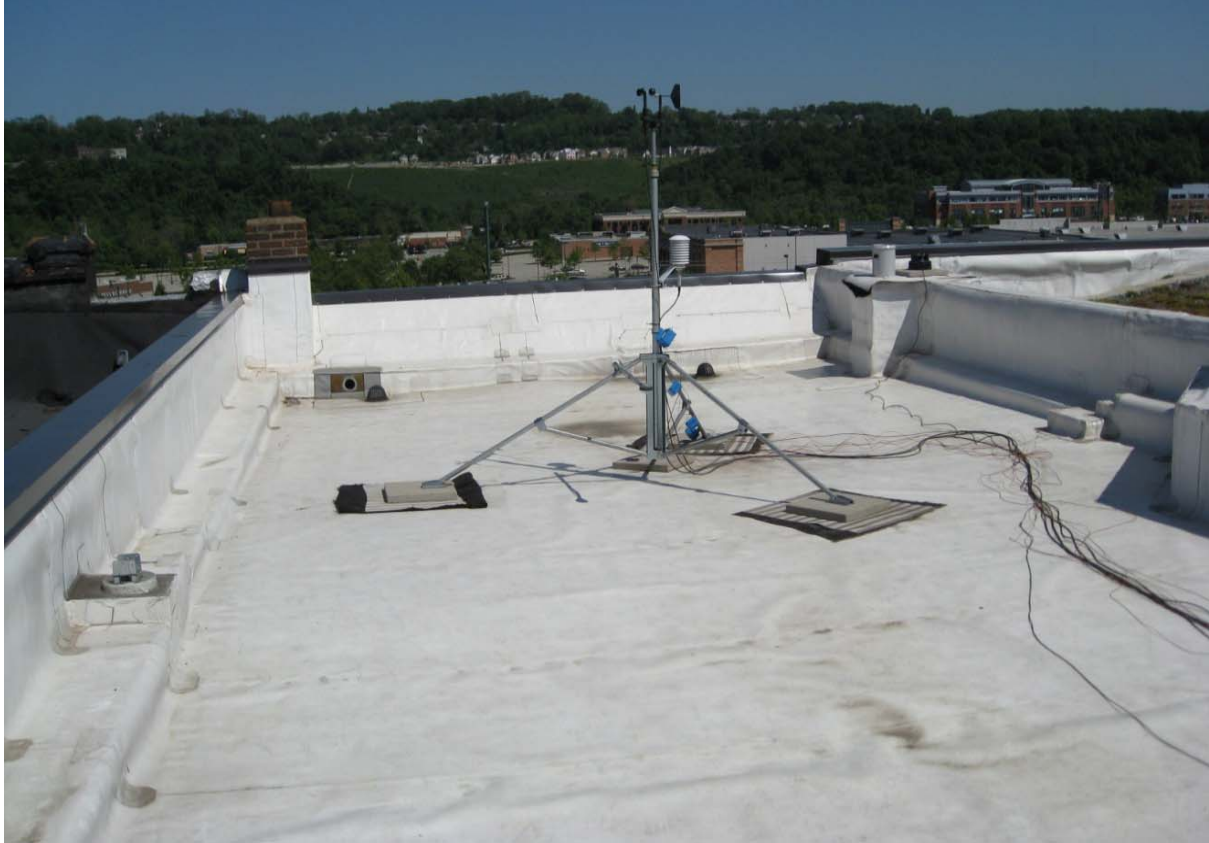
Figure 15. Control roof at Homestead site

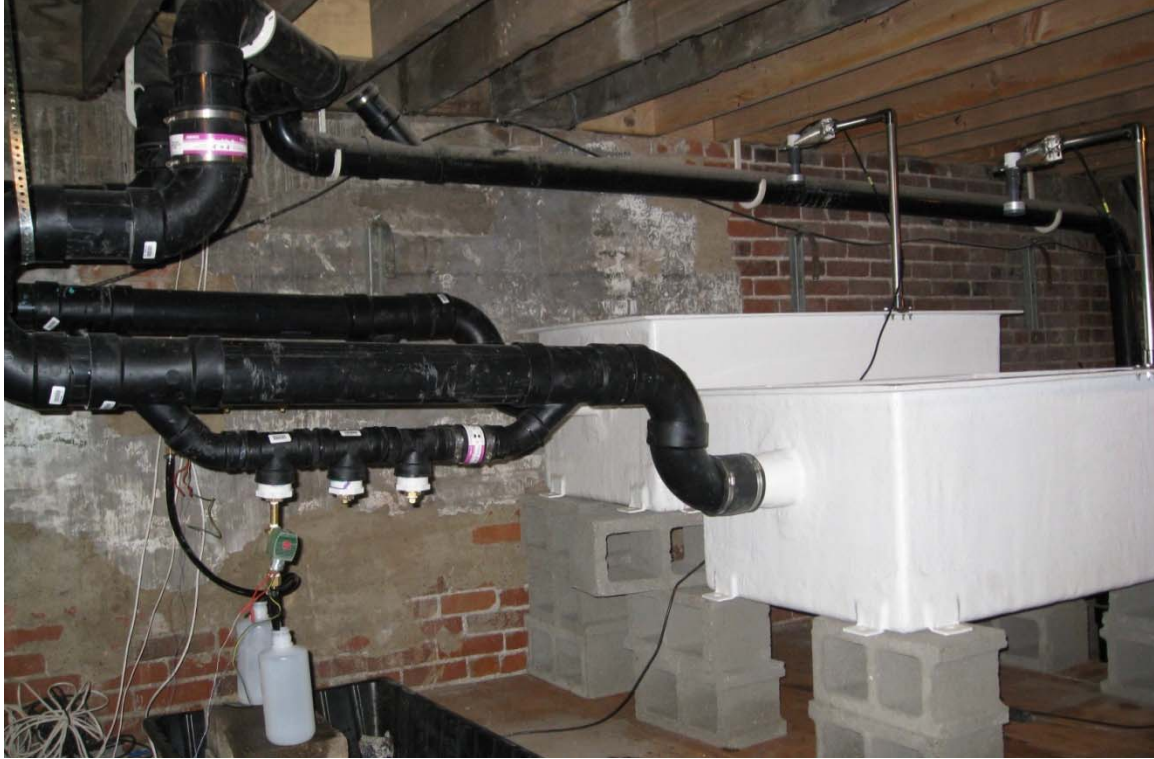
Figure 16. Drainage system at Homestead Site

Two weir boxes are located at the basement of the building. The one next to the wall is used for the green roof and the other one is for the control roof.

Two monitoring locations, one on each roof, were installed for the Homestead roof. There are fewer stations at this site than at the Giant Eagle roofs because both the Homestead roofs, at 2000 sq. ft., are considerably smaller. For runoff monitoring, two separate drains conducted all the runoff from the two roofs to the basement (Figure 16). In the basement, two weir boxes (V-notch at thirty degrees angle) were installed to receive the runoff.

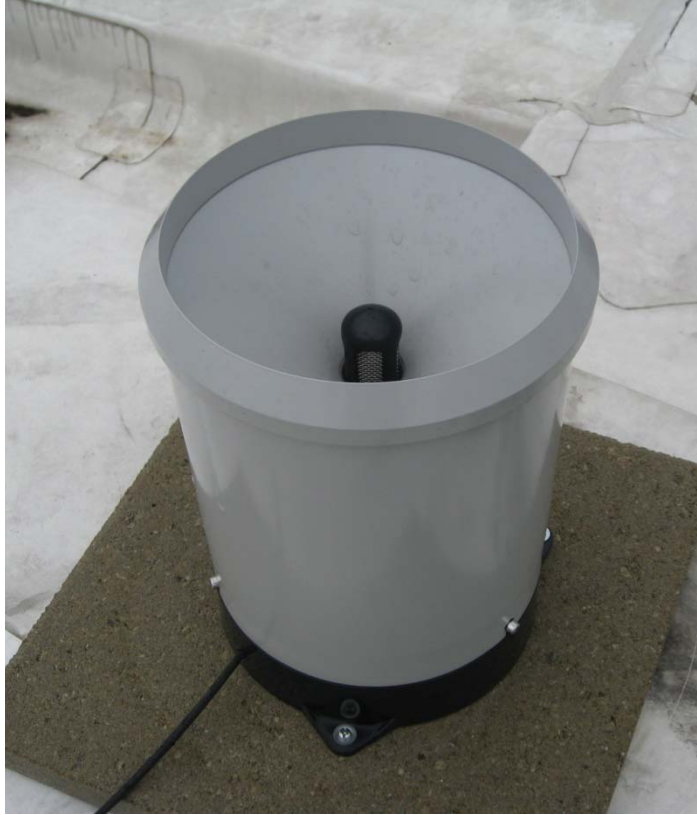
Figure 17. Rain gauge installed on the roof

The rain gauge is used to determine the amount of rainfall reaching the rooftop. A Hydrologic Services RG703 8 inch Tipping Bucket Rain Gauge (Figure 17) was used to accomplish this. A siphon mechanism allows the gauge to measure all rainfall intensities. After each one hundredth of an inch of rain falls, the bucket tips (Figure 18) and sends a reading to the datalogging system, which will be discussed in detail later. The rain gauge not only takes a measurement on the rainfall volume that falls on the roof, but also rate of rainfall. The rainfall data was used to calculate both the total volume of water that reaches the roof and the rate. Along with runoff data, this will show the affect the green roof has on reducing runoff. Similarly, the rainfall rate will show the delay in runoff accumulation from each roof (Bliss 2007). The types of rain gauges used for Giant Eagle and Homestead site are identical.

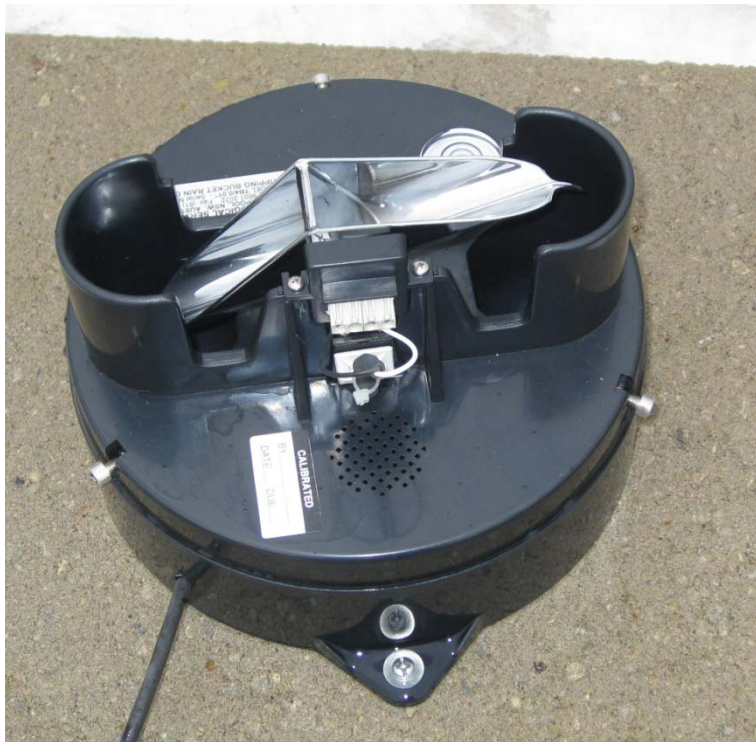
Figure 18. Tipping bucket (silver) inside the rain gauge

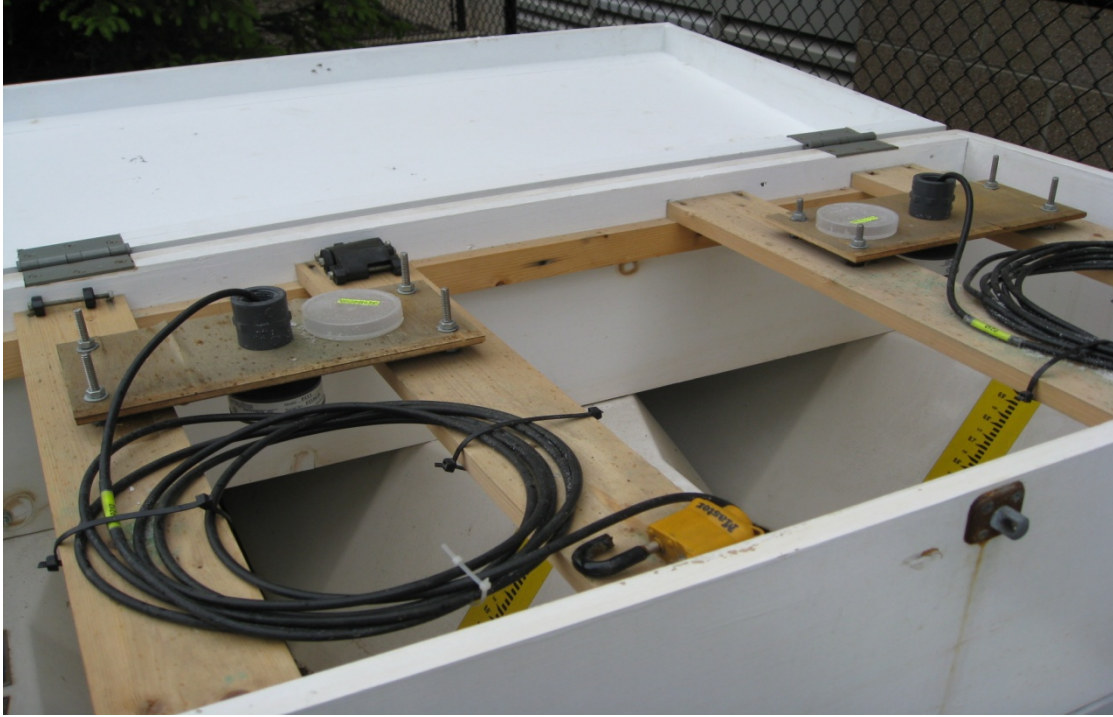
Figure 19. Ultrasonic sensors installed at Giant Eagle site

To measure the runoff created by each roof, the Greyline Instruments LIT25 (Level Indicating Transmitter) Ultrasonic sensors. These sensors send a sound wave into the flume, which then bounces back. The time that the wave takes to return allows the equipment to measure the depth of water in the flume at that point. From the depth of water, the flow rate and cumulative volume of runoff are calculated (Bliss 2007). Same types of the ultrasonic sensors were installed at both Giant Eagle and Homestead site. Figure 19 and Figure 20 show the ultrasonic sensors at Giant Eagle and Homestead, respectively, but with different mounting techniques.

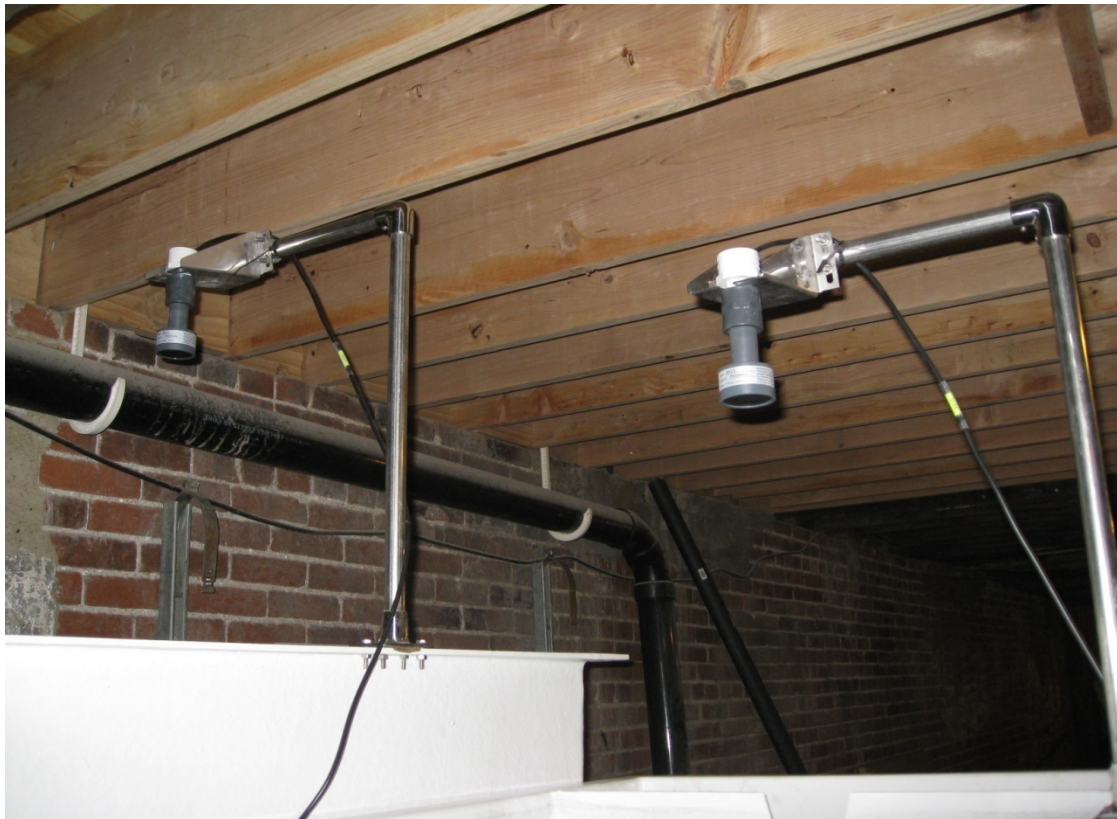
Figure 20. Ultrasonic sensor installed at Homestead site

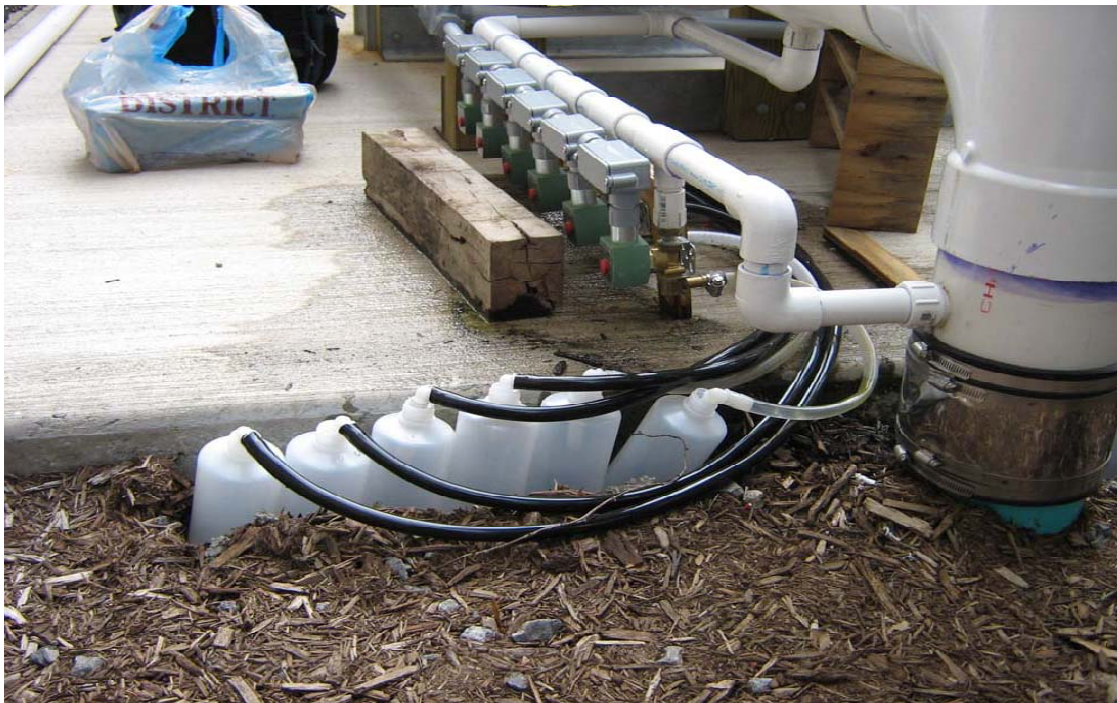
Figure 21. Solenoid Valves and Sample bottles at Giant Eagle site (Bliss 2007)

The valves are used for runoff samples collection system and to control the volume of samples. Solenoid valves are used at both sites, but with different runoff sample collection systems. The valves at Giant Eagle were removed after the first phase of the project, but the valves at Homestead are operational. Runoff samples collected from the Homestead will be compared with the sample results from Bliss (2007). Picture is still available for the sample collection system at Giant Eagle site, as seen in Figure 21, six solenoid valves were attached with the collection pipe for each flume. These solenoid valves are normally closed and are opened when energized. Each of the valves was connected to a 500 mL low density polyethylene sample bottle. The valves are wired to the datalogger located on the roof, which controls when the valves are opened. Each of the six valves is programmed to open at a set value of cumulative runoff. Since runoff can start at different times and flow at different rates on the green and control roofs, this allows the samples to be matched from both roofs. Additionally, the series of valves allows for samples to be taken at six different points during a storm. With samples taken in this manner, the first flush effect can be studied. Less specifically, it lets the changes in water quality throughout the storm be measured. The 500 mL of sample provided enough water to complete the series of water quality tests in the protocol. The valves were programmed to stay open for as short a time as possible to allow the sample bottles to fill while minimizing overflows.

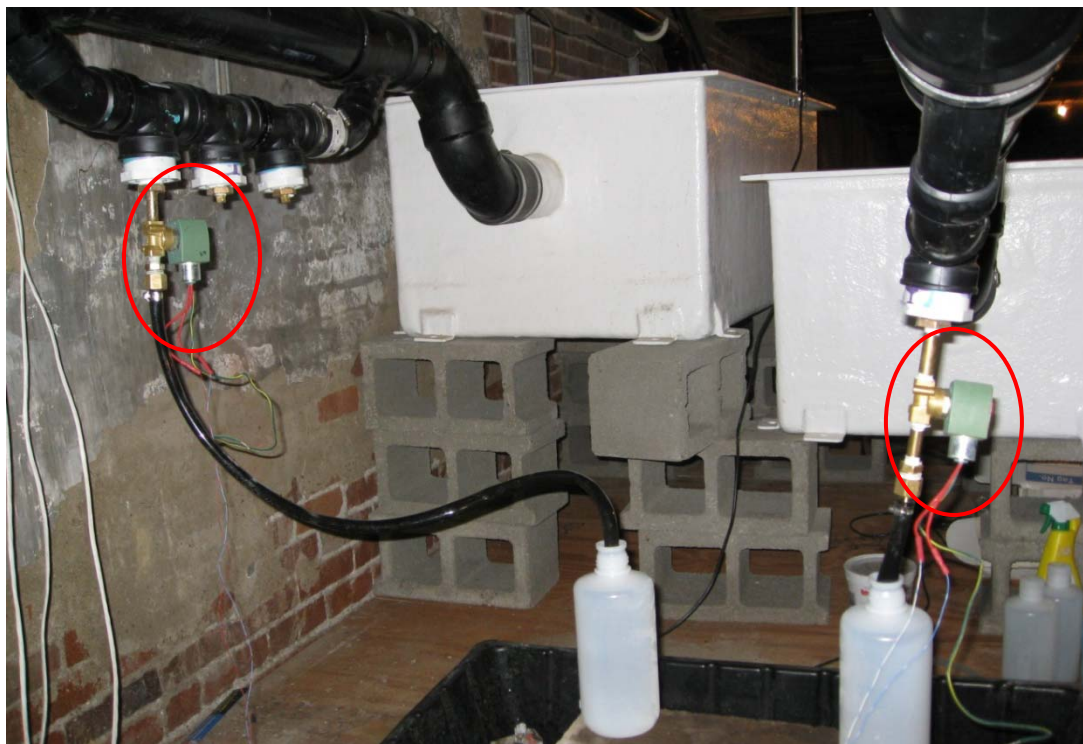
Figure 22. Solenoid valves (circled) and sample bottles at Homestead site

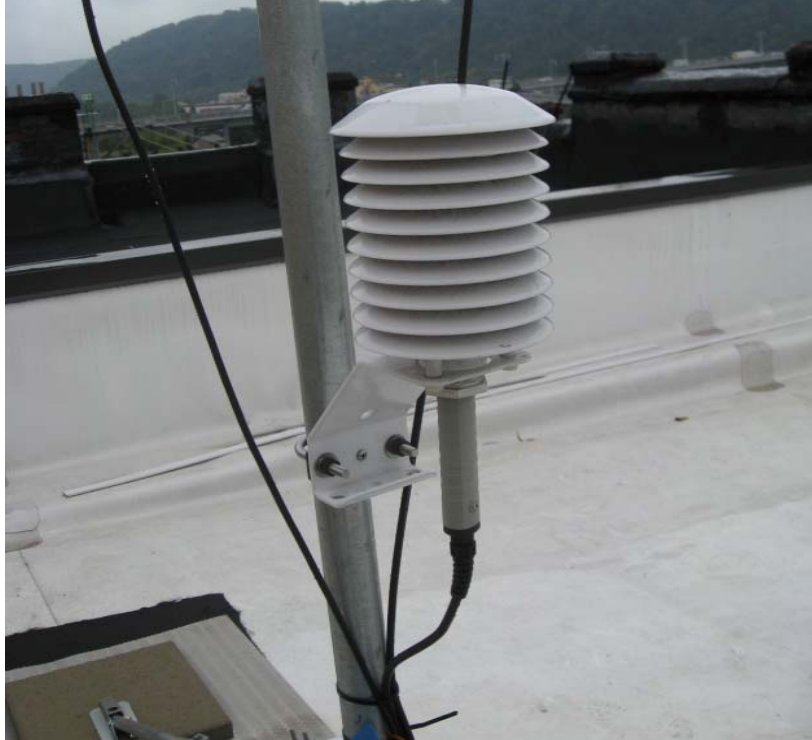
Figure 23. Temperature and Relatively Humidity probe

The temperature measurements were taken with a combination of thermocouple wire (Figure 23), HMP 45C Relative Humidity and Temperature Probes (Figure 24), and Model 107AT Temperature Probes. These sensors will provide a temperature profile vertically throughout the green and conventional roof structures. The thermocouples exposed to the outside environment will need to be shielded from solar radiation. A simple, open-air shelter, protect each above surface monitoring point. Additional soil temperature measurements will be obtained with the temperature probes. These model 107 temperature probes are buried 3 inches into the soil substrate on the green roof. The ambient air temperature is monitored by the RH probes, a dual function probe, which is protected in a radiation shield (Kosareo 2007).

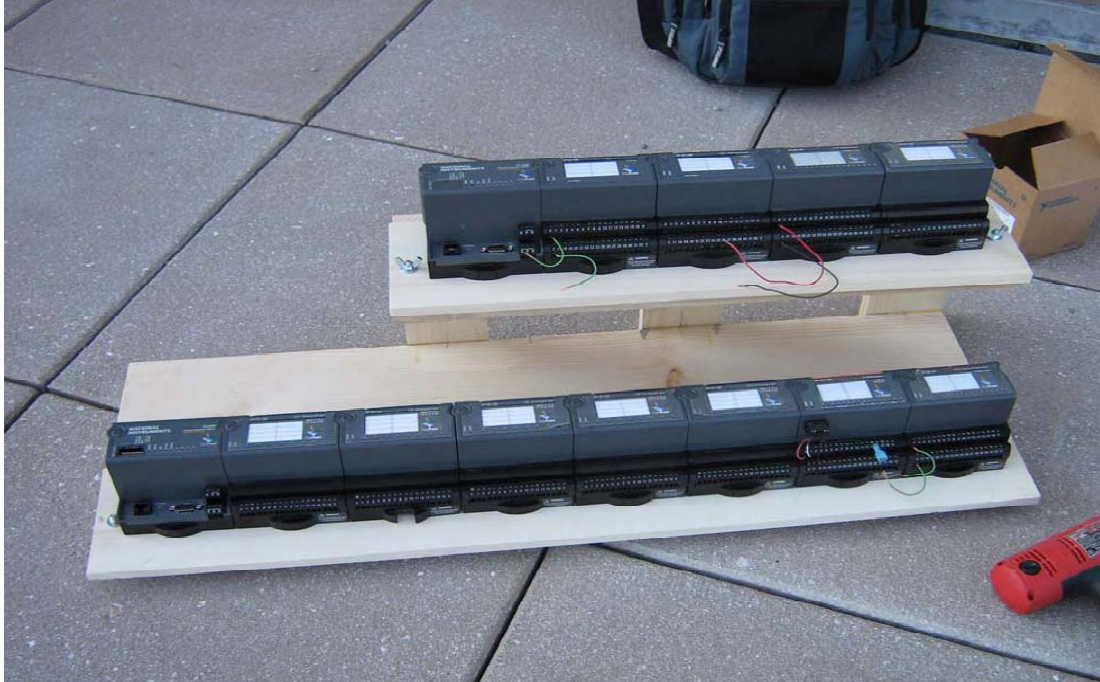
Figure 25. National Instrument Fieldpoint Dataloggers at Giant Eagle site (Bliss, 2007)

Two Fieldpoint banks (Figure 25) were established at Giant Eagle site. First bank of modules contain five FP-TC-120 units, each of them accepts eight thermocouples. One FP-CTR-502 counter module records the rainfall. Each time one hundredth of an inch of rain falls, the rain gauge tips and sends a reading to the counter module to be recorded. A FP-DO-401 digital output module was used to control the opening and closing of the solenoid valve (not used currently). The second Fieldpoint bank contains two FP-AI-100 analog input modules. These units acquire data for all of the equipment on the roof, with the exception of the thermocouples, rain gauge and solenoid valves. The analog input modules are able to accept both voltages and currents that are output by the equipment. This bank also includes a FP-DO-401. The majority of the equipment on this bank is able to draw its power constantly, which is done from the analog input modules. Finally, there is one thermocouple module for the last eight thermocouples on the roof (Bliss 2007).

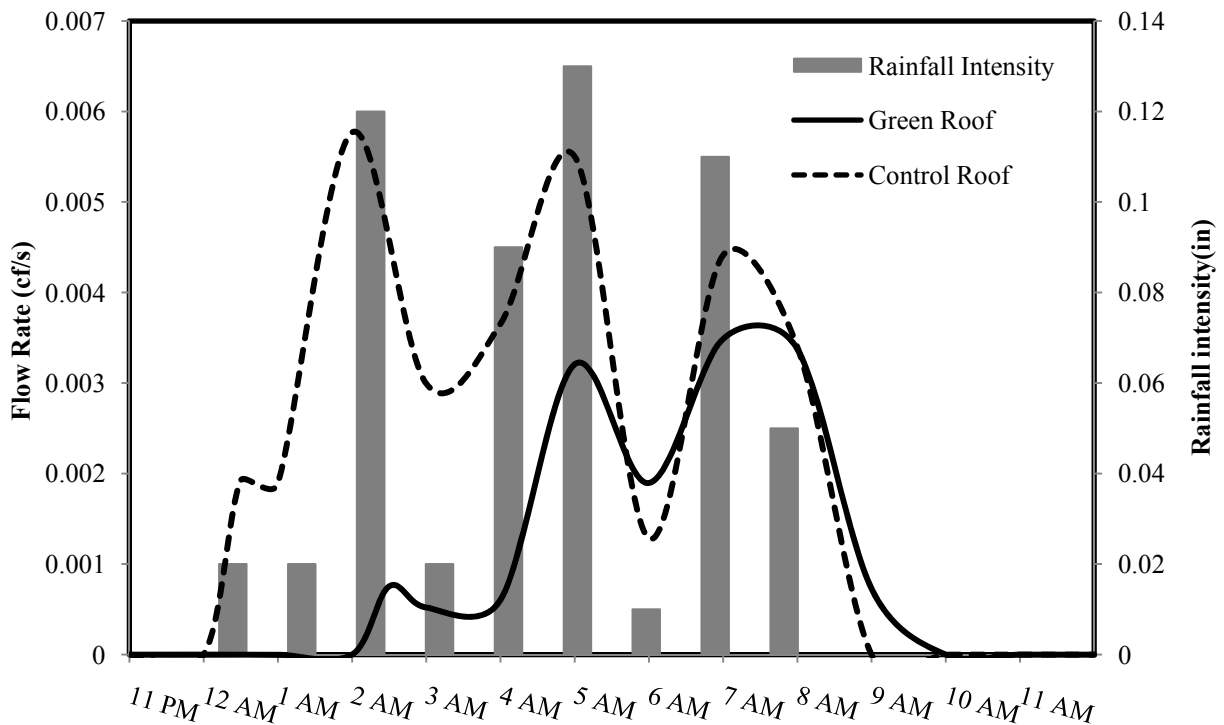
The green roof retarded the time of appearance of runoff and showed significant water retention capacity in comparison to the conventional roof. The runoff from the green roof started approximately two hours after the time that the control roof began discharging as illustrated in Figure 27. One plausible explanation for the 2-hour retardation time may be that the soil was dry conditions prior to the storm, since there was little rainfall preceding this event (0.09 in. of rainfall on April 19) (*data from Weather Underground Inc*). The dry soil would be able to absorb water and maintain the runoff until the soil became saturated. In contrast to runoff from the green

roof, the control roof runoff rate follows the rainfall intensity very closely where the three peaks in the control roof runoff coincide with the corresponding peaks in rainfall intensity. However, the green roof runoff rate was constant during the first peak in rainfall intensity. Subsequent peaks of in the green roof runoff rate coincide with the peaks in rainfall intensity. It was observed that the peaks in the runoff rate from the green roof are consistently lower than the control roof peaks. For the first peak in the rainfall intensity, the runoff rate from the green roof was less than 8% of the rate of runoff from the control roof. Overall, peak runoff rate of the green roof was less than 80% of the control roof. While there was an onset of runoff delay, there was also a delay when runoff ceased to flow as the flow from the control roof stopped nearly an hour before the green roof indicating tailing and longer term soil-moisture drainage.

Figure 27. Runoff Flow Rates and Rainfall intensity – April 20, 2008 Storm (Homestead)
