**GREEN ROOF STUDY: STORMWATER QUANTITY, QUALITY AND THERMAL
PERFORMANCE**

Submitted to the Graduate Faculty of
Swanson School of Engineering in partial fulfillment
of the requirements for the degree of
Master of Science

University of Pittsburgh

2009

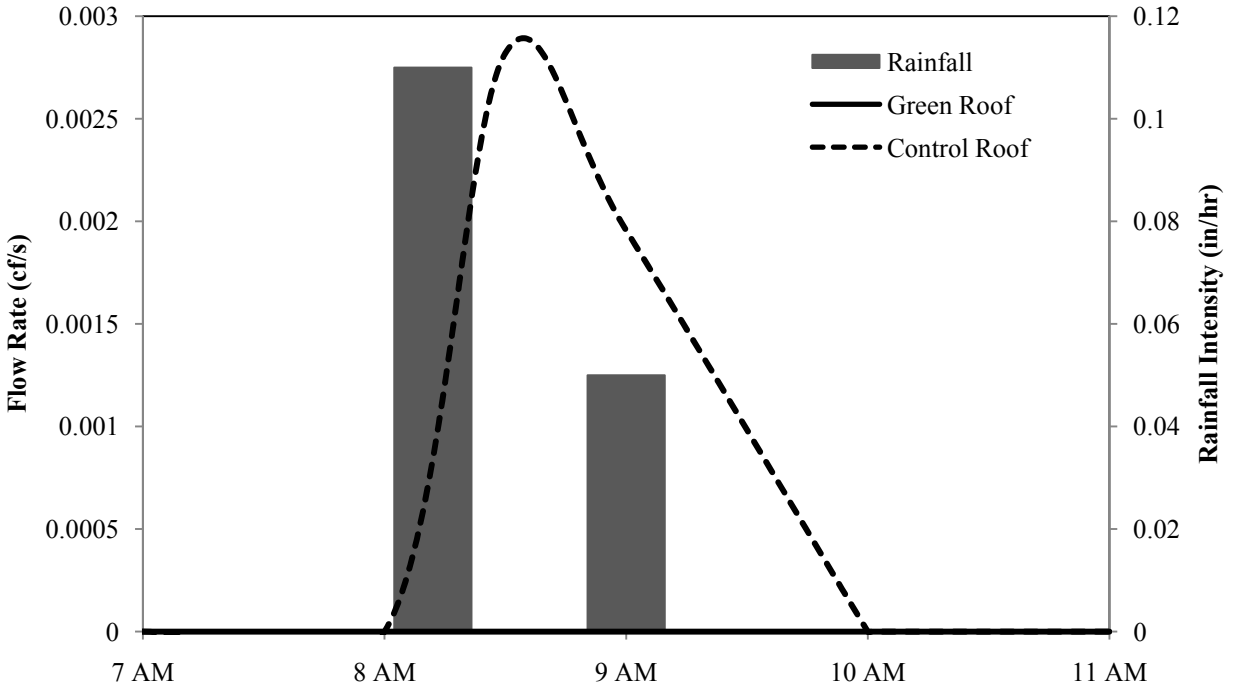
A low volume rain event of 0.17 inches occurred on September 9, 2008. This followed a thirteen day dry period (the previous rainfall was observed on August 27, 2008) that left the soil in a dry condition. As shown in Figure 31, there was no runoff from the green roof and all of the rain that fell on the green roof was absorbed by the soil medium. The total runoff from the control roof was 3.15 cf/1000sf, which was 22% of the total equivalent rainfall as shown on Figure 5-6.

Figure 31. Runoff Flow Rates and Rainfall Intensity – September 9, 2008 Storm (Homestead)

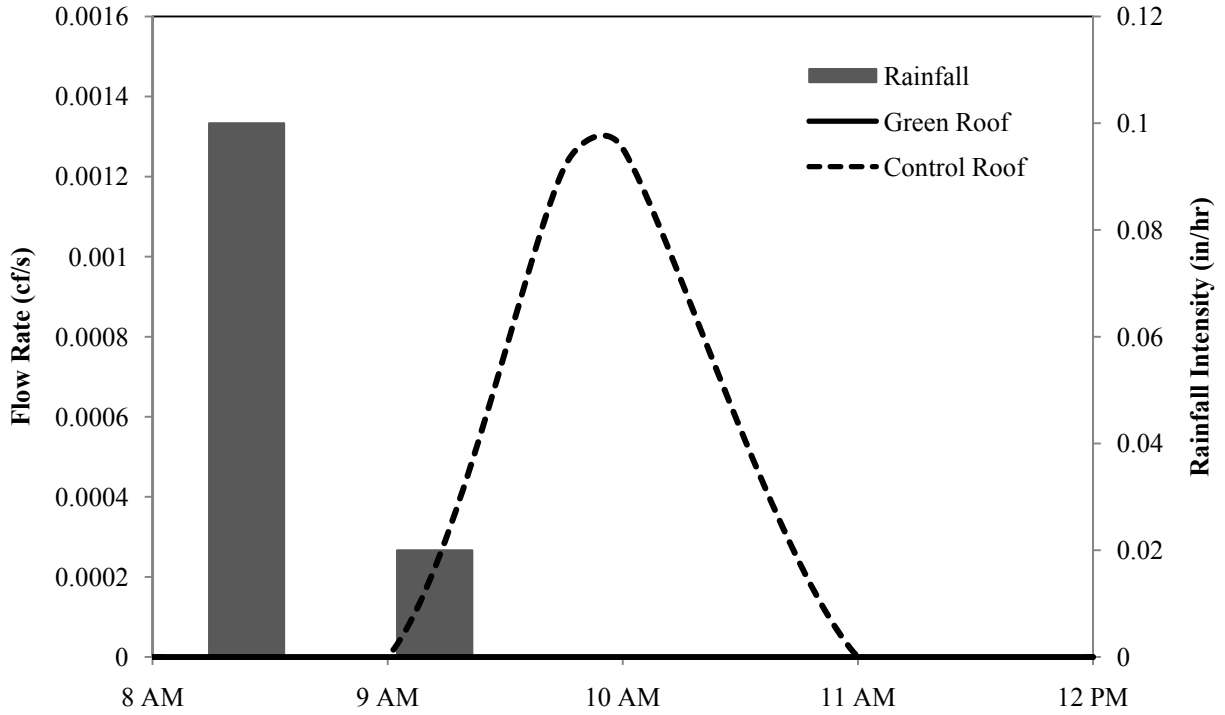
There was no runoff detected by the ultrasonic sensor from the green roof. The data suggests that the green roof retained 100% of the rain water at lower rainfall and dry soil condition (as shown in Figure 39). The normalized total runoff volume from the control roof (Figure 40) was 1.83 cf/1000sf; 18% of the total equivalent rainfall, thereby indicating that the water flow was measurable by ultrasonic sensors and that indeed the green roof did not allow any runoff.

Figure 39. Runoff Flow Rates and Rainfall Intensity – September 9, 2008 Moderate Storm (Giant Eagle)

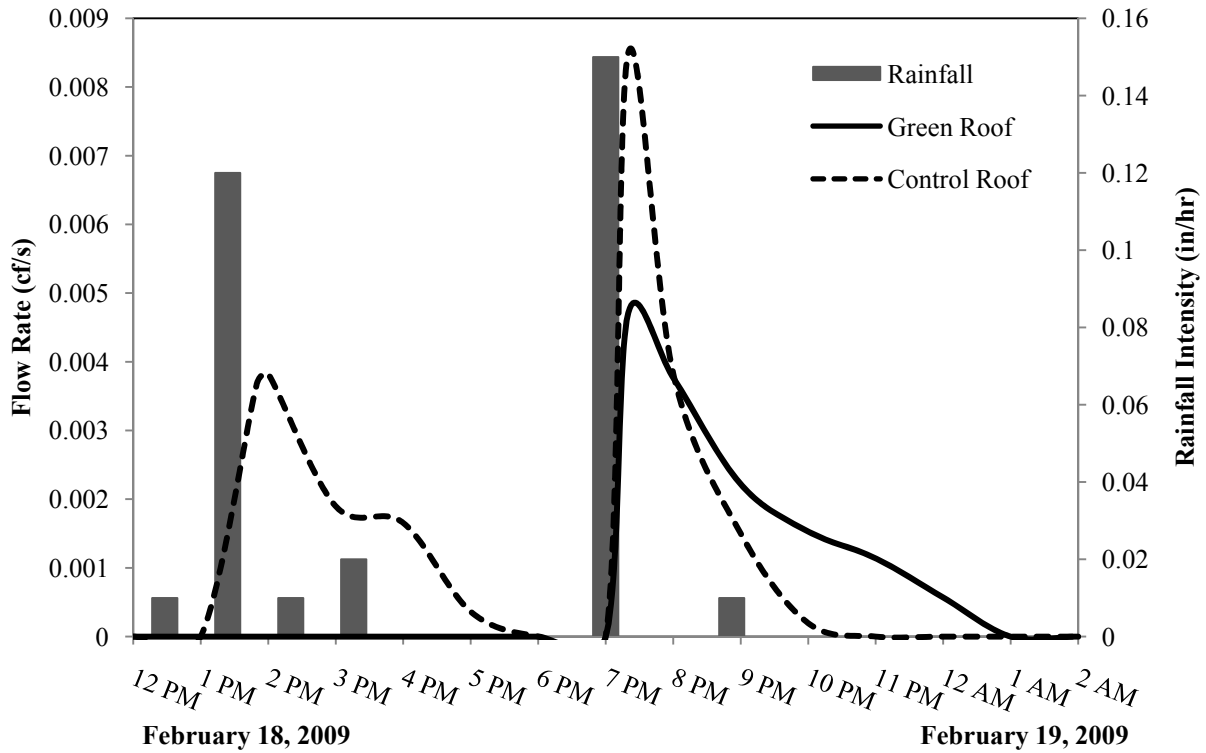
Even though the soil was wet before the storm, the initial runoff from the green roof occurred six hours later than the control roof (Figure 41). This was coincidentally the same retardation as measured at the Homestead site for a similar amount of rainfall (0.34 in.). Additionally, the green roof runoff from Giant Eagle exhibited a three hour long tail of extended flow compared to the control roof. The green roof runoff at Homestead did not show a similar extension or tailing over time after the storm. The maximum peak flow rate from the green roof at Giant Eagle was 55% of the control roof and 58% of the total runoff volume from the control roof. Compared to the total rainfall, the runoff was 42% as indicated in Figure 42.

Figure 41. Runoff Flow Rates and Rainfall Intensity – February 18-19, 2009 Storm (Giant Eagle)

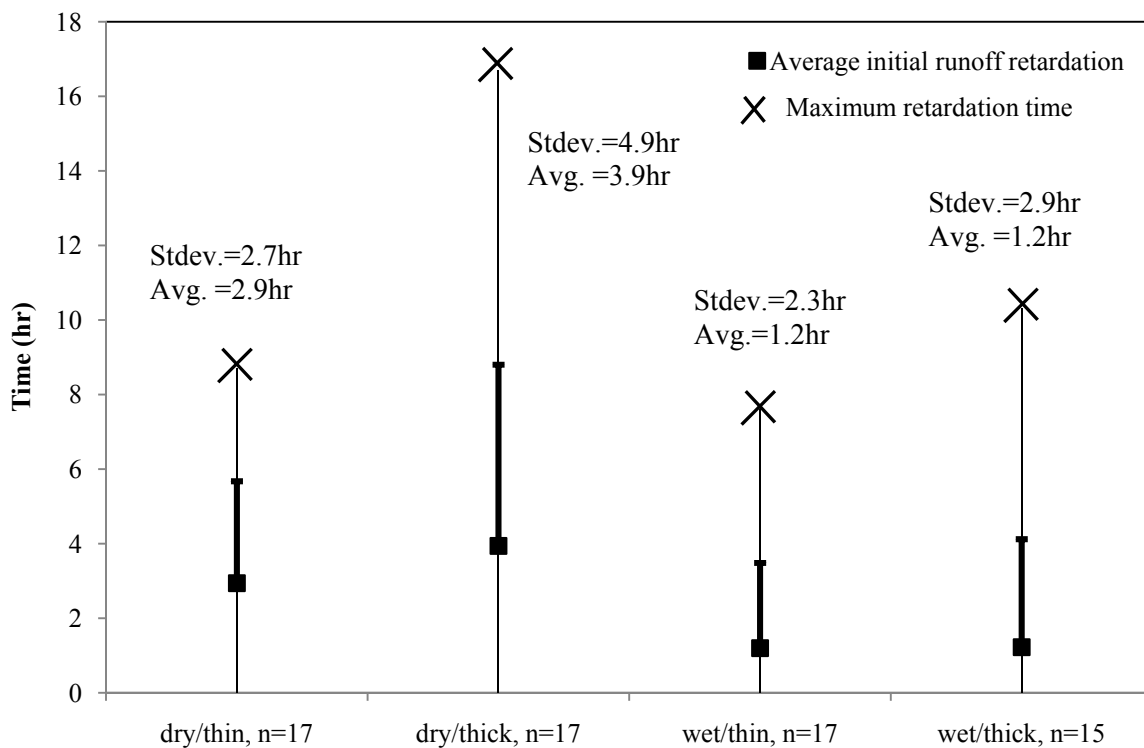
For the wet soil-thick roof, however, a maximum time of runoff retardation of 8.7 hours and an average of 2.9 hours had been observed. With about 4 inches more of soil the thick green roof is able to retain more water and better delay the onset of stormwater discharge. Wet soils exhibit less of a capability to retain runoff water. For the both the thin or thick wet soil green roof, there is a similarity average time delay of runoff of about 1.2 hours.

Figure 44. Time of initial runoff retardation under different soil condition and thickness

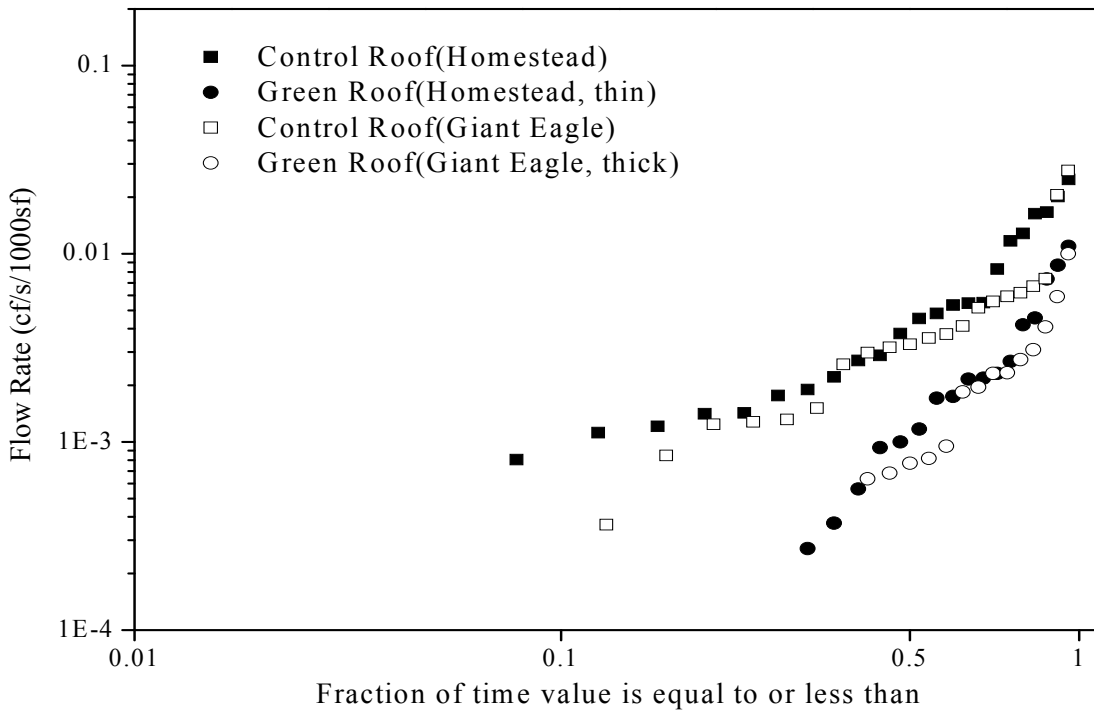
Figure 46. Probability of occurrence of maximum peak flow rate under dry soil condition

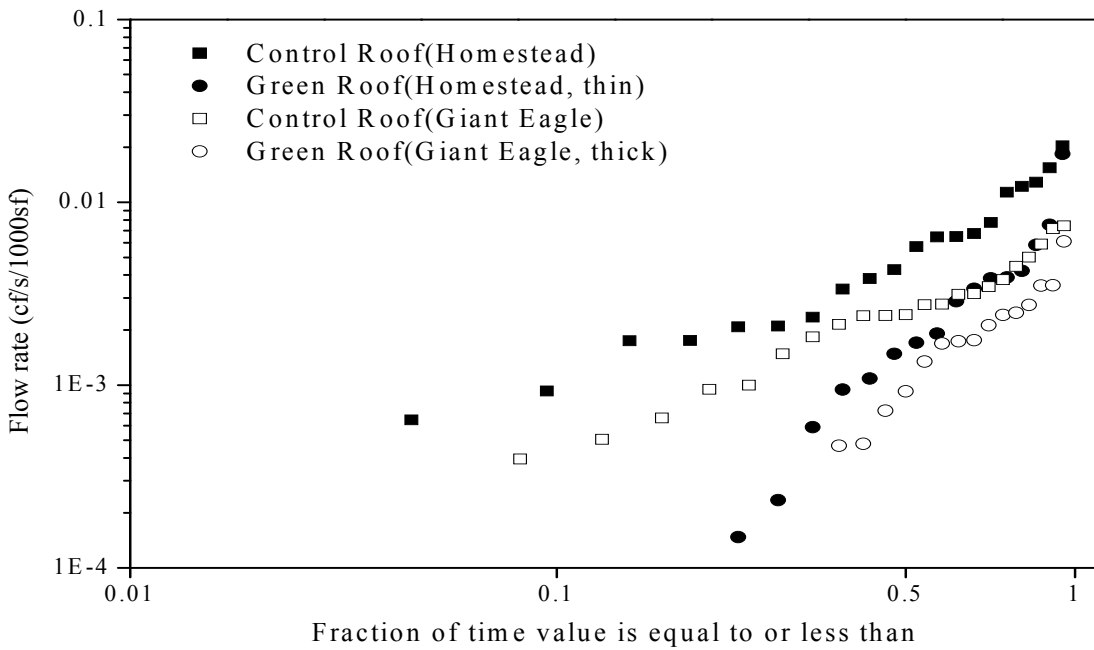
When it comes to the wet soil condition, the peak flows of green roof runoff at both locations are always lower than that of the control roof runoff Figure 47, shows the thin roof peak flow is slightly higher rate than that of the thick roof. Rainfall intensity is a key variable for runoff flow rates.

Figure 47. Probability of occurrence of maximum peak flow rate under wet soil condition

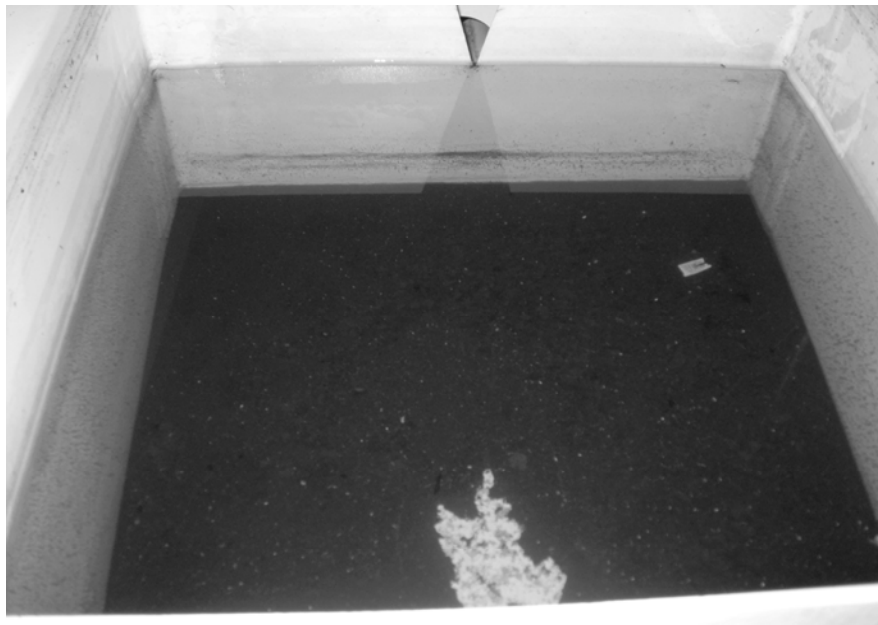
Figure 64. Runoff water from control roof stored in the weir box (Homestead)
