**FAILURE OF THICK, LOW DENSITY AIR PLASMA SPRAYED THERMAL  
BARRIER COATINGS**

**Michael Aaron Helminiak**

Submitted to the Graduate Faculty of  
Swanson School of Engineering in partial fulfillment  
of the requirements for the degree of  
Doctorate of Philosophy

University of Pittsburgh

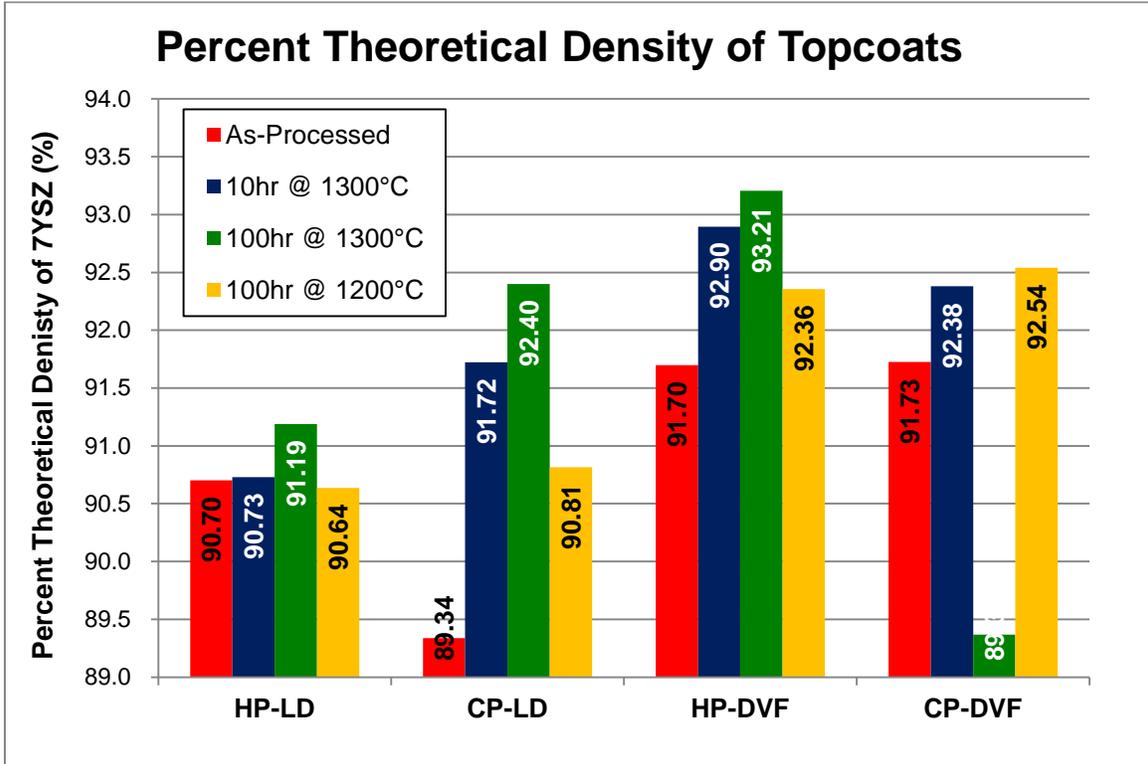
**Figure 19 - Percent theoretical density of as-processed and sintered topcoats. Measured according to ASTM-B328.**

The HP-LD topcoats were very resistant to sintering indicated by their comparatively small sintering rates. The small negative sintering rate of the 100 hour 1200°C HP-LD coating (gold bar Figure 19) is attributed to the experimental error associated with the resolution of the microbalance used to measure the mass of the specimens. The differences in the various mass measurements used to compute the densities were on the order of ~9mg which is just above the resolution of the microbalance which is 10<sup>-4</sup> grams (0.1mg). This resulted in the as-processed and the 100 hour at 1200°C specimens roughly having the same density, at least according to the resolution of the microbalance used.

Since the CP-LD specimens had a lower starting density than the HP-LD specimens, 89.3% and 90.7% respectively, they would be expected to sinter faster. However, differences in coating porosity will only account for so much of the difference between the observed sintering rates. Vassen et al [30] estimated a difference in porosity of 1.4% could account for roughly a 25% difference in the sintering rates. Since there is an order of magnitude difference in the sintering rates (i.e. 100% difference) of these two coatings it seems other variables besides coating porosity are having an influence on the sintering rates.

In summary, the HP-LD coating experienced little densification during the thermal treatments whereas the CP-LD and HP-DVF coatings experienced significant densification in all three exposures. Furthermore, the CP-LD and HP-DVF coatings experienced a rapid increase in the density after 10 hours at 1300°C but then saw little additional shrinkage upon extending the aging time to 100 hours. The CP-DVF coating exhibited unique behavior as its density decreased during the 100 hour heat treatment at 1300°C. The decrease was attributed to an increase in the volume of the specimen, not due to a decrease in mass.

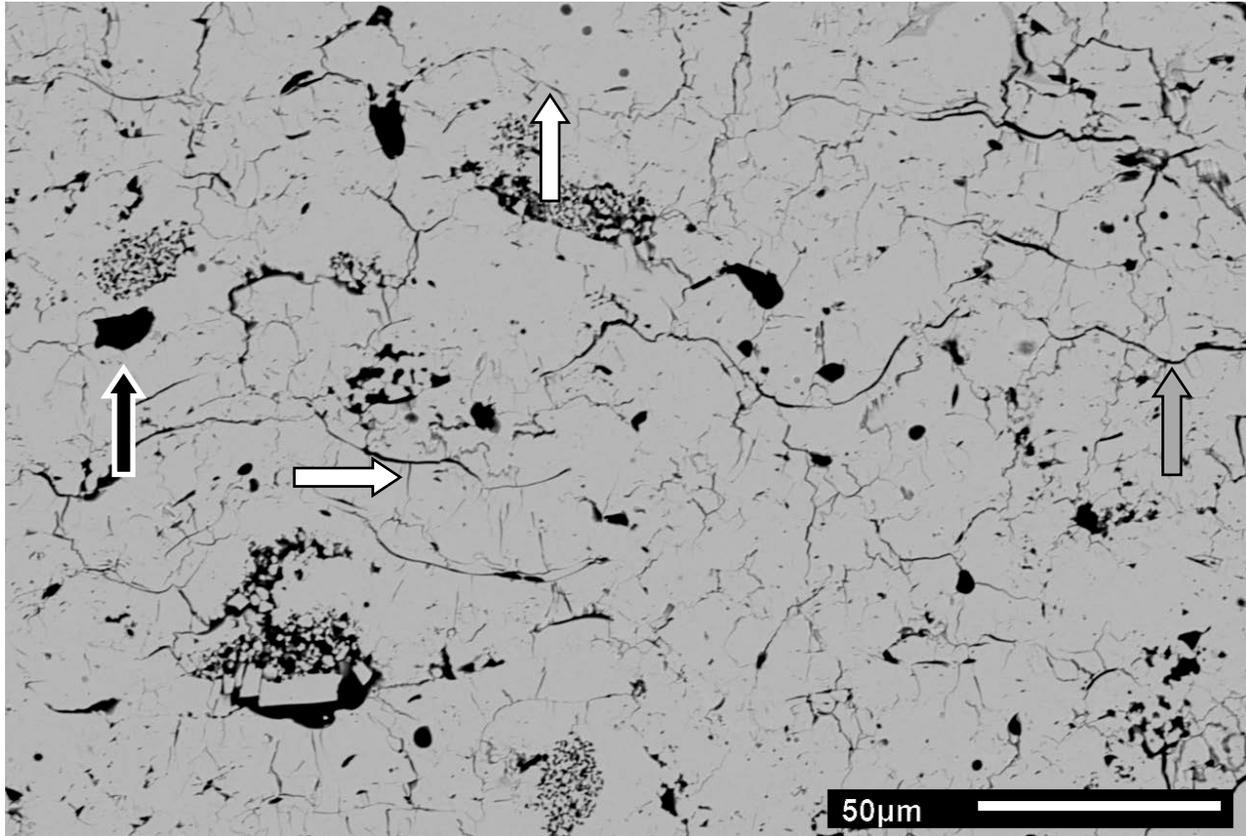
**Figure 20 - HP-LD in the as-processed condition. White arrows indicate small micro-cracks, black – globular pores and grey – horizontal delaminations.**

In the as-processed state, the coating contained small horizontal and vertical microcracks (white arrows), larger globular pores (black arrows) and large horizontal splat boundaries (gray arrow). After 10 hours at 1300°C, Figure 21, many of the small micro-cracks had partially healed/bridged and some had completely disappeared. This is depicted in Figure 21 by the lack of small black cracks.

The HP-DVF coating had a faster sintering rate than the HP-LD coating which could be partially attributed to the HP-DVF coating having a silica content double of that of the HP-LD coating. Another explanation could stem from the difference in the type of porosity of the two coatings. Referring back to Figure 20 (HP-LD) and Figure 32 (HP-DVF), the HP-LD coating visually contained a wider size range of pores meaning it contained globular pores, micro-cracks and large horizontal delamination cracks. After the aging at 1300°C the small micro-cracks were the first to disappear, however, since these small pores only constituted a fraction of the overall

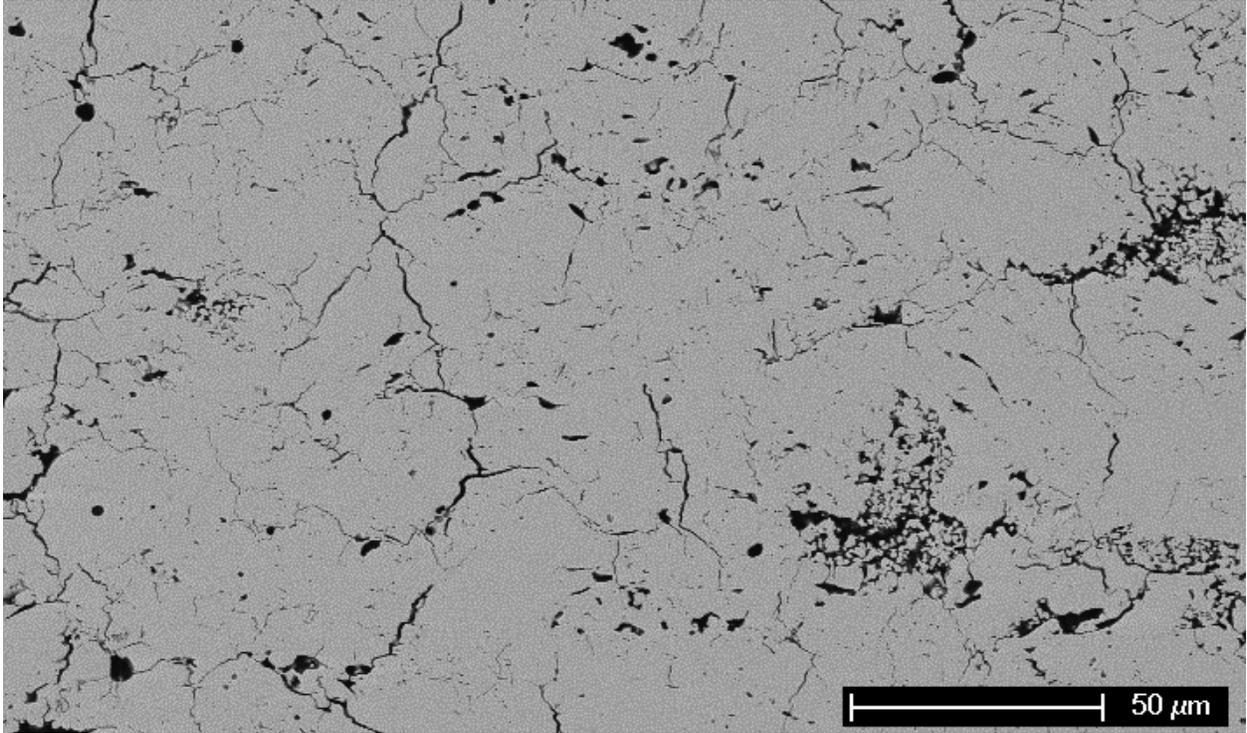
**Figure 21 - HP-LD after 10 hours at 1300°C.**

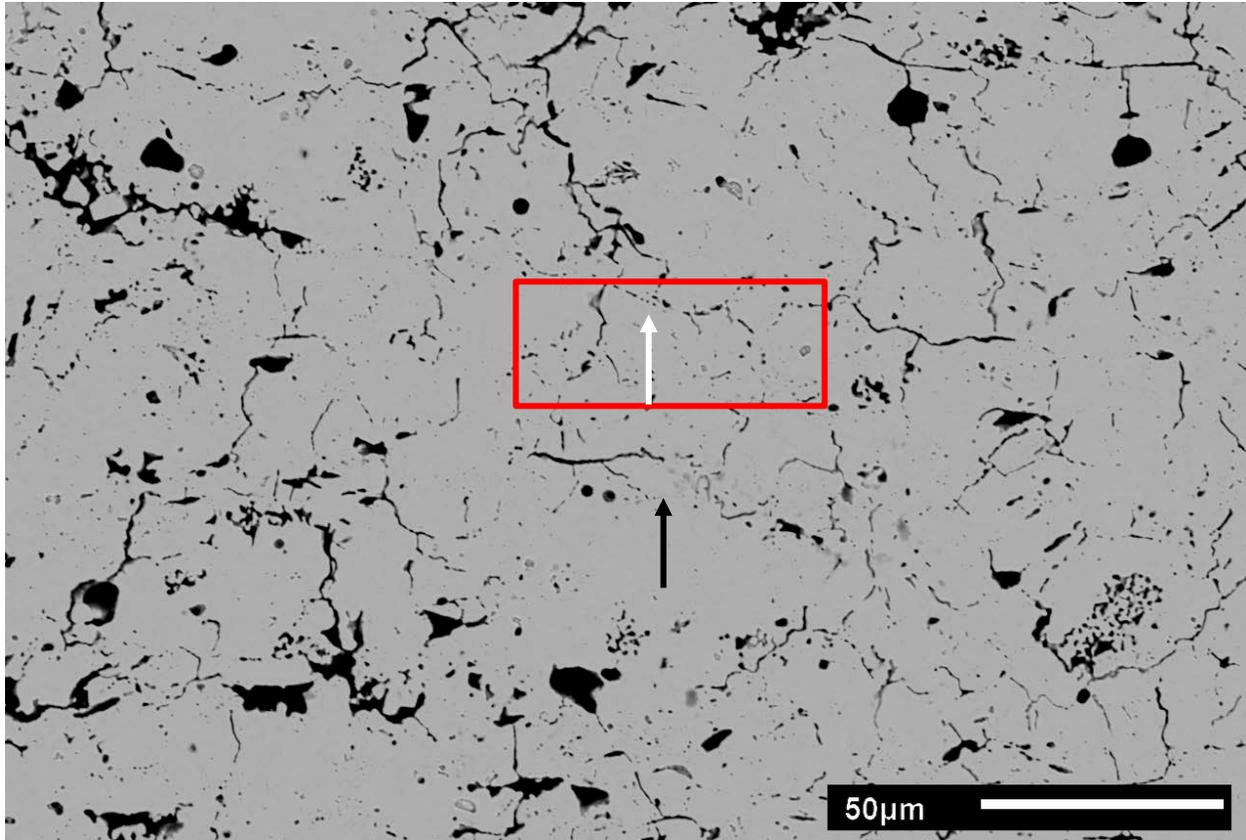
After 100 hours at 1300°C, Figure 22, few changes beyond those discussed in the 10 hour specimen had occurred. The small micro-cracks, the large horizontal delaminations and the vertical cracks have begun to heal/bridge. As an example, a bridged horizontal micro-crack is highlighted in red in Figure 22. The pore was broken-up by several YSZ bridges (white arrow) that extended over the crack. The large globular pores are still present.

**Figure 22 - HP-LD after 100 hours at 1300°C.**

Comparing the as-processed and the 100 hour at 1300°C specimens, it is clear some densification has occurred, at least visually confirming the measured increase in density. After 100 hours at 1200°C there again was bridging of micro-cracks in isolated areas, red box in Figure 23. However, many of the microstructural features in the as-processed coating still exist in the 100 hour 1200°C coating. Impurities such as  $\text{SiO}_2$  and  $\text{Al}_2\text{O}_3$  were not found in this coating during any of the observation sessions.

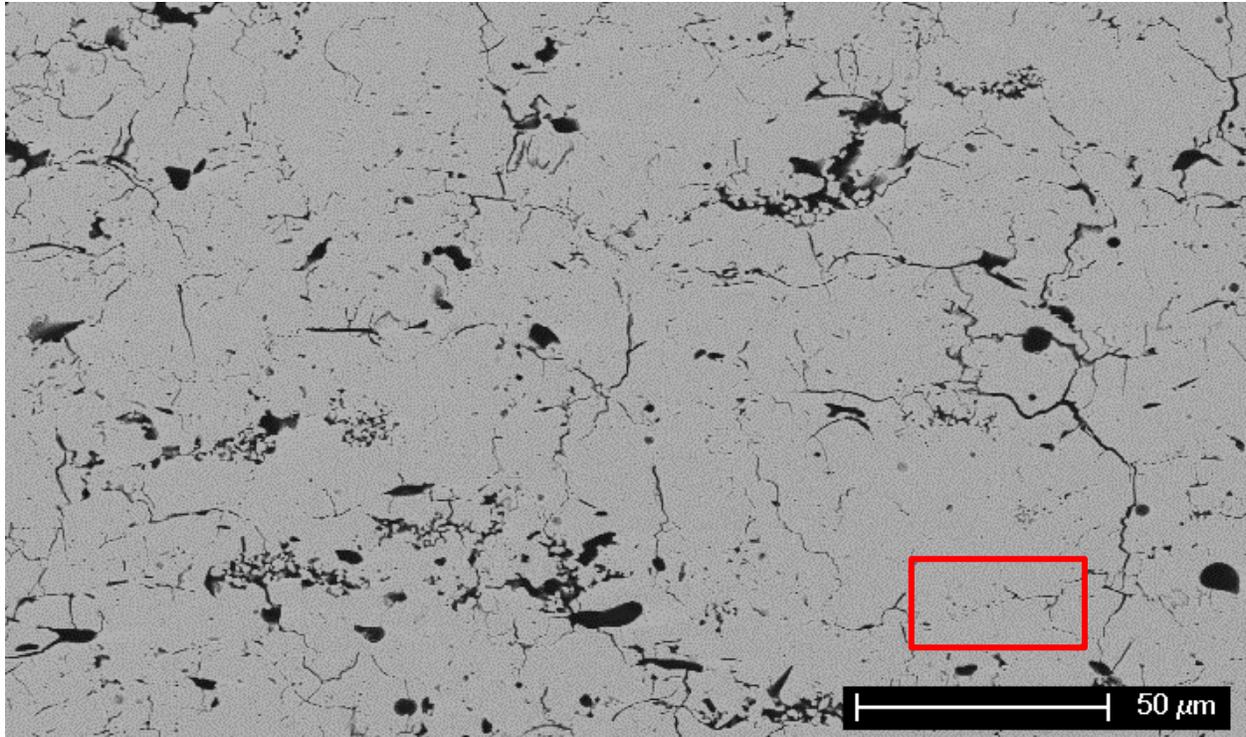
**Figure 23 - HP-LD after 100 hours at 1200°C.**

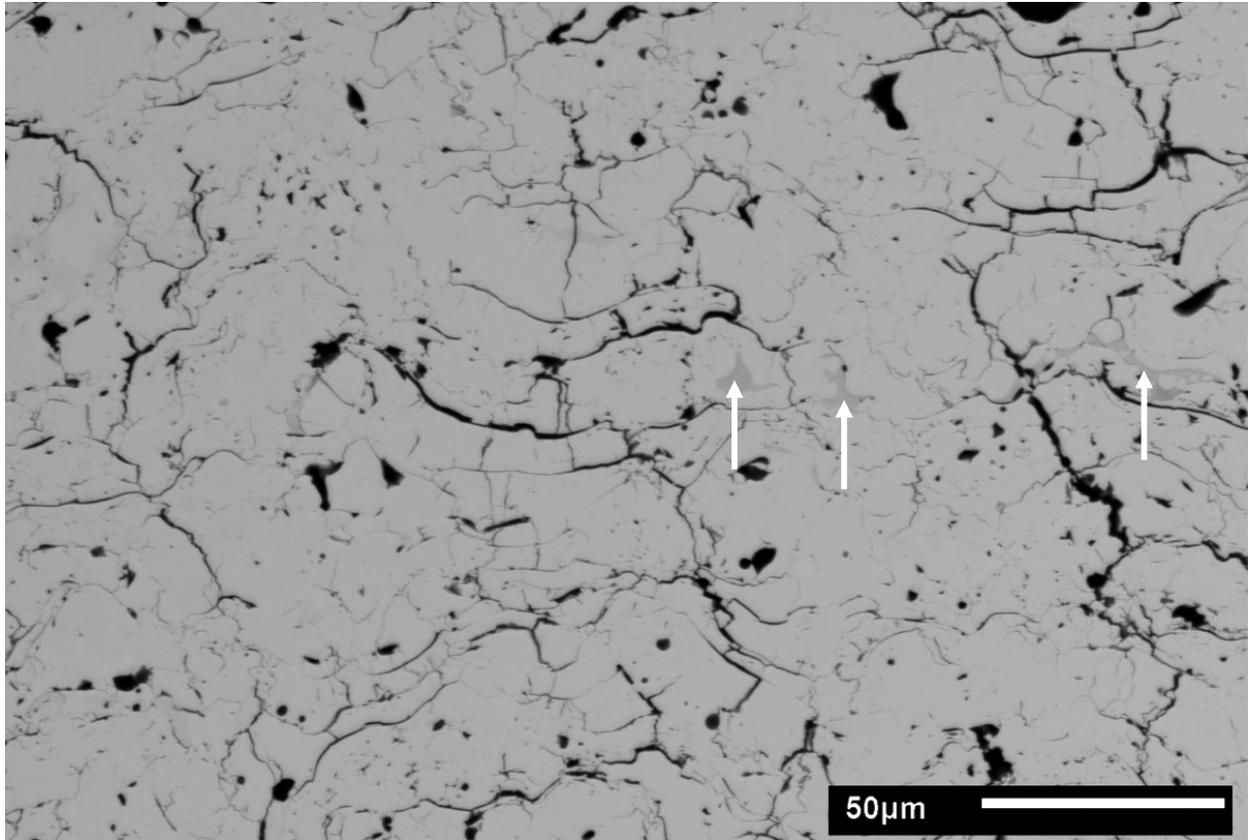
The starting microstructure of the CP-LD coating is shown in Figure 24. As with the HP-LD specimen, this coating also contained small horizontal and vertical microcracks, larger globular pores and large horizontal splat boundaries. In addition, this coating also contained isolated regions of high  $\text{SiO}_2$  and  $\text{Al}_2\text{O}_3$  content, Figure 25, indicated by white arrows. The impurity regions appear dark because of the atomic number difference between silicon/aluminum and zirconium/yttrium.

Figure 24 - CP-LD in the as-processed condition. White arrows indicate regions of SiO<sub>2</sub> and Al<sub>2</sub>O<sub>3</sub> impurities.

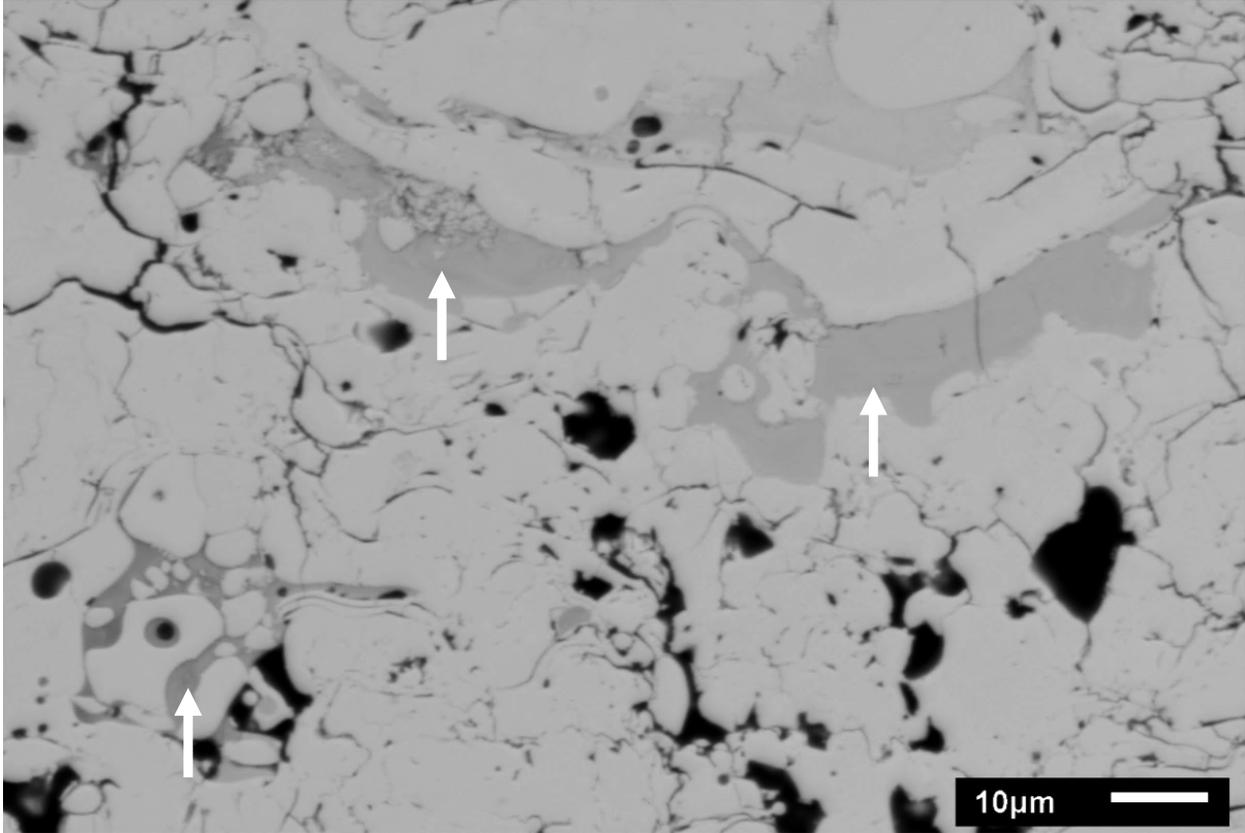
**Figure 25 - CP-LD in the as-processed condition. White arrows indicate regions of SiO<sub>2</sub> and Al<sub>2</sub>O<sub>3</sub> impurities.**

Some of the impurity regions appear to be individual splats (Figure 25 - far right arrow) whereas others seem to be unmelted particles (Figure 25 - lower left arrow). This observation suggests the impurity elements are discrete powder particles that are randomly incorporated into the coating during the spraying process.

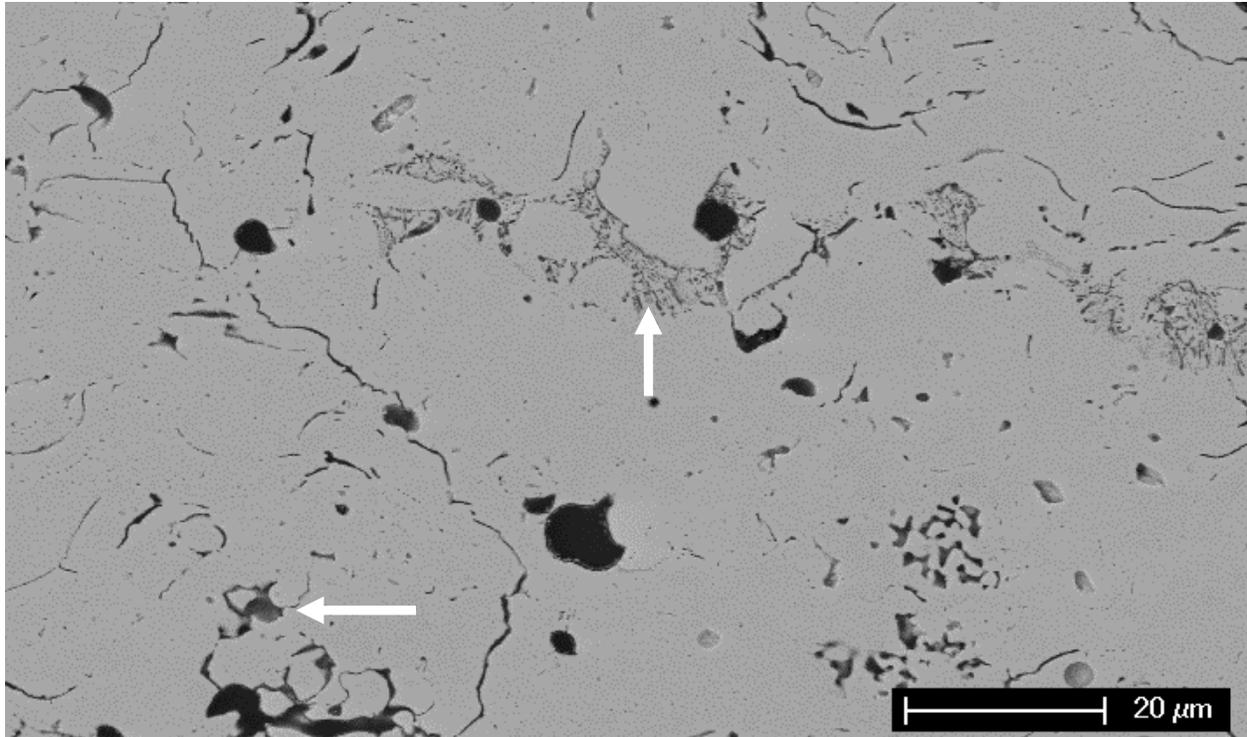
After 10 hours at 1300°C, Figure 26, many of the micro-cracks have disappeared while the larger horizontal delaminations remain present.

**Figure 26 - CP-LD after 10 hours at 1300°C. White arrows indicate regions of SiO<sub>2</sub> and Al<sub>2</sub>O<sub>3</sub> impurities.**

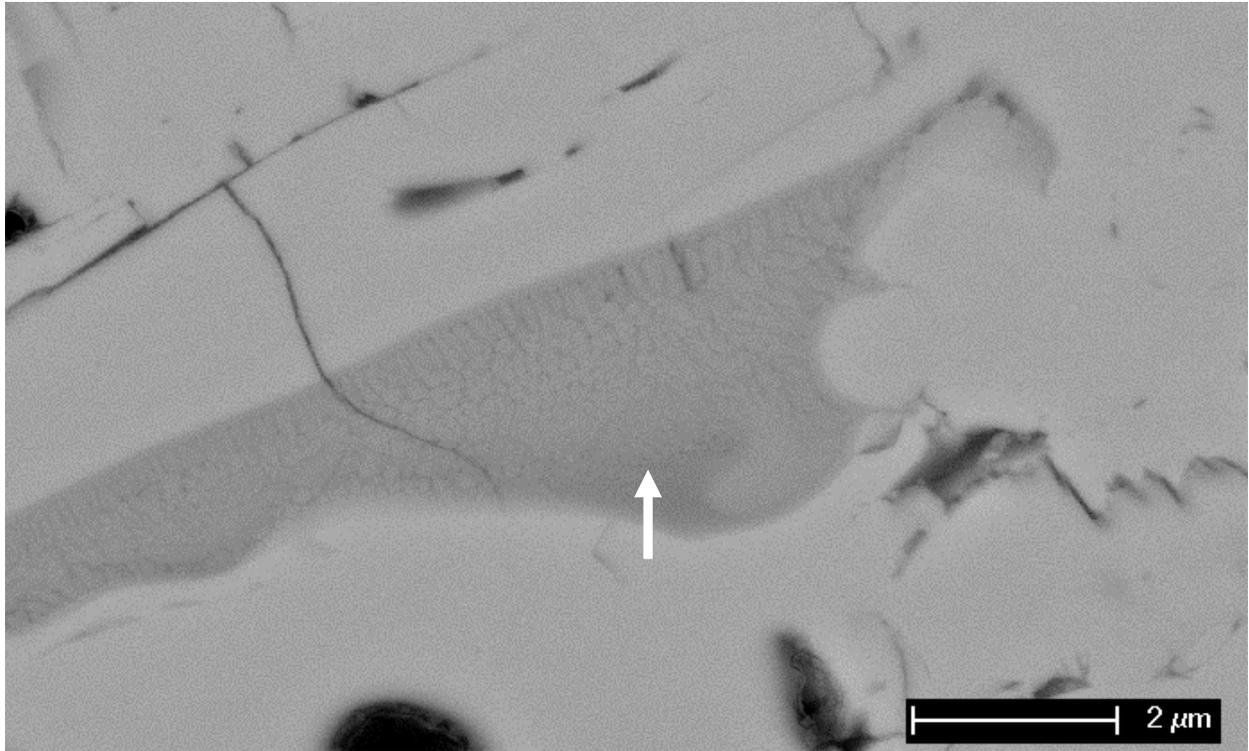
The impurity regions have changed in appearance from splat-like structures (Figure 27) to a more segregated structure (Figure 28 – red box). Thus the silica-alumina rich regions appeared to have redistributed and/or coarsened.

**Figure 27 - CP-LD in the as-processed condition. White arrows indicate regions of SiO<sub>2</sub> and Al<sub>2</sub>O<sub>3</sub> impurities.**

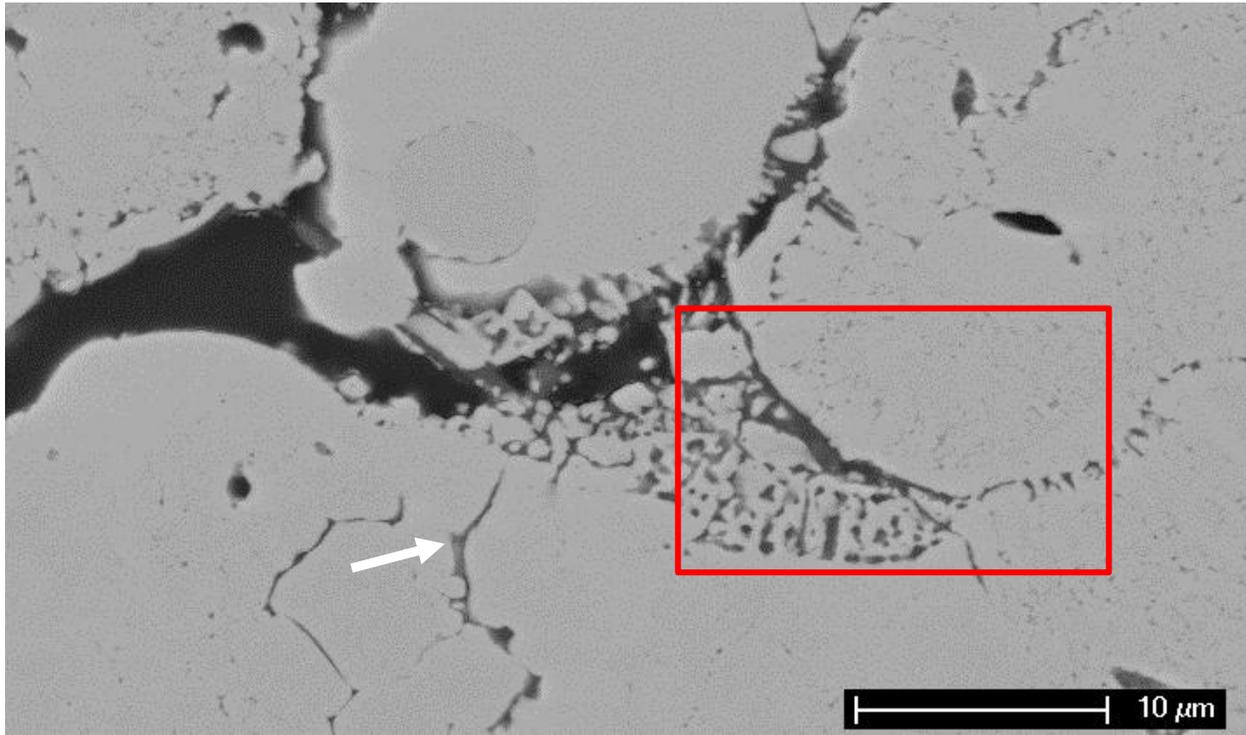
**Figure 28 - CP-LD after 10 hours at 1300°C. White arrows and red box indicate regions of  $\text{SiO}_2$  and  $\text{Al}_2\text{O}_3$  impurities.**

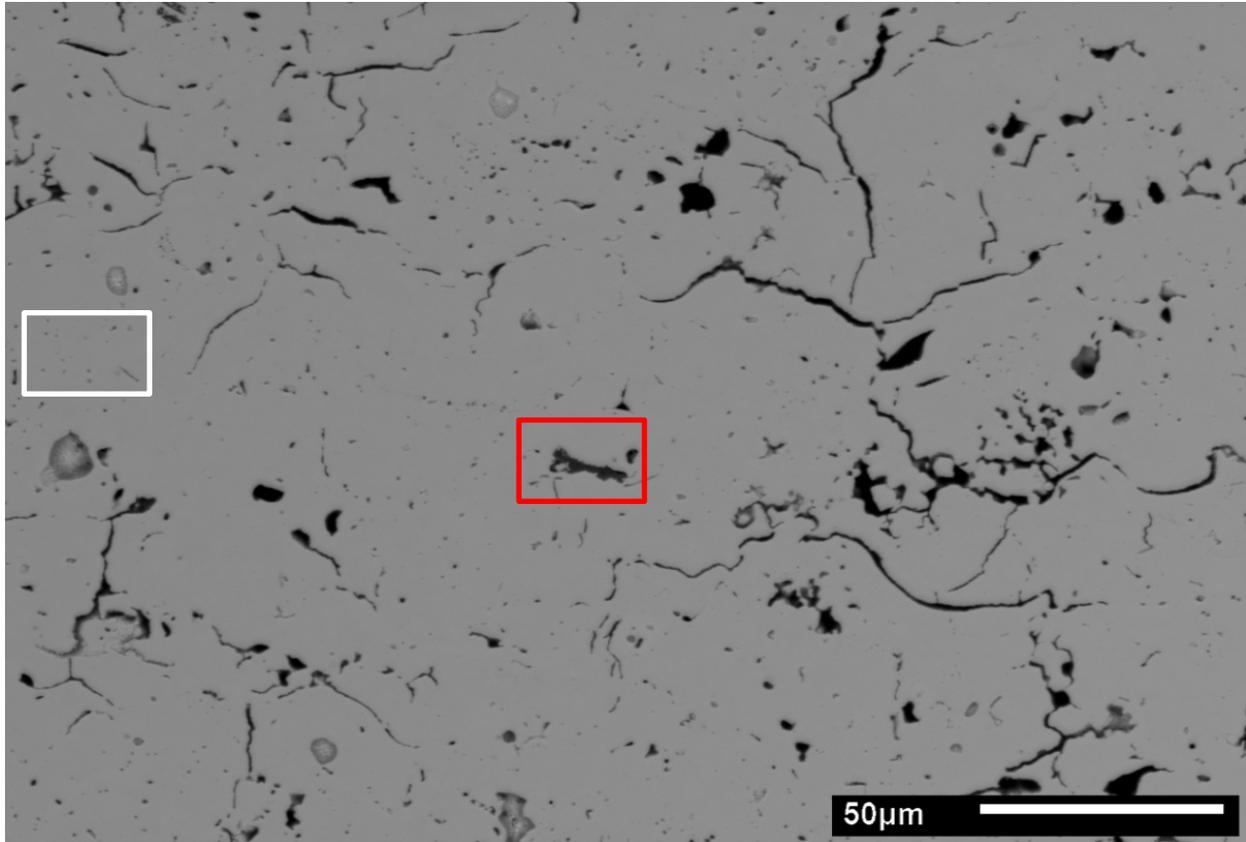
After 100 hours at 1300°C, Figure 29, the splat-like structure of the as-sprayed coating was no longer distinguishable.

**Figure 29 - CP-LD after 100 hours at 1300°C. White box highlights small pores. Red box indicates a region of  $\text{SiO}_2$  and  $\text{Al}_2\text{O}_3$  impurities.**

Vertical and horizontal micro-cracks had almost completely healed, leaving small isolated pores behind (white box). The larger horizontal delaminations had also begun to bridge and heal, although some of the larger delaminations still exist.

Small pools of the impurity elements appeared all over the coating (Figure 29 - red box). A higher magnification micrograph of the highlighted region is shown in Figure 30.

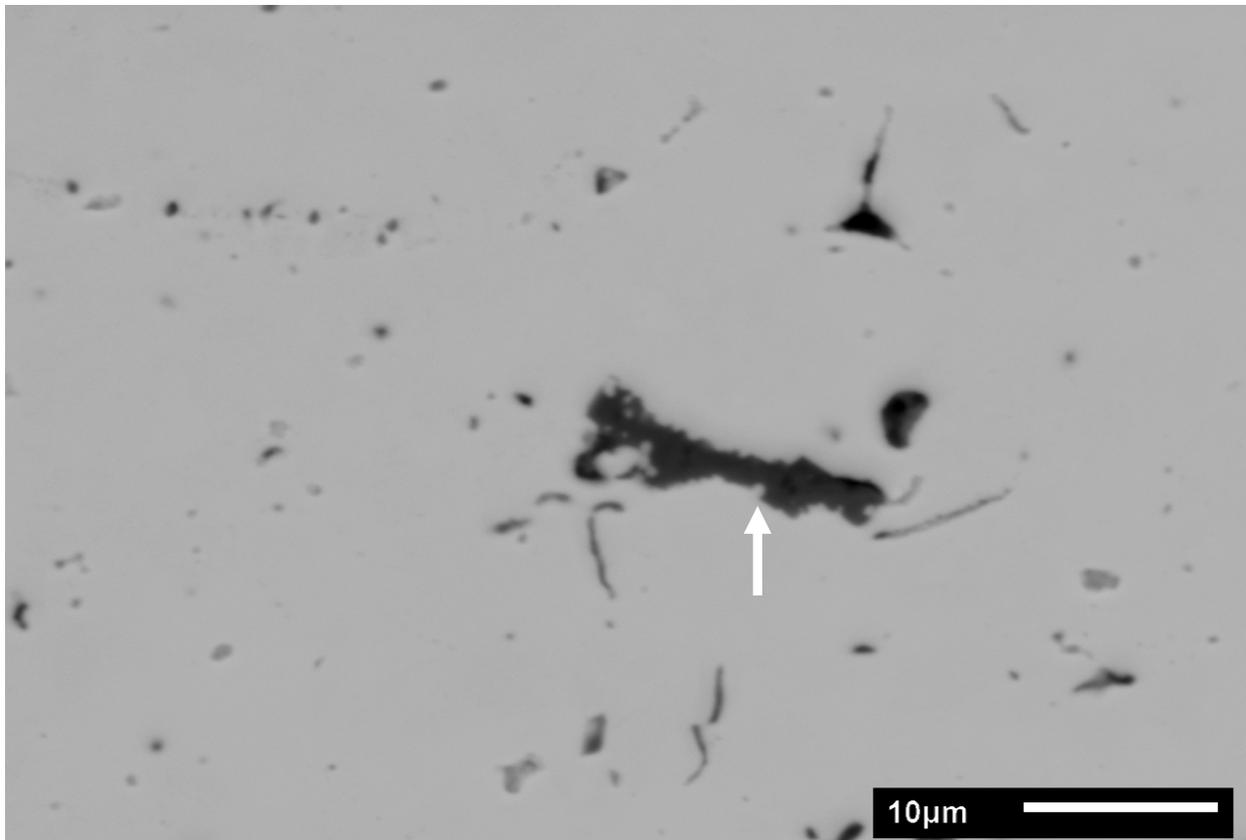
**Figure 30 - CP-LD after 100 hours at 1300°C. White arrows indicate regions of SiO<sub>2</sub> and Al<sub>2</sub>O<sub>3</sub> impurities.**

Composition of these pooled regions were difficult to measure as they were very small (<1µm) and pickup from the surrounding regions during EDS analysis was a problem. Regardless, the primary constituents were silicon, aluminum with traces levels of magnesium and sodium.

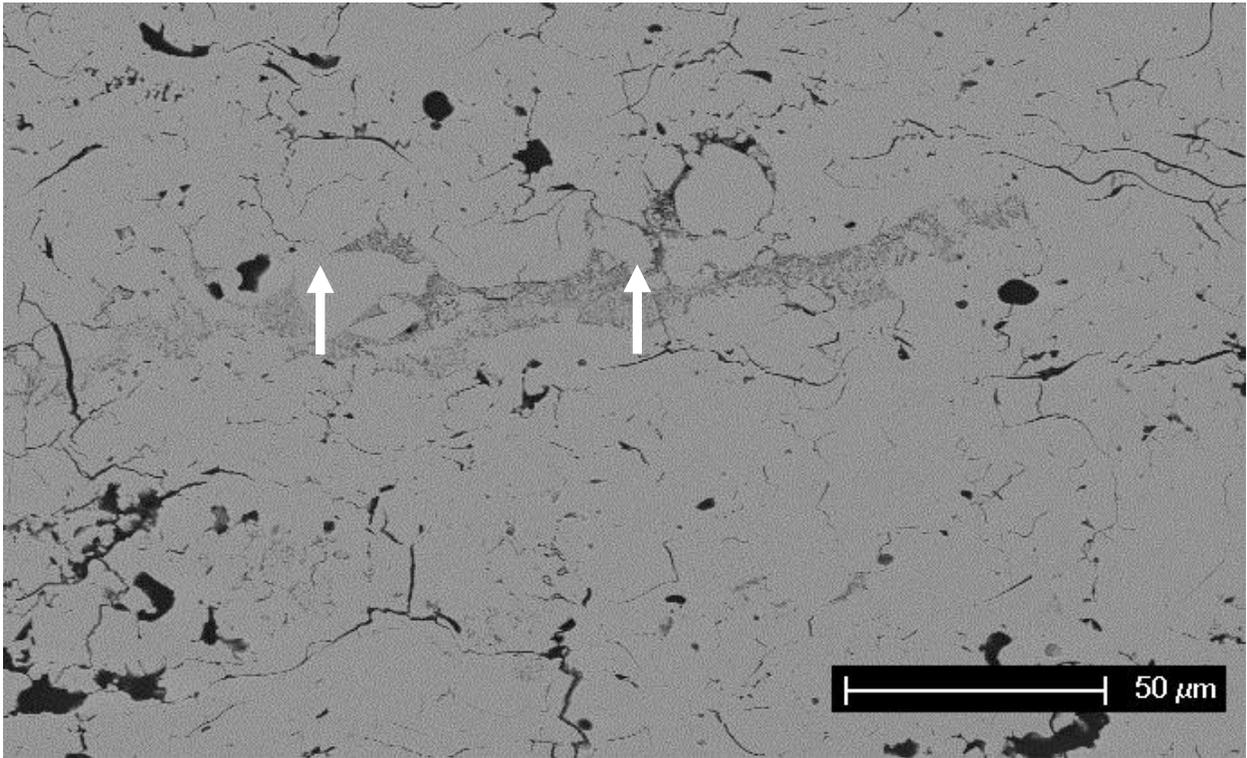
After 100 hours at 1200°C, Figure 31, many of the small microcracks had healed. The morphology of the impurity regions did not seem to change to the extent they did after 100 hours at 1300°C. Many of these regions, such as that indicated by the white arrows in Figure 31, still appeared to have a splat-like shape whereas the impurity regions in the 100 hour 1300°C coatings appeared more like pools.

**Figure 31 - CP-LD after 100 hours at 1200°C. White arrows indicate regions of SiO<sub>2</sub> and Al<sub>2</sub>O<sub>3</sub> impurities.**

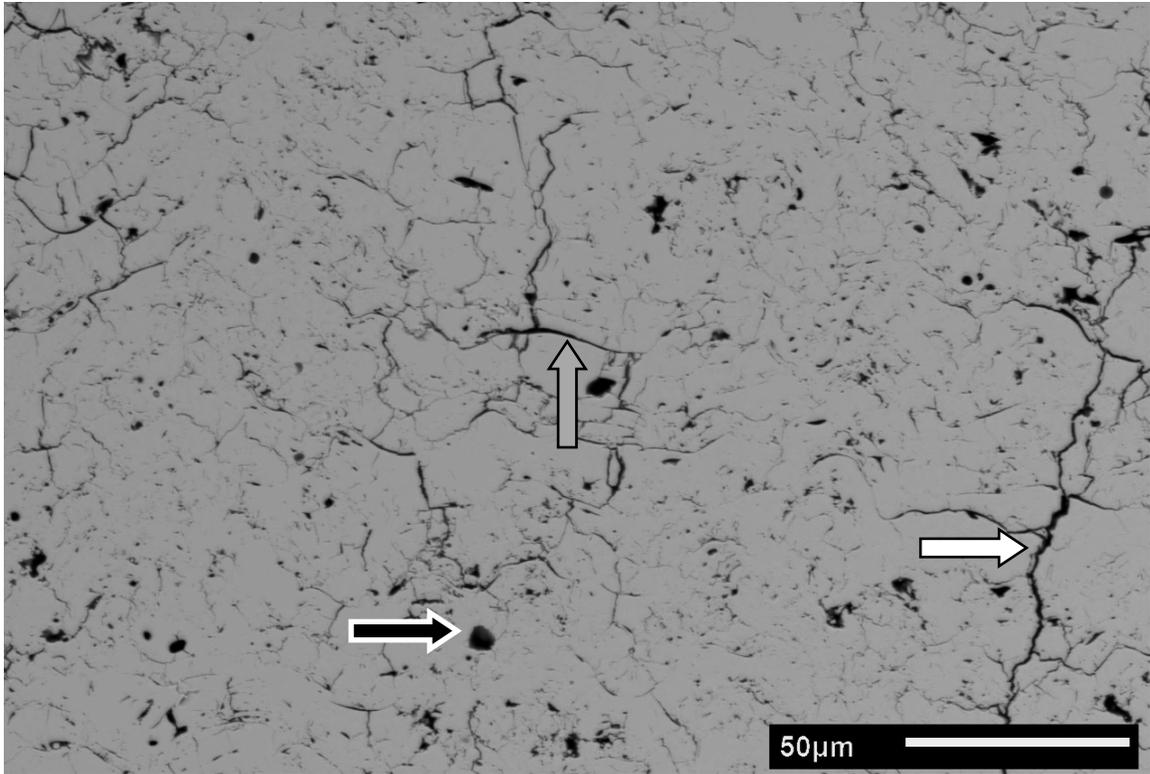
**Figure 32 - HP-DVF in the as-processed condition. White arrows indicate vertical fissures, black – globular pores and grey – horizontal delaminations.**

The large vertical fissures, which are characteristic of this coating, are indicated by the white arrow, horizontal delaminations by the gray arrow and globular pores by the black arrow. This coating also contained a high density of fine micro-cracks which are scattered all over the coating.

porosity, the density did not change much. In the HP-DVF coating, Figure 32, the porosity was split between small micro-cracks/pores and large vertical fissures. After thermal exposure at 1300°C, the large fissures remained open but the micro-cracks healed (Figure 34). Since the micro-cracks/pores visually appeared to account for a larger fraction of the overall porosity, the density would have increased more. This is a qualitative analysis based on visual comparisons of the coatings. An accurate pores size distribution could quantitatively verify this observation, however, measurement methods such as mercury porosimetry do not always accurately resolve the larger pores/cracks and therefore tend to over misrepresent the pore-size distribution. Thus a qualitative analysis may be sufficient.

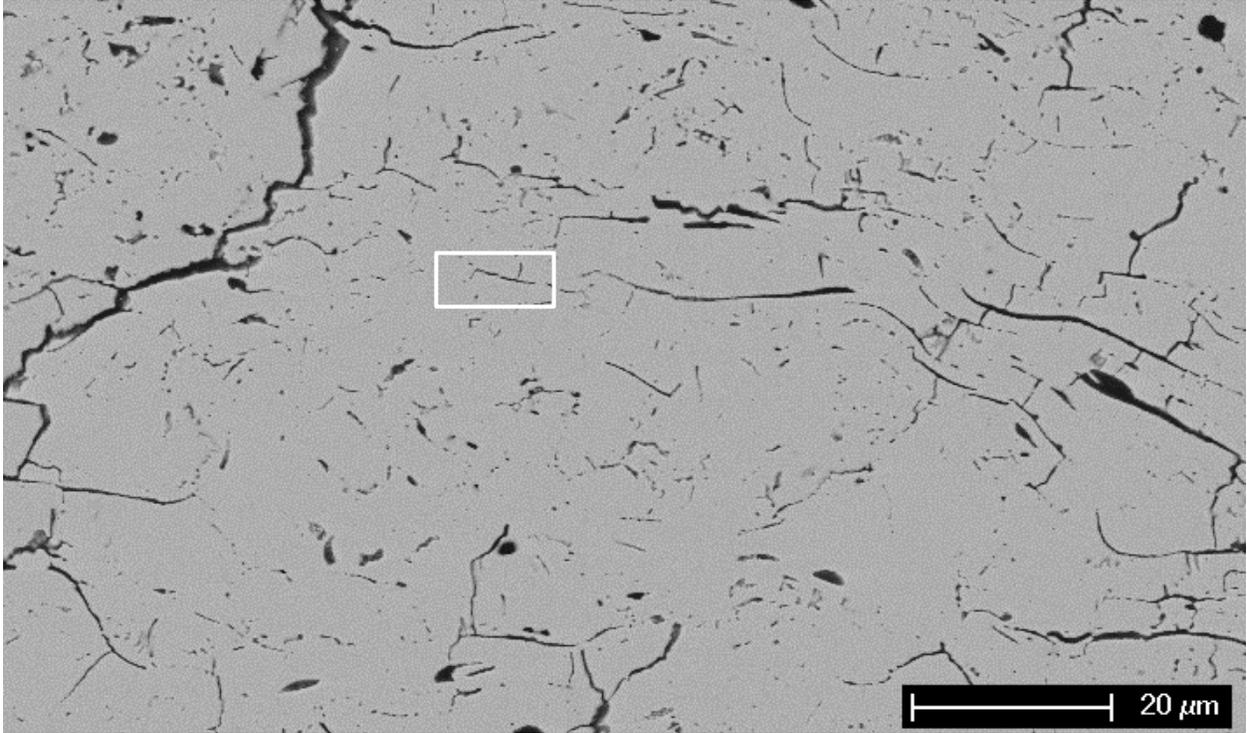
With 10 hours at 1300°C, Figure 33, many of the small micro-cracks had begun to heal/bridge as indicated by the white box. The larger vertical fissures and horizontal delaminations remained open though.

**Figure 33 - HP-DVF after 10 hours at 1300°C.**

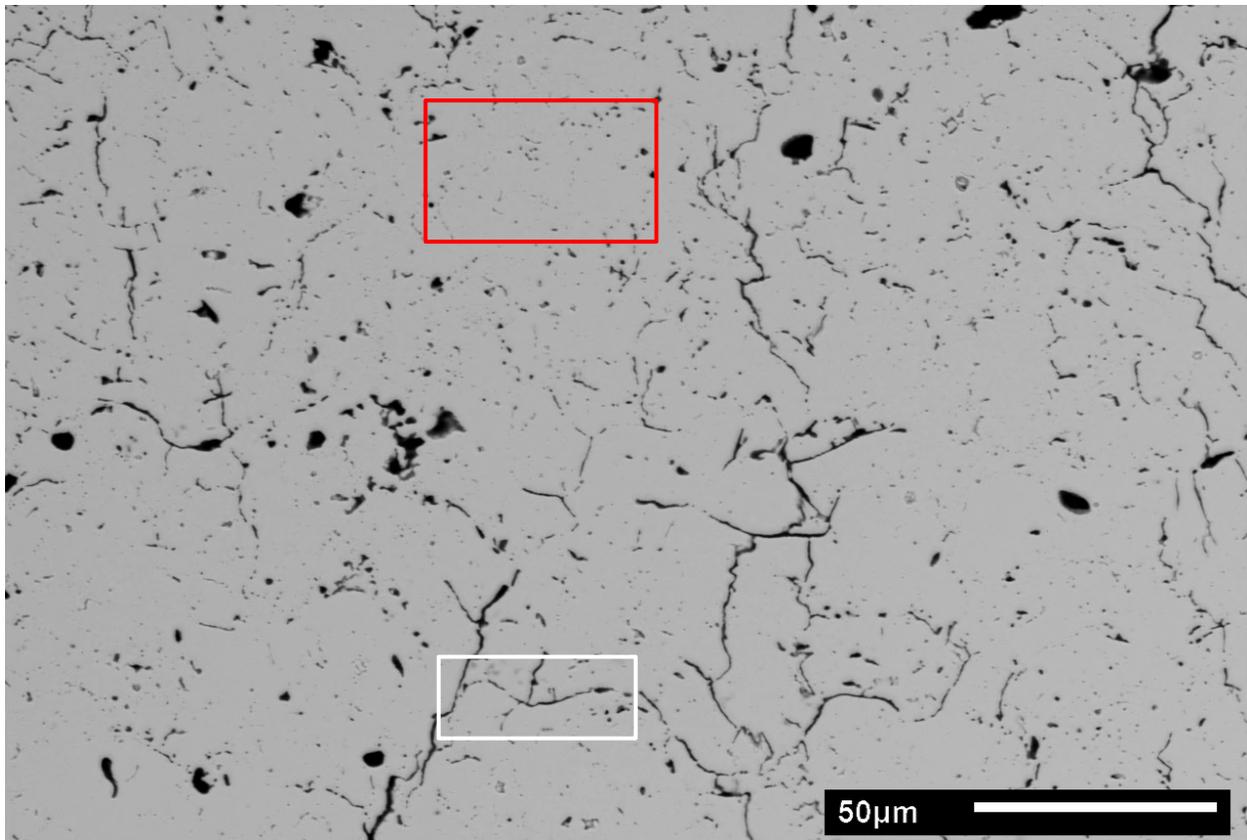
With an additional 90 hours, the micro-cracks in the 100 hour specimen at 1300°C, Figure 34, healed even further leaving small round pores throughout the coating (red box).

**Figure 34 - HP-DVF after 100 hours at 1300°C.**

Furthermore, some of the larger horizontal delaminations (white box) had begun to make contact/heal. The large vertical fissures still remained open though.

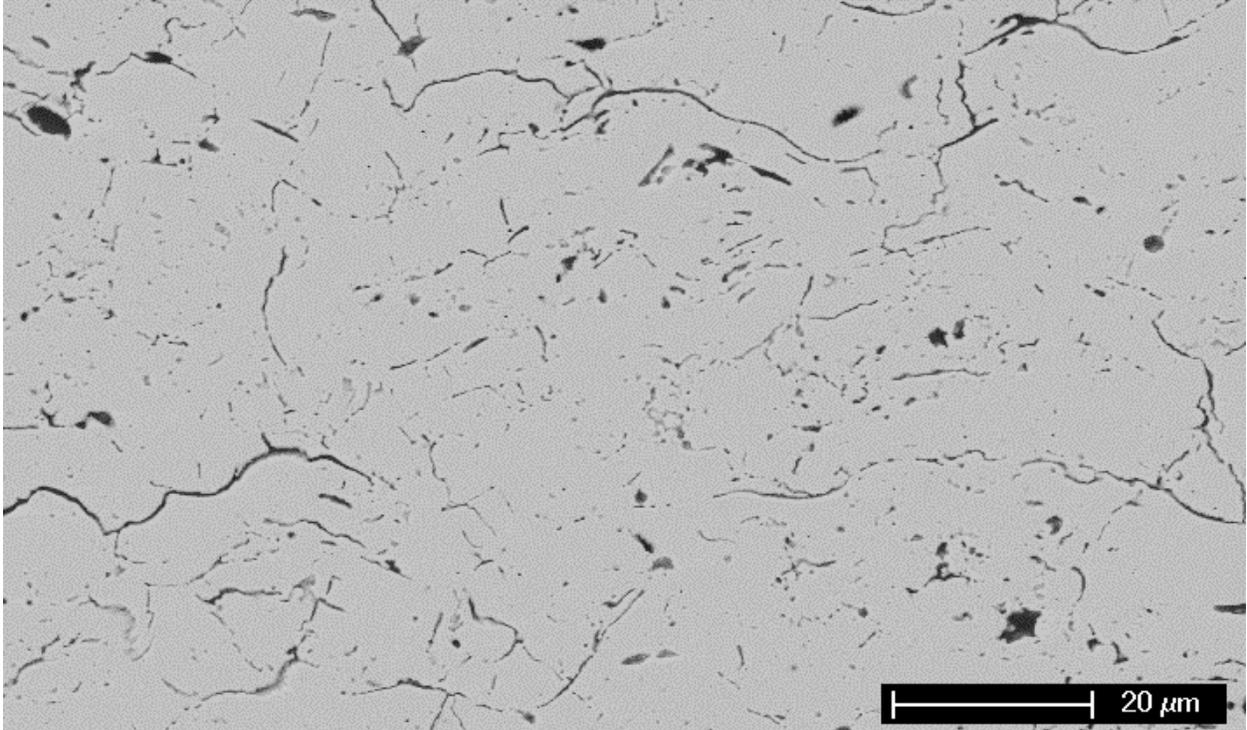
The 100 hour 1200°C specimen, shown in Figure 35, again exhibited significant closure of the micro-cracks. Larger delaminations and pores remained open.

**Figure 35 - HP-DVF after 100 hours at 1200°C.**

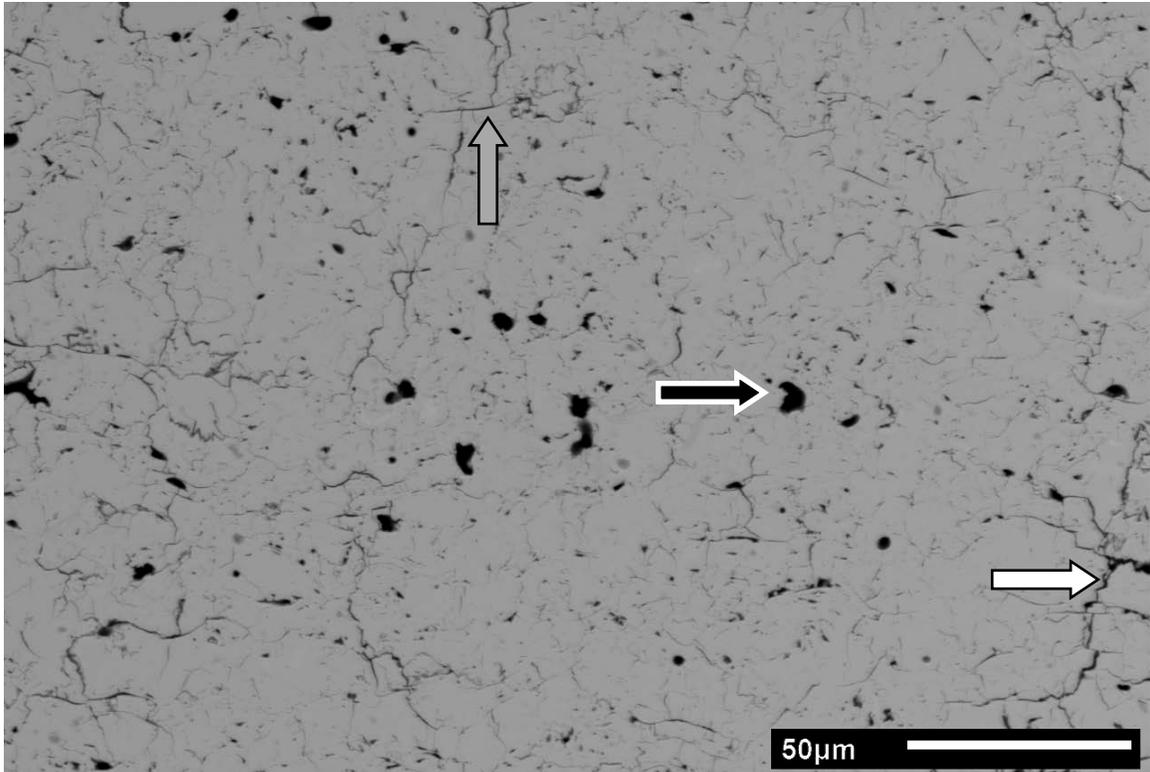
**Figure 36 - CP-DVF in the as-processed condition. White arrows indicate vertical fissures, black – globular pores and grey – horizontal delaminations.**

At first glance, the microstructure of the CP-DVF coating appeared similar to that of the HP-DVF coating. There were large vertical fissures, horizontal delaminations, globular pores and a high-density of the micro-cracks. However, closer examination revealed impurity splats and particles. The splat highlighted in Figure 37 was composed of zirconium, magnesium and oxygen.

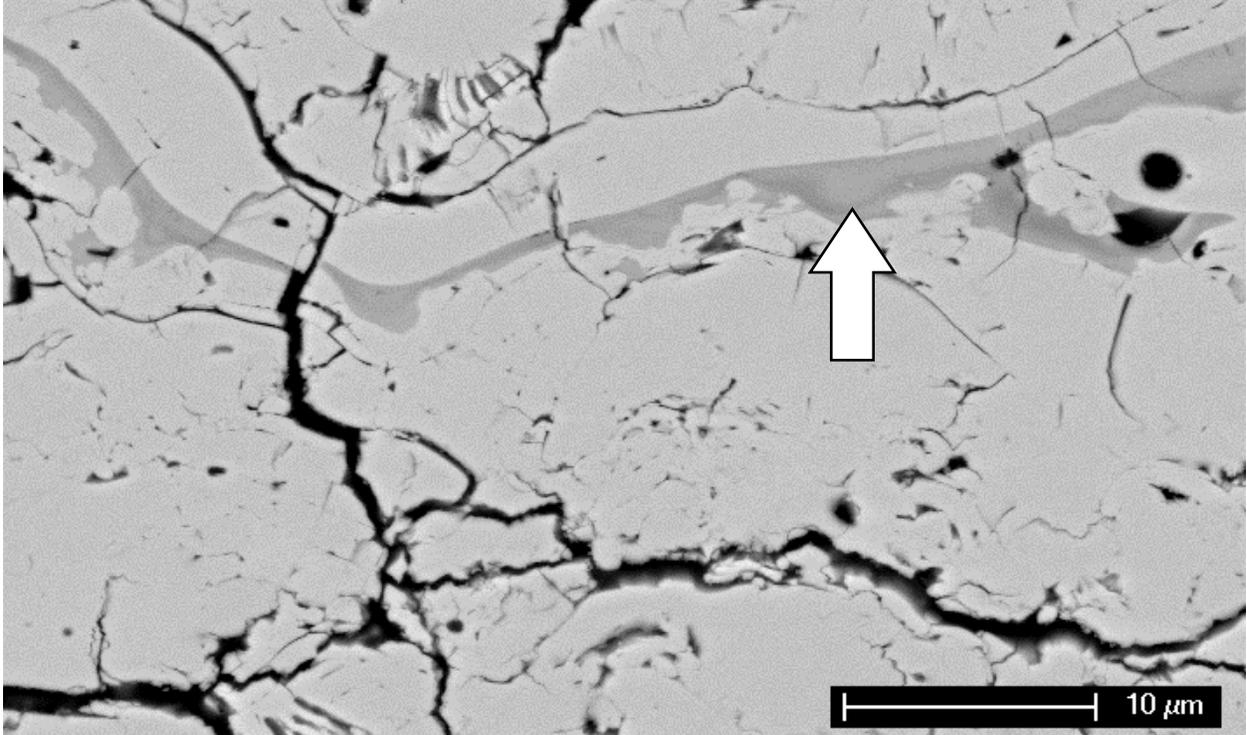
**Figure 37 - CP-DVF in the as-processed condition. White arrows indicates a splat rich in magnesium and zirconium.**

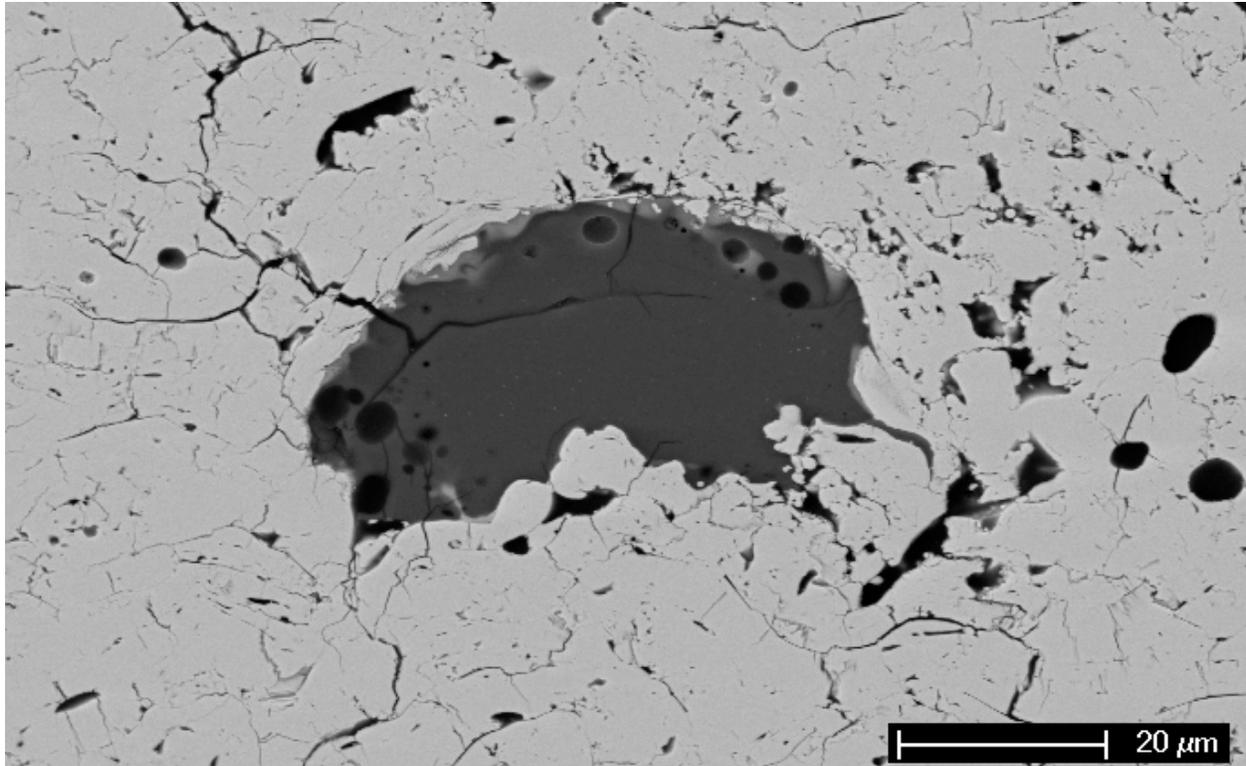
**Figure 38 – CP-DVF in the as-processed condition. Large black particle was a silica-alumina rich phase.**

This particle's composition, determined by standardless EDS, was approximately: 42 at% Si, 5 at% Al, 1 at% Hf and 51 at% oxygen. This composition does not seem to correspond to any  $\text{SiO}_2\text{-Al}_2\text{O}_3\text{-HfO}_2$  combination, as the oxygen content is not high enough to permit the appropriate molar ratios to be satisfied, thus either the EDS is not measuring the composition accurately or this particle is oxygen deficient. Most likely the EDS measurement is inaccurate and the particle is silica with minor alumina contents.
