**FAILURE OF THICK, LOW DENSITY AIR PLASMA SPRAYED THERMAL  
BARRIER COATINGS**

**Michael Aaron Helminiak**

Submitted to the Graduate Faculty of  
Swanson School of Engineering in partial fulfillment  
of the requirements for the degree of  
Doctorate of Philosophy

University of Pittsburgh

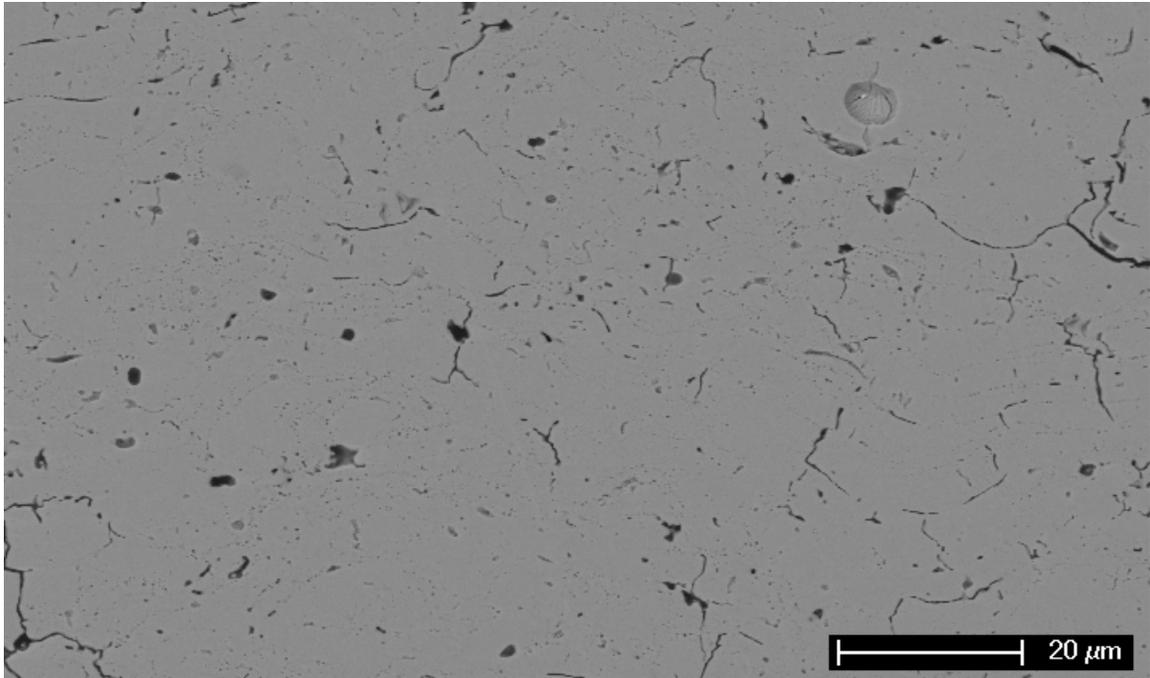
Upon exposure for 10 hours at  $1300^\circ\text{C}$ , Figure 39, the micro-cracks in the coating healed.

**Figure 39 - CP-DVF after 10 hours at 1300°C**

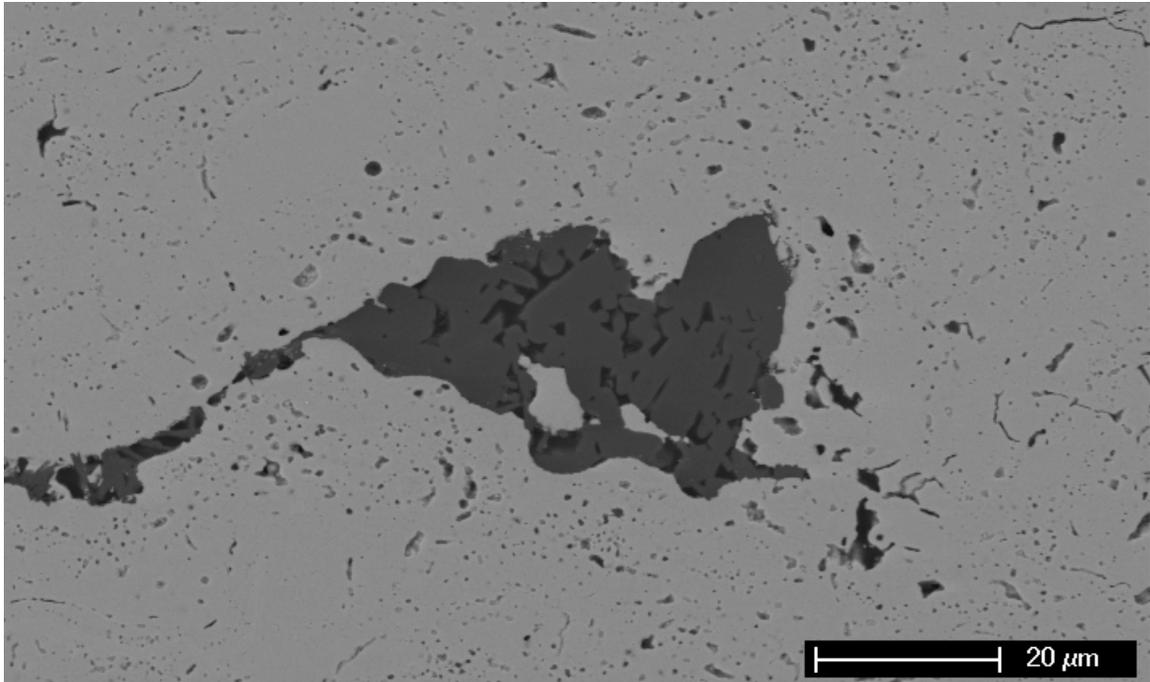
Furthermore, small pores appeared all over the coating, which are visible in Figure 40.

**Figure 40 - CP-DVF after 10 hours at 1300°C. The dark structure is a silica-alumina impurity particle.**

These pores were scattered all over the coating. As shown in Figure 40, the pores were scattered around an impurity particle rich in silicon and aluminum, however, they were also located all over the coating.

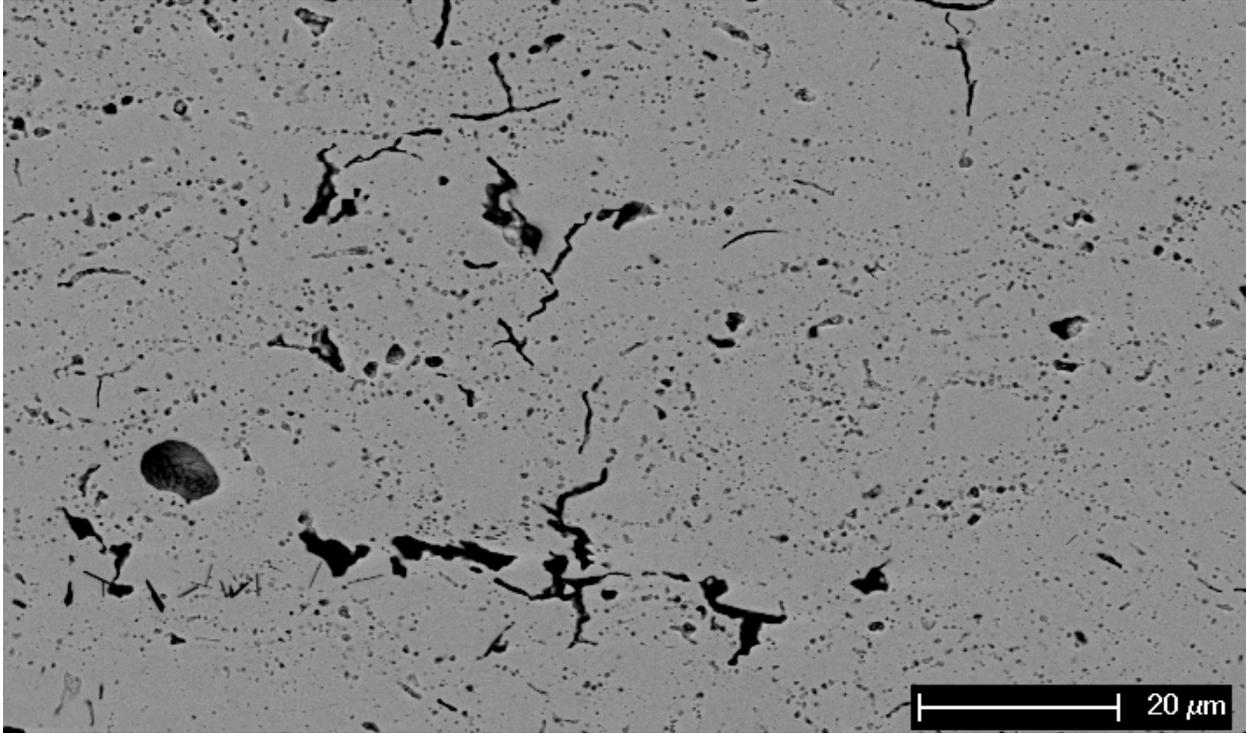
After 100 hours at 1300°C, the quantity and size of the small pores increased, Figure 41.

**Figure 41 - CP-DVF after 100 hours at 1300°C**

Likewise, the splat-structure present in the as-processed coating no longer existed in this specimen and many of the large fissures and horizontal delaminations closed. A high magnification image of the small pores is shown in Figure 42.

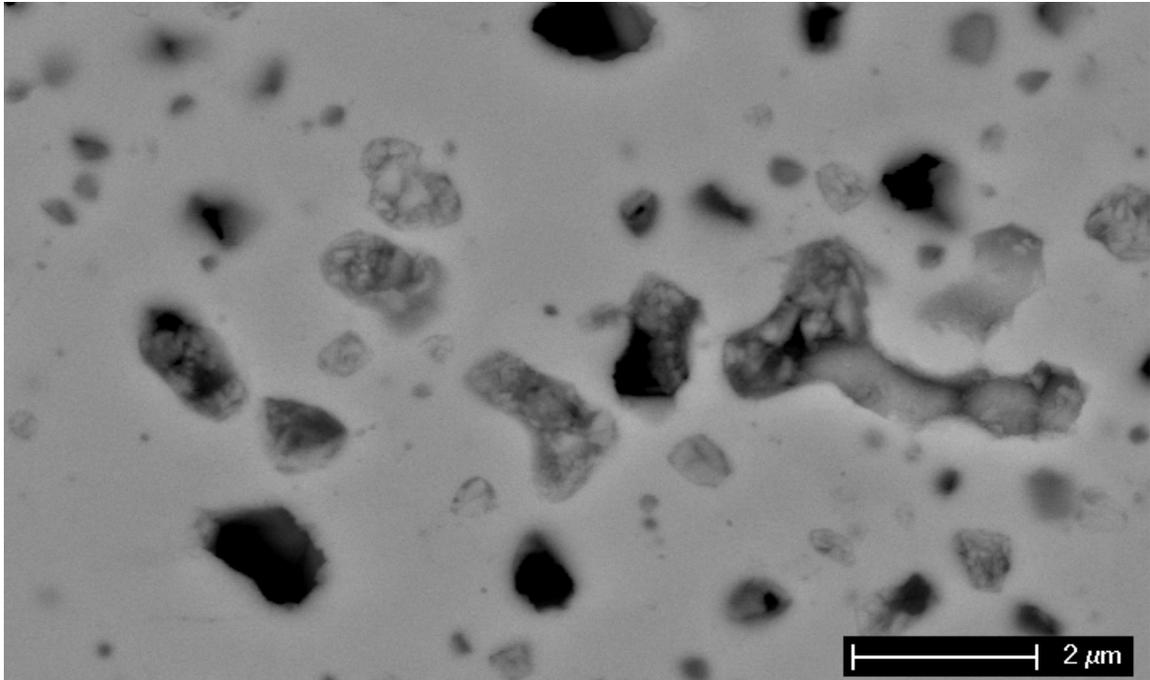
**Figure 42 - CP-DVF after 100 hours at 1300°C. High-magnification image of pores in the coating.**

The pores did not appear to contain any secondary impurity phase, at least to the detectable limit of the EDS equipment. The formation and growth of these pores during the 100 hour sintering period could account for the additional volume needed to cause the decrease in the density which was observed in the previous section. However, the source and driving force for their formation is unclear.

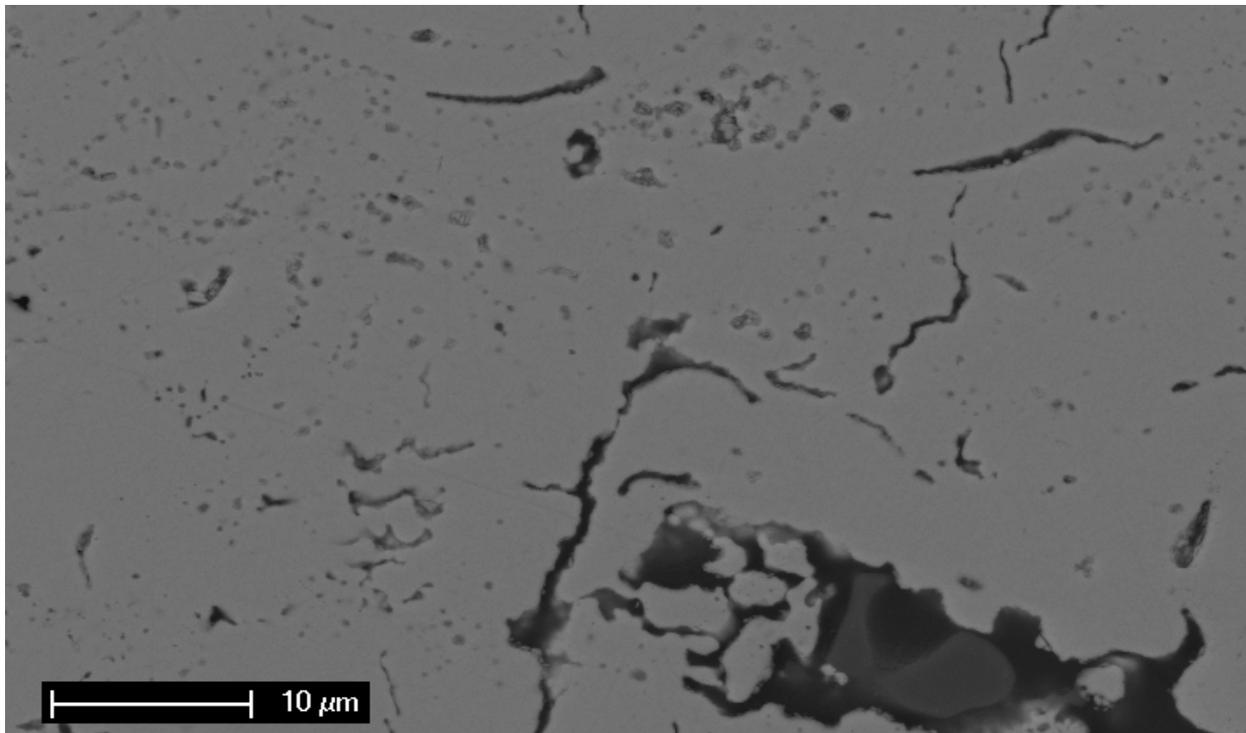
The 100 hour 1200°C coating, Figure 43, also contained these pores, though they were much smaller than those in the 1300°C specimen.

**Figure 43 - CP-DVF after 100 hours at 1200°C.**

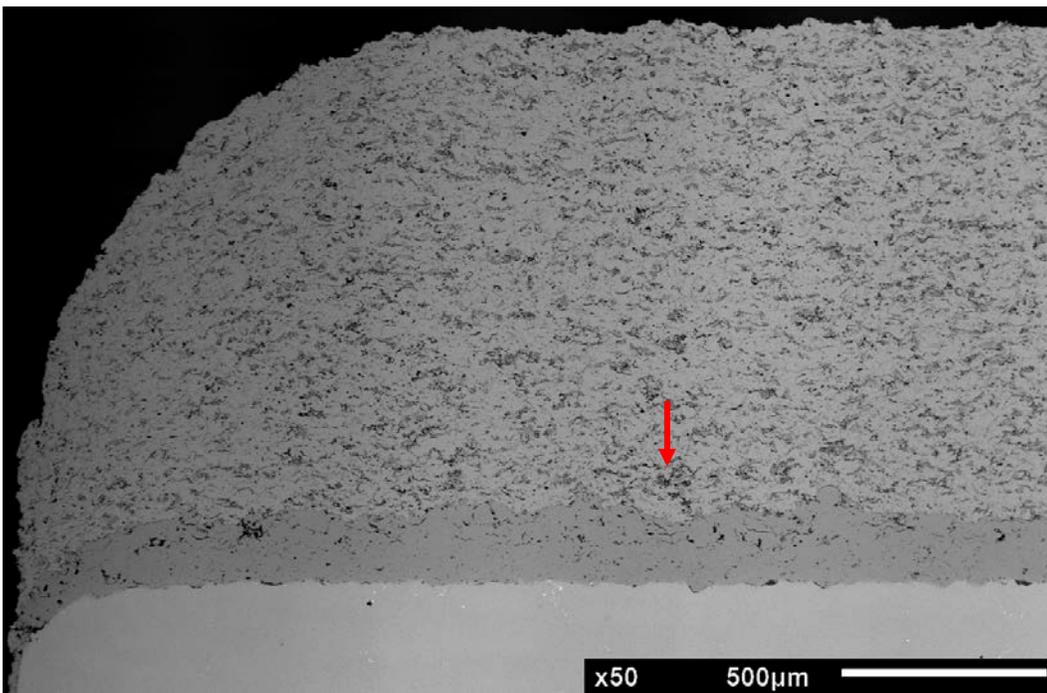
**Figure 58 – 1150 μm TBC in the as-processed condition. Red arrow indicates pull-out in the topcoat as a result of metallographic preparation.**

The red arrows in Figure 58 and Figure 59 indicate areas in the topcoat where the YSZ has pulled-out. These defects are a result of the epoxy not penetrating the topcoat the entire way down to the bond coat interface to preserve the fragile microstructure during grinding and polishing. This was not a problem with the thinner topcoat specimens since the epoxy could easily penetrate the pores so as to preserve the entire topcoat. Besides these artifacts, all of the coatings appeared similar with regards to porosity and the amount of over-spray at the edges.

Moving down in topcoat thickness, the diagonal cracking was only observed near the free-edges of the thinner topcoat specimens. This cracking is likely caused by both the stress singularity that exists at the free edge of a multi-layered coating system subjected to biaxial thermal stresses and by the curvature of the bond coat – topcoat interface at this free edge [22]. This curvature can clearly be seen in Figure 58.

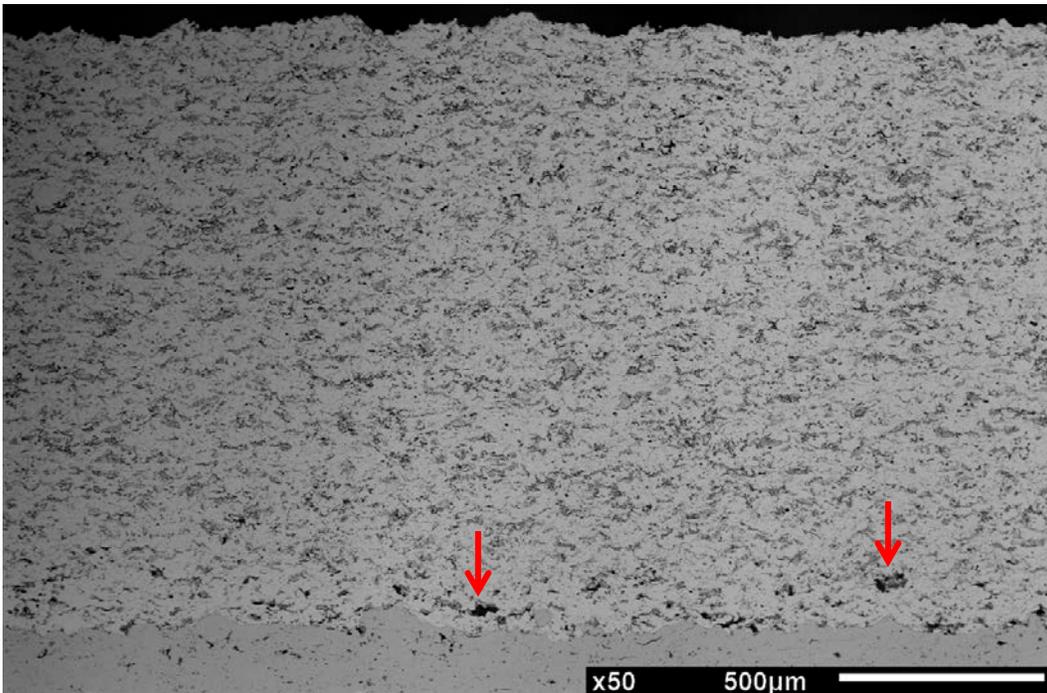
**Figure 59 – 1425  $\mu\text{m}$  TBC in the as-processed condition. Red arrows indicate pull-out in the topcoat as a result of metallographic preparation.**

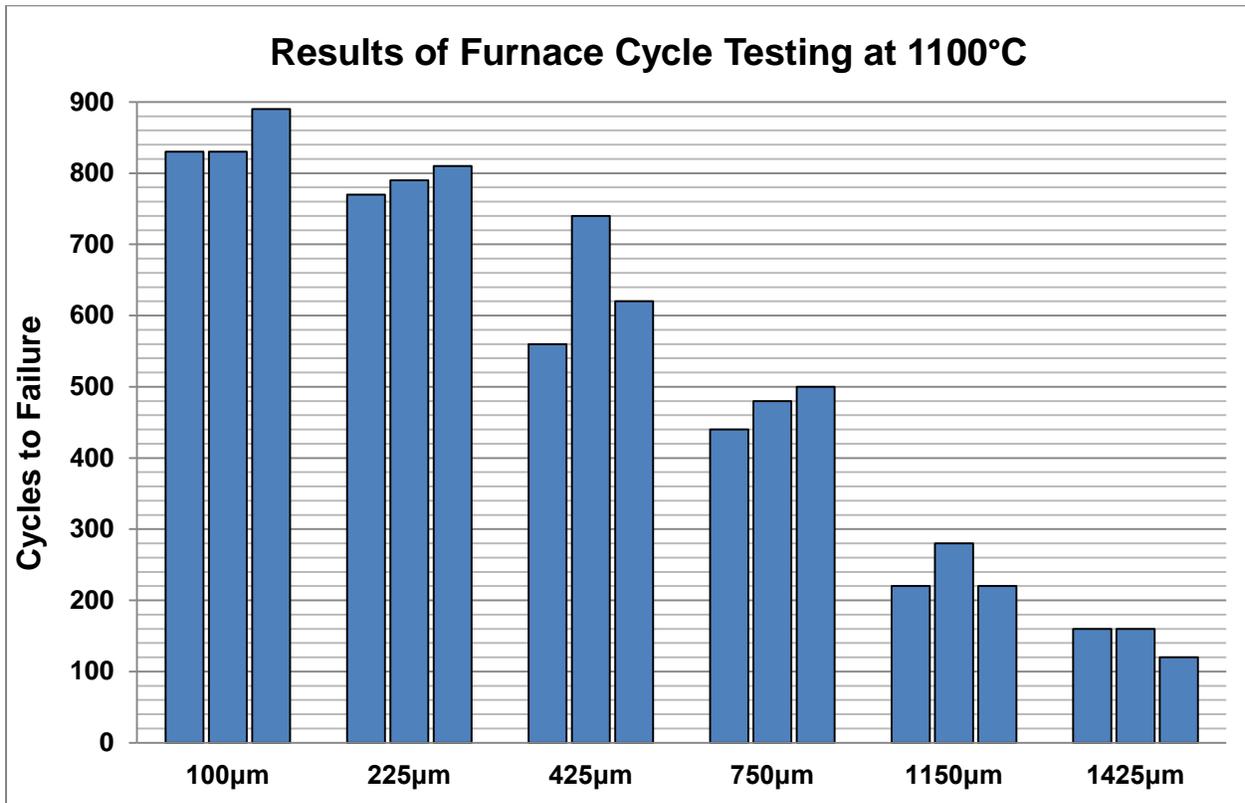
Figure 60 - FCT results for TBCs with varying topcoat thicknesses. All specimens had the same substrate (PWA 1484) and bond coat type (dual layer NiCoCrAlY).

The reproducibility within each coating thickness was relatively good indicated by the tight group of the bars in Figure 60. The 425µm coating had the largest spread in lifetime with a standard deviation of  $\pm 80$  cycles.

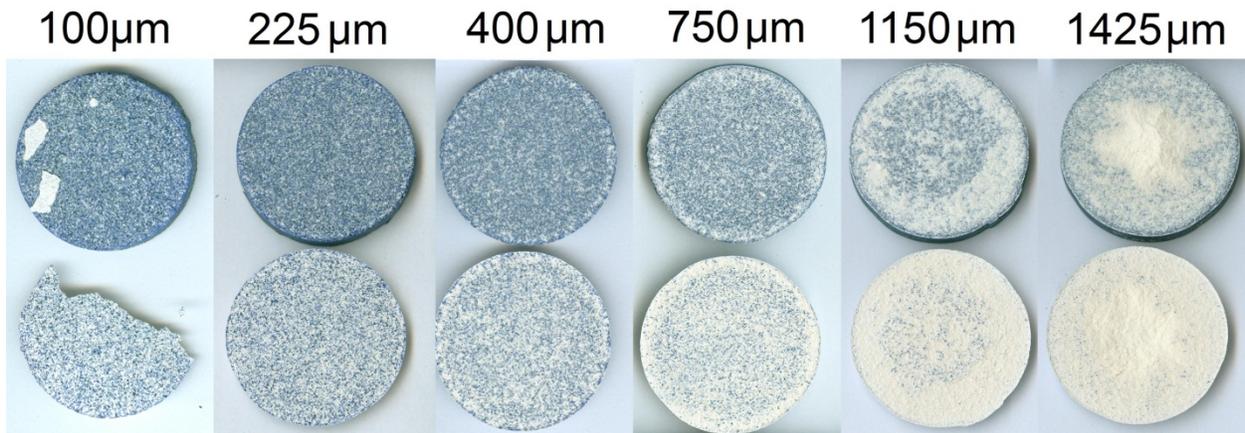
The representative fracture surfaces of each of the 6 different thicknesses are shown in Figure 61 which are high-resolution images taken with a flatbed scanner. The bluish color is

from the  $\text{NiAl}_2\text{O}_4$  spinel oxide that forms in the transient period [39] and the white material is YSZ left on the fracture surface.

**Figure 61 - High resolution images of the fracture surfaces of each of the 6 different thickness coatings. The upper circles are the substrate-bond coat portion of the TBC and the lower circles are the undersides of the corresponding topcoats that spalled off.**

Moving from left to right (thin to thick topcoat), the amount of YSZ on the fracture surface increases indicating the spallation crack is primarily propagating through the topcoat in the thicker TBCs. This observation is consistent with previous work [2] where 375, 750 and 1150  $\mu\text{m}$  topcoats on IN 718 were furnace cycle tested at the same temperature and produced similar results. Specifically, the 1150 $\mu\text{m}$  coating on IN718 produced a fracture surface almost identical to the 1425 $\mu\text{m}$  TBC in Figure 61.

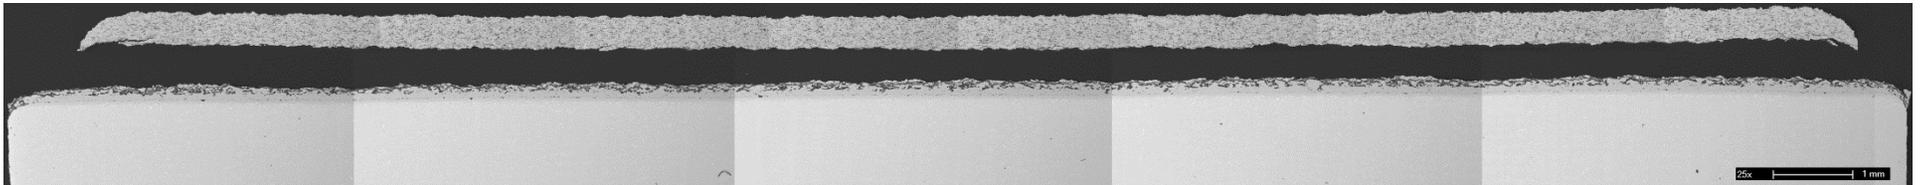
**Figure 64 - 425 µm TBC with 560 cycles at failure. Note, the topcoat and the substrate were cross-sectioned at different positions which accounts for their apparent differences in length.**

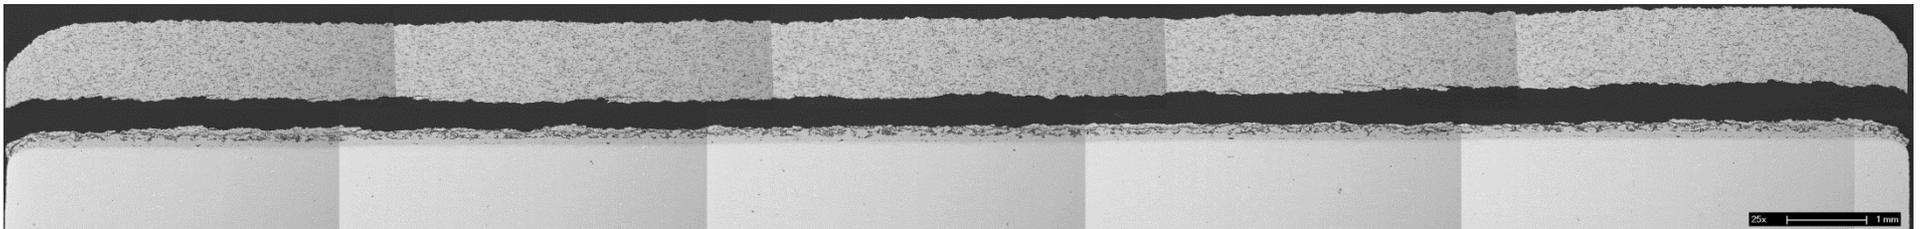
**Figure 66 - 1150  $\mu\text{m}$  TBC with 280 cycles at failure.**

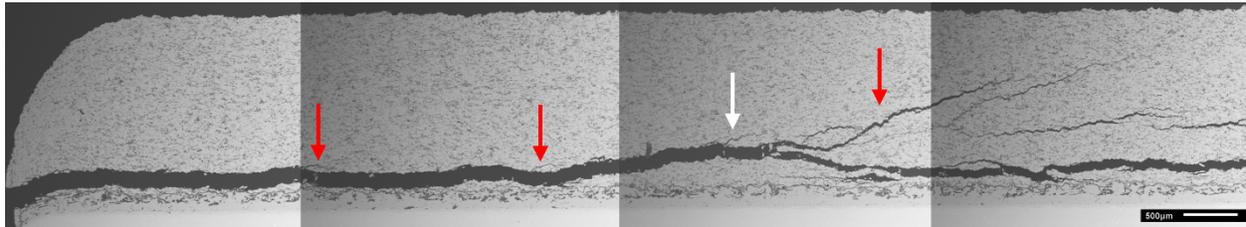
The 1425 $\mu\text{m}$  coating and, to some extent, the 1150  $\mu\text{m}$  and 750  $\mu\text{m}$  coatings all experienced cracking within the topcoat layer. In the case of the 1425 $\mu\text{m}$  coatings, there was heavy diagonal cracking up into the topcoat which is depicted in Figure 68.

**Figure 68 - 1425 $\mu\text{m}$  coating which failed at 160 cycles. Note both the horizontal and diagonal cracking within the topcoat. The red arrows point out diagonal cracks which have formed but not propagated to the extent of the other diagonal cracks.**

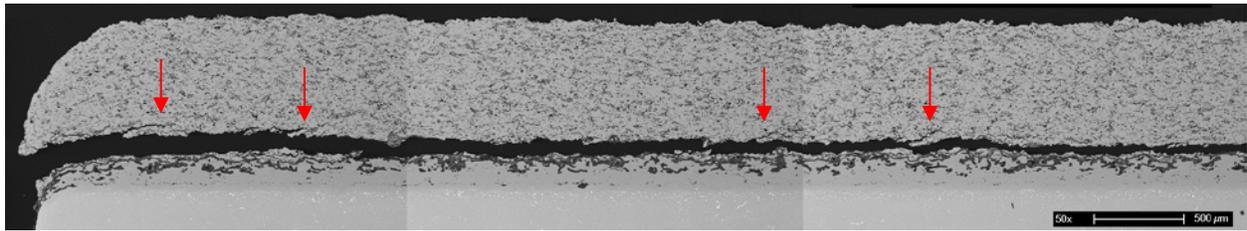
While the 1150  $\mu\text{m}$  and the 750  $\mu\text{m}$  coatings exhibited some diagonal cracking, shown in Figure 69 and Figure 70, the horizontal cracking ultimately led to the spallation of the YSZ topcoat. This conclusion is based on the lack of extensive diagonal cracking (relative to that seen in the 1425 $\mu\text{m}$  coating) in the topcoats of these specimens.

**Figure 69 - 1150µm topcoat after spalling off with 280 cycles. The red arrows highlight diagonal cracking that occurred near the topcoat-TGO interface.**

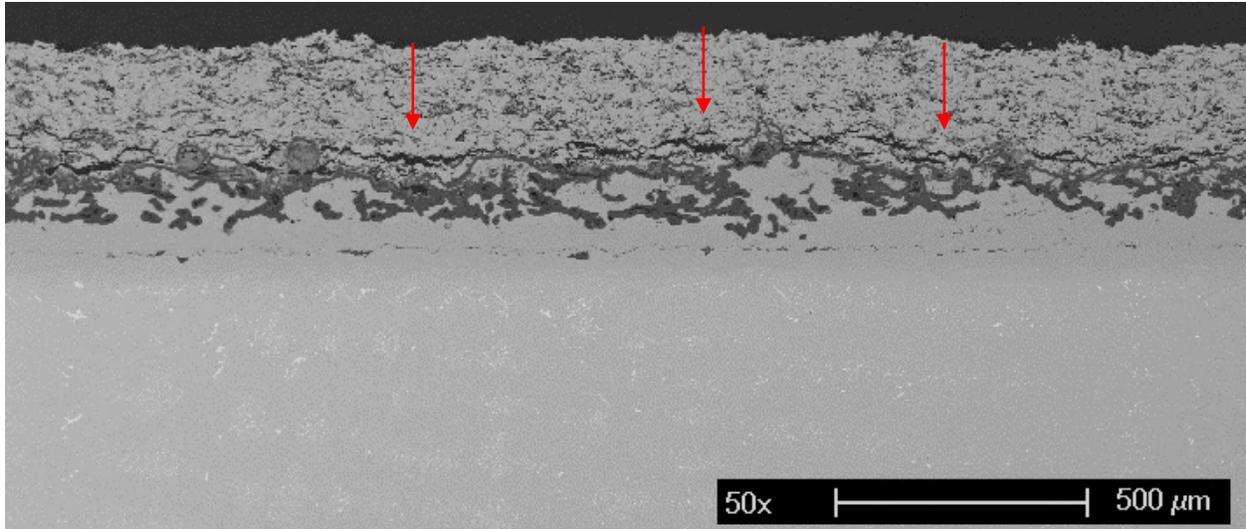
Similarly, the 225  $\mu\text{m}$  coating shown in Figure 63 appeared almost entirely intact, with only the right side of the coating becoming delaminated. Closer examination of the ‘intact’ region also revealed extensive cracking depicted in Figure 72 by the red arrows.

**Figure 72 – 225 μm coating with 810 cycles until technical failure.**

Based on these observations, both edge cracking and cracking within the bulk of the specimens seemed to be occurring. Furthermore, it is possible the spallation event was the end result of all of the individual pockets of cracks in the bulk (Figure 72) and at the edges linking together, however, this is speculation as a detailed picture of how these cracks formed, propagated and eventually caused failure was not available.

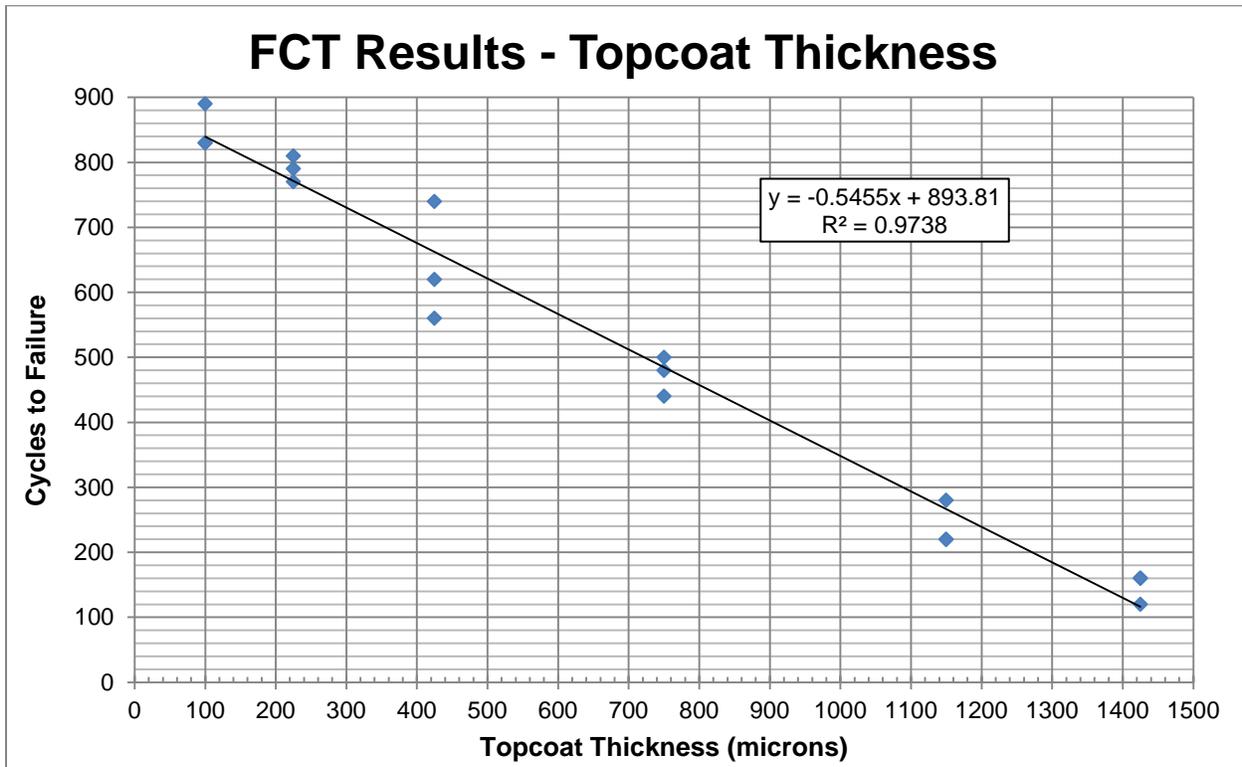
**Figure 74 - Plot of topcoat thickness vs. cycles to failure.**

The data was fit with both linear and parabolic trend lines. A parabolic trend was investigated because the stress intensity factor induced by the topcoat should increase with the square root of the thickness of the topcoat. Microsoft Excel offers a linear fit option but to fit the data with a parabolic trend line, the raw data had to first be manipulated by squaring either the cycles to failure or the thickness and then fitting this new plot with a linear trend line. A similar technique is used to measure the growth rate of oxide scales on metals and alloys where the mass

The data was fit best with the pure linear fit line (Cycles to Failure – Thickness) but the other fit lines had R-squared values close to one indicating the data trend was somewhat inconclusive since it could be described by several different trend lines. For the sake of analysis, the best fit line (Cycles to Failure – Thickness) is shown in Equation 9.

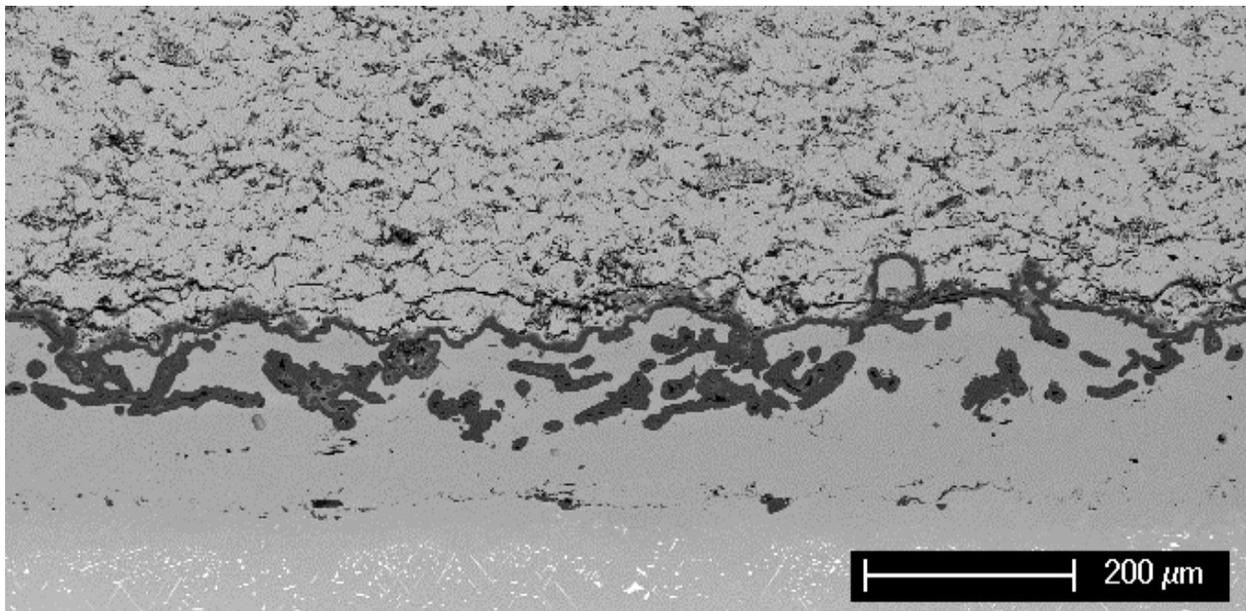
Moving down in topcoat thickness to 750, 425 and 225  $\mu\text{m}$  TBCs, the failure characteristics changed. Taking the 750  $\mu\text{m}$  TBC as an example, the failure occurred at the YSZ-TGO interface. The change in the location of the failure indicated topcoat's stress intensity factor did not exceed the fracture toughness of the YSZ. As Figure 65 depicts, edge cracks were the ultimate cause of the large scale delamination in this TBC but ahead of these cracks, significant damage had already taken place at the YSZ-TGO interface as depicted in Figure 75.

**Figure 75 - 750 $\mu\text{m}$  TBC after 440 cycles. This portion of the topcoat was still intact and far ahead of an edge crack.**

It appeared as though the edge crack was “consuming” an already damaged or weakened region of the interface. Such damage to the YSZ-TGO interface has been modeled by several

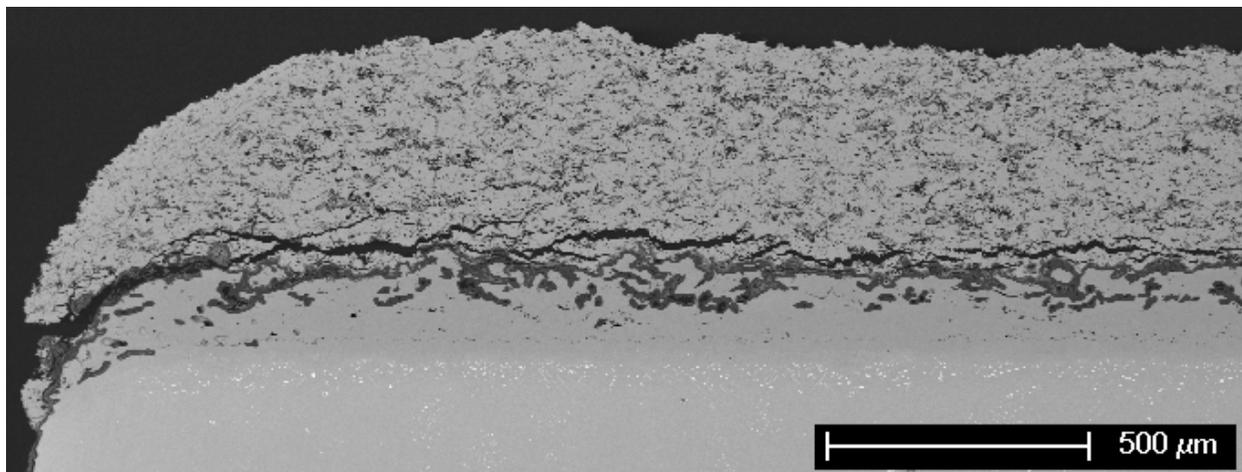
This cyclic damage was also observed in a 425 $\mu\text{m}$  topcoat which was thermally cycled to 90% of its FCT lifetime, at which time the specimen was removed from the furnace, mounted in epoxy, cross-sectioned and observed in the SEM. After 510 cycles, there was visible edge cracking, Figure 76, and cracking within the interior of the specimen, Figure 77, yet the TBC was still intact.

**Figure 76 – The edge of a 425 $\mu$ m topcoat after 510 cycles (91% lifetime).**

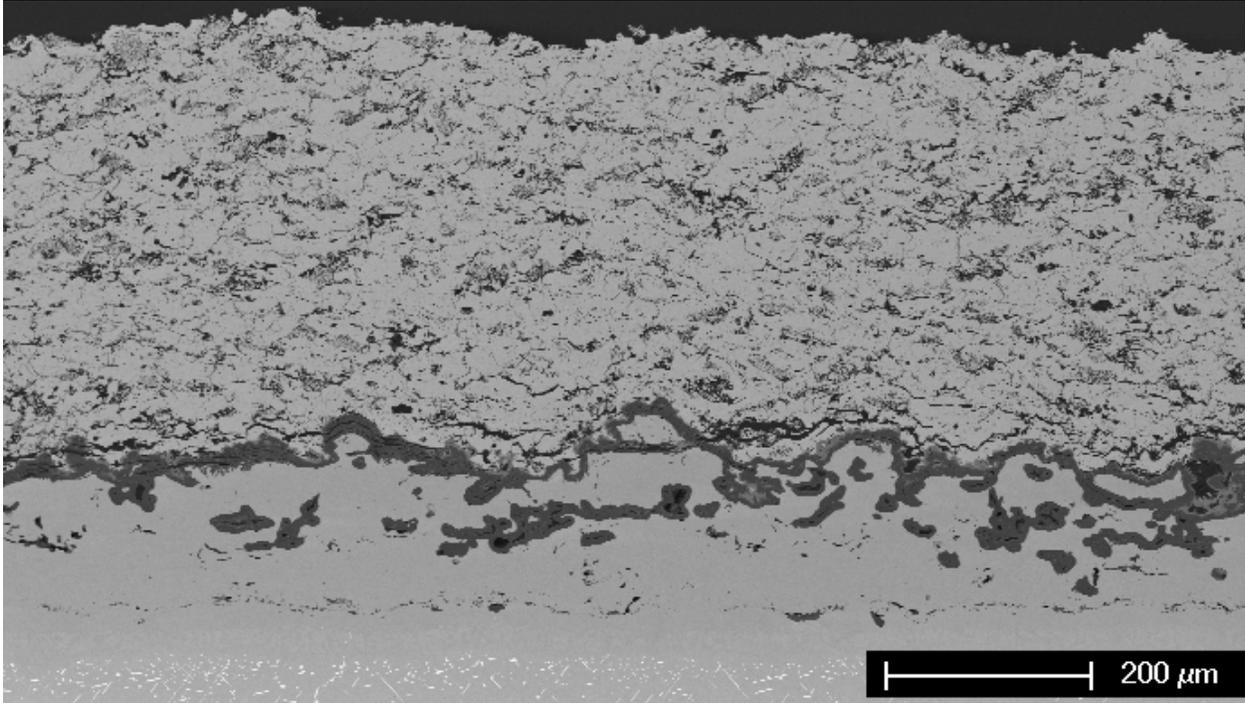
**Figure 77 – The interior of a 425 $\mu$ m topcoat after 510 cycles (91% lifetime).**

The entire interface appeared to be accumulating damage over the lifetime of the specimen, even though the topcoat remained attached. Eventually, edge cracks in the 750, 425 and 225  $\mu$ m TBCs extended causing complete topcoat spallation.

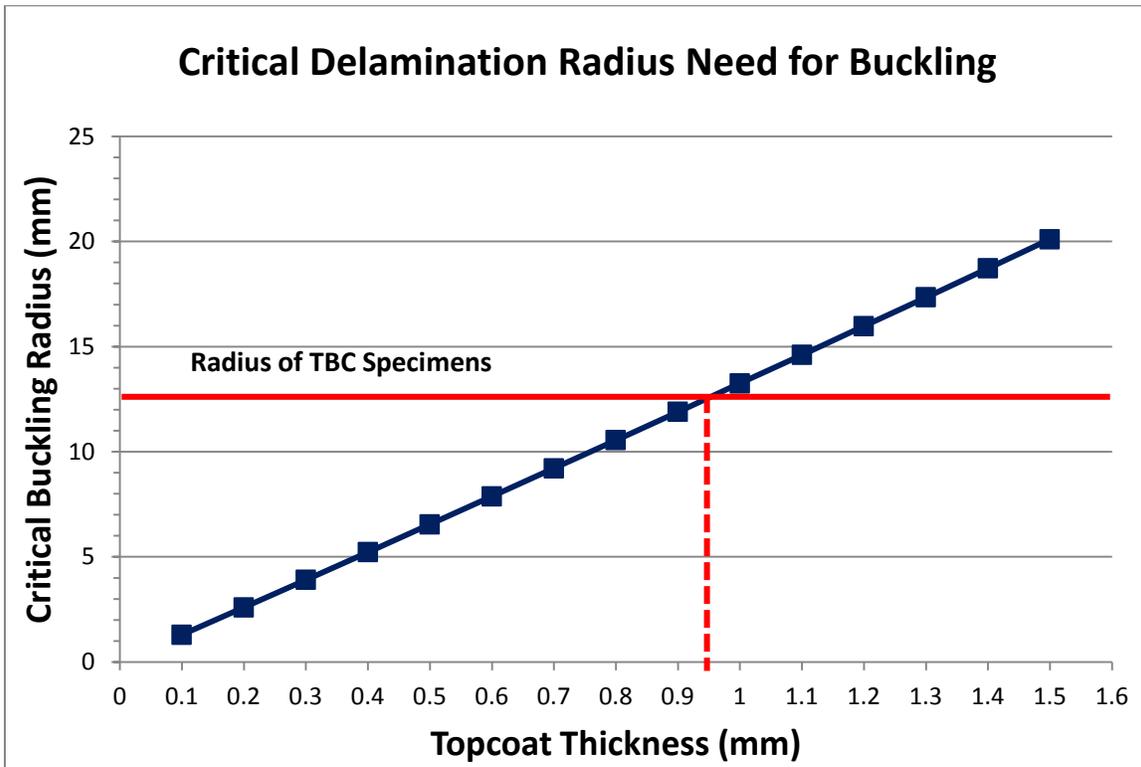
Figure 78 - Critical delamination radius needed for topcoat buckling.

For topcoats above ~0.95mm, buckling should be prohibited because the radius of the TBC specimens (12.5mm) is smaller than the critical radius needed for buckling. For the 750 and 425  $\mu\text{m}$  specimens, delamination of radii 10 and 6mm, respectively, are needed for buckling to occur. While these are physically achievable, buckling was not observed and instead edge delaminations dominated. Yu et al [67] determined that for thin films under a residual stress, an edge flaw of size  $h$  or  $2h$ , where  $h$  is the thickness of the coating, was needed to induce edge delamination whereas, in general, a delamination radius of  $10-20h$  was needed to induce

Based on Figure 78, buckling could more so be a possibility for the 225 and 100  $\mu\text{m}$  TBCs since only  $\sim 3\text{mm}$  and  $\sim 1.5\text{mm}$  delaminations are needed to permit buckling. However, buckling was not observed in the 225  $\mu\text{m}$  TBC but only in the 100 $\mu\text{m}$  specimen. Possible reasons being that not enough small cracks, such as those seen in Figure 72, combined to form a delamination large enough for buckling, or that the edge driven delamination occurred before a large enough delamination could occur. The roughness of the TGO-YSZ interface and the discontinuous cracking could also hinder the crack coalescence thereby preventing buckling.

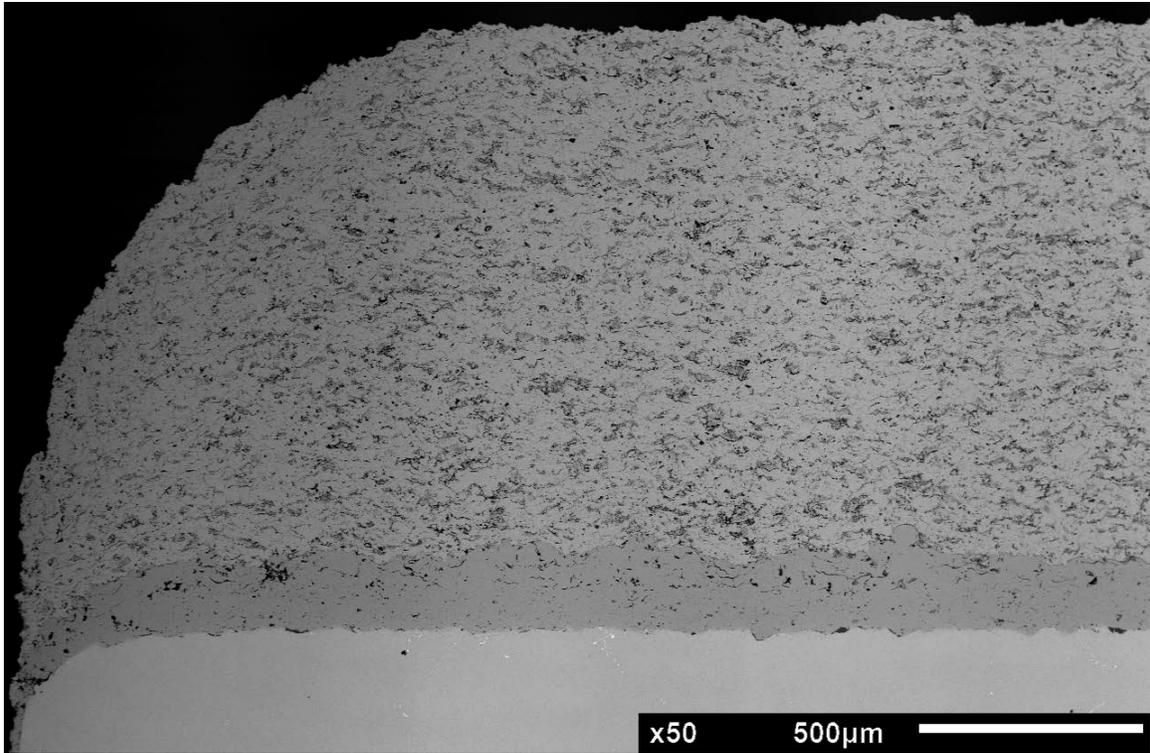
**Figure 79 – As-processed LD topcoat on DL bond coat on PWA 1484 substrate.**

coating. The LD topcoat layers in Figure 82 and in Figure 79 contained large globular pores, inter-splat pores, and small micro-cracks. All of these pore types combine to yield a low density coating.

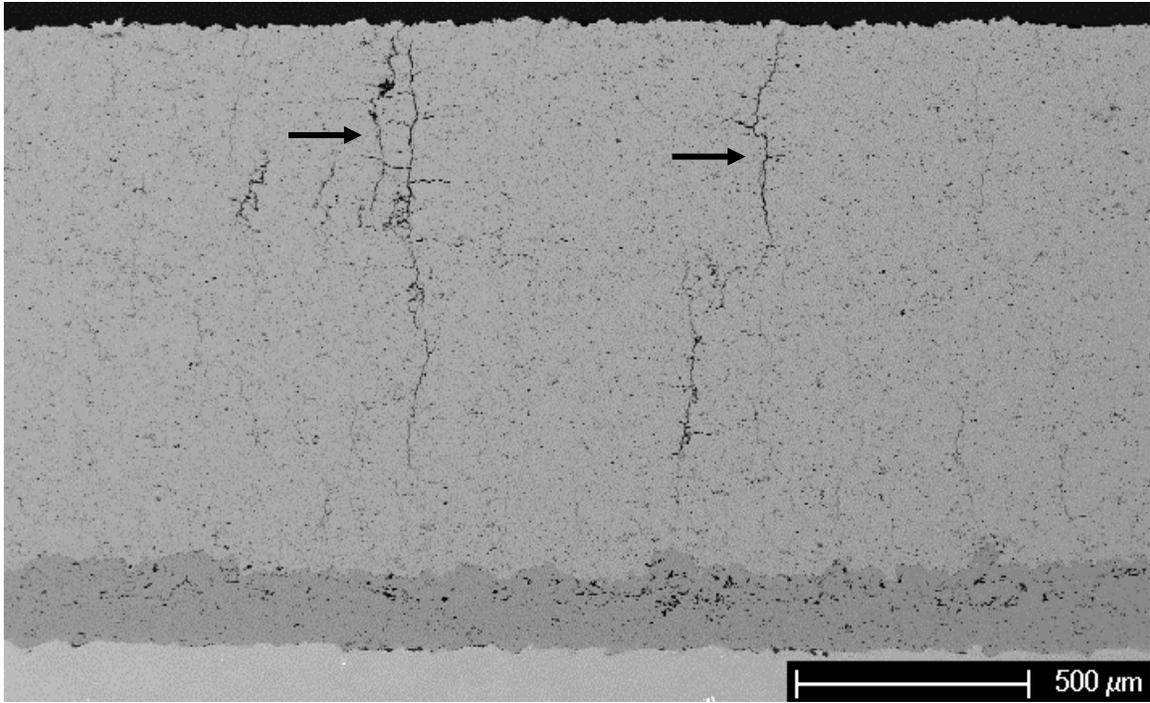
**Figure 80 - As-processed DVF topcoat on DL bond coat on PWA 1484 substrate. Black arrows indicate large vertical fissures.**

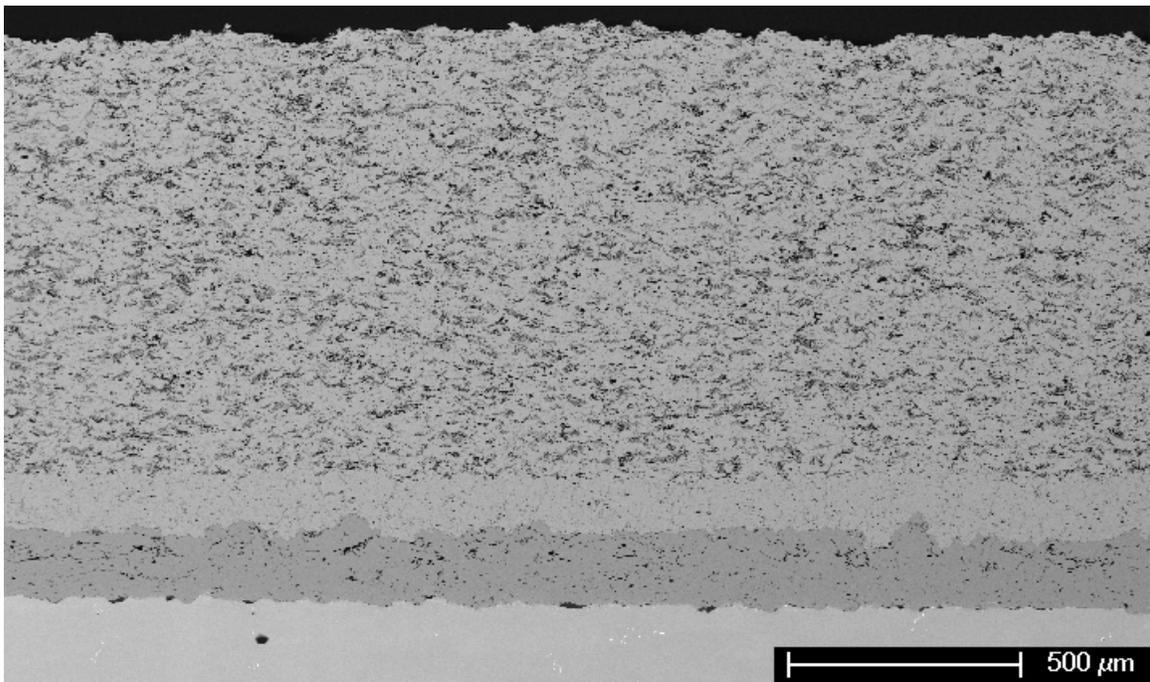
**Figure 81 - As-processed dual TBC on DL bond coat on PWA 1484 substrate.**

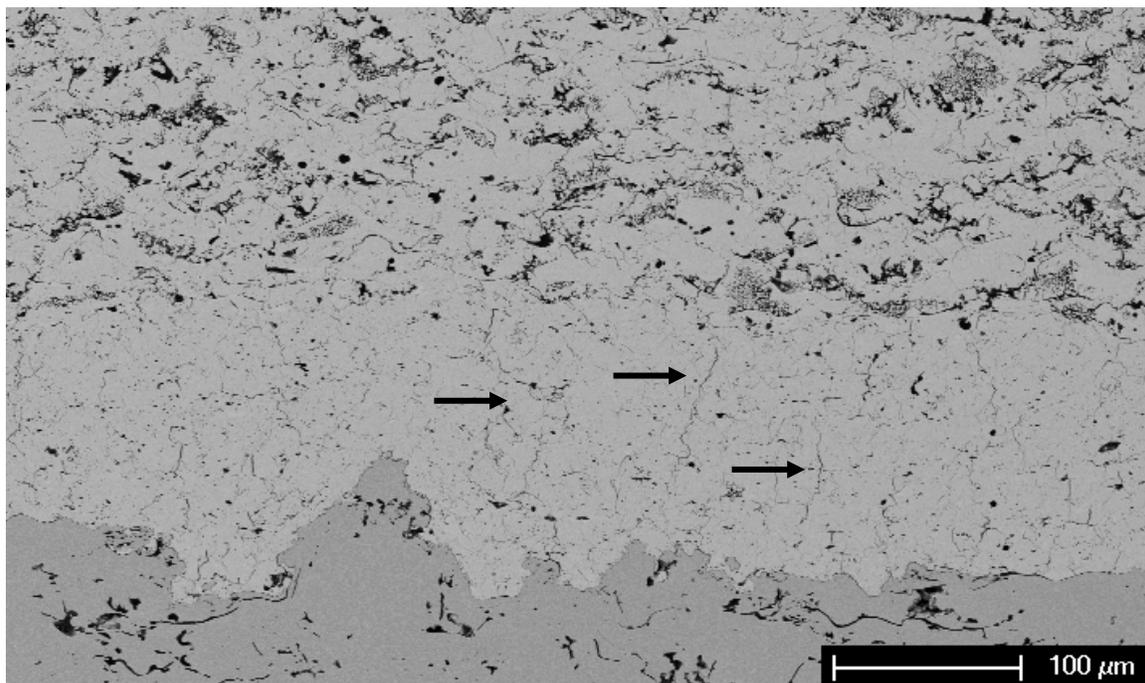
**Figure 82 - High magnification micrograph of interface between LD and DVF layers showing good adherence and no large delamination cracks between the layers.**

As the micrograph depicts, the adherence between the two layers was exceptional since no large separation cracks ( $<50\mu\text{m}$ ) were observed. Furthermore, from this micrograph, there is an obvious difference in the density and porosity between the two coatings. The DVF layer is dense and contains small vertical fissures throughout it (black arrows in Figure 82). The full DVF topcoat, Figure 80, also contains these small cracks, but it also contains large vertical fissures which extend anywhere from 50% to 100% of the  $1100\mu\text{m}$  thick topcoat (black arrows). The density of these large fissures was measured to be 11 fissures per centimeter of DVF

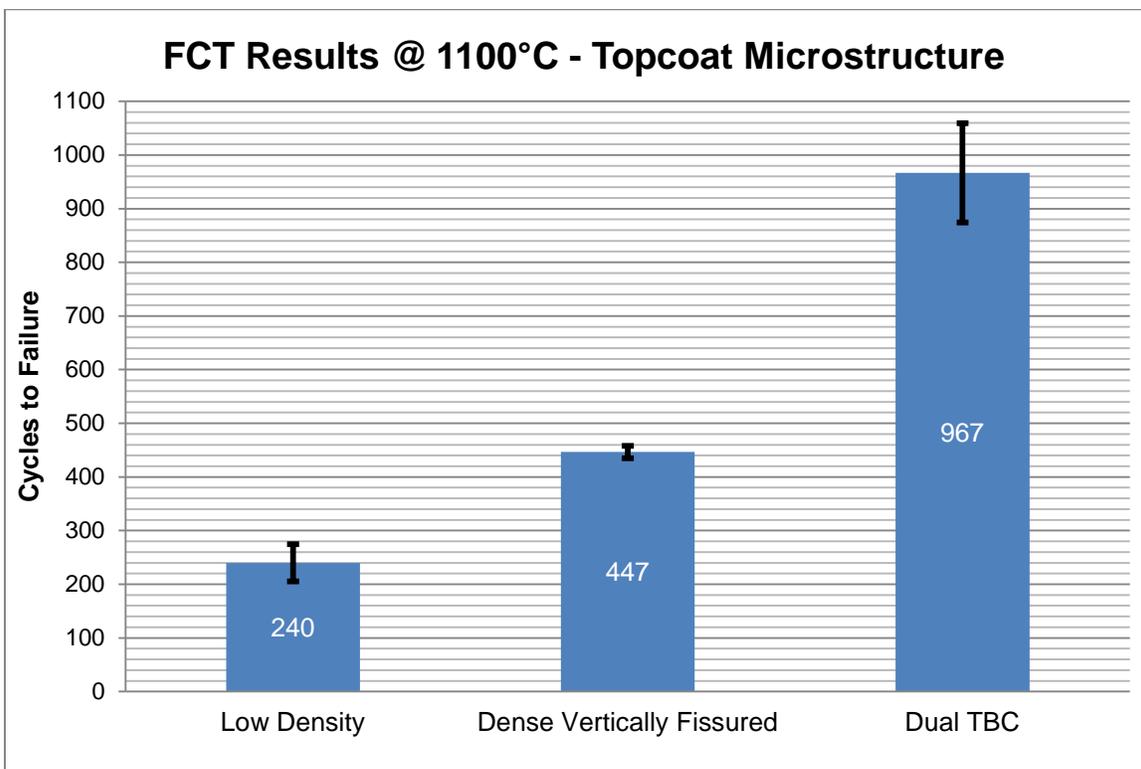
**Figure 83 – FCT results for the topcoat microstructure specimens.**

The reproducibility in the LD and DVF coatings was good as there was little scatter in the lifetime of the three specimens in each group (indicated by the small error bars), however, the dual TBC specimens had a much larger scatter in lifetime  $\pm 100$  cycles. Despite this, there was a statistically significant difference in the FCT lifetimes of the three topcoats. A factor of two

differentiated the LD and DVF TBC and another factor of two separated the DVF and the dual TBC specimens. These results indicate topcoat microstructure strongly influences FCT lifetime.

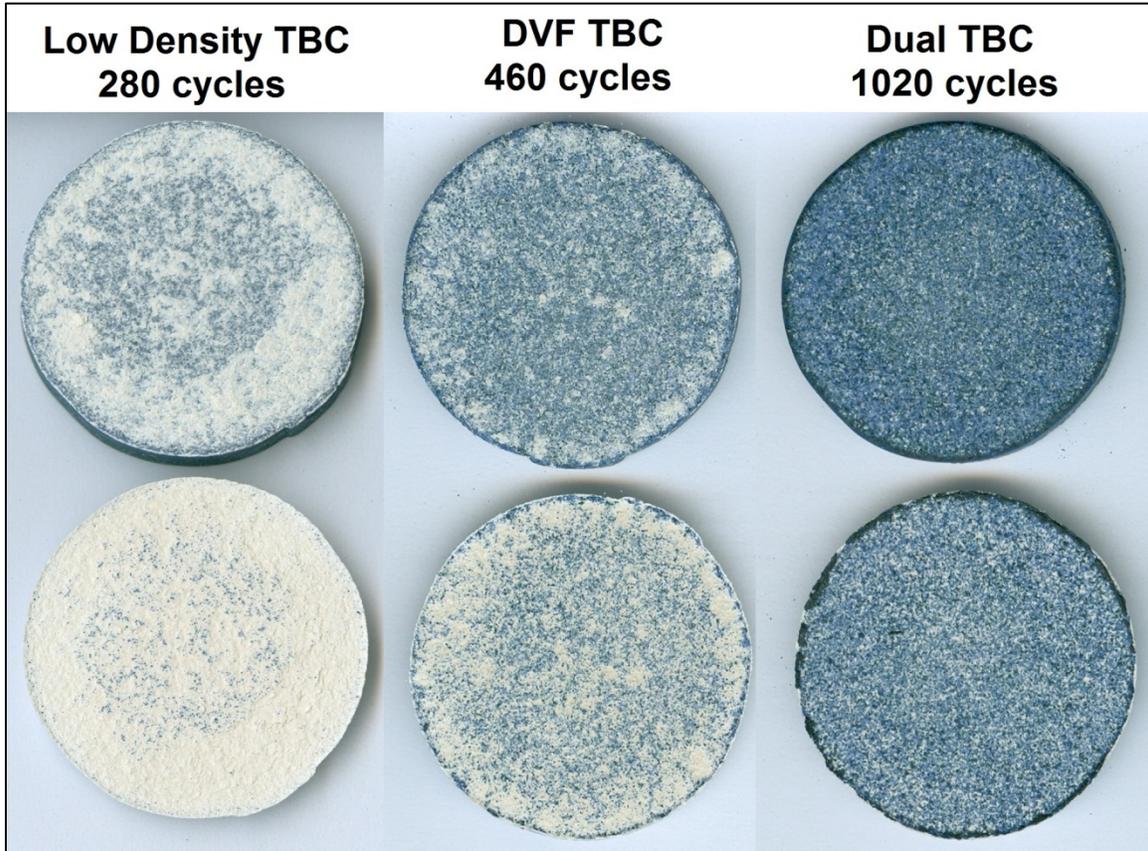
**Figure 84 - High resolution image of failed LD, DVF and dual TBC specimens.**

The LD specimen had heavy amounts of YSZ on the fracture surface while the DVF and the dual TBC had more TGO on their fracture surfaces. The surface of the dual TBC was covered with a dark blue oxide which is indicative of nickel aluminum spinel oxide. Furthermore, since the fracture surface of both the topcoat underside (lower right circle in Figure

84) and the bond coat surface (upper right circle in Figure 84) were covered heavily with TGO, this indicated failure primarily occurred within the TGO and not at the interface between the two topcoat layers (i.e. between the LD and DVF layers). Cross-sections of the three specimens are shown in Figure 85 through Figure 87. The DVF and the dual TBC specimens in these figures were technical failures meaning while the topcoats are still intact, significant delamination has taken place in other regions of the specimens rendering their failures.

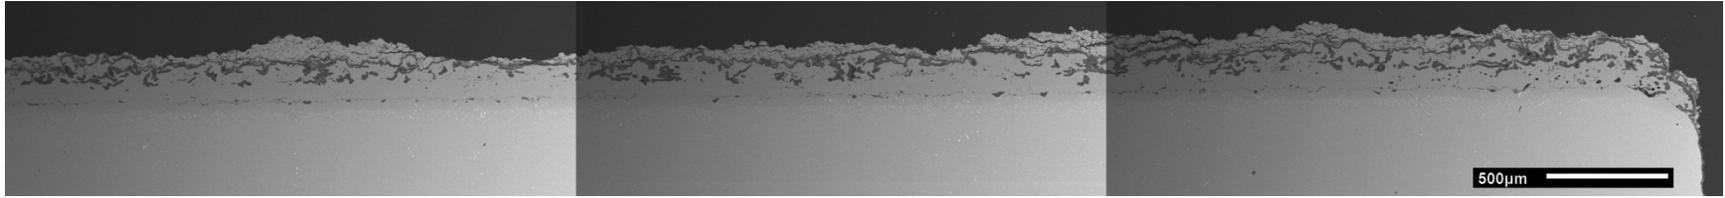
**Figure 85 - Failed LD specimen with 280 cycles at failure. Topcoat completely spalled off.**

The final spallation crack in the LD specimen occurred within the topcoat, above the topcoat-TGO interface. Very little of the fracture took place in or around the TGO. As for the DVF specimen, cracking occurred along the topcoat/TGO interface. This observation alone indicates there was either a difference in the amount of stored strain energy or fracture resistance between the two coatings. Examining a higher magnification micrograph of the DVF TBC, Figure 88, the crack path went over the bond coat peaks and propagated through the YSZ valleys which is indicative of a bond coat oxidation induced failure.
