**FAILURE OF THICK, LOW DENSITY AIR PLASMA SPRAYED THERMAL  
BARRIER COATINGS**

**Michael Aaron Helminiak**

Submitted to the Graduate Faculty of  
Swanson School of Engineering in partial fulfillment  
of the requirements for the degree of  
Doctorate of Philosophy

University of Pittsburgh

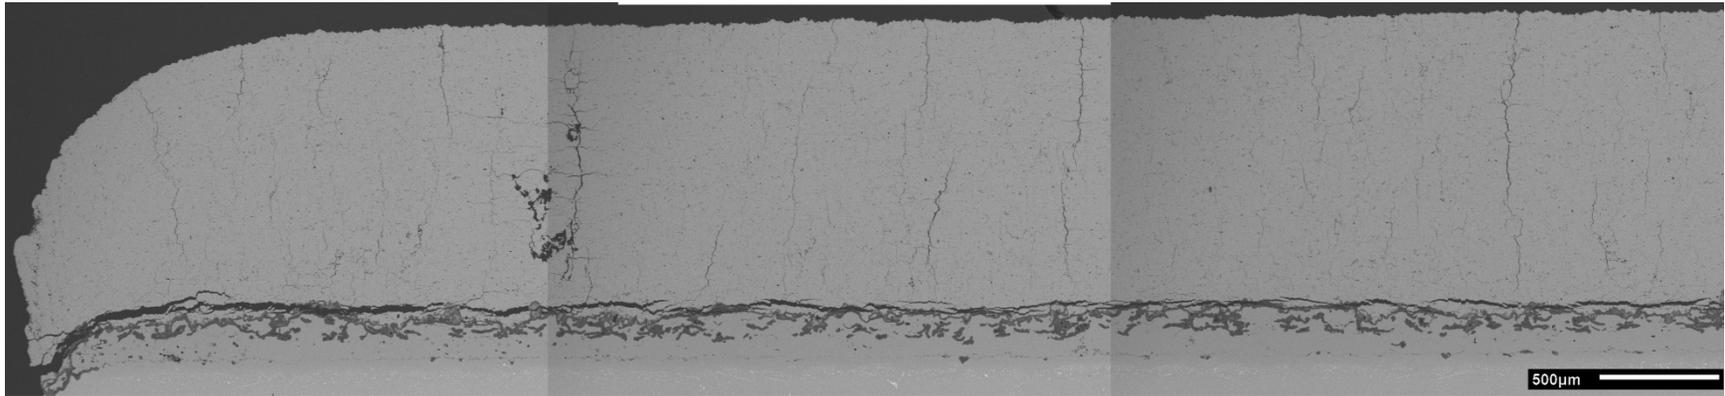
**Figure 86 - Failed DVF specimen with 440 cycles at failure.**

The final spallation crack in the LD specimen occurred within the topcoat, above the topcoat-TGO interface. Very little of the fracture took place in or around the TGO. As for the DVF specimen, cracking occurred along the topcoat/TGO interface. This observation alone indicates there was either a difference in the amount of stored strain energy or fracture resistance between the two coatings. Examining a higher magnification micrograph of the DVF TBC, Figure 88, the crack path went over the bond coat peaks and propagated through the YSZ valleys which is indicative of a bond coat oxidation induced failure.

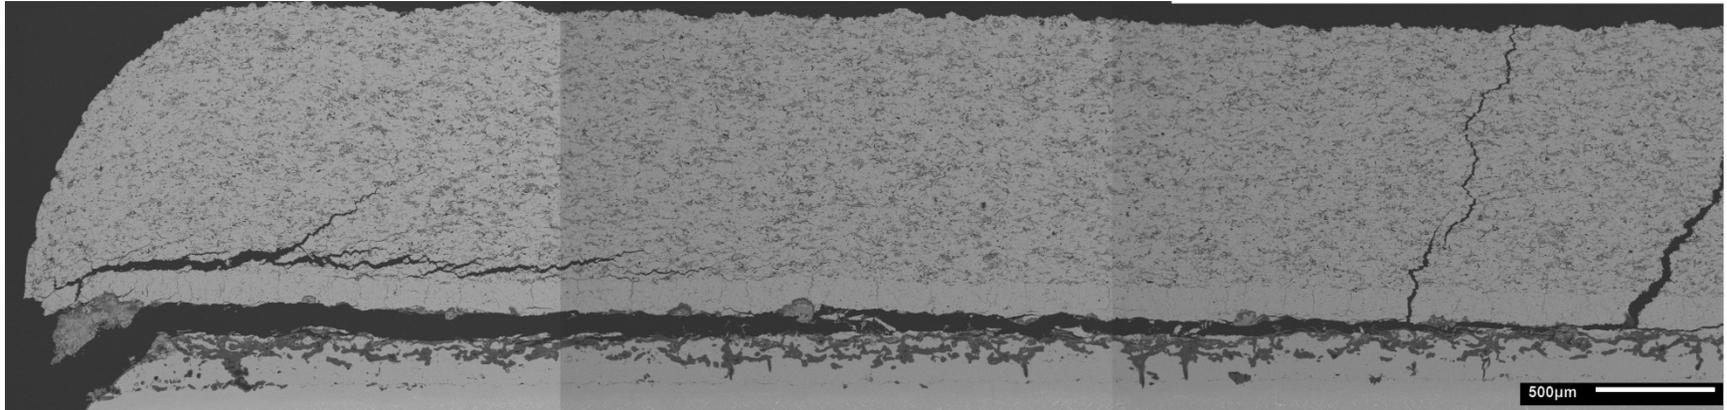
**Figure 87 - Failed dual TBC specimen with 1020 cycles at failure**

In the dual TBC, isolated separations between the two TBC layers was observed near the edges of the specimens as shown in Figure 87 and within the interior of the specimen as shown in Figure 89 and Figure 90.

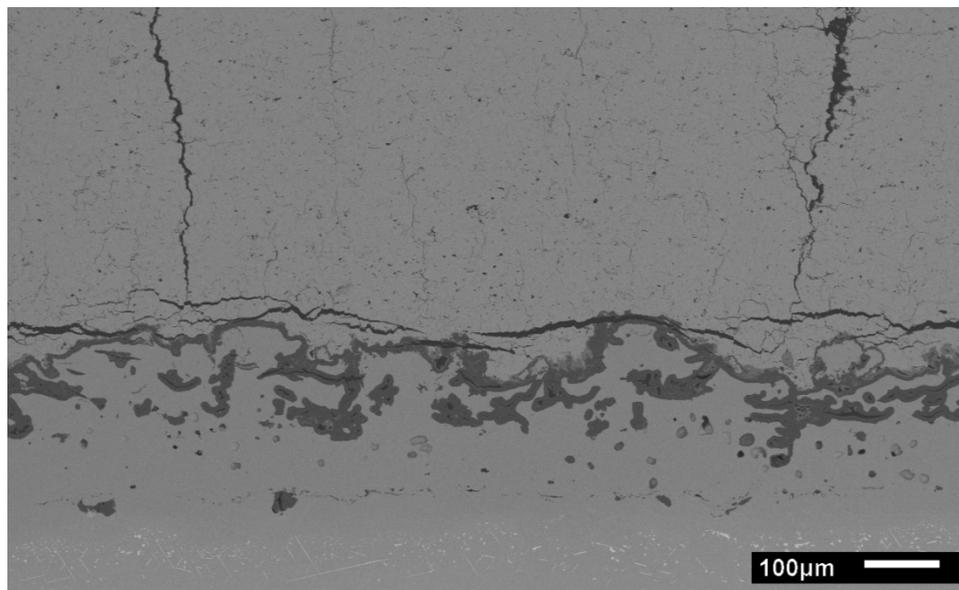
**Figure 88 - Failed DVF specimen with 440 cycles at failure.**

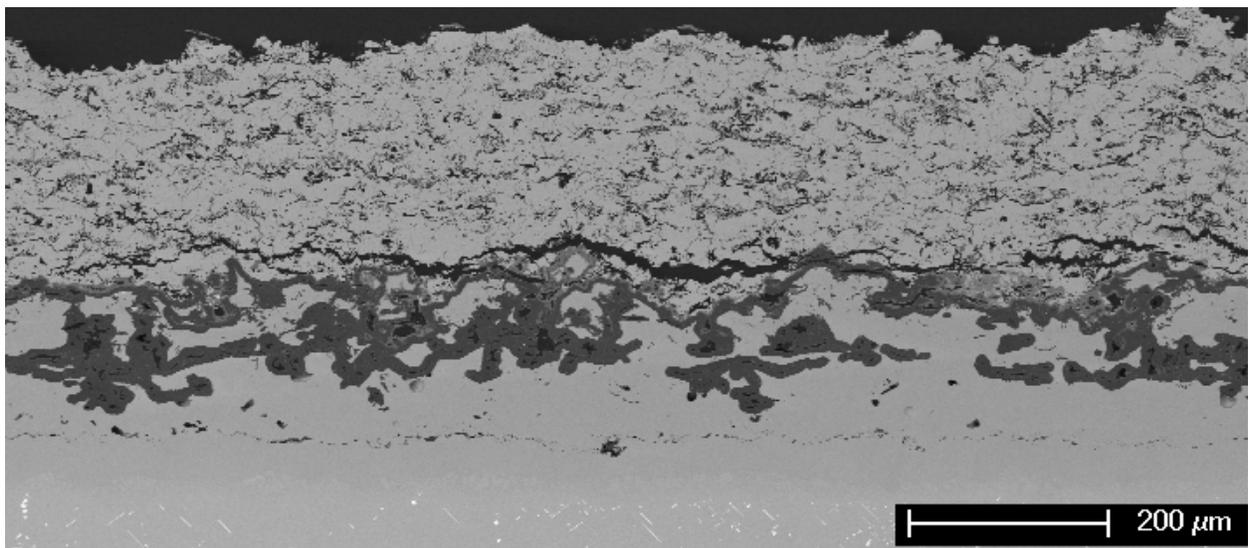
**Figure 92 – 225  $\mu\text{m}$  topcoat after 810 cycles at 1100°C.**

Note the difference in the amount of cracking and damage between the two specimens around the topcoat-TGO region. This suggests the driving force for crack growth is different between the two specimens or that the toughnesses of the two topcoats are substantially different.

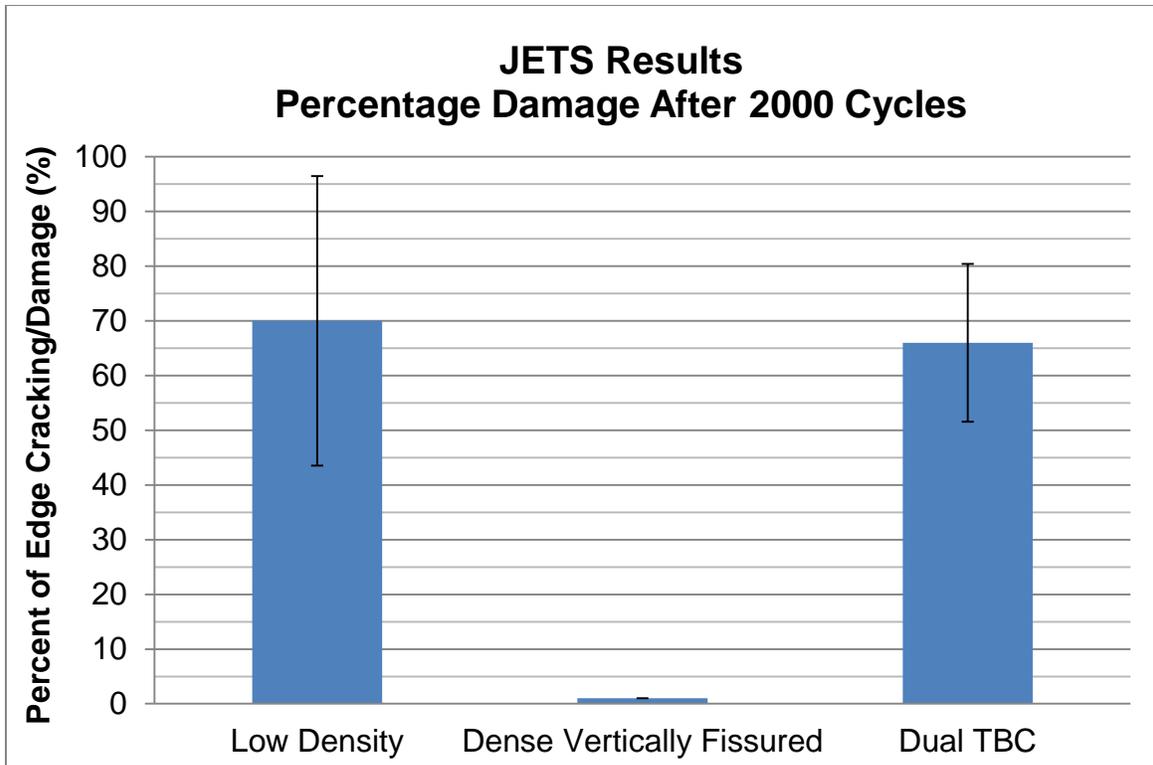
**Figure 93 - Percent edge cracking after 2000 cycles in the JETS apparatus.**

Remarkably, the DVC specimens did not record any increase in edge cracking whereas the dual TBC and the LD specimens experienced large amounts of cracking around the edges.

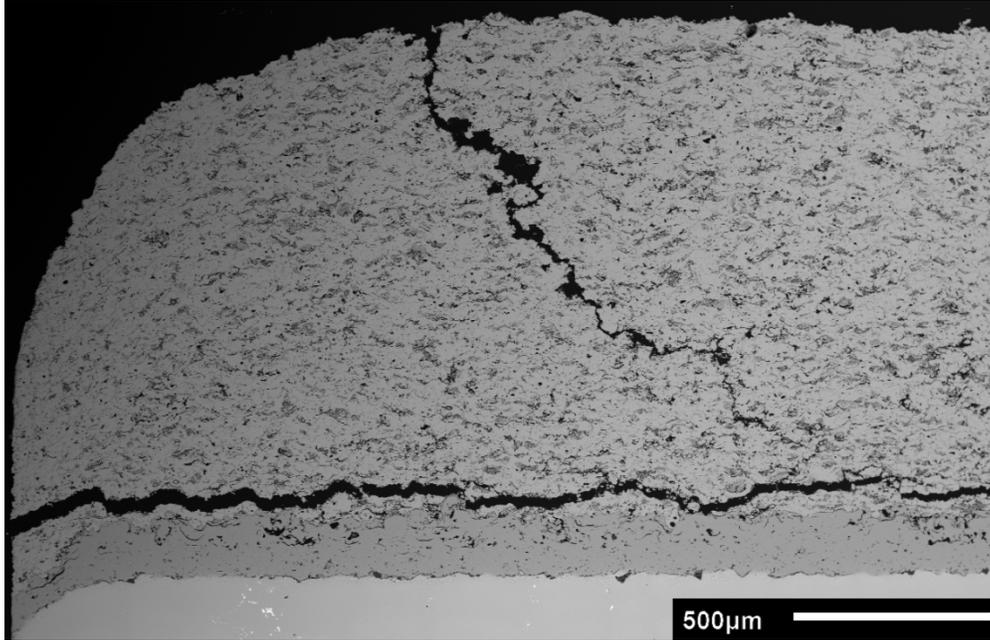
The LD topcoat experienced edge cracking (Figure 94), vertical cracking (Figure 95) and horizontal cracking near the bond coat/ topcoat interface.

**Figure 94 - 1.1mm LD topcoat on PWA 1484 after 2000 JETS cycles.**

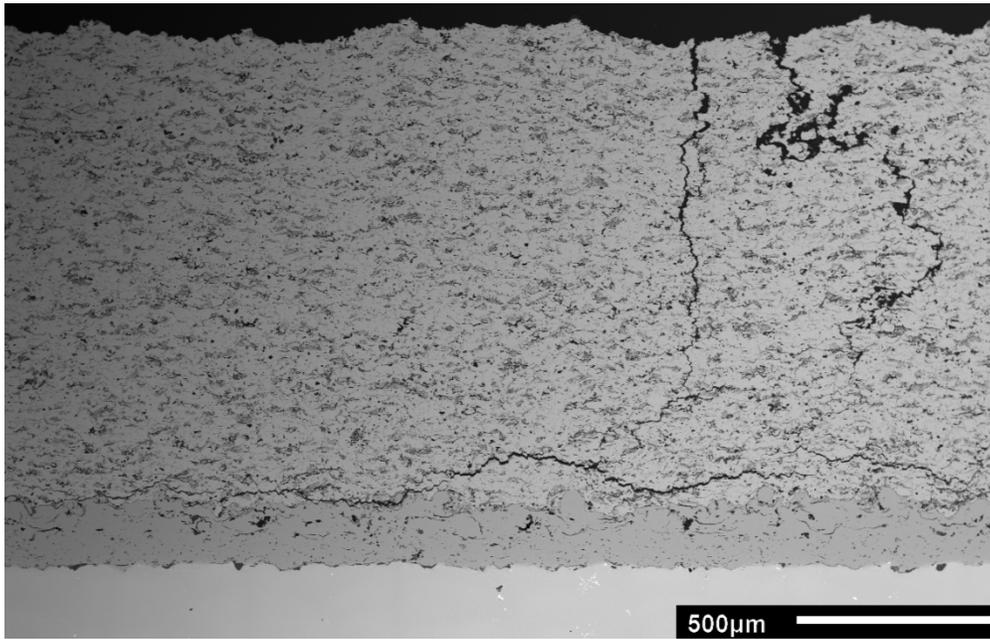
**Figure 95 - 1.1mm LD topcoat on PWA 1484 after 2000 JETS cycles. Micrograph was taken far from the edge of the specimen.**

The vertical cracks extended down from the outer surface and branched out horizontally as they approached the bond coat. Several of these vertical cracks were observed along the cross-section of the specimen.

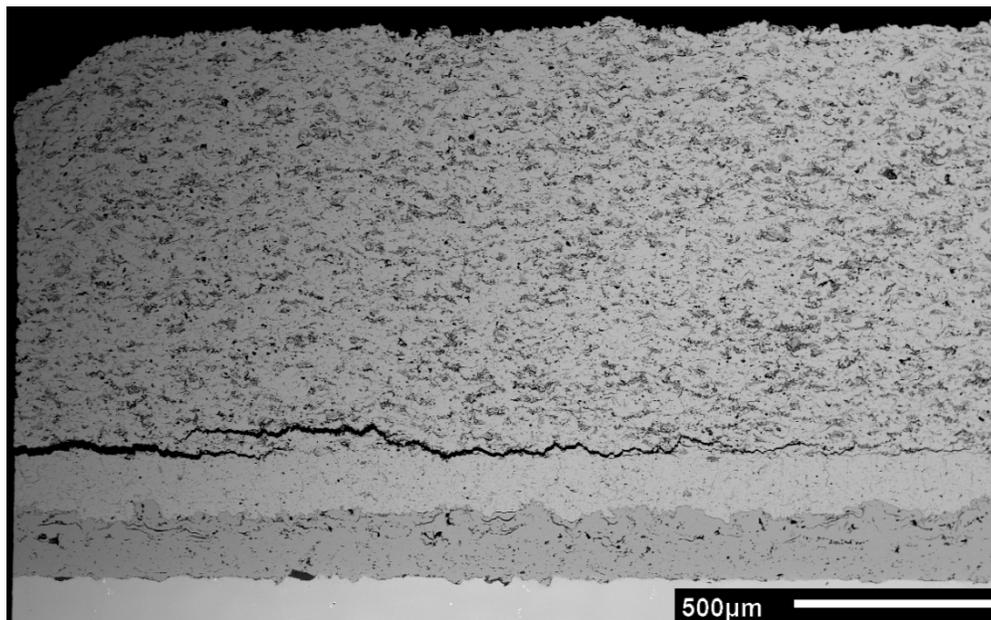
The dual TBC exhibited similar cracking within the topcoat which is shown in Figure 96 and Figure 97.

**Figure 96 - Dual TBC on PWA 1484 after 2000 JETS cycles.**

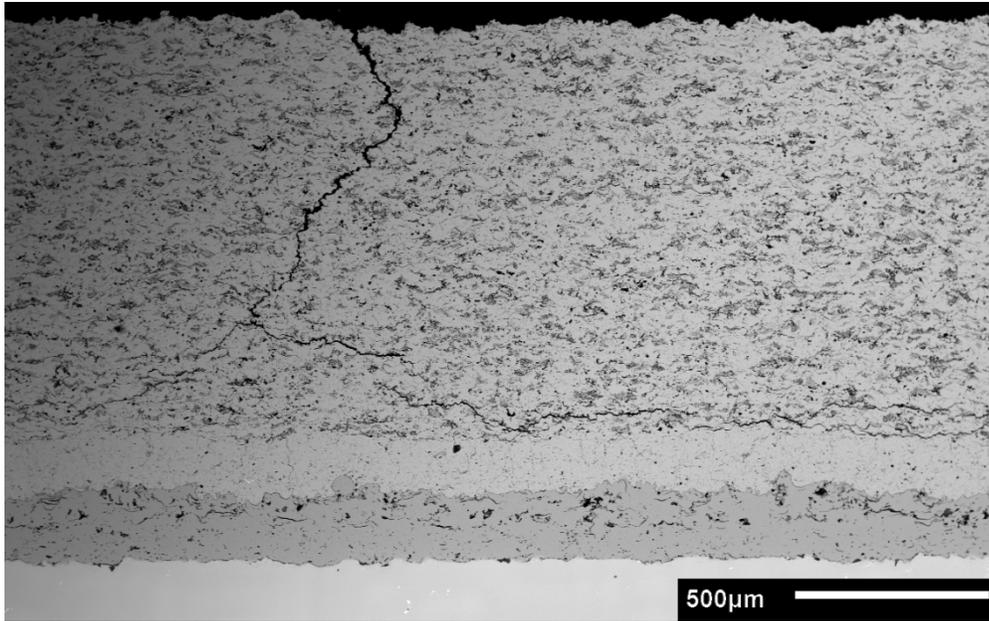
**Figure 97 - Dual TBC on PWA 1484 after 2000 JETS cycles. Micrograph was within the interior of the specimen away from the free edge.**

The same vertical cracking was observed as with the LD coating. This is somewhat expected since the LD microstructure is adjacent to the flame in both the LD and dual TBC specimens. The horizontal cracking, however, occurred between the LD and DVF layers and not at the DVF-bond coat interface. No cracking was observed within the DVF layer, aside from the already present vertical fissures.

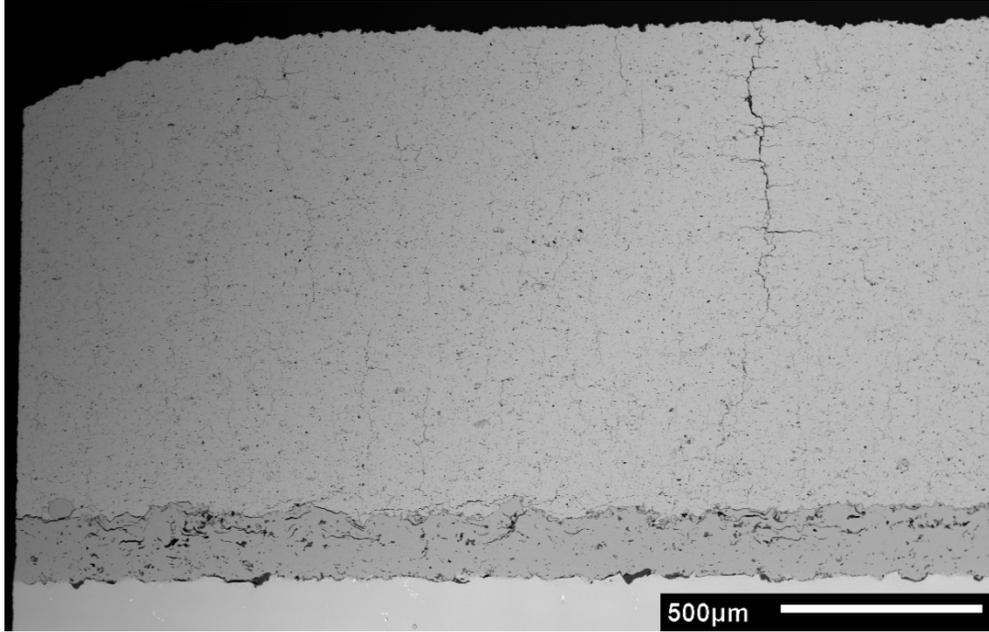
The DVF TBCs experienced very minor edge cracking, Figure 98, and no large scale horizontal cracking near the bond coat interface.

**Figure 98 - 1.1mm DVF topcoat on PWA 1484 after 2000 JETS cycles.**

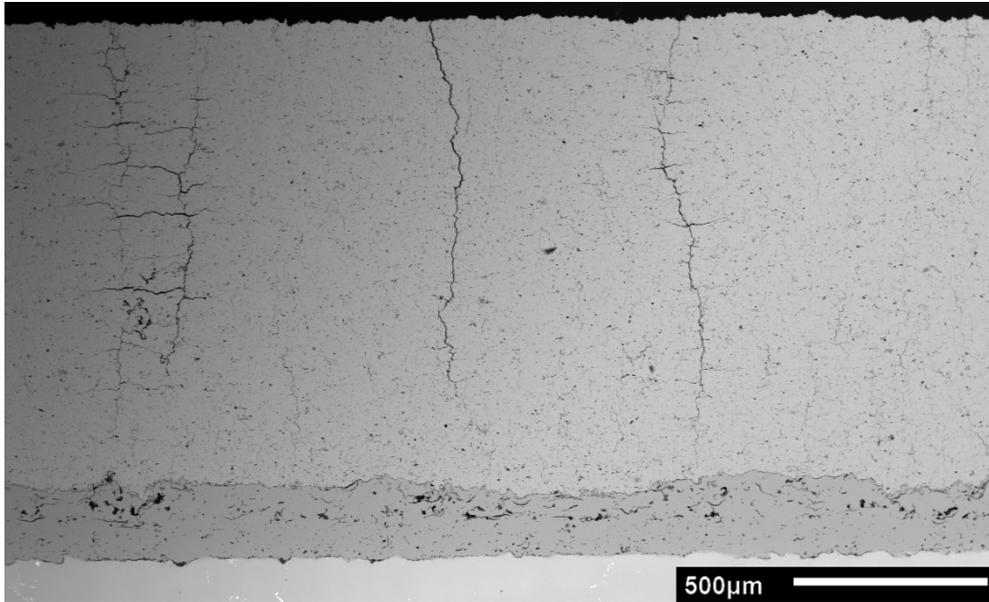
The already present vertical fissures within the specimen did not appear to grow, extend, or branch out any more than they were in the as-processed state, Figure 99.

**Figure 99 - 1.1mm DVF topcoat on PWA 1484 after 2000 JETS cycles. Micrograph was taken far from the edge of the specimen.**

These specimens withstood the 2000 JETS cycles very well, likely because of the vertical fissures within the coating which relieved the stress buildup during heating.

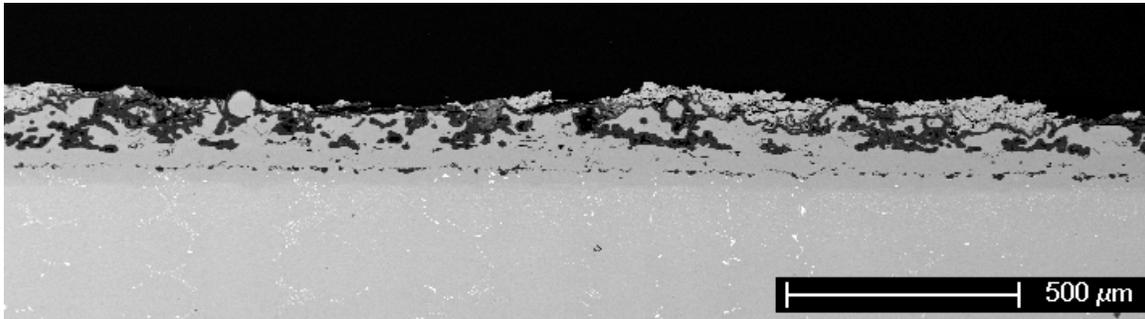
**Figure 101 - Generation II 85% dense 1100  $\mu\text{m}$  topcoat on a dual layer bond coat and N5 substrate with 560 cycles at failure.**

The 89% and the 82% both failed within the topcoat layer whereas the 85% dense coating failed at the topcoat/TGO interface. This fracture behavior indicates the fracture resistances of the topcoats were substantially different. The 85% dense topcoat was able to resist crack growth within the topcoat and failed only after considerable bond coat oxidation induced damage had occurred at the topcoat/TGO interface. The 89% dense topcoat on the other hand, was much less resistant to cracking within the topcoat. This TBC did not experience enough cycles for bond coat oxidation to be a contributing factor and instead failed after crack propagation occurred in the topcoat. The 82% dense coating followed the behavior of the 89% dense coating however, the amount of YSZ left on the fracture surface was much less than the 89% dense coating.

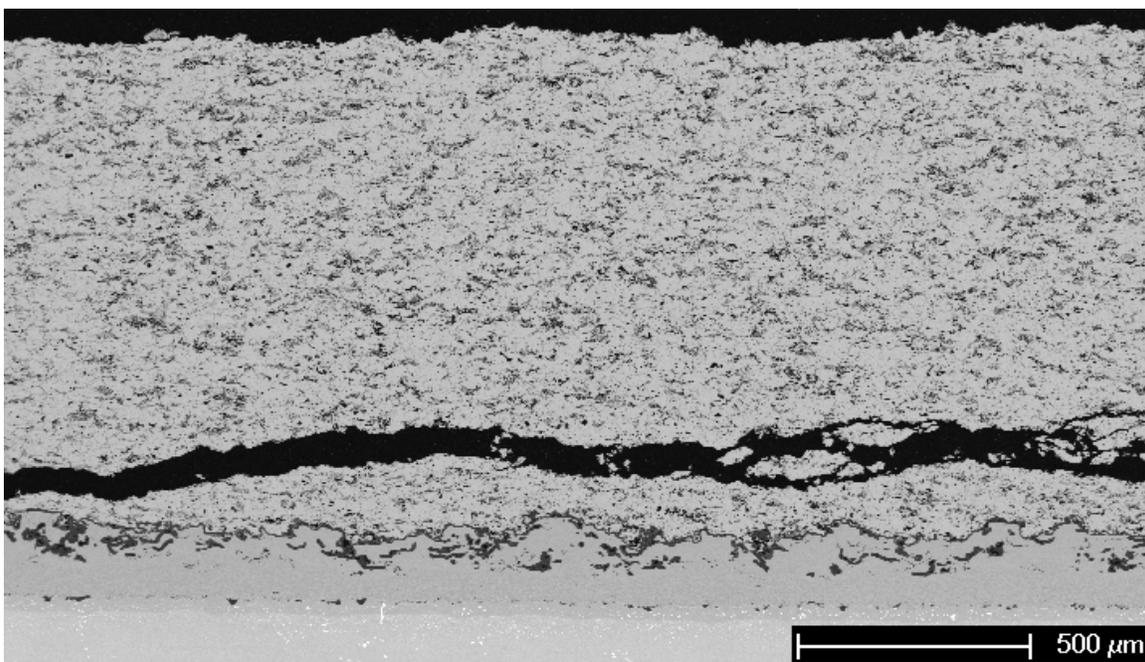
**Figure 102 - Generation III 89% dense 1100  $\mu\text{m}$  topcoat on a dual layer bond coat and N5 substrate with 120 cycles at failure.**

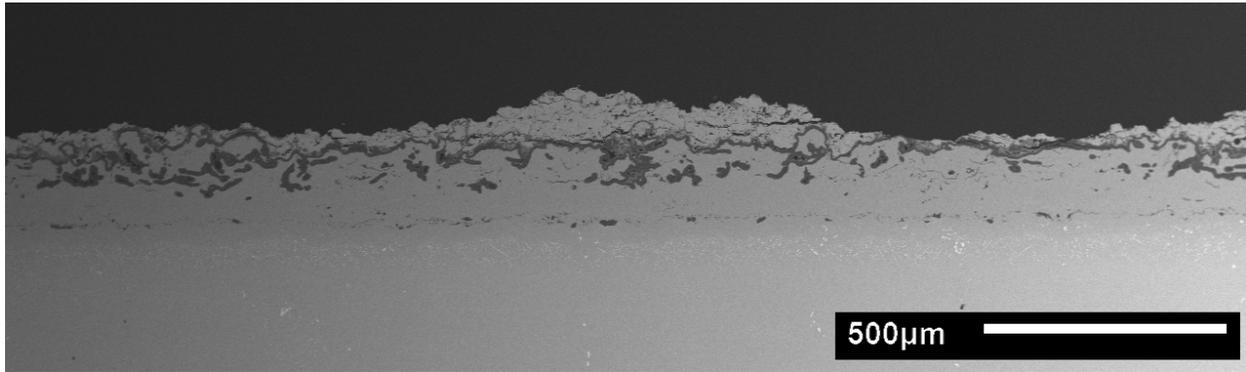
**Figure 103 - Generation IV 82% dense 1100  $\mu\text{m}$  topcoat on a dual layer bond coat and PWA 1484 substrate with 280 cycles at failure.**

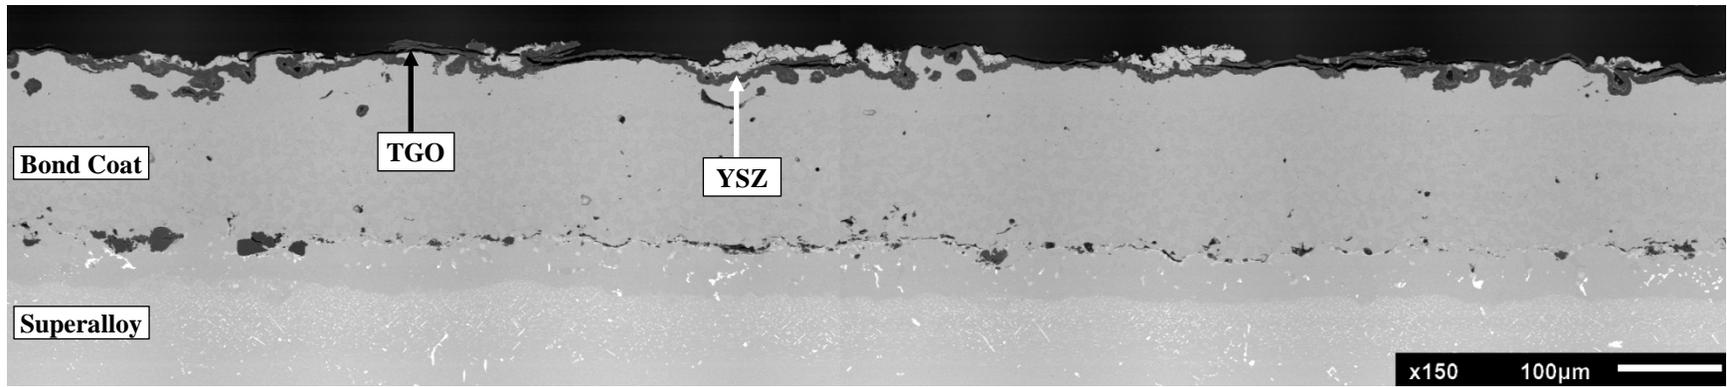
Figure 118 - Failed SL bond coat TBC on N5 after 320 cycles.

surface of the bond coat (i.e. the mating surfaces) were covered with alumina. Small patches of YSZ were present but surface coverage was dominated by the TGO, more so in the case of the SL bond coat (Figure 118) than in the case of the 75:25 bond coat (Figure 119). The DL and 50:50 specimens had fracture surfaces with a mix of YSZ and TGO. In cross-section, it was revealed the YSZ patches were actually bond coat valleys that contained YSZ, where the delamination crack extended above the valley (Figure 121).

smooth level surfaces with small ( $<25\mu\text{m}$ ) peaks and very few valleys as shown in Figure 118. They both had large patches of relatively flat defect-free bond coat surfaces. If a crack in the TGO were to form near one of these regions there would be nothing to stop it from propagating the entire length of the smooth regions. Sources of these cracks could be the larger bond coat peaks such as those in Figure 131 (far-right black arrow). Once enough of these cracks form, the interface between the TGO and the YSZ becomes so weak that large scale delamination becomes possible. Furthermore, because failure occurs in the TGO, both fracture surfaces (topcoat and bond coat) would be covered with TGO which is entirely consistent with the observations. Based on this understanding, the slightly longer lifetime of the 75:25 bond coat, as compared to the SL bond coat, could be rationalized by taking into consideration the large, yet infrequent, surface asperities (Figure 135) scattered across the surface of the 75:25 bond coat. These large features could again act as barriers delaying the coalescence of these individual TGO cracks. Continuing with this reasoning, the 50:50 and DL bond coats have rough irregular surface morphologies, so even if small scale buckling of the TGO occurs, the cracks would only propagate a short distance before either reaching a free surface of some type or a propagation barrier such as another bond coat peak or a YSZ valley. A highly porous topcoat, such as the topcoats used in this study, have small elastic moduli and high toughness as compared to an alumina TGO and are able to arrest small cracks. A denser YSZ topcoat, however, may be unable to arrest such a crack [45] leading to shorter lifetimes for TBC with dense topcoats.

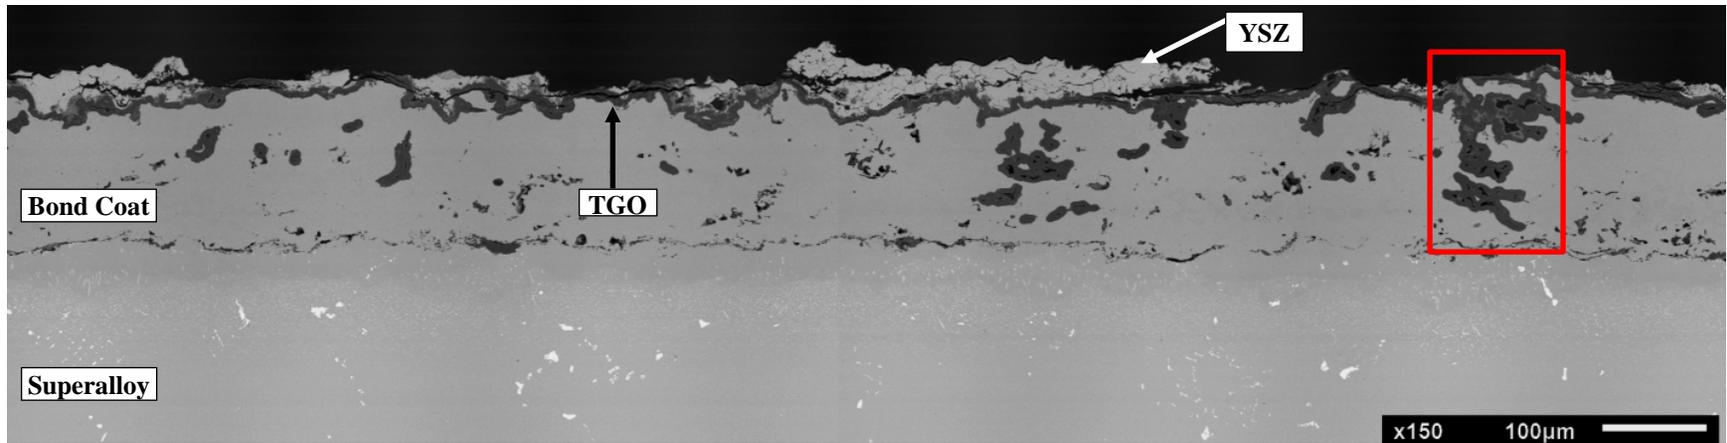
Figure 119 – Failed 75:25 bond coat TBC on N5 after 320 cycles.

There is some  $\beta$ -phase left, however, much less than with the SL bond coat. Likewise, there are more open pores than in the SL coating. In some regions (Figure 119 ‘red box’) the surface connected pores extended the entire way down to the bond coat/superalloy interface.

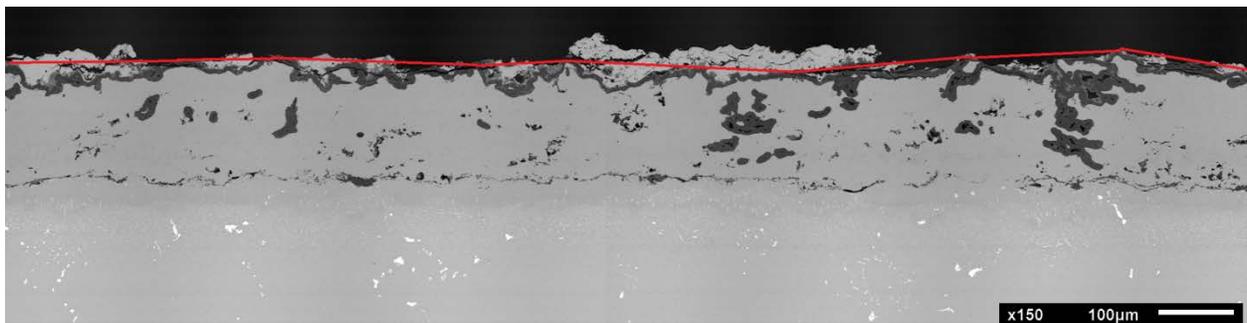
A general observation when examining these cross-sections was that – the crack which lead to spallation of the topcoats seemed to follow a straight line which connected all the highest peaks along the bond coat surface. To clarify this point, a red line has been added to the cross-sections of the 75:25 and DL bond coats which are shown in Figure 122 and Figure 123. The red line touches all of the peaks in the bond coats and extends over and above the valleys.

**Figure 122 - Failed 75:25 bond coat TBC on N5 after 320 cycles. The red line connects the peaks along the bond coat surface.**

In the case of the DL specimen (and 50:50), the crack climbed over large peaks and propagated through patches of YSZ located over valleys in the bond coat. In the cases of the 75:25 and SL bond coats, the peaks and valleys still existed, however their relative size and frequencies were smaller. The relative size of these valleys and peaks are reflected in the  $R_z$  measurements ( $R_{zDL} > R_{z50:50} > R_{z75:25} > R_{zSL}$ ) performed in the previous section.

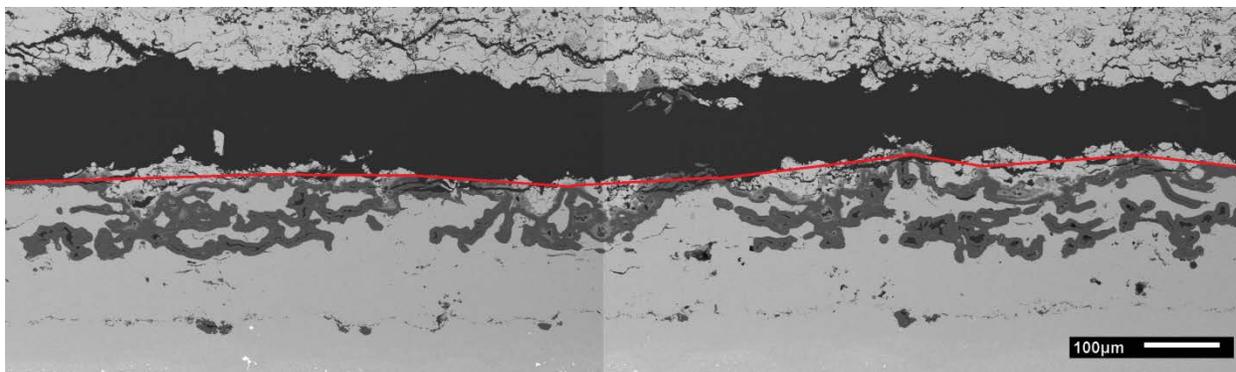
**Figure 123 - Failed DL bond coat TBC on N5 after 600 cycles. The red line connects the peaks along the bond coat surface.**

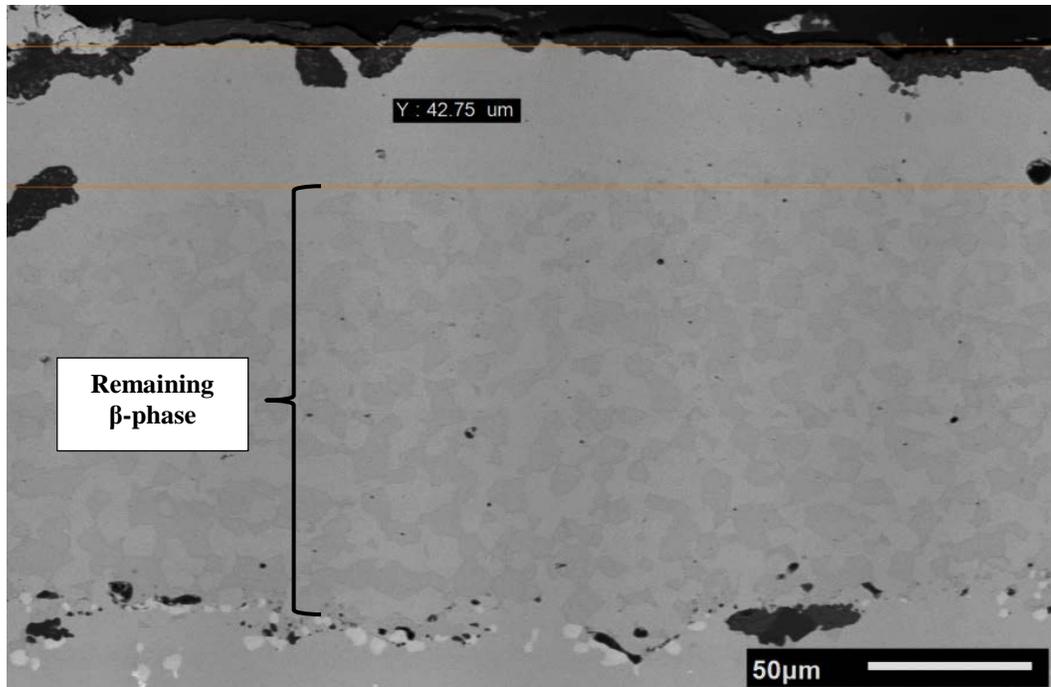
Figure 124 - SL bond coat after 320 cycles. Note 80%+ of the aluminum rich  $\beta$ -phase is still remains.

The SL bond coat was very protective and contained very few surface connected pores. After 320 cycles over 80% of the aluminum-rich  $\beta$ -phase was still present. There was minimal aluminum loss into the substrate through interdiffusion as there is no visible  $\beta$ -depletion zone adjacent to the substrate. Bond coat – superalloy interdiffusion is the subject of the next chapter to which the reader is referred for further interdiffusion discussion. The 75:25 bond coat is shown in Figure 125 and before in Figure 119.

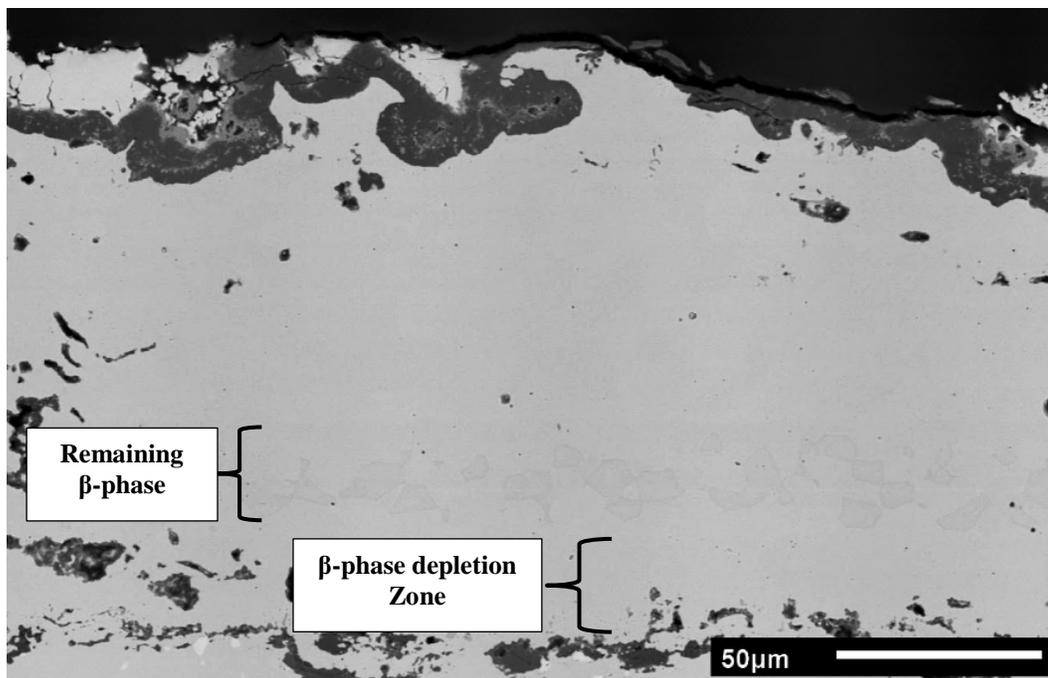
**Figure 125 - 75:25 bond coat after 320 cycles. Note the limited amount of aluminum-rich  $\beta$ -phase remaining and the presence of a  $\beta$ -phase depletion zone adjacent to the bond coat / superalloy interface .**

Despite having the same number of cycles as the SL specimen, there appears to be a significant depletion zone extending up from the superalloy substrate which is the result of interdiffusion. As to why there is  $\beta$ -phase dissolution at the bond coat/superalloy interface in this specimen and not in the SL specimen (despite having the same number of cycles) remains unclear. It is possible the depletion zone emanating from the aluminum loss to the TGO is having an influence on the depletion zone between the bond coat and substrate even though they are occurring at opposite sides of the bond coat. In the case of the 75:25 coating, this interaction could potentially be augmented by the presence of deep surface connected pores which effectively reduce the thickness of the bond coat thereby increasing the interaction zone between the two depletion mechanisms.

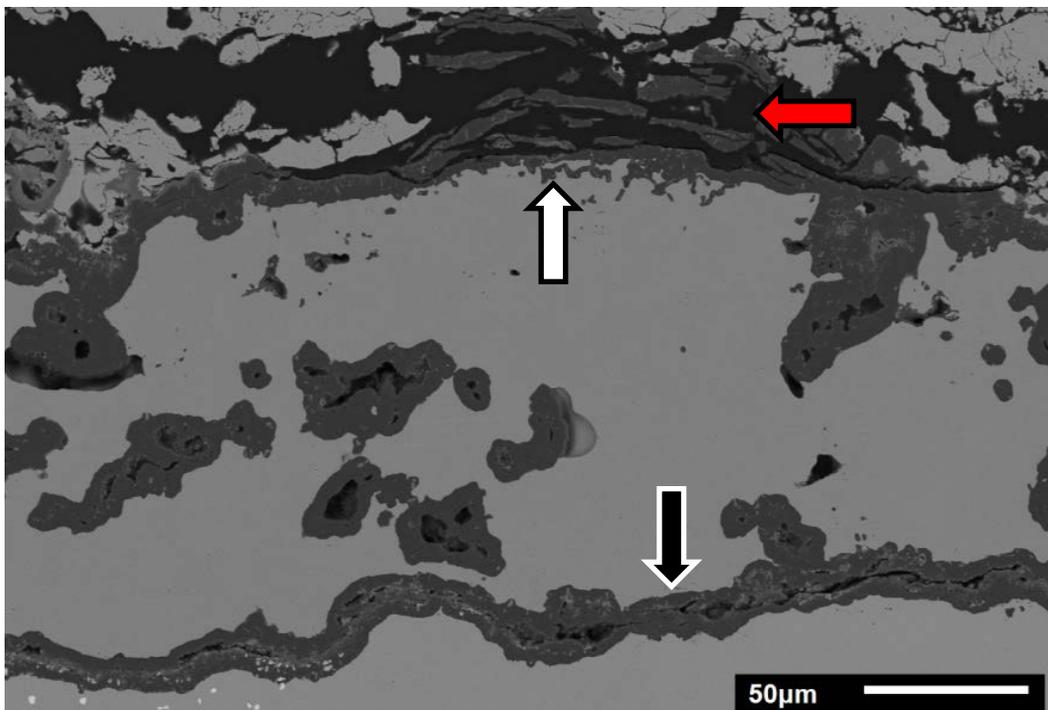
**Figure 126 - Failed 50:50 bond coat TBC on N5 after 720 cycles. Note the oxide layer at both the bond coat surface (white arrow) and at the superalloy-bond coat interface (black arrow).**

In this specimen, the bond coat did not seal off the superalloy at all. Both the outer (white arrow) and inner surfaces (black arrow) of the bond coat oxidized as did the surface of the superalloy along with the open pores. Repeated cracking and reformation of the TGO was observed (red arrow) which was likely caused by the thermal cycling [72]. Furthermore, the dark oxide fingers (at the tip of the white arrow) appear to be growing inward instead of laterally, indicating the kinetic criteria needed to reform an external alumina scale are not being met. Standardless energy dispersive spectroscopy (EDS) measurements in bond coat regions just below these fingers record the aluminum content to be less than 1at%Al which is below the critical level needed to reform a continuous oxide scale [40] and further confirms this hypothesis.

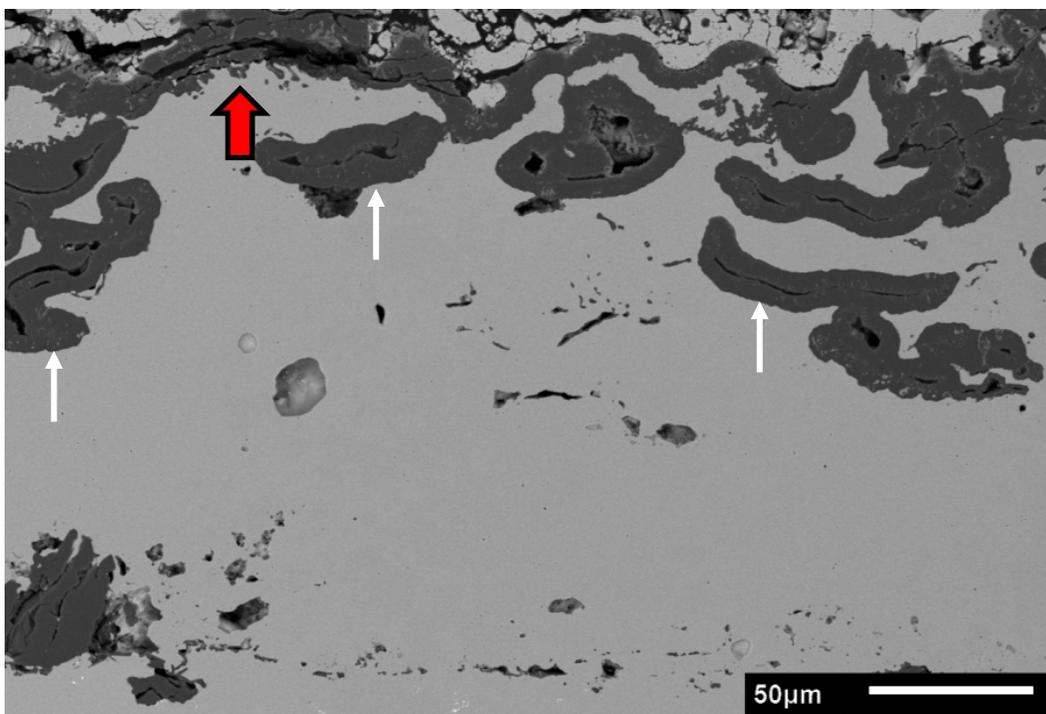
**Figure 127 - Failed DL bond coat TBC on N5 after 620 cycles. Note the surface connected pores which have oxidized (white arrows).**

As with the 50:50 bond coat, the outer layer of the dual layer bond coat completely oxidized. However, since this bond coat had a dense inner layer, the superalloy did not experience direct oxidation. In select regions (red arrow) the outer portion of the bond coat formed the inward growing alumina fingers indicating the aluminum content in these regions of the bond is dropping below the critical level needed to reform the protective oxide.

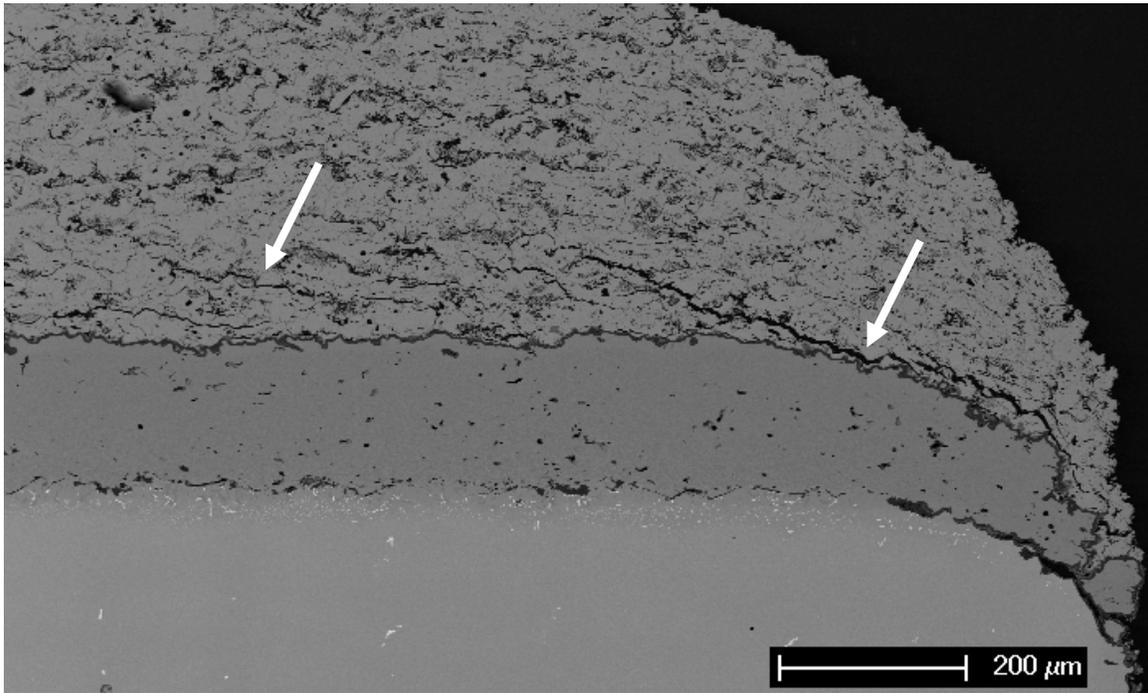
**Figure 128 - SL bond coat on PWA 1484 with 140 cycles (~50% Lifetime).**

This micrograph was taken at the edge of the specimen where cracks were found extending from the free edge into the coating. Cracking was also observed in the interior of the specimen, shown in Figure 129, (away from the free edge) however this cracking was very minimal.

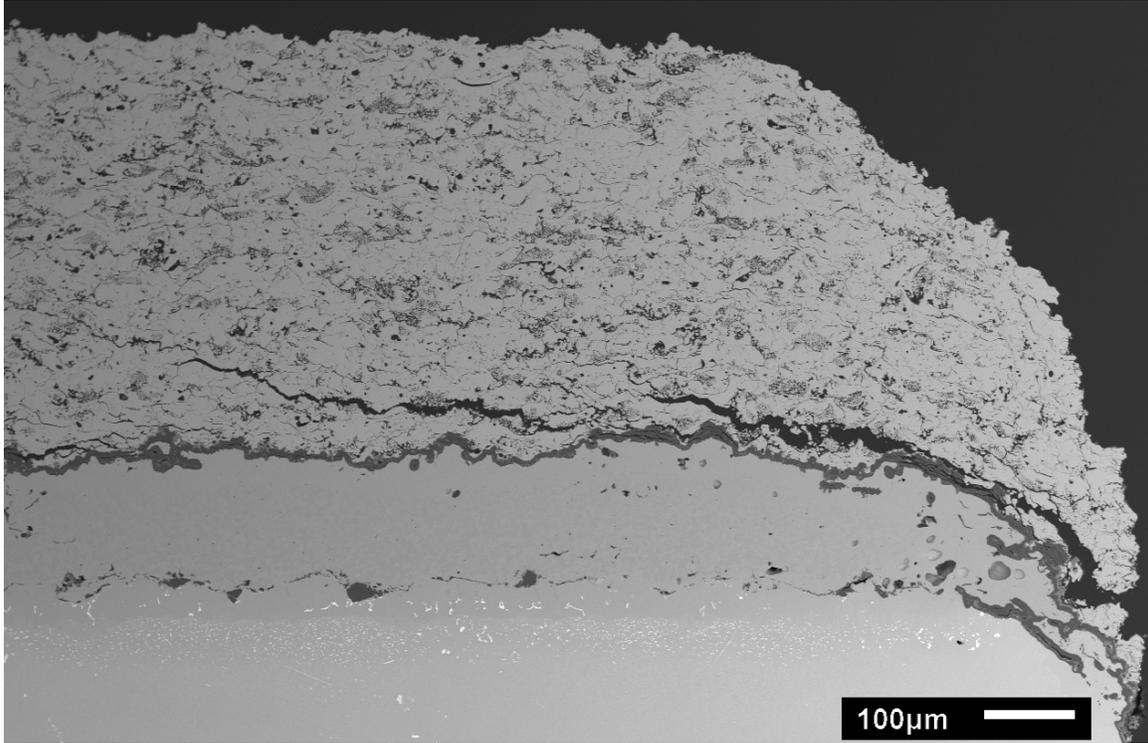
After 200 cycles the cracking in the SL bond coat was much more severe. The amount of edge cracking did not increase much as seen in Figure 130 however the cracking in the interior of the specimen increased, which is shown in Figure 131.

**Figure 130 - SL bond coat on PWA 1484 with 200 cycles.**

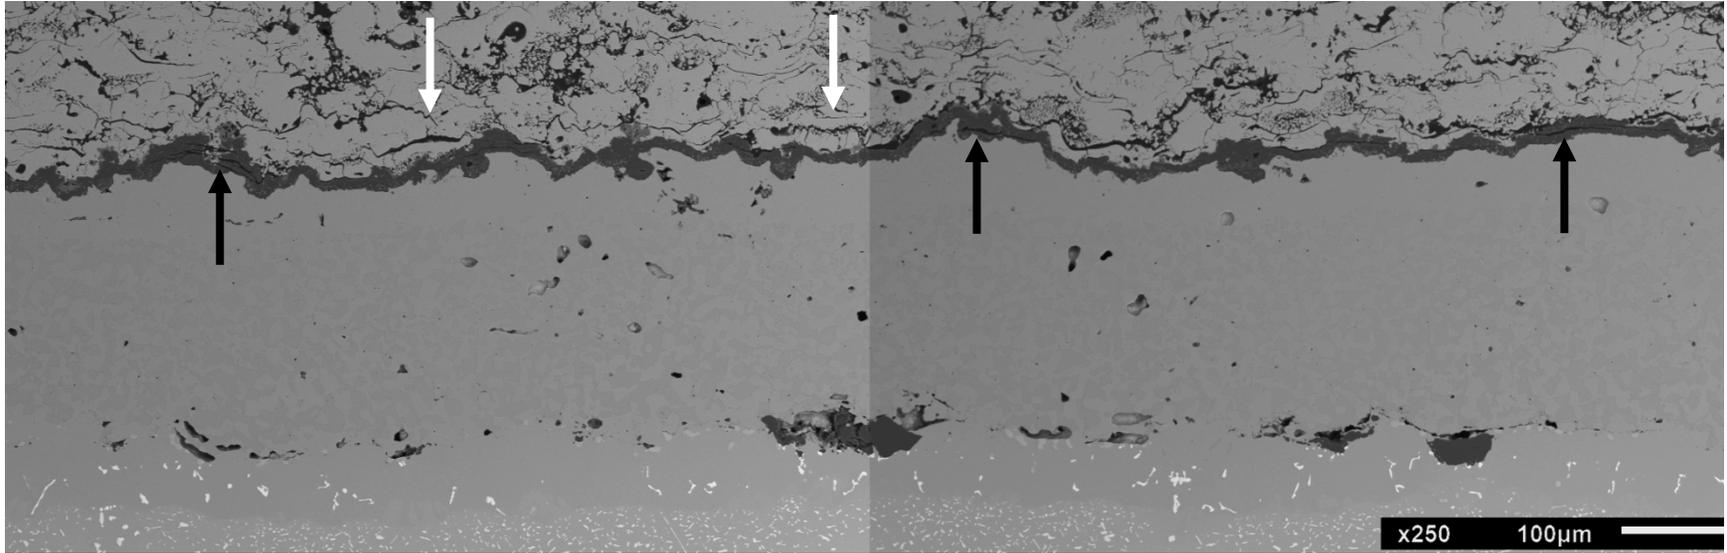
Figure 131 - SL bond coat on PWA 1484 with 200 cycles.

Heavy cracking occurred both in the TGO (black arrows) and in the YSZ (white arrows). The YSZ cracking seemed to occur over valleys/depressions in the bond coat while cracking in the TGO appeared to occur at peaks in the bond coat. This form of TGO cracking could be better described as a form of small scale buckling aided by the curvature of the bond coat and driven by the thermal misfit stresses between the bond coat and alumina TGO [73].

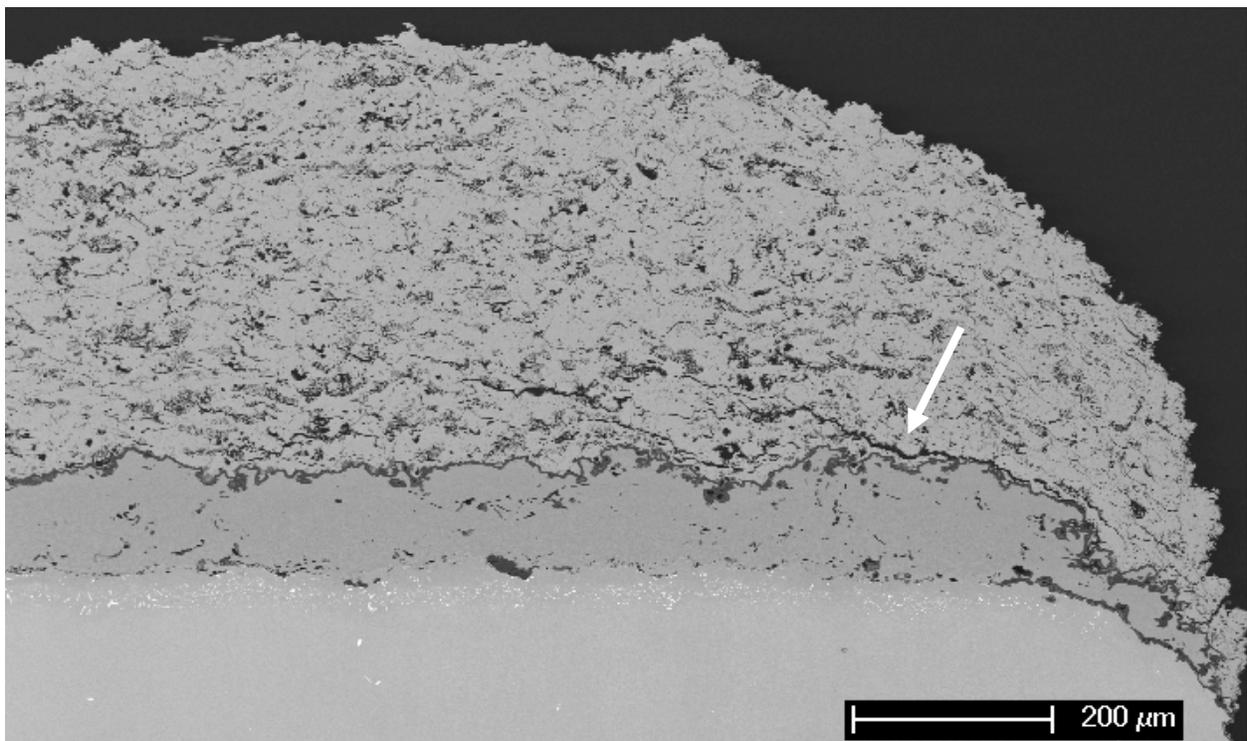
The 75:25 bond coat behaved much like the SL bond coat. It too experienced edge cracking after 140 cycles, Figure 132, but the amount of edge cracking did not seem to increase once it reached 200 cycles, Figure 133.

**Figure 132 - 75:25 bond coat on PWA 1484 with 140 cycles (50% lifetime).**

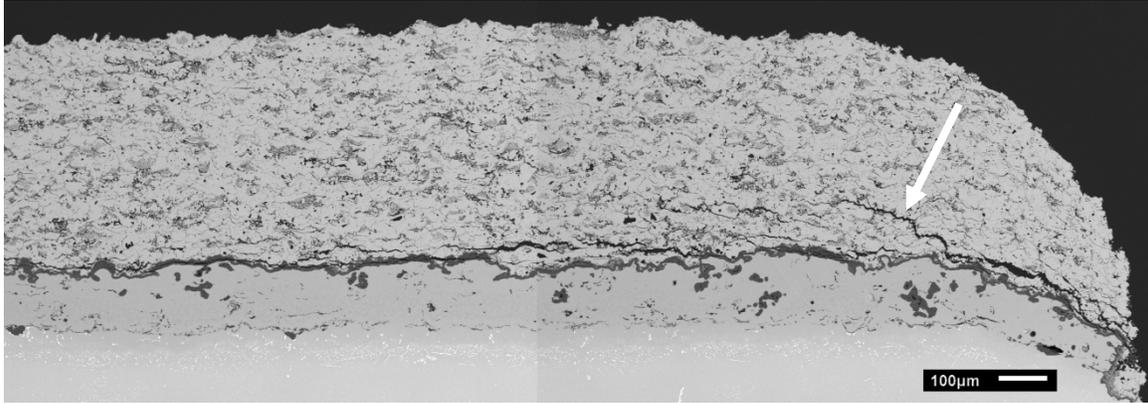
**Figure 133 - 75:25 bond coat with 200 cycles (71% lifetime).**

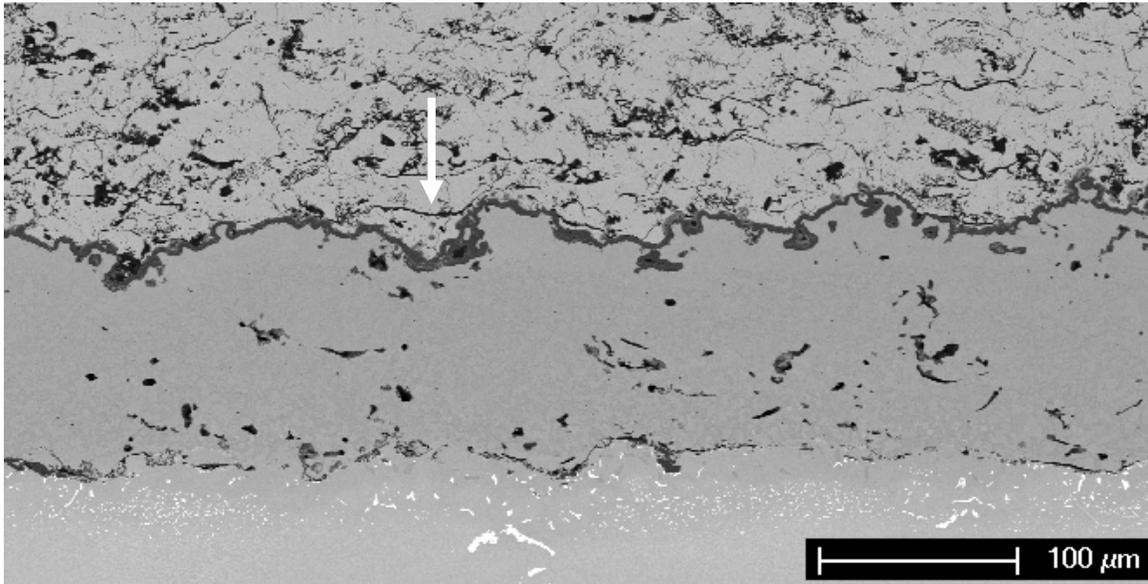
After 140 cycles, the 75:25 bond coat had noticeable amounts of cracking within the interior of the specimen shown in Figure 134.

**Figure 134 - 75:25 bond coat with 140 cycles (50% lifetime).**
