**FAILURE OF THICK, LOW DENSITY AIR PLASMA SPRAYED THERMAL  
BARRIER COATINGS**

**Michael Aaron Helminiak**

Submitted to the Graduate Faculty of  
Swanson School of Engineering in partial fulfillment  
of the requirements for the degree of  
Doctorate of Philosophy

University of Pittsburgh

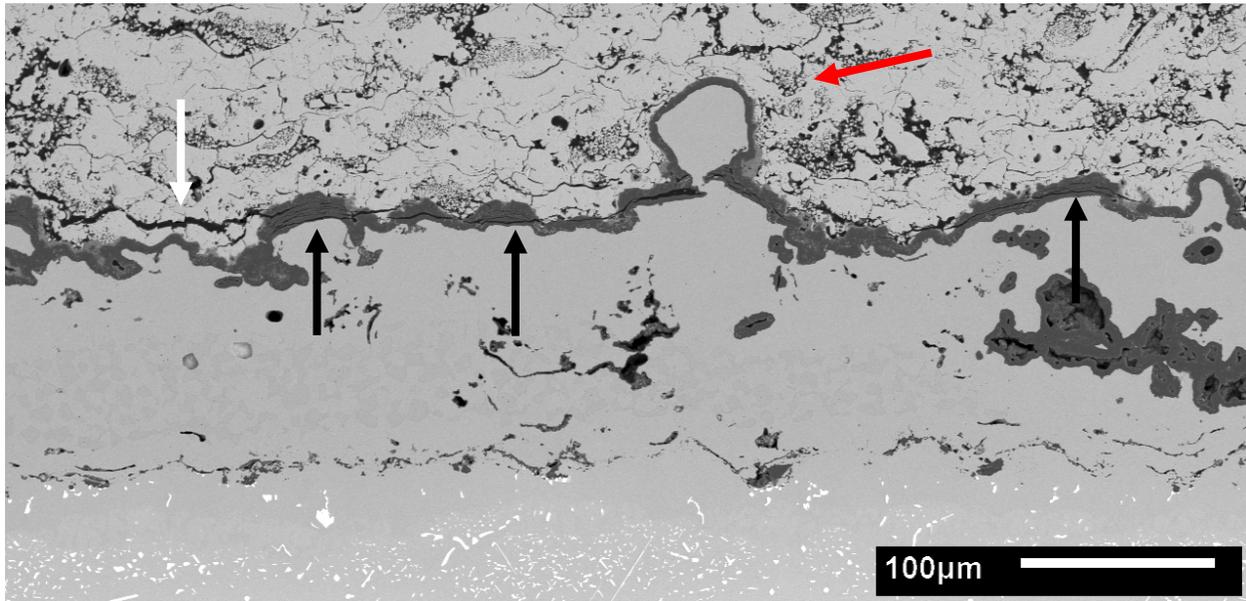
along with cracking in the YSZ above valleys. The only noticeable difference between the SL and 75:25 bond coats was the 75:25 bond coat had isolated regions with very high roughnesses. Such a region is shown in Figure 135 (red arrow).

**Figure 135 - 75:25 bond coat with 200 cycles (71% lifetime).**

Interestingly, the large peak in the center of this micrograph, likely an LN14 particle, does not have cracking along its outer edge. Instead cracks from both sides of the particle appear to be propagating into its base where it is attached to the bulk of the bond coat. The two cracks seem to be cutting away at its base, attempting to coalesce. Essentially, this bond coat particle appears to be a barrier preventing the cracks on each side from coalescing. Such a feature could provide strength to the interface by either forcing cracks to propagate through them or around them.

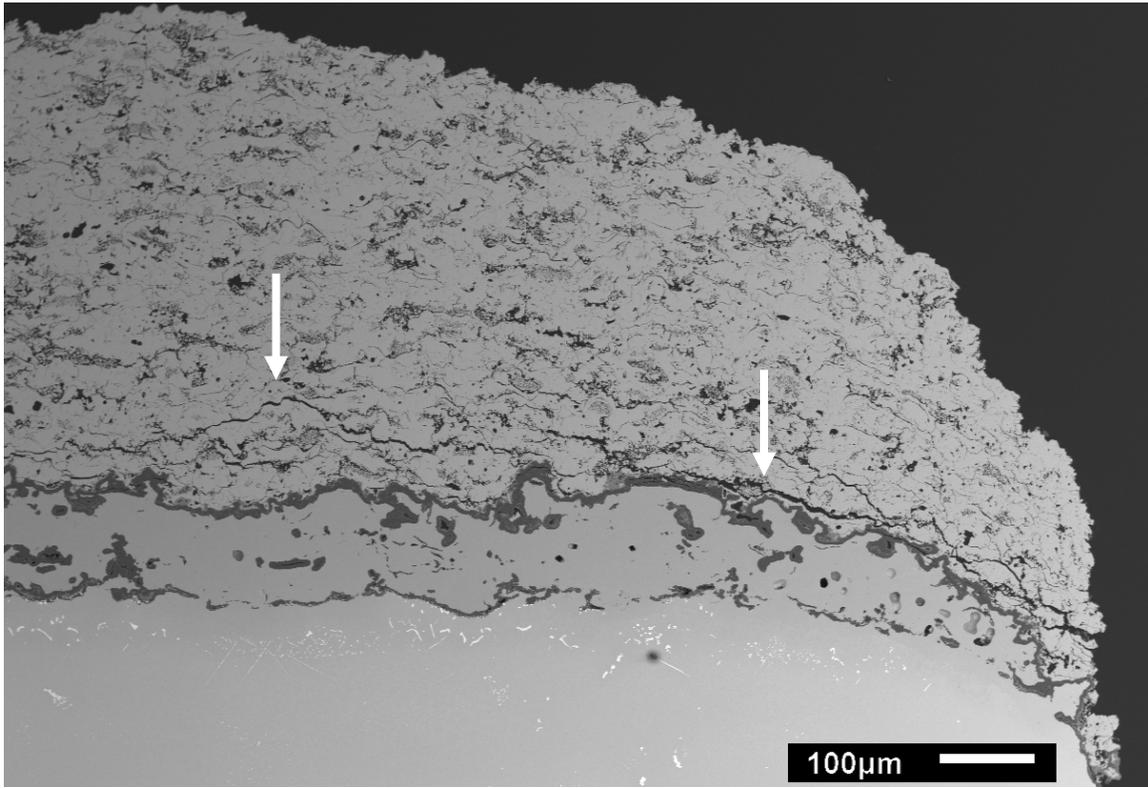
Moving to the 50:50 bond coat, after 200 cycles this bond coat also exhibited edge cracking (Figure 136) and moderate cracking within the interior of the coating Figure 137.

**Figure 136 - 50:50 bond coat with 200 cycles (33% lifetime).**

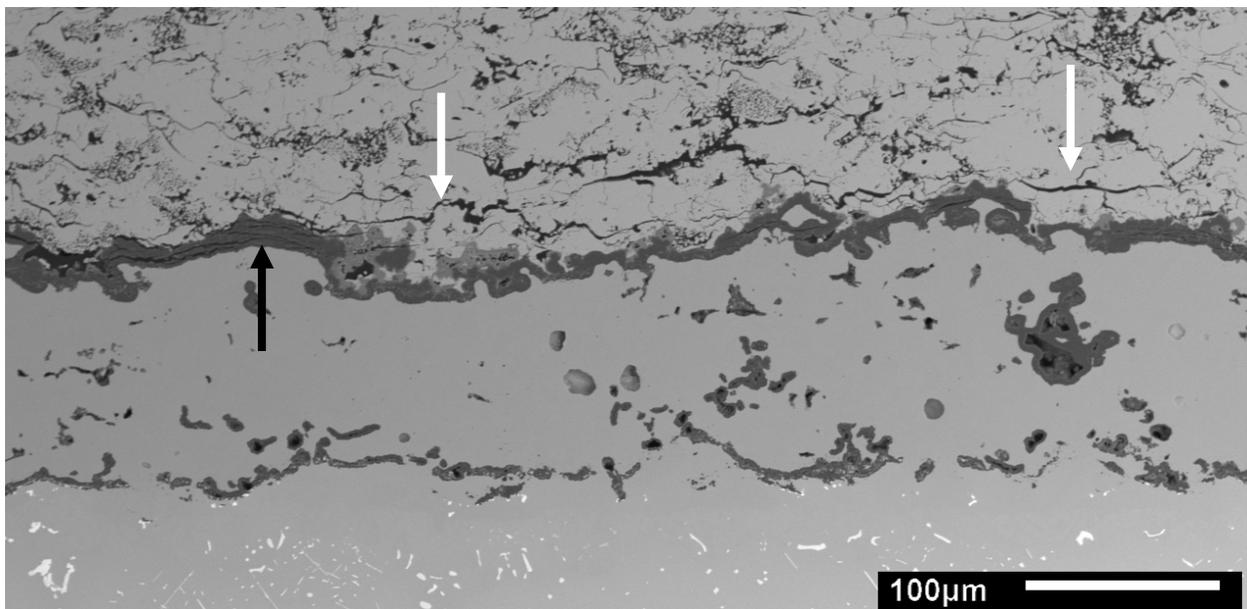
**Figure 137 - 50:50 bond coat with 200 cycles (33% lifetime).**

While extensive damage has occurred to the TGO/YSZ interface, the TBC is only at 33% of its lifetime. The amount of damage here is comparable to that of the 75:25 specimen after 200 cycles, where 200 cycles is 71% of the 75:25 coating's lifetime. The main microstructural difference between the two is the 50:50 bond coat had more of the large surface asperities spread over its surface, two of which are shown in Figure 138.

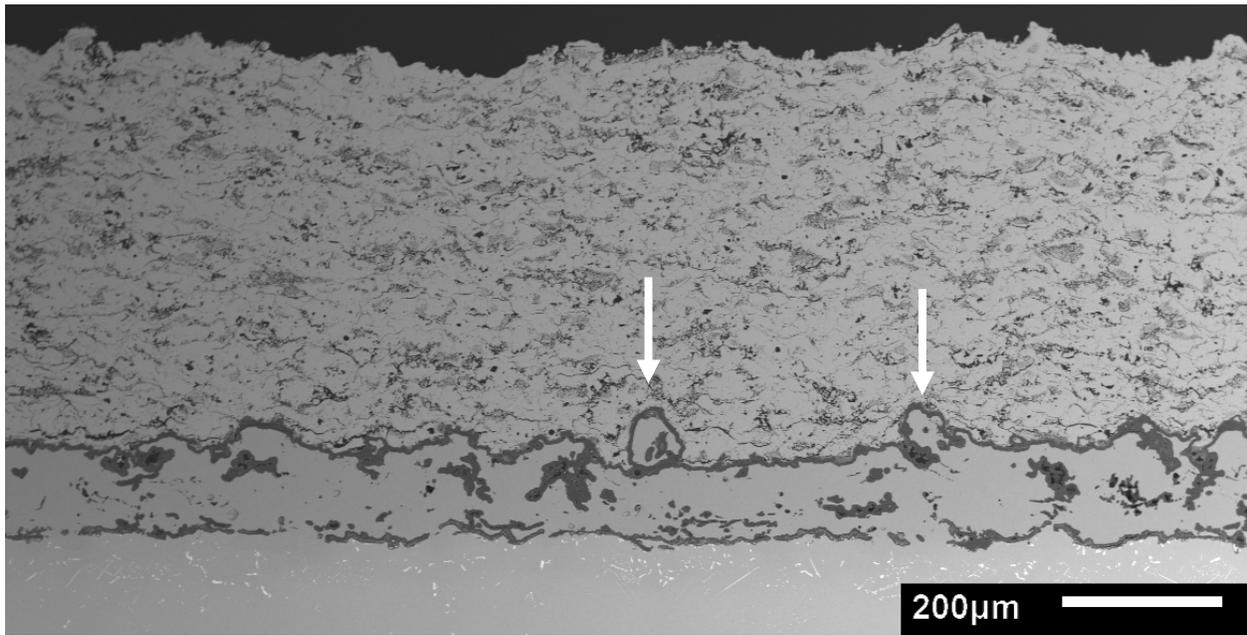
**Figure 138 - 50:50 bond coat with 200 cycles (33% lifetime).**

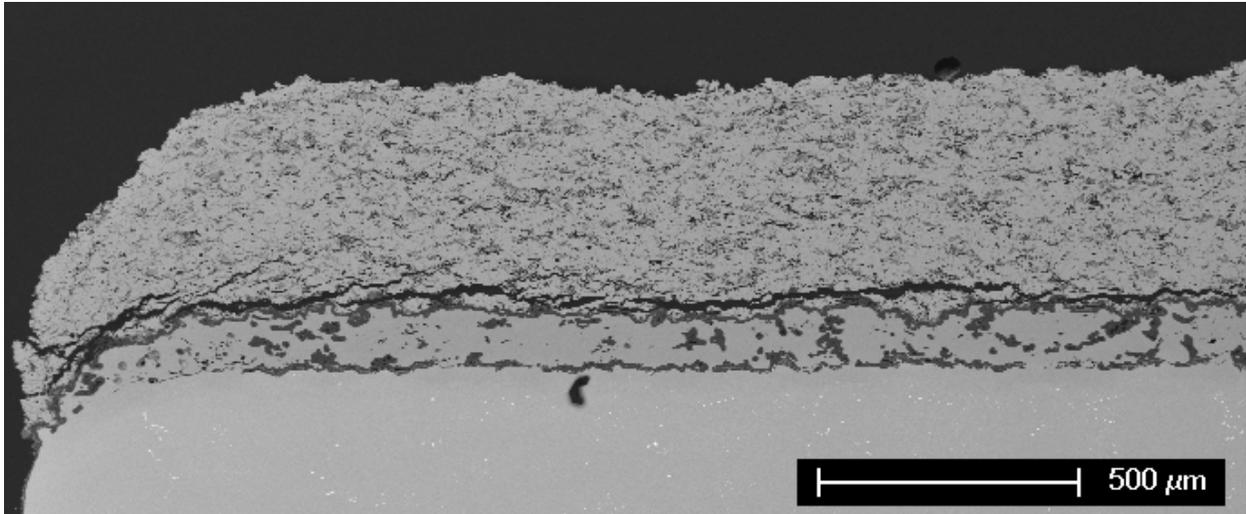
After 510 cycles, the scale and topcoat had severe damage. Large cracks extending in from the edges were visible (Figure 139) as were large delaminations within the bulk of the coating (Figure 140).

**Figure 139 - 50:50 bond coat with 510 cycles (85% lifetime).**

Ahead of the edge crack front (i.e. to the left of the crack shown in Figure 139) are smaller individual cracks similar to those in Figure 140. The large edge crack appears to be “consuming” or following the path of the smaller cracks, which have formed prior to the start of this edge delamination. In certain regions, such as that in Figure 141, the small individual cracks are approaching a large peak (black arrow) from the right and left (white arrows) and are being deflected up into the YSZ. This type of microstructural feature again appears to be deterring the two cracks from coalescing.

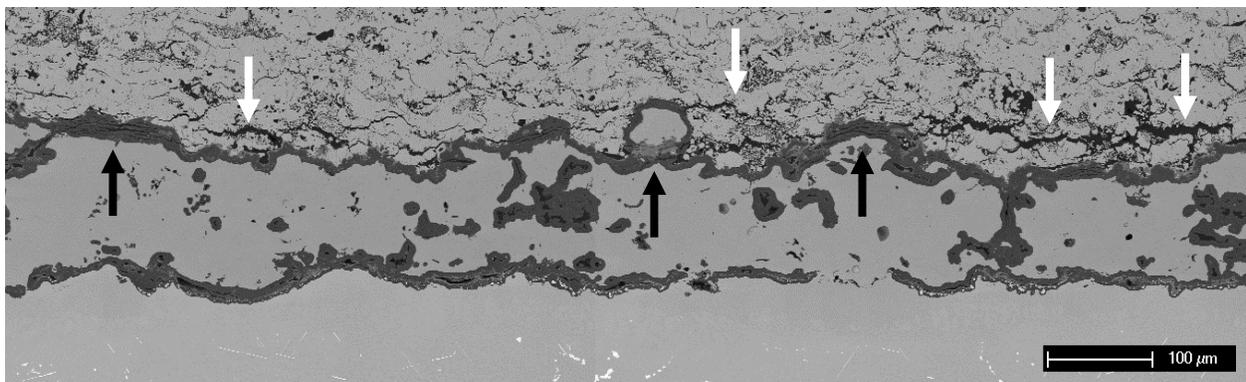
**Figure 140 - 50:50 bond coat with 510 cycles (85% lifetime).**

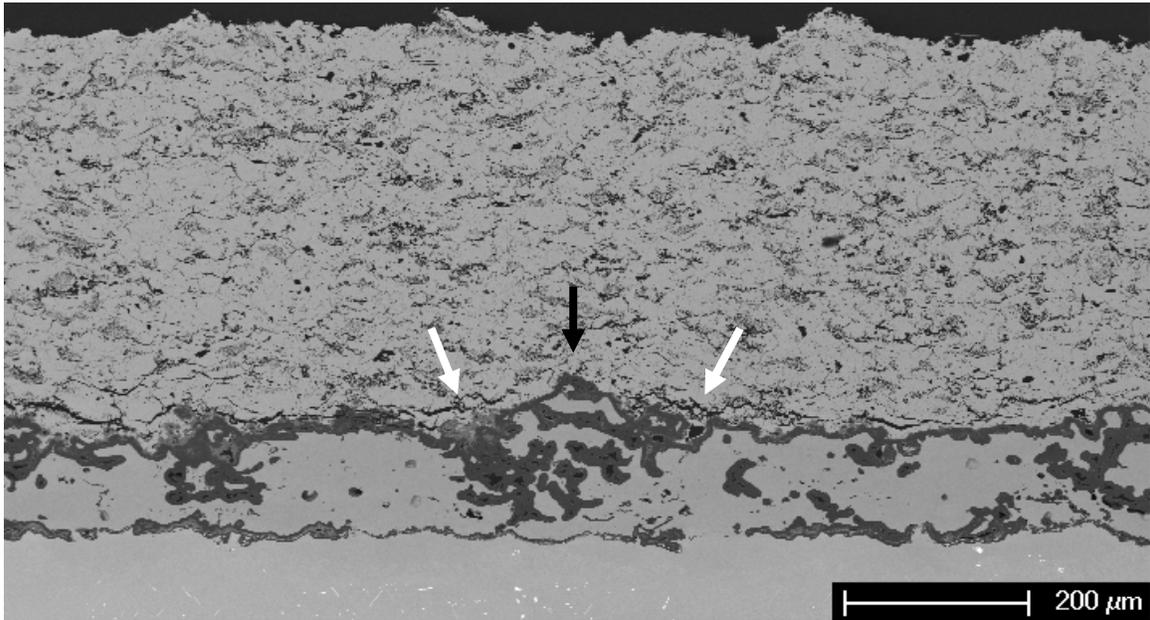
**Figure 141 – 50:50 bond coat with 510 cycles (85% lifetime).**

Failure of the DL and 50:50 bond coats requires a different explanation, as although there was heavy cracking within the TGO (Figure 145 and Figure 141 respectively); their fracture surfaces were primarily covered with YSZ whereas the 75:25 and SL bond coats were more so TGO. This type of cracking within the topcoat has been modeled by several authors [62, 65, 75]

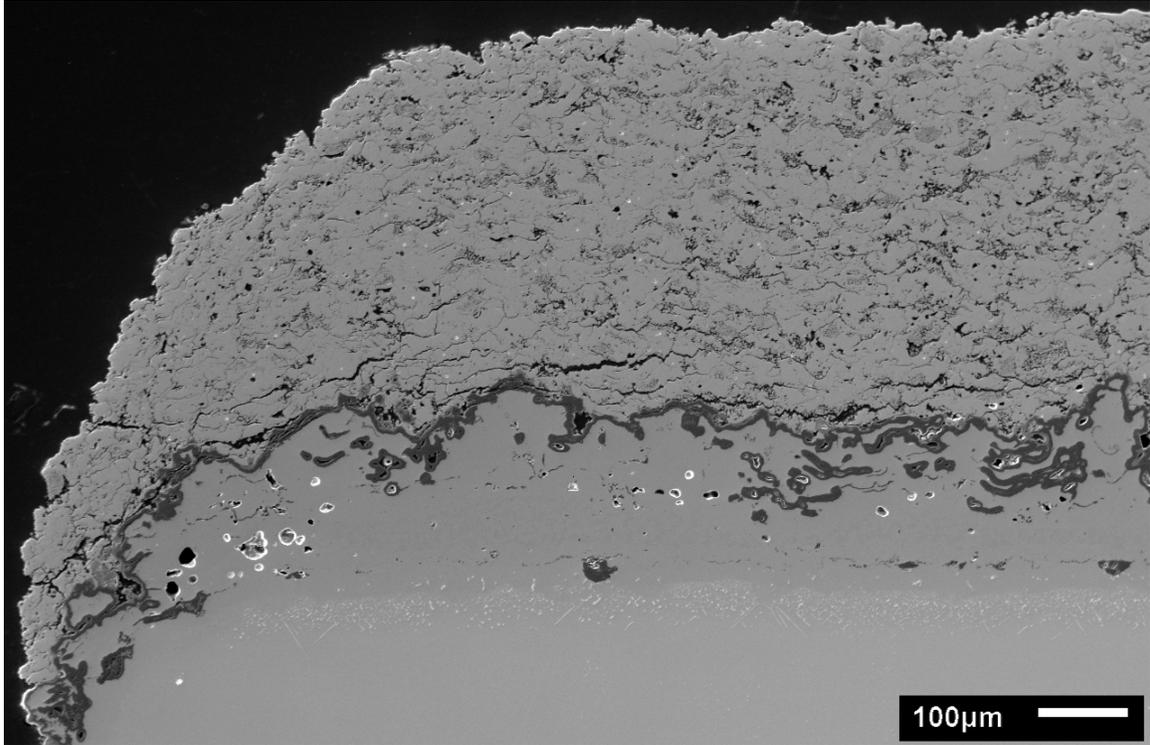
Figure 142 - DL bond coat with 200 cycles (35% lifetime).

As with the 50:50 bond coat, after 200 cycles the DL bond coat had minimal cracking at the edges, Figure 142, and in the interior of the specimen, Figure 143.

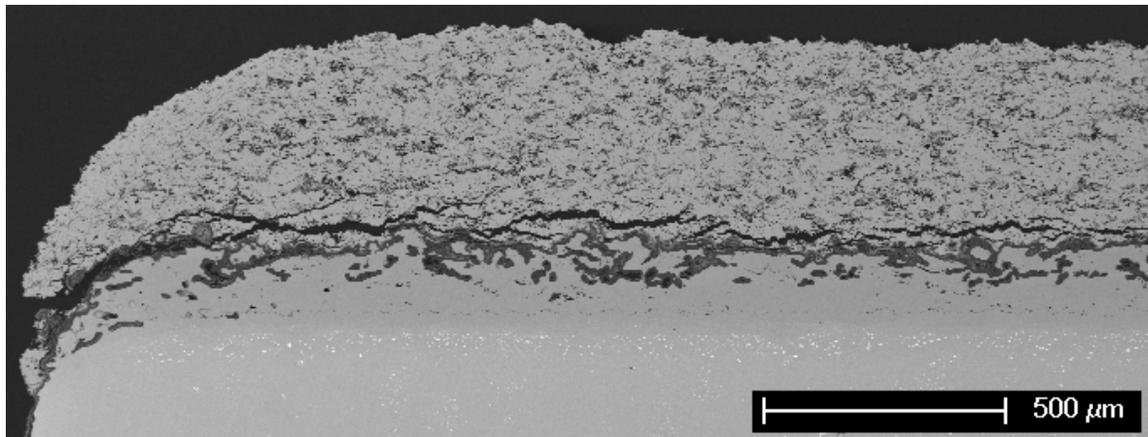
After 510 cycles, which represents 80% of the coatings lifetime, the topcoat was almost completely delaminated, Figure 144. Heavy cracking in the TGO and within the YSZ was also prevalent, Figure 145. Overall, the DL coating appeared similar to the 50:50 coating after 510 cycles. It is thus not surprising they performed similarly in the FCT testing.

**Figure 144 - DL bond coat with 510 cycles (91% lifetime).**

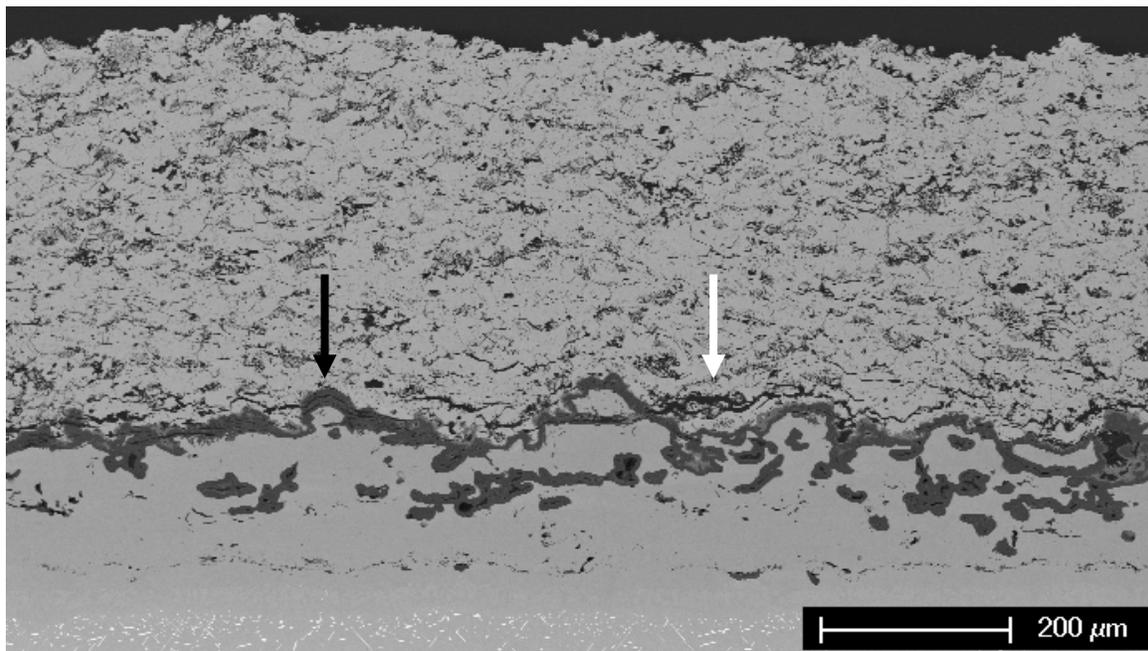
**Figure 145 - DL bond coat with 510 cycles (91% lifetime).**

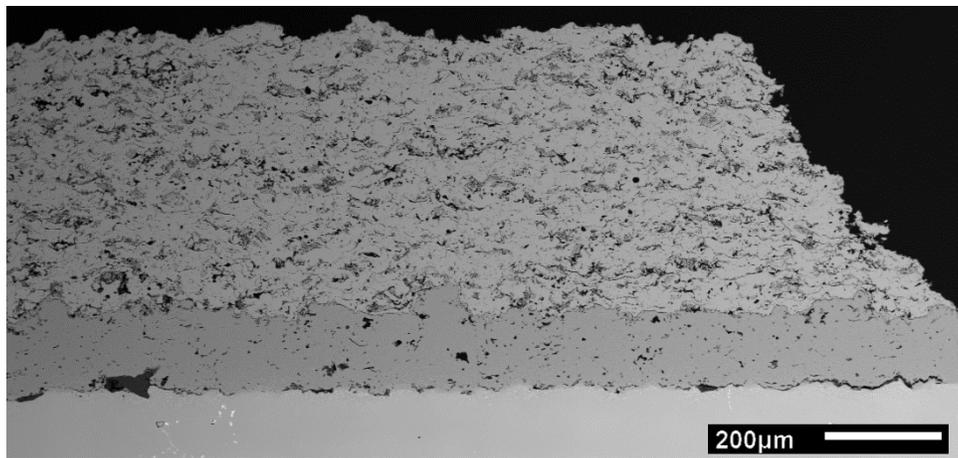
After they were measured, they were loaded into the rig and run for 2000 cycles with the flame adjusted to yield a topcoat surface temperature of 1250°C. Once they reached 2000 cycles, they were removed and measured again for edge cracking. Their post-test cracking levels were identical to their pretest levels. This is not a surprising result considering the JETS test is primarily used to test the durability of topcoats and has minimal effect on the bond coat type because of the short dwell times under the flame [74]. Since all of the specimens have the same topcoat it seems reasonable to find they performed similarly in the JETS test. Figure 146 through Figure 148 show the tested specimens of each bond coat type. Note the large edge cracks and chips which were induced during grinding.

**Figure 146 - 75:25 bond coat on PWA 1484 with 2000 JETS cycles.**

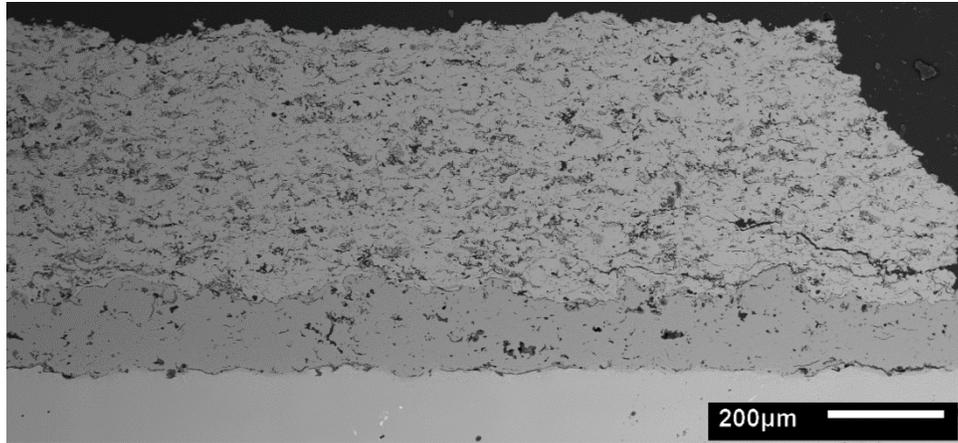
**Figure 147 - 50:50 bond coat on PWA 1484 with 2000 JETS cycles.**

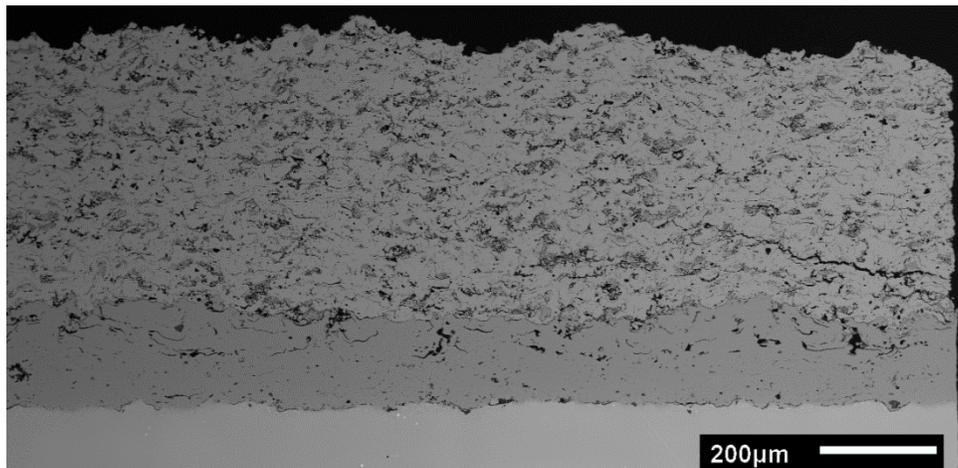
**Figure 148 - DL bond coat on PWA 1484 with 2000 JETS cycles.**

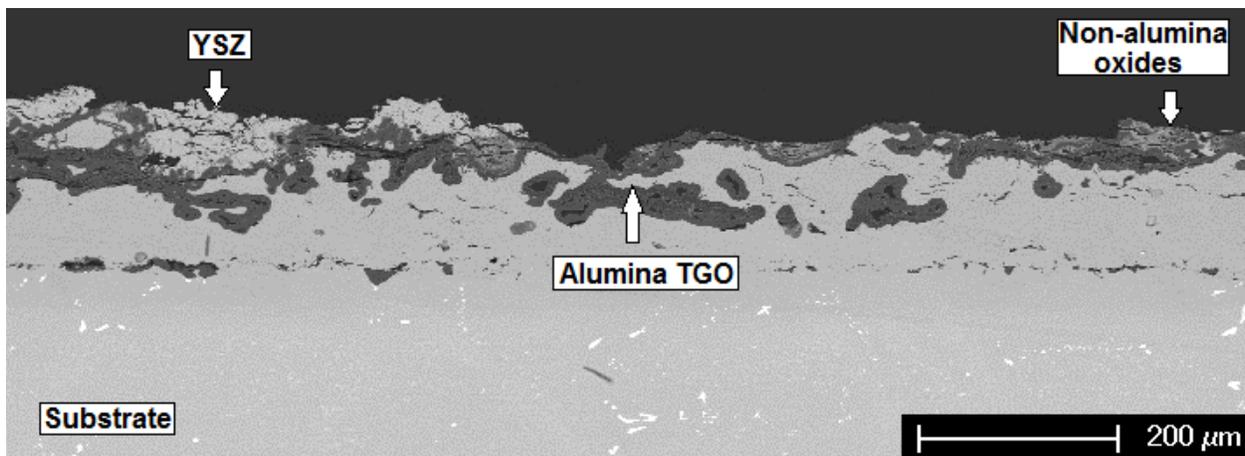
Moving to the thinner topcoat specimens, the 375  $\mu\text{m}$  TBCs had significantly longer lifetimes than the 1100  $\mu\text{m}$  specimens and appeared to experience bond coat oxidation related failure. This type of failure is characterized by fracture along the bond coat/TGO/topcoat interface and only occurs after extensive bond coat oxidation has taken place. An example of such a failure is depicted in Figure 152.

Figure 152 - Failed 375  $\mu\text{m}$  TBC on N5 after 920 cycles.

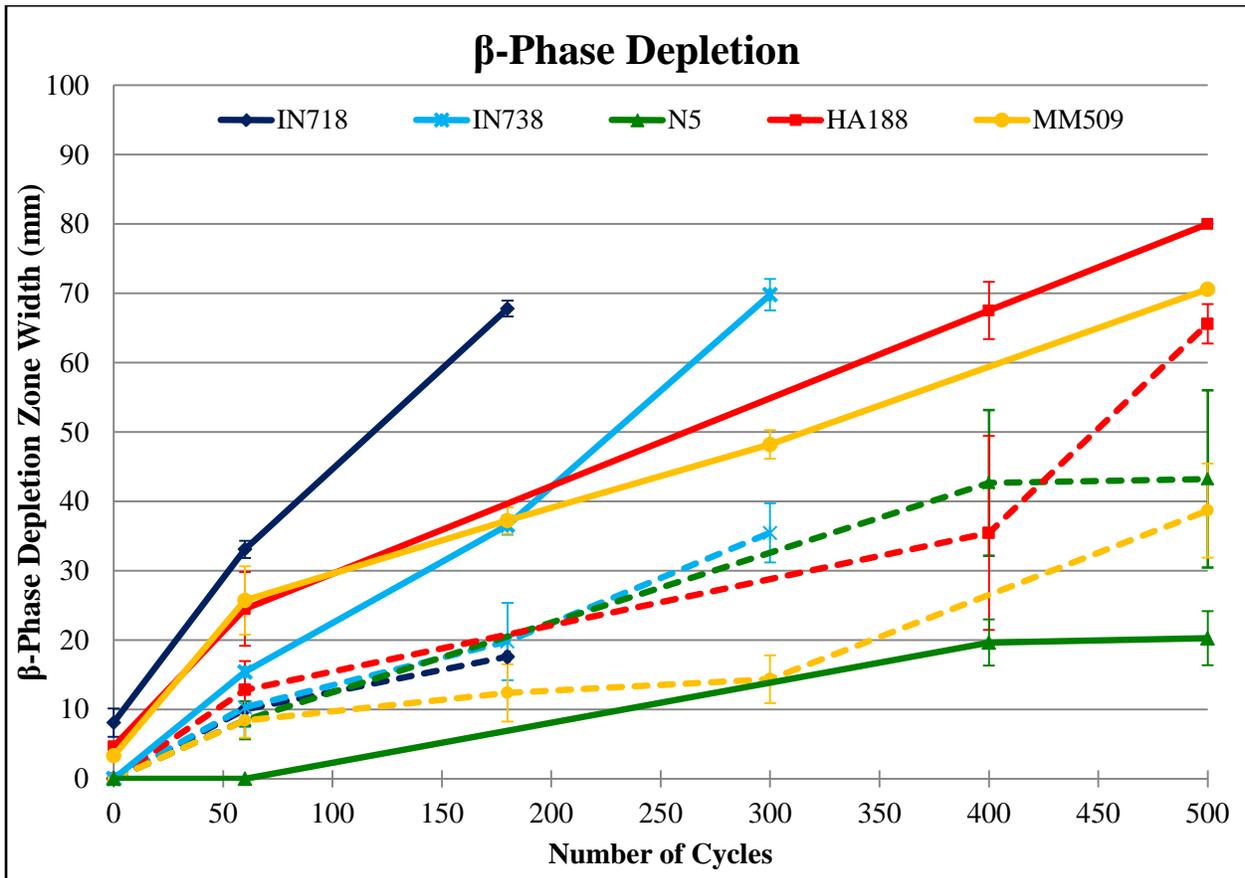
Figure 154 - Depth of  $\beta$ -phase depletion zone as a function of thermal cycles. Solid lines represent depletion due to interdiffusion and the dashed lines represent depletion due to TGO formation.

The rate of aluminum depletion due to substrate interdiffusion was highest in IN718 followed by IN738 then HA188 and MM509, which had similar rates, and finally by N5 with the slowest rate.

The rate of depletion caused by TGO growth, dashed lines in Figure 154, did not seem to depend on the substrate material, especially after a short number of cycles (< 60 cycles), which is evident by the tight grouping of the dashed lines in the figure. This suggests that substrate elements, such as niobium or tantalum, which were found to have diffused into the bond coat, did not have a significant influence on the TGO growth rate and subsequently the rate of

When comparing aluminum depletion due to interdiffusion and TGO growth, interdiffusion dominated in the cases of IN718, IN738, MM09 and HA188. In fact, the substrate interdiffusion was far more detrimental to the overall aluminum depletion than the growth of the TGO. In the case of René N5 the difference between the rates of the two mechanisms was far less significant which is attributed to the higher aluminum concentration in N5 than in the other superalloys.

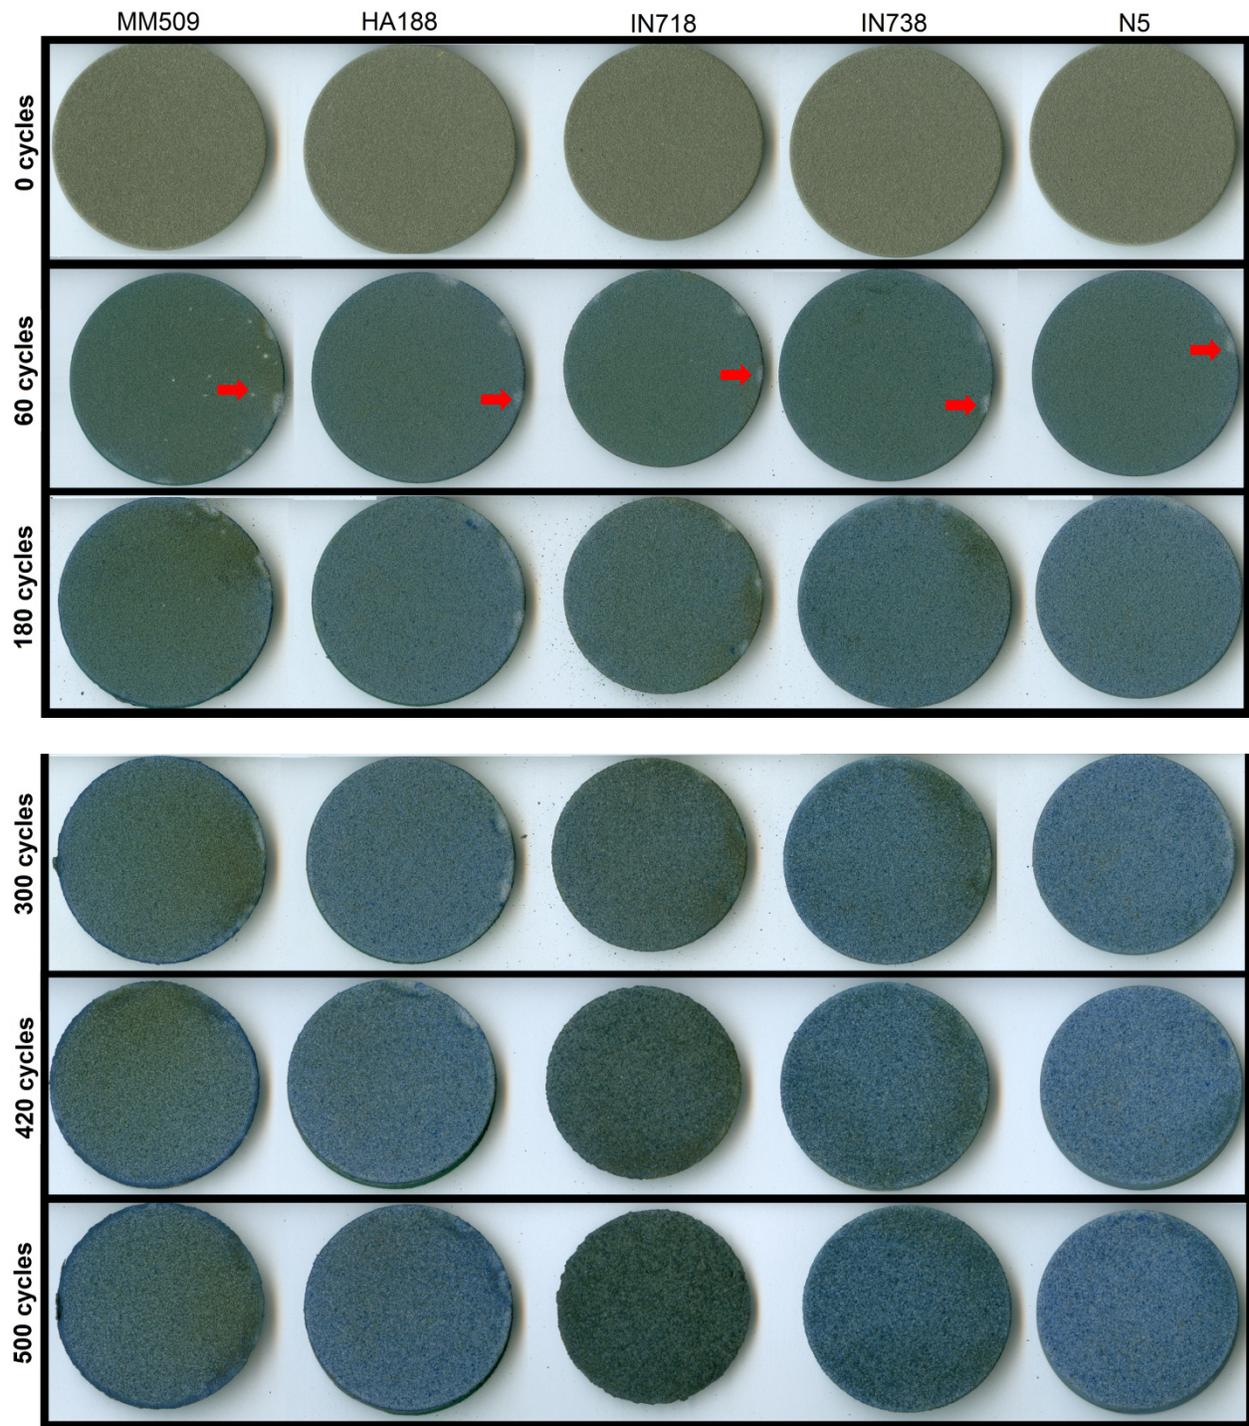
Figure 155 - High resolution images of the surfaces of the specimens for various number of cycles. Red arrows point out some of the marks left by the ceramic trays the specimens are placed in during thermal cycling.

The white marks that appear on the specimens (red arrows in Figure 155) are marks left by the ceramic trays which supported the specimens during the thermal cycling in the bottom loading furnace.

After 60 cycles the specimens appeared identical. Both surface and cross-sectional microscopy confirmed this as well as a visual inspection of the surfaces in Figure 155. The TGO consisted of  $\alpha$ -alumina with small isolated areas of nickel, chromium, and aluminum mixed oxides. These non-alumina oxides are most likely transient oxides formed during the first few thermal cycles. Based on these observations, the early stages of oxidation are independent of substrate material.

After 500 cycles, significant changes occurred in the oxide scale on the IN718 specimen. Visually, the specimen's size has reduced slightly due to scale spallation and the color has changed to a dark green with black spots. Surface EDS (standardless) indicated the presence of nickel and chromium rich oxides along with the alumina. A cross-sectional image of this specimen is shown in Figure 156.

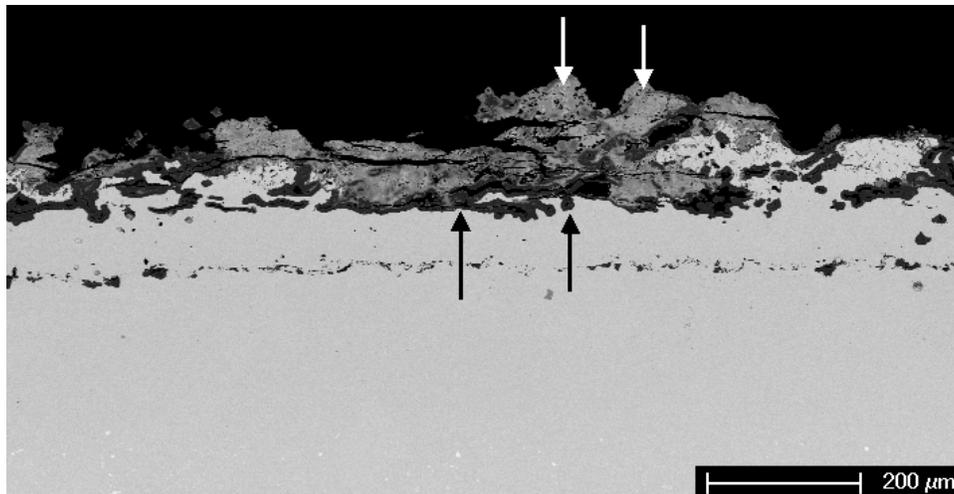
**Figure 156 - Cross-section of IN718 specimen after 500 cycles. White arrows indicate oxides rich in Ni, Co, Cr, Nb, and Fe and the black arrows point out  $\text{Al}_2\text{O}_3$ .**

The dark regions in the TGO, indicated by the black arrows, are alumina and the light-appearing oxides, indicated by the white arrows, were rich in nickel, chromium, and cobalt with traces of niobium and iron. Based on the structure of the dual layer bond coat and the location and composition of the oxide scale after 500 cycles, it appears the base metal in the outer layer of the bond coat has completely oxidized, forming a layer of Ni, Cr, and Co rich oxides. Standardless EDS measurements made during SEM characterization revealed the composition of the bond coat material below the outer oxidized layer was almost completely depleted of aluminum.

For the IN718 specimens, it is proposed that the combination of rapid depletion of aluminum due to substrate interdiffusion, oxidation of the porous outer region of the bond coat and cracking and healing occurring in the undulating TGO during thermal cycling all caused the bond coat aluminum content to drop below the minimum concentration needed to maintain an alumina scale. This then resulted in the oxidation of the base metal in the bond coat. This series of events is often referred to as chemical failure of the bond coat, or the point at which an

alumina scale can no longer form resulting in the formation of less protective oxides [40]. Furthermore, since it is likely the chemical failure was influenced/enhanced by the mechanical damage to the TGO during thermal cycling, the more accurate term of mechanically-induced chemical failure is the better fitting nomenclature [40]. Based on the timeline of all of the observations, it appears the IN718 specimens experienced chemical failure somewhere between 300 and 500 cycles. Comparing this with the lifetime of the 375  $\mu\text{m}$  TBCs on IN718, 420 cycles (taken from Figure 150), reveals the two events occurred at nearly the same number of cycles. This supports the literature sources that link the formation of these non-protective oxides to the failure of the TBCs [33, 38, 40, 44].

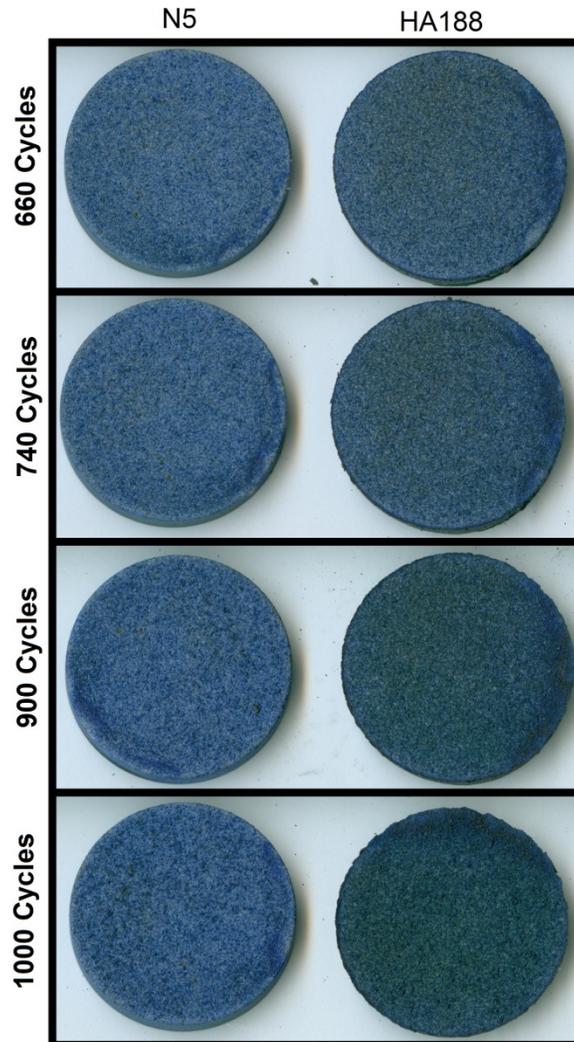
The bond coats on HA188 and N5 also visually showed significant changes after 500 cycles. XRD and cross-sectional microscopy revealed the TGO was primarily alumina but with isolated areas of nickel, chromium and aluminum spinel oxides. Extensive cracking in the alumina TGO was also observed in both specimens.

After 1000 cycles the HA188 specimen, Figure 157, visually appeared similar to the IN718 bond coat after 500 cycles.

**Figure 157 - High resolution scanned images of HA188 and N5 specimens after a set number of cycles.**

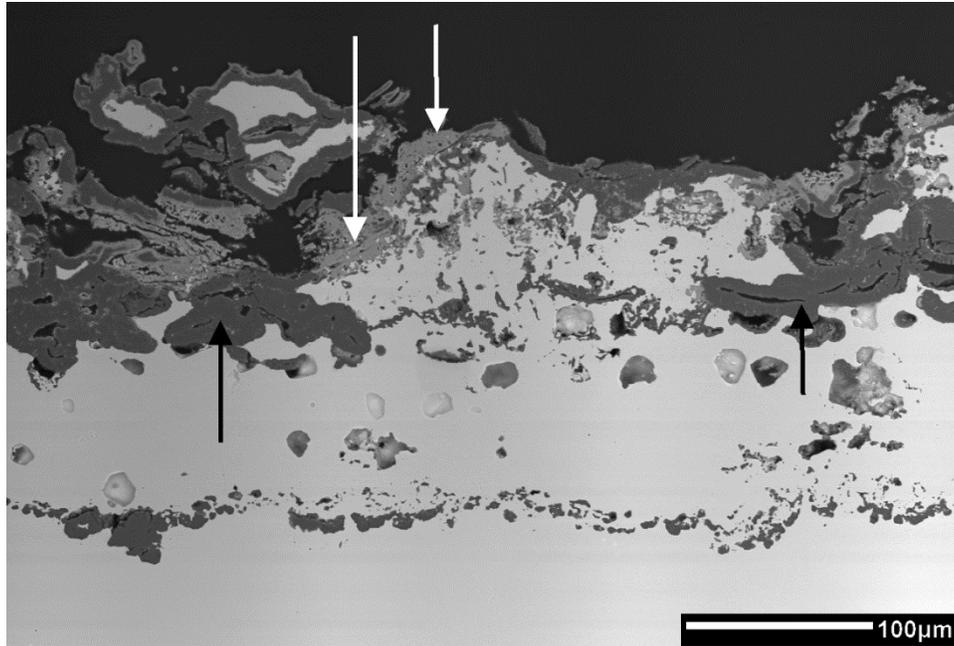
The surface EDS (standardless) indicated the presence of nickel, chromium, cobalt, and aluminum rich oxides. As with the IN718 specimen, the outer layer of the dual layer bond coat on HA188, seen in Figure 158, is almost completely depleted of aluminum with approximately 1wt%Al remaining (determined by standardless EDS analysis during SEM observation), and Ni, Cr, and Co rich oxides were present throughout the TGO (white arrows).

**Figure 158 - HA188 specimen with 1000 cycles. White arrows indicate non-aluminum oxides and the black arrows point to the aluminum oxides.**

The presence of these oxides and the low aluminum content in the bond coat indicate mechanically induced chemical failure has occurred or is in the process of occurring. Comparing the time to chemical failure with the lifetime of the 375  $\mu\text{m}$  TBC on HA188, 793 cycles, there is again generally good agreement between the two events. This further supports the relationship between the formation of non-alumina oxides and TBC failure being linked [33, 38, 40, 44].

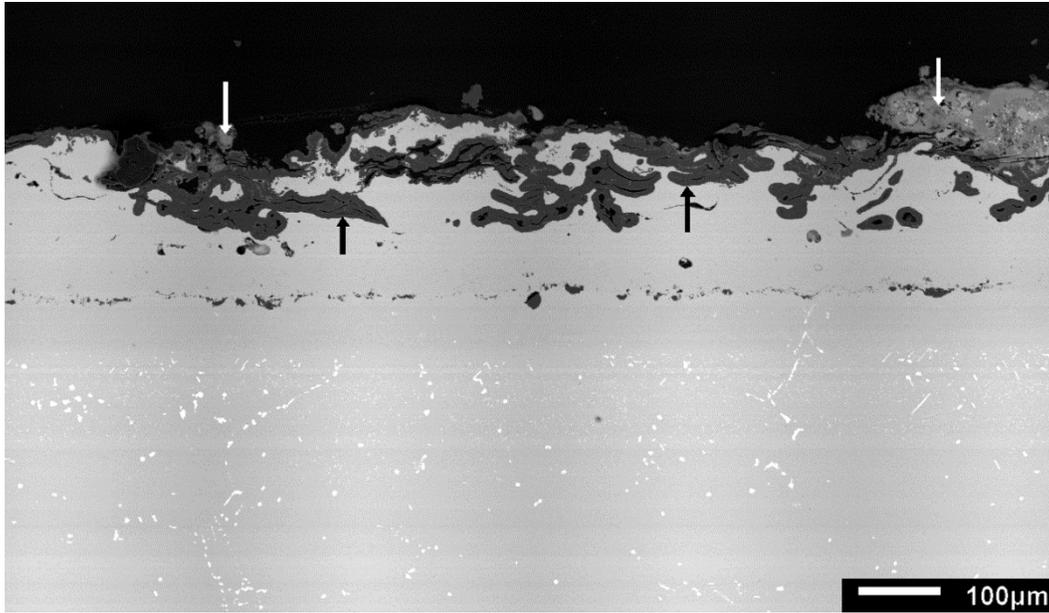
After 1000 cycles, the dual layer bond coat on N5 still had an alumina TGO, however, there were numerous isolated regions in the outer region of the bond coat that contained Ni, Cr, Co spinel oxides which are highlighted by white arrows in Figure 159.

**Figure 159 - N5 specimen after 1000 cycles. White arrows indicate non-aluminum oxides and the black arrows indicate aluminum oxide.**

Below these spinel regions in the dense portion of the bond coat, the aluminum content was between 3.0-6.0at%. This amount of aluminum is close to the amount required to reform an alumina TGO if scale cracking/spallation occurs and well above the required amount needed to sustain the growth of an established adherent alumina scale [40].

It is proposed these isolated regions of spinel oxide are a byproduct/drawback of the dual layer bond coat structure. More specifically, during high temperature exposure, the surface connected pores in the outer layer oxidize and form a TGO as does the external surface of the bond coat. Thus the bond coat material in the outer region is depleted of aluminum by scale formation on the pore surfaces and the external surface. Normally the aluminum content in the outer region is replenished by the bulk of the coating however as the pores oxidize and consume aluminum, the supply to the external surface gradually decreases. Over time, these outer regions become isolated from the bulk of the coating (white arrows in Figure 159). Once isolated, it is a

matter of time (i.e. thermal cycles) until chemical failure, whether it be intrinsic or mechanically induced, occurs. These isolated regions are analogous to the “diffusion cell” concept introduced by Evans et al [40] for the case of air plasma bond coats and argon-shrouded plasma sprayed bond coats. In their model, regions of the bond coat become isolated from the bulk of the coating due to oxidation of the molten bond coat particles during deposition. This produces isolated diffusion cells throughout the coating. During subsequent oxidation, the aluminum content in these cells decreases as the TGO grows. Since these cells are cut off from the bulk of the coating, the aluminum content decreases without replenishment from the bulk. Eventually, due to kinetic and thermodynamic limitations, alumina is no longer the stable oxide and other less protective oxides form [40].

This scenario is unlike the cases for HA188 and IN718 because the bond coat on the N5 specimen still contained 3.0-6.0at% aluminum. So instead of complete chemical failure of the bond coat, as it was with the IN718 and HA188 specimens, only isolated chemical failure occurred with the N5 specimen.

When the time to isolated chemical failure is compared to the time to failure of the TBCs on N5 with dual layer bond coats, 850 cycles, there is again generally good agreement between the two events. This indicates that localized chemical failure is sufficient to contribute to TBC failure. Likewise, these findings suggest the dual layer bond coats, even when paired with an alumina forming substrate alloy, will have an upper limit to lifetime which is brought about by rapid aluminum depletion in the outer portion of the coating.
