#### IDENTIFICATION OF FACTORS CONTROLLING THE DEVELOPMENT OF SUBSIDENCE IMPACTS FORECASTING METHODOLOGY TO THE I-70 ALIGNMENT OVER LONGWALL MINING OF THE TUNNEL RIDGE MINE, WASHINGTON COUNTY, PA

Task 1: Pre-Undermining Activities Report Submitted 2 July 2019; Finalized 19 January 2020

#### The University of Pittsburgh Master Agreement Contract No. 4400018535

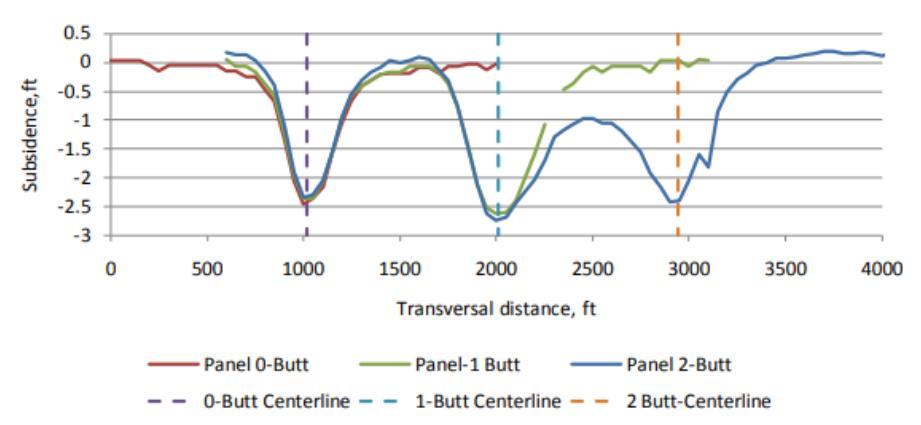
Figure IIa.3 – Final subsidence profiles for three Gateway panels undermining northbound I-79 (Yancich, 1986)

The surveys clearly depict three separate subsidence basins, all of which that come to a point around a maximum vertical subsidence of 2.5-ft. It is also noteworthy that, after the completion of all three panels, there is a foot of vertical subsidence over the gateroads between Panel 1-Butt and Panel 2-Butt; this amount of vertical subsidence indicates yielding pillars in the gateroads between these two panels.

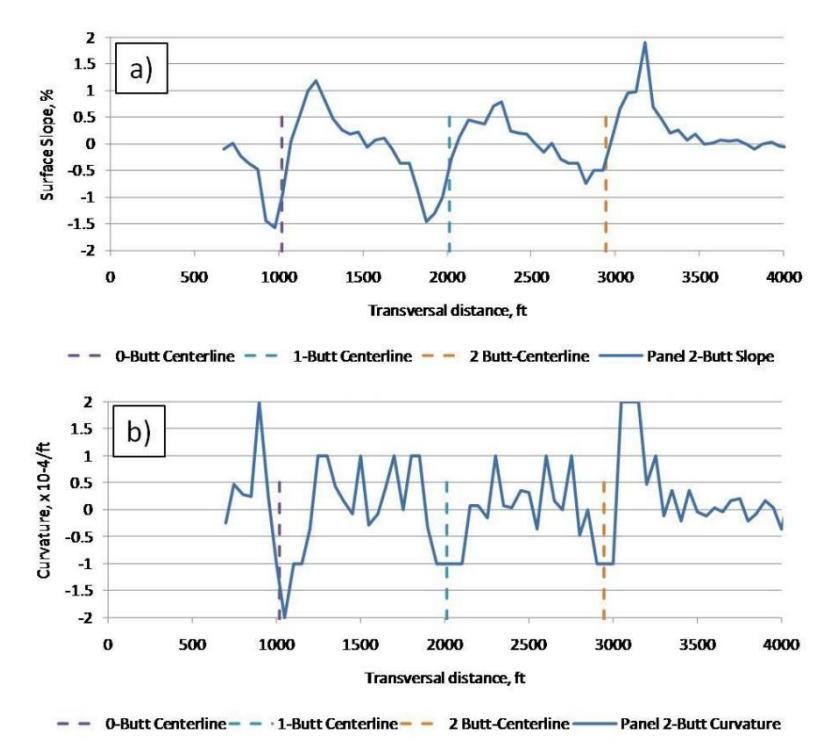
Figure IIa.4 – Profiles of a) surface slope and b) curvature from three Gateway panels undermining I-79 northbound (Yancich, 1986)

The study went on to examine the slope and curvature of these panels derived from the final subsidence basins (Figure IIa.4). The maximum slope ranged from +1.9% to -1.56% and the

points of zero slopes were located at the approximate location of the center of the panels and the gateroad entries. The maximum curvature ranged between  $+2x10^{-4}$ /ft and  $-2x10^{-4}$ /ft, with the areas of highest curvature between the edges and centers of the panels. Most impacts on I-79 were expected to occur in these areas of highest slope and curvature.

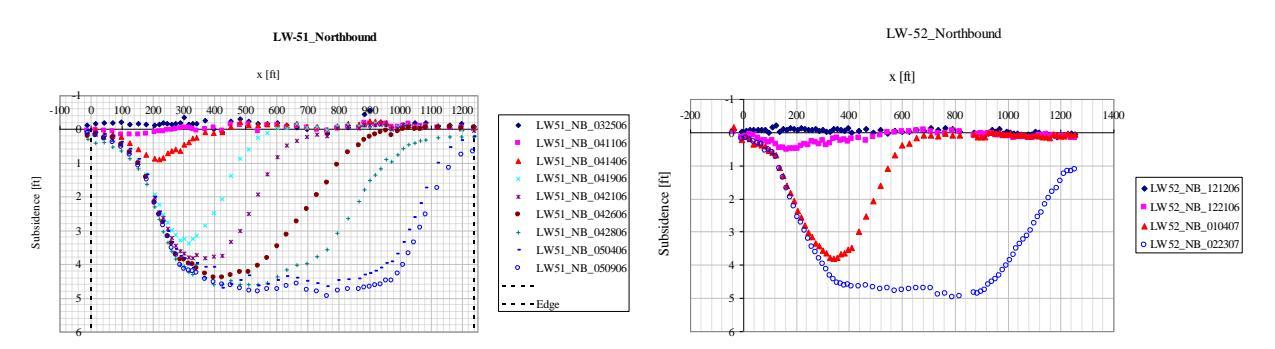
Figure IIa.9 – Measured subsidence profiles over time of Cumberland panels LW51 (left) and LW52 (right) (Vallejo and Lin, 2010)

A study completed by Vallejo and Lin in 2010 analyzed the undermining of I-79 through the examination of two Emerald panels and six Cumberland panels. Survey data was collected for the highway alignments that crossed all eight panels on multiple dates during the undermining process. This data showed not only the final subsidence basin underneath the highway, but also the dynamic subsidence as the basin formed. The data collected for Cumberland panels LW51 and LW52 can be seen below in Figure IIa.9.

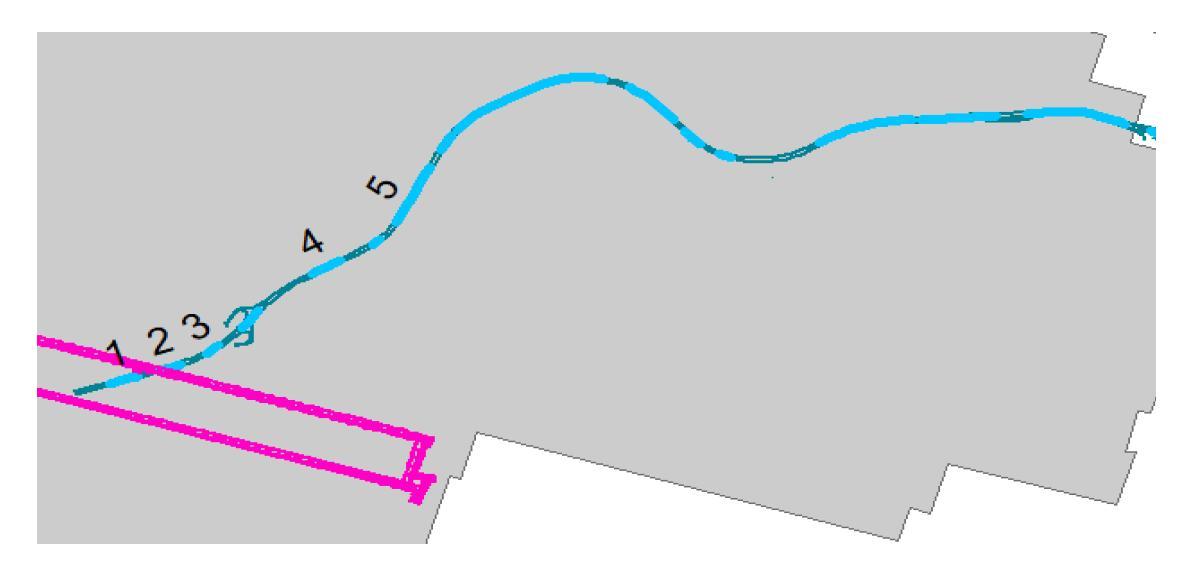
Figure IIIa.4 – Location of areas of fill and five embankments along section of I-70 that may be undermined by Tunnel Ridge Mine

Along the relevant section of I-70, there are five large embankments. These five embankments include the two embankments located above Panel 15 which will be monitored and observed for future predictions. The embankments range in length from 350 to 650-ft and range in height from 50 to 85-ft. All of the embankments were designed with 2:1 slope. The five (5) embankments are numbered from left to right and are labeled in Figure IIIa.4 below and the characteristics are summarized in Table IIIa.1.

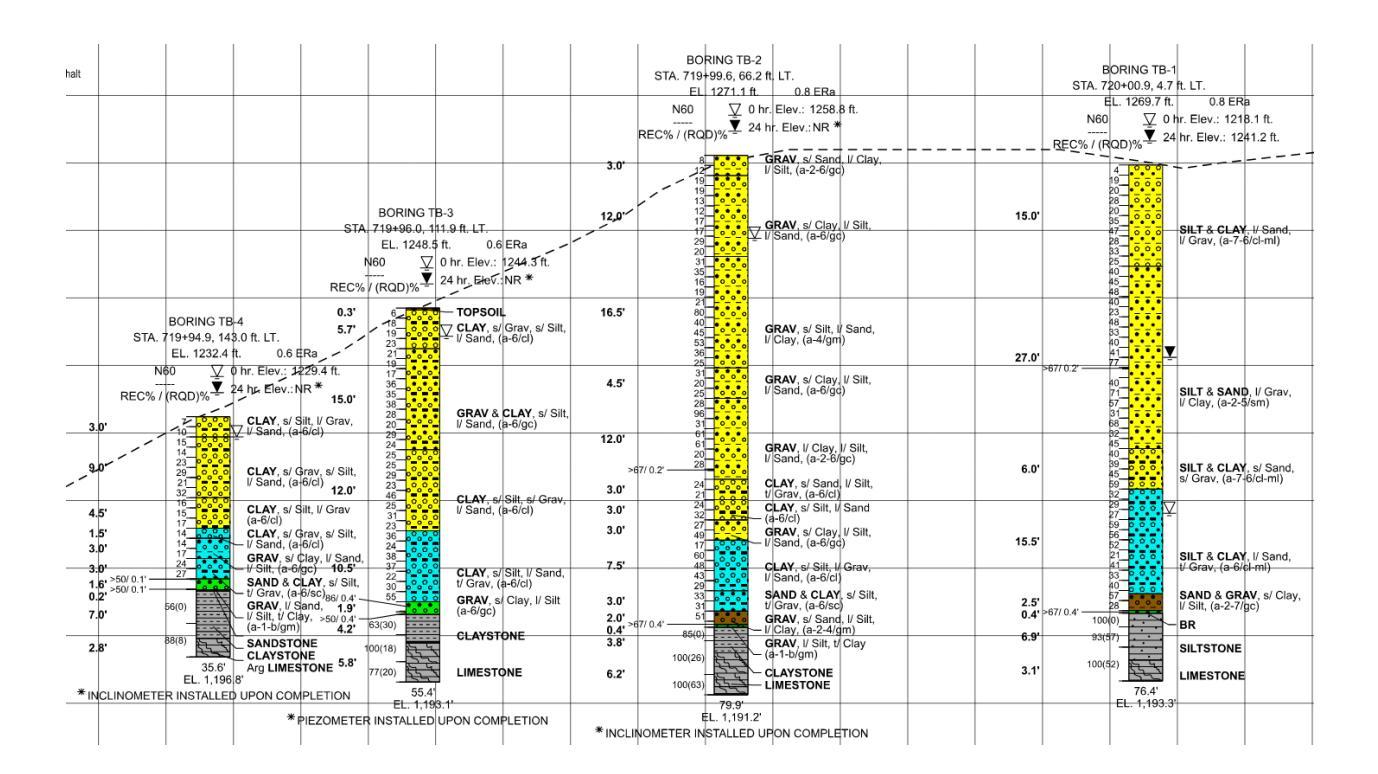
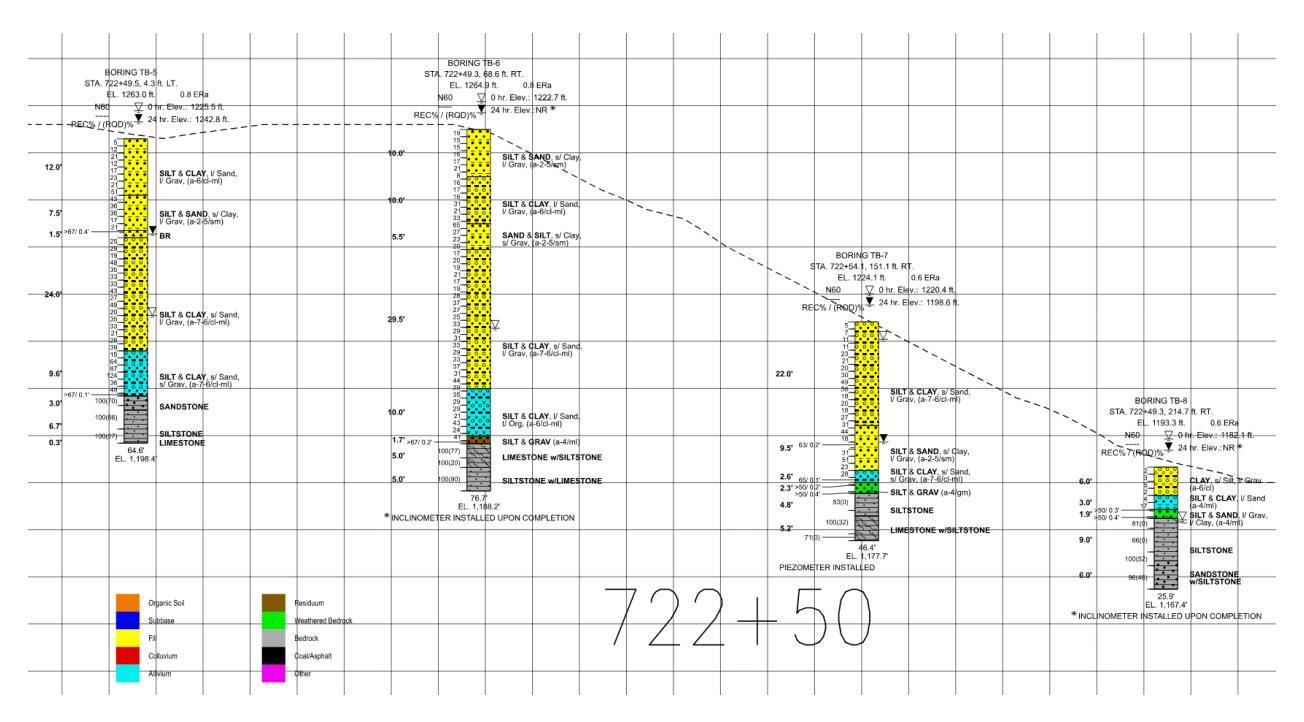
Figure IIIa.5 – Boring log summaries along Embankment #1 showing fill (yellow), alluvium (blue), weathered bedrock (green), residuum (brown), and bedrock (grey) -North side (Top) and South Side (Bottom)

Based on the SPT values from the borings, the north and south sides of the embankments are composed of different strength soils. On the northern side of the roadway, the middle of the embankment has a thick layer of medium to weak silt/clay soils on top of a layer of stronger silt/clay mixed with sand and gravel that sits on top of the sandstone, siltstone, and limestone layers. At the toe of the northern side embankment there is a layer of weak silt/clay soils directly on top of the siltstone and sandstone layers. On the southern side of the roadway, the middle of the embankment has a layer of medium to weak gravel/sand/clay soils on top of a layer of stronger clay mixed with silt and gravel that sits on top of the soft claystone, and limestone layers. There is also evidence in this area of the soil getting weak again before the rock layer, indicating that the alluvium and clay may not have been removed before the embankment was constructed. At the toe on the southern side of the embankment, near TB8, there is a layer of medium to weak clay/silt/gravel soils sitting on a layer of soft claystone and limestone.

In addition to the boring and piezometer data showing water inside the embankment, it is believed that the water may be attributed to a perched water table. During a series of onsite inspections, the University observed saturated soil in this embankment. On the southern side of the embankment it was observed that the soil between TB-7 and TB-8 was saturated and that the water appeared to be draining out of the toe of the slope creating pooling. All these tests and observations indicate that there may be perched water table in the embankment, which may cause stability issues as the formation is undermined.
