IDENTIFICATION OF FACTORS CONTROLLING THE DEVELOPMENT OF SUBSIDENCE IMPACTS FORECASTING METHODOLOGY TO THE I-70 ALIGNMENT OVER LONGWALL MINING OF THE TUNNEL RIDGE MINE, WASHINGTON COUNTY, PA

Task 2: Undermining Activities Report
Submitted 3 February 2020; Finalized on 4 January 2021

The University of Pittsburgh Master Agreement
Contract No. 4400018535

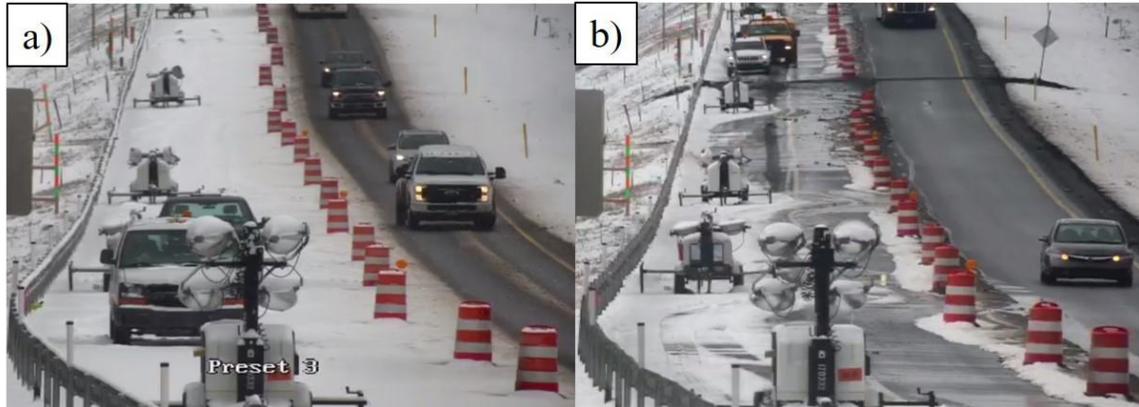
Several examples of subsidence impact recovery measures were observed. For example, on 2 February a compression bump formed on the east-bound highway alignment, cutting across both lanes of traffic, the shoulder, and both berms (Figure IIc.3). A detailed description of subsidence impacts is presented in Section 3. When this kind of impact occurred to the highway, PennDOT personnel:

Figure IIc.3 – a) photograph taken at 12:50 on 1 February 2019; b) photograph taken at 12:09 on 2 February 2019 showing a compression bump forming across the entire East Bound highway alignment.

- 1) monitored conditions,
- 2) alerted vehicles to slow-down with flagging, signs, and flares,
- 3) mobilized surface grinders, often stored close-by, and
- 4) applied asphalt patches.

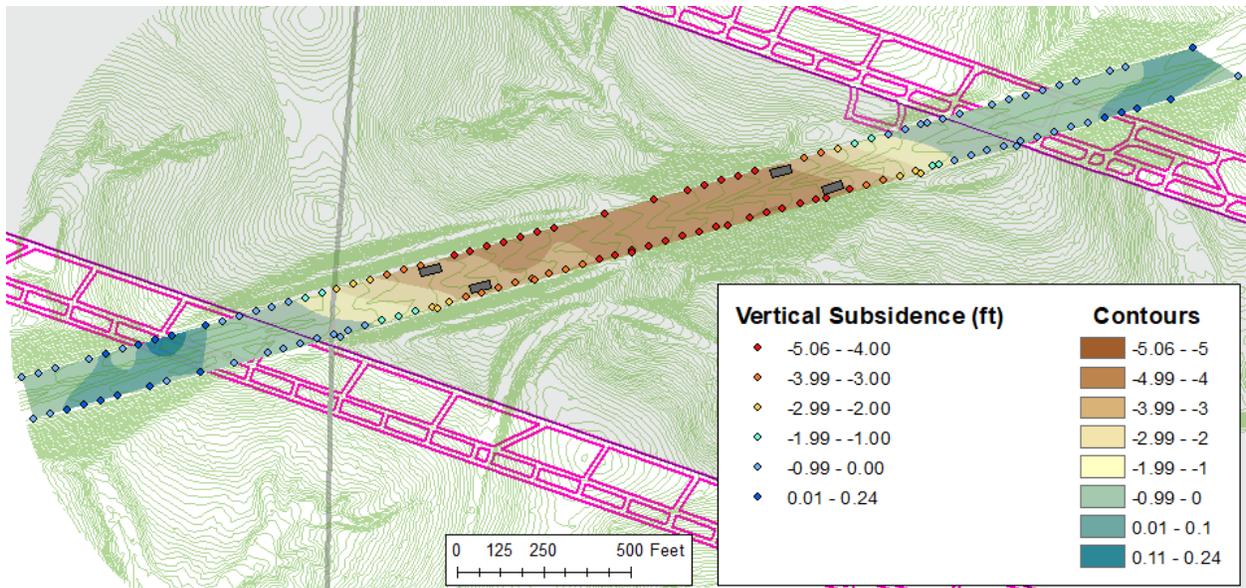
The points observed on the highway alignment extended the full width of the longwall panel. This means that the amount of maximum vertical subsidence observed varied along the roadway. The most vertical movement observed was just over 5-ft of subsidence. This maximum subsidence was observed on the road along the southern slope of Embankment #1. It is also noteworthy that this data shows as much as 0.25-ft of heave over the gate road entries of Panel 15. The impact of the final subsidence basin can be seen in Figure IIIa.2.

Figure IIIa.2 – Vertical drop of highway surface due to subsidence after longwall mining

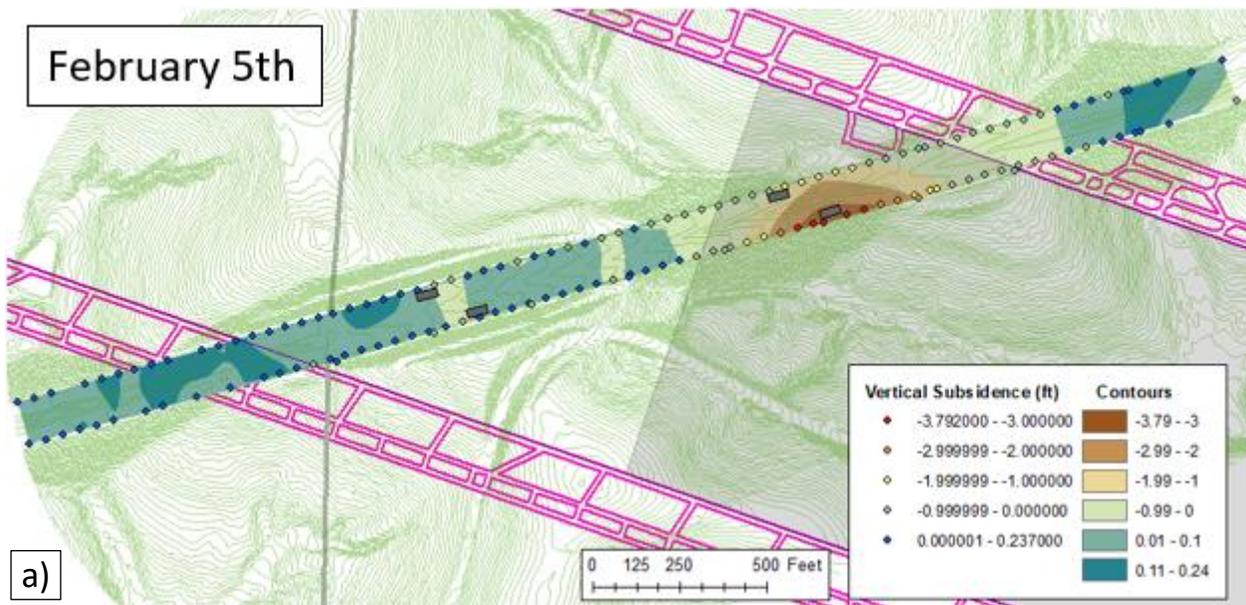
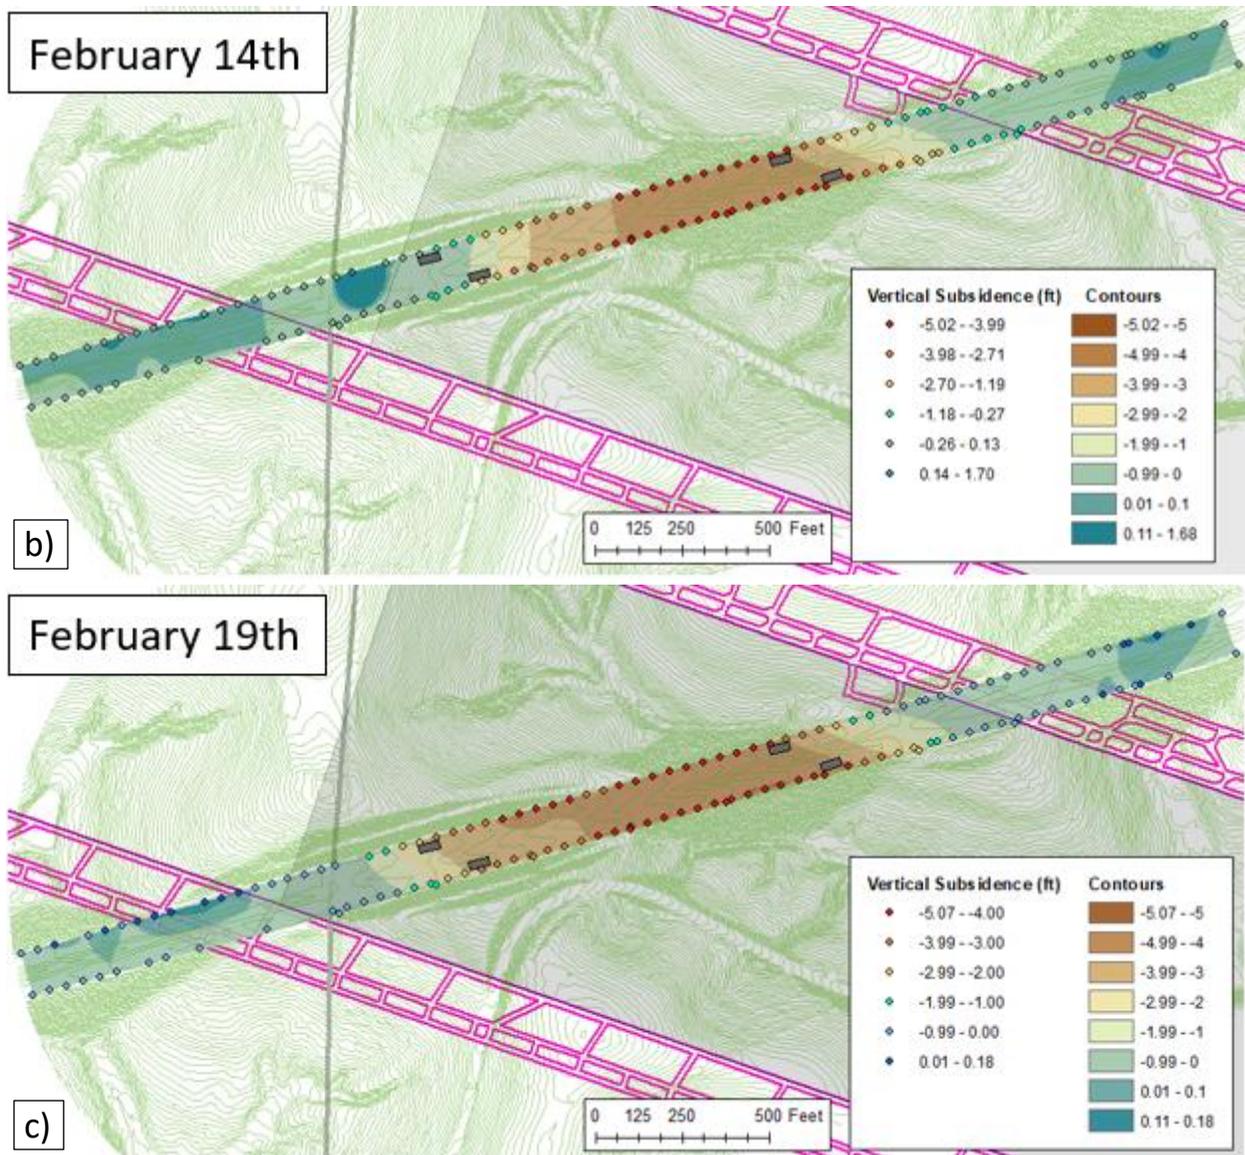
Figure IIIa.3 – Vertical subsidence as longwall face progresses

On 5 February, the longwall face was in the middle of the study area, below Embankment #1, as can be seen in Figure IIIa.3a. The data from the survey taken on this day shows the maximum vertical displacement occurring over the eastbound asphalt relief section, located about 315-ft behind the longwall face. At this point, the maximum displacement observed was just under 4-ft, meaning that it has not reached the maximum subsidence. Very little movement was observed beyond the longwall face.

Weather delays caused surveys to be suspended until 14 February, when the longwall face was just beyond the western asphalt relief section, as can be seen in Figure IIIa.3b. At this point in time a maximum subsidence of between 4-ft and 5-ft was observed above the entirety of the central embankment. As the central embankment is slightly east of the center of the panel, the

The next survey was taken on 19 February, when the longwall face was at the end of the highway section, as can be seen in Figure IIIa.3c. The eastern side of the subsidence basin looks the same as it did during the previous observational period. However, the longwall face progression caused the area of 4 to 5-ft of subsidence to extend further beyond the central embankment. The maximum subsidence observed on this day was about 5.07-ft of vertical displacement and occurred in the center of Embankment #1 on the eastbound lanes. On the western side of the highway, the slope is closer to that on the eastern side, making the subsidence basin symmetrical throughout the panel.

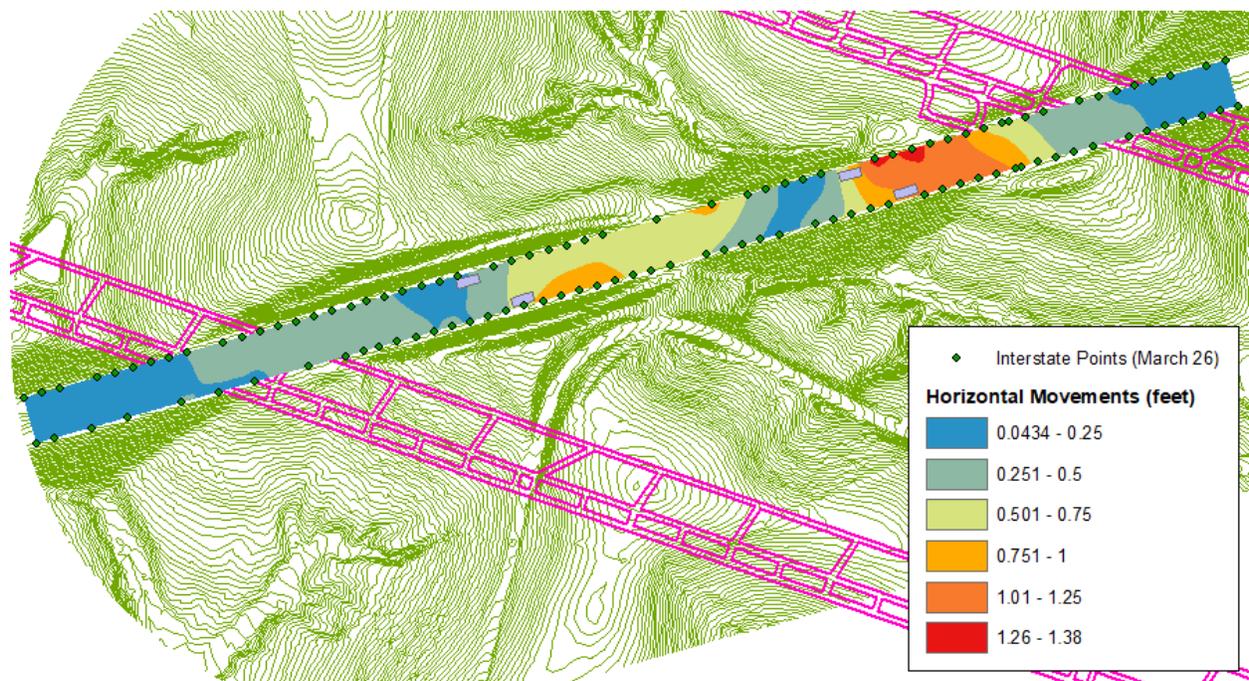
In the horizontal plane, survey points throughout the highway moved in both the north-south and east-west directions. Like in the vertical plane, the extent of horizontal movement of these points varied depending on their location in the longwall panel. The points on the eastern side of the highway experienced more horizontal movement than those on the western side. As can be seen in Figure IIIa.4 below, points were observed to move as much as 1.4-ft in the horizontal plane.

Figure IIIa.4 – Horizontal movement of highway surface due to subsidence after longwall mining

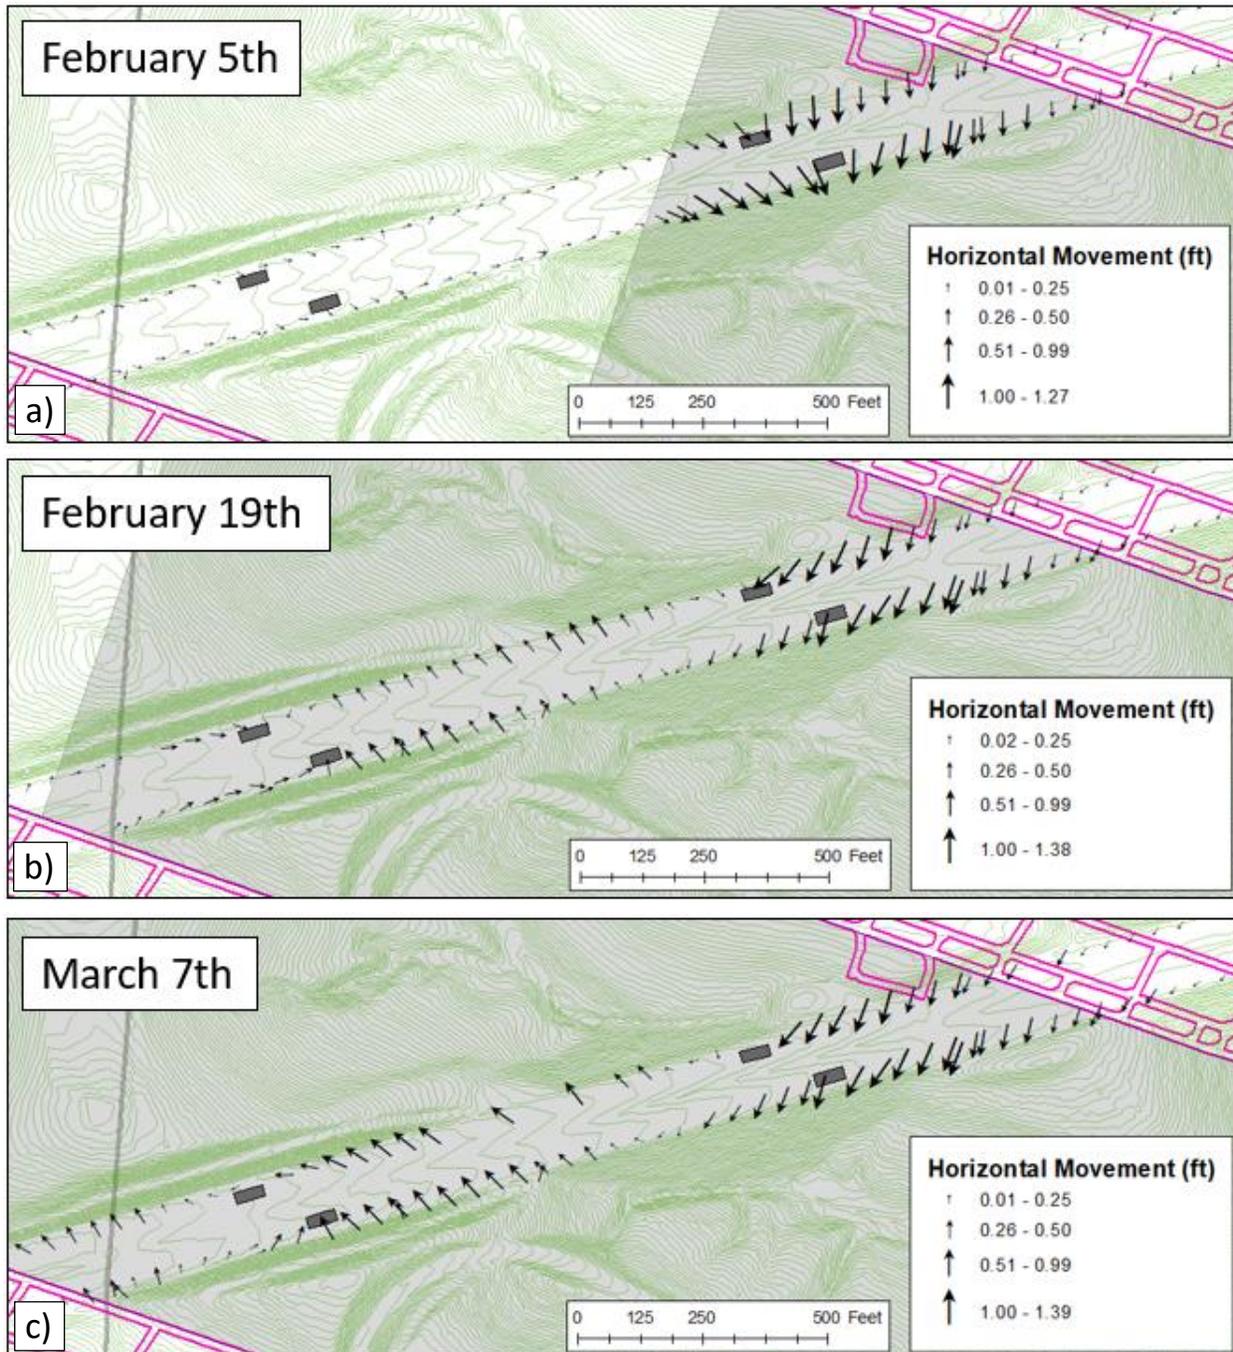
Figure IIIa.5 – Magnitude and direction of horizontal movement as longwall face progresses

On 5 February, the longwall face was in the middle of the study area, below Embankment #1, as can be seen in Figure IIIa.5a. The data from the survey taken on this day shows horizontal movements of up to 1.3-ft concentrating around the eastern asphalt relief sections just behind the longwall face and that the highway moved down the southern slope of the embankment. It also shows that there was little to no horizontal movement beyond the longwall face.

The next survey was taken on 19 February, when the longwall face was at the end of the highway section, as can be seen in Figure IIIa.5b. The movement observed at this moment in time show that there is significantly more movement on the eastern side of the highway than on the western side. Large movements up to 1.4-ft were observed pointing towards the center of the longwall basin leading up to the eastern asphalt relief sections. The asphalt relief sections dissipated the stress, which resulted in almost no movement being observed over the center embankment. On the western side of the embankment, the magnitude of horizontal movements was lower, primarily ranging between 0.5 and 1.0-ft, and movement tended to move towards the longwall face.

Another survey was performed on 7 March, when the longwall face was approximately 1,200-ft beyond the highway. The movement observed on the eastern side of the highway matches that which was observed on 19 February, with large movement pointing towards the center of the longwall basin. Once again, these movements dissipate at the first asphalt relief sections. However, with the longwall face so far away, much more movement is observed on the western side of the highway. In the section of highway adjacent to the cut slope leading up to the second set of asphalt relief sections, movements of 0.5 to 1.0-ft were observed pointing towards the longwall face. Once again, the asphalt relief sections dissipate the stress causing the western most side of the highway to experience little horizontal movement. This movement can be seen in Figure IIIa.5c.

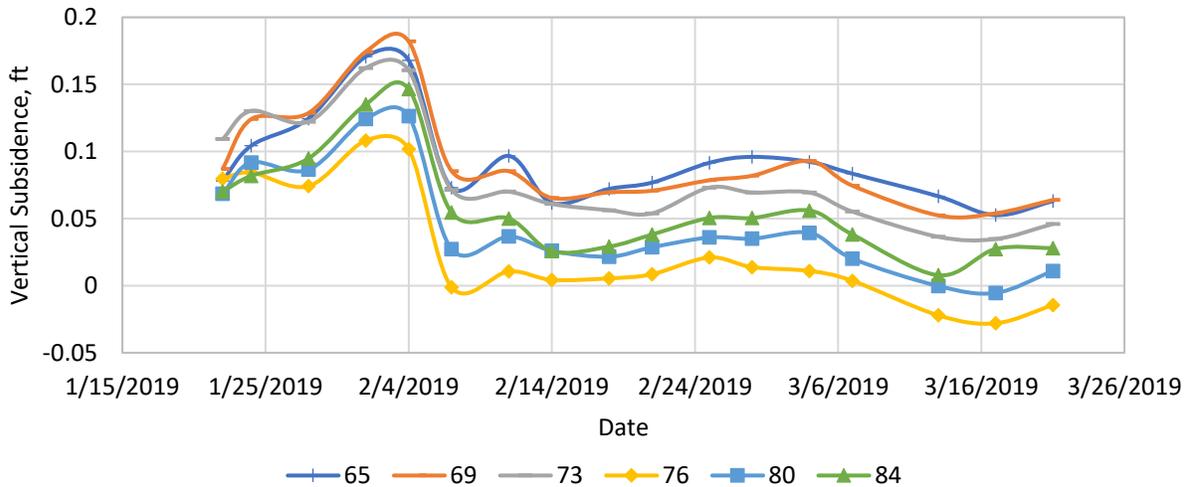
As Embankment #2 is located over the gate road entries, it experienced minimal amounts of vertical movement. The vertical movement in this area ranged from -0.06 to 0.22-ft. The majority of vertical movement in this area was heave rather than subsidence. Figure IIIb.3 below shows the vertical movement from a selection of points. The vertical movement from the remainder of points that have been analyzed can be seen in Appendix I. When this data was compared with the longwall face positions, it can be determined that the spike in vertical movement occurred when the longwall face was about 1000-ft passed the points on Embankment #2.

Figure IIIb.3 – Vertical subsidence of select points on Embankment #2 (Figure IIIb.2) within survey group 6S

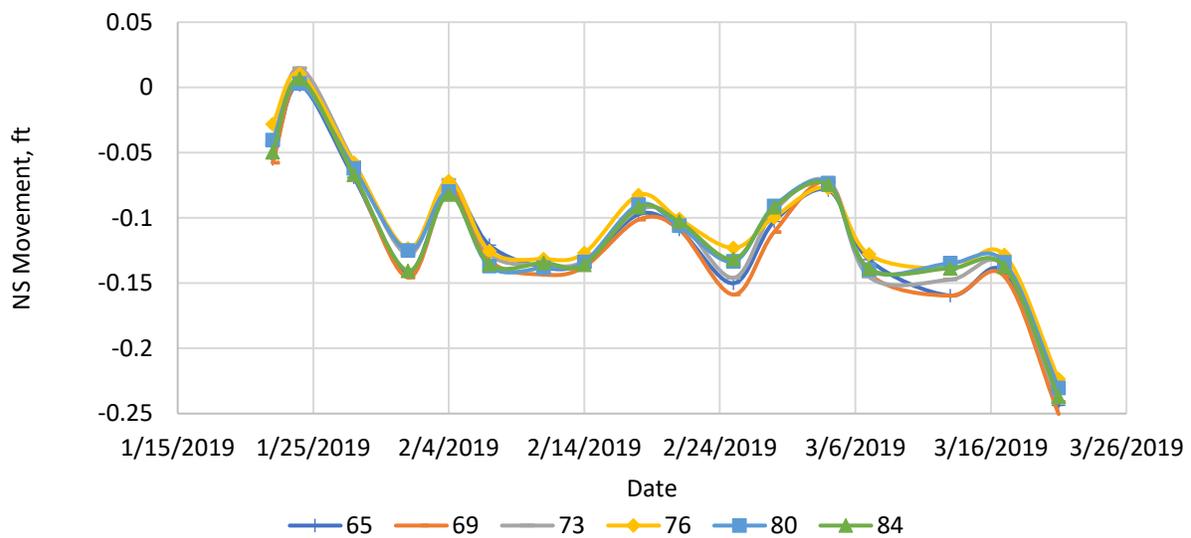
In the horizontal plane, survey points on Embankment #2 moved in both the north-south and east-west directions. In the east-west direction, the movement in this area ranged from -0.33 to 0.19-ft; in the north-south direction, the movement in this area ranged from -0.53 to 0.02-ft. Most of these points moved in the south and west directions, meaning that the points along these embankments moved toward the center of the basin. However, the movement of these points fluctuated in both the north-south and east-west directions. Figures IIIb.4 and IIIb.5 below show the horizontal movement from a selection of points on Embankment #2. The horizontal movement from the remainder of points that have been analyzed can be seen in Appendix I.

Figure IIIb.4 – Horizontal movement in the north-south direction of select points on Embankment #2 survey group 6S

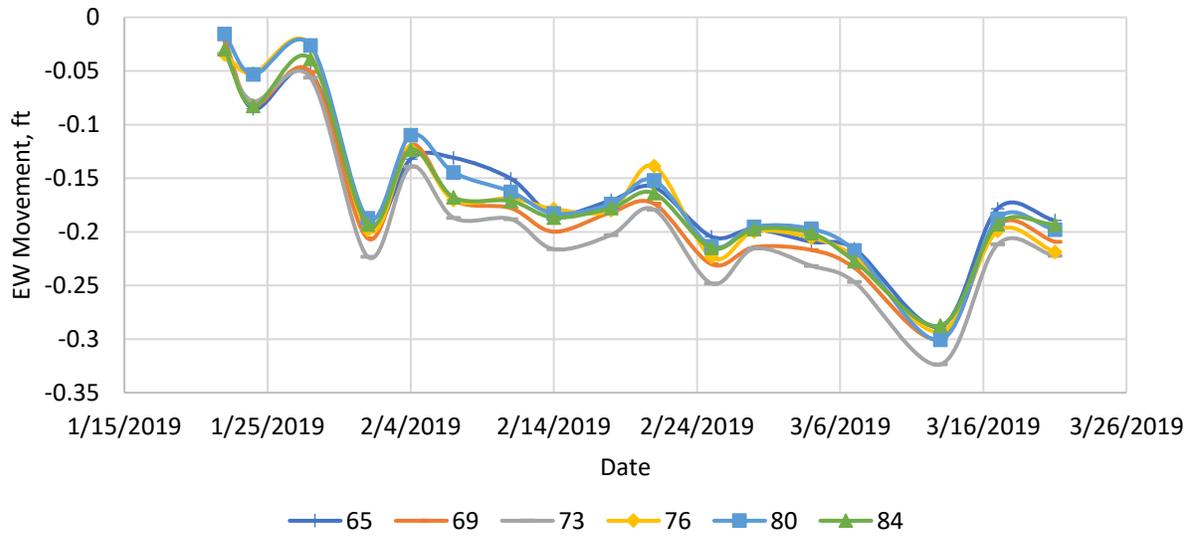
Figure IIIb.5 – Horizontal movement in the east-west direction of select points on Embankment #2 survey group 6S

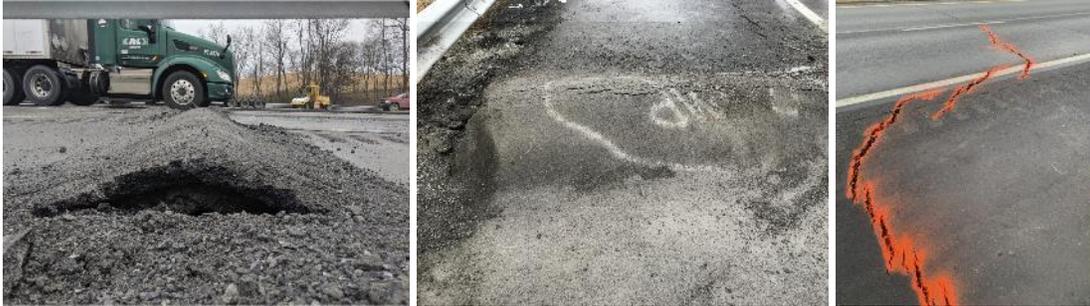
Some of the most notable features observed during this site visit were the three compression bumps and a large transverse crack. The compression bump and adjacent blowup on the westbound lane formed on 5 February, approximately 150-ft behind the longwall face. The two compression bumps on the eastbound lane formed on 4 February, between 175-ft and 225-ft behind the longwall face. Two of the three compression bumps formed in the asphalt relief sections. The large transverse crack formed about 60-ft behind the longwall face and opened to a width of more than 2.5-in wide. Images of these failures can be seen in Figure IIIc.3 below.

Figure IIIc.3 – Field images of observed features from left to right; eastbound blowup 1-ft tall, westbound blowups, eastbound large transverse crack 2.5-in wide

Perhaps the most interesting observed failure is the occurrence of the large transverse crack that formed on the eastbound lanes that then transitioned into a blowup. The transverse crack that occurred in this location was 2.5-in wide, making it one of the largest that formed on the pavement surface. The section of this fracture in the shoulder transitioned into a 7-in tall blow-up, while the other sections of the initial fracture remained open as a crack. This failure occurred halfway between two expansion joints that were spaced 40-ft apart; generally, the expansion joints were placed 20-ft apart, indicating that there may be an expansion joint in the concrete that was not cut into the asphalt at the location the failure occurred, and the lack there of may have contributed to the damage that occurred there.

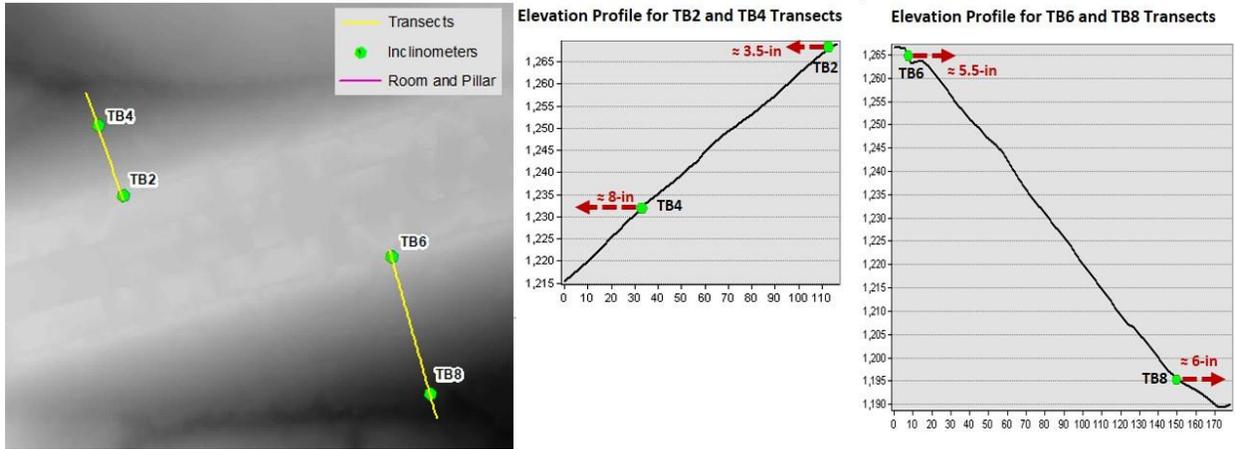
Figure III.d.3 – Depiction of the outward movements 2-ft below the surface that the inclinometer borehole casings experienced on Embankment #1. The lines represent the elevation of the transect for each inclinometer grouping

Several conclusions can be determined from the inclinometer data. First, noticeable shifts were not recorded until either the day of undermining or on the following day. They also did not begin to settle until the longwall face was approximately 600 to 850-ft away passed the instrument. Second, movements were highest in the A+ direction for each inclinometer, which means the slopes deformed outwards from the interstate. Movements on the B-axis were less uniform than movements on the A-axis. B-axis movements tended to move opposite the direction of mining before eventually reversing directions and following the mining direction as the subsidence basin settled. Third and final, cumulative movement was often heavily influenced by high incremental movement in the bottom portions of the inclinometer casings. Each interval with these high levels of movement was associated with an interface among two sediments. Figure III.d.3 depicts the trends of outward movement near the surface, while Figure III.d.4 represent movements both near the surface at towards the bottom of the casing. It is important to note that Figure III.d.4 depicts the inclinometers as if they are projected on the same vertical plane, which is not true. True representations of their locations are depicted in Figure III.d.3

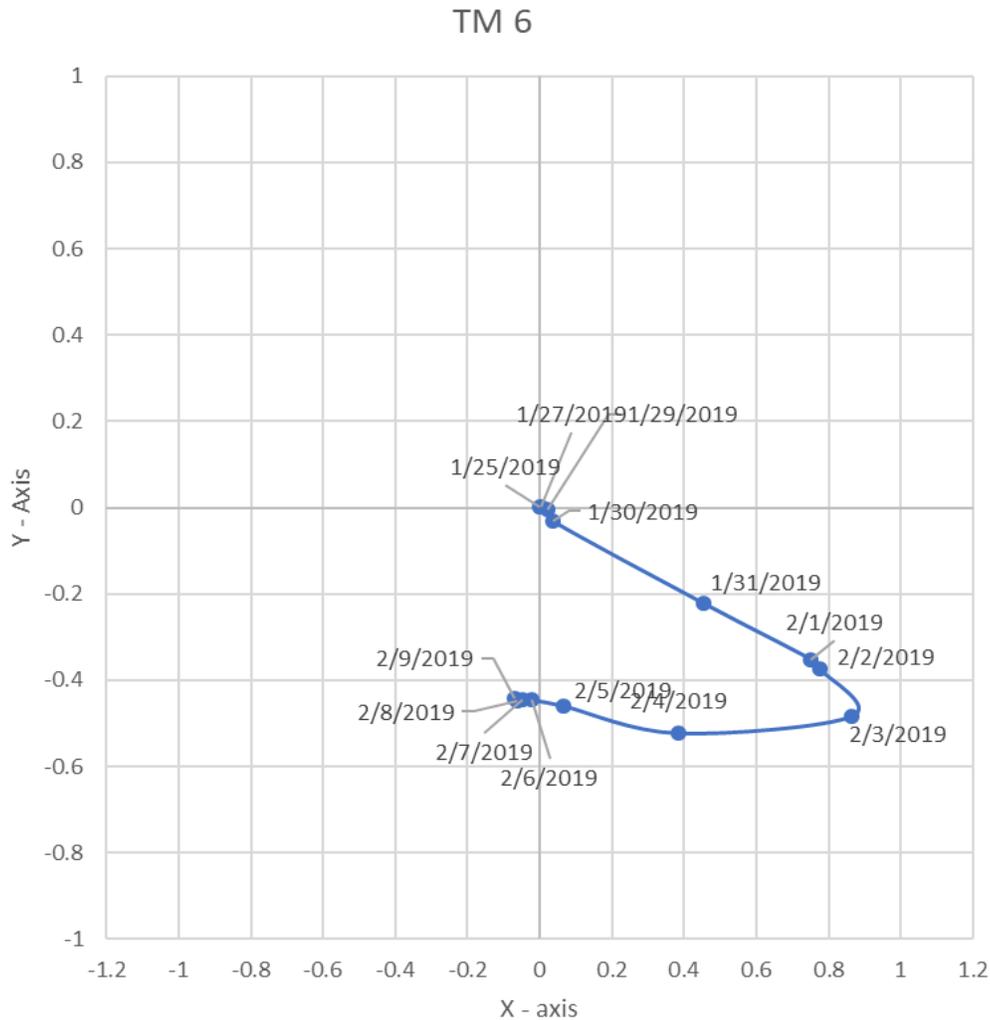
Figure IIIe.3 – Tilt measurements of TM-6 as undermining occurred

The plot in Figure IIIe.3 depicts that the tiltmeter began to tilt in the X+ and Y- directions as the longwall face approached TM-6. In other words, as the longwall face approached the instrument, it began to tilt towards the position of the longwall face and into the center of the basin. It continued tilting in this direction until 3 February, or when the longwall face was approximately 180-ft passed the tiltmeter. At this point, the tilt reversed its direction and began to tilt in the direction of mining. The tilt continued in this direction until it began to settle on 7 February. At

that point, the longwall face was approximately 550-ft passed TM-6. It settled with very little change in tilt on the X-axis, and more dramatic change on the Y- direction. This indicates a tilt towards the center of the basin for TM-6.

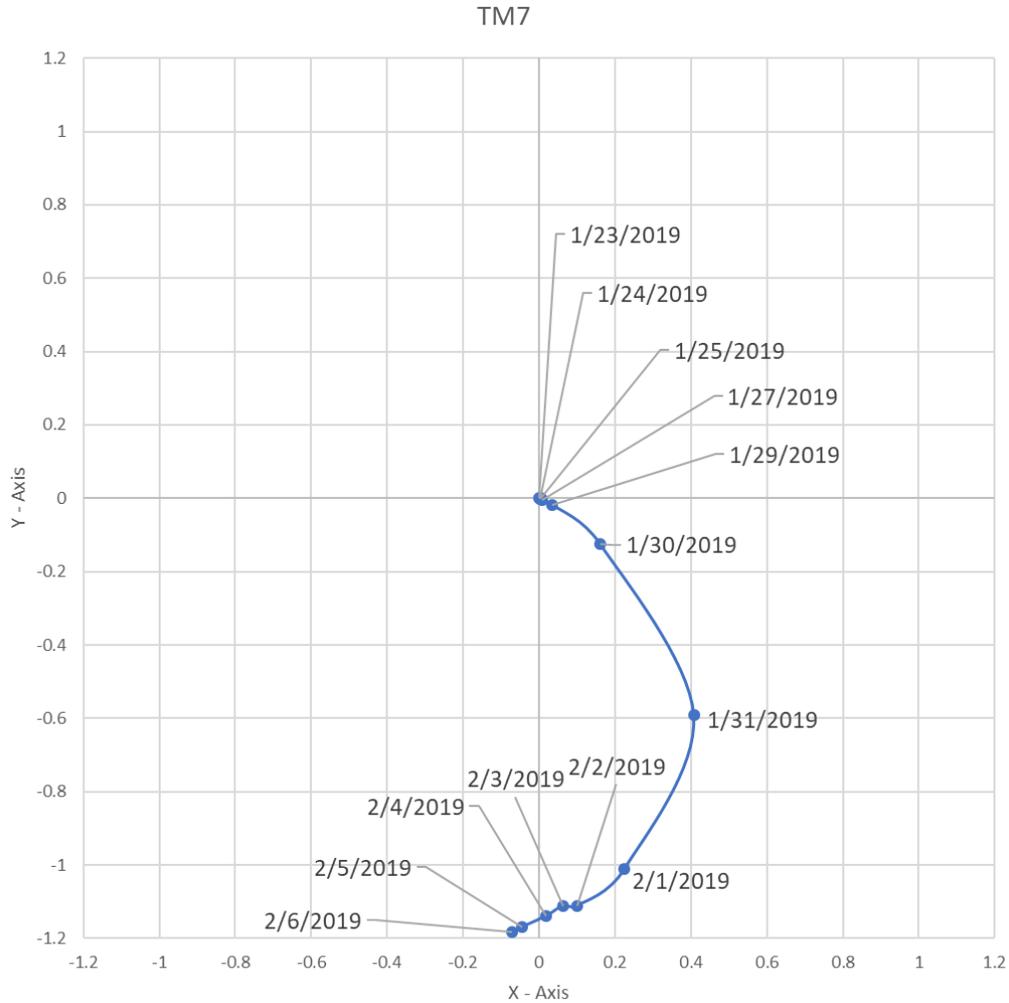
Figure IIIe.4 – Tilt measurements of TM-7 as undermining occurred

Figure IIIe.4 plots the movement of TM-7. Although the movement of TM-7 appears to differ greatly from the movement that TM-6 experienced, it has some similarities. Like TM-6, TM-7 tilts in the X+ and Y- directions, then reversed direction, tilting towards the longwall face.

One difference between the two tiltmeters, the permanent tilt change, is related to the instrument position within the subsidence basin. TM-6 is within the subsidence basin where the maximum subsidence will be achieved. In this region, minimal permanent surface slope changes are expected. Conversely, TM-7 is within the portion of the subsidence basin where permanent surface slope changes are expected. As a result, the permanent tilt change associated with the development of the subsidence basin in the area of TM-6 is approximately 50 % less than TM-7.

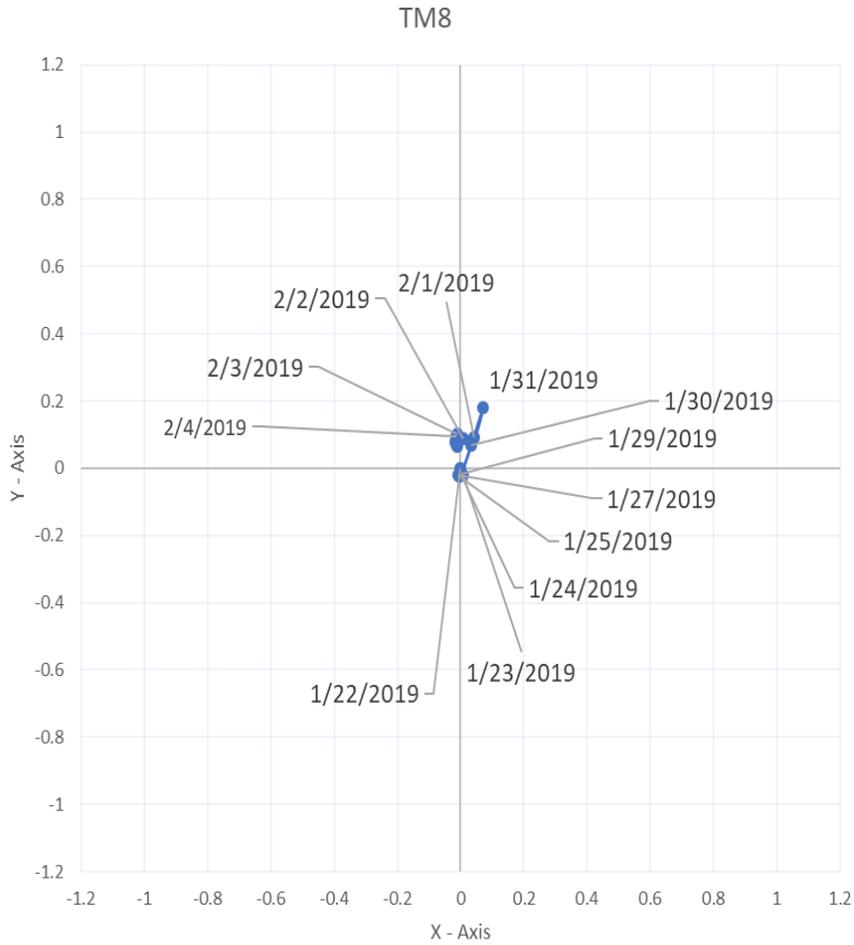
Figure IIIe.5 – Tilt measurements of TM-8 as undermining occurred

Figure IIIe.5 plots the movement of TM-8. The borehole for TM-8 is located close to the edge of the panel and therefore experienced far less dramatic tilt changes when undermining took place. It was not until 29 January, when the longwall face was approximately 300-ft passed the instrument that the tiltmeter began to move in the Y+ direction, and slightly in the X+ direction. In other words, it began to point away from the center of the basin and opposite the direction of mining. On 31 January when the face was approximately 430-ft passed the instrument, it reached its maximum in both the X+ and Y+ direction, and after this date it reversed direction. Like TM-6 and TM-7, TM-8 settled close to the same value on the X-axis and around 0.1-degrees in the Y+ direction. It settled around 3 February when the longwall face was approximately 660-ft away.

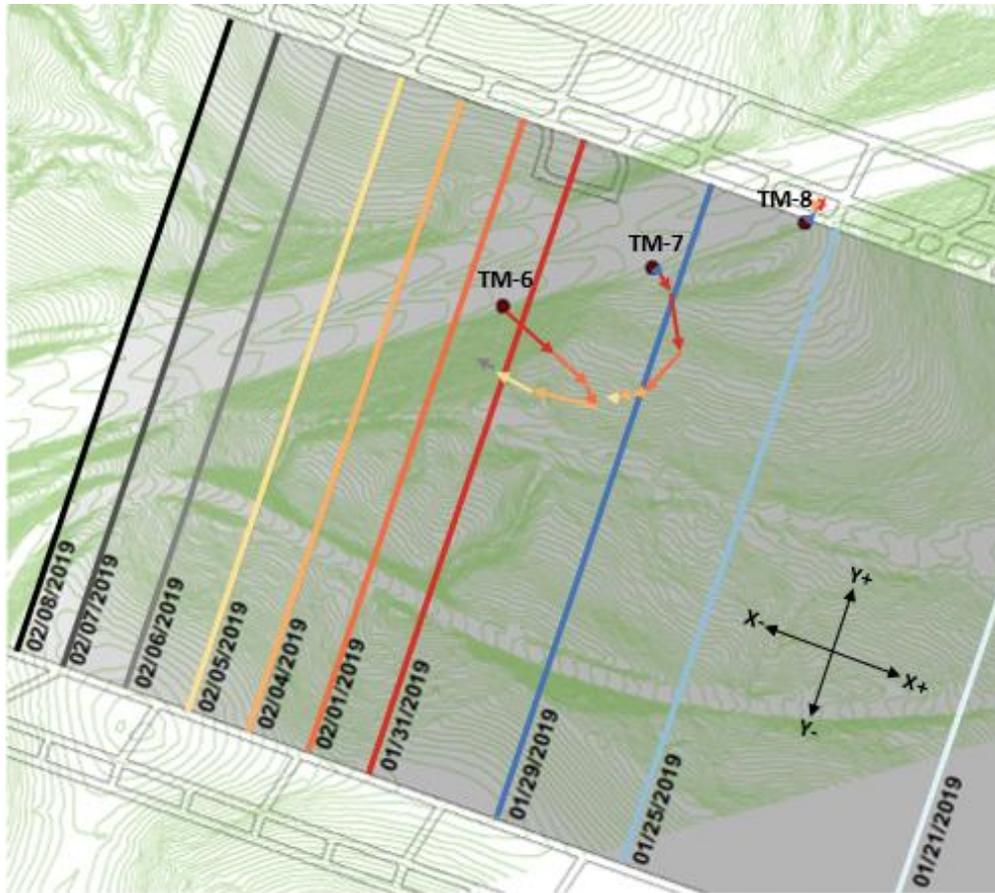
Figure IIIe.6 – TM-6, TM-7, and TM-8 vector representations of instrument tilt with respect to longwall face position

Figure IIIe.6 is depicting a map that displays the movement of the tiltmeters seen in the previous three scatterplots. The map contains vectors of the movements displayed over the tiltmeters, as well as the face positions on the dates when this section was undermined. The vectors and face positions were colorized so that it is possible to analyze when the movements were occurring and where the face position started on that day.

Aside from TM-8, which experienced a very small degree of tilt away from the basin, the general trend seen was tilt in the direction of the center of the basin. The severity of movement varied based on where in the basin the tiltmeter is placed. TM-7 experienced the highest degree of tilt in the Y- direction. This could be expected as it is located very close to the inflection line (Figure IIIe.2), which is where a higher degree of slope was expected. Finally, TM-6 experienced the highest degree of tilt on the X-axis, but ultimately settled with a smaller change in the Y- direction when compared to TM-7.

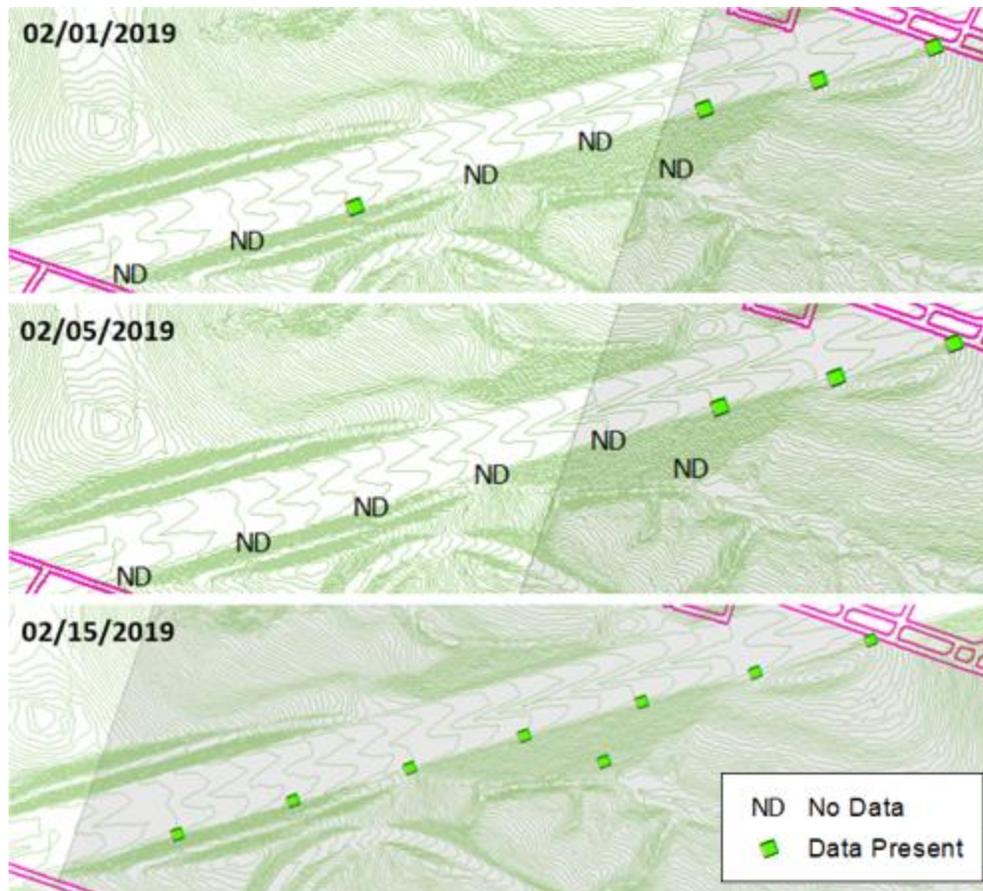
Figure IIIe.7 – Locations of tiltmeters with the timetable of when data was or was not lost

As has been noted, TMs 1-5 lost data during the times in which they were undermined. This means that TM-9 also lost data, as that is the same instrument that was used in TM-1. As a result, a complete analysis cannot be performed on their movements during undermining. However, it is still possible to observe the tilt positions of these instruments before and after undermining, as the data was still present at these times. Figure IIIe.7 displays the locations of each tiltmeter that lost data as well as the longwall's face position when the data was overridden.

As seen above, the tiltmeters first experienced this loss of data on 1 February. On this date, the longwall face had just progressed beyond TM-9. Data was not present again until 15 February, at which point the longwall face was already approximately 230-ft past TM-2. As stated, it is still possible to analyze the tilt positions from before and after undermining for tiltmeters 1-5. Just like for TMs 6-8, their data was plotted and examined by date.

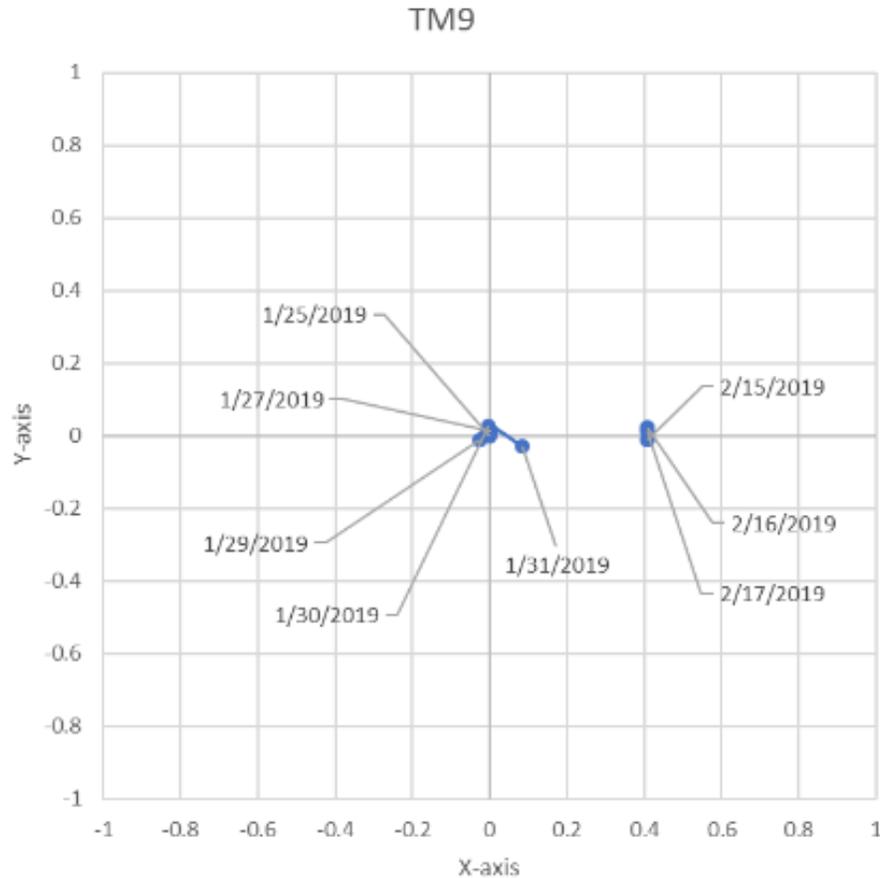
Figure IIIe.8 – Tilt measurements of TM-9 before and after undermining

TM-9 readings were present until the day it was undermined. On this day, TM-9 began to tilt into the basin in the X+ direction. After this point, it lost its readings until 15 February. Once the readings were present again, it indicated movement had settled further in the X+ direction. Very little change in tilt was present on the Y-axis. It is unclear what movements occurred in the times that data was not present, but if it reacted similarly to the movements seen in TM-6 and TM-7, then it is possible that it moved even further in the X+ direction before reversing closer to its origin. The final tilt position indicated the slopes tilted outwards and down the slope, which would align with the expectation that the embankment slopes would shift away from the interstate. Figure IIIe.8 displays the plot for TM-9.

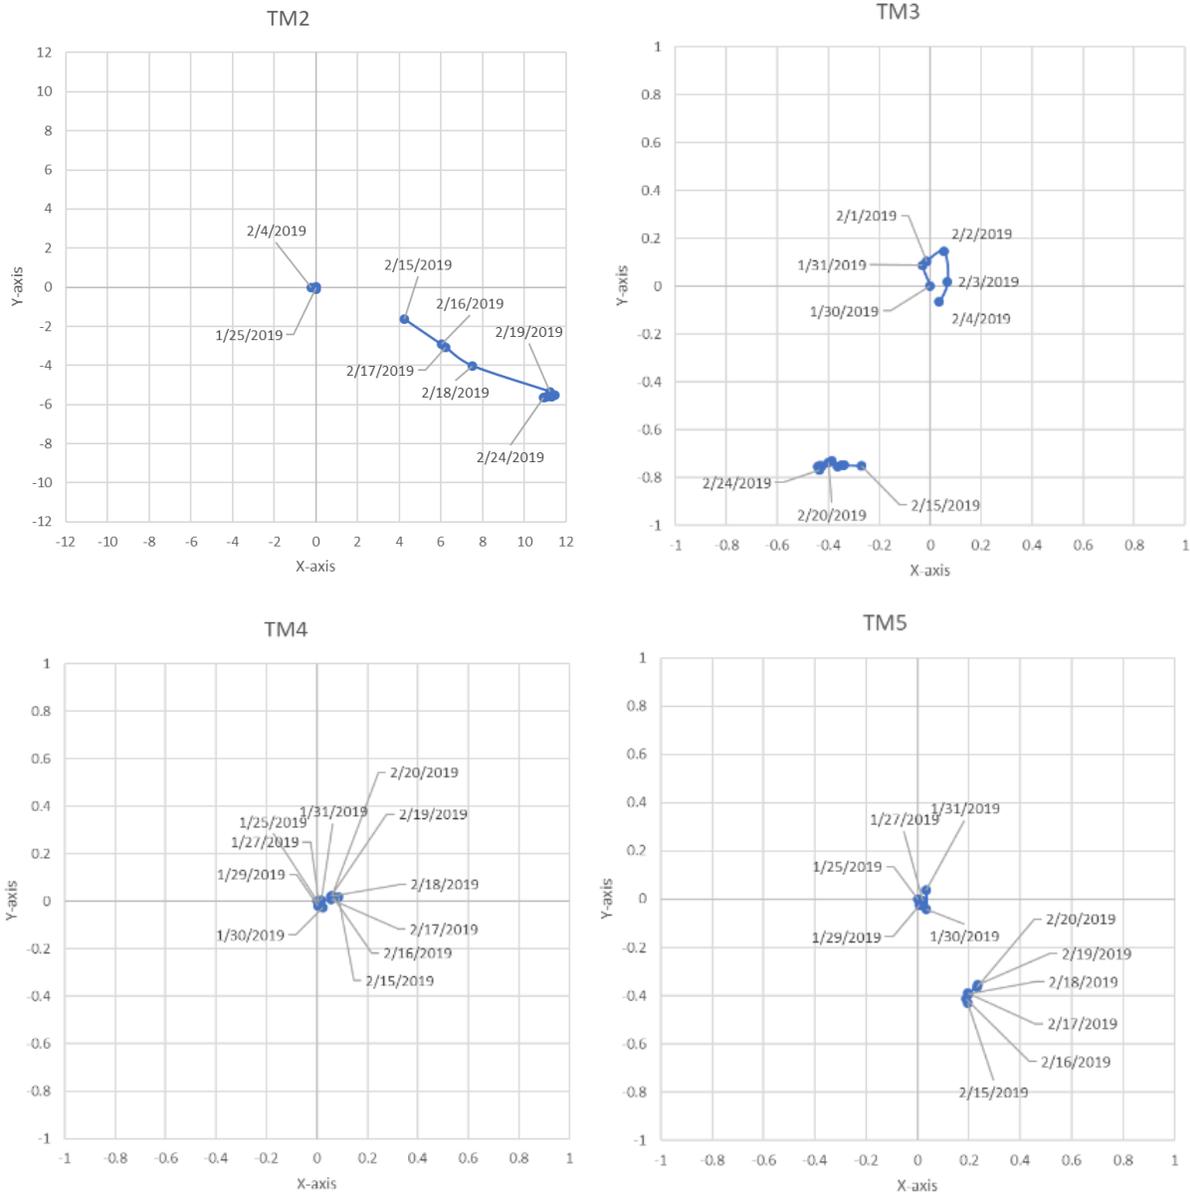
Figure IIIe.9 – Tilt measurements of TM-2, TM-3, TM-4, and TM-5 before and after undermining

Tiltmeters 2-5 each lost data during the entirety of their undermining, so only before and after tilt positions can be compared for these instruments. TM-5 was located near the center of the basin and on top of Embankment #1. No movements were present before the override. Once the readings were present again, the plot indicated movement toward the center of the basin, with predominant tilt in the Y- direction and less severe tilt in the X+ direction. The movements for TMs 2-5 are all displayed in Figure IIIe.9.

TM-4 was located very close to the center of the basin in between Embankment #1 and the cut slopes of the bedrock. The readings for TM-4 indicated little differences in tilt before and after undermining. Assuming there was movement in this location, this would indicate the tilt settled close to its zero-point reading from before undermining.

TM-3 was located closer to the center of the bedrock towards the western portion of the study area. Small levels of movements were detected for TM-3 before data was lost. At this point, the longwall face was still approximately 600 to 700-ft away from its location. When the readings were present again, the tilt indicated it had moved in the Y- and X- directions. This would certainly not be expected as movement in the Y- direction at this location indicated the surface was tilting further away from the basin.

approximately 10 degrees from its zero point. The University determined this was due to a miscalibration to the instruments. This determination is based on the fact that the majority of differences were within approximately one degree for the other tiltmeters.

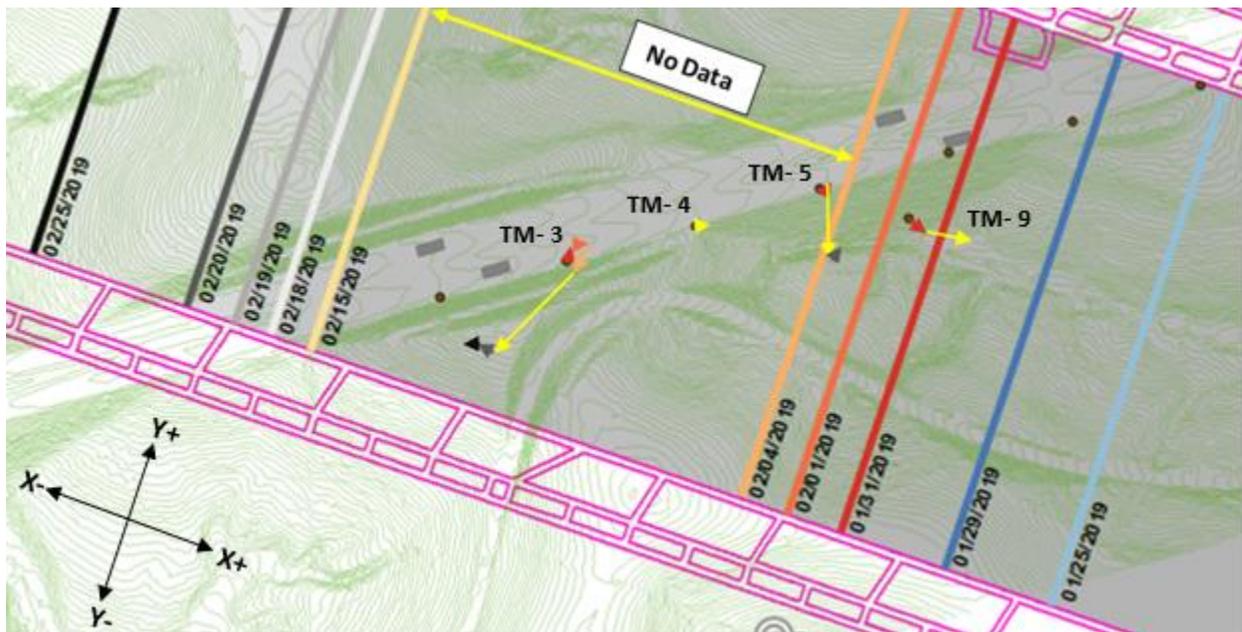
Figure IIIe.10 – TB-2, TB-3, TB-4, TB-5, and TB-9 vector representations of instrument tilt with respect to longwall face position

Vector representations for TB-2, TB-3, TB-4, TB-5, and TB-9 are depicted on a map of the study area in Figure IIIe.10. The vectors and the longwall face positions were again colorized so that movements could be analyzed in relation to where the face position was on that day. The yellow lines in Figure IIIe.10 represent the direction that tilt moved before and after data was lost. TM-2's readings are not displayed as they are believed to be miscalibrations.

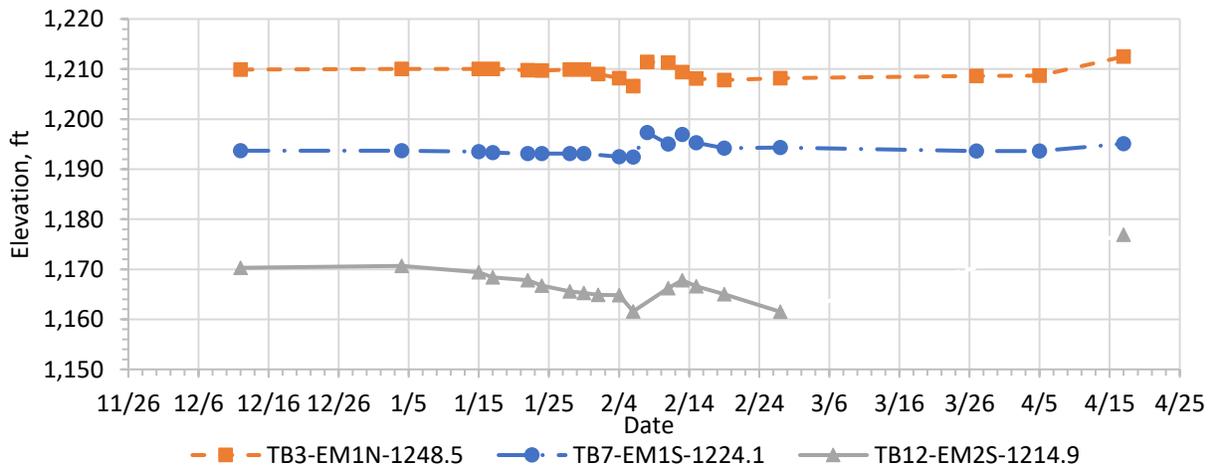
Figure IIIf.2 – Variations of the water levels due to longwall mining from 12 December 2018 to 17 April 2019

This figure demonstrates that the water level in all three boreholes drop below the typical level and then spike to greater than the normal water level before returning to the original water elevation. This movement of the water table is directly related to the passage of the longwall face and the disruption of the underground strata. An in-depth analysis of the piezometer data in
