IDENTIFICATION OF FACTORS CONTROLLING THE DEVELOPMENT OF SUBSIDENCE IMPACTS FORECASTING METHODOLOGY TO THE I-70 ALIGNMENT OVER LONGWALL MINING OF THE TUNNEL RIDGE MINE, WASHINGTON COUNTY, PA

Task 2: Undermining Activities Report
Submitted 3 February 2020; Finalized on 4 January 2021

The University of Pittsburgh Master Agreement
Contract No. 4400018535

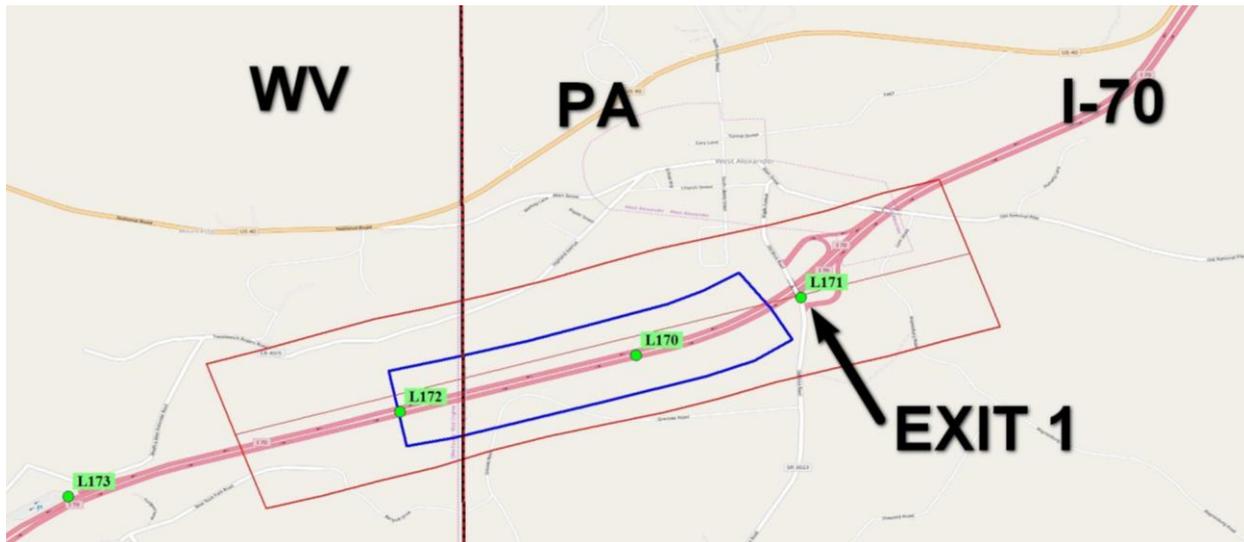
Figure IIIg.1 – Locations of LiDAR control points used for the surveys

The MCS included stations located far beyond the outer extents of the longwall panel. It was set up this way so that it would contain points that were not expected to experience any subsidence impacts. After the undermining took place beneath I-70, T3 Global Strategies informed the University that several far-field stations experienced unexpected movements. The points that were the biggest surprise were points L171 and L173. Station L171 was located approximately 1300-ft from the eastern edge of the panel on the West Alexander bridge overpass, while L173 was located approximately 2,400-ft from the western edge on a concrete sewer structure near the West Virginia welcome center. The locations of these points relative to the study area can be seen in Figure IIIg.1. T3 Global maintained that these points converged approximately 2-in.

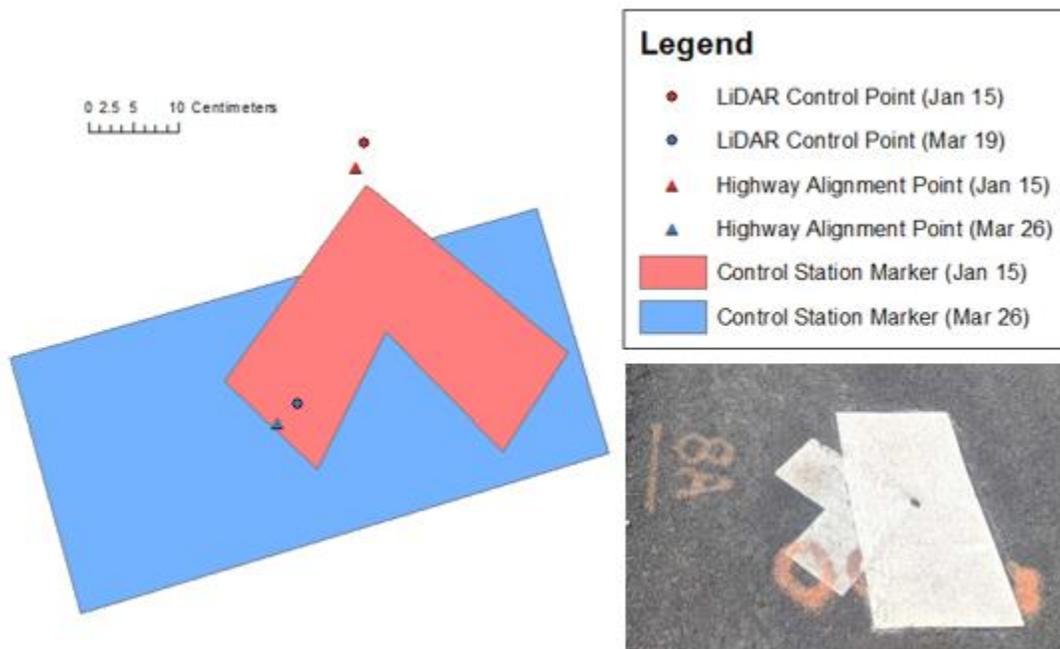
Figure IIIg.4 – Locations of station “EB17+50BK”/”T10A” before and after subsidence impacts

There were four circumstances where the same station was used in both the Mapping Control Survey and the Highway Alignment Surveys. One of these stations was labeled “EB17+50BK” in the Highway Alignment Survey and “T10A” in the LiDAR control survey. The University assumed the point in both datasets were of the same station as they were only 1.1-in (2.9-cm) from each other, which is above the combined range of accuracy, but still very close. Since the same point was used in both surveys, the University was able to compare the location of the point as subsidence impacted that station.

Figure IIIg.4 depicts graphic representations of this point through time in both datasets. It also shows an image taken showing the pin and markers for the MCS. The pins and markers are color coated according to the date of the surveys; red indicates the pre-mining survey (15 January 2019) and blue indicates the post-mining survey (19/26 March 2019). The circles represent the LiDAR control points, the triangles represent the highway alignment points, and the polygons represent the station markers observed in the LiDAR point cloud. The ability to see these markers in the point clouds allowed for the digitization of the markers and for them to be compared to their control points. As the image shows, the pin is located in the center of the box marker and at the end of the arrow. In both surveys, the control points are located very close to their actual positions.

Of the four stations that were surveyed on 15 January, the average point separation was 0.65-in (1.6-cm), which is the exact number for the combined accuracy of the surveys. For the post-mining surveys, the average point separation was 1.43-in (3.6-cm). This number is considerably higher than the combined accuracy of the surveys, however, since these surveys were taken a week apart from each other, the increase in separation could be due to continued movement on the surface. Based on these results, the University can conclude that the stated accuracy of 1-cm for the LiDAR surveys was achieved and that it is now comfortable carrying on with the appropriate analysis of the LiDAR data.

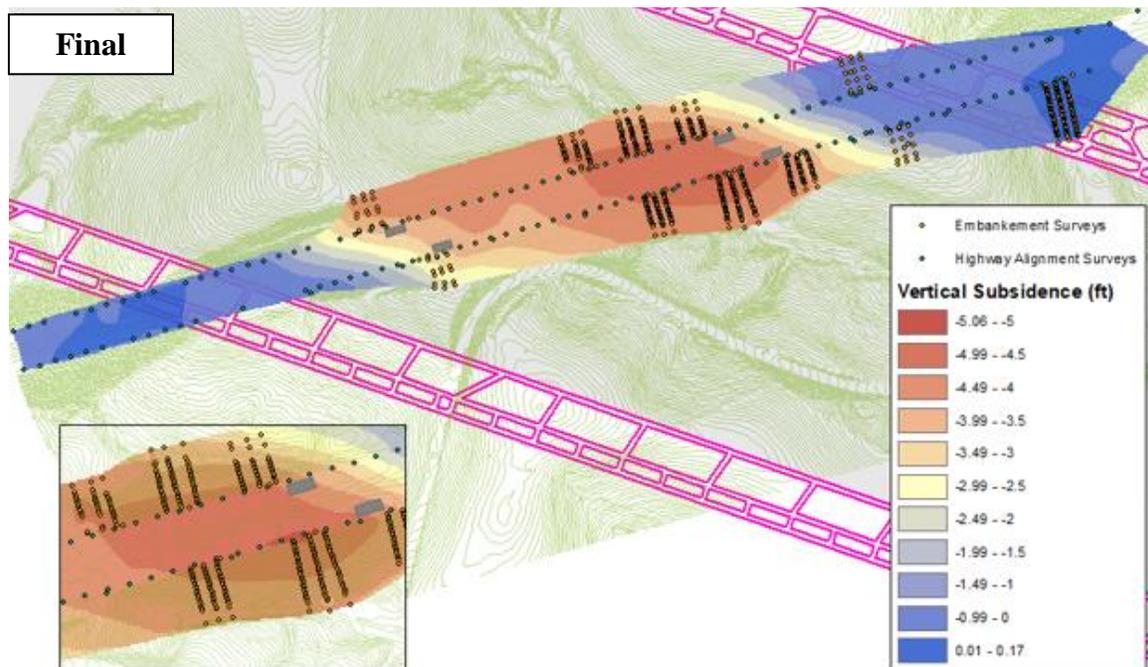
Figure IVa.1 – Final vertical movement of I-70 caused by Panel 15 subsidence

As can be seen in this figure, the majority of subsidence occurred over Embankment #1 on the highway surface.

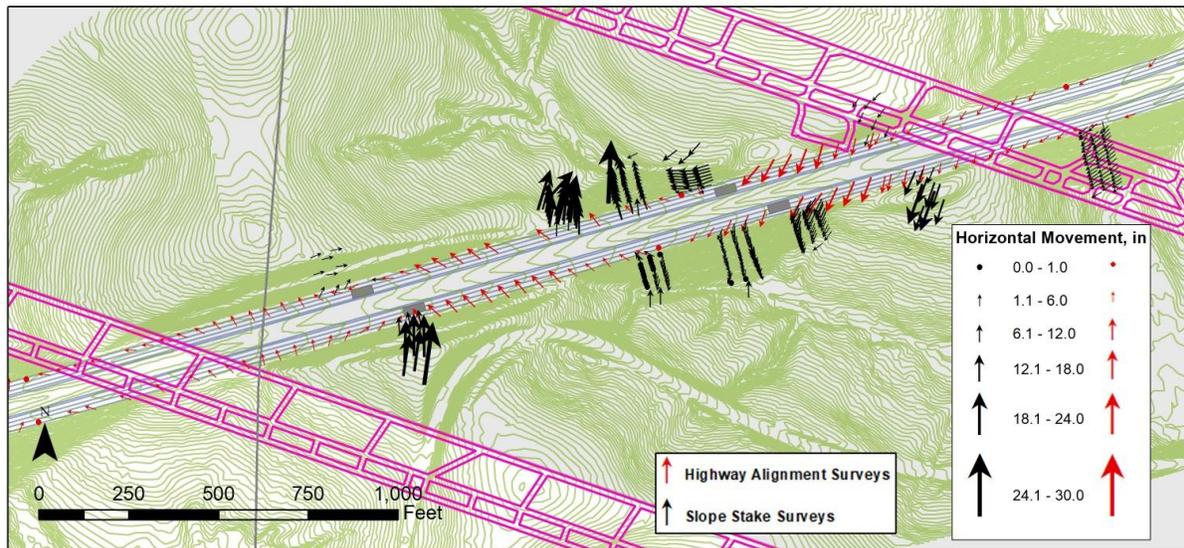
Figure IVa.2 – Final horizontal movement of I-70 caused by Panel 15 subsidence

This figure shows the magnitude and direction of horizontal movement of all of the points surveyed during the undermining. The maximum horizontal movement was observed at the bottom of the northern slope of Embankment #1. The point at this location moved over 2-ft north in the horizontal plane, which indicates movement out from the slope.

Overall, more horizontal movement was observed on the slopes than on the highway surface. The western side of northern slope of Embankment #1 moved primarily in the north-northeast direction at large magnitudes, showing that this the embankment slope is moving outwards from the core of the embankment. Though this movement is not towards the center of the basin, it can be explained by a spreading phenomenon of the embankment when subjected to subsidence. The opposite side of the embankment also show movement primarily moving outward from the core of the embankment, but at significantly lower magnitudes. This indicates that more spreading occurred on the northern slope than the southern slope of the embankment.

The highway surface experienced less horizontal movement, with the maximum movement observed around 1.5-ft. The eastern side of highway surface experienced the most horizontal movement, which was oriented primarily towards the center of the subsidence basin. This direction of movement is typical of a traditional subsidence basin. This movement dissipated at the eastern asphalt relief sections at the edge of embankment #1, which served to absorb the excess movement. The movement over the embankment was minimal and in no specific orientation. The highway surface adjacent to cut slope #1 to the east of the western asphalt relief sections also experienced significant movement. These points moved primarily in a north-west orientation at a magnitude between 0.5-ft and 1-ft. The western asphalt relief sections also dissipated the horizontal movement, causing minimal movement at the western most edge of the study area.

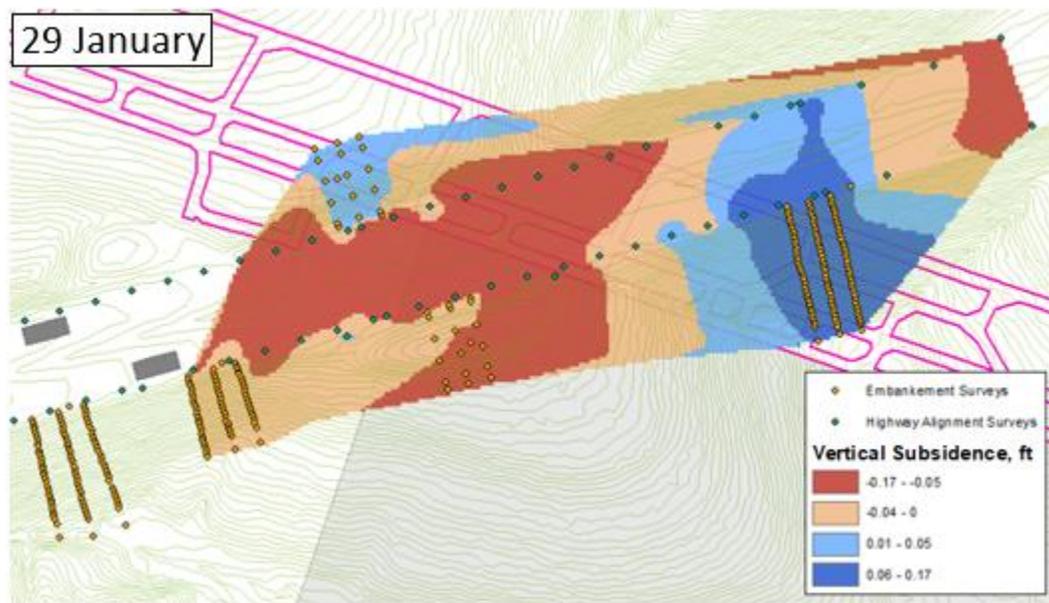
Figure IVa.3 – Vertical subsidence on 29 January 2019

Figure IVa.3 shows very small movements as the longwall face begins to influence the interstate. Up to 0.17-ft of heave was observed over Embankment #2 and up to 0.17-ft of vertical subsidence was observed on the eastern-much portion of the highway alignment. The majority of the movement observed is likely due to noise in the surveys.

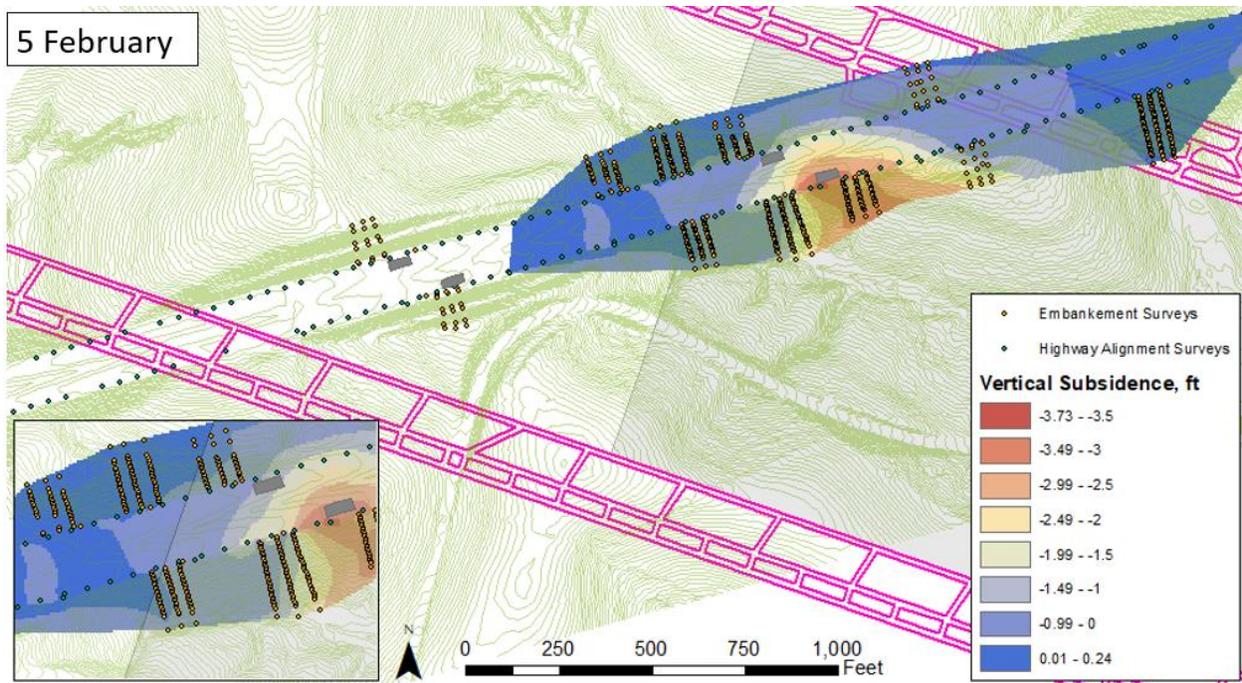
Figure IVa.4 – Vertical subsidence on 5 February 2019

Figure IVa.4 shows the vertical subsidence when the longwall face was below embankment #1. This shows the maximum subsidence of about 3.75-ft at the top of the south slope of embankment #1, occurring about 300-ft behind the longwall face. No point in the study area has reached the maximum predicted subsidence at this point in time. This is due to the fact that the points far enough behind the longwall face to drop to the maximum allowable subsidence are too close to the gate road entries to experience this maximum drop in surface elevation.

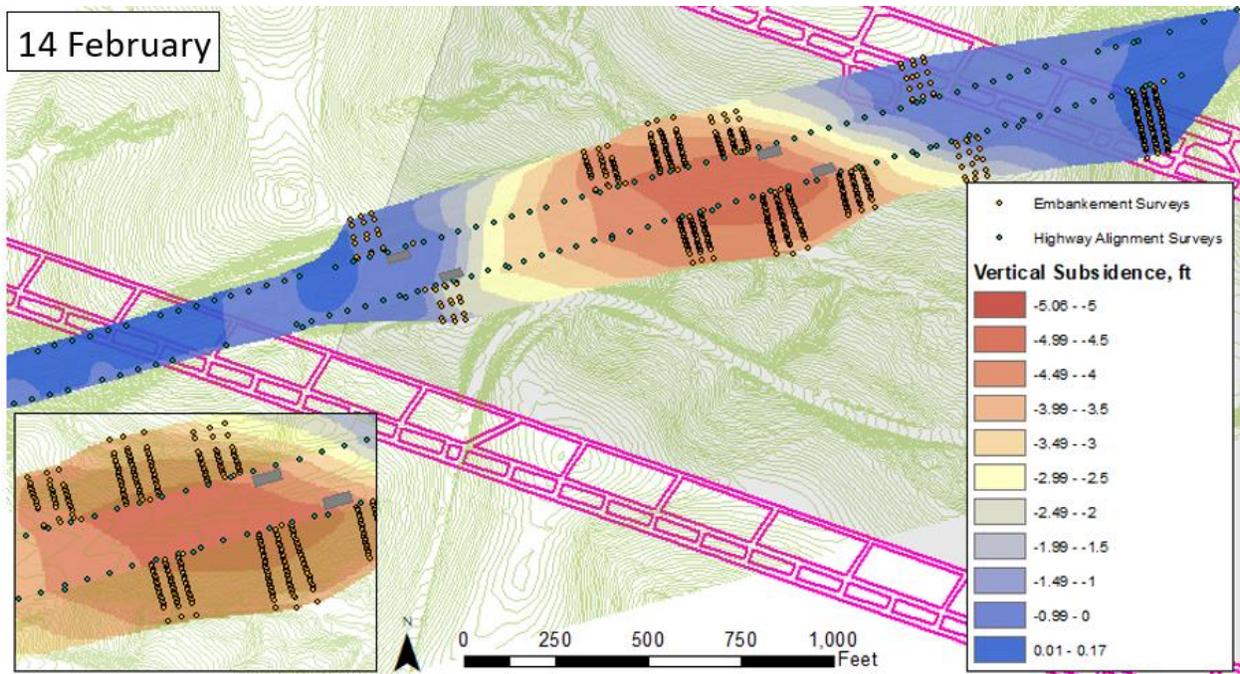
Figure IVa.5 – Vertical subsidence on 14 February 2019

Figure IVa.5 shows the vertical subsidence when the longwall face was just beyond the western asphalt relief sections. At this point in time, a maximum subsidence of about 5-ft was observed over the center of the embankment. The embankment was approximately 650-ft behind the longwall face on 14 February. The entire embankment subsided over 4.5-ft. It can also be seen that the change in surface drop between the gate road and the maximum subsidence occurs in a shorter distance on the eastern side of the study area than the western, meaning the slope is steeper on the eastern half of the study area.

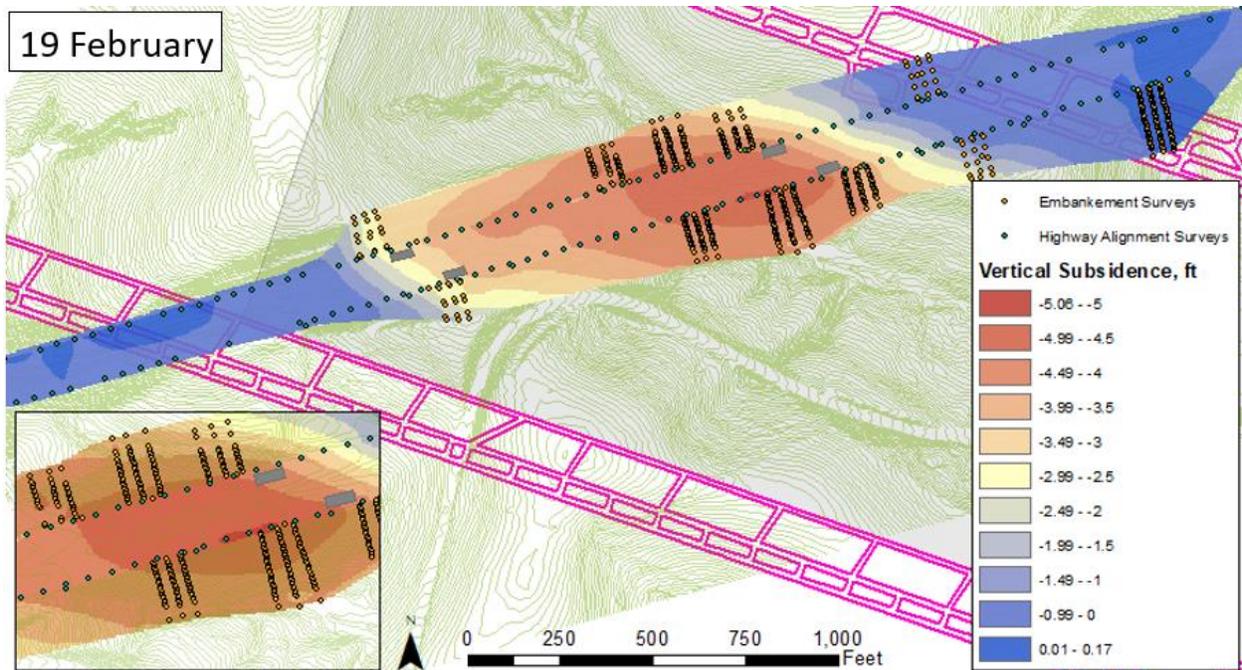
Figure IVa.6 – Vertical Subsidence on 19 February 2019

Figure IVa.6 shows the vertical subsidence when the longwall face was at the end of the highway section. This shows a small area of maximum subsidence of just over 5-ft at the top of the south slope of embankment #1, occurring about 1,200-ft behind the longwall face. By this point in time, the slope on the western side of the study area is closer to that on the eastern side, making the subsidence basin closer to symmetrical throughout the panel. It is also worth noting that small amounts of heave were observed over the gate road entries of the panel.

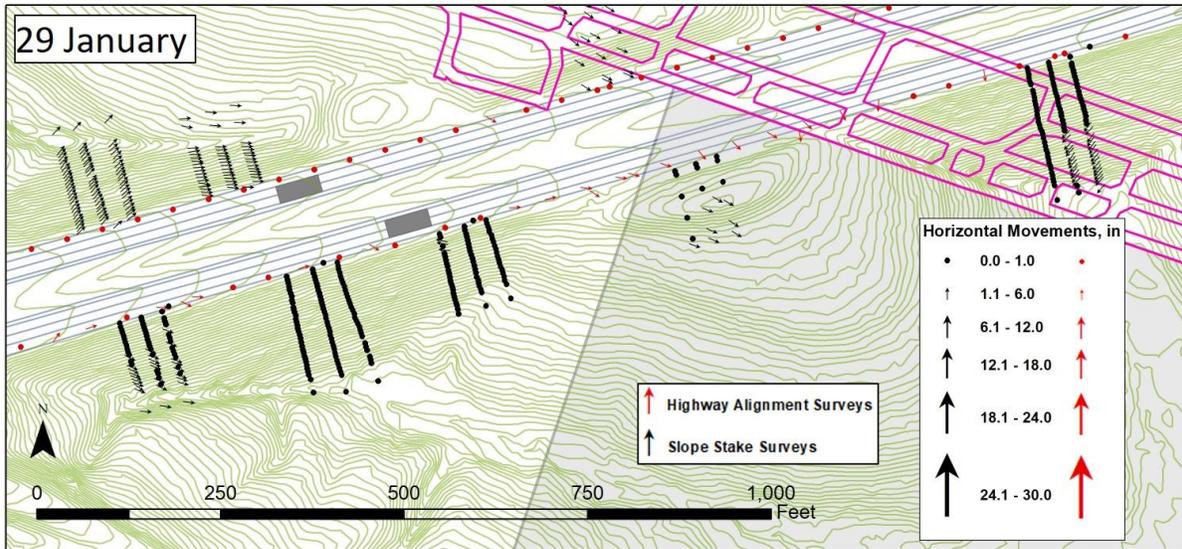
Figure IVa.7 – Cumulative horizontal movement on 29 January 2019

Figure IVa.7 shows the horizontal movement on the eastern portion of the study area on 29 January 2019. As the longwall face is just starting to influence the interstate at this point, the horizontal movements are very small, less than 0.5-ft in any direction. The movement is generally oriented towards the longwall face.

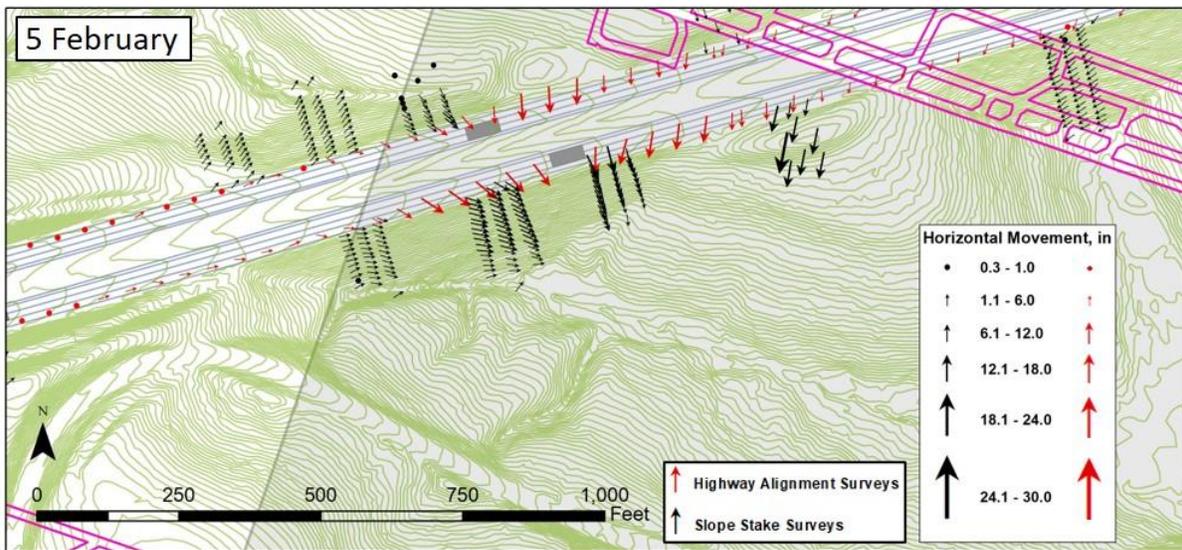
Figure IVa.8 – Cumulative horizontal Movement on 5 February 2019

Figure IVa.8 shows the cumulative horizontal movement of the ground surface on 5 February 2019, when the longwall face was beneath the central embankment. At this point in time, most of the points along the embankments experienced minimal movement, with magnitudes of less than

1-ft. The cut slope nearest to the gate road entries experienced larger movements, with magnitudes of almost 2-ft, oriented towards the center of the longwall panel. This section of highway also experienced significant horizontal movement, with magnitudes around 1.5-ft, oriented towards the center of the longwall panel. These movements on the highway surface are dissipated at the asphalt relief section, causing there to be minimal movement beyond the longwall face.

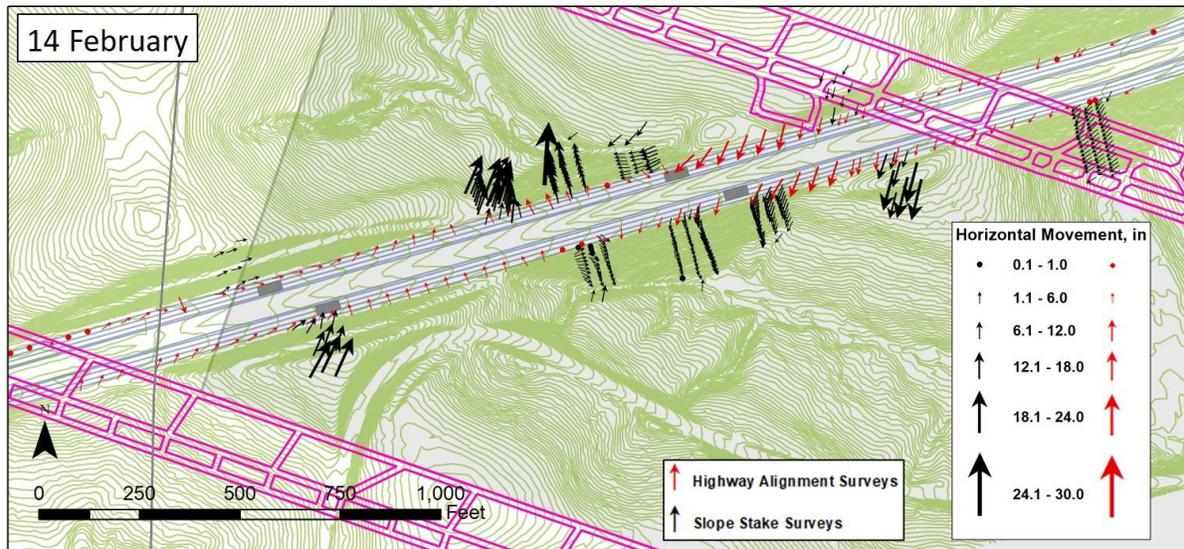
Figure IVa.9 – Cumulative horizontal Movement on 14 February 2019

Figure IVa.9 shows the cumulative horizontal movement of the ground surface on 14 February 2019, when the longwall face was just past the western asphalt relief sections. At this point in time, some of the slopes within the study area had begun to experience significant movement. The northern slope of embankment #1 moved away from the center of the embankment, with magnitudes as high as 2.5-ft. These movements are larger than and in a different orientation than that which would be typically be expected on a longwall panel, but this is likely due to spreading of the embankment. Like on 5 February, the eastern side of the highway surface experienced horizontal movements with magnitudes around 1.5-ft that are oriented towards the center of the longwall panel. These movements are dissipated at the asphalt relief sections, causing there to be very minimal movement west of these relief sections.

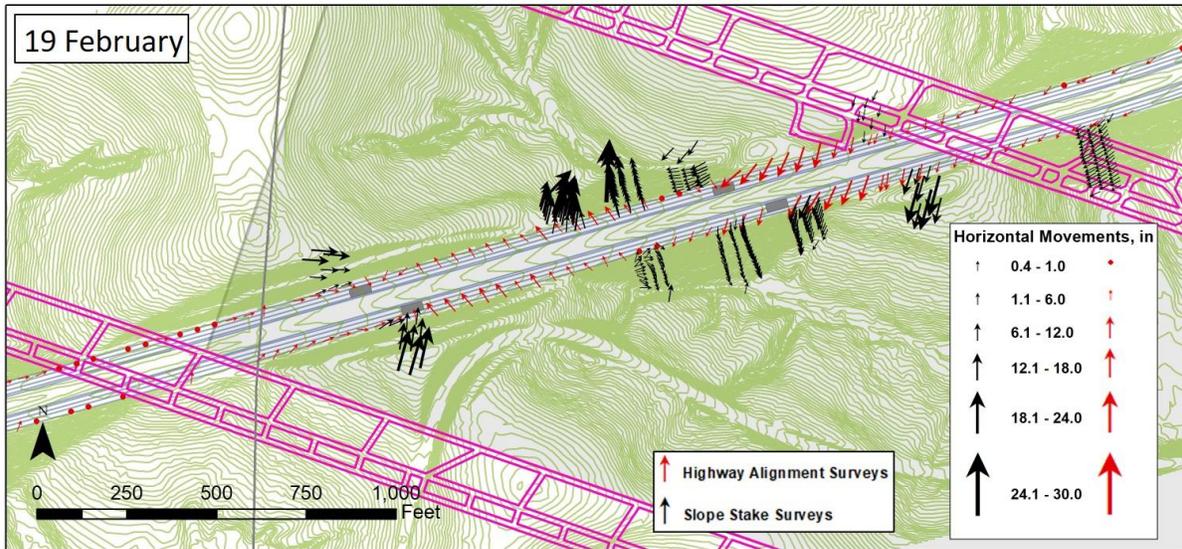
Figure IVa.10 – Cumulative horizontal Movement on 19 February 2019

Figure IVa.10 shows the cumulative horizontal movement within the study area on 19 February 2019 when the longwall face was at the end of the area of highway influence. At this point in time, most of the slopes within the study experienced significant movement. The northern western cut slope moved away from the longwall face with magnitudes of movement up to 1.5-ft. The movement of the remainder of the slopes remained mostly unchanged from that observed on 14 February. The movement observed on the highway surface had magnitudes of up to 1.5-ft on the eastern side of the study area oriented towards the center of the basin and up to 1-ft on the western side of the study area oriented towards the longwall face. These movements were dissipated at the asphalt relief sections, causing the areas just west of the asphalt relief sections to experience minimal horizontal movement.

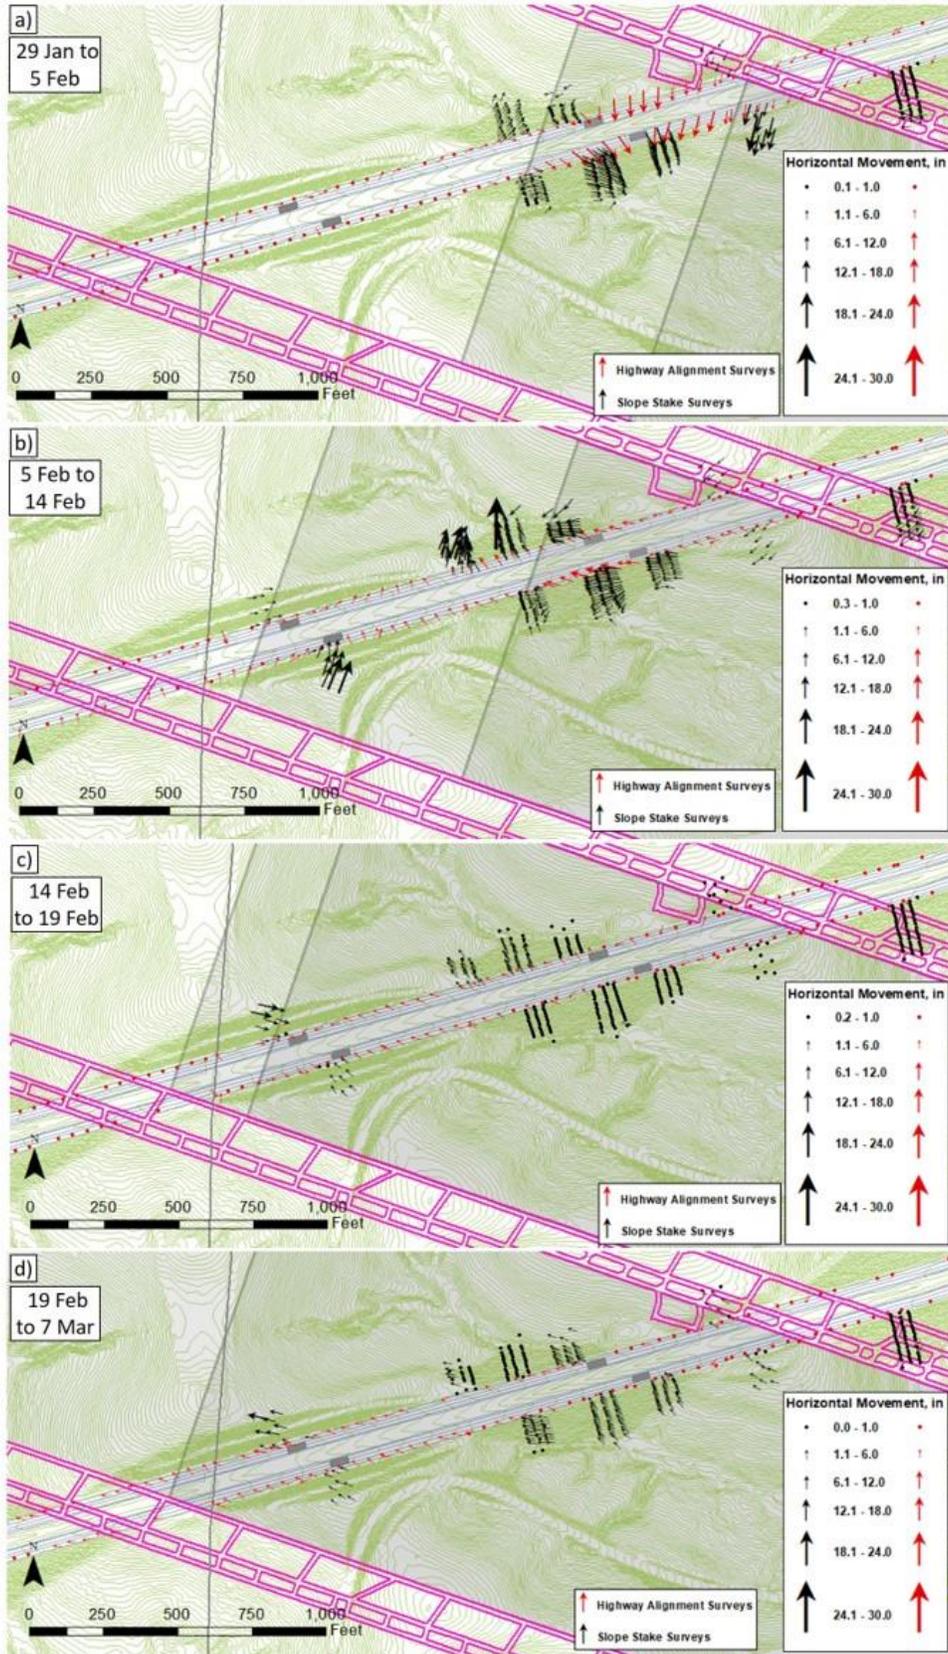
Figure IVa.11 – Incremental horizontal movement throughout study area influenced by undermining

The horizontal movements can also be examined incrementally between surveys. The incremental movements can be seen in Figure IVa.11. As this figure shows, the eastern side of the highway surface experienced the majority of movement between 29 January and 5 February, when it was about 150-ft behind the longwall face. The western side of the highway surface experienced the majority of movement weeks later between 19 February and 7 March, when the longwall face was far beyond the movement area. It is also worth noting that between 5 and 14 February, there was significant change in the direction of the horizontal movement adjacent to the southern slope of embankment #1. Embankment #1 experienced the majority of movement between 5 and 14 February, when the longwall face was approximately 550-ft beyond the embankment. The western cut slopes each experienced the majority of movement when the longwall face was approximately 250-ft past the points. By looking at the movements of the surface incrementally, it is evident that the progression of the longwall face has a significant impact on the horizontal surface movements.

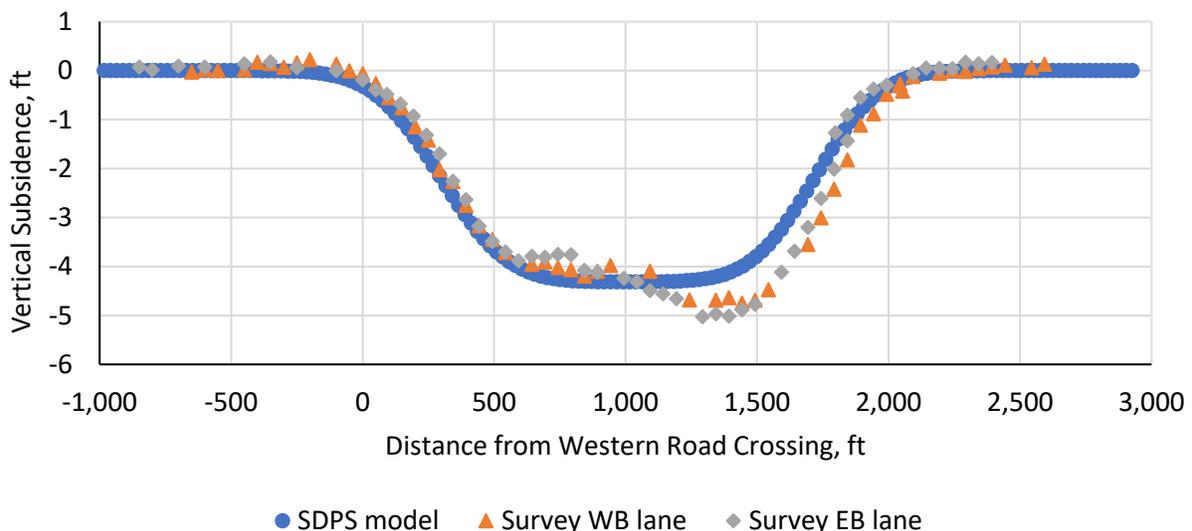
Figure IVb.6 – Vertical subsidence relationship between SDPS model and highway alignment survey data

These figures show the relationship between the model predictions and the survey data. Looking at Figure IVb.6, it is evident that the model is well calibrated to the observed highway movement; the area in the figure that shows subsidence greater than the model is the location of Embankment #1, which experienced additional vertical movement due to consolidation and spreading of the fill. Unfortunately, the horizontal deformations observed did not match those

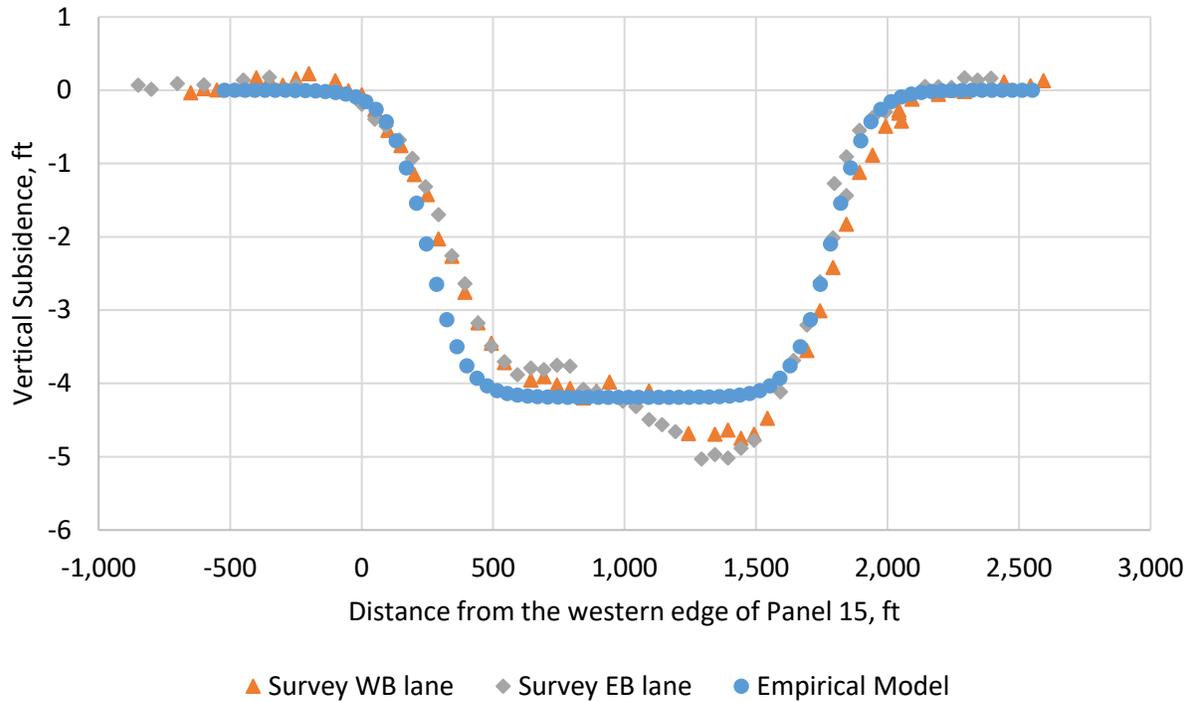
The empirical/profile function model can also be compared with the final survey data collected on the highway alignment (Figure IVc.3). This comparison shows that this model would also be effective to be used to predict the vertical subsidence on the highway surface. The maximum amount of subsidence predicted by this model matches the maximum subsidence observed in areas of cut along the highway. The curvature of the model also matches very well with the data observed on the eastern side of the highway; however, the curvature does not match as well with the data observed on the western side of the highway. The empirical/profile function cannot predict heave like that which was observed over the gate road entries when mining Panel 15.

Figure IVc.3 – Vertical subsidence relationship between empirical/profile function model and highway alignment survey data

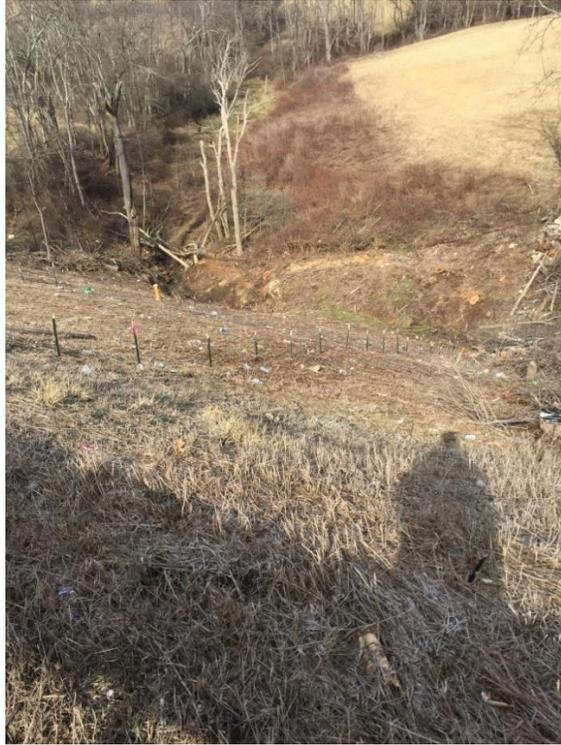
Figure Va.7 – Photograph taken on 19 February 2019 of the surface of the north slope in section 720+00

Analyses of the photographs show evidence that the slope, at section 720+00 (Figure Va.7) experience lateral displacement on the lower portion of the slope (see possible bulge at the lower part of the slope). Also, the embankment at section 720+50 experienced small lateral deformations at the top of the slope.

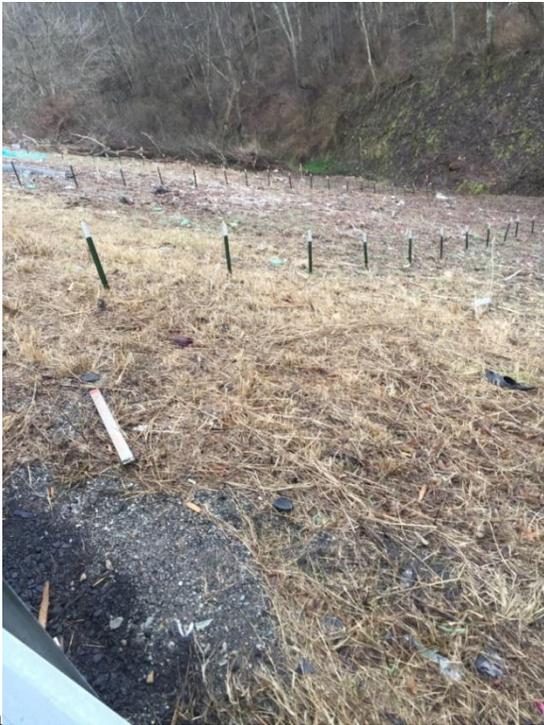
Figure Va.8 – Photograph taken on 19 February 2019 of the surface of the south slope in section 720+50

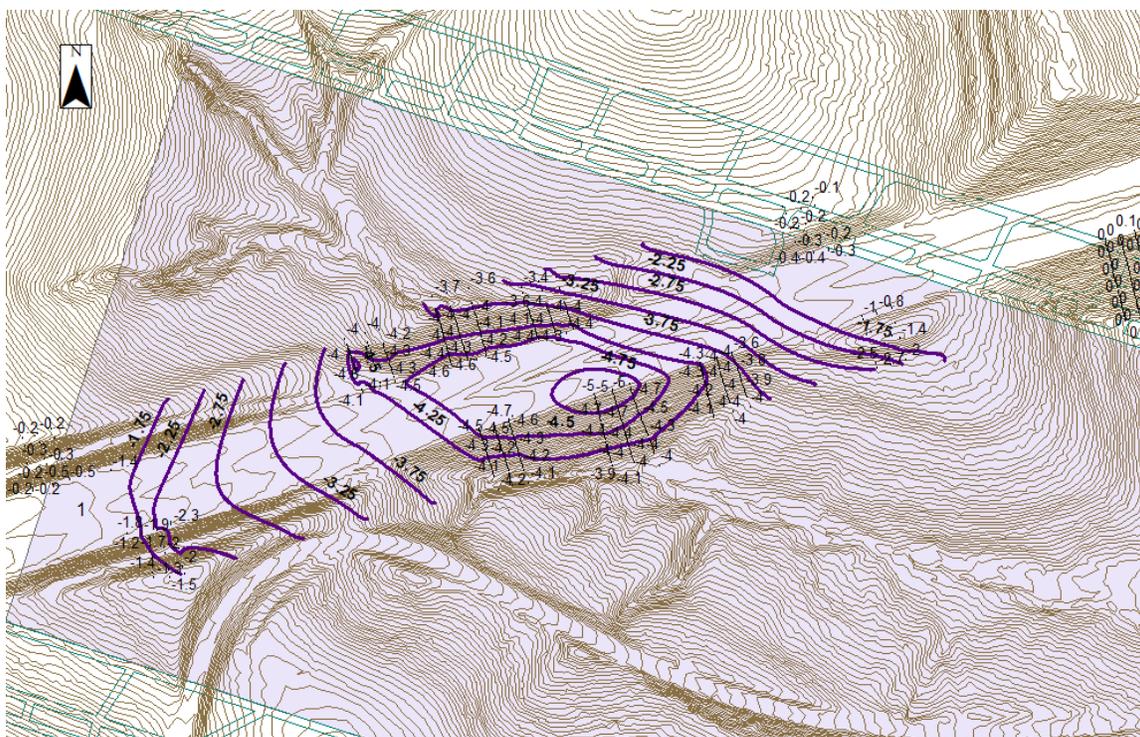
Section IIIb provides information on vertical subsidence along the I-70 highway alignment within the study area. Figure Va.9 shows vertical subsidence contours in the area of Embankment #1. The maximum subsidence (-5.5-ft) occurred on the top surface of the embankment. Measurably less subsidence occurred along the bottom portions of Embankment #1, ranging from 3.9 to 4.2-ft. The difference of more than 1-ft and suggests that portions of the embankment consolidated as a result of the subsidence.

Figure Va.9 – Vertical surface subsidence contours along the I-70 highway alignment in the study area

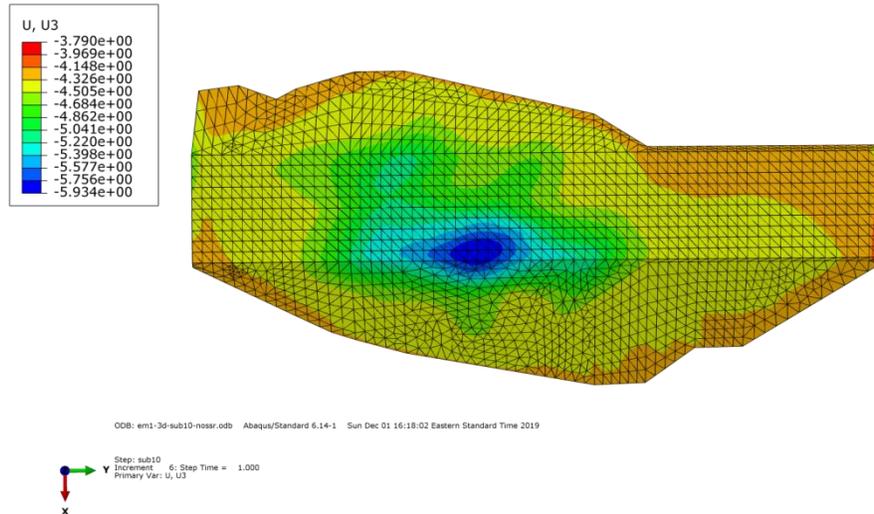
A numerical study was carried out to analyze the vertical deformations experienced by the Embankment #1. This numerical analysis uses the University's previously discussed FEM. The results of the numerical analysis is shown in Figure Va.10. The vertical deformation experienced by Embankment #1 using the numerical analysis was -5.9 ft.

Figure Va.10 – FEM vertical displacements of Embankment #1 after subsidence

This maximum subsidence within the FEM (Figure Va.10) took place at approximately the same location in Embankment #1 as that measured by slope survey (Figure Va.9). These similar locations indicate that the FEM is adequately predicating the actual subsidence measured within the study area. The numerical results of vertical subsidence (-5.9-ft.) are greater than the field subsidence using the SDPS approach (-4.3-ft), and the subsidence measured at the surface of Embankment #1 using the slope surveys (-5.5-ft.). The extra-subsidence (5.5-ft.- 4.3-ft) = 1.2-ft likely represents the amount of consolidation experienced by Embankment #1 during subsidence.

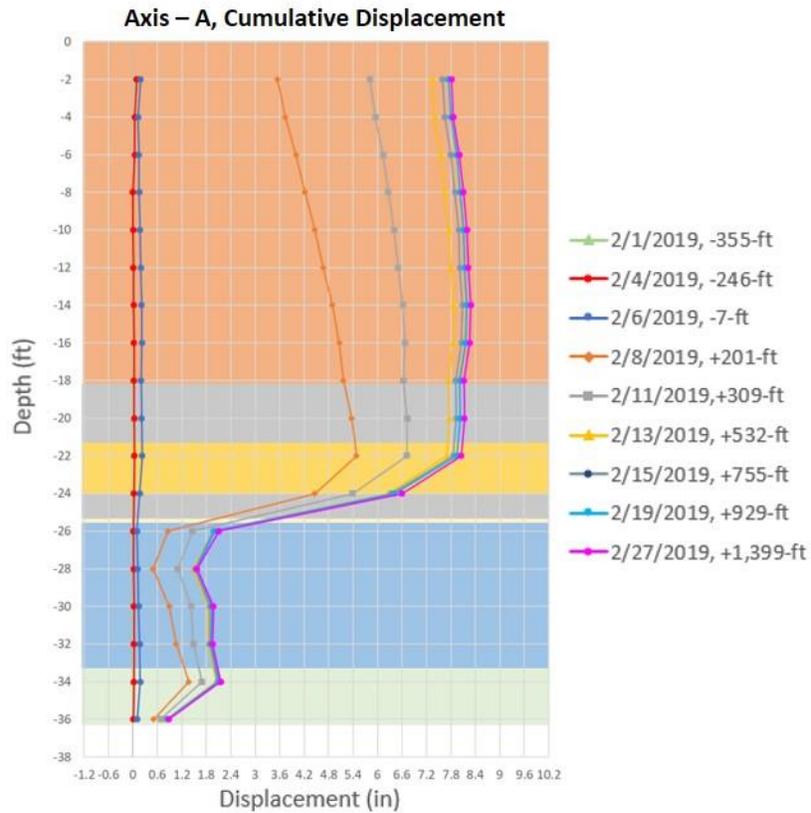
Lateral deformations of Embankment #1 was previously discussed in Section IIIId. The results of the lateral deformations are shown with the borehole TB-4 inclinometer (Figure Va.11). This data confirms the lateral spreading within the embankment during subsidence. Using the SDPS

Figure Va.11 – Lateral deformations in an inclinometer located in borehole TB-4 in the south slope located in section 720+50 (see Figure Va.1)

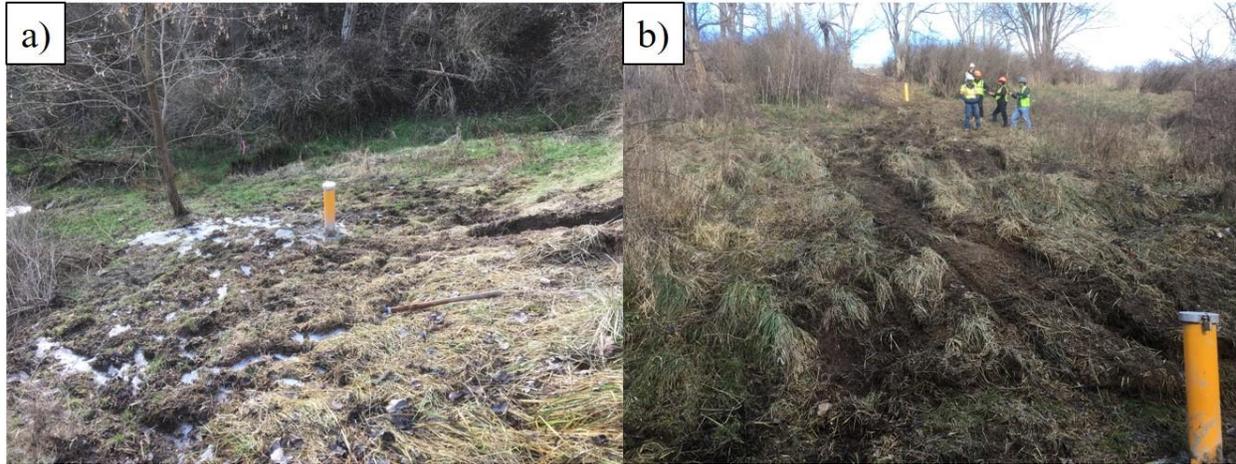
Several inclinometers and piezometers had already been installed across the highway alignment (Figure Vb.1) and extended down the north and south slopes of Embankment #1 (Figure Vb.5). As is evident from the photographs, the slopes were impacted by the drilling of the boreholes.

Figure Vb.5 – Tiltmeters and piezometers installed in 2017 along the slopes of Embankment #1 showing the conditions of the south slope around TB-7 and 8: a) looking down on TB-8; and b) looking up the slope from TB-8 to TB-7.

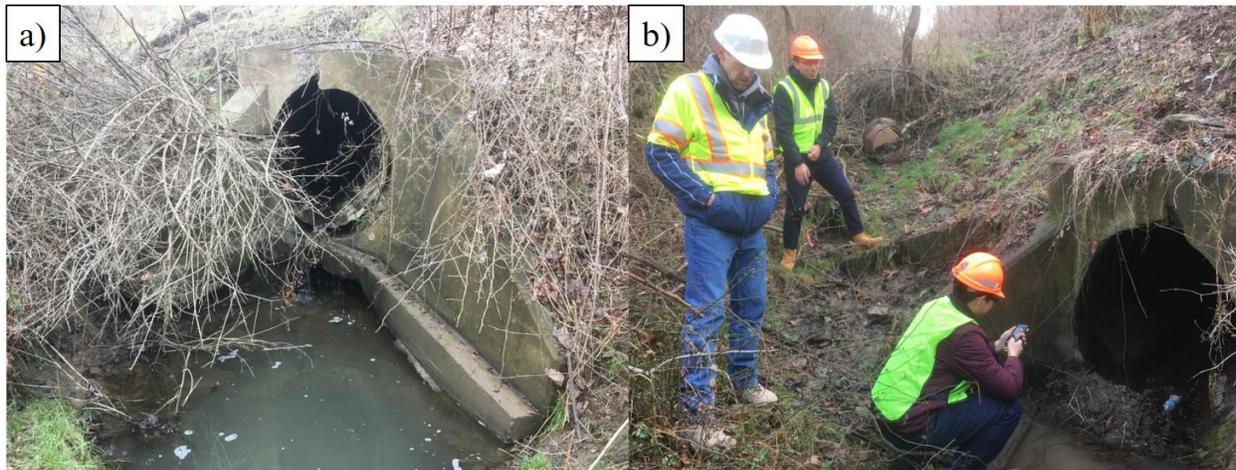
There are culverts that pass through the base of both Embankment #1 and #2 (Figure Vb.1). The culverts remained open on both ends during the mining of Panel 15. The concrete facing on Embankment #1 south slope was cracked or fractured and part of the wall rotated out of position (Figure Vb.6a).

Figure Vb.6 - a) the culvert pipe and concrete facing on Embankment #1 south slope, and b) the culvert pipe on Embankment #1 north slope

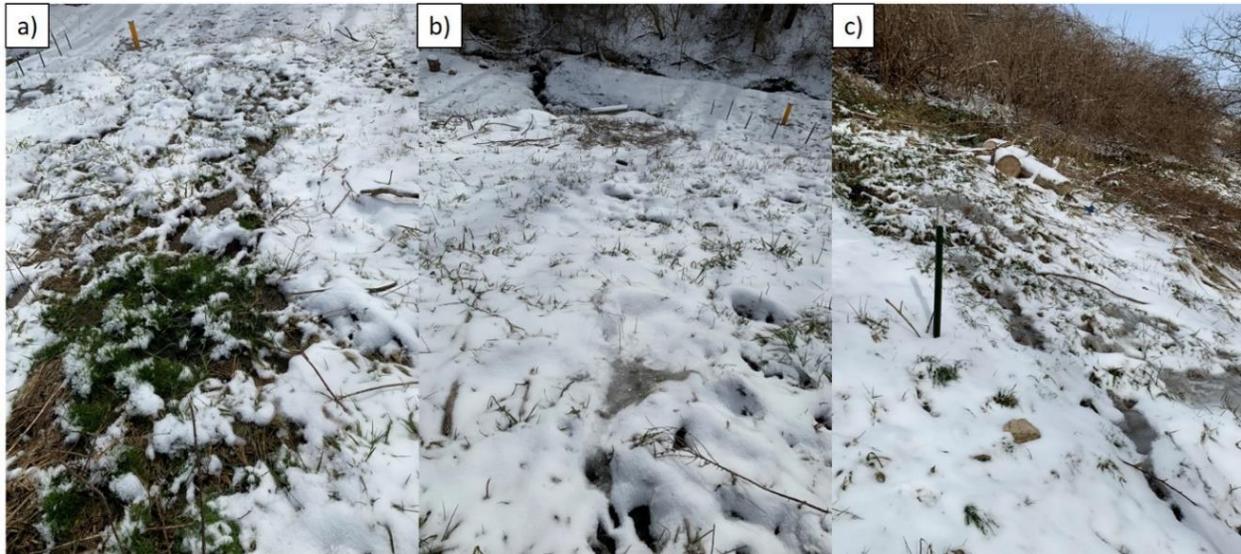
A detailed inspection of the Embankment #1 south slope was made. Due to the very cold temperatures (overnight 5 to 15 degrees Fahrenheit), water seeping from the embankment froze rapidly forming ice sheets (Figure Vb.8). These ice sheets typically formed stair step patterns down the slope in ribbons 2 to 4-ft wide. In addition, several wet areas where walking was difficult were observed. All ice sheets and wet areas were located within the bottom quarter of the south slope.

Figure Vb.8 – Photographs were all taken from the approximate elevation between 1,210 and 1,216-ft (estimated for surface topographic contour maps) along Embankment #1 south slope. The approximate location and direction of the three photographs are shown in Figure Vb.9; a) western side; b) center; and c) eastern side

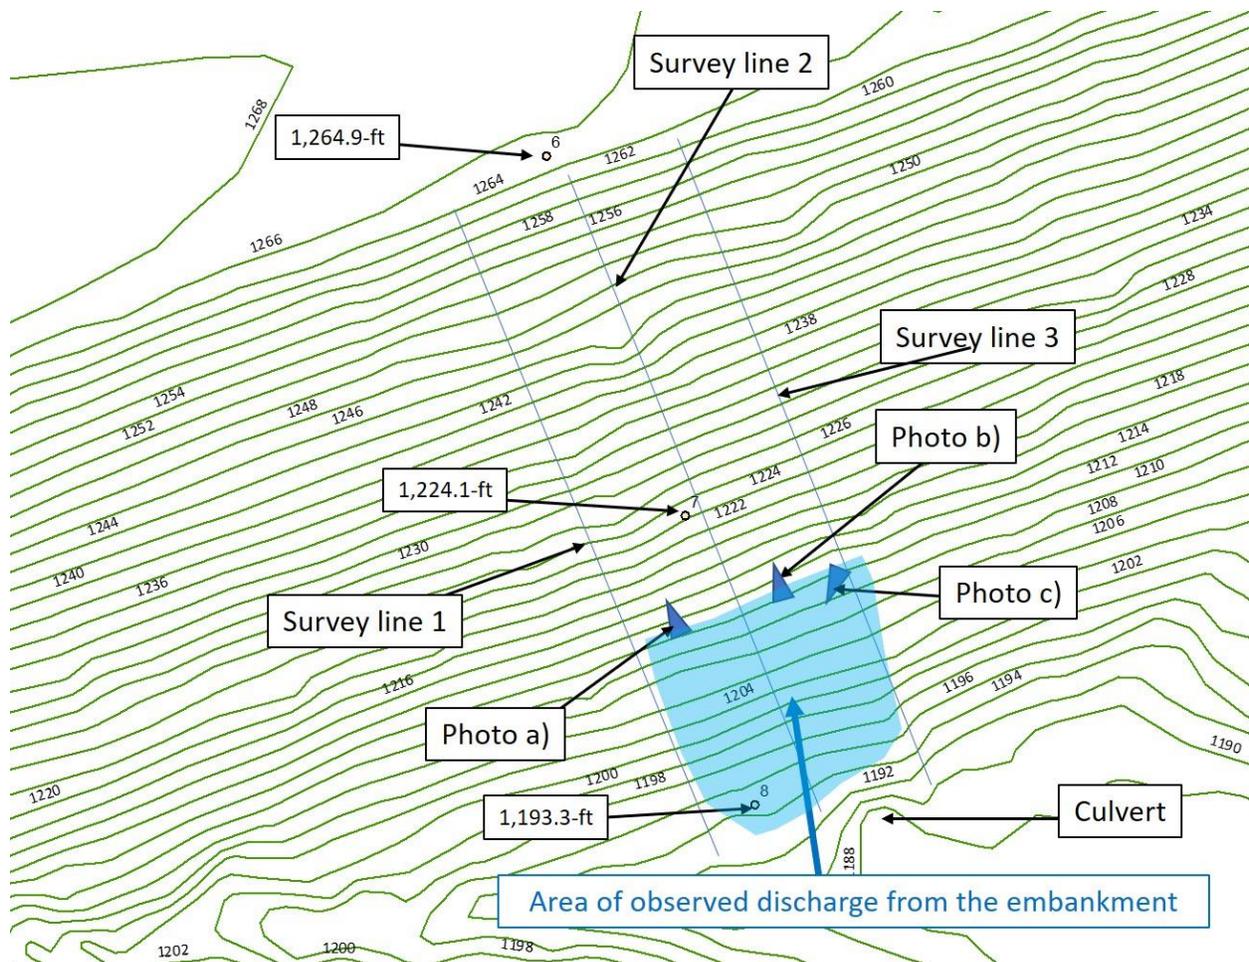
The highest occurrence of ice sheets is thought to represent the highest elevation of discharge from the south facing slope of Embankment #1 (Figure Vb.9). Using the surface contours from the Pennsylvania Spatial Data Access (PASDA) online database for this area, the University estimated the elevation to be between 1,210 and 1,216-ft.

Figure Vb.9 – Surface topographic contour on 2-ft intervals showing the east-bound lane of I-70 and the south facing slope of Embankment #1. Of particular note are the location of the photographs from Figure Vb.8 as well as the general area of observed discharge.
