IDENTIFICATION OF FACTORS CONTROLLING THE DEVELOPMENT OF SUBSIDENCE IMPACTS FORECASTING METHODOLOGY TO THE I-70 ALIGNMENT OVER LONGWALL MINING OF THE TUNNEL RIDGE MINE, WASHINGTON COUNTY, PA

Task 2: Undermining Activities Report
Submitted 3 February 2020; Finalized on 4 January 2021

The University of Pittsburgh Master Agreement
Contract No. 4400018535

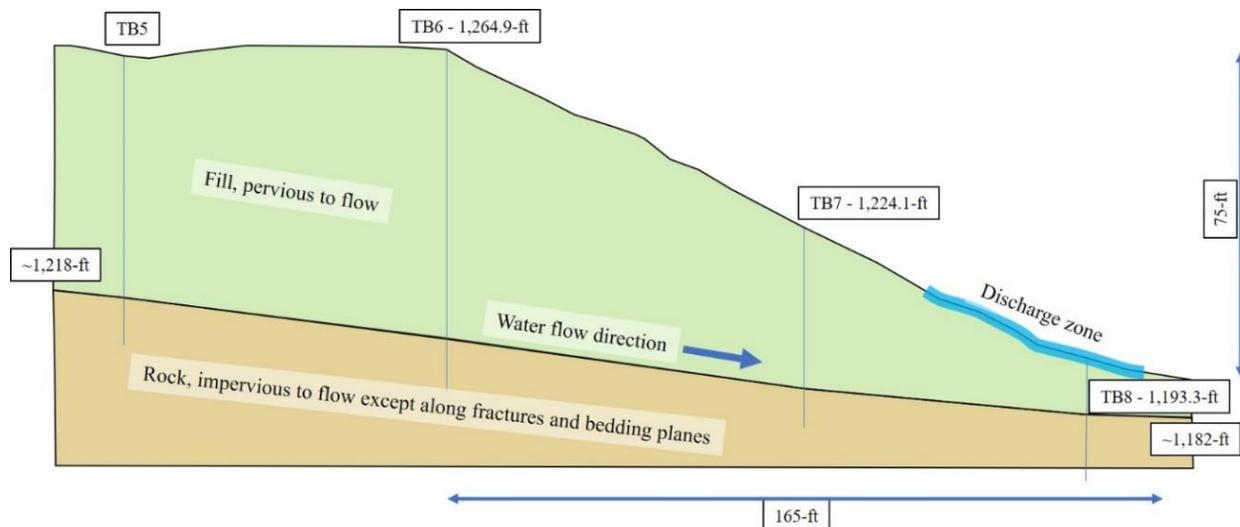
The material properties of the fill are discussed in other sections of this document (Section Vd). The fill is underlain by bedrock comprised of siltstone, sandstone, limestone and thin claystone. The bedrock will be generally impervious to the flow of water, except where fractures and beddings planes provide adequate flow paths. The fill is generally a cohesionless material (comprised mainly of fine-grained material) with varying concentrations of clay, silt, and sand. There are also boulders of varying size, especially near the base of the fill. The constructed fill comprising the embankment appears to be pervious to flow. As discussed in the Task 1 Report, the construction method used to construct the embankments is unknown. It is possible that the colluvium (surface soil) which previously covered the bedrock may not have been removed and could had been reworked into the fill. This data suggests that water entering the embankment from the highway alignment flows down-dip along the relatively impervious contact with the bedrock (Figure Vb.10). The zone of soil saturation measured along the south slope surface is ~50-ft.

Figure Vb.10 – Cross-section of the Embankment #1's south slope constructed from borings and indicating the most likely direction of flow

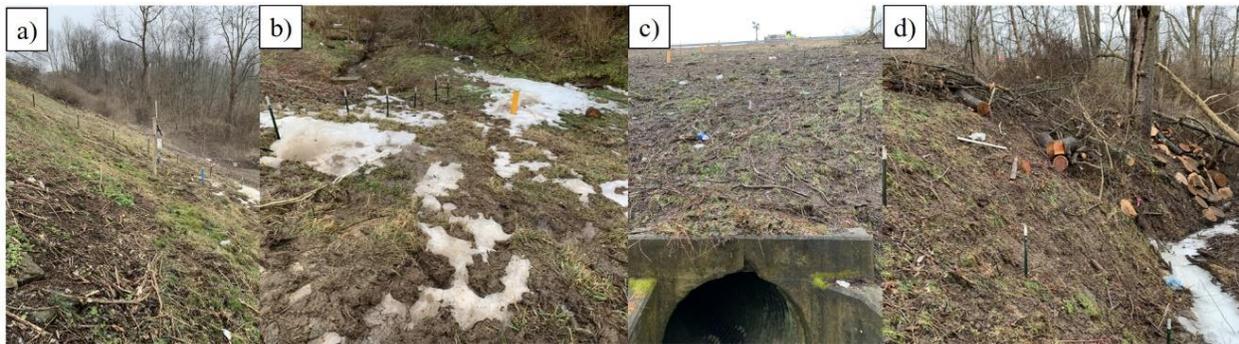
Because of south slope conditions and the position of the longwall face in early February 2019, PennDOT decided to drill another tiltmeter within Embankment #1 (Figure Vb.11a). This borehole was located between TB-7 and TB-8 within an area of highly saturated fill (Figure Vb.11b). The amount of water that emitted from this area seemed higher than at any other time. The Embankment #1 north slope did not show the same magnitude of water saturation as the south slope (Figure Vb.11c). This could be a result of the general slope of the bedrock/fill contact, allowing water to flow to the south. The north slope to the west of the culvert did not yet show signs of distress (Figure Vb.11d).

Figure Vb.11 – a) new borehole (BH14) added to Embankment #1 south slope; b) highly-saturated conditions of Embankment #1 lower south slope; c) Embankment #1 observation north slope survey line; and d) conditions of Embankment #1 lower north slope

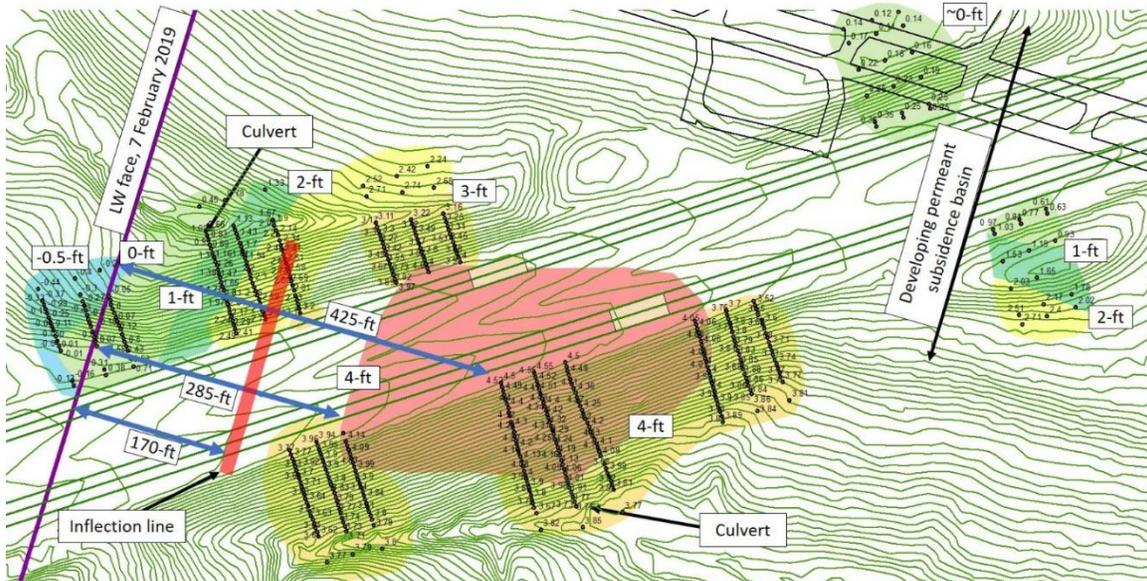
During the weeks of 7 February 2019, several of the inclinometers within Embankment #1 began to show significant movement (Section III d). At this same time, vertical subsidence of over 4-ft occurred on Embankment #1's south slope. Conversely, portions of the north slope were only beginning to experience vertical subsidence (Figure Vb.12).

Figure Vb.12 – location of survey stakes monitored by SPK within the study area and vertical subsidence contours between 7 January (no mining related subsidence) and 7 February 2019 (subsidence related to the longwall face position on 7 February). Of particular note is the distances (170, 285, 425-ft) from the longwall face to the 4-ft and 4.5-ft vertical subsidence and to the inflection line.

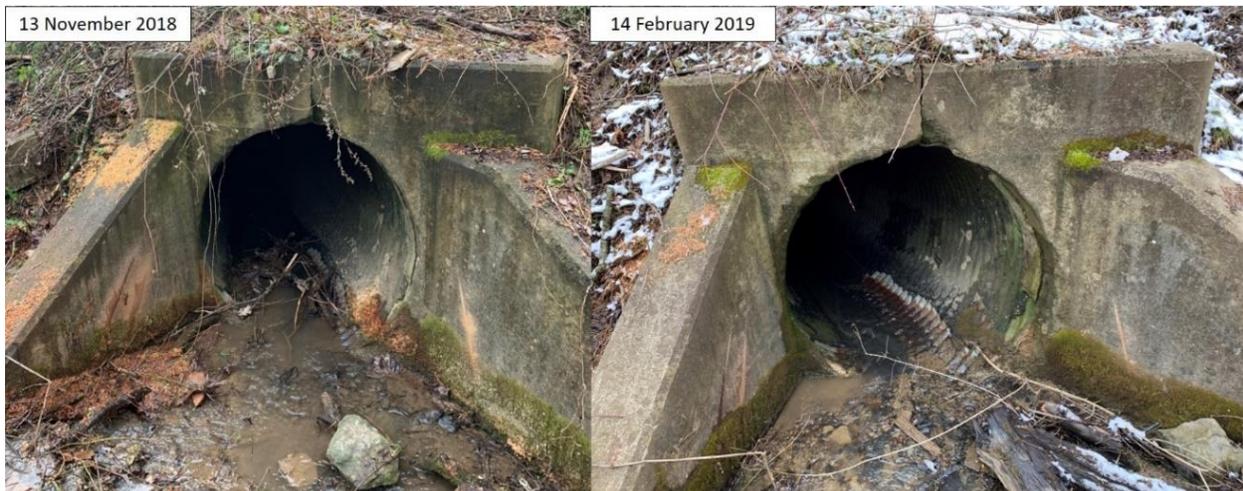
The culverts are critical structures within the embankments. If stream flow is disrupted, the embankment could become distressed. That being said, no visual changes occurred to the culvert on Embankment #1's north slope from 13 November 2018 to 14 February 2019 (Figure Vb.13). The crack at the apex of the culvert has remained ~0.5-in wide and no new cracks have been observed.

Figure Vb.13 - Two photographs of the culvert at the base of Embankment #1's north slope three months apart. Both photos show very similar features.

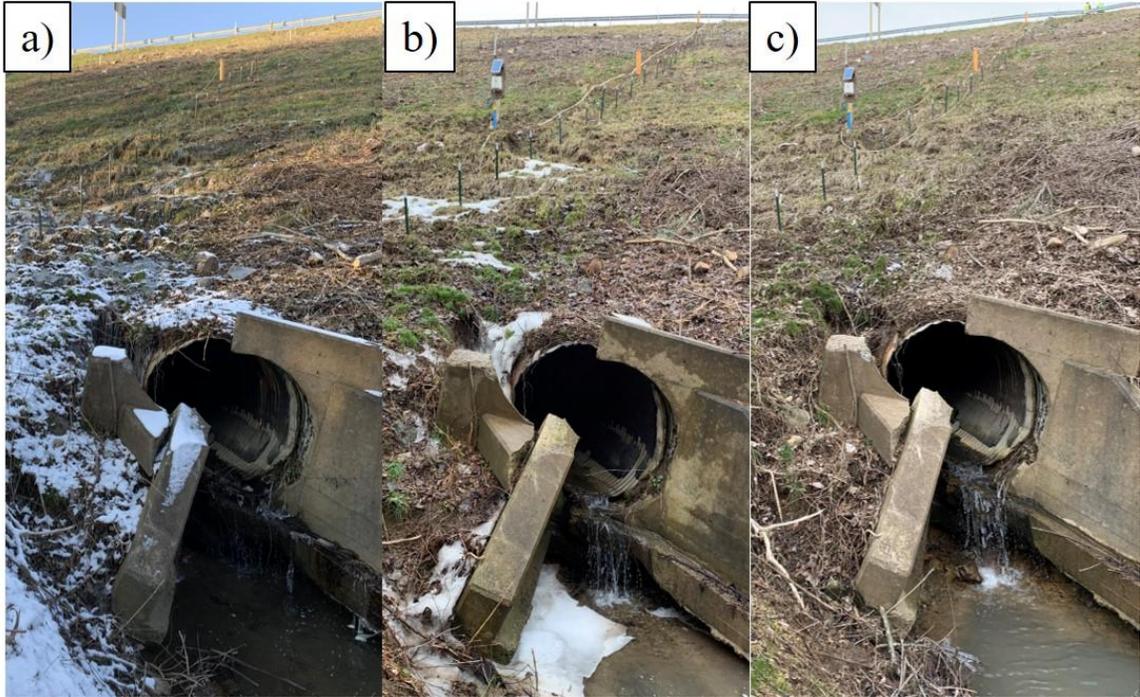
The Embankment #1 south slope culvert was observed twelve times. An effort was made to photograph the culvert from multiple angles. One of these angles is shown in Figure Vb.15. As is confirmed from these photographs, no significant deformation occurred to the Embankment #1 south slope culvert during the undermining by Panel 15.

Figure Vb.15 – Embankment #1 south slope culvert: a) 8 January 2019; b) 5 February 2019; and c) 26 February 2019

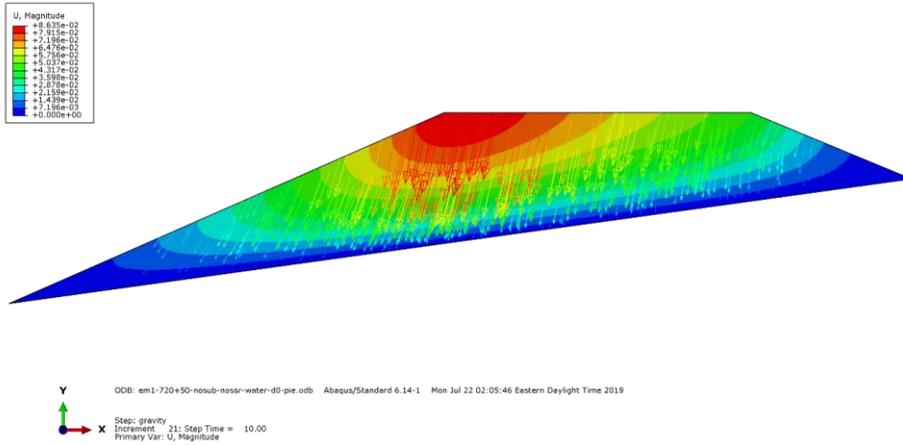
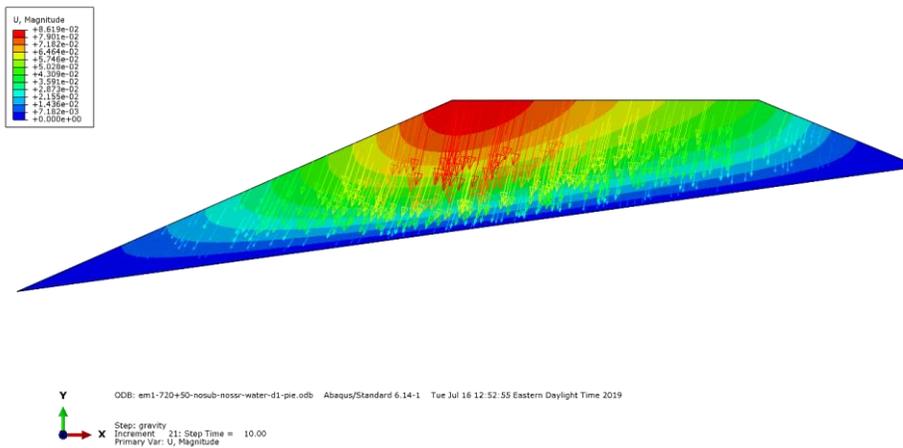
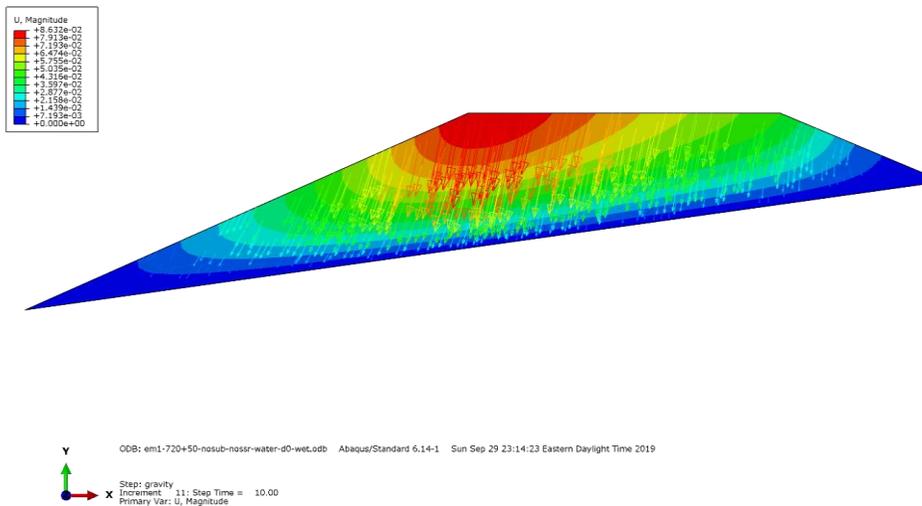
Figure Vd.7 indicated the total displacement at cross section 720+50 with different elevations of the water table. The magnitudes of the total displacement under these four conditions were plotted against the vertical distance between the phreatic surface and the lower toe of the slope in Figure Vd.8. The slope with water presented a 7.6% higher displacement at the crest than that without water.

Figure Vd.7 – Total displacement in the Embankment #1 at cross section 720+50 with (a) no water and with phreatic surface at an elevation of (b) 1204-ft; (c) 1208-ft and (d) 1206-ft with field saturated zone

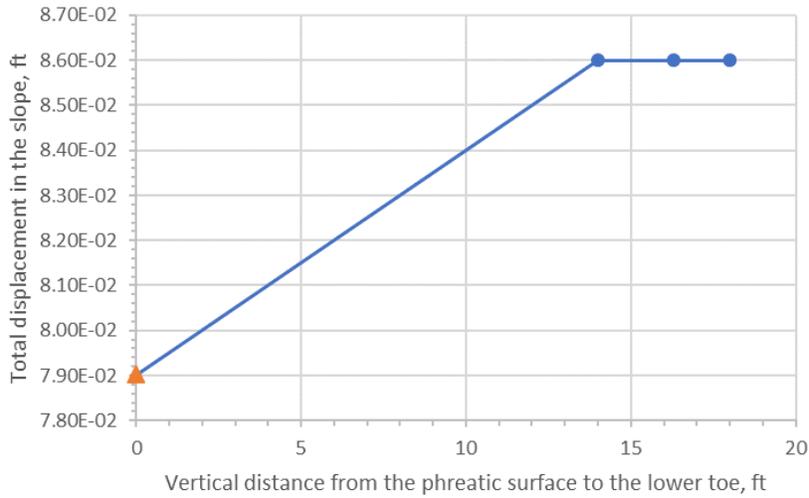
Figure Vd.8 – Total displacement versus the vertical distance between the phreatic surface and the lower toe

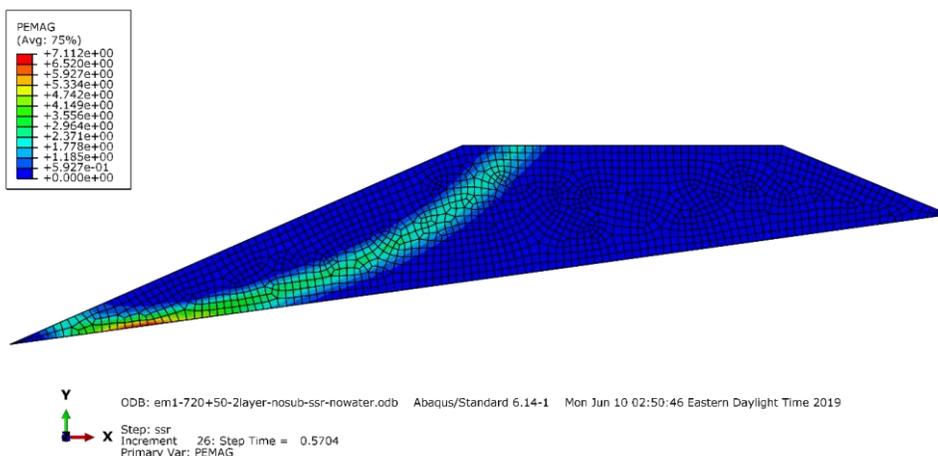
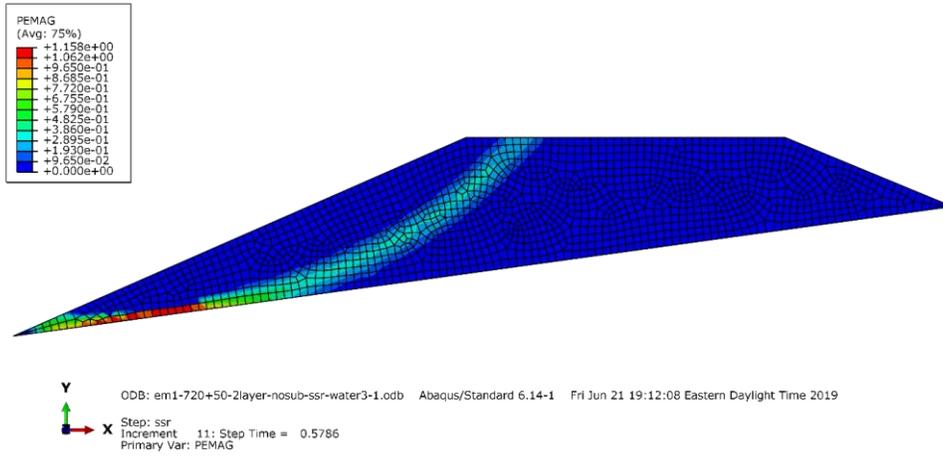
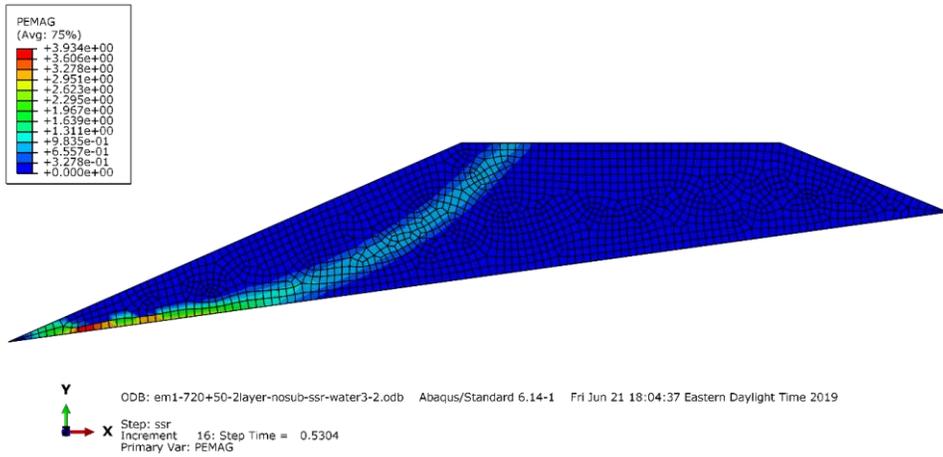
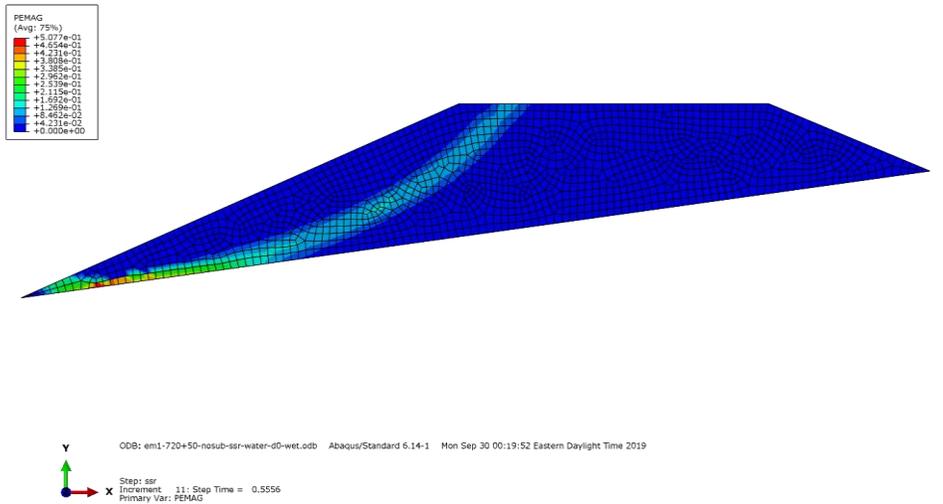
The rupture surface at failure was tracked by the development of plastic shear strain. Figure Vd.9 indicates the magnitude of the plastic strain at cross section 720+50 with different elevations of water table. A large difference was observed in the potential plastic zone between no water and in different elevations of water table. The magnitude of plastic strain reached the maximum on the bottom of the embankment near the toe area. For the conditions with water, the plastic zone is more concentrated in the area near the toe. The majority of the plastic zone remains in the lower part of the slope where there was water, while on the upper part of the slope, the magnitude of the plastic strain was much lower. Besides, the slope with a higher water level presented the plastic strain with more intense concentration on the bottom.

Figure Vd.9 – Potential plastic strain at failure in the Embankment #1 at cross section 720+50 with (a) no water and with phreatic surface at an elevation of (b) 1204-ft; (c) 1208-ft and (d) 1206-ft with field saturated zone

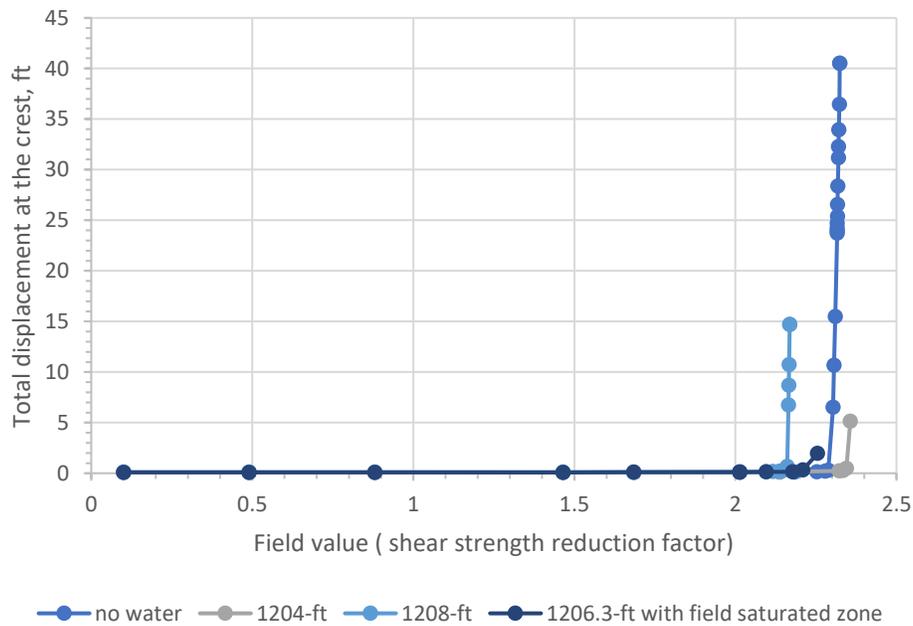
The determination of the factor of safety in four different conditions of water content was summarized in Figure Vd.10. The total displacement was plotted against the strength reduction factor in this process. The field value at the inflection point represented the factor of safety. The resulted factor of safety was plotted versus the vertical distance between the phreatic surface and the lower toe in Figure Vd.11. The factor of safety was the lower when there was water compared to the dry conditions, but still above one, indicating that the embankment was safe. However, the increase of the water level contributed to the decrease of the factor of safety. When the water level increased from 1204-ft to 1208-ft, factor of safety decreased from 2.3 to 2.16.

Figure Vd.10 – Determination of the factor of safety by plotting the total displacement at the crest versus the shear strength reduction factor

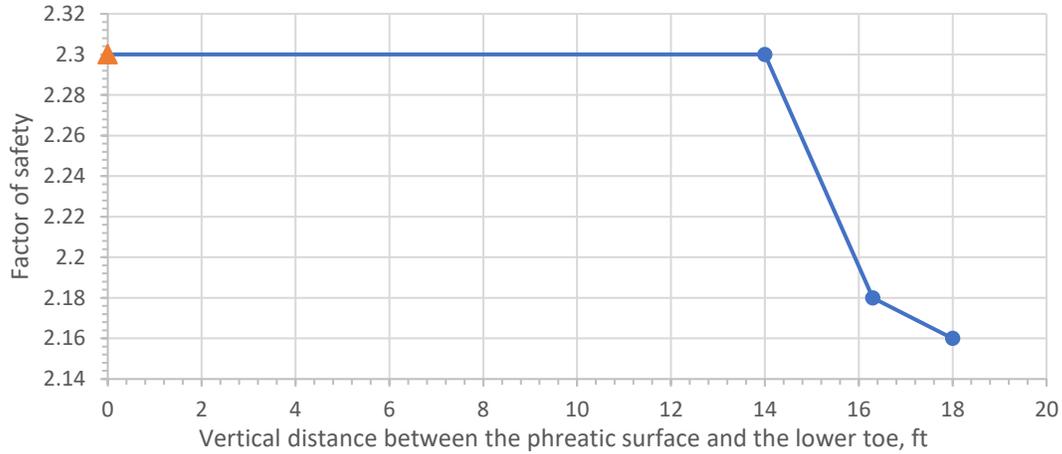
Figure Vd.11 – Factor of safety of Embankment #1 at cross section 720+50 with different ground water tables

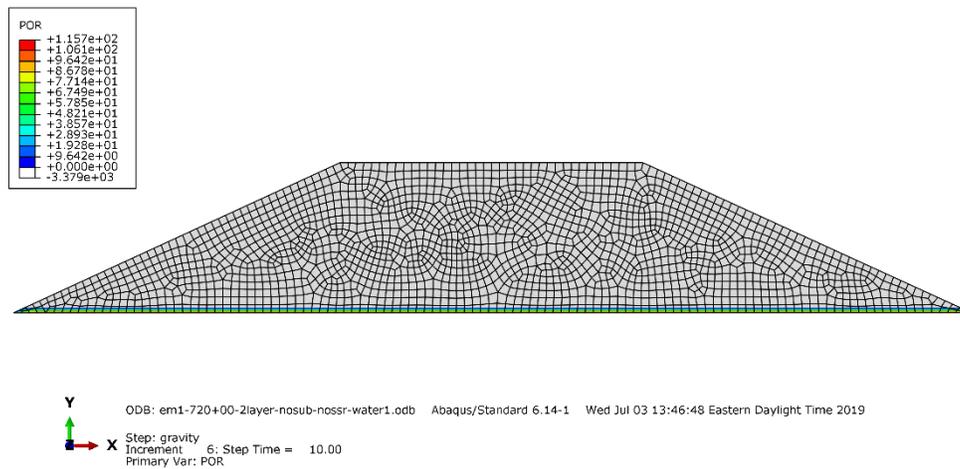
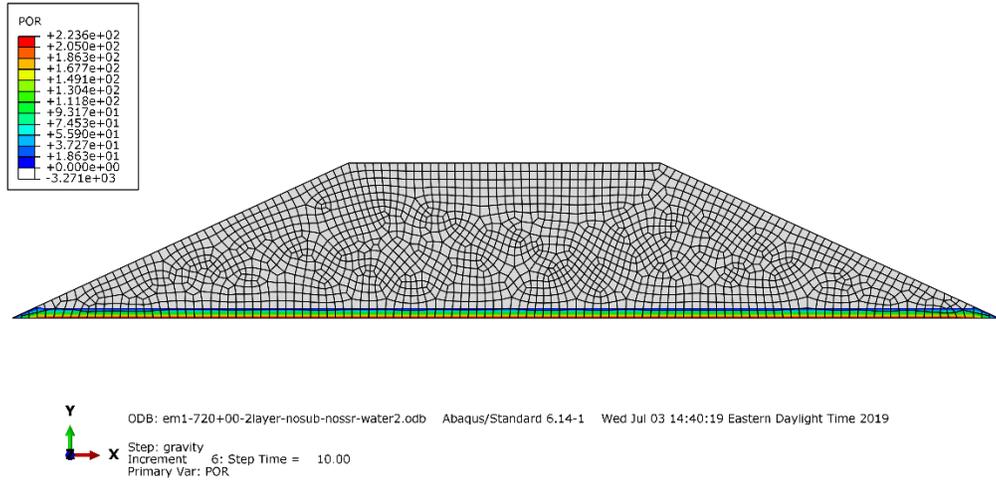
The water table varied from 1206.6-ft to 1214.0-ft from the piezometer readings at cross section 720+00. This indicated that the water table was below the bottom of the embankment, which was at 1216-ft. However, considering the growing trend in the latest readings of April, there is a possibility that the water table will reach the elevation which is above the bottom of the embankment. Two elevations were selected to analyze the influence of the potential water level, 1218-ft and 1220-ft, which were 2-ft and 4-ft above the toe, shown in Figure Vd.12.

Figure Vd.12 – Two elevations of the phreatic surface indicated by the positive pore pressure

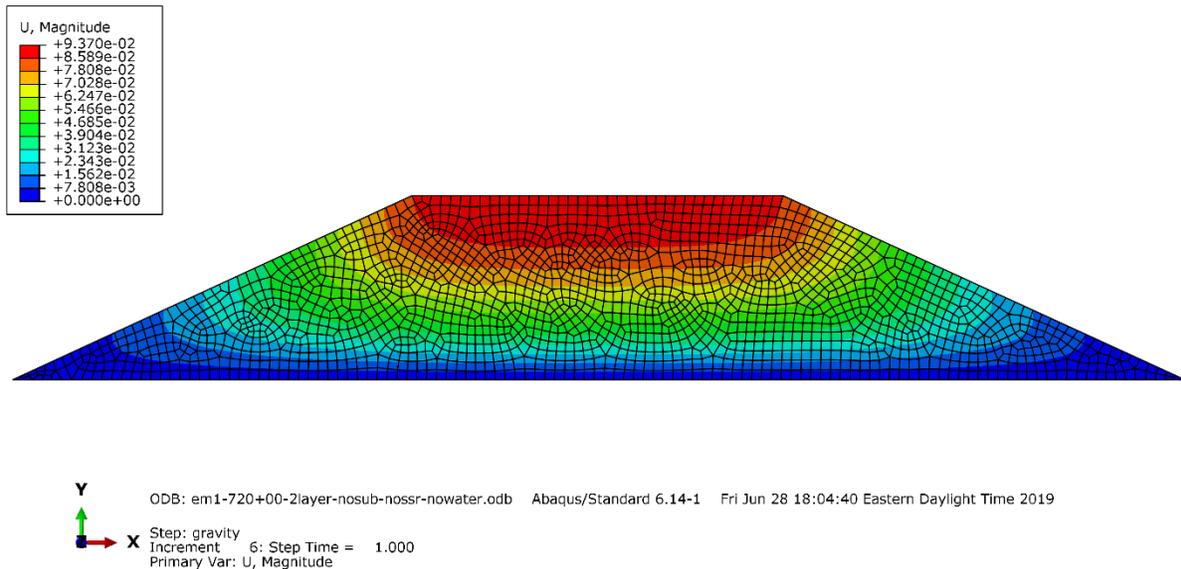
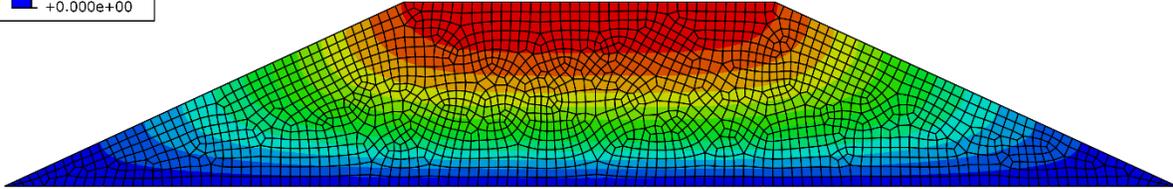
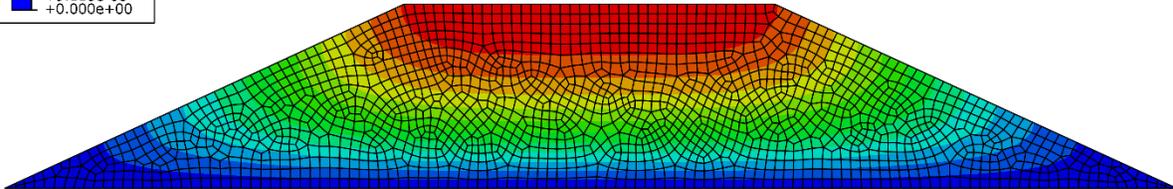
Figure Vd.13 indicated the total displacement at cross section 720+00 with different elevations of water table. The total displacement was plotted against the vertical distance between the phreatic surface and the lower toe in Figure Vd.14. The total displacement increased when the water level rose from 0-ft to 2-ft from the toes.

Figure Vd.13 – Total displacement in the Embankment #1 at cross section 720+00 with (a) no water as well as with phreatic surface at an elevation of (b) 1218-ft and (c) 1220-ft

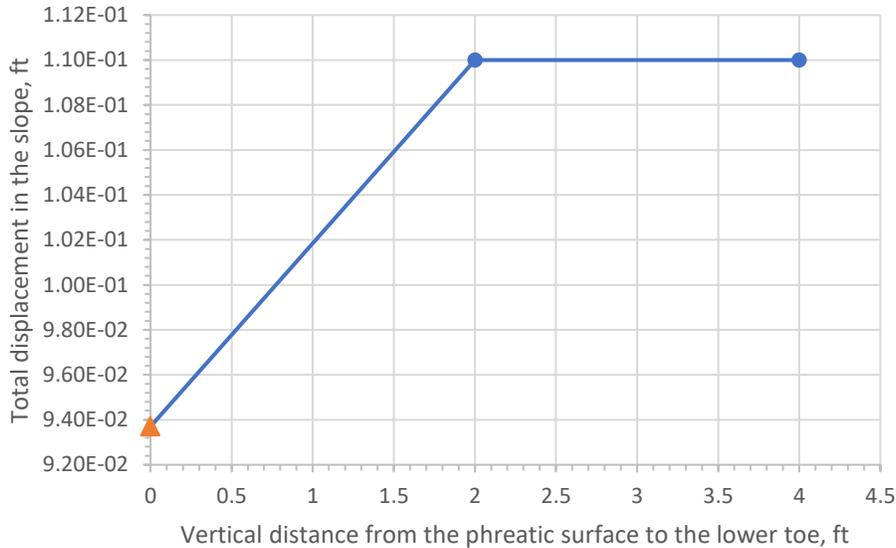
Figure Vd.14 – Total displacement versus the vertical distance between the phreatic surface and the lower toe at cross section 720+00

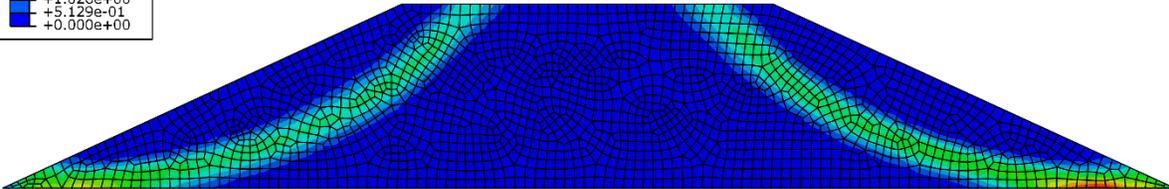
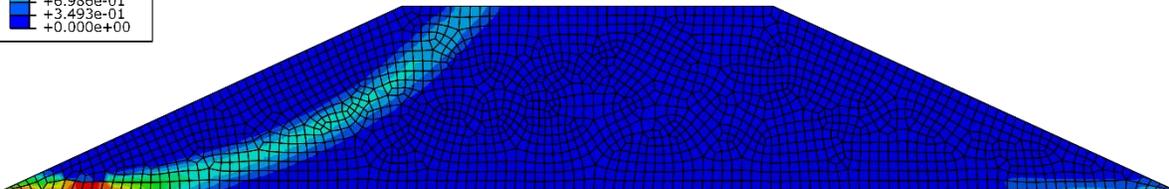
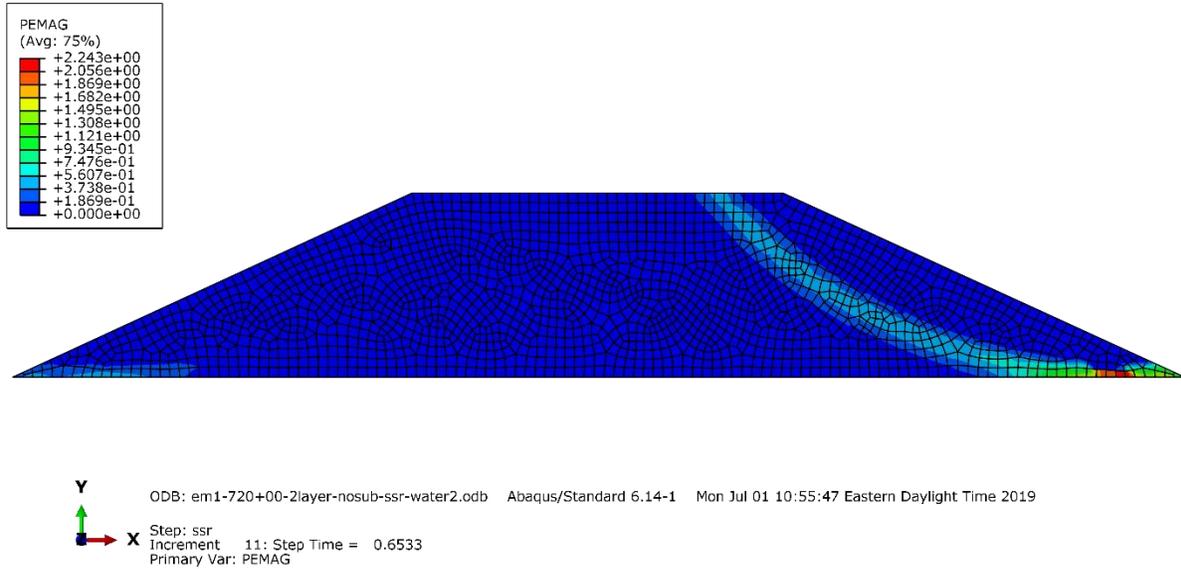
The rupture surface at failure was tracked by the development of plastic shear strain. Figure Vd.15 indicates the magnitude of the plastic strain at cross section 720+00 with different elevations of water table. A large difference was observed in the potential plastic zone in different water contents. Without water, both slopes present the plastic strain zone which indicated that the slipping surface will happen at both sides. When the water level was 2-ft above the toe, the left side was the critical one for the reason that the water level is still very low and the left side, which is the lower side, will take more influences from water than the higher side, the right side. However, when the water level reached 4-ft, the right side becomes the critical one because the water level has covered both sides, and due to the right side has a higher slope, and water will enlarge such difference, making the weaker side much weaker.

In addition to the locations, the plastic zone itself was different. When there was water, the plastic zone more concentrated on the lower part, and the concentration at the bottom of the slope became more intense.

Figure Vd.15 – Potential plastic strain in the Embankment #1 at cross section 720+00 with (a) no water as well as with phreatic surface at an elevation of (b) 1218-ft and (c) 1220-ft

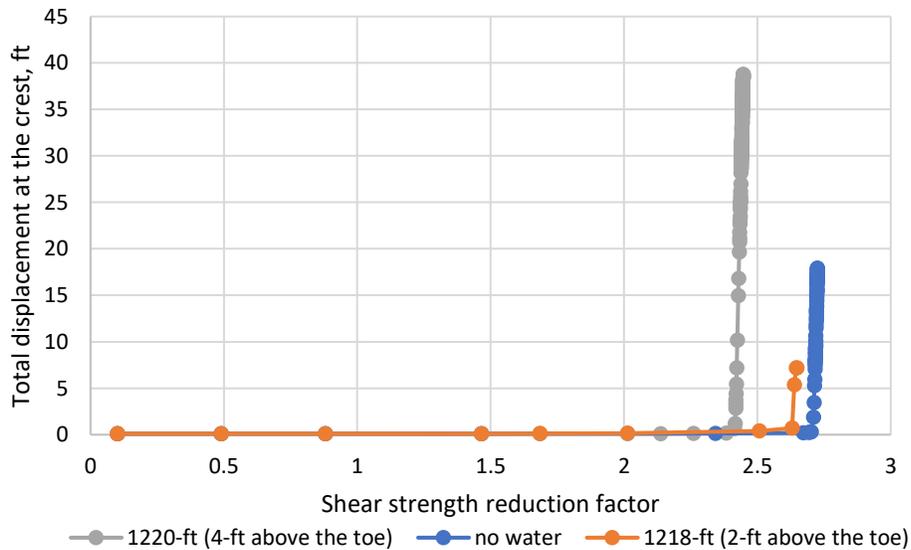
The determination of the factor of safety in three different conditions of water content was summarized in Figure Vd.16. The total displacement was plotted against the strength reduction factor in this process. As the water level increased, the factor of safety decreased a little bit, but the embankment was still safe as shown in Figure Vd.17.

Figure Vd.16 – Determination of the factor of safety by plotting the total displacement at the crest versus the lower point of the slope

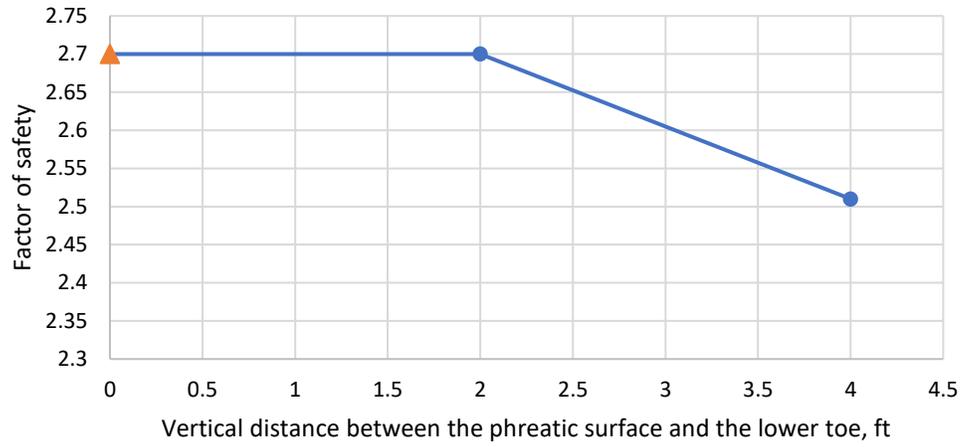
Figure Vd.17 – Factor of safety of Embankment #1 at cross section 720+00 with different ground water tables

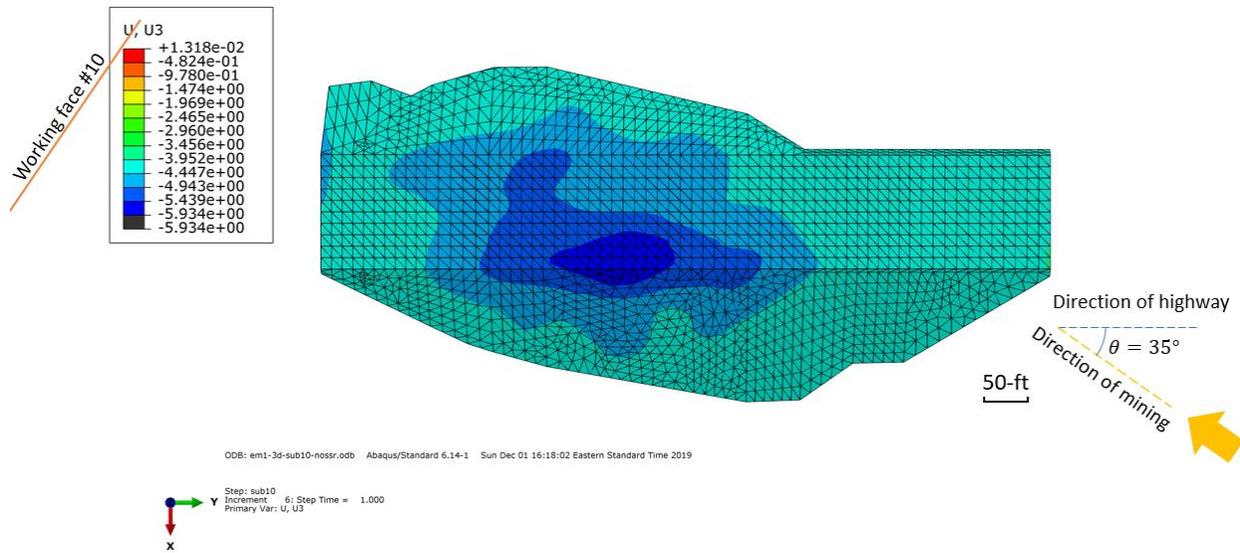
Figure Ve.7 – Vertical displacement on the surface of the Embankment # 1 subjected to successive subsidence

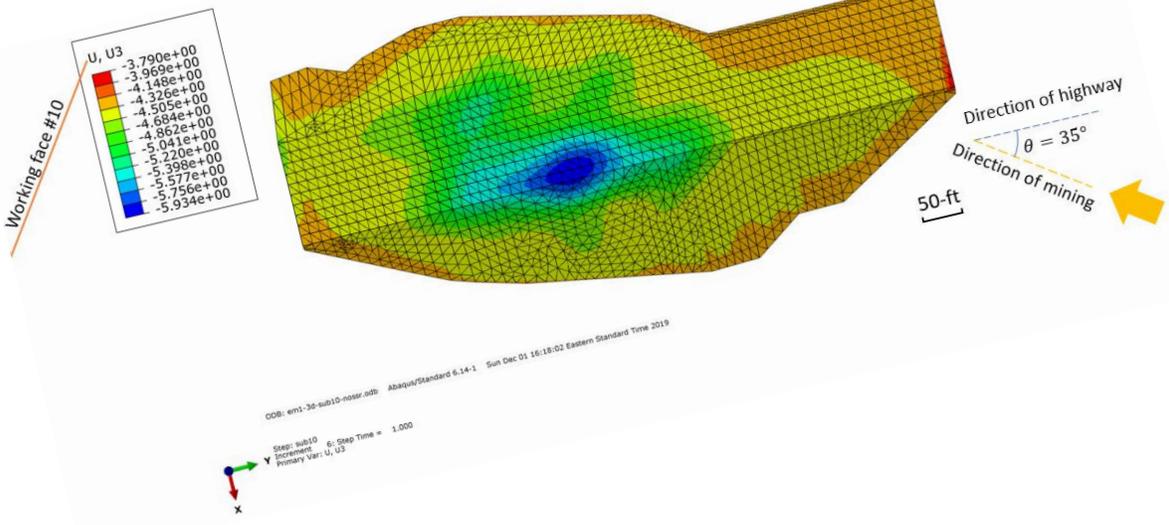
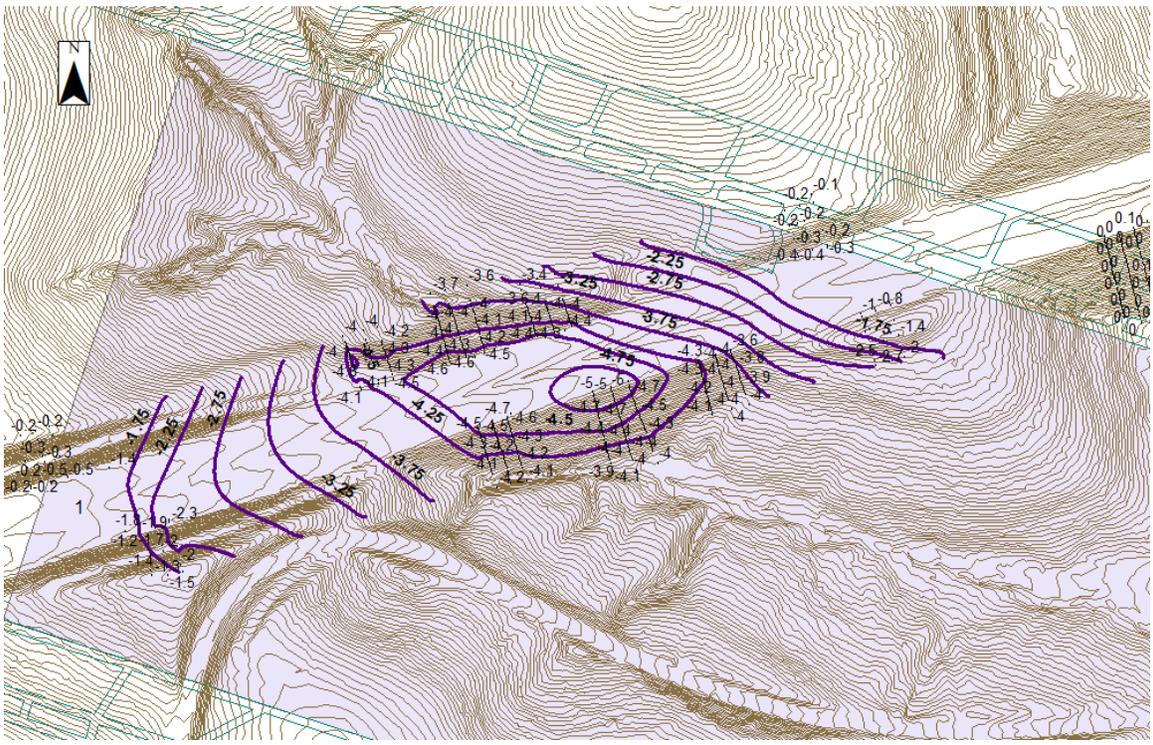
The final vertical displacement from the FEM was then compared to what was measured in the field shown in Figure Ve.8. The vertical component of the displacement was obtained from the slope stake survey and was plotted using ArcGIS.

Both figures show that the region with the maximum displacement was located in the center of the highway segment on the east bound lane. The magnitude of the maximum displacement from the FEM was 5.9-ft, which was larger than the field measurement of 5-ft. The possible the reason for this difference is that the FEM embankment was subjected to a flat subsidence in this preliminary result. In Task 3, a 3D subsidence basin will be applied to the FEM of the embankment to get a more accurate representation of the subsidence effects on the embankment.

Figure Ve.8 – Vertical subsidence contour on the highway Embankment #1 from (a) Finite Element model and (b) field measurement with the working face as shown (also see Figure Va.9)

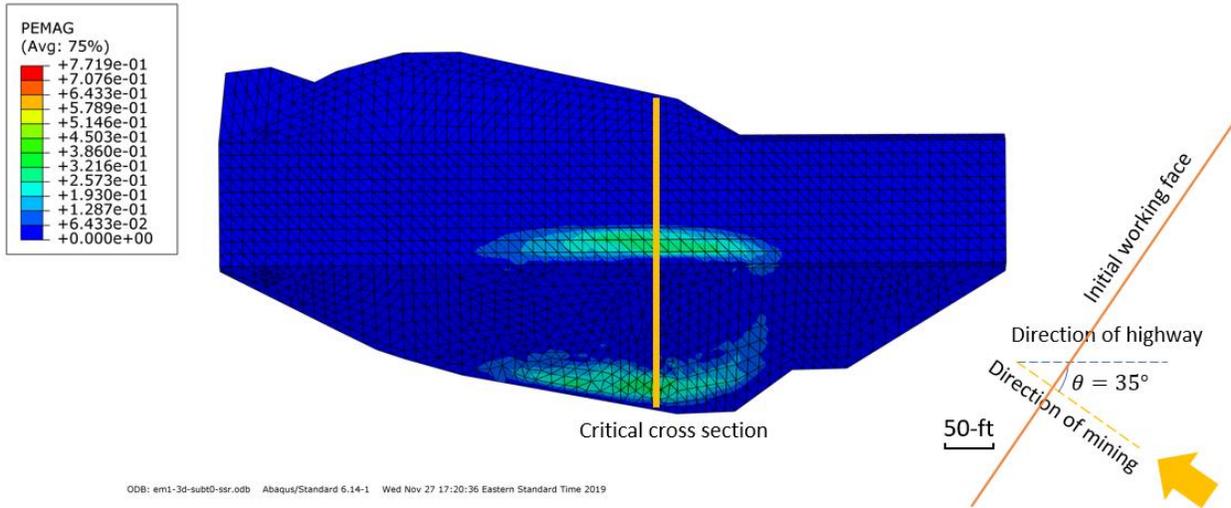
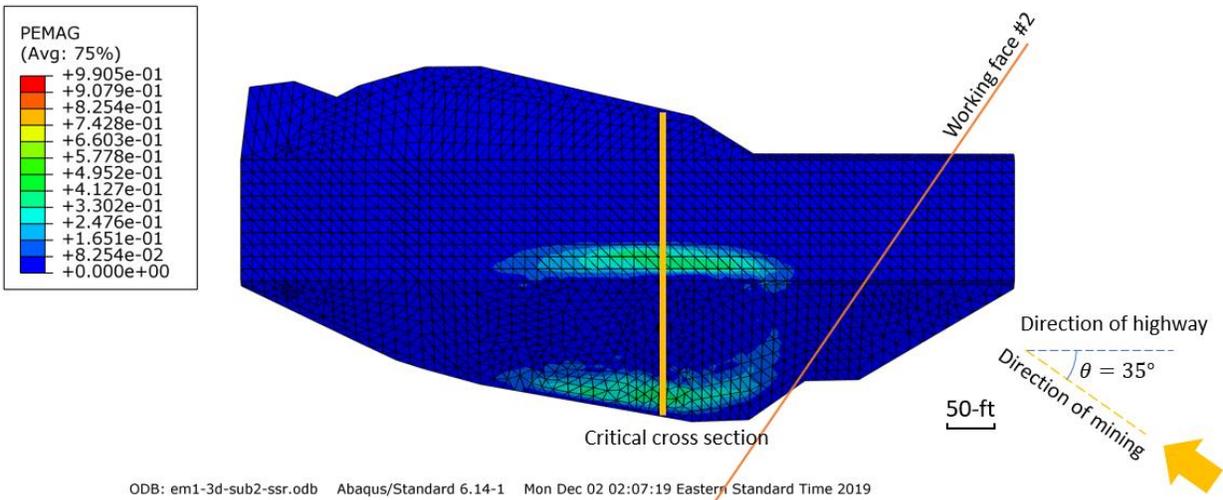
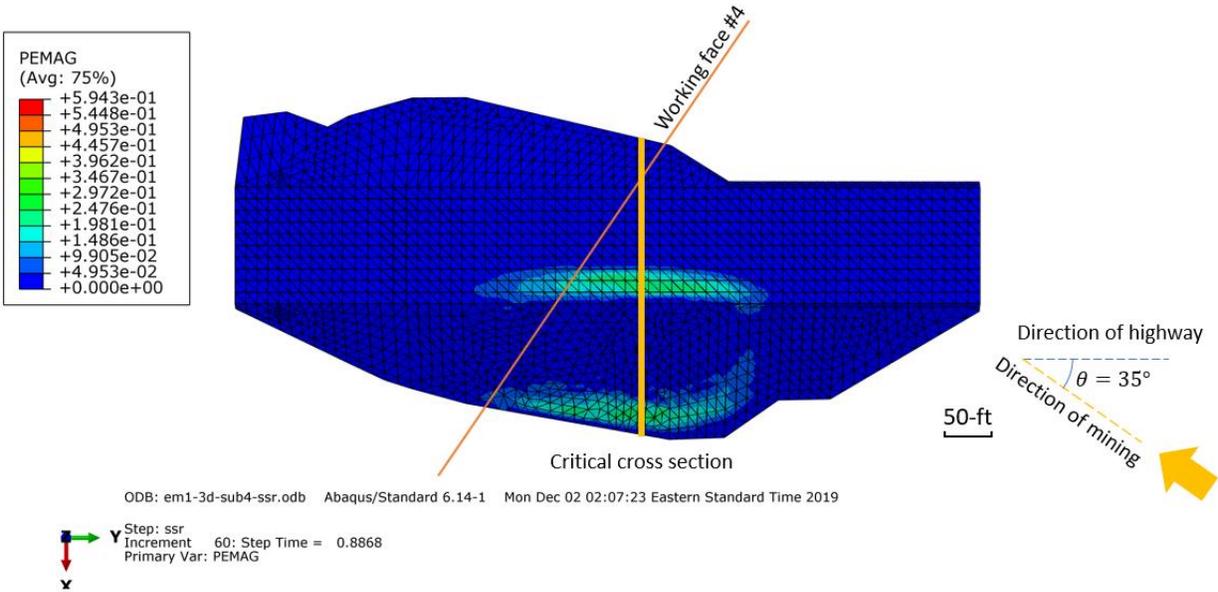
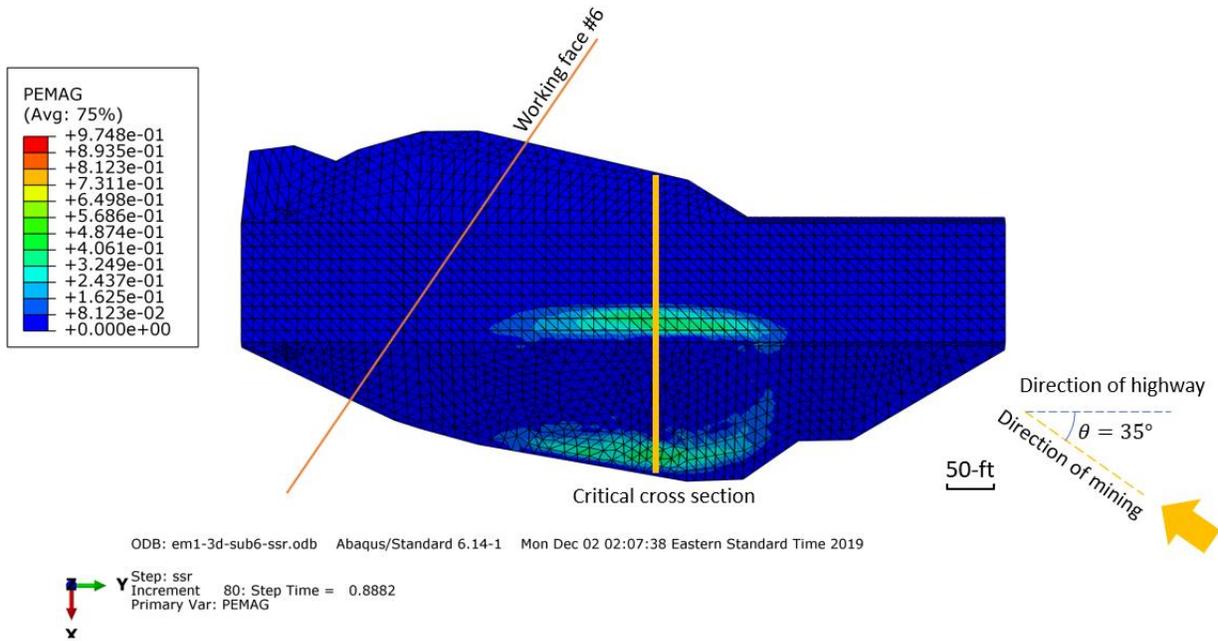
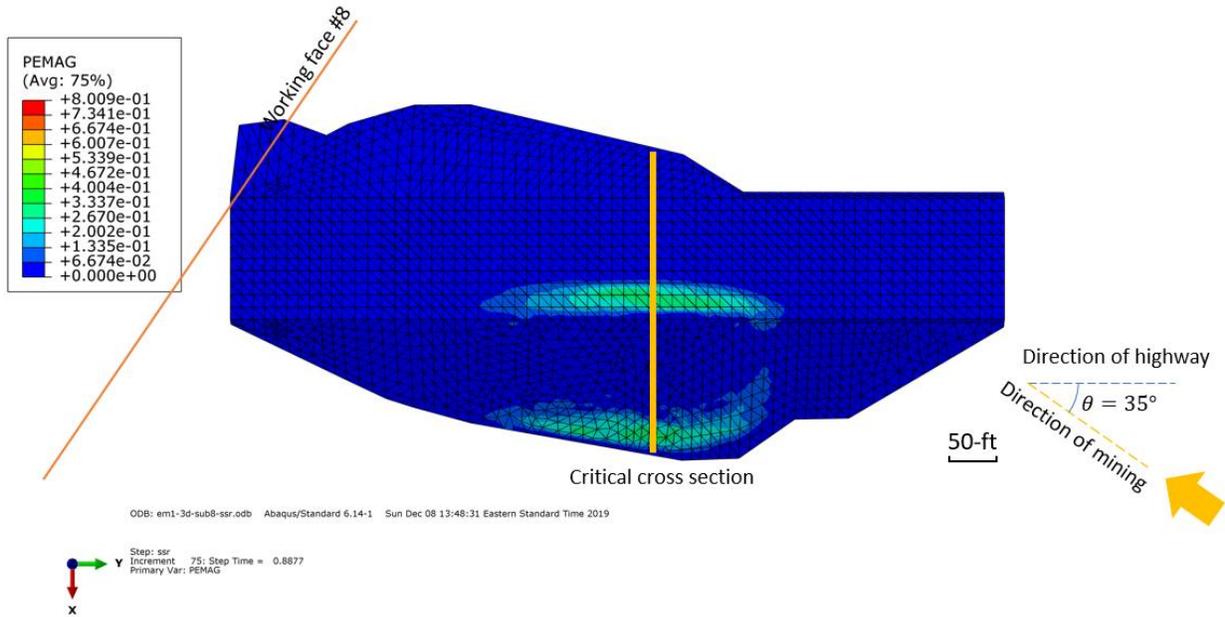
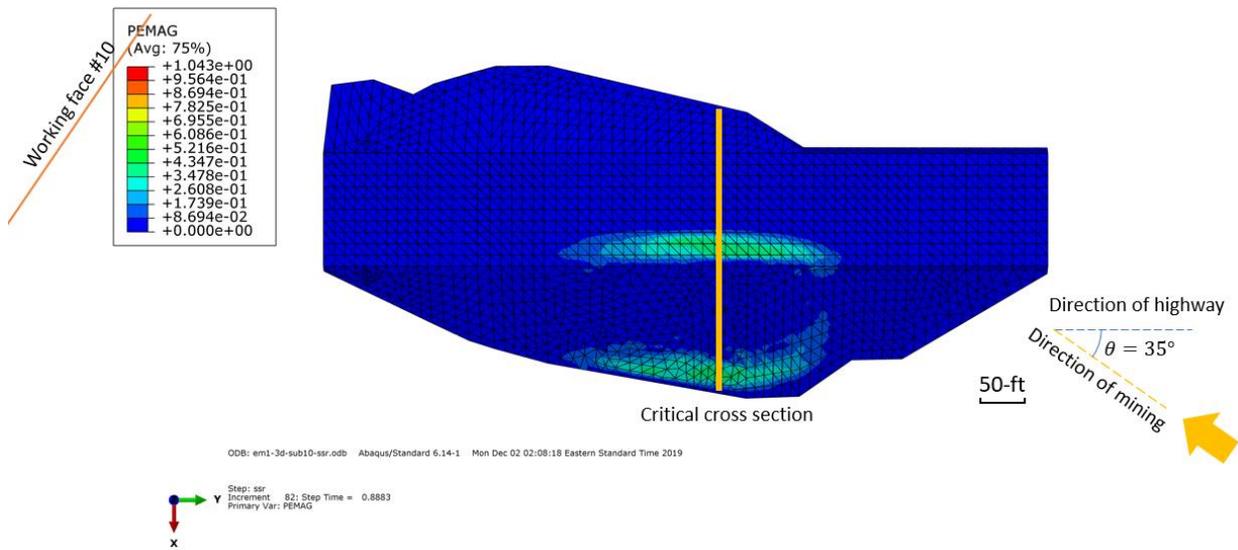
Centrifuge tests have indicated that the plastic shear strain zone in unstable slopes coincided with rupture surface (Roscoe, 1970). The SRM can be utilized to make the embankment collapse and identify the critical area with the higher plastic strain. The critical area was utilized to conduct the factor of safety analysis in the next section. Figure Ve.9 indicates the magnitude of the plastic strain in the embankment at the final point of SRM when a complete sliding failure happened. The contours resulted from four steps of successive subsidence wave. The critical cross section was located on the south facing slope in the middle of the longitudinal length of the embankment.

Figure Ve.9 – Critical cross section for the factor of safety analysis when the working face is (a) 0-ft; (b) 270-ft; (c) 540-ft; (d) 810-ft; (e) 1080-ft and (f) 1350-ft away from the initial position

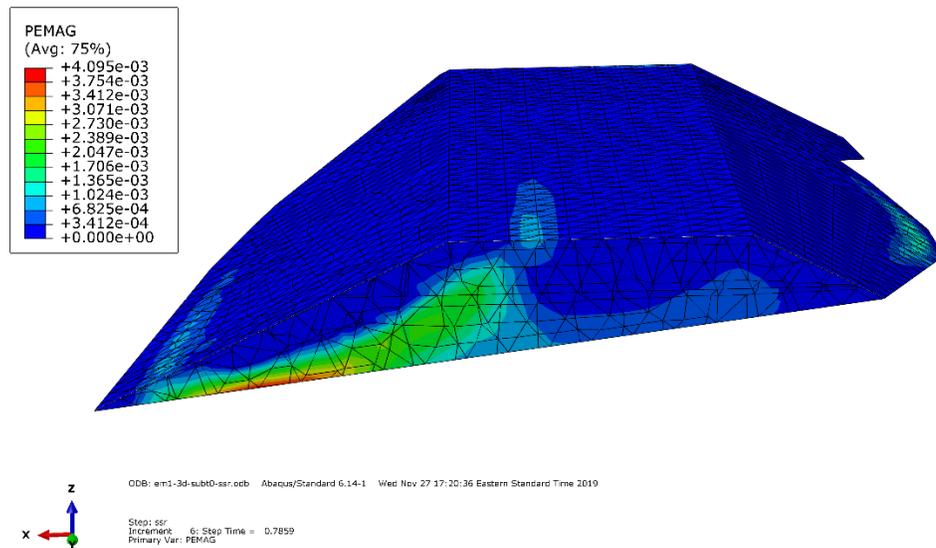
The factor of safety analysis of the embankment without subsidence was conducted first. Figure Ve.10 indicates the plastic strain inside the embankment at the critical cross section. This state of plastic strain happened when the analysis reached the knee point of the factor of safety plot (Figure Ve.11). The shear band has reached the top of the embankment and a complete rupture face was formed.

Figure Ve.10 – Magnitude of plastic strain inside the Embankment #1 at the critical cross section
