IDENTIFICATION OF FACTORS CONTROLLING THE DEVELOPMENT OF SUBSIDENCE IMPACTS FORECASTING METHODOLOGY TO THE I-70 ALIGNMENT OVER LONGWALL MINING OF THE TUNNEL RIDGE MINE, WASHINGTON COUNTY, PA

Task 2: Undermining Activities Report
Submitted 3 February 2020; Finalized on 4 January 2021

The University of Pittsburgh Master Agreement
Contract No. 4400018535

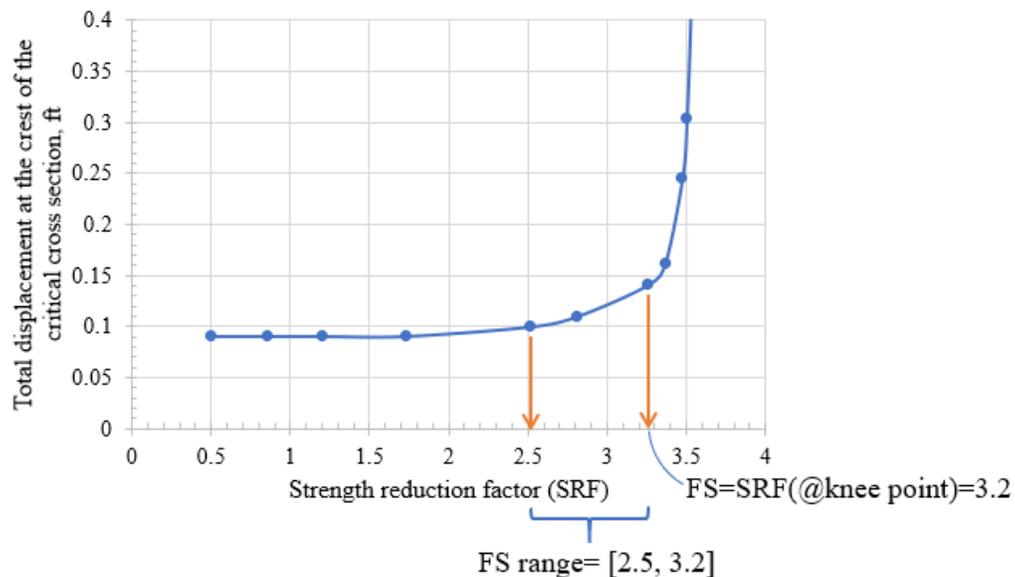
Figure Ve.11 – Total displacement at the crest of the critical cross section versus the shear strength reduction factor for the case without subsidence

However, before the displacement started to increase exponentially (which means the embankment collapsed), the plot was not horizontal but an inclined curve, indicating that the embankment already experienced sliding deformation before the total collapse. The factor of safety range is introduced here to better describe the stability of the embankment. It started from the point when the displacement started to increase and ended at the knee point. The lower bound of this range can be utilized to identify if the embankment will experience sliding deformation. And the upper bound helped us determine if the embankment will collapse and experience large deformation. For this case, without subsidence, the upper bound and lower bound are close to each other. The embankment started to slide at an SRF of 2.5 and failed at an SRF of 3.2.

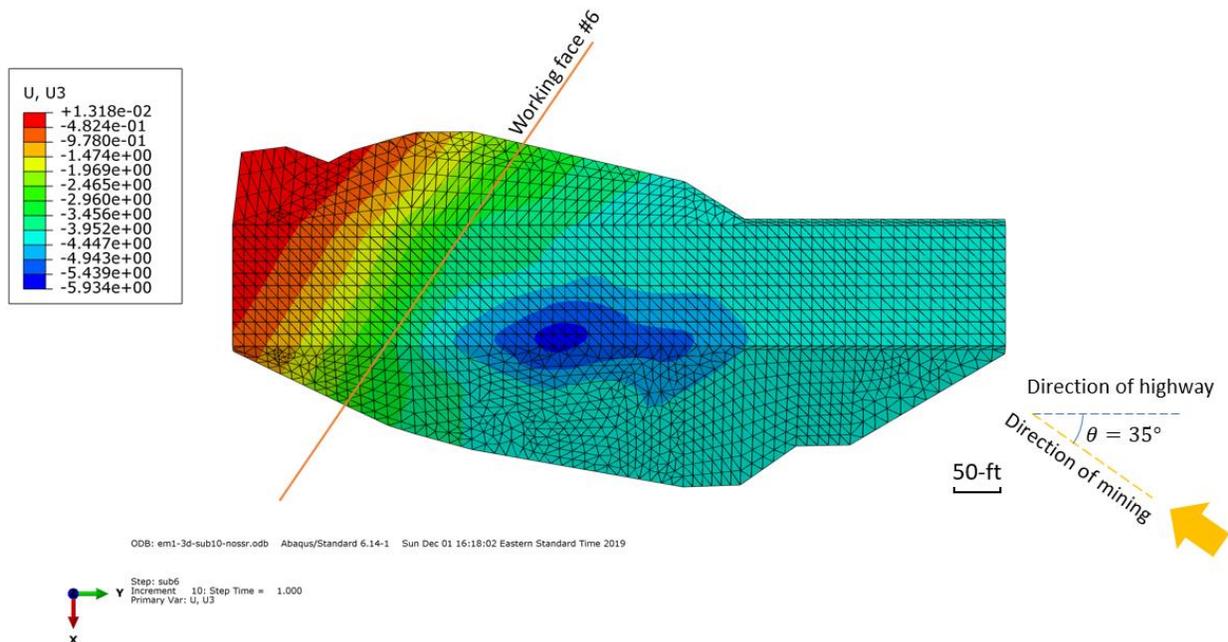
For the case when the embankment was subjected to the subsidence, it was more difficult to identify the knee point because more deformation appeared before the knee point. Consequently, the factor of safety range is more reasonable than using a single factor of safety. The case when the Embankment #1 was subjected to the subsidence with the working face reached the middle of the highway segment (Subsidence #6 in Figure Ve.12) was chosen to explain how the factor of safety was determined.

Figure Ve.12 – Embankment #1 subjected to subsidence #6

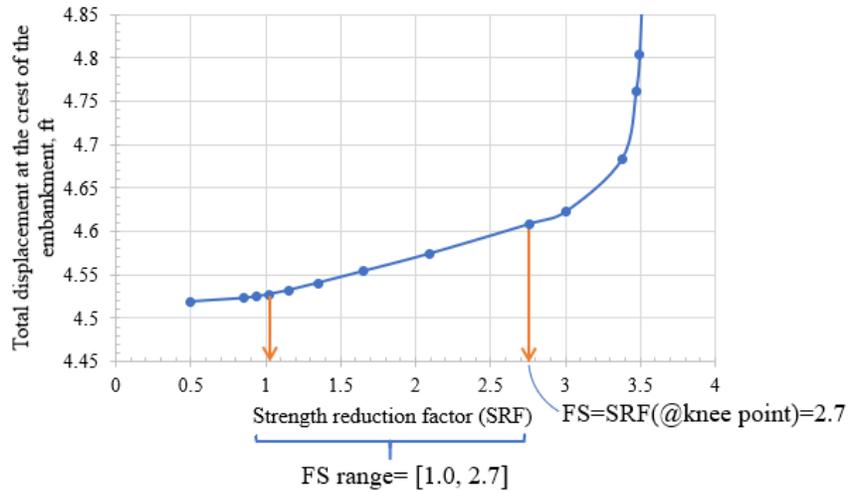
As shown in Figure Ve.13, the upper bound of the factor of safety range is 2.7, which means that the embankment was safe and would not collapse. However, the plot before this point presented more movement compared to that without subsidence. In addition, the embankment started to slide at 1.0. The movement increased at a greater rate from this point. Before this point (SRF=1), the displacement increased at a rather low rate and the plot is almost horizontal. The lower bound of the factor safety reflected that the embankment will experience some sliding deformation

though it is safe and stable. In this way, the factor of safety range better describes the stability and behavior of the embankment, especially when subjected to subsidence.

Figure Ve.13 – Total displacement at the crest of the critical cross section versus the shear strength reduction factor for the case with subsidence of #6

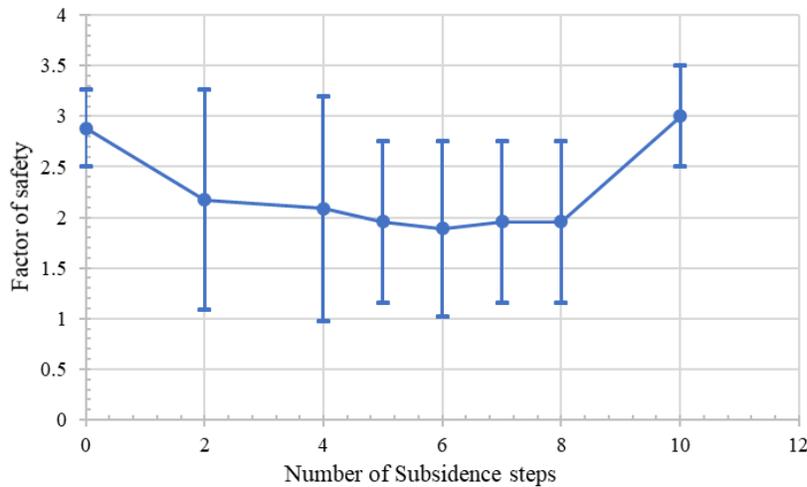
Figure Ve.14 – Plot of factor of safety versus the longwall face positions or subsidence steps

The factor of safety of the embankment decreased when subjected to subsidence and reached the lowest value at step #6 where the working face is around the middle of the embankment. After the subsidence passed the highway segment and the embankment settled down, the factor safety increased and even became higher than the factor of safety before subsidence. The position of working face at each step and the vertical displacement contour was shown in Figure Ve.9.

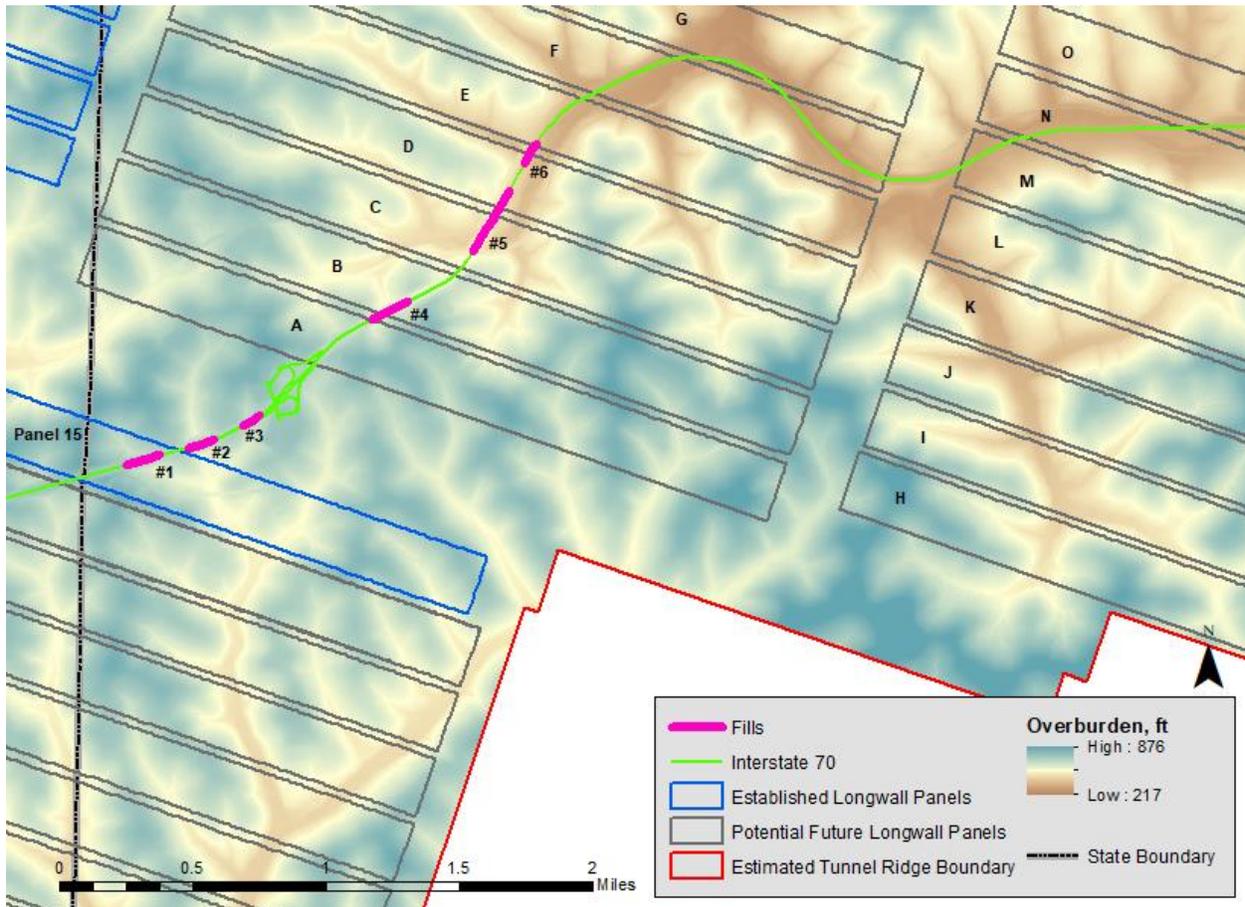
A major focus of this research study has been to understand how embankments, constructed to carry the I-70 alignment, would perform when subjected to subsidence from longwall mining. Two of these embankments (Embankments #1 and #2) are located above or adjacent to Panel 15 (Figure VIc.1). The University has provided extensive field and laboratory analysis to help characterizing embankment performance throughout this report. Embankment #1 was subjected to over 4-ft of vertical subsidence at its base. Consolidation and spreading of the embankment added to this total resulting in as much as 5-ft of vertical subsidence. In addition, shear bands near the base of the embankment were partially mobilized, indicating a potential instability in parts of the embankment. The threat of instability was overcome by the strain-hardening material properties of the embankment fill (see Section V). As a result, Embankment #1 did not fail. Embankment #2 was located on the edge of the Panel 15 subsidence basin and was not adversely affected.

Figure VIc.1 – Five significant embankments were constructed between the West Virginia State Line and the Claysville Interchange. Two of the embankments, #4 and #5, are located within the extended study area.

Three other embankments occur within the extended study area (Figure VIc.1). Embankment #3 is close to the West Alexander Interchange and is not expected to be undermined by longwall mining. Embankment #4 will likely be undermined with an overburden ranging from 500 to 730-ft. The angle of the I-70 highway alignment with the projected orientation of the longwall face will be approximately 10-deg less than the 35-deg angle formed by Panel 15. This embankment is approximately 650-ft long and 52-ft tall. Embankment #5 will likely be undermined with an overburden ranging from 410 to 640-ft. The embankment and I-70 highway alignment are both parallel to the longwall face. It is approximately 650-ft long and 70-ft tall. Embankment #5 represents an increased risk and will be analyzed in greater detail in the coming months.
