## **SECTION VII: Effects of Mining on Land**

## **VII.A - Overview**

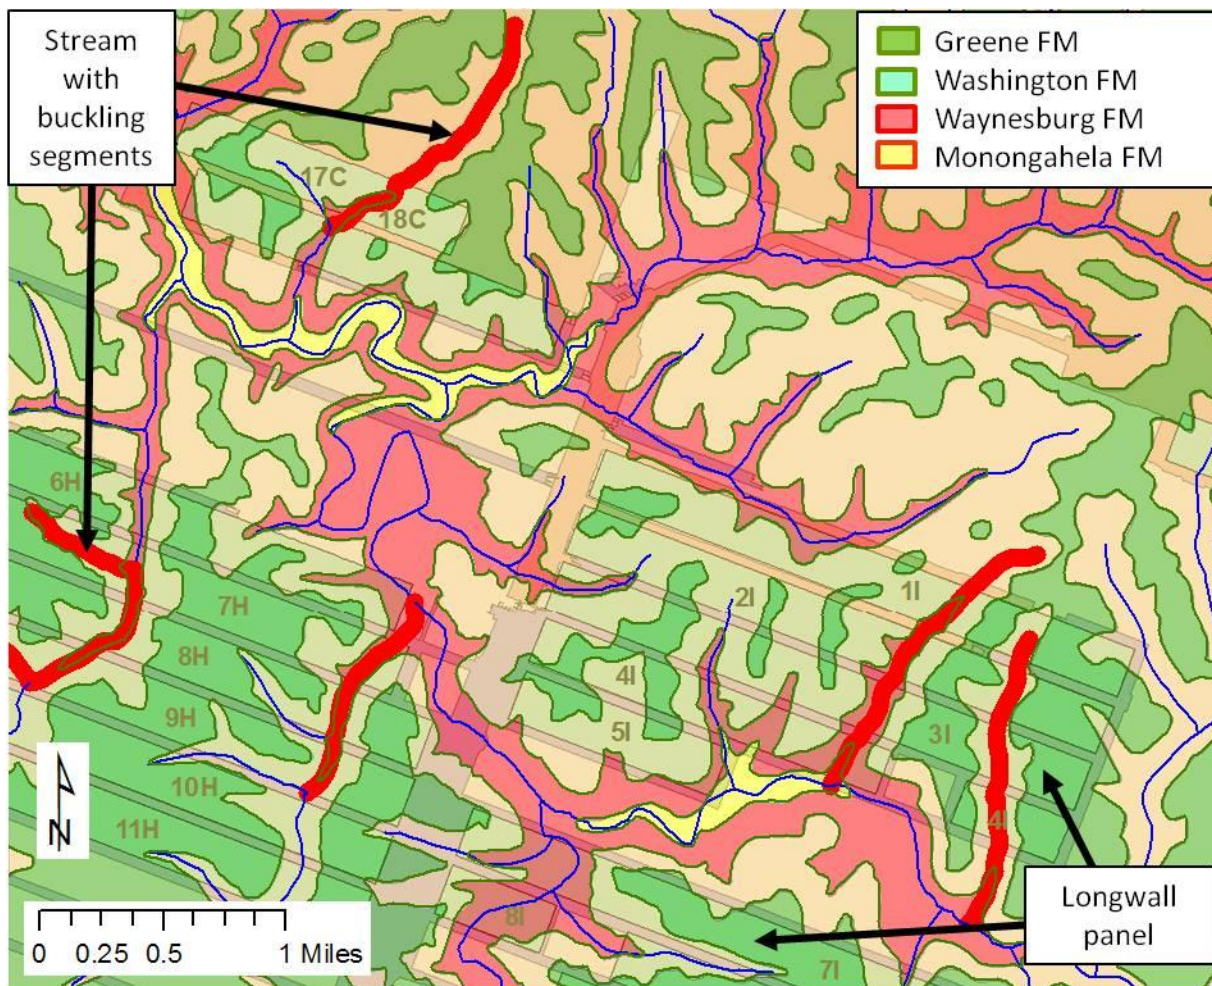
The compression ruptures shown in Figure VII-7 were located over the Bailey Mine (Figure VII-8). The majority of the segments were oriented in the Northeast direction. Molinda, et al. (1992) reported similar stream orientation for areas of increased roof instabilities in coal mines. The University believes that streams oriented in this direction have a higher likelihood for compression ruptures. Also note that most of the streams with compression ruptures were located within the Washington and Waynesburg Formations (Figure VII-8).

Figure VII-8 – Location of stream segments with compression rupture (thick red lines) above the Bailey Mine. Rock formations outcrop areas are also shown: Greene FM, Washington FM, Waynesburg FM, and Monongahela FM.

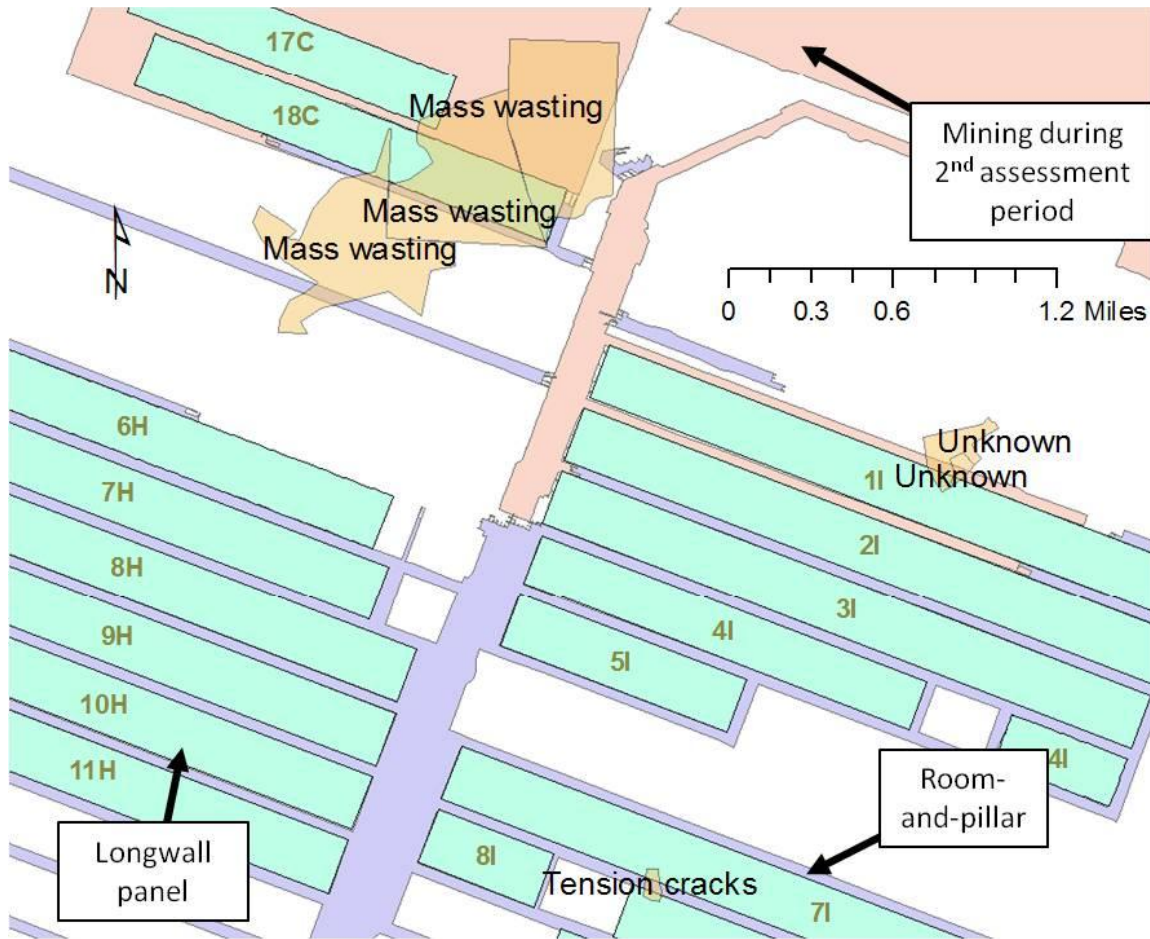
The Bailey Mine had 13 land reported effects. The location of the six assigned as Company Liable or Interim Resolution are shown in Figure VII-9. The three properties having impacts caused by mass wasting were adjacent to one another. The two unknown causes were related to driveway impacts. The one property with tension cracks was located over a gate road.

*Figure VII-9 - Location of properties with land reported effects where Company Liable or Interim Resolution was the outcome at the Bailey Mine. Note – property boundaries are in tan and the principle causes are highlighted.*

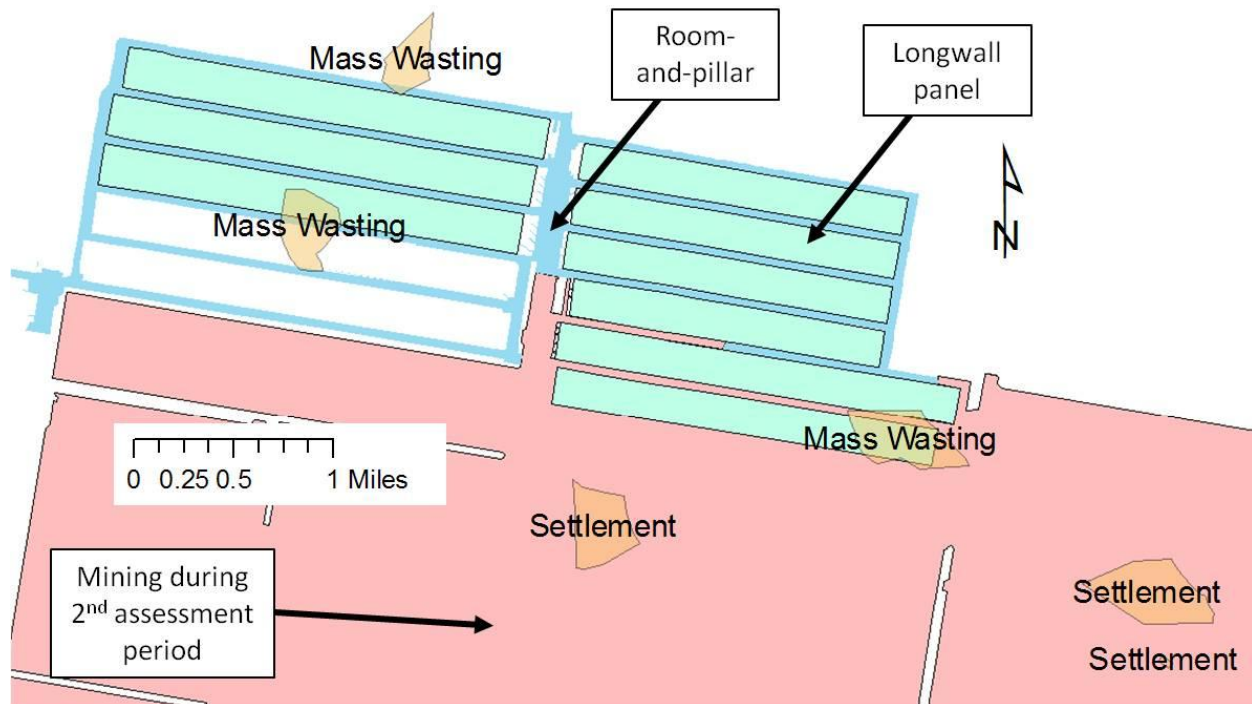
The Blacksville No.2 Mine had seven land reported effects. The location of the six assigned as Company Liable or Interim Resolution are shown in Figure VII-10. Three were caused by settlement and three from mass wasting. All three of the properties with settlement impacts were located over areas mined during the 2<sup>nd</sup> assessment period. Two of the three properties with mass wasting impacts were located, at least in part, over longwall panels mined during the 3<sup>rd</sup> assessment period.

Figure VII-10 – Location of properties with land reported effects where Company Liable or Interim Resolution was the outcome at the Blacksville No. 2 Mine. Note – property boundaries are in tan and the principle causes are highlighted.

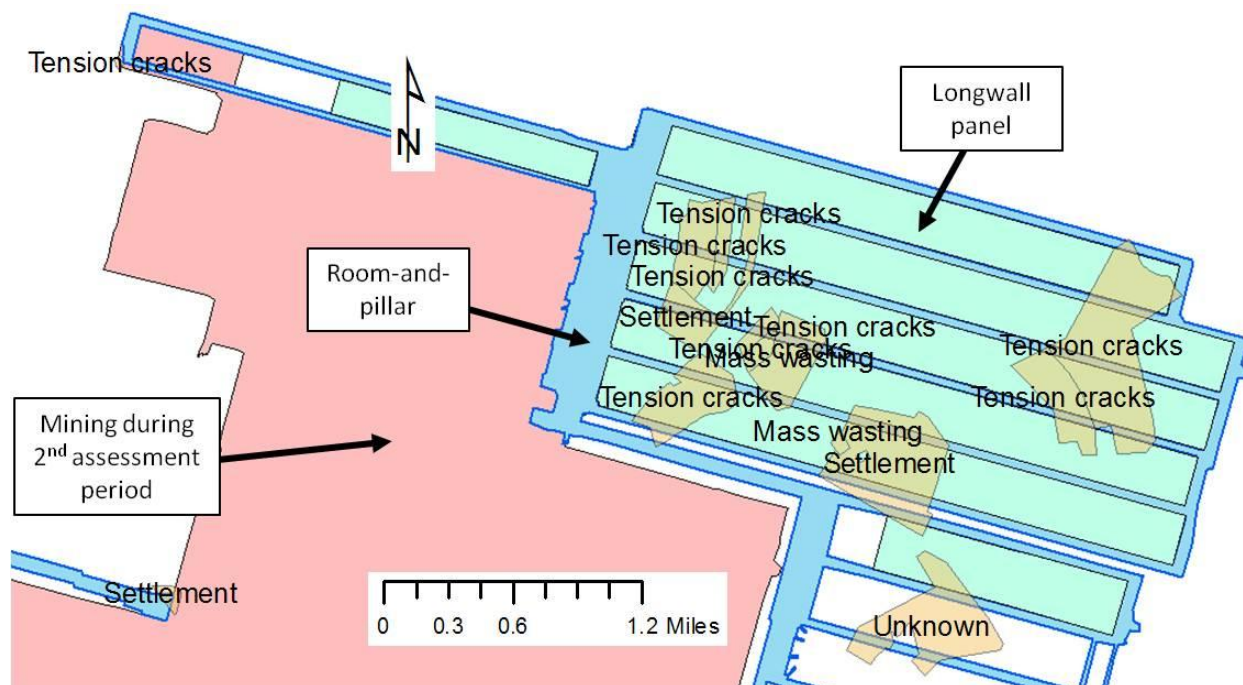
The Cumberland Mine had 21 land reported effects. The location of the 15 assigned as Company Liabile or Interim Resolution are shown in Figure VII-13. The 14 properties, having impacts caused by tension cracks, settlement or mass wasting, were all over longwall panels or gate road entries. The one unknown reported effect occurred late in the 3<sup>rd</sup> assessment period and a cause has not been established.

Figure VII-13 – Location of properties with land reported effects where Company Liable or Interim Resolution was the outcome at the Cumberland Mine. Note – property boundaries are in tan and the principle causes are highlighted.

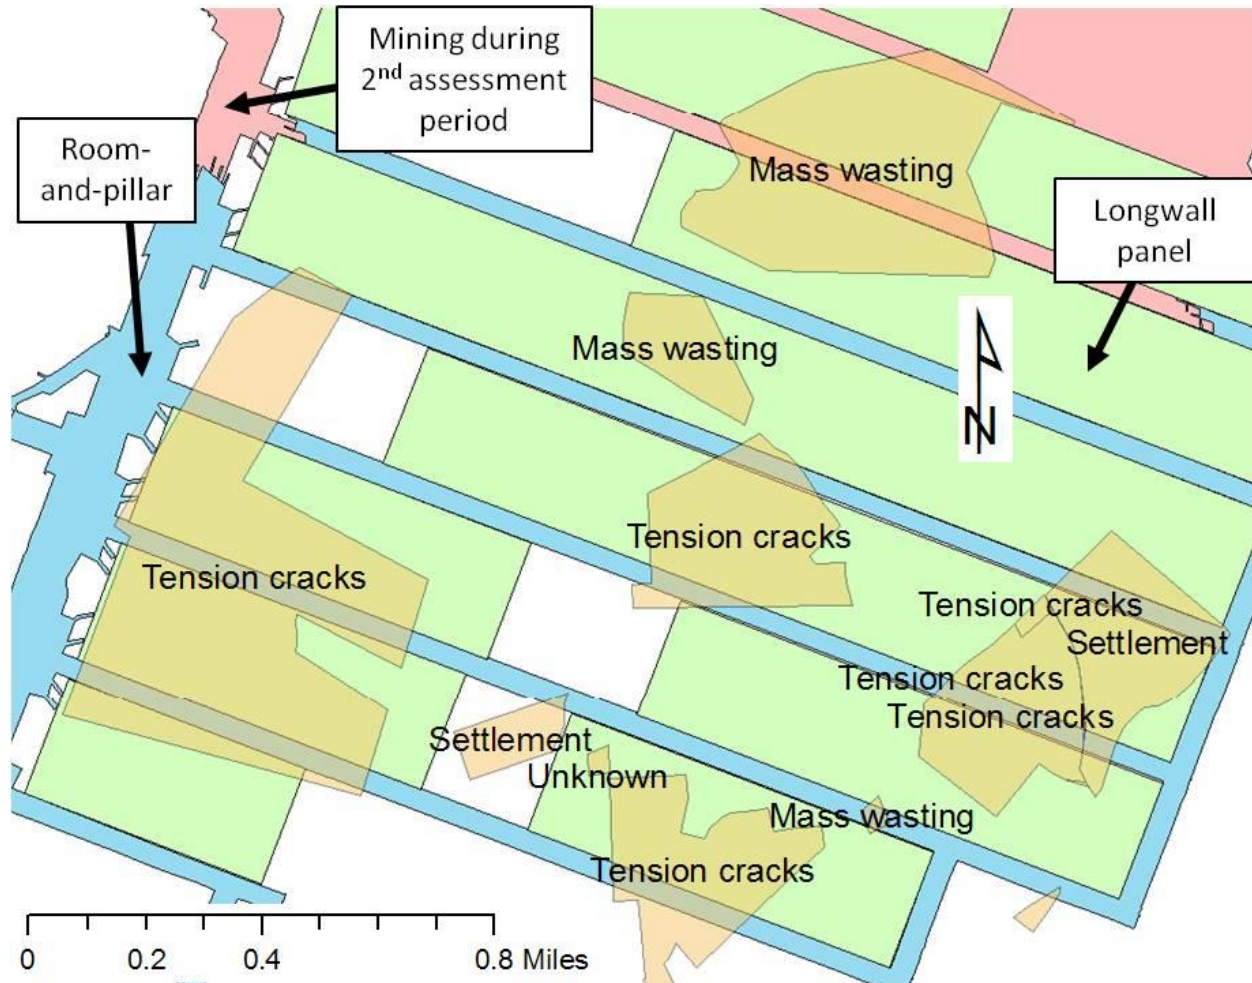
The Mine Eighty-Four had 16 land reported effects. The location of 12 of the 13 assigned as Company Liable, Interim Resolution or, No Resolution are shown in Figure VII-15. One of these properties is far to the north, located over areas mined during the 2<sup>nd</sup> assessment period. Twelve of the properties were located over longwall panels and gate road entries mined during the 3<sup>rd</sup> assessment period.

Figure VII-15 - Location of properties with land reported effects where Company Liable or Interim Resolution was the outcome at Mine Eighty-Four. Note – property boundaries are in tan and the principle causes are highlighted.

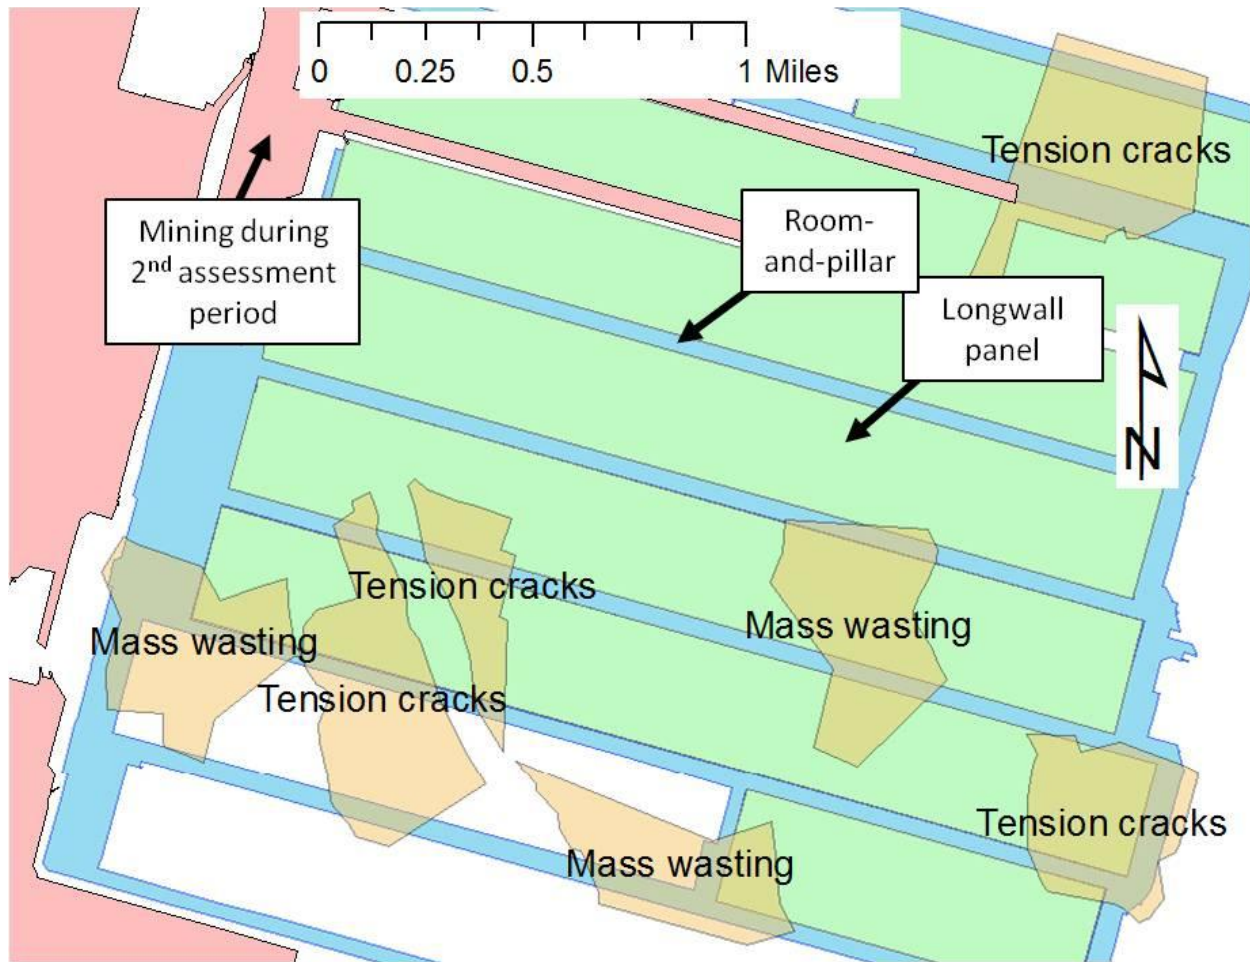
The Emerald Mine had 15 land reported effects. The location of seven of the properties assigned as Company Liable or Interim Resolution at the end of the 3<sup>rd</sup> assessment period are shown in Figure VII-16. Two other properties could not be located. It is possible that they were located over areas mined during the 2<sup>nd</sup> assessment period.

*Figure VII-16 - Location of properties with land reported effects where Company Liable or Interim Resolution was the outcome at the Emerald Mine. Note – property boundaries are in tan and the principle causes are highlighted.*

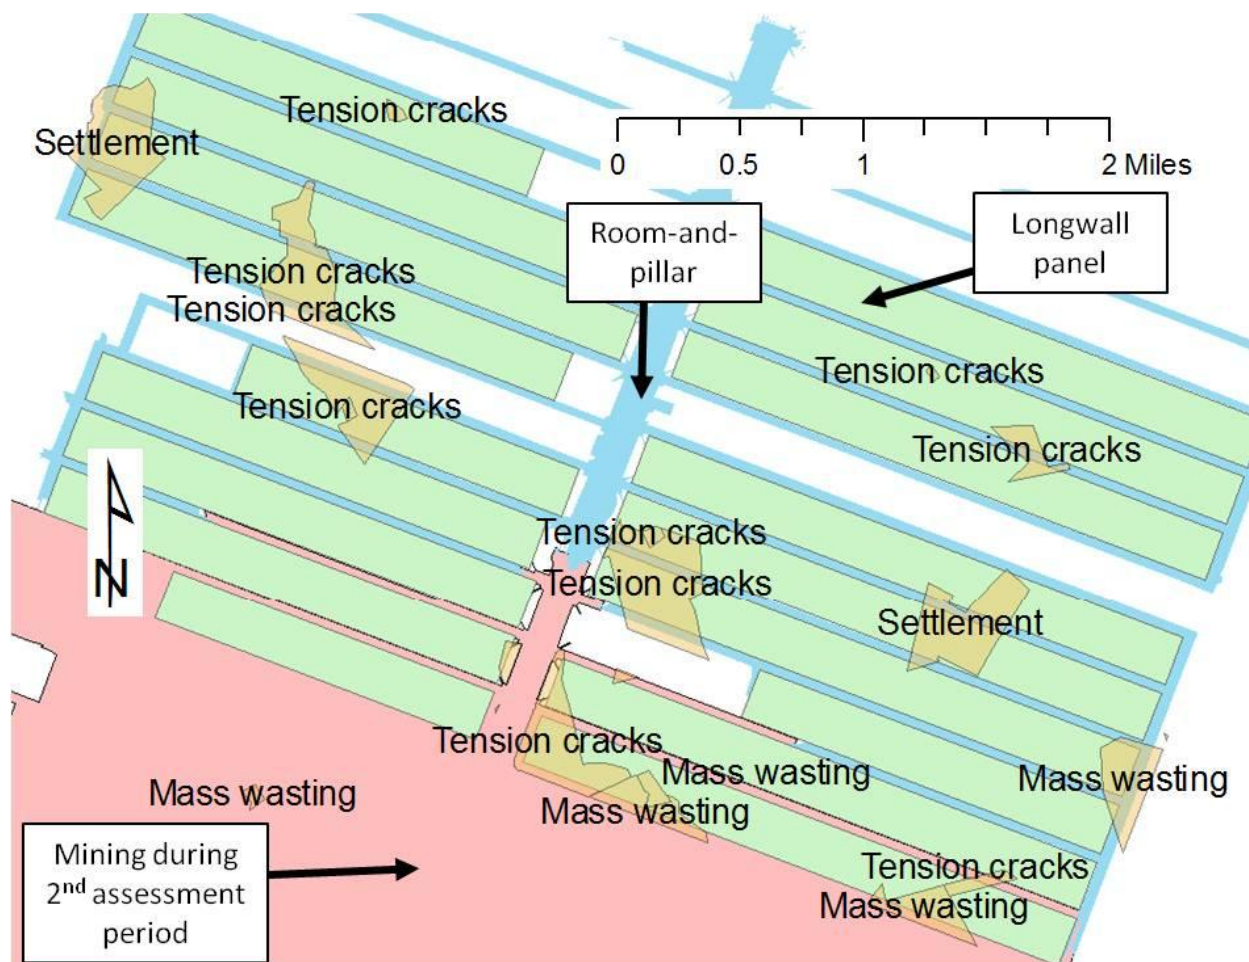
The Enlow Fork Mine had 18 total reported effect, three occurring during the 2<sup>nd</sup> assessment period. The location of the 17 assigned as Company Liable or Interim Resolution are shown in Figure VII-17. There were ten properties with tension cracks as the main cause, five with mass wasting, and two with settlement. Only one of the properties was not over an area mined during the 3<sup>rd</sup> assessment period.

Figure VII-17 - Location of properties with land reported effects where Company Liable or Interim Resolution was the outcome at the Enlow Fork Mine. Note – property boundaries are in tan and the principle causes are highlighted.

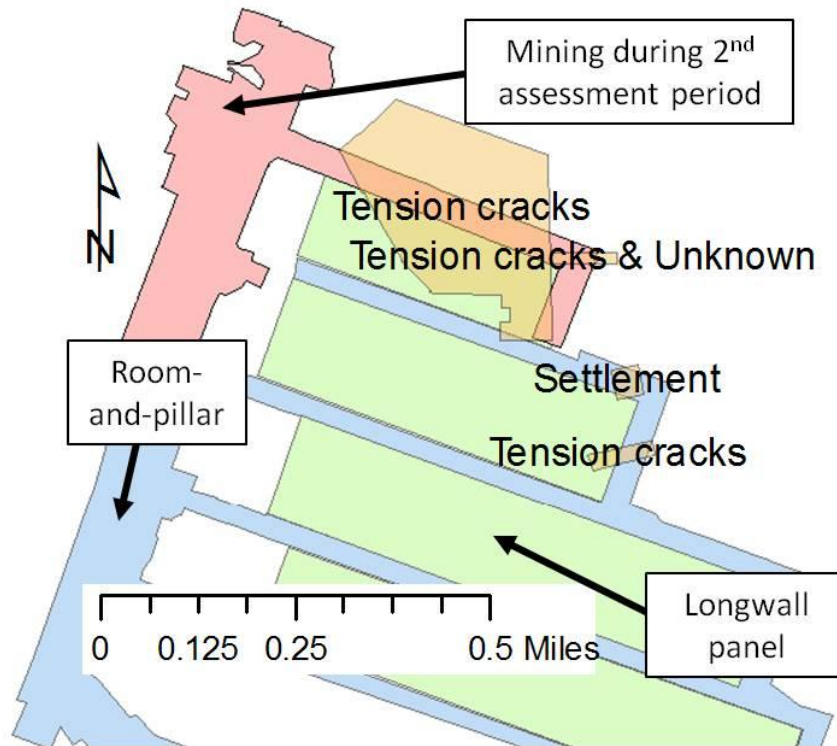
The High Quality Mine had eight land reported effects. The location of the five assigned as Company Liable or Interim Resolution are shown in Figure VII-18. There were three properties with tension cracks as the main cause, one with settlement, and one unknown.

*Figure VII-18 - Location of properties with land reported effects where Company Liable or Interim Resolution was the outcome at the High Quality Mine. Note – property boundaries are in tan and the principle causes are highlighted.*
