THE FAILURE OF THERMAL BARRIER COATINGS AT ELEVATED TEMPERATURES

Submitted to the Graduate Faculty of
the School of Engineering in partial fulfillment
of the requirements for the degree of
Doctor of Philosophy

University of Pittsburgh

2004

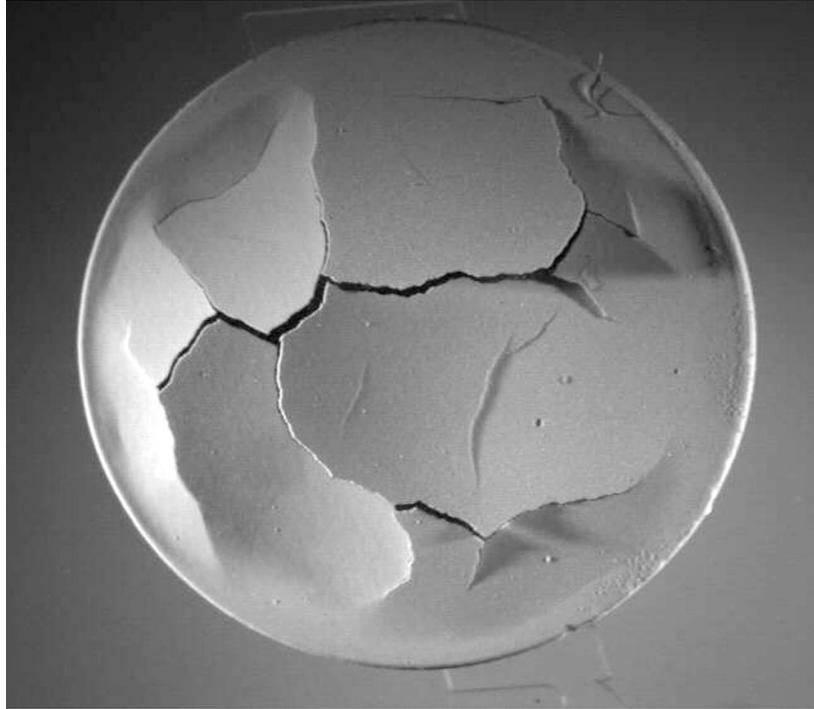
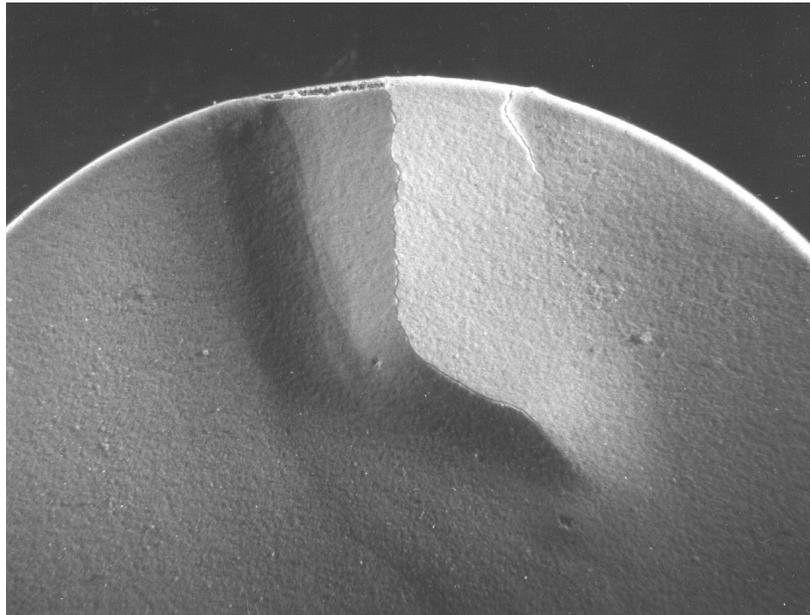
Figure 7 Macrographs showing the typical TBC failures, (a) and (b).

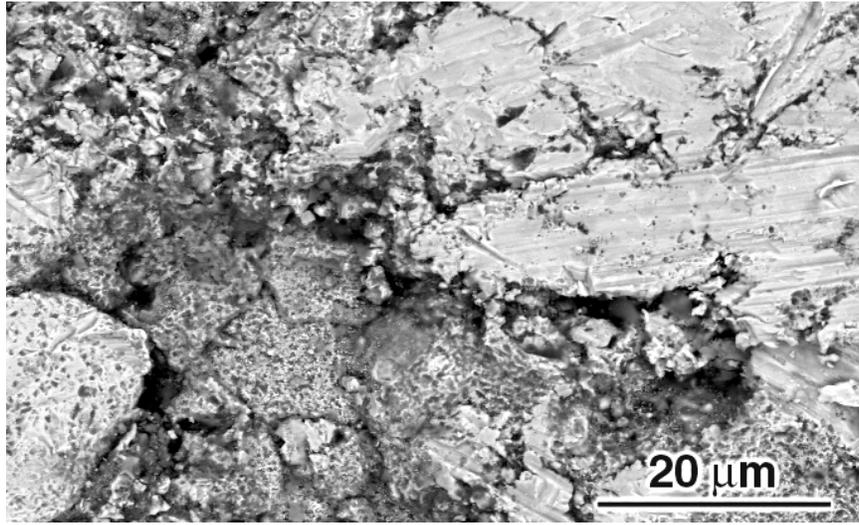
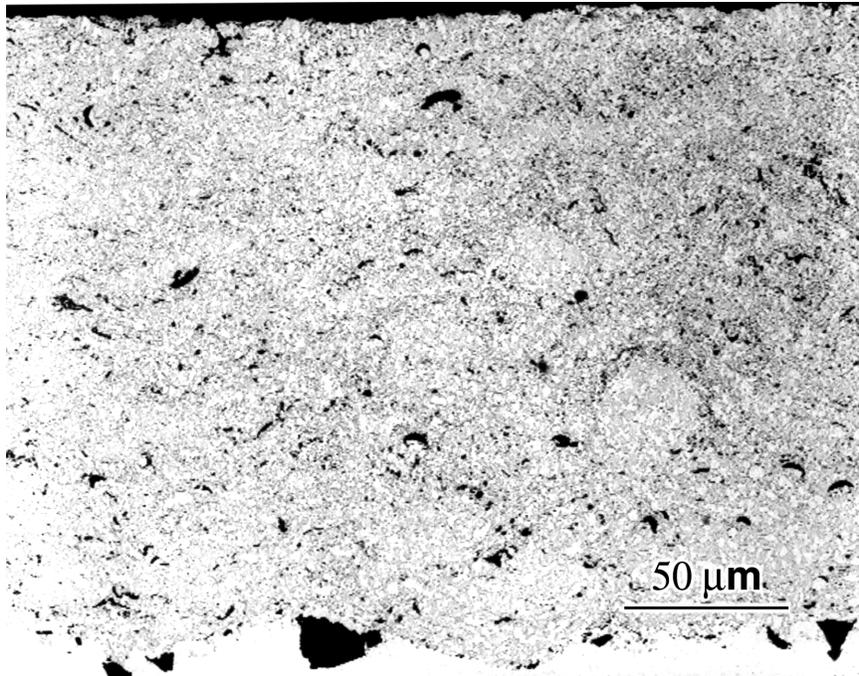
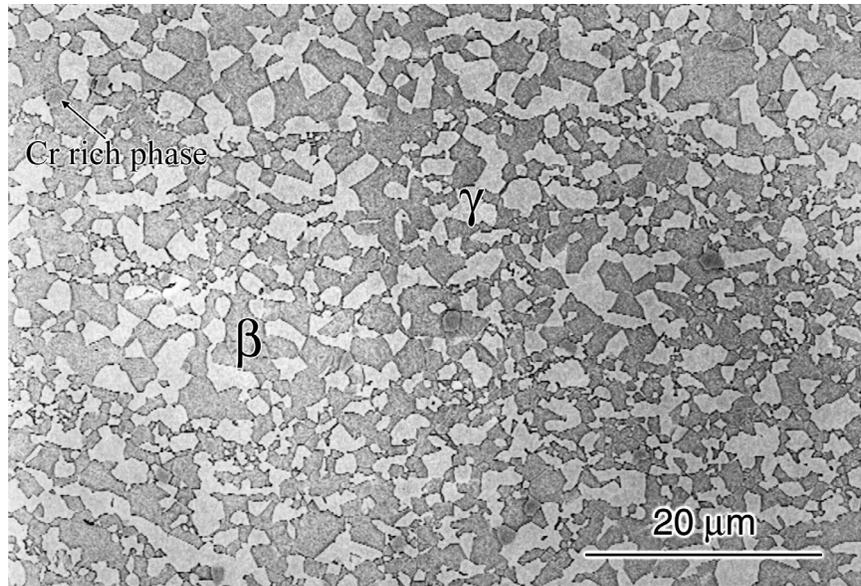
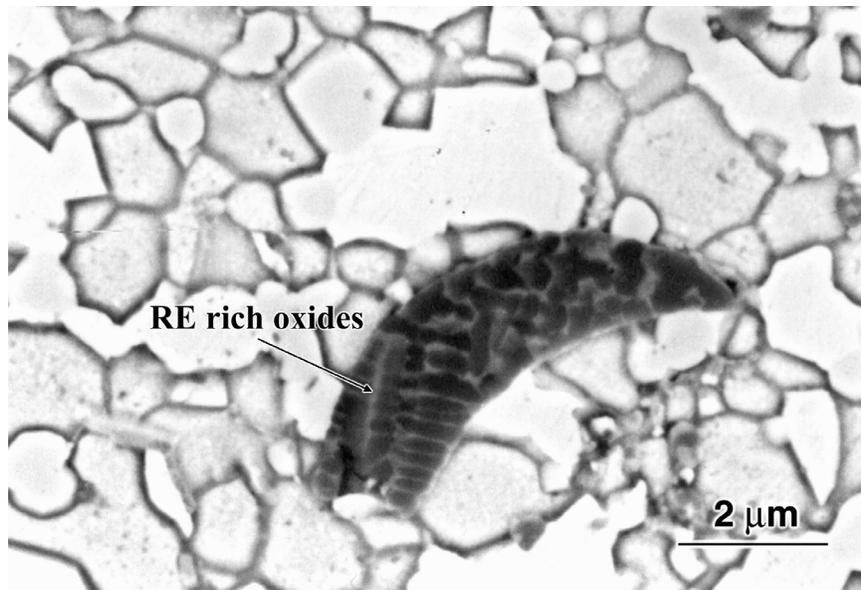
The surfaces of the NiCoCrAlY bond coats deposited either by argon shrouded plasma spray (NiCoCrAlY-A) or detonation gun technique (NiCoCrAlY-B) were very irregular (Figure 8a) and the as-processed coatings exhibited some porosity and oxide inclusions as shown in Figure 8b. The microstructures consisted of γ (Ni solid solution), β (NiAl) and Cr rich phases as well as Y and/or Hf containing phases (Figure 8c). In the case of the NiCoCrAlY-B coatings, significant amount of yttrium containing oxides encapsulated with alumina were observed throughout the cross section (Figure 8d).

Figure 8 The surface, (a), and cross-sectional micrographs, (b), of NiCoCrAlY bond coats showing the presence of surface defects as well as porosity and oxide inclusions in the as processed condition. The phases present in NiCoCrAlY-A and NiCoCrAlY-B coatings are labeled in (c) and (d) respectively.

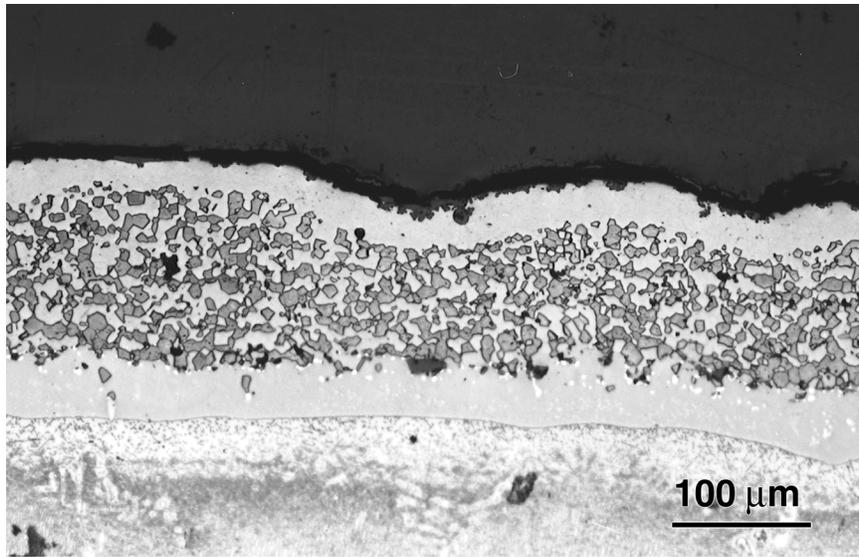
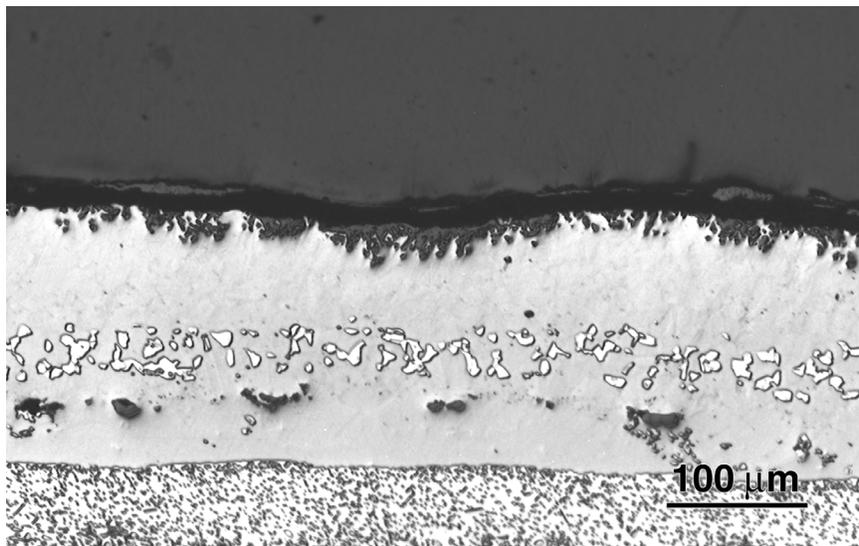
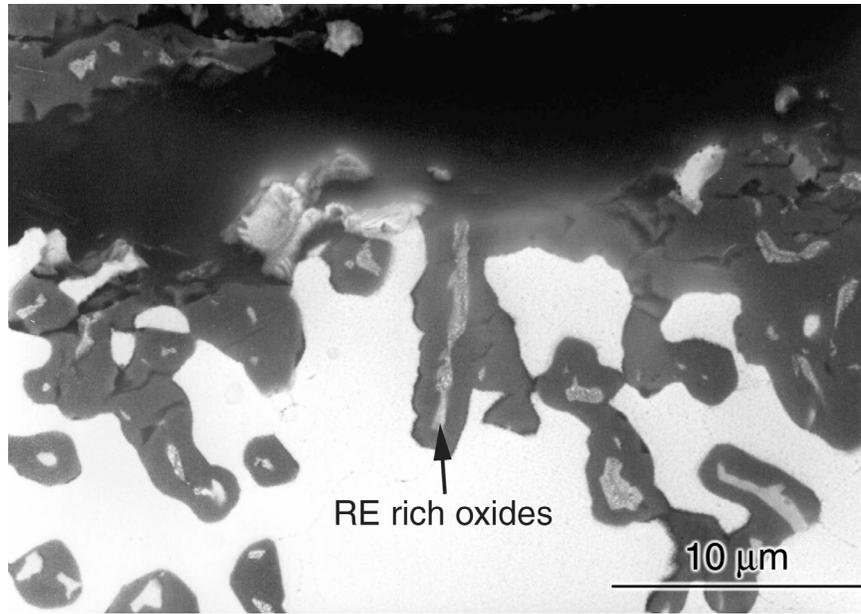
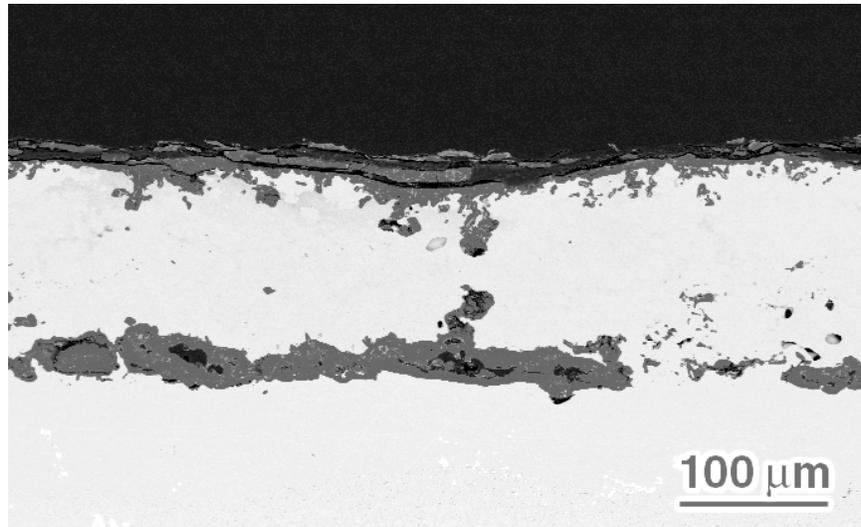
Photomicrographs showing the degradation of these coatings as a function of time at 1100 °C are presented in Figure 8 and Figure 9 for NiCoCrAlY-A and NiCoCrAlY-B coatings, respectively. After 209 cycles of exposure (Figure 9a and 10a) the β phase was depleted from both the surface and the substrate/bond coat interface as a result of oxidation and interdiffusion with the substrate, respectively. Oxide protrusions, which developed by rapid transport of

oxygen through the Y and Hf containing oxides and its reaction with aluminum in the alloy, were observed and they became more pronounced after 955 cycles of exposure (Figure 9b). This is shown in a high magnification micrograph of the alumina scale developed on these coatings (Figure 9c). However, these stringers of oxides protruding into the bond coat were very rare in the case of the NiCoCrAlY-B coatings. This is related to the yttrium being tied up as an oxide in the bond coat during processing (Figure 8d). Comparison of the microstructures of the NiCoCrAlY coatings after 955 cycles of exposure (Figure 9b and 10b) shows a difference in the amount of aluminum depletion between these two coatings. This difference may be related to the excessive oxidation in the NiCoCrAlY-A coatings due to formation of the reactive element rich oxides, which were rapid oxygen transport paths through the alumina scale. After 3031 cycles of exposure, the β phase was depleted completely from both of the coatings, leaving only the γ phase (Figure 9d and 10c) Penetration of oxidation through the thickness of the coating was observed in the NiCoCrAlY-A coatings in some localized areas and it propagated along the substrate-bond coat interface. Depletion of aluminum in the cyclic test will lead to development of less protective oxides and more rapid consumption of the coating. Penetration of the coating as in Figure 9d may be caused by the large amounts of reactive element oxides in the scale.

Figure 9 Scanning electron micrographs showing the degradation of NiCoCrAlY-A bond coats after 209, (a), 955, (b and c), and 3031, (d), cycles of exposure at 1100°C.

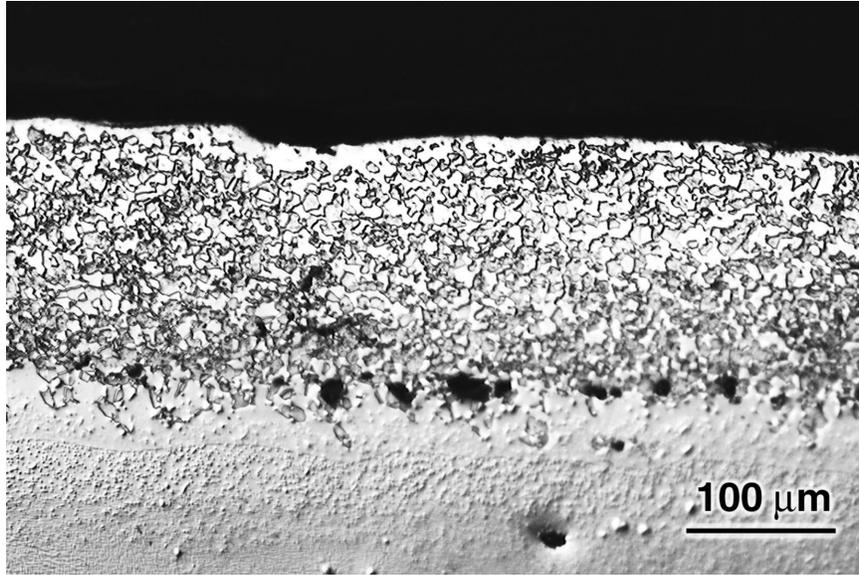
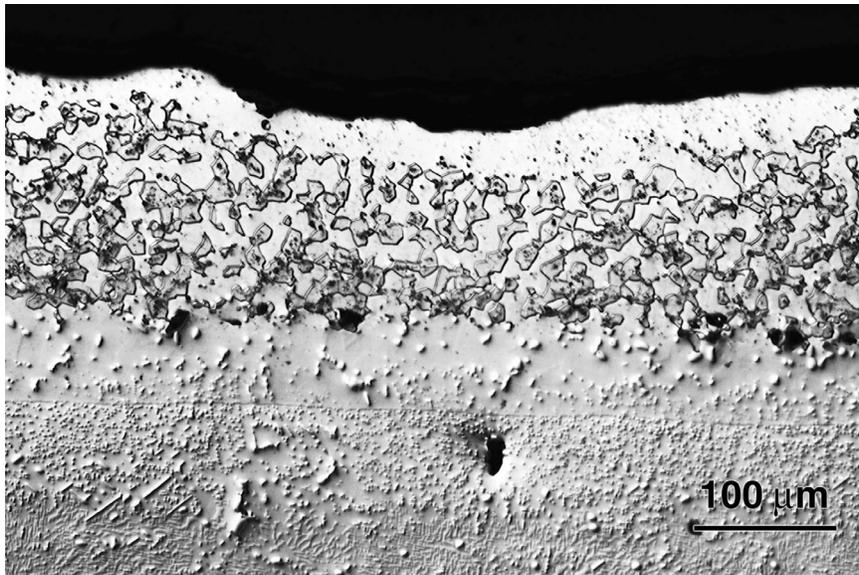
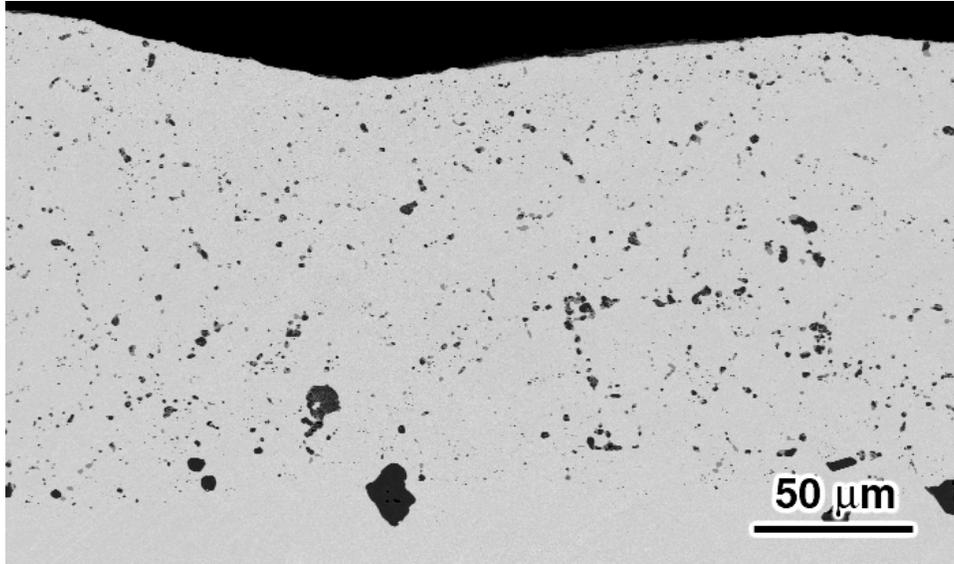
Figure 10 Scanning electron micrographs showing the degradation of NiCoCrAlY-B coatings after 209, (a), 955, (b), and 3031 cycles, (c), of exposure at 1100°C.

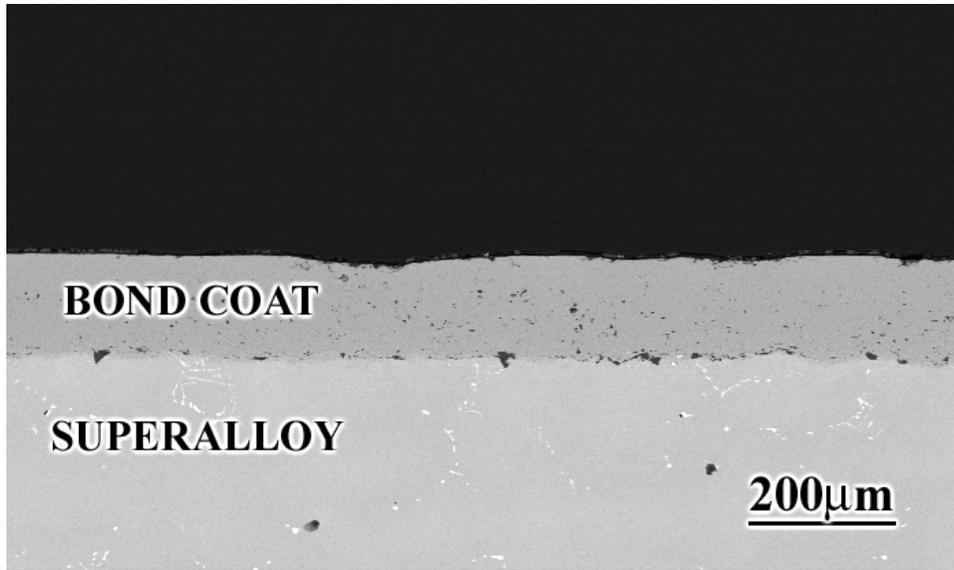
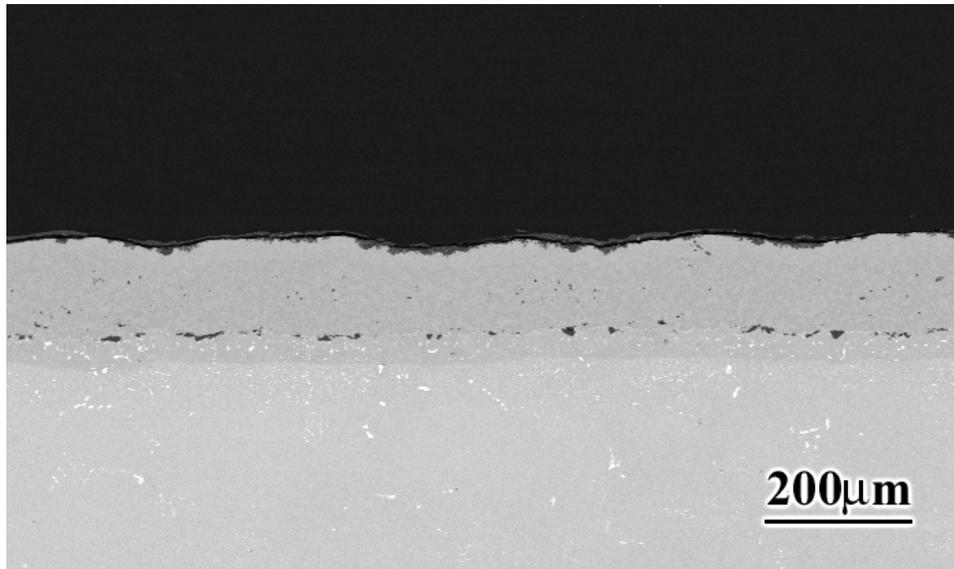
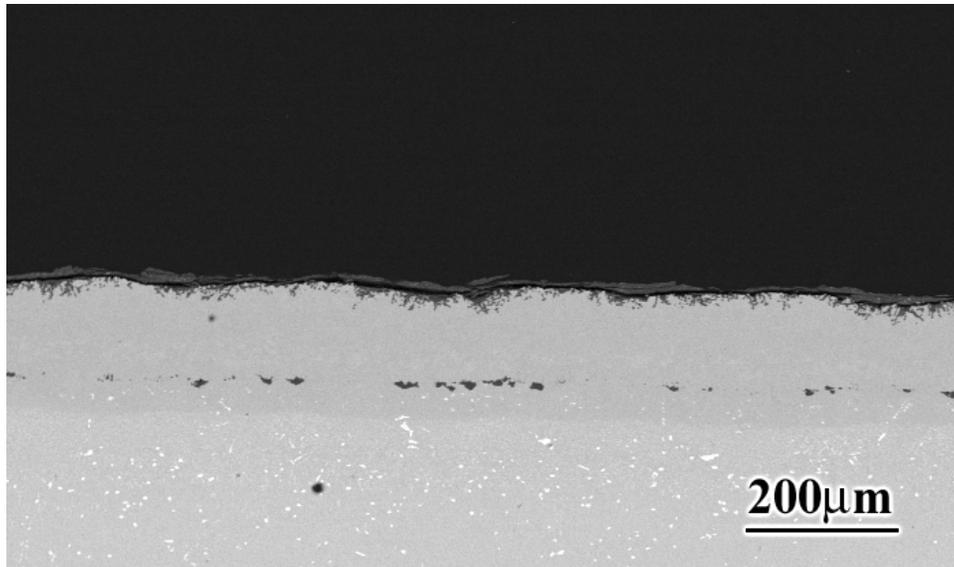
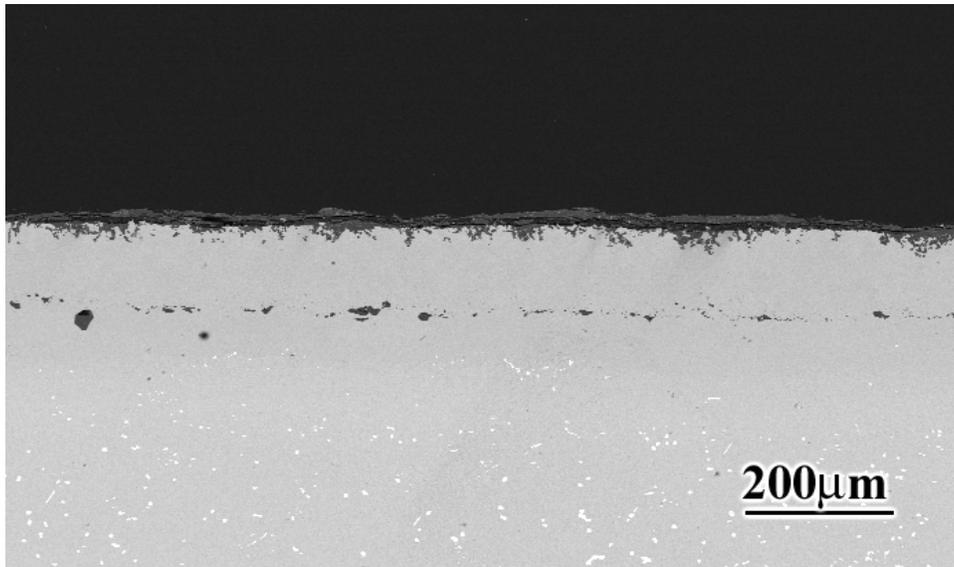
The surfaces of these coatings were observed to become wavy with exposure as evident by comparing Figure 11a, in the as-processed condition, with Figures 11b and 11c after 209 and 955 cycles of exposure at 1100°C, respectively. However, the surfaces became smoother after still longer exposure times (such as after 3031 cycles at 1100°C as in Figure 11d). The surfaces might have become rougher as a consequence of thicker oxide formation at localized areas due to reactive element rich oxides, followed by spallation along the oxide/bond coat interface at these sites. The smoothening of the surface at longer exposure times, then, can be explained by these

reactive element rich oxide protrusions which became more uniformly distributed over the surface with time as can be seen from the sequence of micrographs given in Figure 11. On the other hand, the plastic deformation of the bond coat in the presence of thermal and growth stresses is a possibility, but, in this case, it becomes difficult to explain the smoothing of the surface with longer exposure times. More work needs to be done to understand the surface roughening of the NiCoCrAlY bond coats which appears to be different than the surface roughening of the Pt aluminide bond coats, which will be shown later on.

Figure 11 Cross sectional micrographs from a NiCoCrAlY-A bond coat in the as processed condition, (a), and after 209, (b), and 955, (c), cycles of exposure at 1100°C showing the roughening of the surface. The surface became smoother after 3031 cycles of exposure (d).

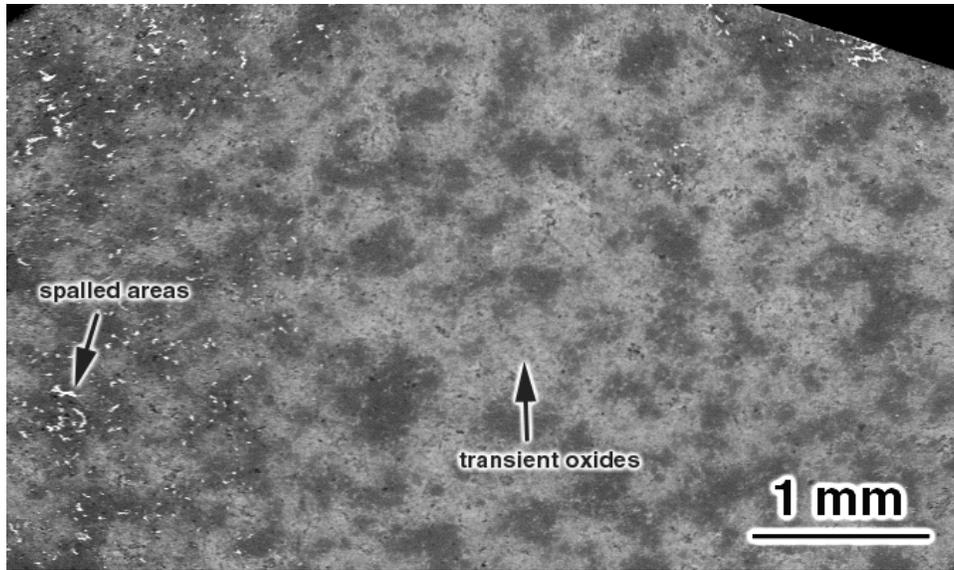
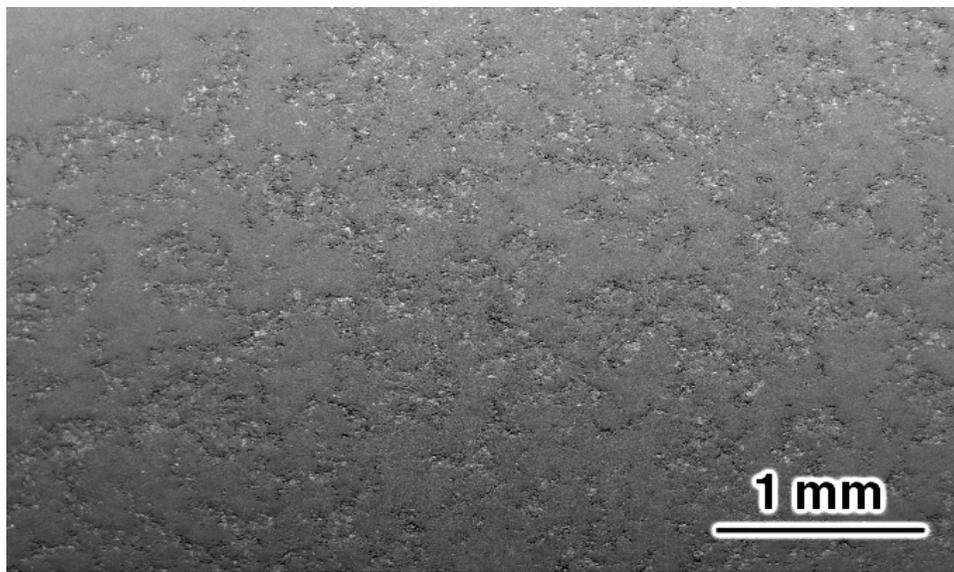
Oxides other than alumina developed on the surfaces of these bond coats at the very early stages of oxidation due to transient oxidation effects. Figures 12a and Figure 13a show the transient oxides formed on the surfaces of NiCoCrAlY-A and NiCoCrAlY-B coatings after 2 hours of exposure at 1080 °C in air, respectively. Oxidation experiments were performed under low partial pressure of oxygen to prevent transient oxidation. The oxide scales formed on these preoxidized bond coats were purer which shows that the oxygen partial pressure obtained was lower than that required for the oxidation of other elements in the alloy such as Ni, Cr and Co. Moreover, the oxide scale was observed to spall from the specimens which were exposed in air, whereas it was still adherent on those which were preoxidized under a low partial pressure of oxygen and then exposed in air under the same conditions (Figures 12b and Figure 13b).

Figure 12 (a) Surface micrograph of the NiCoCrAlY-A bond coat after exposure at 1080°C for 2 hrs in air showing the transient oxides developed and the spallation of the oxide scale. (b) Surface micrograph showing the purer and more adherent alumina scale developed after the bond coat was preoxidized in an Ar-4% H_2 atmosphere at 1100°C for 100 hrs and then exposed in air under the same conditions as in (a).

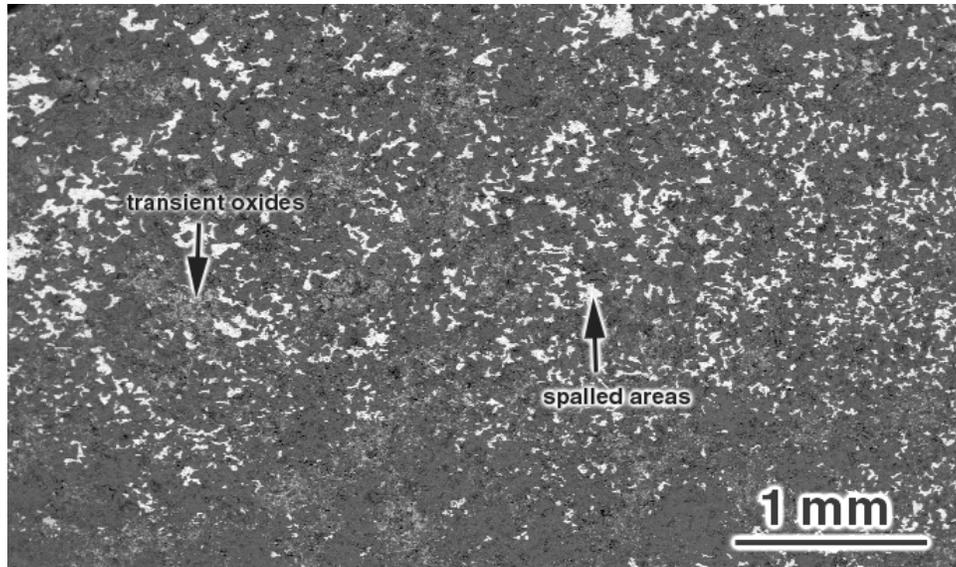
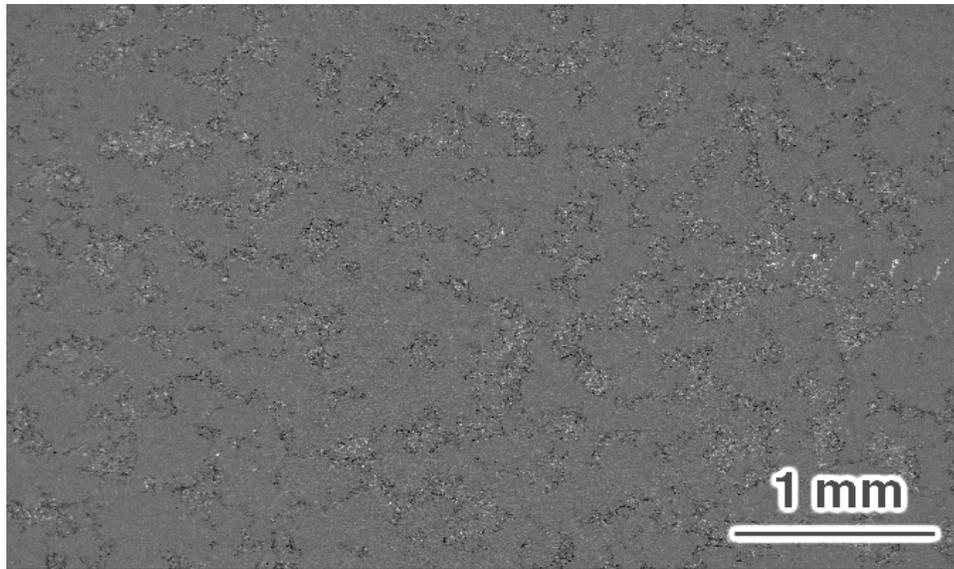
Figure 13 (a) Surface micrograph of the NiCoCrAlY-B bond coats after exposure at 1080°C for 2 hrs in air showing the transient oxides developed and the spallation of the oxide scale. (b) Surface micrograph showing the purer and more adherent alumina scale developed after the bond coat was preoxidized in an Ar-4% H_2 atmosphere at 1100°C for 100 hrs and then exposed in air under the same conditions as in (a).

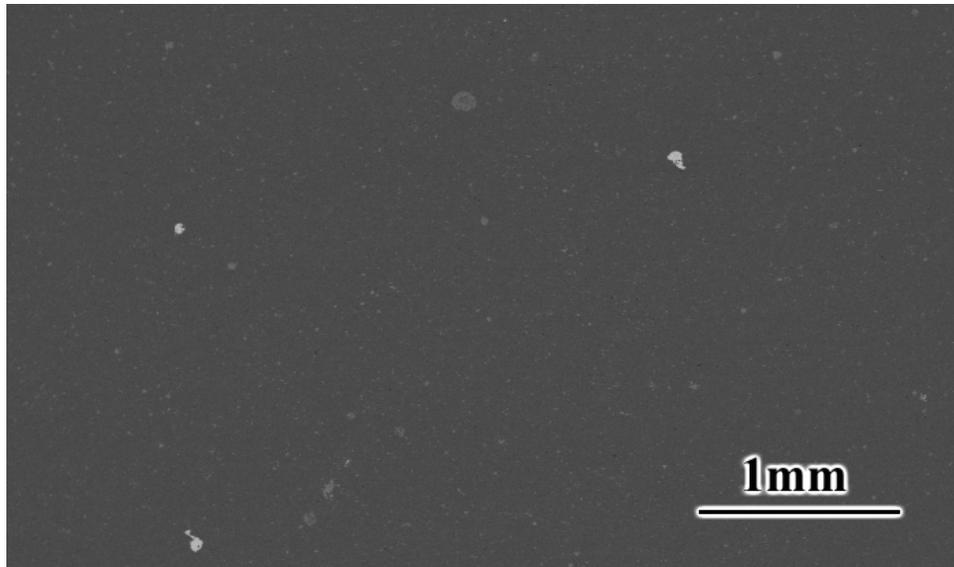
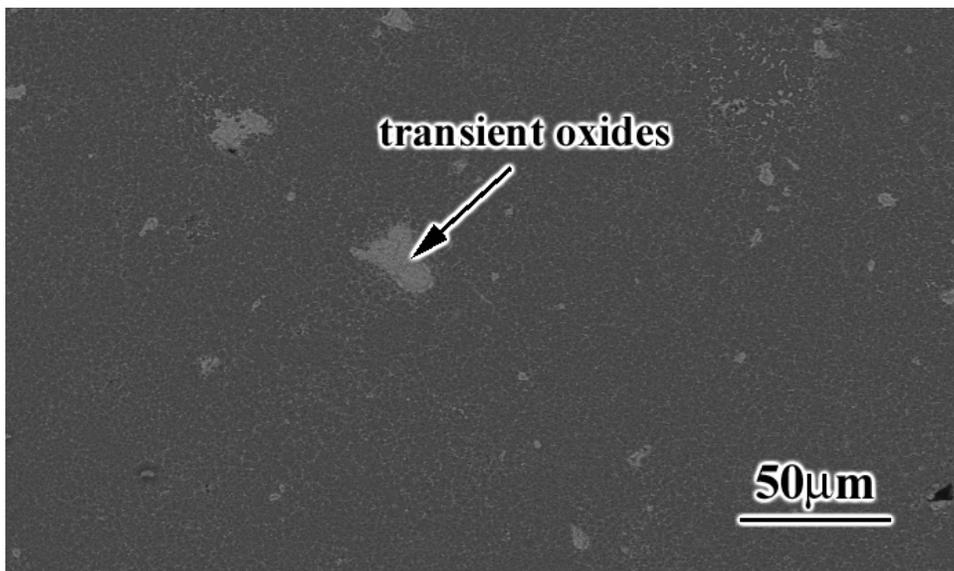
The adherence of the oxide scales on these bond coats were also affected by the surface condition. The alumina scales developed on hand polished NiCoCrAlY bond coats were more adherent (Figures 14a and 14b) compared to the alumina scales developed on heavy grit blasted NiCoCrAlY bond coats (Figures 15a and 15b). Moreover, the alumina scales had fewer transient oxides on hand polished specimens.

Figure 14 Scanning electron micrographs showing the surface of a hand polished NiCoCrAlY-A bond coat after exposure at 1100°C for 100 cycles at (a) low and (b) high magnifications.

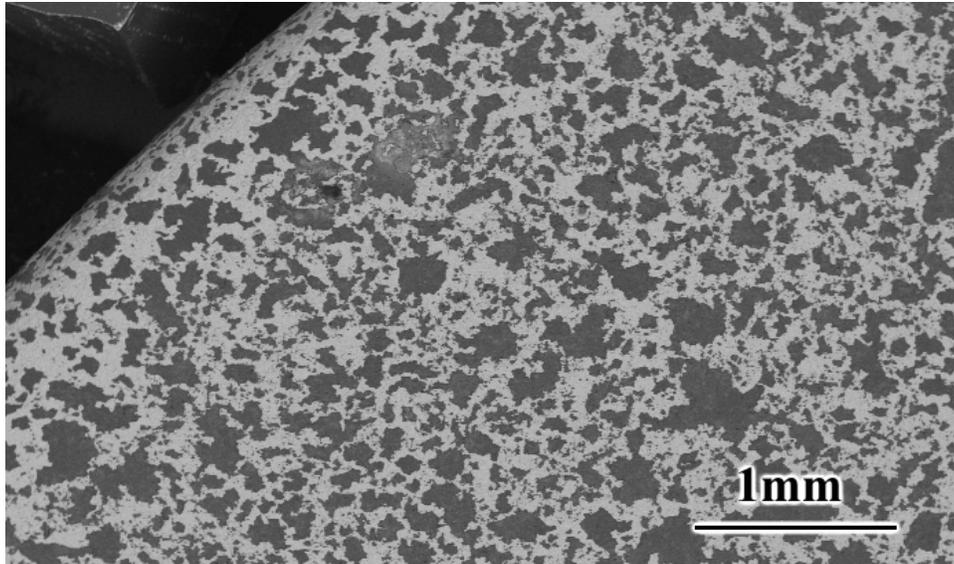
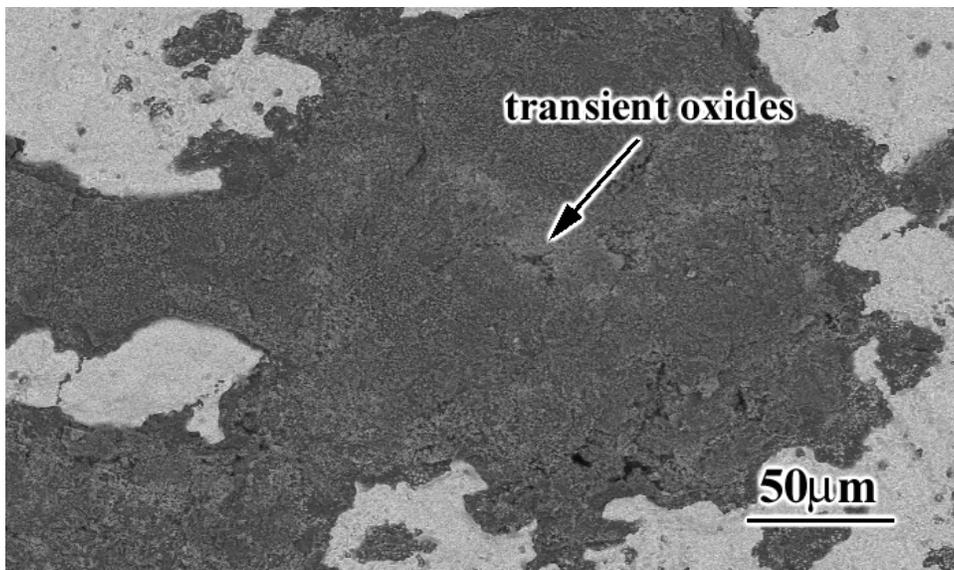
Figure 15 Scanning electron micrographs showing the surface of a heavy grit blasted NiCoCrAlY-A bond coat after exposure at 1100°C for 100 cycles at (a) low and (b) high magnifications.

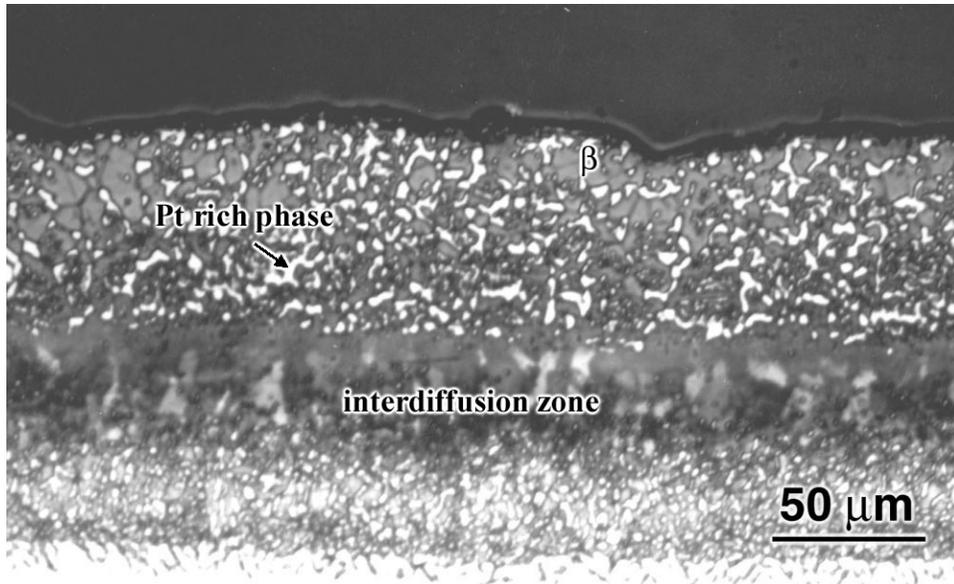
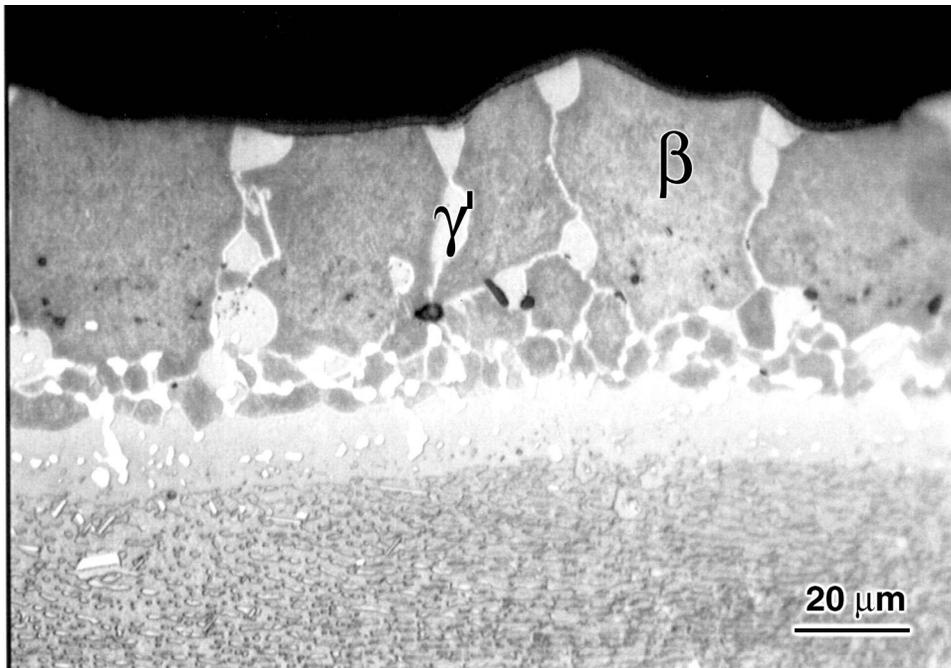
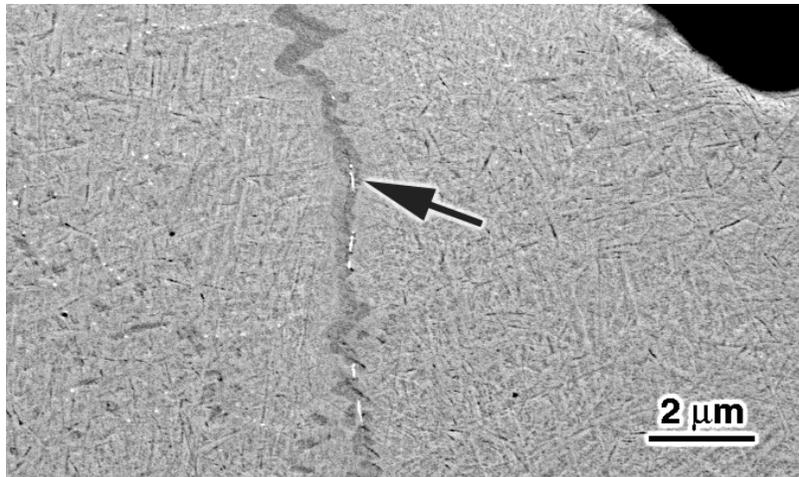
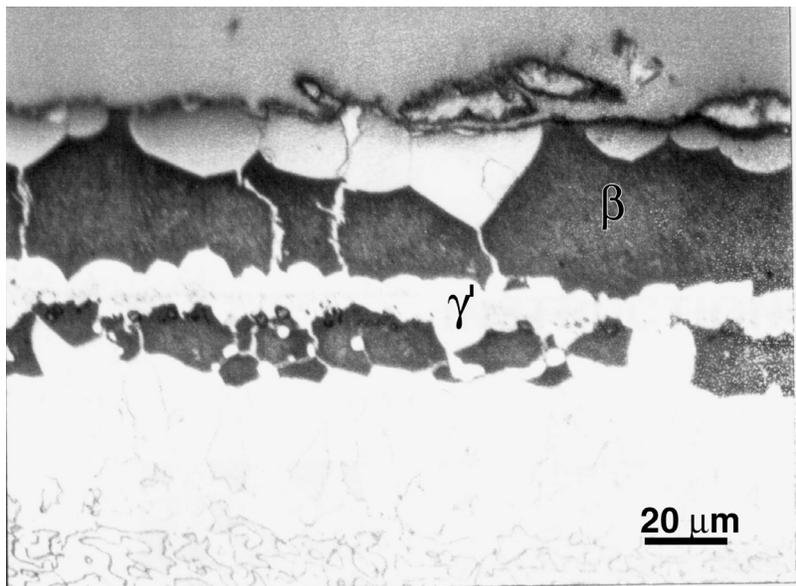
The microstructural evolution of Pt modified aluminide bond coats under cyclic oxidation conditions was examined as a function of time at both 1100 and 1200°C. In the as-processed condition, the coating microstructure consisted of β (NiAl) and Pt rich phases. Refractory metal rich precipitates, which form as a result of low solubility of certain substrate elements (W, Ta, Re...) in β (NiAl), were observed in the interdiffusion zone (Figure 16a).

After 20 cycles of exposure at 1200°C, the bond coat consisted of mainly β phase with some γ' (Ni₃Al) which nucleated preferentially at the grain boundaries of the β phase (Figure 16b). The grain boundaries of the bond coat are paths for the outward diffusion of refractory elements. Figure 16c shows a β phase grain boundary, which is enriched in refractory elements. The presence of these refractory elements may also be enhancing the nucleation of γ' at the grain boundaries. The grain size of the β phase just below the original alloy surface where refractory metal rich precipitates are pronounced, was found to be smaller and the nucleation of γ' at these grain boundaries resulted in the formation of a continuous layer of γ' in the β phase (Fig 16d)

Figure 16 Optical micrographs of the Pt-Aluminide bond coat a) in the as processed condition, b) after exposure at 1200°C for 20 cycles showing the γ' that nucleated preferentially at the β phase grain boundaries, (c) Scanning electron micrograph showing a β phase grain boundary enriched in refractory metal rich particles, (d) optical micrograph of the TBC system with the Pt Aluminide bond coat, which failed at 1200°C after 132 cycles, showing the development of a continuous layer of γ' in β phase.

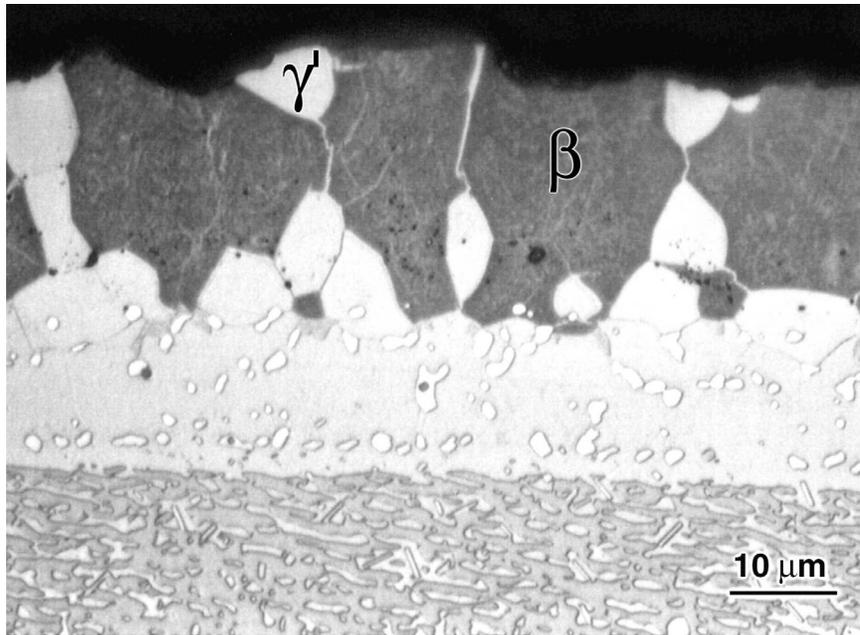
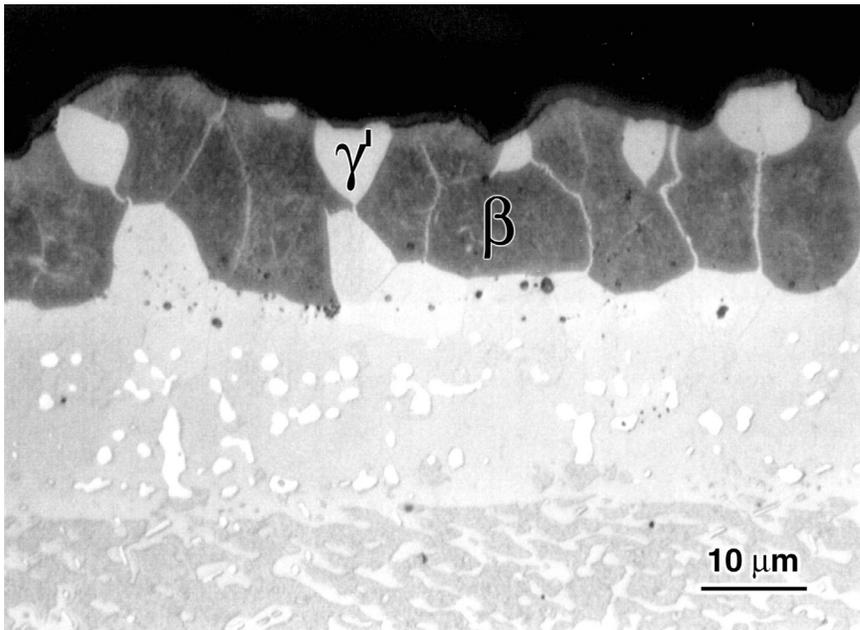
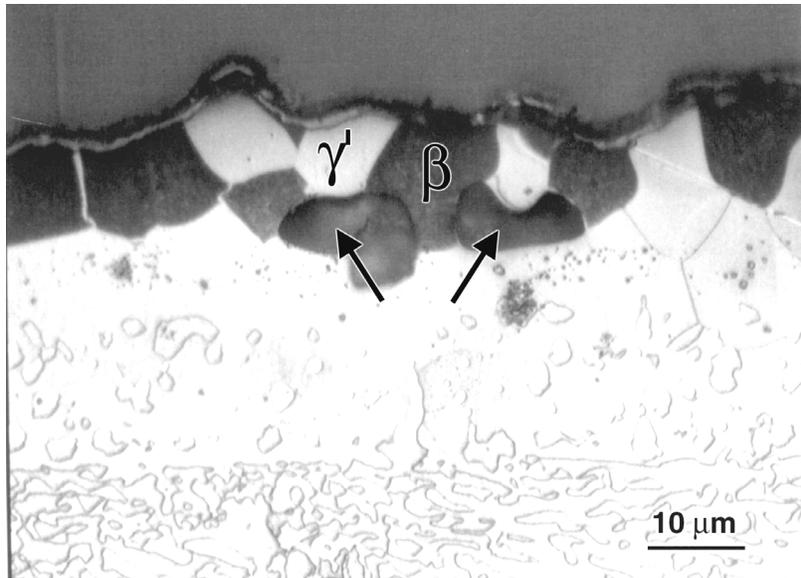
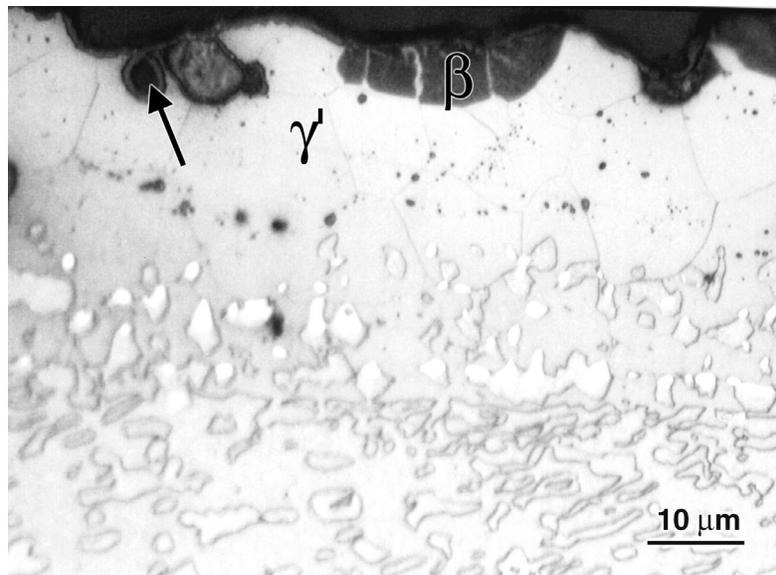
Surface rumpling is one of the basic features of the Pt aluminide bond coats. Figure 20a shows the surface of a Pt aluminide bond coat, which was highly rumpled after exposure at 1100 °C for 955 cycles. After large numbers of exposure cycles, large cavities formed in the bond coat (Fig 17e) and at the bond coat/oxide interface (Figure 20b). It appears that alumina formed on the surface of these cavities as a result of oxygen diffusion through the cracks present in the initially formed alumina (Figure 20c). In some places, spinel formation was observed on the alumina scales formed at these cavities (Figure 20d). The gamma phase observed in the bond

Figure 17 Cross-sectional micrographs showing the degradation of Pt aluminide bond coats after exposure at 1200°C for 40, (a), 60, (b), 80, (c), 100, (d), 130, (e), and 200 cycles, (f), respectively. The arrows point to the large cavities formed at the later stages of oxidation in the bond coat, (e), and at the bond coat/oxide interface, (f).

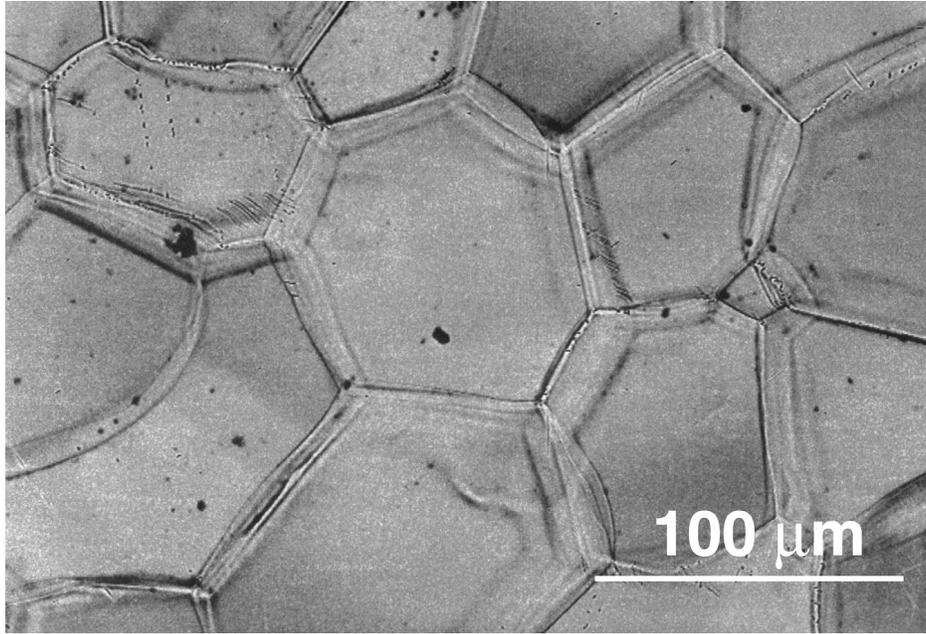
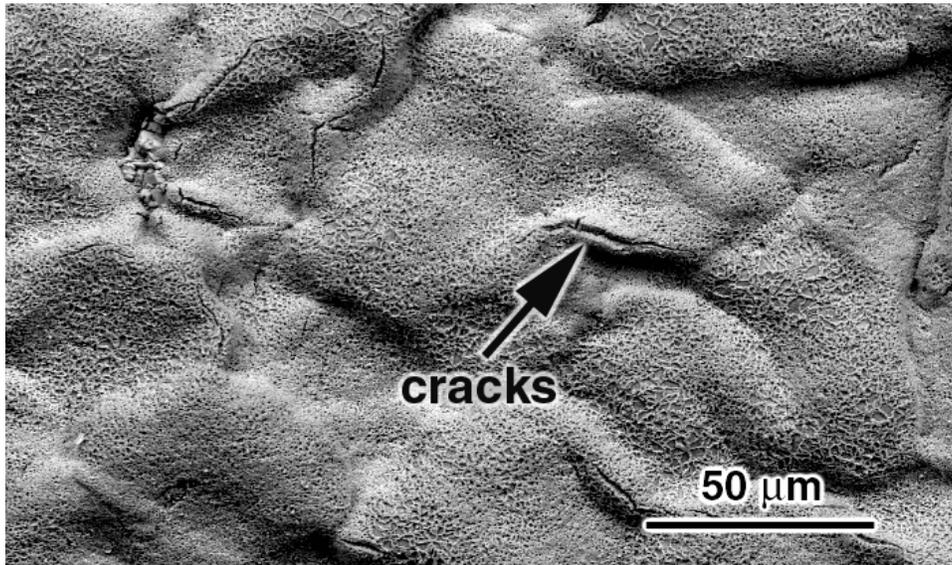
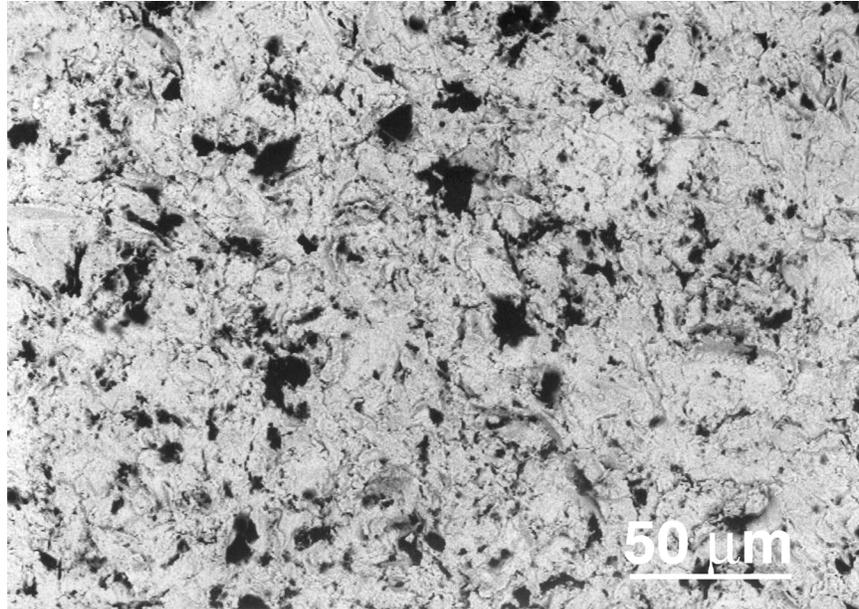
Figure 18 Scanning electron micrographs from the surface of Pt aluminide bond coats showing a) the ridges that developed at the grain boundaries of the bond coat , b) the cracks that formed on these grain boundary ridges after exposure at 1200°C for 40 cycles, c) the absence of ridges after grit blasting operation, which is generally applied prior to TBC deposition.
