THE FAILURE OF THERMAL BARRIER COATINGS AT ELEVATED TEMPERATURES

Submitted to the Graduate Faculty of
the School of Engineering in partial fulfillment
of the requirements for the degree of
Doctor of Philosophy

University of Pittsburgh

2004

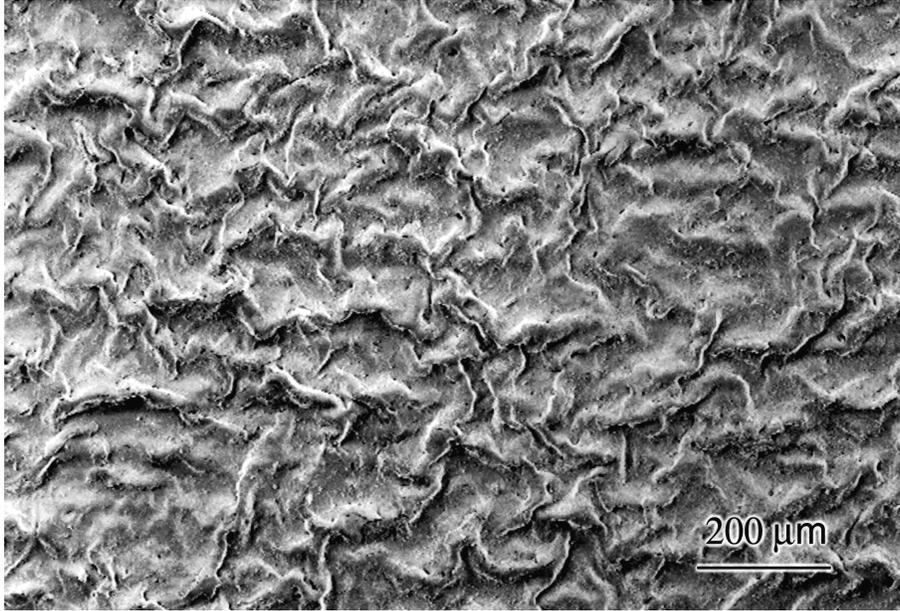
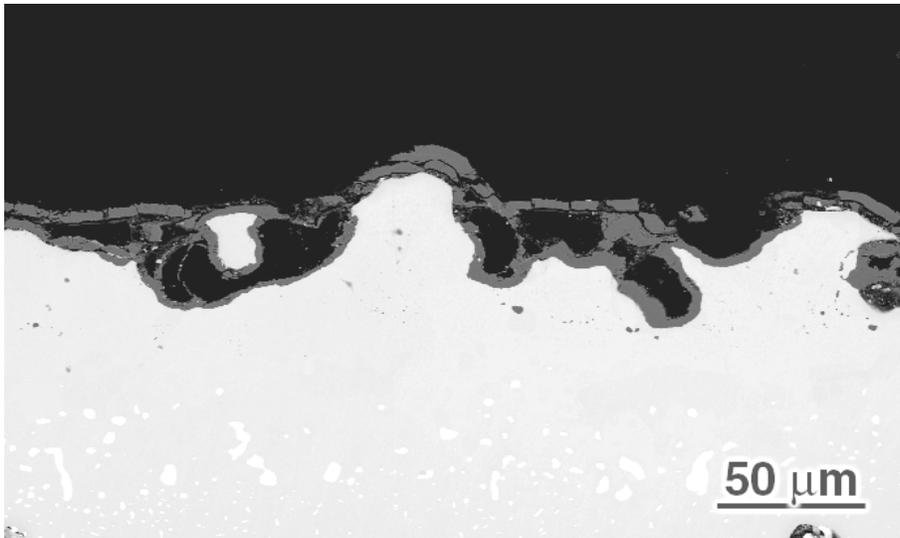
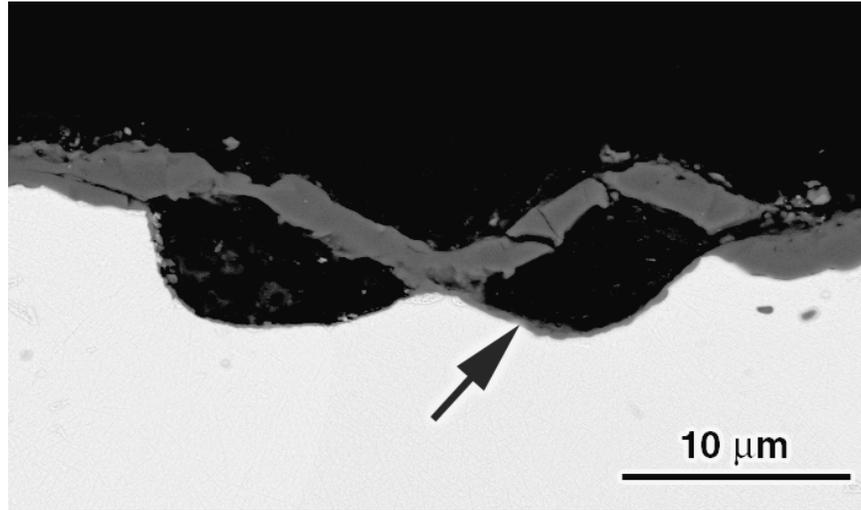
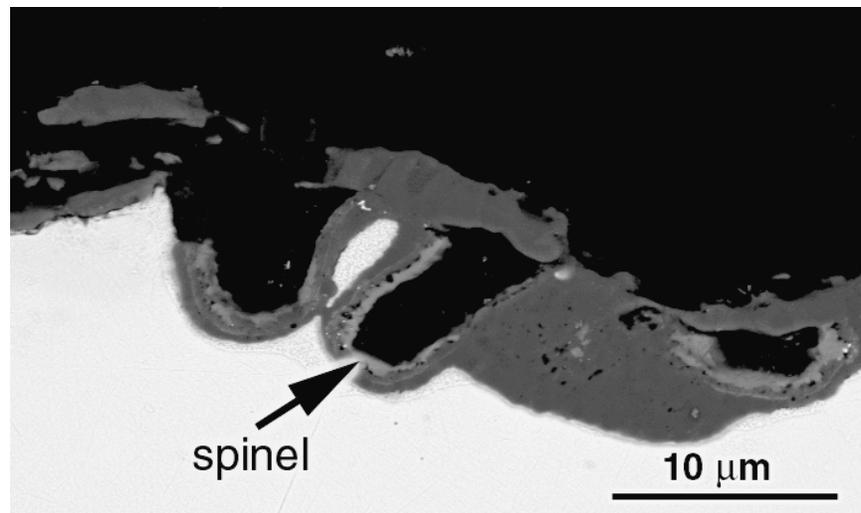
Surface rumpling is one of the basic features of the Pt aluminide bond coats. Figure 20a shows the surface of a Pt aluminide bond coat, which was highly rumpled after exposure at 1100 °C for 955 cycles. After large numbers of exposure cycles, large cavities formed in the bond coat (Fig 17e) and at the bond coat/oxide interface (Figure 20b). It appears that alumina formed on the surface of these cavities as a result of oxygen diffusion through the cracks present in the initially formed alumina (Figure 20c). In some places, spinel formation was observed on the alumina scales formed at these cavities (Figure 20d). The gamma phase observed in the bond

Figure 20 a) Scanning electron micrograph from the surface of the Pt-Aluminide bond coat, which was highly rumpled after exposure at 1100°C for 955 cycles. Cross sectional scanning electron micrographs showing (b) the large cavities formed at the bond coat/oxide interface after exposure at 1100°C for 3031 cycles. (c) the alumina formed on the surface of the large cavities, (arrow), as a result of oxygen diffusion through the cracks present at the initially formed alumina,(d) the spinel phase formed on the alumina scale in these cavities.

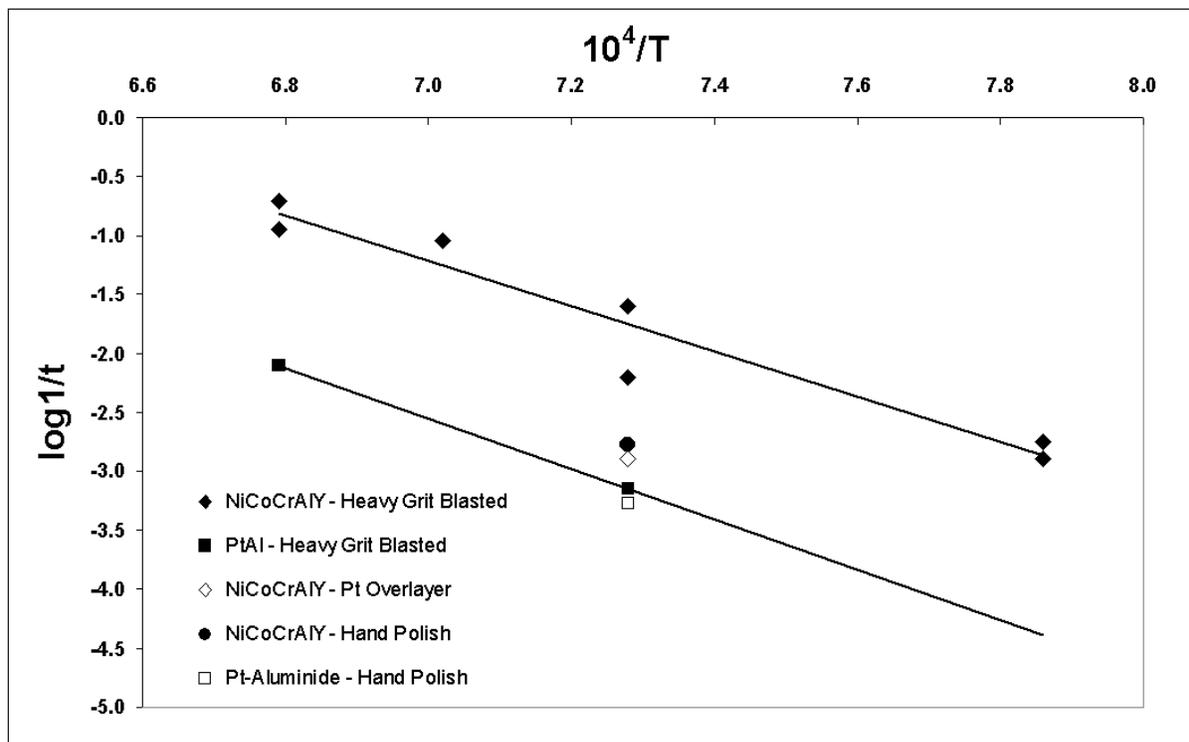
temperature for the state of the art TBC systems with NiCoCrAlY and Pt Aluminide bond coats (Figure 21) shows a decrease of failure times of these systems by about an order of magnitude with 100 °C increase in exposure temperature. An Arrhenius relationship is followed with an activation energy of 356 kJ/mole which is close to that obtained from the parabolic rate constants for the growth of α -alumina scales on Pt-Al alloys [36]. These results suggest the role of TGO growth rate and accordingly, the stored strain energy in the TGO on the failure of these systems. However, relatively thick TGOs could be attained by minimizing the defects in these systems by various modifications. The data points of the failure times for some of these modified systems at 1100°C are also shown in Figure 21. It is believed that the defects were the crack initiation sites and the stored energy in the TGO was the driving force for the propagation of failure. Thus, the systems could withstand larger strain energies in the presence of fewer defects.

Figure 21 The plot of inverse of the failure times (t) versus reciprocal temperature (T) for the state of the art TBC systems with NiCoCrAlY and Pt aluminide bond coats.

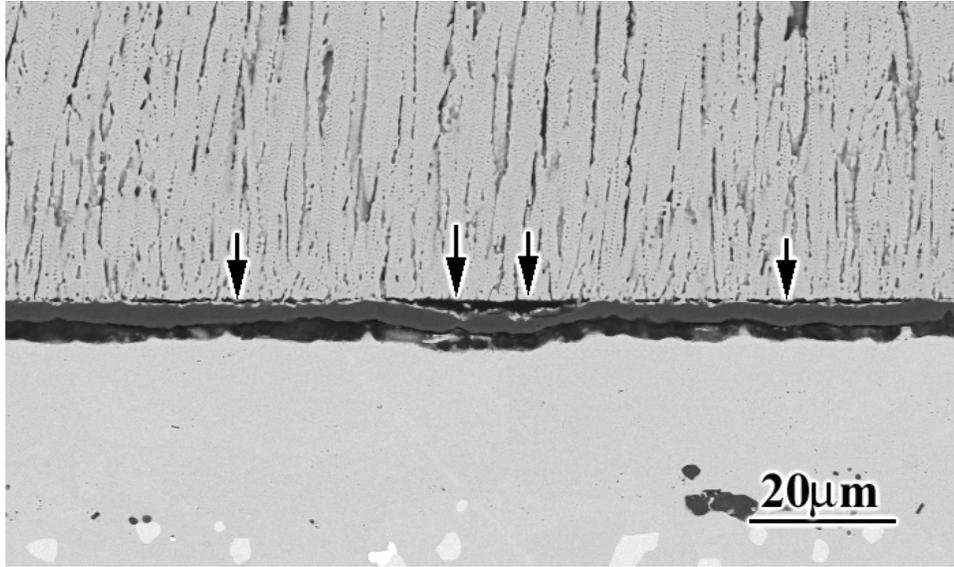
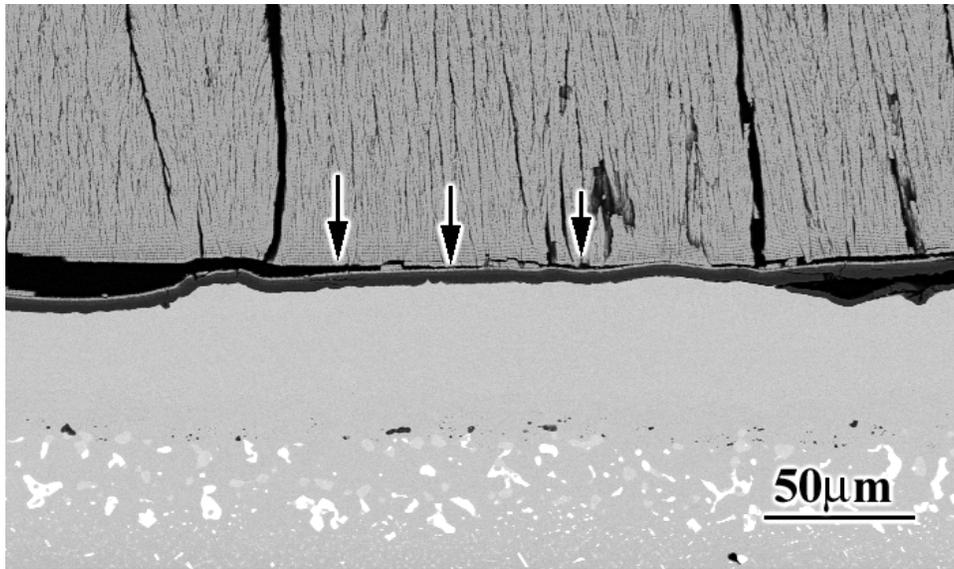
The stored energy in the TBC is usually considered negligible due to the open and porous structure of the YSZ. However, it has been observed that a relatively dense TBC can develop depending on the surface condition and/or the TBC deposition conditions. There is also the sintering factor, which results in densification in the TBC. In these situations, the stored energy in the TBC can also become a contributing factor in the failure. Separations can occur along or close to the TGO/TBC interface to release this energy (Figure 22a) or cracks that initiated elsewhere in the system can propagate in the dense TBC (Figure 22b).

Figure 22 Scanning electron micrographs showing that dense TBCs can be a source of crack initiation (a) and / or propagation sites (b), probably due to relatively high stored energy in the TBC.

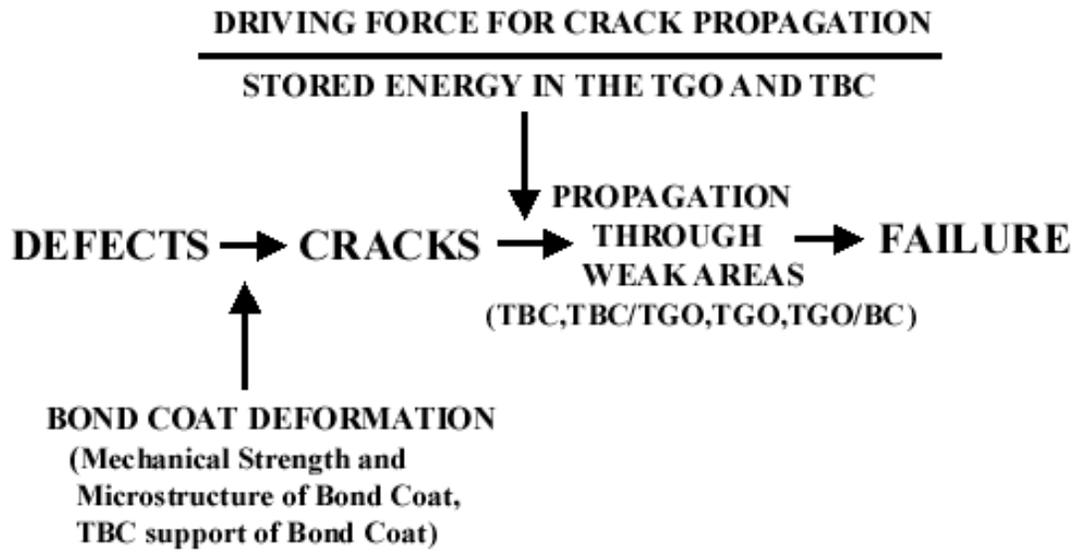
A simple schematic summarizing the preceding discussion on TBC failures is given in Figure 23. In the following section, the defects in TBC systems will be described in general regardless of the system, followed by the failure characteristics of these TBC systems where the defects specific to each system will be given.

Figure 23 Schematic diagram summarizing the TBC failures based on experimental results.

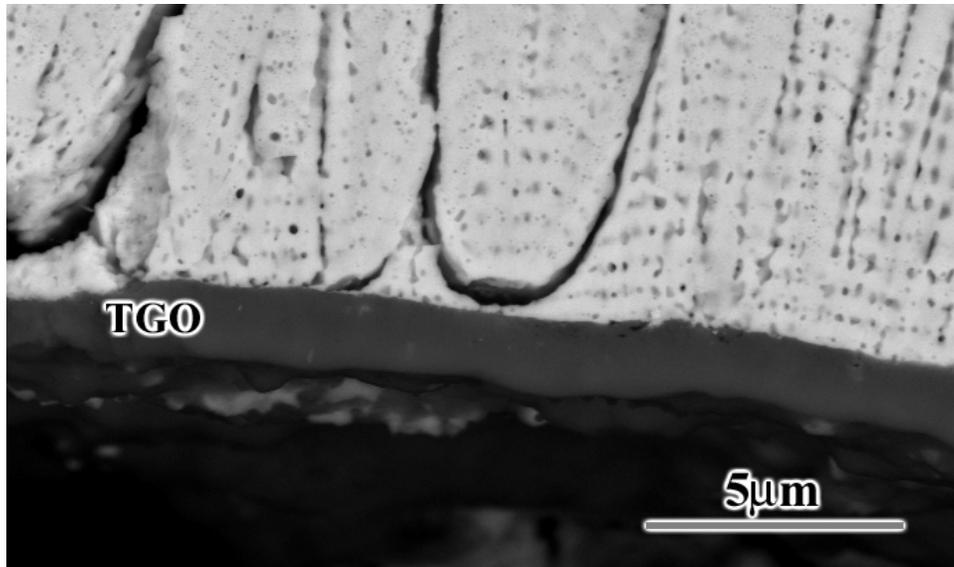
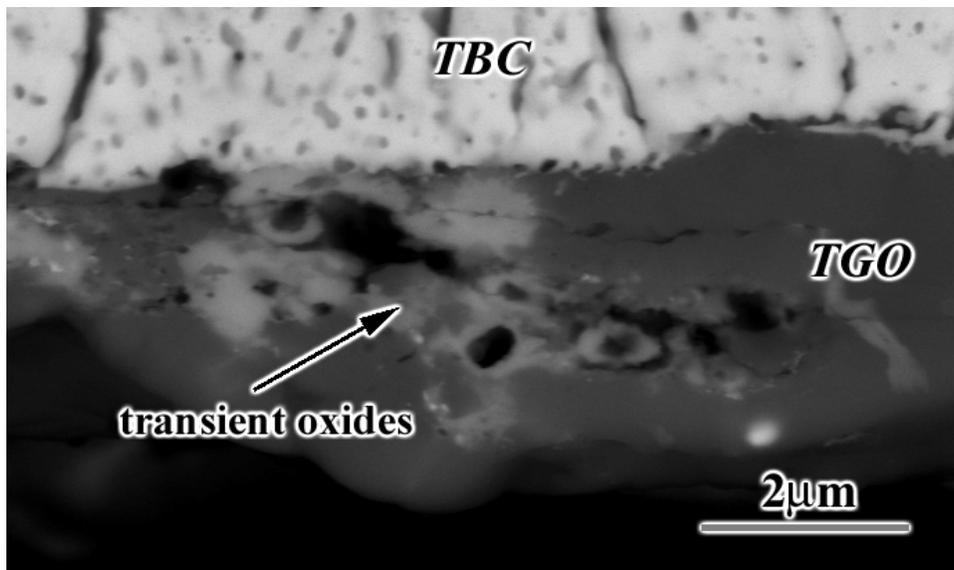
4.2.2.1 Transient Oxides When the TGO is pure alumina, it usually forms as a dense and continuous layer as in Figure 24a. However, when oxides other than alumina are present (e.g. Cr_2O_3 , NiAl_2O_4), the TGO is porous and non-uniform (Figure 24b). Moreover, the adherence between the transient oxides and the TBC, as well as the alumina, seems to be weaker (Figures 25a and 25b, respectively) compared to adherence between the alumina and the TBC. The arrow in Figure 25c points to a part of a TGO where it is pure alumina and in good contact with the TBC, in contrast to the neighboring parts with significant amounts of transient oxides. It has also been observed that the thickness of the transient oxide is important for adherence. The interface between the transient oxide and the TBC seemed to become weaker as the thickness of the transient oxide increased. The arrow in Figure 25d points to a relatively thin transient oxide,

Figure 24 Scanning electron micrographs showing the presence of a dense and uniform TGO when it is pure alumina, (a), and the porous and non uniform TGO when oxides other than alumina are present, (b).

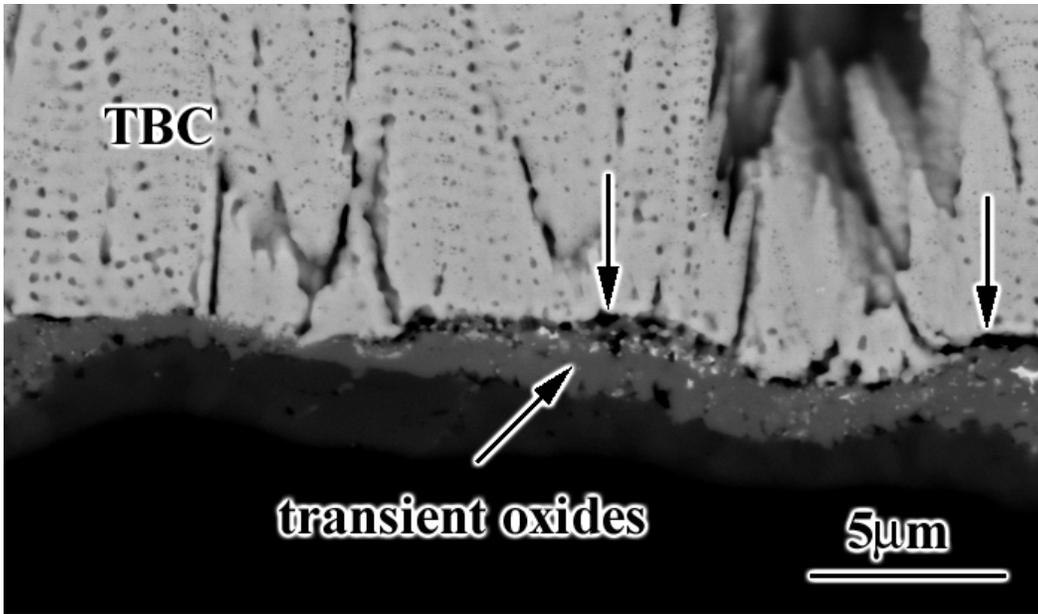
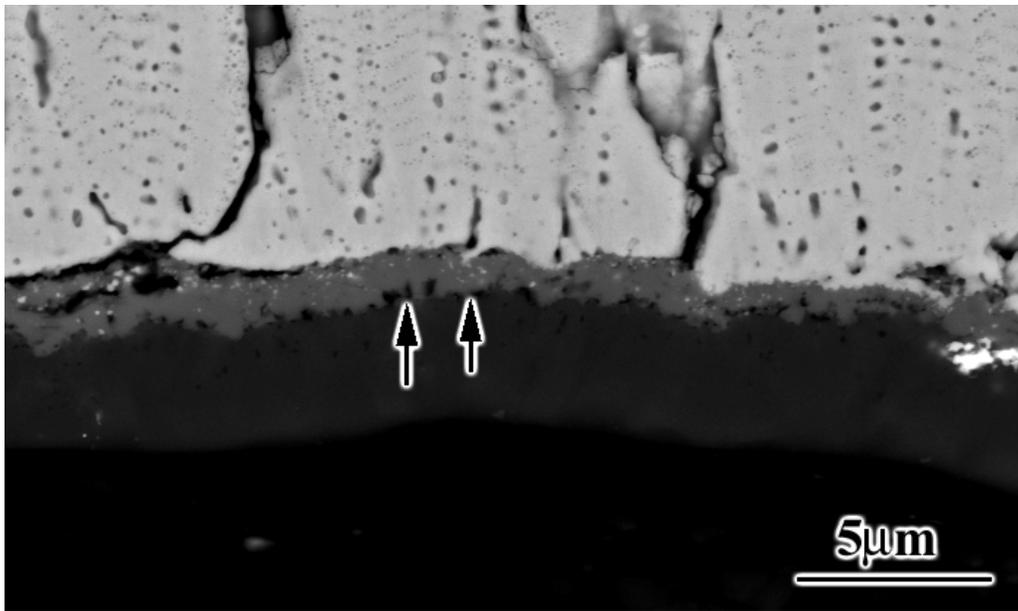
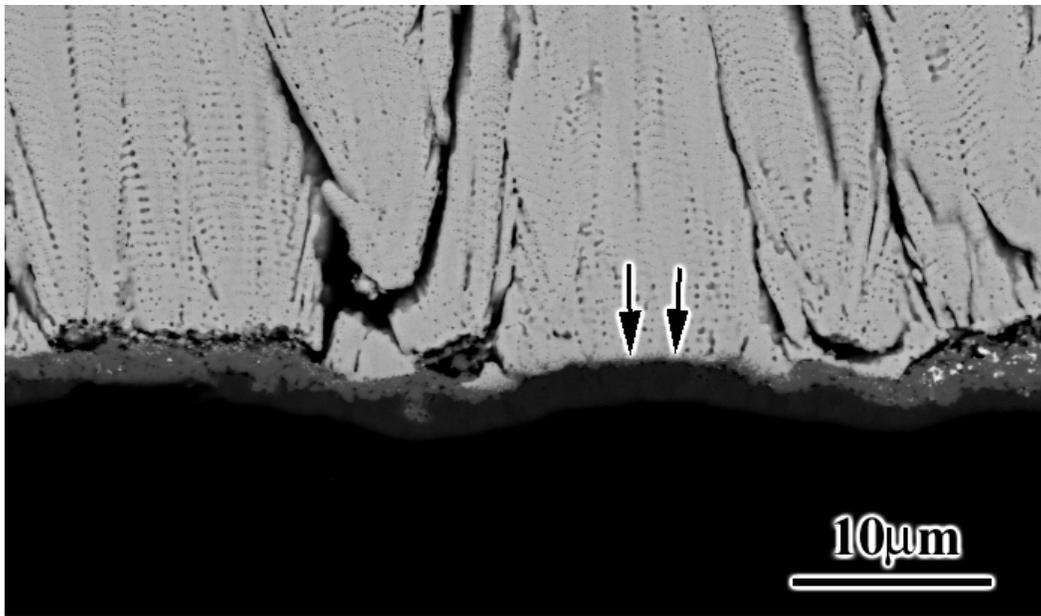
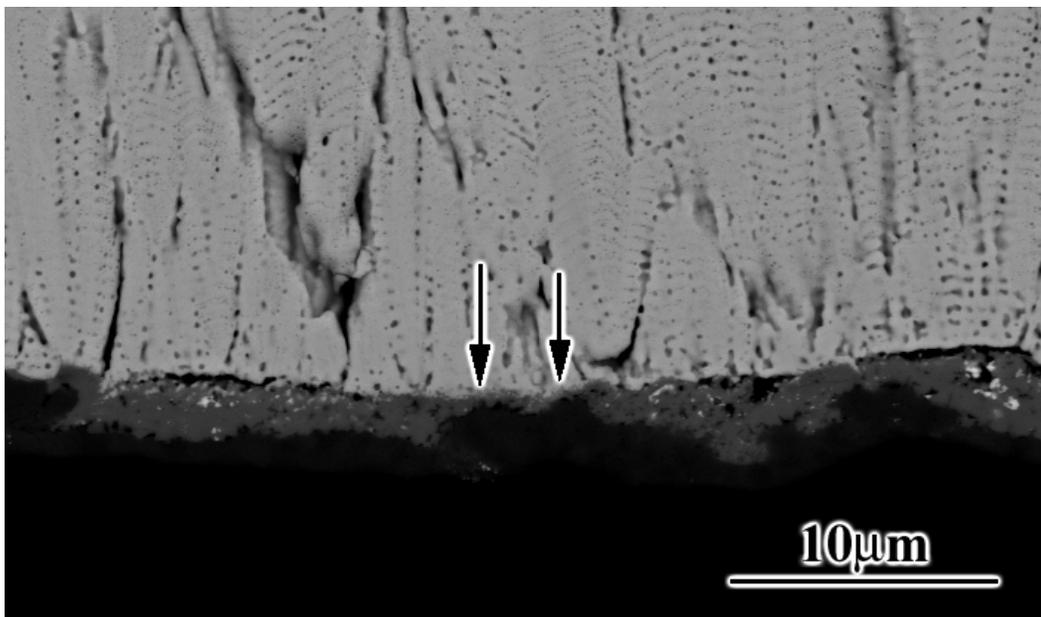
which appears to have a better bond to the TBC, compared to the other areas with thicker transient oxides.

Figure 25 Scanning electron micrographs showing the poor adherence between the transient oxides and the TBC, arrow in (a), as well as between the transient oxides and the alumina, arrow in (b). The adherence between the TBC and the TGO is stronger when it is pure alumina, arrow in (c) and also when the transient oxide is relatively thin, arrow in (d).

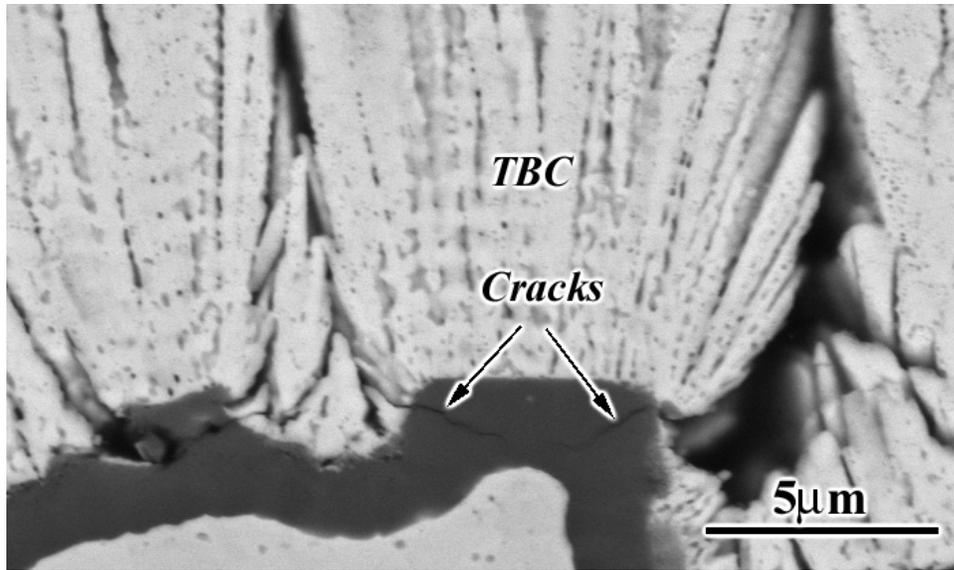
- **regions of separation in the TBC** - This is a very general classification which refers to any kind of discontinuities in the TBC, especially close to the TGO/TBC interface. These type of defects can act as stress concentration sites in the TBC where cracks can nucleate (Figure 26). Corn Kernel defects are specific cases of regions of separation in the TBC which appear as conical shaped TBC segments close to the TGO (Figure 27) These conical shaped TBC segments are poorly bonded to the rest of the TBC, resulting in the development of points of weakness in the TBC.

Figure 26 Scanning electron micrograph showing cracks initiated in the vicinity of defects, which were referred to as “points of separation in the TBC”.

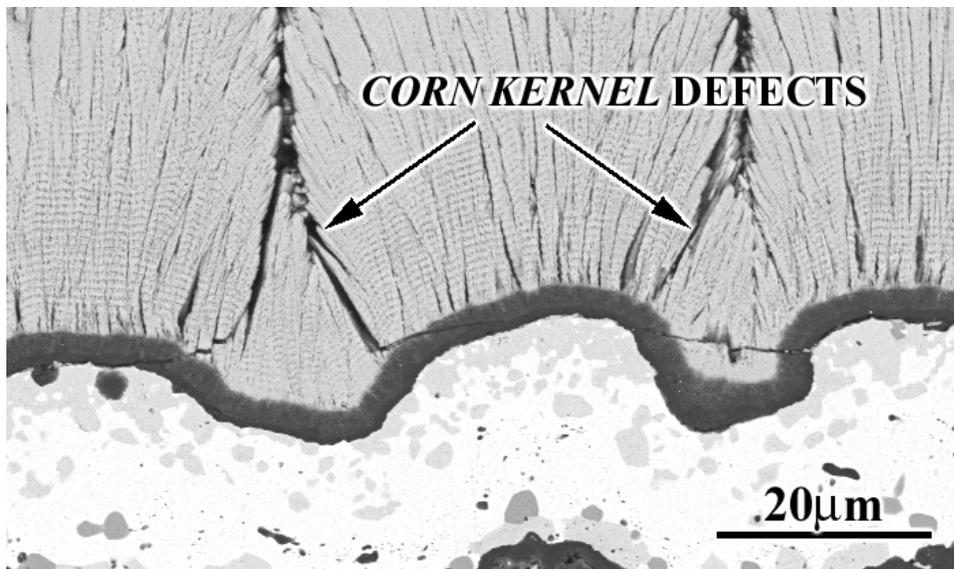
Figure 27 Scanning electron micrograph showing a corn kernel type of defect in the TBC.

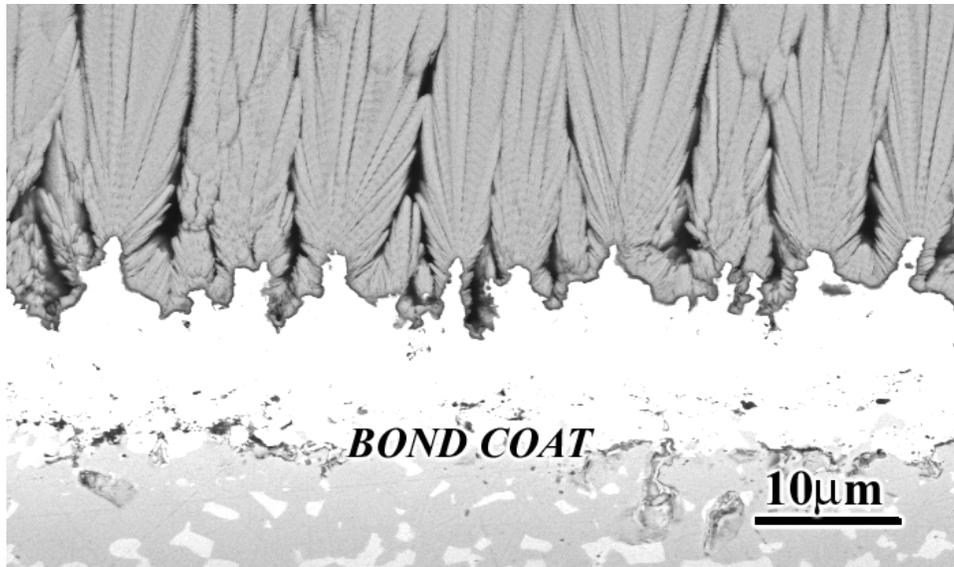
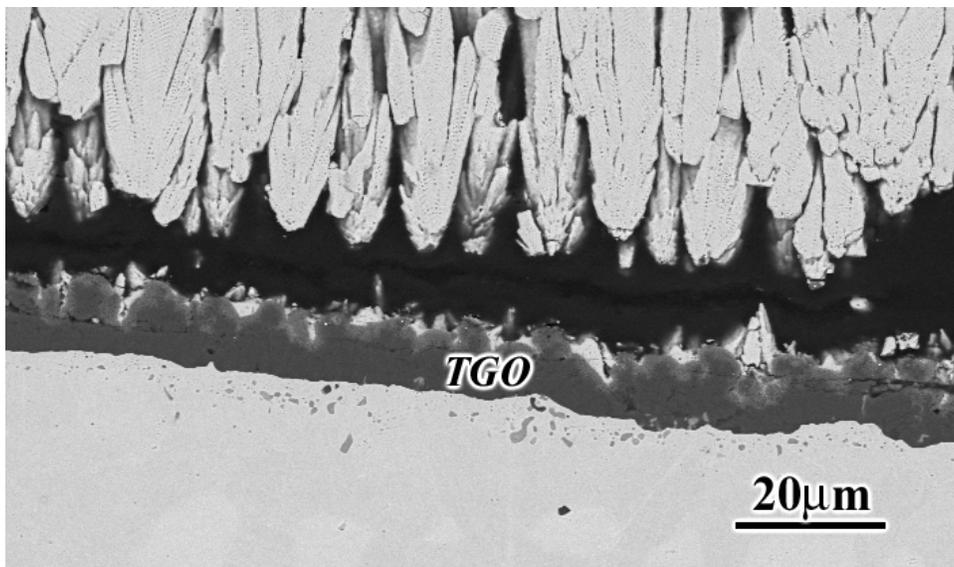
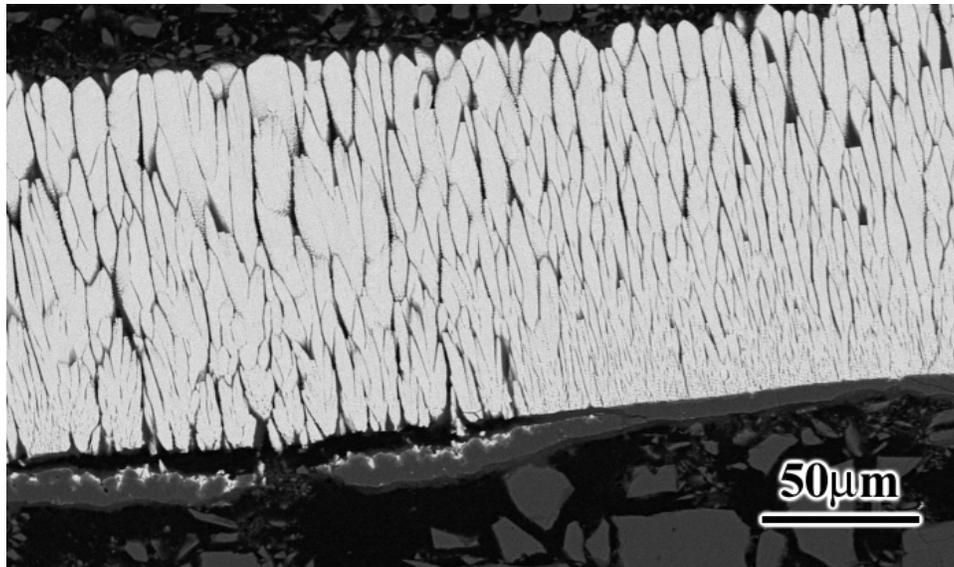
Depending on the surface condition and/or TBC deposition conditions, regions of separation in the TBC can form so frequently that weaknesses, which are continuous over relatively long distances, develop in the TBC in the vicinity of these defects (Figure 28a) The failure can easily initiate and/or propagate in the vicinity of these defects (Figure 28b) In this case, the development of these defects seems to be a function of an initially very irregular interface. Figure 28c shows failure propagating along these weak points until a stronger TGO/TBC interface, which lacks these TBC defects, has been encountered. The failure, then, changed its direction towards the TGO/bond coat interface.

Figure 28 Scanning electron micrographs of a specimen with many TBC defects, which were referred to as “points of separation in the TBC”, in the as processed condition, (a), and after the failure, (b) and (c).

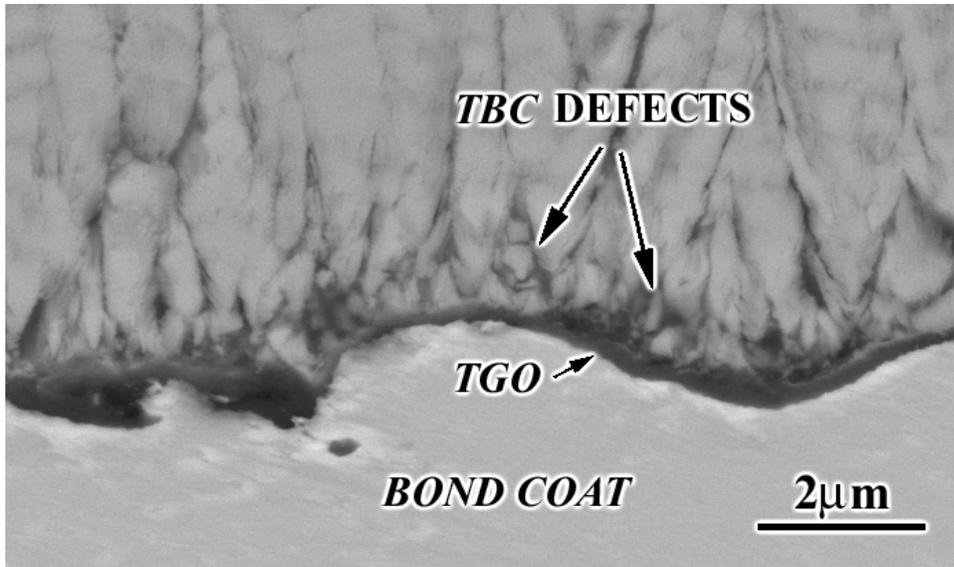
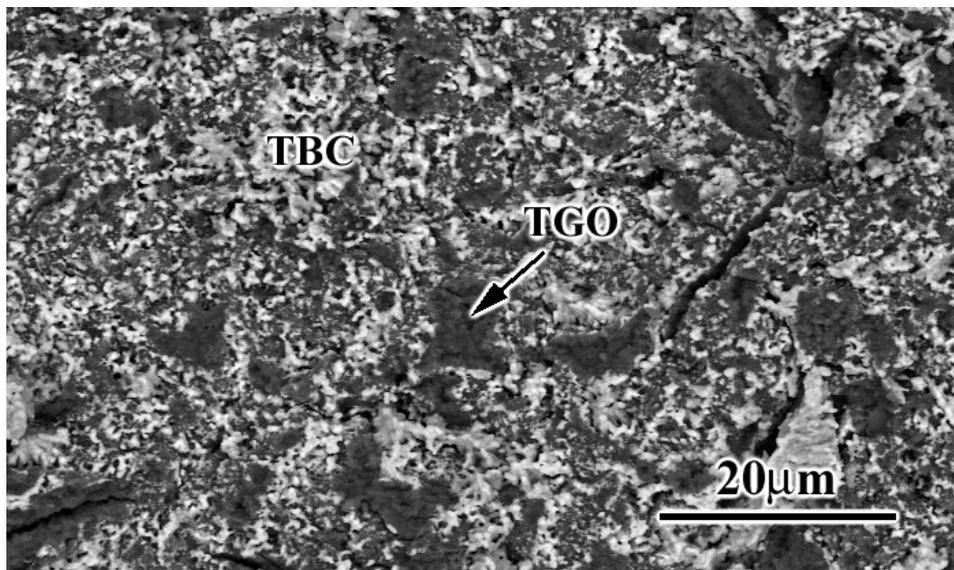
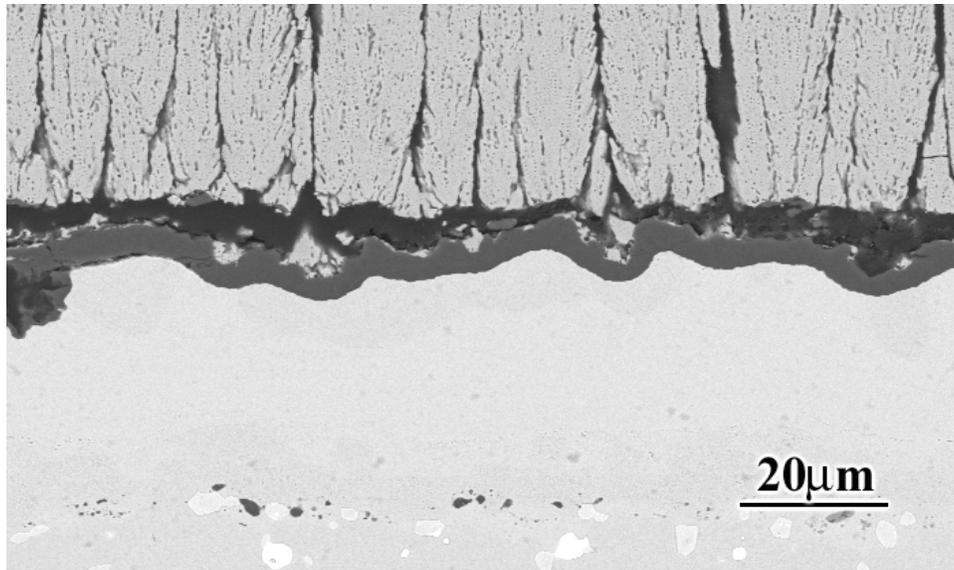
Figure 29a is another example showing similar TBC defects with a much finer scale, which developed on a smoother interface. Closer examination of this interface showed a significant amount of very small conical shaped TBC segments that seemed to be poorly bonded to the rest of the TBC. The TBC deposition conditions are believed to result in such a

morphology. This specimen also had a significant amount of failure along this weak interface as can be seen from the fracture surface as well as cross sectional micrographs given in Figures 29b and 29c.

Figure 29 Scanning electron micrograph showing another example to “points of separation in the TBC” in the as processed condition (a). The failure propagated mainly in the TBC in the vicinity of these defects as can be seen from the fracture surface (b), and the cross section (c) of the failed specimens.

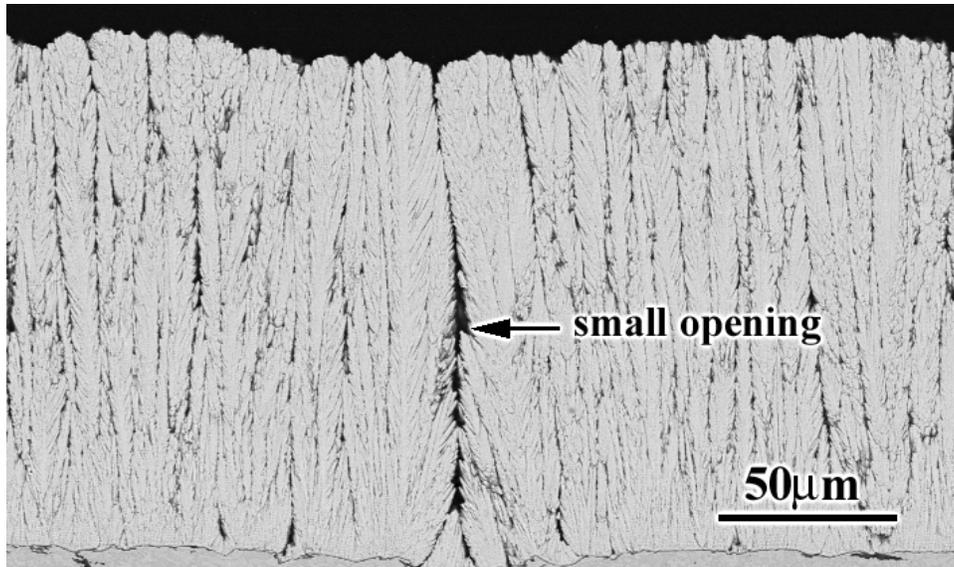
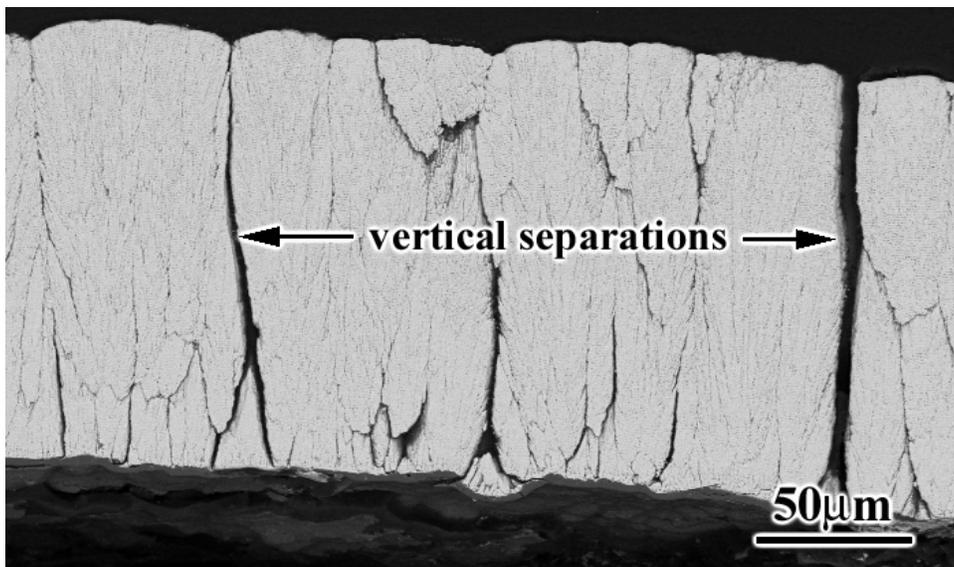
- **vertical separations** - These defects usually form on initially irregular surfaces. Due to shadowing effects during TBC deposition, small openings develop between the columns above the surface irregularities (Figure 30a). Upon exposure at high temperatures, these openings can enlarge resulting in the formation of so called “vertical separations” (Figure 30b) The sintering between the columns, which are already in contact, as well as the sintering within columns appear to be responsible for the enlargement of the openings that were already present between the columns in the as-processed condition.

Figure 30 Scanning electron micrograph of a specimen with small openings in the TBC in the as processed condition, (a). These openings enlarged with exposure resulting in the formation of so-called “vertical separations” in the TBC, (b).

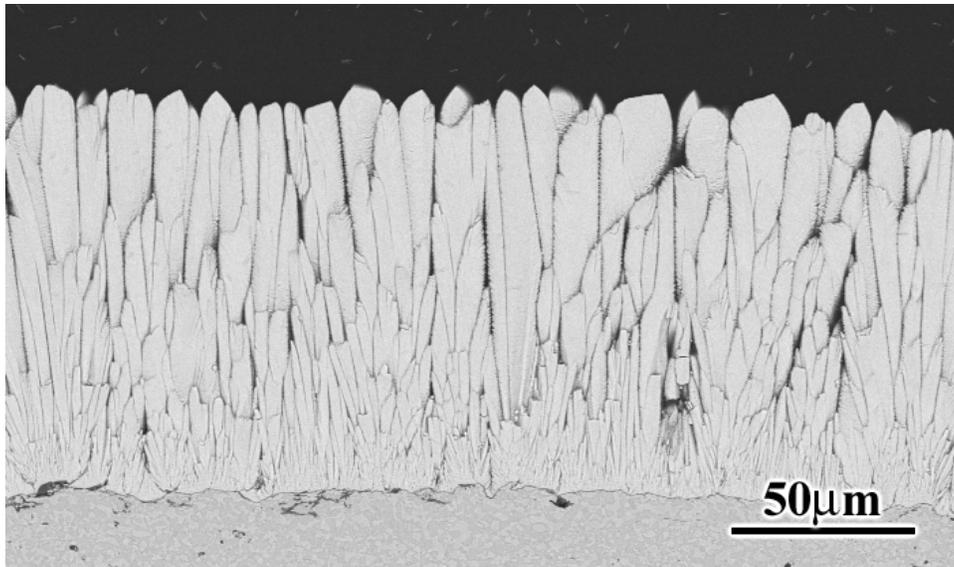
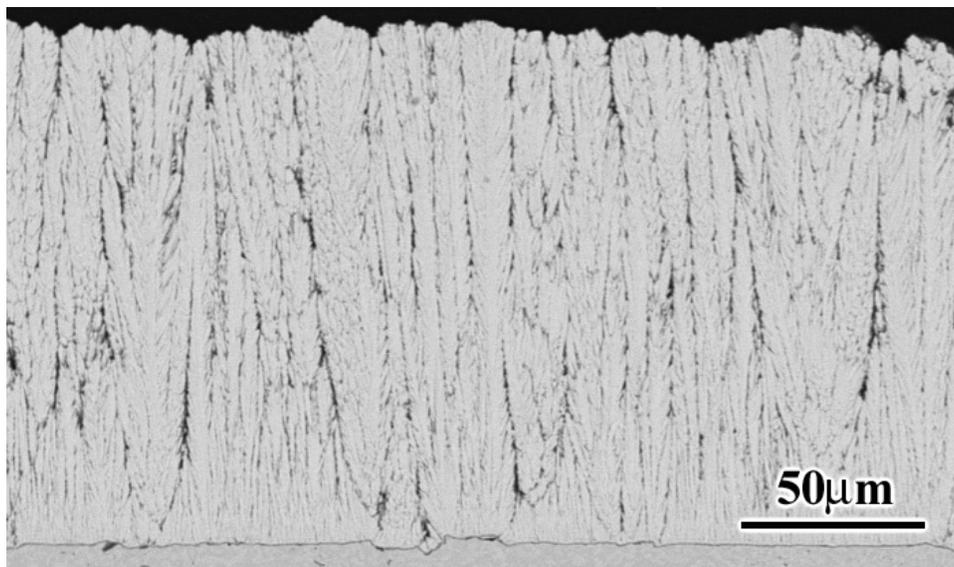
The reasons that lead to formation of vertical separations for some systems but not for the others with similar initial surface roughness have been investigated and it has been found that the TBC morphology also plays a role in their formation. The TBCs that did not develop vertical separations, had well defined, dense and relatively larger columns in the as-processed condition (Figure 31a) compared to the ones that developed vertical separations (Figure 31b). On the other hand, the column width increased with distance away from the interface. Figures 32a through 32c show high magnification micrographs from areas close to the interface, middle and then the top of the TBC, respectively. For systems which developed vertical separations, the column width did not change much with distance away from the interface as can be seen from Figures 33a through 33c. The widening of the columns away from the interface seems to fill in the gaps preventing the formation of openings that go all the way through the TBC in the as-processed condition as observed for the TBCs that developed vertical separations (Figure 30a)

Figure 31 Scanning electron micrographs showing the morphology of the TBC in the as-processed condition for the specimens that did not (a) and that did develop vertical separations in the TBC with exposure (b).

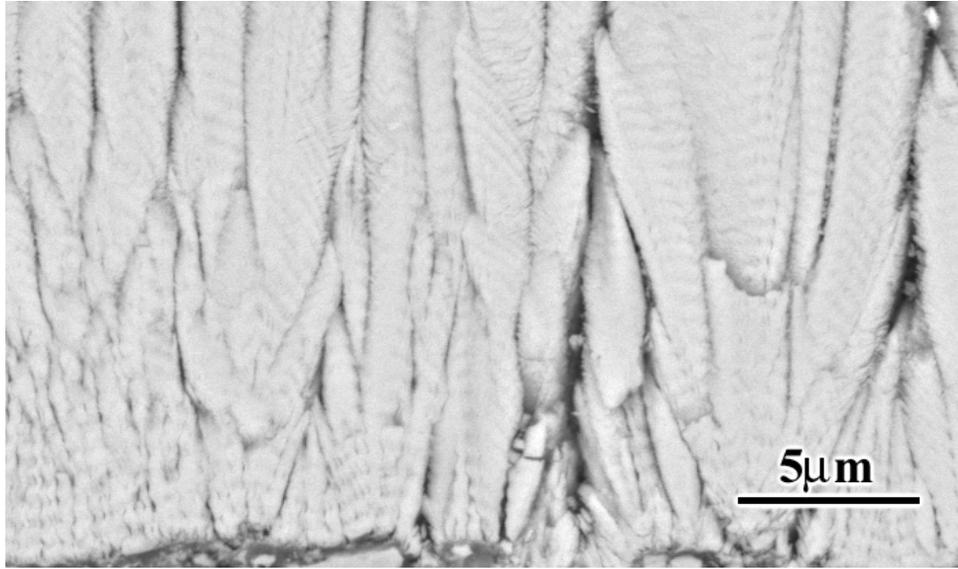
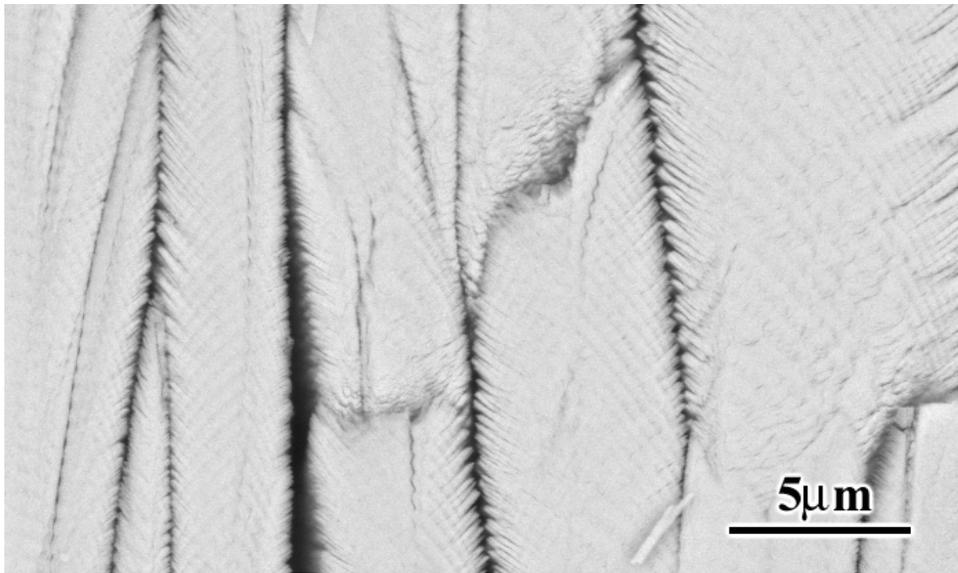
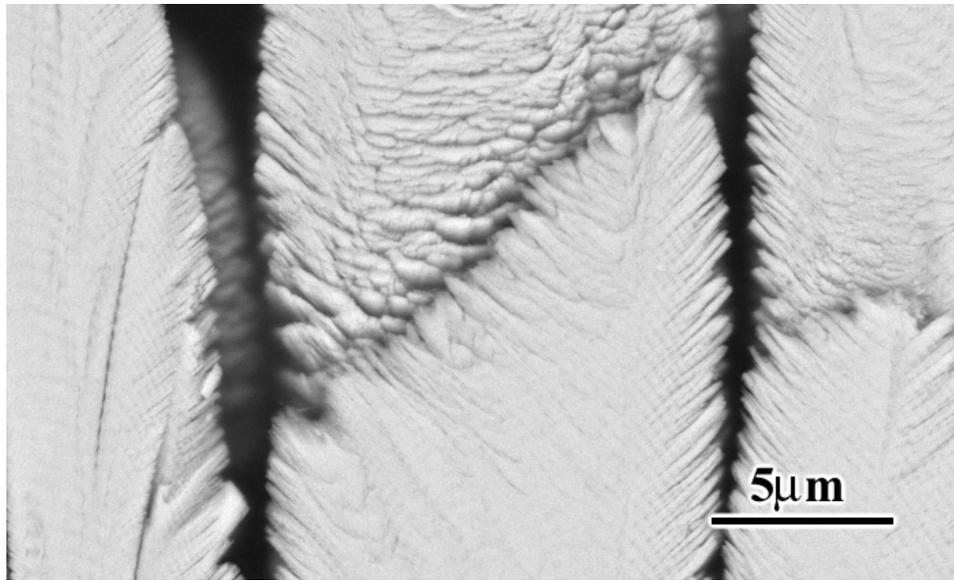
Figure 32 High magnification scanning electron micrographs from areas (a) close to the interface, (b) middle and (c) the top of the TBC of an as processed TBC system which did not develop vertical separations in the TBC.

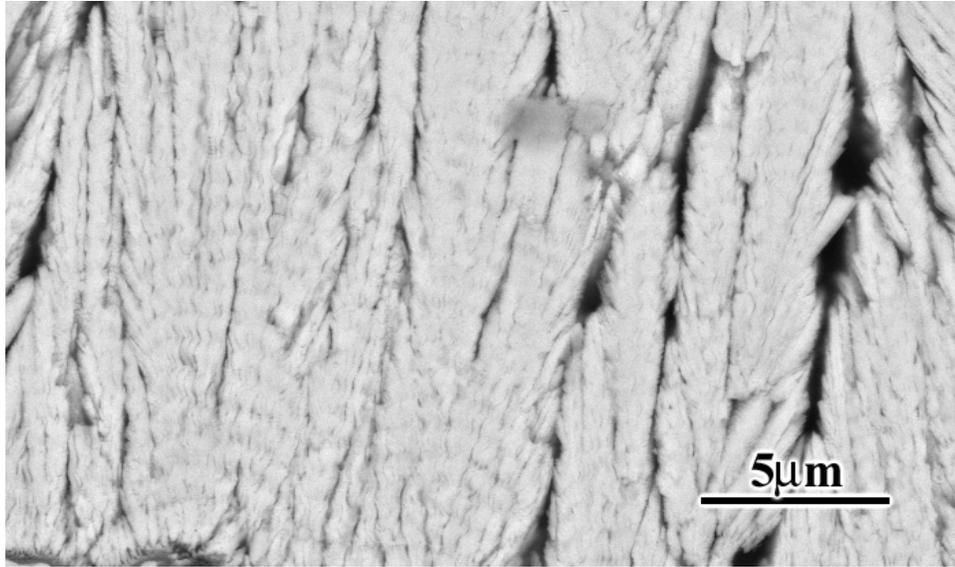
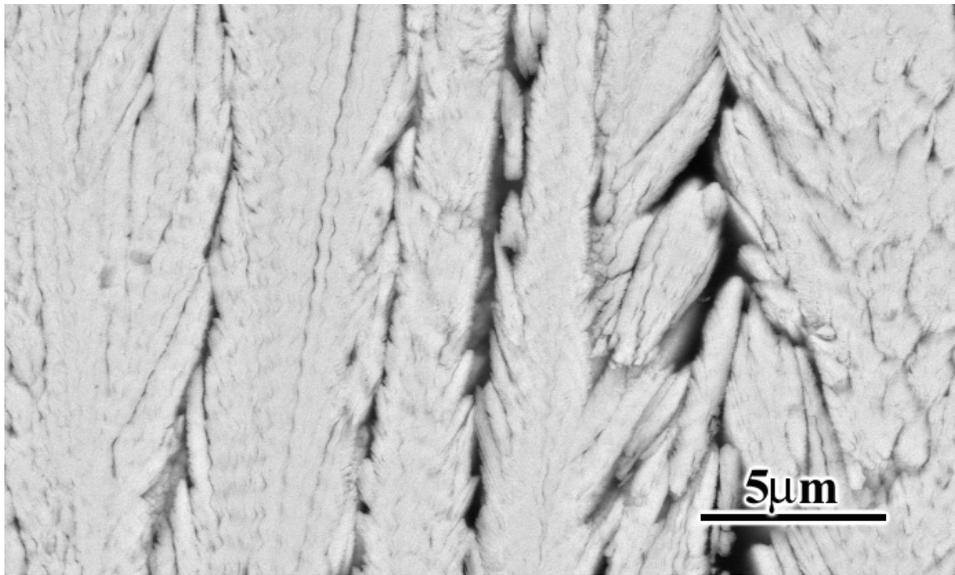
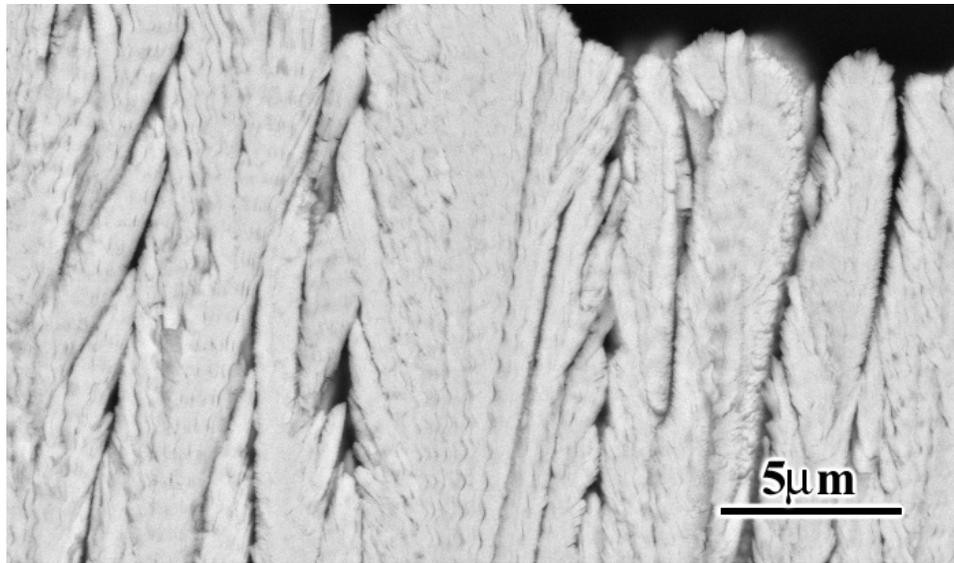
Figure 33 High magnification micrographs from areas (a) close to the interface, (b) middle and (c) the top of the TBC of an as processed TBC system which developed vertical separations in the TBC.

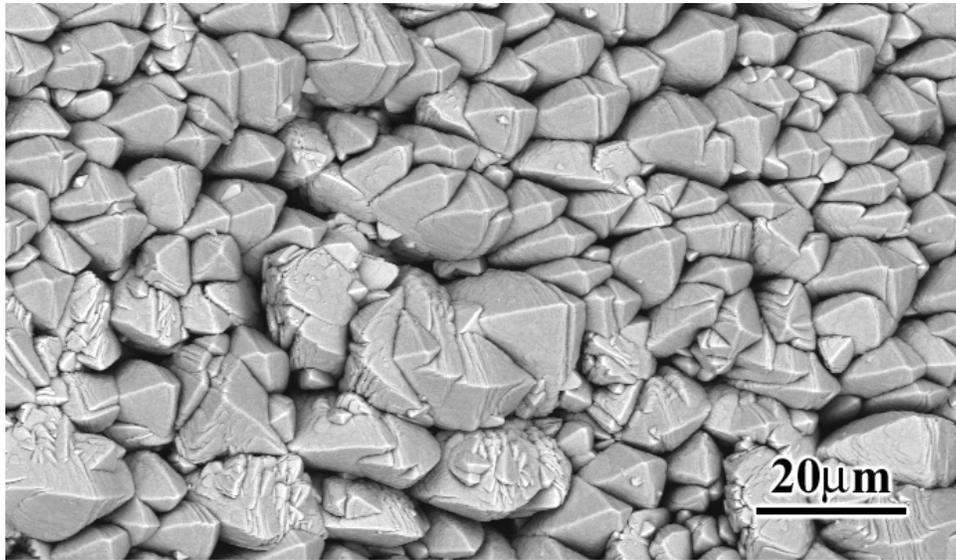
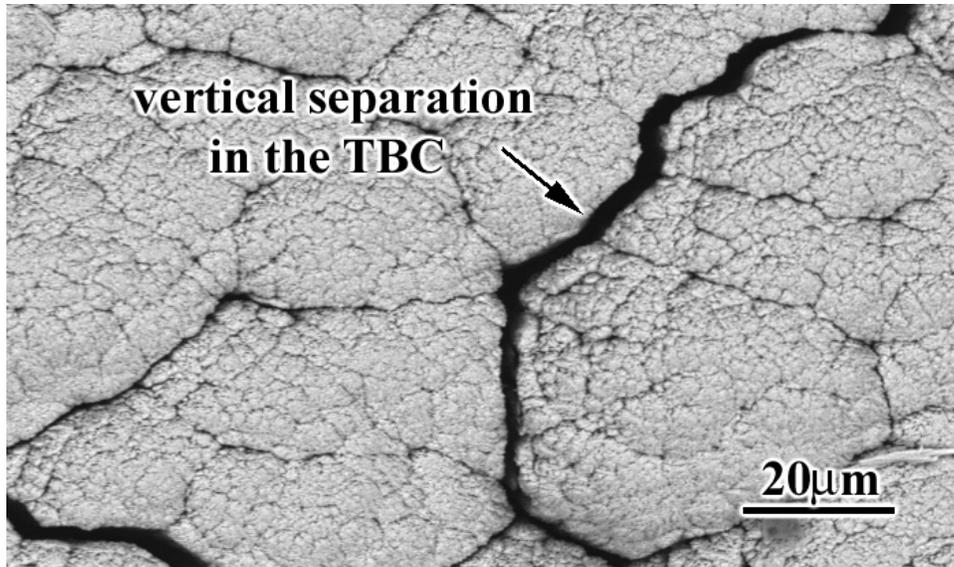
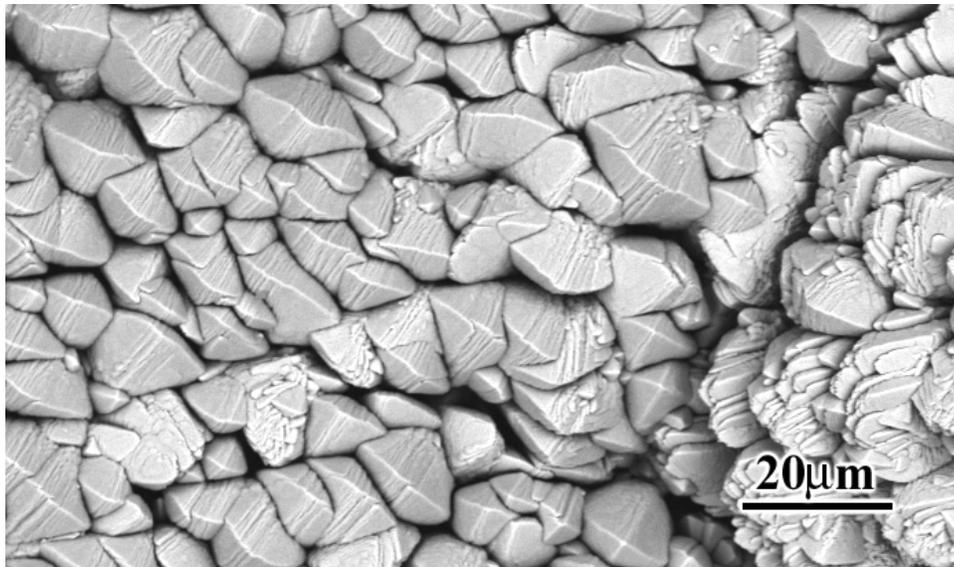
The marked difference in the morphology of these TBCs can also be seen by comparing the top views of the TBCs. Figure 34a and Figure 34b show the TBCs in the as-processed condition for the specimens which developed vertical separations and which did not, respectively. The columns that had a fine morphology sintered during exposure whereas the ones with denser columns remained almost the same (Figures 34c and 34d respectively). This is believed to be one of the reasons which leads to formation of vertical separations for the TBCs with a finer structure. The already present openings enlarge as the columns get sintered with exposure. The vertical separations being more well developed with exposure at higher temperatures (compare Figures 35a and 35b after exposure at 1000°C and 1150°C, respectively) is also consistent with sintering being an important factor for their formation.

Figure 34 Top views of TBCs in the as-processed condition for the specimens (a) which developed vertical separations in the TBC and (b) which did not. The columns in (a), which had a fine morphology, got sintered during exposure resulting in the formation of vertical separations (c), whereas the denser columns, (b), remained almost the same (d).
