THE FAILURE OF THERMAL BARRIER COATINGS AT ELEVATED TEMPERATURES

Submitted to the Graduate Faculty of
the School of Engineering in partial fulfillment
of the requirements for the degree of
Doctor of Philosophy

University of Pittsburgh

2004

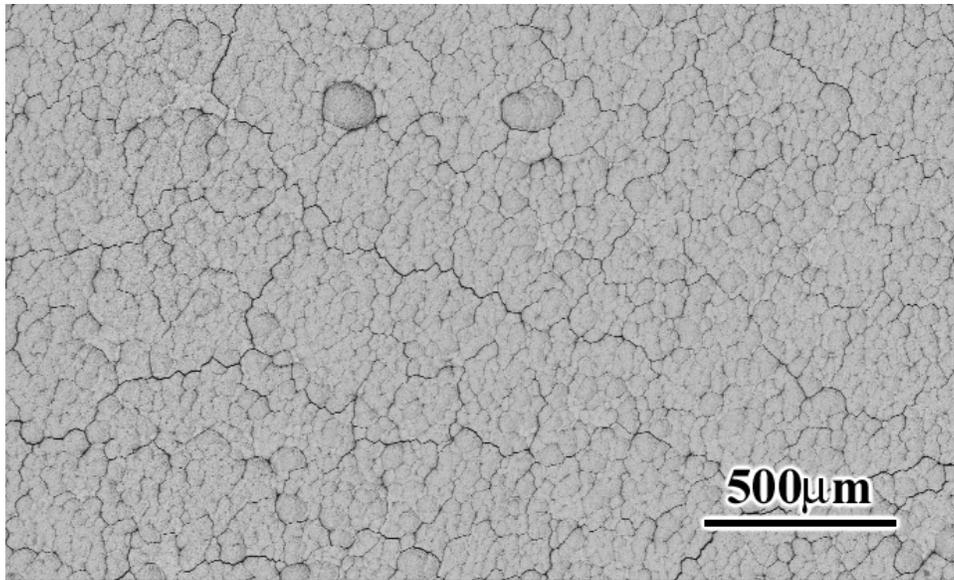
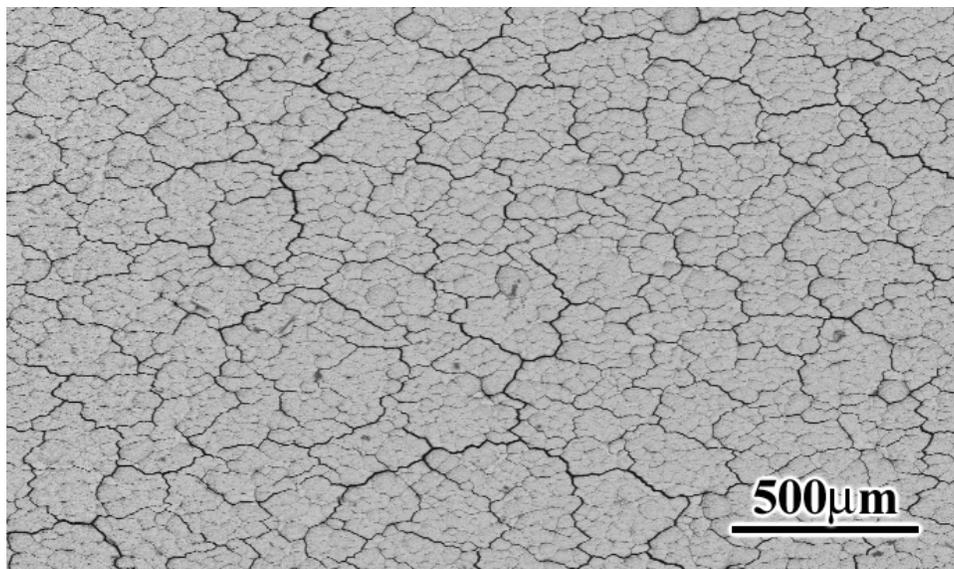
Figure 35 Top views of TBCs for specimens that developed vertical separations after exposure at (a) 1000°C for 780 cycles and (b) 1150°C for 15 cycles. The vertical separations were more well developed after exposure at 1150°C.

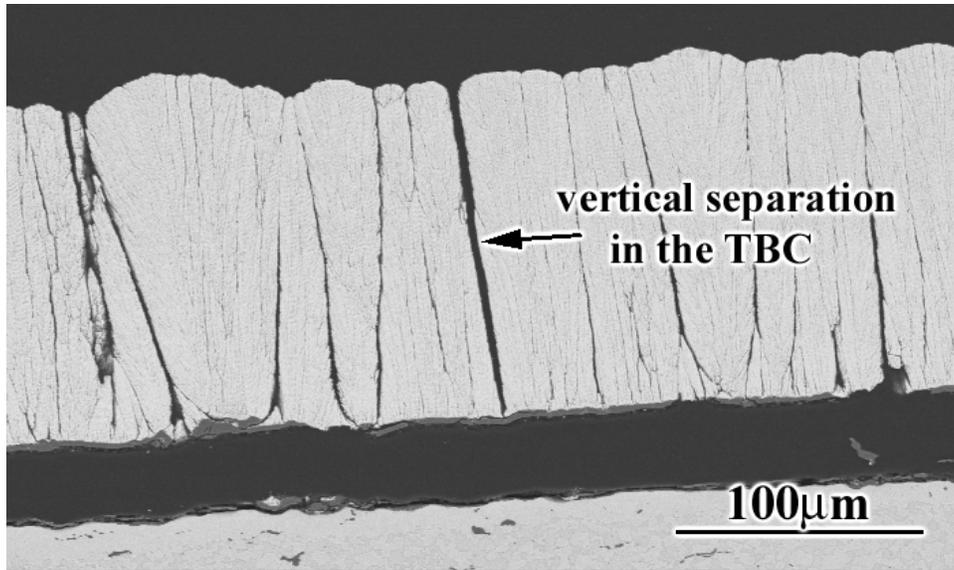
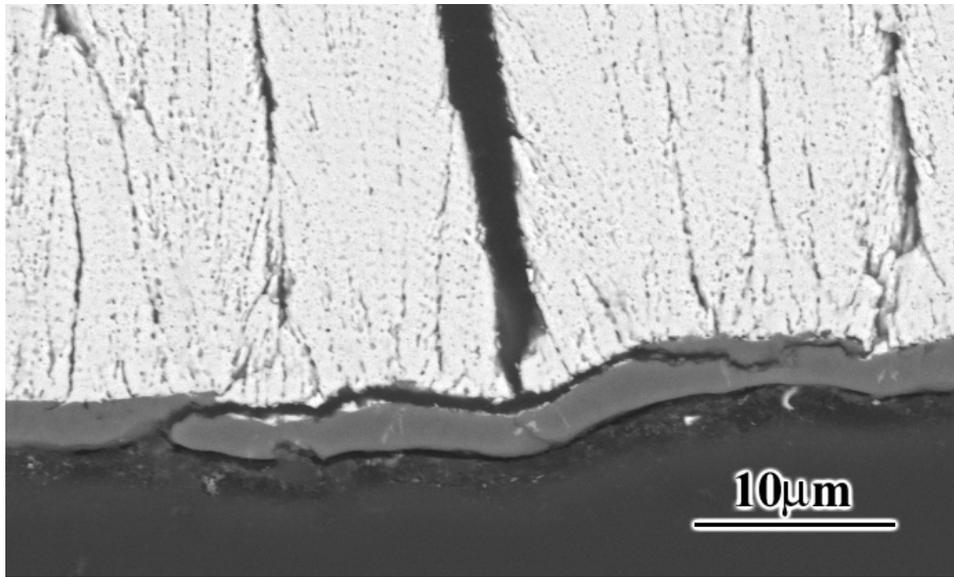
These vertical separations may also contribute to the failure of TBC systems by acting as crack initiation sites (Figures 36a and 36b) The importance of these vertical separations on the failure was also explained by Evans [52]. However, it is also worth mentioning that long lives were obtained despite a large number of vertical separations for some TBC systems (Figure 37) which shows that the presence of these defects alone is not sufficient to cause failure of these systems. More work is required to better define the role of these defects on the failure of TBC systems.

Figure 36 Cross sectional micrographs showing vertical separations and cracks in their vicinity at (a) low and (b) high magnifications.

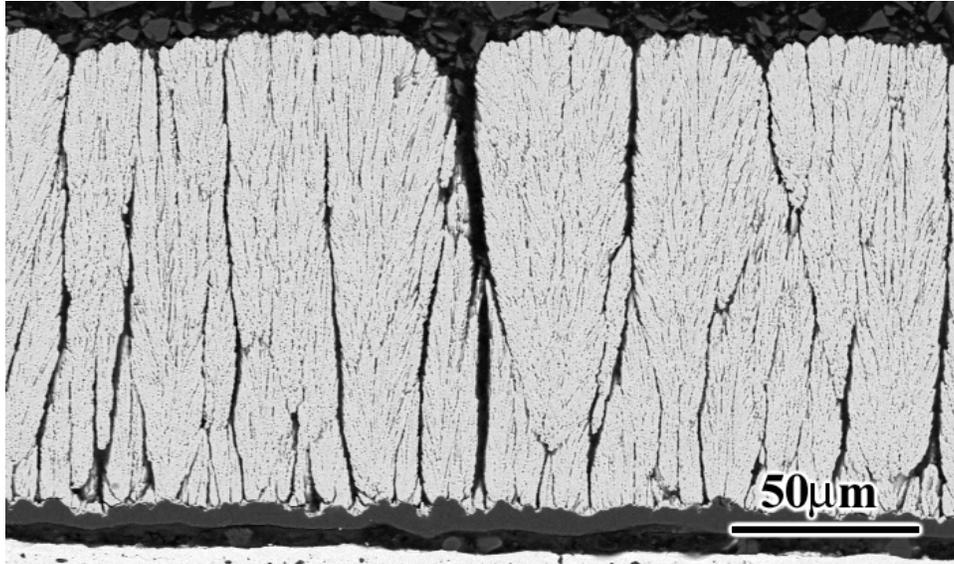
Figure 37 Scanning electron micrograph showing a large number of vertical separations in a TBC system which had a significantly long life.

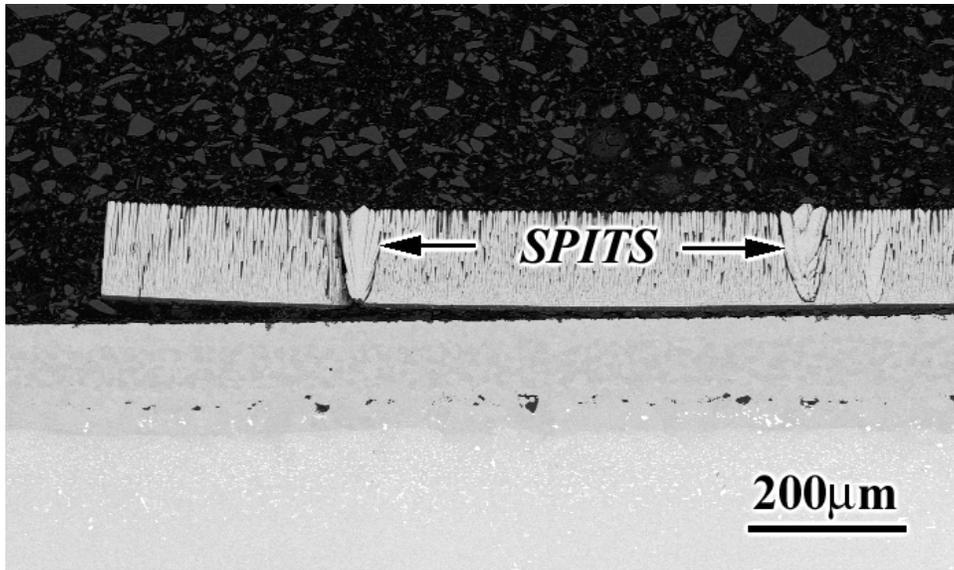
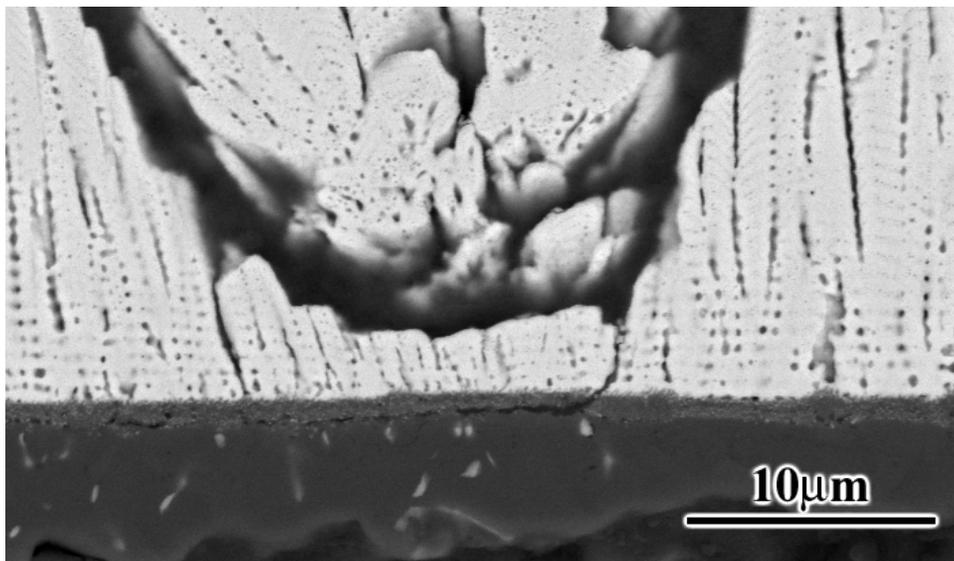
- **spits** - This is another type of TBC defect that may form during TBC processing (Figure 38a). In some cases, cracks have been observed to initiate in the vicinity of these spits as in Figure 38b.

Figure 38 Scanning electron micrographs showing (a) spits in the TBC and (b) cracks initiating in the vicinity of a spit.

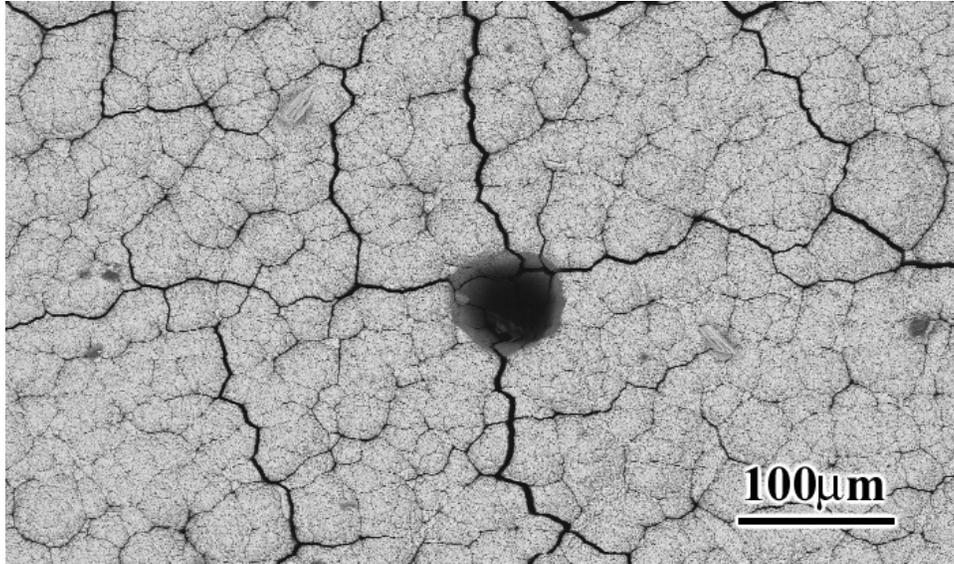
of defect almost always showed cracks passing through the holes as in Figure 39. These observations may suggest the role of these defects also as crack initiation and/or propagation sites.

Figure 39 Top view of a TBC showing a hole and cracks passing through it.

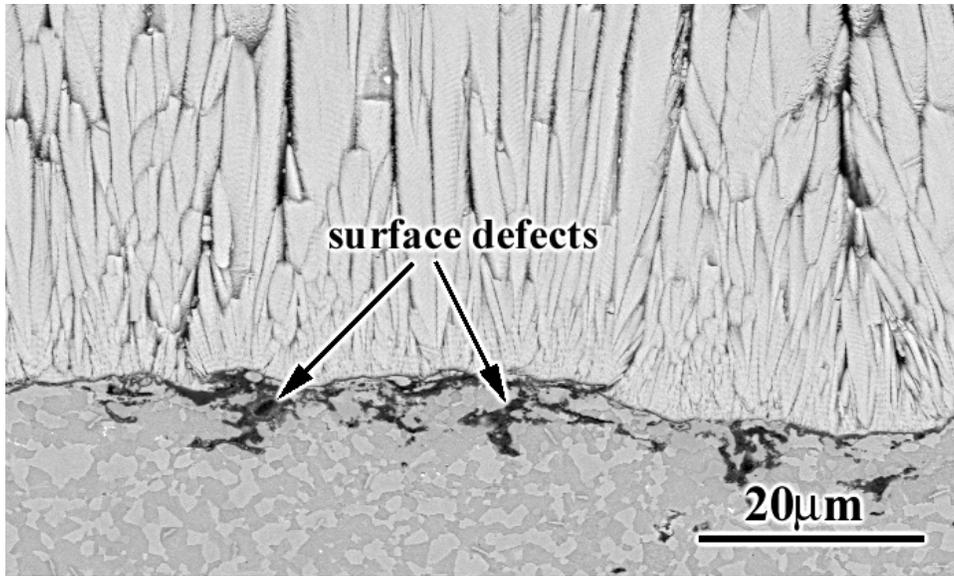
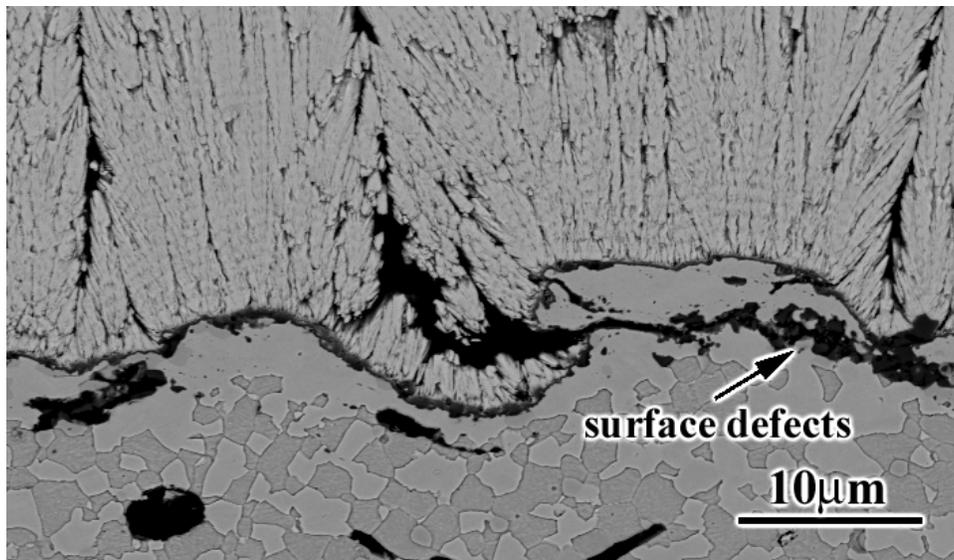
4.2.2.3 Surface defects The features that are referred to as surface defects in this study are the embedded grit blast particles and oxide inclusions, that cut the surface at various angles (Figure 40a). These oxide inclusions may have formed by cracking of the bond coat during surface preparation and then oxidation during subsequent heat treatment or TBC deposition. In some areas, the alloy was undercut by these surface defects (Figure 40b), which is believed to cause formation of oxides other than alumina with subsequent exposure.

Figure 40 (a) Scanning electron micrographs showing oxide inclusions that cut the surface at various angles. In some areas, the alloy was undercut by these oxide inclusions, (b).

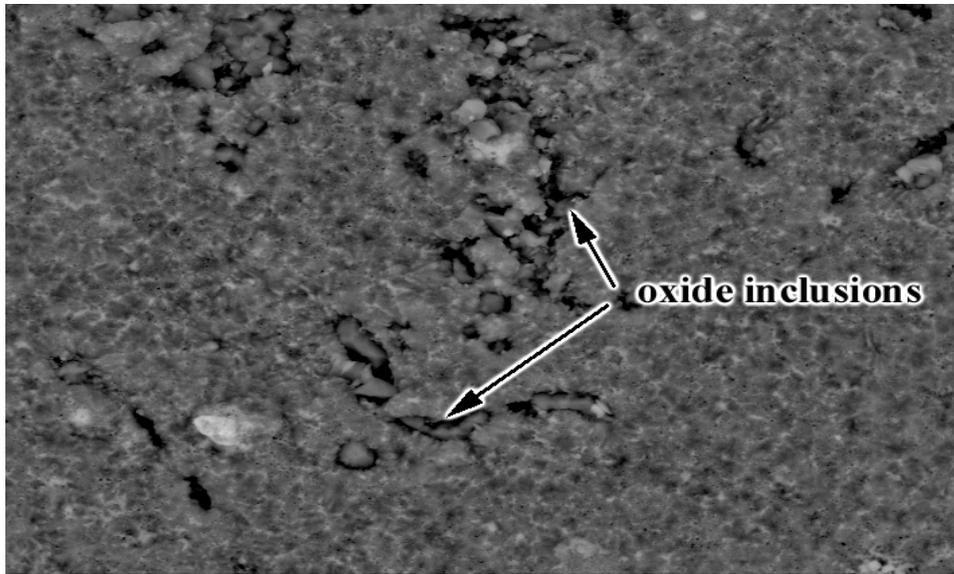
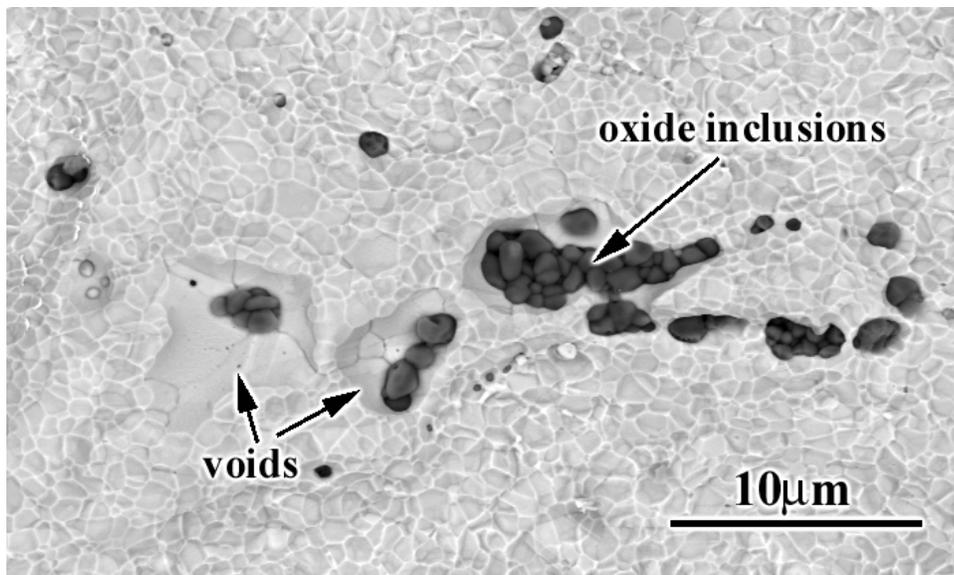
The presence of oxide particles on the surface makes it more difficult to form an adherent TGO. Figure 41a is from a fracture surface, which was reoxidized after TBC spallation. The arrow points to these oxide inclusions and the discontinuous oxide that formed around these oxide inclusions. In some cases, voids were also observed to develop around these oxide inclusions (Figure 41b)

Figure 41 Scanning electron micrographs from the fracture surfaces of specimens with surface defects showing the development of a discontinuous oxide in the vicinity of oxide inclusions, (a) and voids around some of these oxide inclusions , (b).

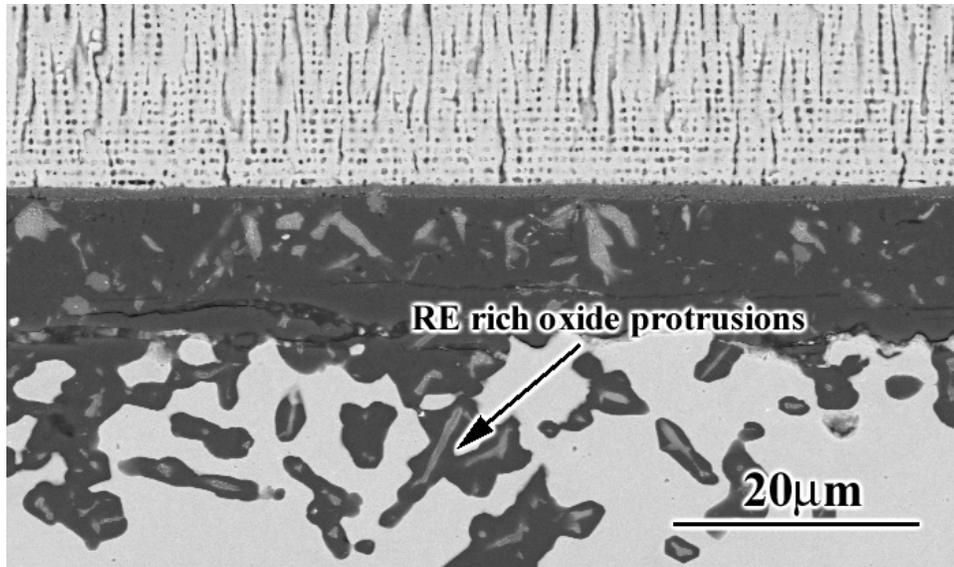
4.2.2.4 Reactive Element Oxide Protrusions Rapid transport of oxygen through reactive element rich oxides and its reaction with aluminum in the alloy results in formation of stringers of reactive element rich oxides encapsulated in alumina (Figure 42) The amount and distribution of these oxides vary depending on the composition of the alloy and deposition technique, as well as the preoxidation conditions.

Figure 42 Scanning electron micrograph showing stringers of reactive element rich oxides encapsulated in alumina.

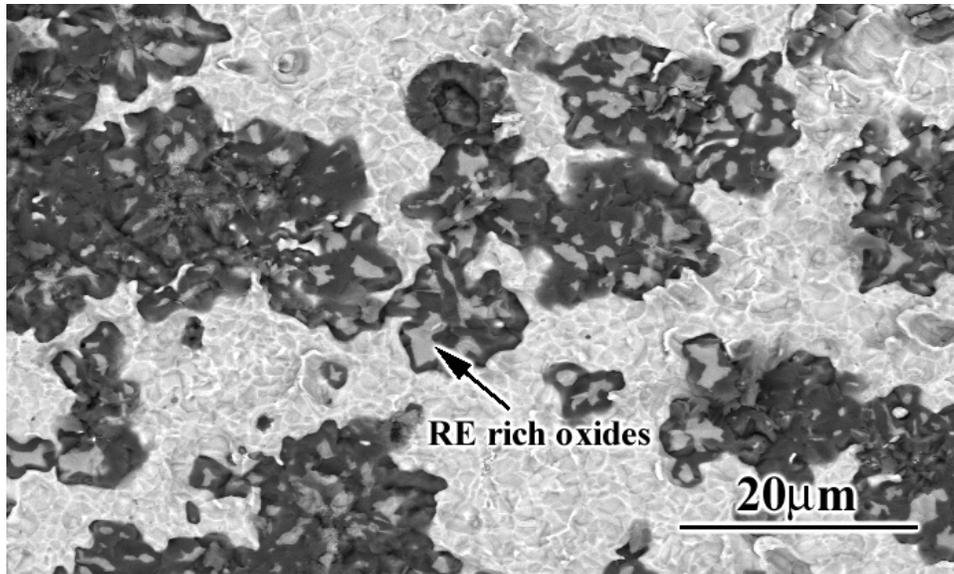
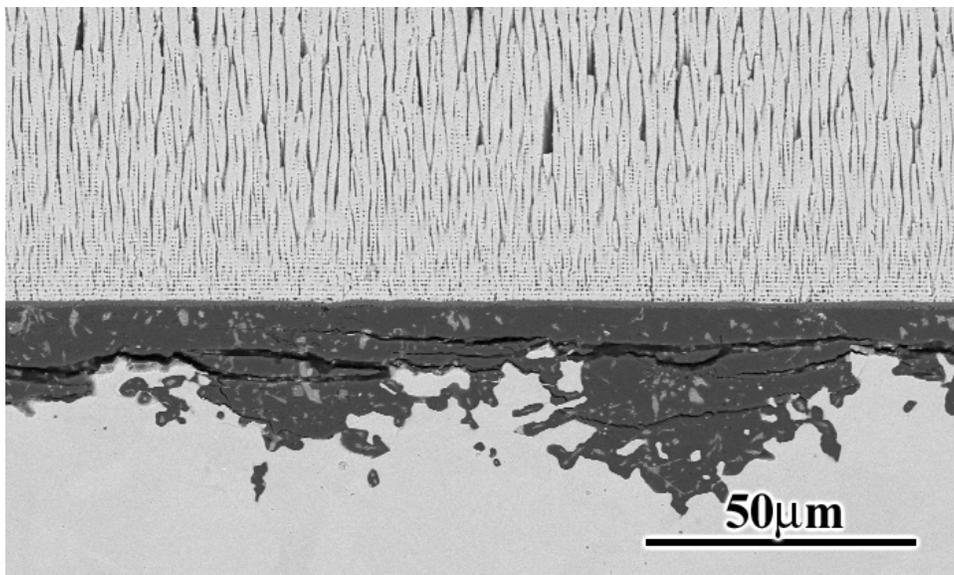
When TBC systems with NiCoCrAlY bond coats fail, a significant amount of failure usually propagates along the TGO/bond coat interface, cutting through RE rich oxide protrusions (Figure 43a). Even though clear evidence that suggests crack initiation in the vicinity of these oxide protrusions could not be found, the presence of cracks in the TGO where excessive amounts of these oxide protrusions are present (Figure 43b), is believed to be partly due to stress concentration in the vicinity of these oxide protrusions. The importance of these reactive element rich oxide protrusions for the failure of TBC systems was also discussed by other investigators [31, 32, 51].

Figure 43 (a) Scanning electron micrograph showing the fracture surface of a specimen where the failure cut through RE rich oxide protrusions. (b) Cross sectional examination showed the presence of cracks in the vicinity of these oxide protrusions.

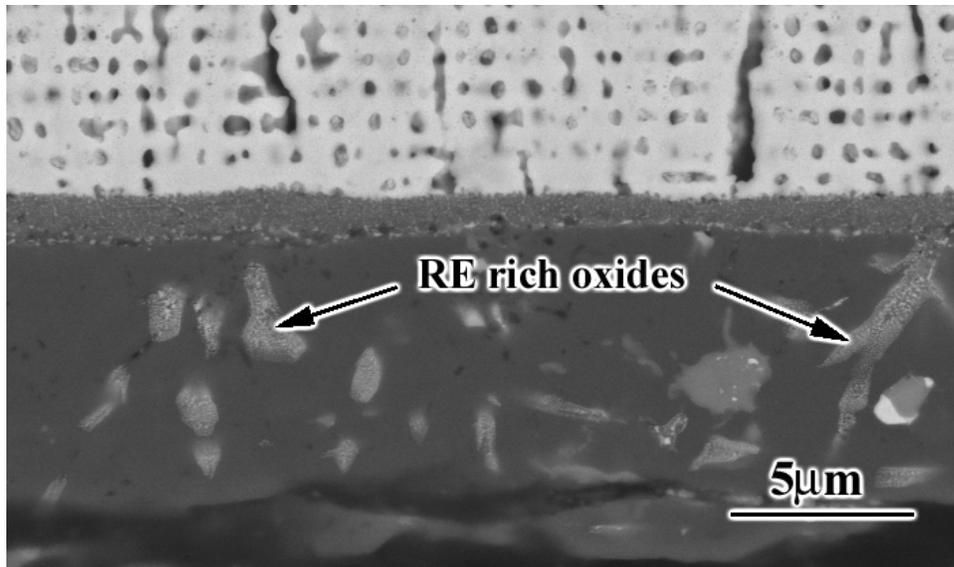
Incorporation of these reactive element rich oxides into the TGO is also believed to result in the formation of thick TGOs by acting as fast diffusion paths for oxygen (Figure 44) Therefore, these reactive elements can also contribute to failure this way by increasing the stored strain energy in the TGO, which is a strong function of TGO thickness.

Figure 44 Scanning electron micrograph showing the presence of a thick TGO which had incorporated RE rich oxides

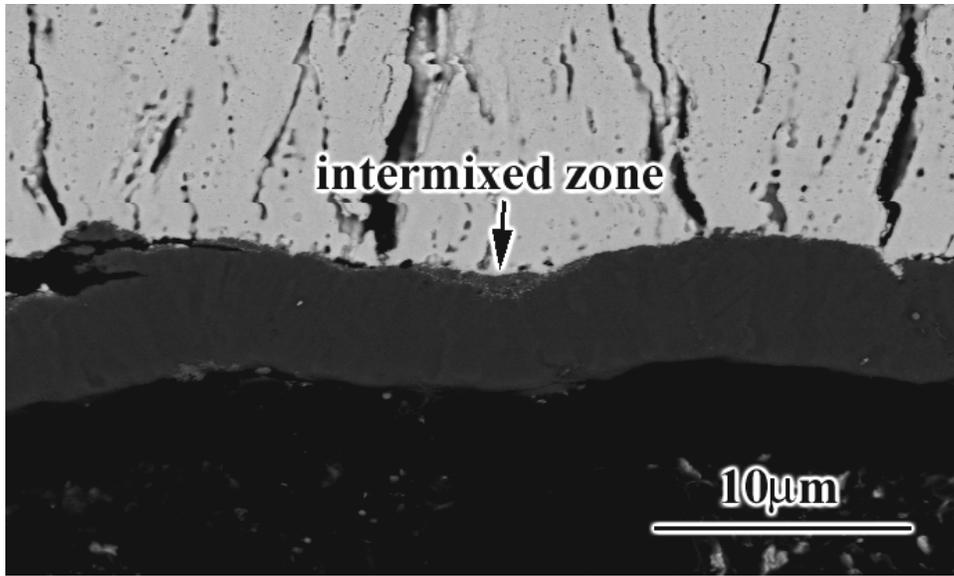
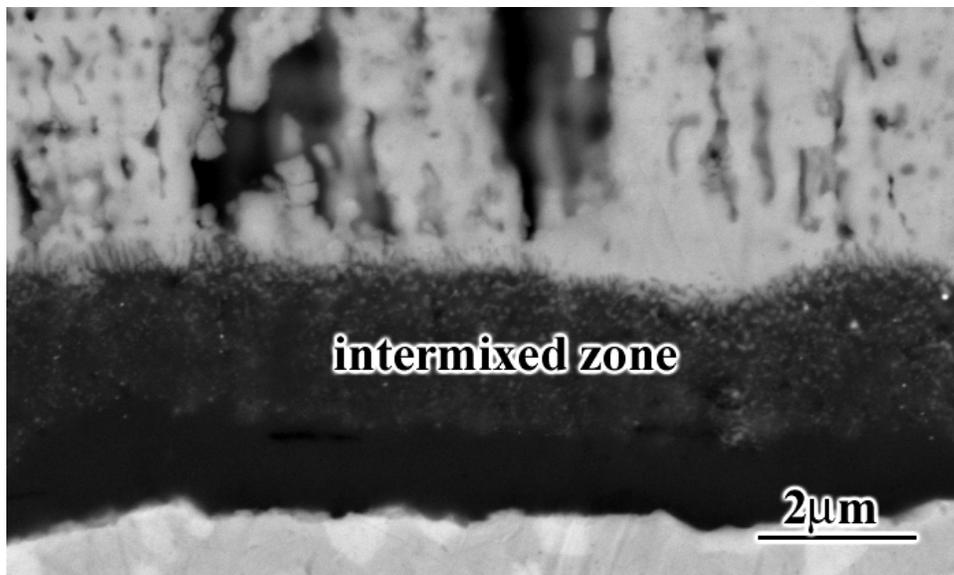
4.2.2.5 Intermixed zone The intermixed zone is usually a mixture of alumina and zirconia plus yttria [70] which forms along the TGO/TBC interface. It may form discontinuously at localized areas (Figure 45a) as well as a uniform continuous layer (Figure 45b) Examination of one set of specimens as a function of exposure time at 1100°C showed that a continuous layer of intermixed zone increased in thickness with exposure time after TBC deposition and it stopped growing after a short amount of time. Figures 46a through 46e show the SEM micrographs from

Figure 45 Scanning electron micrographs showing a discontinuous, (a), and a continuous layer of intermixed zone, (b).

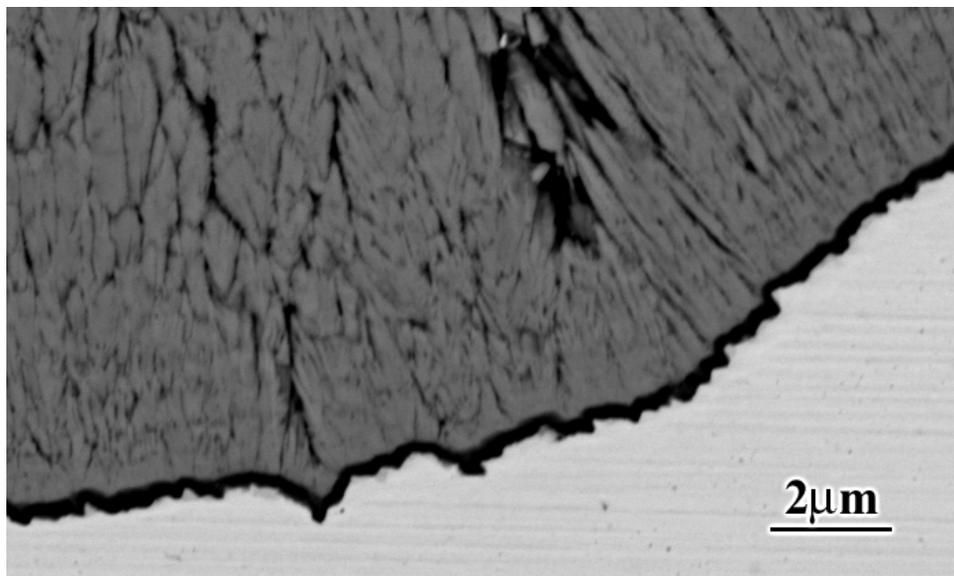
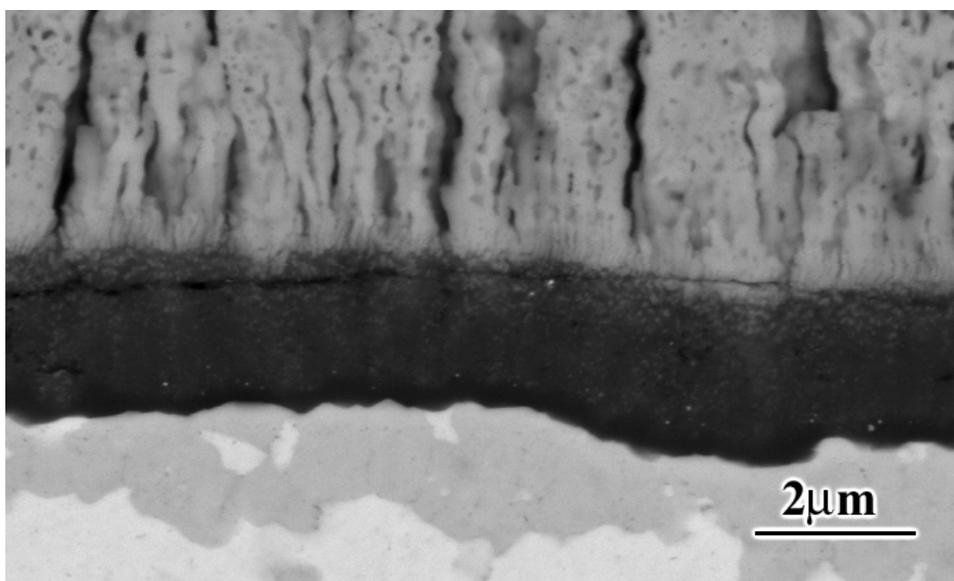
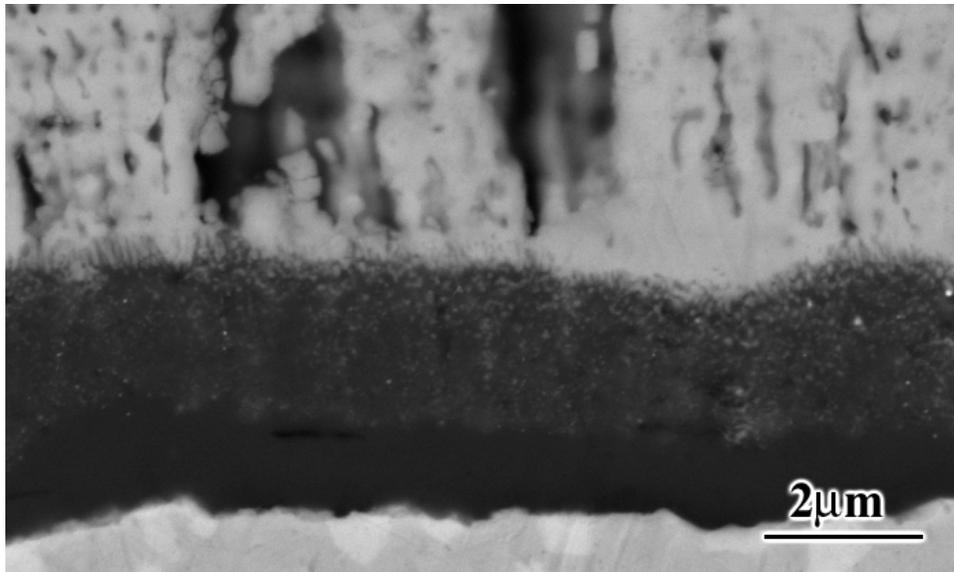
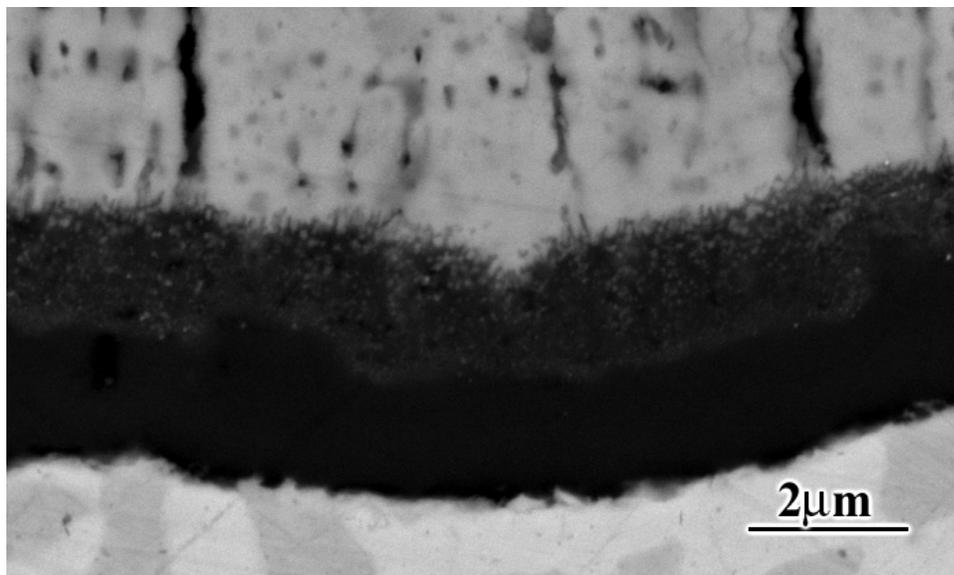
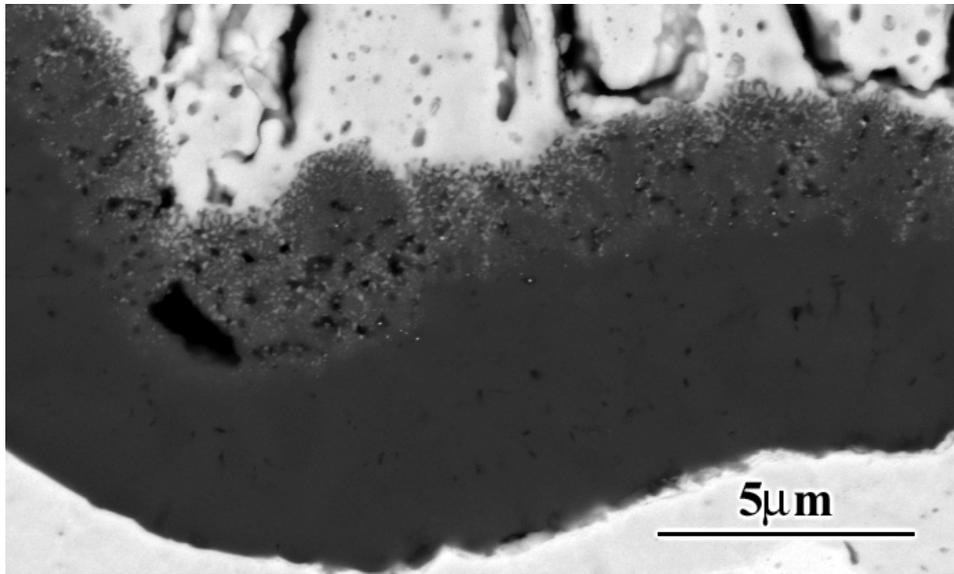
these specimens in the as-processed condition as well as after exposure at 1100°C for 10, 60, 100 and 880cycles, respectively. The formation of this intermixed zone seems to involve outward transport of Al as proposed by Stiger et al. [70]. Figures 47a and 47b are high magnification micrographs from the fracture surface of a specimen that developed a continuous intermixed zone. As can be seen from these tapered sections from the TGO/TBC interface, the TBC consists of nanosized equiaxed grains as well as porosity close to TGO/TBC interface and the alumina seems to incorporate these grains and porosity by outward diffusion. In some cases, the intermixed zone consisted of whiskers of alumina penetrating into the zirconia (Figure 47c). Metastable aluminas, which are known to grow by outward aluminum diffusion, also have a whisker like morphology, which looks similar to whiskers of alumina observed to penetrate into the TBC for some of these systems. Therefore, it is possible that the intermixed zone in these specimens formed as a result of formation of outward growing metastable aluminas. However, the TEM study of a specific system by Stiger et al. [70] did not show any evidence of metastable aluminas in the intermixed zone. In some specimens, the intermixed zone was observed to consist of zirconia and transient oxides (Figure 47d).

Figure 46 Scanning electron micrographs from a specimen in the as-processed condition (a), as well as after exposure at 1100°C for 10, (b), 60 (c), 100 , (d), and 880 cycles, (e), showing the development of the intermixed zone with time.

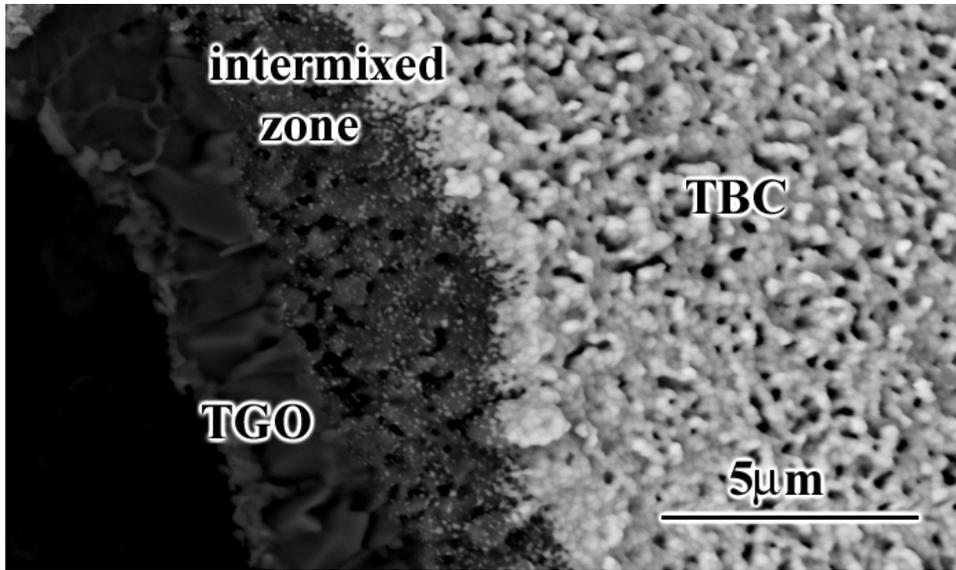
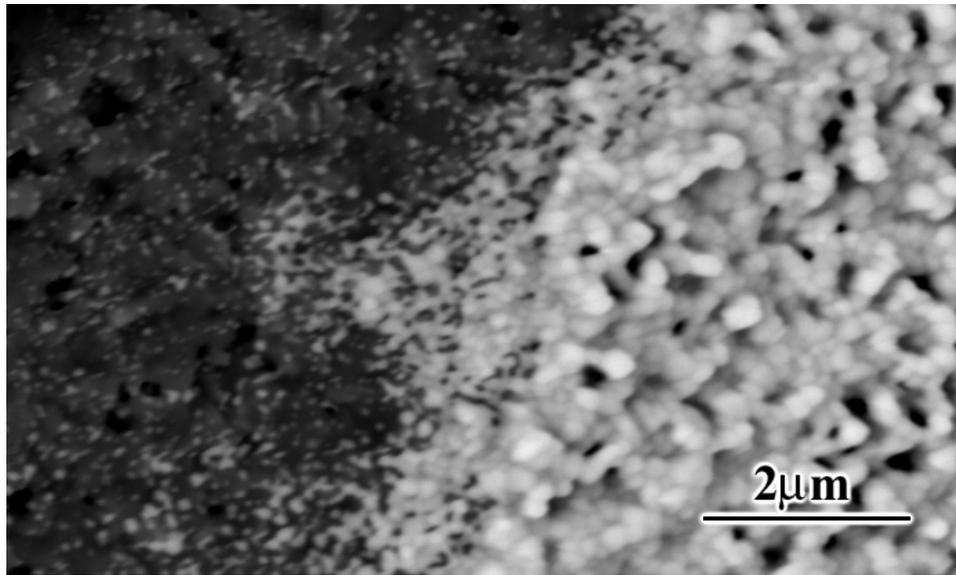
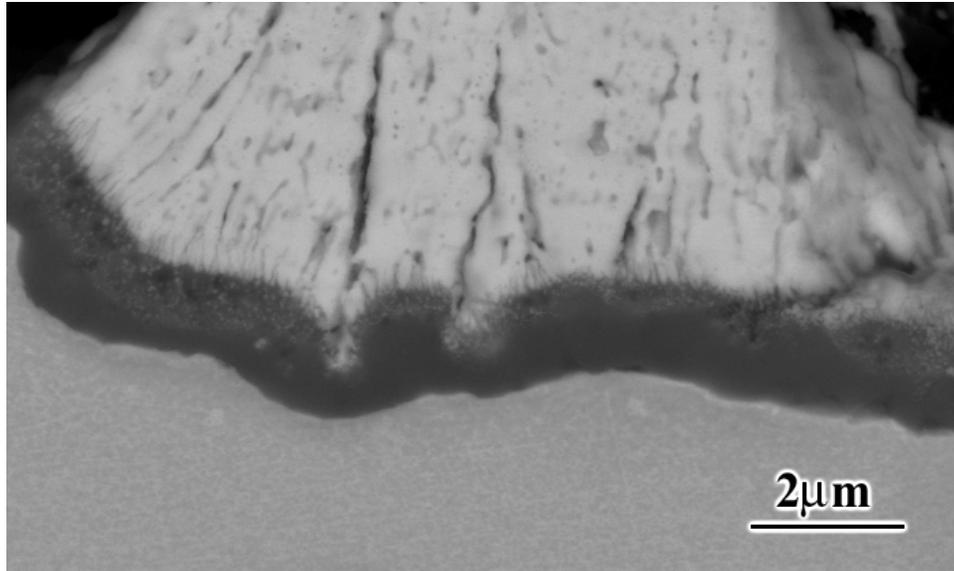
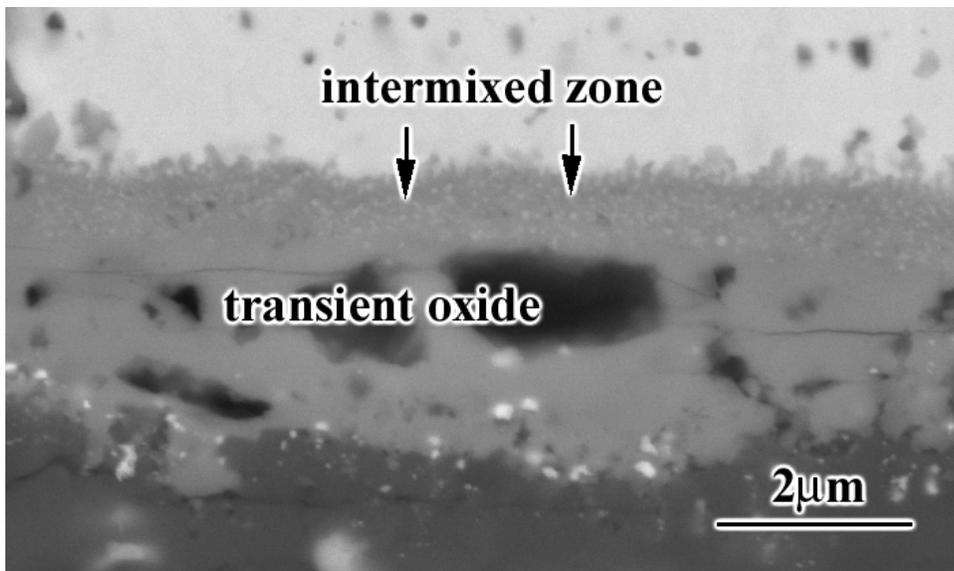
Figure 47 Scanning electron micrographs of the fracture surfaces, (a) and (b) , and cross sections, (c) and (d) , of specimens that developed intermixed zones. See text for details.

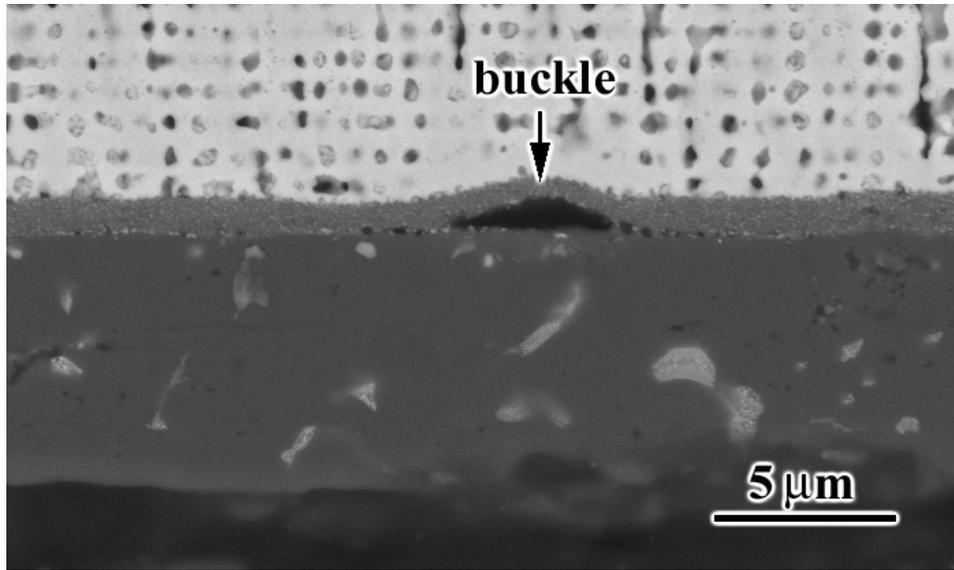
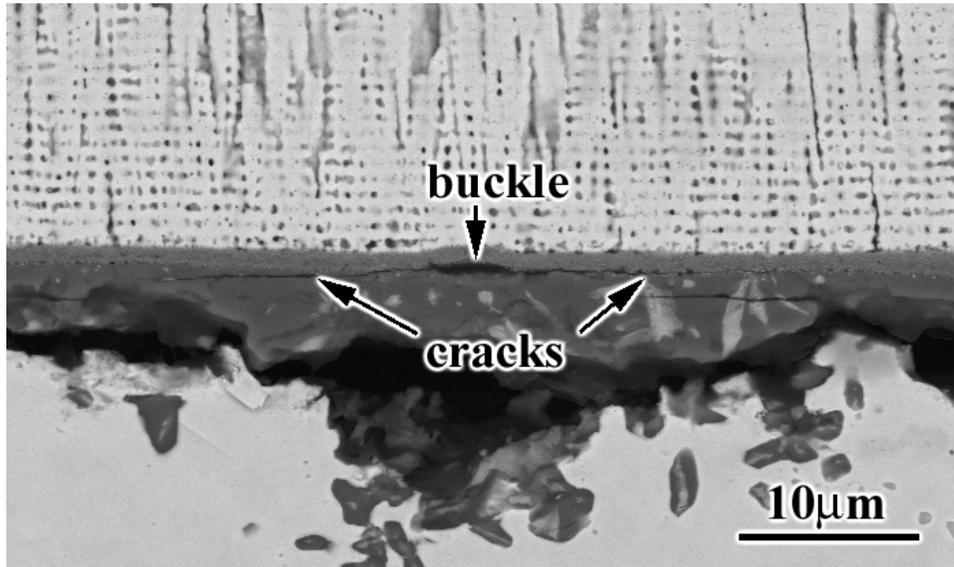
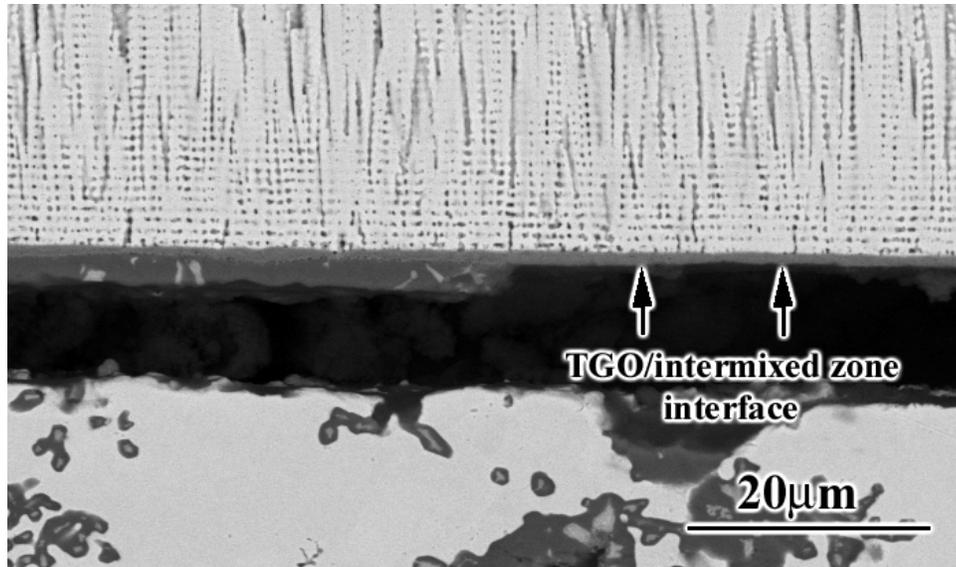
Examination of some specimens which developed a continuous layer of intermixed zone showed small buckles along the TGO/intermixed zone interface (Figure 48a) and cracks emanating from these buckles (Figure 48b) In some areas a significant amount of failure was observed to propagate along this interface (Figure 48c). These observations indicate that the intermixed zone can also contribute to failure through acting as crack initiation and/or propagation sites.

Figure 48 Scanning electron micrographs showing a buckle, (a), and cracking in the vicinity of a buckle along the TGO/intermixed zone interface, (b). Significant amount of failure was sometimes observed to propagate along this TGO/intermixed zone interface, (c).

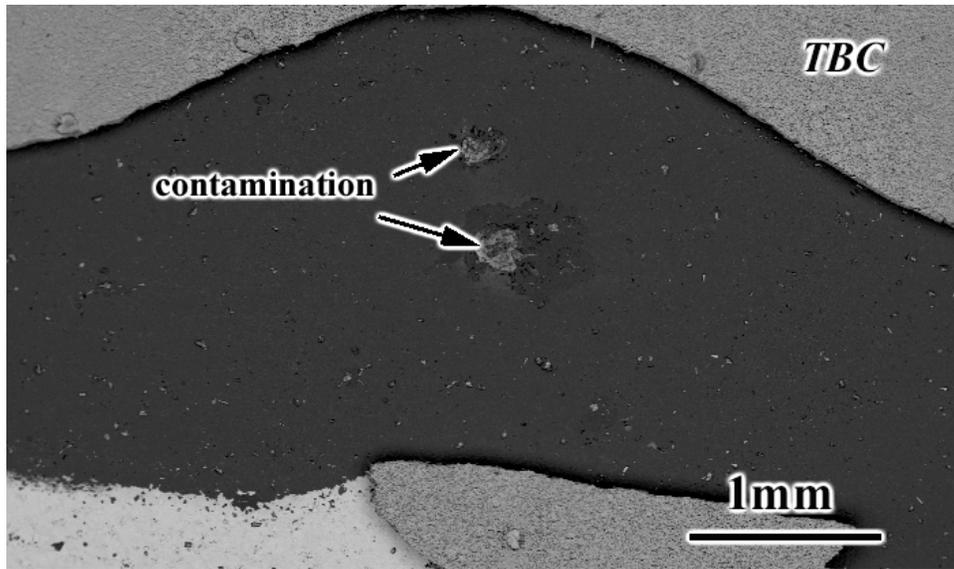
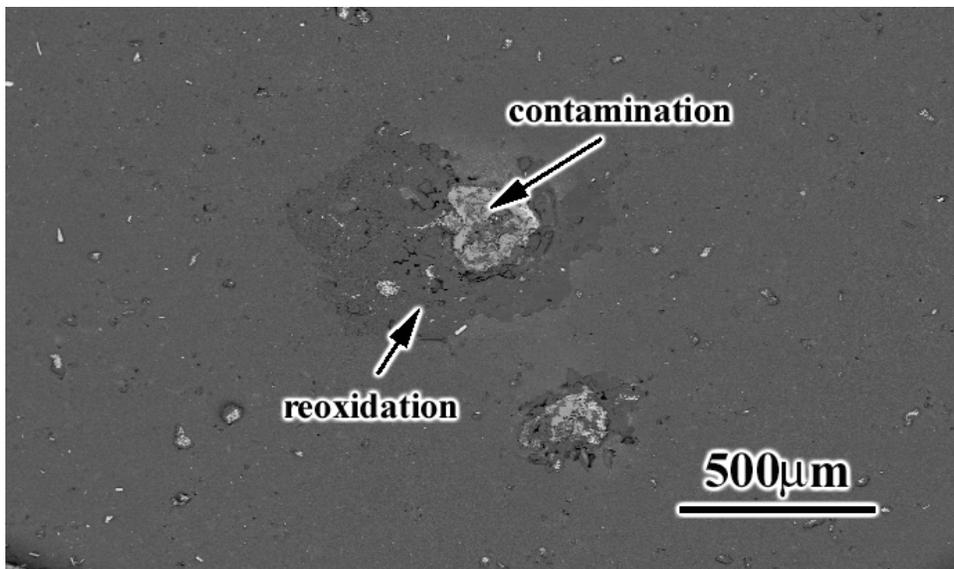
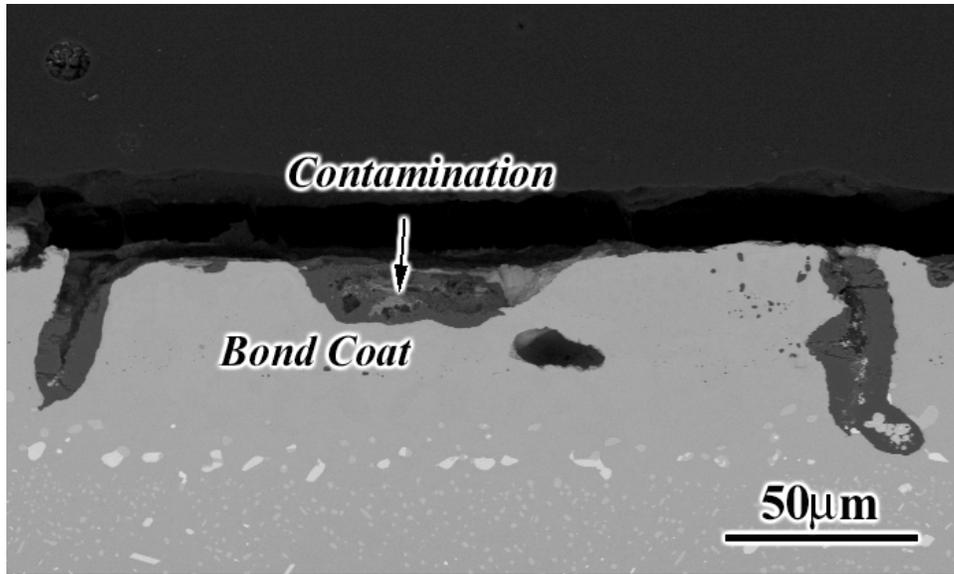
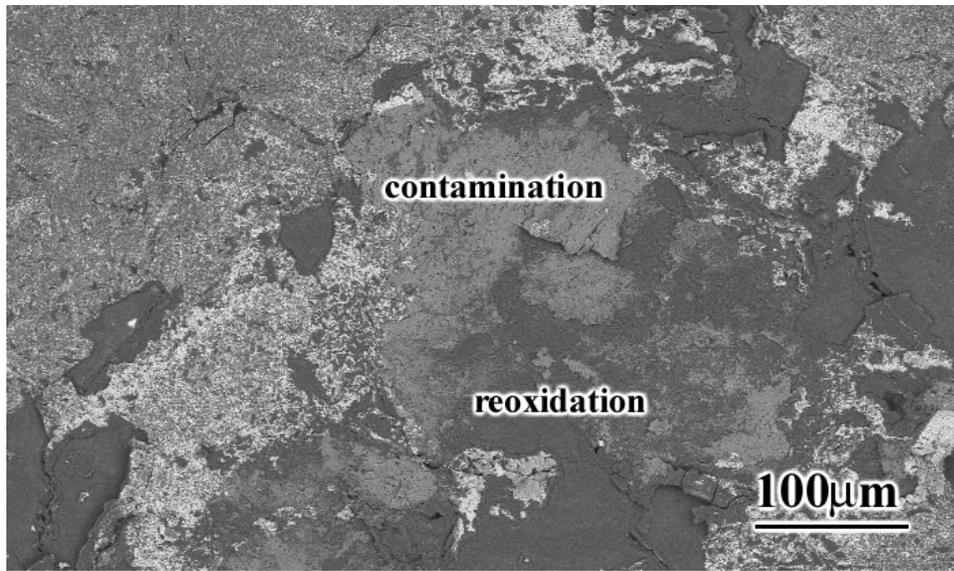
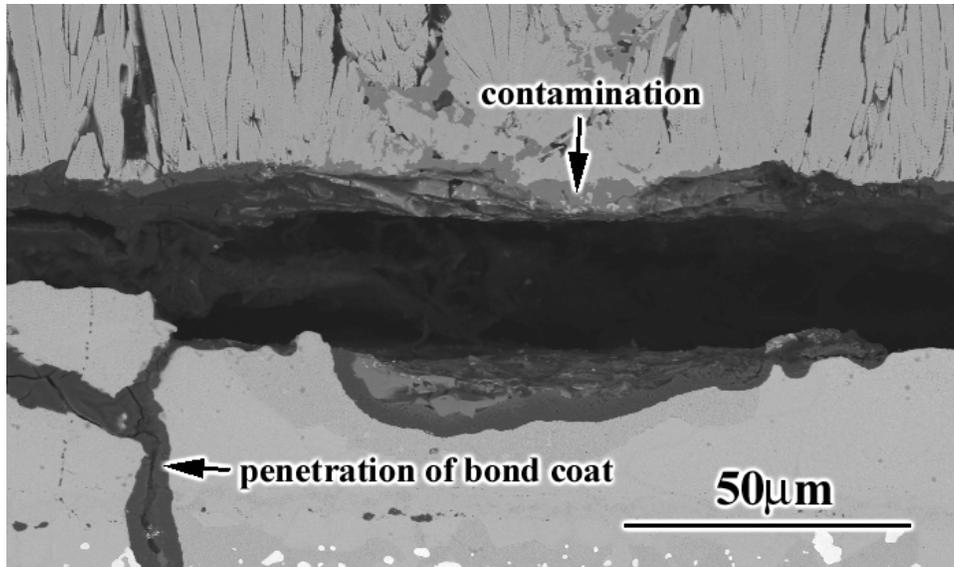
4.2.2.6 Contamination Contamination during processing of the TBC, especially with Fe, provides another area where cracks can initiate. Figure 49a shows a large Fe rich oxide contamination close to the center of a region where the specimen failed. It is possible to determine whether the alumina was in contact with the TBC during exposure or it separated and reformed before final failure by examining the morphology of the TGO as will be explained later on in the microstructural observations section. This is important because it gives clues about where the separations occurred before final failure. In Figure 49b, the light gray areas are where the bond coat surface was reoxidized after failure whereas the dark gray areas around the contamination correspond to thicker alumina where the bond coat was reoxidized before final failure. Cross sectional examination of this specimen showed accelerated oxidation and penetration of the bond coat in the vicinity of these defects (Figure 49c). Figures 49d and 49e are

from different specimens also showing reoxidized areas and accelerated oxidation in the vicinity of contamination sites, respectively. All these results indicate that separations occurred in the vicinity of these defects followed by accelerated oxidation.

Contamination is believed to be responsible for some of the early failures. However, there are some long lived specimens which were also contaminated. Thus, it is believed that the size of the separation in the vicinity of the contamination as well as its interaction with the other weaknesses in the system determines its effect on the final failure.

Figure 49 Scanning electron micrographs of the fracture surface of a specimen showing an Fe rich contamination and re-oxidation around it at (a) low and (b) high magnifications. Accelerated oxidation and penetration of the bond coat was evident in the vicinity of a contamination site, (c). Other examples of reoxidation and accelerated oxidation for different specimens in the vicinity of contamination sites are given in (d) and (e), respectively.
