THE FAILURE OF THERMAL BARRIER COATINGS AT ELEVATED TEMPERATURES

Submitted to the Graduate Faculty of
the School of Engineering in partial fulfillment
of the requirements for the degree of
Doctor of Philosophy

University of Pittsburgh

2004

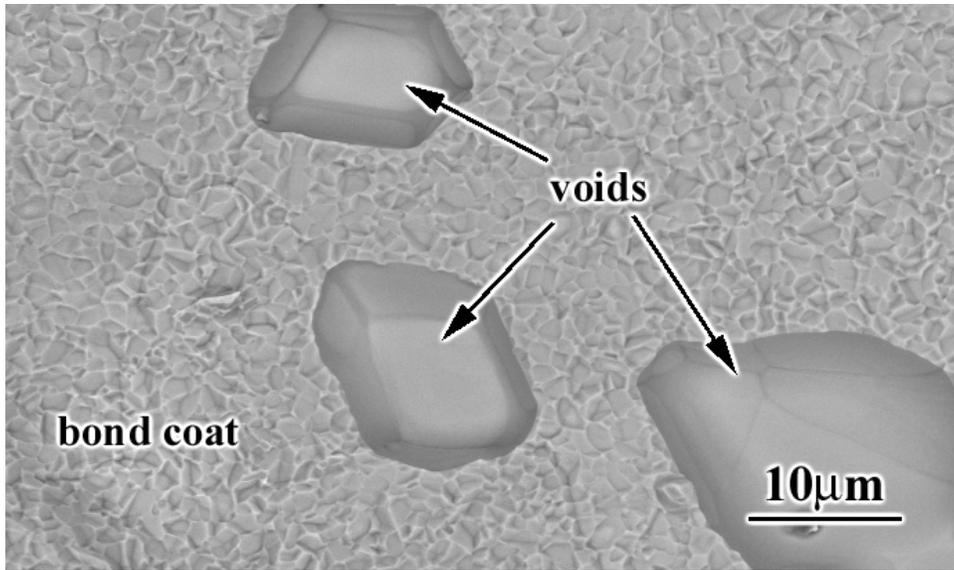
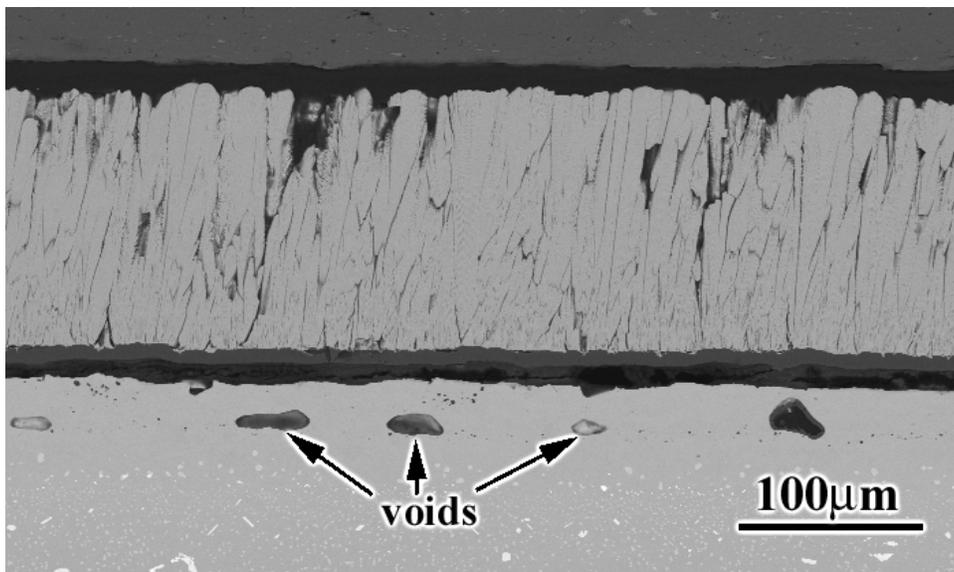
4.2.2.7 Voids Voids were observed to develop in some TBC systems along the TGO/bond coat interface (Figure 50a) and/or along the initial bond coat / superalloy interface (Figure 50b). Most of these voids are believed to form as a function of exposure time and diffusion in the bond coat seems to be responsible for their development. They were usually associated with the grain boundaries in the bond coat (Figure 50c), which are known to be fast diffusion paths as well as sinks for vacancies. On the other hand, fewer voids were observed to develop in the Pt aluminide specimens with thicker Pt as well as aluminide layers. This change in void density seems to be related to diffusion kinetics, which are affected by the presence of different thicknesses of Pt and aluminide layers. However, systematic diffusion studies are needed to be able to give a detailed description of diffusion phenomena for these systems.

Areas of reoxidation before final failure were also observed around some of these voids, which are indications of separations in the vicinity of voids prior to final failure (Figure 50d) as explained previously. Therefore, they are believed to act as stress concentration sites as in the case of many other defects, causing cracks to initiate in their vicinity. They also reduce the area of contact between the TGO and the bond coat, which is believed to be another important undesirable effect of having too many voids.

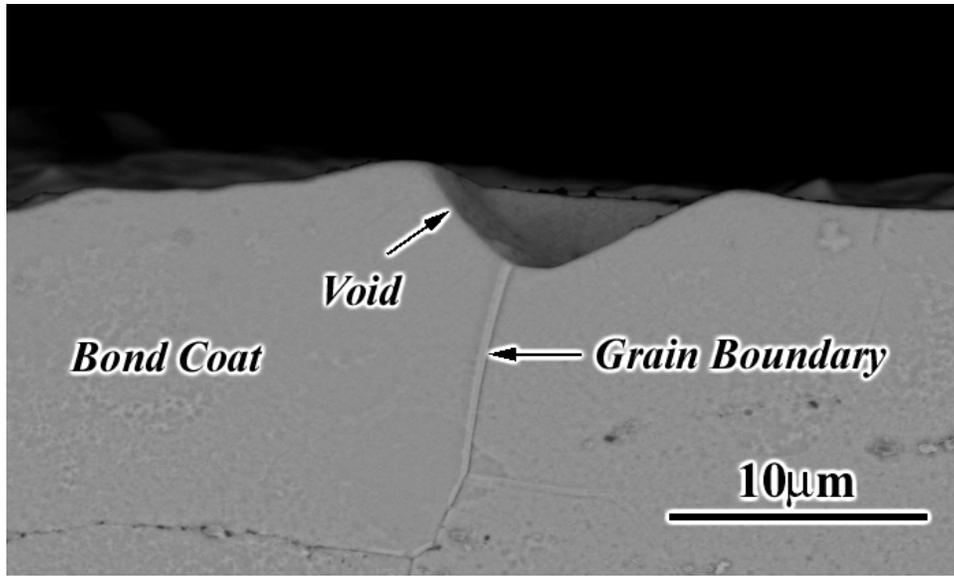
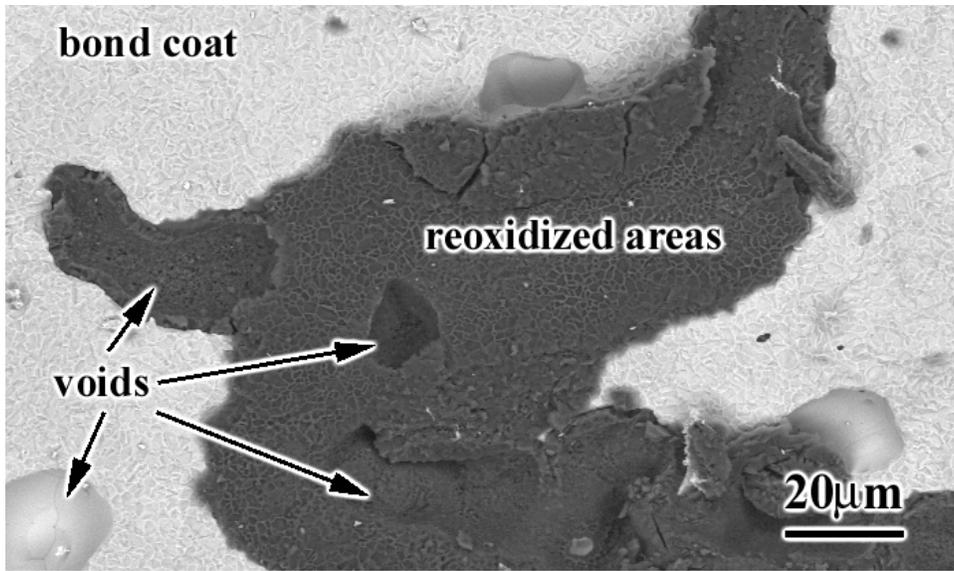
Figure 50 Scanning electron micrographs (a) from the fracture surface and (b) the cross sections of the specimens that developed voids along the TGO/BC and BC/superalloy interface, respectively. These voids were usually associated with the grain boundaries, (c), and reoxidized areas were present around some of these voids, (d).

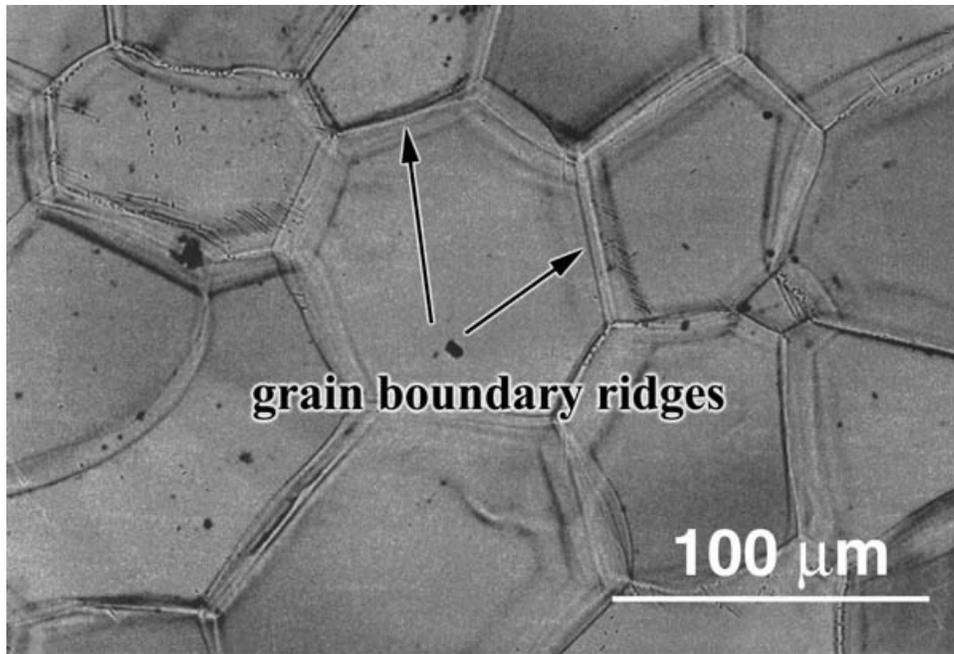
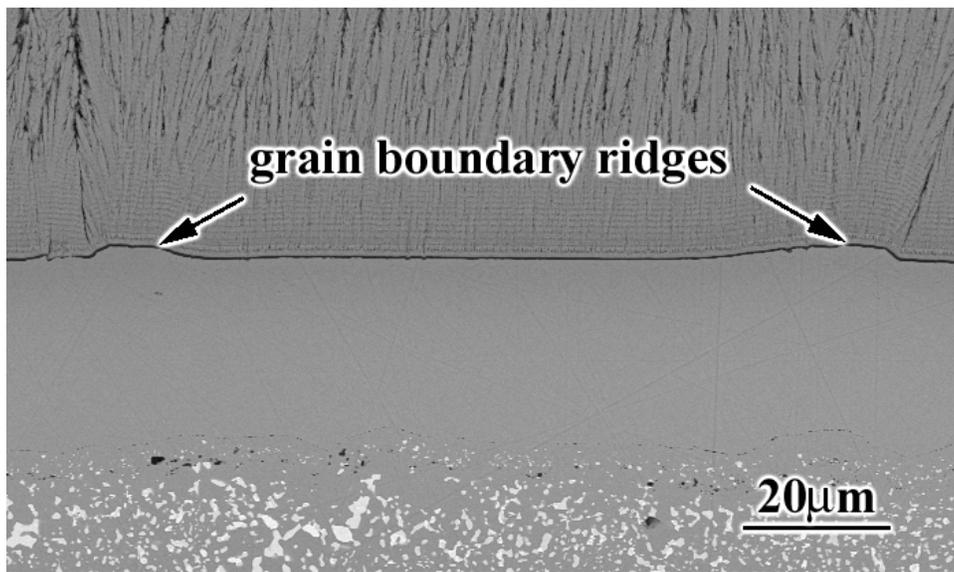
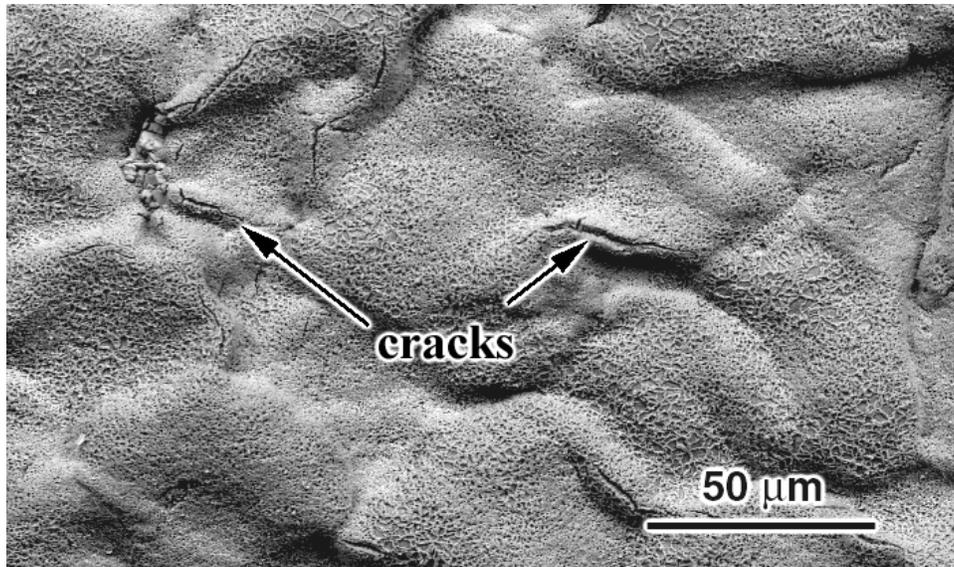
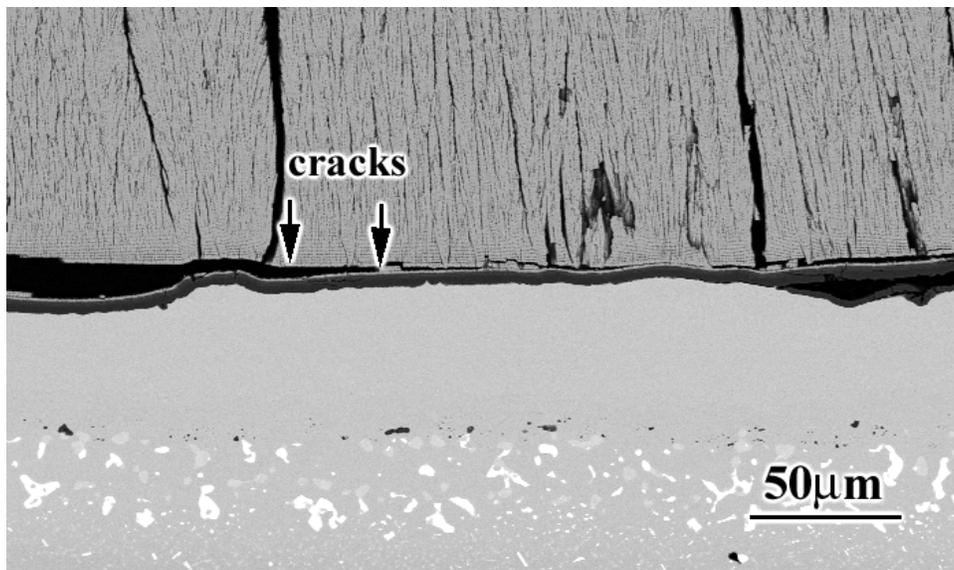
Figure 51 Scanning electron micrographs showing the grain boundary ridges on the surface of a Pt aluminide bond coat without a TBC, (a) and Pt aluminide bond coat with a TBC, (b). Upon exposure, the surface of a Pt aluminide bond coat without a TBC, (c), and cross section of a TBC system, (d), showed cracks in the vicinity of grain boundary ridges.

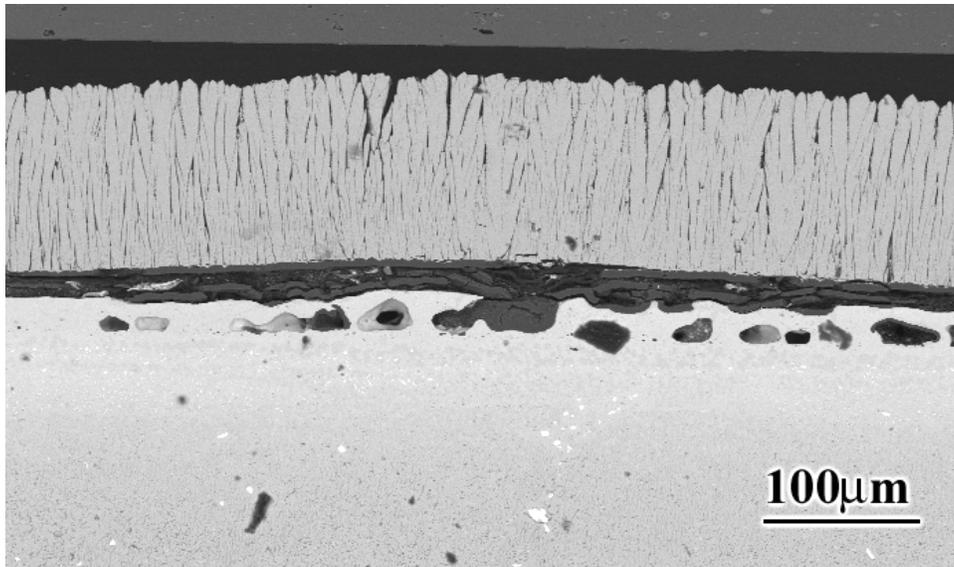
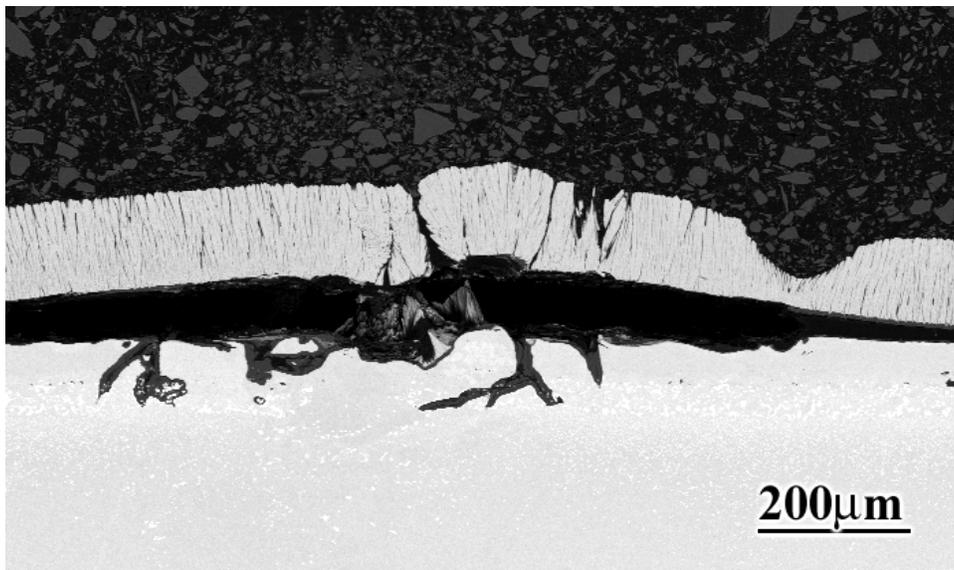
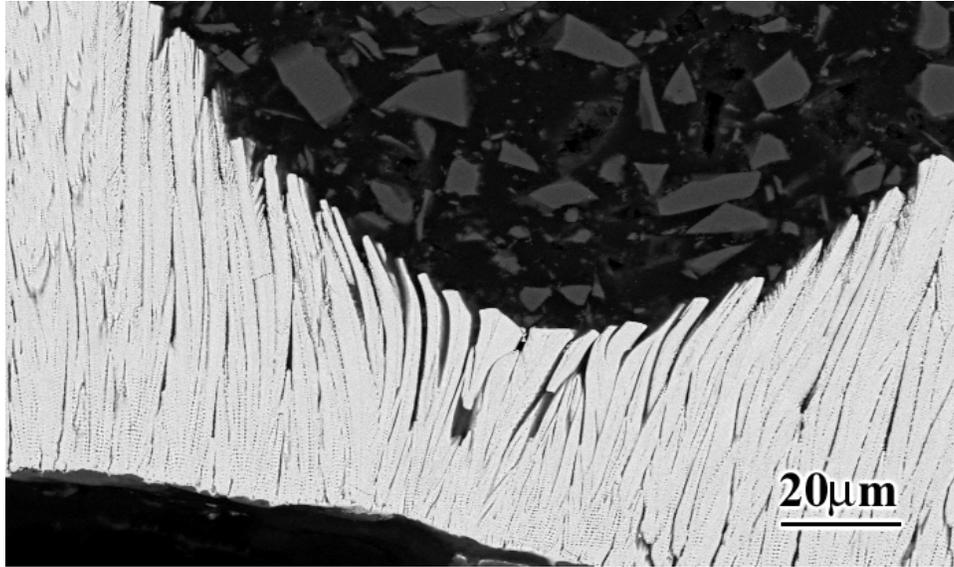
Figure 52 Scanning electron micrographs showing examples of abnormal defects, above which buckles developed.

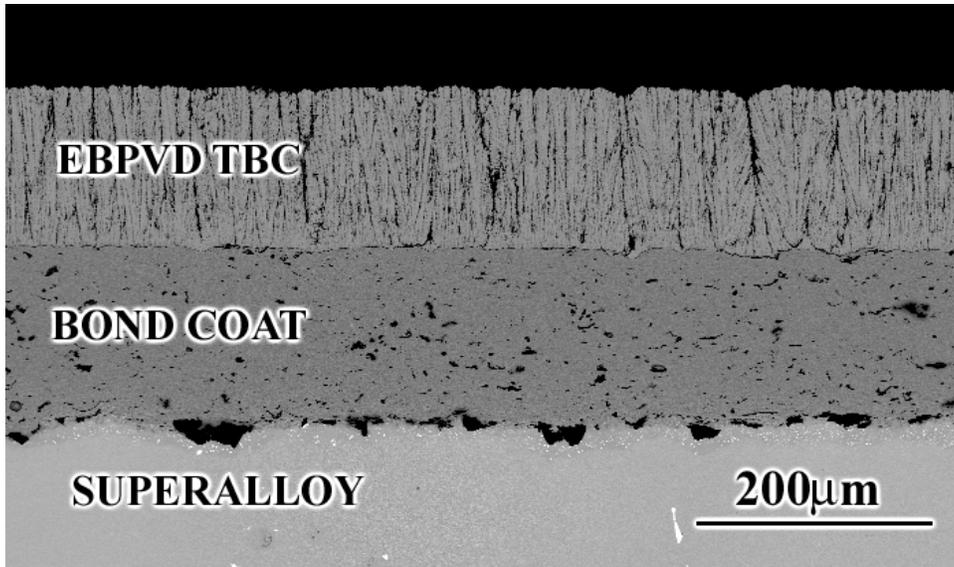
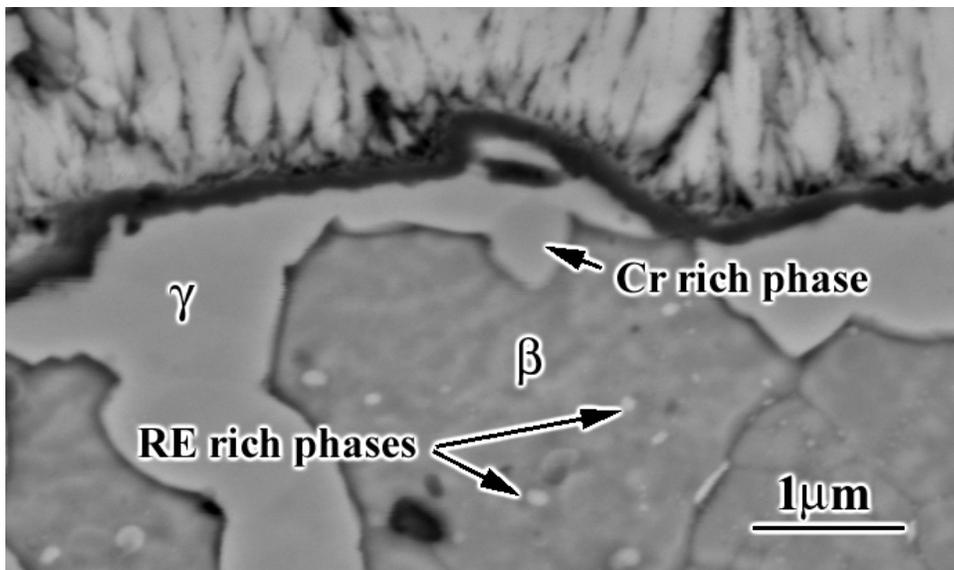
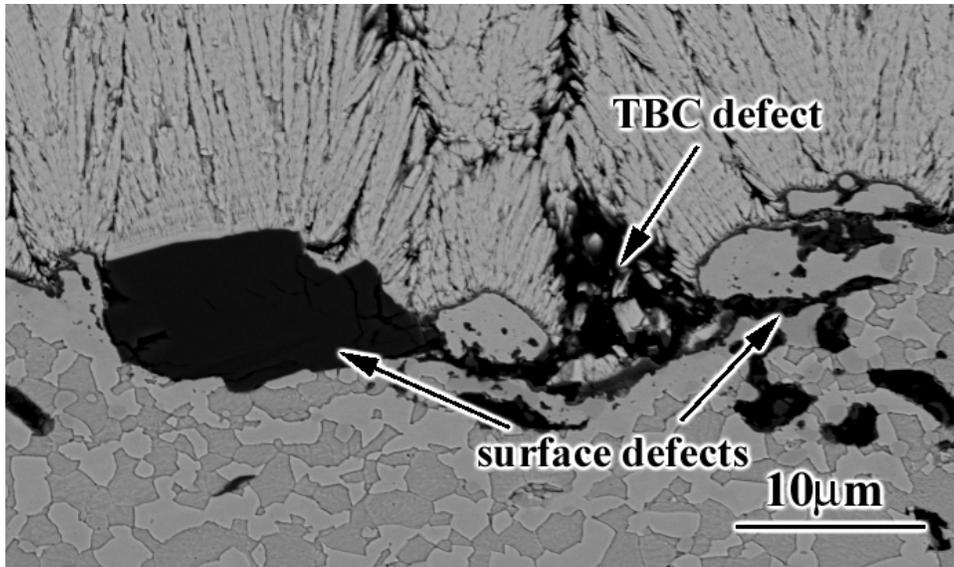
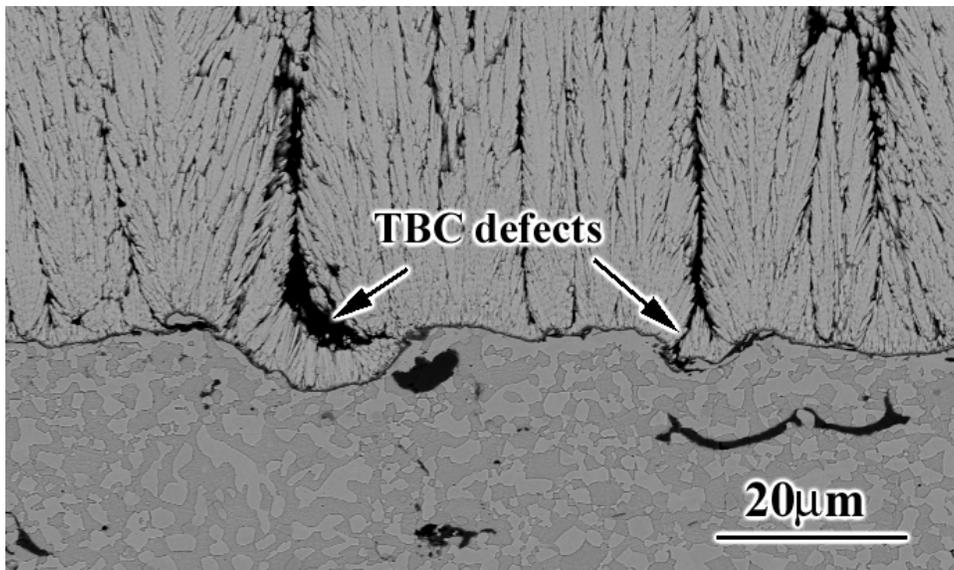
Figure 53a shows a typical cross sectional micrograph from a NiCoCrAlY bond coat with a TBC in the as-processed condition. As can be seen from this low magnification micrograph, some oxide inclusions as well as porosity, which are common for the plasma sprayed coatings, were present throughout the coating. The microstructure of the bond coat consisted of γ (Ni solid solution), β (NiAl) and Cr rich phases as well as Y and/or Hf rich phases (Figure 53b).

The TGO was not uniform, exhibiting variations in thickness and also it was not always pure alumina. The interface was highly irregular. Surface defects (Figure 53c) as well as TBC defects (Figure 53d), which were referred to as “regions of separation in the TBC”, were present as described before.

Figure 53 Scanning electron micrographs showing the typical state of the art TBC systems with NiCoCrAlY bond coats in the as processed condition. The bond coat consisted of porosity and oxide inclusions throughout the coating, (a), and β , γ as well as Cr and RE rich phases, (b). Surface defects (c), as well as TBC defects (d), were present.

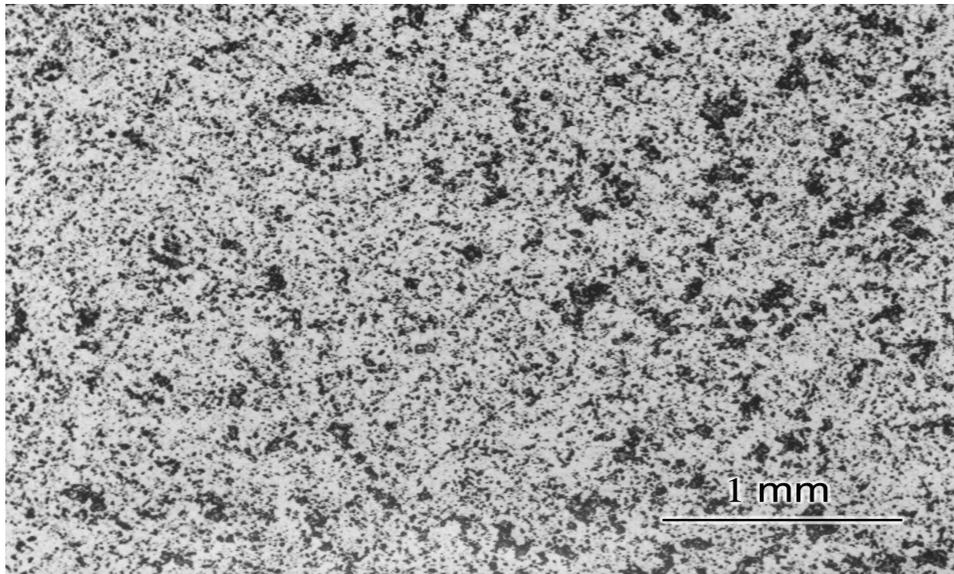
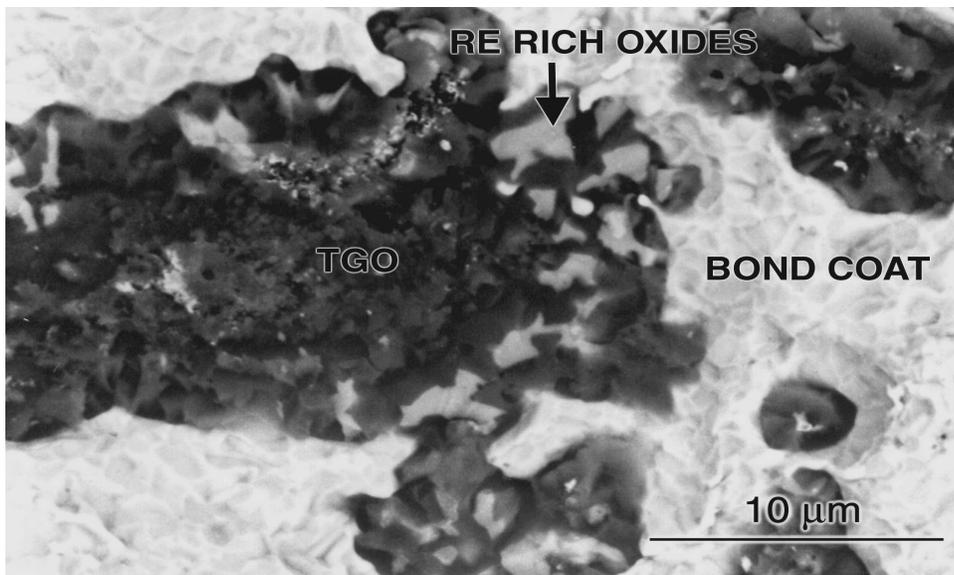
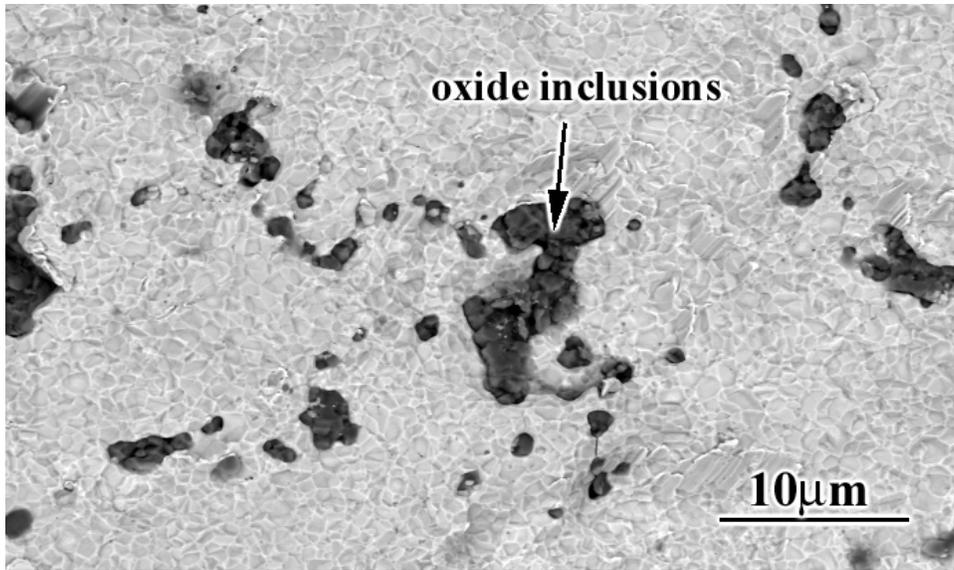
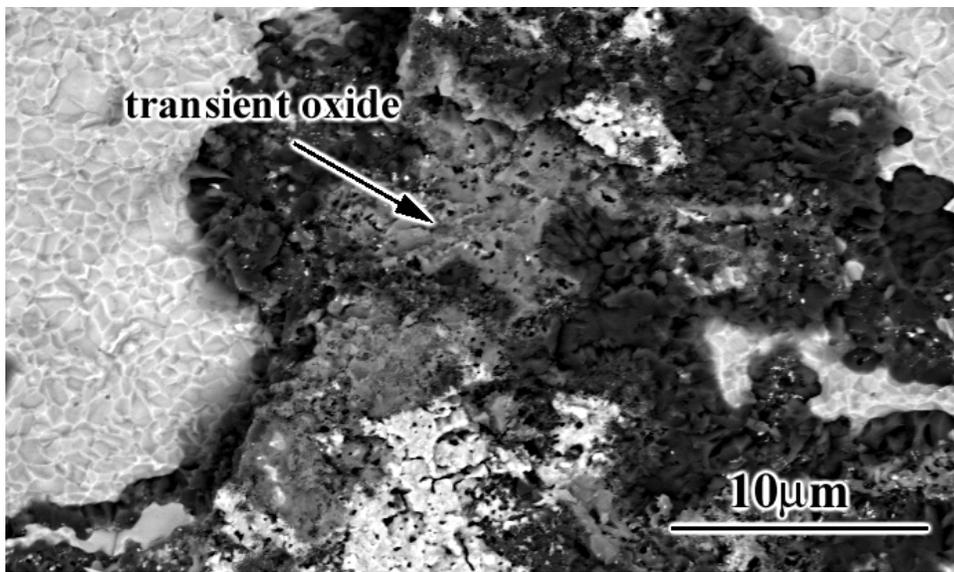
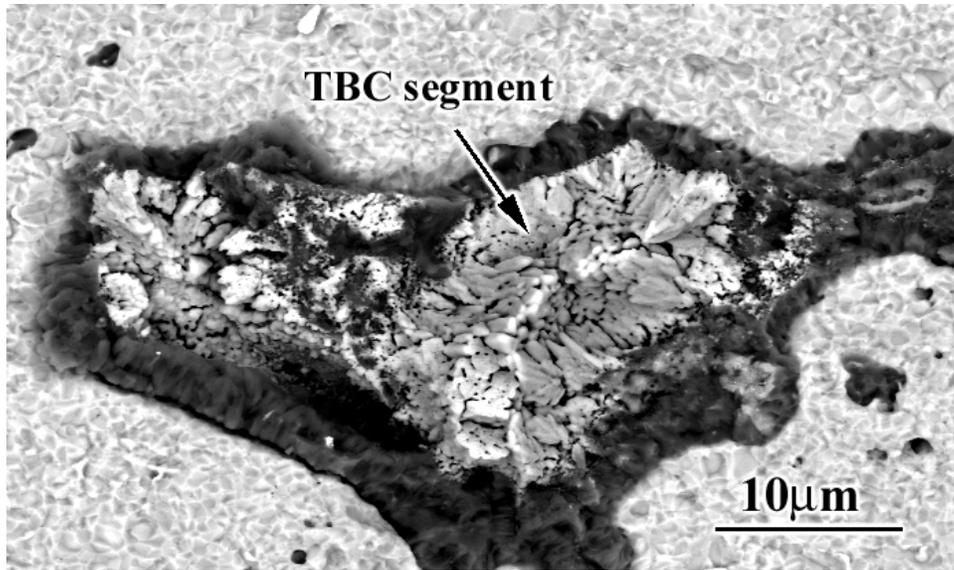
These specimens were subjected to cyclic oxidation testing at 1100°C and they failed after significantly shorter times compared to TBC systems with platinum aluminide bond coats as mentioned previously. The failure occurred mainly along the TGO/bond coat interface with numerous excursions into the TGO and TBC (Figure 54a). Examination of the fracture surfaces of these coatings after spalling of the TBC showed the presence of Y and sometimes Hf rich oxides encapsulated in alumina (Figure 54b), oxide inclusions (Figure 54c), oxides other than alumina (Figure 54d) and TBC segments (Figure 54e). It should be mentioned here that the proportions of these features observed on the fracture surfaces varied from batch to batch. However, the failure times did not change much. Figure 55 is an example showing a buckle formed following a significant amount of separation along the TGO/TBC interface in contrast to some other samples where the failure was more along the TGO/bond coat interface. Moreover, some batches of specimens developed vertical separations in the TBC, whereas some did not. This difference seems to be a consequence of different TBC morphologies, as mentioned previously.

Figure 54 Scanning electron micrographs showing the fracture surfaces of state of the art NiCoCrAlY bond coats. The failure was mainly along the TGO/BC interface with numerous excursions into the TGO and TBCs (a). The typical features observed on the fracture surfaces were RE rich oxide protrusions (b), oxide inclusions (c), transient oxides (d), and TBC segments (e).

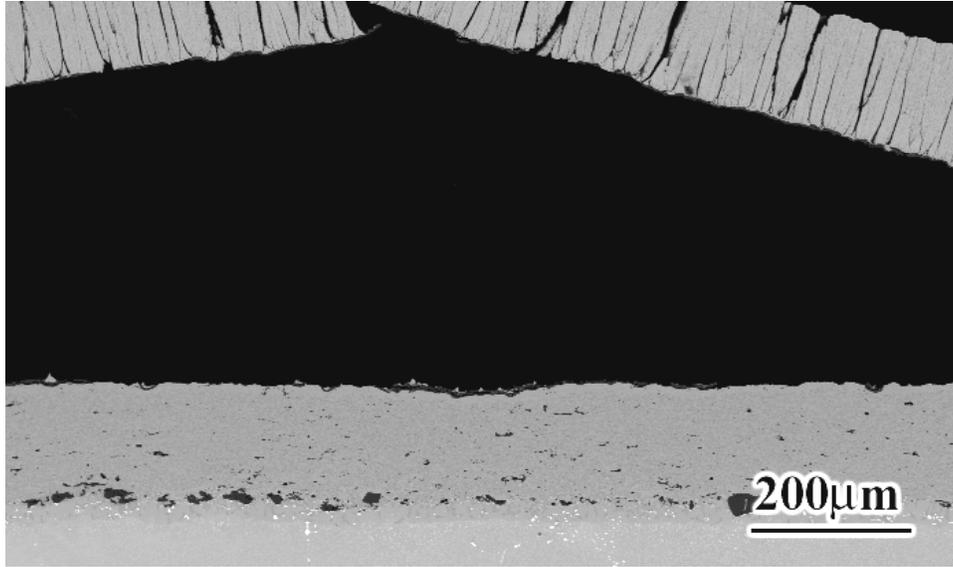
Figure 55 Scanning electron micrograph of a TBC system with state of the art NiCoCrAlY bond coat showing a significant amount of separation along the TGO/TBC interface followed by buckling

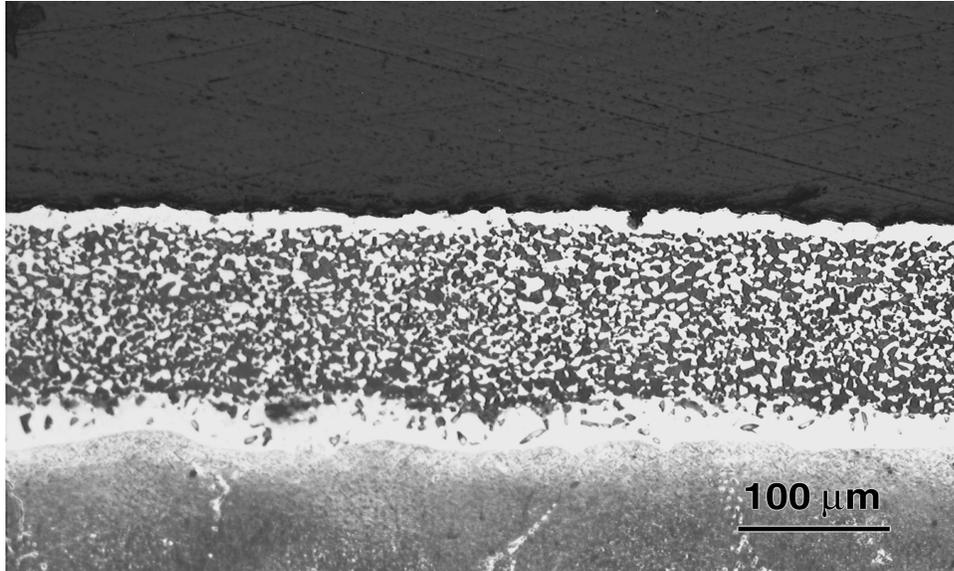
Cross sectional examination of the failed specimens showed that the Al depletion was not the cause of failure since there was still a significant amount of Al rich β phase left at the time of failure (Figure 56).

Figure 56 Optical micrograph of a TBC system with state of the art NiCoCrAlY bond coat after failure showing that a significant amount of Al-rich β phase was present at the time of failure.

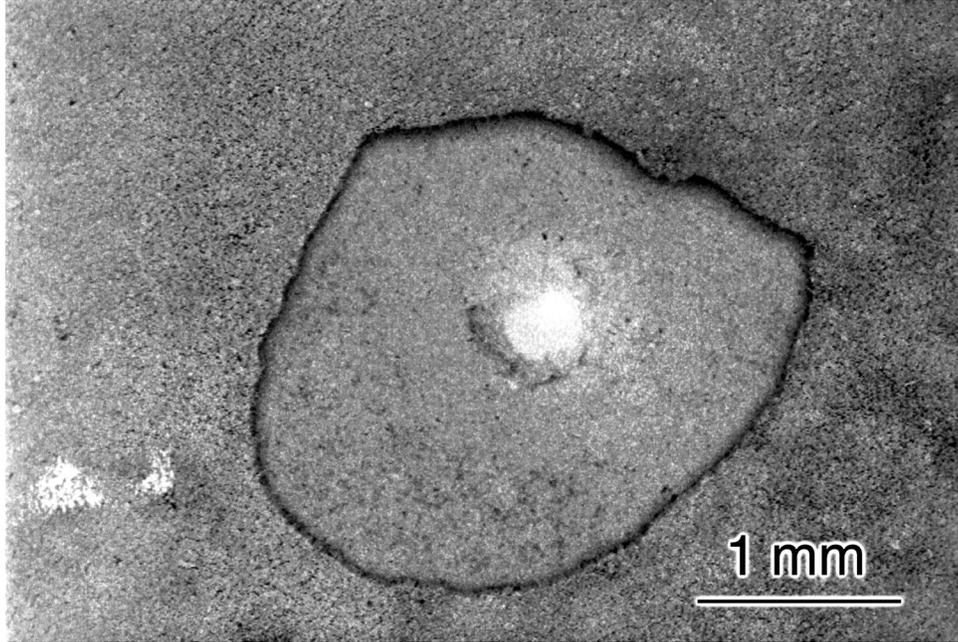
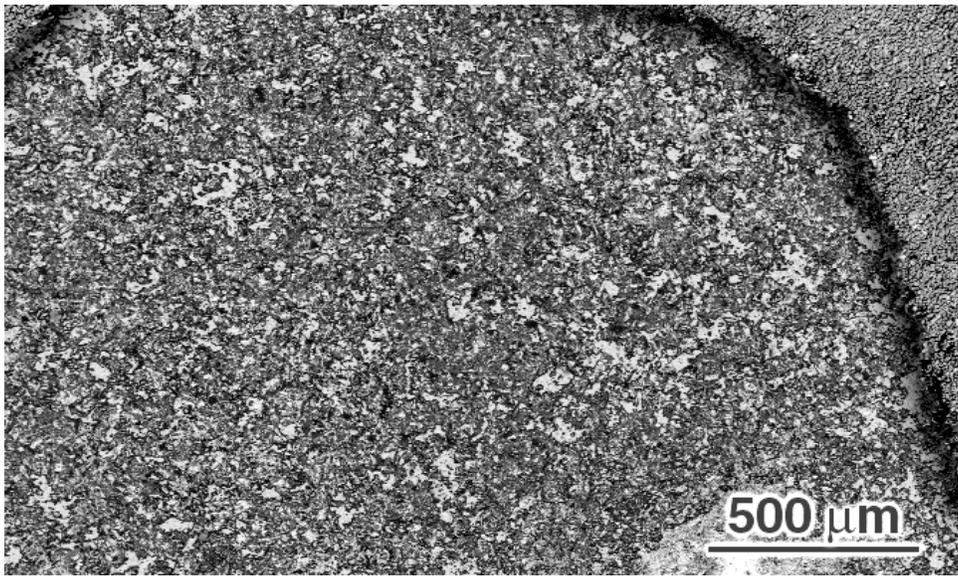
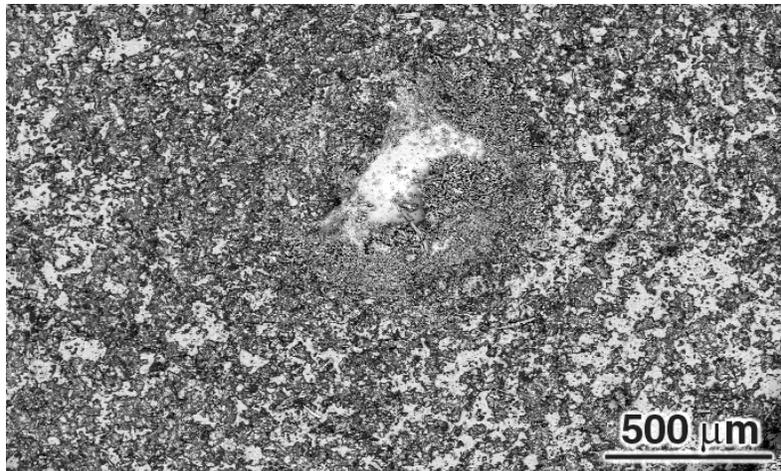
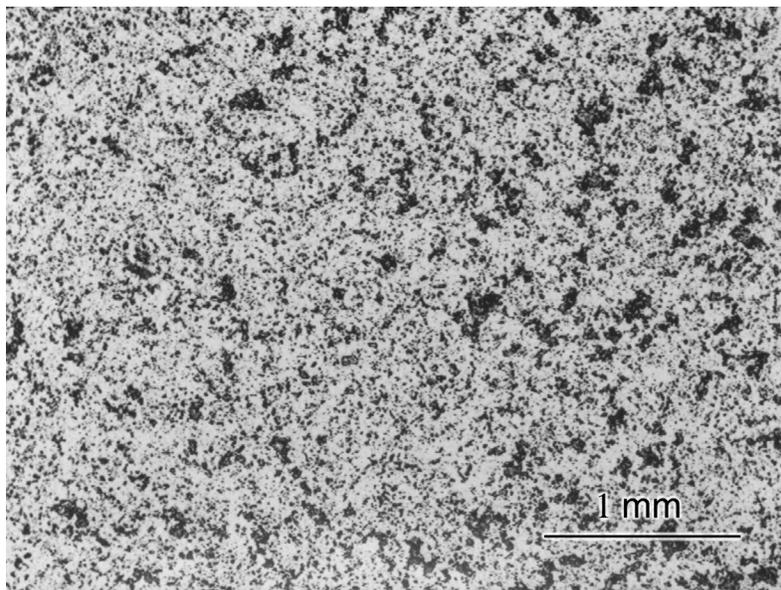
An indentation test was performed on the as-processed specimens as well as on specimens exposed to cyclic oxidation conditions and the fracture surfaces have been examined as a function of exposure cycle. In the as-processed condition, the failure was along the TGO/TBC interface with some excursions into the TGO and TBC (Figure 57a). After 10 cycles of exposure at 1100°C, the failure was still mainly along the TGO/TBC interface and in the TGO and TBC with some spallation along the TGO/bond coat interface (Figure 57b). With continued

exposure (after 25 cycles and failure) , the dominant fracture path changed from the TGO/TBC interface to the TGO/bond coat interface (Figures 57c and 57d).

Figure 57 Scanning electron micrographs from the fracture surfaces of the TBC systems with the state of the art NiCoCrAlY bond coats after an indentation test has been performed on the as-processed specimens (a), as well as on the ones which were exposed at 1100°C for 10 (b), and 25 cycles (c). The fracture surfaces of the specimens, which failed after 102 cycles of exposure is also shown in (d). Dark areas correspond to the TGO and the TBC while white areas correspond to the bare bond coat.

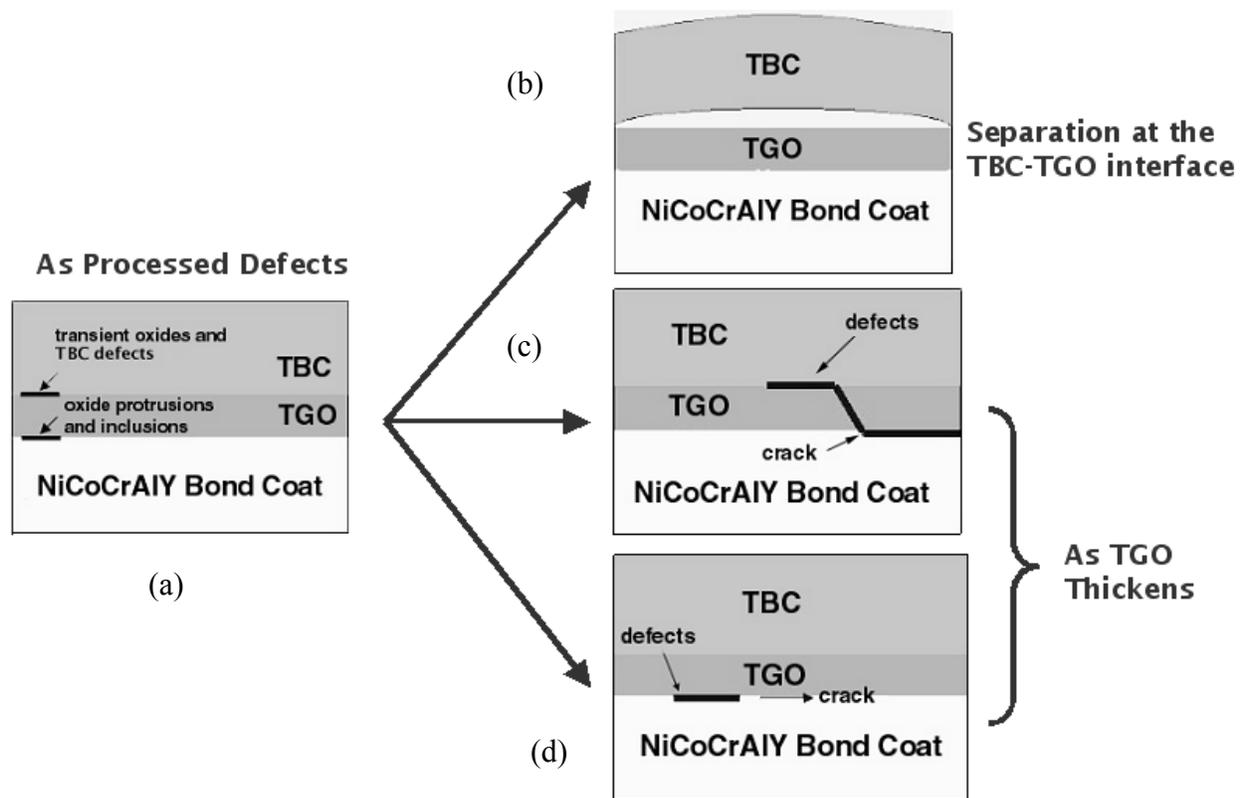
-The cracks can also initiate in the vicinity of the defects along the TGO/bond coat interface. These cracks, once initiated, can propagate along the TGO/bond coat interface (Figure 58d)

-The failure can occur by a mixture of the above-mentioned failure processes, which is usually the case for the specimens used in this study.

Figure 58 A simple schematic summarizing the failure behavior of the state of the art TBC systems with NiCoCrAlY bond coats. See text for details

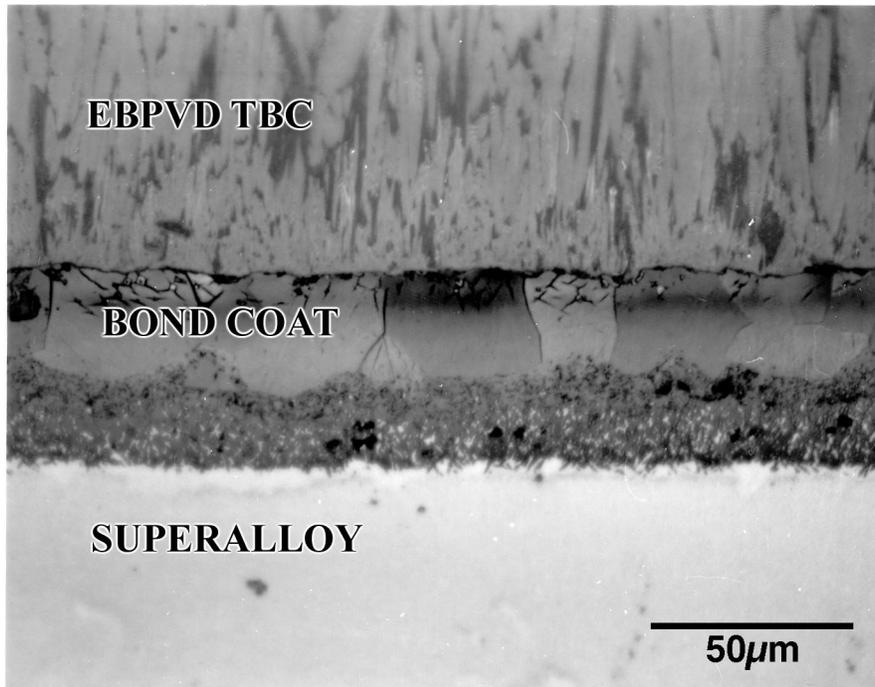
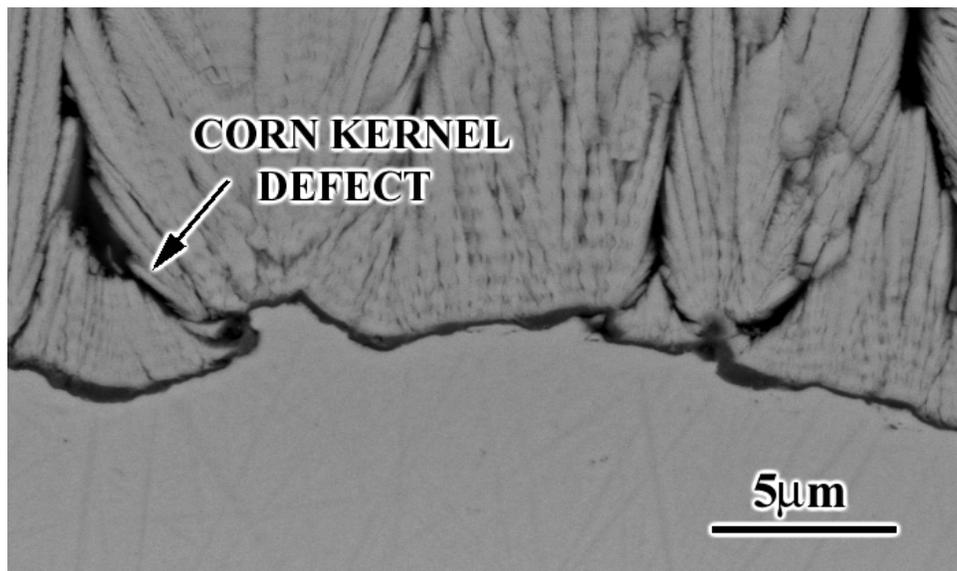
The microstructure of the platinum modified aluminide bond coats with a TBC in the as-processed condition consisted of only β (NiAl) phase with Pt, Cr and Co in solid solution (Figure 59a). The interface was irregular due to heavy grit blasting and corn kernel type TBC defects, which were discussed previously, were present in the TBC (Figure 59b) above the surface irregularities. This type of defect is believed to make a big contribution to the failure of these TBC systems as will be explained in the following paragraphs.

Figure 59 Scanning electron micrographs of typical state of the art TBC systems with Pt aluminide bond coats in the as processed condition. The microstructure consisted of only β phase with Pt, Cr and Co in solid solution (a). Corn Kernel TBC defects were present (b).

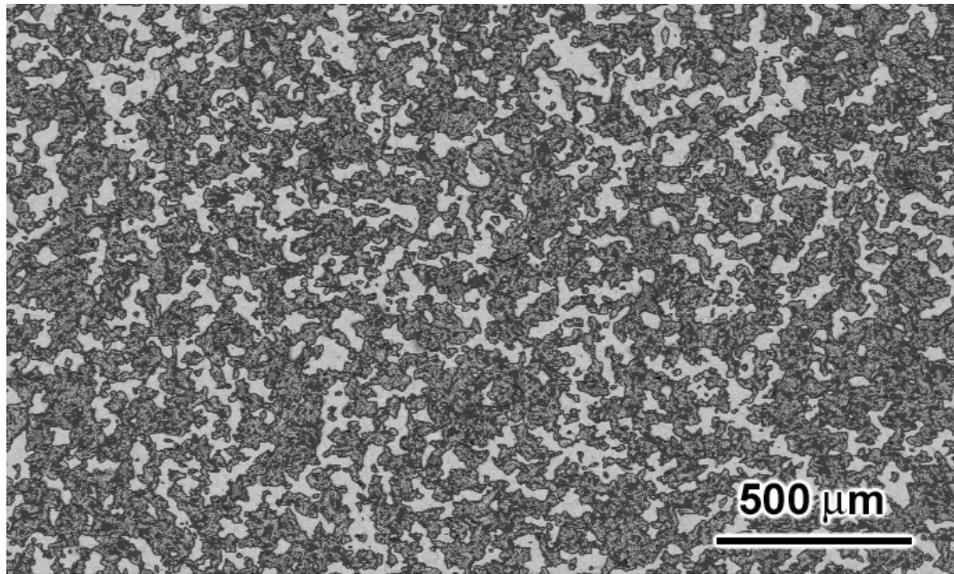
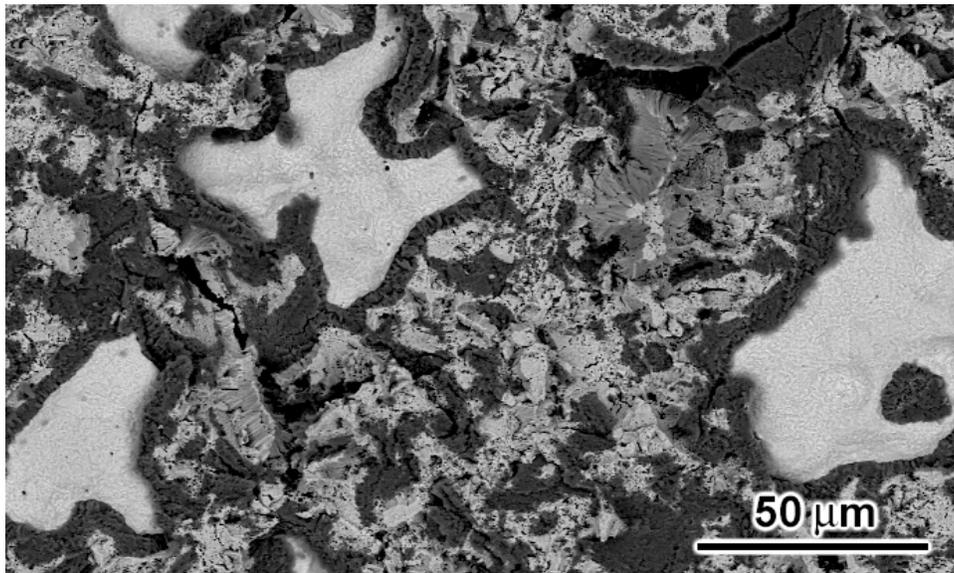
The failures have been observed to be mainly along the TGO/TBC interface and in the TBC and TGO. However, there was also spallation along the TGO/bond coat interface (Figures 60a and 60b). Examination of cross sections of these TBC systems before and after failure indicated that the bond coat surfaces deformed resulting in an increase in the initial surface roughness. (Figures 61a and 61b, respectively) Cracks were observed to develop in the TBC in the vicinity of these deformed areas (Figure 61c). This is known as a ratcheting mechanism, which was explained in detail in the background section, and it dominates the failure of the state of the art Pt aluminide systems.

Figure 60 Scanning electron micrographs from the fracture surface of a state of the art TBC system with Pt Aluminide bond coat at (a) low and (b) high magnifications. A significant amount of failure was above the TGO/BC interface.

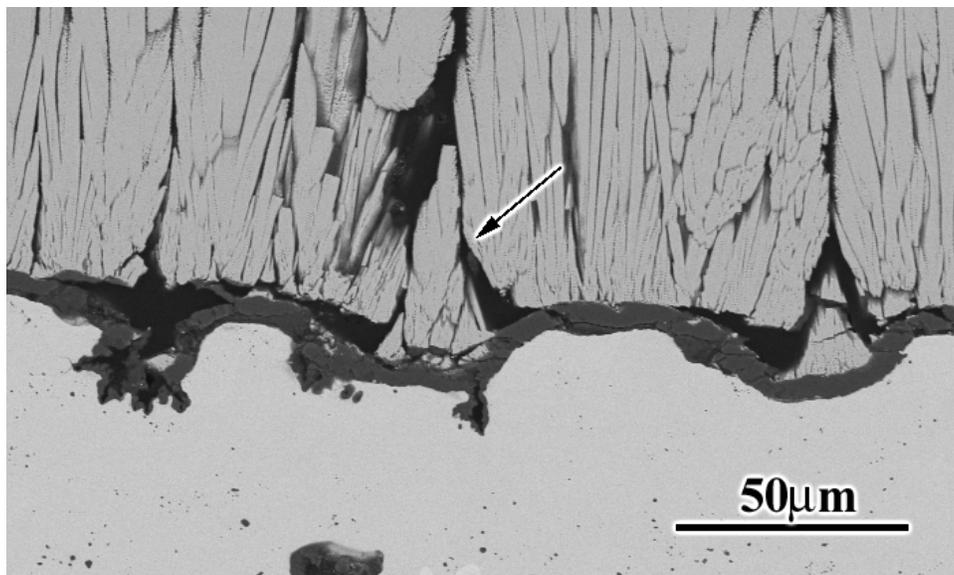
Figure 61 Scanning electron micrographs of TBC systems with state of the art Pt aluminide bond coats before (a), and after failure (b), both of which give examples to deformation of the bond coat with thermal exposure. Cracks initiate in the vicinity of the deformed areas (c).

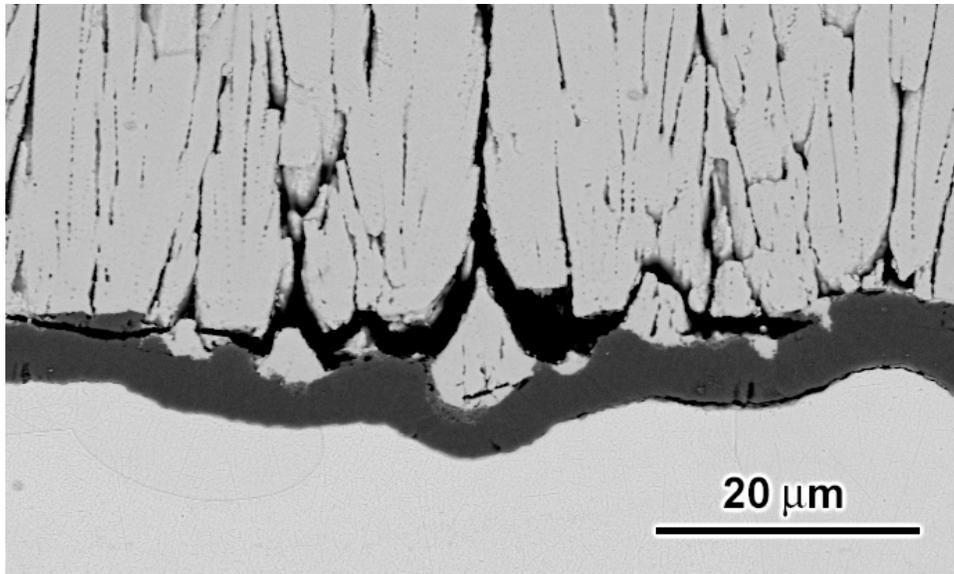
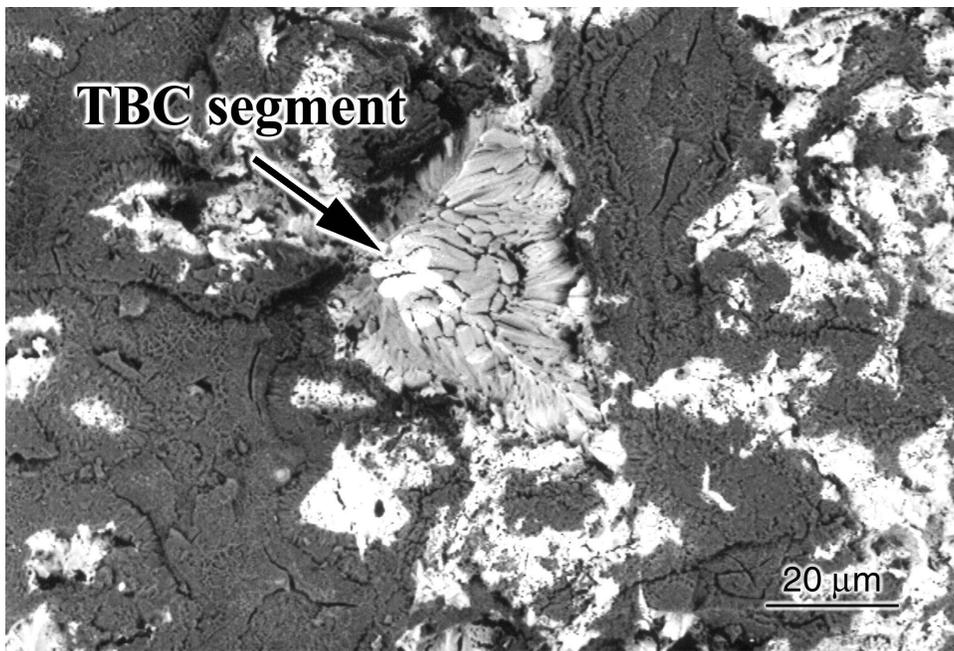
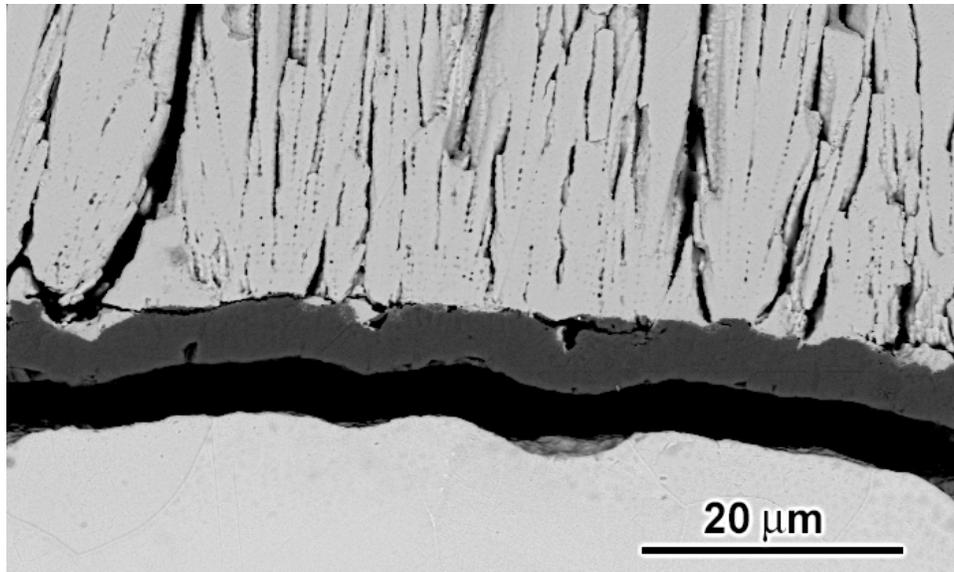
In the following sections, it will be shown that the TBC constrains the deformation of the bond coat. Based on this observation, it is believed that the ratcheting occurred first at areas that were referred to as corn kernel TBC defects. The reason behind this idea is the weaker TBC constraint to deformation of the bond coat in the vicinity of these defects. Accordingly, the bond coat could deform more easily with less constraint given by the TBC (Figure 62a). The stresses are also higher at these initial interface imperfections, which drives the deformation of the bond coat at these sites as proposed by Evans et al. [42] Figure 62b is from the fracture surface showing a TBC segment that was pulled from the TBC due to ratcheting at a corn kernel type TBC defect. In other areas, where the interface was initially smoother, the TBC constraint to deformation of the bond coat was larger as a result of a more well-developed columnar TBC morphology. Thus, the resistance to ratcheting was stronger in these areas and the interface remained relatively smooth (Figure 62c).

Figure 62 Scanning electron micrographs of state of the art TBC systems with Pt aluminide bond coats showing (a) ratcheting in the vicinity of corn kernel defects, (b) a TBC segment that was pulled from the TBC due to ratcheting at a corn kernel defect, (c) presence of a smooth interface in the absence of corn kernel defects.
