THE FAILURE OF THERMAL BARRIER COATINGS AT ELEVATED TEMPERATURES

Submitted to the Graduate Faculty of
the School of Engineering in partial fulfillment
of the requirements for the degree of
Doctor of Philosophy

University of Pittsburgh

2004

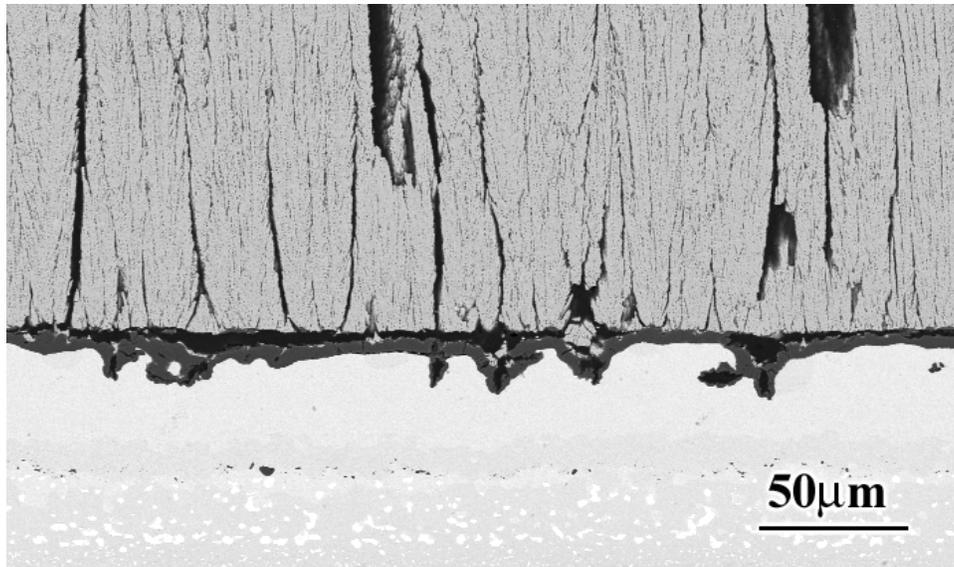
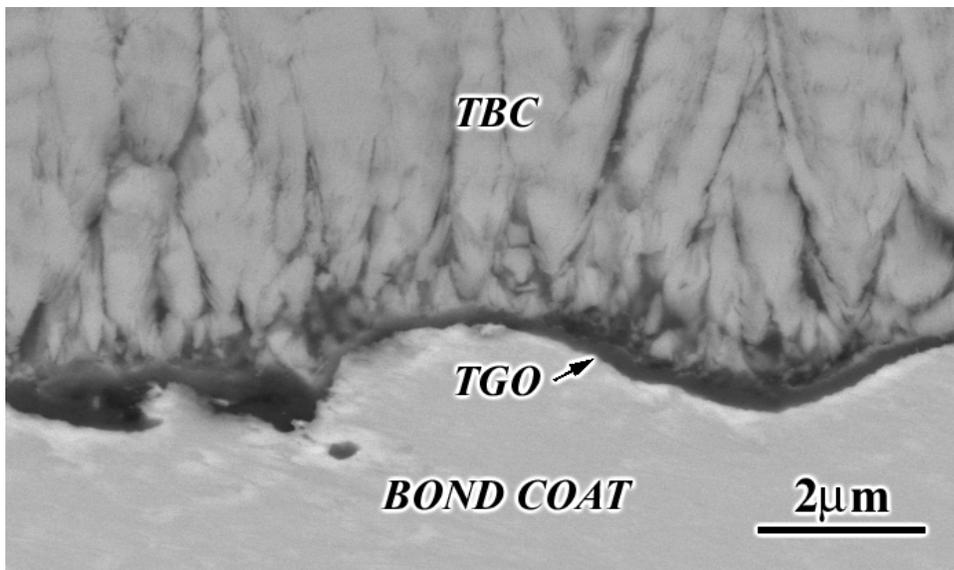
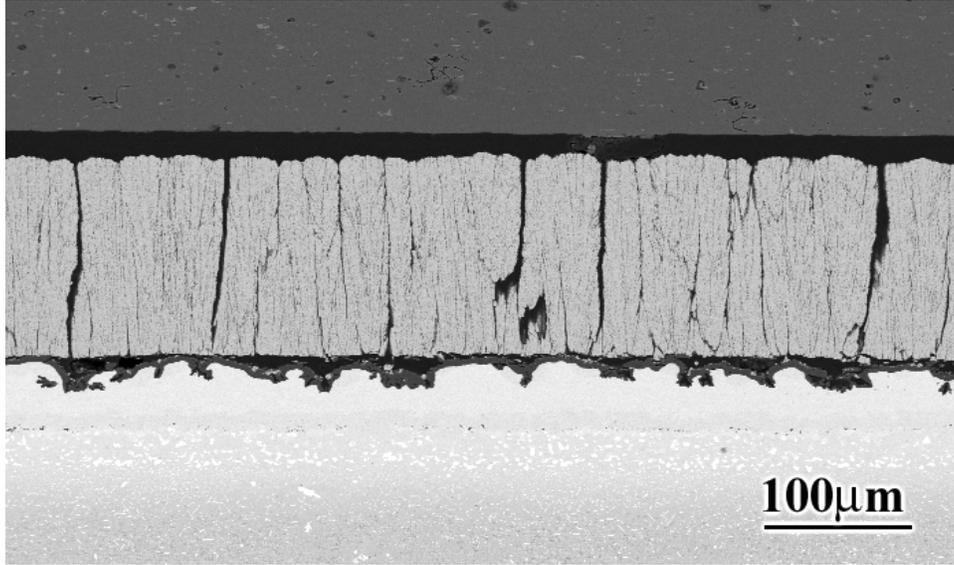
A different batch of TBC systems with heavy grit blasted Pt aluminides, which had TBCs deposited by a different company, failed at relatively shorter times at 1100°C after 500 and 760 cycles of exposure. Cross sectional examination of this specimen showed very significant amounts of ratcheting even after a fewer number of cycles to failure compared to other batches (Figure 63a). Examination of the as-processed specimen indicated the presence of a different TBC morphology close to the TGO even though the surface roughnesses were similar. The TBC close to the TGO consisted of small corn kernel type TBC defects lined up side by side in the as-processed condition (Figure 63b) and it also developed vertical separations with time (Figure 63c). This different type of morphology is believed to be a function of TBC deposition conditions. Based on the argument given previously, the TBC constraint to deformation of the bond coat must be less for these specimens, which can explain the early failure and the significant amount of ratcheting for these specimens. The vertical separations may also be a contributing factor in their early failure. These results show that the TBC deposition conditions also can have an effect on the TBC morphology, and accordingly on the failure, besides the surface condition.

Figure 63 Scanning electron micrographs of a state of the art TBC system with Pt aluminide bond coat, which failed relatively early compared to its counterparts. There were significant amounts of ratcheting, (a), which were believed to be associated with the different TBC morphologies in the as processed condition, (b). This specimen also developed vertical separations in the TBC, (c).

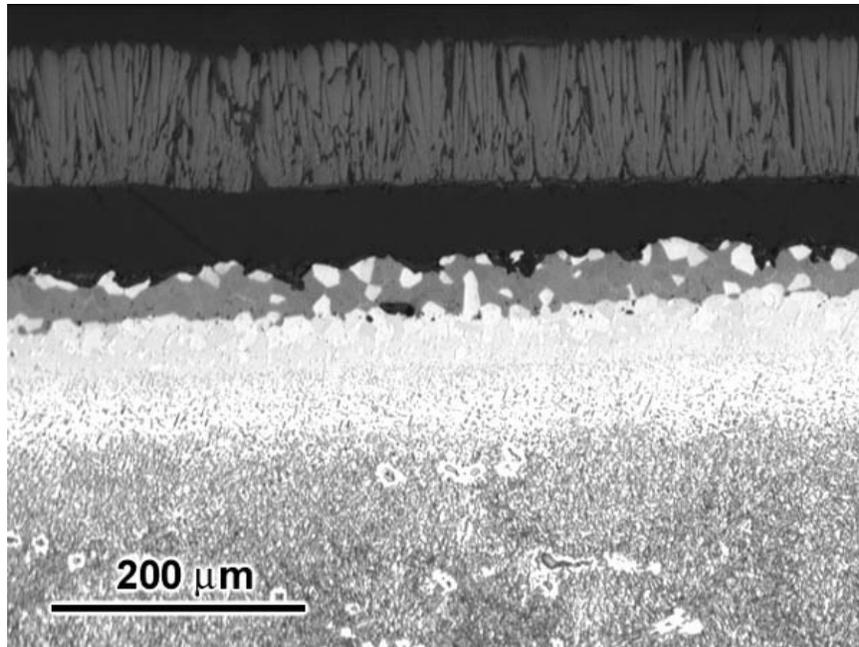
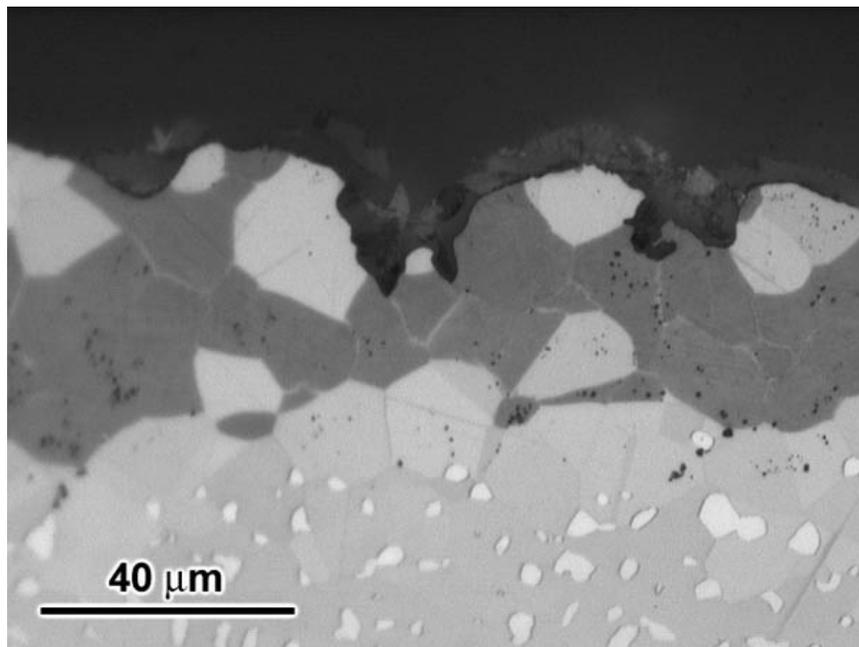
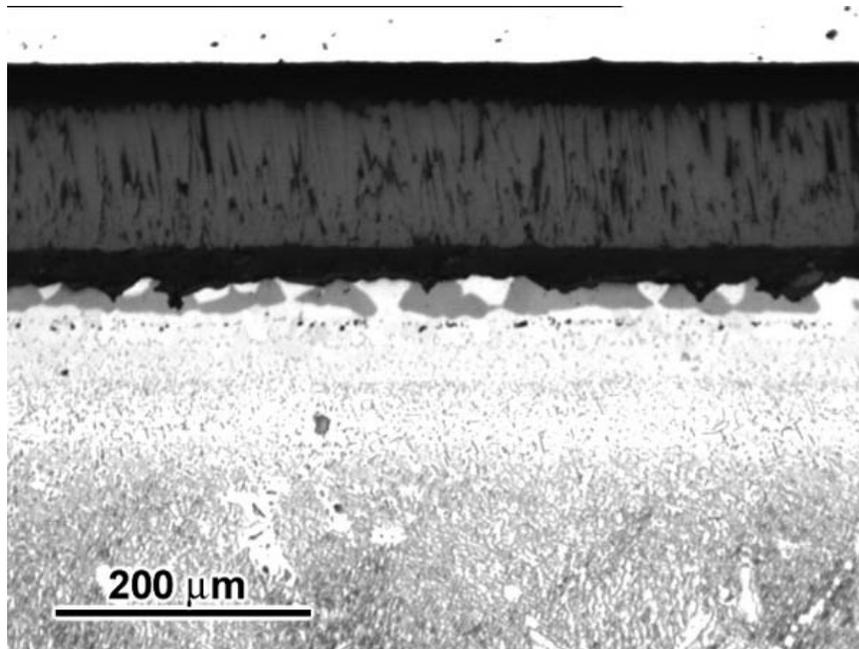
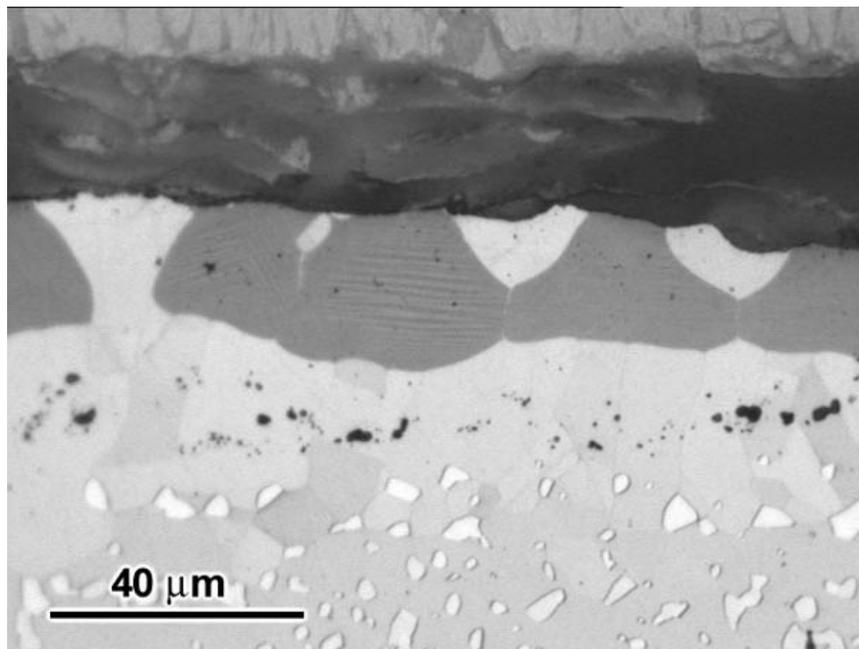
There are various proposed mechanisms for ratcheting as mentioned in the background section. Plastic deformation of the bond coat, as well as the volume reductions as a result of phase transformations in the bond coat may be all playing a role in the ratcheting type of failure. Our results also indicate the importance of grain boundaries for ratcheting. Specimens obtained from one of the companies had comparatively smaller grain size. Cross sectional examination of this specimen showed more pronounced ratcheting (Figures 64a and 64b) compared to other

specimens with larger grain size (Figures 64c and 64d). The failure was more along the TGO/TBC interface as a result of this significant amount of ratcheting. Also, the ratchets were usually associated with the grain boundaries (Figure 64b). These observations may suggest the importance of grain boundaries in ratcheting. One explanation may be the role of grain boundary sliding in the plastic deformation of the bond coat. However, more work has to be done to make this argument stronger.

Figure 64 Optical micrographs of state of the art TBC systems with Pt aluminide bond coats with fine (a, b) and coarser grain size (c, d) at low and high magnifications. The amount of ratcheting was more pronounced for the specimens with finer grain size.

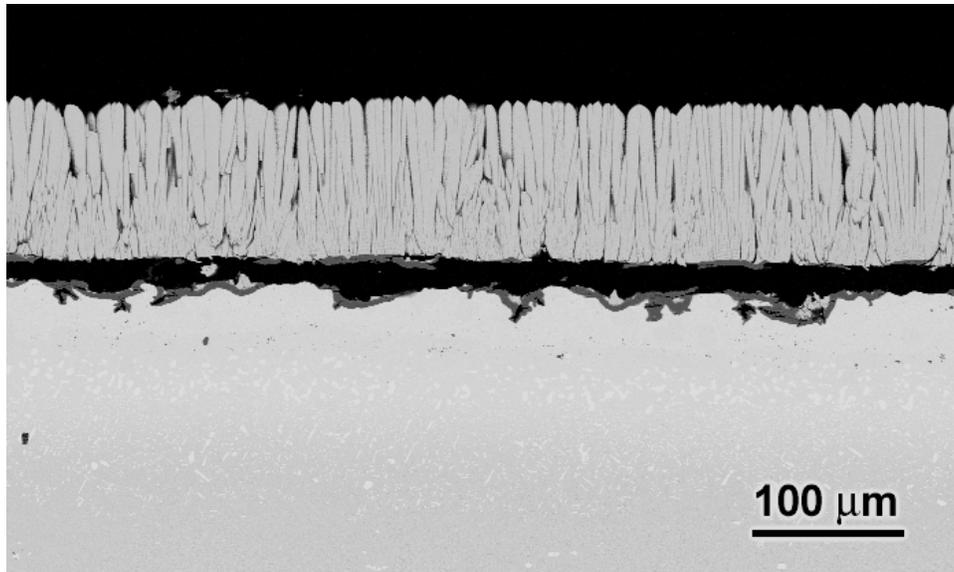
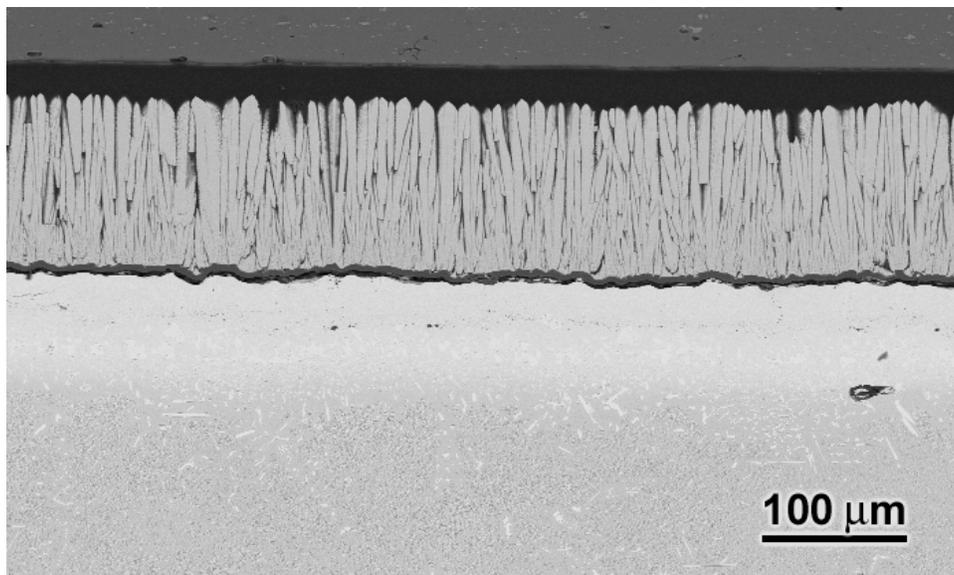
Figure 65 Scanning electron micrographs of state of the art TBC systems with Pt aluminide bond coats showing a marked difference in the amount of ratcheting for specimens which were subjected to cyclic, (a) and isothermal test, (b).

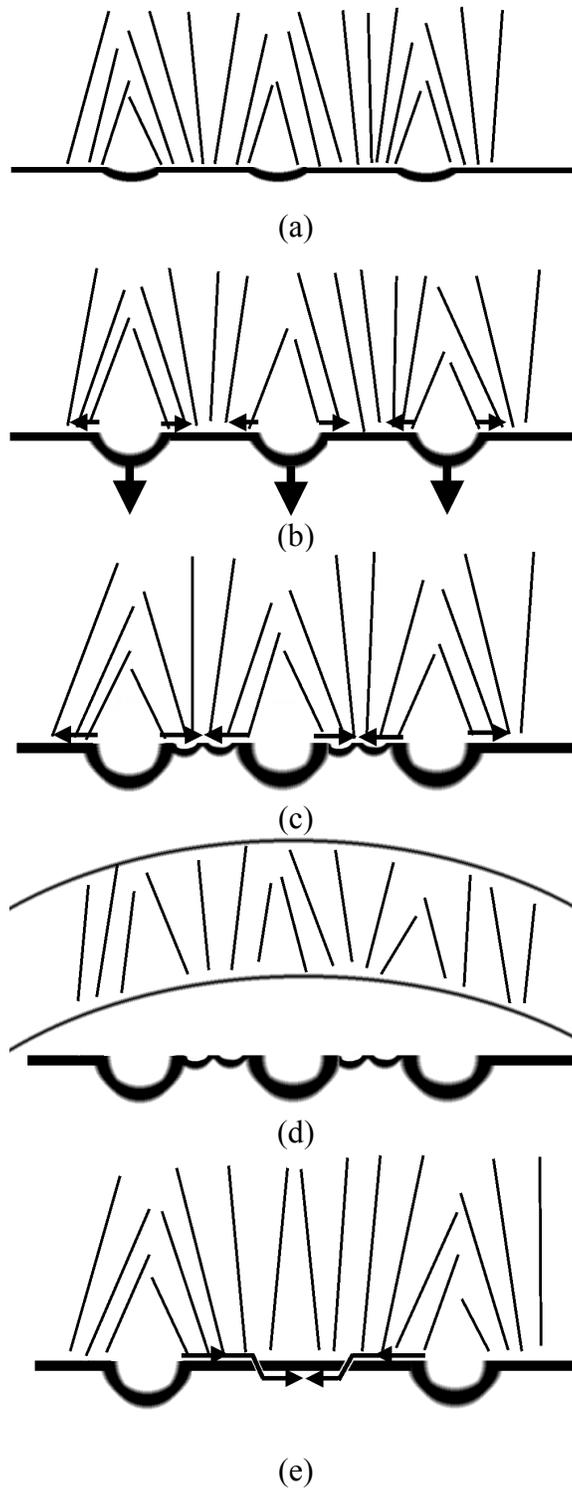
from these ratchets causing separations along the TGO/TBC interface. The TBC constraint also becomes weaker at these separated areas, which may lead to formation of new ratchets (Figure 66c).

-The failure occurs when these cracks in the vicinity of the ratcheted areas link up reaching a critical size. In this case, the failure is more along or close to the TGO/TBC interface (Figure 66d).

-On the other hand, the TGO/bond coat interface also becomes more susceptible to fracture due to stored strain energy in the TGO. If the amount of ratcheting is not very significant, the cracks that initiated in the vicinity of the ratchets can propagate through the TGO and then along the TGO/bond coat interface as the stored energy in the TGO increases (Figure 66e).

Figure 66 schematic diagram summarizing the failure behaviour of state of the art Pt Aluminide bond coats. See text for details

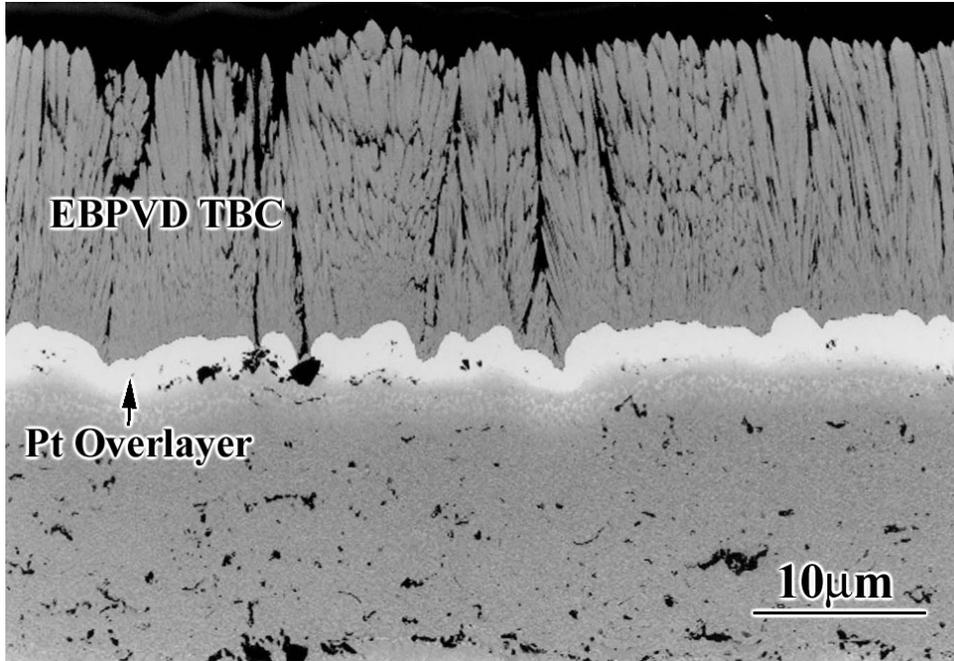
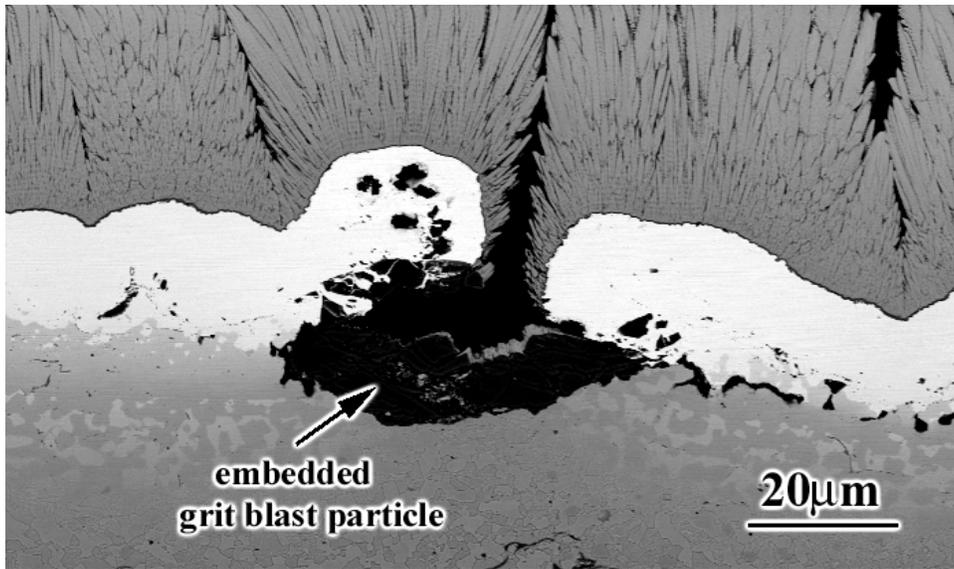
• **NiCoCrAlY Bond Coats with Pt Overlayer** - The surfaces of the as-processed TBC systems with Pt overlayers on NiCoCrAlY bond coats were highly irregular and numerous defects in the TBC were present as a result of this irregular interface (Figure 67a). In some localized areas, where large pieces of grit blast particles were embedded on the surface, the Pt layer did not develop continuity resulting in a defective area such as is evident in Figure 67b. On the other hand, a very uniform, continuous TGO, which was pure alumina, developed on the surface (Figure 67c). Moreover, the interface was free of the oxide inclusions, which were referred to as surface defects previously. Figure 68 gives the composition profile away from the interface. As can be seen from this profile, the bright layer is rich in Pt with small amounts of other elements (Ni, Al, Cr, Co), which diffused into the Pt layer during subsequent heat treatment as well as TBC deposition. An attempt was made to identify the platinum rich phase from Pt-Al-Ni ternary phase diagram [72]. However, the presence of Cr and Co complicated the identification. Therefore, transmission electron microscopy (TEM) and/or X-ray diffraction (XRD) analyses are required to determine this phase.

suggests a high interfacial toughness. A substantial amount of oxidation was also observed at the initial bond coat/Pt overlayer interface (Figure 71). This may be the combined result of rapid oxygen transport through the large surface defects present in the as-processed condition (Figure 67b) and the lack of adequate adhesion at the initial bond coat/ Pt overlayer interface due to surface defects present in the bond coats. All these results led to the idea of even greater improvements that might be obtained by applying proper surface preparation techniques before and after the deposition of the Pt overlayers. On the other hand, the initially irregular interface might have had beneficial effects due to reduced strain energy in the presence of parallel cracks that run in the TGO. This possibility was also considered. To clarify these uncertainties, new samples with surface modifications were prepared. These modifications included: deposition of Pt overlayers onto media finished NiCoCrAlY bond coats, media finishing the Pt overlayers that were deposited onto media finished NiCoCrAlY bond coats and preoxidizing the media finished Pt overlayers deposited onto media finished NiCoCrAlY bond coats. The failure times for these specimens were relatively short compared to the first batch of NiCoCrAlYs with Pt overlayers (Table 4). Unfortunately, these specimens had even more irregular interfaces with many associated defects in the TBC (Figure 72a) from which significant amounts of failure were observed to propagate (Figure 72b). These results showed that the surface irregularities might also develop during electro-plating of Pt itself, probably due to the dendritic growth of Pt. Media finishing performed after the deposition of the Pt layer was not very effective for smoothing the surface (Figure 72c), resulting in similar failure behavior.

Figure 67 Scanning electron micrographs of a TBC system with a Pt overlayer on NiCoCrAlY bond coat in the as processed condition showing (a) highly irregular interface with associated TBC defects, (b) defective areas in the vicinity of large embedded grit blast particles, (c) very uniform and continuous TGO.

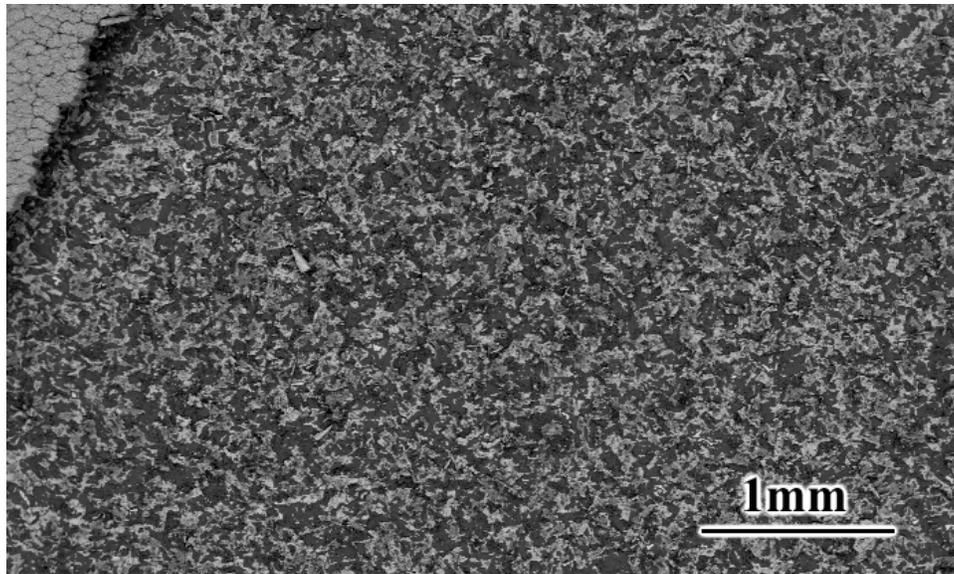
These specimens were also subjected to cyclic oxidation testing at 1100°C. Significant improvements in the lives of these TBC systems have been obtained in the presence of platinum overlayers as can be seen from Table 4. The failure was observed to be along the TGO/TBC interface as well as in the TGO and TBC (Figure 69a and 69b). Examination of these specimens prior to failure showed cracks initiating in the vicinity of the TBC defects (Figure 70a) and then they usually propagated in the TBC laterally, cutting through the TGO where the surface had a convex shape. These cracks, while they were propagating through the TGO, either linked-up (Figure 70b) or missed each other (Figure 70c) resulting in a fractured, layered alumina scale (Figure 70d). These cracks almost never propagated along the TGO/Pt overlayer interface, which

Figure 69 Fracture surface of the TBC system with Pt overlayer on the NiCoCrAlY bond coat showing that the failure was mainly along the TGO/TBC interface, as well as in the TBC and in the TGO (a). A higher magnification micrograph from the fracture surface is presented in (b).

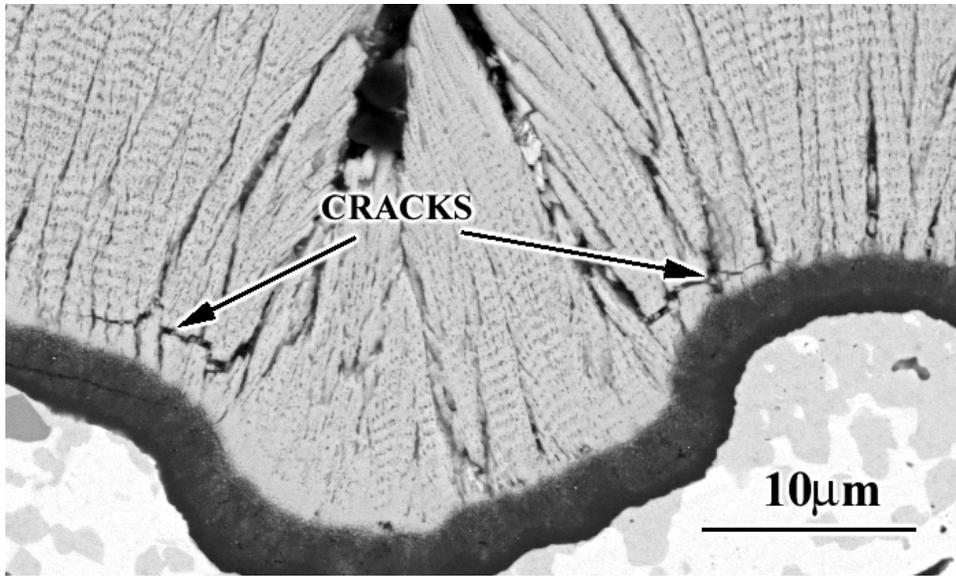
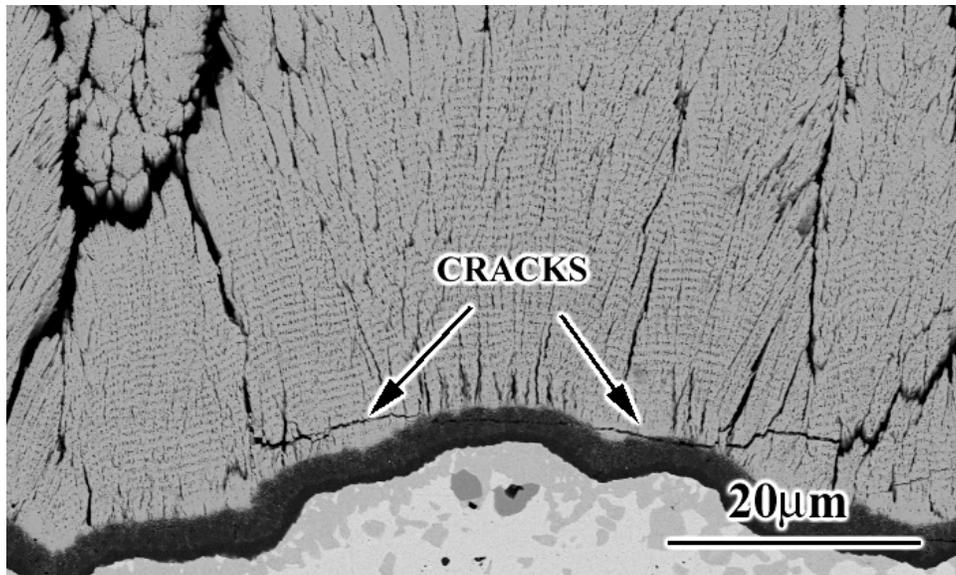
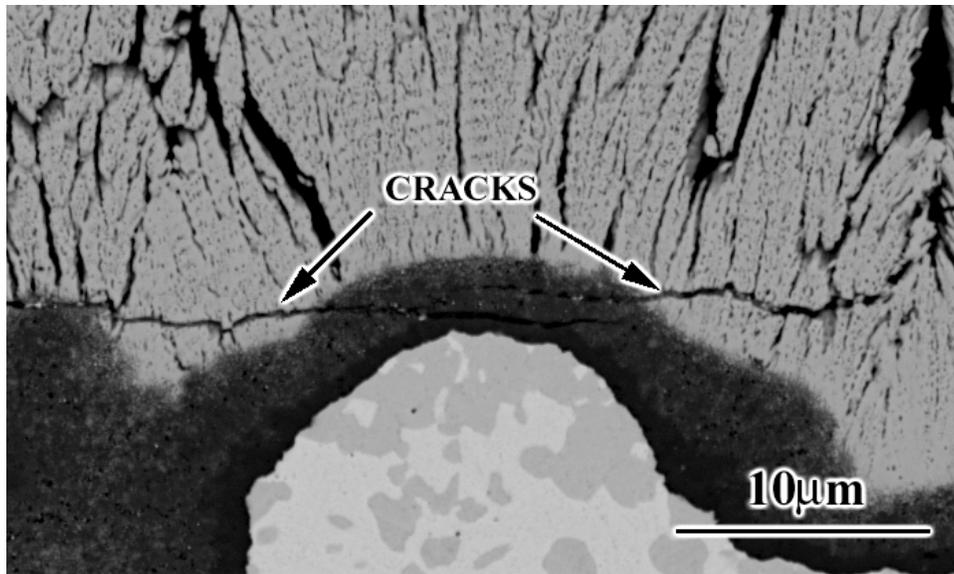
Figure 70 Scanning electron micrographs of the TBC system with Pt overlayer on the NiCoCrAlY bond coat after exposure at 1100 °C for 40 cycles showing that the cracks that initiated at TBC defects, (a), either linked up, (b), or missed each other, (c), causing a layered alumina scale, (d).

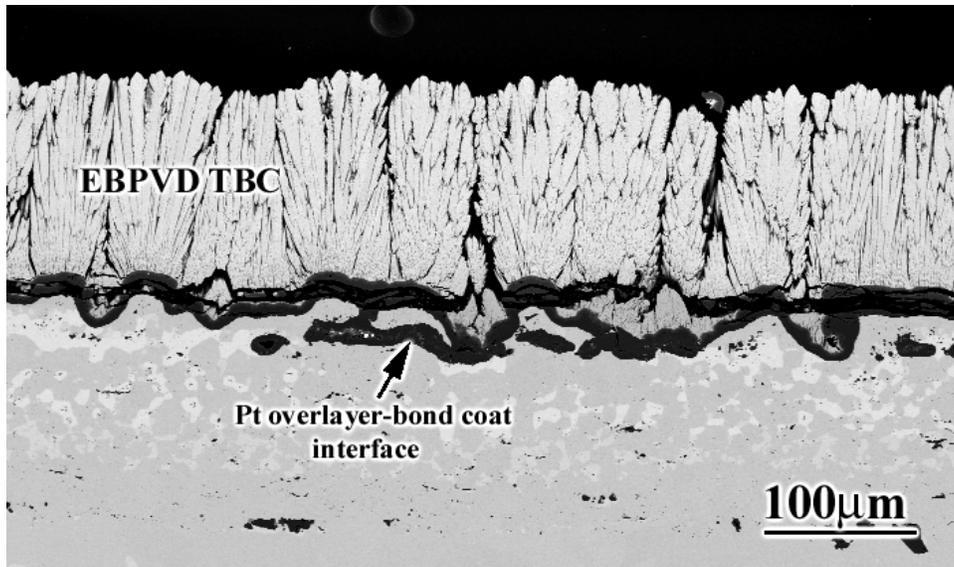
Figure 71 Scanning electron micrograph of the TBC system with Pt overlayer on the NiCoCrAlY bond coat after it failed, showing the extensive amount of oxidation along the initial bond coat/ Pt overlayer interface

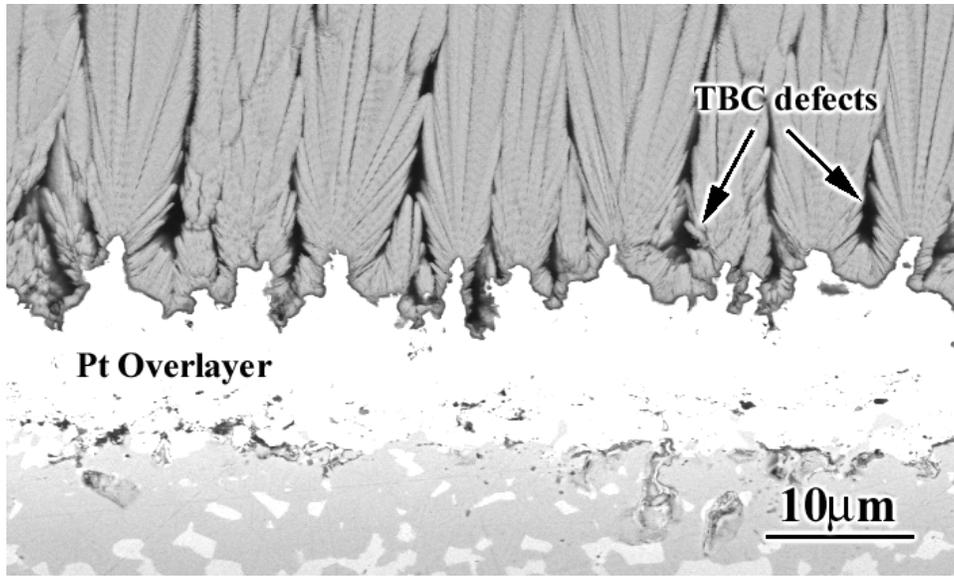
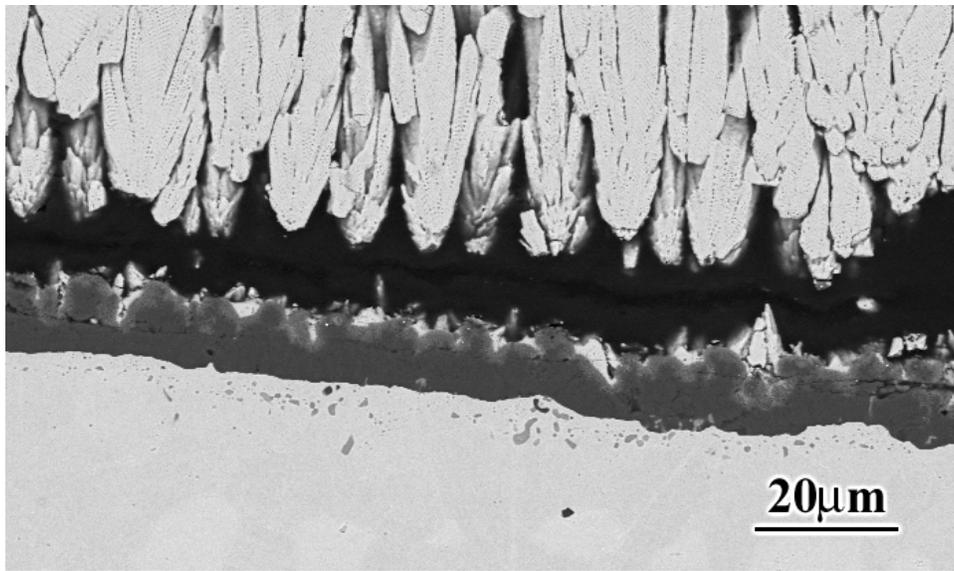
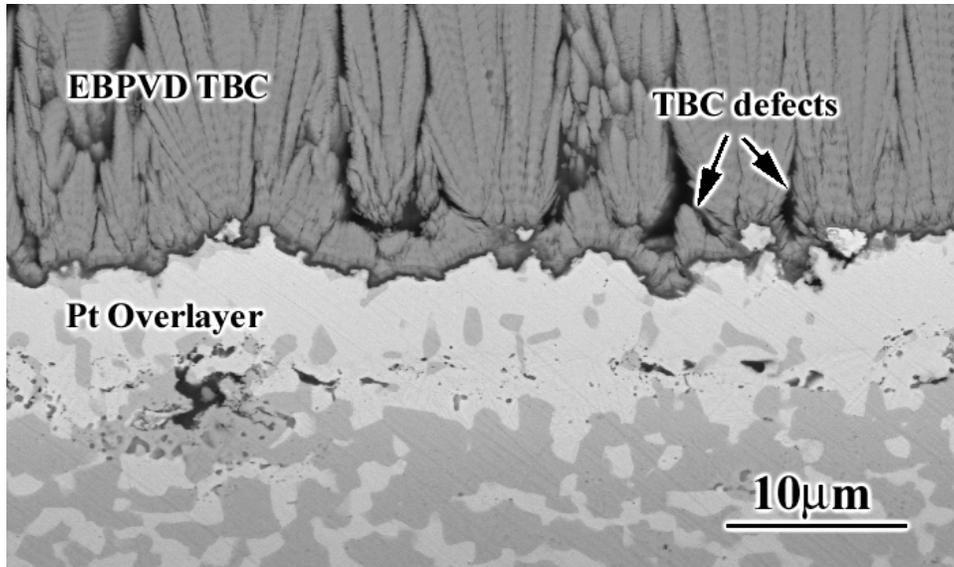
Figure 72 Scanning electron micrographs of the TBC systems with Pt overlayer on the media finished NiCoCrAlY bond coats. The interface was highly irregular with associated TBC defects, (a), from which significant amounts of failure were observed to propagate, (b). The interface of the specimen that was given media finish after Pt deposition was still irregular, (c).

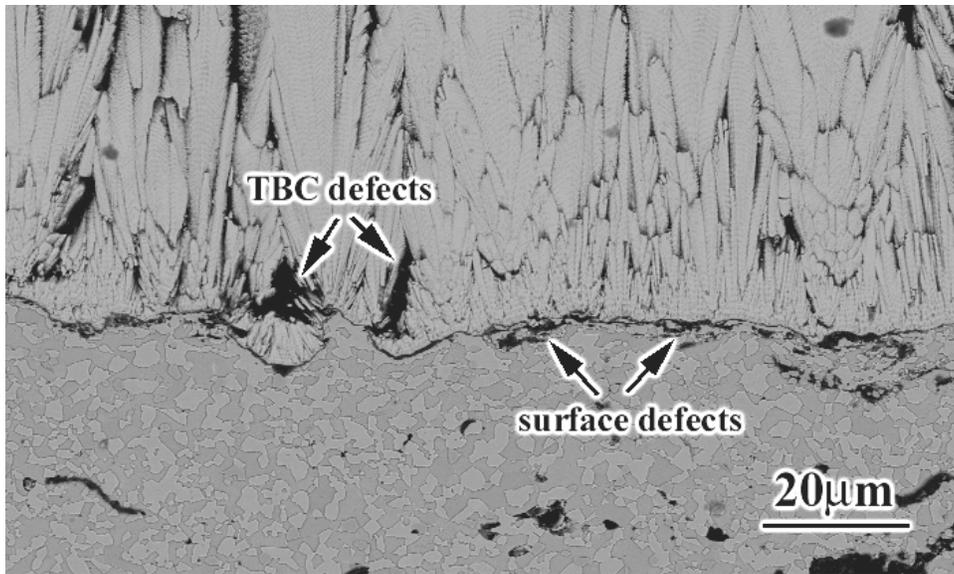
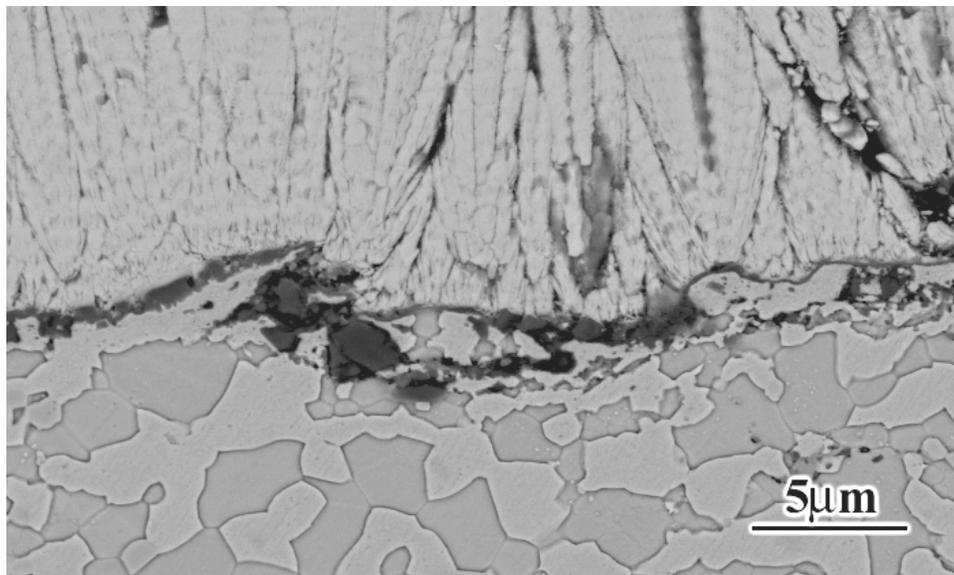
Even though there was some improvement in the lives of NiCoCrAlY systems in the presence of Pt underlayers, it was not significant compared to improvements achieved with other modifications. Cross sectional examination of these TBC systems in the as-processed condition did not show any difference in terms of the as-processed defects observed for the current state of the art TBCs. Figure 74a shows the surface defects and the highly irregular interface with associated TBC defects whereas Figure 74b shows the very non-uniform TGO, which is not always pure alumina.

Figure 74 Scanning electron micrographs of the TBC systems on NiCoCrAlY bond coats with Pt underlayers in the as processed condition. Surface as well as TBC defects were evident, (a). The TGO was very non-uniform, (b).

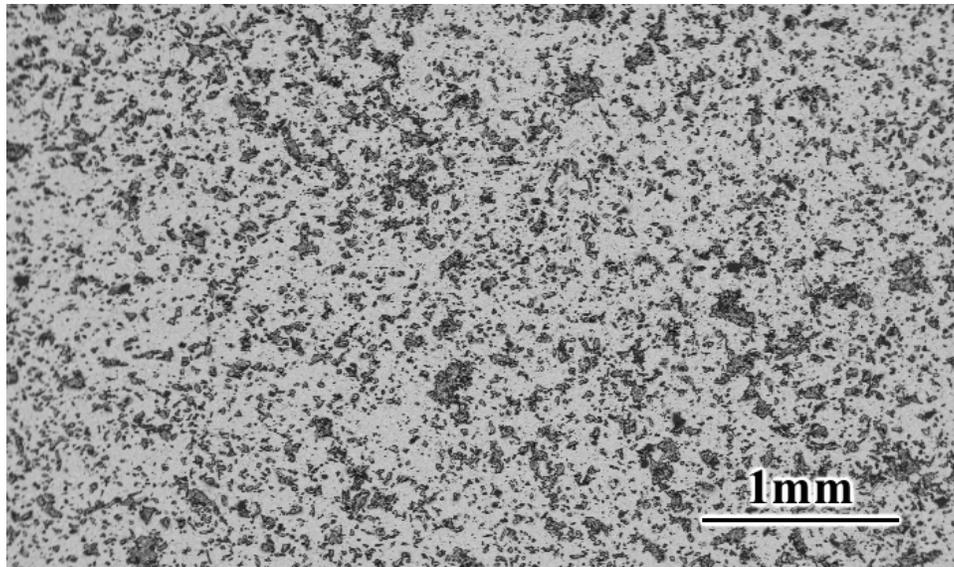
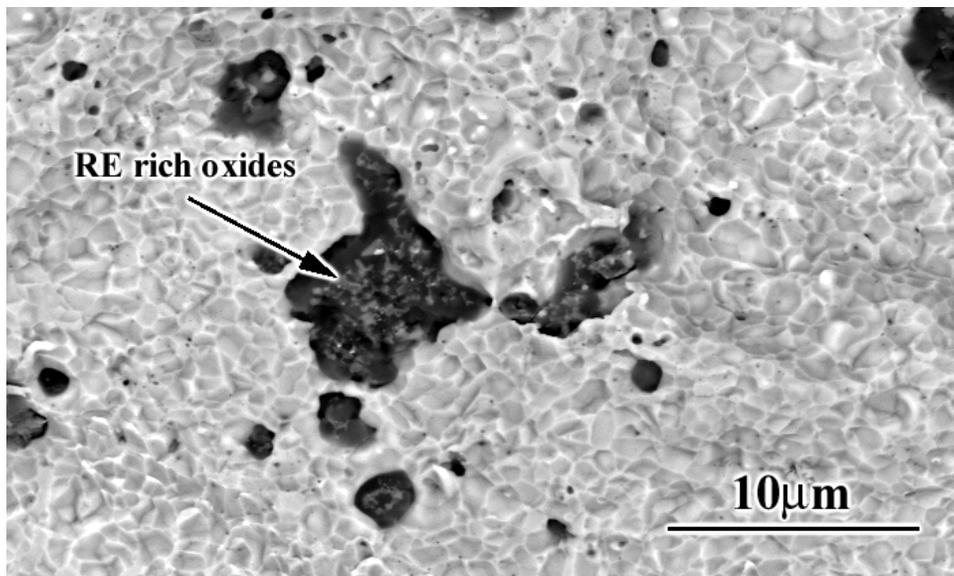
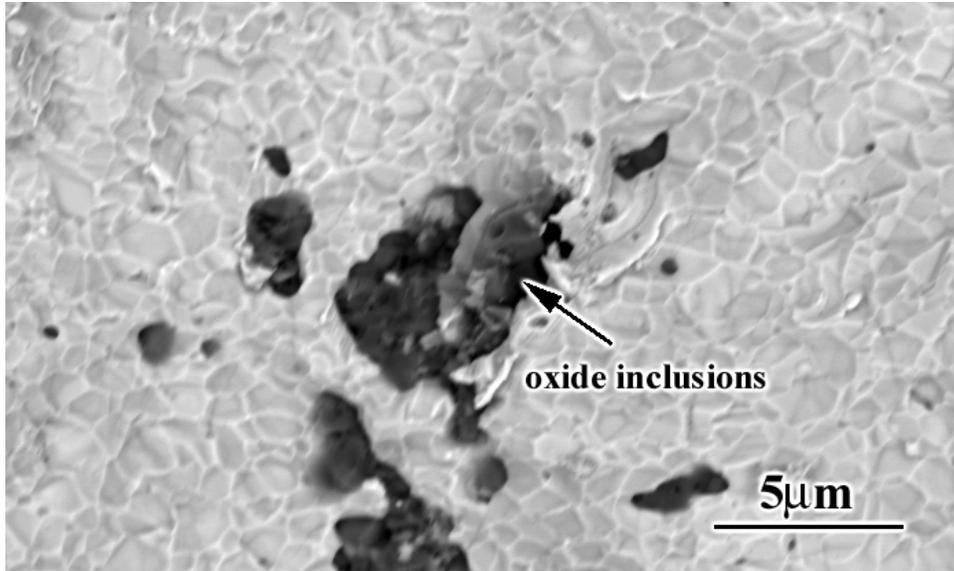
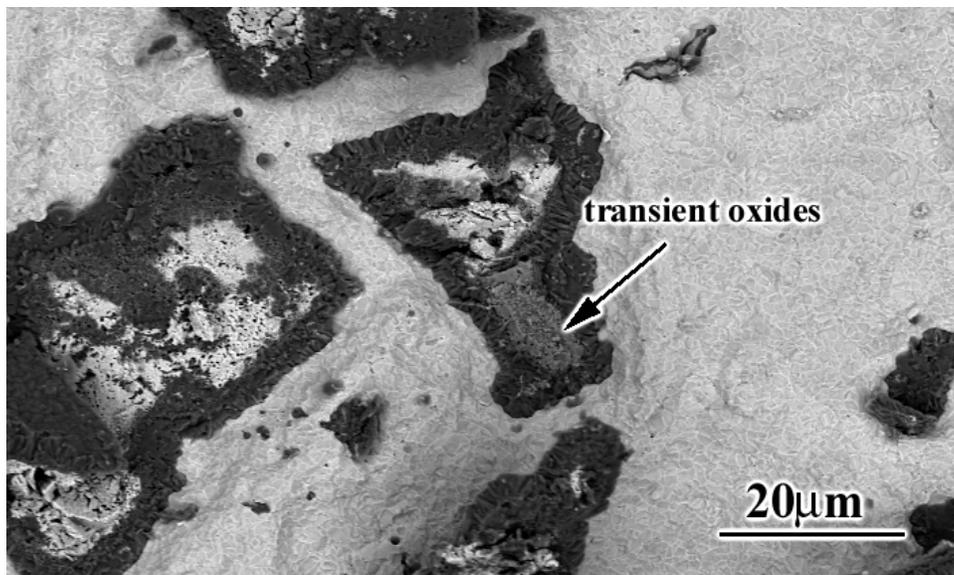
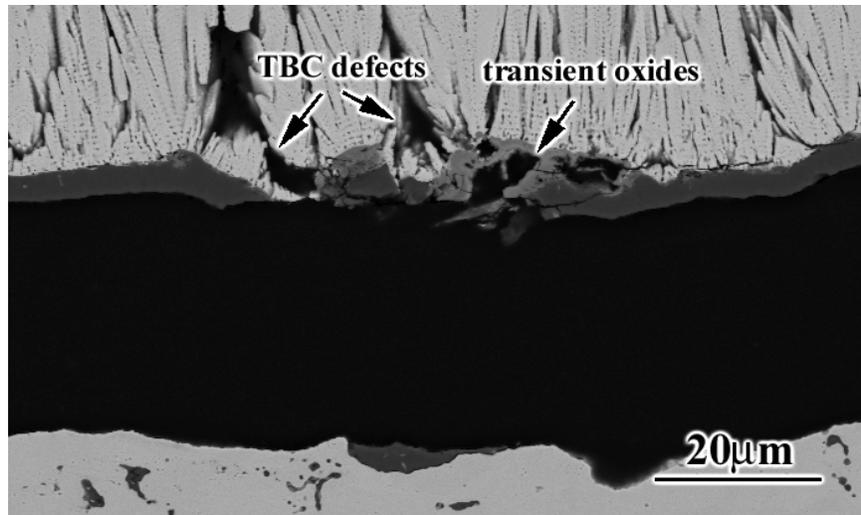
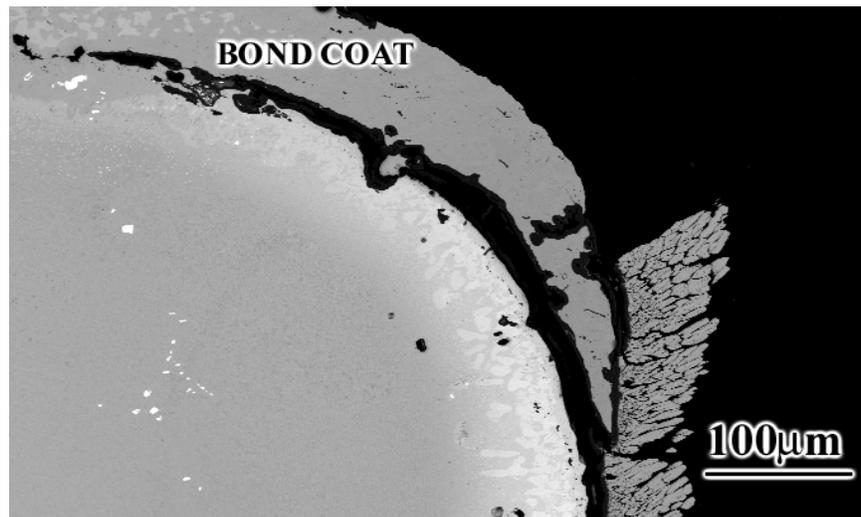
The general failure behaviour of these systems was also very similar to those without any modification. The failure was mainly along the TGO/bond coat interface with numerous excursions into the TGO and TBC (Figure 75a). The typical features observed on the fracture surfaces were reactive element rich oxide protrusions (Figure 75b), oxide inclusions (Figure 75c), transient oxides and TBC segments (Figure 75d). Figure 75e is a cross sectional micrograph from the failed specimen showing damage in the vicinity of transient oxides and TBC defects. Some localized separation along the initial Pt underlayer / superalloy interface was also observed (Figure 75f), which is not believed to have contributed to failure in this case. However, this observation shows the likelihood of separations along this interface, which may result in complete detachment of the bond coat.

Figure 75 Scanning electron micrographs of TBC systems on NiCoCrAlY bond coats with Pt underlayers after failure showing the fracture path (a), as well as typical features observed on the fracture surfaces such as RE rich oxides, (b), oxide inclusions, (c), transient oxides and TBC segments, (d). A cross sectional micrograph indicating damage in the vicinity of transient oxides and TBC defects is presented in (e). It is also possible to get separation along the Pt underlayer- superalloy interface (f).

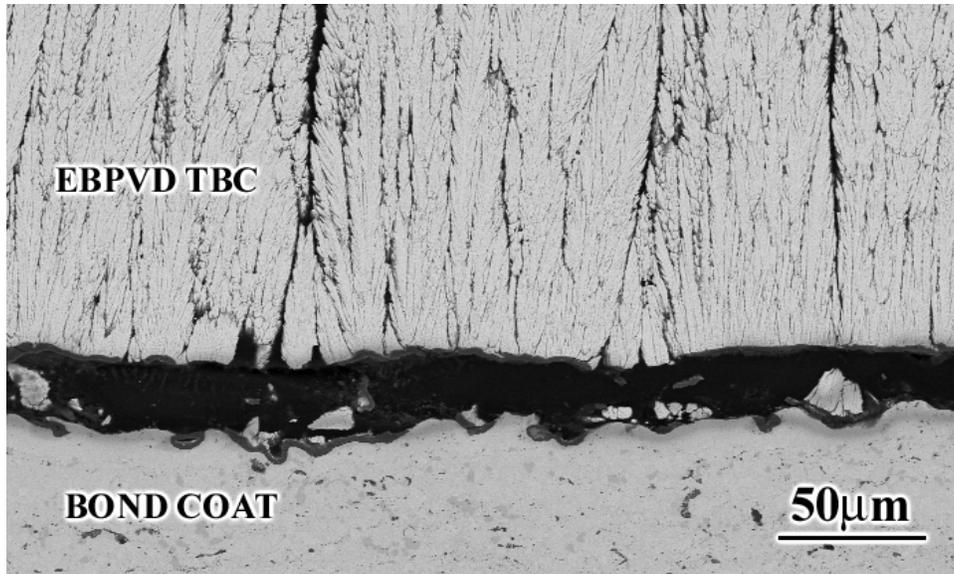
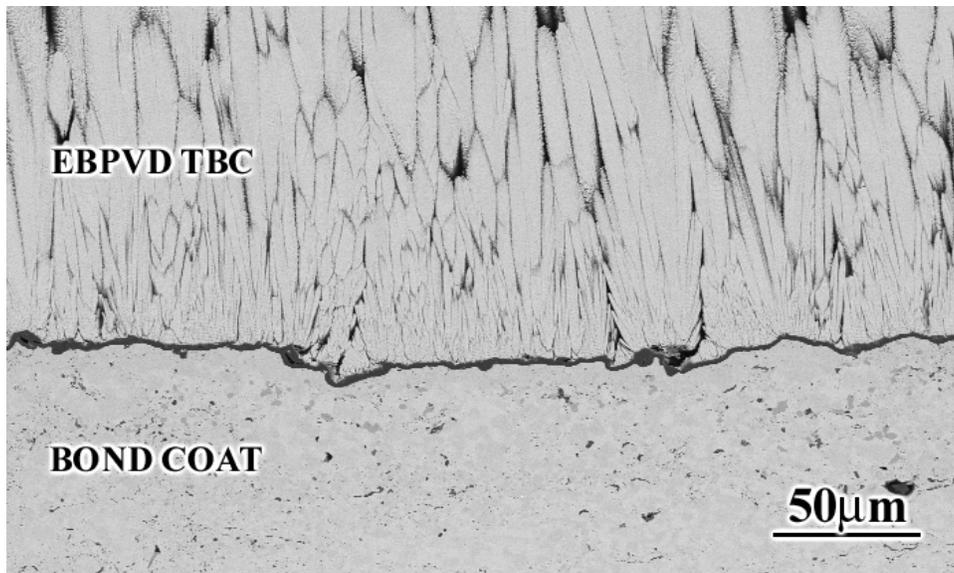
Figure 77 Scanning electron micrographs from TBC systems with state of the art NiCoCrAlY bond coats, (a), and the NiCoCrAlY bond coats with Pt underlayers, (b), after 20 cycles of exposure at 1100°C before failure. The absence of separation during metallographic preparation for the specimen with Pt underlayer suggests improved interfacial toughness.

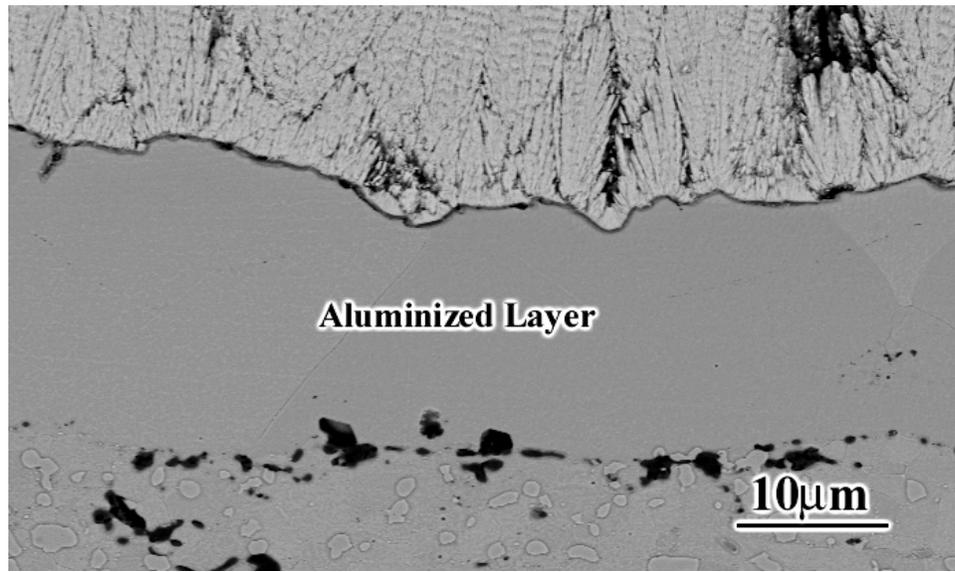
- **Aluminized NiCoCrAlY Bond Coats** - Aluminizing the NiCoCrAlY bond coats also improved the lives, but not to the extent obtained by Pt overlayers and surface polishing. In the as-processed condition, fewer defects were present along the interfaces compared to the ones identified for the state of the art NiCoCrAlY systems. The TGO was pure and more uniform and the interface was free of the surface defects. However, the interface was still irregular with associated TBC defects (Figure 78).

Figure 78 Scanning electron micrograph of a TBC system with aluminized NiCoCrAlY bond coat in the as processed condition showing the presence of a relatively defect free interface with more uniform TGO compared to the state of the art TBC systems. However, the interface was still irregular.

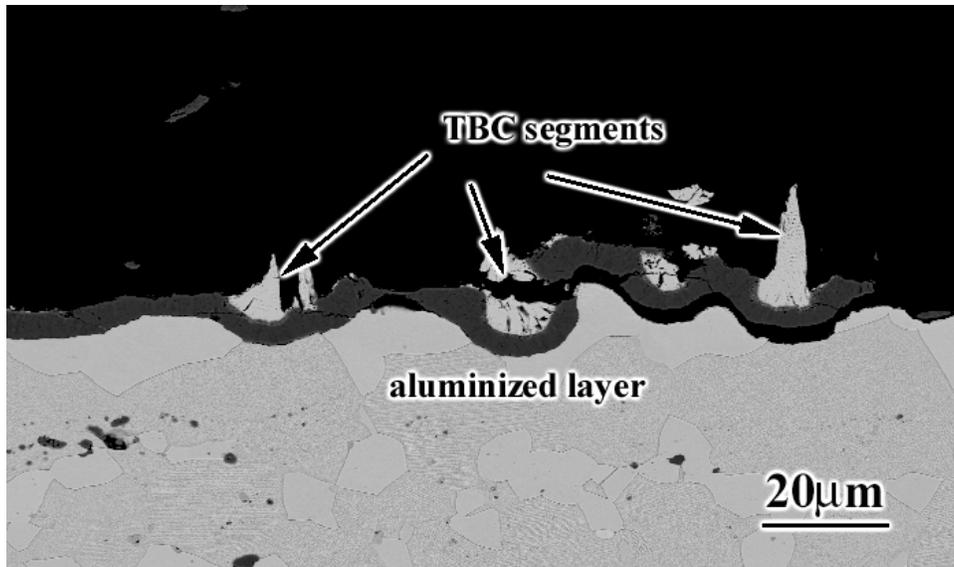
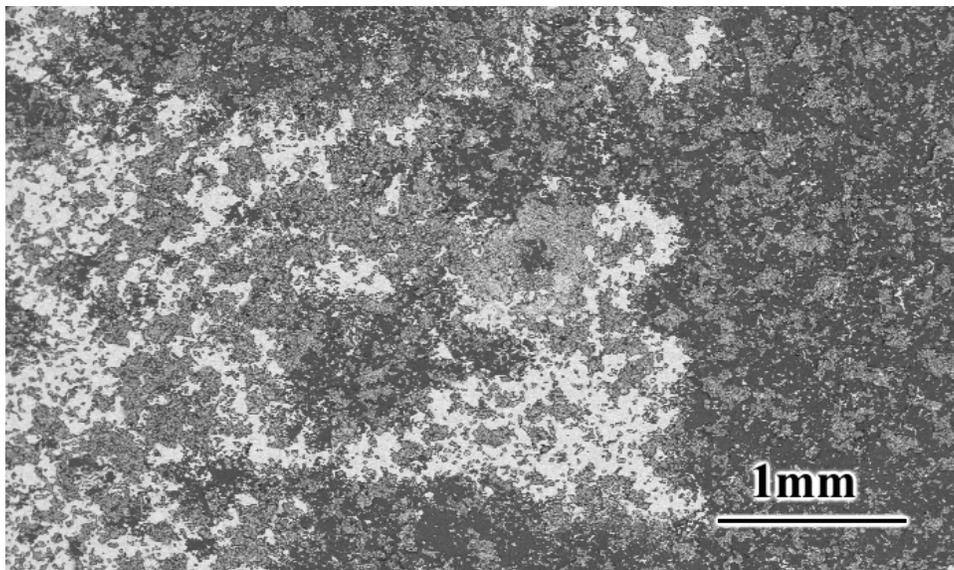
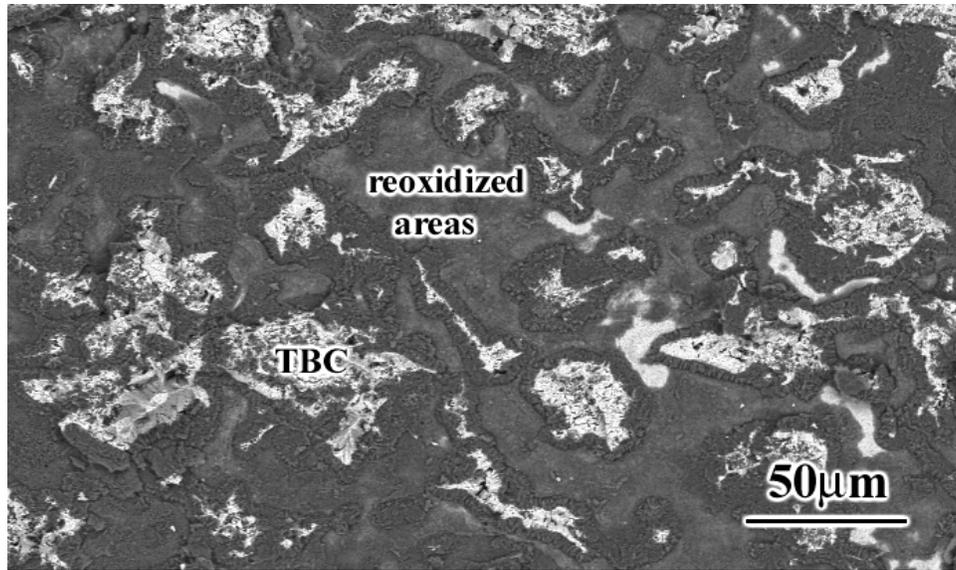
Examination of these specimens as a function of exposure cycle showed that the interface became more irregular with time, similar to the behavior of the state of the art Pt aluminides (Figure 79a). The failure was more along or close to the TGO/TBC interface with some spallation also along the TGO/bond coat interface (Figure 79b). There were indications of separations along the TGO/bond coat interface prior to failure (Figure 79c). Al-rich nitrides were observed in these areas, which appear to have formed following the interface separation (Figure 79d).

Figure 79 Scanning electron micrographs of TBC systems with aluminized NiCoCrAlY bond coats after failure. (a) The interface became more irregular with time, (b) Significant amount of failure was along or close to TGO/TBC interface, (c) There were indications of separation and reformation of the alumina prior to failure, (d) Al rich nitrides were observed at these sites where separation occurred prior to failure
