THE FAILURE OF THERMAL BARRIER COATINGS AT ELEVATED TEMPERATURES

Submitted to the Graduate Faculty of
the School of Engineering in partial fulfillment
of the requirements for the degree of
Doctor of Philosophy

University of Pittsburgh

2004

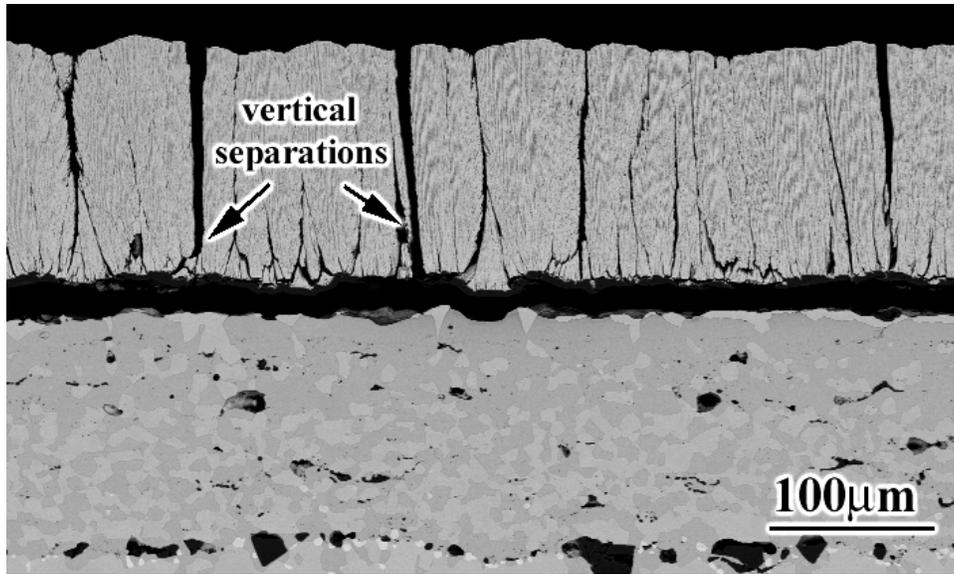
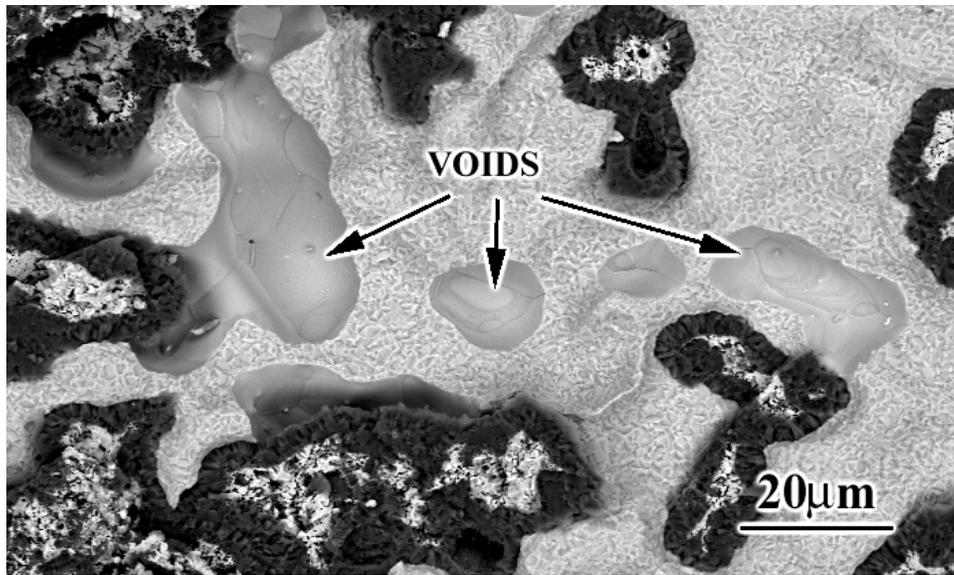
The failure of the aluminized NiCoCrAlY systems are believed to be similar to the failure of the state of the art Pt aluminides which failed by the ratcheting mechanism. However, in addition to the ratcheting type of failure, aluminized bond coats also developed vertical separations in the TBC (Figure 80a) as well as voids along the TGO/bond coat interface (Figure 80b), both of which are also believed to contribute to the failure. These observations explain the relatively shorter lives of these systems compared to the state of the art Pt aluminides. The absence of Pt in the aluminized coatings is another factor that is believed to be important also in the performance difference.

Figure 80 Scanning electron micrographs of TBC systems with aluminized NiCoCrAlY bond coats after failure showing the development of (a) vertical separations in the TBC, (b) voids in the bond coat.

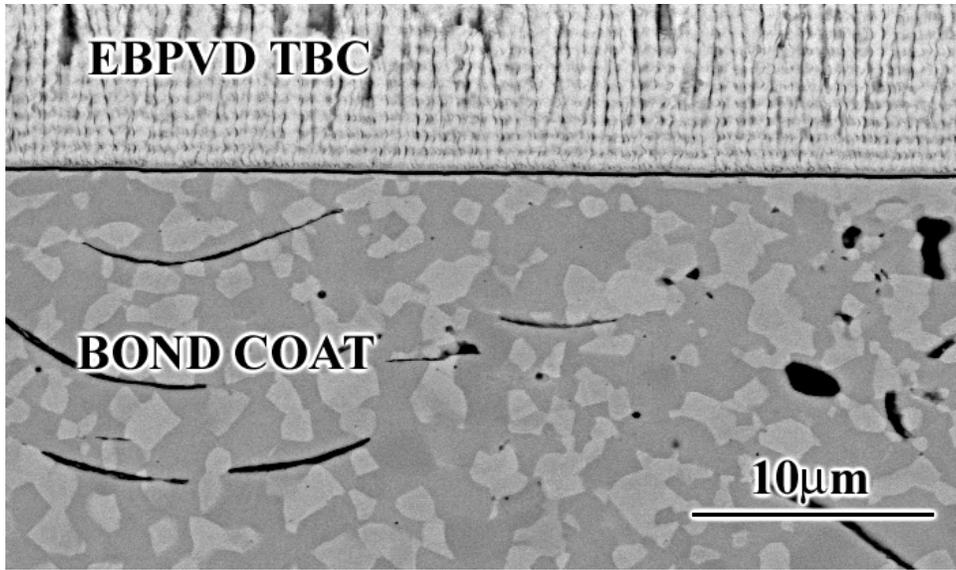
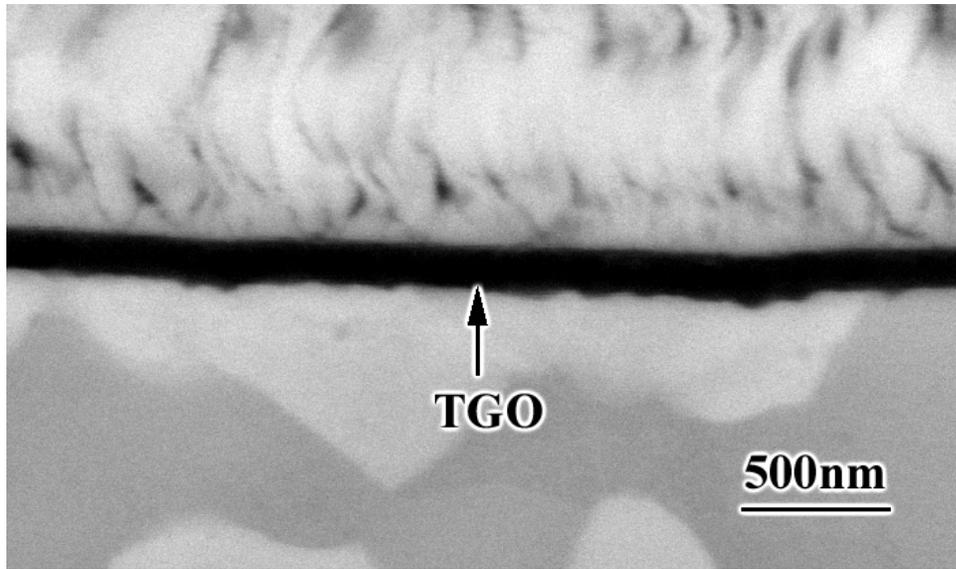
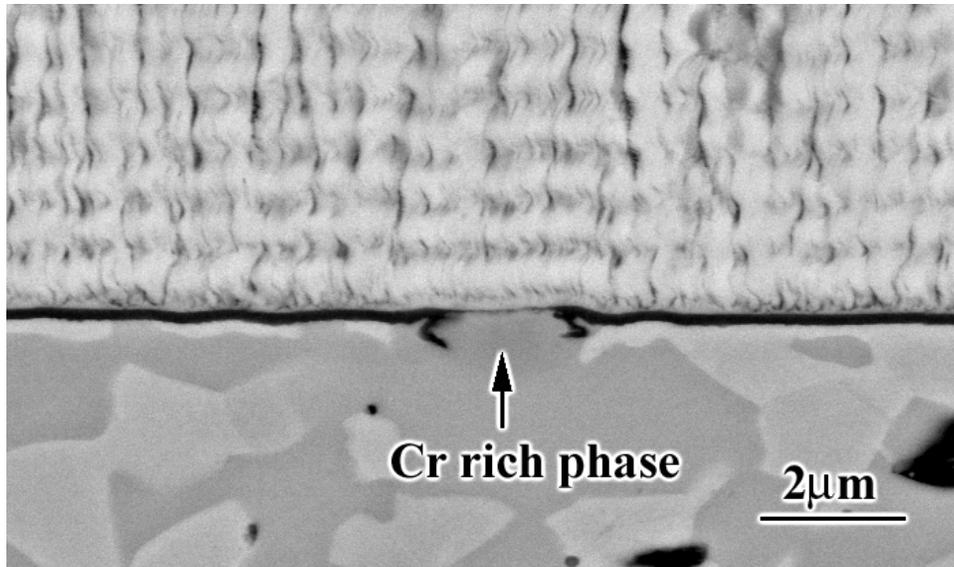
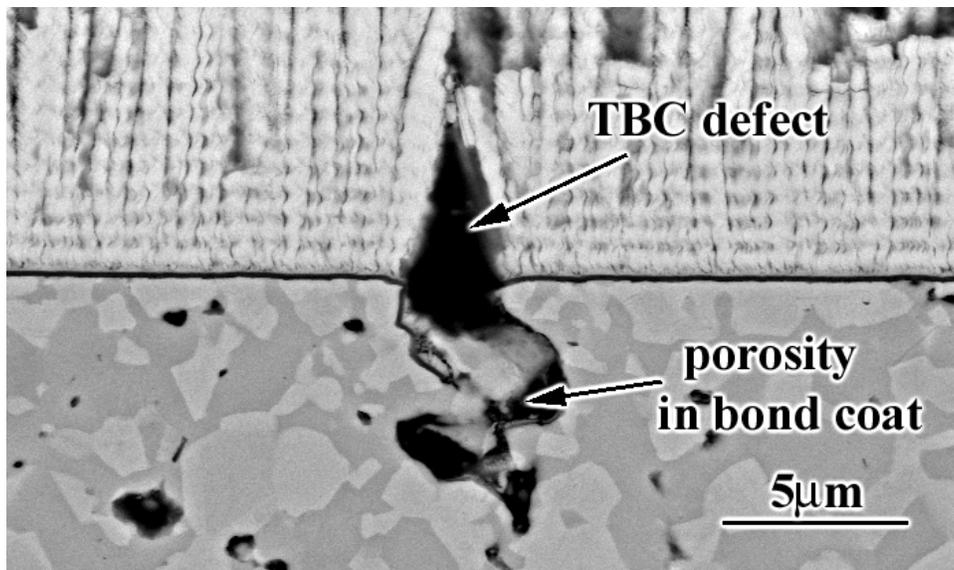
Hand polished NiCoCrAlY Bond Coats: These specimens were hand polished resulting in a surface finish with an approximate Ra value of 0.2 μ m. The cross sectional examination of these specimens in the as-processed condition showed that the interface was very smooth and free of the surface defects as well as the TBC defects (Figure 81a). Closer examination of the interface area showed the presence of a very uniform and continuous TGO (Figure 81b) except in some localized areas where the continuity of the TGO was interrupted above Cr rich phases along the interface (Figure 81c). A few TBC defects were also observed above the areas where the porosity in the bond coat intersected the surface (Figure 81d).

Figure 81 Scanning electron micrographs of a TBC system with hand polished NiCoCrAlY bond coat in the as processed condition, at (a) low and (b) high magnifications, showing a very smooth interface which is free of many defects identified for the state of the art systems except at some localized areas where the continuity of the TGO is interrupted above the Cr rich phases, (c), and where the porosity in the bond coat intersected the surface, (d).

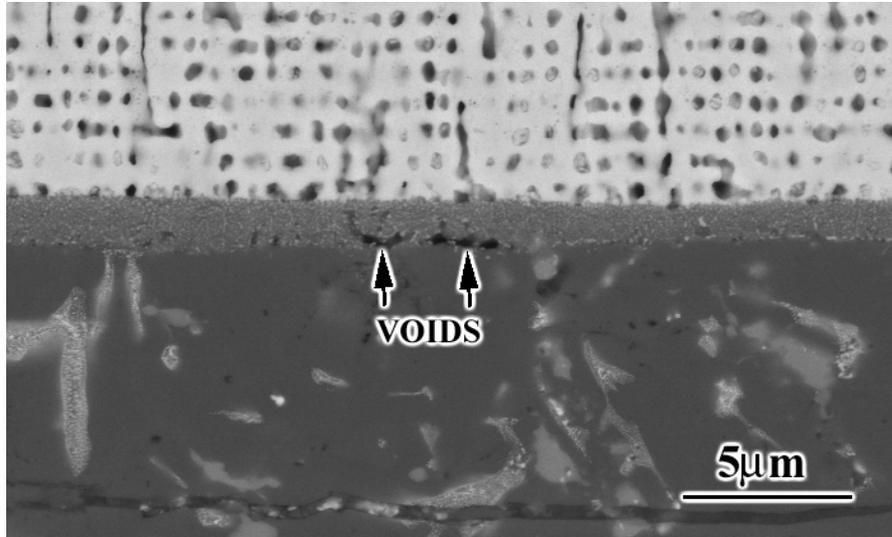
(e)

Figure 82 SEM micrographs of a TBC system with hand polished NiCoCrAlY bond coat after 1520 cycles of exposure at 1100°C before failure showing the presence of a very thick TGO with significant amounts of RE rich oxide protrusions, (a). The TGO/TBC interface was almost free of defects, (b), except at localized areas with transient oxides, (c), and small buckles along the TGO/intermixed zone interface, (d), which seemed to develop by linking up of small voids along this interface, (e). Cracks were present in the vicinity of RE rich oxide protrusions, (f)

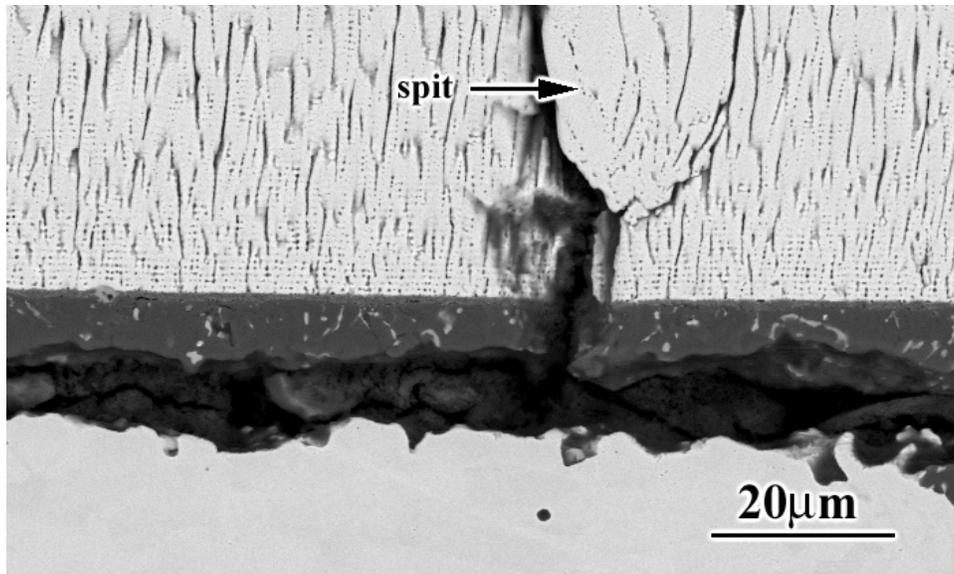
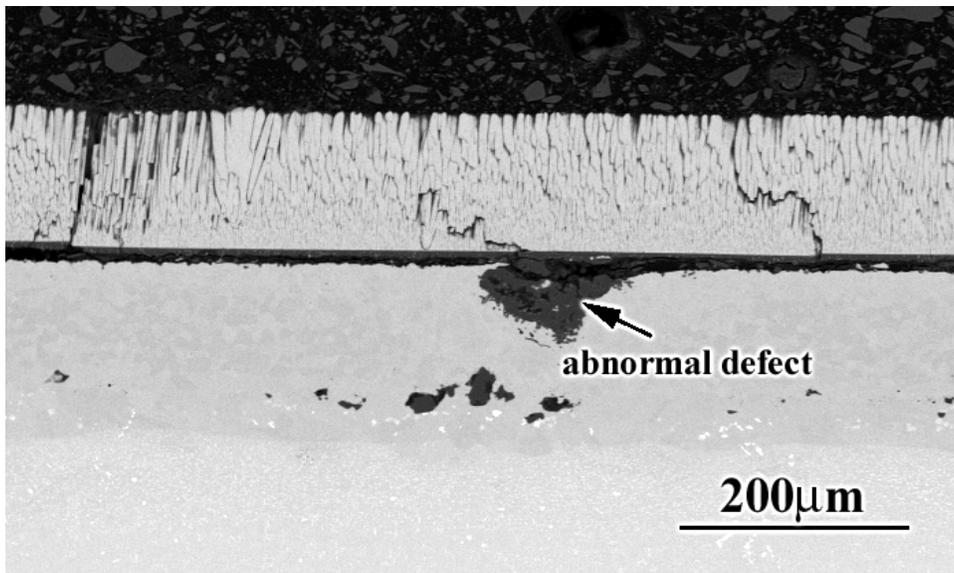
Figure 83 Scanning electron micrographs of TBC systems on hand polished NiCoCrAlY bond coats which failed after 720 cycles of exposure at 1100°C. Spits, (a), as well as an abnormal defect, (b), were observed.

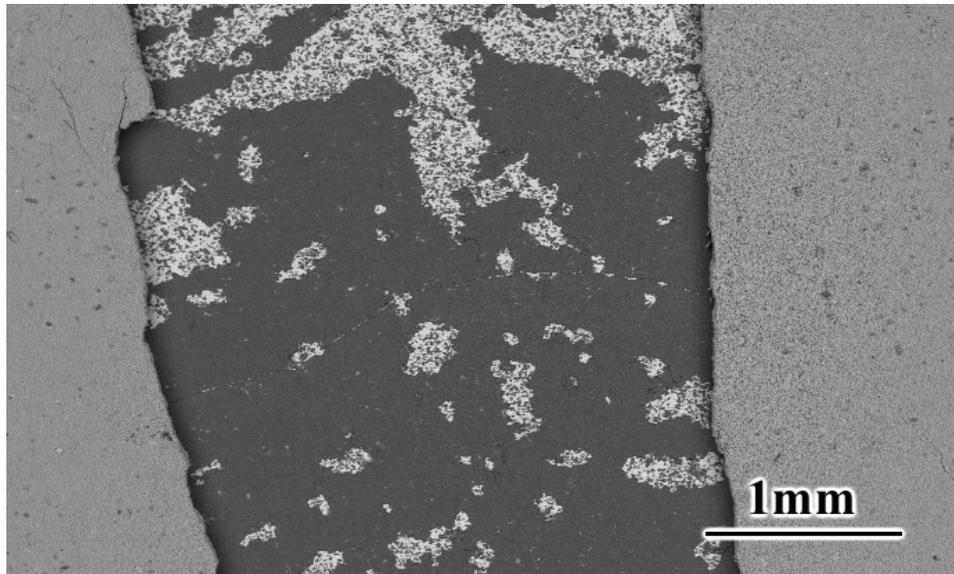
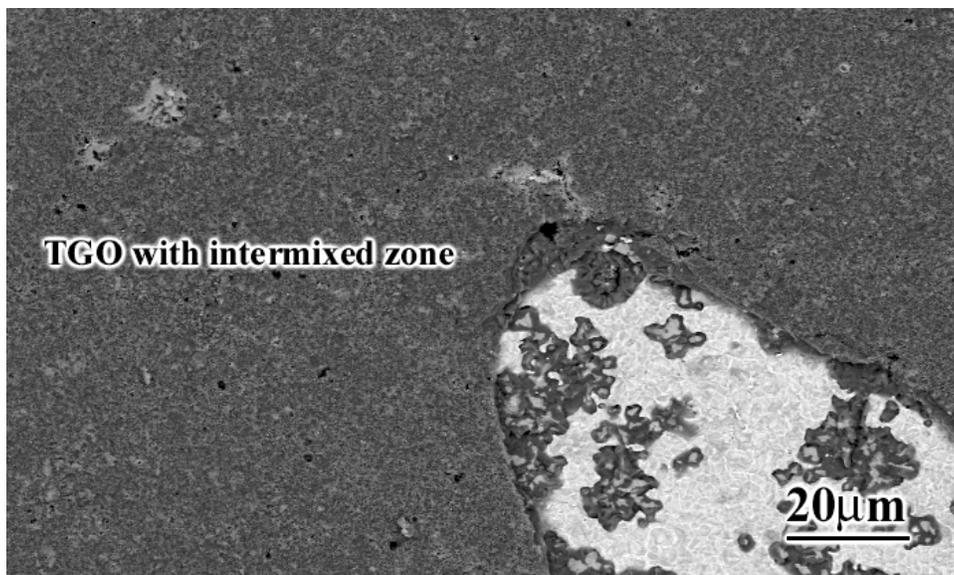
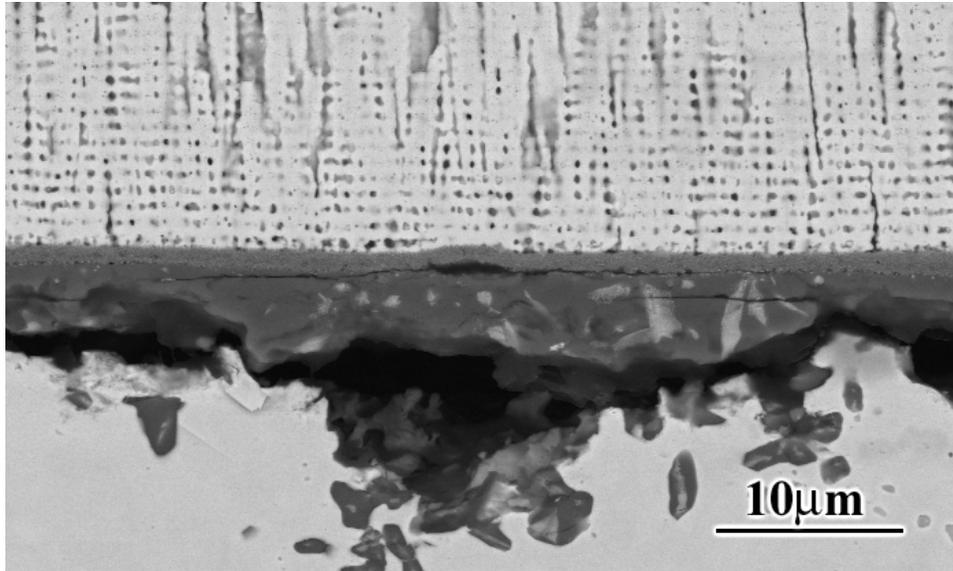
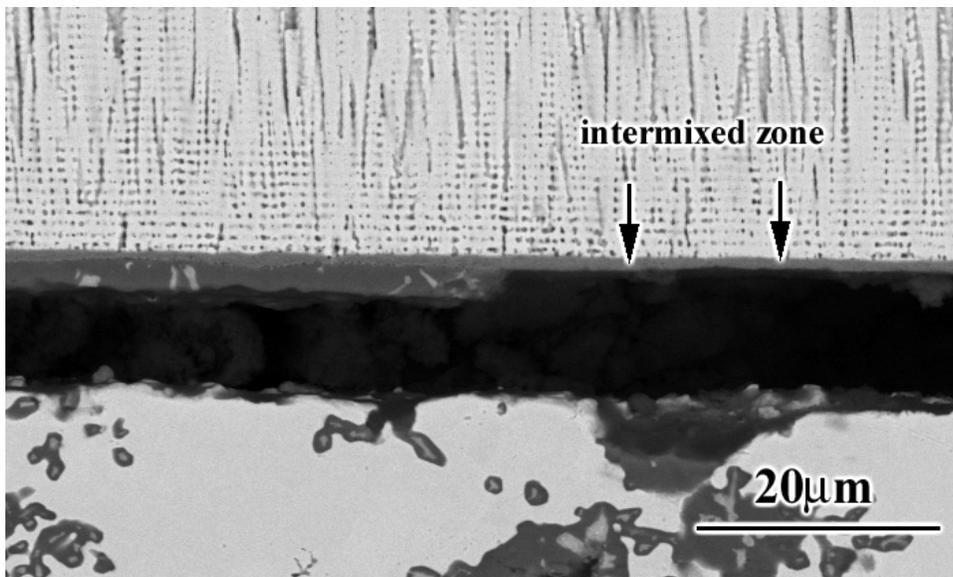
Figure 84 Scanning electron micrographs of a TBC system on hand polished NiCoCrAlY bond coat which failed after 220 cycles of exposure at 1100°C. Significant amount of failure was along the TGO/intermixed zone interface as can be seen at (a) low and (b) high magnification micrographs from the fracture surface, as well as cross sectional micrographs, (c) and (d). Transient oxides were also present embedded in the intermixed zone, (e).

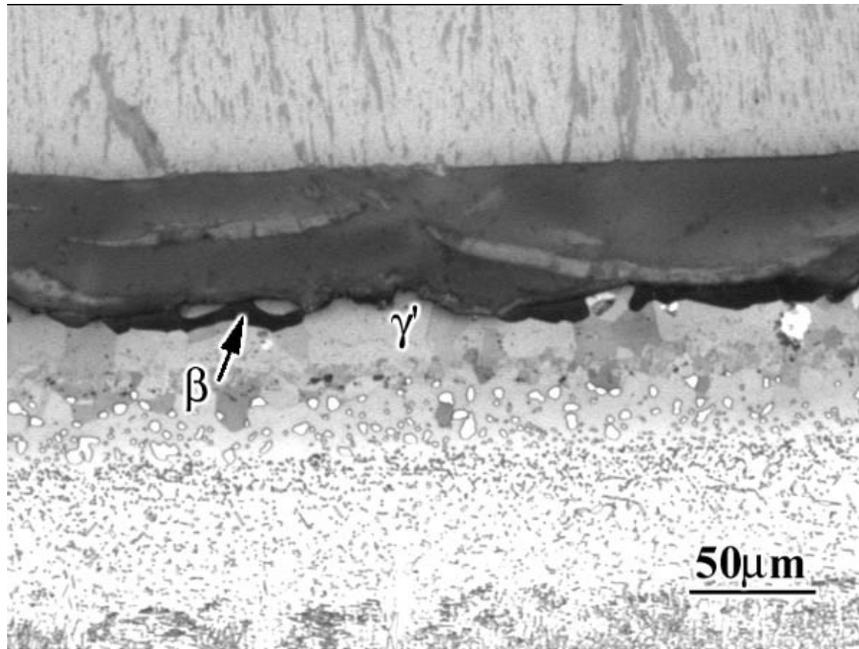
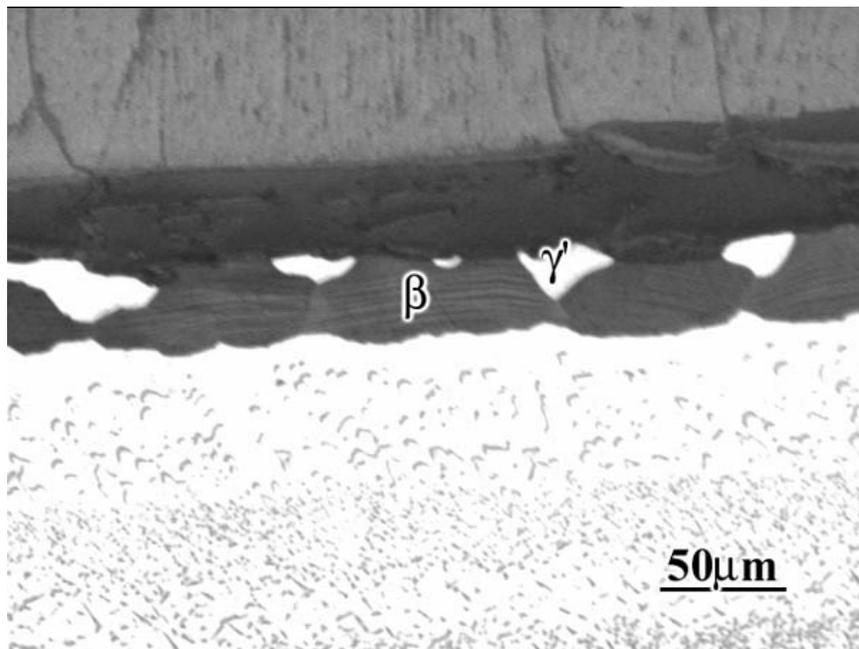
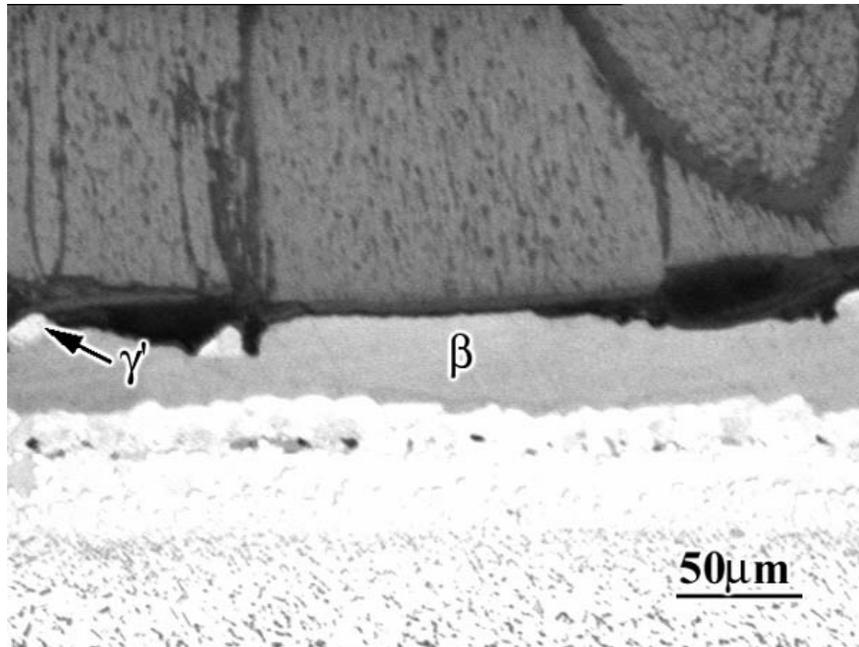
One general observation that could be obtained on the thickness variations was less Al depletion for the specimens with thicker layers of Pt as well as aluminides. Figure 88a is from a specimen with normal thickness of Pt and aluminide layers (6.35 μ m Pt, 38.1 μ m aluminide) after 1080 cycles of exposure and the microstructure consisted of mainly γ' phase with small amounts of β phase left whereas the specimens with double thickness of aluminide (Figure 88b) as well as double thickness of Pt and aluminide layers (Figure 88c), after 1240 and 860 cycles of exposures at 1100°C, respectively, consisted of mainly β phase with some γ' phase at the grain boundaries. These microstructural differences are expected to cause a marked difference in failure for longer lives where Al depletion becomes a major issue. However, Al depletion of the bond coats examined under this study did not seem to be the major factor for their failures.

Figure 88 Optical micrographs of TBC systems with as aluminized Pt aluminide bond coats with varying thicknesses of Pt and Aluminide layers after exposure at 1100°C. The bond coat with normal thickness of Pt and aluminide layers consisted of significant amounts of γ' phase after 1080 cycles, (a), whereas the specimens with double thickness of aluminide, (b), and with double thickness of Pt and aluminide layers, (c), after 1240 and 860 cycles of exposure, respectively, had much less γ' phase.

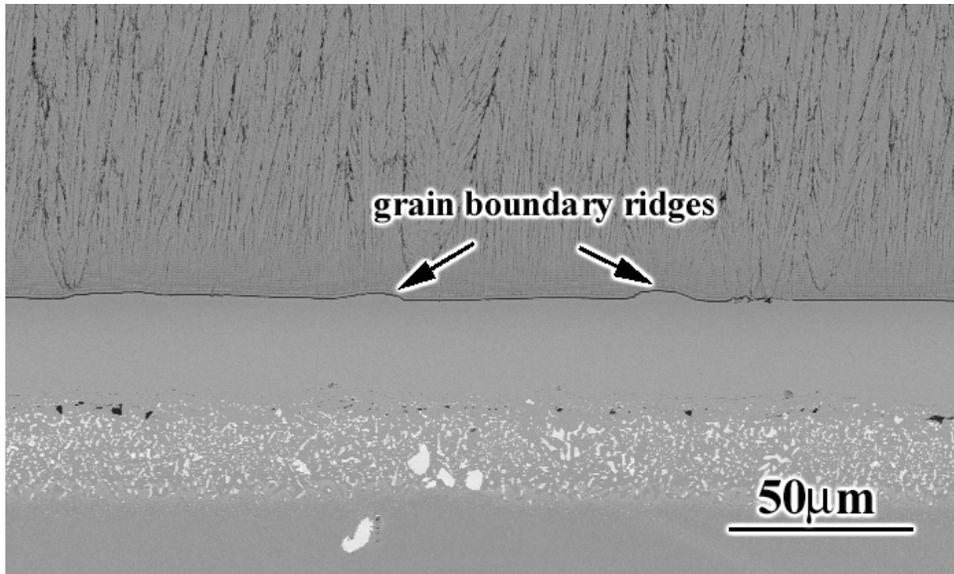
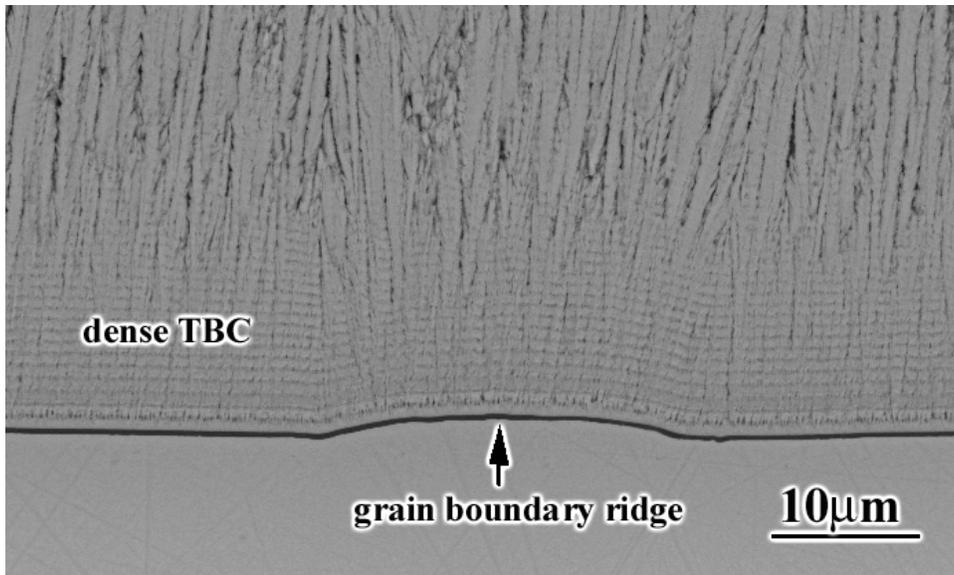
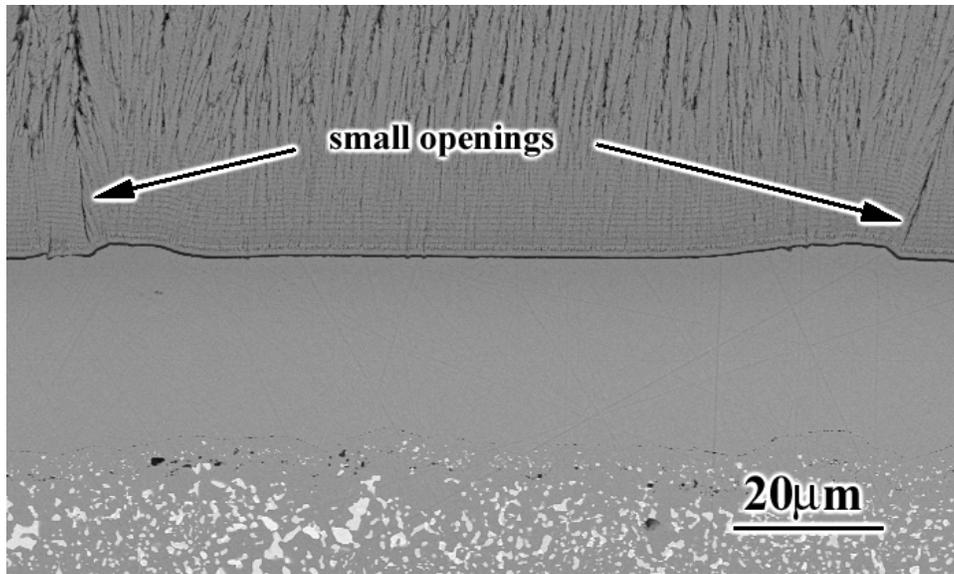
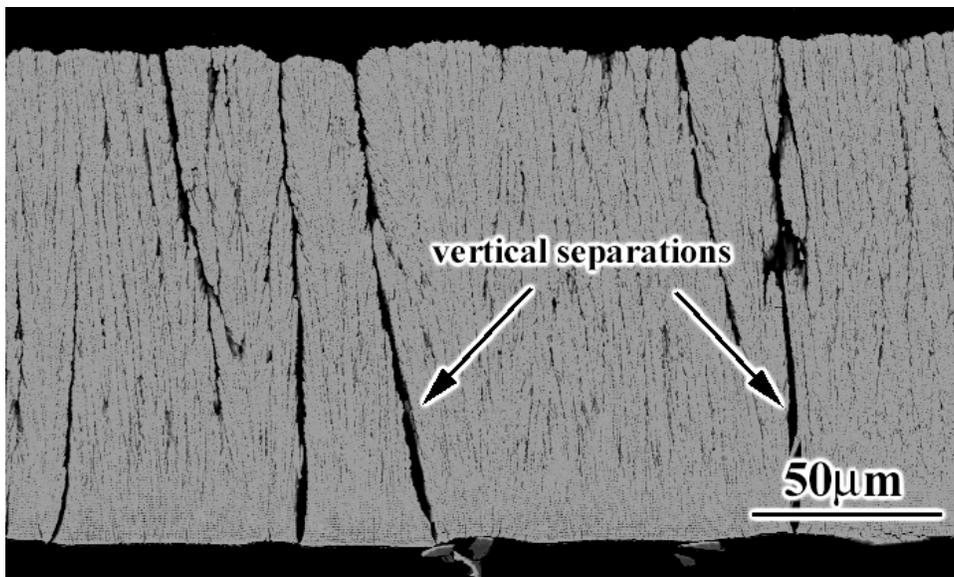
Figure 89a shows a typical cross section of TBC systems on as-aluminized Pt aluminide bond coats. The TBC was very dense close to TGO ($\sim 10 \mu\text{m}$) with parallel rows of pores (Figure 89b). This morphology is probably a result of an initially very flat interface except at the ridges. TBC deposition conditions may also be playing a role for the development of this dense TBC. Small openings developed in the TBC above these ridges (Figure 89c), and then they enlarged with exposure resulting in the formation of vertical separations in the TBC (Figure 89d).

Figure 89 Scanning electron micrographs of TBC systems with as aluminized Pt aluminide bond coats in the as processed condition showing grain boundary ridges, (a), dense TBC with parallel row of pores, (b) and small openings in the TBC above the ridges, (c), which enlarge with exposure resulting in the formation of vertical separations in the TBC, (d).

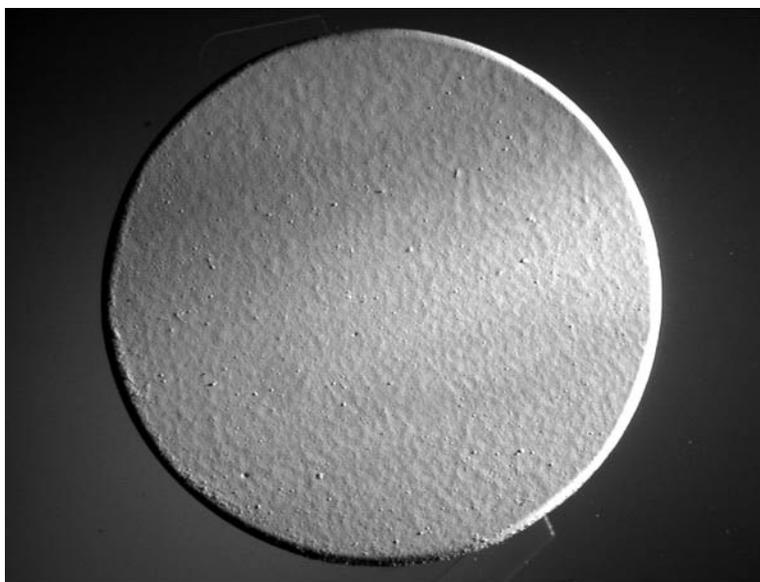
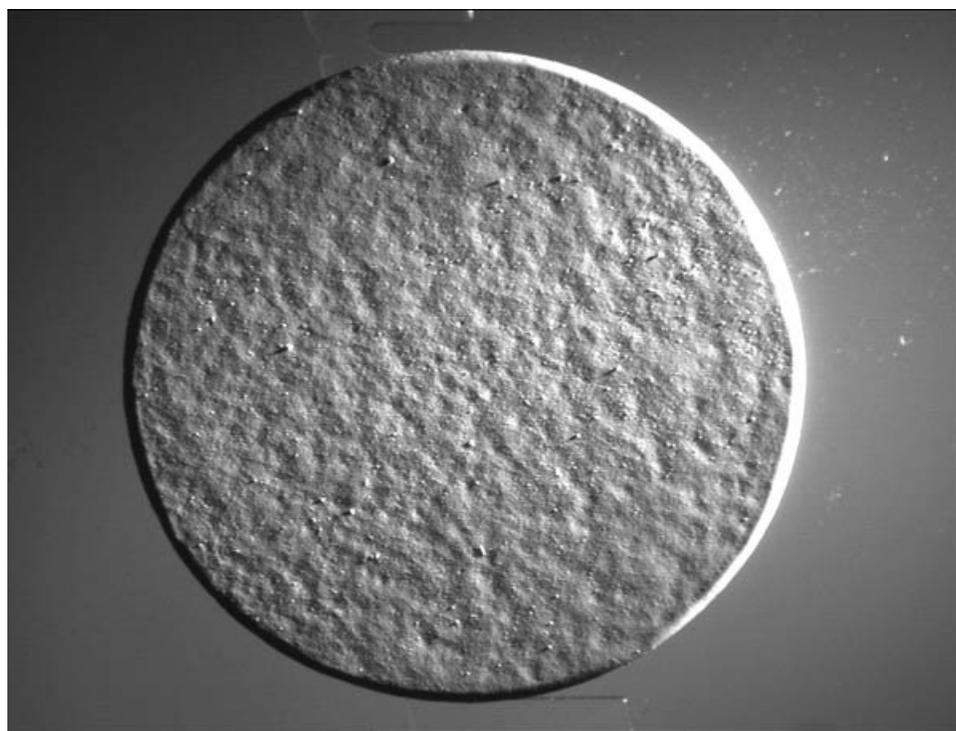
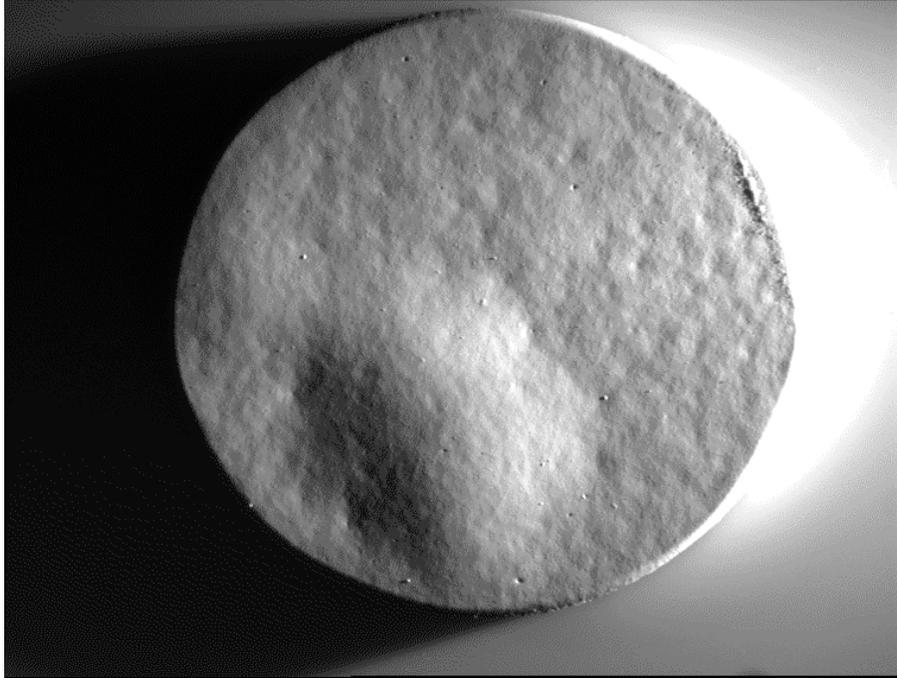
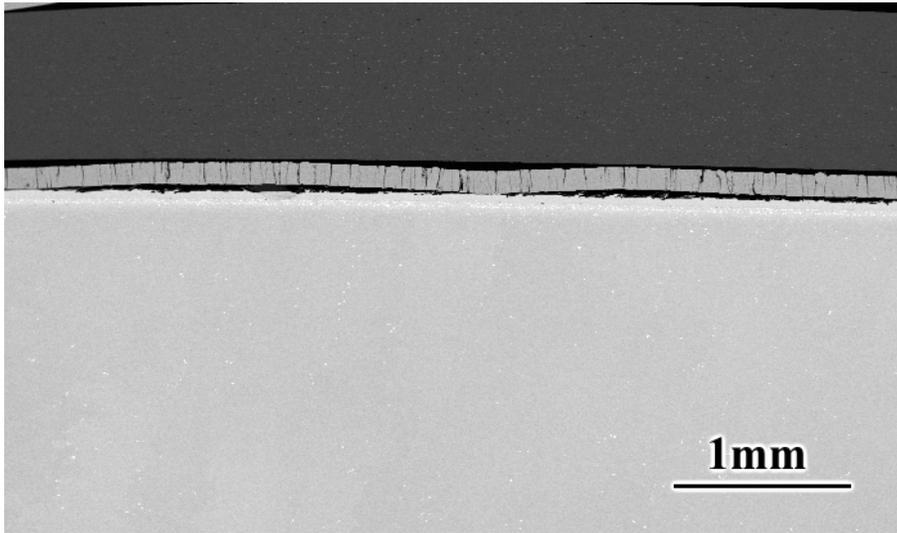
When these specimens were exposed to cyclic exposure conditions, small buckles, which were visible even by the naked eye, formed on the surface at early stages of their lives. Figures 90a through 90c are macrographs taken from the same specimen as a function of time. As can be seen from this sequence of macrographs, the specimens did not fail until the small localized buckles got larger and then linked together forming a critical sized buckle. Figure 90d is a cross sectional micrograph showing these buckles.

Figure 90 Macrographs of a TBC system on as aluminized Pt aluminide bond coat after exposure at 1100°C for 360 (a), 680 (b) and 860 cycles, (c), showing propagation of failure with time. The SEM micrograph in (d) shows the buckles in cross section.

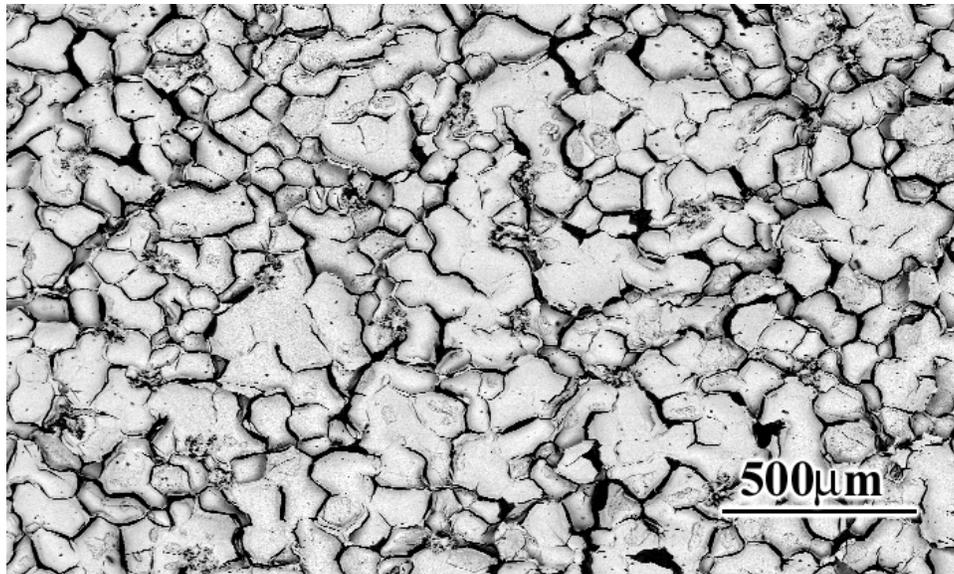
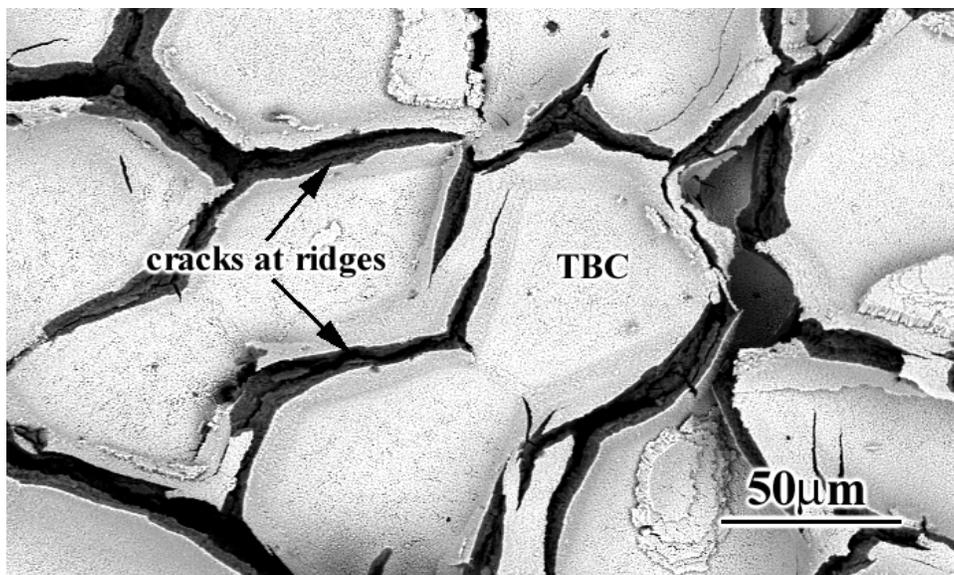
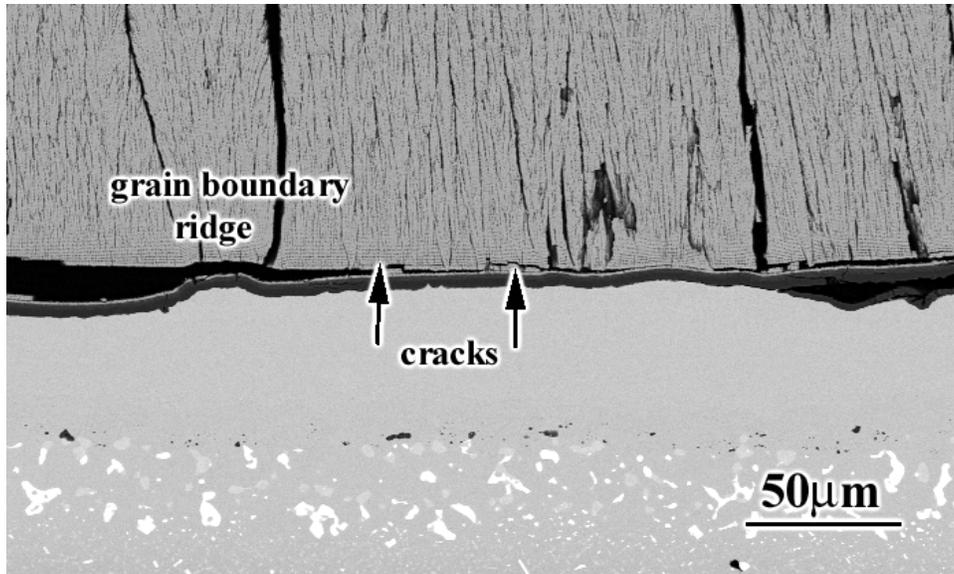
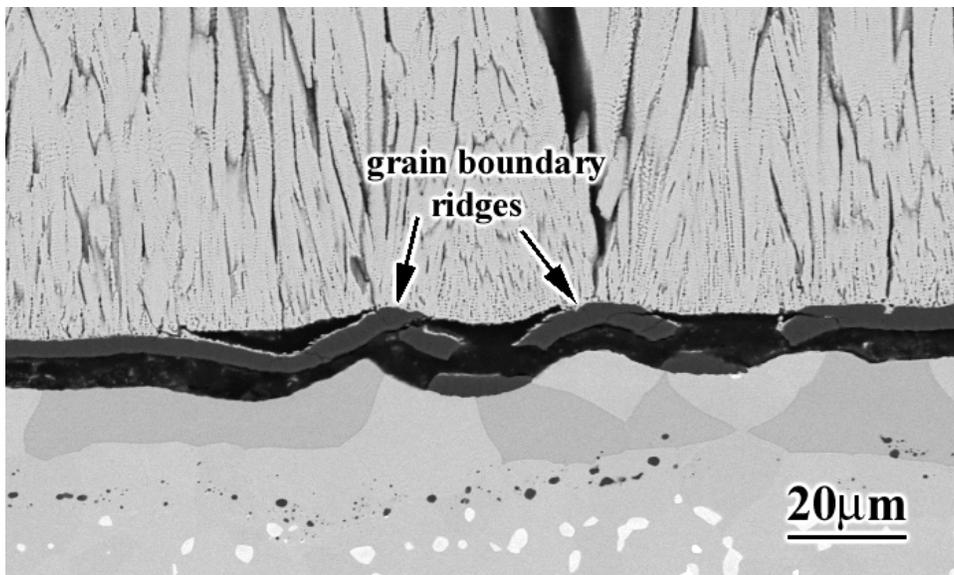
Examination of the fracture surface showed that the failure was mainly in the TBC (Figure 91a). Higher magnification micrographs of the fracture surface (Figure 91b) as well as the cross sections (Figure 91c) clearly showed the cracks that developed at these grain boundary ridges. These cracks, once initiated, propagated along the weak points, which were the row of

Figure 91 Scanning electron micrographs of TBC systems on as aluminized Pt aluminide bond coats after failure. The failure was mainly in the TBC, (a), and cracks were present at the grain boundary ridges as can be seen from the fracture surface, (b), as well as cross section, (c). Cracks at the ridges were also present in the absence of vertical separations in the TBC, (d).

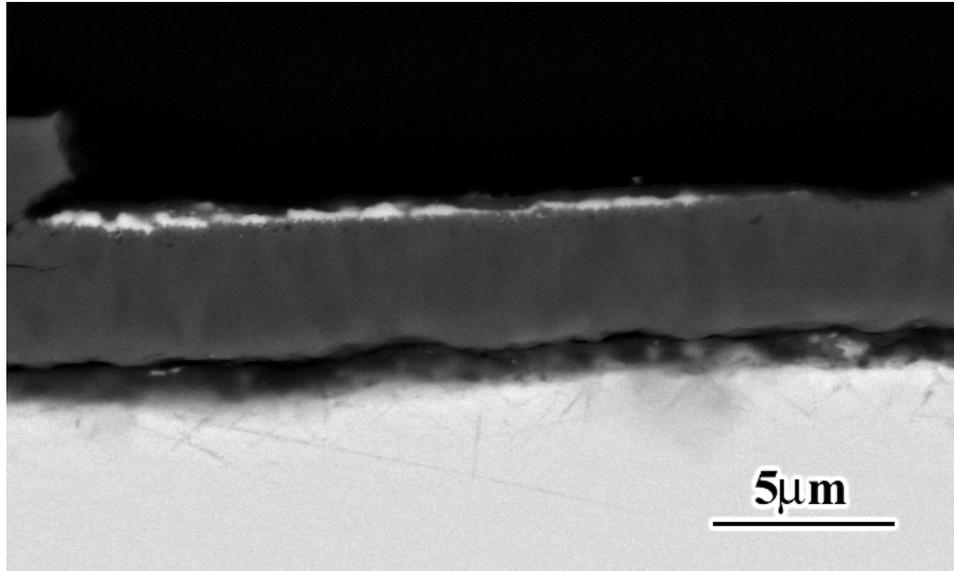
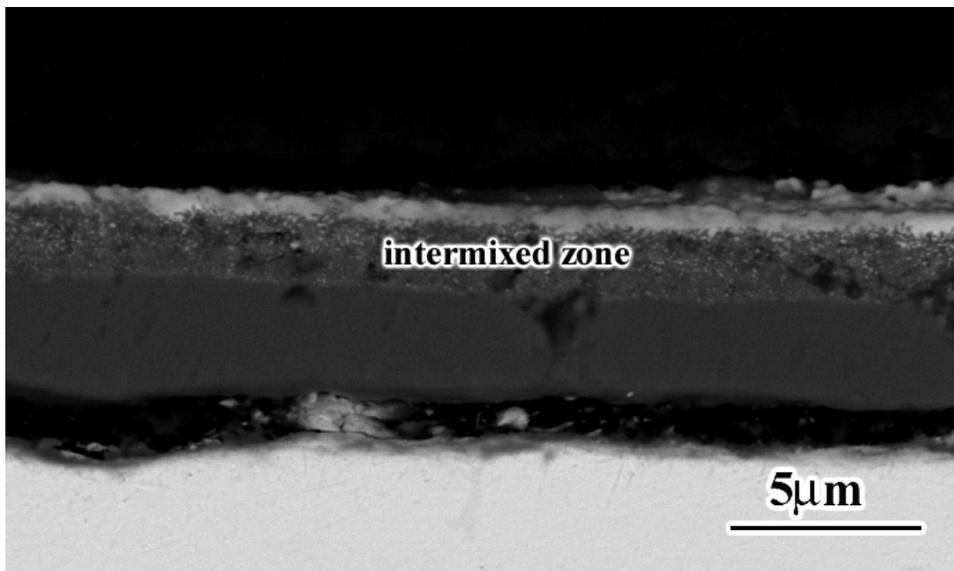
Figure 92 Scanning electron micrographs of TBC systems on as aluminized Pt aluminide bond coats with TBCs deposited by different companies. There was not any evidence of an intermixed zone for one set of specimens, (a), whereas there was a continuous layer of intermixed zone for the other set of specimens, (b)

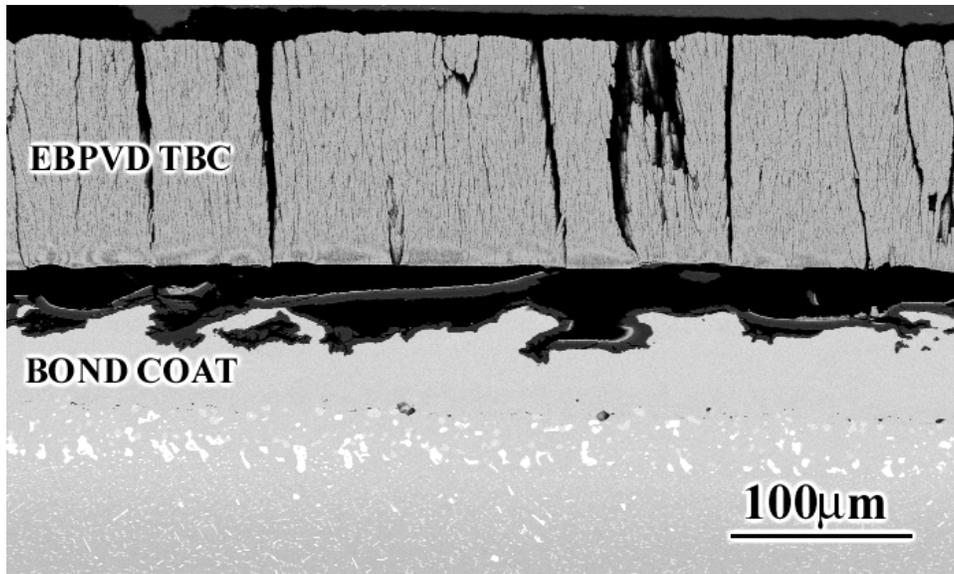
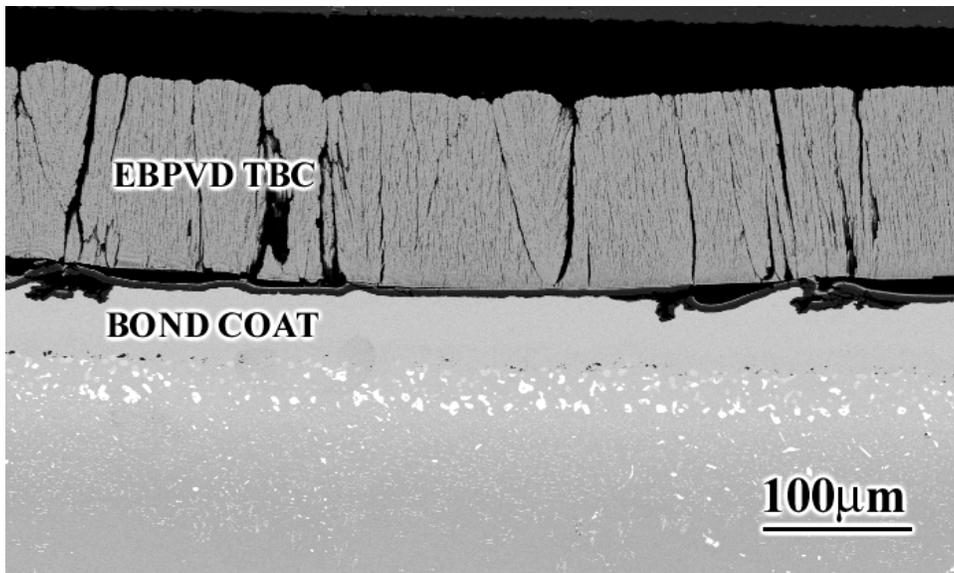
Cross sectional examination of these specimens showed a highly deformed bond coat surface (Figure 93a) except at areas where the bond coat was still in contact with the TBC at the time of failure (Figure 93b) This observation can be explained by the presence of a TBC constraint to deformation of the bond coat. Therefore, once the TBC separated from the TGO as a result of crack initiation at the ridges and their propagation in the TBC, the bond coat beneath it could deform freely without the constraint given by the TBC. In other areas where the TBC was in contact with the bond coat, the interface remained smooth. Similar observations on TBC constraint to the deformation of the bond coats were also reported by Tolpygo and Clarke [74].

Figure 93 Scanning electron micrographs of TBC systems with as aluminized Pt aluminide bond coats after failure showing a highly deformed bond coat surface, (a), except at areas where the bond coat was still in contact with the TBC at the time of failure, (b).

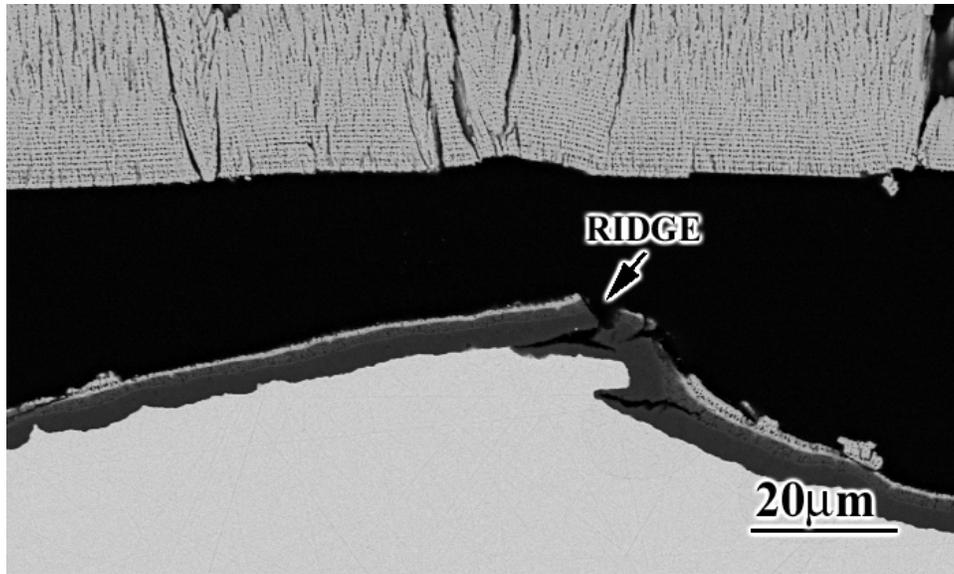
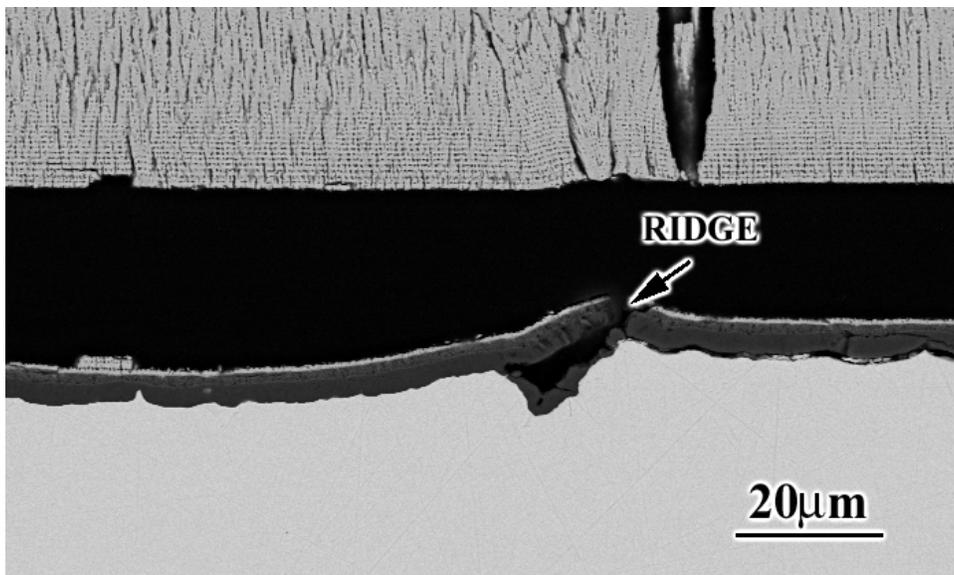
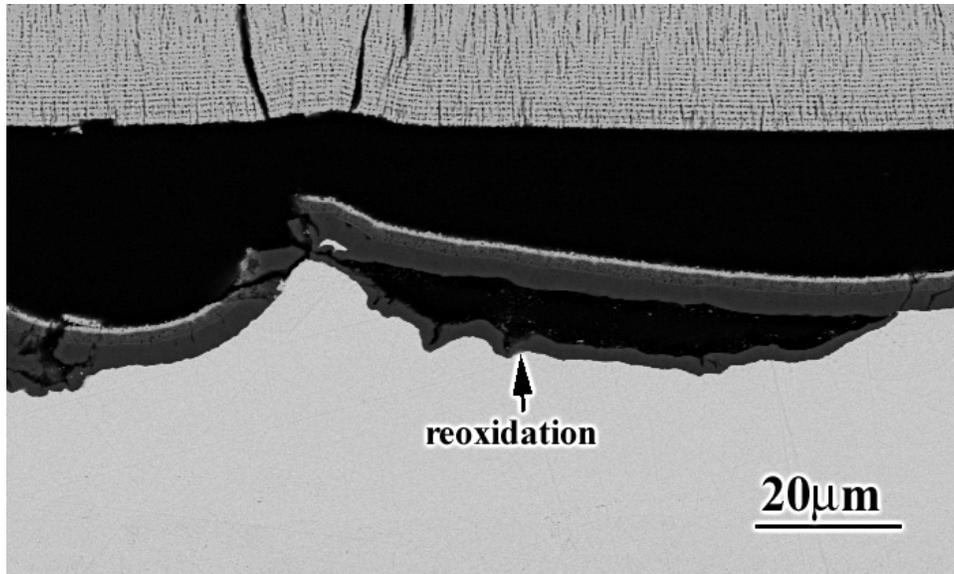
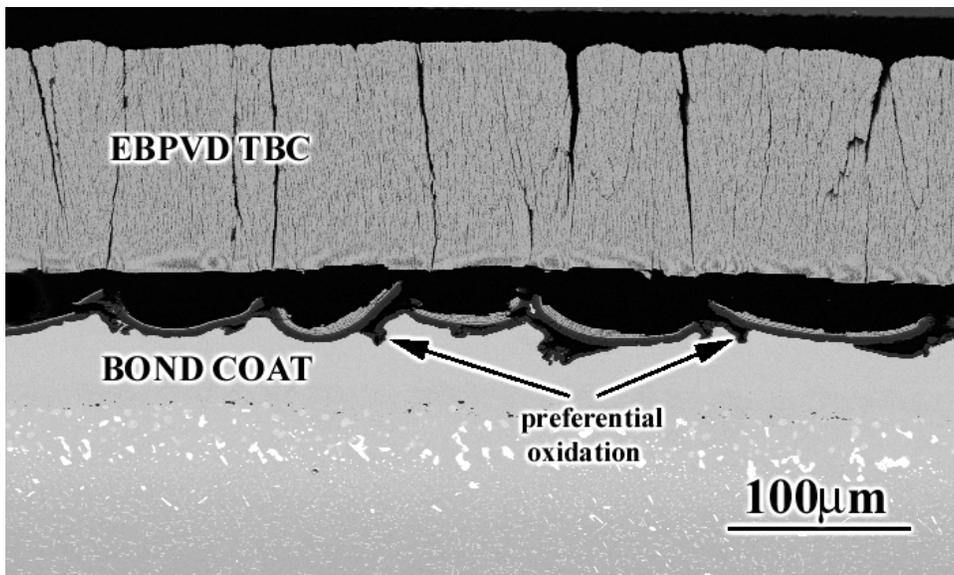
The TGO on top of the ridges also cracked vertically (Figure 94a) and then with continued exposure, the cracks propagated along the TGO/bond coat interface (Figure 94b) followed by reoxidation along this interface (Figure 94c) Preferential oxidation, probably at the grain boundaries, was observed in some areas (Figure 94d).

Figure 94 Scanning electron micrographs of TBC systems with as aluminized Pt aluminide bond coats showing vertical crack formation at the ridges, (a), and their propagation along the TGO/bond coat interface, (b), followed by reoxidation along this interface, (c). Preferential oxidation, usually at the grain boundaries, was observed in some areas, (d).
