THE FAILURE OF THERMAL BARRIER COATINGS AT ELEVATED TEMPERATURES

Submitted to the Graduate Faculty of
the School of Engineering in partial fulfillment
of the requirements for the degree of
Doctor of Philosophy

University of Pittsburgh

2004

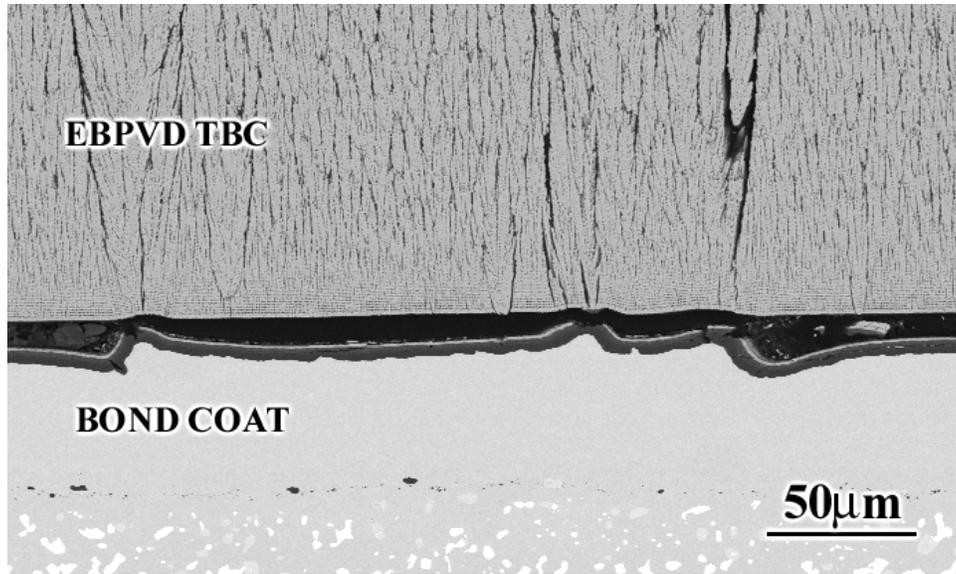
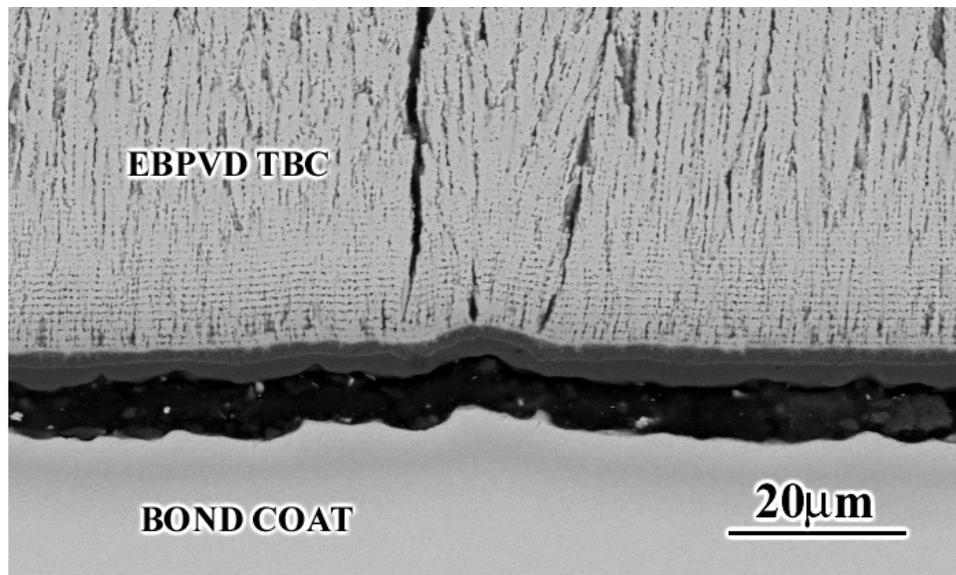
Some of the specimens were also tested under 15 hour cycles. Cracks, that initiated at the grain boundary ridges, were also observed for these specimens (Figure 95a) However, the cracking along the TGO/bond coat interface and then reoxidation was not present in contrast to specimens exposed to 1 hour cycles. Thus, the failure of this specimen under 15 hour cycles, even after shorter hot times, without separation along the TGO/bond coat interface may indicate that the failure of these specimens were mainly due to linking up of the cracks in the TBC.

One other specimen was exposed to an isothermal test at 1100°C for 1125 hours, which is a little bit longer than the time at temperature for the cyclically tested specimens. This specimen did not fail. Examination of the cross section showed that there was not much cracking in the TBC and the separation during metallographic preparation was mainly along the TGO/bond coat interface (Figure 95b). These results also show the importance of thermal cycles on crack formation at the ridges. In the absence of these cracks, the failure is expected to be more along the TGO/bond coat interface as the stored energy in the TGO increases.

Figure 95 Scanning electron micrographs of TBC systems with as aluminized Pt aluminide bond coats after exposure under 15 hr cycles, (a), as well as under isothermal conditions, (b). Separation along the TGO/bond coat interface followed by reoxidation was not observed for these specimens. Cracking at the grain boundary ridges was not evident for the isothermally tested specimen.

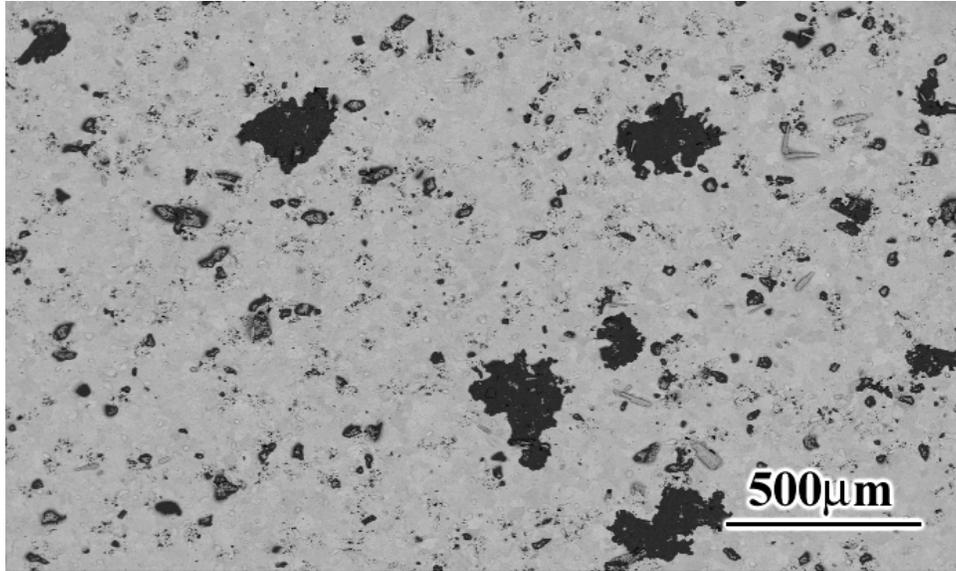
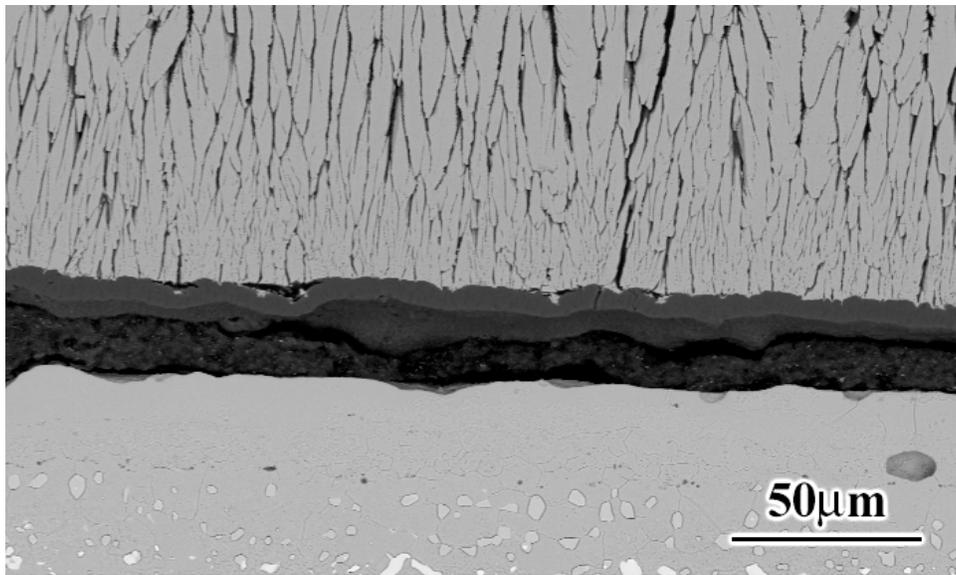
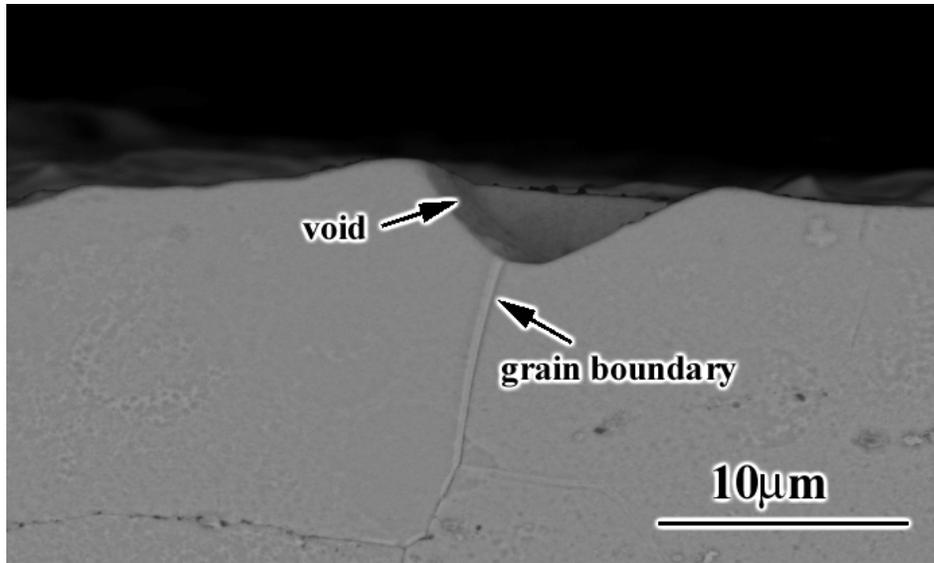
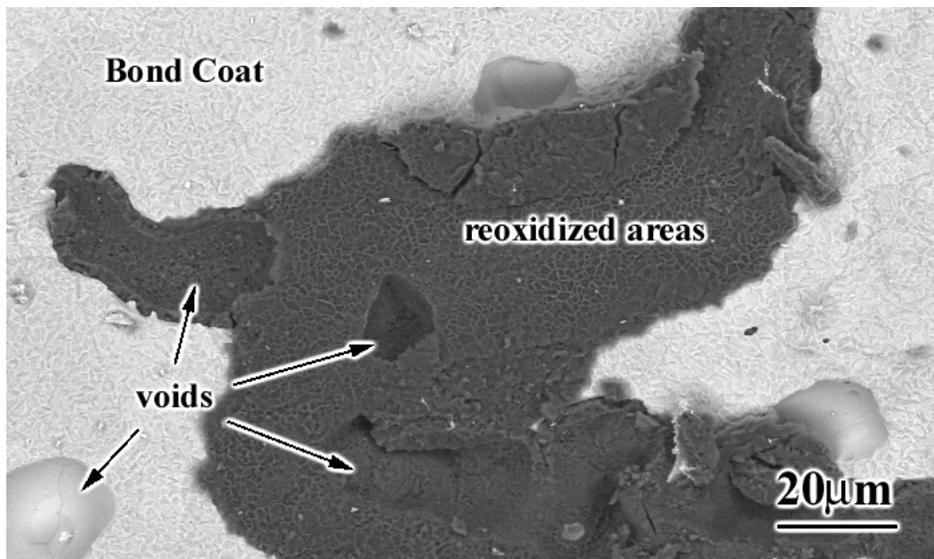
When these specimens failed after relatively long amounts of time compared to the failure of other Pt aluminides, the failure was mainly along the TGO/bond coat interface (Figure 97a). The interface remained relatively smooth with few ratchets (Figure 97b). Examination of the fracture surface as well as the cross section revealed the presence of a large amount of voids, many of which seemed to develop at the grain boundaries (Figure 97c). In some localized areas, the voids as well as the flat bond coat surfaces around them were reoxidized before final failure (Figure 97d). This indicates that some separation along the TGO/bond coat interface prior to failure occurred in the vicinity of these voids. However, it should be mentioned here that the void density changed for specimens with thicker Pt and aluminide layers as mentioned previously. Void formation in bond coats must be due to vacancy condensation at preferred sites such as grain boundaries in the bond coat. It also appears that some voids may also be caused by phase transformations whereby volume changes arise.

Figure 97 Scanning electron micrographs of TBC systems with light grit blasted Pt aluminide bond coats after failure showing that the failure was mainly along the TGO/bond coat interface, (a). The interface remained smooth with very few ratchets, (b), and voids, which were usually at the grain boundaries of the bond coat, were evident (c). There were indications of separations along the TGO/bond coat interface in the vicinity of the voids prior to failure, (d).

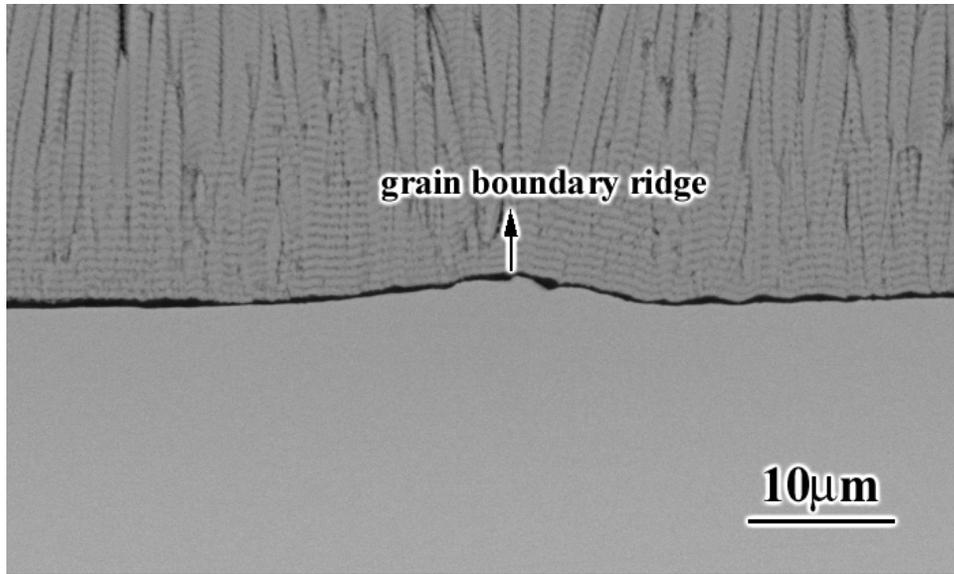
Media Finished Platinum Aluminide Bond Coats: Another conventional surface preparation technique used was media finishing. The media finished specimens were also preoxidized prior to TBC deposition. In the as-processed condition, the interface was smooth, nevertheless, there was some evidence of grain boundary ridges, which could not be removed completely as evident in Figure 98.

Figure 98 Scanning electron micrograph of a TBC system with media finished Pt aluminide bond coat in the as processed condition showing the presence of remnants of grain boundary ridges.

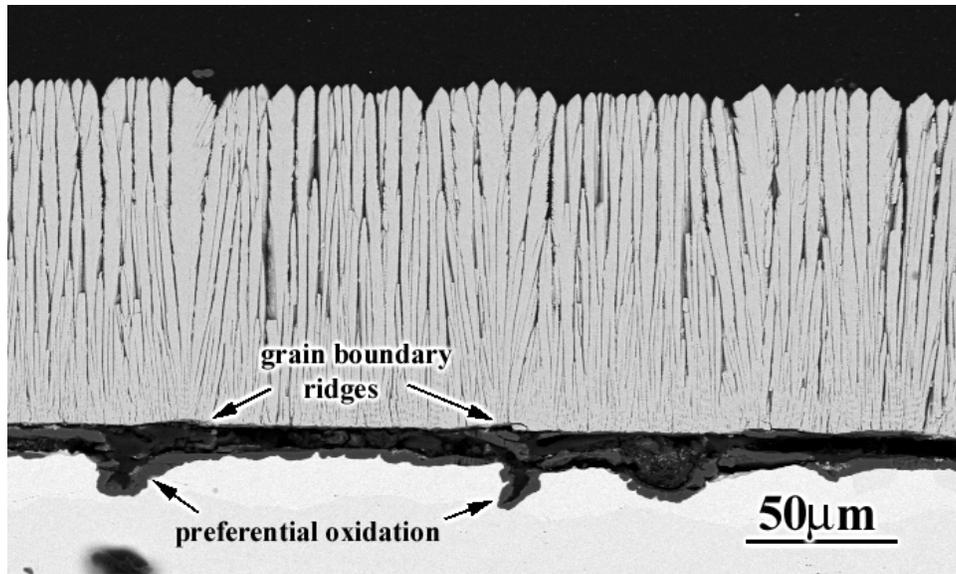
(c)

Figure 99 Scanning electron micrographs of a TBC system with media finished Pt aluminide bond coat after failure. The failure was mainly along the TGO/bond coat interface, (a), and the interface was relatively smooth compared to heavy grit blasted Pt aluminides except at areas of preferential oxidation which were usually observed to be along the grain boundaries, (b) and (c).

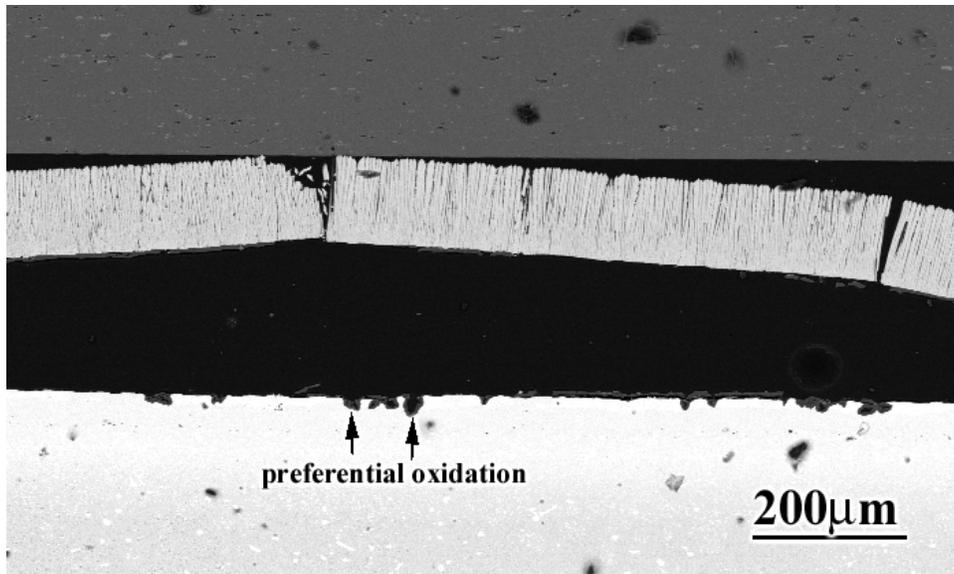
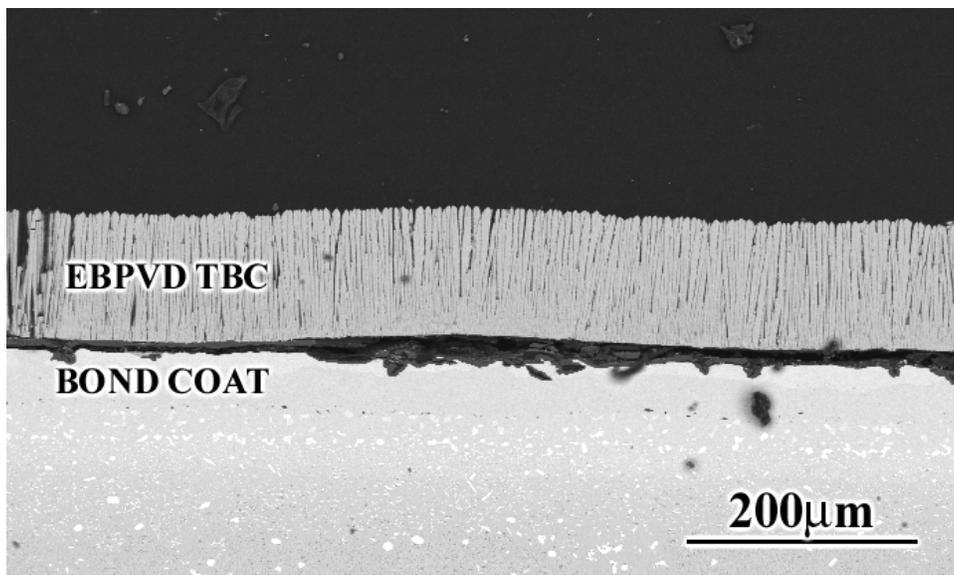
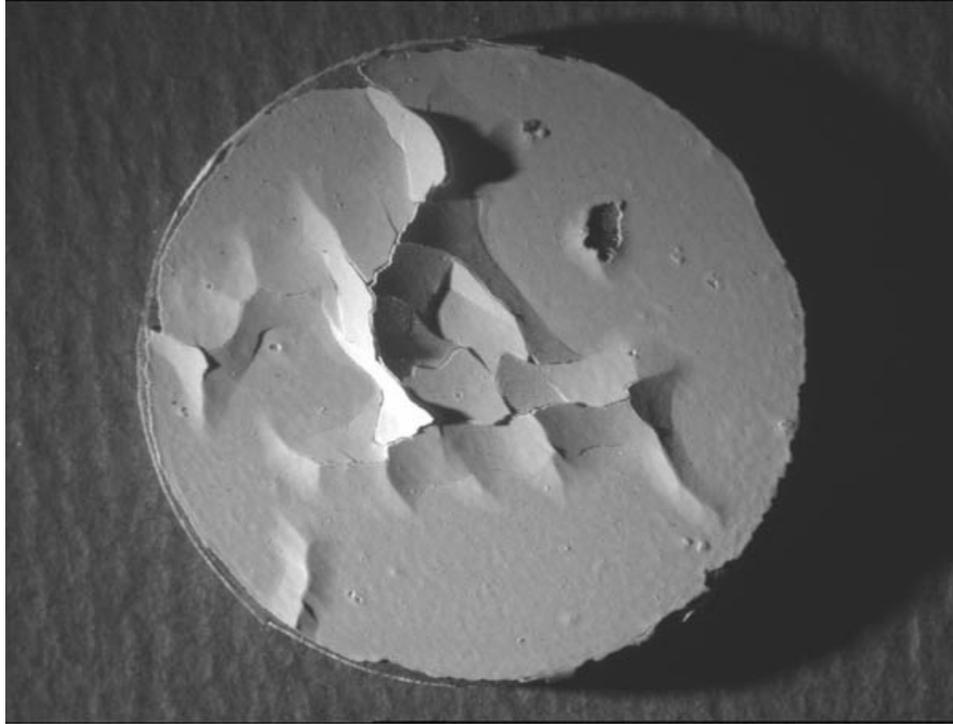
Figure 100 Scanning electron micrographs of a TBC system with media finished Pt aluminide bond coat after failure showing buckles above areas with pronounced amounts of preferential oxidation, (a) and (b). The macrograph of this specimen after failure also indicated failure initiation at localized areas, (c).

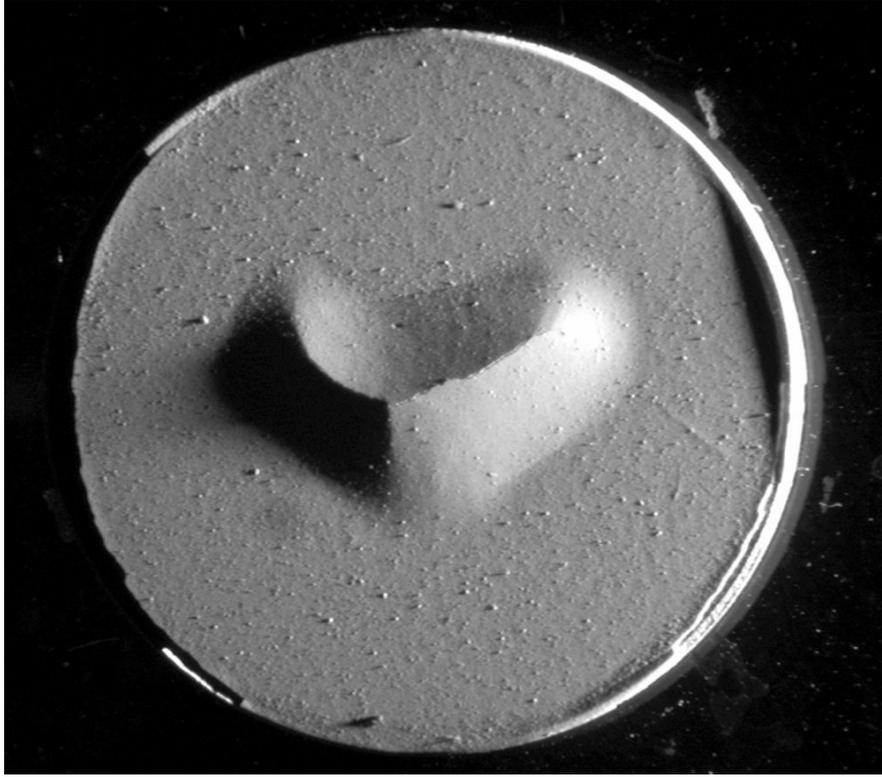
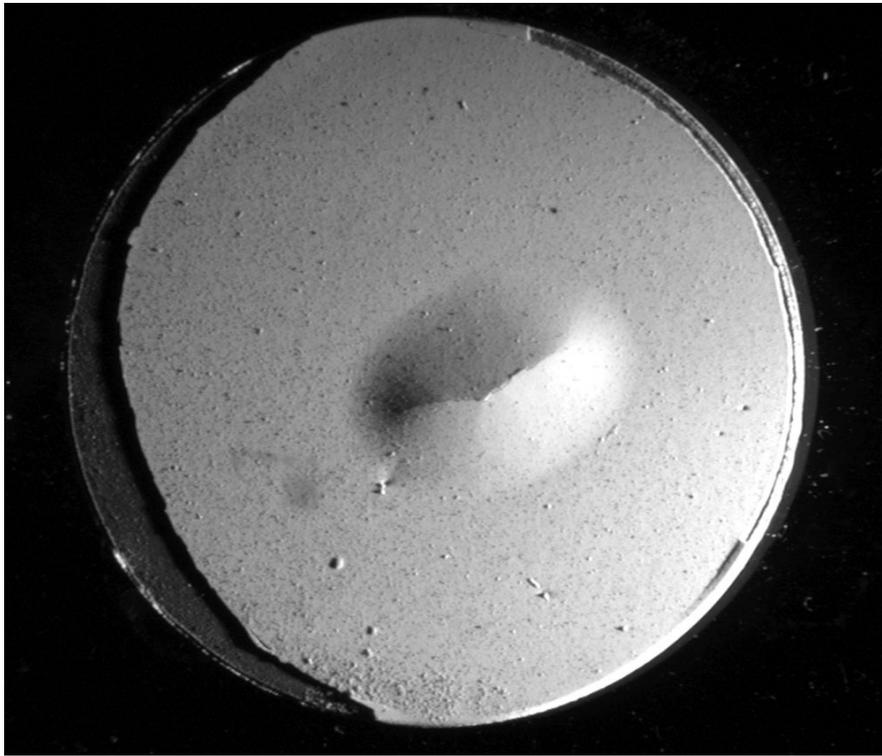
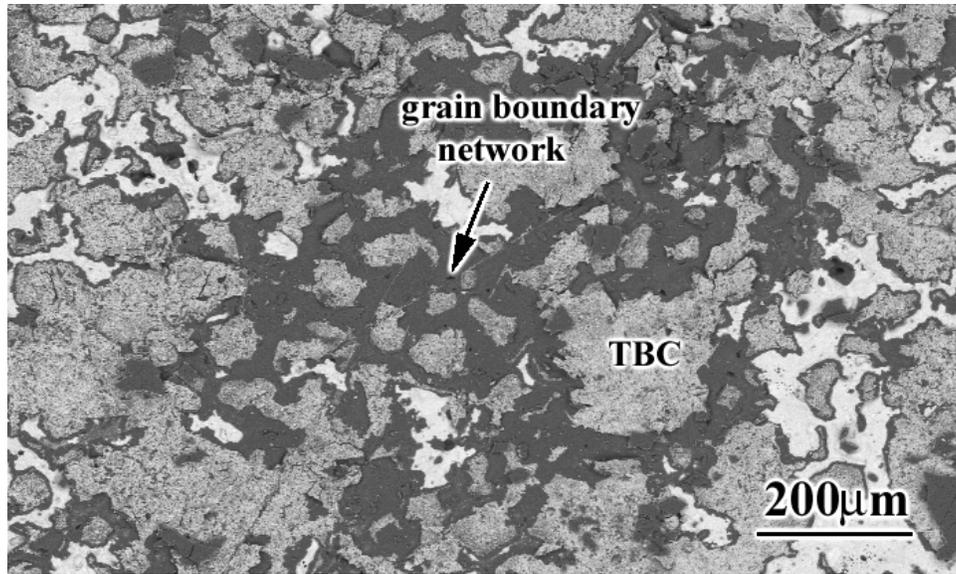
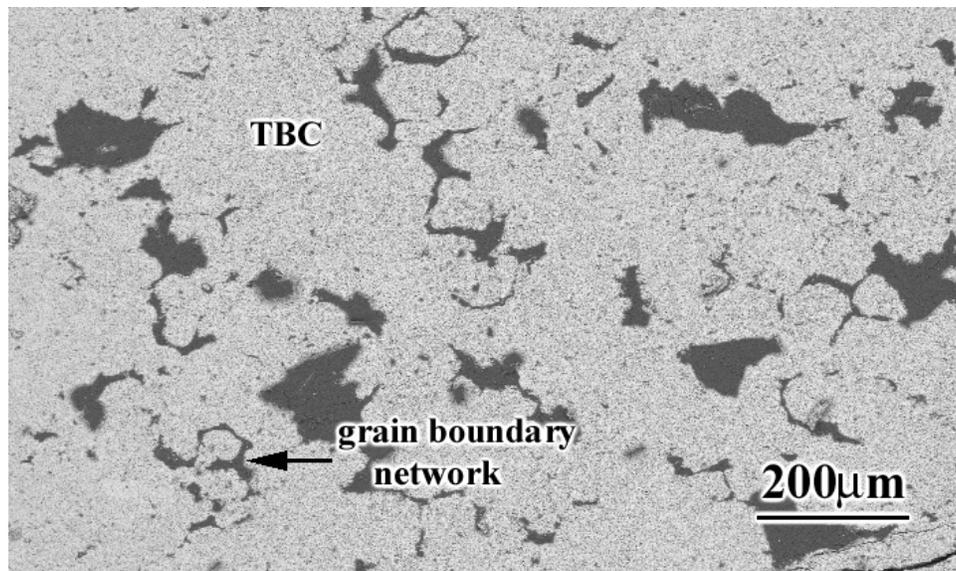
Figure 101 Macrographs of TBC systems with hand polished Pt aluminide bond coats showing buckles formed close to the center of the specimens, (a) and (b). Examination of the fracture surface, (c), as well as underside of the TBC, (d), under these buckles showed a grain boundary network.

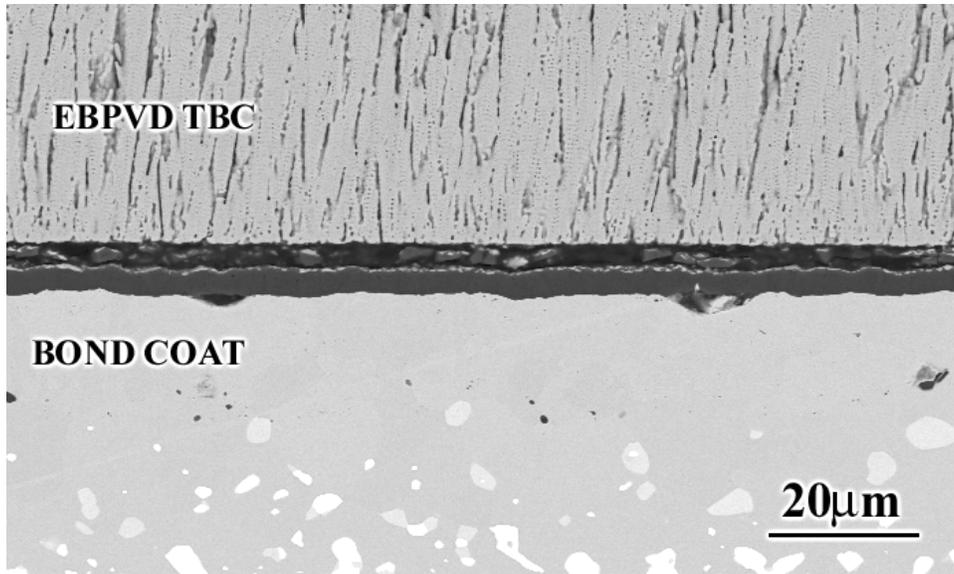
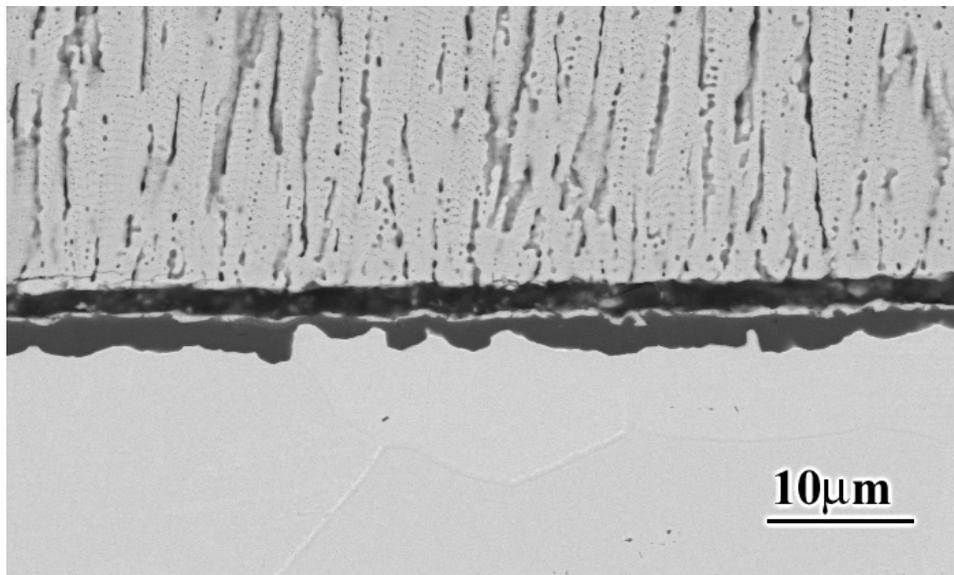
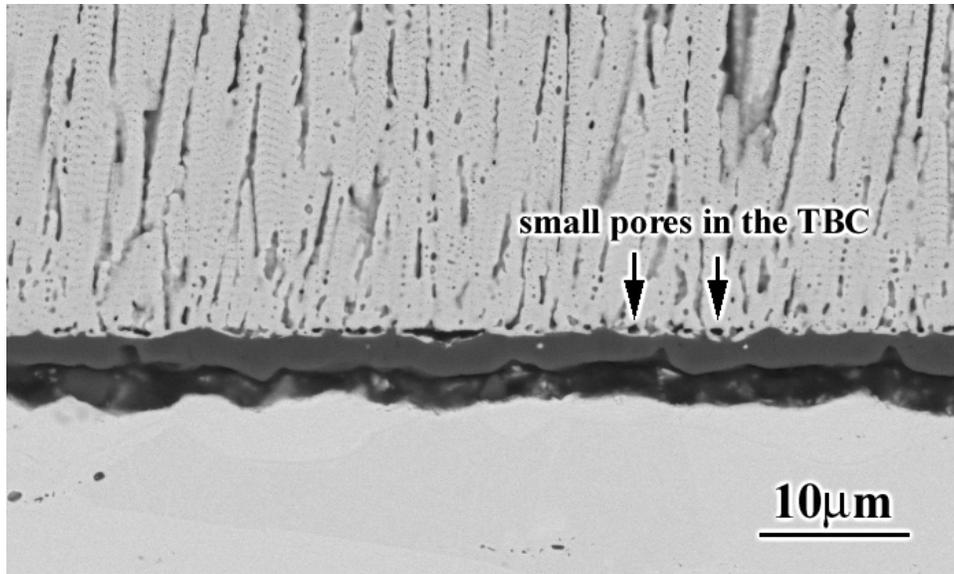
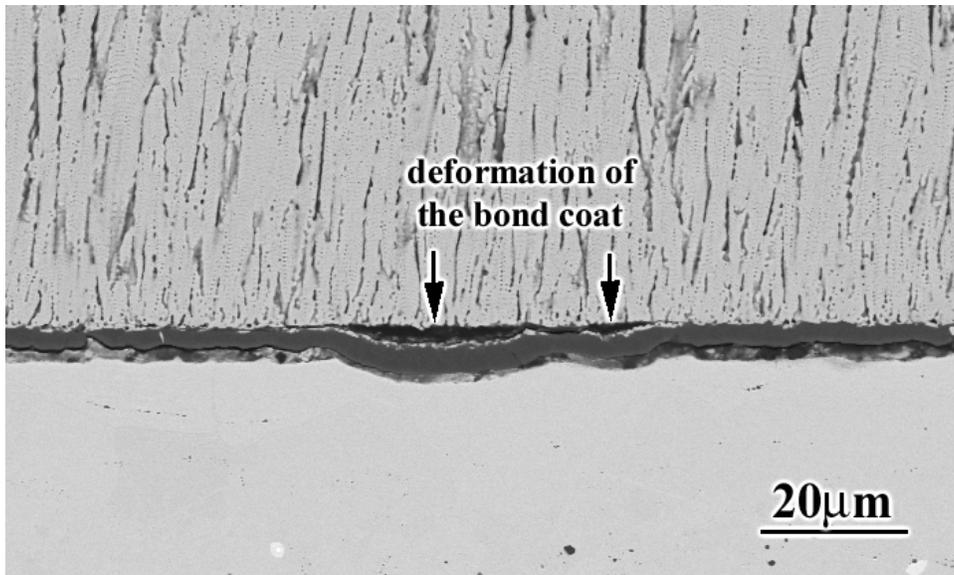
Figure 102 Scanning electron micrographs of TBC systems with hand polished Pt aluminide bond coats after failure. The TGO/TBC interface remained smooth, (a), whereas the TGO/bond coat interface was irregular due to thickness variations in the TGO, (b). Small pore like openings developed in the TBC, (c), which then linked up causing larger separations which were followed by deformation of the bond coat underneath, (d).

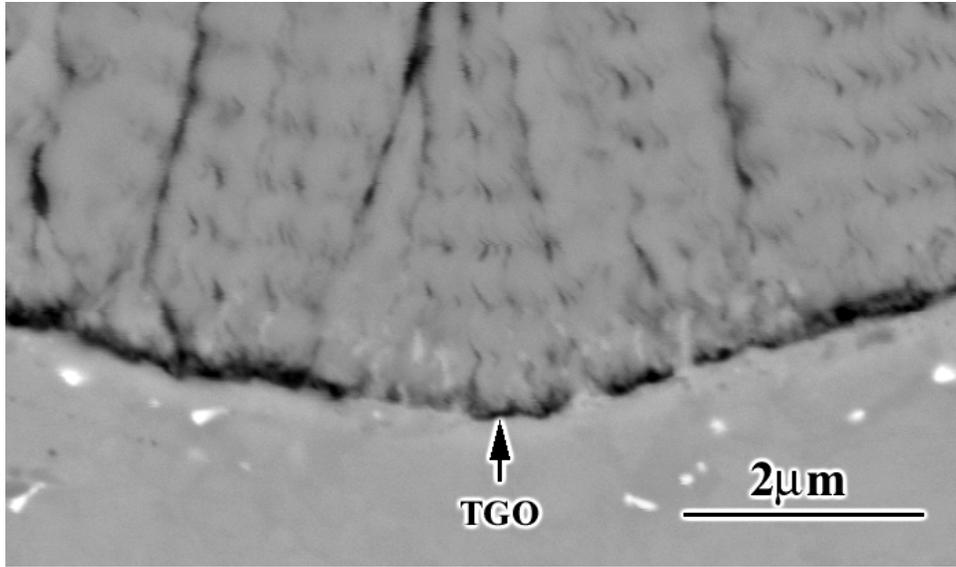
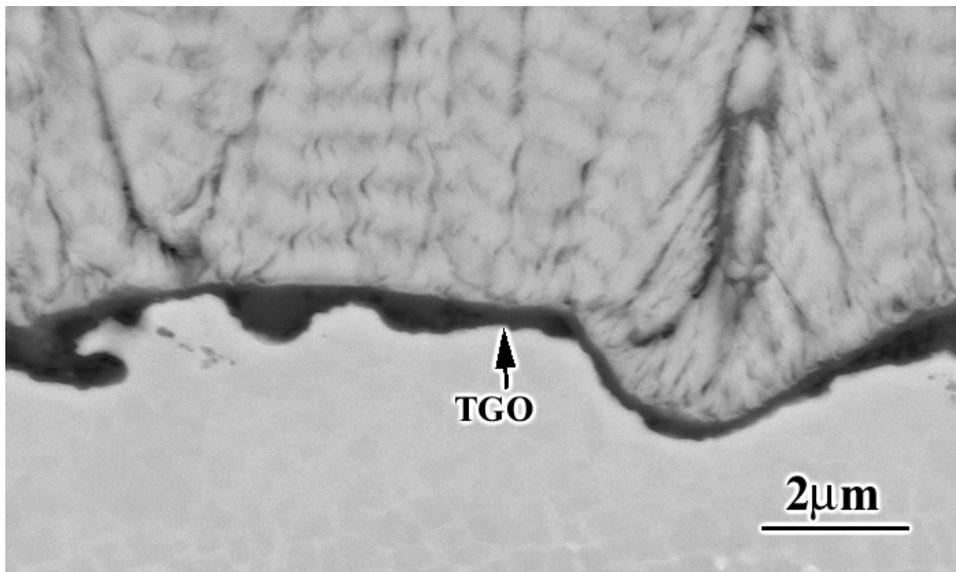
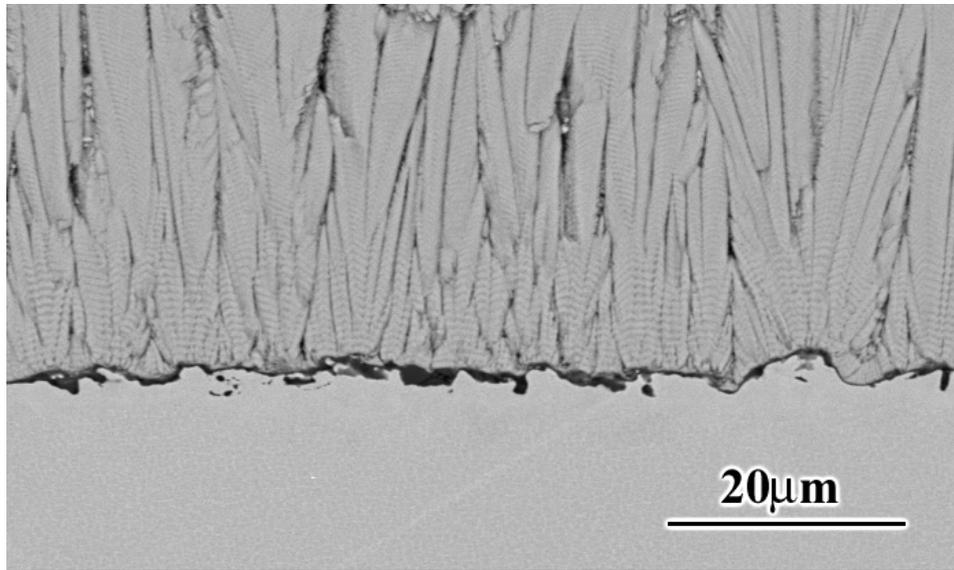
There were two different batches of no bond coat TBCs. The first batch was given a preoxidation heat treatment prior to TBC deposition whereas the second batch was just heavy grit blasted without any preoxidation. The cross sectional examination of these specimens in the as-processed condition showed that the specimens from the first batch did not develop a continuous layer of TGO (Figure 103a) whereas the ones from the second batch did (Figure 103b). Some irregularity of the interface was evident as a result of grit blasting, which also left numerous grit particles embedded at the interface (Figure 103c).

Figure 103 Scanning electron micrographs of no bond coat TBC systems in the as processed condition. The specimens from the first batch did not develop a continuous layer of TGO, (a), whereas the ones from the second batch did, (b). Some irregularity of the interface was evident as a result of grit blasting, (c).

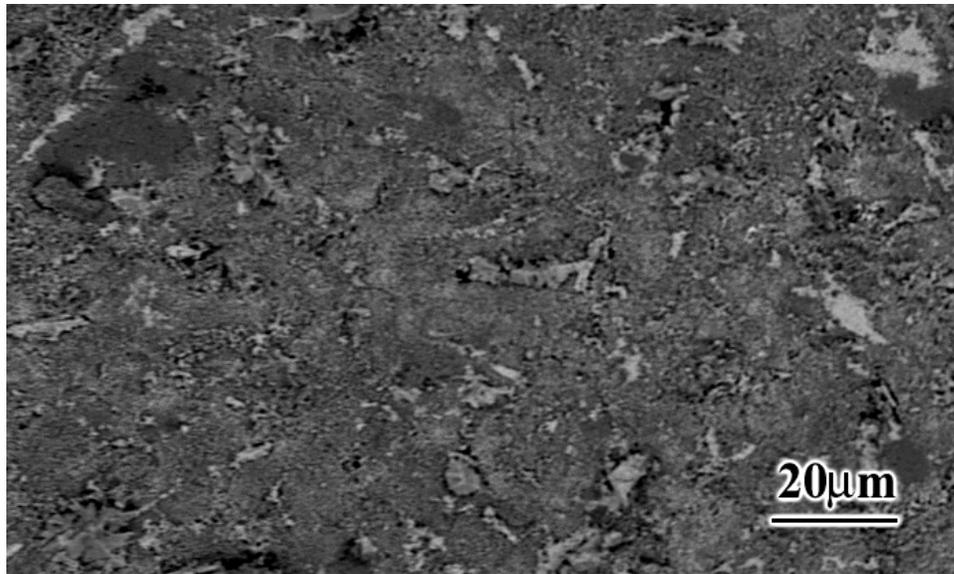
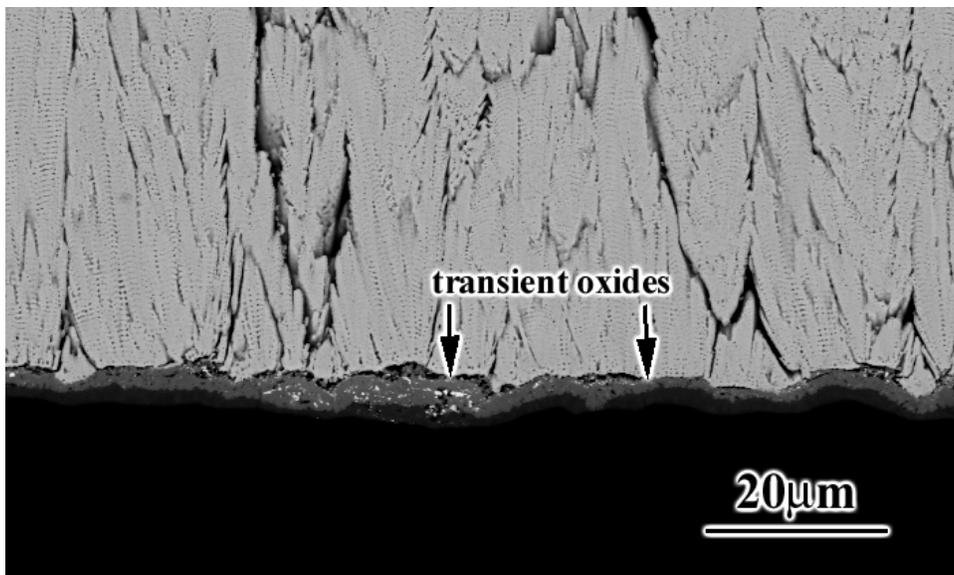
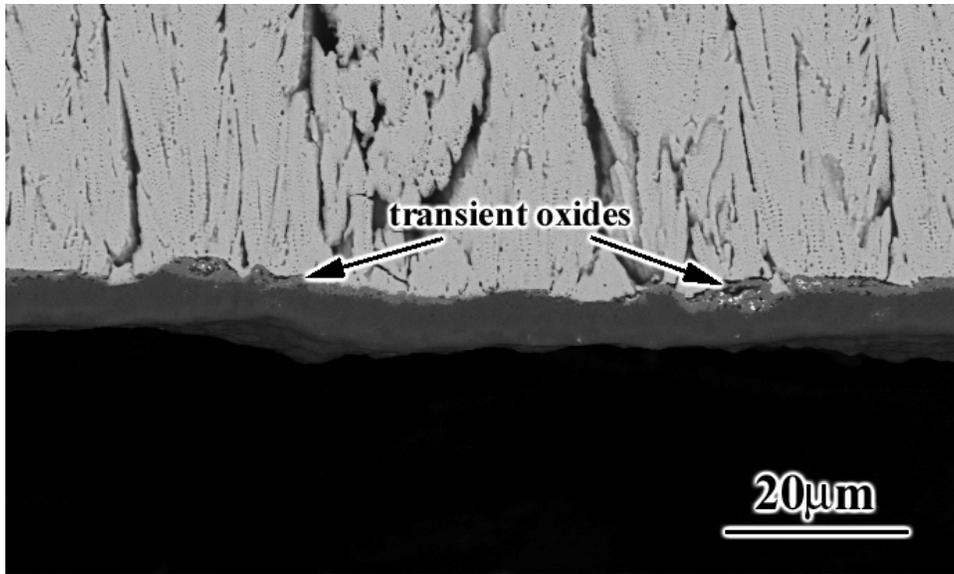
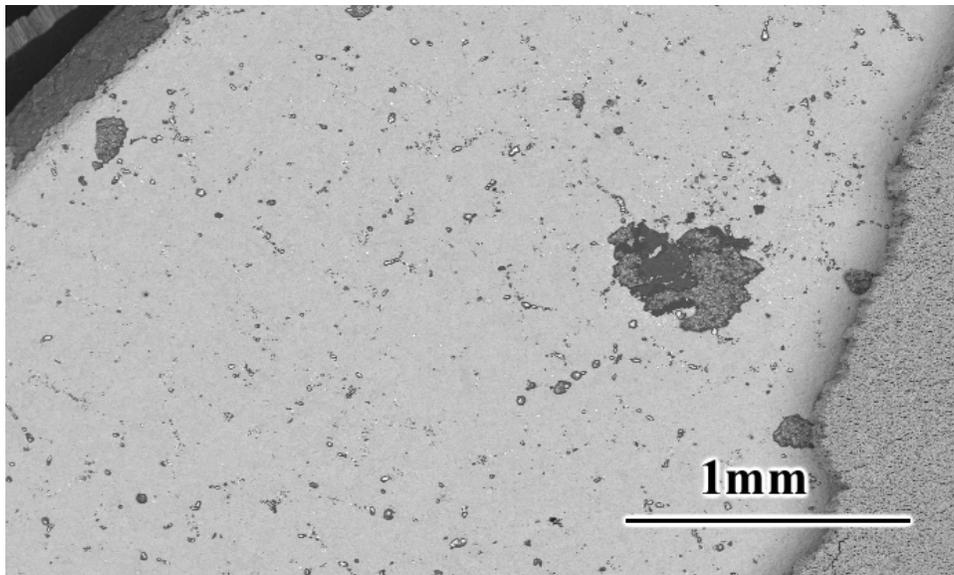
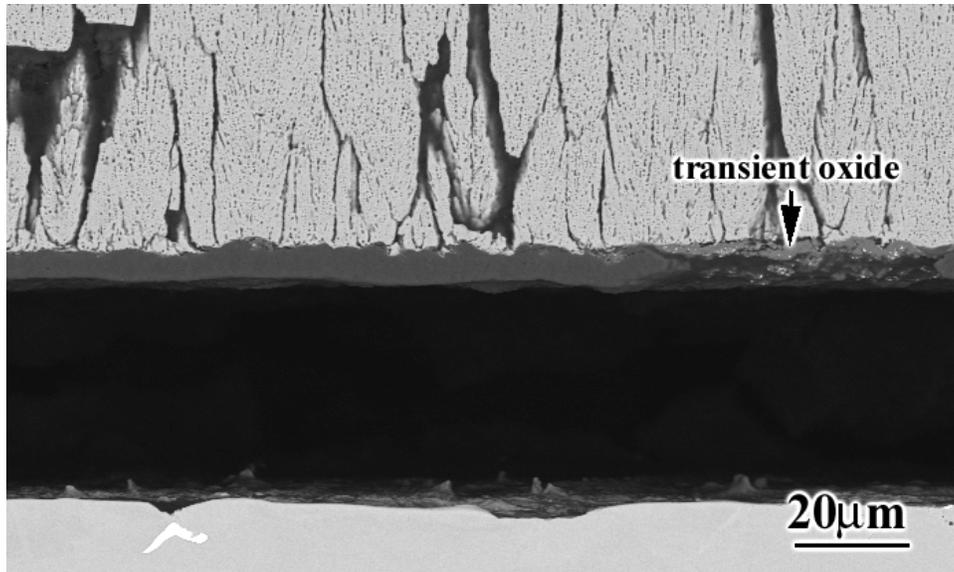
The first batch of specimens had relatively shorter failure times compared to the second batch of specimens. The failure of one of the specimens from the first batch after 140 cycles at 1100°C was entirely along the TGO/TBC interface. Significant amounts of transient oxides were observed at this interface (Figure 104a). Cross sectional examination of this specimen showed that the transient oxides formed as a thick and continuous layer and were poorly bonded to the TBC (Figure 104b). This observation explains the early failure of this specimen all along this interface. There was a good trend showing improvements in lives with decreased amounts of transient oxides. Figure 104c is a cross sectional micrograph from one of the specimens, also from the first batch, showing fewer amounts of transient oxides which did not develop as a continuous layer. This specimen failed after 1280 cycles and the failure was more along the TGO/superalloy interface (Figure 104d). The specimens from the second batch had even longer

lives, the shortest being 1580 cycles. One of these specimens was examined after 1840 cycles before failure and this one had even fewer transient oxides compared to the longest lived specimen from the first batch (Figure 104e). This observation also confirms the improved lives of no bond coat TBC systems with smaller amounts of transient oxides. The other specimens from the second batch had lives longer than 3500 cycles. The test was stopped before they failed.

Figure 104 Scanning electron micrographs from no bond coat TBC systems after 140 cycles, (a) and (b), 1280 cycles, (c) and (d), as well as after 1840 cycles before failure, (e). There was a good trend showing improvement in lives with less transient oxides.

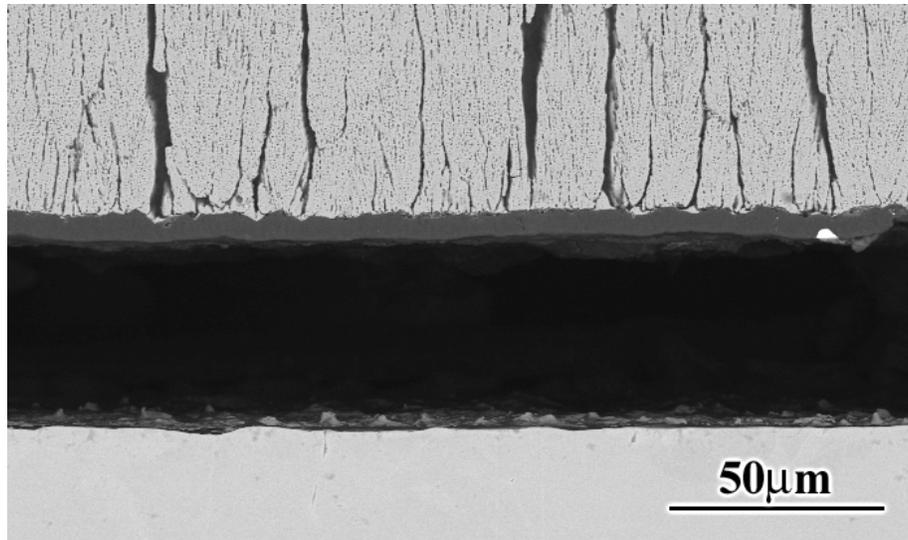
The surfaces remained smooth after long exposure times such as after 1840 cycles as evident in Figure 105. The high strength of the superalloy, which did not let the surface deform, seems to play a crucial role for the significantly long lives of these specimens. However, our results also showed that premature failures could occur if significant amounts of transient oxides were present. Therefore, it is very important to determine the optimized processing conditions that result in the formation of as few transient oxides as possible for the expected durability and the reliability of these systems.

Figure 105 Scanning electron micrograph from a no bond coat TBC system after 1840 cycles of exposure before failure showing the presence of a very smooth interface.

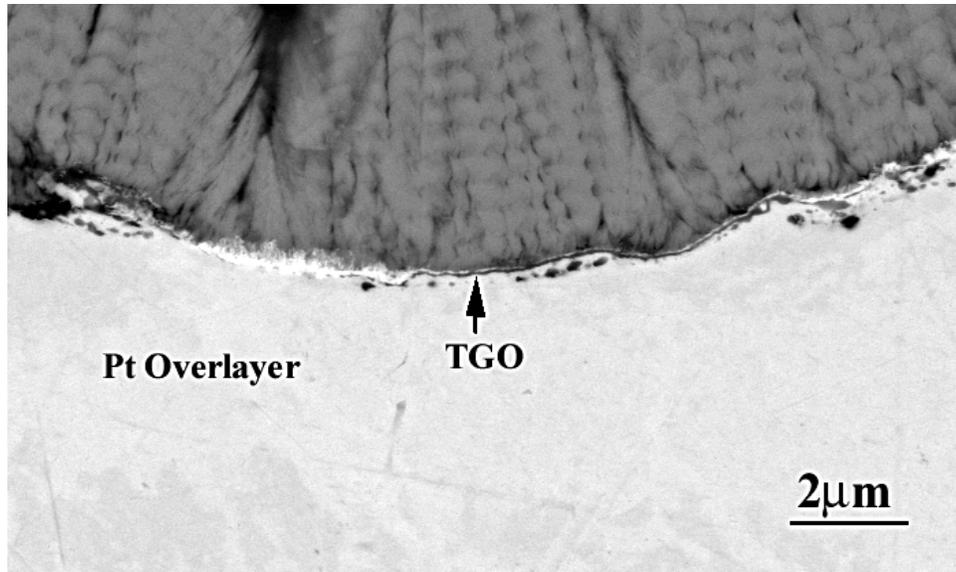
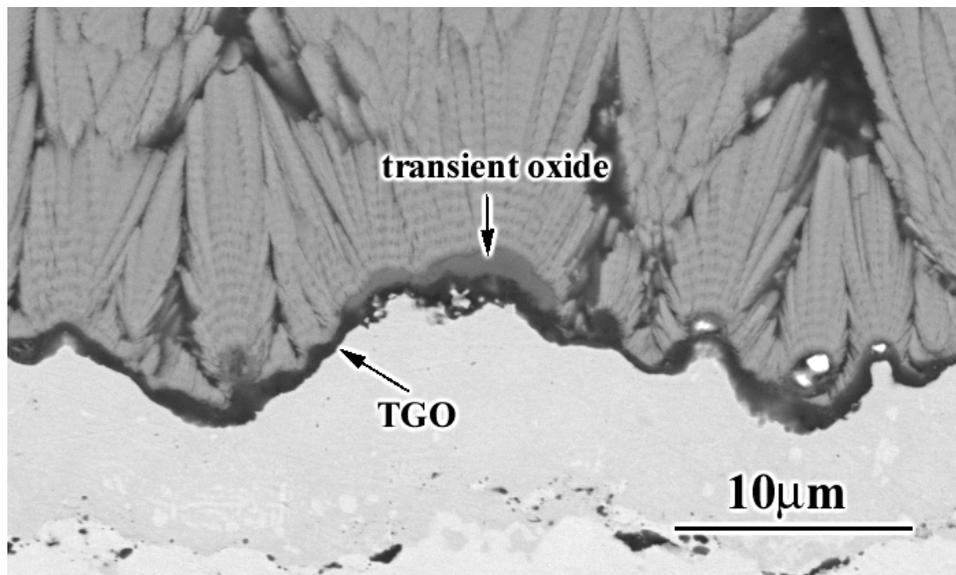
Some of the superalloys were electroplated with Pt prior to TBC deposition. There were also two different batches of these systems. The cross sectional examination of the as-processed specimens from the first batch showed the presence of a non-continuous TGO (Figure 106a) as in the case of the first batch of no bond coat TBCs. On the other hand, the specimens from the second batch had a continuous layer of TGO as evident in Figure 106b. The interfaces were irregular, probably due to electroplating of Pt as mentioned earlier.

Figure 106 Scanning electron micrographs of no bond coat TBC systems with Pt overlayers in the as processed condition. The specimens from the first batch did not develop a continuous layer of TGO, (a), whereas the ones from the second batch did, (b).

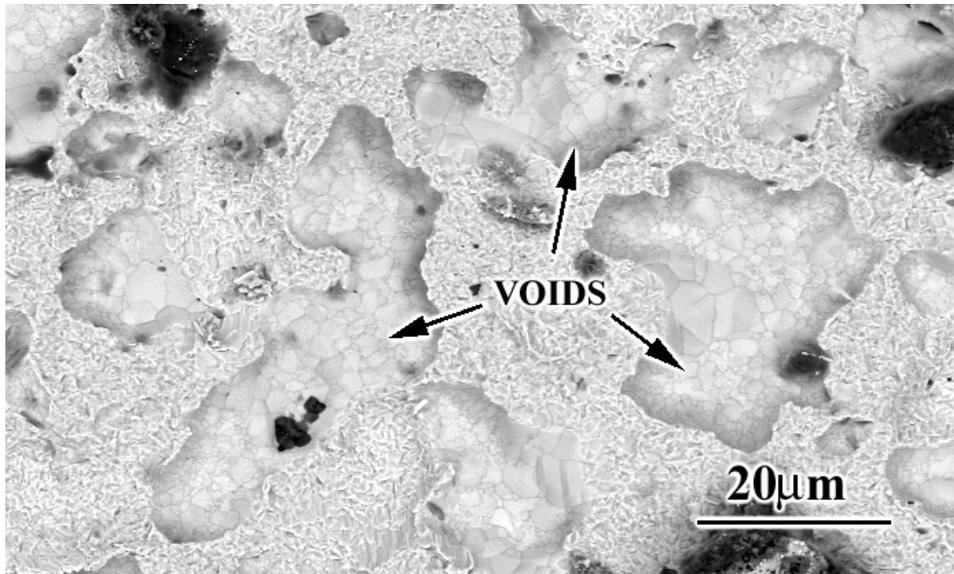
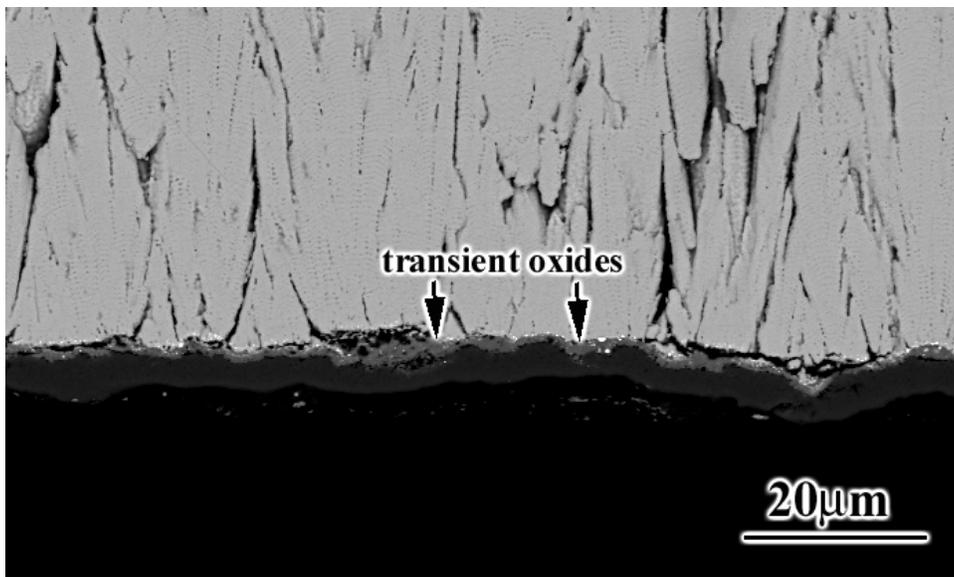
The first batch of specimens had relatively shorter lives compared to the very long lives of the second batch of specimens (Table 6) Figure 107a is from the fracture surface of a specimen from the first batch, showing significant amounts of voids. Transient oxides in addition to voids were also present (Figure 107b). The significant amounts of voids seem to be responsible for the relatively early failure of these specimens, mainly along the TGO/Pt overlayer interface

Figure 107 Scanning electron micrographs of no bond coat TBCs with Pt overlayers from the first batch showing the presence of voids, (a), and transient oxides, (b), after failure.

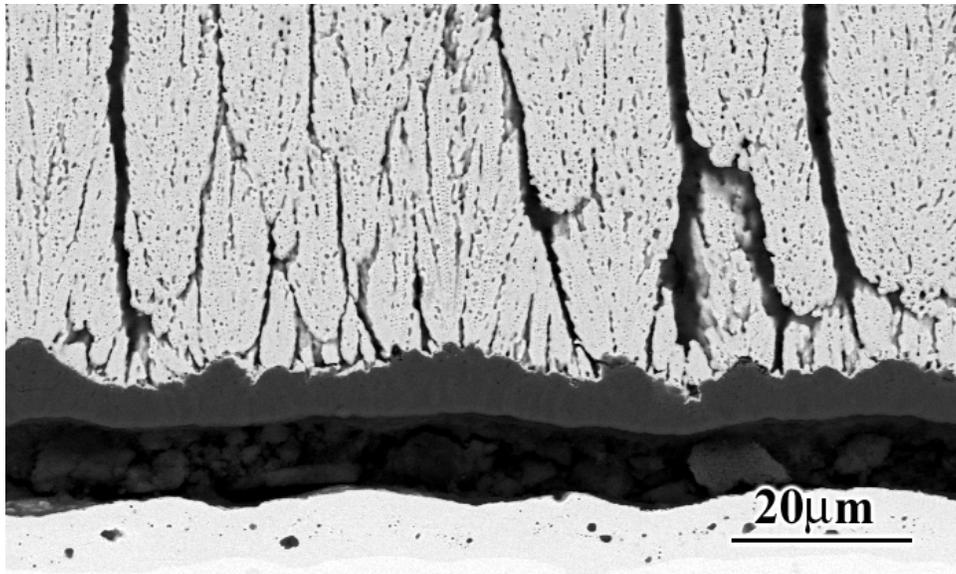
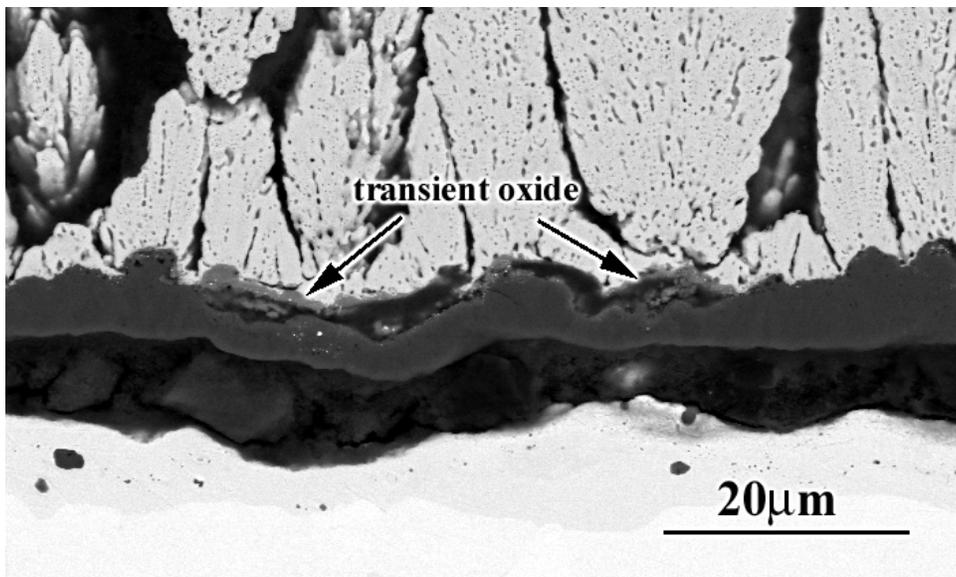
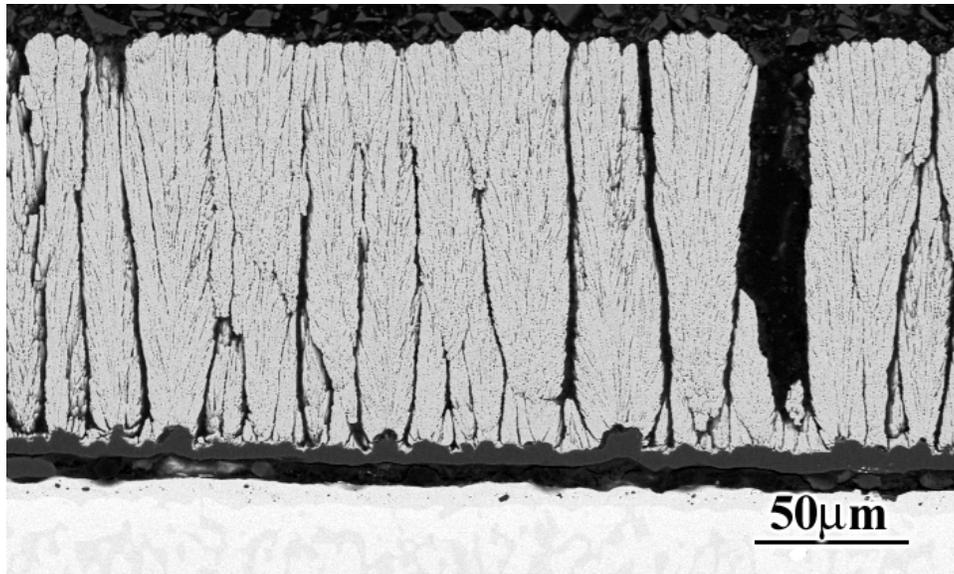
compared to the second batch. None of the specimens from the second batch failed up to date. However, examination of one specimen after 2300 cycles of exposure before failure indicated the presence of a rather pure TGO (Figure 108a) with intermittent areas of transient oxides (Figure 108b) Separation along the TGO/Pt overlayer interface occurred during metallographic preparation, however, the TGO/TBC interface looked quiet adherent, except at localized areas of transient oxides, despite the presence of numerous vertical separations (Figure 108c).

Figure 108 Scanning electron micrographs of second batch of no bond coat TBCs with Pt overlayers after 2300 cycles of exposure before failure. The TGO was rather pure, (a), with intermittent areas of transient oxides, (b). Numerous vertical separations were present in the TBC, (c).
