THE FAILURE OF THERMAL BARRIER COATINGS AT ELEVATED TEMPERATURES

Submitted to the Graduate Faculty of
the School of Engineering in partial fulfillment
of the requirements for the degree of
Doctor of Philosophy

University of Pittsburgh

2004

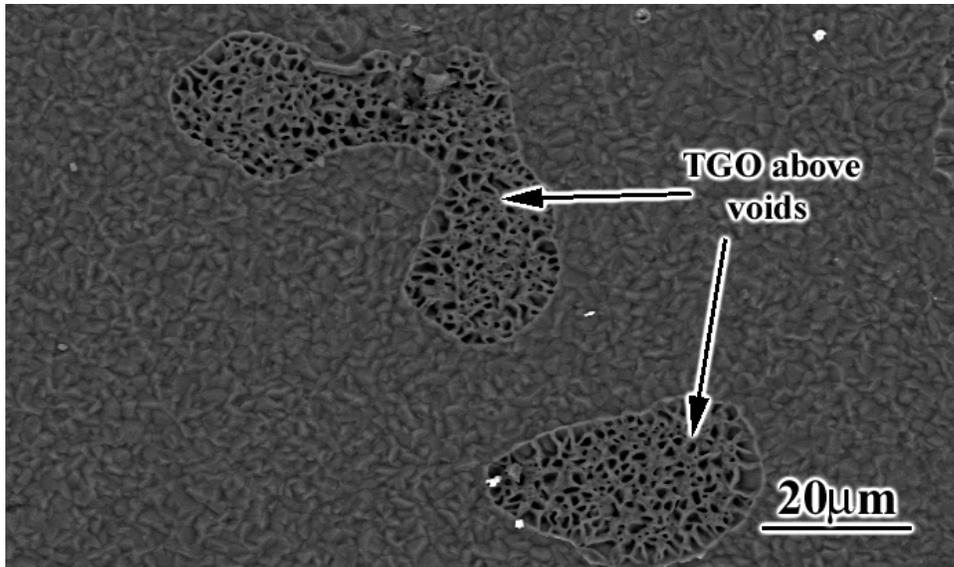
The morphology of the TGO underside of the spalled TBC is different depending on whether it was in contact with the bond coat during exposure or not as evident from Figure 109. The ridge like TGO morphology observed above a void seems to develop by the reaction of incoming oxygen through the TGO with Al available from the vapor phase or surface diffusion above the void.

Figure 109 Scanning electron micrograph from the underside of a spalled TBC showing the ridge like morphology of the alumina that developed above voids.

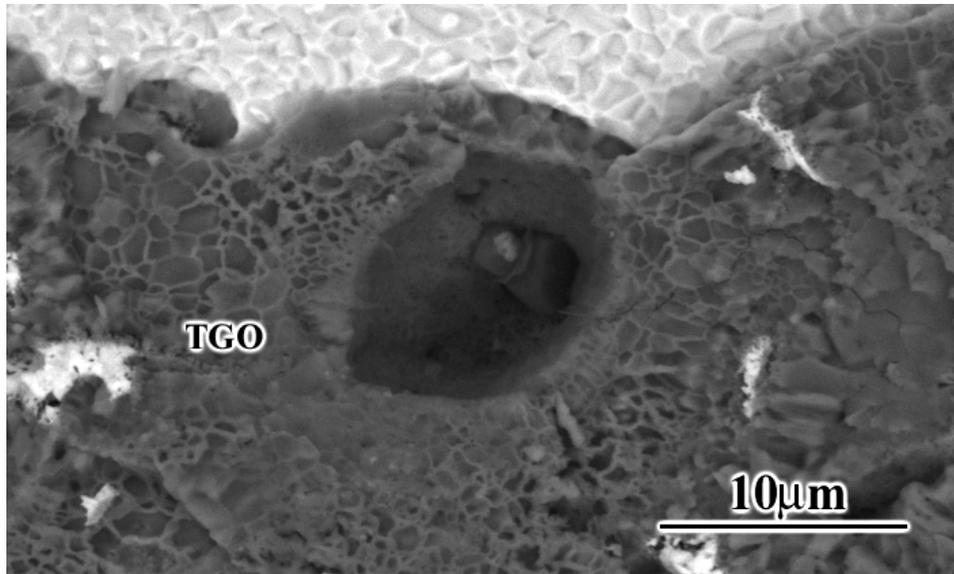
It is also possible to determine if the TGO had spalled and reformed before the final failure by examining the morphology of the TGO on the fracture surface. If it has a ridge like morphology, it was not in contact with the TBC at the time of failure (Figure 110). These observations may give important clues on where the separations occurred before final failure. However, it is also important to know the history of the specimen, since similar morphologies may develop if the TBC spalls in the furnace and the exposed bond coat reoxidizes.

Figure 110 Scanning electron micrograph from the fracture surface of a specimen showing a ridge like alumina morphology which indicates that the TGO was not in contact with the TBC at the time of failure.

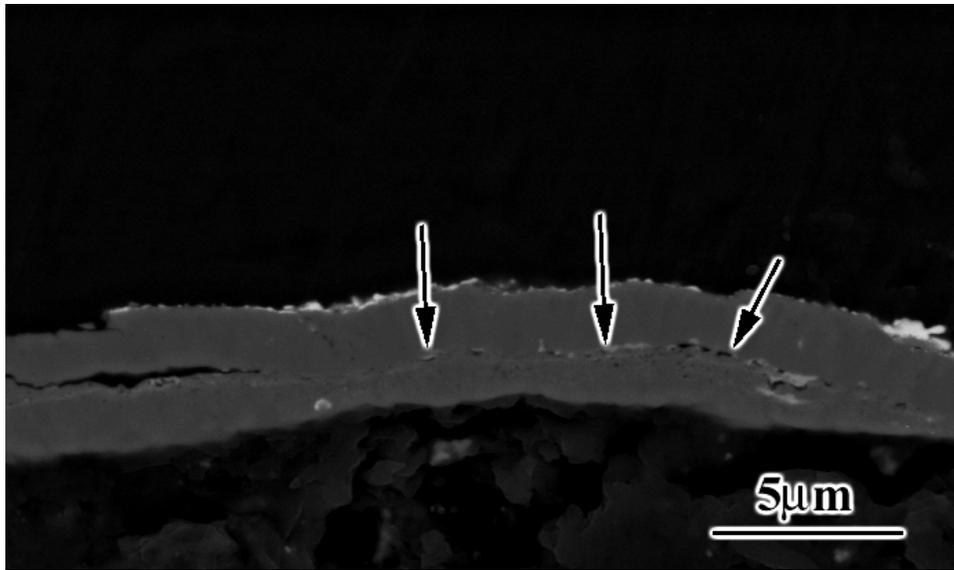
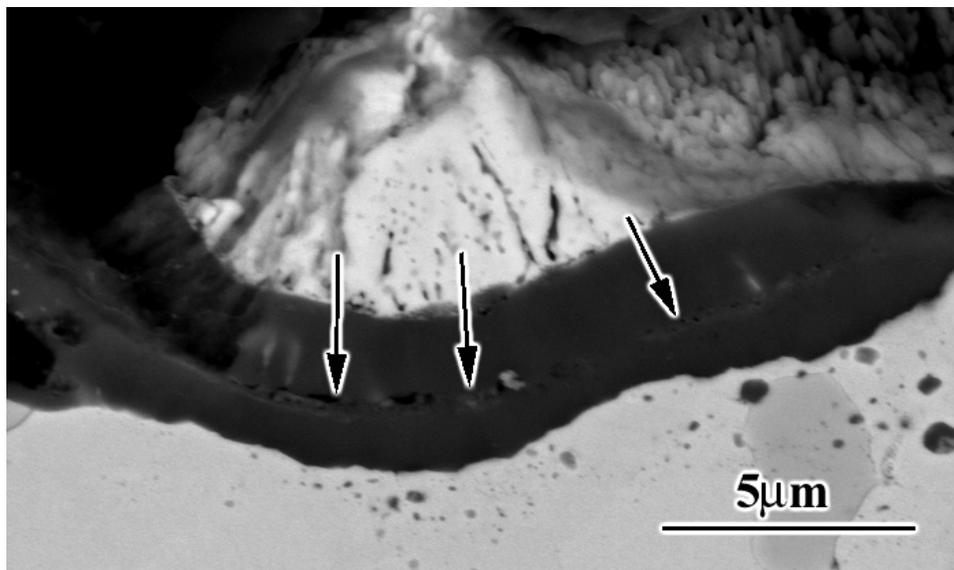
For some of the specimens there was evidence of sintering between the spalled and the reformed alumina. (Figure 111a and 111b).

Figure 111 Scanning electron micrographs showing examples to sintering between the spalled and the reformed alumina. The arrows point to the interfaces where sintering occurred.

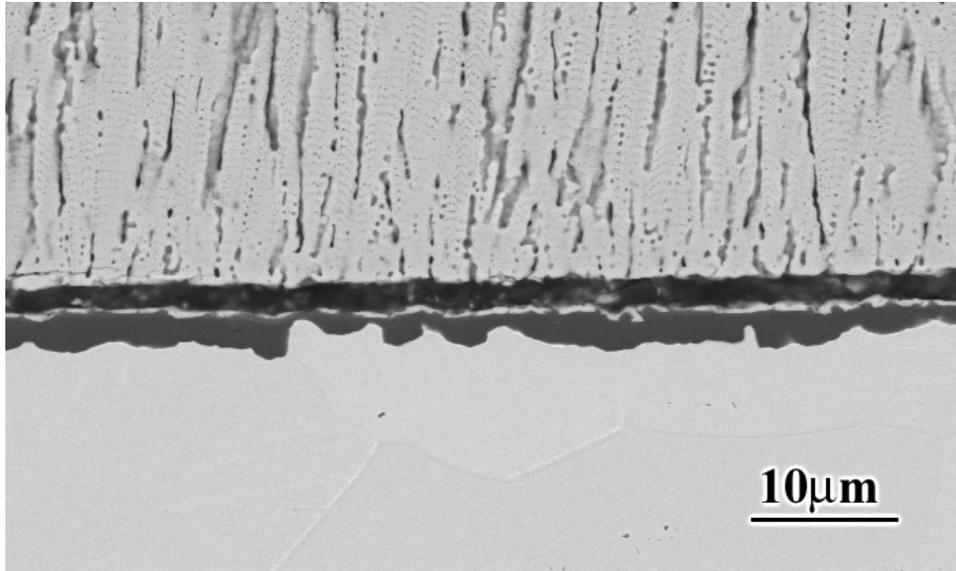
The TGO developed on some of the specimens was observed to be non-uniform in thickness (Figure112). The origin of these thickness variations is not clear. However, one possible explanation may be the more rapid transport of oxygen through the grain boundaries of the TGO resulting in the formation of thicker oxides at these sites. These thickness variations in the TGO became less apparent as the TGO grew, probably due to conversion of small bond coat protrusions into oxides .

Figure 112 Scanning electron micrograph showing an example to thickness variations in the TGO.

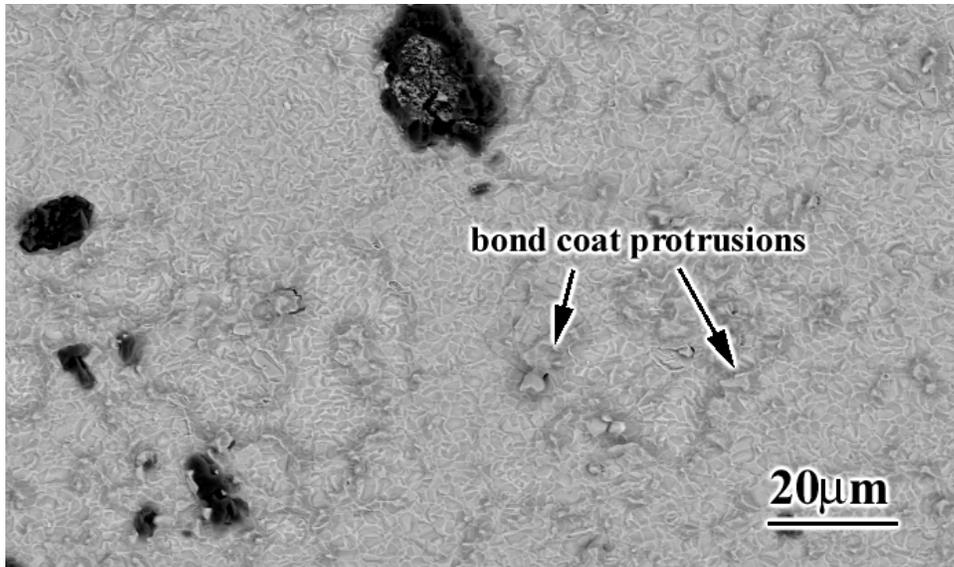
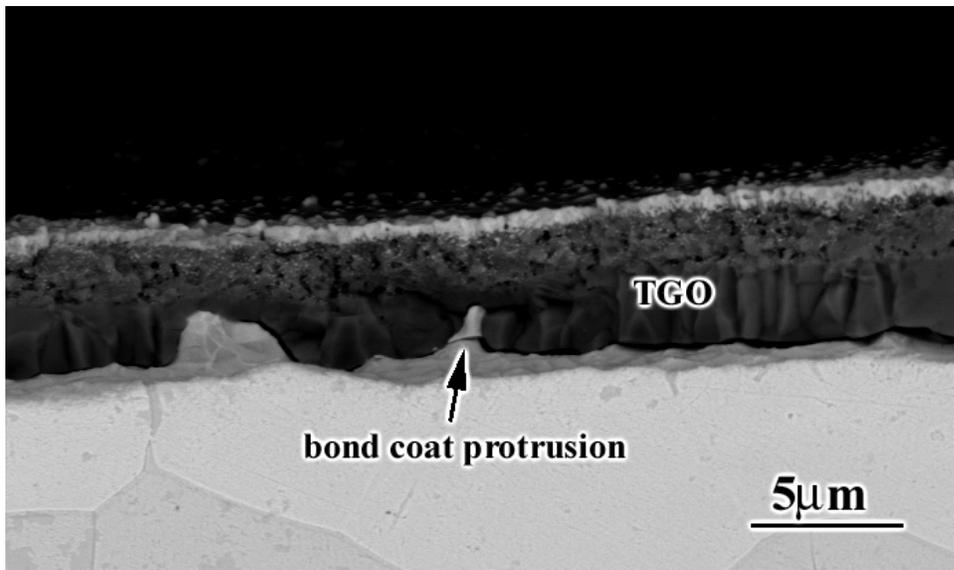
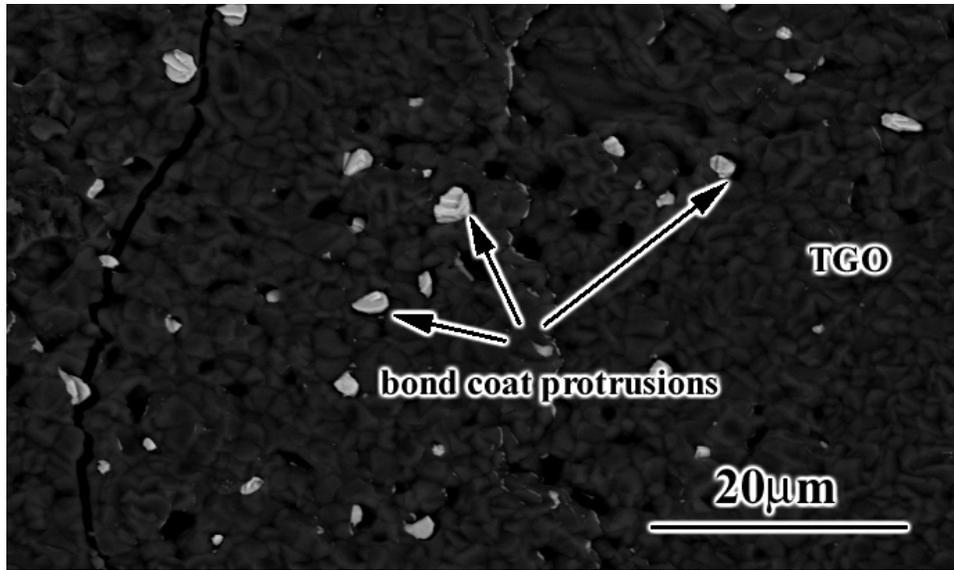
When the specimens with thickness variations in the TGO failed along the TGO/bond coat interface, the fracture surface consisted of small protrusions of bond coat (Figure 113a). Cross sectional examination as well as examination of the underside of the spalled TBC showed that the failure could sometimes cut through these protrusions of bond coats leaving them isolated in the TGO (Figures 113b and 113c, respectively).

Figure 113 Scanning electron micrographs from the fracture surface, (a), cross section, (b) and underside of the spalled TBC of a specimen which developed bond coat protrusions. The failure sometimes cut through these bond coat protrusions leaving them isolated in the TGO as can be seen in (b) and (c).

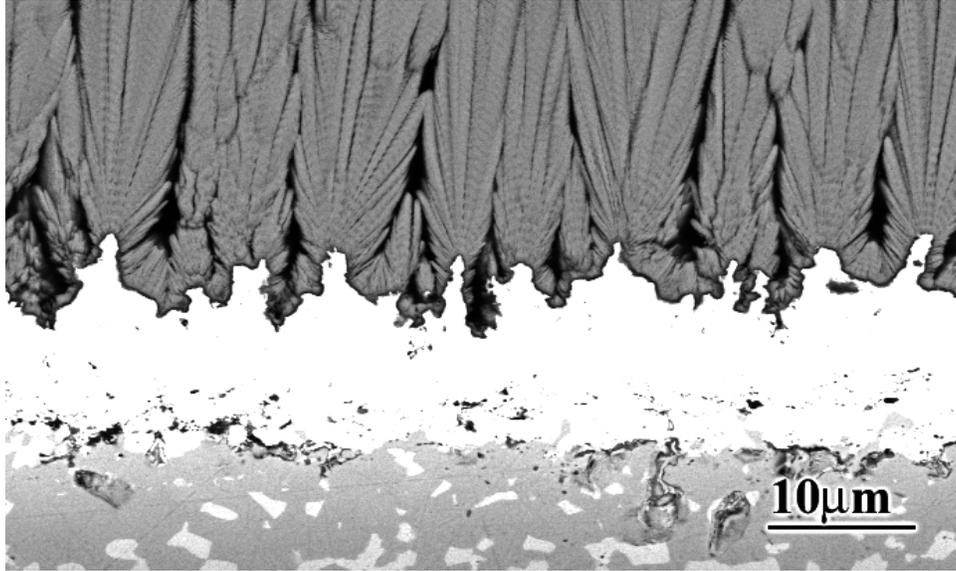
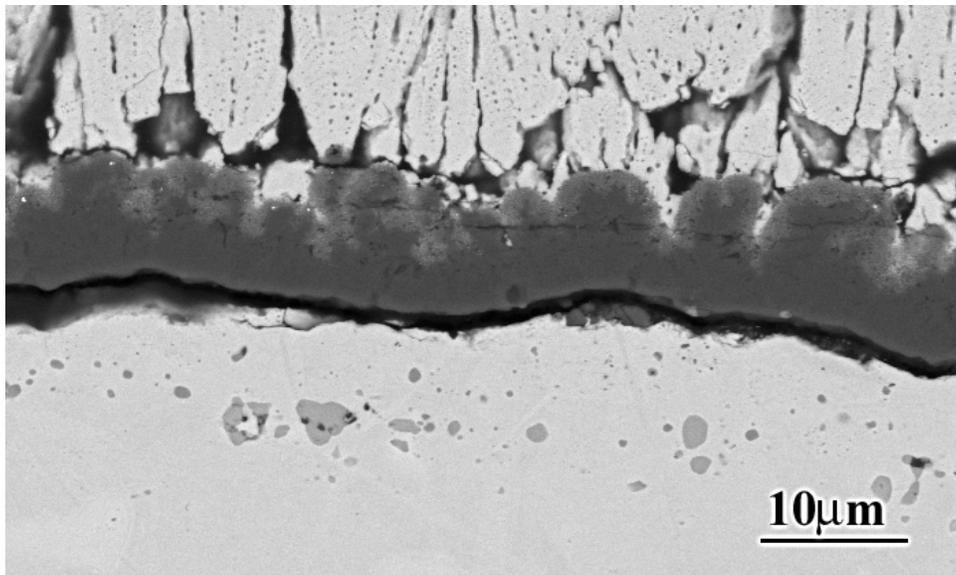
Thickness variations in the TGO can sometimes be a consequence of an initially highly irregular interface such as is evident in Figure 114a. The protrusions of bond coat into the TBC, due to the irregularity of the interface, are converted into oxide quickly as a result of increased surface/volume ratio. This results in thickness variations in the TGO. The TGO/bond coat interface gradually becomes smoother as a result of this process whereas the TGO/TBC interface tries to retain the initial surface roughness (Figure 114b).

Figure 114 Scanning electron micrographs from a specimen which had a highly irregular interface in the as processed condition, (a). Upon exposure, thickness variations in the TGO developed as a result of the initially irregular interface, (b).

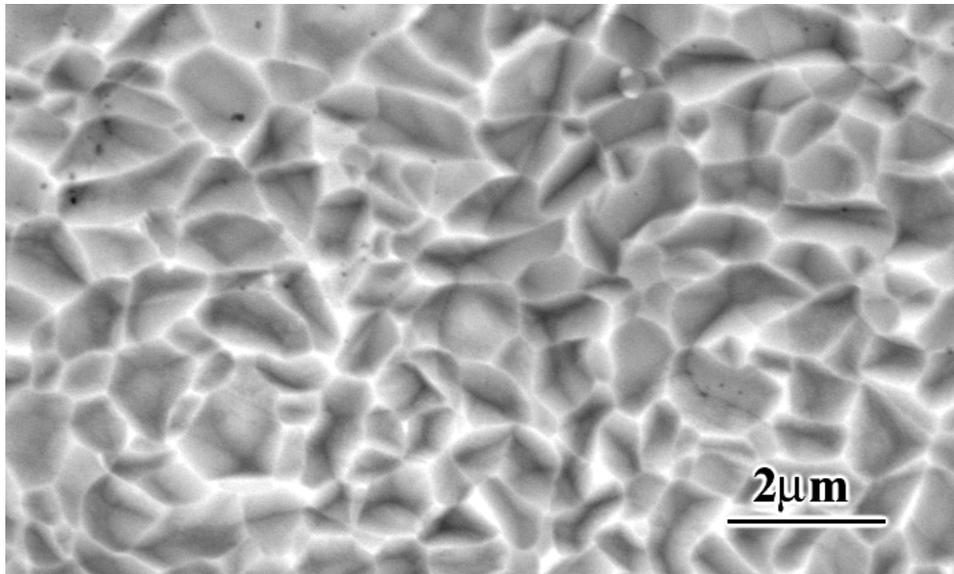
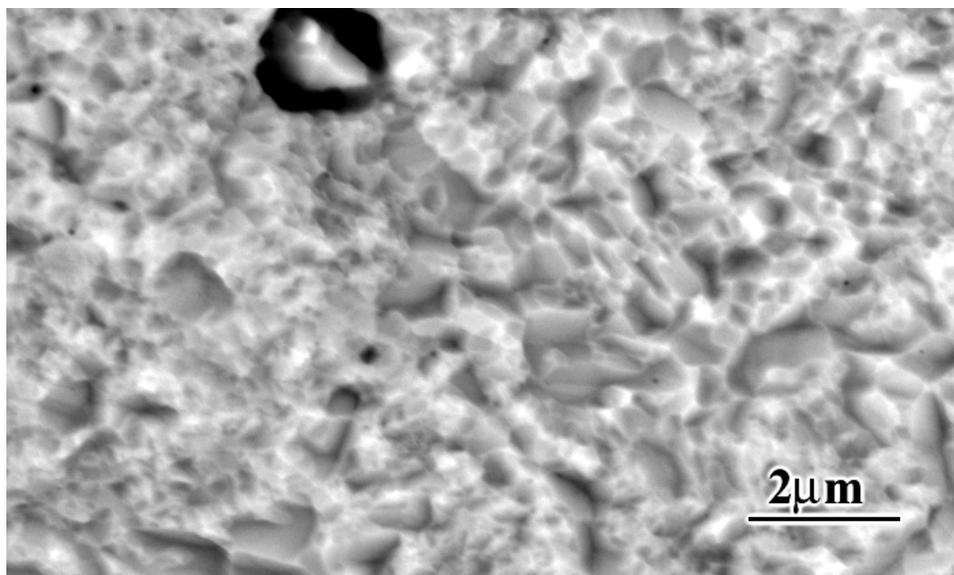
Grain imprints of the TGO were observed on the bond coat surfaces if the TGO was in contact with the bond coat during exposure (Figure 115a). It is an effective way to determine the grain size of the alumina at the bond coat interface by measuring the size of the grain imprints. It is also sometimes possible to observe the grain growth if the reformed alumina also spalls, leaving new grain imprints. Figure 115b shows the grain imprints of the reformed alumina that developed on the previous grain imprints of the spalled alumina. The difference in the grain size showed a significant amount of grain growth that took place in the TGO upon exposure. Figure 115c is another example showing the grain imprints of both original and reformed alumina side by side.

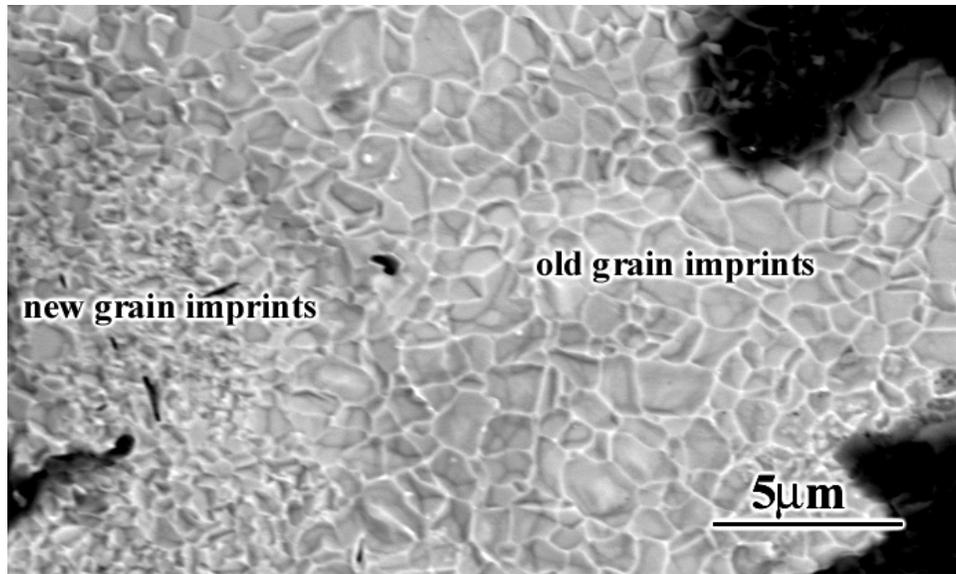
(b)

Figure 115 Scanning electron micrographs from the fracture surface of a specimen showing grain imprints of the original TGO, (a), as well as the grain imprints of the reformed and then spalled TGO, (b). The grain imprints of the original and reformed TGO can be seen side by side in (c).

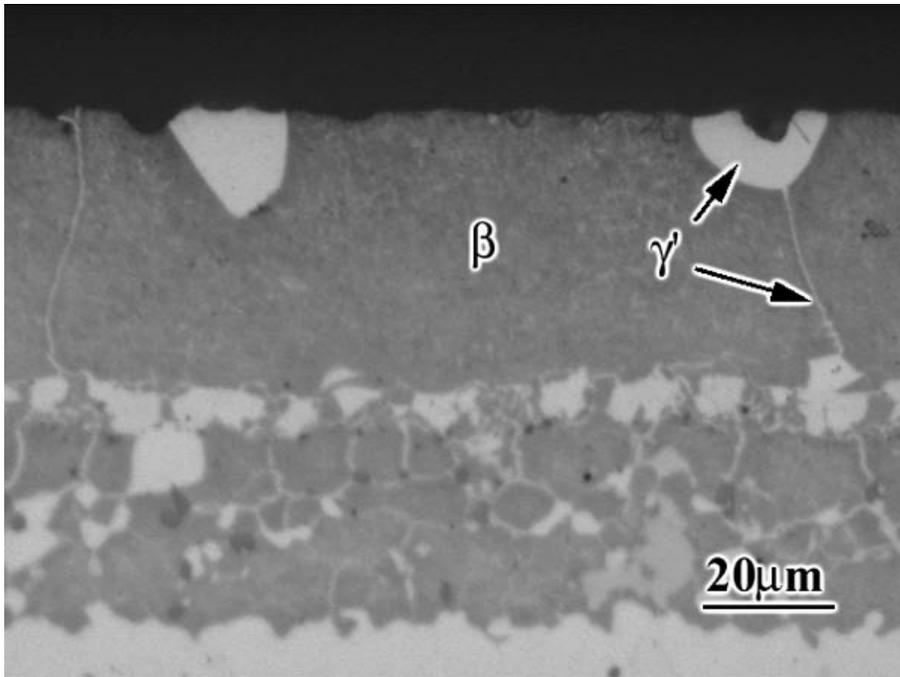
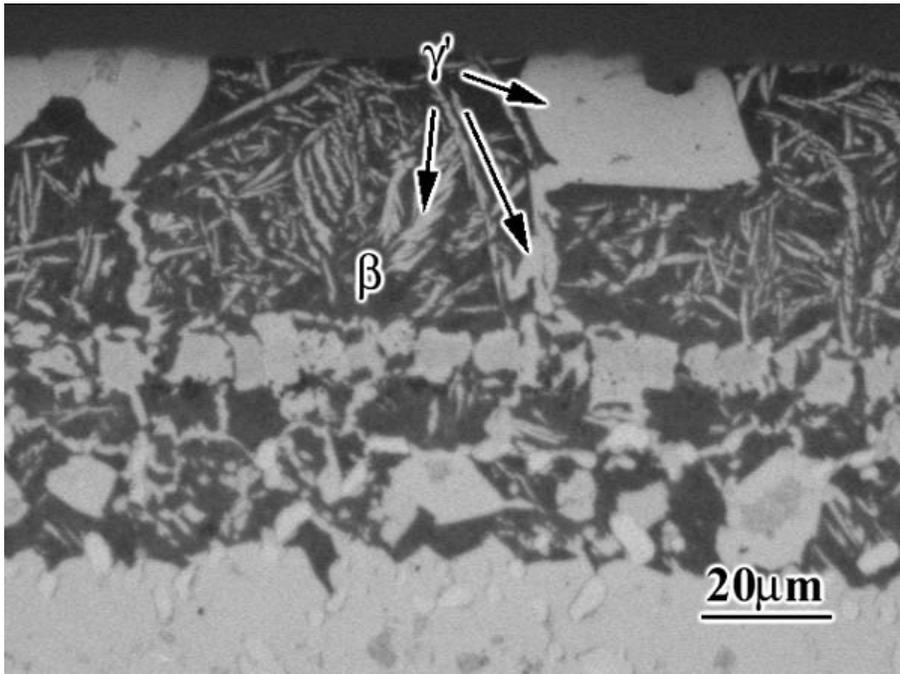
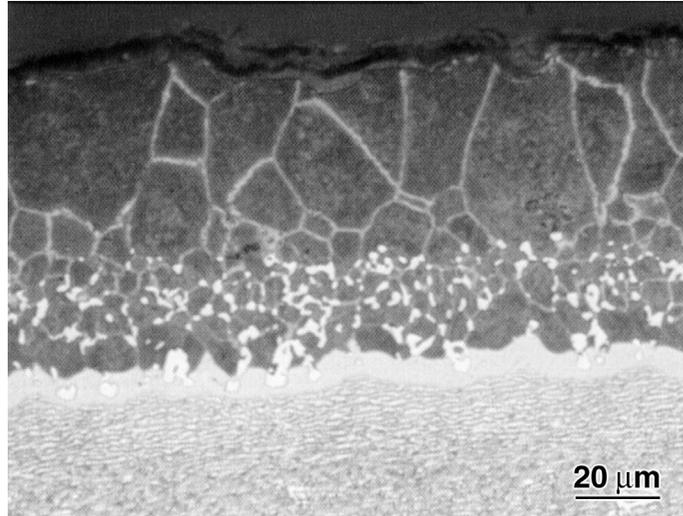
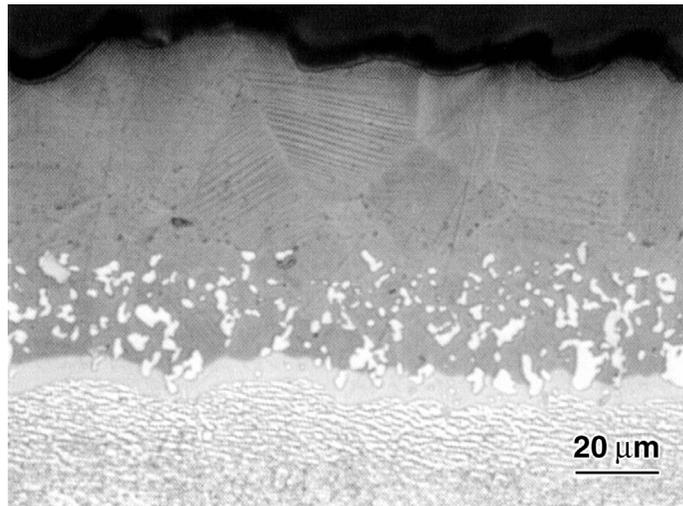
The γ' phase was usually observed to form at the grain boundaries of the β -phase of Pt Aluminide bond coats (Figure 116a). One set of specimens cooled slowly in the furnace due to some problems that developed during a cyclic test. The γ' was then observed to form not only at

the grain boundaries but also in the β -phase (Figure 116b). Another observation was the absence of γ' phase after 15 hours of exposure at 1200°C followed by quenching the specimen in cold water (compare Figures 116c and 116d where the former was quenched and the latter was not) All these results indicate the importance of cooling rate on γ' formation.

Figure 116 Optical micrographs showing the effect of cooling rate on the formation of γ' phase. The γ' phase usually developed along the grain boundaries after air cooling, (a), whereas it developed in the β phase as well as along the grain boundaries after furnace cooling, (b). One of the specimens that was air cooled after 15 hrs of exposure at 1200°C developed γ' phase along the grain boundaries, (c), whereas the other specimen which was quenched after same exposure did not develop γ' phase , (d).

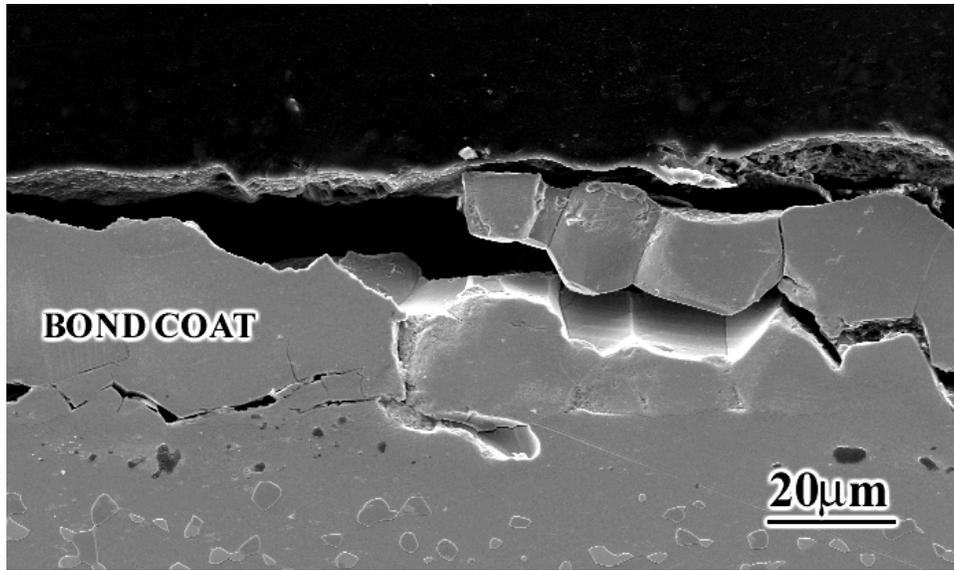
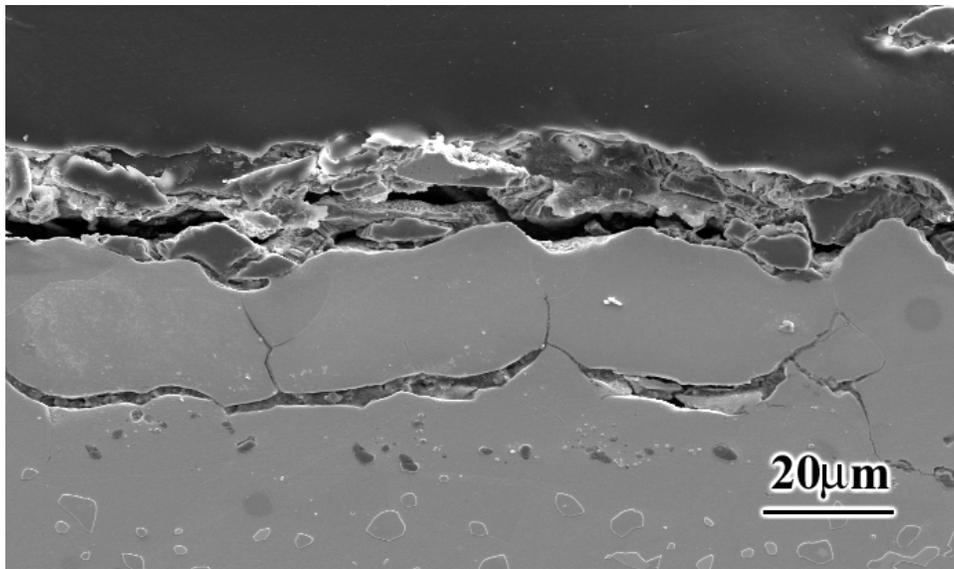
During metallographic sample preparation, separation along the interfaces as well as cracking in the bond coat may occur. The cracking along the β grain boundaries and/or β/γ' interfaces, as evident in Figures 117a and 117b, may be an indication of weaknesses at these sites.

Figure 117 Scanning electron micrographs showing cracking along the β grain boundaries and/or β/γ' phase boundaries during metallographic sample preparation.

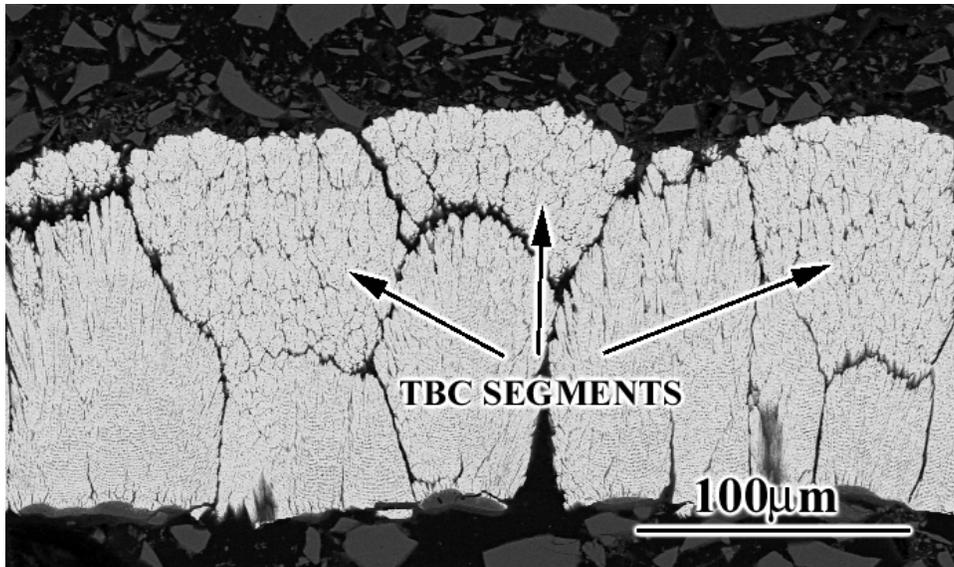
Segmentation can take place in the TBC upon exposure (Figure 118) This seems to be an undesirable situation since the TBC segments, which are not connected to the rest of the TBC, can come off leading to localized failure of TBCs. These segments are believed to have formed by a mechanism similar to the development of vertical separations in the TBC, where small separations present in the as-processed condition enlarge with exposure as a consequence of sintering.

Figure 118 Scanning electron micrograph showing TBC segmentation.
