AN EVALUATION OF THE SUBSTRATE EFFECT ON THE PERFORMANCE OF
YSZ EB-PVD THERMAL BARRIER COATINGS

Igor Steven Garcia

Submitted to the Graduate Faculty of
School of Engineering in partial fulfillment
of the requirements for the degree of
Master of Science

University of Pittsburgh

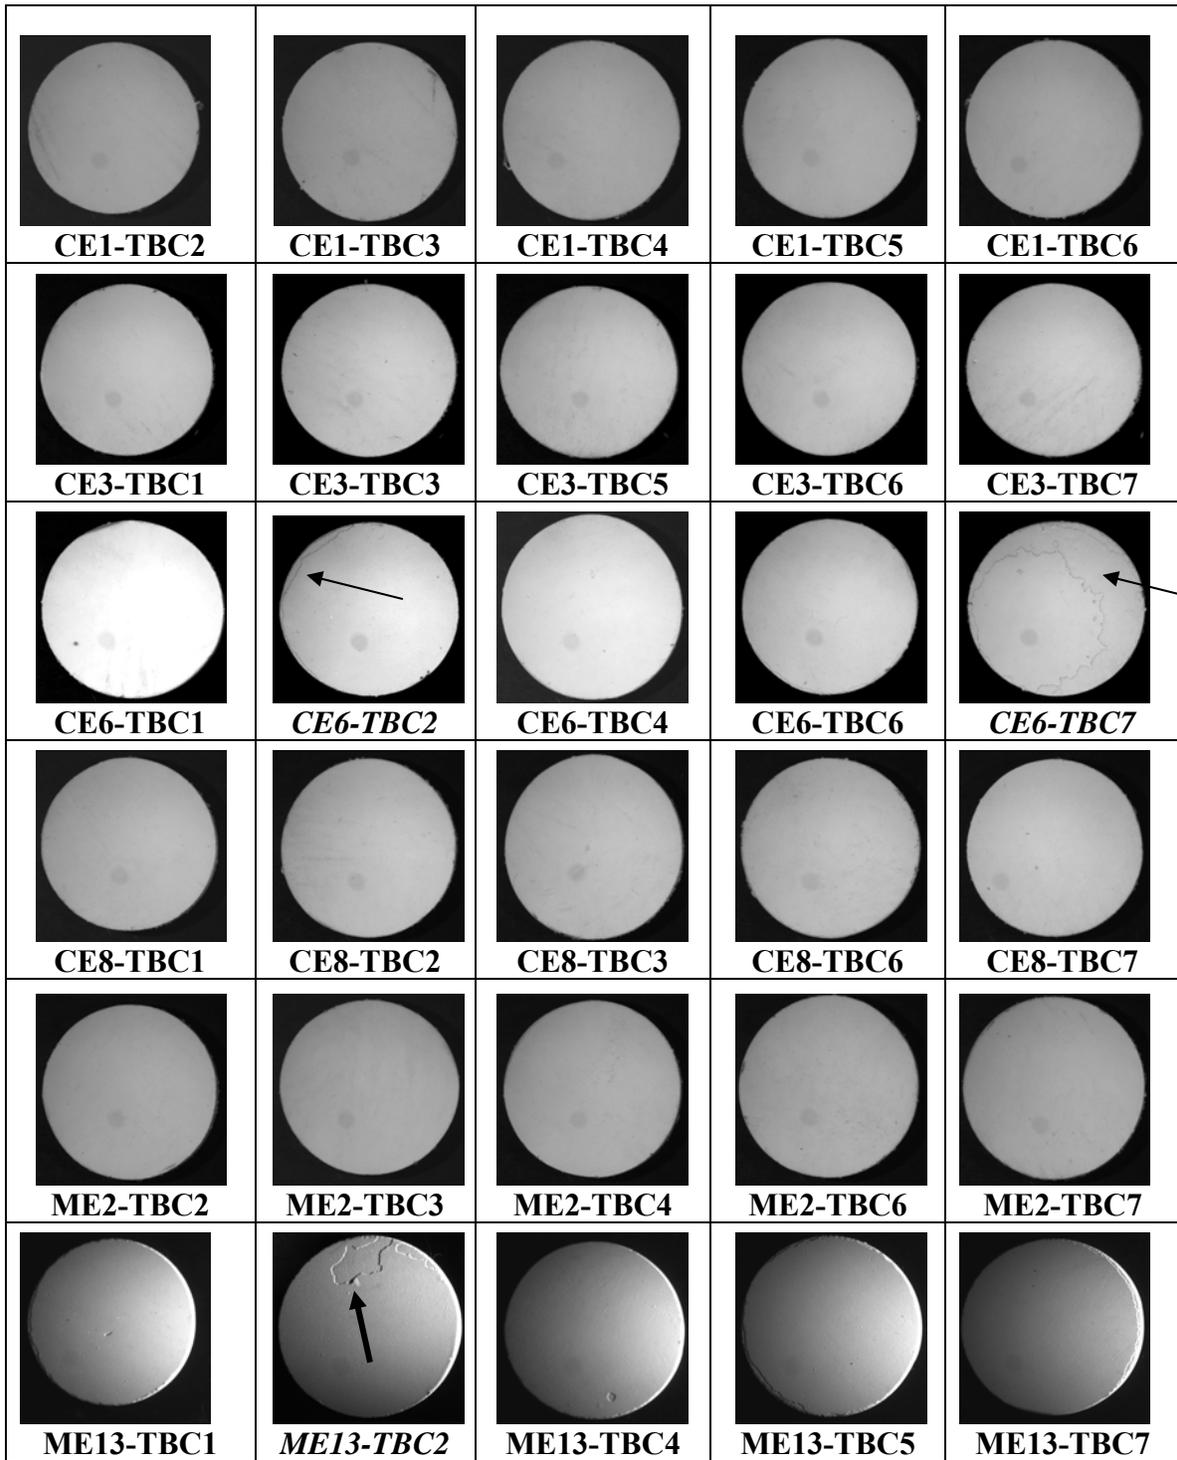
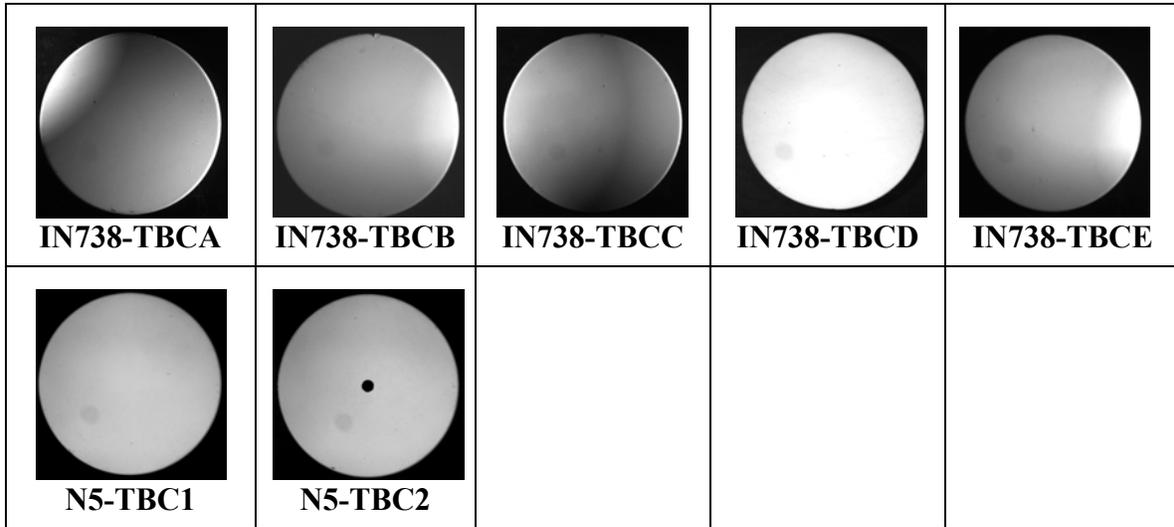
The complete study included thirty seven coupons; five coupons for each of the third generation superalloys, five for IN738 (polycrystalline) and two for René N5 (generation 2). These as processed coupons can be seen on Figure 6.1. It is possible to view that some spallation of the thermal barrier coating did occur prior to the start of thermal cycles. This can be seen for CE6-TBC2, CE6-TBC7, and ME13-TBC2.

Figure 6.1 Single Crystal Superalloys coated with Y_2O_3 - ZrO_3 .

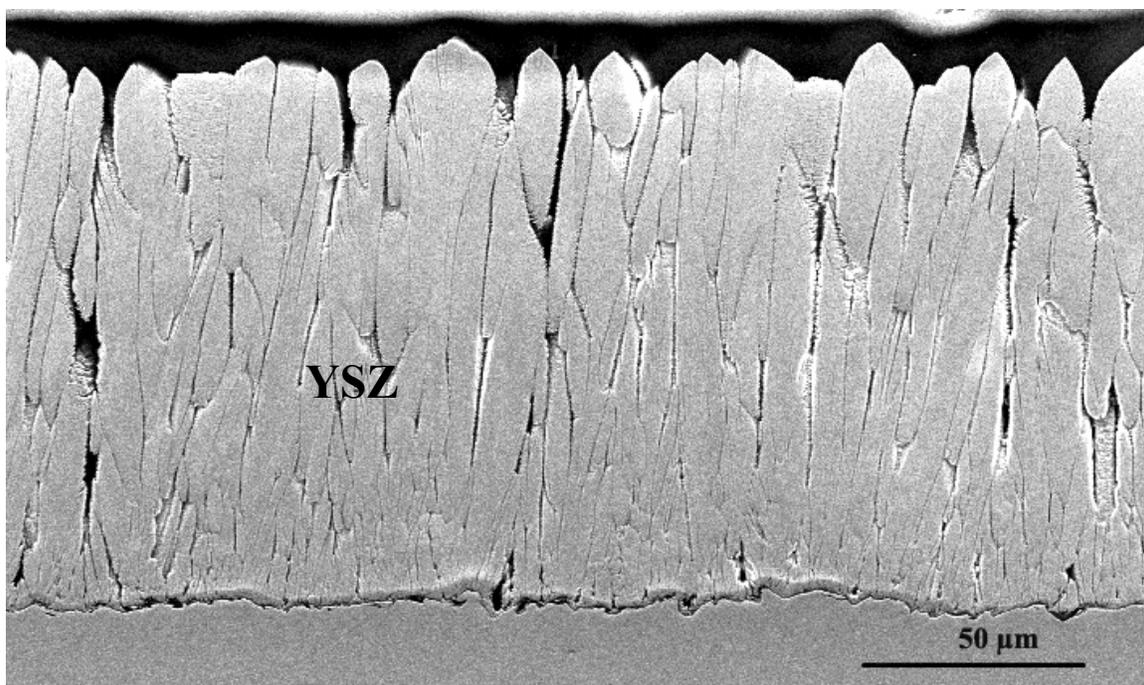
Figure 7.2 As processed YSZ grains on a grit blasted beta β (Ni,Pt) Al bond coat.

Various micrographs are included in this segment in order to present a visual perception of the general defects of the specimens. Figure 7.2, displays the as-processed YSZ layer, along with the grit blasted bond coat. It is easy to note from this micrograph

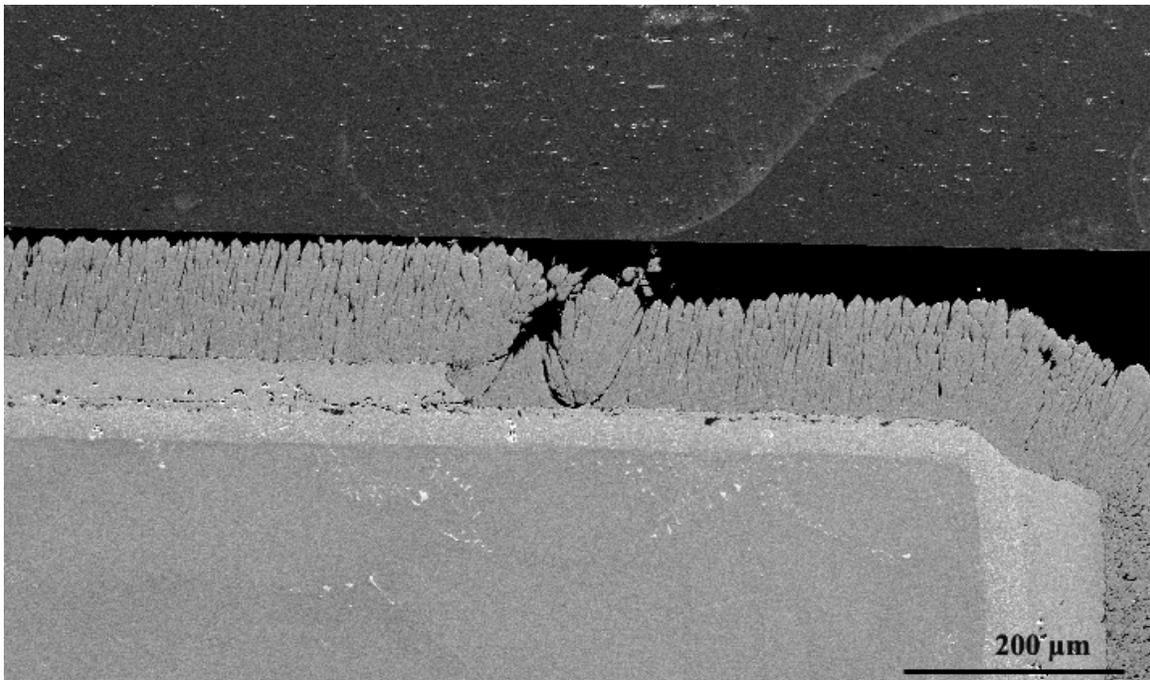
Figure 7.5 Thermal barrier coatings system without the bond coat can be seen here due to the heavy grit blasting technology.

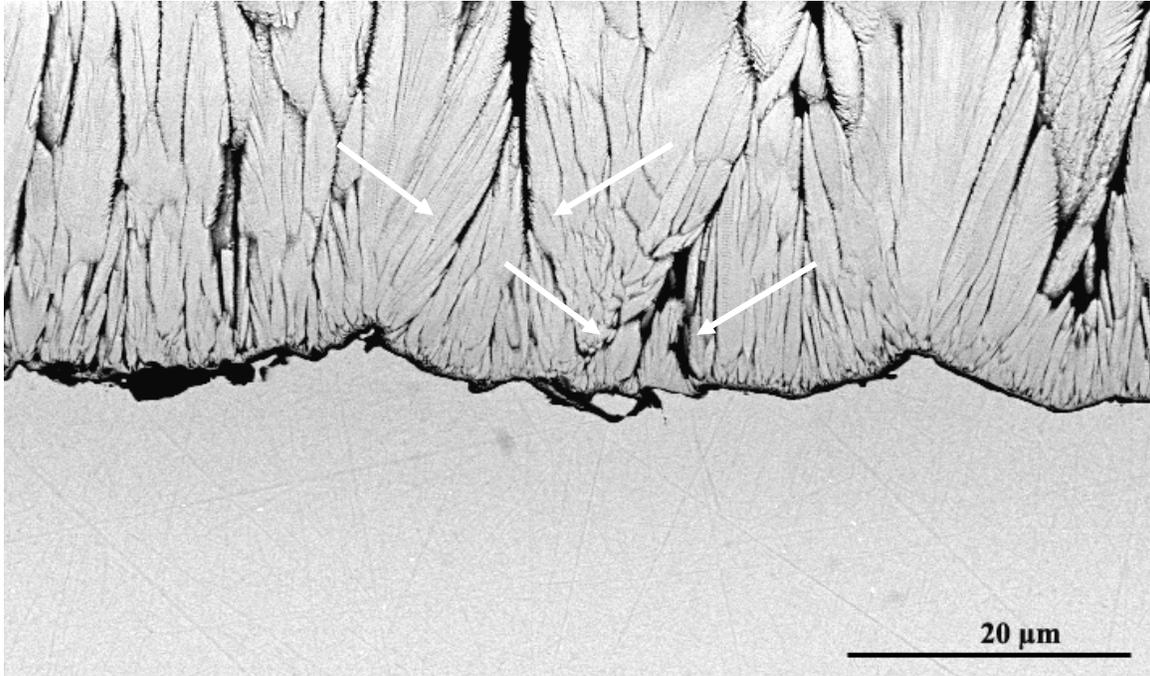
Closer examination of the as-processed specimens, shows a weak interface constituted by porous and discontinuous grains. Figure 7.7 - 7.9 show once again the response of the EB-PVD YSZ to the rough-surfaced bond coat. Figure 7.7 shows no contact surfaces, which can easily slip during high tensile stress conditions. On a larger magnification in Figure 7.8, the discontinuous growth of the YSZ scale created by a deep undulation and competition among the YSZ grains to grow, can be seen; hence, a void is formed and high stress points at each one of its ends are produced. Although heavily grit blasted, the thermal barrier system contains a thin thermally grown oxide as exhibited in Figure 7.9. The TGO formed during YSZ deposition which occurred after the grit blasting. The TGO is continuous along this interface and is the product of high temperatures used during the deposition of the YSZ.

Figure 7.7 Undulations of the rough surface create zero contact planes, easy to pull under normal stresses.

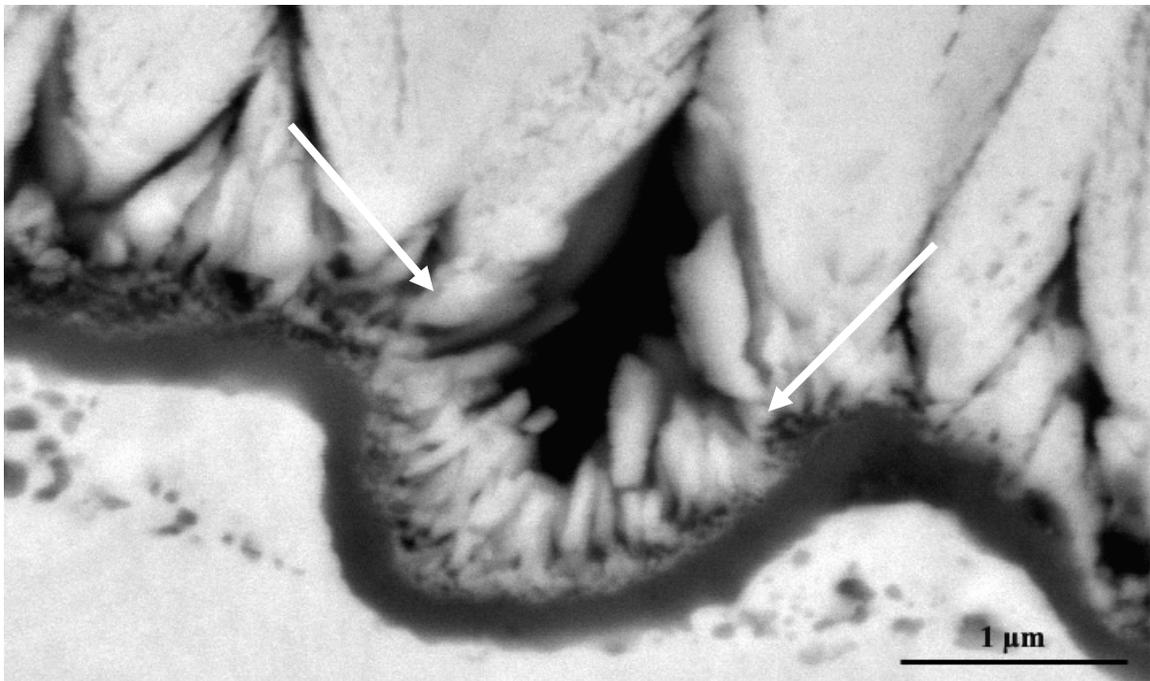
Figure 7.8 Rough Surface undulations create inhibitions for the continuous growth of YSZ leaders, creating vacancies and stress concentration points.

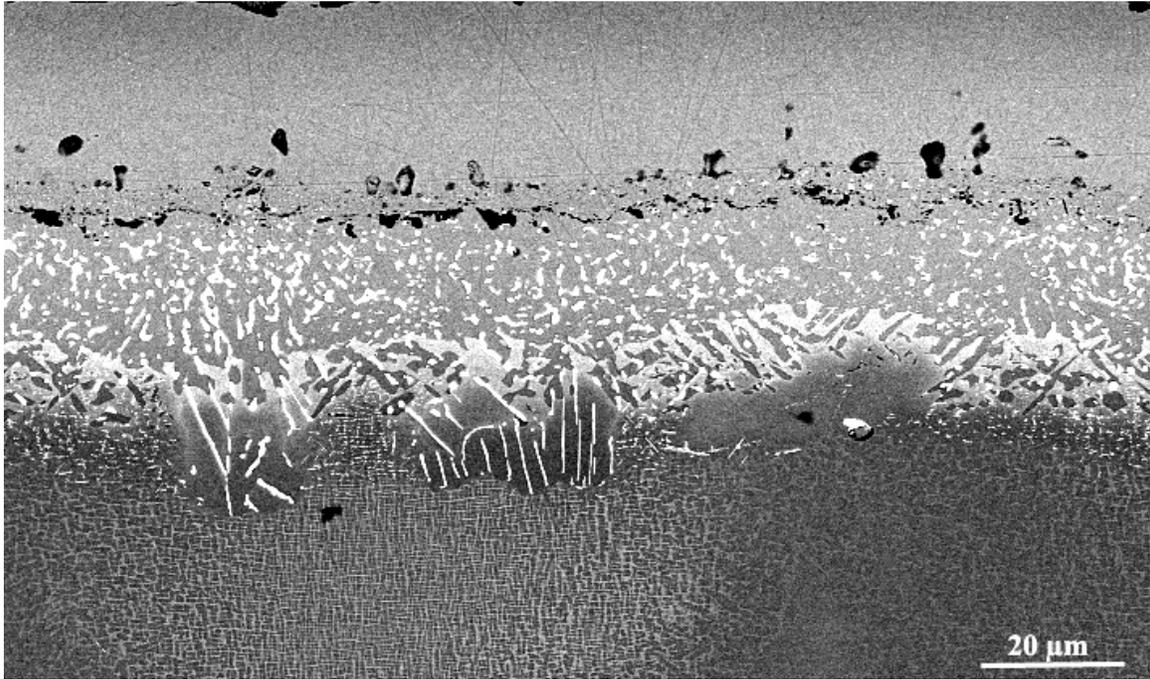
The interdiffusion area is also another very important area within the system. Micrographs were taken to represent the different interdiffusion areas that ranged from highly dense areas to dense when compared to each other. Figure 7.10 represents the interdiffusion area of high cyclic failure samples. The entire interdiffusion area has a width close to 20 microns, comprised by globular and acicular precipitates. In addition to the dense precipitate area, alumina particles are also present above the interdiffusion area. Figure 7.11 unlike the previous figure, represents the interdiffusion area of a low cycle failure specimen. Noted is the distance between the interdiffusion area and the bond coat, which when compared with the previous and next figure is a very small distance. Figure 7.12 corresponds to mid-cycle failures and, as seen here, there are various precipitates, mostly globular of different sizes which become larger as they get closer to the bond coat.

Figure 7.10 The interdiffusion area below the thermal barrier coating system.

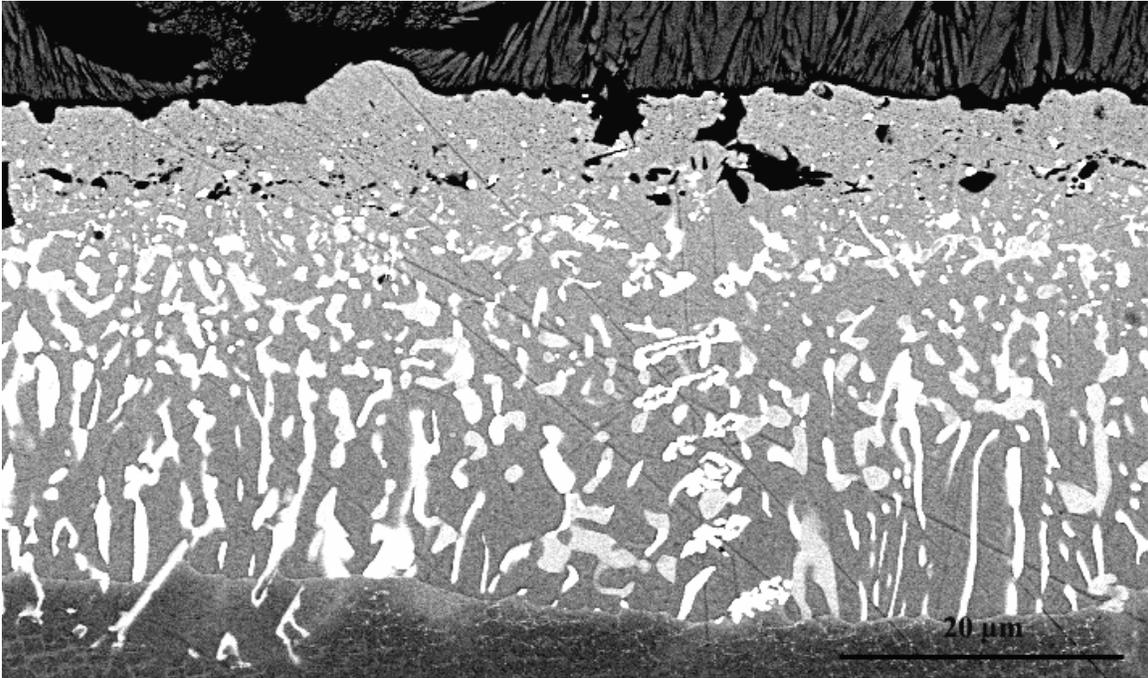
Figure 7.11 Interdiffusion area of a low cycle failure specimen.

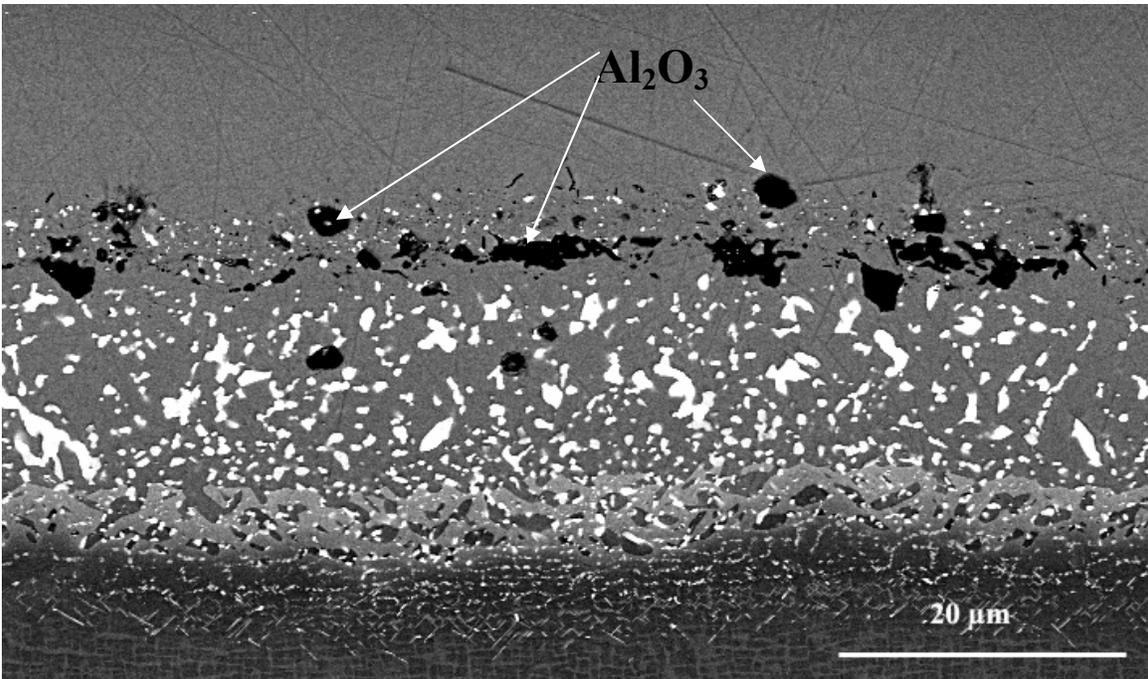
In addition to the precipitates, Figure 7.10 - 7.12 all show Al_2O_3 particles most likely incorporated during deposition of the bond coat.

Figure 7.12 Interdiffusion area of a mid-cycle failure TBC specimen for as processed, atop some alumina particles.

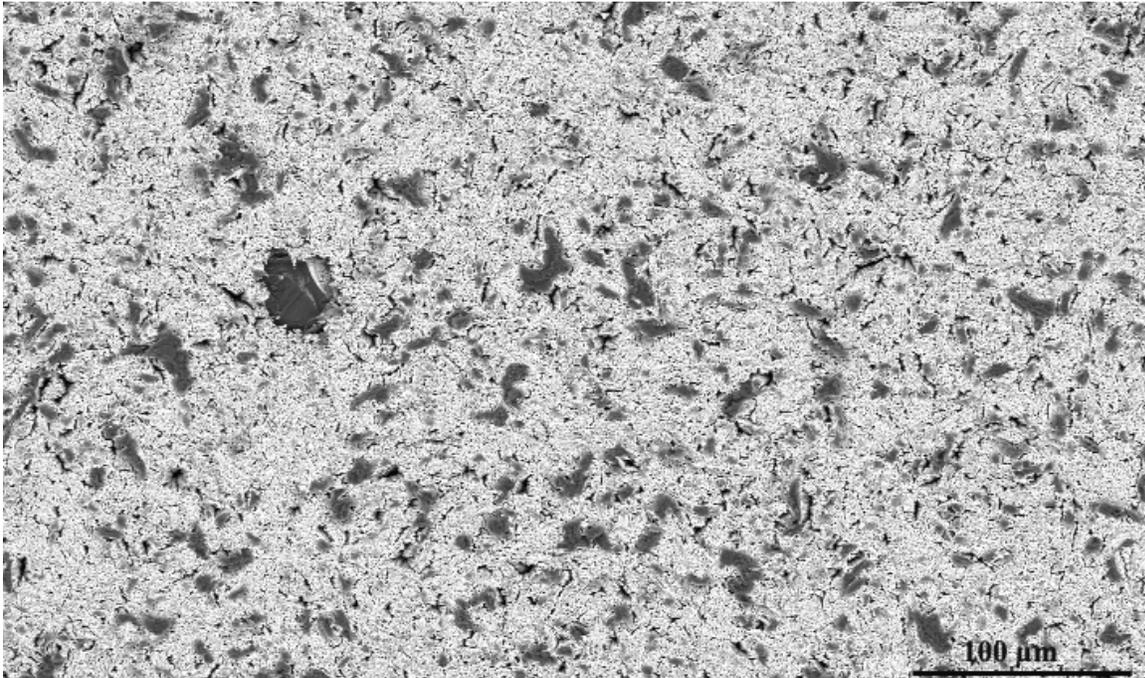
René N5 outperformed all of the third generation alloys by a percentage difference ranging between 4% for the closest and 92% for the furthest, as seen in Figure 7.1. It also outperformed Inconel 738 which is not a single crystal, but rather a polycrystalline alloy. The main form of failure for these specimens includes one along the YSZ/TGO interface as seen from the failure surface of the YSZ scale and the failure surface of the substrate, Figure 7.13. On the YSZ failure surface, as seen in Figure 7.14,

Figure 7.13 YSZ failure of Rene N5 comprised of the supporting YSZ ceramic (white area) and the thermally grown oxide (dark areas).

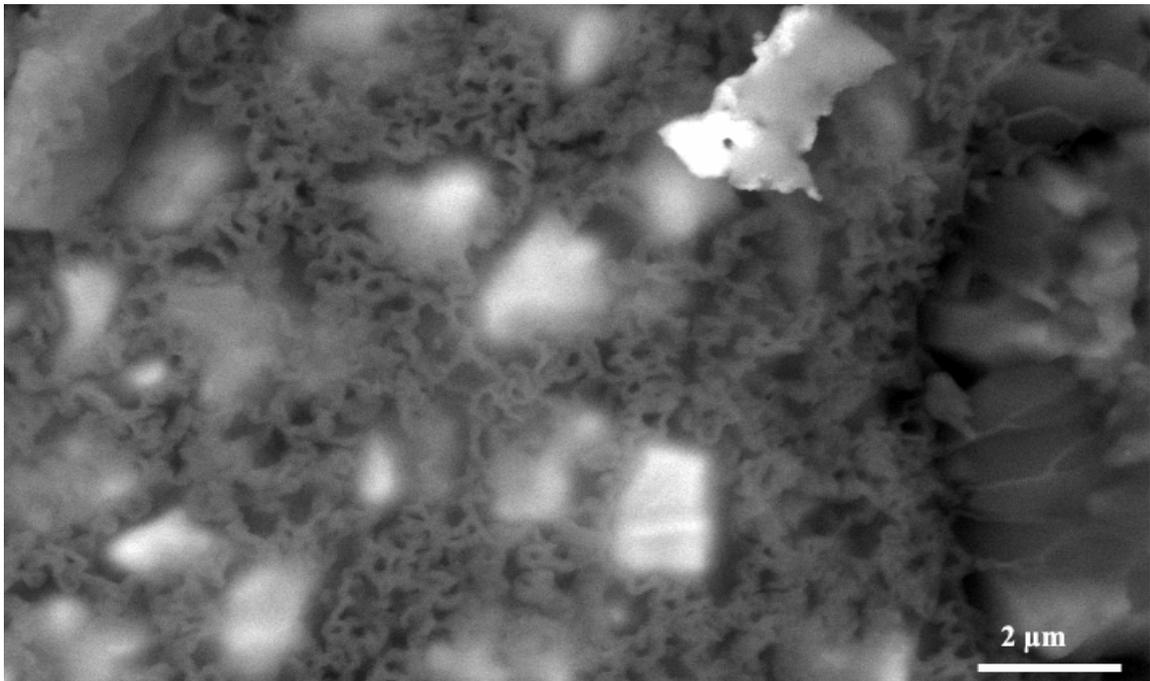
Figure 7.20 Reoxidized substrate surface shows precipitates of Al rich in Ni.

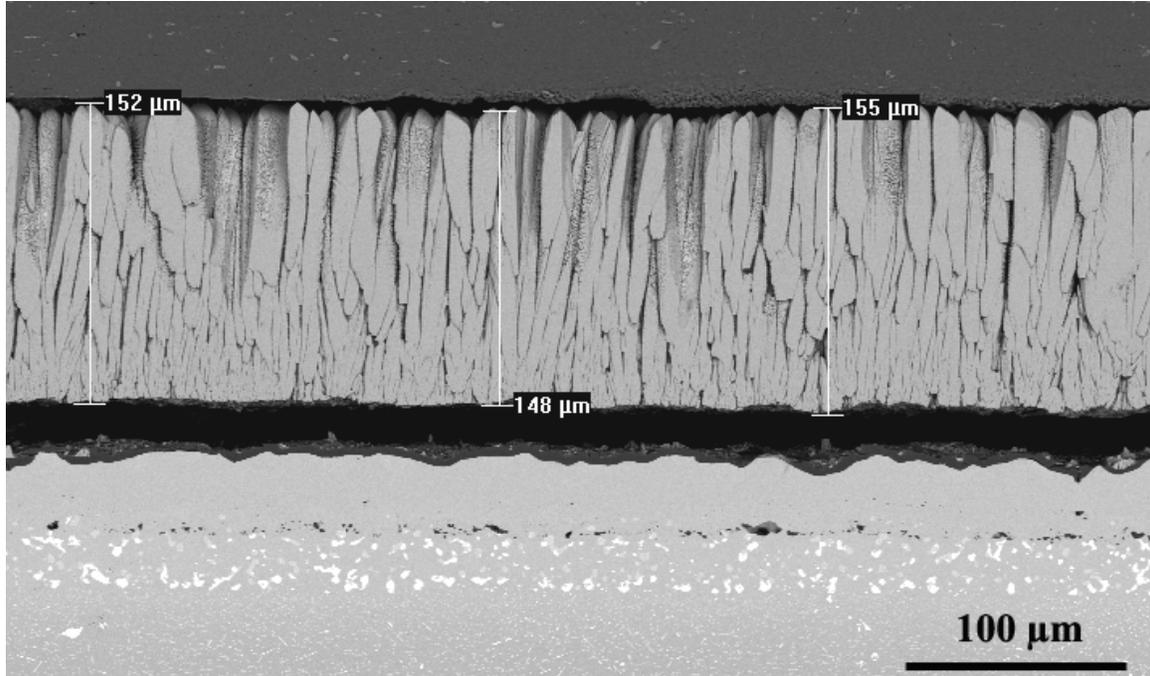
Cross sectional examinations of these specimens indicated a very weak interface between the YSZ and the TGO was responsible for the failure seen, (Figure 7.22). Moreover, oxidation of the bond coat surface in many areas as the undulations increased in size show that the specimens failed by ratcheting (Figure 7.23). Another characteristic of these N5 coupons as well as most of the rest of the other third generation alloys is the complete phase transformation from the β (NiAl) \rightarrow β' ($L1_0$) taking place in the bond coat (also Figure 7.23). β' was identified by composition analysis and later by etching. TGO thickness plays a significant role in the failure of TBCs, as residual and growth stresses in the TGO can increase and produce failure along the TBC/TGO interface. Here it is seen in Figure 7.24 that the TGO on N5 accumulated an average thickness of 5 μm at failure. Figure 7.24 notes that most deformation occurred at martensitic regions, and not at γ' regions. Yet, in observance of the substrate composition as the primary variable in

Figure 7.22 YSZ and TGO separation after failure indicative of a weak interface.

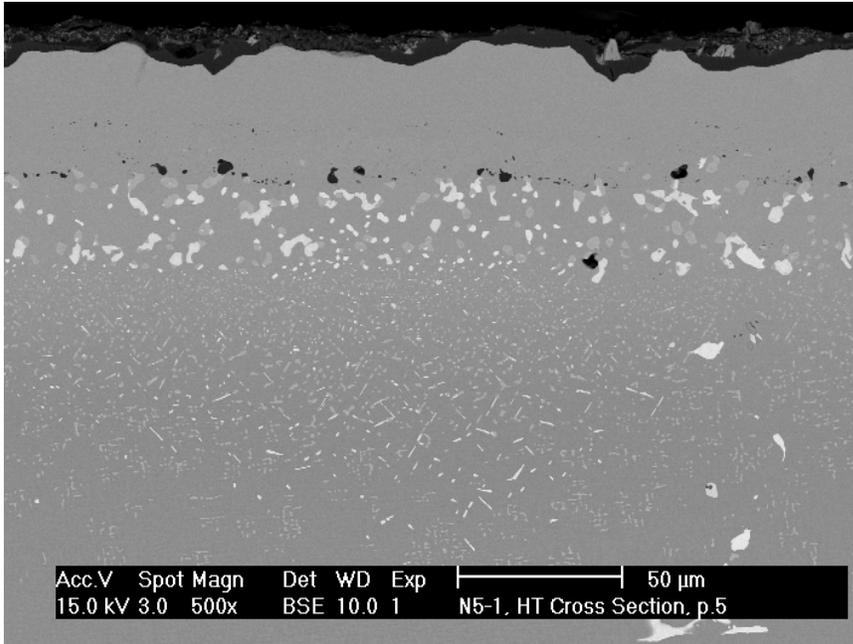
this study, it is important to indicate what happens to the substrate elements, primarily the refractory metals, during the cyclic thermal exposure. Tantalum is seen to segregate to the gamma prime phase at the interfacial boundary with the thermally grown oxide. Figure 7.25 shows the interdiffusion area, including large precipitates and small precipitates. Closer to the bond coat are TCP precipitates in the globular and acicular shapes, mainly constituted from two phases; one phase contains W, Ni, Cr, Co, and Mo, the other phase contains Cr, Ni, Re, W, Co, and Mo. The secondary reaction zone is populated by finer globular precipitates composed of the same elements seen in the primary reaction zone, while the tertiary reaction zone has acicular precipitates rich in Re, Ni, Cr, W, Co, and Al. All these zones differ in the size of their precipitates as well as the distance from the bond coat.

Figure 7.25 Interdiffusion area of N5 at failure.

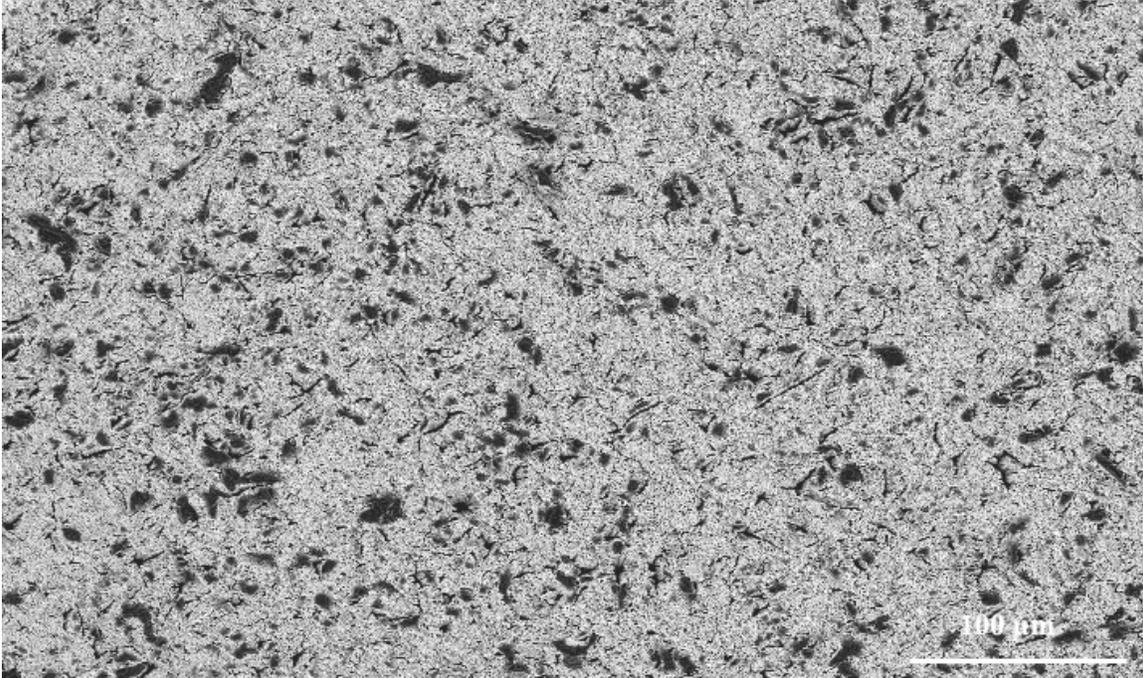
Substrate ME2 performed particularly well, being among the third generation alloys and the only substrate of its kind in this category of high cycle failure. ME2 averaged 765 cycles per specimen, or 96% of N5s total. Like the best performer N5, ME2 also failed along the YSZ/TGO interface, as seen in Figure 7.26. Some areas from which the TGO spalled did appear, although they were not as prevalent as on N5. Thermally grown oxide portions or bits are attached to the YSZ, an indication of a crack that changes planes during propagation. Some of the largest portions can be seen in Figure 7.27. The substrate side of the failure did not show as many spalled or reoxidized areas as N5 showed (see Figure 7.28 and 7.29). Nevertheless, some were present as seen in Figure 7.29. Besides spallation of the TGO and exposure of the bond coat, another important feature is seen in Figure 7.30. As it appears on Figure 7.30, a compilation of

Figure 7.26 YSZ Failure Surface of an ME2 specimen after 780 cycles at failure.

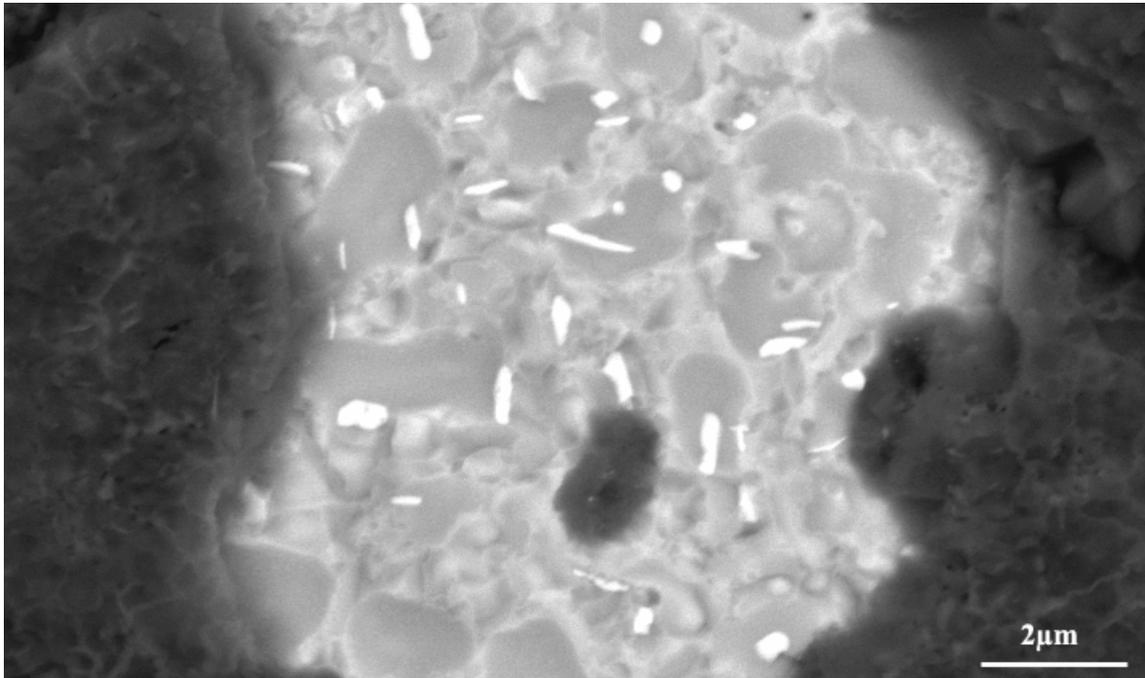
Figure 7.29 Spalled area on the failed substrate surface shows Re precipitates on a Ni matrix.

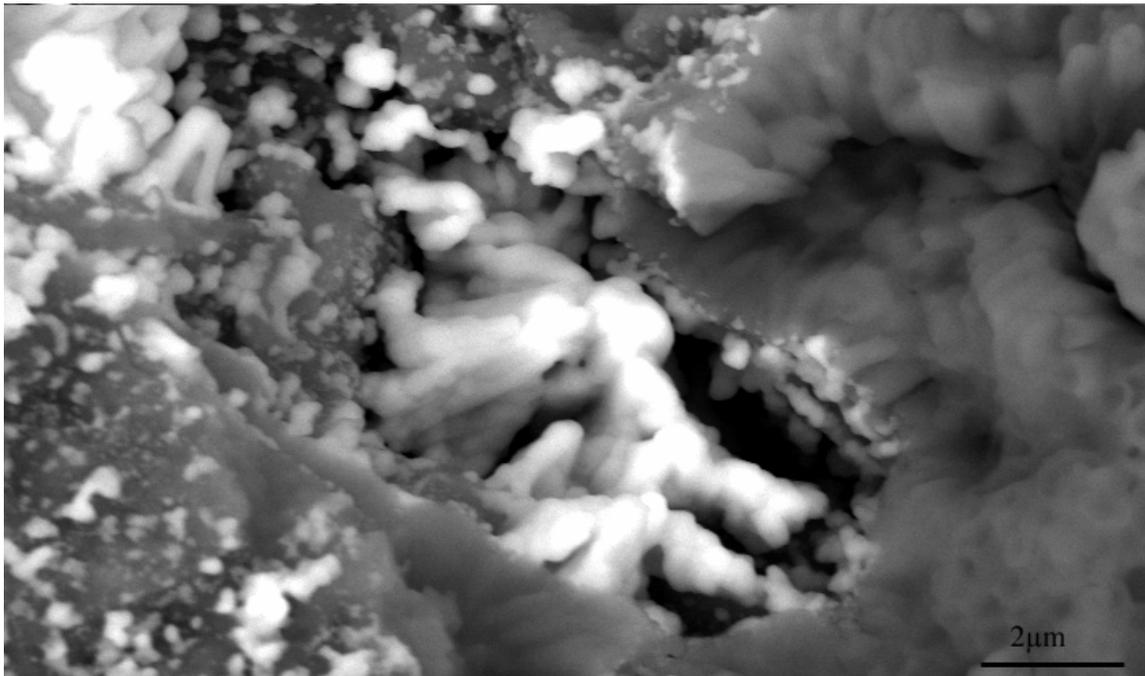
YSZ grains remained attached to the surface of the TGO while the TGO extended into the bond coat. This loss of YSZ grains produces holes in the YSZ scale, in addition to cracks that lead to failure. ME2 also developed more surface holes than N5, as seen in the Figure 7.31.

Figure 7.30 YSZ grains being absorbed by out of plane stresses created by TGO residual stresses.

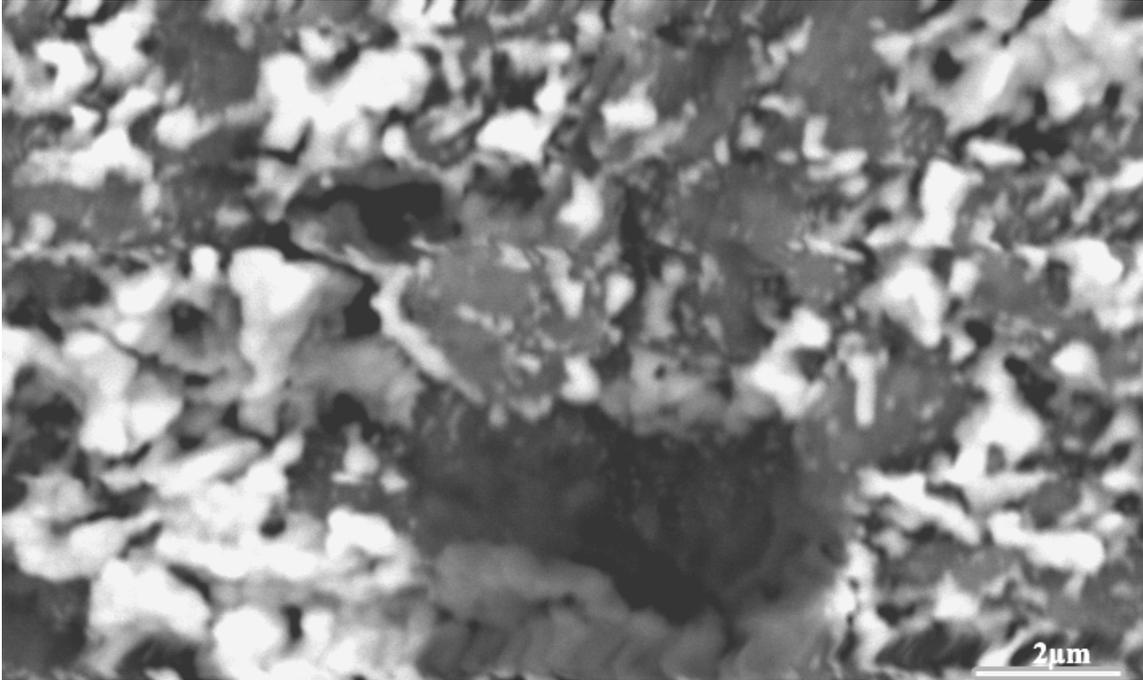
Figure 7.31 Holes on the surface of an ME2 specimen after failure due to ratcheting effect.

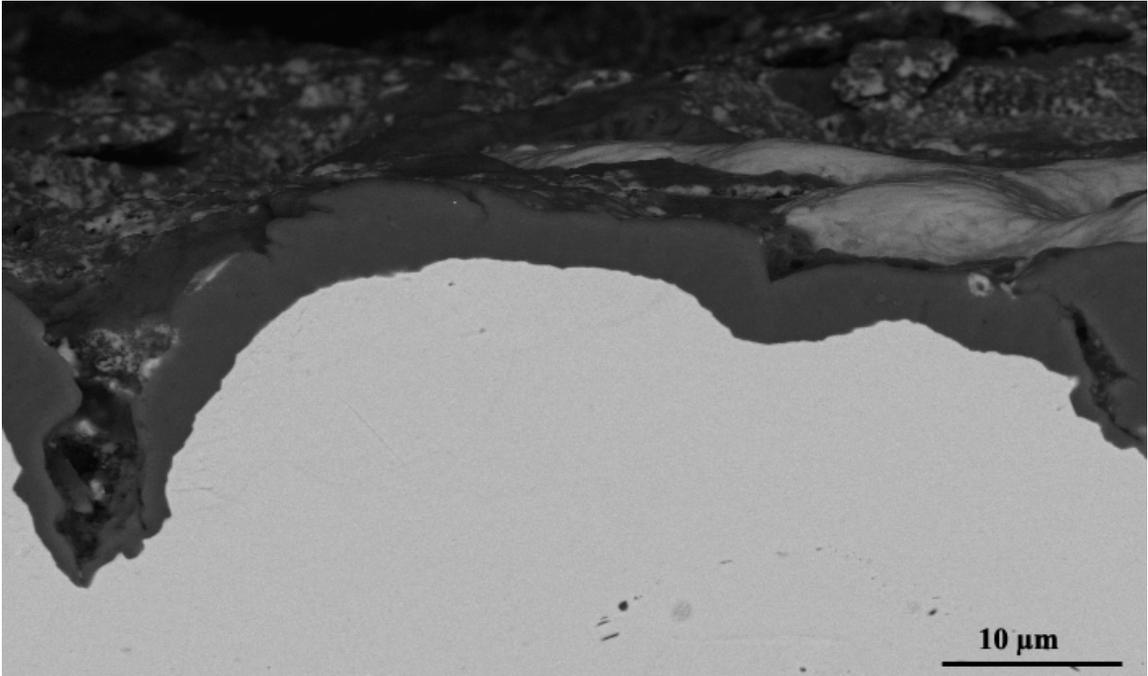
The cross section of the substrate develops a more pronounced deformation of the bond coat as the cycles increased, i.e. the depth of the undulations extended into the bond coat as seen in Figure 7.32. The TGO thickness, as seen in Figure 7.33, averages the same as that for N5, between 4 and 5 microns. Then moving downwards, it can be seen in Figure 7.34 that most of the substrate components did not significantly influence much in the adhesion or failure of the TBC system, as most of them formed precipitates at the interdiffusion area, both acicular and globular. The globular precipitates are rich in Re, Cr, Ni, and Co, all in descending atomic percentage concentration. The acicular precipitates are rich in Ni, Re, Cr, W, Co, Al, and Mo also all in descending atomic percentage concentration. Ni content for the globular precipitates is half of the Ni found in the acicular precipitates, while Re content in the globular precipitates is 2 times the amount of Re found in the acicular precipitates. As seen from Figure 7.34, the population

Figure 7.33 Deformation of the bond coat by a ratcheting mode allows for the oxide to penetrate the bond coat and oxidize eventually causing failure.

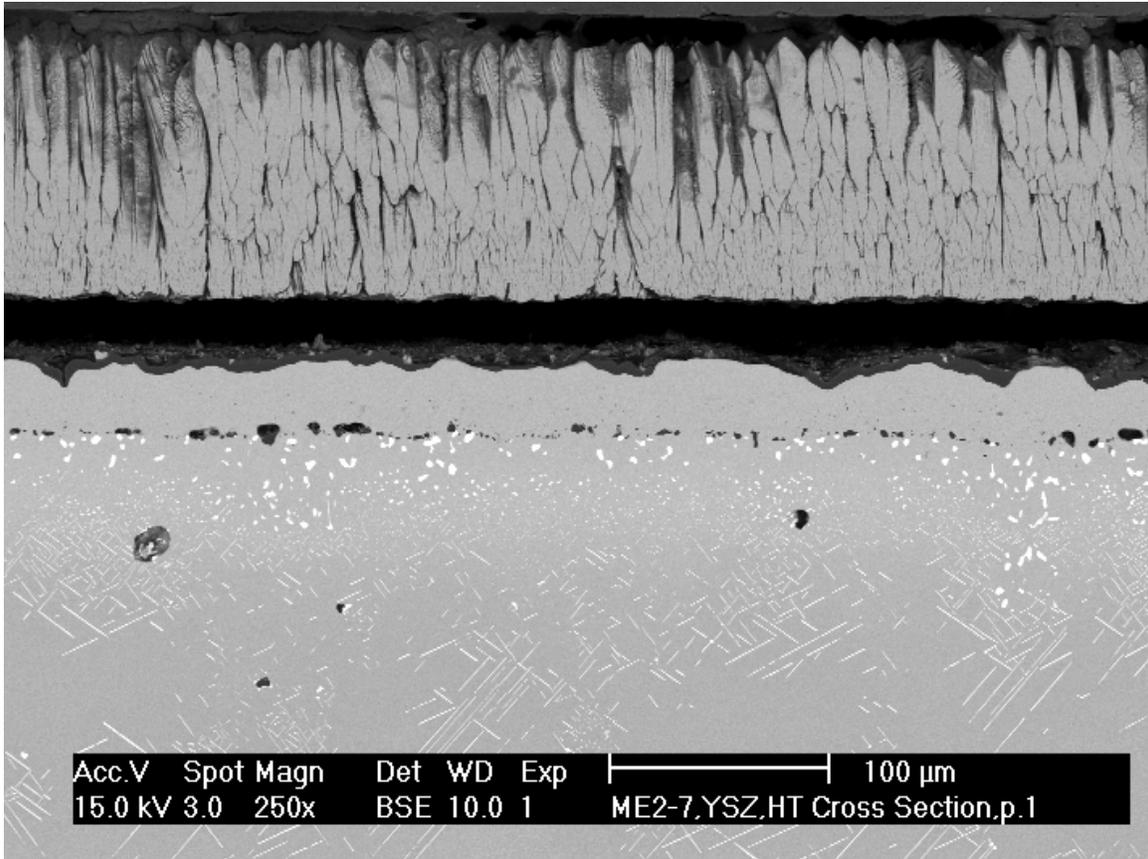
Figure 7.34 Interdiffusion area stretches vastly from the bond coat into the substrate matrix, various forms of precipitates in globular and acicular shapes.

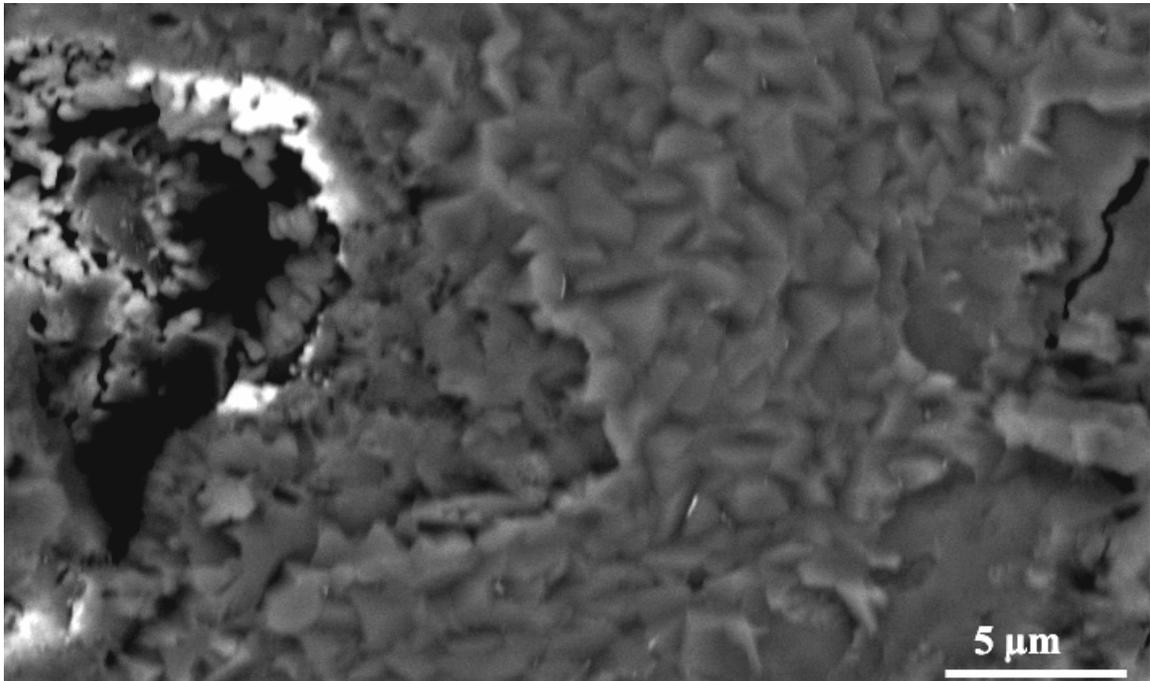
Figure 7.36 TGO on YSZ failure surface shows engraved details. These are the TGO grains in contact with the bond coat.

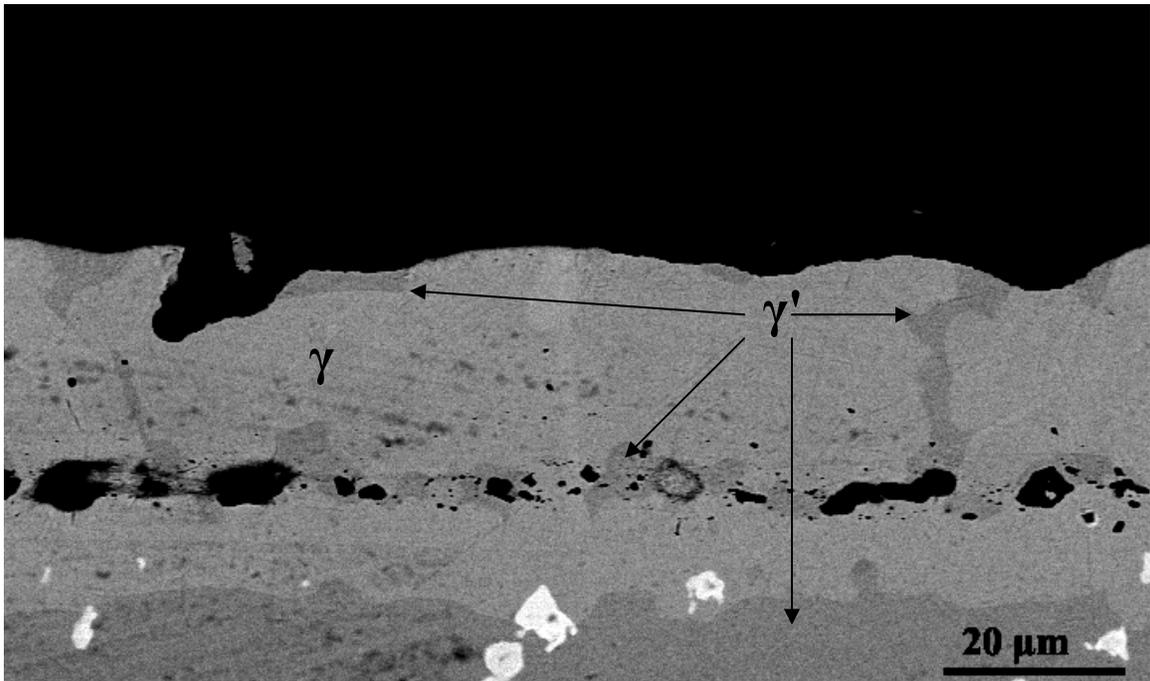
Figure 7.43 A closer look at phase distribution along the bond coat of IN738, displays γ and γ' .

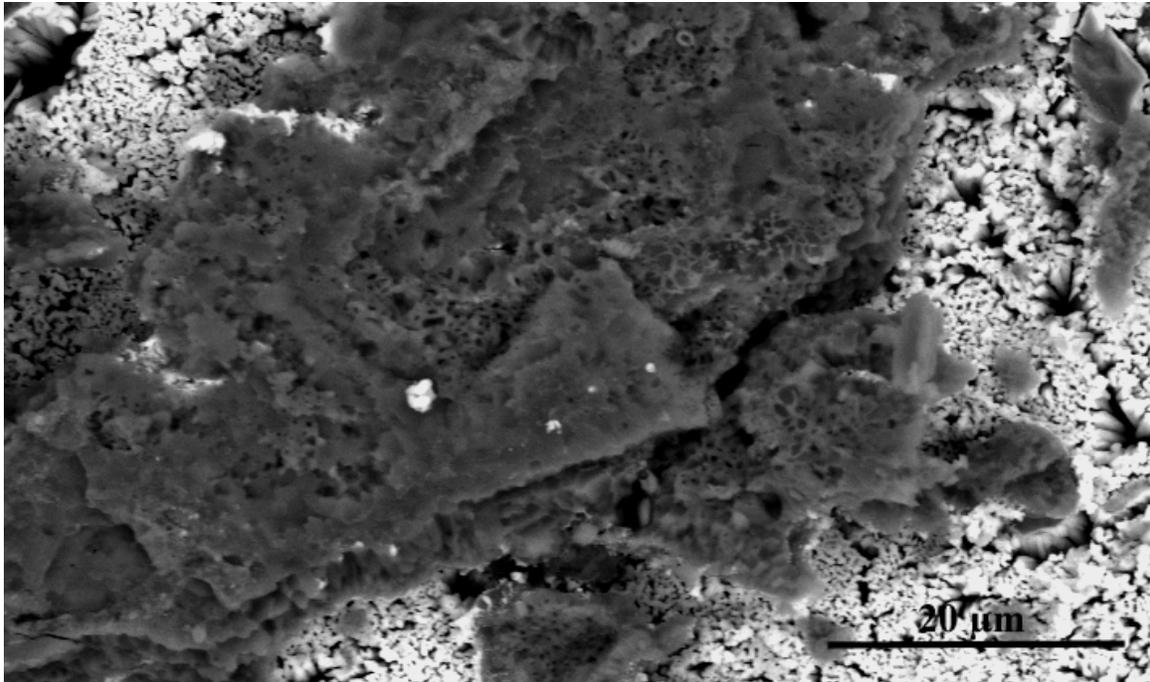
CE1, like all the other specimens, also failed along the YSZ/TGO interface. Figure 7.45 presents the YSZ failure surface of CE1. Like the high cycle failure specimens, CE1 has bits of TGO attached to the YSZ, as well as missing YSZ in certain areas. A closer look at these TGO bits in Figure 7.46, shows a porous surface as well as ragged edges. The substrate surface after failure resembled that of IN738, though less spalled, see Figure 7.47. In Figure 7.48, spalled areas as well as reoxidized areas and cracks all populate the same area, again similar to the substrate surface of IN738 after failure; additional holes are also present. Holes seem not to be in high density as previously seen in other substrate failure surfaces.

Figure 7.46 Alumina on YSZ of CE1 is large and porous.

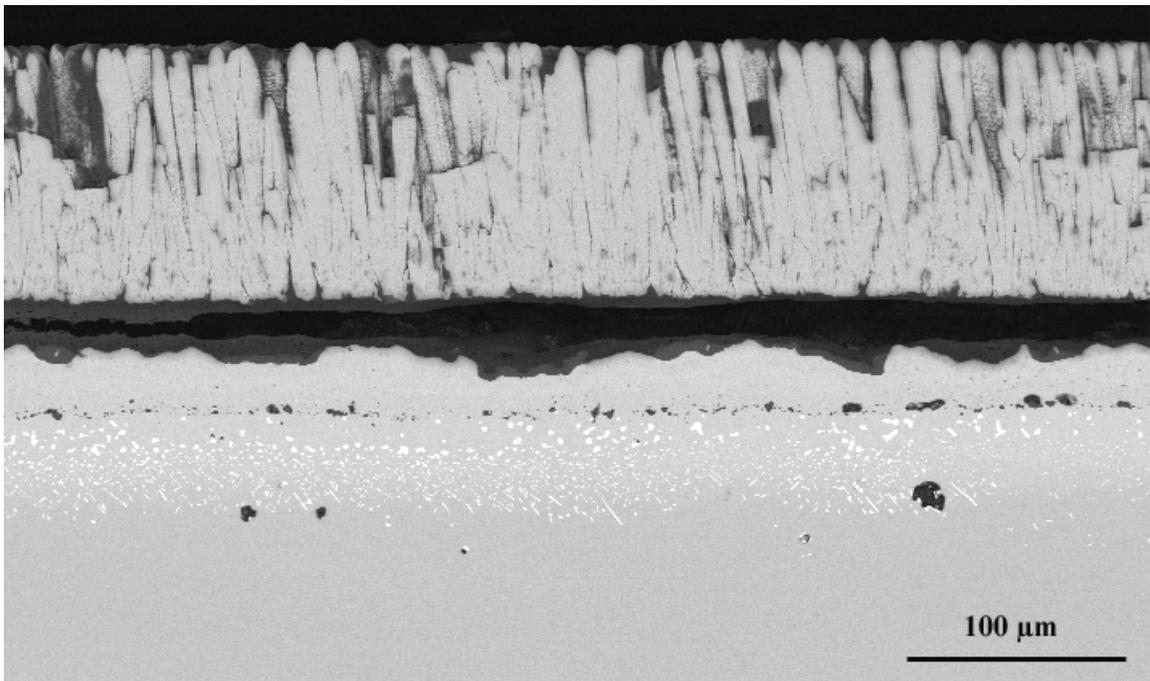
The cross sectional view of CE1 revealed a similar behavior to that of the higher failure cycles, like N5. As seen in Figure 7.49, the bond coat cross section displays less sections of the oxides expanding into the bond coat and presents a more consumed bond coat than that of N5. Additionally, Figure 7.49 shows that TGO thickness exceeds that of previous superalloys. Furthermore, one can see the interdiffusion area and its geometrical shapes. Again, the shapes are in the form of circles and needles, as seen in the previous alloys. However, the density lies between IN738 and N5, considering that ME2 has the most dense interdiffusion area. The composition of these precipitates includes W, Re, Ni, Cr, Co, Mo, and Al for the globular shaped ones. Meanwhile, forming the secondary reaction zone, one sees the acicular shaped precipitates formed by Cr, Ni, W, Co, Re, and Mo. Figure 7.50 displays the thermally grown oxide at failure time. As seen in the figure, the thermally grown oxide cracks parallel to the YSZ/TGO

Figure 7.49 CE1 cross section after TBC failure along YSZ/TGO interface.

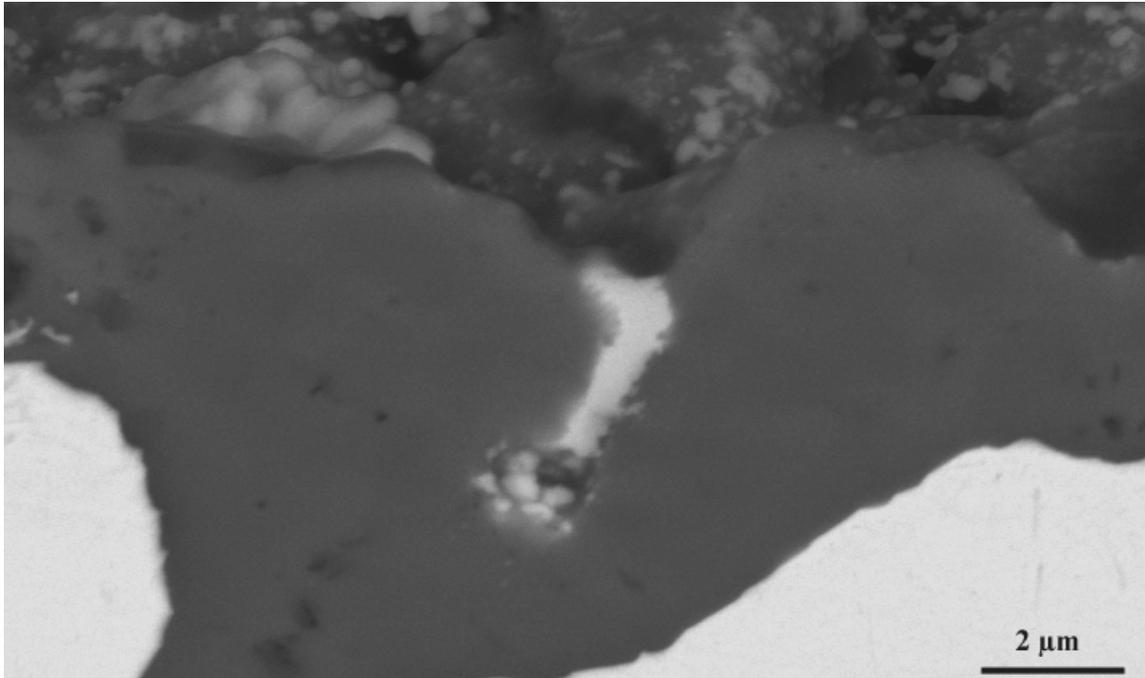
interface and not normal to the interface, as seen in the previous superalloys. Figure 7.51 also displays the unprotected area adjacent the thermally grown oxide with YSZ adhered to it. Again, Figure 7.51 additionally shows the thickness of the TGO and significant deformation of the bond coat without much increasing of the concavity of the oxide penetration. Moreover, Figure 7.51 also shows the phase distribution along the bond coat. As seen here, most of the bond coat has transformed to β' ($L1_0$) and some to γ' ($L1_2$). Tantalum segregated to the gamma prime phase. Finally, Figure 7.52 shows the oxide extending into the bond coat and retaining YSZ.

Figure 7.52 Oxide extends into bond coat and retains YSZ inside as seen in this figure.
