AN EVALUATION OF THE SUBSTRATE EFFECT ON THE PERFORMANCE OF
YSZ EB-PVD THERMAL BARRIER COATINGS

Igor Steven Garcia

Submitted to the Graduate Faculty of
School of Engineering in partial fulfillment
of the requirements for the degree of
Master of Science

University of Pittsburgh

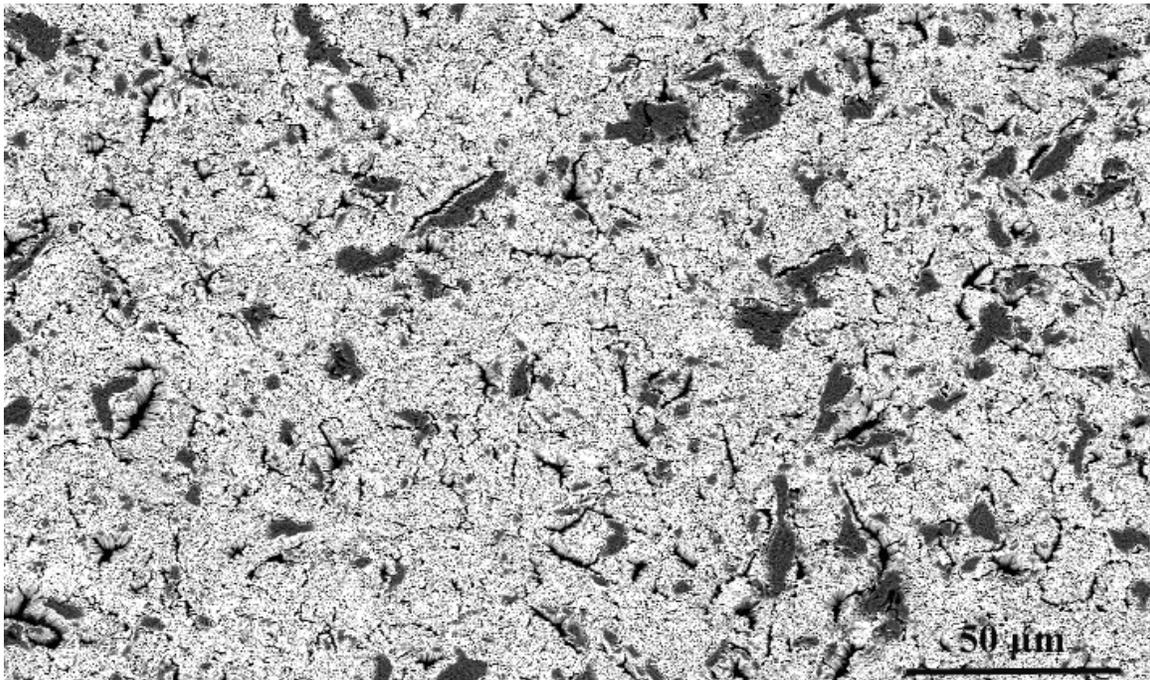
The performance of CE3 specimens averaged 310 cycles or 39% of N5s total average. As seen in Figure 7.53, the failure of the TBC system occurred along the YSZ/TGO interface. Like the rest of the previously discussed specimens, subject to the ratcheting failure type, there is attachment of some TGO on to the YSZ surface and vice versa. Figure 7.54, shows a micrograph of an alumina bit attached to the YSZ surface. In addition to the TGO in Figure 7.54, there is also the presence of holes on the YSZ surface as well as cracks. Figure 7.55 shows the substrate surface which is protected by the TGO. Unlike the previously seen specimens, CE3 does not show any spallation at the TGO/BC interface nor reoxidation surfaces. These characteristics could be seen in Figure 7.55 and 7.56. Nevertheless, other not yet seen features do appear on the failure surface of the substrate, including the formation of a button like precipitate whose

Figure 7.53 YSZ failure surface of CE3 shows similar failures of other substrates in the study, YSZ/TGO interface failure.

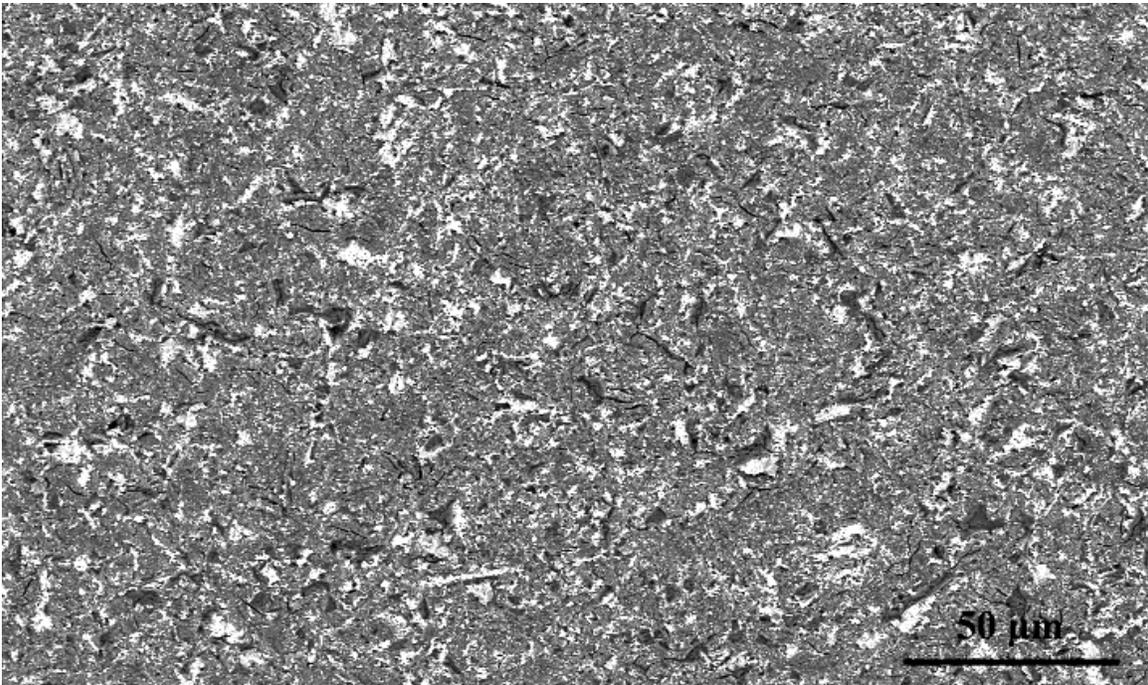
Figure 7.55 CE3 substrate failure surface elucidates on the failure type, and failure traits.

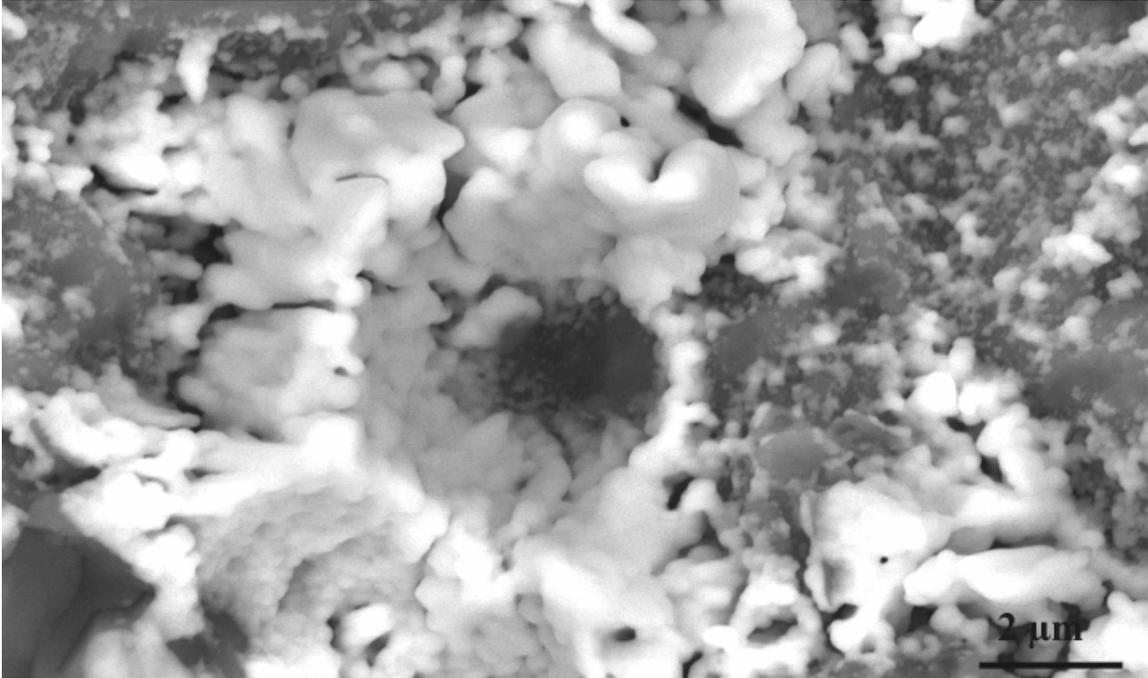
composition includes Al, O, Ta, Ni (see Figure 7.56). Some holes are also seen in Figure 7.56 accompanied by cracks and YSZ debris from the detachment of the systems components. A closer look at the features seen on top of the substrate is seen in Figures 6.57 and 6.58, which show magnifications of a crack and grains adhering to the TGO after failure, respectively.

Figure 7.58 YSZ grains attached to the TGO on the substrate surface after failure.

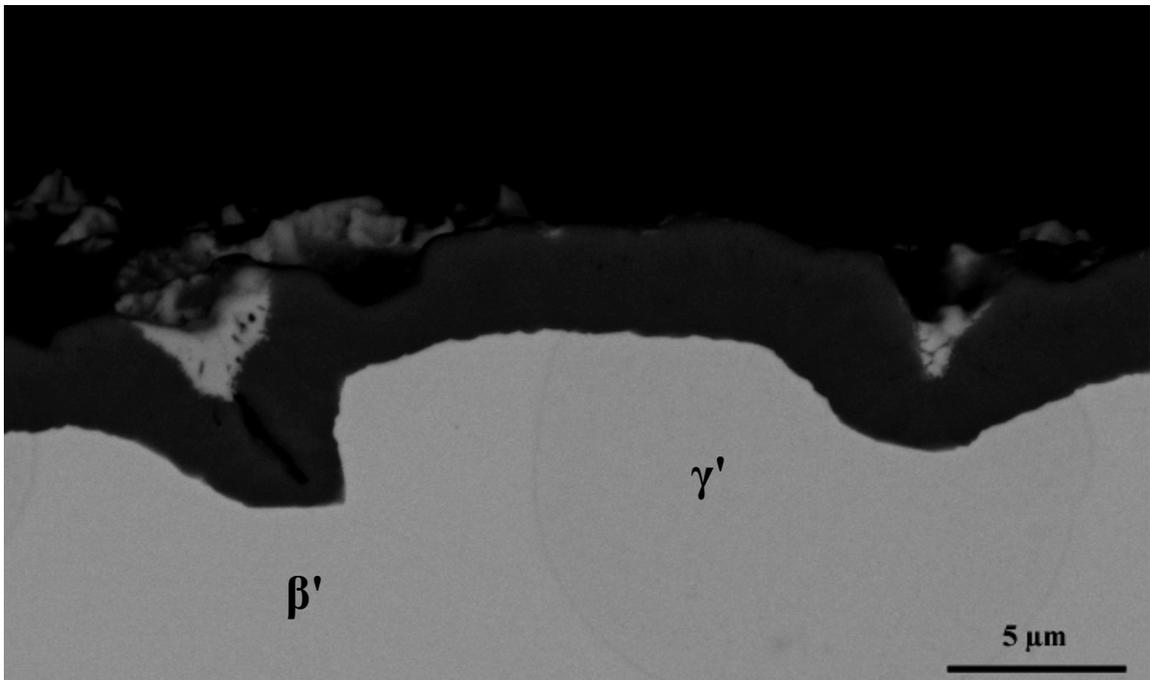
Figure 7.60 TGO thickness on the bond coat of CE3 did not exceed 4 μm. Additional is the presentation of the β' and the γ' phases.

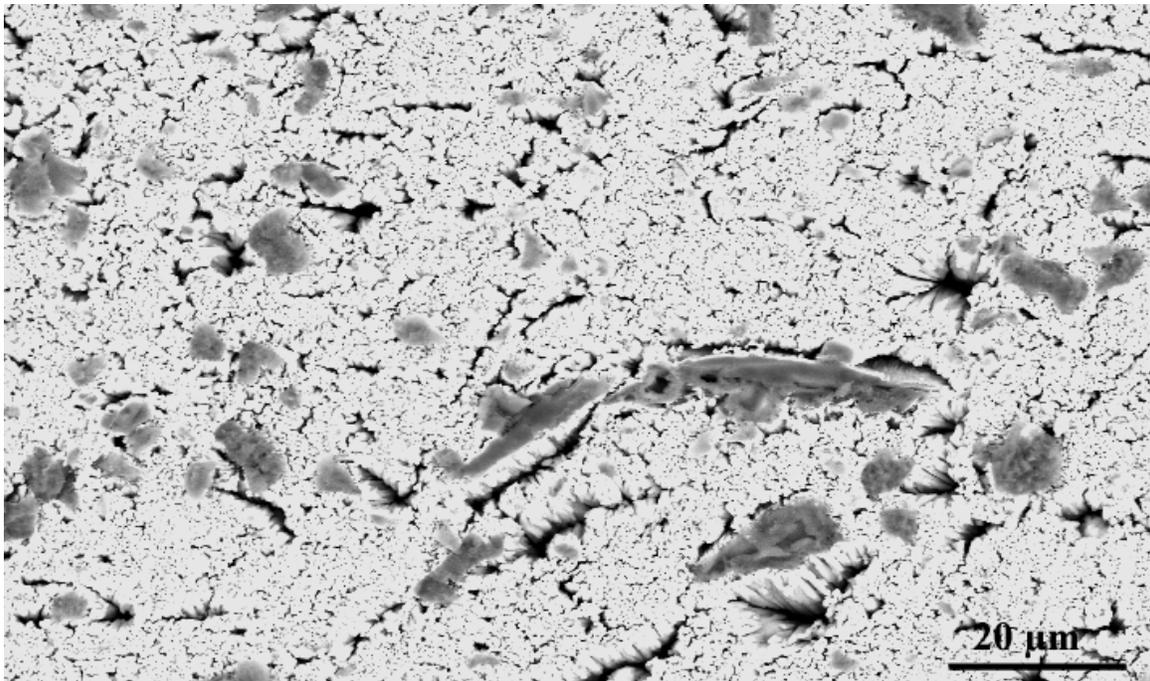
The failure of this TBC system occurred along the YSZ/TGO interface, as seen in Figure 7.61. Again, thermally grown oxide portions remain on the failure surface of the YSZ, as seen in Figure 7.61 and Figure 7.62. Other features of this failure mechanism include the loss of YSZ, creating holes and/or cracks on the YSZ, as seen in Figure 7.63. The failure surface of CE8 shows cracks, holes and YSZ that remained attached to the TGO after failure of the TBC system, as seen in Figure 7.63. Not representative of the CE8 specimens is the spallation of the TGO from one specimen, allowing for reoxidation and/or complete exposure of the bond coat to the environment, as seen in Figure 7.64. This last figure is from a specimen that underwent 380 cycles. Figure 7.65 is a close up of the holes and cracks seen on the CE8 failure surface.

Figure 7.61 The YSZ failure surface from a CE8 specimen.

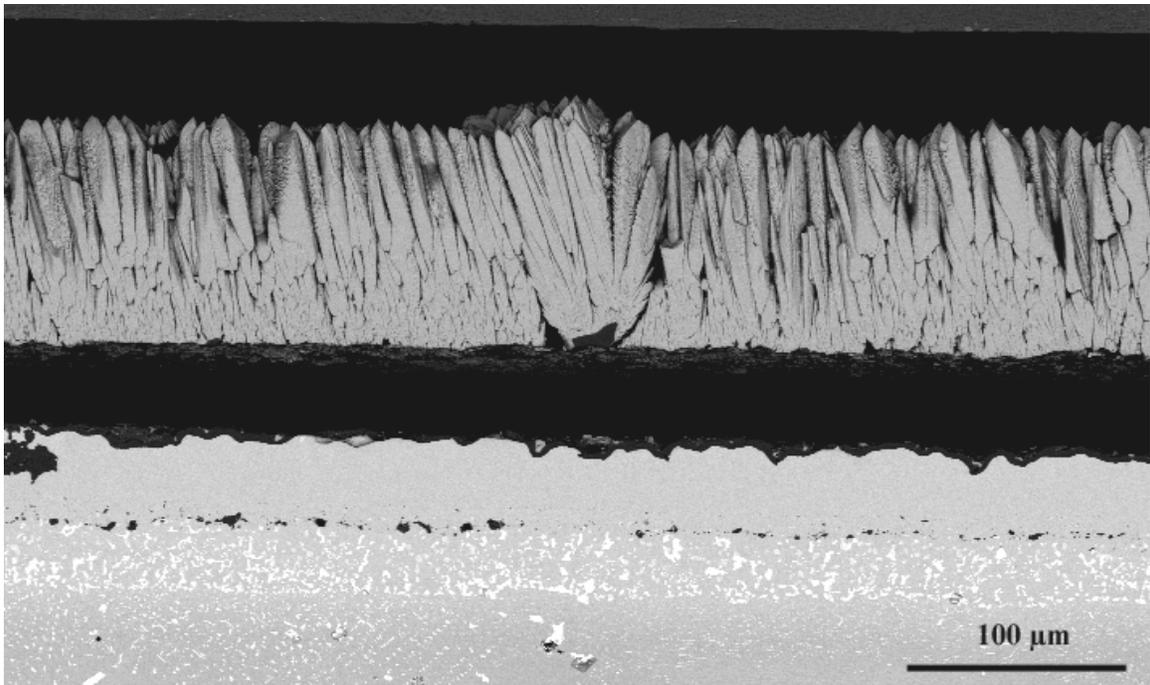
A cross section representing the CE8 system is seen in Figure 7.66. Here it is possible to see that a weak interface between the YSZ and the TGO leads to failure. Moreover, the ratcheting effect is also seen to affect these specimens. The interdiffusion area also seems very dense, and involves the formation of Tantalum-Carbides. Other precipitates included are those seen in N5, ME2, CE1, and CE3. The TGO thickness did not exceed $4\mu\text{m}$ and can be seen in Figure 7.67. Another feature that is visible is the attachment of YSZ grains on the TGO after failure of the TBC system, see Figure 7.68. Figures 6.67 and 6.68 both display martensitic and gamma prime phases seen on the bond coats of the TBC system at failure. Some tantalum is found in the present martensitic phases. Nevertheless, the Ta concentration detected in the gamma prime phase is not as high as those found in the higher failure specimens.

Figure 7.66 Cross section of the TBC system from a CE8 specimen after failure. Observe the rough surface, interdiffusion area and YSZ defect.

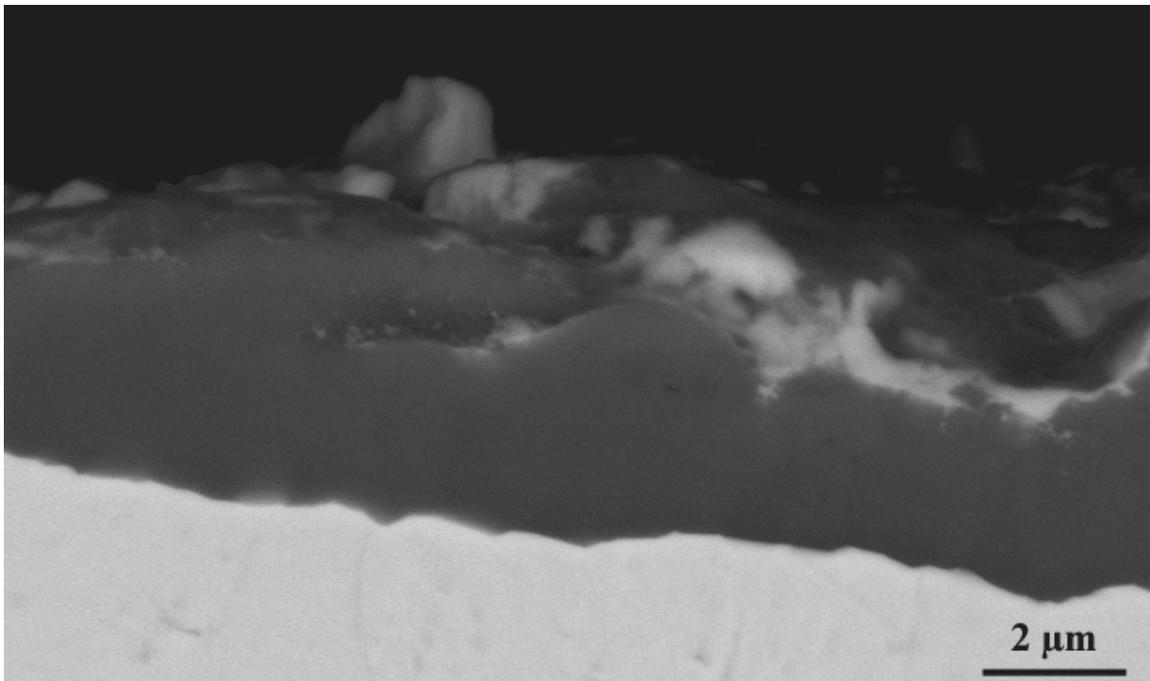
Figure 7.68 Thickness of the TGO did not exceed 4 μm. Martensite and gamma prime are also present.

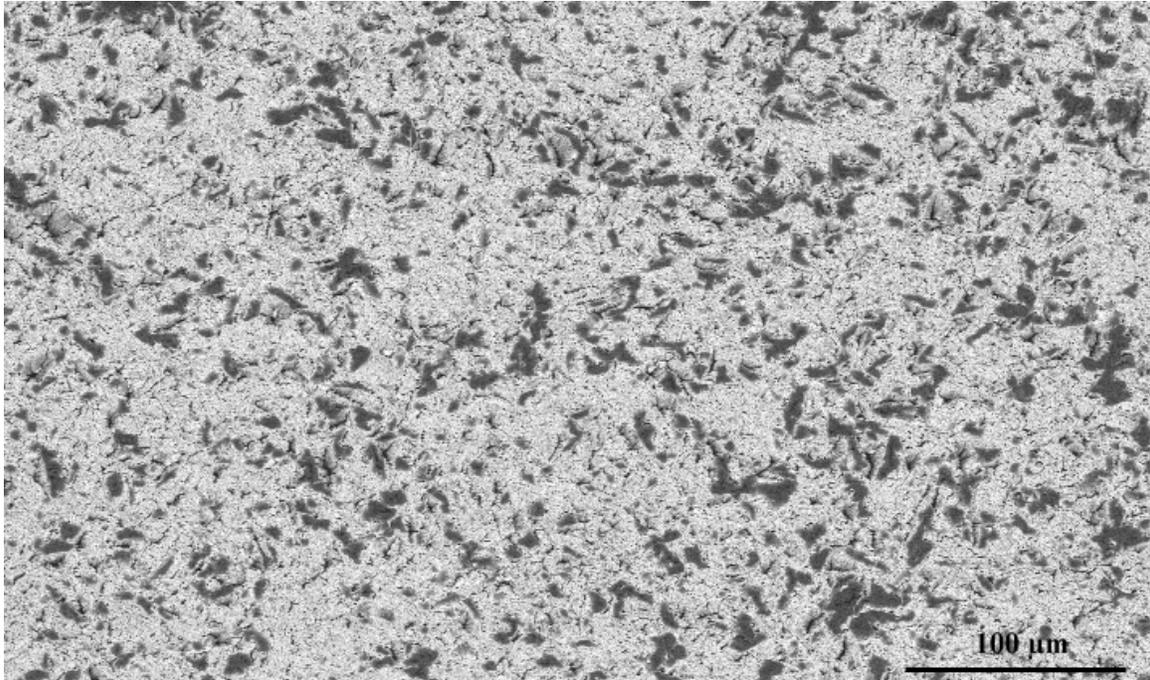
Specimens of the ME13 type failed at an average of 110 cycles per specimen or 13% of N5s total cyclic life. As seen from Figure 7.69, the failure of the TBC system occurred along the YSZ/TGO interface. The failure allowed for the retention of the TGO on the YSZ, while some YSZ also remained on the substrate protected by the TGO. Numerous holes were observed, even more so than for any of the mid range specimens or the high range failure specimens. The holes show traces of Ni, along with Al and O, nevertheless, it is not any sort of spinel. The second figure shows the attachment of the TGO onto the surface of the YSZ interface where it failed (Figure 7.70). Figure 7.71 shows a low magnification micrograph of the failure surface at the substrate, noting the YSZ as white area, gray areas as the alumina, and dark spots as the holes which develop in the surface. Figure 7.72 shows a high magnification micrograph of a group of YSZ grains that have been detached from the YSZ scale during deformation of the bond coat.

Figure 7.69 Standard failure surface of the YSZ from a ME13 specimen, dark area is the TGO and light area is the YSZ.

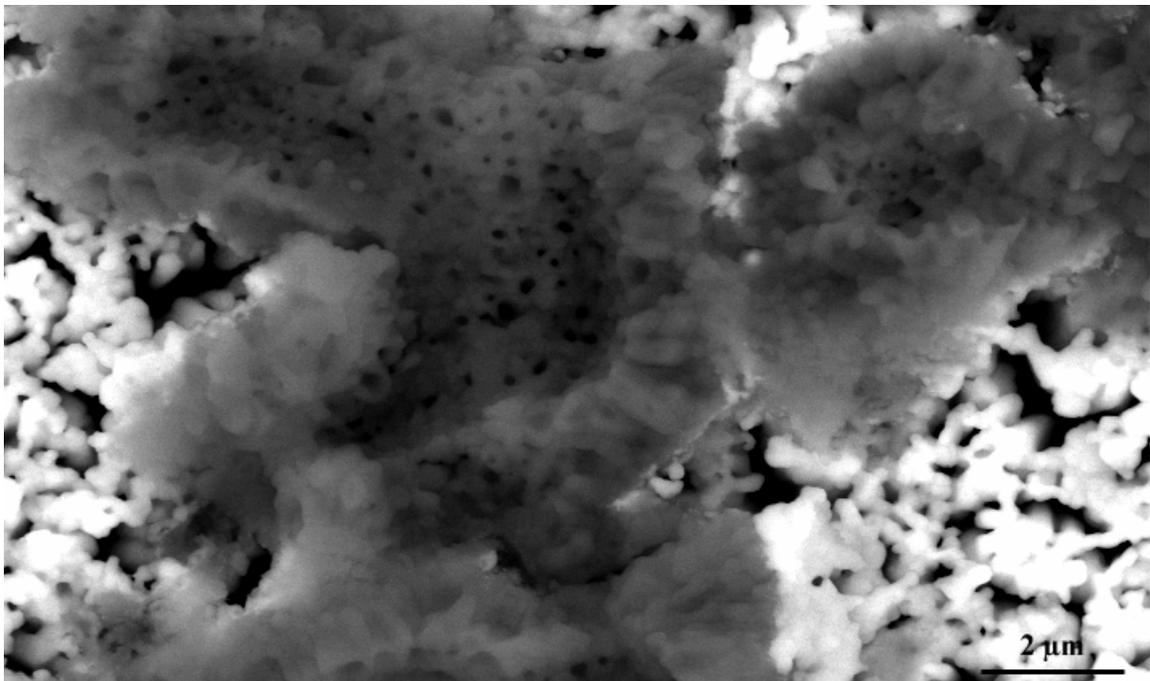
Figure 7.70 TGO bit on the YSZ surface after failure of a ME13 specimen.

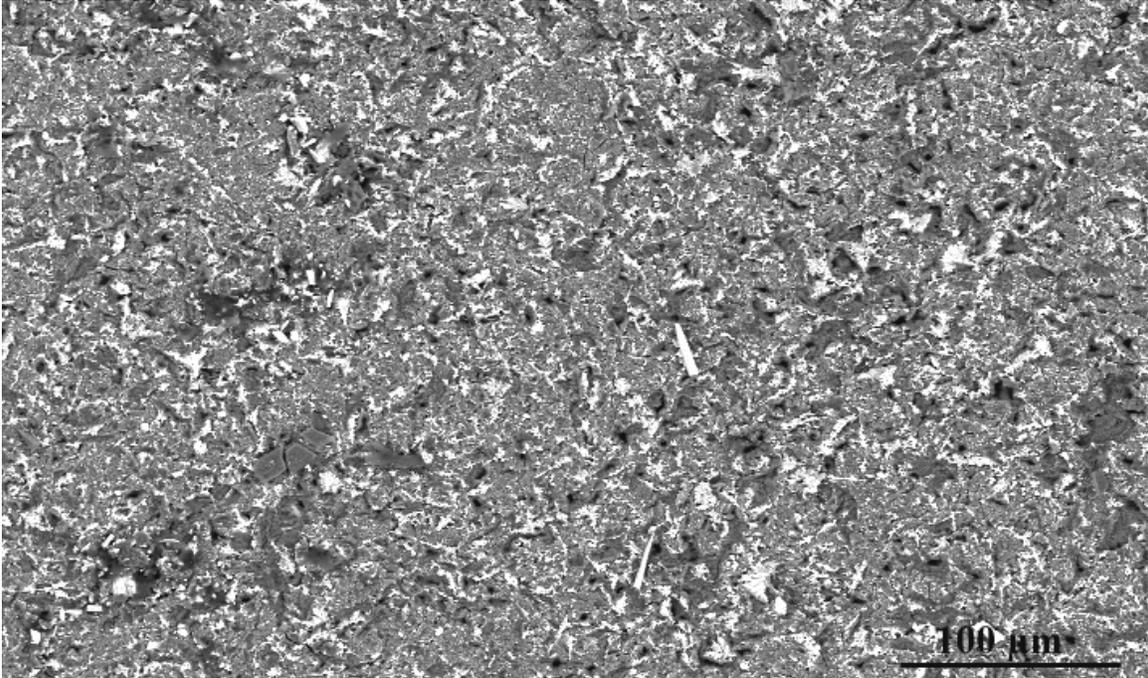
Figure 7.71 Failure surface of the substrate elucidates on the numerous holes, as well as the YSZ debris on the TGO, note there are not any spall areas.

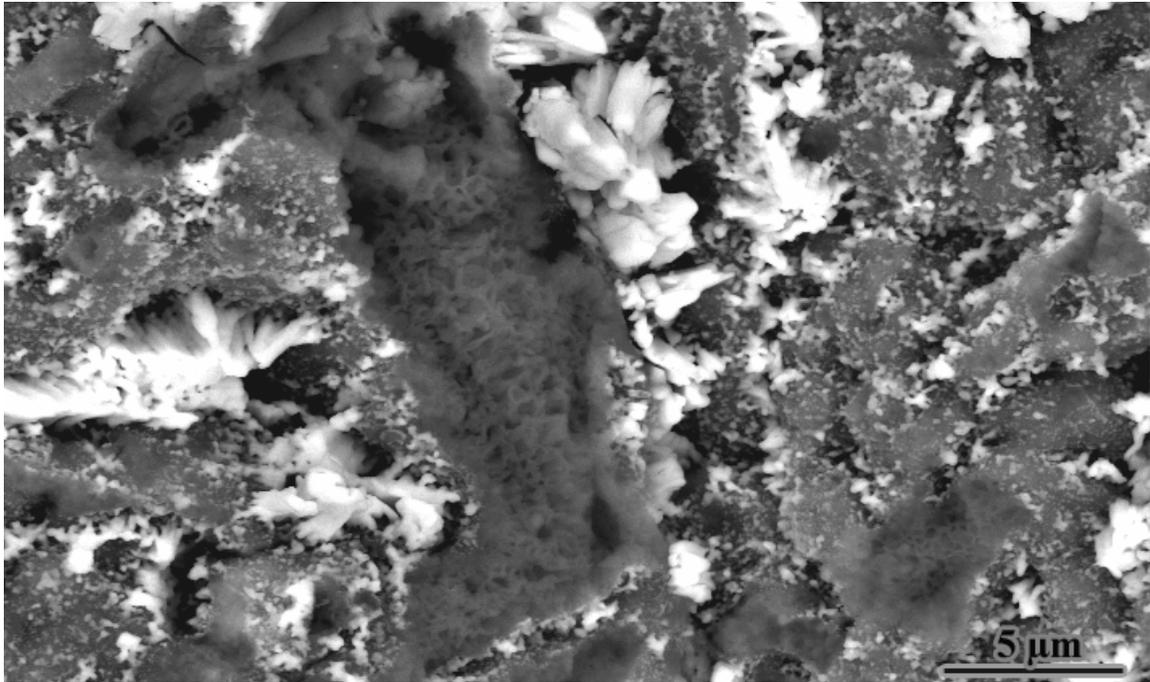
CE6 failed along the YSZ/TGO interface at 65 cycles per specimen or 8% of N5s total average failure. The YSZ surface is seen in Figure 7.77, which shows again the numerous bits that remain attached to the YSZ TBC after failure of the TBC system. By taking a closer look in Figure 7.78, it is easy to see the holes created on the YSZ TBC after failure, along with the TGO bits which are larger than those on N5. The substrate surface on Figure 7.79 contains cracks, and YSZ bits, but not many holes are seen. Figure 7.80 also shows the amount of YSZ that remained on the TGO after failure of the TBC system.

Figure 7.80 Substrate surface shows the TGO, and YSZ debris on the surface of a CE6 specimen.

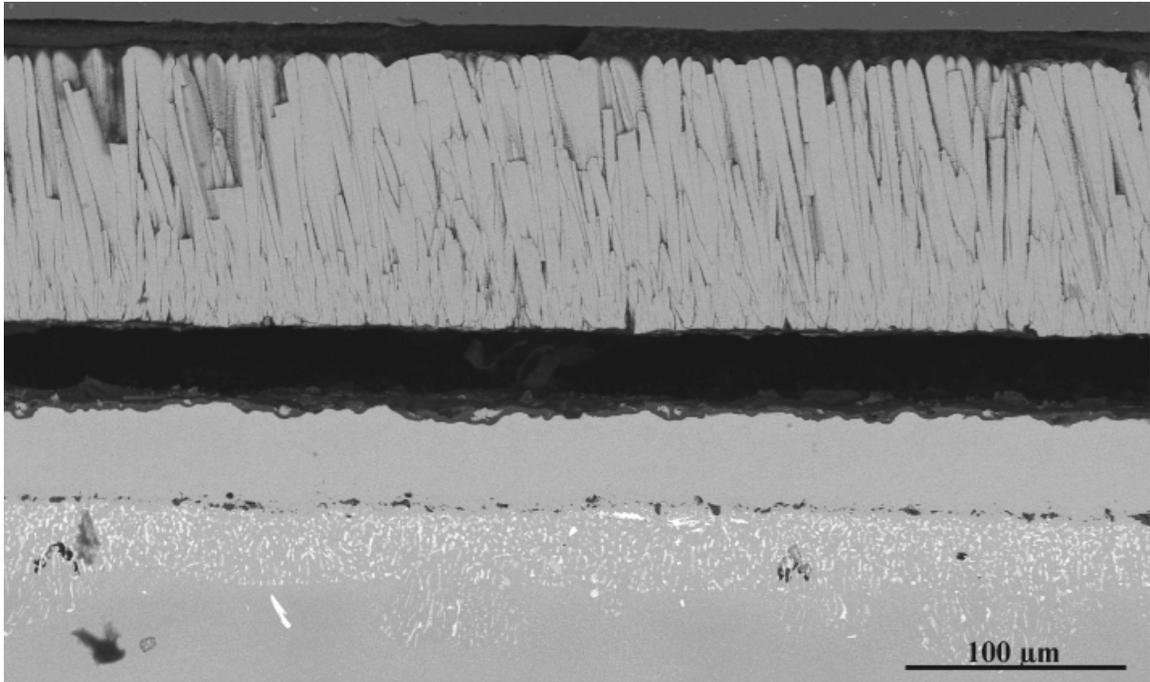
The cross section of CE6 shows similar patterns to those of ME13, posing a large amount of precipitates, a relatively thin TGO, phase composition of the bond coat, and YSZ in the TGO, as well as ratcheting. Figure 7.81 shows the ratcheting effect expanding all along the YSZ/TGO interface. The thickness of the TGO, visible in Figure 7.82 has not exceeded 3 microns and yet contains remains of the YSZ inside. Figures 6.82 and 6.83 also elucidate on the bond coat phase, the bond coat has completely transformed to martensite, there is not any gamma prime. Other features from the cross section is the interdiffusion area. The interdiffusion area is not as thick as that of N5 and additionally forms tantalum carbides, already seen in ME13 and CE8. From Figure 7.84, it is possible to see the number of alumina particles above the interdiffusion area and a thin phase layer composed of gamma prime. Again, as for ME13, gamma prime does not form an interface with the TGO.

Figure 7.81 Cross sectional view of a CE6 substrate and its TBC system after failure.

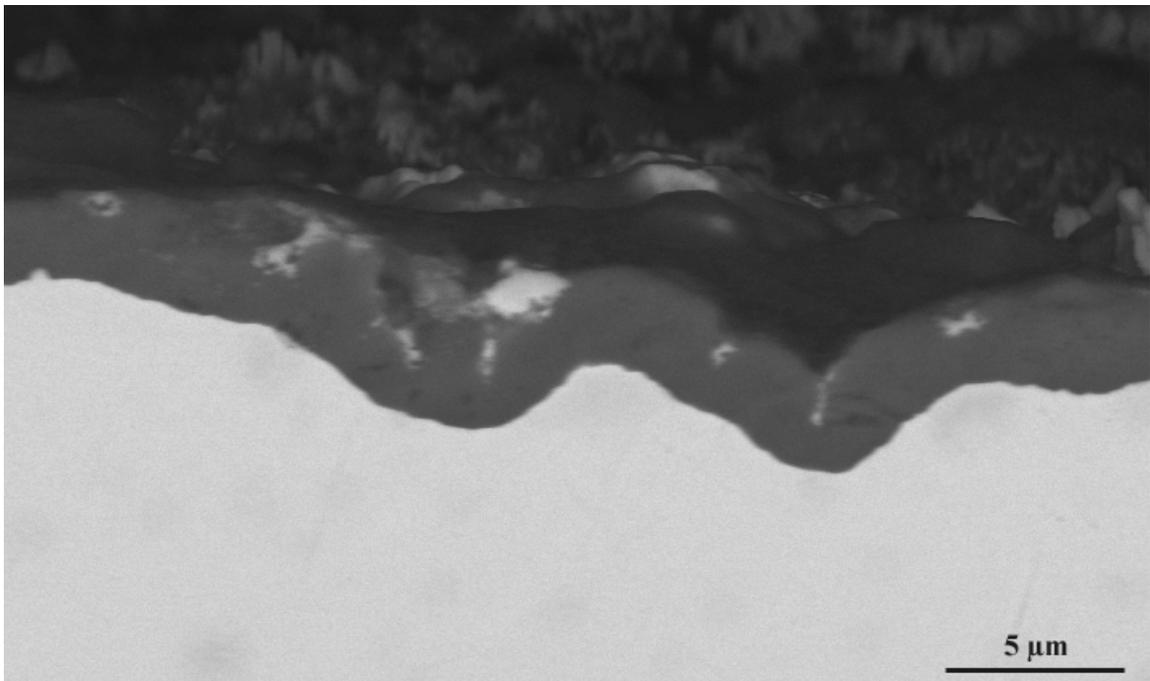
Figure 7.82 TGO thickness shows a relatively thin TGO and YSZ debris, note the homogeneous phase of the bond coat.

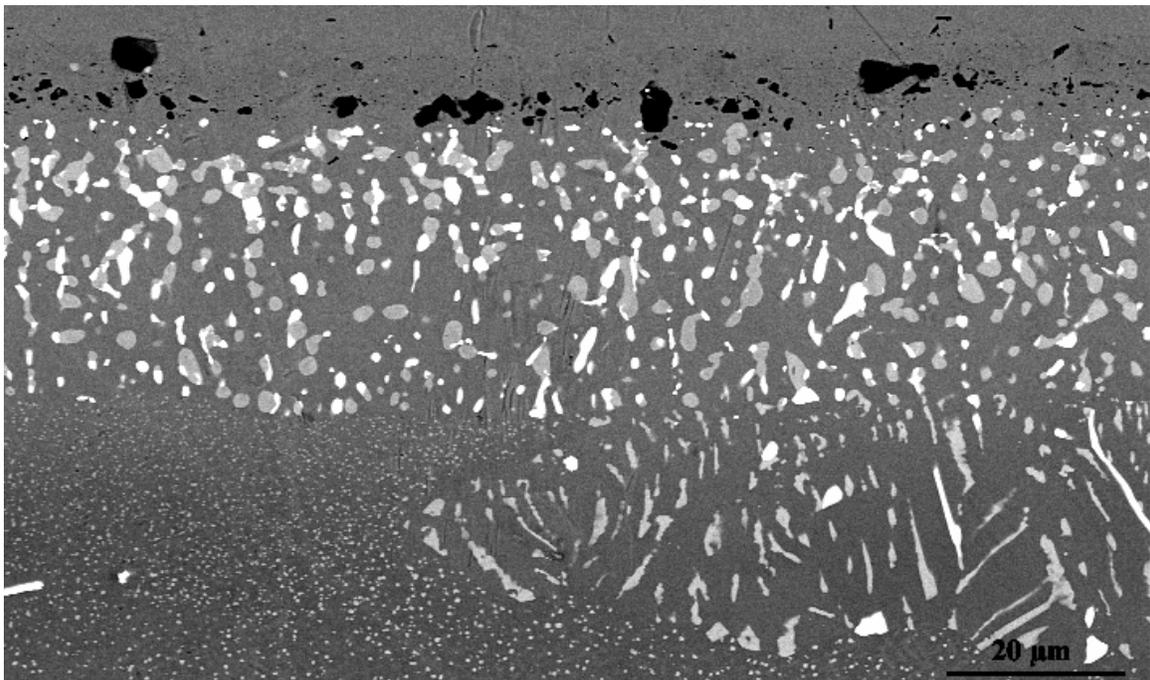
Figure 7.84 Interdiffusion area of a CE6 specimen shows numerous precipitates including the formation of carbides and other precipitates.
