DEGRADATION OF TBC SYSTEMS IN ENVIRONMENTS RELEVANT TO ADVANCED GAS TURBINES  
FOR IGCC SYSTEMS

Submitted to the Graduate Faculty of  
the Swanson School of Engineering in partial fulfillment

Doctor of Philosophy

University of Pittsburgh

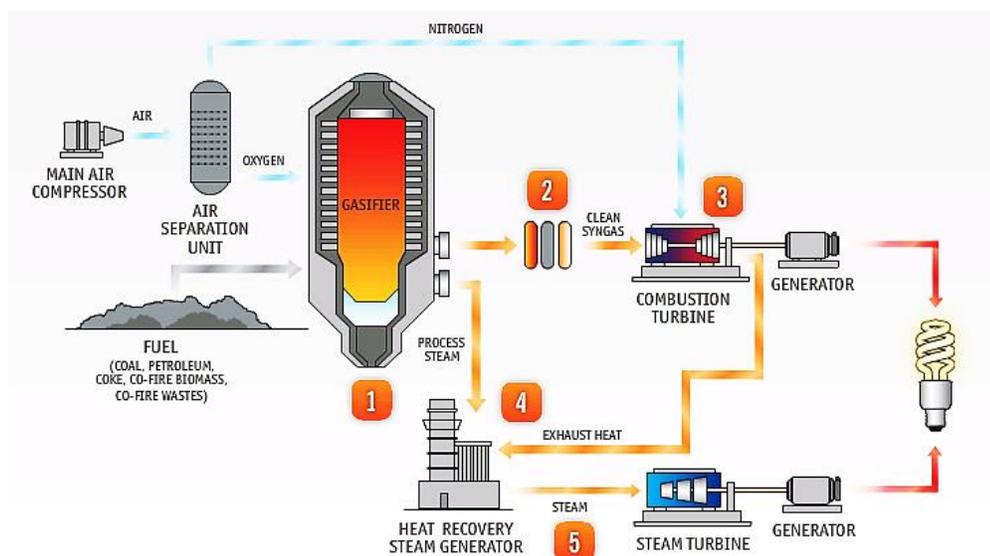
The IGCC process, like other combined cycle power generation methods, takes advantage of steam which is generated from the primary combustion turbine and generates additional electricity using a steam generator [14]. In addition to this, the IGCC process also utilizes steam generated by the gasification process itself to generate electricity via the steam turbine. Figure 1 shows the layout of an IGCC process [15].

**Figure 1:** Overview of the IGCC Process [15].

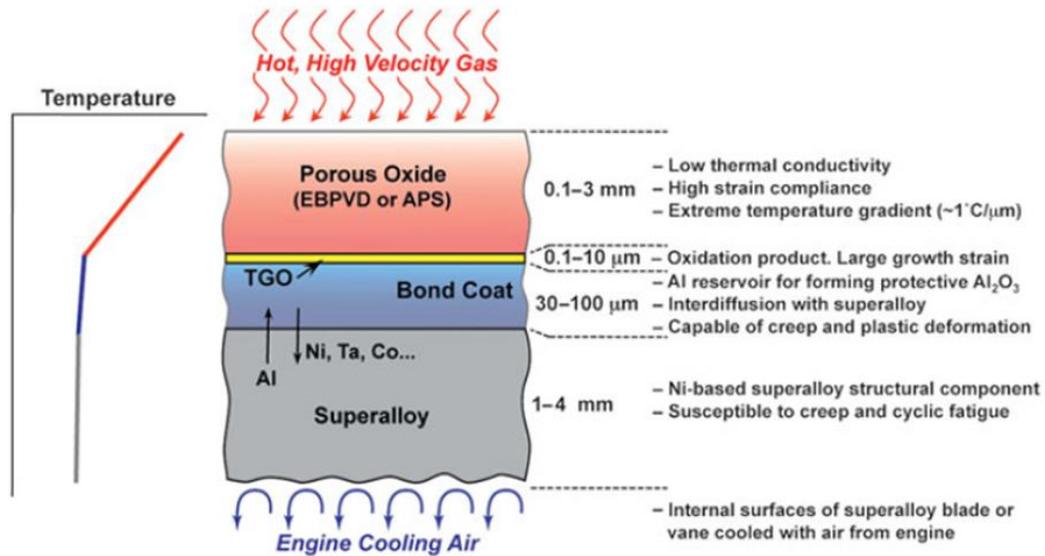
The thermal barrier coating system shown in Figure 2 is constructed of three layers: (1) the bond coat attached to the substrate, (2) a thermally grown oxide (TGO) on the bond coat, and (3) a top coat. Each of the layers above the substrate needs to exhibit good adherence to the other layers around it. These layers also need to exhibit minimal coefficient of thermal expansion (CTE) mismatch with the substrate in order to avoid detrimental stresses upon thermal cycling [25, 26].

**Figure 2:** Overview of the TBC system [21].

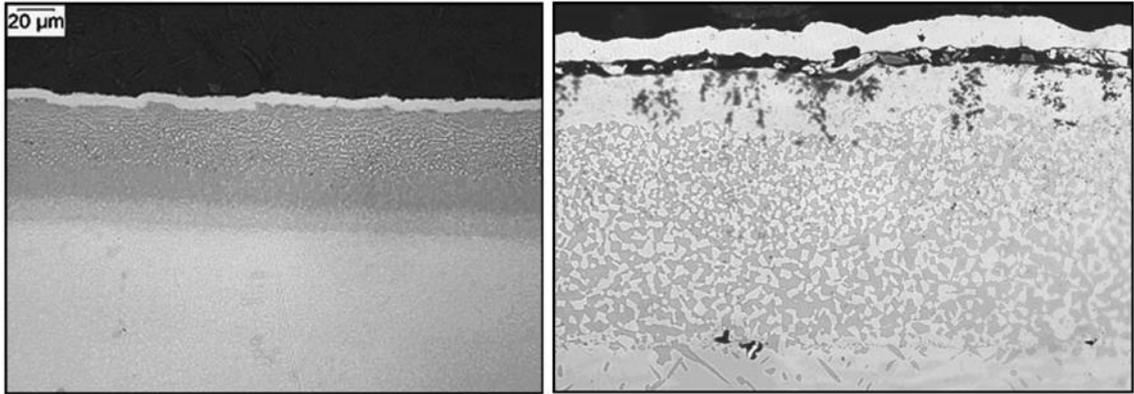
**Figure 3:** (a) Two phase platinum aluminide diffusion coating, and (b) MCrAlY overlay coating, showing depletion of dark  $\beta$ -phase from alumina growth [27].

alumina-forming alloy. The addition of aluminum necessary to form continuous alumina would adversely affect its mechanical properties. The bond coat, however, does not have any substantial structural requirements and thus can contain the necessary aluminum concentration to form  $\alpha$ -alumina [27]. The ability of the bond coat to grow and maintain  $\text{Al}_2\text{O}_3$  is an important requirement for durability of the system. Transient oxides other than  $\text{Al}_2\text{O}_3$ , and other allotropes of  $\text{Al}_2\text{O}_3$  (such as  $\theta$ - $\text{Al}_2\text{O}_3$ ) can have detrimental effects on the system durability. Two types of bond coats are most commonly used in TBC systems: diffusion aluminide coatings, and plasma sprayed overlay coatings[23]. An example of each is shown in Figure 3 [27].

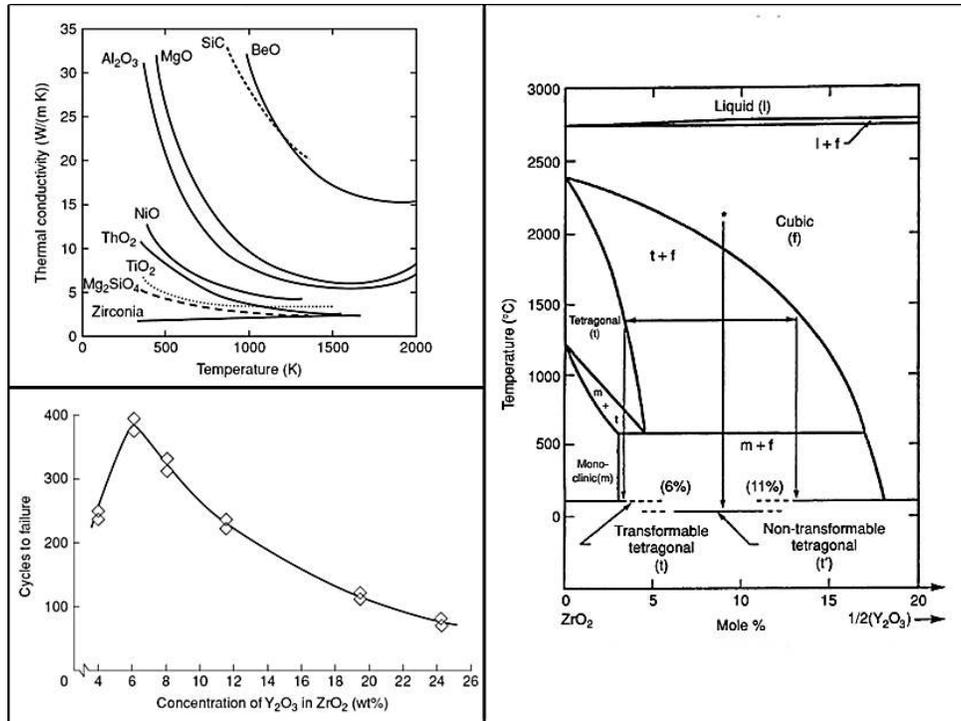
**Figure 4:** (a) Thermal conductivity of ZrO<sub>2</sub> compared to other materials, (b) a portion of the ZrO<sub>2</sub>-Y<sub>2</sub>O<sub>3</sub> phase diagram and (c) cycles to failure as a function of Y<sub>2</sub>O<sub>3</sub> [29].

The portion of the ZrO<sub>2</sub>-Y<sub>2</sub>O<sub>3</sub> phase diagram in Figure 4 shows the relevant phases for TBC applications. The three phases at temperatures of interest for current TBC requirements (~1100°C) are the tetragonal (t), cubic (c), and monoclinic (m) phases. The addition of around 7-wt% Y<sub>2</sub>O<sub>3</sub> (~4-mol%) results in a metastable phase in the two-phase region between t and c which is labeled non-transformable t' phase. (Here it lies at ~8-mol% because mol% is shown as YO<sub>1.5</sub>.) At 1100°C, the 7YSZ should separate into a Y-lean tetragonal phase and a Y-rich cubic phase, and upon cooling the tetragonal phase would transform into the monoclinic phase as it crosses over the T<sub>0</sub> (t/m) line [30]. Below this line, the monoclinic phase is stable. This phase change occurs

Zirconia ( $ZrO_2$ ) has been used extensively in structural applications for several decades due to the fact that it can be stabilized with other oxides in order to control its mechanical properties [28]. It has been used extensively in TBCs because of its low thermal conductivity. The most commonly used ceramic for TBC top coats is zirconia that is partially stabilized with yttria ( $Y_2O_3$ ). The yttria stabilized zirconia (YSZ) coating exhibits low thermal conductivity, relatively high coefficient of thermal expansion (CTE), excellent adhesion to the  $Al_2O_3$  layer, and high strain tolerance [6, 24, 25]. The YSZ top coat must also demonstrate resistance to delamination upon thermal cycling. The addition of 6-8 wt% yttria, commonly referred to as 7YSZ, has become the most widely used material for TBC applications. This is partly as a result of its superior durability in thermal cycling, as shown in Figure 4.

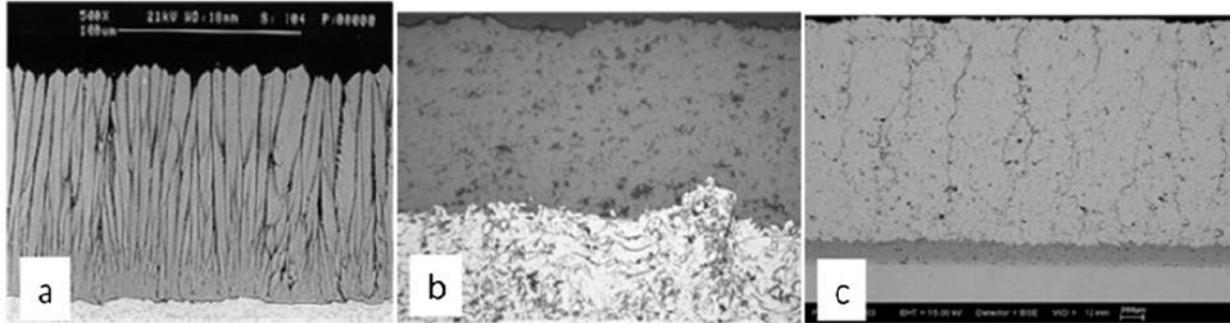
**Figure 5:** Comparison of (a) EBPVD, (b) APS, and (c) DVC ceramic top coats [24].

Two common techniques have been widely used to deposit the YSZ top coat layer of TBCs: the air plasma spray (APS) process and electron beam chemical vapor deposition (EB-PVD) [35]. The two processes are fundamentally different in that the  $t'$  phase in EB-PVD grows directly from the vapor phase, whereas in APS coatings it evolves from the transformation from a liquid phase as it cools across the  $T_0(c/t)$  curve. These differences result in different microstructures in the two types of YSZ [28]. An APS coating is characterized by a “splat” morphology and horizontal cracks which run parallel to the substrate. The surface of the substrate is rough, which leads to undulations at the interface of the YSZ and the TGO. This surface roughness helps the adherence between the bond coat and YSZ. In contrast, the EB-PVD top coat morphology is characterized by a columnar structure and a relatively smooth substrate surface [25]. TBCs with APS coatings are generally cheaper to produce and can be applied to much larger surfaces, making them the preferred top coats for land based turbines. The different YSZ structures lead to varying properties. The APS TBCs tend to have a lower thermal conductivity due to the splat morphology and overall lower density [27]. The EB-PVD coatings exhibit a superior strain tolerance and erosion resistance due to the columnar structure. The rough surface of the APS top coat compared to the planar EBPVD interface also affects failure mechanisms which will be discussed in another section. The dense vertically cracked (DVC) TBC is a variation of the APS top coat which incorporates a dense YSZ body, but produces vertical cracks similar to that of the EB-PVD coat [25]. The DVC top coat offers some advantages (and disadvantages) of each of the other two top coats. Micrographs showing typical morphologies of all three top coats are shown in Figure 5.

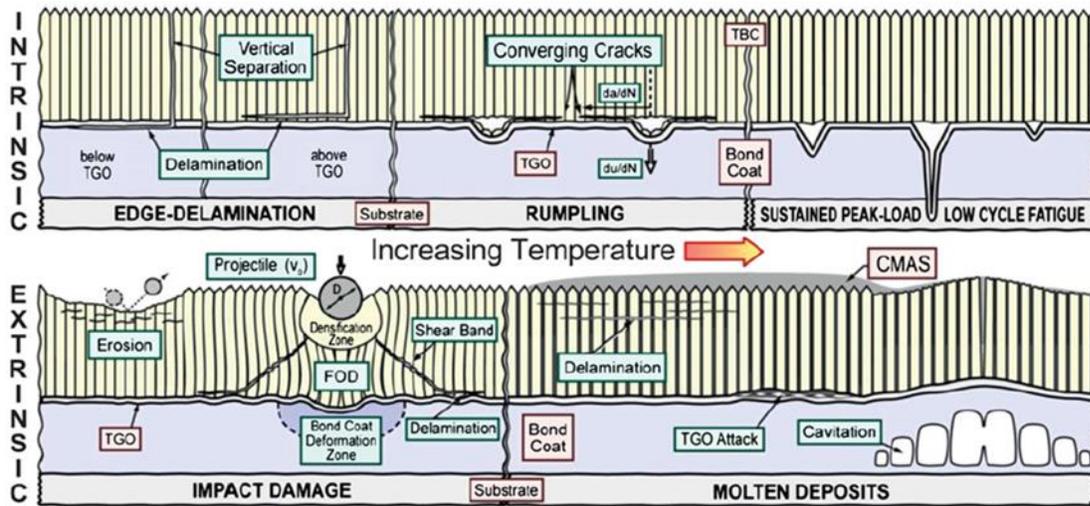
**Figure 6:** TBC failure mechanisms [45].

TBCs typically fail when cracks form and propagate in the top coat, causing the YSZ to delaminate and spall off. Since the TBC is not self-healing, once the spalling has occurred the life of the TBC is over [23]. Figure 6 summarizes the most common failure mechanisms which lead to the spallation of the YSZ layer in a TBC. They are classified into two broad categories: intrinsic mechanisms which arise from factors within the TBC system, and extrinsic mechanisms which arise from external factors [44].

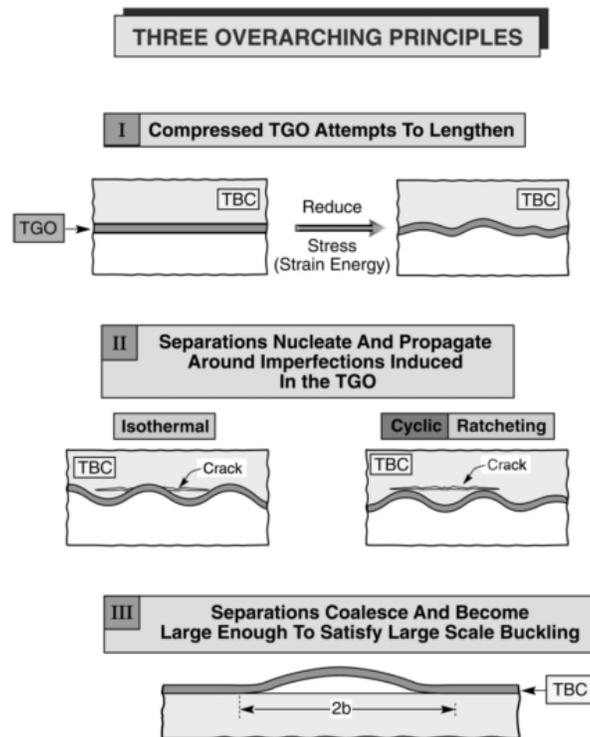
Figure 7 highlights general principles which govern stress as well as crack formation and propagation at undulations in the YSZ/TGO interface [25]. Initially, the TBC experiences in-plane compressive stress upon cooling due to CTE mismatch with the substrate. The interface attempts to alleviate this stress through deformation of the bond coat, which also causes out-of-plane tensile stress normal to the interface. Cracks eventually form as a result of TGO growth after thermal exposure. The location of crack formation can vary depending on thermal history, but the cracks generally originate from imperfections or defects. Eventually cracks grow and coalesce to cause large-scale delamination.

**Figure 7:** Overarching principles affecting TBC delamination[25].

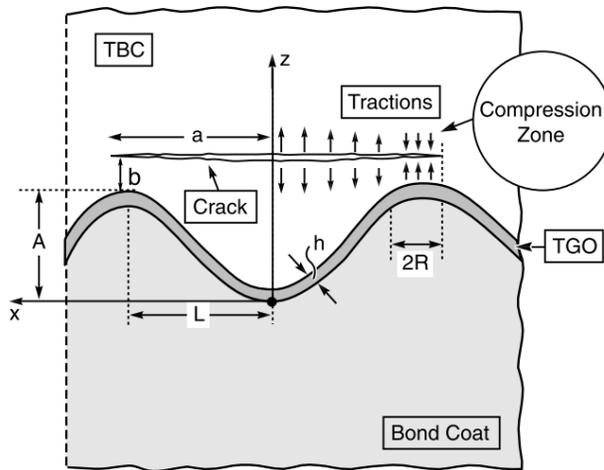
TGO growth, thermal expansion coefficient mismatch between TBC layers, and deformation in the TGO and bond coat [47]. Figure 9 shows the residual stresses in the TBC due to TGO growth and thermal cycling. The stresses in the top coat normal to the YSZ/TGO interface alternate between regions of tension and compression. As the TGO grows and stresses increase, cracks originate in the tensile regions. These cracks spread through the tensile stress region, but are arrested when they encounter regions of compressive stress. After further thermal cycling, the energy release rate is large enough to propagate the crack all the way through the region of compressive stress into the next area of tensile stress. Eventually, these spreading cracks meet and large-scale delamination occurs.

**Figure 9:** Crack propagation in APS top coat [47].

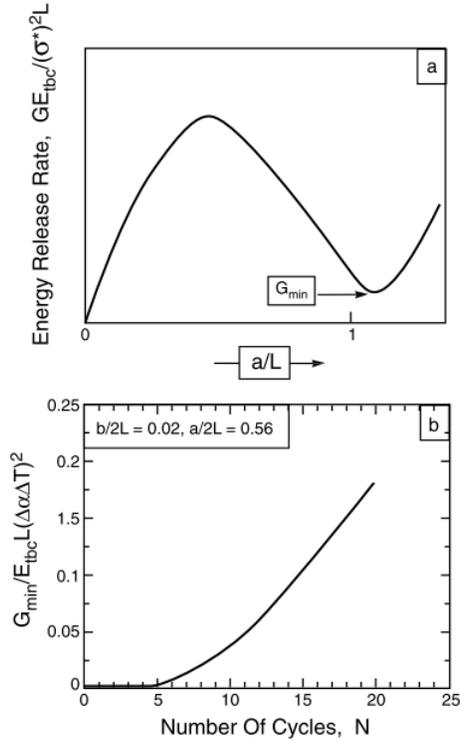
Where  $N_0$  is the number of cycles before  $G_{\min}$  increases linearly. The value of  $k$  is dependent on assumptions made about the TGO and bond coat. Figure 10 shows the energy release rate as a function of crack length, and also the change in  $G_{\min}$  upon cycling.

**Figure 10:** Minimum energy release rate for large scale delamination of TBC top coat [47].

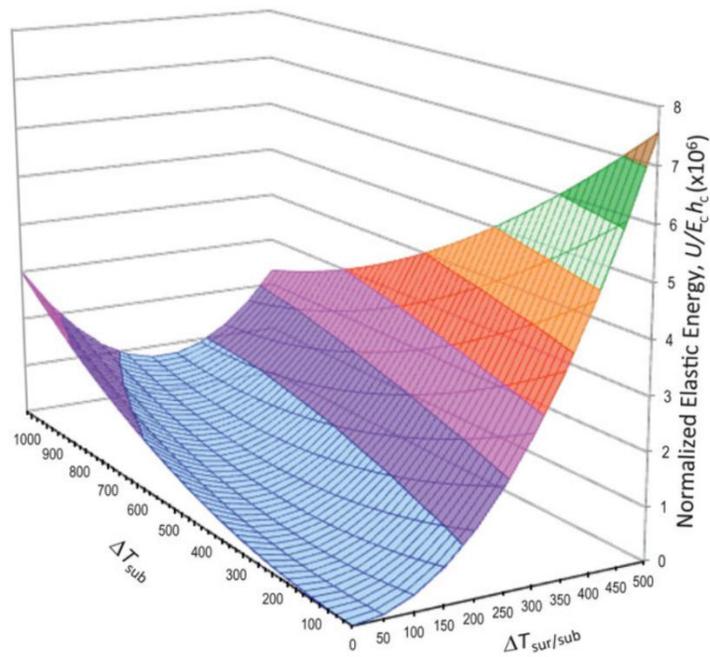
Equation 2-6 shows that the stored energy in the YSZ is determined by two competing factors: compressive stress arising from cooling of the substrate,  $\Delta T_{SUB}$ , and tensile stress arising from cooling of the surface relative to the substrate,  $\Delta T_{SUR/SUB}$ . The stored elastic energy/unit area is plotted in Figure 11 normalized to  $U/E_c h_c$ . The  $\Delta T_{SUB}$  axis represents isothermal heating/cooling where the TBC surface is assumed to be heated and cooled to the same temperatures as the substrate ( $\Delta T_{SUR/SUB}=0$ ). In some regimes, the cooling of the surface can somewhat reduce overall strain energy. Larger values of  $E$  and/or  $h_c$  would cause strain energy to increase. This agrees with previous studies which have reported reduced lifetimes for increasing TBC thickness [50] and also liquid infiltration from CMAS [51].

**Figure 11:** Normalized elastic energy/area in the TBC coating [45].

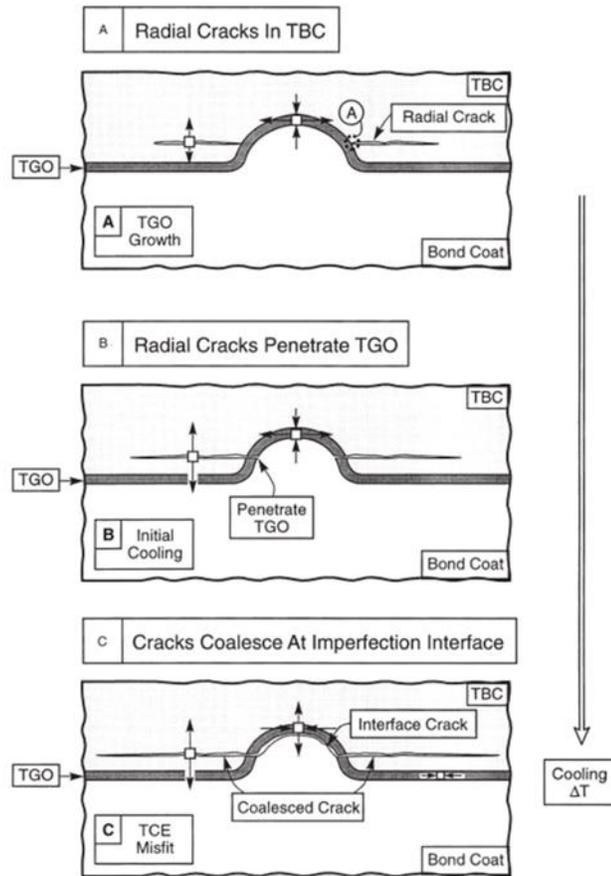
The severity of thermal cycling is determined not only by the maximum temperature, but also by the difference between maximum and minimum. Imperfections which form in the thickening TGO cause a significant amount of stress upon cycling [52]. Figure 12 shows the cracking sequence around a growth misfit as the temperature is decreased in a thermal cycle. Radial cracks can initiate in the top coat near an imperfection. As the system cools during the thermal cycle, the CTE mismatch between layers results in a large tensile stress. Eventually, cracks coalesce and spallation occurs through the TGO at the imperfection.

**Figure 12:** Stress-induced cracking around a growth misfit upon thermal cycling [52].

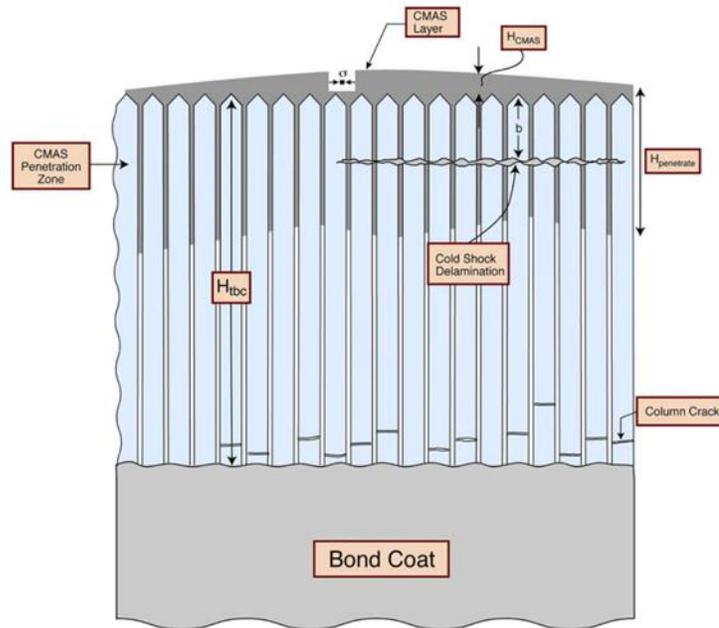
Thermo-mechanical damage to TBC top coats results from changes in the mechanical properties of the YSZ from CMAS infiltration. Figure 13 illustrates a typical CMAS attack on an EB-PVD coated TBC [64]. Molten CMAS penetrates the porous YSZ where it solidifies due to the imposed thermal gradient in the TBC. The solidified CMAS layer causes stress in the YSZ because of the loss of strain tolerance, increased modulus, and low thermal expansion coefficient [64]. The modulus of elasticity in the CMAS-penetrated region can be raised by as much as a factor of three [45]. The infiltrated YSZ eventually spalls from the TBC upon rapid cooling, and in the

**Figure 13:** Schematic of CMAS attack on an EB-PVD TBC [64].

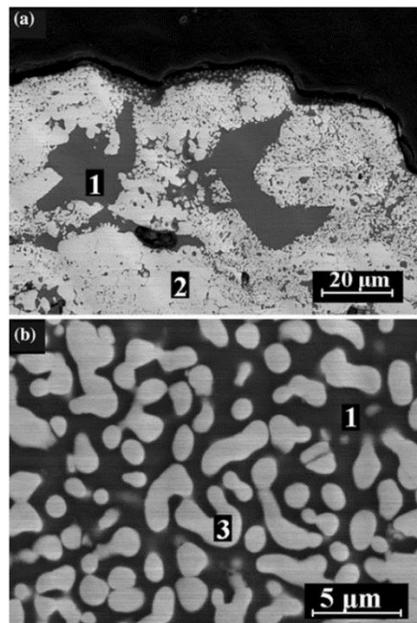
completely different morphology. The columns of an EBPVD coating, or the splats of an APS coating, would be replaced by globules of transformed YSZ. Figure 14 shows an APS YSZ coating of a TBC which has been attacked by liquid CMAS, resulting in dissolution and reprecipitation of the YSZ [65]. The porous structure of the YSZ is completely destroyed, and the reprecipitated  $ZrO_2$  grains are not the same composition of YSZ compared to the original coating.

**Figure 14:** APS TBC top coat that has been infiltrated by CMAS at 1300°C. Regions 1 and 2 show a CMAS island and an unaffected region of YSZ, respectively. Region 3 shows YSZ that has been dissolved by liquid CMAS and reprecipitated [65].

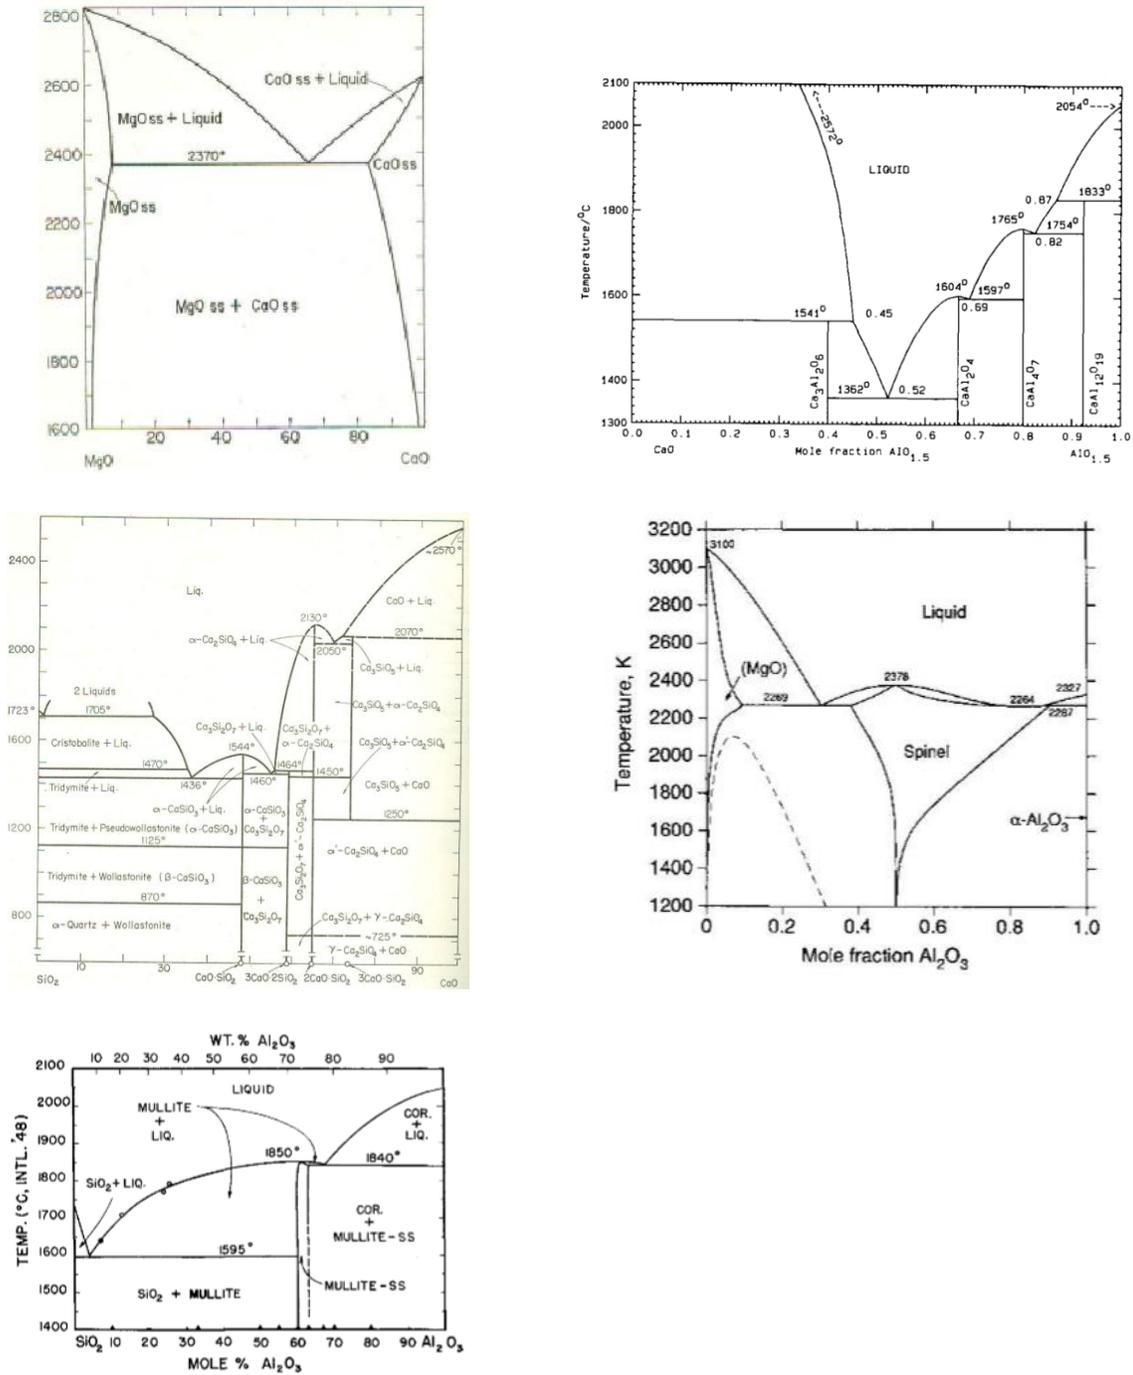
**Figure 15:** Binary phase diagrams of oxide constituents which comprise CMAS deposits. Phase diagrams are shown for the MgO-CaO [82], CaO-Al<sub>2</sub>O<sub>3</sub> [83], SiO<sub>2</sub>-CaO [82], MgO-Al<sub>2</sub>O<sub>3</sub>[84], and SiO<sub>2</sub>-Al<sub>2</sub>O<sub>3</sub> [85] systems.

Damage from infiltration requires liquid formation from two or more oxide constituents in the CMAS deposit. If one considers binary mixtures of the primary CMAS oxide constituents, the minimum temperatures for liquid formation can be identified. The binary phase diagrams between the oxide components shown in Figure 15 do not indicate any liquids formed from eutectic compounds below 1360°C. This shows that liquid silicate infiltration from CMAS which has been observed at temperatures ~1250°C involves more than two oxides.

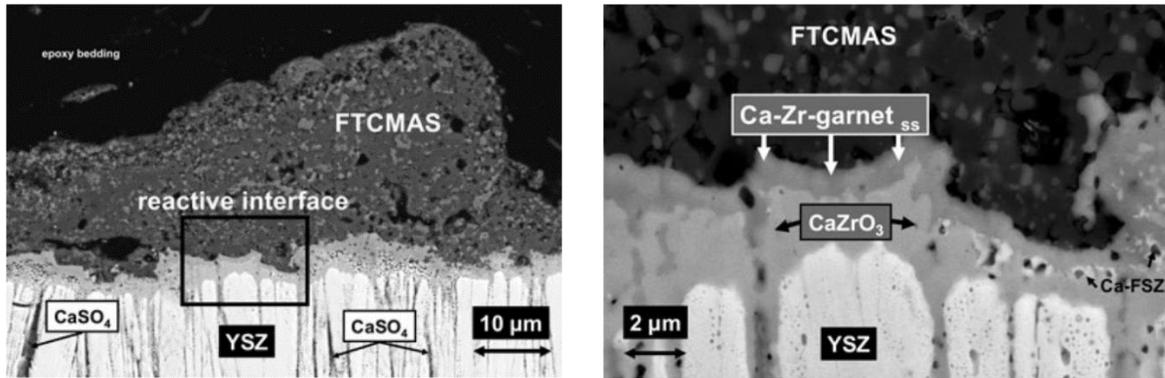
**Figure 16:** Corrosion of EB-PVD TBC from Fe, Ti-rich CMAS (FTMAS). (a)  $\text{CaSO}_4$  infiltration was observed in open pores of YSZ and FTCMAS deposit on surface. (b) Closer inspection of the FTCMAS/YSZ interaction revealed additional Ca-containing layers [91].

Recent CMAS studies, however, of in-service turbine blades have identified corrosion which involves Ca-rich deposits which degrade TBCs by a process that involves reaction with YSZ in the solid state [90-93]. Substantial  $\text{CaSO}_4$  infiltration shown in Figure 16(a) was observed deep into the inter-columnar gaps of the EB-PVD YSZ. The TBC surface shown in the figure was covered with a Fe,Ti-rich crystalline CMAS (FT-CMAS) deposit. The FT-CMAS was likely deposited from particle impingement on the turbine components resulting from impurities in the gas atmosphere. A magnified image near the YSZ surface shown in Figure 16(b) indicates two additional layers: a Ca-Zr-garnet, and a  $\text{CaZrO}_3$  layer. The  $\text{CaZrO}_3$  layer formed from a solid-state reaction between  $\text{CaSO}_4$  and  $\text{ZrO}_2$  at the expense of the YSZ, which left the column tips blunted

The reaction layers shown in Figure 16 occurred instead of typical molten silicate infiltration because the deposit contained lower levels of  $\text{SiO}_2$  compared to typical CMAS degradation studies. The  $\text{CaZrO}_3$  layer is expected to be stable under zero or very low Si-activity. The formation of distinct layers was explained by the temperature dependence of the stable phases shown in Figure 17. The temperature at the column tips during operation would be around 1150-1200°C. Laboratory experiments with  $\text{CaSO}_4$ /YSZ mixtures showed that the onset of  $\text{CaZrO}_3$  formation occurred around 1150°C [91]. The garnet formed at increased temperatures of >1200°C further from the column tips.

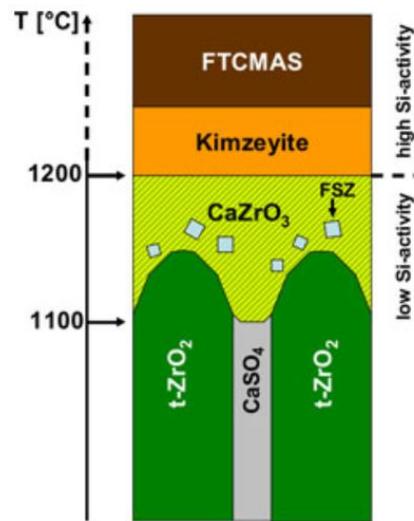
**Figure 17:** Schematic of FTCMAS degradation of EB-PVD TBC showing layers of corrosion [91].

The reported layers of YSZ degradation caused by  $\text{CaSO}_4$  and FT-CMAS are summarized in the schematic in Figure 17. The infiltrated  $\text{CaSO}_4$  regions were attributed to a vapor phase deposition in the YSZ pores from a Ca- and S-rich vapor phase prior to FT-CMAS impingement. The  $\text{CaSO}_4$  near the surface reacted with the YSZ to form  $\text{CaZrO}_3$ . The fully-stabilized  $\text{ZrO}_2$  grains formed from Y-rich  $\text{ZrO}_2$  that did not react to form  $\text{CaZrO}_3$ . The Ca-Zr-garnet layer that formed between the  $\text{CaZrO}_3$  was determined to be kimzeyite,  $\text{Ca}_3(\text{Zr,Ti,Fe})_2(\text{Al,Fe,Si})_3\text{O}_{12}$  [91]. This garnet layer was inferred to have formed predominantly from a solid-state reaction at the expense of the YSZ.

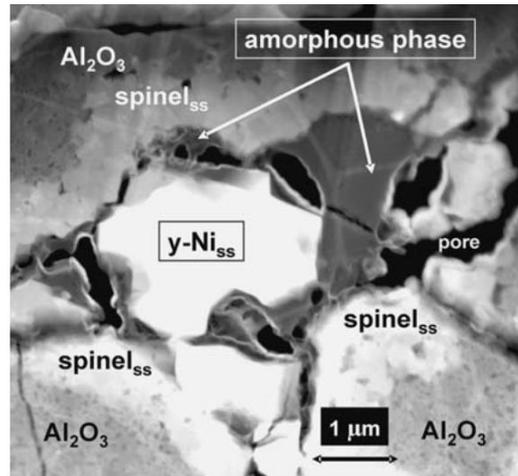
**Figure 18:** Inter-diffusion between  $\text{CaSO}_4/\text{FT-CMAS}$  constituents and TGO [92].

Some TBC degradation from FT-CMAS was also observed at the TGO/bond coat interface [92]. The TEM image in Figure 18 shows pockets of amorphous TGO which contained  $\text{CaSO}_4$  and CMAS components (Mg, Ca, S). Newly formed spinel phases ( $\text{CaTiO}_3$ ,  $\text{MgAl}_2\text{O}_4$ ) also indicated

some inter-diffusion with the deposit. This degradation at the TGO could contribute to cracking and eventual spallation of the TBC; although, such failure was not observed in these studies.

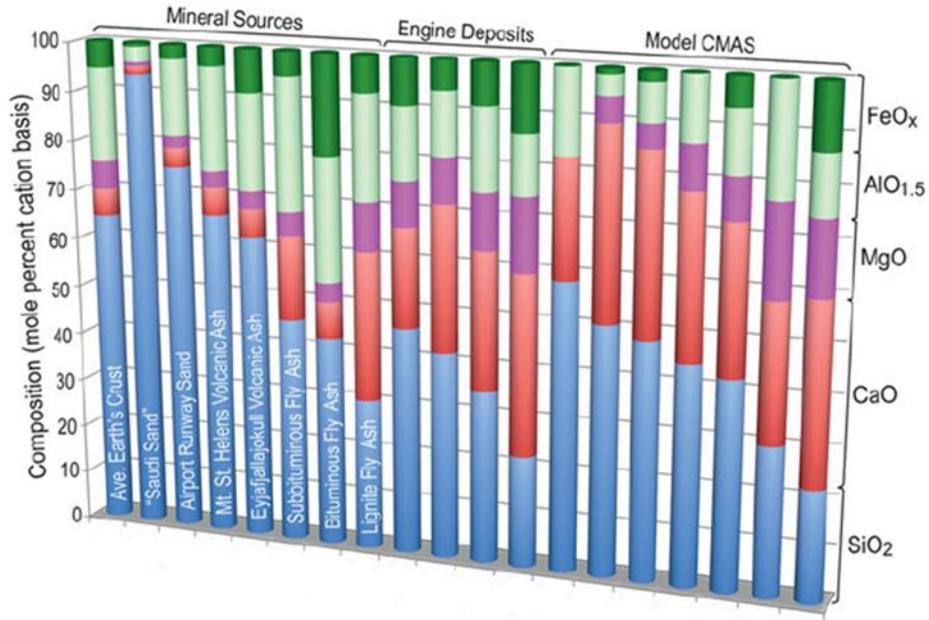
**Figure 19:** Comparison of common CMAS and fly-ash compositions[45].

Figure 19 shows a comparison between common CMAS compositions and typical fly-ash from various sources. One primary difference between typical fly-ash and is a greater concentration of sulfur containing species such as  $K_2SO_4$ ,  $Na_2SO_4$ , and FeS that can enter the ash from the initial fuel source or interaction with engine components upstream from the TBC [45, 94]. Another main difference between CMAS and fly-ash is that the operating temperatures of land based turbines tend to be lower than those of aeroengines. The overall melting point of the deposit is therefore not exceeded, and in many cases the degradation is the result of a solid state interaction between the deposit and TBC. In some cases, partial melting of some constituents may result in some degradation similar to CMAS.

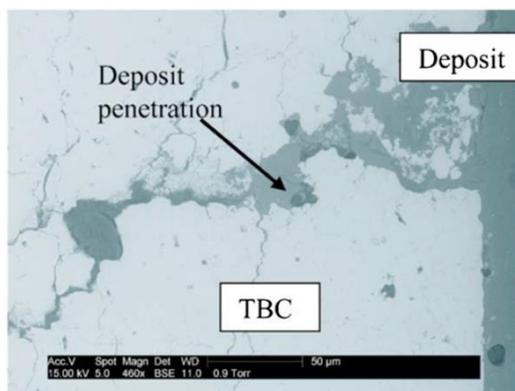
**Figure 20:** Coal fly-ash that has been reacted with a DVC TBC [94].

Previous studies have shown some interaction between fly-ash and TBCs. Figure 20 shows the DVC top coat of a TBC which has been reacted with a coal fly-ash deposit with a composition similar to Table 1 [94]. Some ash deposit can be seen to have penetrated a large crack in the TBC surface. This can be detrimental to the overall lifetime of the TBC because the vertical cracks are necessary to provide strain tolerance in thermal cycling. The infiltration could potentially cause spallation similar to a cold shock mechanism found in CMAS degradation. The infiltration could be made worse with additional levels of lower melting salts such as KCl and  $K_2SO_4$  which could bind fly-ash particles together [94]. The detrimental effects of this type of infiltration in TBCs are not well understood.

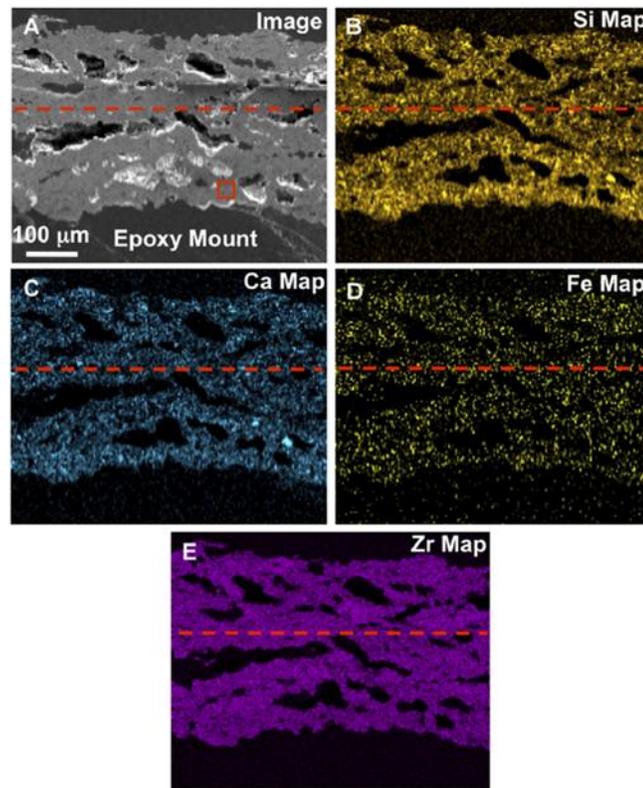
**Figure 21:** APS TBC that has been reacted with lignite fly-ash.[98]

Another recent study has examined damaging effects of lignite fly-ash in APS TBCs and mitigation strategies [66]. Figure 21 shows fly-ash has penetrated through the APS coating to the substrate after a 24 hour exposure at 1200°C. Molten fly-ash filled the voids in the YSZ and caused

delamination of the TBC from the substrate. The elemental maps show that fly-ash constituents have penetrated through the entire thickness of the YSZ. Clearly when heated beyond the melting temperature of the ash, the interaction with the TBC is similar to that of CMAS. The ash used in this study was not a typical ash from an IGCC plant. Also, it is not clear what detrimental effects this ash would have had on the TBC at slightly lower temperatures at which the ash (or at least its main constituents) would remain solid.

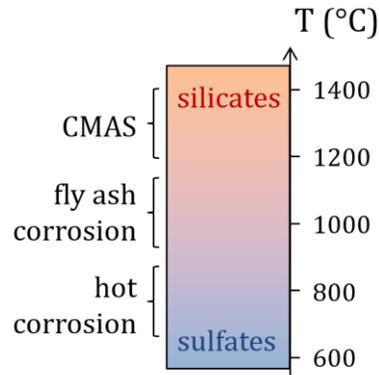
**Figure 22:** Temperature range of fly-ash corrosion compared to that of hot corrosion and CMAS studies.

The purpose of this study is to identify degradation mechanisms of fly-ash deposits on 7YSZ TBCs at 1100°C. As shown schematically in Figure 22, this is a temperature range between that of typical hot corrosion studies and CMAS studies. This temperature is typically not considered detrimental for hot corrosion because of sulfate volatilization. Degradation from CMAS deposits is also not considered at this temperature because extensive liquid silicate formation in the deposit would not be expected. This study, however, aims to identify degradation mechanisms which could be classified in between hot corrosion and CMAS.

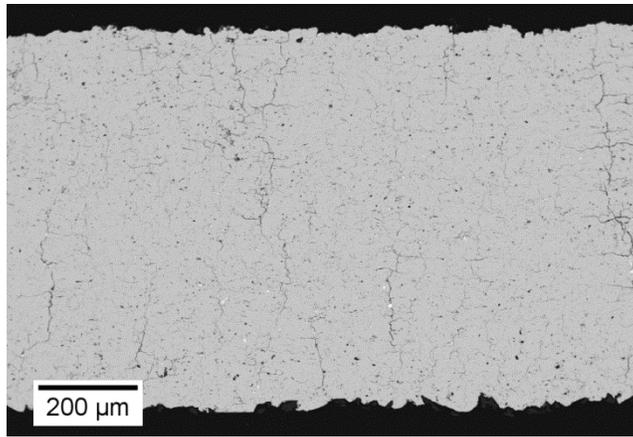
**Figure 23:** A Dense vertically cracked (DVC) free-standing YSZ sample used in isothermal testing

Free standing dense vertically cracked (DVC) 7YSZ coatings were used for isothermal testing. The microstructure of the free-standing YSZ is shown in Figure 23. Large vertical cracks are distributed throughout the specimen along with smaller horizontal cracks and open pores. The ceramic coatings were initially deposited on aluminum panels. The aluminum was then dissolved in a solution of NaOH and deionized water. For each YSZ panel, 30g of NaOH was added to a 500mL beaker filled with deionized water. The panels were left in the solution at room temperature with a magnetic stir bar for 24 hours, and then ultrasonically cleaned in deionized water. Residual aluminum was removed from the back of the 7YSZ panels with grinding paper. The free-standing YSZ panels were then cut into smaller coupons for testing. Changes in mechanical properties (coefficient of thermal expansion and elastic modulus) of YSZ due to fly ash exposures could also be determined with free-standing YSZ.

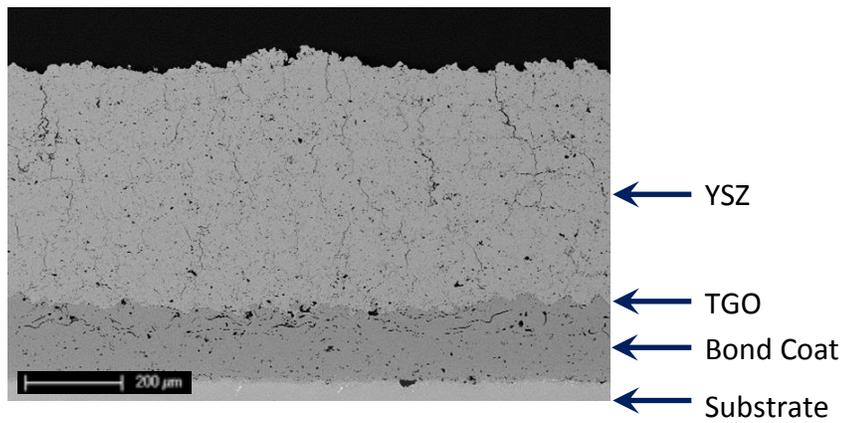
**Figure 24:** As-processed TBC with DVC top coat which is characterized by an overall dense morphology which includes large vertical cracks

in Figure 24 and 26 in their as-received conditions. As indicated in Figure 23 and 25, the as-deposited DVC morphology can be characterized as having a relatively dense microstructure with large vertical cracks. As discussed previously, these cracks formed during TBC processing and can provide improved strain tolerance in thermal cycling. The HPLD top coat exhibited a comparatively less dense morphology, with discernable horizontal splats and relatively larger voids.

The same dual layer NiCoCrAlY overlay bond coat (175-200  $\mu\text{m}$  thick) was used for all TBC systems. This type of bond coat, exhibiting the two-phase  $\beta$ - $\gamma$  microstructure, is commonly used in land-based gas turbines. The  $\beta$ -NiAl phase, which is shown in the micrographs as the darker phase, provides the source of Al for  $\text{Al}_2\text{O}_3$  scale growth at high temperatures. A thin thermally grown oxide (TGO) had formed during processing, but was virtually indistinguishable at the magnification shown ( $\times 100$ ) in Figure 24 and 26. Both 2<sup>nd</sup> generation nickel-based substrate alloys, PWA1484 and Rene' N5, were specifically chosen because they are commonly used for turbine blades. It should be noted that these two superalloys were very similar in composition,

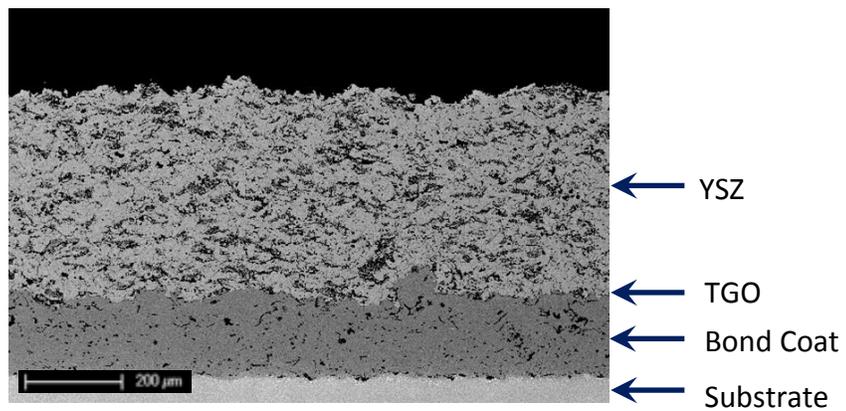
**Figure 25:** As-processed TBC with conventional top coat which is characterized by splat morphology

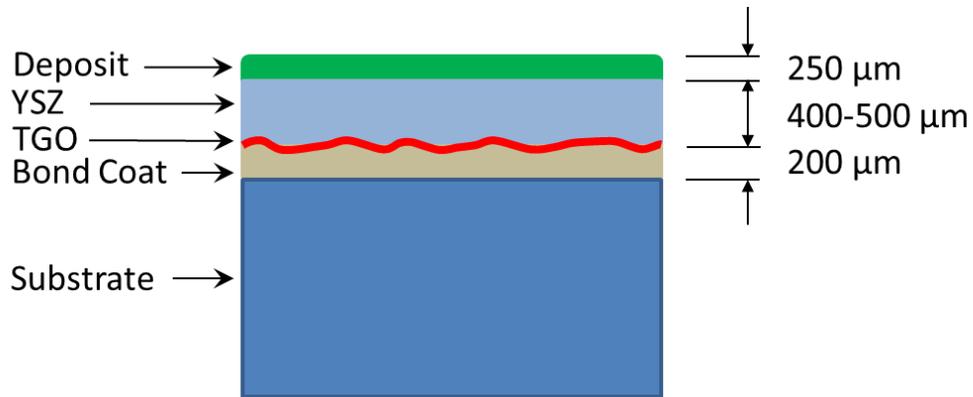
**Figure 26:** Ash deposit applied to surface of TBC before cyclic testing.

Testing was done with commercial fly ash, which was obtained from a combustion coal power plant through Boral Fly Ash, and will be described in more detail in the subsequent section. Model deposits were then used to study specific reaction processes. Fly ash was deposited on the surface of all samples before thermal exposure. This was done by mixing a deposit with ethanol to create a slurry. The slurry was applied to the sample with a dropper and allowed to dry. Samples were weighed before and after slurry application to ensure that a deposit loading of  $35 \text{ mg/cm}^2$  was achieved. This resulted in a typical ash deposit thickness of approximately  $250 \text{ }\mu\text{m}$ . The TBC samples were then tested in the thermal cycling rig with the synthetic deposit in contact with the YSZ top coat. The deposited assembly with approximate thicknesses is shown schematically in Figure 26.

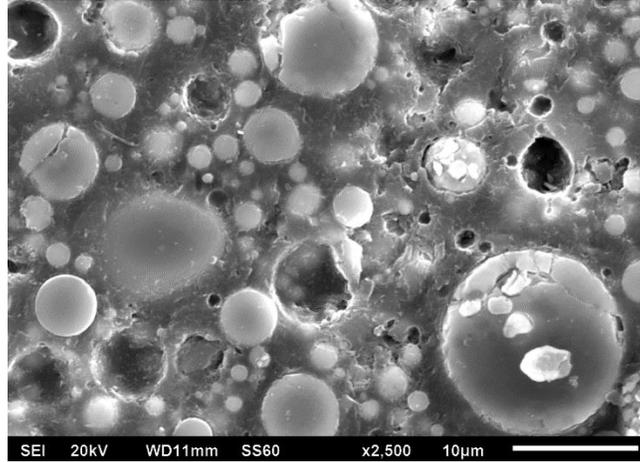
**Figure 27:** Commercial class C fly ash

Commercial fly ash from a conventional pulverized coal power plant was purchased from Boral fly ash company, San Antonio, TX. The composition of this Class C fly ash is summarized in Table 6. The morphology of the fly ash is shown in Figure 27 and is characterized as spherical ash particles which contain fused ash constituents. This is a typical morphology of coal fly ash which has been reported in literature [9]. The same ash constituents (oxides and sulfates) are expected in a typical IGCC resulting from syngas combustion, though perhaps in different ratios [94, 97].

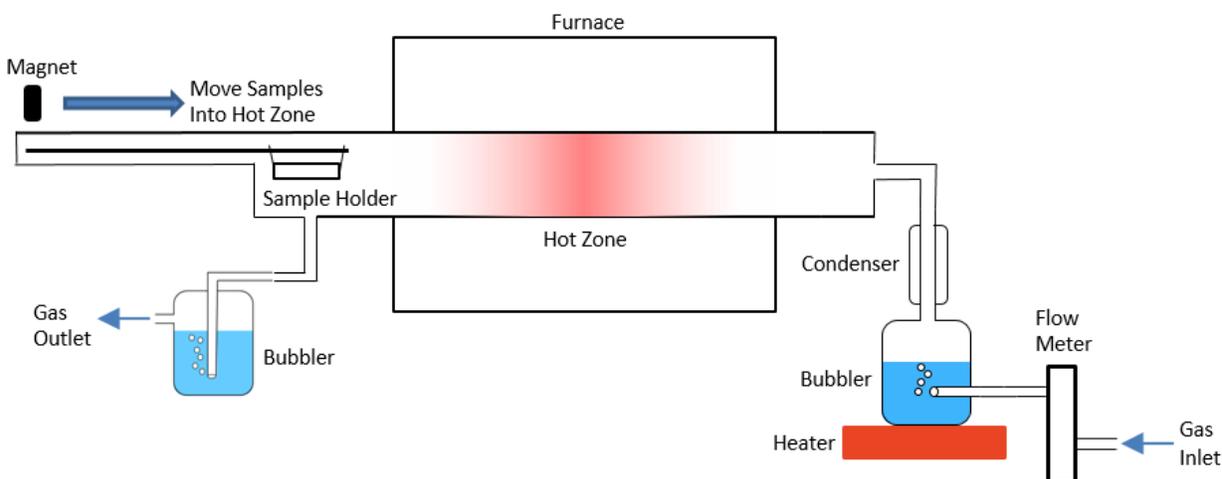
**Figure 28:** Experimental setup

Two different horizontal tube furnaces were used in the configuration shown in Figure 28 for testing of free-standing YSZ and complete TBC systems. A Thermo Scientific three zone furnace was used for isothermal exposures at 1100°C, and an Applied Test Systems (ATS) single zone furnace was used for cyclic exposures between 1100°C (45 minutes) and 160°C (15 minutes). Both furnaces were capable of maintaining gas atmospheres containing dry air, CO<sub>2</sub>, SO<sub>2</sub>, or steam by using glass end caps that were sealed to both ends of the furnace tubes. Samples were moved horizontally using a magnet outside of the glass end cap that forced an iron-based metal slug to move the sample rod. The opposite end of the sample rod was attached to the sample holder (alumina boat) which was attached via Kanthal wire. Moving samples with a magnet was done manually for the isothermal furnace. The cyclic apparatus utilized an automated ball nut which traveled along a rotating ball screw to move the magnet. This was operated automatically using a programmable controller.

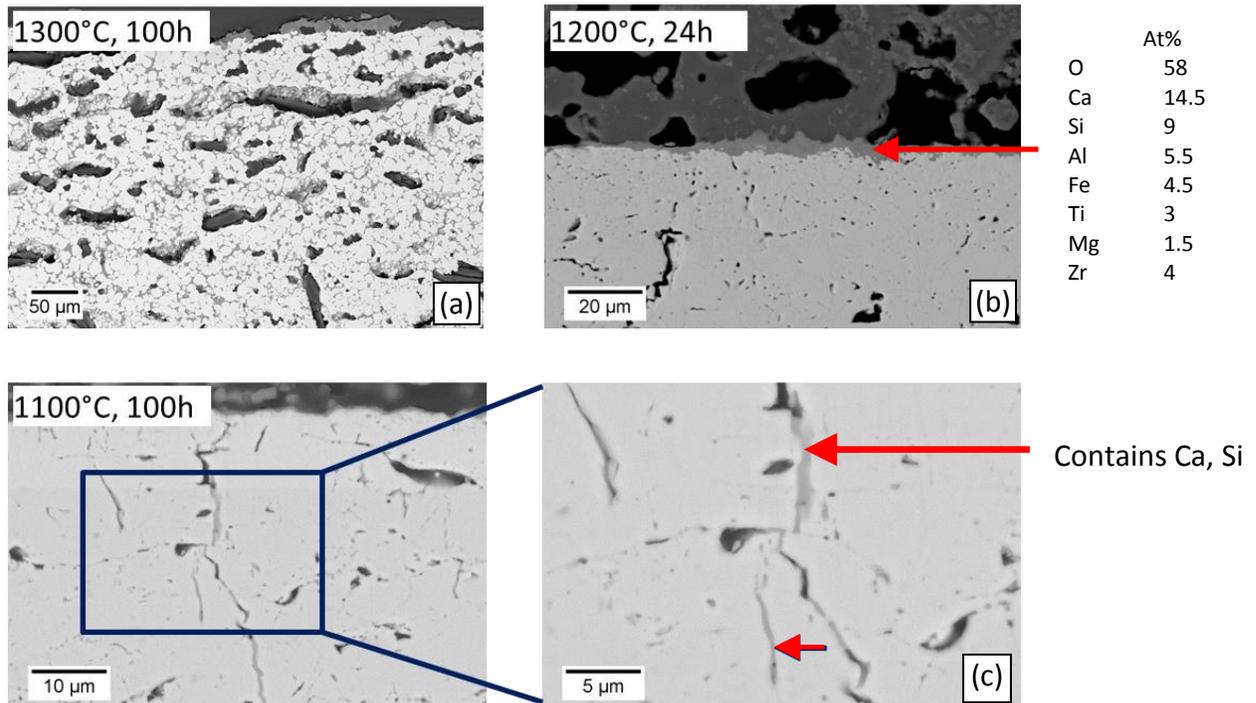
**Figure 29:** Reaction between YSZ commercial class C fly ash in dry air at three different temperatures. At relatively lower temperatures the extent of damage appears to decrease.

Free-standing YSZ was reacted in dry air at several temperatures with the commercial fly-ash summarized in Table 6. The 100 hour exposure at 1300°C shown in Figure 29(a) caused severe degradation of the YSZ. The depth of the degradation into the YSZ is indicated in

The exposure at 1200°C shown in Figure 29(b) resulted in less overall damage to the free-standing YSZ. The morphology of the bulk DVC YSZ was not significantly altered from the as-processed state. Although, the formation of a complex reaction layer between the deposit and YSZ surface was evidence that some damage could occur at this temperature. The dense reaction layer along the surface of the YSZ contained ash constituents and did not appear to significantly infiltrate the YSZ as was the case in the 1300°C exposure.

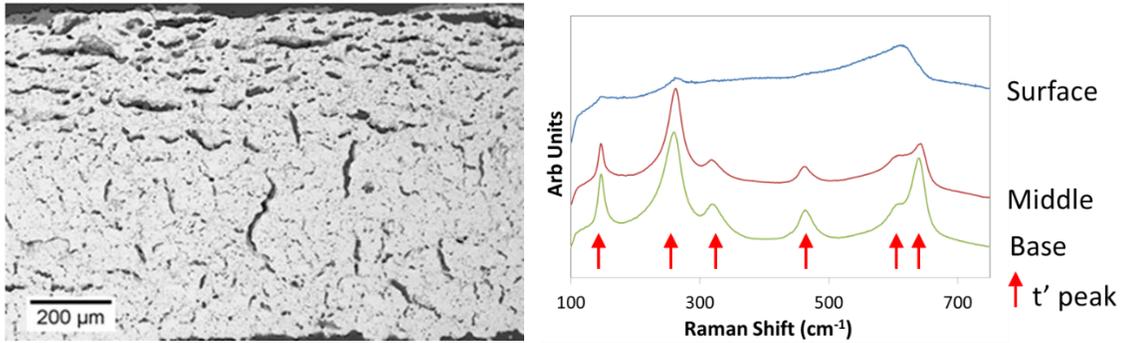
**Figure 30:** (a) YSZ degradation from 100h exposure to class C fly ash at 1300°C. (b) Raman spectra show loss of metastable t' phase at three penetration depths from the YSZ surface.

Figure 30(a). Much of the initial DVC microstructure was unrecognizable after the exposure. This type of severe degradation was similar to CMAS exposures at temperatures  $\geq 1200^{\circ}\text{C}$  [32, 65, 86], which was discussed in section 2.5.2. The Raman spectra shown in

Figure 30 indicate the  $t'$  phase (indicated by the six distinct peaks) was still evident 500-600 $\mu\text{m}$  into the sample, away from the deposit. Closer to the deposit, however, where degradation was more severe, the characteristic  $t'$  peaks were less pronounced, indicating loss of the  $t'$  phase in the YSZ around 200-300 $\mu\text{m}$  from the deposit. The  $t'$  phase was not recognizable in the most severely degraded areas  $\leq 200\mu\text{m}$  from the surface, where the ash was deposited.

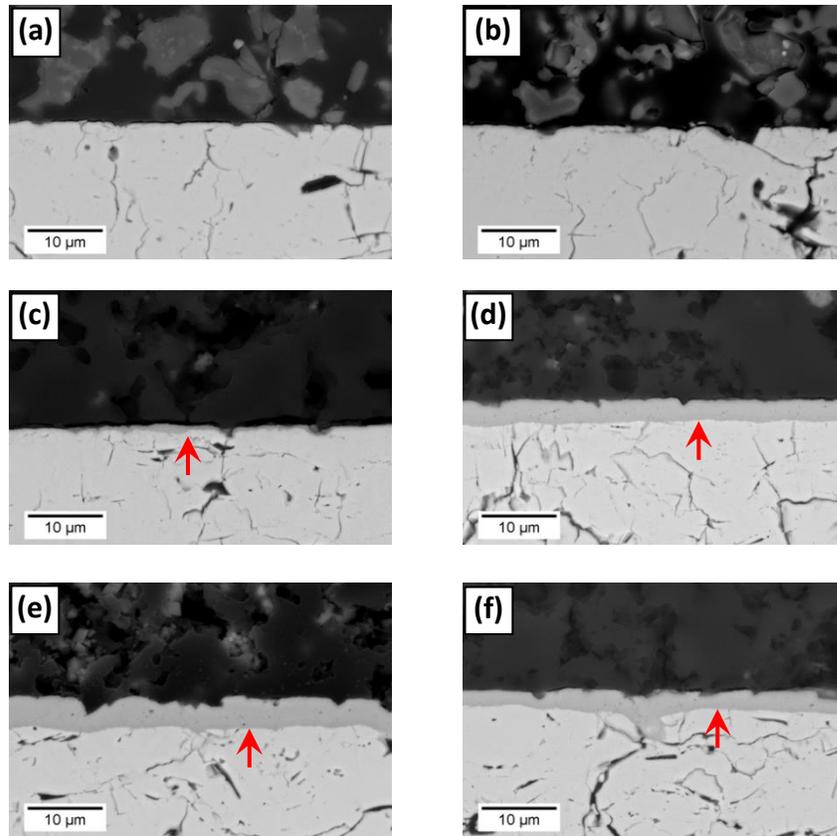
**Figure 31:** Reaction with YSZ and synthetic ash mixtures containing oxides with (a) 12, (b) 46, (c) 63, (d) 74, (e) 85, and (f) 100 at. % CaO for 72h in dry air at 1100°C. High-CaO ( $\geq 60\%$ ) mixtures form dense reaction product layers on the YSZ surface, indicated by arrows in the micrographs. Synthetic ash compositions are shown in Table 7.

Figure 31 shows the reaction of YSZ with synthetic-ash deposits containing systematically varying levels of CaO. High concentrations of CaO ( $\geq 63$  at. %) in the deposit resulted in the

formation of a reaction product at the YSZ surface where the deposit was applied, indicated by arrows in Figure 31. EDS analysis indicated that the reaction product contained only Ca, Zr, Y, and O. Therefore, other oxide constituents in the synthetic ash did not appear to affect reaction with the YSZ. Analysis with EDS also showed the same 1:1:3 molar ratio of Ca:Zr:O in the product formed from exposure to pure CaO and CaO-rich synthetic ash. The reaction layer was continuous along the YSZ surface after exposures to deposits with  $\geq 70$  at. % CaO. Examination of high magnification SEM images taken beneath the surface showed that the reaction product did not penetrate significantly into cracks in the YSZ.
