DEGRADATION OF TBC SYSTEMS IN ENVIRONMENTS RELEVANT TO ADVANCED GAS TURBINES  
FOR IGCC SYSTEMS

Submitted to the Graduate Faculty of  
the Swanson School of Engineering in partial fulfillment

Doctor of Philosophy

University of Pittsburgh

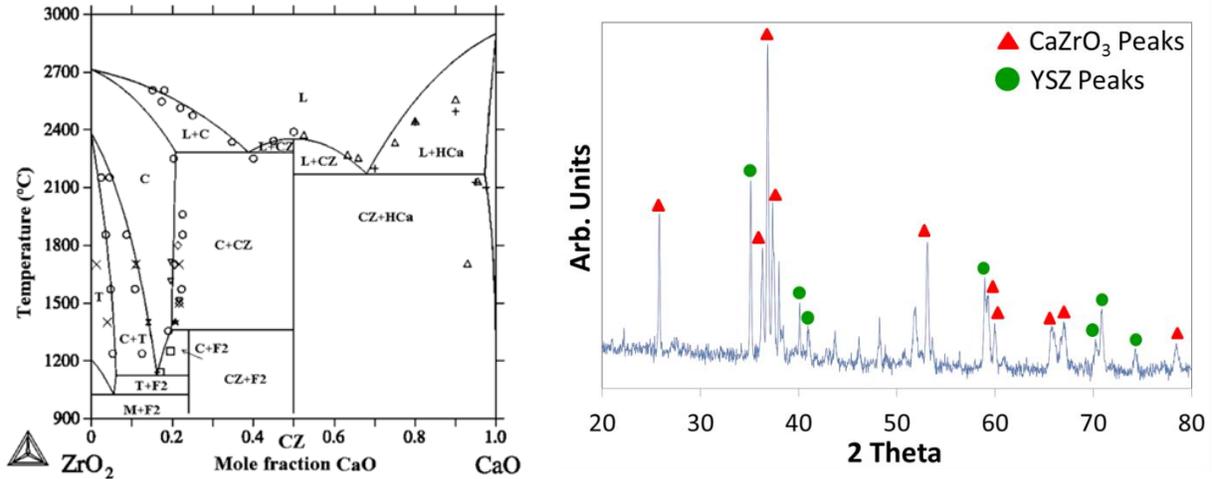
**Figure 32:** (a) Binary ZrO<sub>2</sub>-CaO phase diagram showing two possible compounds at 1100°C, and (b) XRD scan of YSZ surface after a 72 hour dry air exposure to CaO-rich ash at 1100°C showing formation of CaZrO<sub>3</sub> product.

The reaction between CaO and ZrO<sub>2</sub> can produce several products. The ZrO<sub>2</sub>–CaO phase diagram shown in Figure 32 indicates that two compounds are possible at 1100°C, CaZr<sub>4</sub>O<sub>9</sub> and CaZrO<sub>3</sub>. The 1:1:3 molar ratios of Ca:Zr:O consistently measured by EDS in the reaction products shown in Figure 31 indicated that the product formed in all exposures was CaZrO<sub>3</sub>. XRD analysis of the surface reaction layer shown in Figure 32 confirmed that the reaction product was CaZrO<sub>3</sub>,

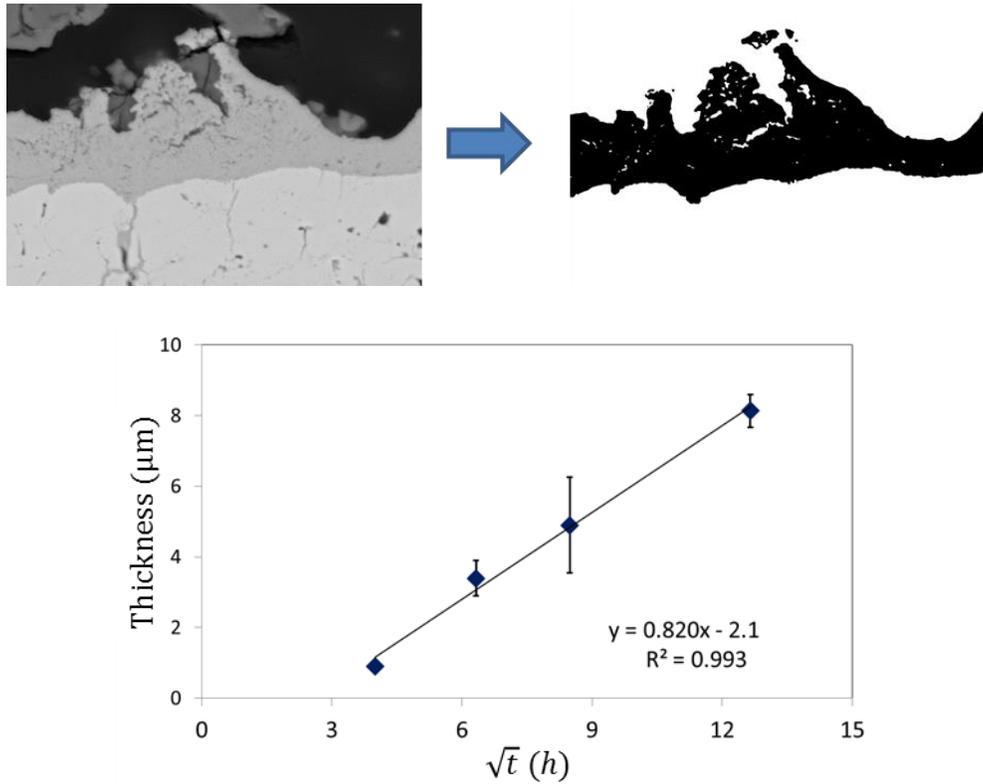
The CaZrO<sub>3</sub> surface layer formed between YSZ and CaO thickened over time. The reaction layer thickness was calculated using image threshold analysis. An example of the threshold analysis shown in Figure 33 shows how the area of CaZrO<sub>3</sub> was isolated. The overall thickness of the reaction layer was then estimated by dividing the area of CaZrO<sub>3</sub> by the total width of the micrograph. This was repeated for several locations along the YSZ surface. The thickening kinetics of the CaZrO<sub>3</sub> layer are shown in Figure 33 as a plot of reaction layer thickness ( $x$ ) vs. the square root of time ( $t^{1/2}$ ). The fact that the plot of  $x$  vs.  $t^{1/2}$  is linear shows that the reaction layer thickens according to parabolic kinetics, which indicates that growth was diffusion-controlled. The plot also indicates an incubation period in which a continuous layer had not yet formed on the YSZ surface. The formation of a continuous surface layer could have been initially obstructed by lack of even contact between CaO particles and YSZ. The details of this incubation period were not investigated in this study.

**Figure 33:** (a) Image analysis used to calculate reaction layer thickness on YSZ surface, and (b) growth kinetics of  $\text{CaZrO}_3$  layer formed from reaction between YSZ and  $\text{CaO}$ .

where  $y$  is the layer thickness at time  $t$  and  $k_p$  is a rate constant. The plot of the growth kinetics shown in Figure 33 indicated that there was a delay in the initiation of the continuous reaction layer growth during the exposure to CaO. The time  $t_0$  represents an incubation period during which YSZ was in contact with the deposit but the continuous  $\text{CaZrO}_3$  layer had not yet formed. Some  $\text{CaZrO}_3$  formation is expected during this early stage, however the reaction is not sufficient to produce a continuous solid layer. The reasons for this incubation period are likely related to the lack of even contact between the large CaO particles and the YSZ surface which would result in localized  $\text{CaZrO}_3$  formation during initial exposure. The details of this, however, were not studied any further in this work. Eventually, the surface reaction layer forms over the YSZ and act as a barrier to any liquid infiltration. The observed delay in continuous reaction-layer formation, however, suggests that during the initial stage of exposure the surface could be susceptible to liquid infiltration.

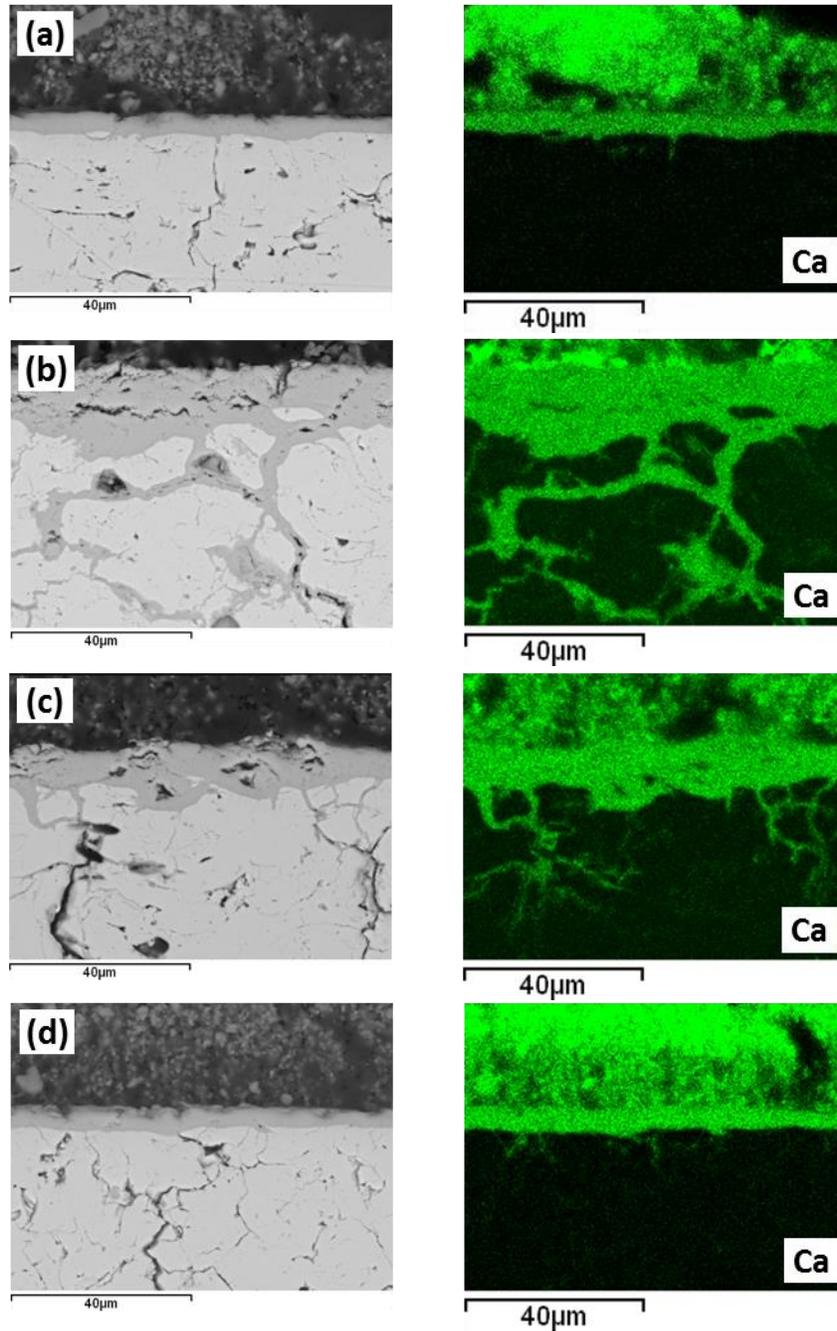
components (oxides,  $K_2SO_4$ , FeS). Figure 34 shows micrographs and EDS maps of Ca for the same high-CaO deposit with variations in the addition of  $K_2SO_4$  and FeS. Each 72h exposure at  $1100^\circ C$  resulted in the formation of a  $CaZrO_3$  layer on the YSZ surface. The combined addition of  $K_2SO_4$  and FeS, as indicated in Figure 34(b) caused a reaction product to form in cracks inside the free-standing YSZ samples. This reaction product was determined through EDS analysis to be  $CaZrO_3$  because of a 1:1 molar ratio of Ca:Zr. The  $CaZrO_3$  formation is shown in more detail in Figure 35. The internally forming  $CaZrO_3$  was observed more than  $100\mu m$  into the YSZ.

**Figure 34:** Free-standing YSZ that was reacted in dry air for 72 hours at 1100°C with the same high-CaO synthetic fly ash (a) containing only oxides, and with additions of (b) 2 mol %  $K_2SO_4$  and 4 mol % FeS, (c) 2 mol %  $K_2SO_4$ , and (d) 3 mol % FeS. The Ca map for each shows the extent of Ca corresponding to  $CaZrO_3$  reaction product in the YSZ for each exposure. Deposit compositions for each exposure are presented in Table 8.

The presence of FeS in the deposit did not appear to significantly affect the extent of internal  $\text{CaZrO}_3$  formation in the YSZ. The Ca mapping shown in Figure 34 indicates that the same internal  $\text{CaZrO}_3$  formation occurred for deposits containing both  $\text{K}_2\text{SO}_4$  and FeS compared to the deposit which contained only  $\text{K}_2\text{SO}_4$ . This suggests that the addition of FeS to the deposit did not cause internal  $\text{CaZrO}_3$  formation in the YSZ.

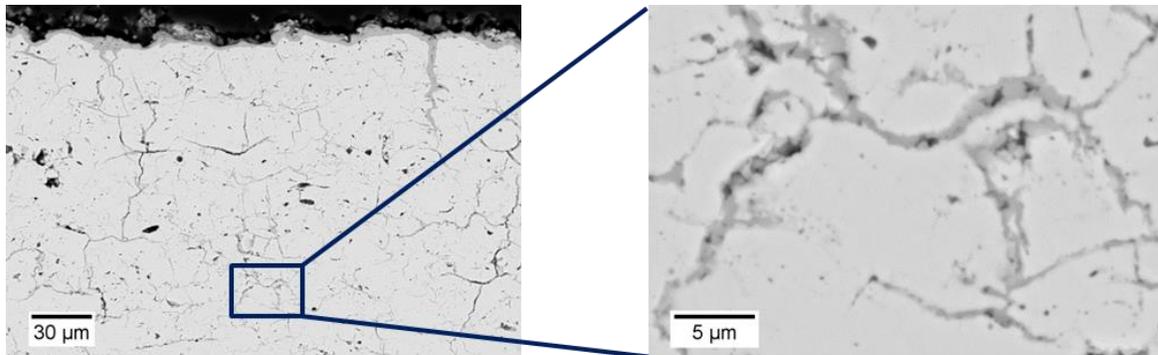
**Figure 35:** CaO-rich synthetic ash with  $\text{K}_2\text{SO}_4$  causes  $\text{CaZrO}_3$  formation in small cracks in YSZ after 72h dry air exposure at  $1100^\circ\text{C}$ .

The internal  $\text{CaZrO}_3$  formation was studied in more detail using localized FIB milling and corresponding TEM analysis. Representative images are shown in Figure 36. These images were obtained from the same 72 hour dry air exposure at  $1100^\circ\text{C}$  shown in Figure 35. The TEM images were taken at a depth of about  $150\mu\text{m}$  below the TBC surface. The reaction product is shown filling the entire width of the crack. There do not appear to be any additional phases between the reaction product and the YSZ, which would be indicated by a different contrast and/or variation in EDS data. This suggests the absence of secondary products which may have formed between the main product and the YSZ. The Ca:Zr:O molar ratio of 1:1:3 found by EDS analysis of the infiltrated crack, Figure 36, confirms that the reaction product in the crack consists predominantly of  $\text{CaZrO}_3$ . The figure also shows  $\text{K}_2\text{SO}_4$  (labeled as scan 1 in Figure 36) which contains  $\sim 1$  mol % Ca in solution.

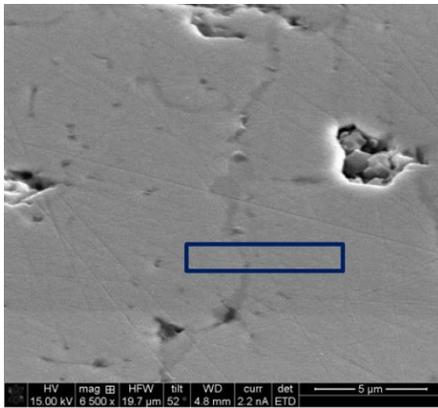
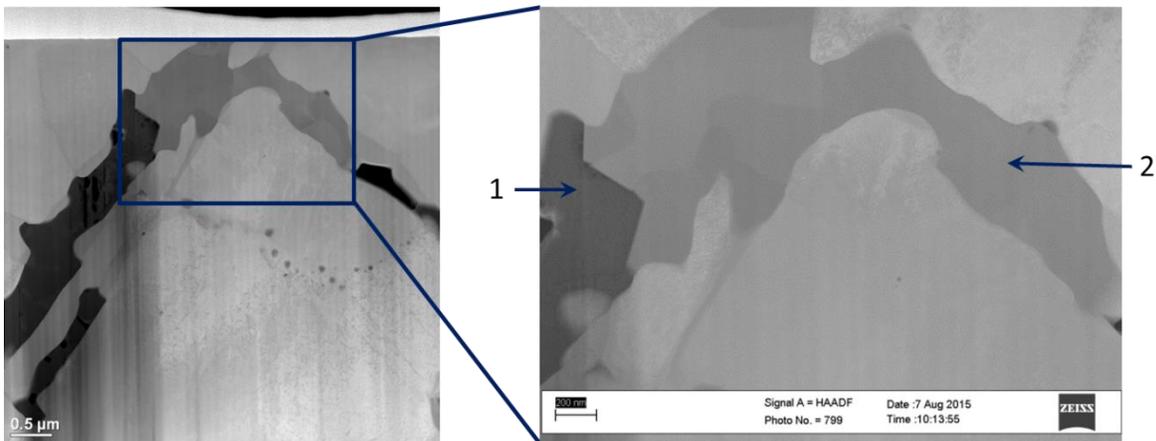
1	2
O	65	63
Al	0.5	
Si	1	
S	15	
K	17	
Ca	1	17
Fe	0.5	0.5
Zr		19
Y		0.5

**Figure 36:** (a) Location of FIB milling at infiltrated YSZ crack. (b)TEM images show crack filled with  $\text{CaZrO}_3$  and liquid  $\text{K}_2\text{SO}_4$ . EDS data (mol %) shows  $\text{CaZrO}_3$  formation and some solubility of Ca in  $\text{K}_2\text{SO}_4$ .

which agrees with the TEM analysis presented in Figure 36. The XRD scan of the mixture after exposure shown in Figure 42 indicates CaO and K<sub>2</sub>SO<sub>4</sub>. The Al<sub>2</sub>O<sub>3</sub> in the XRD is from the crucible.

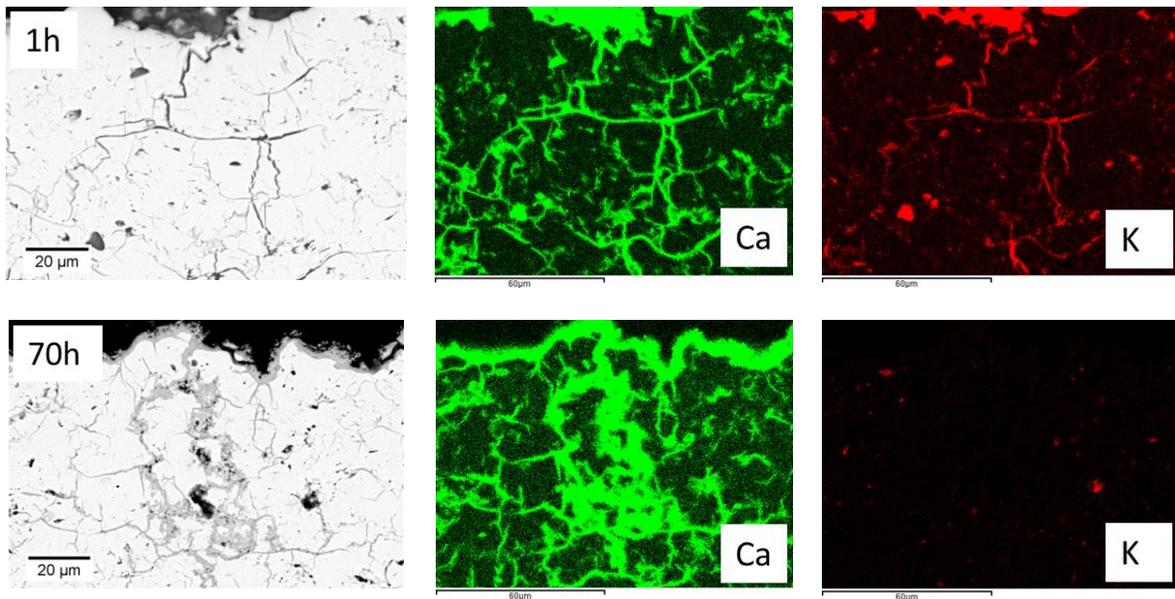
CaO and  $K_2SO_4$  were reacted with free-standing YSZ samples at  $1100^\circ C$  in dry air.  $CaZrO_3$  formation on the surface and in cracks inside the YSZ was observed after reaction with CaO- $K_2SO_4$  deposits. The result of reaction with 0.5CaO-0.5 $K_2SO_4$  (wt. %) deposit is shown in Figure 37 for exposure times of 1 and 70h. EDS mapping of K and Ca for each time shows the penetration of K and Ca into the YSZ. The EDS mapping of S matched that of K. After a 1 hour exposure, significant levels of both K and Ca were observed in many of the cracks in the YSZ. However, there did not appear from SEM images to be significant  $CaZrO_3$  formation after 1 hour. The EDS mapping after 70 hours showed considerable Ca in cracks inside the YSZ, and  $CaZrO_3$  formation was observed in SEM images of the sample. The presence of K, however, was significantly decreased after the 70 hour exposure. The EDS signal from S was also reduced to the same extent as that of K.

**Figure 37:** Free-standing DVC YSZ exposures with 0.5CaO-0.5 $K_2SO_4$  (wt%) deposit in dry air at  $1100^\circ C$ . EDS mapping after 1h and 70h reaction times show Ca and K in porous YSZ.

from the YSZ sample in approximately 5 hours. The expected evaporation rate from inside the YSZ cracks would be slower than that of the open crucible. Evaporation, however, could account for some of the substantial decrease in  $K_2SO_4$  with longer exposure time. The remaining  $K_2SO_4$  would also be spread to such an extent that the relative K signal in EDS scans would be reduced over longer times, as was observed in Figure 37.

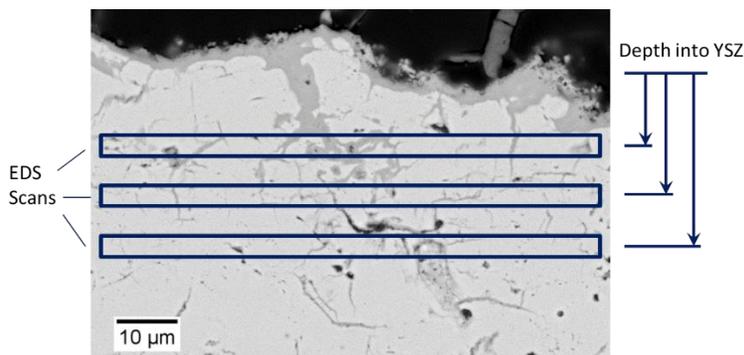
The progression of K and Ca into YSZ was studied in more detail at several different exposure times. A 0.5CaO-0.5K<sub>2</sub>SO<sub>4</sub> (wt. %) deposit was reacted in dry air with free-standing YSZ at 1100°C for three different times. EDS scans after each reaction were obtained over narrow areas at increasing depths under the YSZ surface, as described in Figure 38. The EDS scan at each distance was used to identify relative intensities of Ca and K at the depth indicated by the distance to the middle of the corresponding rectangle. The measured relative concentrations of Ca and K as a function of depth in the YSZ are summarized in Figure 39. The EDS scans showed significant levels of K distributed relatively evenly through the YSZ after a 15 minute exposure. The Ca penetration measured by EDS analysis increased at longer times. After 70 h exposure, very little signal from K remained in the YSZ, while the Ca signal was the strongest. The lines in each graph represent the trends at the three different times. Thus, K diminished in amount at a given depth while Ca increased.

**Figure 38:** EDS scans conducted in thin rectangular regions parallel to the YSZ surface at increasing distance below YSZ surface were used to quantify relative intensities of Ca and K signals.

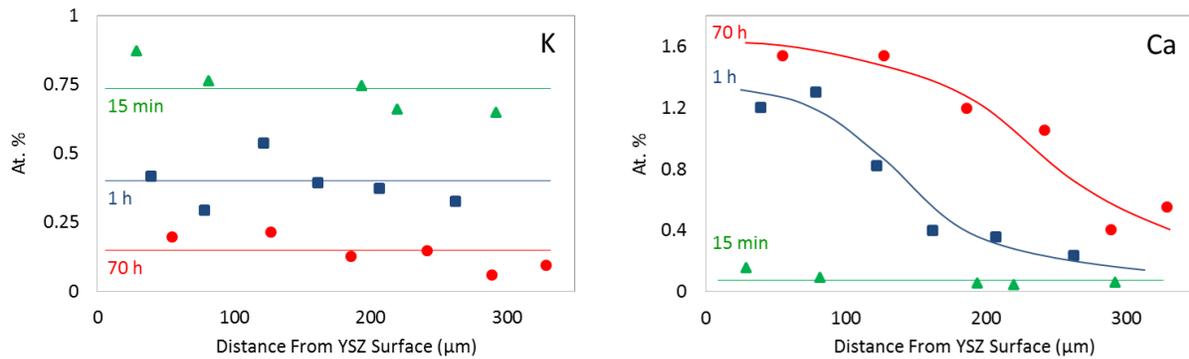
**Figure 39:** Free-standing YSZ exposures to 0.5CaO-0.5K<sub>2</sub>SO<sub>4</sub> deposit in dry air at 100°C results in progression of K and Ca EDS signals into free-standing YSZ. EDS scans at various depths beneath YSZ surface show relative decreasing K presence and increasing Ca presence with longer exposure times.

The EDS analysis shown in Figure 39 indicated that both K and Ca were present in the infiltrated regions of YSZ after the 1 hour exposure. This result suggests that the liquid  $\text{K}_2\text{SO}_4$  could be responsible for transporting  $\text{Ca}^{2+}$  into the YSZ where it eventually reacts with YSZ to form  $\text{CaZrO}_3$  at longer exposure times.  $\text{CaO}$  is reported to be essentially insoluble in molten  $\text{K}_2\text{SO}_4$  [105]; however, some amount of  $\text{Ca}^{2+}$  dissolution in a liquid  $\text{K}_2\text{SO}_4$  is necessary for its transport. Solubility of  $\text{Ca}^{2+}$  in liquid  $\text{K}_2\text{SO}_4$  was assessed using mixtures of  $\text{K}_2\text{SO}_4$  and  $\text{CaO}$ . Figure 41 shows a  $\text{CaO-K}_2\text{SO}_4$  mixture after heat treatment at  $1100^\circ\text{C}$  in dry air followed by an air cool at room temperature. EDS results from the solidified  $\text{K}_2\text{SO}_4$  after exposure indicated around 1.5 at. % Ca.,

The infiltration of K and Ca in the YSZ presented in Figure 39 indicated an increase in Ca and loss of K over time, which corresponded to internal  $CaZrO_3$  formation in many small YSZ cracks. The sequence of  $Ca^{2+}$  penetration into YSZ cracks and subsequent  $CaZrO_3$  formation is summarized schematically in Figure 48. Initially, molten  $K_2SO_4$  at  $1100^\circ C$  should wet the YSZ and carry  $Ca^{2+}$  into the YSZ in solution. As previously discussed, the liquid sulfate is expected to readily wet the YSZ surface. This early stage is consistent with EDS results presented in Figure 39, which showed K infiltration and very little Ca signal after a 15 minutes exposure. The  $Ca^{2+}$  would exist in solution with  $K_2SO_4$ , which resulted in relatively weaker Ca mapping in the EDS scans. The  $CaZrO_3$  was not expected to form in significant quantities in short exposure times based on results from the isothermal exposures with free-standing YSZ. This was observed in the delay time measured in  $CaZrO_3$  growth kinetics, shown in Figure 33. Longer exposure time resulted in more overall Ca signal because of  $CaZrO_3$  formation, which filled many small cracks in the YSZ. If one considers the growth kinetics of  $CaZrO_3$ , a small crack which is  $1\mu m$  wide would be completely filled by  $CaZrO_3$  in approximately 2 hours. The delay in continuous  $CaZrO_3$  surface-layer formation of approximately 9 hours would provide enough time for a crack this large to be filled. This delay in surface layer formation also provided the window for  $K_2SO_4$  volatilization, and the subsequent decrease in K signal measured at longer times.

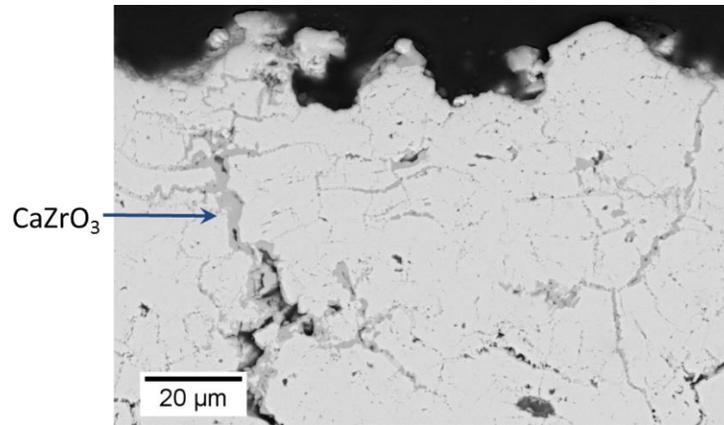
Internal CaZrO<sub>3</sub> formation in the presence of CaO was shown to occur after reactions with CaO+K<sub>2</sub>SO<sub>4</sub> deposits at 1100°C. The presence of CaO in actual fly-ash deposits, however, is not common. Rather, the sulfur levels in combustion environments are more likely to promote CaSO<sub>4</sub> formation. The equilibrium P<sub>SO<sub>3</sub></sub> level for CaO/CaSO<sub>4</sub> at 1100°C is 9x10<sup>-7</sup>atm [104]. Thus, even reported low sulfur levels in IGCC systems of 1-2 ppm SO<sub>2</sub> would be enough to stabilize CaSO<sub>4</sub>. Reaction between free-standing YSZ and a CaSO<sub>4</sub>-K<sub>2</sub>SO<sub>4</sub> deposit was studied at 1100°C. The infiltration from a 0.9CaSO<sub>4</sub>-0.1K<sub>2</sub>SO<sub>4</sub> (wt. %) deposit is shown in Figure 40. The internal CaZrO<sub>3</sub> formation in the YSZ was determined through SEM-EDS to be essentially the same as that found with CaO-K<sub>2</sub>SO<sub>4</sub> deposit. This indicates that a similar liquid penetration into YSZ cracks was responsible for CaZrO<sub>3</sub> formation inside YSZ cracks. Moreover, it reveals the high stability of CaZrO<sub>3</sub>, with either CaO or CaSO<sub>4</sub> being an adequate Ca source.

**Figure 40:** Internal  $\text{CaZrO}_3$  formation in free-standing YSZ after 72 hour dry air exposure to  $0.9\text{CaSO}_4\text{-}0.1\text{K}_2\text{SO}_4$  deposit at  $1100^\circ\text{C}$ .

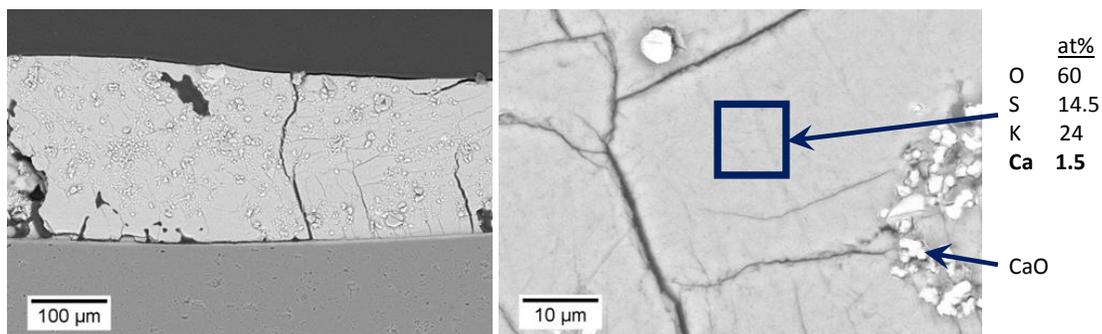
**Figure 41:** (a) Mixture of 90K<sub>2</sub>SO<sub>4</sub>-10CaO (wt. %) that had been heated at 1100°C for 1 hour in dry air, and (b) magnified image showing solidified K<sub>2</sub>SO<sub>4</sub> and also some CaO particles. EDS scans detected some Ca<sup>2+</sup> in the K<sub>2</sub>SO<sub>4</sub>.

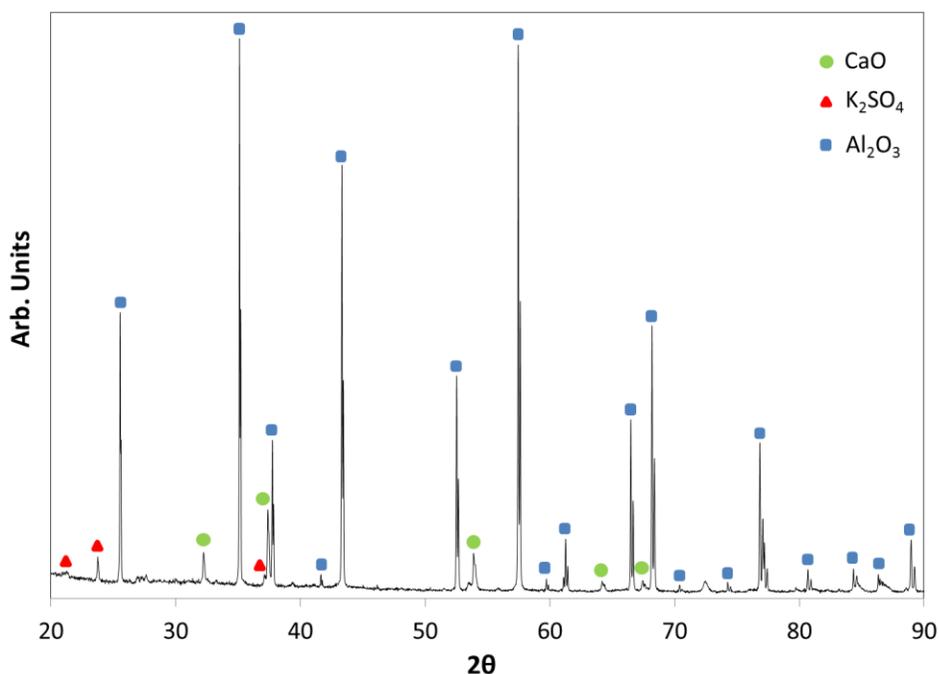
**Figure 42:** XRD scan on 90K<sub>2</sub>SO<sub>4</sub>-10CaO (wt. %) mixture after being heated at 1100°C for 1 hour in dry air and then cooled in lab air. The scan shows distinct peaks corresponding to CaO and K<sub>2</sub>SO<sub>4</sub>. No CaSO<sub>4</sub> was detected. Peaks from Al<sub>2</sub>O<sub>3</sub> were detected from the sample crucible.

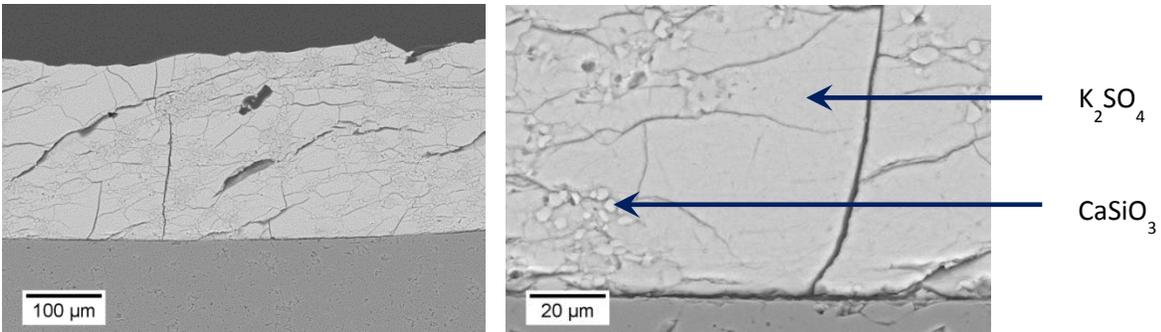
Figure 43 shows cross-sectional images from a CaSiO<sub>3</sub>-K<sub>2</sub>SO<sub>4</sub> mixture heated at 1100°C in dry air for 1 hour. No measurable solubility of Ca<sup>2+</sup> in K<sub>2</sub>SO<sub>4</sub> was detected. This indicates that K<sub>2</sub>SO<sub>4</sub> did not dissolve Ca<sup>2+</sup> when in contact with the silicate, CaSiO<sub>3</sub>. The stability of CaSiO<sub>3</sub> ( $\Delta G^\circ = -1857$  kJ/mol) [104] is greater than that of CaSO<sub>4</sub> ( $\Delta G^\circ = -1709$  kJ/mol) [104] at 1100°C, and the Ca remained bound to the silicate. This suggests that the Ca<sup>2+</sup> penetration (and subsequent internal CaZrO<sub>3</sub> formation) would only be expected in the presence of Ca in the form of either CaO or CaSO<sub>4</sub> in the deposit.

**Figure 43:** (a) Mixture of 90K<sub>2</sub>SO<sub>4</sub>-10CaSiO<sub>3</sub> (wt. %) that had been heat treated at 1100°C for 1 hour in dry air, and (b) magnified image. EDS analysis indicated no solubility of Ca<sup>2+</sup> in liquid K<sub>2</sub>SO<sub>4</sub>.

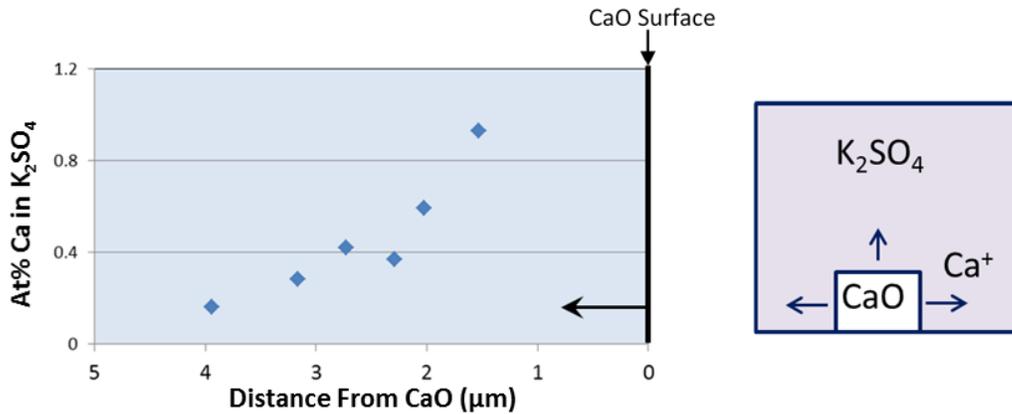
The diffusivity of Ca<sup>2+</sup> in liquid K<sub>2</sub>SO<sub>4</sub> was studied by immersing a compressed pellet of CaO in liquid K<sub>2</sub>SO<sub>4</sub> for 30 minutes at 1100°C in laboratory air. The dissolution of Ca shown in Figure 44 was then measured via EDS at increasing distance from the solid CaO. The concentration of Ca<sup>2+</sup> in solution with liquid K<sub>2</sub>SO<sub>4</sub> at 1100°C is shown to decrease away from the CaO surface. Measurements were not used within 1μm from the CaO pellet because the proximity to CaO was within the accuracy of the EDS probe.

**Figure 44:** Dissolution of Ca in liquid  $K_2SO_4$  at  $1100^\circ C$  in lab air. The concentration of Ca in  $K_2SO_4$  is shown at increasing distance from a particle of CaO.

where  $C_x$  is the concentration at distance  $x$  in the liquid after time  $t$ ,  $C_s$  is the surface concentration of Ca,  $C_o$  is the initial concentration of Ca in  $K_2SO_4$ , and  $D$  is the diffusion coefficient for Ca in liquid  $K_2SO_4$ . The diffusion profile from Figure 44 was used with equation 6-2 to calculate a diffusion coefficient,  $D \sim 10^{-15} \text{ m}^2/\text{s}$ , using  $C_s = 2.25\text{wt}\%$  (extrapolated from Figure 44),  $C_o = 0$ , and  $t = 900\text{s}$ . The diffusion coefficient is presented in the table for several different depths in Table 9.

**Table 9:** Calculated diffusion coefficient of  $\text{Ca}^{2+}$  in  $\text{K}_2\text{SO}_4$  using data presented in Figure 44 and Equation 6-2.

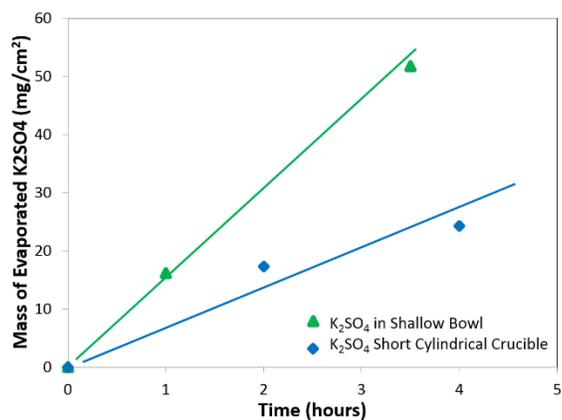
**Figure 46:** Weight loss of  $K_2SO_4$  due to evaporation at 1100°C. Evaporation rate can be affected by geometry of container.

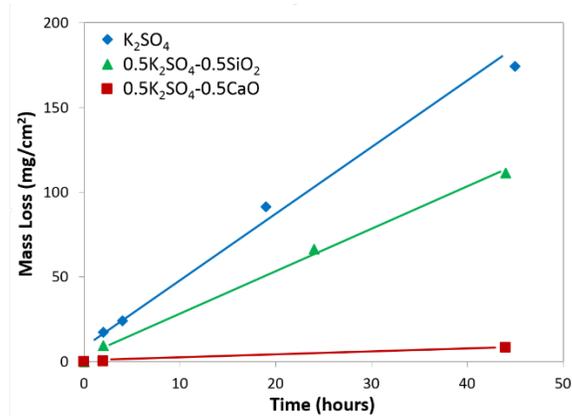
**Figure 47:** Weight loss due to volatilization at 1100°C. The presence of SiO<sub>2</sub> or CaO can influence the mass loss from a deposit.

indicates the existence of sulfate(s) in the deposit after 72h exposure. The 1:1 molar ratio of K:S suggests that the sulfur is not entirely accounted for by  $K_2SO_4$ . This could be explained by the formation of  $CaSO_4$  from the reaction with CaO in the deposit. The presence of sulfate components after exposure is consistent with previous results involving CaO and  $K_2SO_4$  in which very little weight loss was observed after 1100°C heat treatment (see Figure 47).

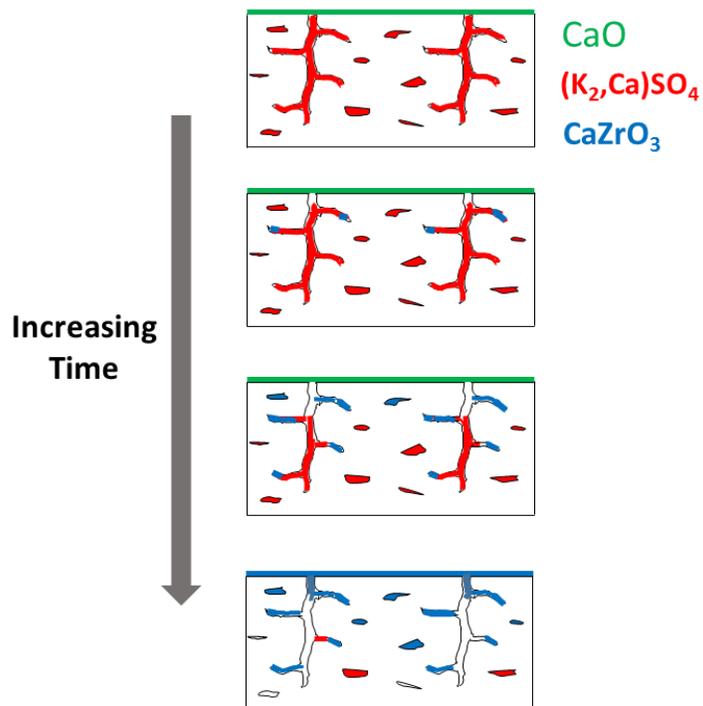
**Figure 48:**  $\text{Ca}^{2+}$  transport and resulting  $\text{CaZrO}_3$  formation. Liquid  $\text{K}_2\text{SO}_4$  carries  $\text{Ca}^{2+}$  in solution into cracks at  $1100^\circ\text{C}$ . At longer exposure times,  $\text{Ca}^{2+}$  reacts with YSZ at crack tips to form  $\text{CaZrO}_3$ .

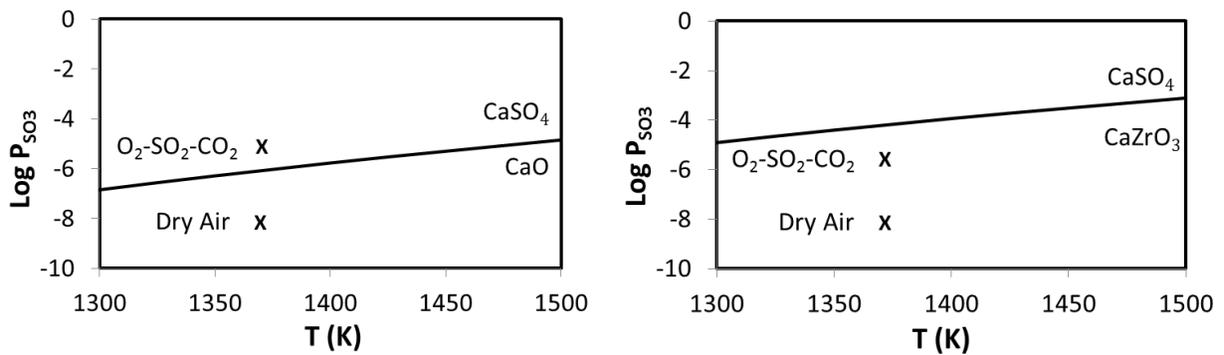
Which (for unity activity of CaSO<sub>4</sub>) is accompanied by an equilibrium P<sub>SO<sub>3</sub></sub>=6.6x10<sup>-5</sup> atm at 1100°C. The CaSO<sub>4</sub>/CaZrO<sub>3</sub> stability diagram shown in Figure 49 indicates that CaZrO<sub>3</sub> would be stable at 1100°C in both the dry air and the 0.2O<sub>2</sub>-100ppmSO<sub>2</sub>-CO<sub>2</sub> atmospheres used in the current study. This is consistent with the internal CaZrO<sub>3</sub> formation observed in Figure 40 from exposure to a CaSO<sub>4</sub>-K<sub>2</sub>SO<sub>4</sub> deposit. From a thermodynamic perspective, deposits consisting of both CaO+K<sub>2</sub>SO<sub>4</sub> and CaSO<sub>4</sub>+K<sub>2</sub>SO<sub>4</sub> would result in the same CaZrO<sub>3</sub> reaction product.

**Figure 49:** Stability diagrams for (a) CaO/CaSO<sub>4</sub> and (b) CaSO<sub>4</sub>/CaZrO<sub>3</sub> formation

The  $P_{SO_3}$  for dry air is below the CaO/CaSO<sub>4</sub> stability level, which indicates the impurity level of SO<sub>3</sub> in the dry air atmosphere is below the equilibrium  $P_{SO_3}$  to form the sulfate. This is consistent with the exposures in dry air in which CaSO<sub>4</sub> formation was not observed. IGCC systems utilize syngas, which is capable of reducing total sulfur to levels below 20 ppm [5]. These low sulfur levels in IGCC systems indicate that CaO could be thermodynamically stable at 1100°C as opposed to conventional coal-fired power plants in which CaSO<sub>4</sub> is typically the predominant Ca-containing species because of the relatively higher  $P_{SO_3}$  levels in combustion atmospheres.

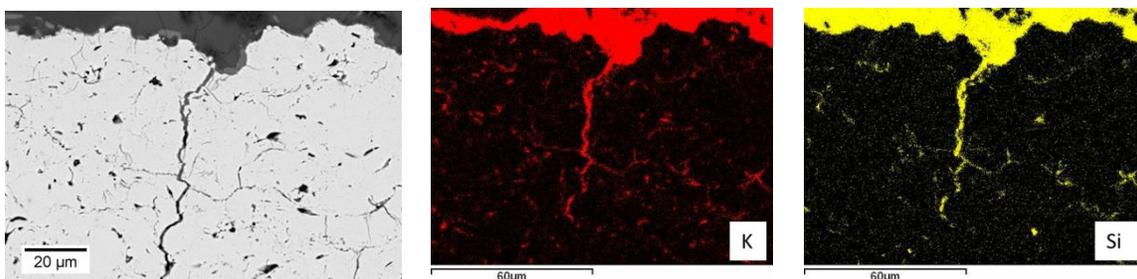
Free-standing YSZ was reacted at 1100°C in dry air with the high-SiO<sub>2</sub> deposit detailed in Table 10. The EDS mapping in Figure 50 indicates that large amounts of Si and K penetrated YSZ

cracks up to around 100  $\mu\text{m}$  into the sample after a 72 hours exposure in dry air. This result was different from internal reaction formed from high-CaO deposit, which indicated very little K signal after 72 hours. The presence of a strong Si and K signal after long exposure times suggests that the penetration was the result of liquid silicate formation. This is consistent with the fact that any potassium silicate which would form from  $\text{K}_2\text{O}$  and  $\text{SiO}_2$  would be liquid at  $1100^\circ\text{C}$  [116].

**Figure 50:** (a) Free-standing DVC YSZ reacted in dry air with  $\text{SiO}_2$ -rich synthetic ash for 72 hours at  $1100^\circ\text{C}$  and EDS mapping of (b) K and (c) Si showing penetration into cracks below YSZ surface.

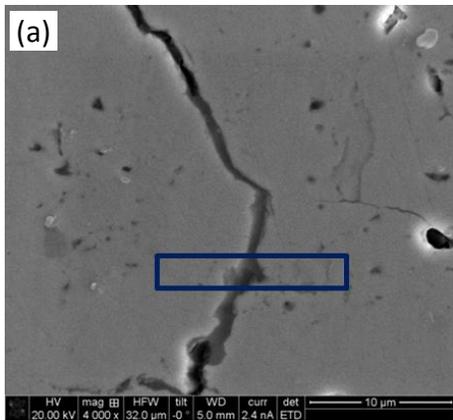
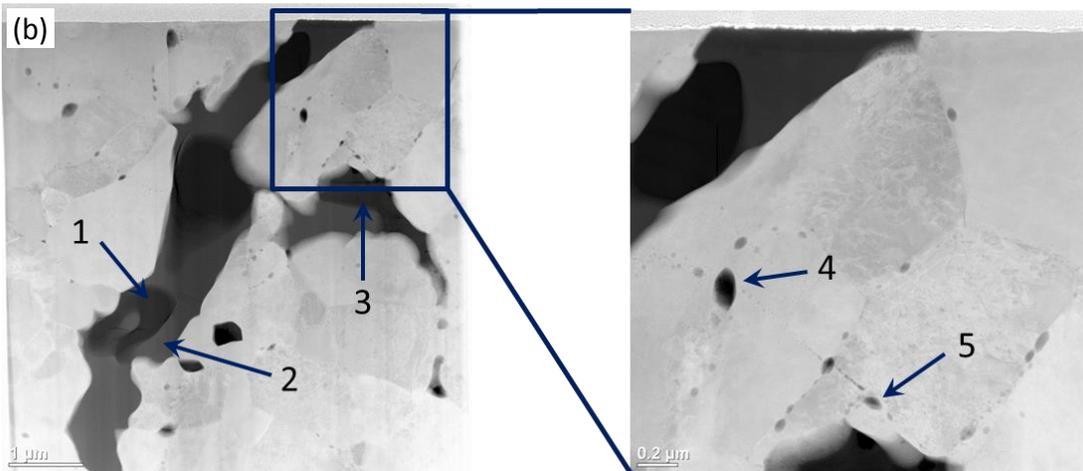
1	2	3	4	5
O	63	60	48	53.5	52.5
Al	8	0.25		1	1.5
Si	22	23		2	3
K	5	10.25	31		
Fe	2		3.5		0.5
Zr		6.5	1	36	37.5
Ca			0.5	1	0.5
S			16		
Y				4	3
Mg				1	1

**Figure 51:** (a) Location of FIB milling at infiltrated YSZ crack. (b)TEM images show crack filled with potassium silicate. EDS data shows different K:S ratios in liquid silicate and grain boundaries affected by ash. (EDS in at. %)

Infiltration of free-standing YSZ after a 72 hour dry air exposure to high- $\text{SiO}_2$  synthetic ash at  $1100^\circ\text{C}$  was studied using FIB milling followed by TEM imaging, Figure 51 shows a crack in the YSZ  $40\mu\text{m}$  below the surface which was completely filled with a product rich in K and S. These

results were consistent with SEM-EDS analysis of the same sample. EDS scans at several locations in Figure 51(b) show that the YSZ crack was filled with a silicate consisting of two distinct regions having molar K:Si ratios of 1:4 and 1:2. This silicate formation will be discussed in a later section. In addition to large cracks filled with liquid silicate, some segregation of ash constituents at grain boundaries is also shown by arrows in Figure 51(b). This was consistent with previous studies, which showed that  $\text{SiO}_2$  will segregate to grain boundaries and degrade the YSZ [117]. Degradation would involve depletion of Y from the YSZ which typically leads to destabilization from the  $t'$  phase. No Y-depletion, however, was observed in this study.

The silicate liquid which penetrated YSZ cracks at  $1100^\circ\text{C}$  appeared to have separated into two distinct phases upon cooling. A potassium silicate which would exist as a liquid at  $1100^\circ\text{C}$  could separate into two silicate compounds upon cooling. The K:Si:O ratios measured by EDS were 1:4:12 and 1:2:6 for the two distinct silicate regions. These molar ratios did not correspond to any two silicates from the  $\text{SiO}_2$ - $\text{K}_2\text{O}$  phase diagram. The liquid observed in these exposures, therefore, cannot be explained by a silicate comprised only of  $\text{K}_2\text{O}$  and  $\text{SiO}_2$ . Examination of the EDS data in Figure 51, however, also indicates a significant amount of Al in one of the two phases, indicated in Figure 51 by a K:Al:Si:O ratio of 1:1.5:4:12.5. The second phase was characterized by a K:Si:O ratio of 1:2:6. The phase diagram shown in Figure 54 shows liquid formation between potassium tetrasilicate,  $\text{K}_2\text{Si}_4\text{O}_9$ , and potash feldspar,  $\text{K}_2\text{Al}_2\text{Si}_6\text{O}_{16}$ , at  $1100^\circ\text{C}$ . A ternary phase diagram indicates that melting in the  $\text{SiO}_2$ - $\text{K}_2\text{O}$ - $\text{Al}_2\text{O}_3$  system can occur at temperatures  $\leq 1100^\circ\text{C}$ . Upon cooling, this liquid melt could separate into the two distinct phases which corresponds with the EDS data in Figure 51.

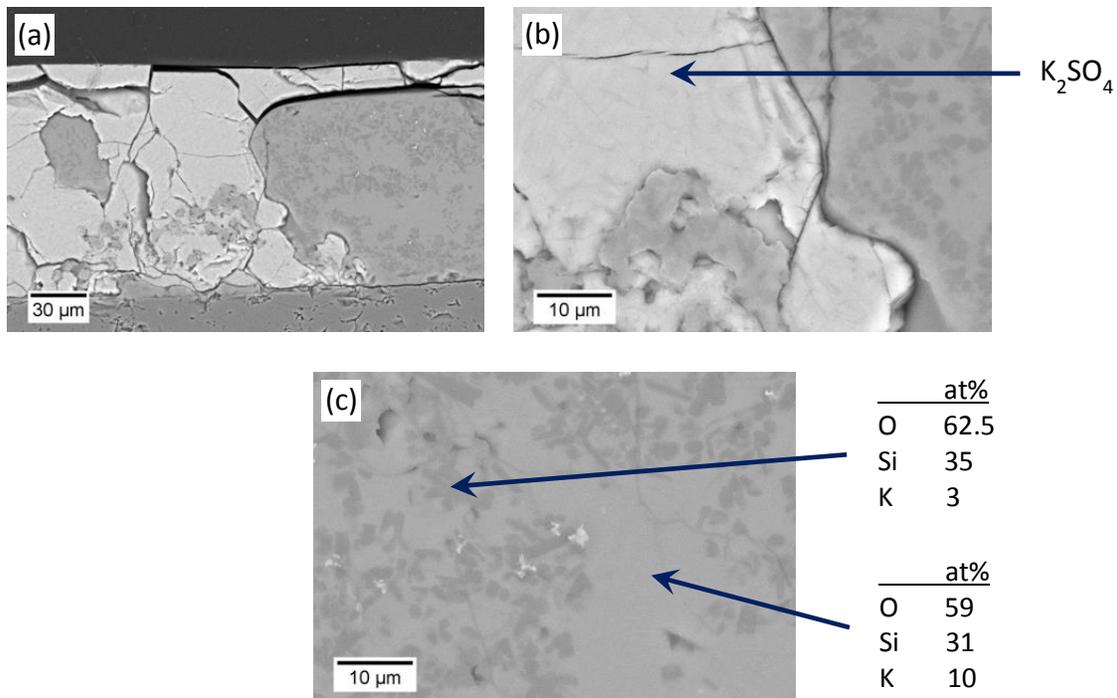
**Figure 52:** (a) A deposit consisting of 0.90K<sub>2</sub>SO<sub>4</sub>-0.10SiO<sub>2</sub> (wt. %) heat treated for 1 hour at 1100°C in dry air. (b) Closer inspection of K<sub>2</sub>SO<sub>4</sub> shows distinct K<sub>2</sub>SO<sub>4</sub> and SiO<sub>2</sub> regions. (c) Much of the SiO<sub>2</sub> and K<sub>2</sub>SO<sub>4</sub> appear to have reacted to form a liquid at 1100°C.

The filling of many YSZ cracks at  $1100^\circ\text{C}$  from the high- $\text{SiO}_2$  deposit involved the infiltration of liquid silicate into open spaces of the YSZ. The reaction product which formed upon cooling from  $1100^\circ\text{C}$  contained high levels of Si and K. In order to study silicate formation from  $\text{SiO}_2$  and  $\text{K}_2\text{SO}_4$ , a mixture of  $0.90\text{K}_2\text{SO}_4\text{-}0.10\text{SiO}_2$  (wt. %) was heated at  $1100^\circ\text{C}$  in dry air for 1 hour in an alumina crucible. The resulting mixture is shown in Figure 52 after air cooling to room temperature. The  $\text{K}_2\text{O-SiO}_2$  phase diagram shown in Figure 53 indicates extensive liquid formation at  $1100^\circ\text{C}$ . Separation of a liquid into distinct compounds would be expected upon cooling. The mixture appeared to have solidified upon cooling and separated into two distinct regions: a region of  $\text{SiO}_2$  (indicated by the molar K:Si:O ratio 1:10:20) and a silicate corresponding closely to  $\text{K}_2\text{Si}_4\text{O}_9$  (indicated by the molar K:Si:O ratio of 1:3:6) shown in Figure 52(c). The details of this liquid silicate formation merit further study. For the purpose of this work, these results show that the presence of  $\text{K}_2\text{SO}_4$  and  $\text{SiO}_2$  leads to significant liquid formation.

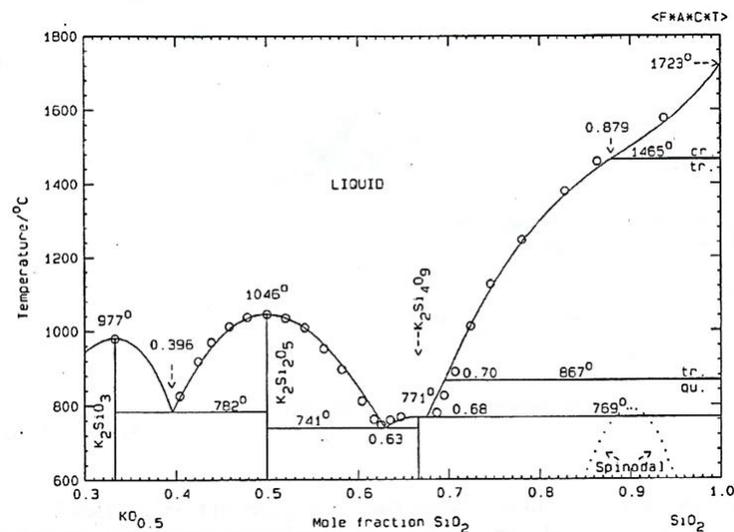
**Figure 53:** Binary phase diagram of the K<sub>2</sub>O-SiO<sub>2</sub> system shows several potassium silicate compounds. Liquid formation is expected at 1100°C [116].

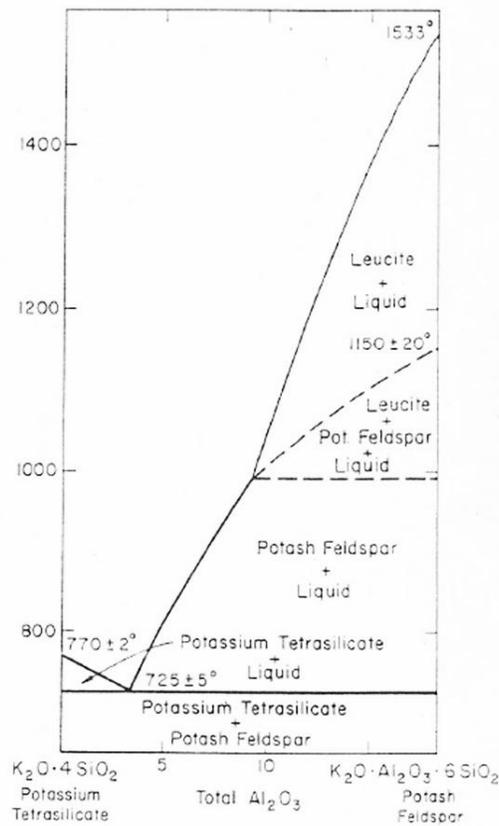
**Figure 54:** Phase diagram from the  $K_2O$ - $SiO_2$ - $Al_2O_3$  system showing liquid formation between two potassium silicates [119].

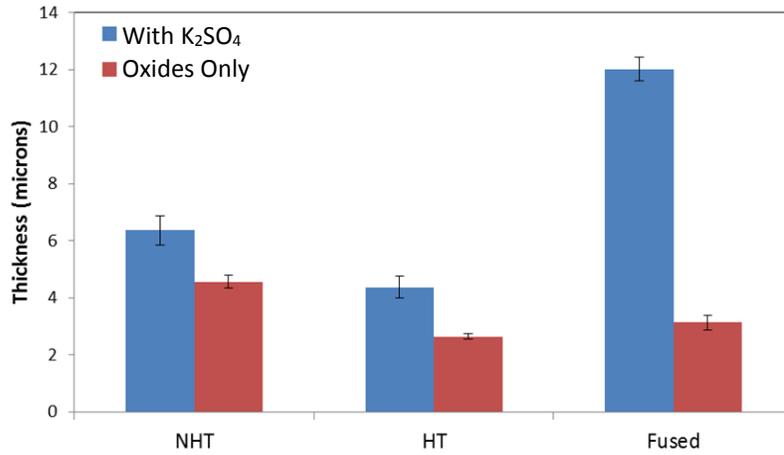
**Figure 55:**  $CaZrO_3$  surface reaction layer thickness after 72h exposures in dry air at  $1100^\circ C$ . Surface layer thickness is compared for three different ash preparation techniques, both with and without  $K_2SO_4$  addition.

The thickness of the CaZrO<sub>3</sub> surface layer is compared in Figure 55 for 72 hours dry air exposures at 1100°C, both with and without K<sub>2</sub>SO<sub>4</sub> addition. In the absence of K<sub>2</sub>SO<sub>4</sub>, all deposits produced similar reaction layers of comparable thickness. The CaZrO<sub>3</sub> surface layer formation was not significantly affected by the thermal history of the deposit. However, it should be noted that the heat-treated deposit consistently produced a slightly thinner surface layer (both with and without K<sub>2</sub>SO<sub>4</sub> addition) compared to NHT and fused deposits. The addition of K<sub>2</sub>SO<sub>4</sub> resulted in some difference in reaction layer thickness for all three preparation techniques. For each deposit, the CaZrO<sub>3</sub> layer thickness increased with the addition of K<sub>2</sub>SO<sub>4</sub>. The increase in thickness with the NHT and HT deposits were very similar when K<sub>2</sub>SO<sub>4</sub> was added (see Figure 55). The addition of K<sub>2</sub>SO<sub>4</sub> to the fused ash, however, resulted in a more dramatic increase in CaZrO<sub>3</sub> surface layer thickness. The thickness of the CaZrO<sub>3</sub> shown in Figure 56 was substantially

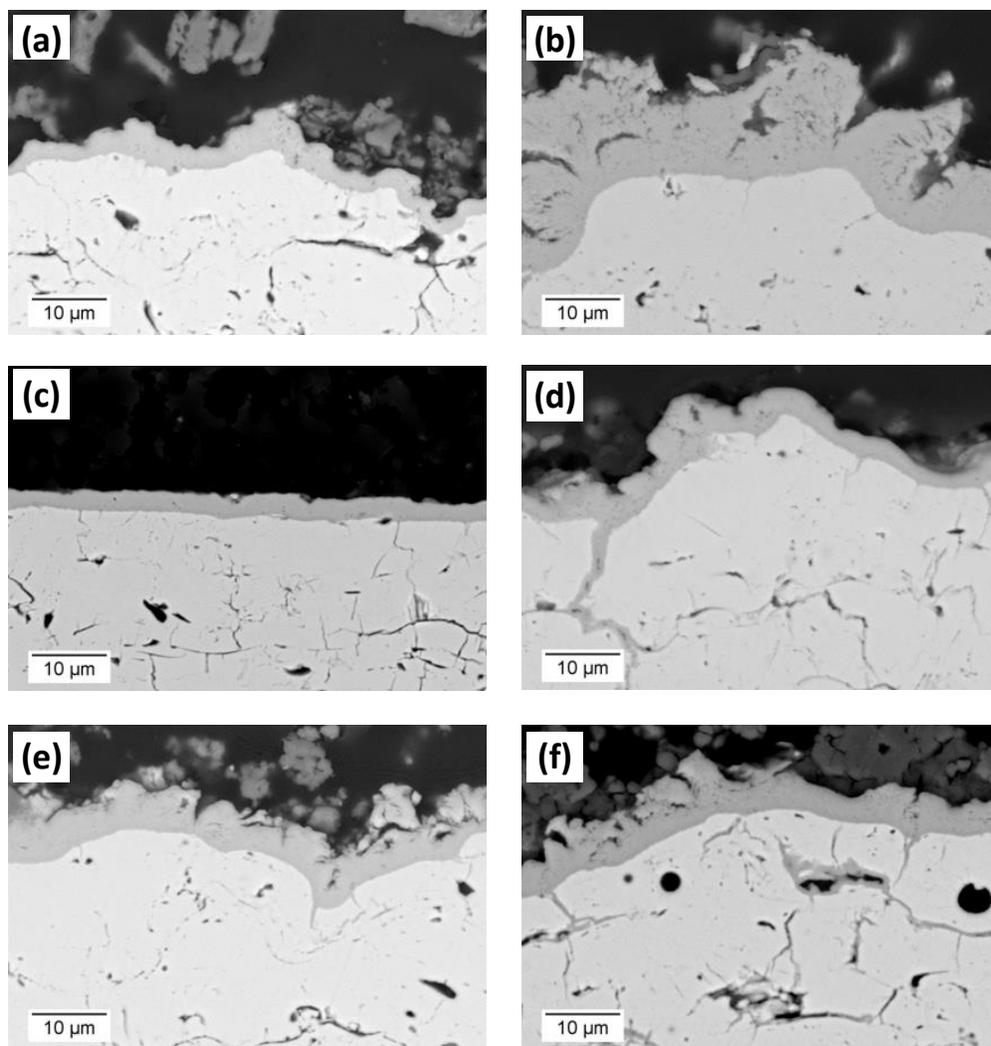
**Figure 56:**  $\text{CaZrO}_3$  layer on YSZ surface after reaction in dry air at  $1100^\circ\text{C}$  with the same high-CaO synthetic ash described in Table 7(d) that was prepared differently before exposure. Reactions are shown for synthetic deposit which was (a) fused and crushed. (b) fused and crushed then mixed with 10 wt%  $\text{K}_2\text{SO}_4$ , (c) heat treated and crushed, (d) heat treated and crushed then mixed with 10wt%  $\text{K}_2\text{SO}_4$ , (e) not heat treated, and (f) not heat treated and mixed with 10 wt%  $\text{K}_2\text{SO}_4$ .

increased with the addition of  $K_2SO_4$  to the fused ash. This will be discussed further in another section.

The morphology of the surface  $CaZrO_3$  layer was not significantly affected by the addition of  $K_2SO_4$  for the HT and NHT deposits. The reaction layers shown in Figure 56 indicate that, other than a slight increase in overall thickness, the addition of  $K_2SO_4$  did not significantly change the  $CaZrO_3$  layer which was formed. The addition of  $K_2SO_4$  to the fused ash, however, did affect the

morphology of the  $\text{CaZrO}_3$  layer formed at the surface. In addition to being much thicker overall, the surface layer consisted of many open pockets absent of CaO. SEM-EDS analysis indicated that these regions contained solidified  $\text{K}_2\text{SO}_4$ . This could have occurred because the surface layer grew very fast and enclosed some molten  $\text{K}_2\text{SO}_4$ . These pockets of  $\text{K}_2\text{SO}_4$  were excluded in the threshold analysis, and the overall thickness reported in Figure 55 represents only the  $\text{CaZrO}_3$  on the YSZ surface. The  $\text{CaZrO}_3$  itself, between the pockets of  $\text{K}_2\text{SO}_4$ , was nearly identical to the zirconate layer which formed without  $\text{K}_2\text{SO}_4$ .

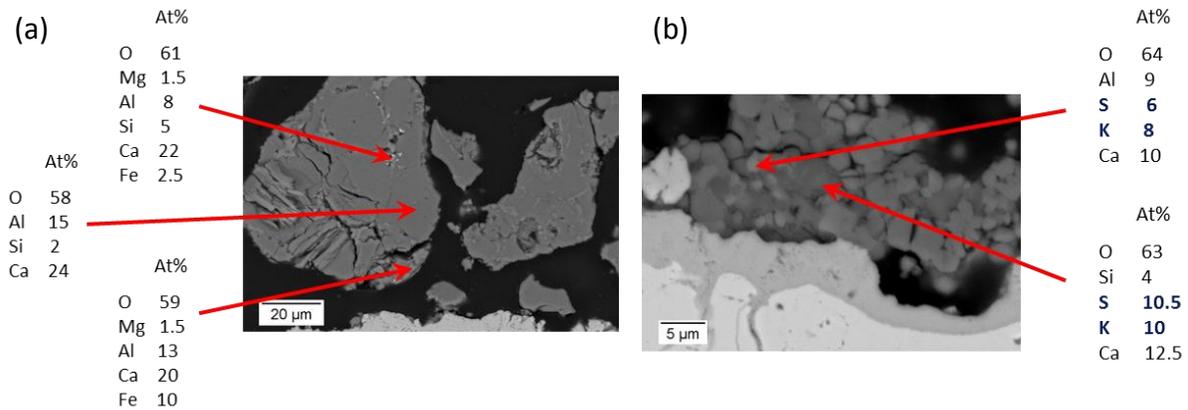
**Figure 57:** Two synthetic ashes of identical initial composition described in Table 7(d) with different thermal histories, after 72 hour dry air reactions with YSZ at 1100°C. (a) Oxide components were fused at 1500°C and then crushed before mixing with  $K_2SO_4$ . (b) The same oxide components were mixed together and did not experience any heat treatment before mixing with  $K_2SO_4$ .

Two different synthetic fly-ash deposits, fused and NHT, are shown in Figure 57 after 72 hours dry air reactions with YSZ at  $1100^\circ\text{C}$ . The fused deposit consists of only oxide constituents, and contained no detectable levels of  $\text{K}_2\text{SO}_4$ . The NHT deposit, however, contained K and S, which

The heat treatment of the synthetic deposit at 1500°C before reaction with YSZ resulted in a synthetic ash which was capable of producing a substantially thicker CaZrO<sub>3</sub> surface layer at 1100°C. The micrographs shown in Figure 57 indicate differences in the deposits after the 72 hours reaction. After reaction, the fused deposit consisted of only the oxide constituents, and contained neither K<sub>2</sub>SO<sub>4</sub> nor any compounds consisting of K or S. This deposit should have consisted primarily of silicates which did not react substantially with K<sub>2</sub>SO<sub>4</sub>. After reaction with the YSZ, some K<sub>2</sub>SO<sub>4</sub> which was added to the fused deposit remained near the YSZ encased in the CaZrO<sub>3</sub> layer (this can be seen in Figure 56(b)). This suggests that, rather than reacting with the deposit, the molten K<sub>2</sub>SO<sub>4</sub> spread along the YSZ surface to provide a medium for transporting Ca evenly to the YSZ surface. The NHT deposit, however, contained compounds which included K and S. Some of the K<sub>2</sub>SO<sub>4</sub> reacted with the NHT deposit and less molten sulfate would be available to act as a conduit for Ca<sup>2+</sup> transport at the surface to facilitate CaZrO<sub>3</sub> growth.
