DEGRADATION OF TBC SYSTEMS IN ENVIRONMENTS RELEVANT TO ADVANCED GAS TURBINES  
FOR IGCC SYSTEMS

Submitted to the Graduate Faculty of  
the Swanson School of Engineering in partial fulfillment

Doctor of Philosophy

University of Pittsburgh

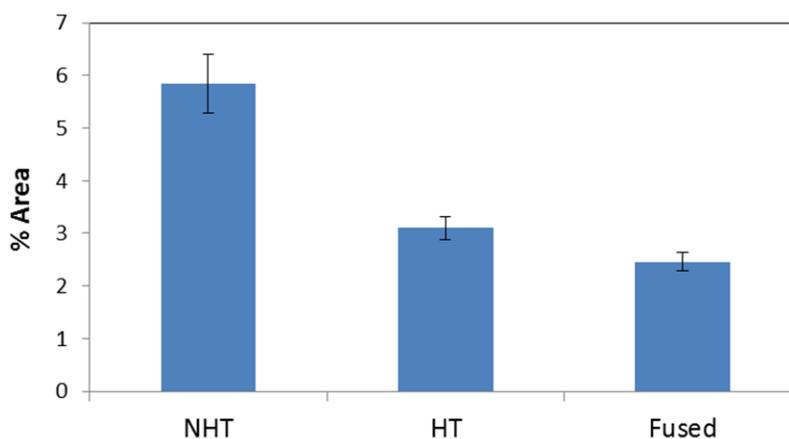
**Figure 58:** Internal  $\text{CaZrO}_3$  formation in YSZ from high-CaO synthetic ash that was prepared with three different preparation techniques before being mixed with  $\text{K}_2\text{SO}_4$ . The same ash composition was not heat treated (NHT), heat treated (HT), and fused before addition of  $\text{K}_2\text{SO}_4$  and subsequent exposure with YSZ at  $1100^\circ\text{C}$  in dry air.

The overall  $\text{CaZrO}_3$  formation after 72h dry air exposures at  $1100^\circ\text{C}$  is shown in Figure 58. The internal formation of  $\text{CaZrO}_3$  reaction product was determined from micrographs taken at locations in a straight line through the thickness of the YSZ, so that areas near the surface and farther away were equally represented. Micrographs at the surface were not included (i.e., surface  $\text{CaZrO}_3$  layer thickness was not represented), so that the results show only  $\text{CaZrO}_3$  which formed in cracks internal to the YSZ. At each location, image threshold analysis was used to calculate the percentage of the area which was accounted for by  $\text{CaZrO}_3$ , similar to the method shown in Figure 33. Overall internal  $\text{CaZrO}_3$  formation was similar for the heat-treated and fused deposits. Thus, the internal  $\text{CaZrO}_3$  formation discussed in chapter 5 was similar to what would be expected from a fused ash. However, the penetration of internal  $\text{CaZrO}_3$  was measured to be

more significant in the deposit which was not heat treated. This difference in NHT deposit confirmed the necessity to heat treat synthetic deposits in order to have infiltration which could be expected from fused deposits. The heat treatment of the oxides may be expected to produce silicates in the deposit which would not transport  $\text{Ca}^{2+}$  as readily into the YSZ compared to the pure oxides in NHT deposits. This is consistent with the result of the  $\text{CaSiO}_3\text{-K}_2\text{SO}_4$  exposure shown in Figure 43; SEM-EDS analysis of the  $\text{CaSiO}_3\text{-K}_2\text{SO}_4$  mixture after heating indicated no measurable solubility of  $\text{Ca}^{2+}$  in the silicate.

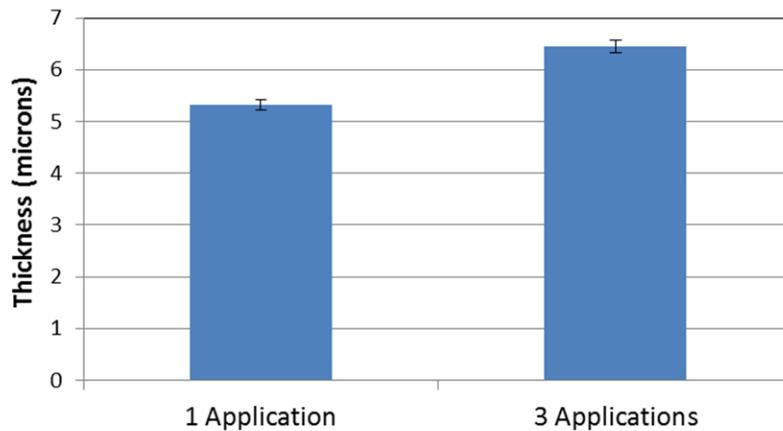
**Figure 59:** Surface  $\text{CaZrO}_3$  layer thickness formed between YSZ and high-CaO synthetic ash after a single application of ash compared to that with 3 different applications of ash. Both exposures were at 100°C in dry air for a total of 72 hours.

Turbine components are constantly exposed to fly-ash buildup as they are continuously subjected to hot gases which contain particulates. The results presented in sections 5-7 were obtained after a single deposition of ash onto YSZ samples. A TBC used in an actual turbine could experience the loss of a deposit, and/or re-application of new deposit throughout its lifetime.  $\text{CaZrO}_3$  formation was examined after multiple deposit applications in order to identify any effects from multiple deposit exposures. Figure 59 compares the thickness measured after a single deposit application to the same length exposure with three separate deposit applications. The  $\text{CaZrO}_3$  layer thickness results did not indicate a substantial dependence on overall surface layer thickness.

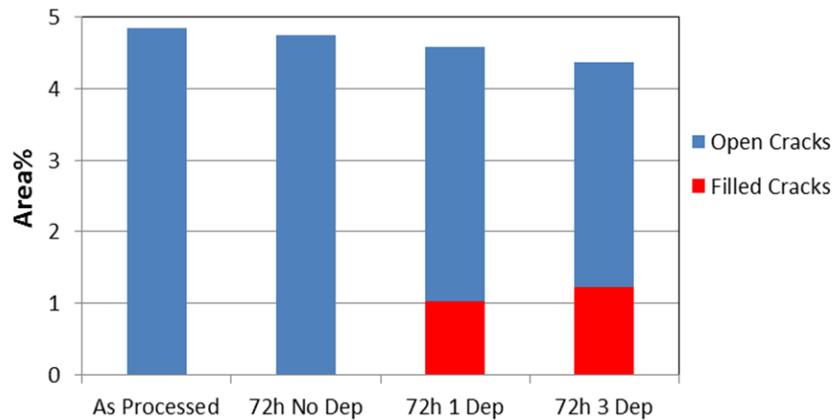
**Figure 60:** Image analysis results in YSZ measured through the thickness of three different samples. The area of open cracks and cracks filled with  $\text{CaZrO}_3$  was measured for as-processed YSZ, Free-standing YSZ that had been heat treated without deposit, YSZ that was exposed to a single application of high-CaO synthetic ash, and also a sample that was reacted while high-CaO synthetic ash was applied at three equally-spaced intervals.

The area percentage of  $\text{CaZrO}_3$  measured with image threshold analysis is shown in Figure 59 after a single high-CaO deposit application and compared to that of three separate applications. The relative amount of open cracks for the same exposure without deposit is also shown to provide a baseline. Relative internal  $\text{CaZrO}_3$  formation through the YSZ thickness indicates that multiple deposit applications did not have a measurable effect on overall penetration distance into YSZ cracks.

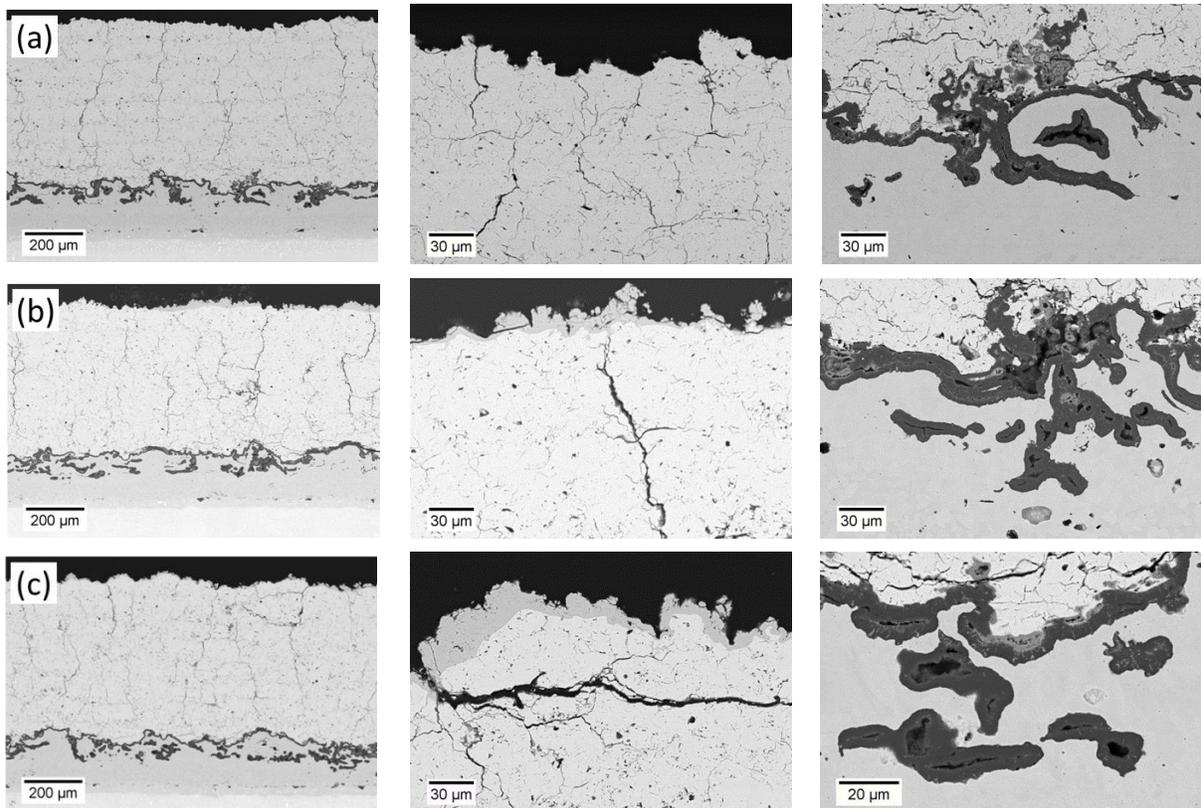
**Figure 61:** DVC TBC tested in cyclic bottom-loading furnace in lab air. After 200 cycles with (a) no deposit, (b) single application of CaO, and (c) re-application of CaO every 20 cycles.

Thermal cycling in the bottom-loading furnace is shown in Figure 61 for a DVC TBC without deposit compared to an identical TBC with a CaO deposit applied to the surface before cycling. All TBCs were intact after 200 cycles. The CaO deposit formed a  $\text{CaZrO}_3$  surface layer during cycling, and did not produce additional damage to the TBC. No observable differences were detected in the YSZ top coat, underlying bond coat, or the TGO formed during cycling between the TBC without deposit and the one with the CaO deposit. Additional testing was done in which the CaO deposit was re-applied every 20 cycles. No additional damage resulted from the re-application of the CaO deposit. The surface reaction layer did not appear to influence the lifetime of the TBC.

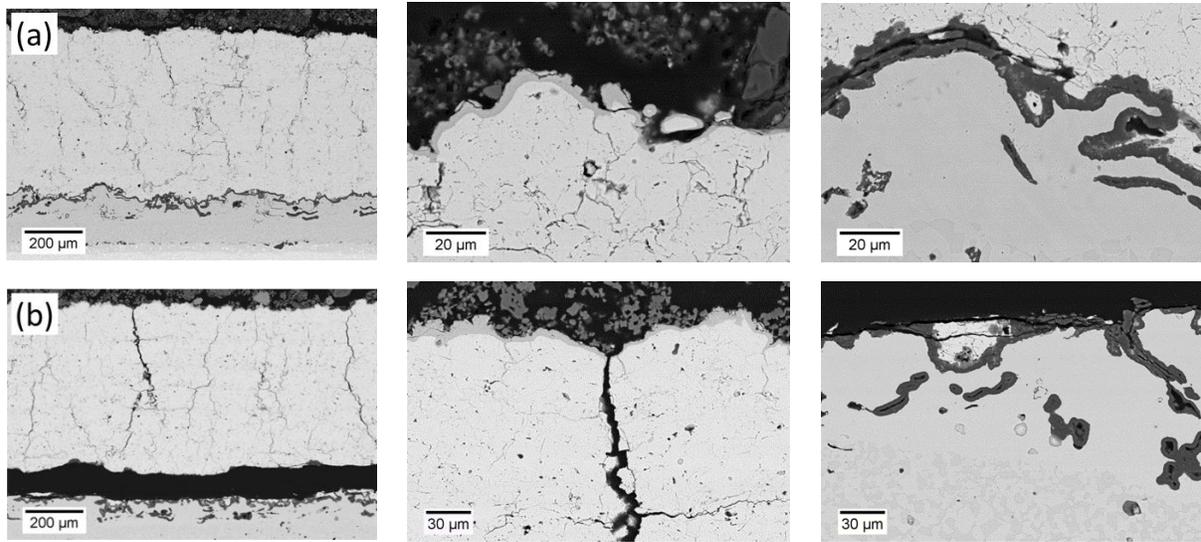
**Figure 62:** DVC TBCs tested in cyclic bottom loading furnace. (a) TBC intact after 140 cycles with high-CaO deposit without  $K_2SO_4$ , and (b) topcoat delamination after 140 cycles with the same high-CaO deposit including addition of  $K_2SO_4$ .

While the  $\text{CaZrO}_3$  layer on the surface of the TBC did not affect TBC lifetime in 200 cycles, internal  $\text{CaZrO}_3$  formation from addition of  $\text{K}_2\text{SO}_4$  caused considerable reduction in TBC lifetime during cycling in lab air. The TBCs shown in Figure 62 both experienced 140 cycles in the bottom-loading furnace. A high-CaO synthetic ash deposit was applied to both: one which contained only

oxides and the other with  $K_2SO_4$  addition. The addition of  $K_2SO_4$ , and subsequent internal  $CaZrO_3$  formation, caused complete spallation of the YSZ top coat. The high-CaO deposit, which formed a  $CaZrO_3$  surface layer similar to the CaO deposit, did not exhibit any signs of damage to the TBC.

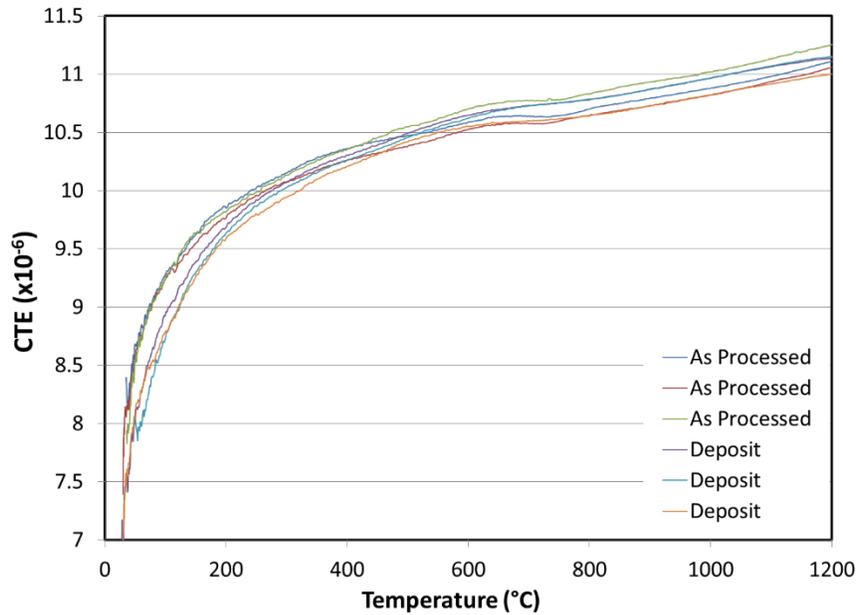
**Figure 63:** Dilatometry results showing no significant effect on thermal expansion coefficient caused by internal CaZrO<sub>3</sub> formation from high-CaO deposit.

The thermal stress described by Equation 9-1 would also increase if the CTE difference between the YSZ and substrate increased. The CTE of YSZ (typically around  $11\text{-}13 \times 10^{-6} \text{ C}^{-1}$ ) is lower than that of the substrate (typically  $\sim 17 \times 10^{-6} \text{ C}^{-1}$ ). If the internal  $\text{CaZrO}_3$  formation resulted in a lowered CTE, then the increased  $\Delta\alpha$  term would also contribute to increased thermal stress. The thermal expansion coefficient was also measured for samples which were heated for 72 hours in dry air at  $1100^\circ\text{C}$ . The high-CaO synthetic deposit was applied to half the samples before heat treatment in order to produce internal  $\text{CaZrO}_3$  formation. Thermal expansion coefficient values obtained by dilatometry measurements done at Praxair Surface Technologies are shown in Figure 63. No significant difference in CTE was measured from the internal  $\text{CaZrO}_3$  formation, which resulted from the high-CaO deposit. This result is not surprising; typical values for CTE of  $\text{CaZrO}_3$  reported in literature are around  $11.5 \times 10^{-6} \text{ C}^{-1}$  [122], which is similar to that of YSZ.

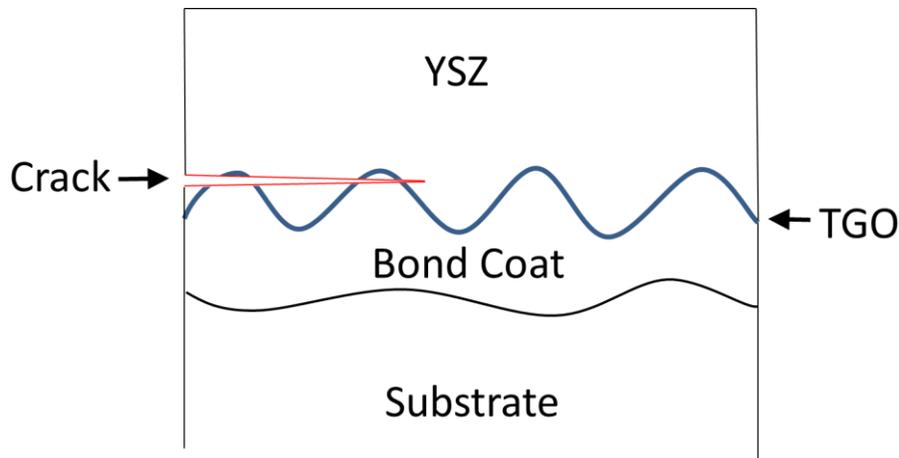
**Figure 64:** TBC failure caused by thermal cycling. Failure typically initiated at a TBC edge and then propagated across the tops of the undulated interface of the bond coat.

Both types of TBC systems were thermally cycled in dry air according to the experimental setup described in chapter 4.3. Typical TBC failure is shown schematically in Figure 64. The delamination initiated at the sample edges during thermal cycling and then quickly extended across the entire sample. Partially delaminated samples were not available because complete delamination would always occur shortly after edge cracking was initiated. Delamination occurred along crests of the undulated interface through the TGO, leaving areas of TGO exposed. The delamination at the troughs of the undulations occurred further into the YSZ, which left some small pieces of YSZ attached to the bond coat. The micrographs of failed TBCs in dry air shown in Figure 65 and 67 for DVC and HPLD TBCs, respectively, represent typical failures. TBC failure was defined by 30% top coat spallation. However, as can be seen in the figures, both DVC and HPLD top coats exhibited complete delamination with cracks propagating along the TGO/YSZ interface. It is important to note that this location of delamination was the same for both DVC and HPLD TBCs without deposit.

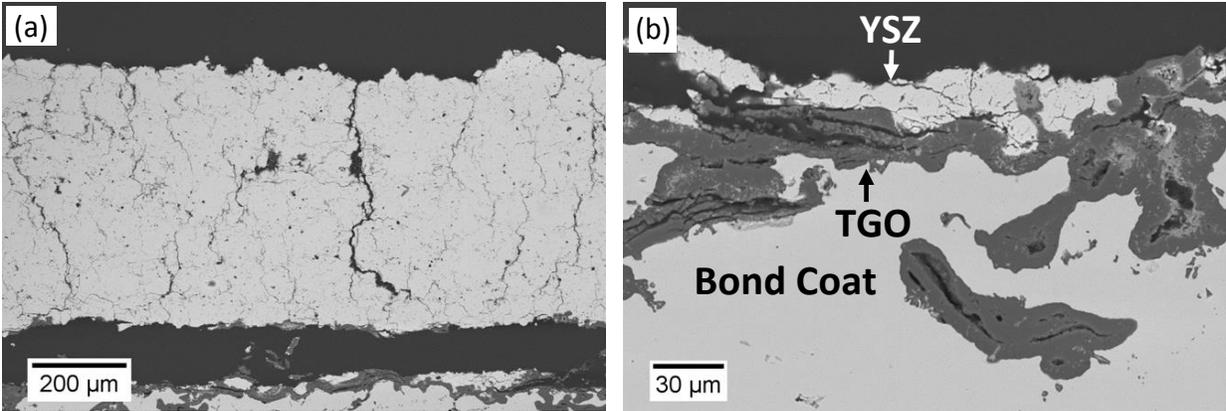
**Figure 65:** DVC TBC failure after 1214 cycles in dry air without deposit. (a) The top coat delaminated entirely from the substrate as a single intact coating, (b) failure occurred along the TGO/YSZ interface.

Oxidation behavior of the bond coat is represented in Figure 65(b) and 66(b). The thermally grown oxide, indicated as TGO in the micrographs, had formed a continuous layer along the bond-coat surface in both types of TBC. Some oxidation of interior pores was also observed in the bond coat. The TGO was determined by EDS analysis to consist predominantly of alumina. Some lighter regions inside the alumina represented mixed oxides of chromium and nickel. Overall, the bond coat oxidation was consistent with normal TBC performance [99]. There was no evidence that the bond-coat oxidation contributed significantly to the TBC failure, which would have been indicated by significant internal oxidation [59], formation of non-protective oxides [63, 123], dissolution of the TGO [32, 123], etc.

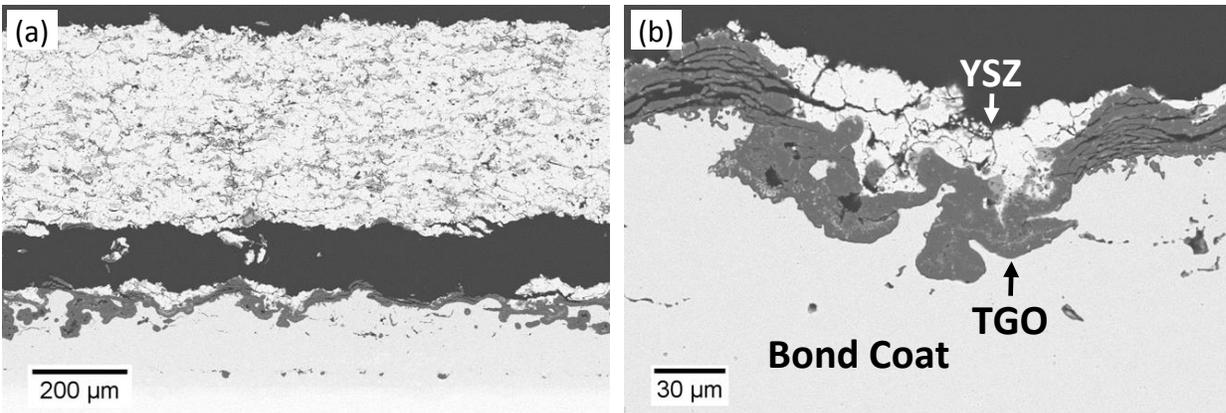
**Figure 66:** Conventional HPLD TBC failure after 1000 cycles without deposit was nearly identical to the DVC TBC failure. (a) The top coat delaminated completely from the substrate as a single intact coating, (b) delamination occurred at the TGO/YSZ interface.

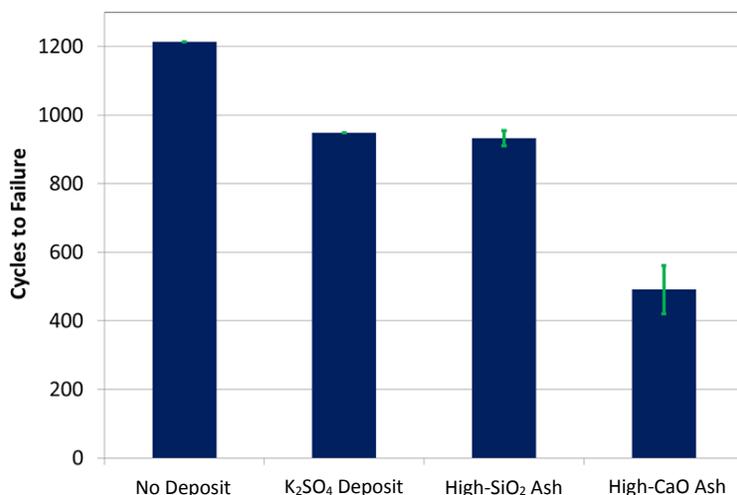
**Figure 67:** Cyclic failure of DVC TBCs in dry air with different deposits compared to failure without a deposit.

Cyclic failure of DVC TBCs was assessed after exposure in dry air and with several different deposits. A single application of a given deposit was applied to a TBC surface before thermal cycling. Deposit application was done using a dropper at a loading of  $35 \text{ mg/cm}^2$  after mixing with ethanol to create a slurry. Figure 67 summarizes the effect on DVC TBC performance from three deposits:  $\text{K}_2\text{SO}_4$ , and the two synthetic ash deposits presented in Table 12. Three TBCs were tested to failure with each deposit. The high- $\text{SiO}_2$  and high- $\text{CaO}$  deposits consisted of oxides and minor constituents ( $\text{K}_2\text{SO}_4$ ,  $\text{FeS}$ ) typically found in fly ash. Reduced TBC lifetimes were observed in the presence of all three deposits compared to cyclic performance without a deposit. The measured cyclic lifetime of 1200 cycles of the TBC without deposit was used to define a normal lifetime under the current cyclic exposures. Further, the nature of the failed TBC shown in Figure 65 was taken to represent a typical failure morphology. Failed TBCs with different deposits were then compared to this baseline to identify additional damage which contributed to the early failure.

The cyclic lifetimes of DVC TBCs reported in Figure 67 show the detrimental effects of surface deposits which include K<sub>2</sub>SO<sub>4</sub>. As shown in chapters 6 and 7, K<sub>2</sub>SO<sub>4</sub> addition to deposits high in CaO and/or SiO<sub>2</sub> cause liquid infiltration in the YSZ top coat. The cyclic lifetimes presented

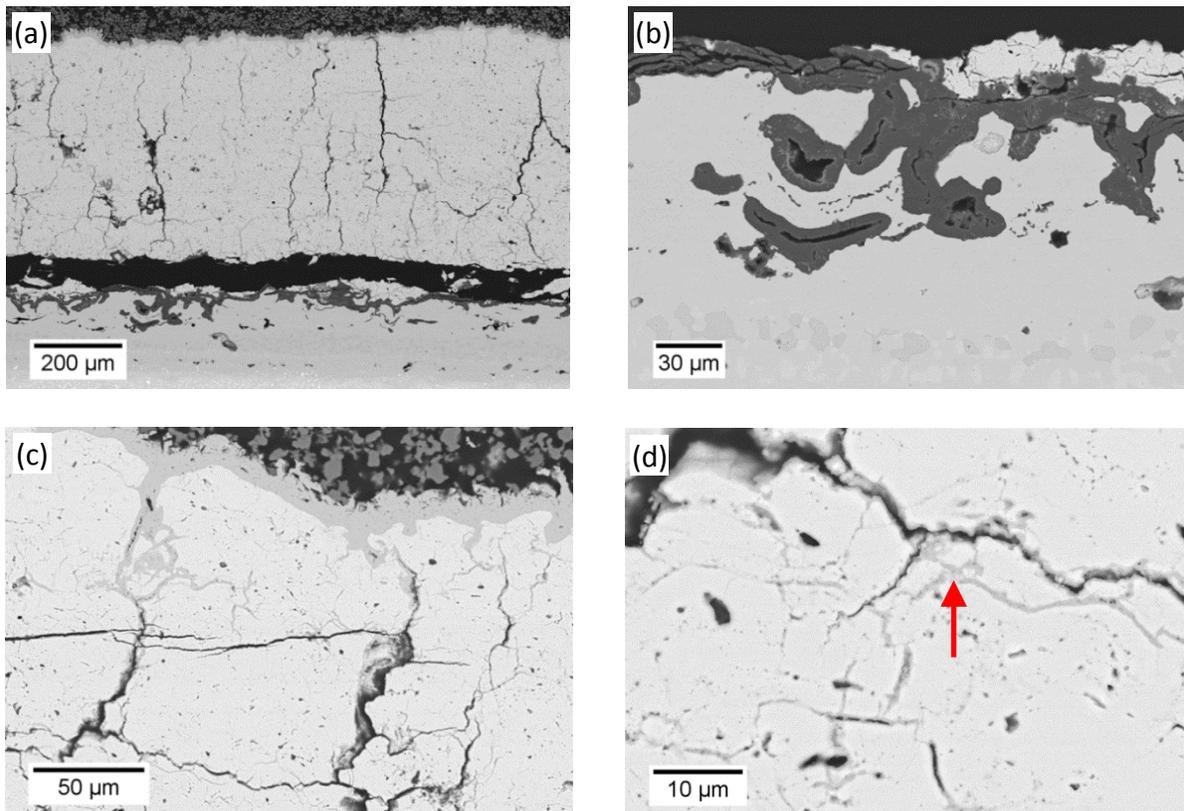
**Figure 68:** Failed DVC TBC after 630 cycles in dry air with high-CaO synthetic ash deposit. (a) Top coat delamination is similar to failure without deposit, (b) Alumina growth in the bond coat was not affected, (c)  $\text{CaZrO}_3$  was observed as a surface layer, and (d) penetrated into the top coat as shown by arrow.

A representative failed DVC TBC with high-CaO deposit is shown in Figure 68. The location of failure was very similar to a typical TBC failure without deposit. Complete top coat delamination occurred at the TGO along the undulations of the bond coat surface. The spallation sheared through the TGO at the peaks of the undulations, which left some YSZ attached to the bond coat in the troughs. The TGO did not appear to be significantly altered by the presence of the deposit. A continuous Al<sub>2</sub>O<sub>3</sub> layer was intact at the bond coat surface and there was no indication of TGO dissolution or a large amount of non-protective oxide formation.

The high-CaO deposit did not significantly affect oxidation of the bond coat. There was, however, a reaction involving the YSZ top coat near the TBC surface. Figure 68c and 69d show a dense reaction product which had formed a continuous layer along the surface and also extended into the YSZ by filling many cracks and open pores in the top coat. This product, which was identified by EDS and XRD to be  $\text{CaZrO}_3$ , was observed to penetrate a significant distance (250-

300 $\mu$ m) from the YSZ surface. The nature of the internal CaZrO<sub>3</sub> formation, which occurred most significantly at the high temperature of the thermal cycling, was discussed in detail in chapter 5. The results shown here agree with the previously-discussed isothermal tests, which showed internal CaZrO<sub>3</sub> formation from a CaO-rich deposit at 1100°C.

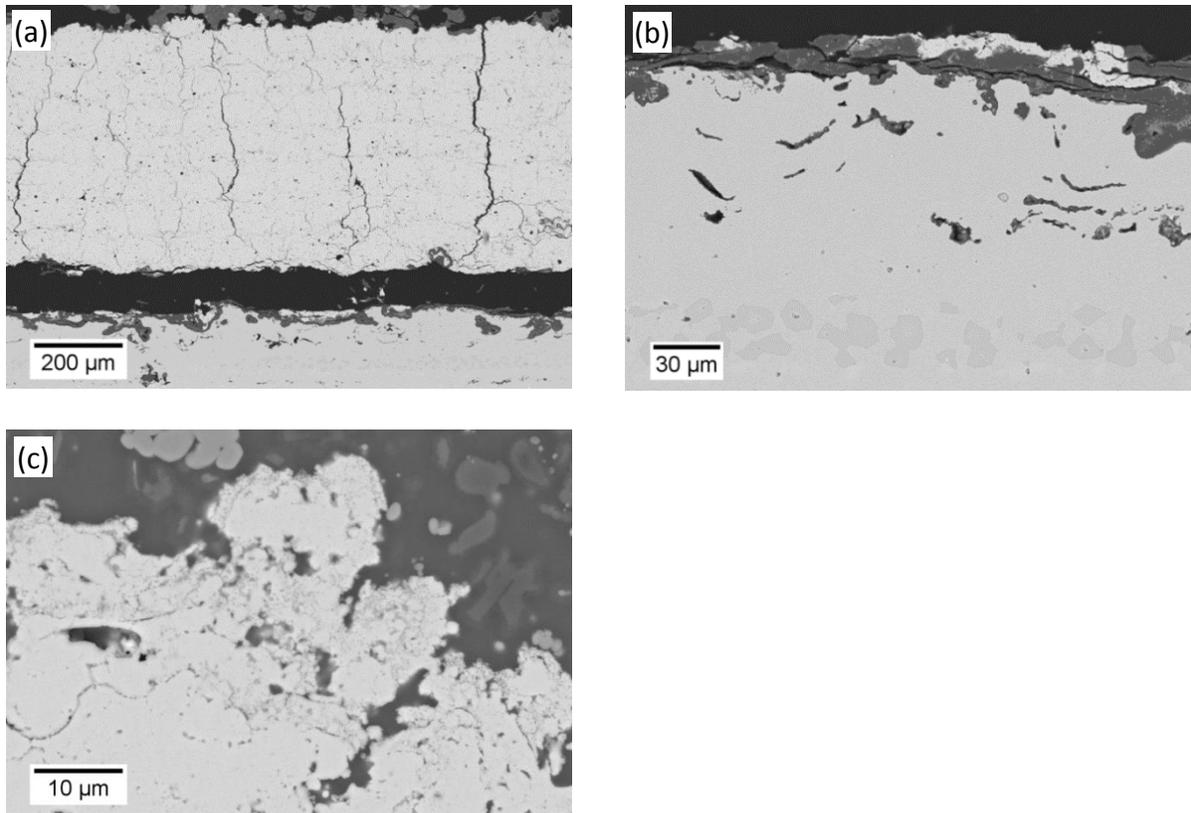
**Figure 69:** DVC TBC failure after 910 cycles in dry air with high-SiO<sub>2</sub> synthetic ash. (a) Complete top coat delamination, (b) typical bond coat oxidation expected after thermal cycling, and (c) change in microstructure at surface indicating some reaction between the ash and YSZ.

The reduction in TBC lifetime after a single application of high-SiO<sub>2</sub> deposit was less severe than that of high-CaO deposit. The failure in the presence of high-SiO<sub>2</sub> deposit after 910 cycles is shown in Figure 69. The failure with the two deposits was very similar. No significant difference was observed at the TGO/bond coat interface: delamination occurred along the TGO along the crests of the undulated YSZ/bond coat interface. Furthermore, the high-SiO<sub>2</sub> deposit did not appear to contribute to any non-protective oxide formation or TGO dissolution. As in the case of the high-CaO deposit, there was no evidence to suggest that the early delamination of the top coat was related to the bond coat oxidation.

A magnified image of the top coat near the deposit indicated some change in morphology between the YSZ and the high-SiO<sub>2</sub> deposit. This reaction did not contain any measurable levels of CaZrO<sub>3</sub>, which was found after exposure with high-CaO deposit. As discussed in chapter 6, the liquid infiltration from high-SiO<sub>2</sub> deposit was determined from EDS to contain potassium, silicon, and oxygen. This infiltration appeared to wet many of the YSZ cracks near the surface, which would indicate some liquid formation at 1100°C during thermal cycling. The change in YSZ morphology shown in Figure 69 at the deposit/YSZ interface could have been the result of some

destabilization of the 7YSZ, similar to what has been reported in other studies with SiO<sub>2</sub>-rich deposits [32]. Typically this occurs after dissolution-reprecipitation of YSZ [32]; although, here it appeared to have occurred only in very small areas at the surface of the YSZ. Overall, the silicate infiltration did not damage the TBC as severely as internal CaZrO<sub>3</sub> formation, as indicated by the longer lifetimes.

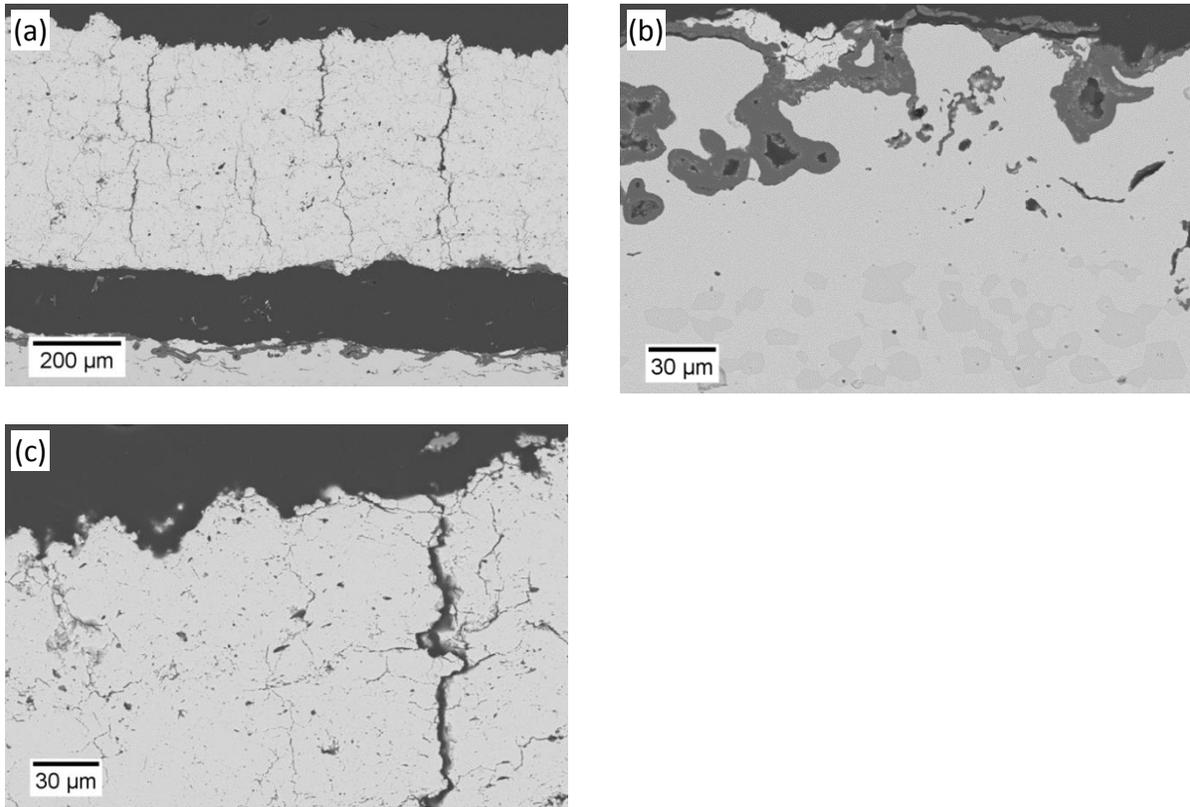
**Figure 70:** Failure of DVC TBC in dry air after 948 cycles with  $K_2SO_4$  deposit. (a) Complete top coat delamination, (b) normal bond coat oxidation, and (c) no reaction with YSZ.

Cyclic testing with a K<sub>2</sub>SO<sub>4</sub> deposit reduced TBC lifetimes to values similar to those measured with the high-SiO<sub>2</sub> synthetic ash deposit. The mode of failure with K<sub>2</sub>SO<sub>4</sub> was also similar to that of exposure to the high-SiO<sub>2</sub> and high-CaO deposits. At failure, the YSZ delaminated along the TGO as a single intact coating. In contrast to other deposits, however, no penetration of YSZ cracks from liquid or reaction product formation near the surface of the top coat was observed with the K<sub>2</sub>SO<sub>4</sub> deposit after failure. Figure 70 shows no indication of K<sub>2</sub>SO<sub>4</sub> on the surface of the YSZ or inside cracks below the surface. This absence of K<sub>2</sub>SO<sub>4</sub> after exposure was consistent with the high volatilization rate of K<sub>2</sub>SO<sub>4</sub> at 1100°C, which was verified experimentally. This was discussed in detail in section 6.5.

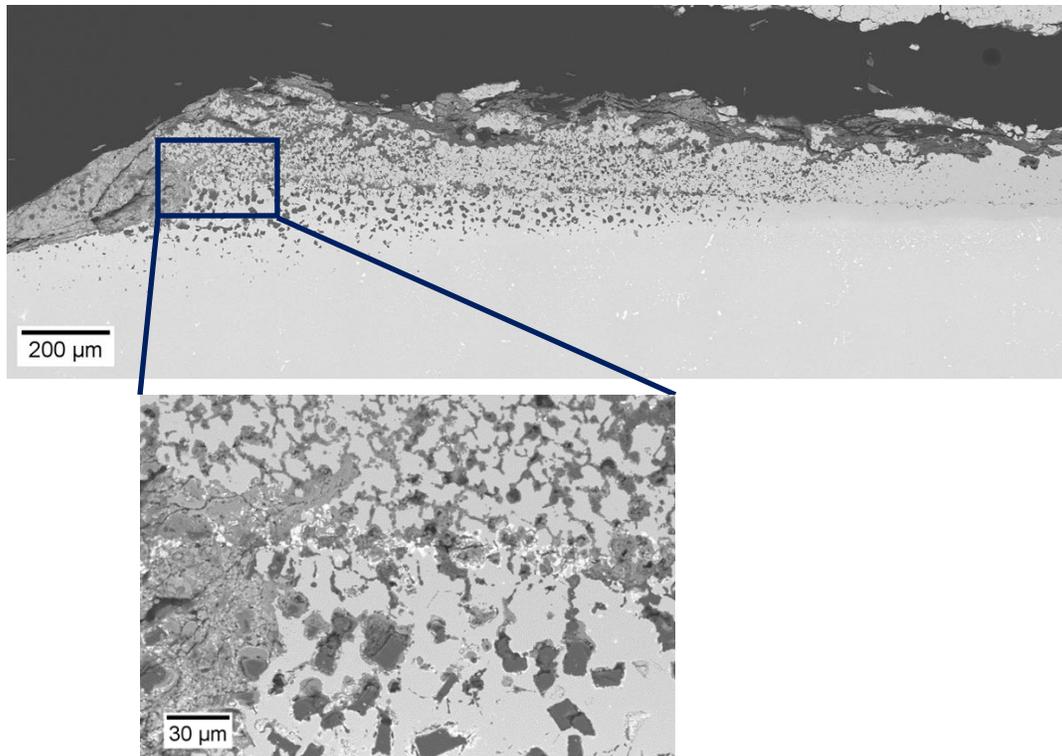
**Figure 71:** DVC TBC failure after 948 cycles in dry air with  $K_2SO_4$  deposit. Internal oxidation of the bond coat is observed near the edge of the TBC after failure.

The effect on bond coat oxidation was different in the case of the  $K_2SO_4$  deposit. Delamination of the TBC with a pure  $K_2SO_4$  deposit, as shown in Figure 71, was a consequence of severe damage of the bond coat near the edge of the sample. Extensive internal oxidation was observed in the bond coat near the edge of the TBC coupon. The inter-linked intrusions were confirmed by EDS to be comprised predominantly of alumina, which would normally form as a continuous layer on the surface of the bond coat (as observed in previous cyclic testing). The areas of bond coat near to these regions were also completely depleted of beta phase, indicative

of extensive Al consumption, which is consistent with the observed internal oxidation. These observations are consistent with studies in sulfur-containing atmospheres, which report the promotion of internal oxidation in alloys which would normally form protective scales [48]. The areas of the TBC farther from the edge were protected by the YSZ top coat, and the detrimental effects on the TGO were only observed on the sample edges where the TGO was exposed to liquid  $K_2SO_4$ . This type of degradation mechanism is similar to what is expected in Type I hot corrosion involving  $Na_2SO_4$  [124, 125]. As the bond coat is oxidized to form the TGO, oxygen potential in liquid sulfate decreases which causes sulfur potential to increase. In Type I hot corrosion, this causes sulfur penetration through the oxide layer and disruption in oxidation as internal sulfides are formed [124].

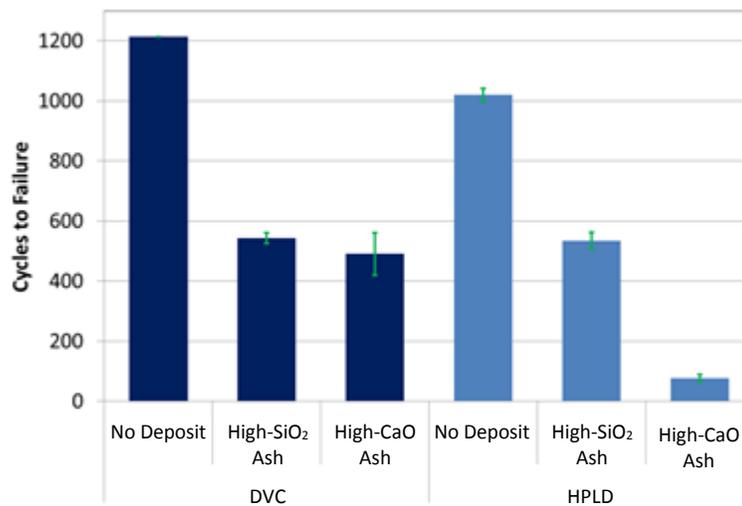
**Figure 72:** Failure of DVC and HPLD TBCs after 1-h cycles at 1100°C in dry air. Synthetic ash compositions are described in Table 13.

Both HPLD and DVC TBCs were tested to failure in dry air with the high-CaO and high-SiO<sub>2</sub> deposits listed in Table 13. Lifetimes shown in Figure 72 are used as a relative comparison between top coat durability with the same deposits. The shorter lifetime for the DVC TBCs with the high-SiO<sub>2</sub> deposit compared to Figure 67 is attributed to the increased  $K_2SO_4$  level in the deposit. The effect of varying  $K_2SO_4$  levels will be examined in more detail in chapter 10. It is important to note that lifetimes of both top coats were comparable without deposits.

The cyclic lifetimes of TBCs with the high-SiO<sub>2</sub> deposit were similar for both DVC and HPLD TBCs. The high-CaO deposit, however, led to a much more dramatic decrease in HPLD TBC lifetime. The distinguishing feature of HPLD TBC failure shown in Figure 73 was that cracking and delamination occurred inside the top coat away from the TGO, as opposed to DVC top coats which remained intact until delamination. Regions in the TBC close to the surface shown in Figure

The increased strain tolerance provided by the vertical cracks in the DVC top coats make them less sensitive to differences in elastic modulus between silicate infiltration and CaZrO<sub>3</sub> formation, and similar lifetimes were reported in Figure 72 for high-CaO and high-SiO<sub>2</sub> deposits. HPLD TBCs, however, experienced degradation and early failure which was more severe with CaZrO<sub>3</sub> formation. The HPLD coating would be more sensitive to the increased stored energy because of the splat morphology. The horizontal splat edges would provide a lower-toughness boundary along which cracks would propagate more readily. This is apparent in the fact that extensive cracking occurred in HPLD TBC the top coat layer, relatively far away from the

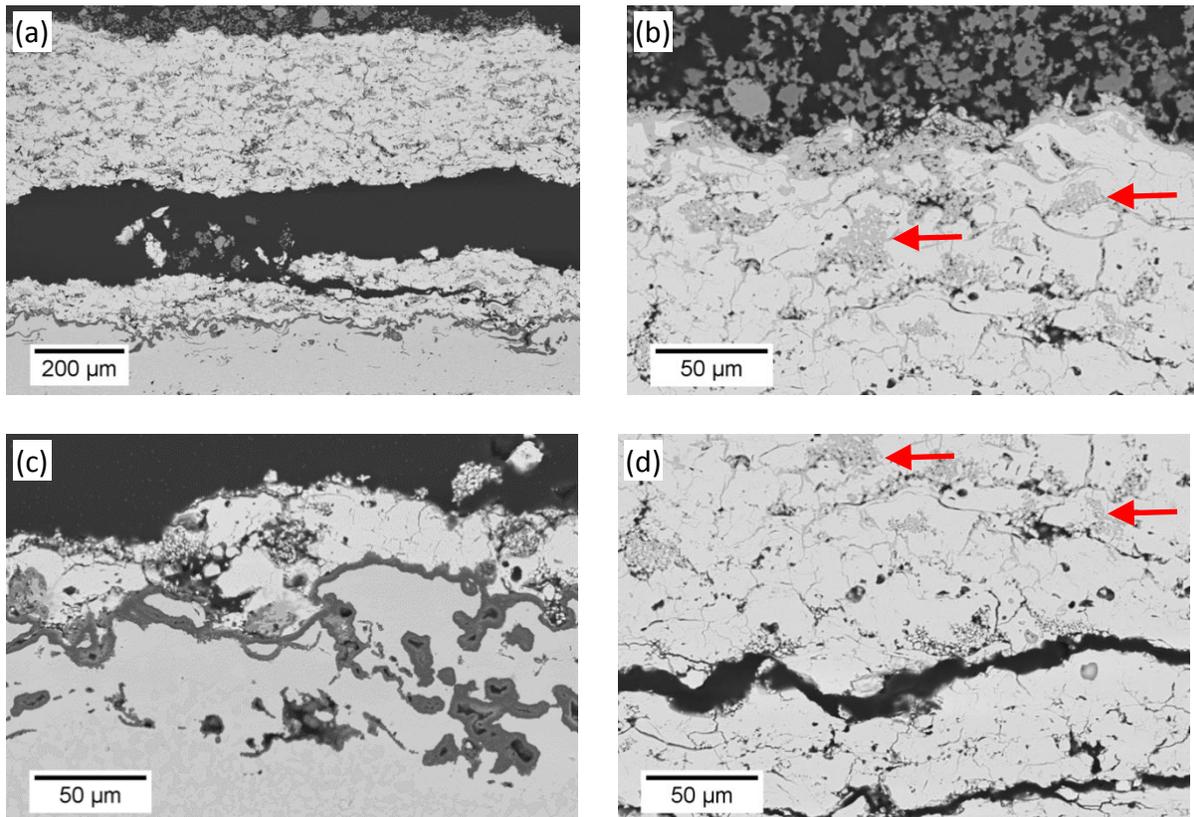
**Figure 73:** HPLD TBC failure in dry after 65 cycles with high-CaO deposit described in Table 13. (a) Complete top coat delamination is shown deep in the YSZ, away from the bond coat. (b) Internal  $\text{CaZrO}_3$  formation in open pores of the YSZ is indicated by arrows near the YSZ surface where the deposit was applied. (c) Bond coat oxidation did not exhibit any abnormalities compared to cyclic exposures without deposit. (d) Internal  $\text{CaZrO}_3$  formation is indicated by arrows in region above cracking in the YSZ.

73 indicate  $\text{CaZrO}_3$  formation similar to what was observed with DVC top coats. TBC cracking is observed below the infiltrated region.

Failure of HPLD TBCs from cracking deep in the top coat is similar to failure which was observed in a previous study [50]. In that study, the increased strain energy associated with a thicker top coat contributed to failure. The early failure observed in this work would result from a similarly increased strain energy caused the internal  $\text{CaZrO}_3$  formation.

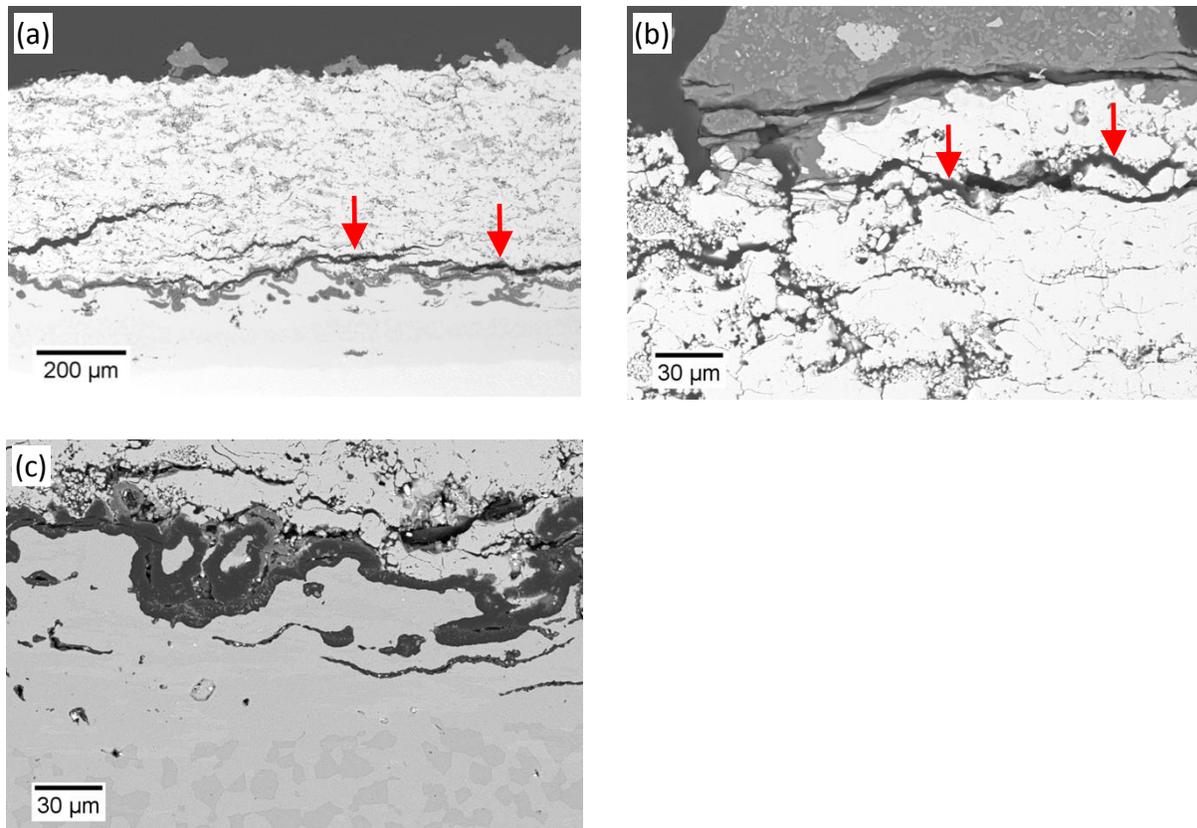
**Figure 74:** HPLD TBC failure in dry air after 575 cycles in dry air with high-SiO<sub>2</sub> deposit described in Table 13. (a) Significant cracking in the YSZ is indicated along the undulated interface with the bond coat. (b) Some infiltration in the YSZ at the surface where the deposit was applied. (c) Normal bond coat oxidation which would be expected from cycling without deposit.

Failure of HPLD TBCs in the presence of a high-SiO<sub>2</sub> deposit shown in Figure 74 was not significantly different from the failure incurred with a high-CaO deposit. Some cracking was observed in the YSZ, however complete delamination of the top coat occurred in the YSZ near the TGO. The significant cracking shown in Figure 74 propagated along the crests of the undulated bond coat surface. The surface of the YSZ near the deposit experienced some infiltration of a liquid silicate during high temperature exposures, and some cracking was also observed near the infiltrated regions.

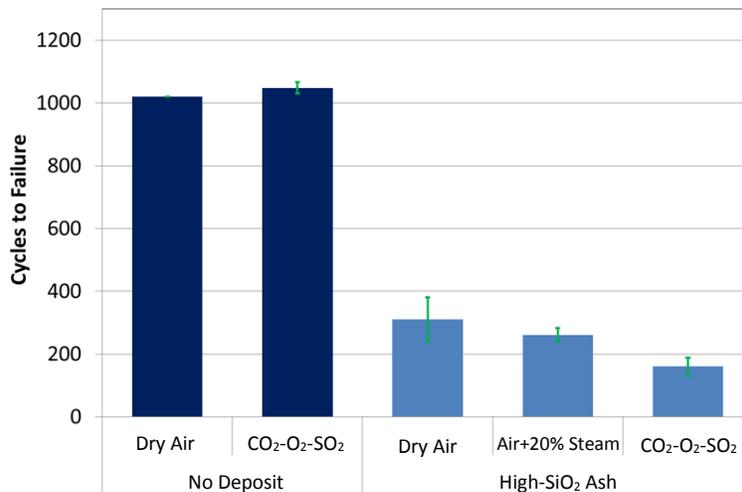
**Figure 75:** HPLD TBC failure in several gas atmospheres.

Cyclic testing was done in three different gas atmospheres: dry air, air+20% steam, and 2%O<sub>2</sub>-1000ppm SO<sub>2</sub>-bal CO<sub>2</sub>. These gas atmospheres were chosen to study possible effects from environments relevant to IGCC systems. The high-SiO<sub>2</sub> deposit was chosen because it more closely represents a typical IGCC fly ash composition. Figure 75 shows that cyclic lifetimes without

deposit were nearly identical in atmospheres of dry air and 2%O<sub>2</sub>-1000ppmSO<sub>2</sub>-bal CO<sub>2</sub>. Early failure with high-SiO<sub>2</sub> deposit was slightly exacerbated in the SO<sub>2</sub>-containing atmosphere (as indicated by slightly shorter lifetimes compared to deposit failure in the other atmospheres). This suggests that some combined effect of deposit and atmosphere may exist in the SO<sub>2</sub>-containing environment. Failure time in the steam-containing atmosphere, however, was nearly identical to that of dry air with the high-SiO<sub>2</sub> deposit.

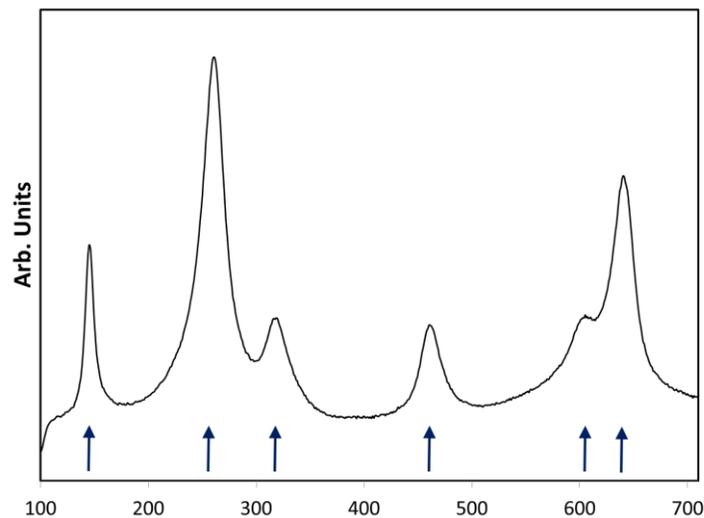
**Figure 76:** Raman scan of YSZ topcoat from failed HPLD TBC after 1000 cycles in 2% $\text{O}_2$ -1000ppm  $\text{SO}_2$ -bal  $\text{CO}_2$  atmosphere. The peaks indicated by the arrows correspond to those expected for the  $t'$  phase, indicating that the no destabilization occurred during cycling.

The Raman scan shown in Figure 76 was obtained at an internal point 100  $\mu\text{m}$  below the surface of a failed HPLD YSZ top coat after failure in the  $\text{CO}_2\text{-O}_2\text{-SO}_2$  atmosphere. The existence of the characteristic peaks which correspond to the  $t'$  phase (and the absence of the peaks corresponding to the cubic and monoclinic phases) indicates that no detectable amounts of YSZ destabilization had occurred as a result of the  $\text{SO}_2$ -containing atmosphere. This result is consistent with the observation that TBC lifetimes in the two atmospheres were nearly identical. Early failure was thus attributed to damage from the deposit.

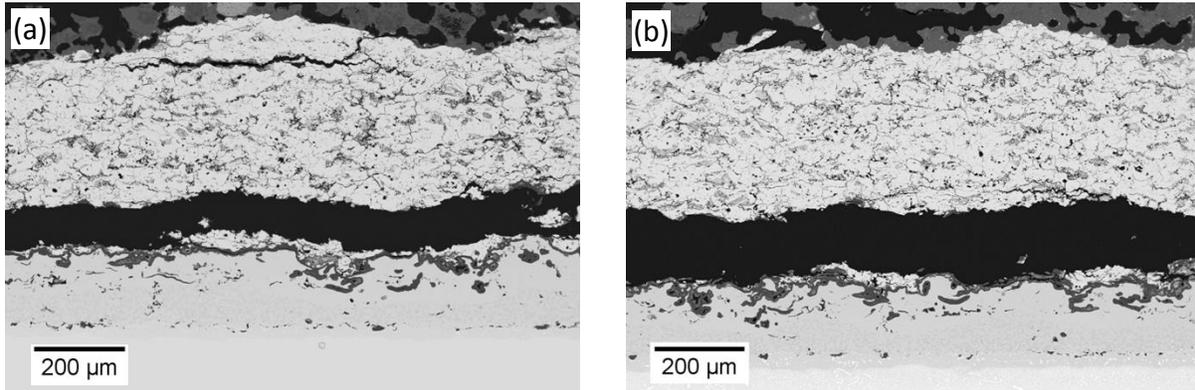
**Figure 77:** HPLD TBC failure from high-SiO<sub>2</sub> deposit (a) after 320 cycles in air+20%steam and (b) after 220 cycles in 2%O<sub>2</sub>-1000ppm SO<sub>2</sub> atmosphere.

Failed TBCs in both the air+steam and CO<sub>2</sub>-O<sub>2</sub>-SO<sub>2</sub> atmospheres with the high-SiO<sub>2</sub> deposit are shown in Figure 77. In both atmospheres, the YSZ top coats experienced large-scale delamination along the TGO. This location of large-scale delamination was similar to what was observed dry air cyclic exposures. Overall failure in the air+steam atmosphere was

indistinguishable from the dry-air failure. The steam also did not noticeably affect infiltration from the silicate formation in the deposit.

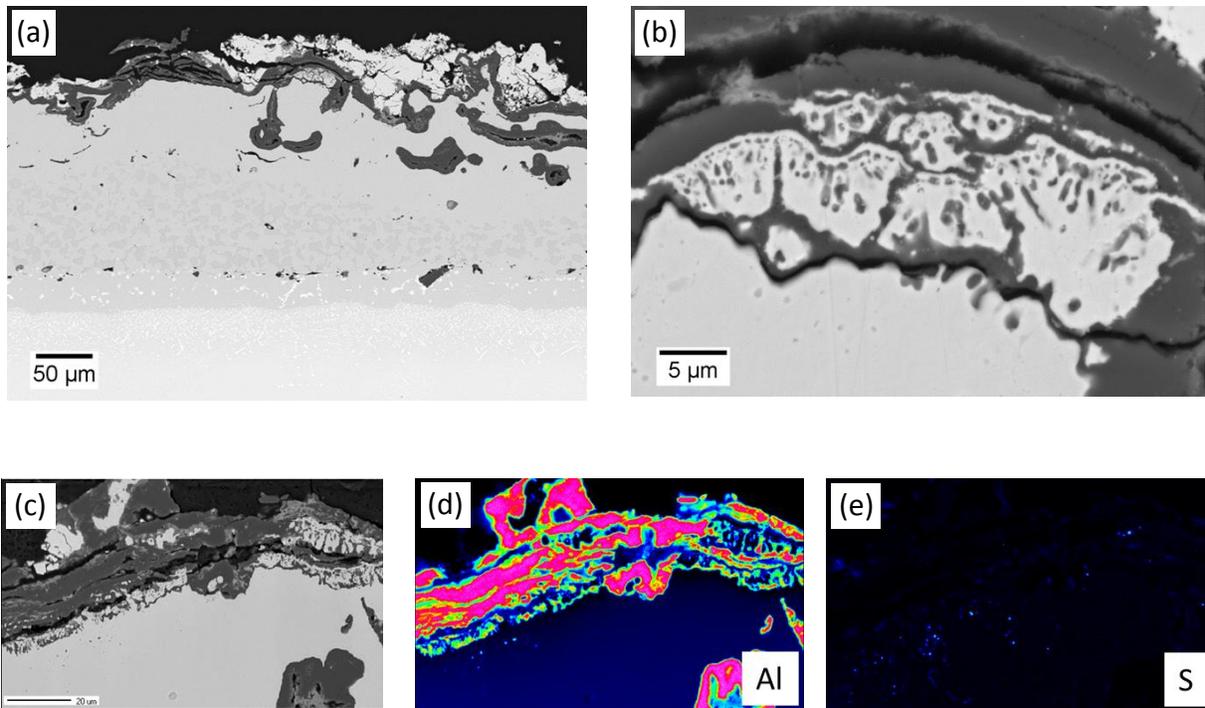
**Figure 78:** (a) Failure of HPLD TBC after 220 cycles with high-SiO<sub>2</sub> deposit in 2%O<sub>2</sub>-1000ppm SO<sub>2</sub> atmosphere and (b) magnified image of alumina intrusion in bond coat. (c) Failed TBC experienced 20 additional cycles with deposit applied directly to exposed bond coat which caused an increase in the internal alumina formation. (d) EDS shows intrusions of alumina and (e) isolated areas of sulfur potentially indicating sulfides near the surface.

TBC failure from cyclic exposures with high-SiO<sub>2</sub> deposit in the CO<sub>2</sub>-O<sub>2</sub>-SO<sub>2</sub> atmosphere was accompanied by additional damage to the bond coat, as shown in Figure 78. Undulated regions of the bond coat surface occasionally exhibited internal oxidation indicated by alumina intrusions. Large numbers of the alumina intrusions occasionally linked together to cut off parts of the bond coat near the YSZ. These intrusions appeared with the combined presence of deposit and SO<sub>2</sub>-containing atmosphere and (at the time of YSZ delamination) only occurred at the crests of the undulated surface.

Additional thermal cycling was done with a TBC which had failed with a high-SiO<sub>2</sub> deposit and exposed to an SO<sub>2</sub>-containing atmosphere. After top-coat spallation, the high-SiO<sub>2</sub> deposit was applied directly to the exposed bond coat, which was then exposed to additional thermal cycling in the SO<sub>2</sub>-containing atmosphere. The failed TBC is shown in Figure 78c after 20 cycles with direct bond coat exposure to the deposit. The extent of internal oxidation increased after the additional thermal cycles, and extended over larger regions of the bond coat. Alumina intrusions reached into the troughs of the undulated surface (rather than only the crests). Additionally, X-ray maps shown in Figure 78d and 79e indicate that the internal alumina was concurrent with the presence of sulfur near the bond coat surface.

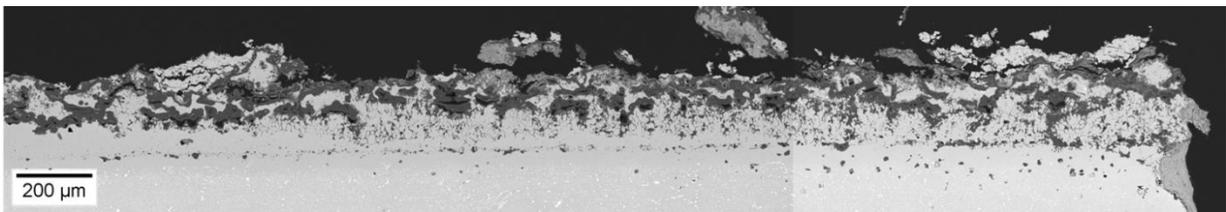
**Figure 79:** Severe degradation of bond coat near the edge of the TBC after 1048 cycles in 2%O<sub>2</sub>-1000ppmSO<sub>2</sub>-bal CO<sub>2</sub> atmosphere without deposit.

TBC lifetimes in the CO<sub>2</sub>-O<sub>2</sub>-SO<sub>2</sub> atmosphere were comparable to those of dry air, and were only shortened when a deposit was applied prior to thermal cycling. Significant edge effects, however, were observed in the CO<sub>2</sub>-O<sub>2</sub>-SO<sub>2</sub> atmosphere without the deposit. Figure 79 shows damage to the bond coat near the edge of a TBC without deposit after 1048 cycles in the CO<sub>2</sub>-O<sub>2</sub>-SO<sub>2</sub> atmosphere. Although the damage near the edge was dramatic, it did not extend to the

center of the TBC. The fact that failure occurred at 1048 cycles also shows that the observed edge damage did not lead to early failure.

Significant internal oxidation of the bond coat was observed near the edge of the TBC in the  $SO_2$ -containing atmosphere in the absence of a surface deposit. This edge damage in the  $SO_2$  atmosphere, however, did not significantly decrease overall TBC cyclic lifetime. This result is important, because similar edge damage was also observed in dry air testing with  $K_2SO_4$  deposit, as shown in Figure 71. In that test, however, TBC lifetime was reduced. The edge damage did not appear to be responsible for the early failure.
