DEGRADATION OF TBC SYSTEMS IN ENVIRONMENTS RELEVANT TO ADVANCED GAS TURBINES  
FOR IGCC SYSTEMS

Submitted to the Graduate Faculty of  
the Swanson School of Engineering in partial fulfillment

Doctor of Philosophy

University of Pittsburgh

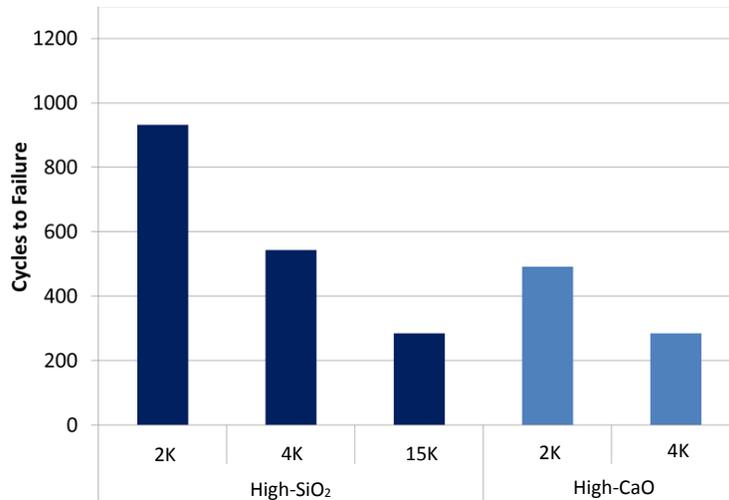
**Figure 80:** Cycles to failure are shown for SiO<sub>2</sub>-rich deposits and CaO-rich deposits with varying levels of K<sub>2</sub>SO<sub>4</sub> and FeS. Compositions of deposits are provided in Table 14. The same loading of 35 mg/cm<sup>2</sup> was applied in each case. Shortened lifetimes correspond to higher levels of K<sub>2</sub>SO<sub>4</sub> addition to the deposits.

The presence of alkali metal species has been reported in fuels derived from coal and biomass [127]. Early TBC failure was observed in the presence of deposits containing a minor amount of  $K_2SO_4$ . Based on the results presented in chapters 5 and 6, the addition of  $K_2SO_4$  should result in liquid formation at 1100°C, either as a result of the sulfate melting in its pure state or as a low-melting silicate formed by reaction with  $SiO_2$ . In both cases, a liquid infiltration involving  $K_2SO_4$  could damage the YSZ top coat in the TBC at 1100°C. The amount of available  $K_2SO_4$  in the deposit should directly affect the amount of infiltration, and therefore the severity of TBC damage. The thermal cycles to failure summarized in Figure 80 show that increased levels of

K<sub>2</sub>SO<sub>4</sub> resulted in decreased TBC lifetime for both types of deposit (rich in SiO<sub>2</sub> and CaO). The deposit compositions with varying K<sub>2</sub>SO<sub>4</sub> concentrations are shown in Table 14. This suggests a direct link between available K<sub>2</sub>SO<sub>4</sub> in the deposit and severity of damage produced in the TBC.

corresponded to a similar shortening in TBC lifetime for both deposits. Figure 80 indicates that the lifetimes were approximately cut in half when the amount of  $K_2SO_4$  was doubled. The fact that this same trend was observed for both types of deposits indicates that the cause of failure is essentially the same in both cases: increased stored strain energy in the top coat which results from a corresponding increase in elastic modulus. The effect is less severe for the high- $SiO_2$  deposit because the infiltrating product is a silicate which does not have as high an elastic modulus as the  $CaZrO_3$  product which forms with the high- $CaO$  deposit. However, in either case the importance of the level of  $K_2SO_4$  in the deposit is clear. Increasing addition of  $K_2SO_4$  (and corresponding increased liquid infiltration) corresponds to shorter TBC lifetimes.

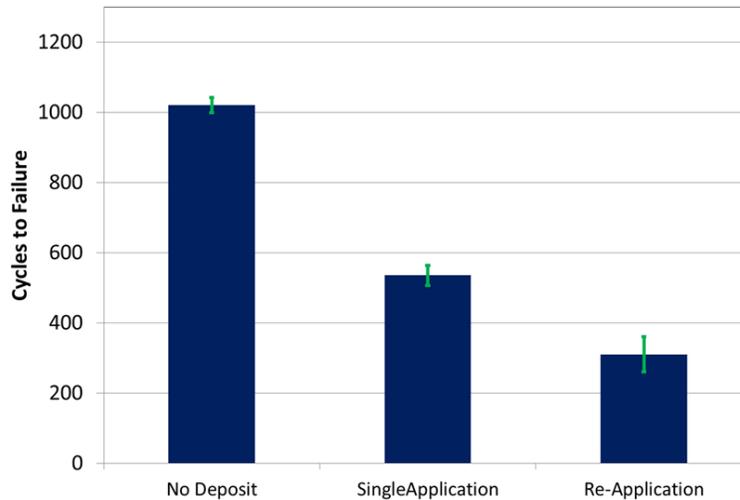
**Figure 81:** Effect of multiple applications of synthetic ash deposit on early cyclic failure. Cyclic failure without deposit is compared to that from a single application of deposit before cycling and re-application of deposit every 20 cycles during testing.

The amount of liquid available for TBC degradation should also depend on the total amount of deposit applied to the sample during testing. TBC components in gas turbines may experience continuous deposition of fly ash. In some cases, fly ash could deposit on components after partial (or complete) top coat spallation. The added detrimental effects of multiple ash deposits on TBCs were therefore examined. HPLD TBCs were tested with high-SiO<sub>2</sub> synthetic ash with varying frequency of deposit application. The cycles to failure result of HPLD TBCs without deposit shown in Figure 81 is compared to failures from a single application of high-SiO<sub>2</sub> deposit before cycling. It is seen that the TBC lifetime was reduced even further by re-application of the deposit every 20 cycles during testing.

The effects of ash re-deposition were shown with high- $\text{SiO}_2$  deposit. A dramatic decrease in TBC lifetime was experienced even with a single deposit before thermal cycling. Reapplications further reduced the lifetime, but the damage did not scale accordingly. The re-deposition of deposit every 20 cycles resulted in 15-20 deposits at the time of failure. The TBC lifetime, however, was only reduced by approximately a factor of two. This indicates that the bulk of the damage was done by the initial deposit. The re-deposition of high-CaO deposit would be expected to have less of an effect on lifetime reduction, because the  $\text{CaZrO}_3$  surface layer would act as a barrier to further YSZ penetration (until spallation occurs.) Isothermal testing with free-standing YSZ verified that re-deposition of surface deposit did not measurably increase overall internal  $\text{CaZrO}_3$  formation.
